Gorski Consulting Website

Archived News - 2014 - August

Mississauga Fatality Reminiscent of Paul Walker Fatal Crash From Fast & Furious Fame

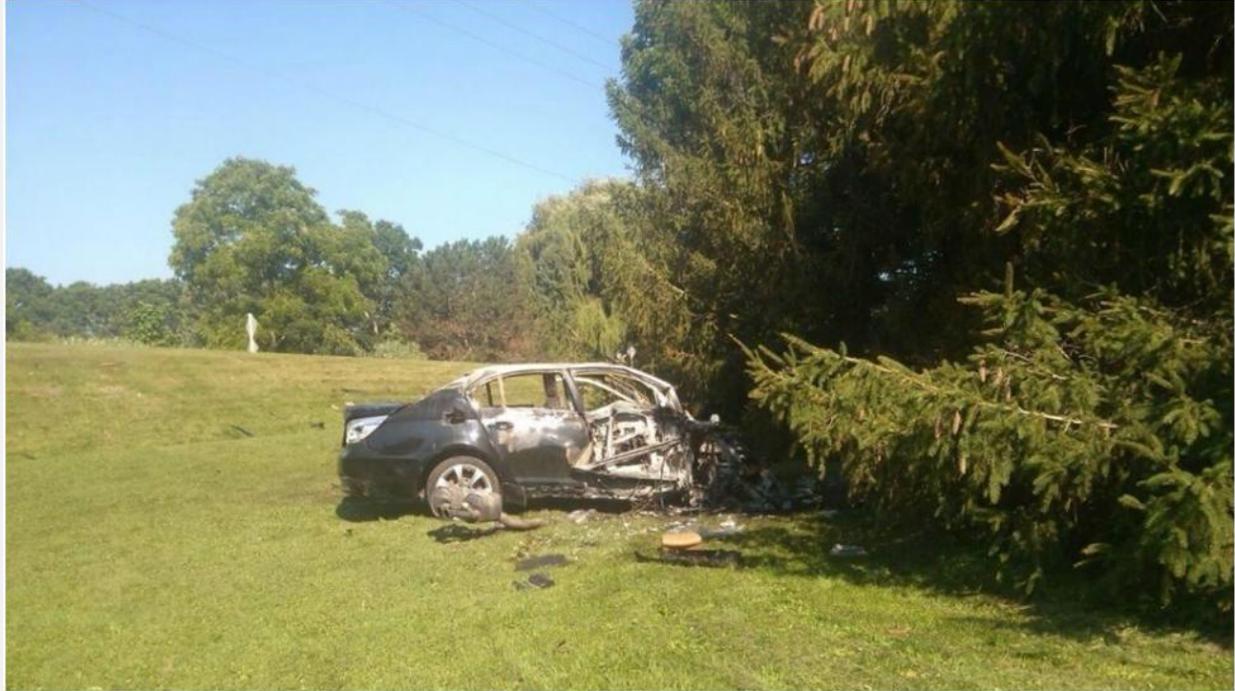
Photo by London Free Press showing the burned out vehicle in which the driver miraculously survived.

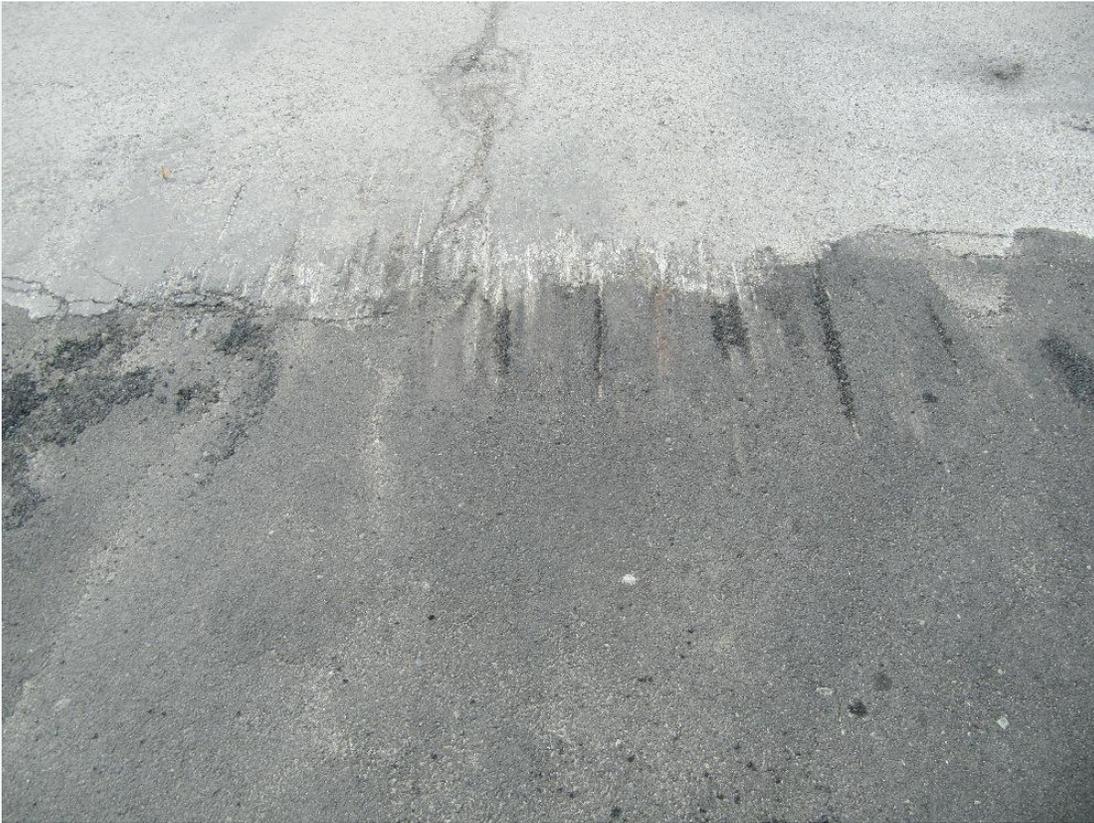
Evidence of numerous impacts of the undersides of vehicles against the lip of an incomplete road repair on Vancouver Street in London, Ontario in the spring of 2014.

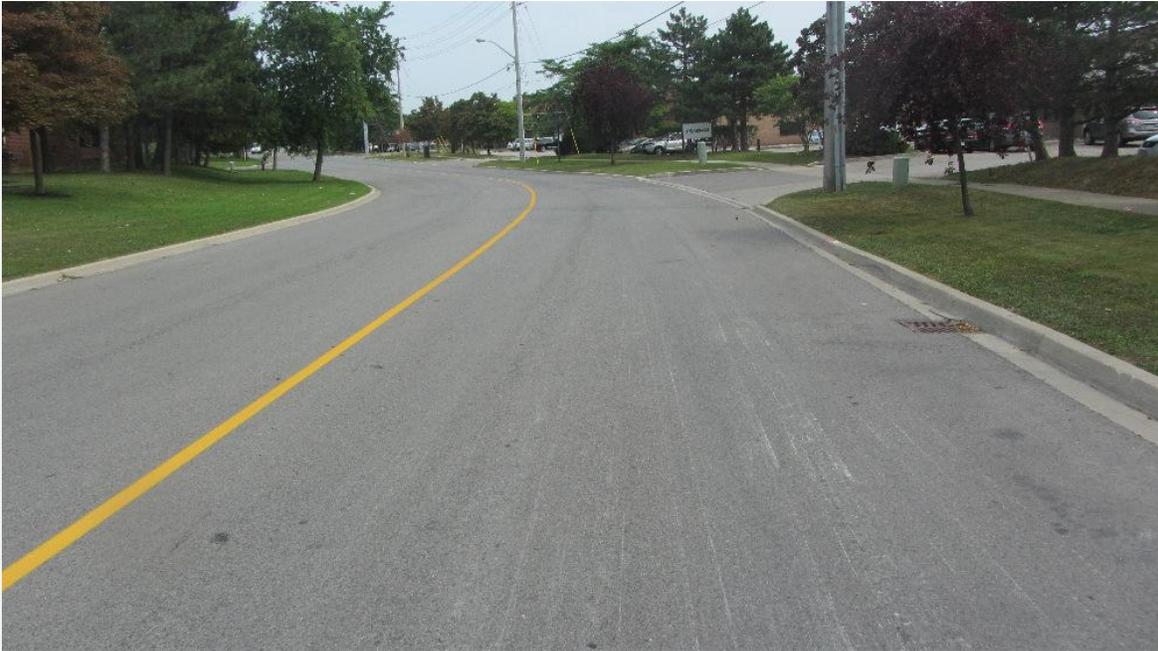
In the Mississauga crash it was possible to detect yaw marks shortly after the vehicle exited a sharp left curve as shown in the photo below.

View, looking partway through the left curve of Kestrel Road where the Honda Accord's yaw marks first became visible, about 92 metres from the eventual tree impact.

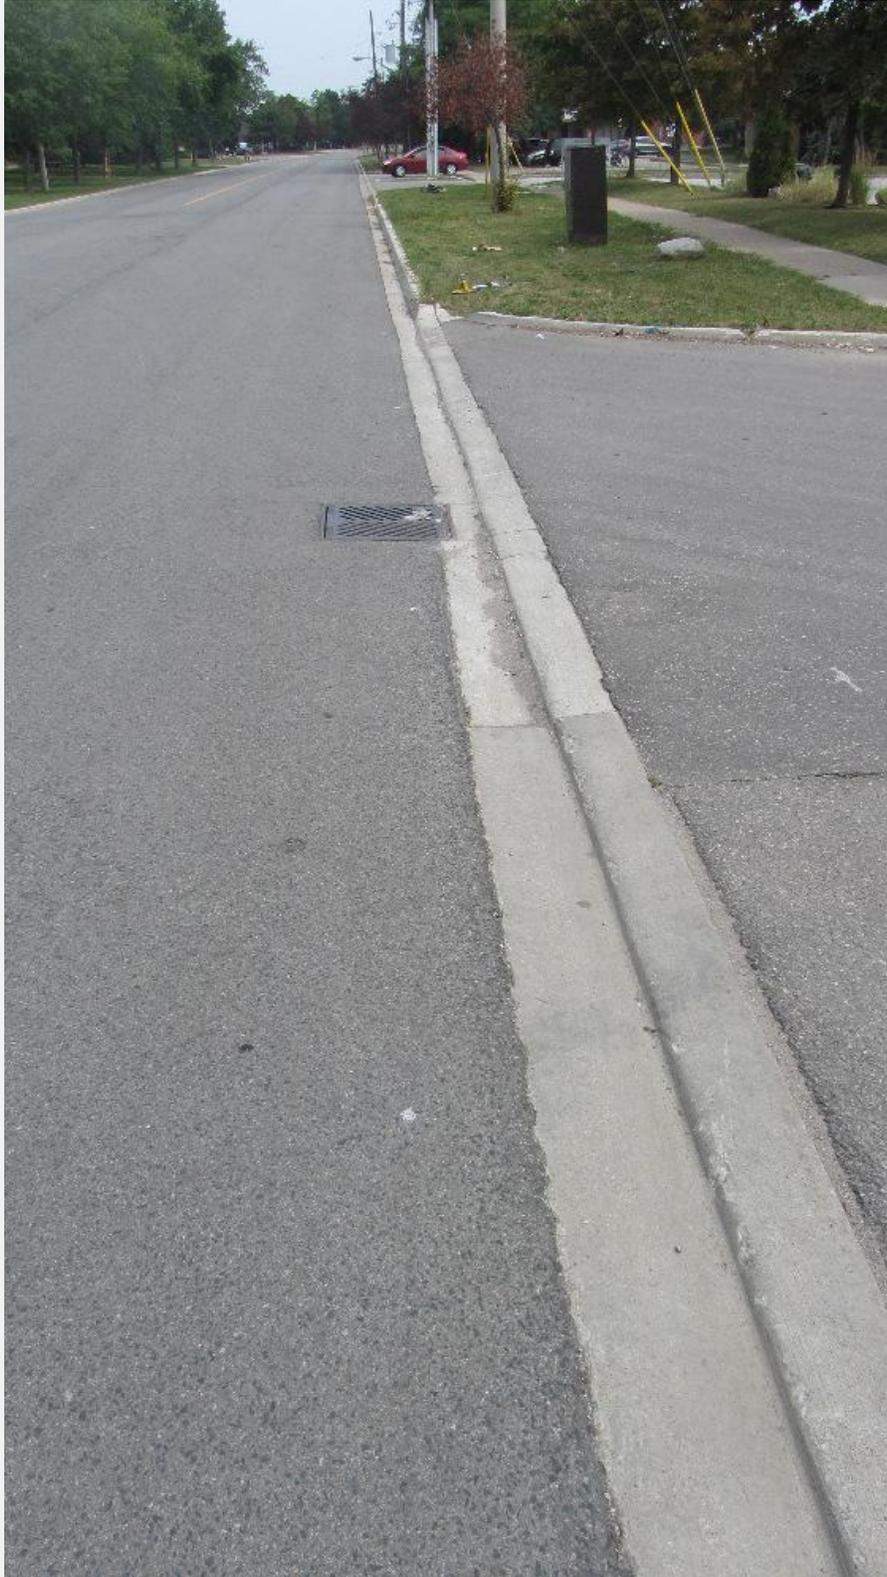
The photo below shows the very faint yaw mark about 92 metres from the tree impact. The visibility of the thin tire mark has been enhanced by our scribbling of grey dots along its length.

View of yaw mark as it approaches the outside curb of the curve. Grey dots have been drawn along the length of the tire mark to help in its visibility.

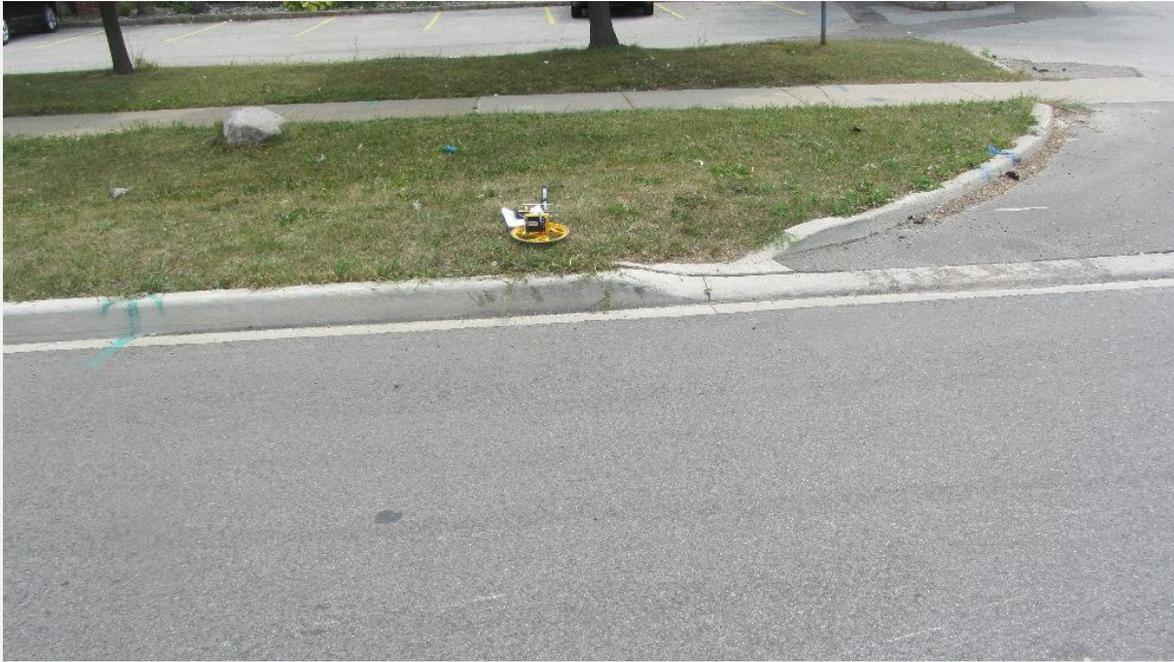
Portion of curb at the junction of a driveway where the right tires of the Honda Accord brushed by the curb and produced some markings.

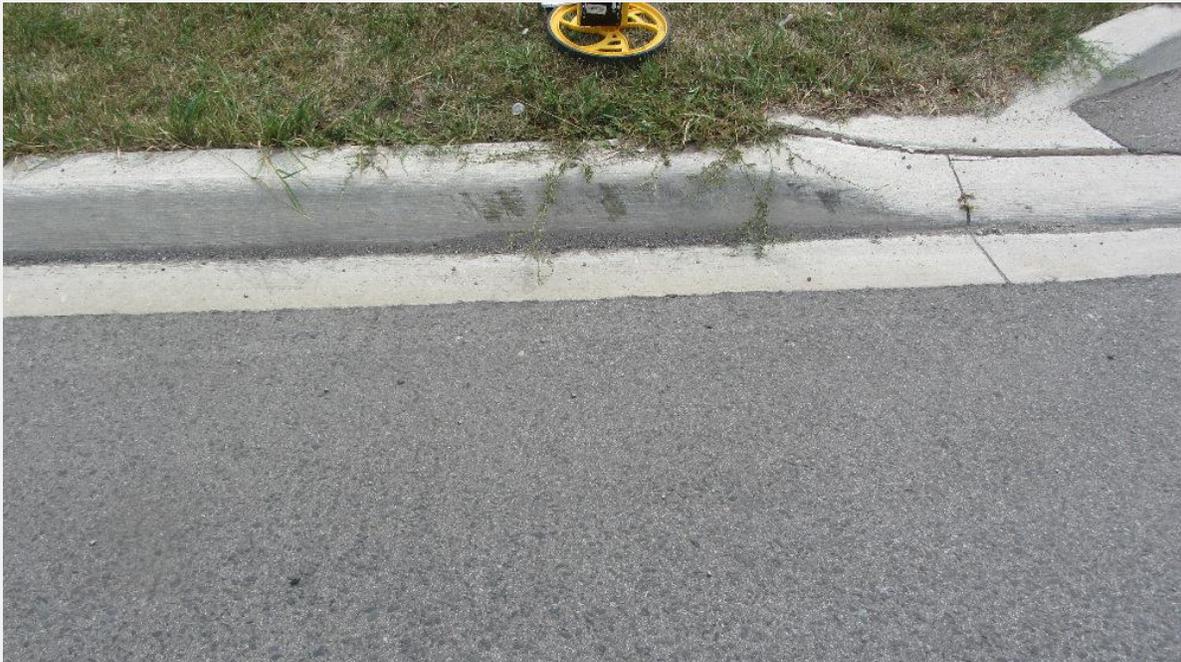
View of curb showing area where the right side tires of the Accord made contact.

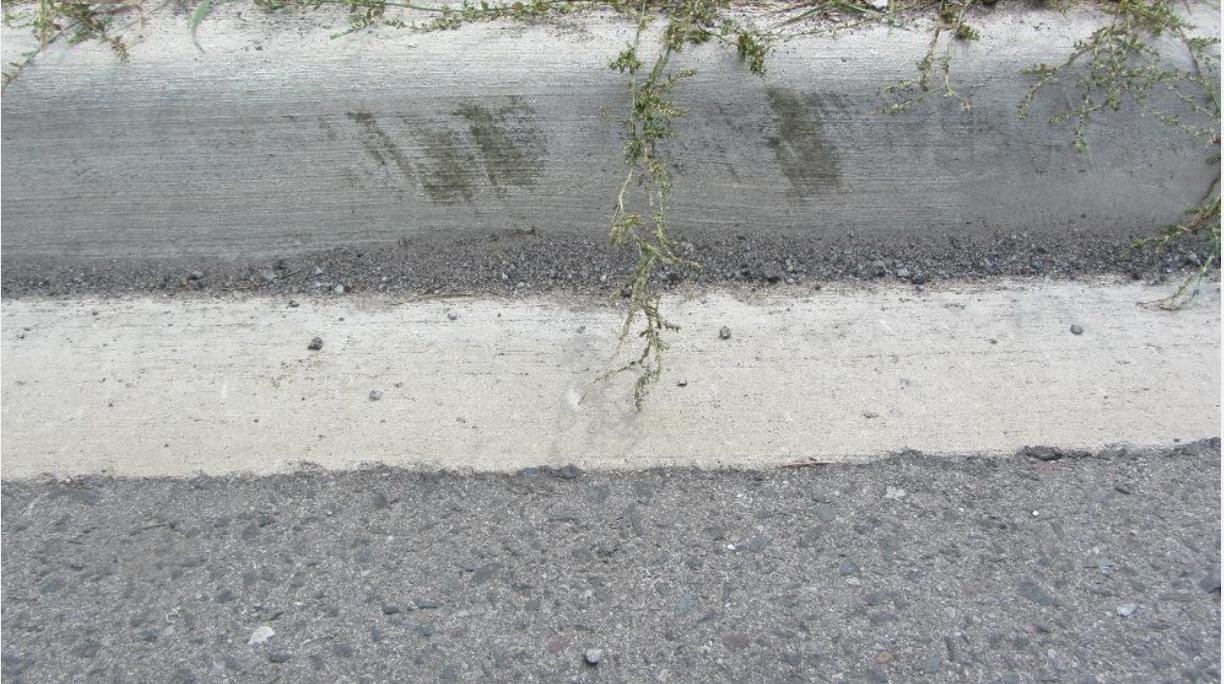
Close-up view of curb showing evidence of the sidewall of the Accord's tire making a black transfer. Also the weeds were also pressed against the curb and the juices of the plants were also pressed onto the wall of the curb.

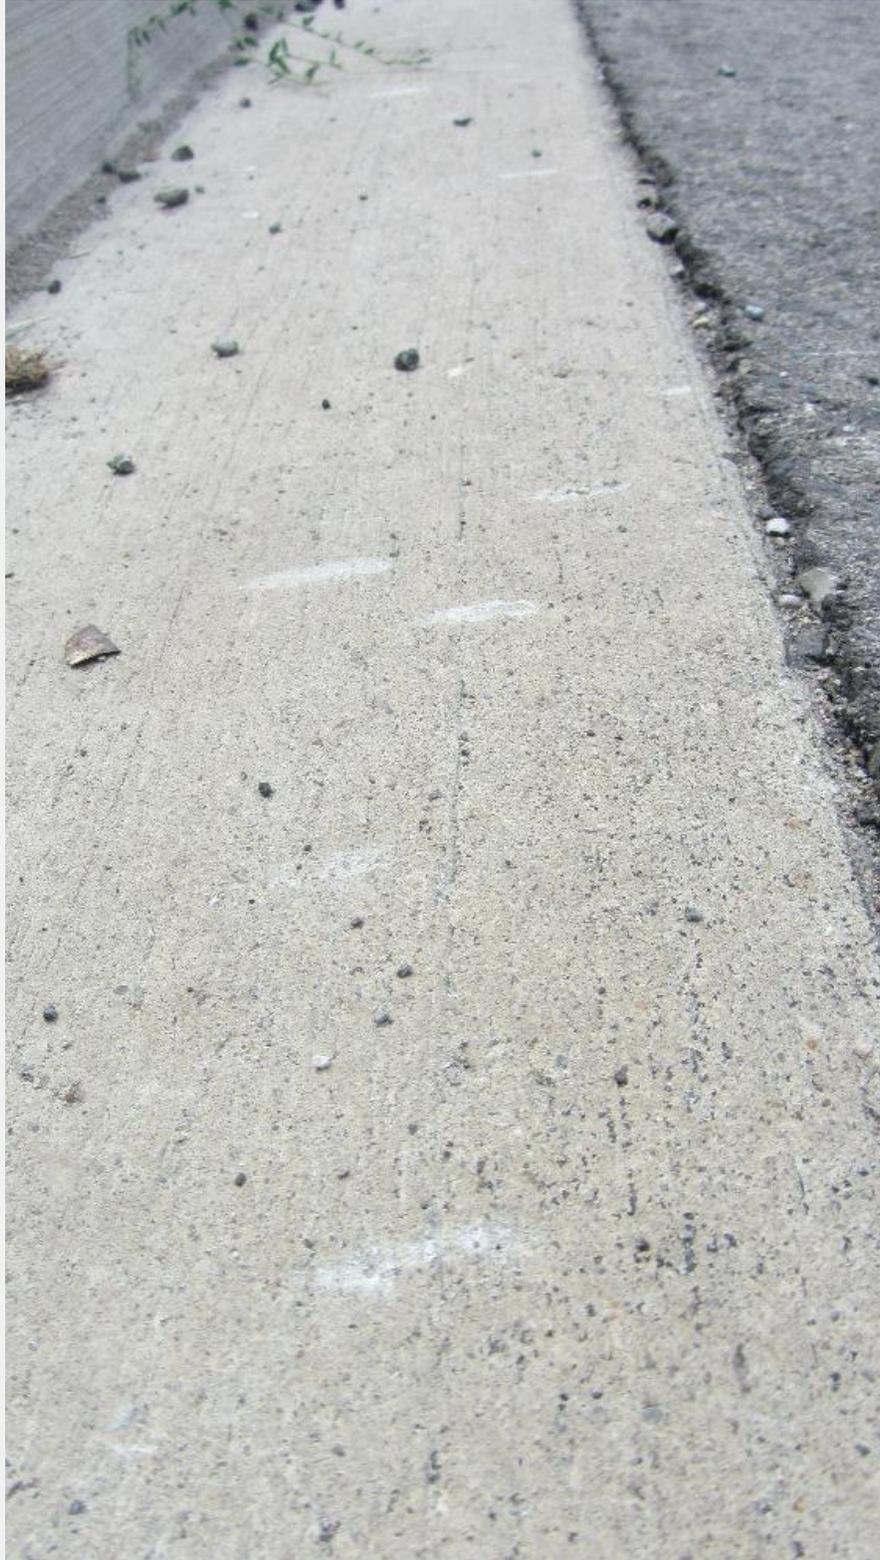
View of concrete gutter next to the outside curb of the curve where the Accord's yawing produced light-coloured scrapes in the concrete. This view is reverse to the Accord's direction of travel (i.e. the Accord is approaching the camera).

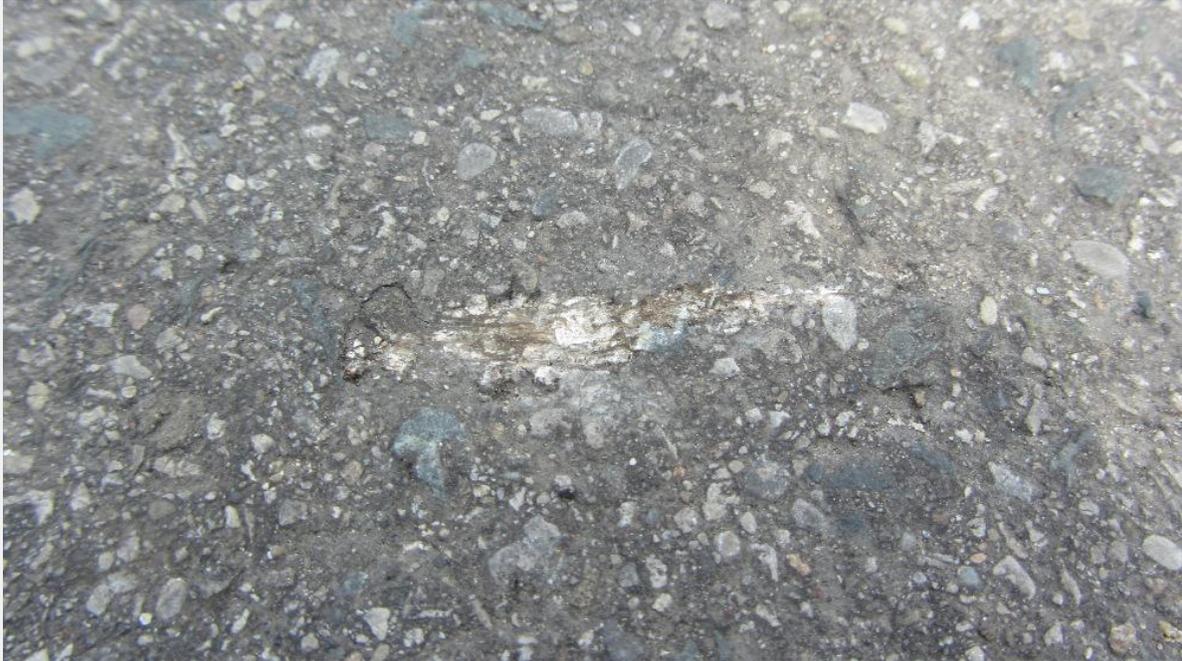
View of the typical, small scrapes in the pavement produced within the yaw mark produced by the Accord.

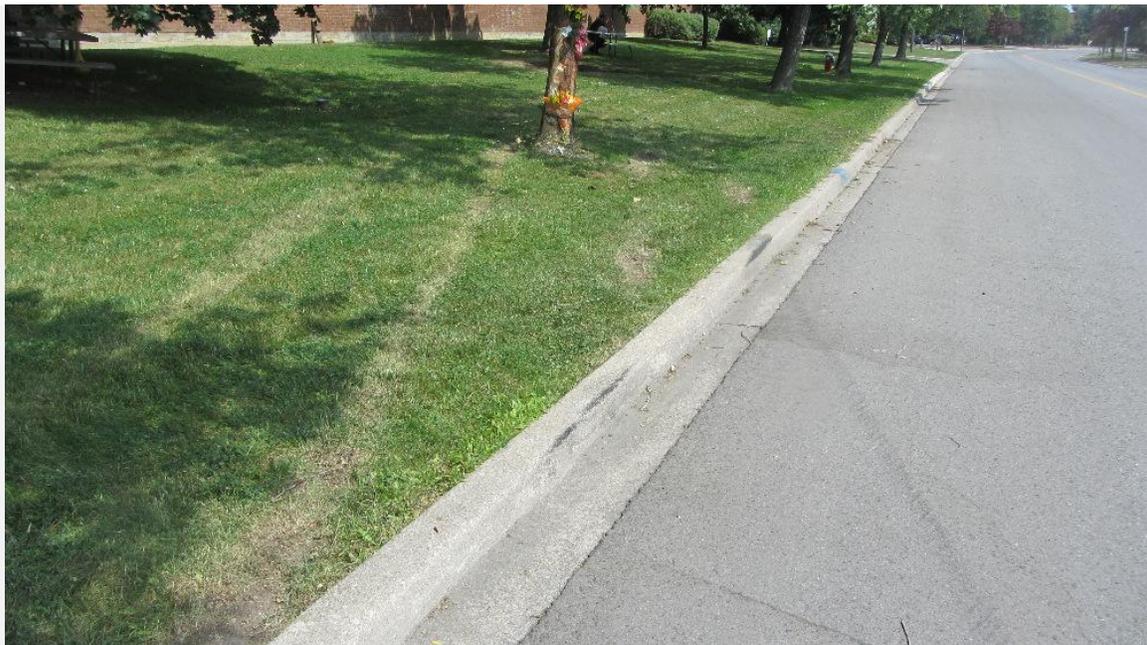
View of yaw marks headed toward the tree that was struck and caused the Accord to separate into three pieces.

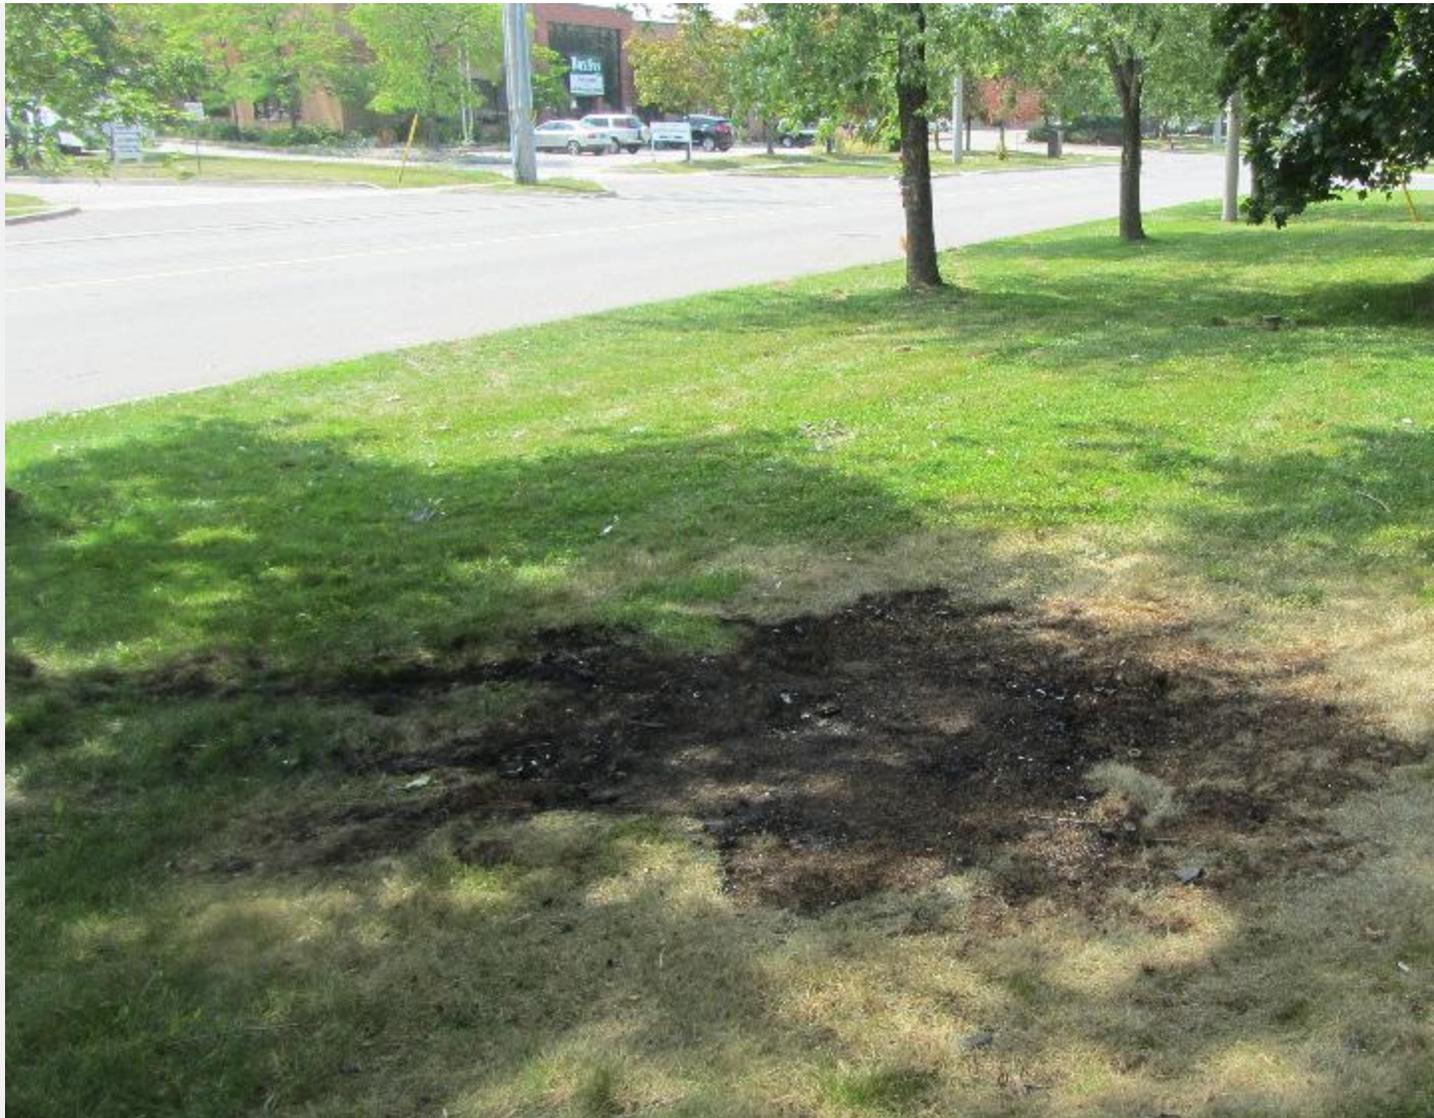
View of burned out grass with the impacted tree shown in the background.
