Gorski Consulting Website

Archived News - 2016 - January

Dangerous Cocktail of Excessive Speed And Variable Road Surface Conditions Served Up To Southern Ontario Drivers

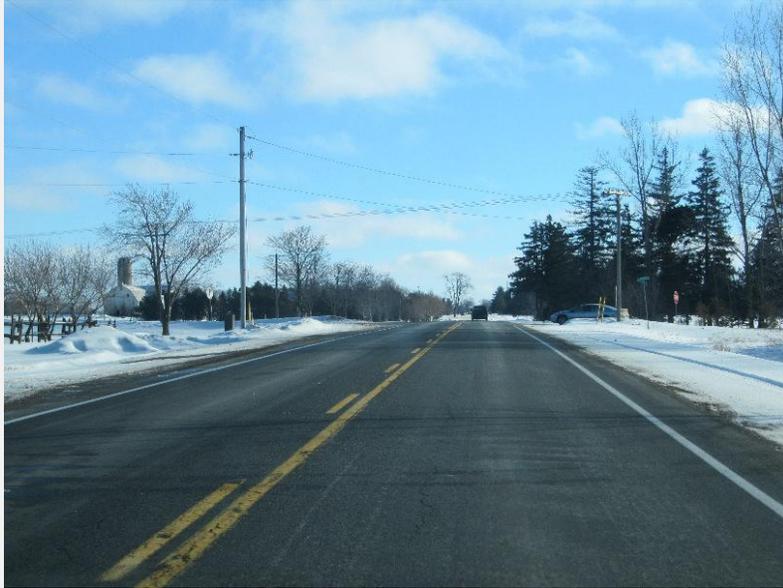
Note the surface of Perth Road 113 just north of the accident site is bare and slightly damp but otherwise in excellent condition. Such conditions lull drivers into the belief that they do not need to pay attention to conditions that might rapidly change.

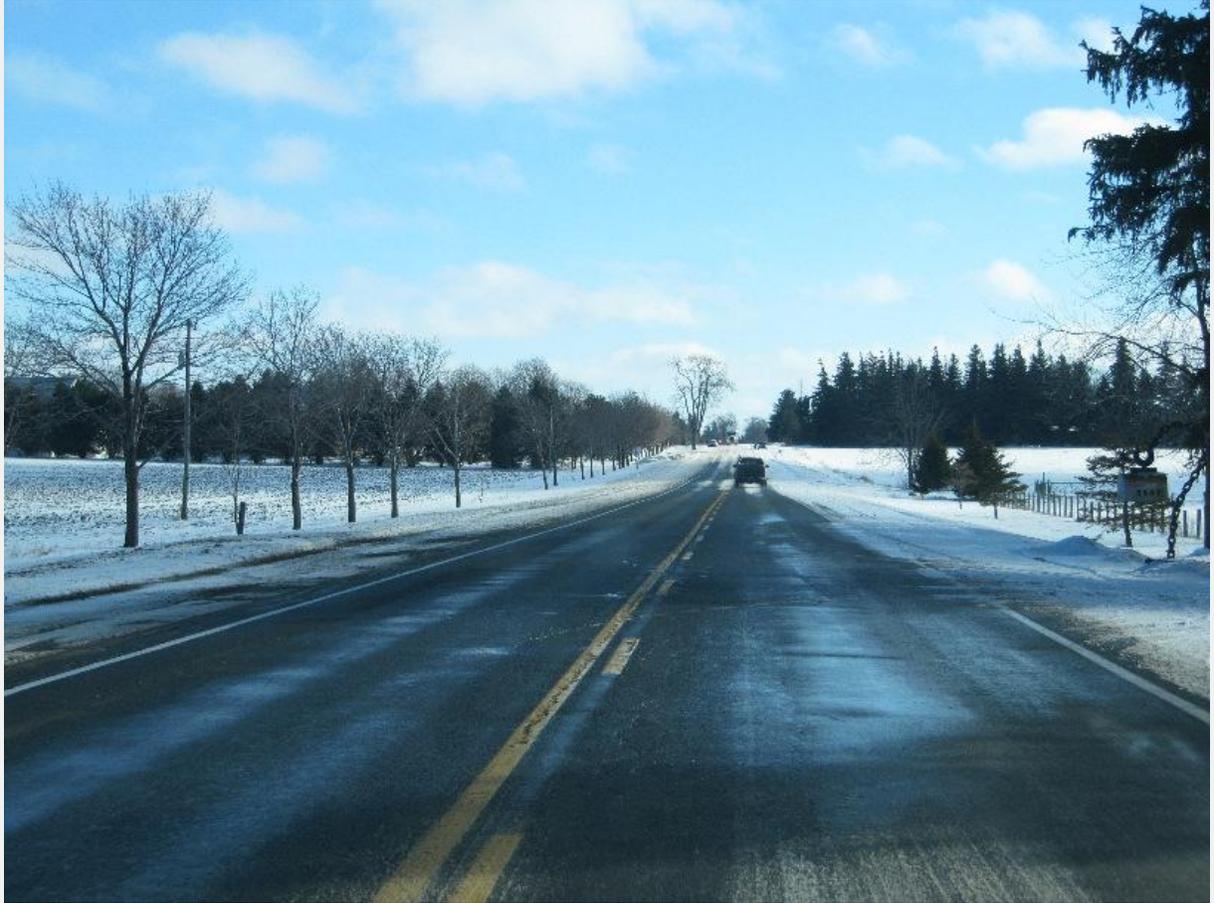
If a driver was sufficiently alert, a look into the distance of this photograph would reveal the potential that snow might have drifted onto the road surface. The problem is that the driver does not know how much snow might have been drifted and whether a drastic reduction in speed is necessary. It is at this point of uncertainty that a driver must assume that conditions are worse than they may appear.

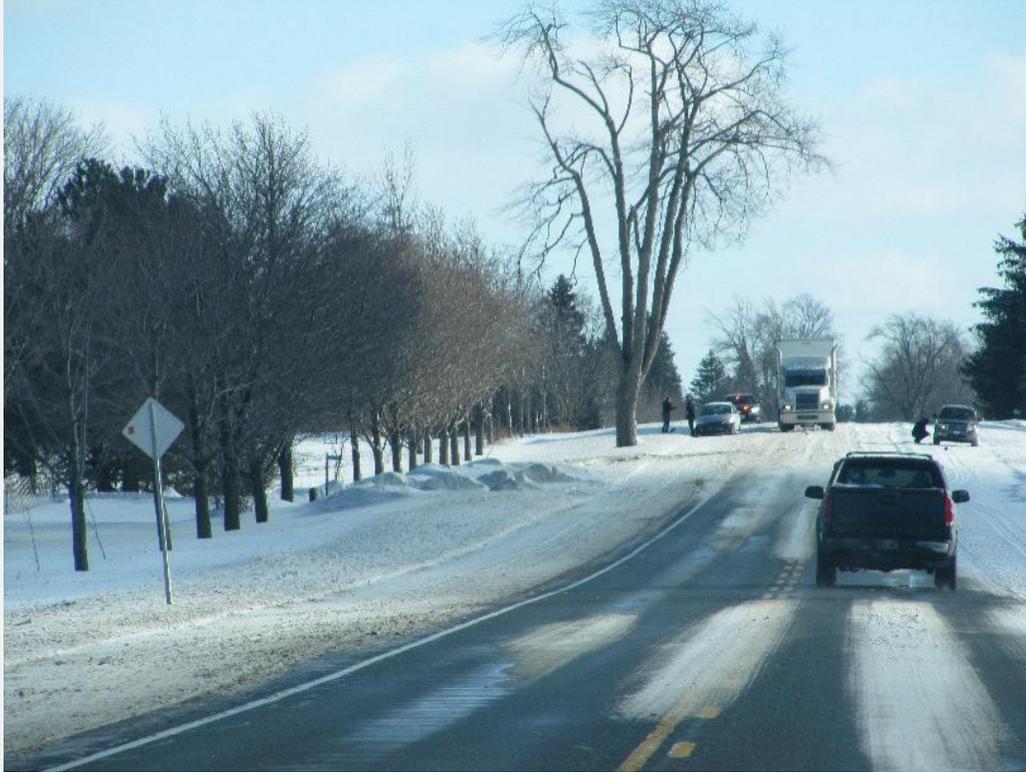
As we approach closer to the collision site the existence of several vehicles on the shoulders suggest that an incident has occurred. More importantly, the road surface can be seen to be covered by drifted snow.

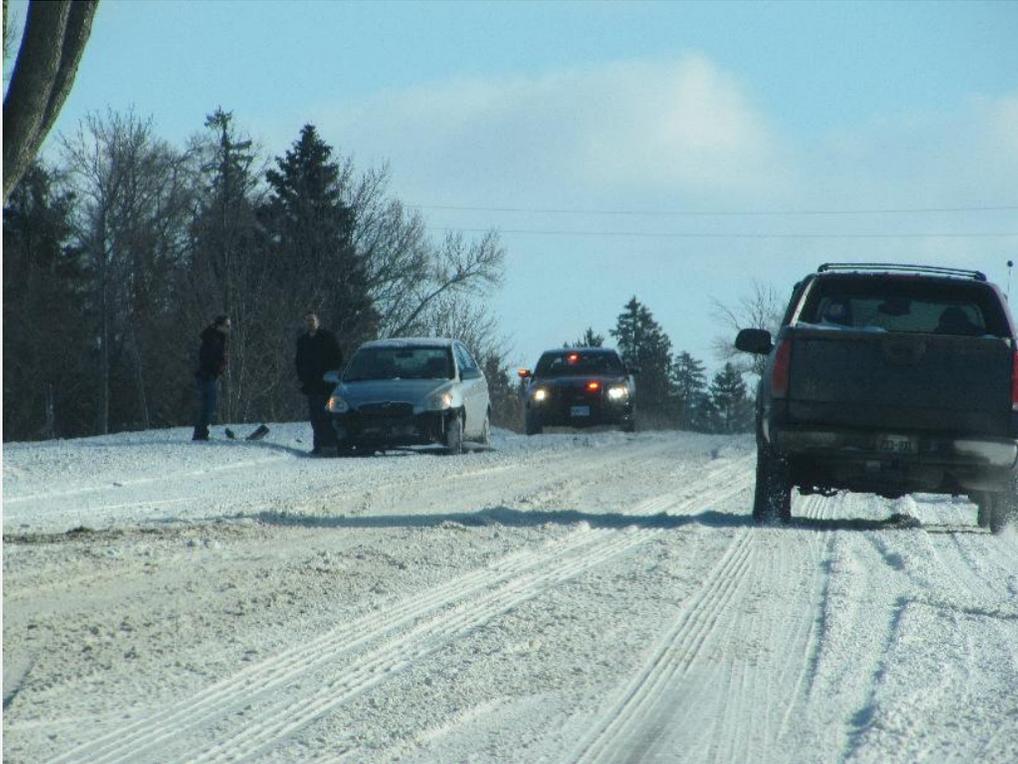
The photo below shows one of the vehicles on the east shoulder. It has frontal damage to its bumper however other structures such as the hood and fenders appear to have minimal or no damage. This suggests there has been a glancing, sideswiping, type of impact indicative of a likely pre-crash, loss-of-control, rotation.

Upon approaching the vehicles on the shoulder it is apparent that the vehicle on the left has frontal damage as the bumper cover is missing. However there is a lack of significant crush to the vehicle's structure indicating a glancing blow.

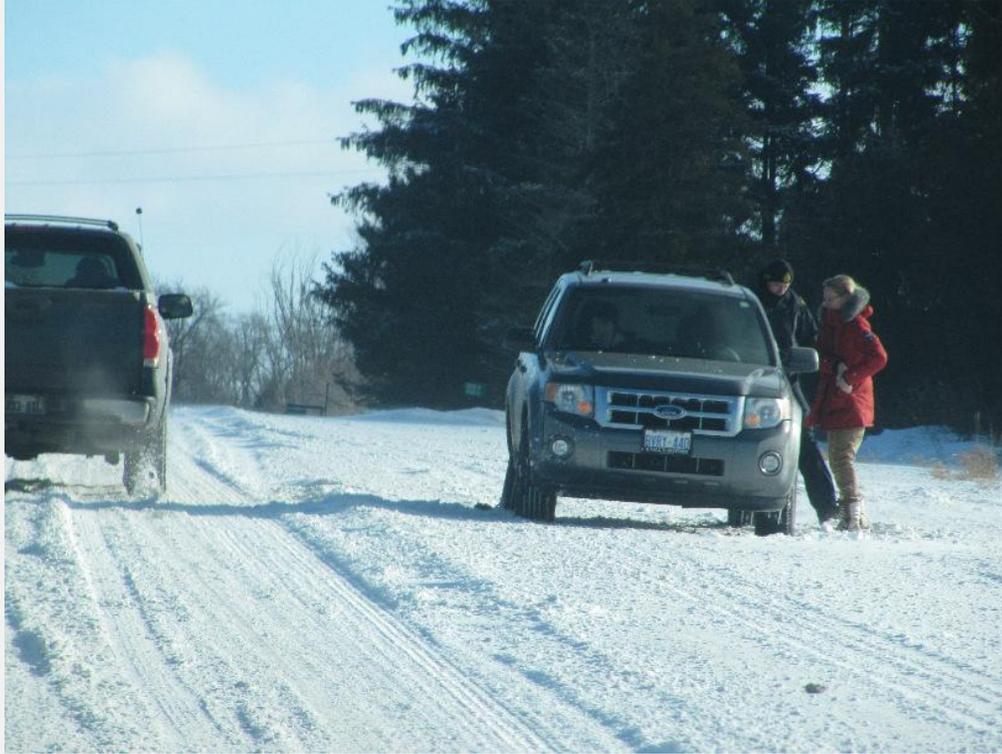
The photo below shows the other vehicle that was involved in the impact which is located on the west shoulder. There was damage to its right rear wheel yet there was no obvious damage to its front end. This confirms that at least one of the impacting vehicle's had entered into a state of loss-of-control prior to impact.

Although not apparent from this southward view, the Ford Escape on the west shoulder sustained damage to its right-rear wheel. Without any other visible damage to its front end it confirms that there has been a loss-of-control of at least one of the vehicles which has led the impact.

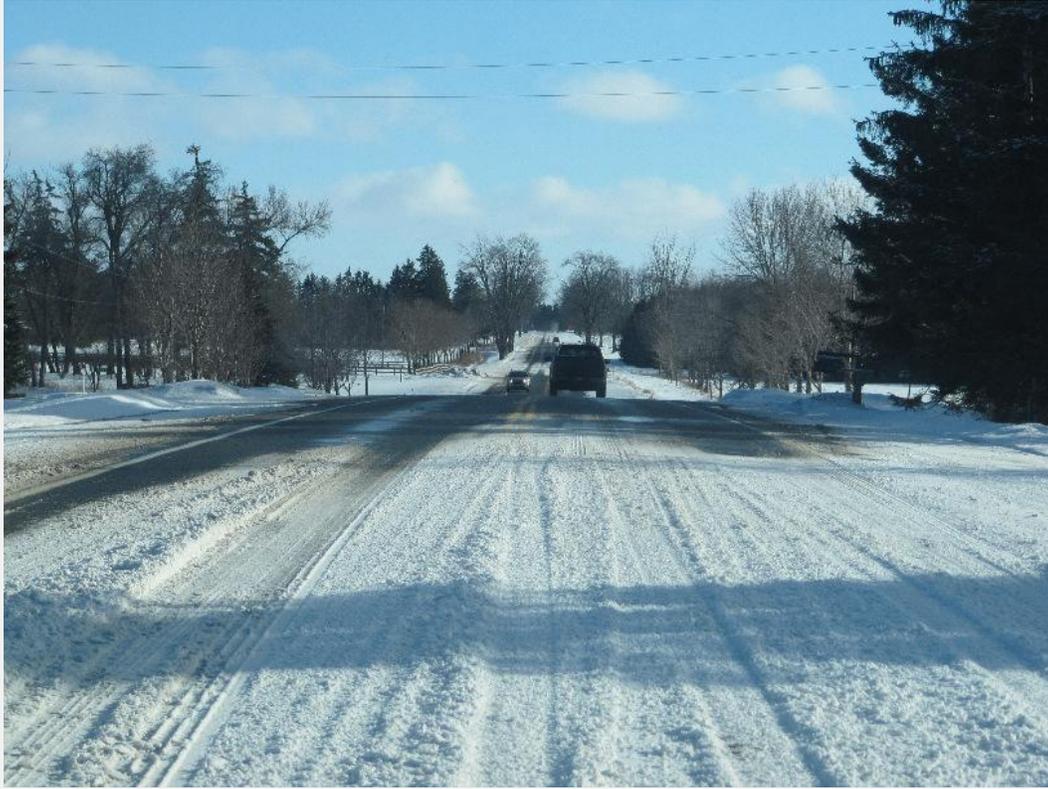
The photo below shows the road surface conditions just south of the area of impact. Small areas of drifting are seen in the background but generally the road surface returns to bare and damp conditions.

View looking south from just south of the collision site. The road surface returns to bare and damp conditions in the background.

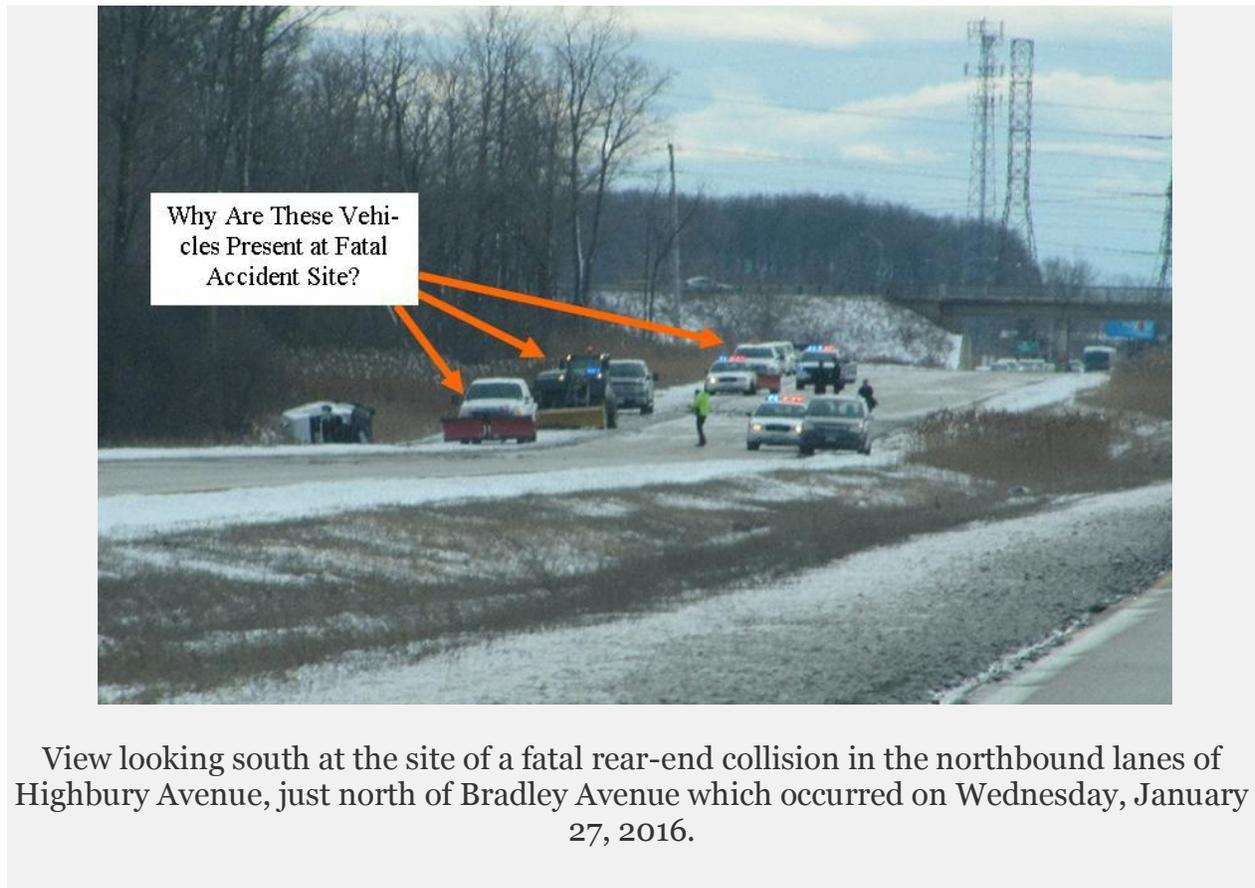
View looking south at the site of a fatal rear-end collision in the northbound lanes of Highbury Avenue, just north of Bradley Avenue which occurred on Wednesday, January 27, 2016.

as to how the collision unfolded. Yet there was obvious, major, frontal crush to the black pick-up truck and substantial rear-end damage to the Voyageur van. One would think that news media might at least have asked police whether the pick-up truck rear-ended the van. However there was an additional lack of curiosity in failing to ask: why was there so much damage from this impact?

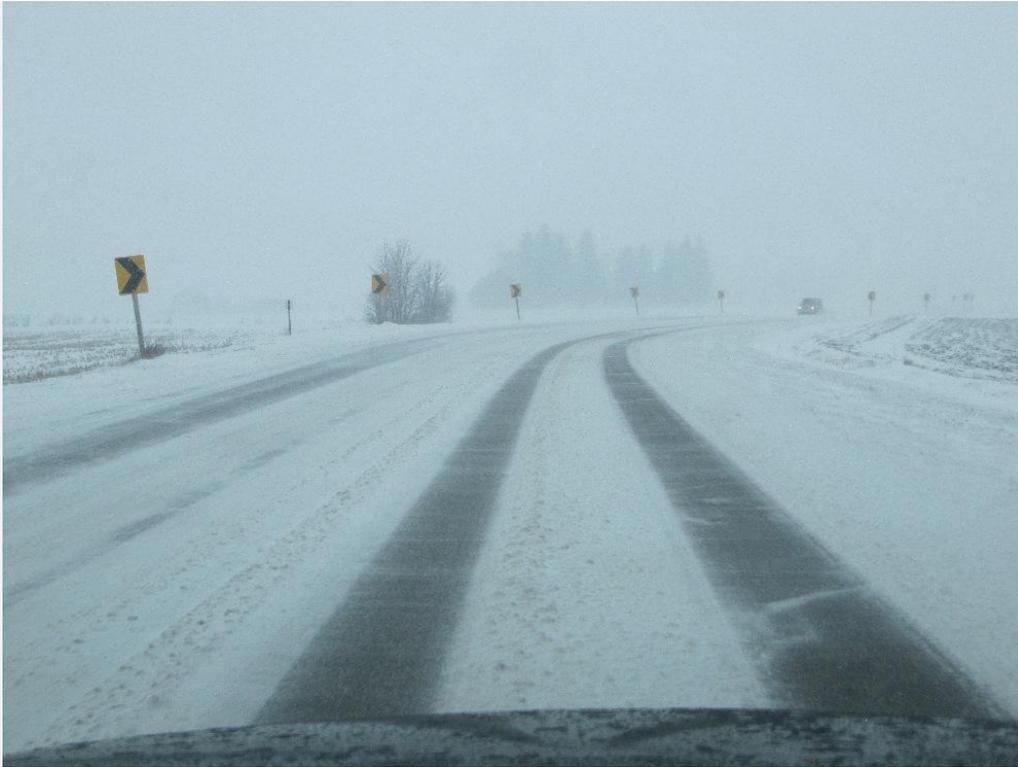
While approaching northbound on Adelaide Street toward Curve #1 the surface of the lane would appear to be centre-bare and therefore easily traversed at relatively high speed. However every driver needs to understand that winter road conditions can change rapidly.

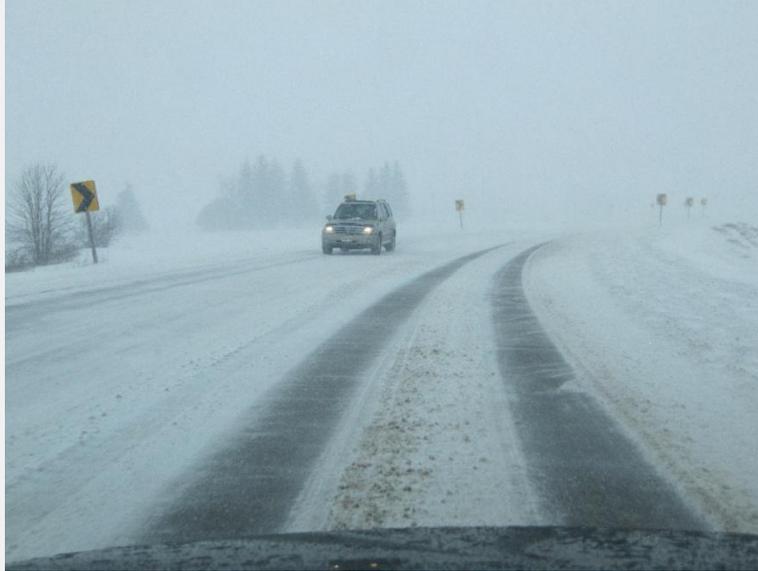
As a southbound vehicle approaches in the first portion of Curve #1 there is still no indication that there are poor road conditions and the wheels tracks of the northbound lane are bare.

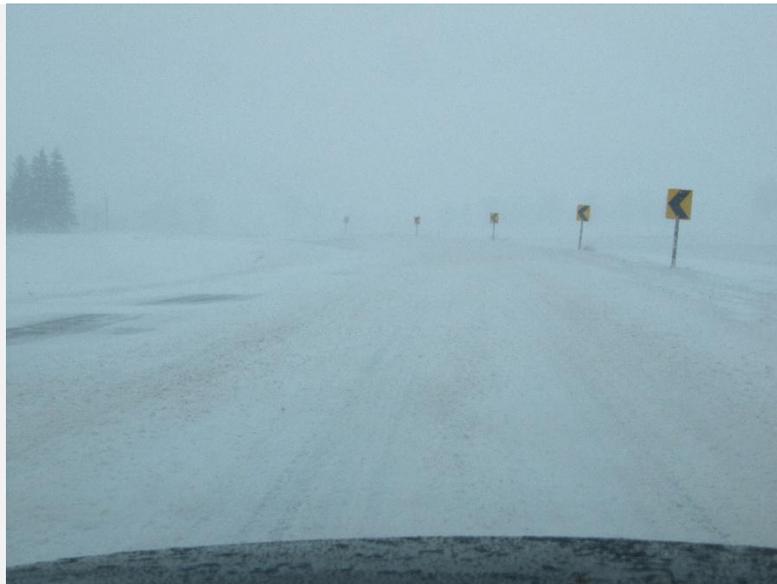
Suddenly and dramatically, as we are in the middle of Curve #1 the wheel tracks disappear as the complete lane is covered in snow, some of the snow depth being rather substantial.

Fortunately the hazard markers located on the right side of the road provide guidance as to the correct orientation of the curve and this indicates how such markers can be extremely important in specific situations like this.

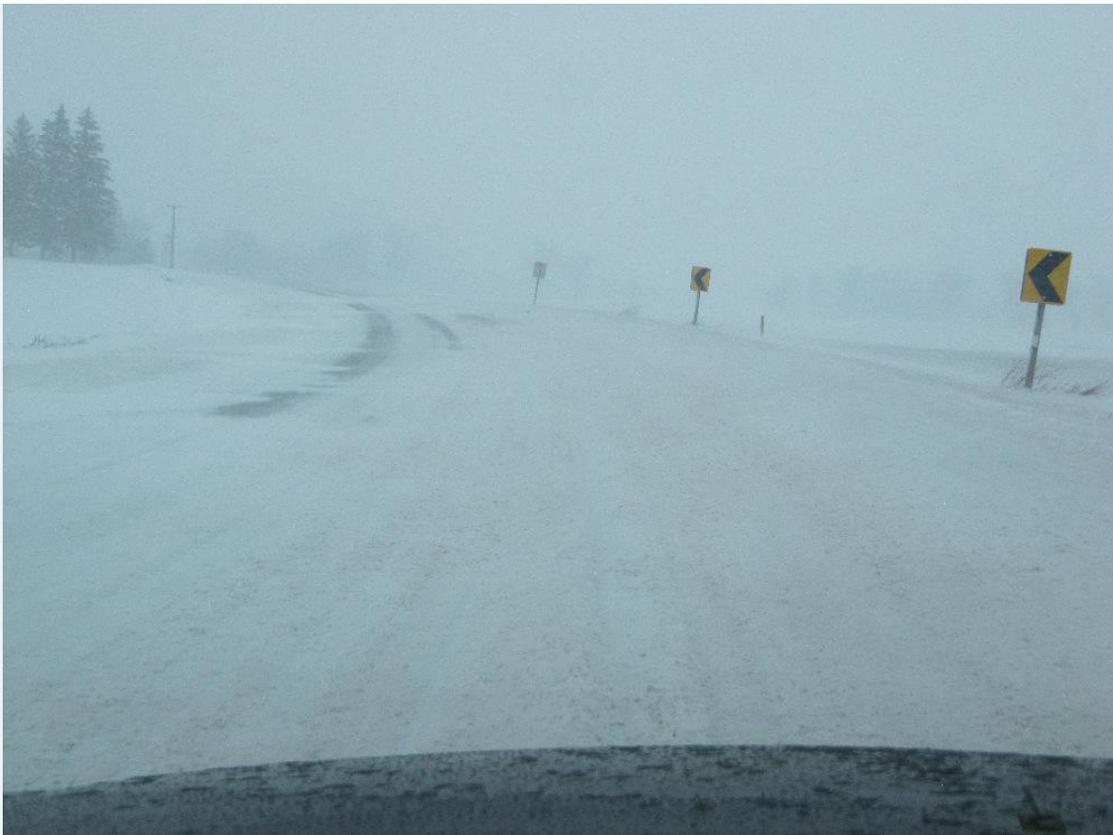
As we proceed into the second half of the S-Curve the snow continues to exist throughout the road width, however, in the background we can see the snow cover begin to diminish as we come out of the end of the curve, particularly in the southbound lane.

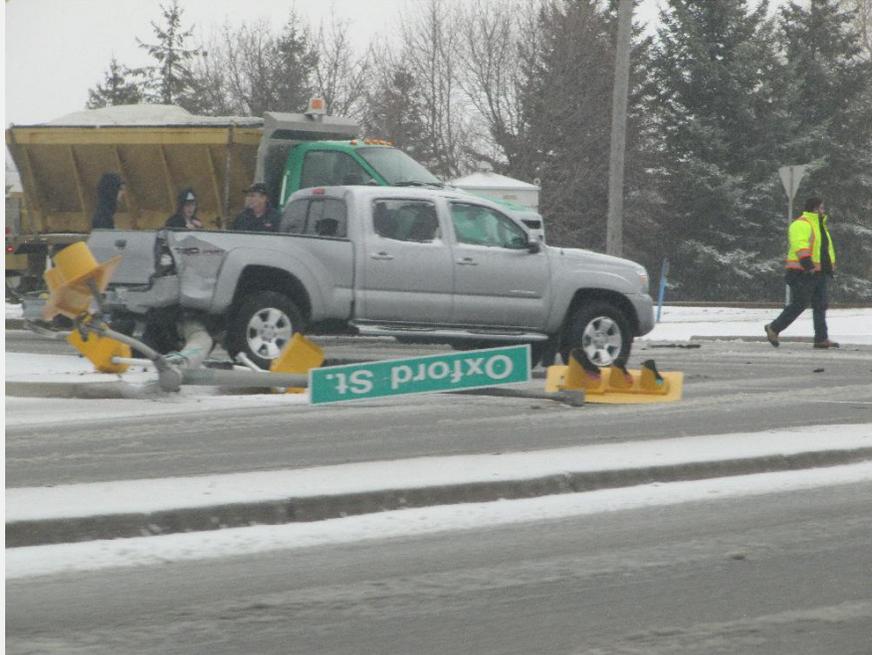
View of a Toyota Pick-up truck that struck down the traffic signal on the south-west quadrant of the intersection of Oxford Street and Clarke Road at approximately 1600 hours of January 16, 2016.

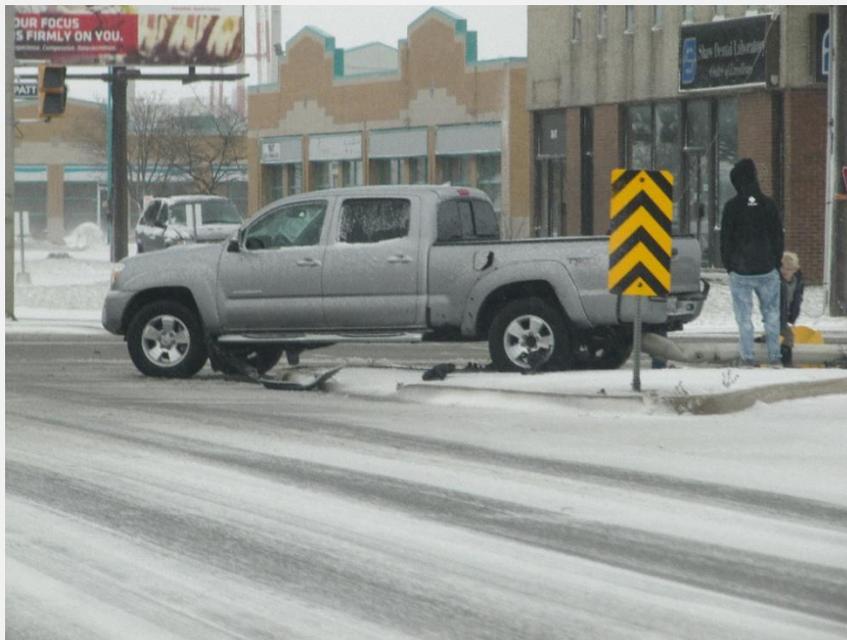
View of relatively minor damage caused to the Toyota whereas there will be substantial costs associated with replacing the traffic signal and its pole. Breakaway poles like this can reduce the severity of impact to the vehicle while potentially increasing the damage to nearby pedestrians.

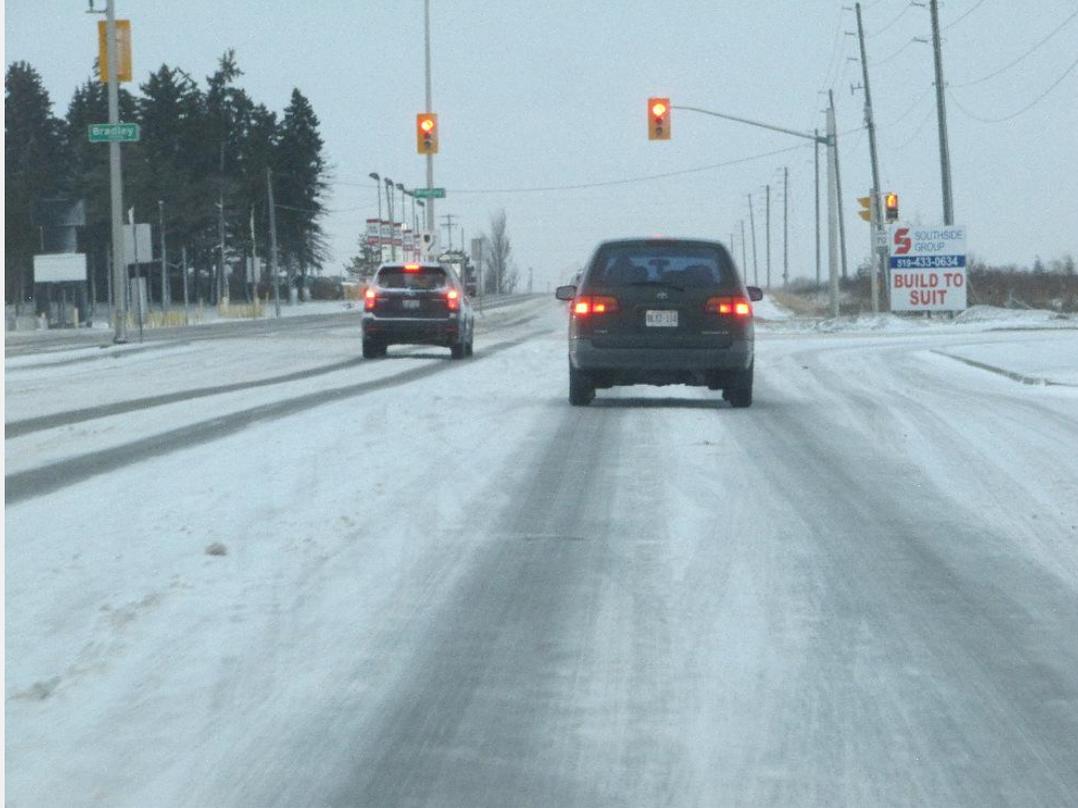
An accident scenario that is rarely acknowledged: ice formation on a road surface is difficult to detect, as shown in this photo of southbound traffic on Wonderland Road in London, Ontario.

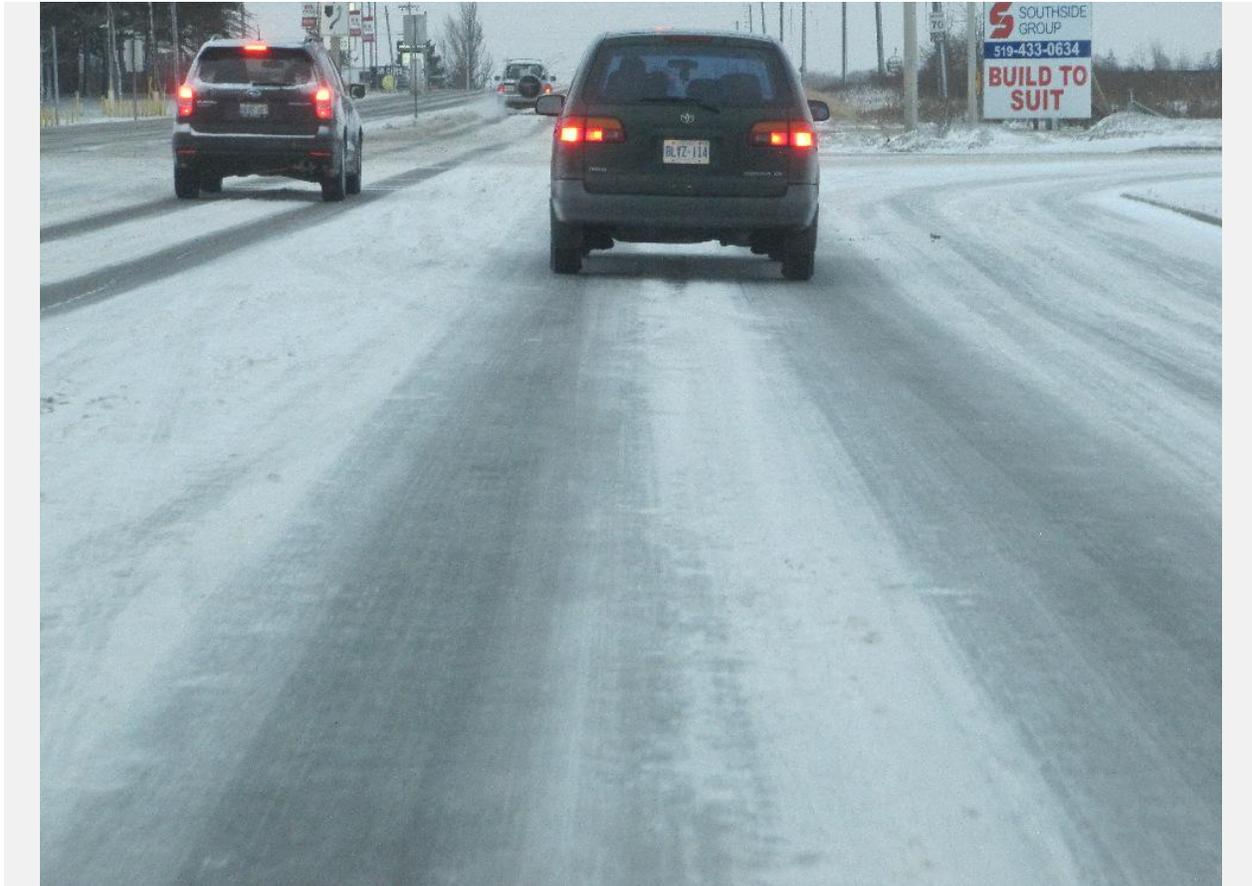
In the passing lane the vehicle on the left experiences bare pavement in the wheel tracks. In contrast, the vehicle to the right, travelling in the curb lane, experiences a sheet of ice.

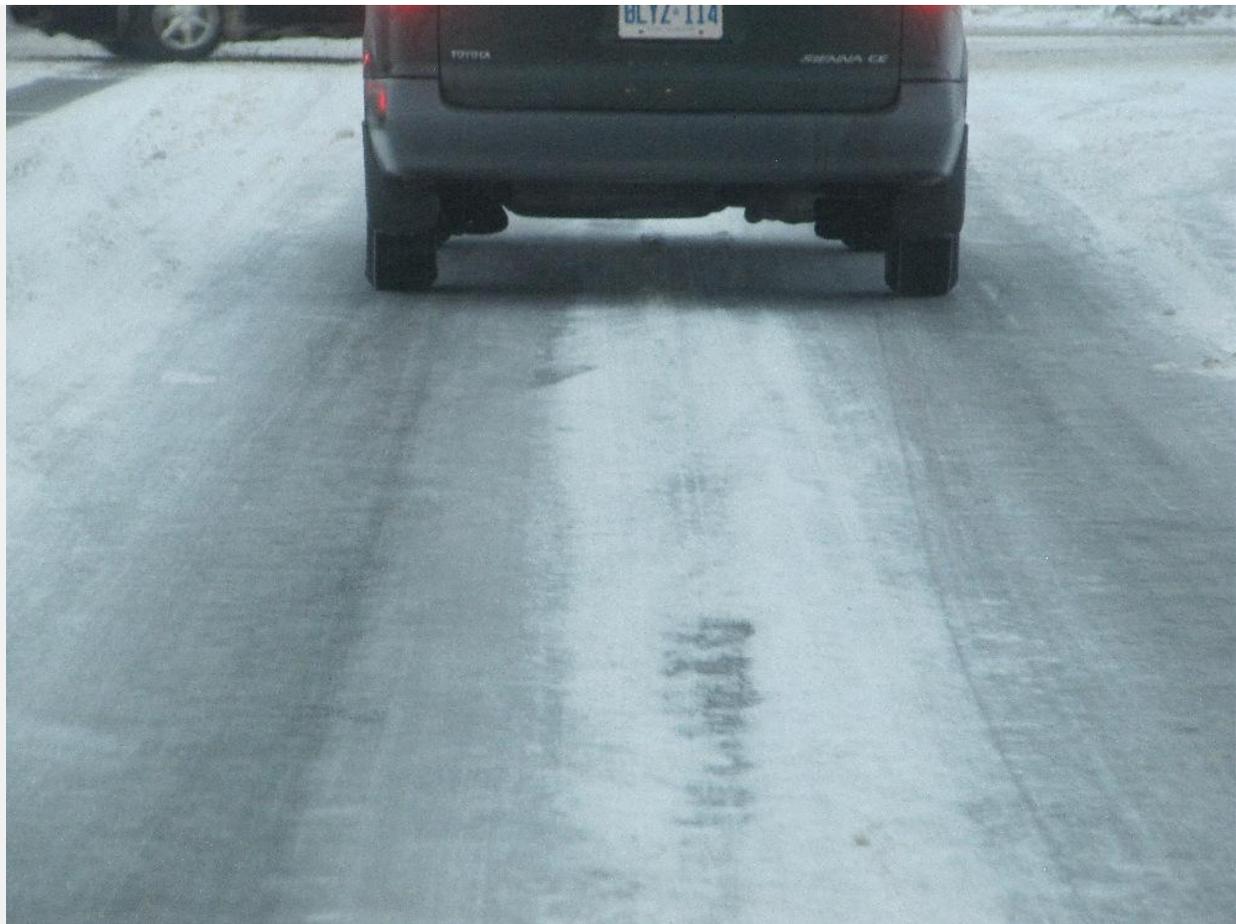
While looking at this photo closely, it is possible to detect the ice, that is not a reasonable expectation for a large percentage of drivers who may not be expecting this development and may not have the luxury of looking down at the road surface at a time when that observation is critical.

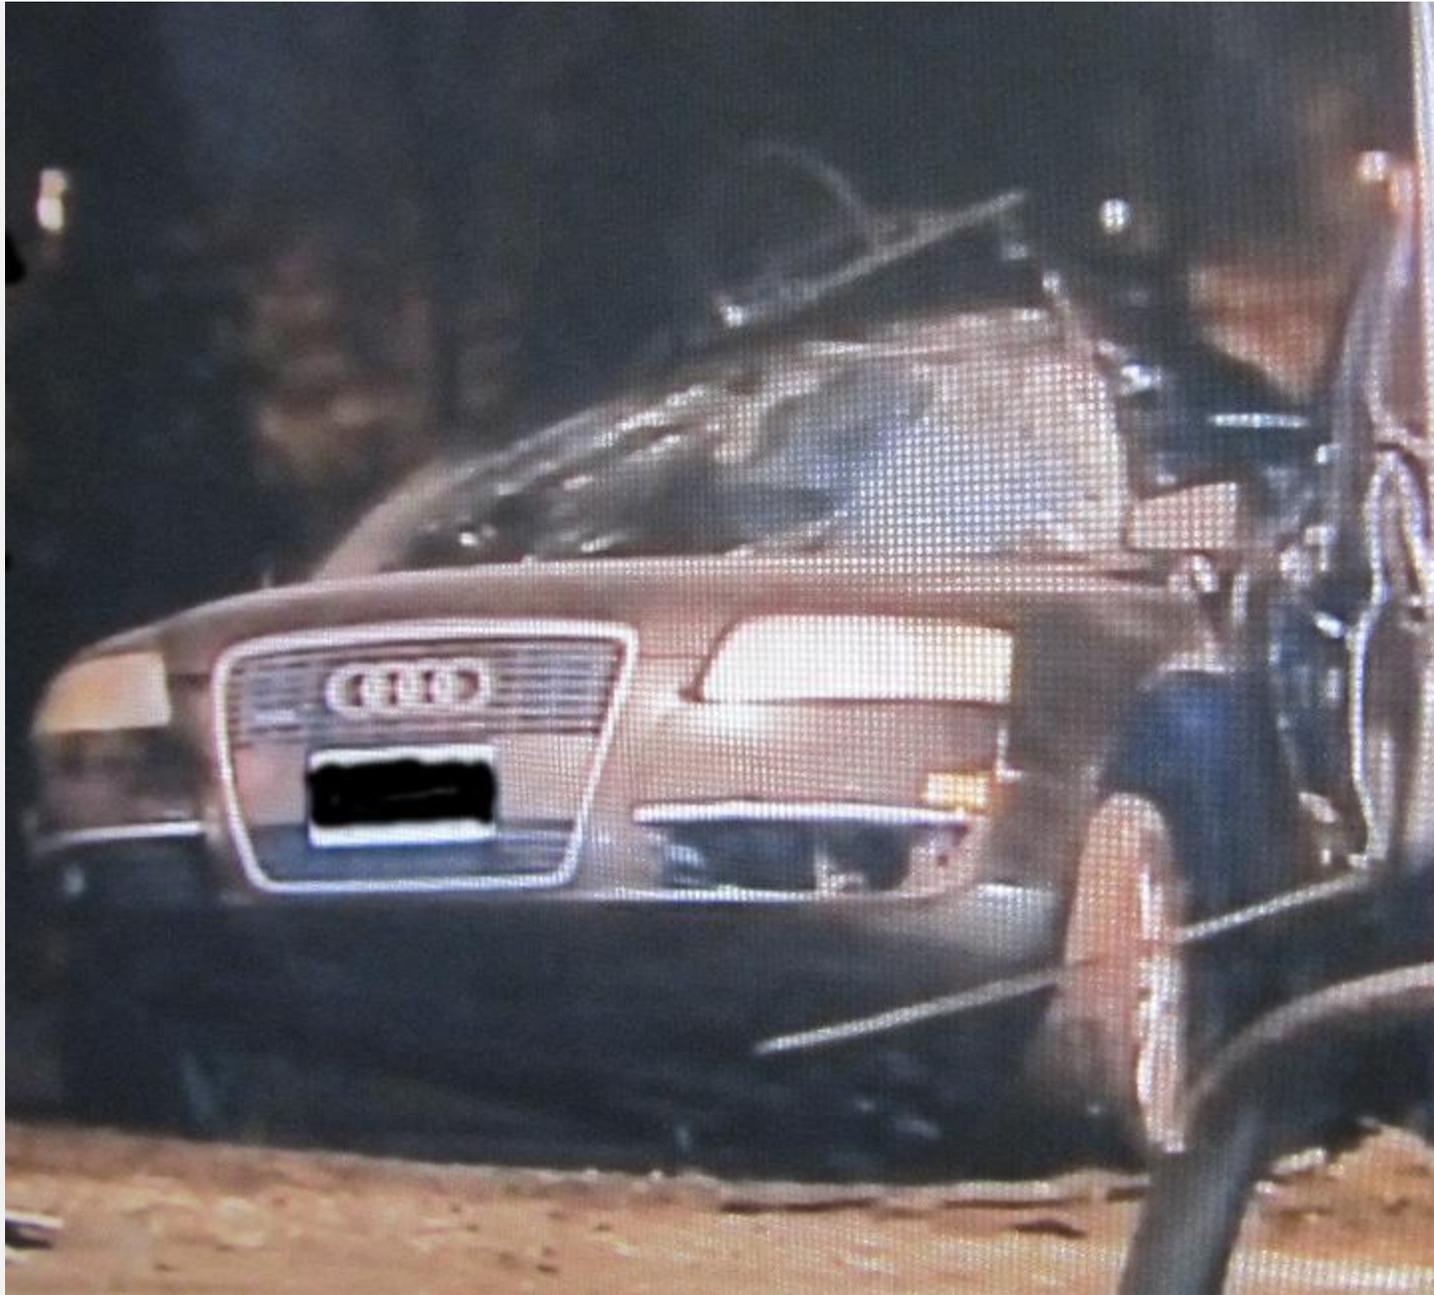
An Audi Sedan is shown at its rest position after striking a utility pole on Oxford Street just east of Highbury Avenue in London, Ontario on the evening of January 7, 2016.

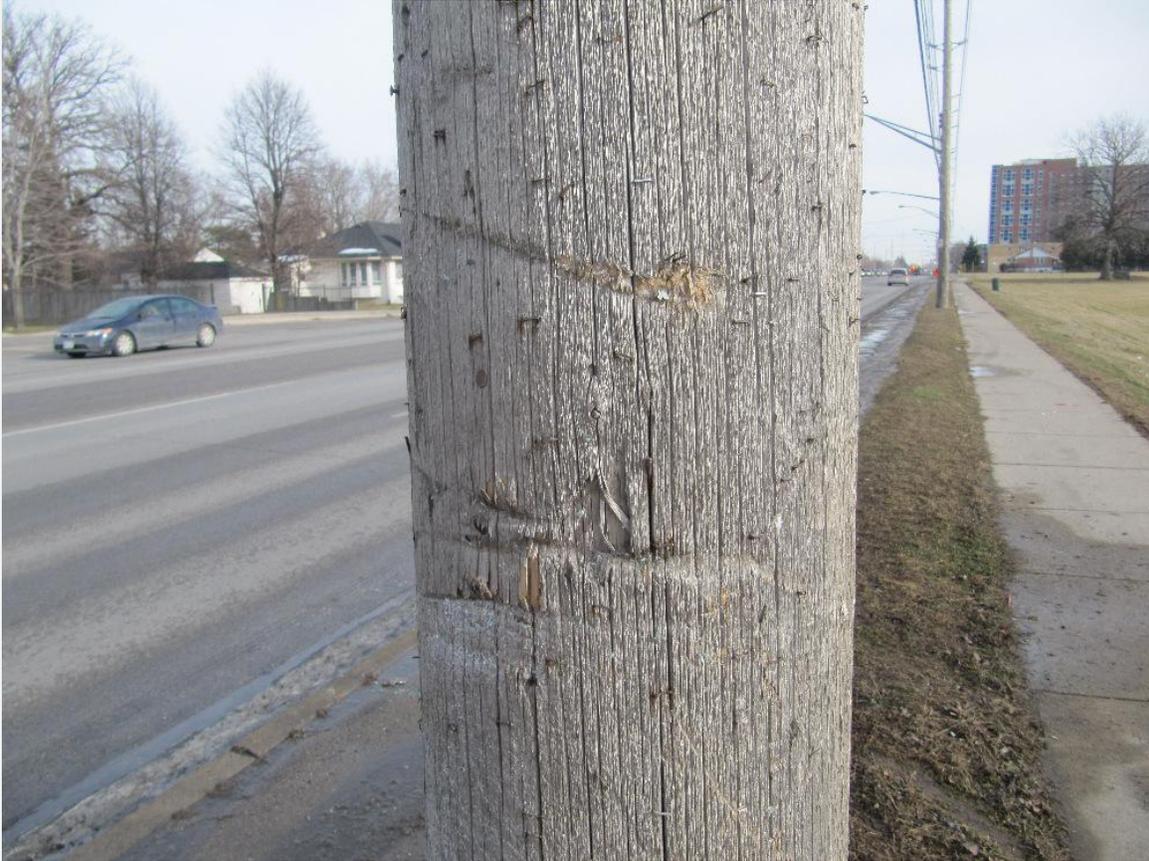
Markings on the pole such as imbedded glass and horizontal imprints confirmed that the contact was with the driver's door.

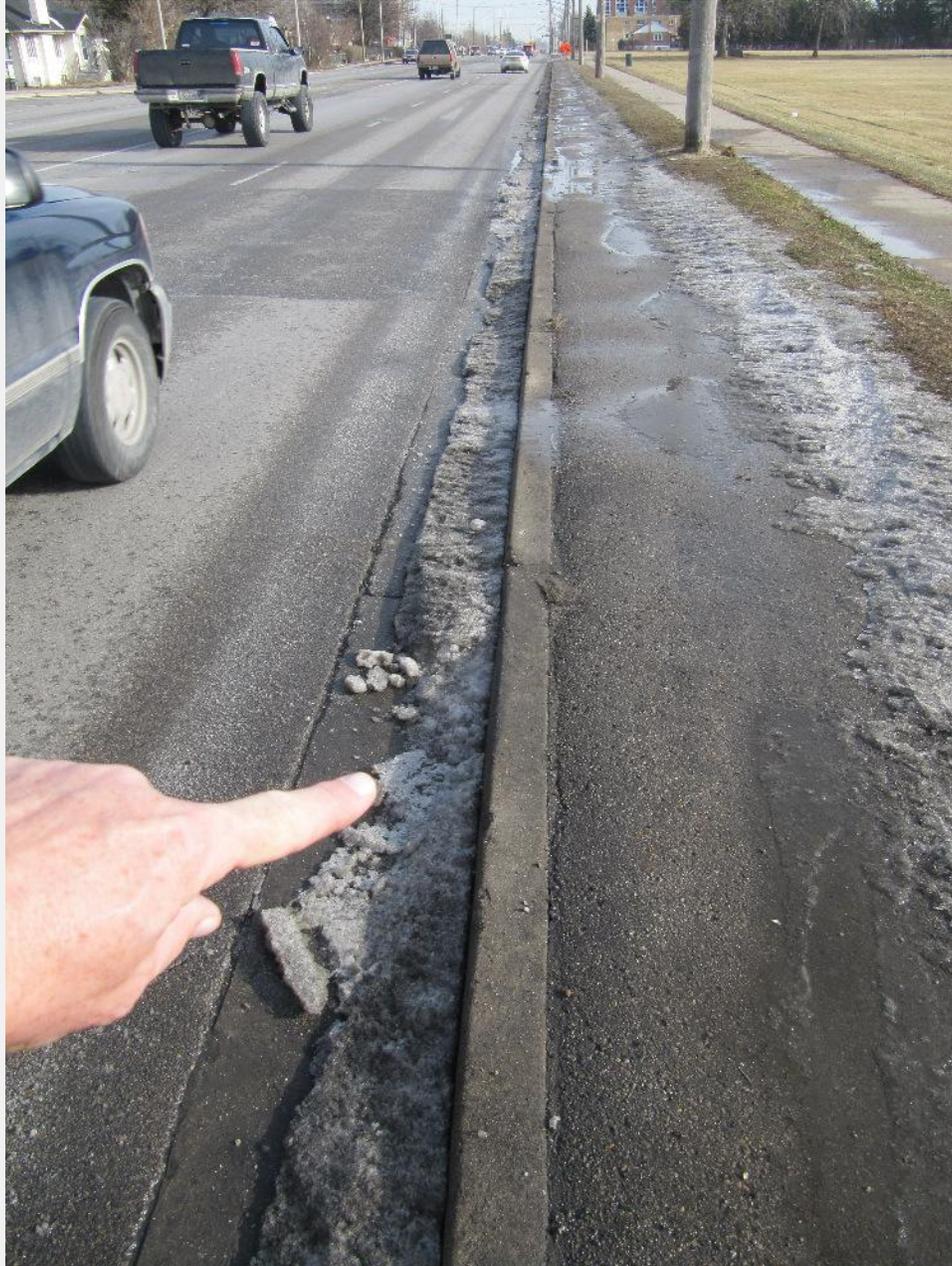
A typical procedure is to identify any tire/wheel markings where the loss-of-control vehicle struck a curb on its way to the impact. Here the investigator's finger is pointing to the location of one of those tire markings on the south curb.

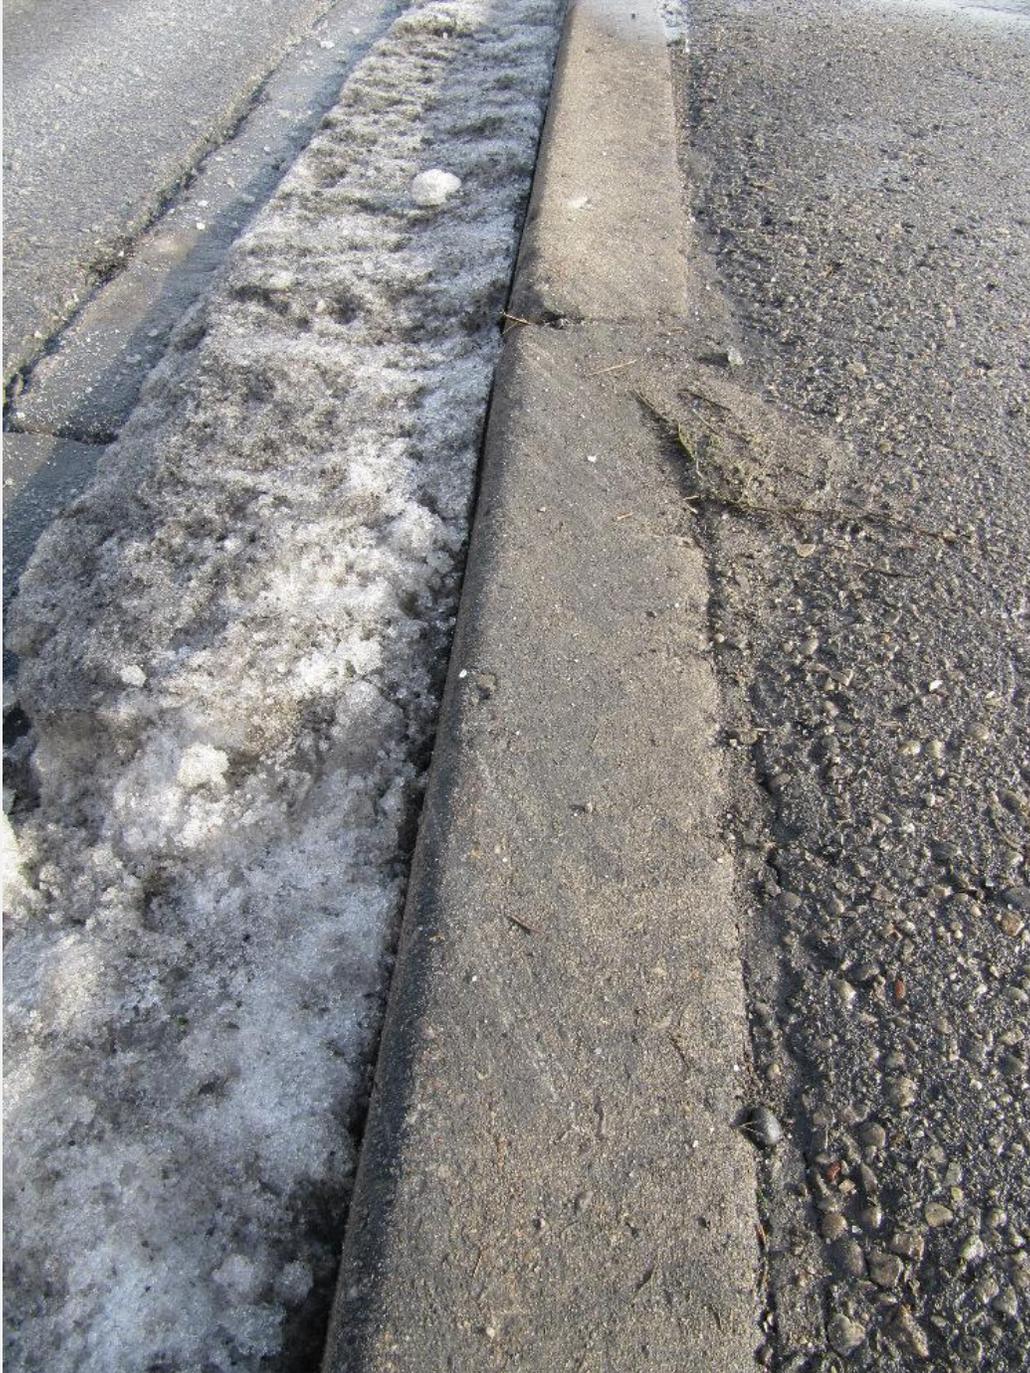
A closer view of the striated markings on the top surface of the curb where the rotating tire of the vehicle produced evidence of a yaw mark.

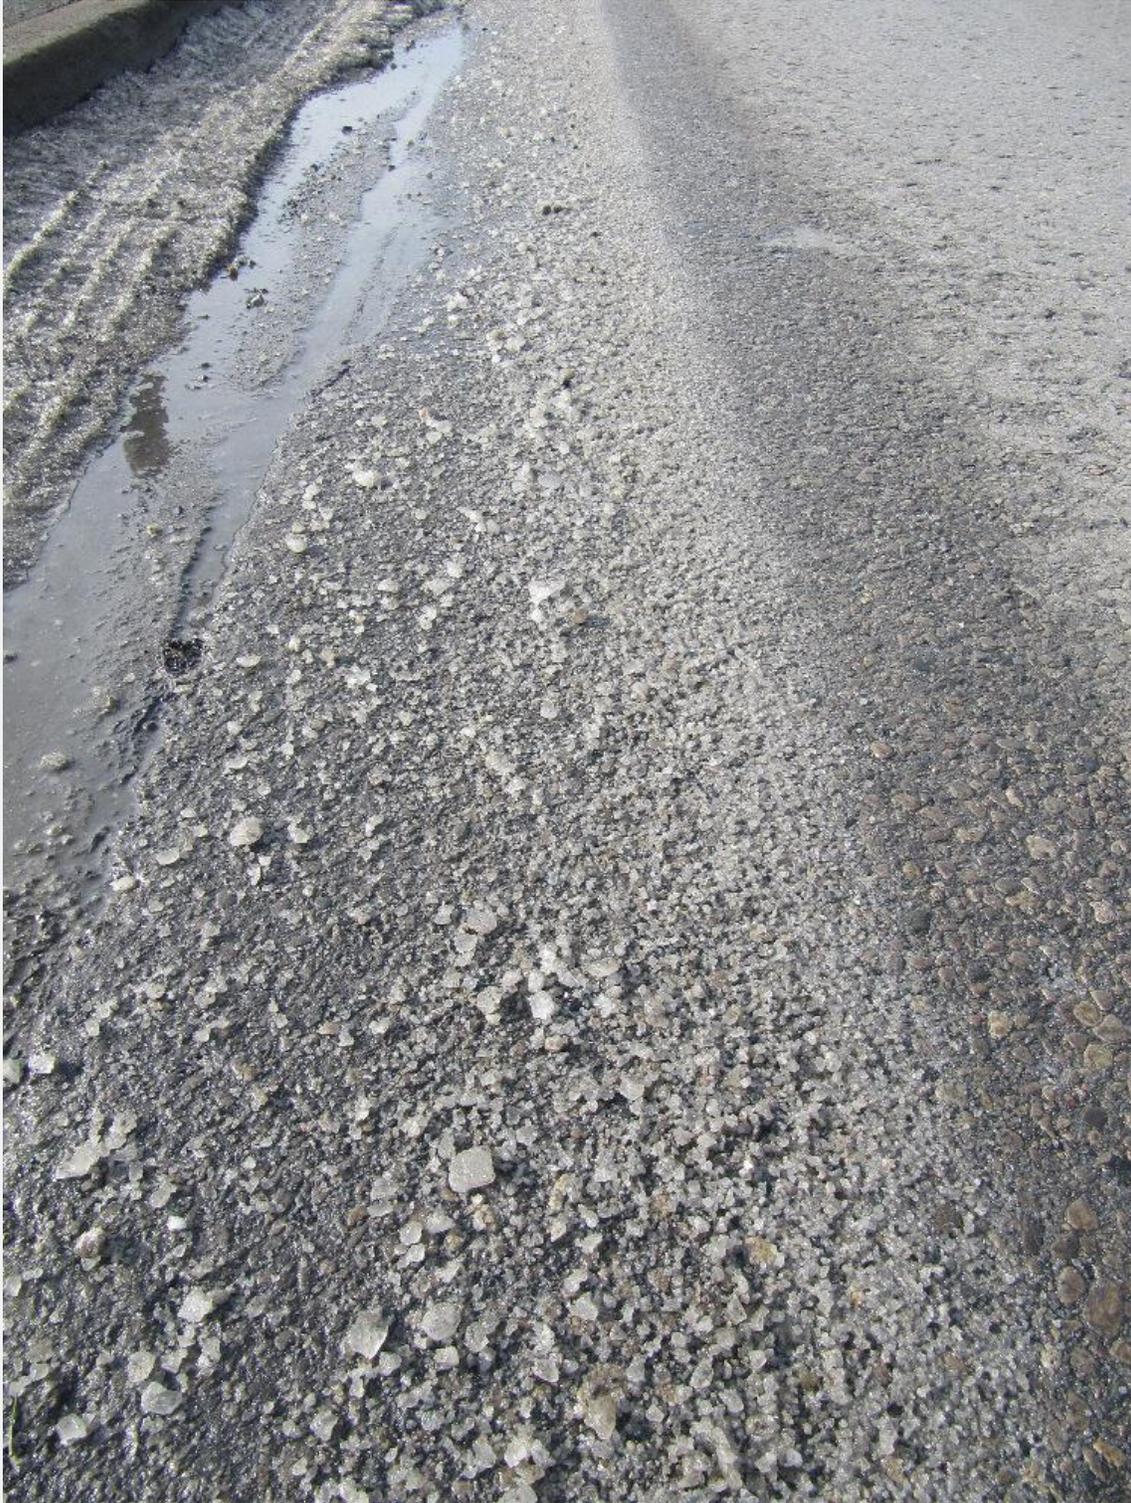
View looking west along the south edge of the curb lane of Oxford Street west of the pole impact. Particles of unmelted salt are visible near this edge indicating that the salt was deposited “in the not to distant past”.

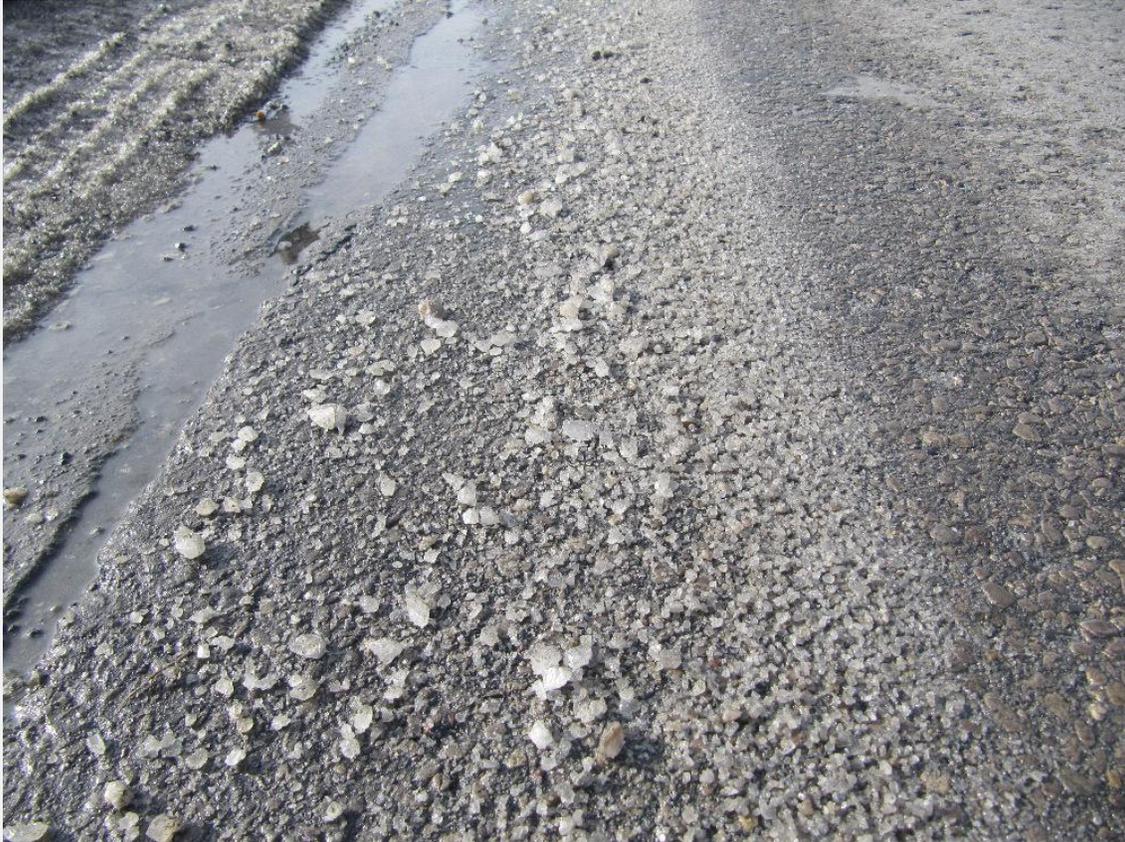
Close-up view of the unmelted salt crystals near the south edge of the curb lane of Oxford Street.
