Gorski Consulting Website

Archived News - 2016 - January

Dangerous Cocktail of Excessive Speed And Variable Road Surface Conditions Served Up To Southern Ontario Drivers

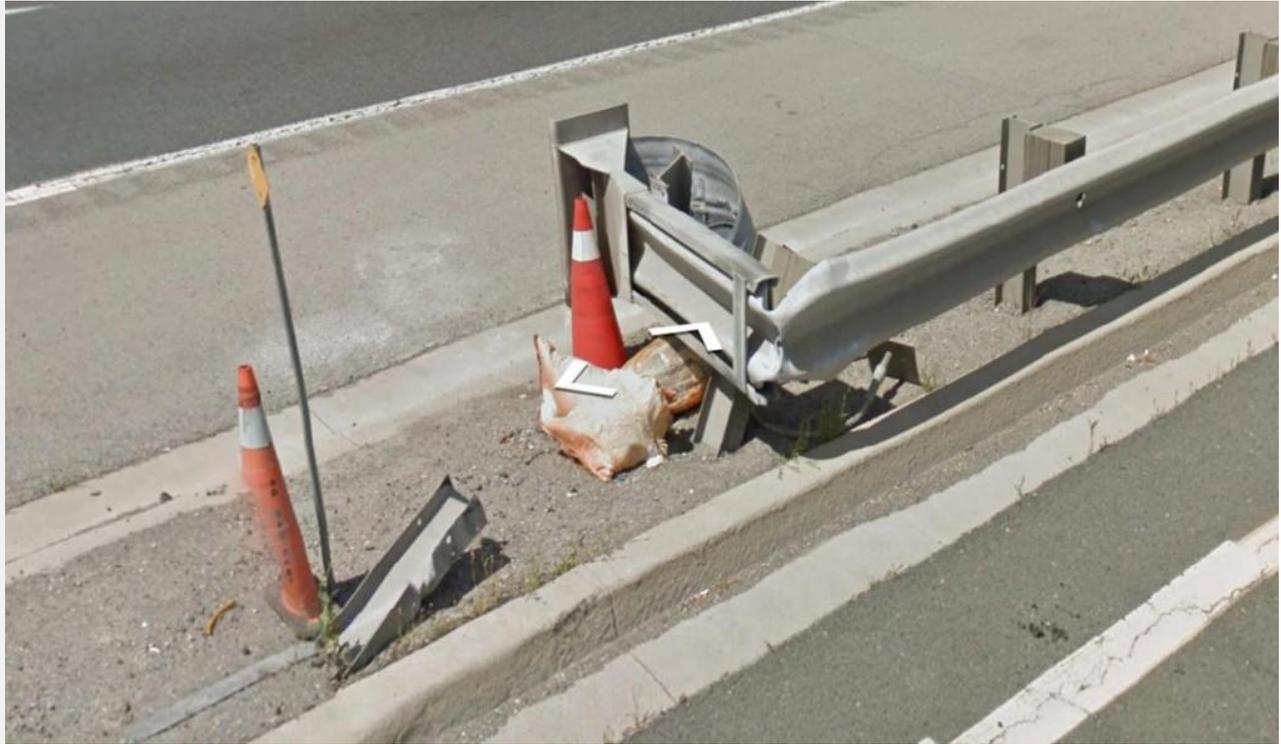
Imagery from Google Maps shows an ET-Plus terminal that has jammed, likely as of an impact, on the northbound lanes of the Red Hill Valley Parkway at Queenston Road in Hamilton, Ontario.

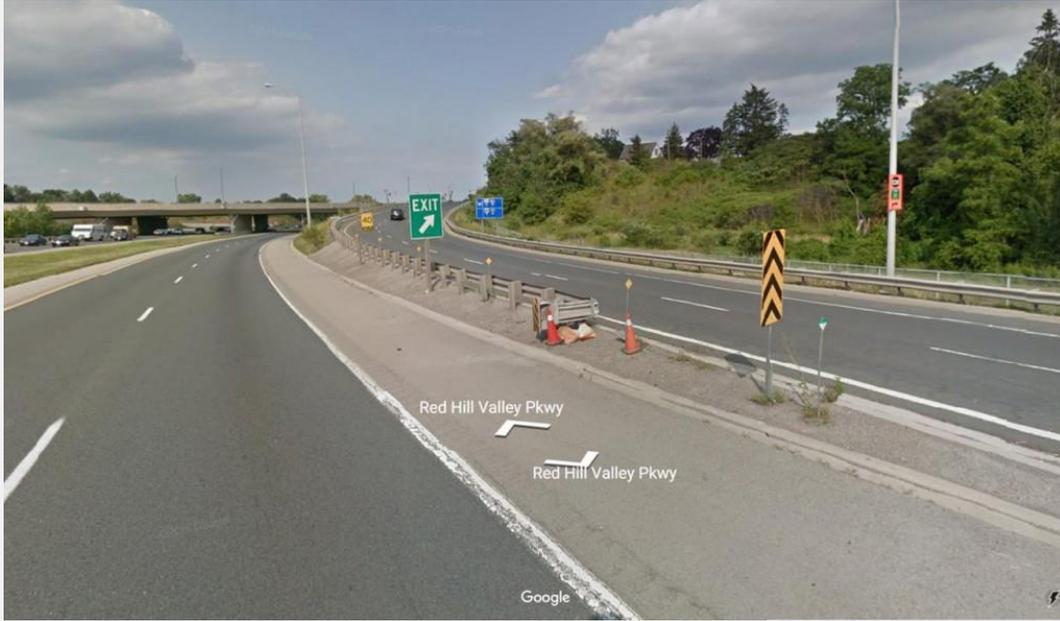
Overall view, northbound on the Red Hill Valley Parkway, while approaching the Queenston Road exit. There is a damaged ET-Plus terminal between the northbound lanes and the Queenston Road exit.

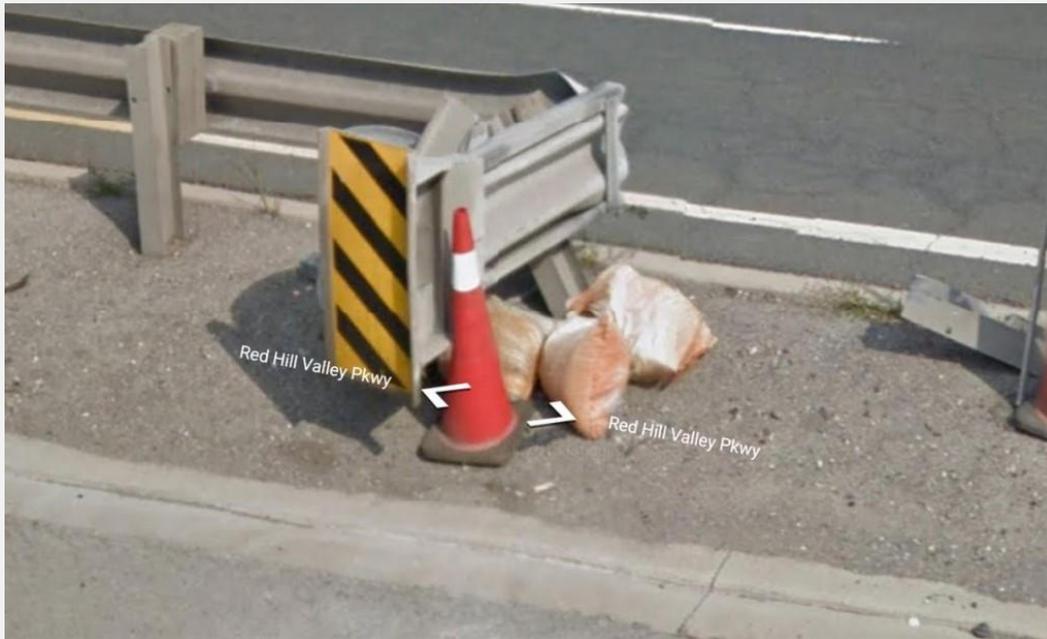
The damage to the ET-Plus terminal is typical of what has been described by whistleblower, Joshua Harmon, in his civil suit against Trinity Highway Products, claiming that the terminal becomes jammed and causes a harpooning of the striking vehicle.

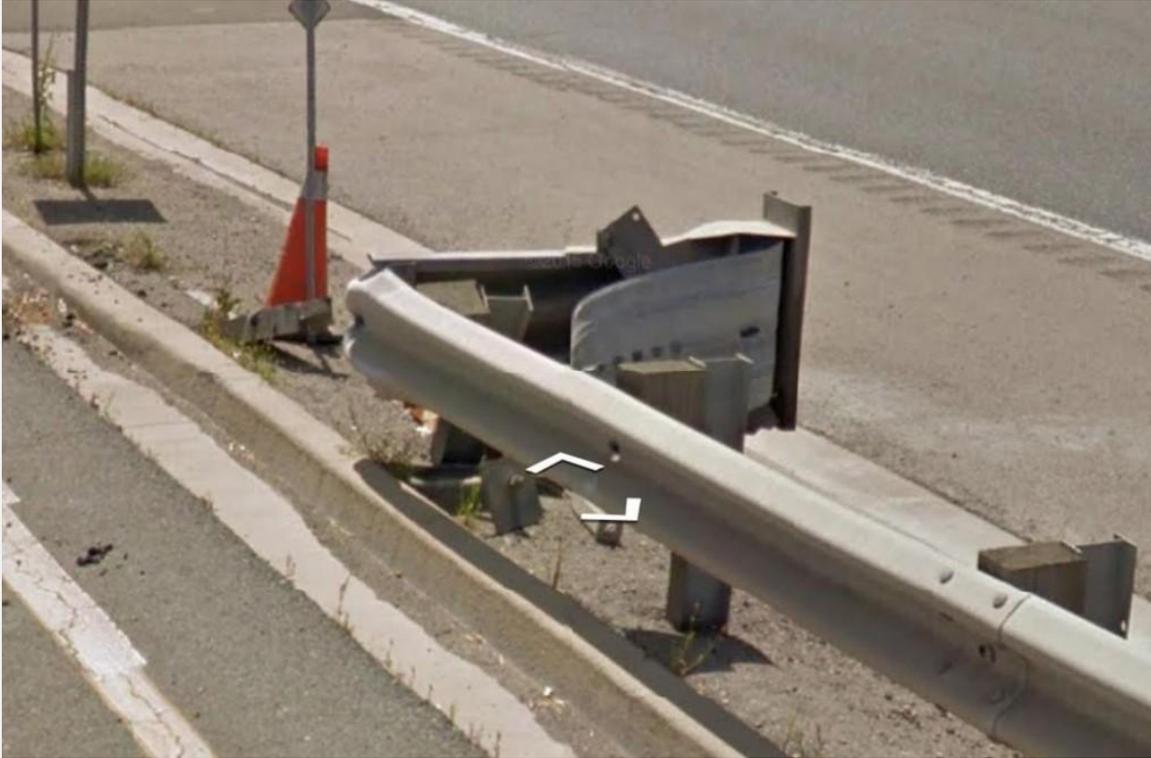
Note how a small amount of the guardrail has passed through the terminal before the terminal folded over the rail and became jammed. This is typical of the detective functioning claimed by Joshua Harmon.
