Archived News - 2016 - July

Fatal Head-On Collision on Glendon Road, West of London, Ontario

Fatal Rear-End Collision At Highway 23 Construction Site Near Woodham, Ontario

Fatal Rollover on Highbury Ave North of Commissioners Road in London, Ontario - What is Known From the Site Evidence

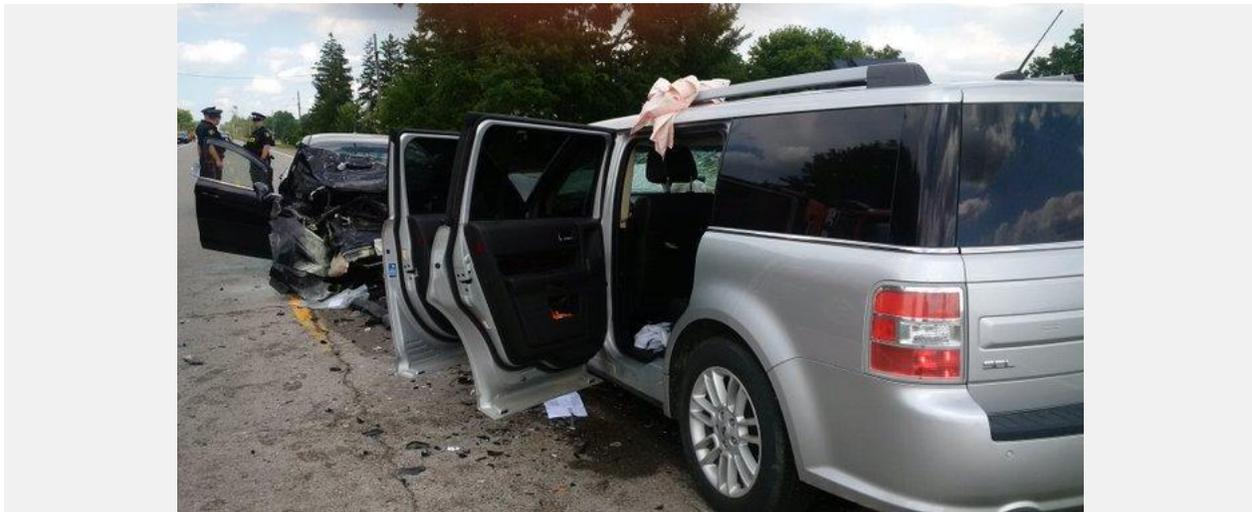
This photo submitted on the OPP twitter account shows the final rest positions two vehicles that resulted in fatal injuries to one of the drivers.

Yet it is extremely rare to see the type of final rest situation shown in the above photo whereby it would appear that there was 100% overlap of the front ends and no post-impact rotation. We have not attended the accident site to determine where the vehicles came to rest with respect to a point of impact (POI) however it would be even more rare if the vehicles came to rest precisely where they collided.

The news media provided some useful photos of the two vehicles which have provided an opportunity to study the performance of the vehicles in the current tragedy. Even though this frontal impact was obviously quite severe, modern vehicles have many additional safety features that were not available in the 1980s. Most importantly air bags, seat-belt pretensions, knee bolsters and more efficient frontal impact energy dissipation by the vehicle structures. This is evident when we see the amount of frontal crush in the car of the deceased. We also note that the A-pillars of the car appear to have remained generally un-displaced. Such a finding is desirable as it provides some general clue as to the extent of structural intrusion into the occupant space and if the vehicle's safety features were given an opportunity to perform before any significant structural component reached the driver's seated area. Generally we do not see any obvious concerns about failures.

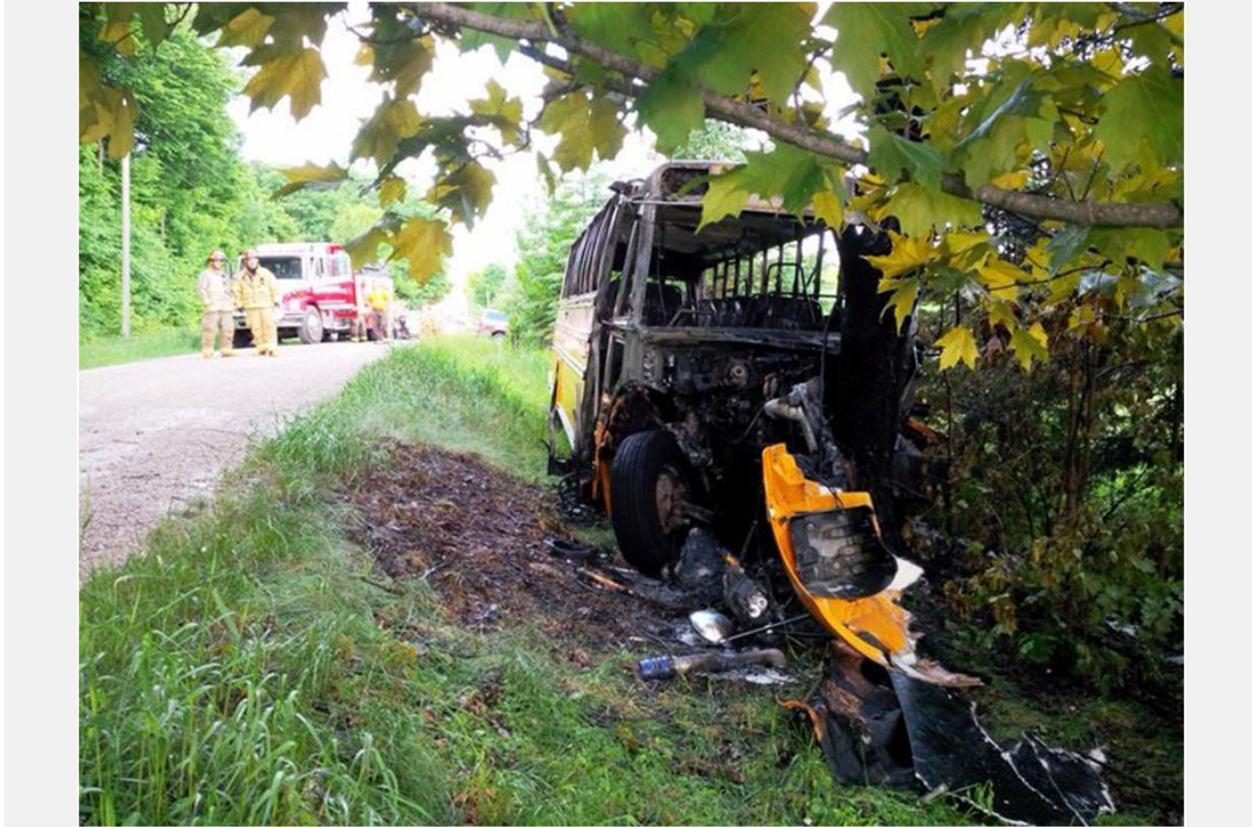
This collision involving a school bus fire after striking a tree was not a trivial matter. While students in the bus reportedly escaped without injury the situation could have been much worse.

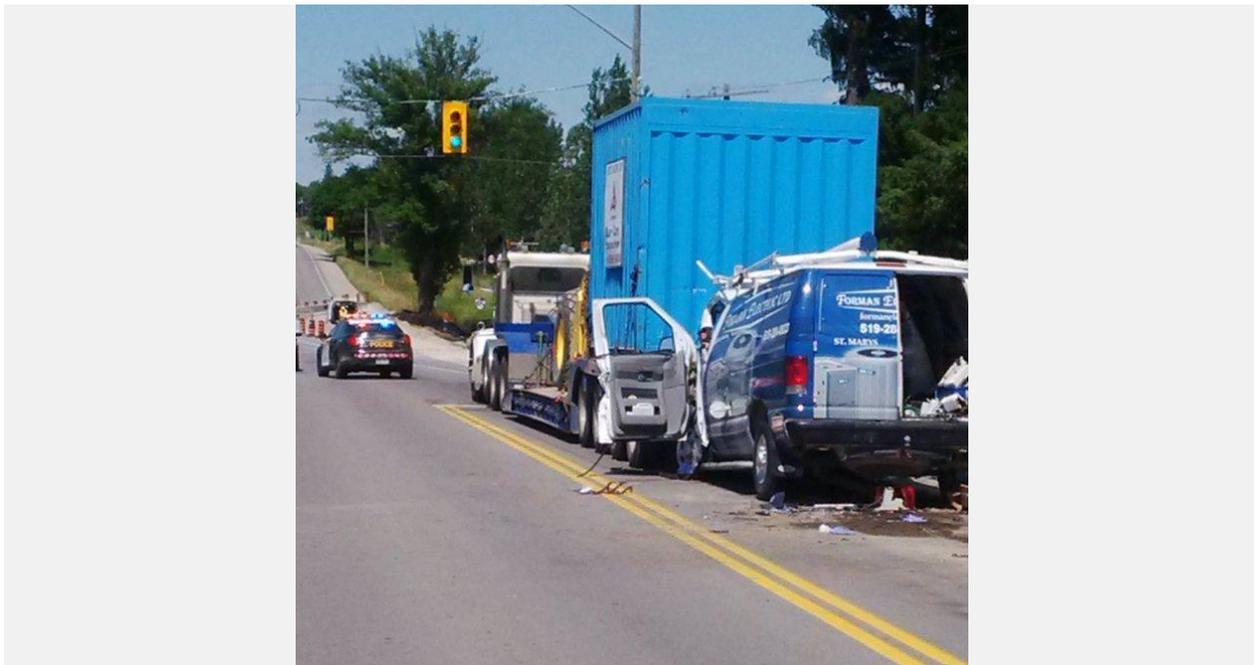
This photo was provided by the OPP with respect to their investigation of a fatal collision whereby a northbound commercial van drove into the back of tractor trailer on Highway 23 near Woodham, Ontario in the afternoon of July 19, 2016.

The Ontario Provincial Police provided a photo (shown above) on their twitter account showing the final rest positions of two vehicles that were involved in a rear-end collision at a construction site just north of Woodham, Ontario on the afternoon of July 19, 2016.

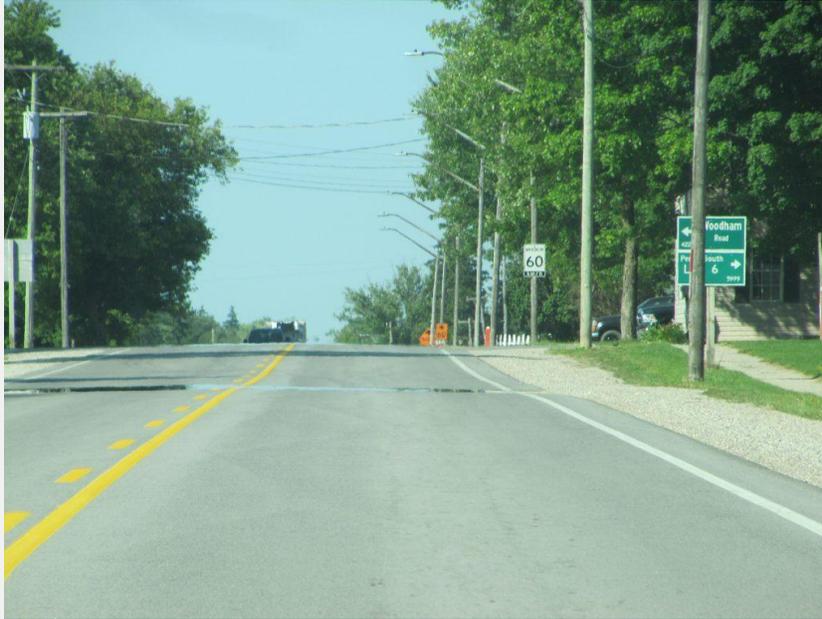
While approaching the site this is a view looking northward from Woodham and some orange construction signs begin to be seen along the right side of the road.

One can appreciate that there is a down-slope on the northward approach to the site because only the top portion of the oncoming traffic can be seen in the distance. As we approach closer that on-coming traffic is more visible in the photo below and we note that one of those approaching vehicles is a tractor trailer. Thus one can sense that, from the long viewing distance of Woodham, there is a limited line of sight toward the point where the impact occurred.

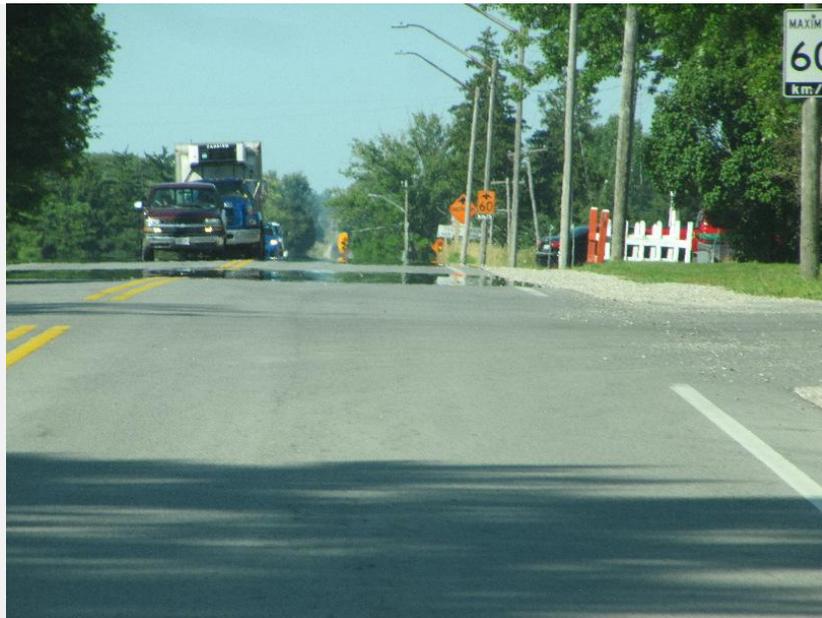
The extent of the down-slope on approach to the collision site can be appreciated by noting that the approaching tractor trailer is not readily visible in the previous photo while it becomes visible here.

The head of a traffic signal begins to be visible in the above photo although not much else can be deciphered about what exists in the vicinity of that signal.

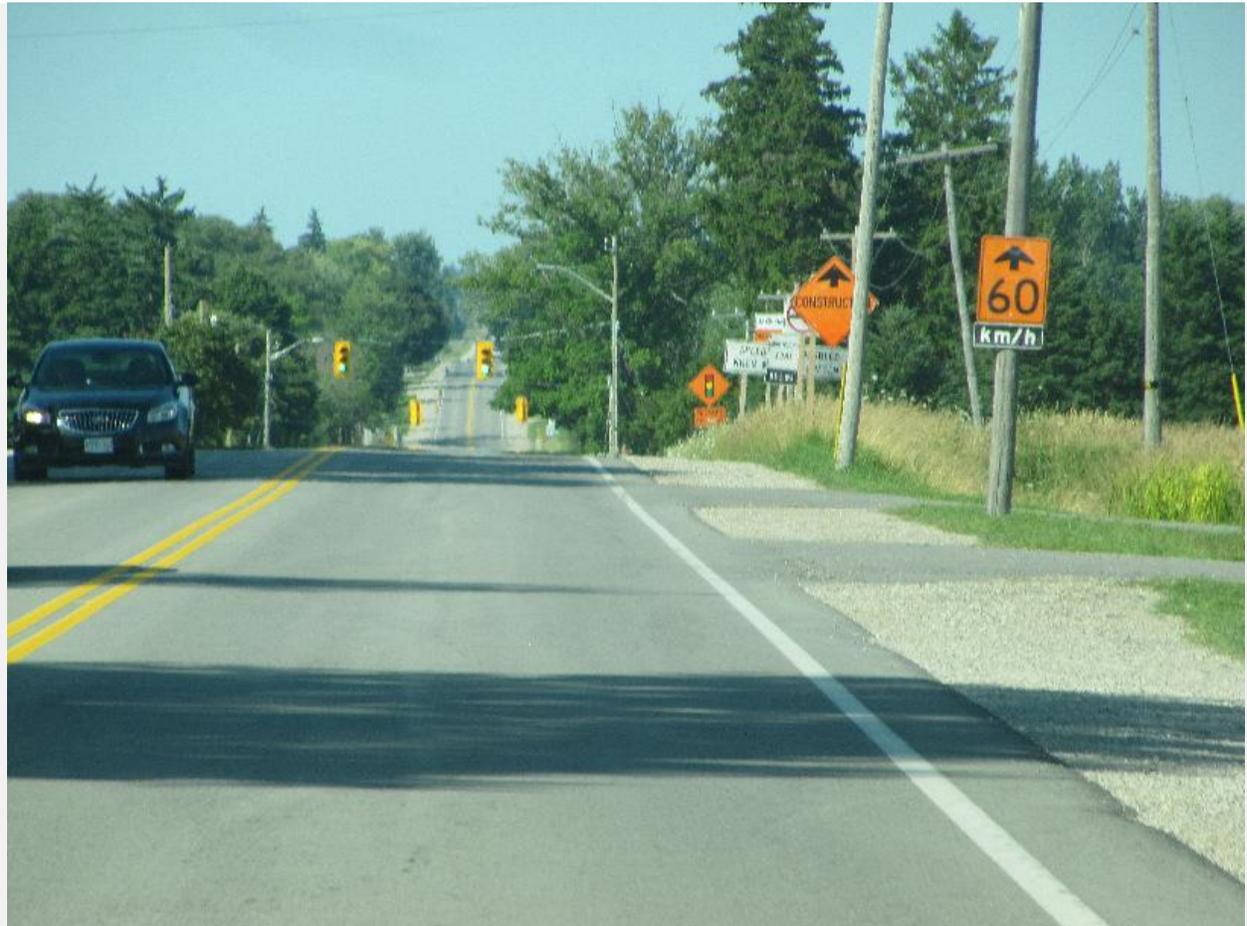
On approach northward to the collision site a number of signs are seen along the right. The traffic signal can be seen in the distance however the road surface in the vicinity of that signal and what exists around it is still not visible.

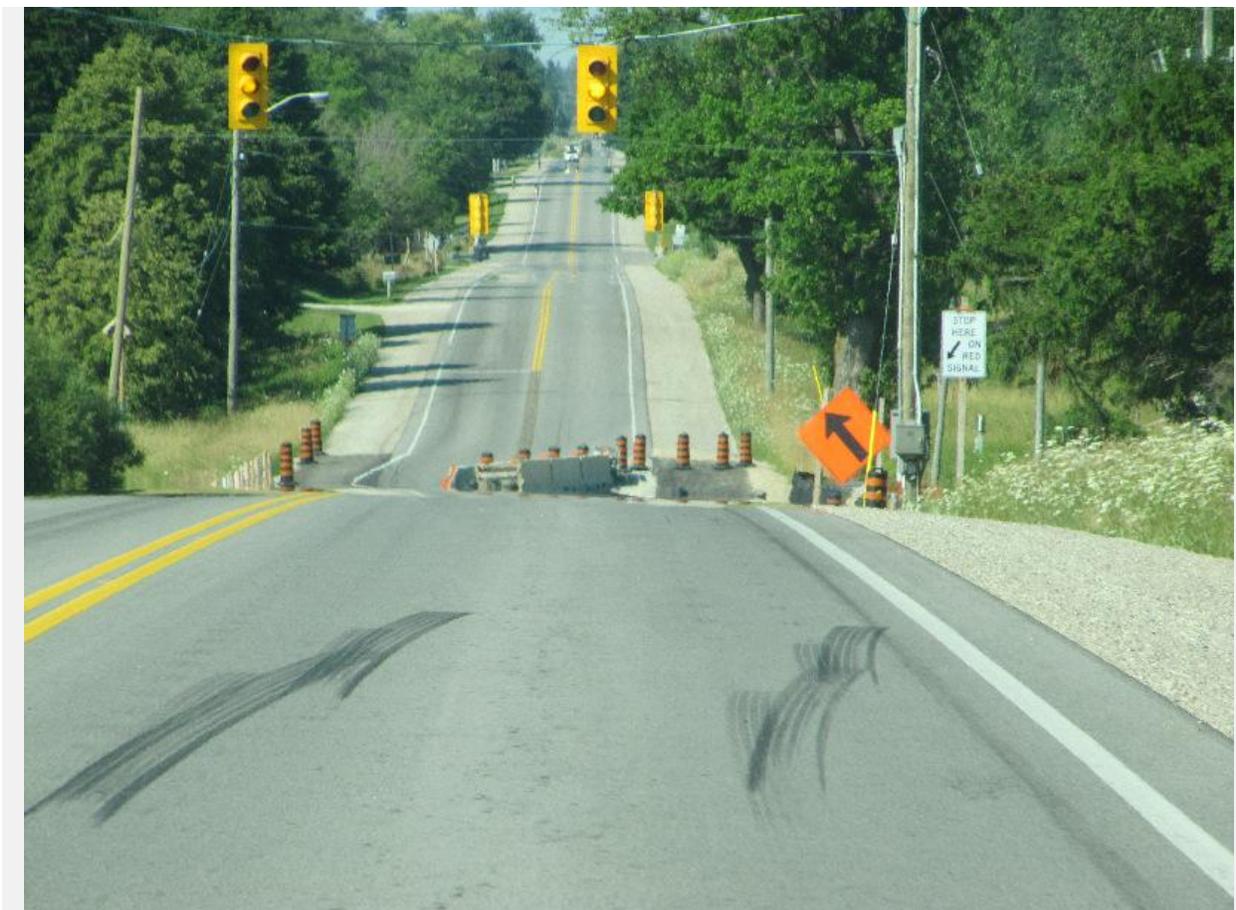
As we approach closer the bottom of the down-grade begins to be visible as construction is taking place of a small bridge. In the foreground one can see the skid marks from testing conducted by police to estimate the road's co-efficient of friction.

In the above photo we can also see the skid marks from 4 braking tests performed by the police investigators. Such testing is performed by a police cruiser to determine the co-efficient of friction (or aggressiveness) of the road surface. Such testing is useful in speed calculations when an investigator wants to know how much speed might be lost if a driver applied maximum braking at a specific location or time before impact. Thus the above skid marks have nothing to do with the actual collision as they were created by police after the collision event.

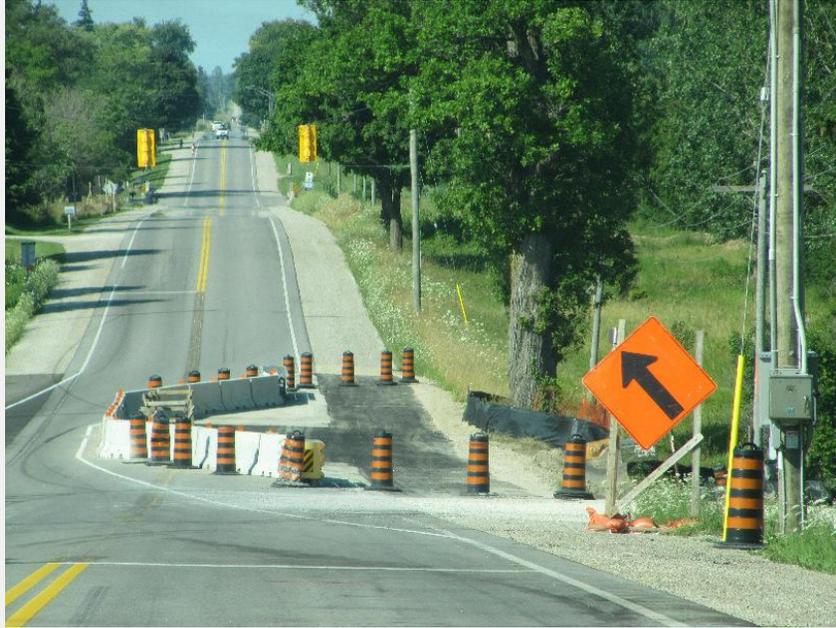
This photo provides an indication of the area of construction at the small bridge.

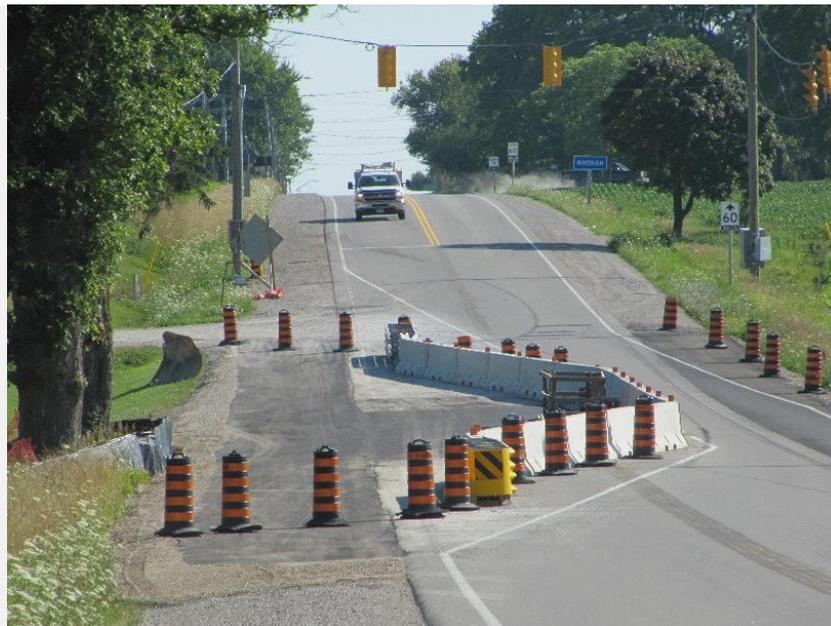
Turning around to face south, this photo shows the layout of the area of impact which is in the background, beyond the bridge. Note that the stopped, northbound vehicle is on a downgrade and northbound vehicles approaching the area would have a limited view of its presence.

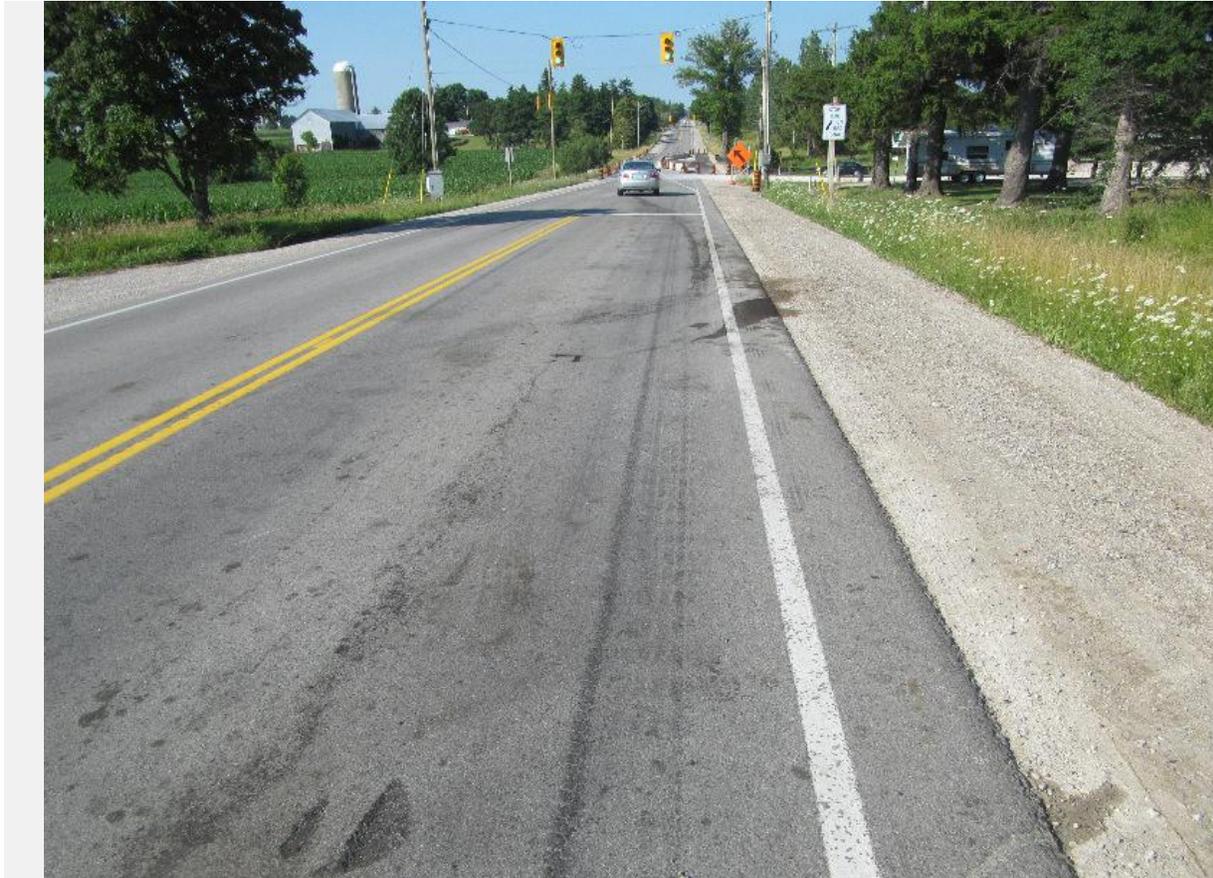
View of deep gouges in the foreground likely indicate the point of impact between the vehicles whereas the fluid stains in the background likely indicate the striking Van's rest position.

It was noted that the gouges were approximately 27 metres south of the white, traffic, stop bar. A tractor trailer would likely be slightly shorter than that distance therefore it is likely that the front end of the truck was close to the stop bar when its rear end was struck. However, although there are a number of braking marks in the area, none of these match the type of evidence that would suggest that the driver of the Econoline Van applied any maximum braking before impact. This might be viewed as unusual.

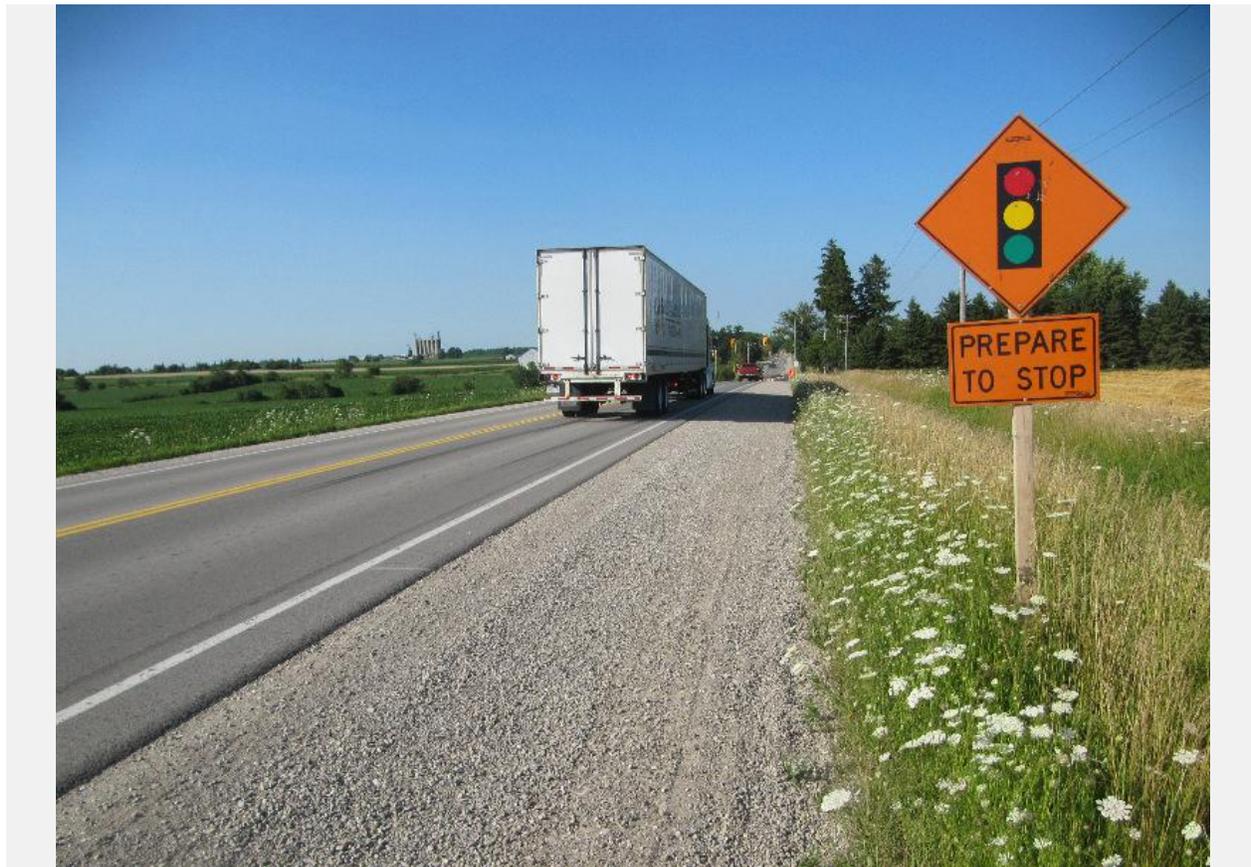
A view of a northbound tractor trailer approaching the area where northbound traffic is supposed to come to a halt while waiting for the traffic signal.

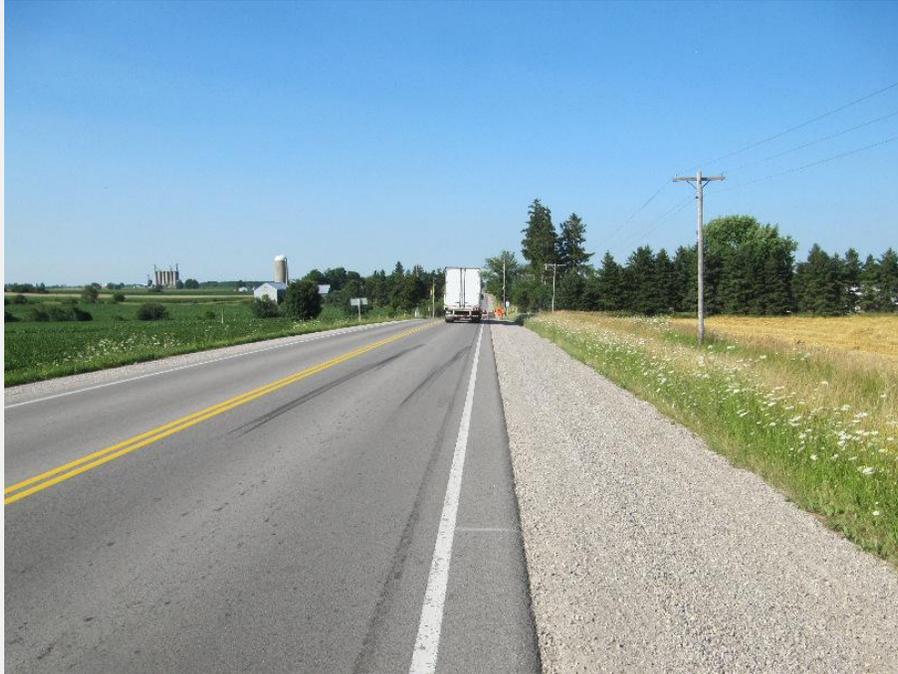
View of the northbound truck as it comes close to the stop location at the traffic signal. The height of the trailer blocks the traffic signal head in the truck's lane.

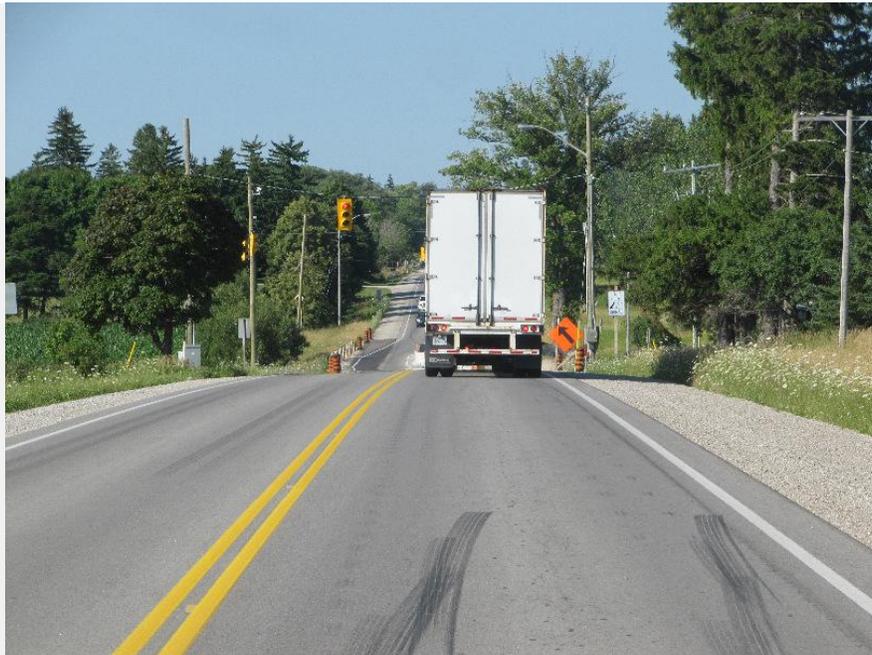
As the driver is approaching the tractor trailer from behind, the one traffic signal is blocked from view by the trailer yet the other traffic signal in the other lane is still visible so one would conclude that the signal should be visible.

Re-examining the above photo, what if there was another tall vehicle, such as another tractor-trailer travelling southbound in the above photo? Could such a southbound truck block the view of the other traffic signal? Examine the top edge of the trailer in the above photo and follow a straight line across to the other traffic signal. The top of the trailer, if it was moved into the southbound lane, would block the other signal. As an example, the photo below shows a southbound tanker truck whose height blocks the view of the traffic signal.

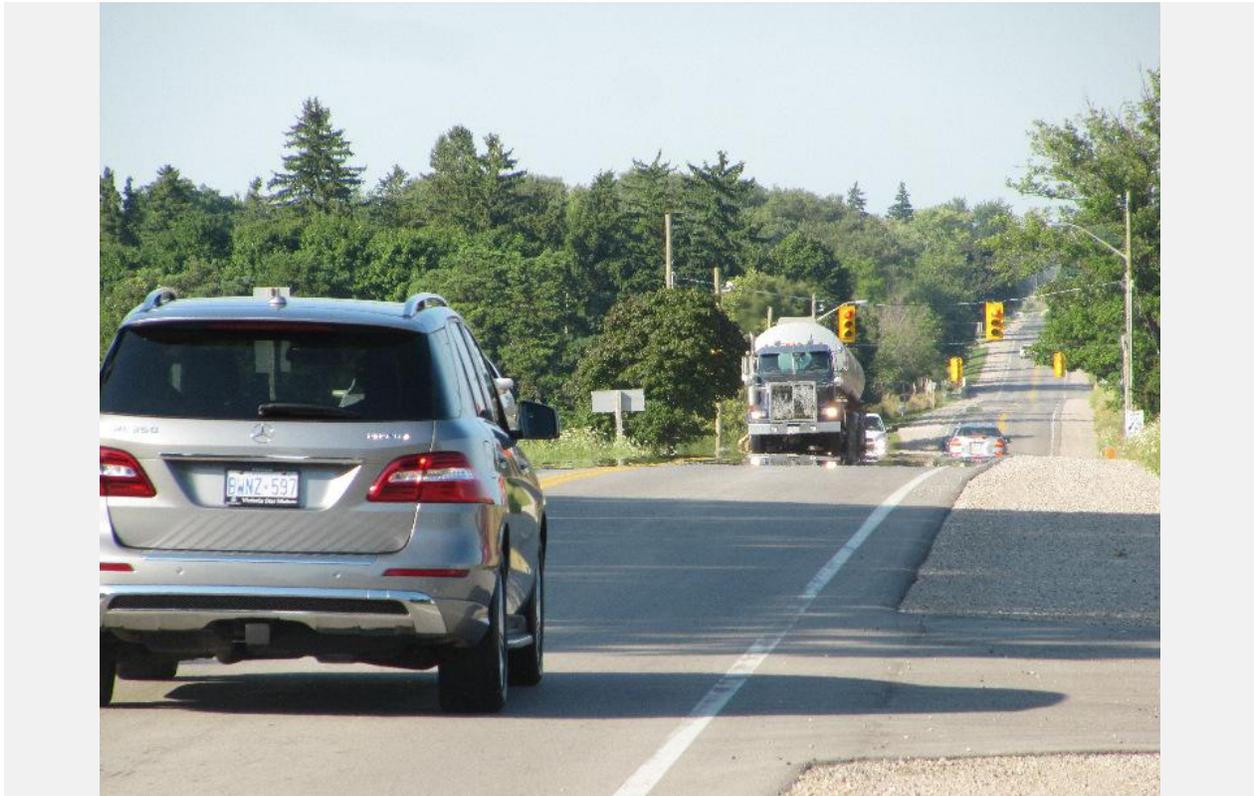
View of a southbound tanker truck whose height would block the view of the traffic signal in the southbound lane.

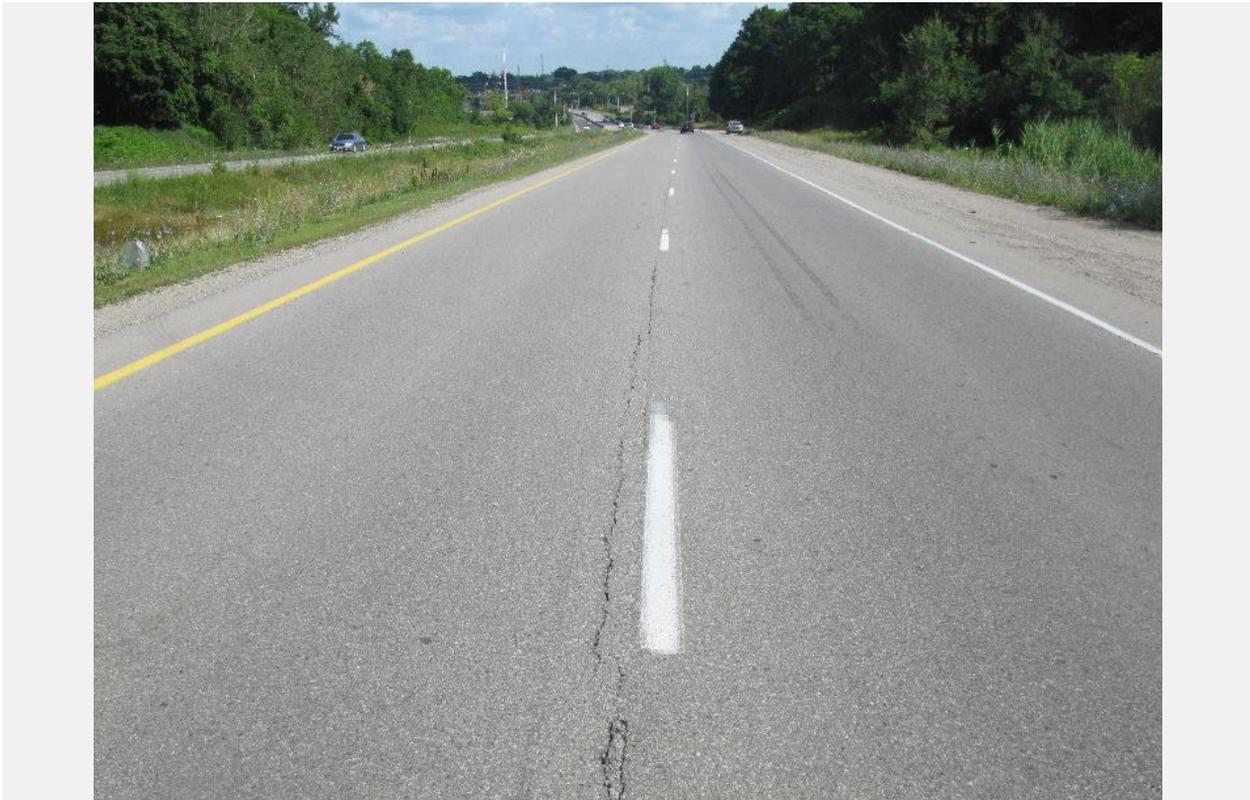
View, looking north, along the northbound lanes of Highbury Ave, north of Commissioners Road. A northbound Chrysler Sebring rolled over on the right shoulder in the distant background.

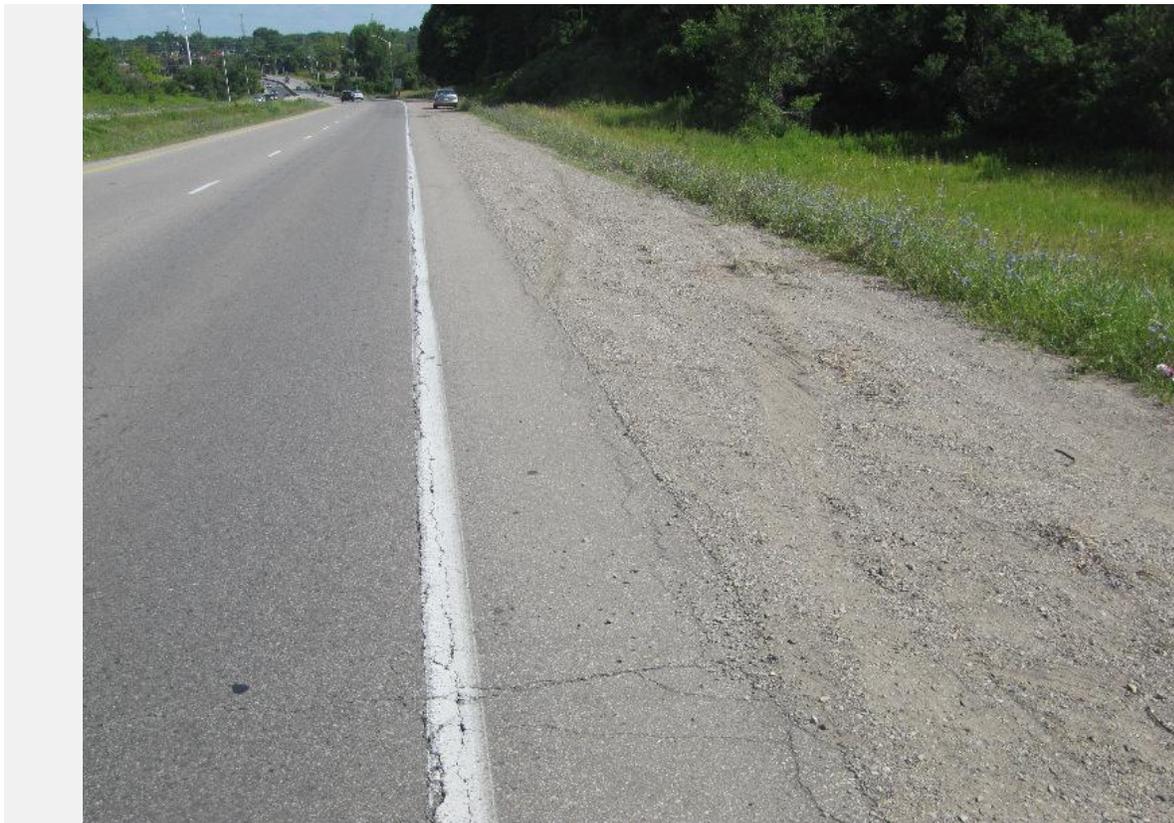
View, looking north, along the east shoulder of Highbury Ave in the vicinity where the "yaw" tire marks of the Sebring first became visible as the vehicle travelled off the pavement.

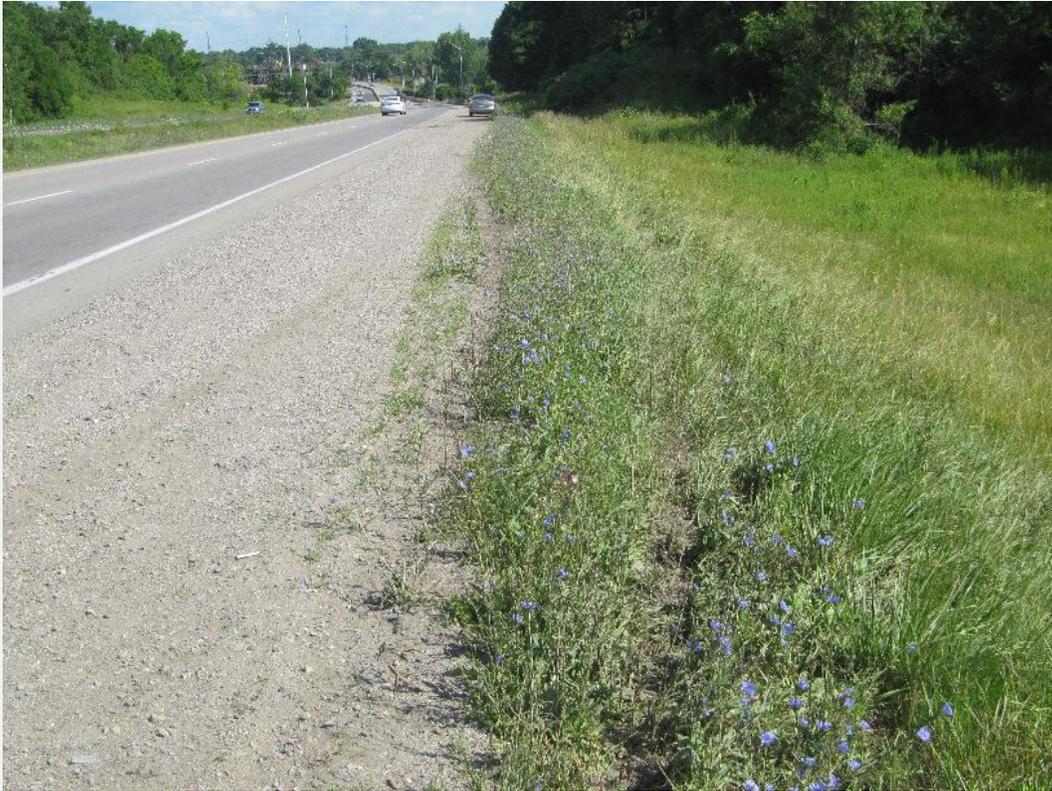
View of the tire marks visible on the east roadside next to the shoulder where the Sebring entered into a sideways orientation prior to beginning its rollover.

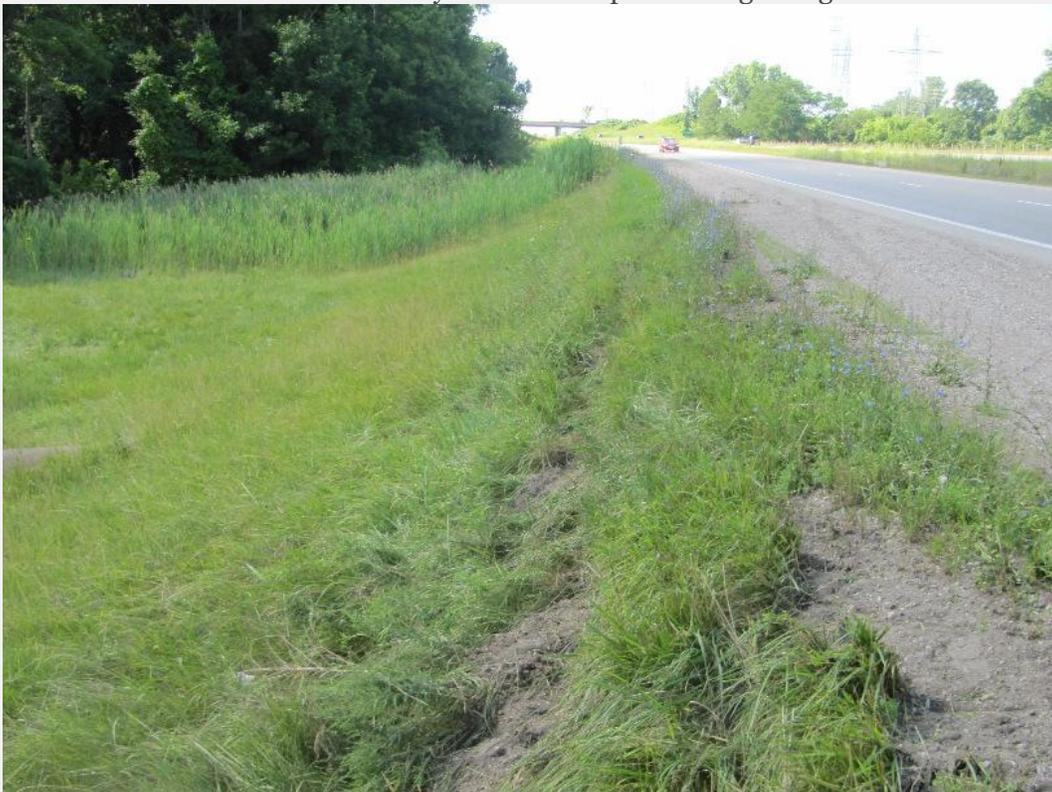
View, looking back, southward, at the tire marks in the east roadside where the Sebring was rotating counter-clockwise prior to commencing its rollover.

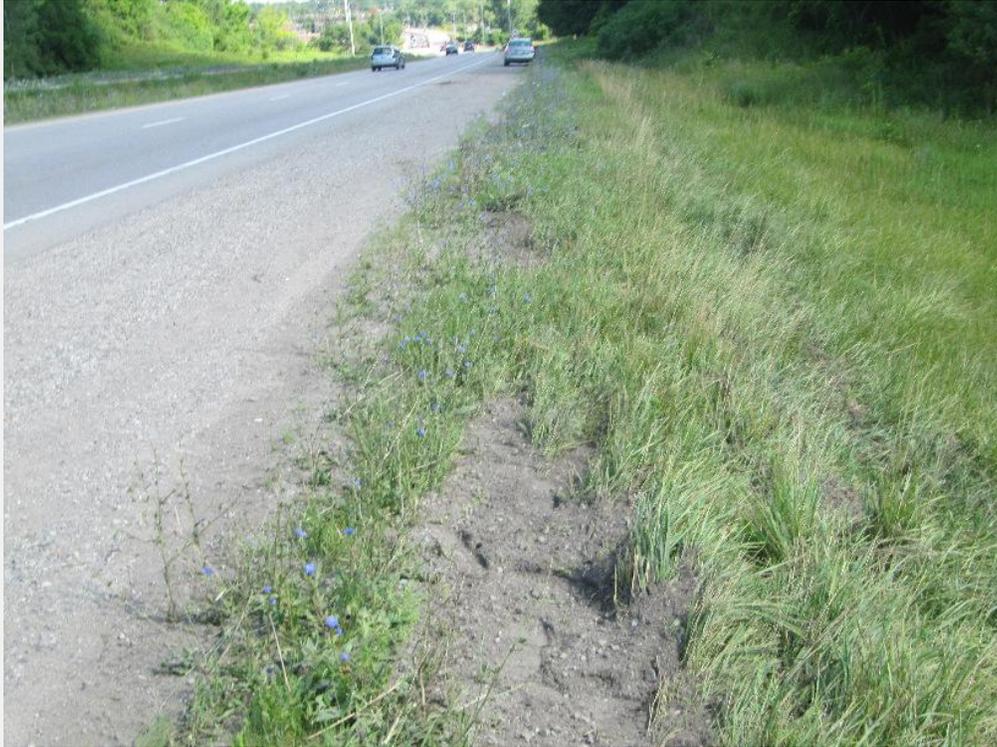
View, looking north, at the approximate location on the east roadside where the Sebring began to rollover. It came to rest in the foreground of the parked vehicle shown in the background.

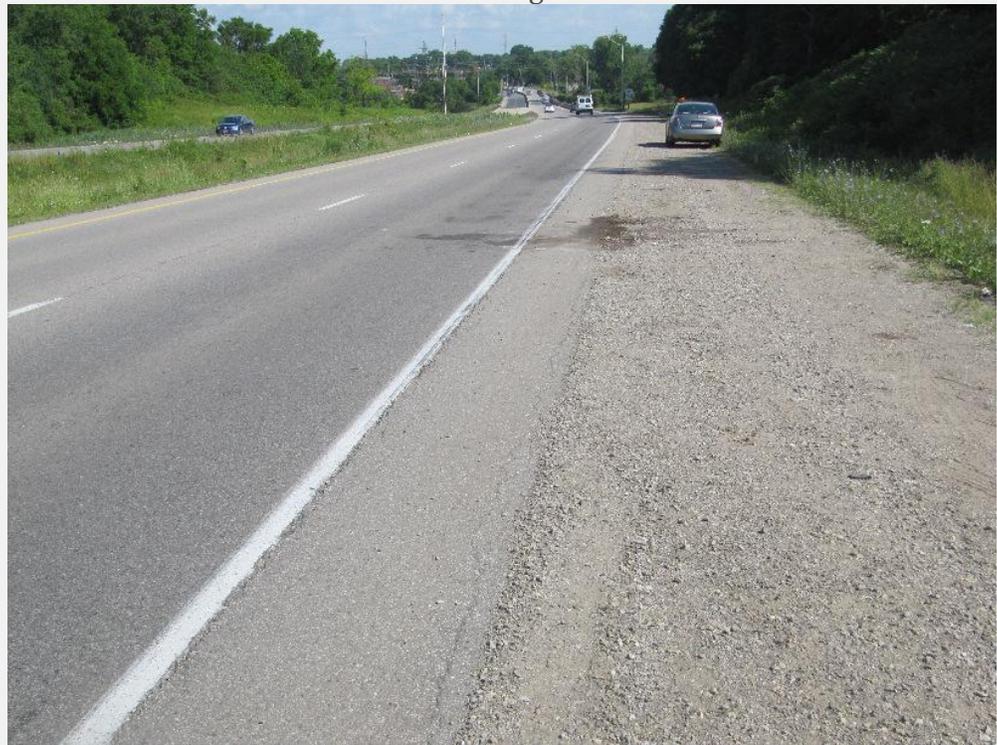
View, looking north, along the east shoulder of Highbury Ave, showing a dark stain at the pavement edge where the Sebring came to rest.

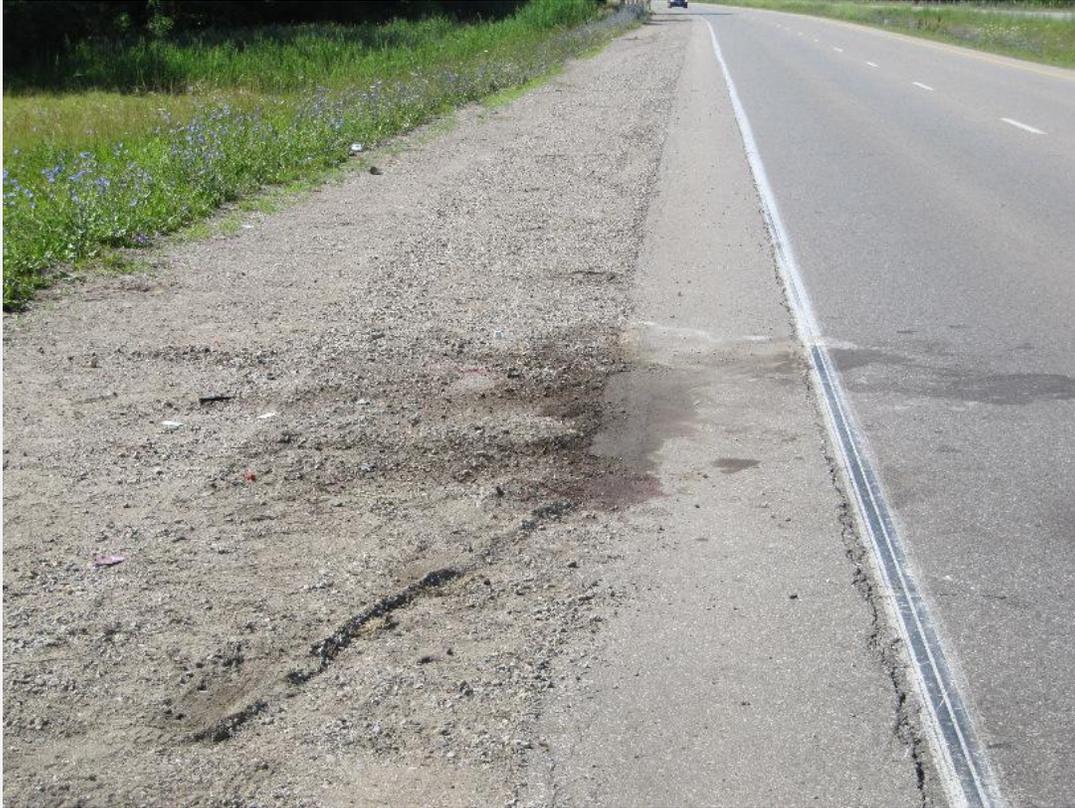
View, looking south, showing the dark stains at the final rest position of the Sebring.

In total, the Sebring travelled approximately 40 metres along the east shoulder and roadside before commencing its rollover. It then rolled for approximately 37 metres before coming to rest. Under such conditions the Sebring would have been travelling approximately 69 km/h when it commenced its rollover and about 88 km/h when it entered the east shoulder. This does not indicate the true travel speed of the vehicle because the vehicle decelerated an additional, unknown, amount prior to entering the east shoulder.

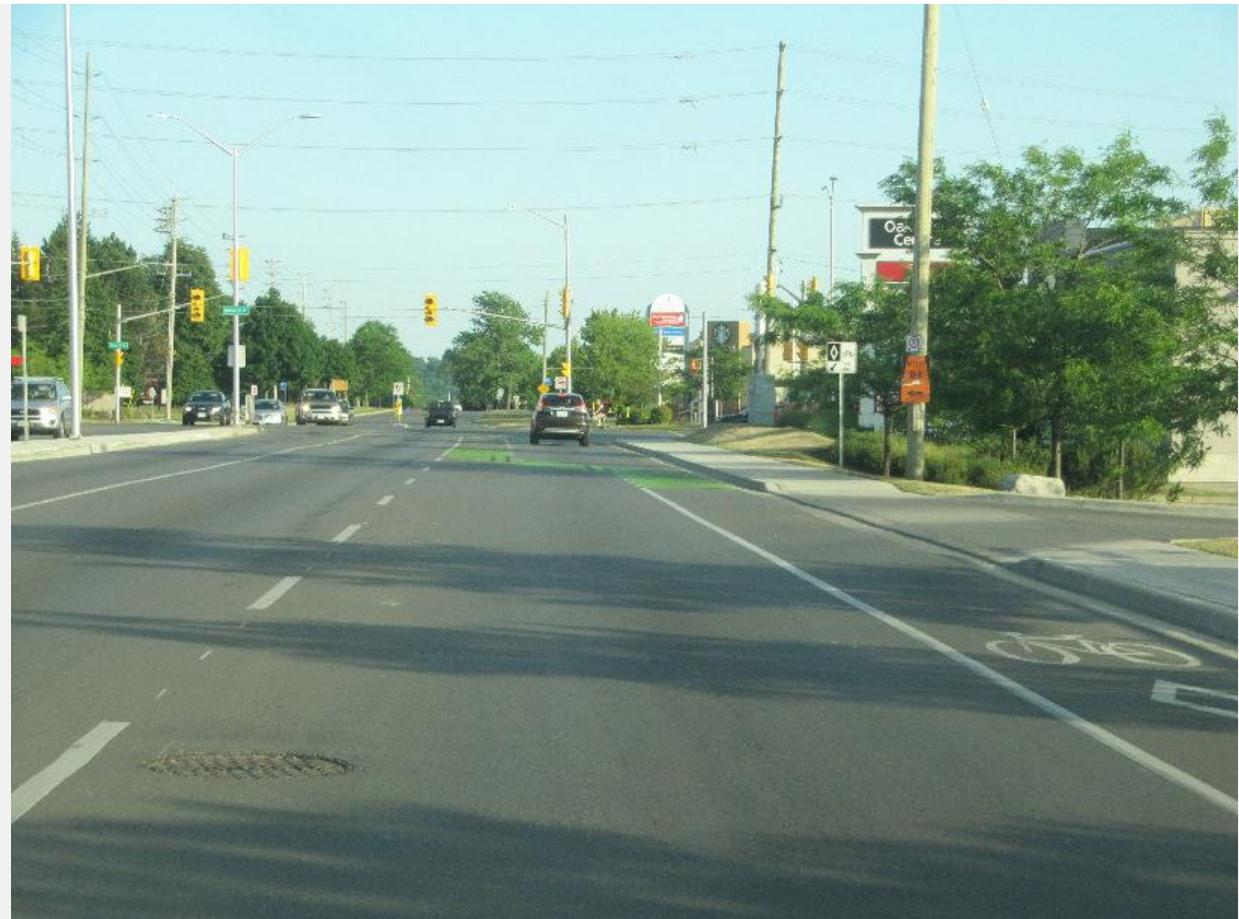
While travelling southbound on Hyde Park Road in the west end of London, Ontario motorists are expected to detect the thin line of a pedestrian "green zone" ahead where the cyclist lane suddenly veers into the driver's lane.

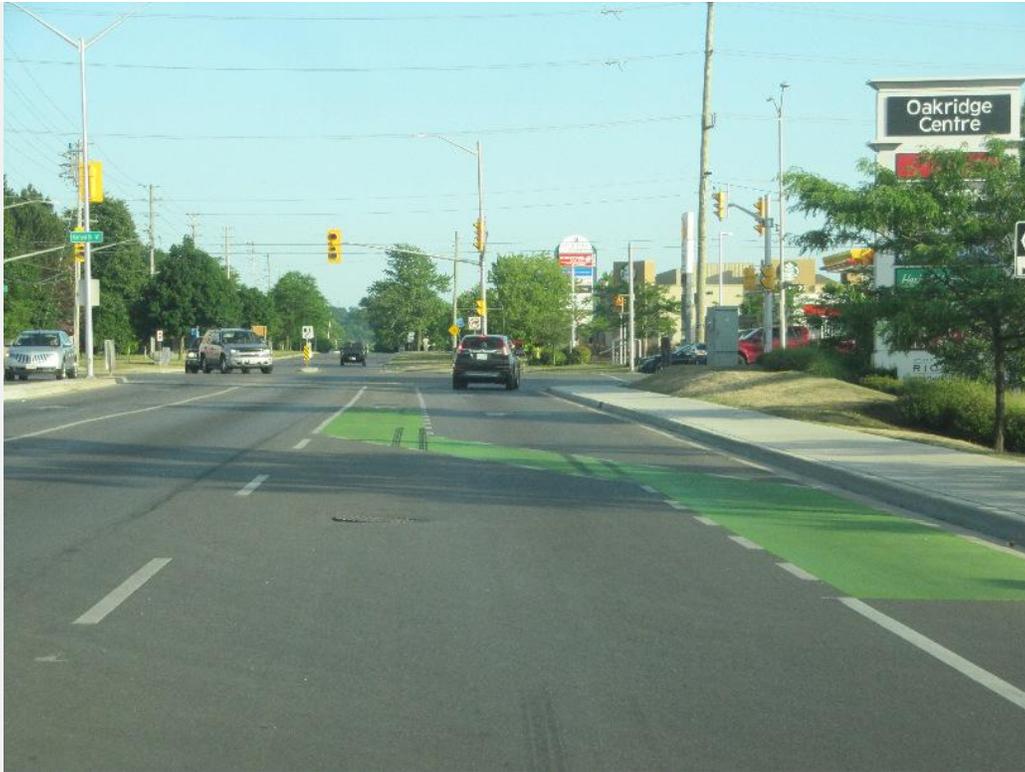
The sudden veer of this cyclist "green zone" into the curb lane of southbound Hyde Park Road means that drivers will have very little warning that cyclists will be moving into their path which requires motorists to change lanes if they intend to proceed further along the road.

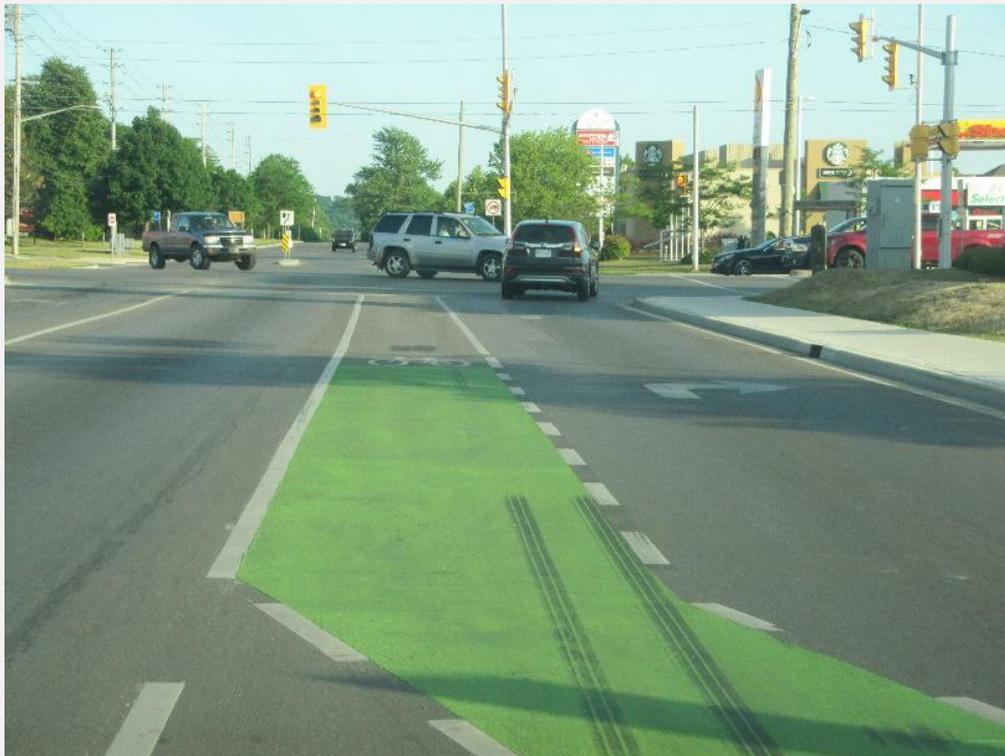
Skid marks from the dual wheels of heavy trucks within the cyclist "green zone" reflect the fact that conflicting conditions exist, as would be expected with this unusual design.
