Archived News - 2016 - July

Fatal Head-On Collision on Glendon Road, West of London, Ontario

Fatal Rear-End Collision At Highway 23 Construction Site Near Woodham, Ontario

Fatal Rollover on Highbury Ave North of Commissioners Road in London, Ontario - What is Known From the Site Evidence

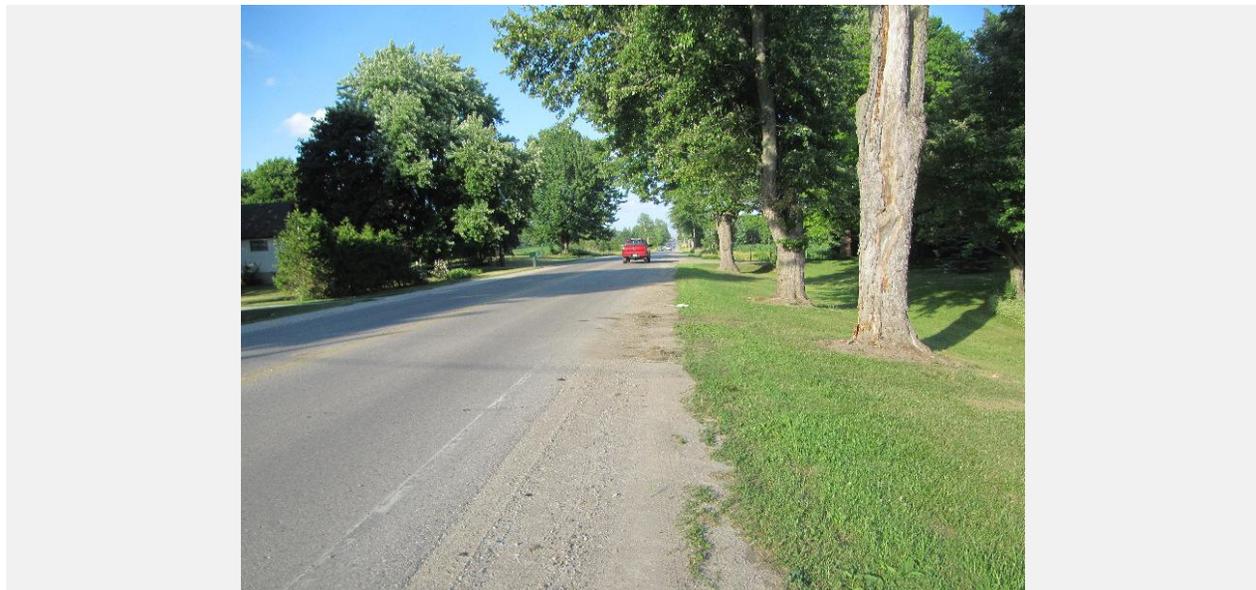
View looking east along the south shoulder of Gainsborough Road with the impacted tree visible in the foreground on the right portion of the view.

One can generally observe a straight and level roadway and the pavement surface is in generally good condition.

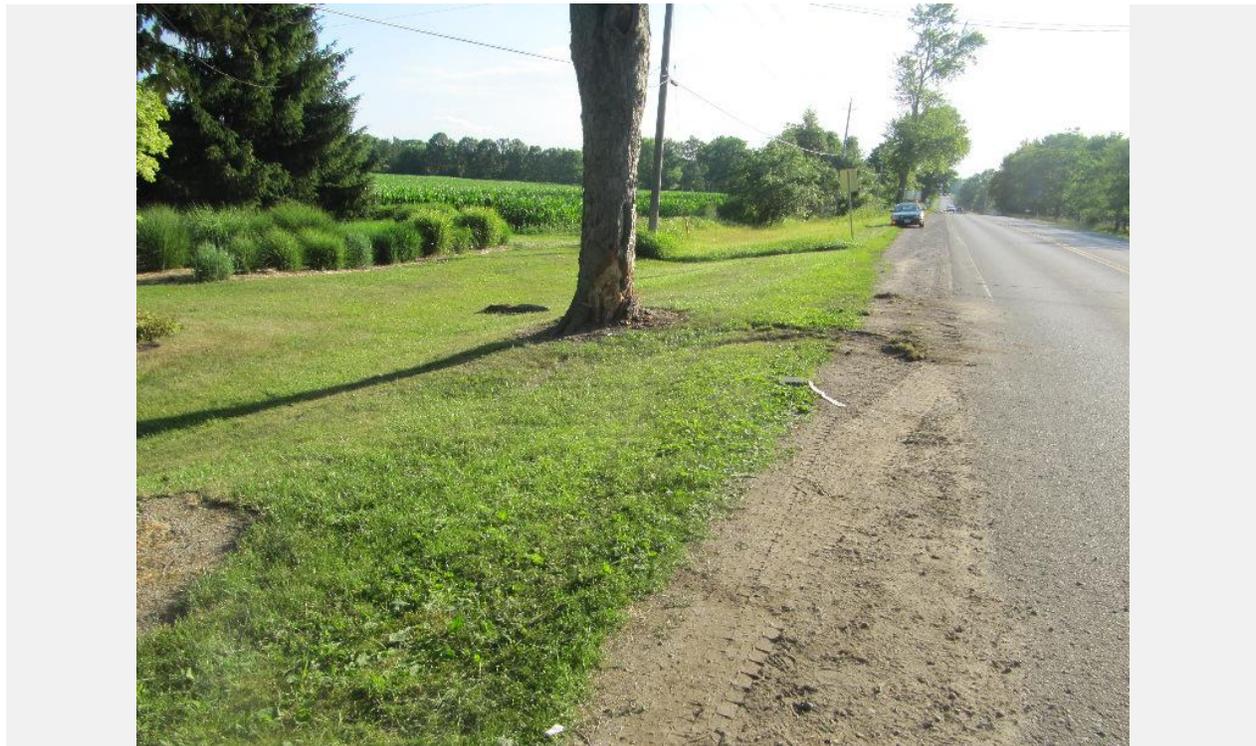
View looking south-west at the struck tree on the south roadside of Gainsborough Road.

Normally, when a vehicle has entered into a yawing rotation, the tires will be sliding sideways and they will rip out the grass along the path of the tires toward the tree impact. Thus the path of the vehicle along with the path of the individual tires can be clearly observed in the curved lines of the torn grass. One can note in the above photo that no such paths of torn grass are visible. This would be common when the vehicle is moving straight ahead and the tires are rolling over the grass.

Furthermore, substantial braking or acceleration would also produce tears in the grass as the slippage of the tires would cause the visibility of the tire marks. Again no such evidence is visible.

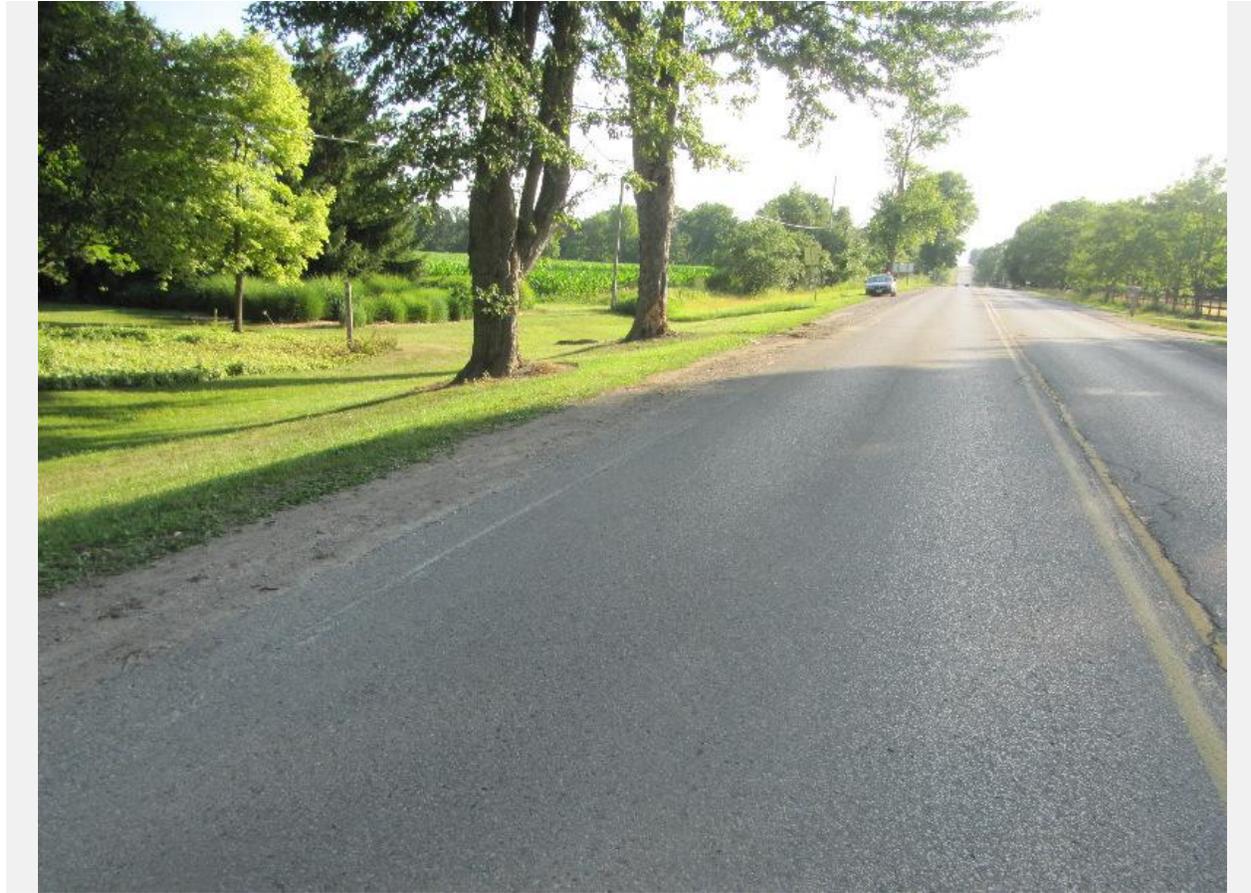
View looking west. The second large tree on the south roadside was the one that was struck.

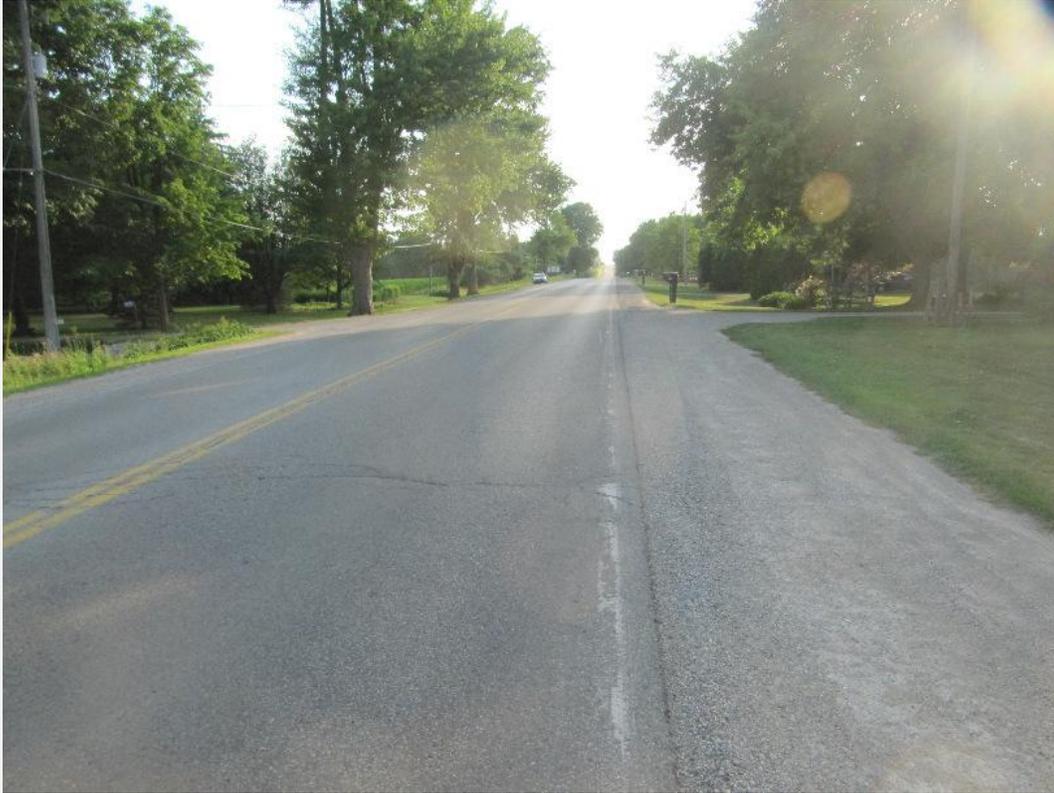
Another typical fact is that, where a tree is struck on the south side of a road, in a large percentage of instances, a vehicle's right side tires will have wandered onto the right (north) gravel shoulder and it is possible to detect "whiter" curved marks on the otherwise grayer portion of the gravel shoulder. The photo below shows a view of the north shoulder of Gainsborough Road from several hundred metres east of the tree impact. No such yaw marks are visible.

View looking west showing the north gravel shoulder where "whiter" yaw marks are often created when a vehicle yaws during pre-crash rotation.

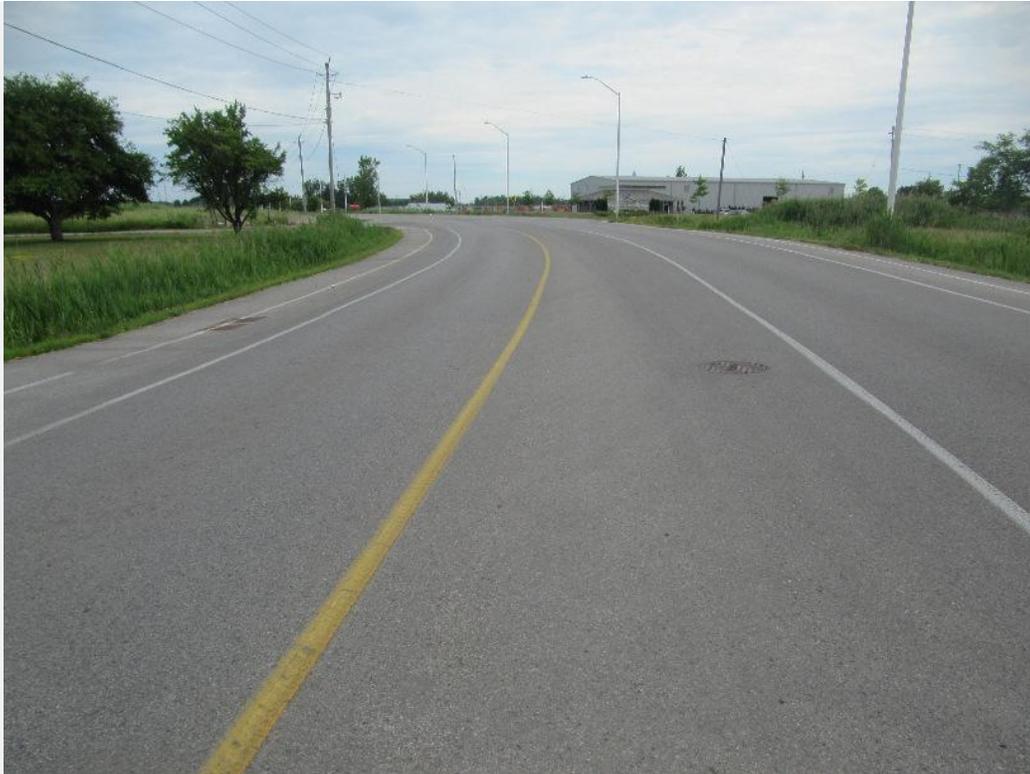
View, looking south along White Oaks Road toward the T-intersection at Blakie Road. A motorcycle travelling around this left curve went out of control and spilled into the right ditch in the background.

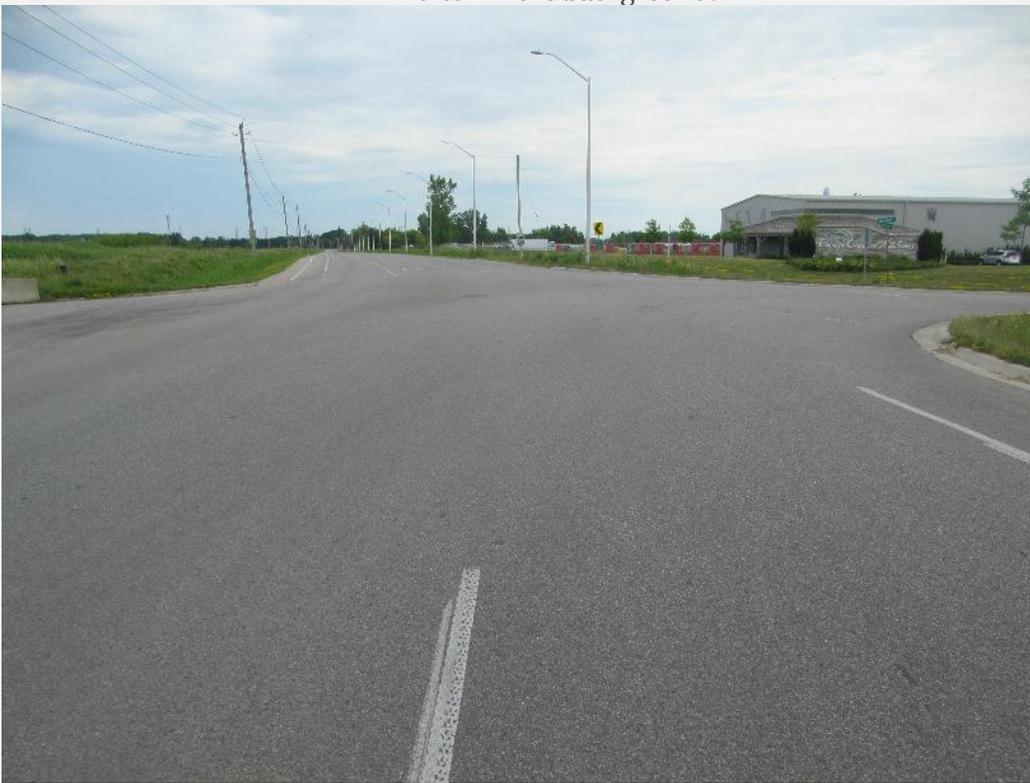
Looking south, the motorcycle fell onto its side and slid toward the lamp post in the centre of this view.

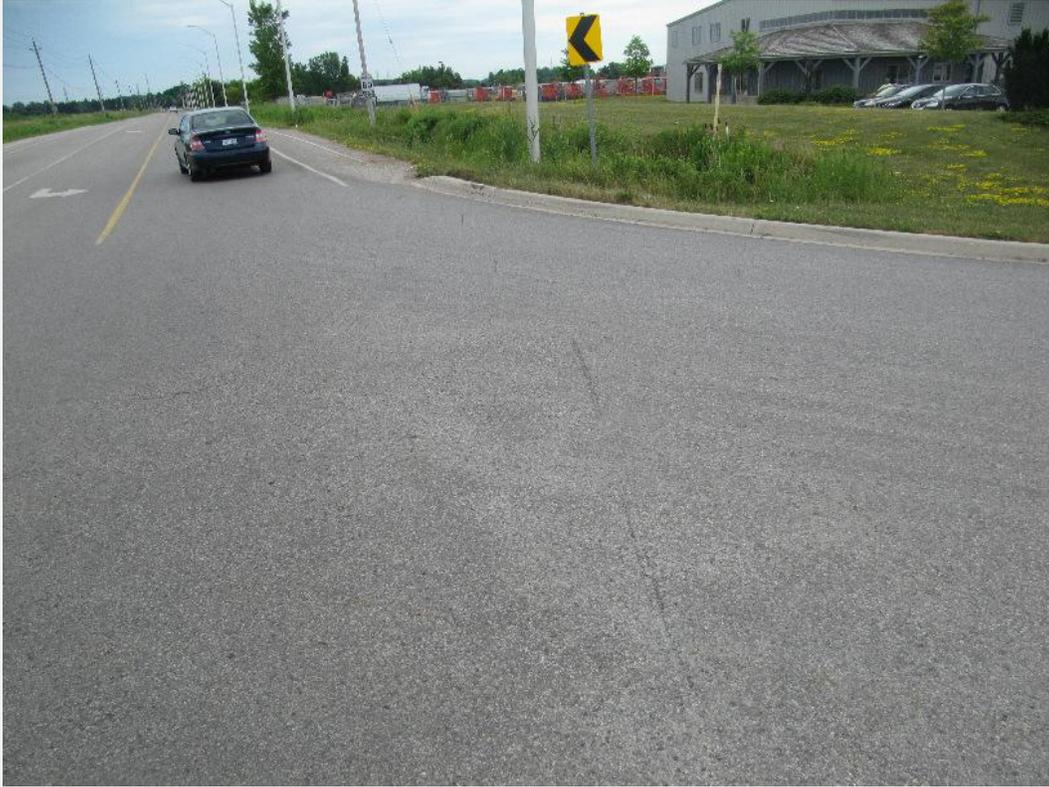
Dark scrape marks seen on the pavement in the foreground indicate where the motorcycle came down before striking the curb in the background.

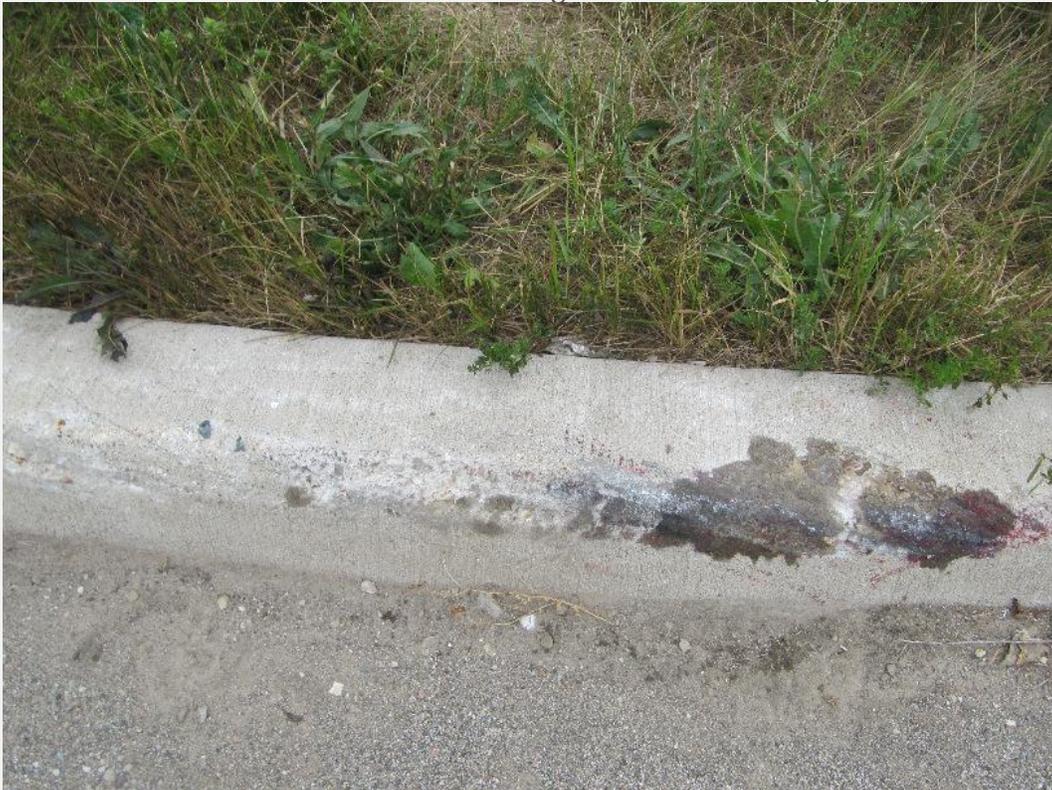
Dark markings on the curb indicate where the contact was made.

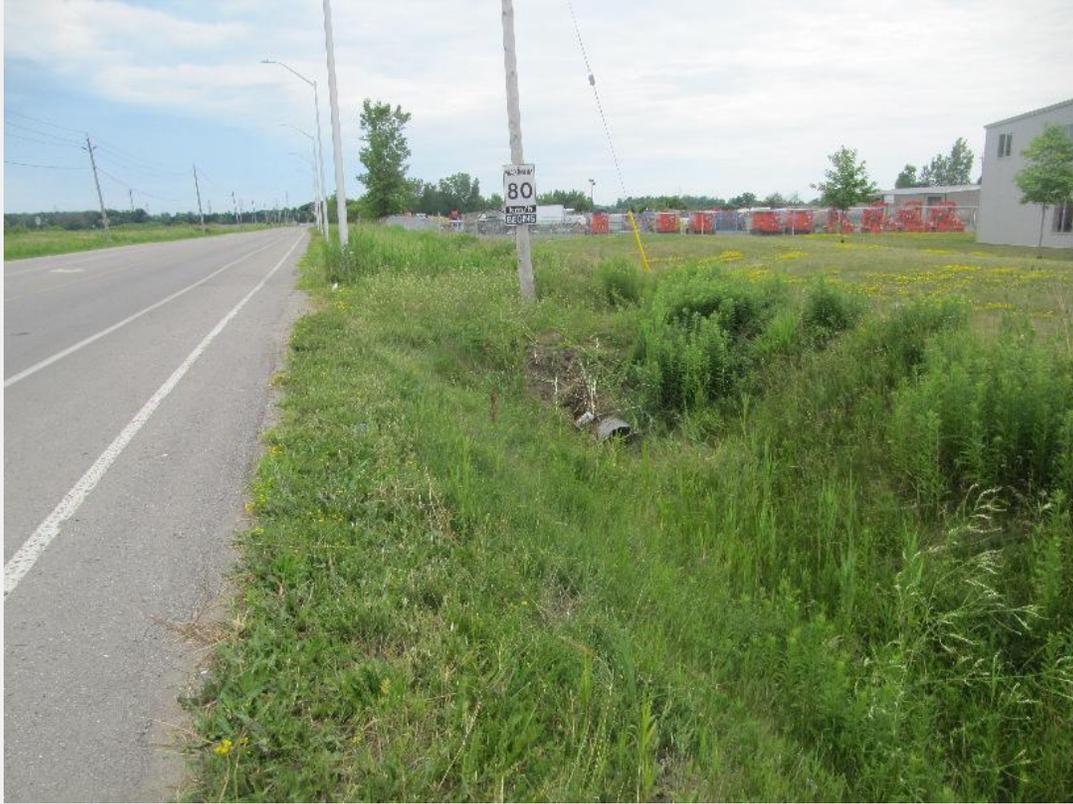
After exiting the road surface the motorcycle travelled into the right ditch where it collided with the end of a culvert in the background.

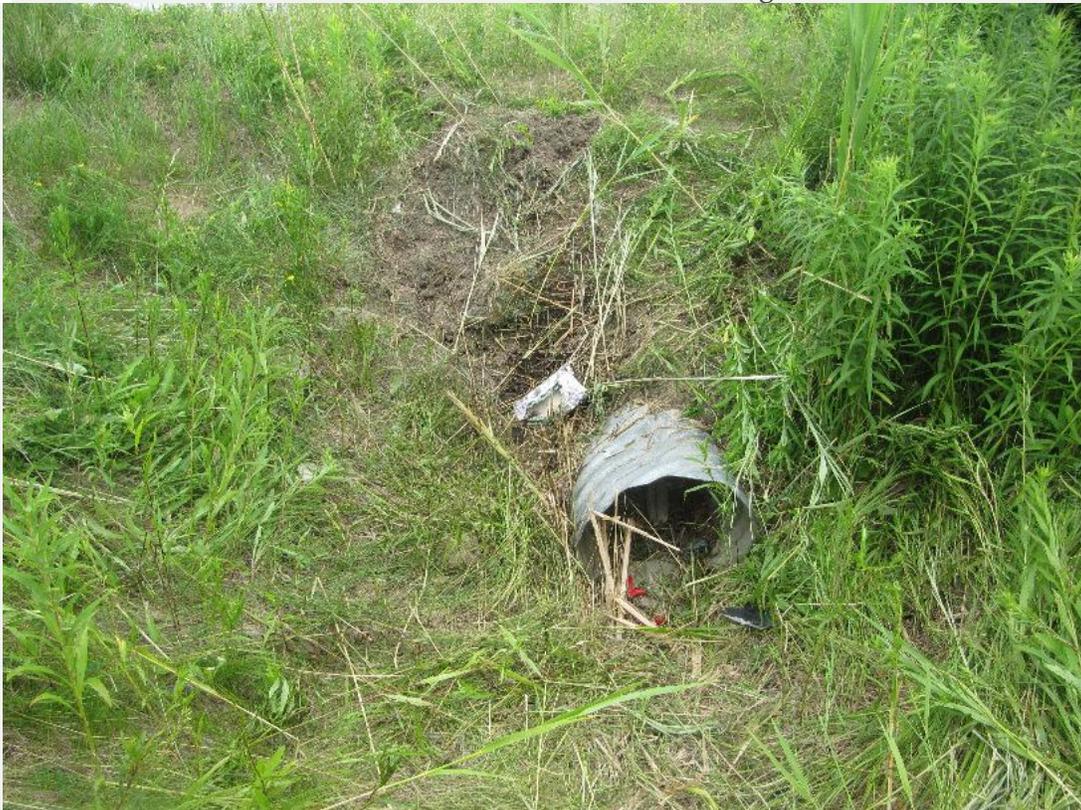
Fresh damage at the end of the culvert indicates where the motorcycle came to rest.

Minus the deceleration from the noted impacts, the total, known deceleration distance was about 45 metres (16 + 29). Using a deceleration level of 0.5g would result in a known speed loss of about 76 km/h. This would be slightly under the posted speed limit sign at the culvert which indicated that an 80 km/h zone was just commencing at that point.
