Are Trinity Guardrail End Caps Defective and Dangerous?

Posting Date: 04-Oct 2014

Gorski Consulting
London, Ontario, Canada

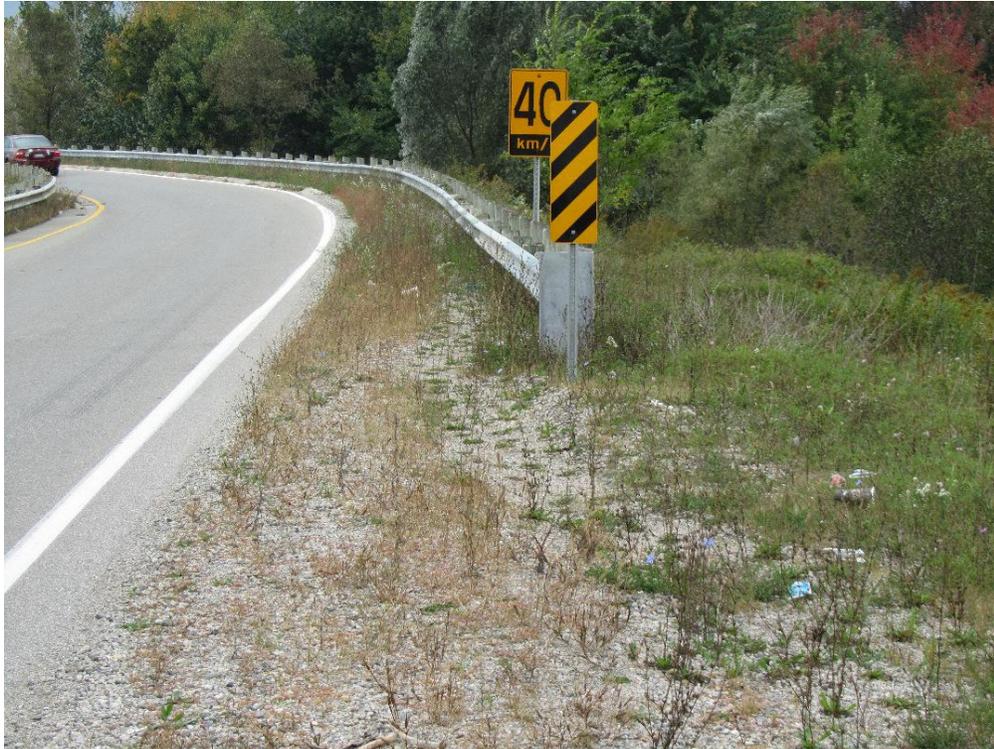
The verbal description of the problem can be difficult to visualize therefore we conducted a brief inspection of a guardrail with similar features to the Trinity guardrail in London, Ontario, Canada. The guardrail we examined was located on the southbound off-ramp from the Highbury Avenue expressway onto Bradley Avenue in south London. Figure 1 provides a view of the west side of the ramp and the terminal end cap on the north end of that guardrail.

Figure 1: View, looking south, at the north end of the terminal end cap of the guardrail on the west side of the exit ramp from the Highbury Ave expressway onto Bradley Ave in south London, Ontario, Canada.

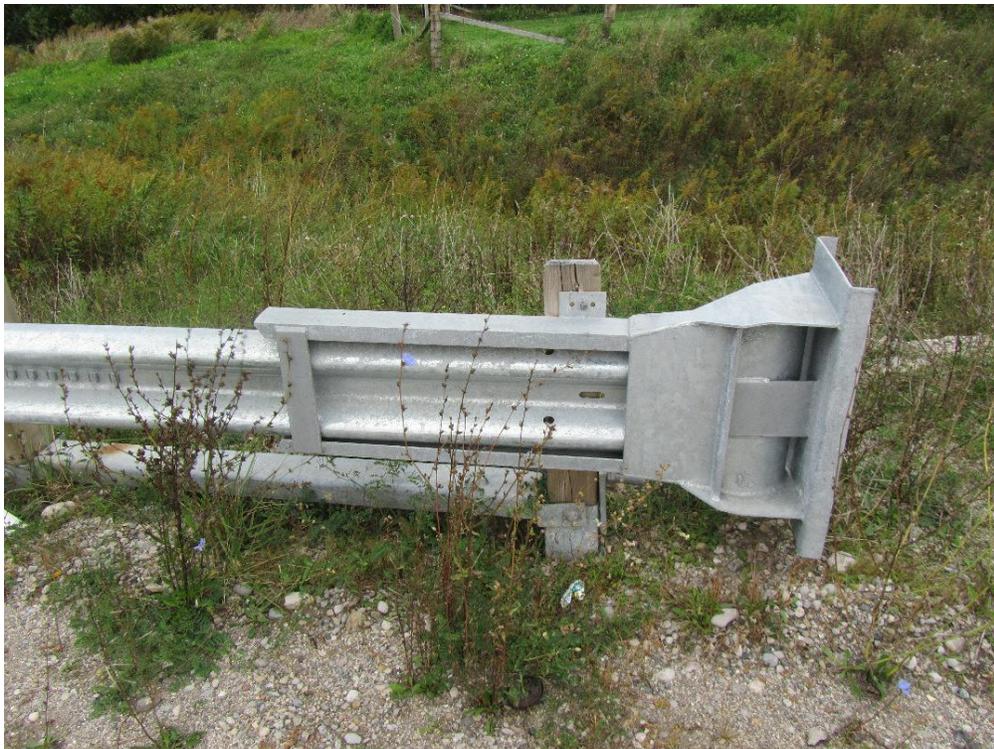
The westward, side view in Figure 2 may help to visualize the mechanism by which a striking vehicle causes the end plate to be driven against the "W" rail. As the end plate is displaced it rides on the rail and allows the rail to pass through its channel. The eastward view in Figure 3 provides a further indication of how the "W" rails rides within the channel.

Figure 2: View, looking west, along the end plate and its channel through which the "W" section passes when the end plate is displaced by an impact.

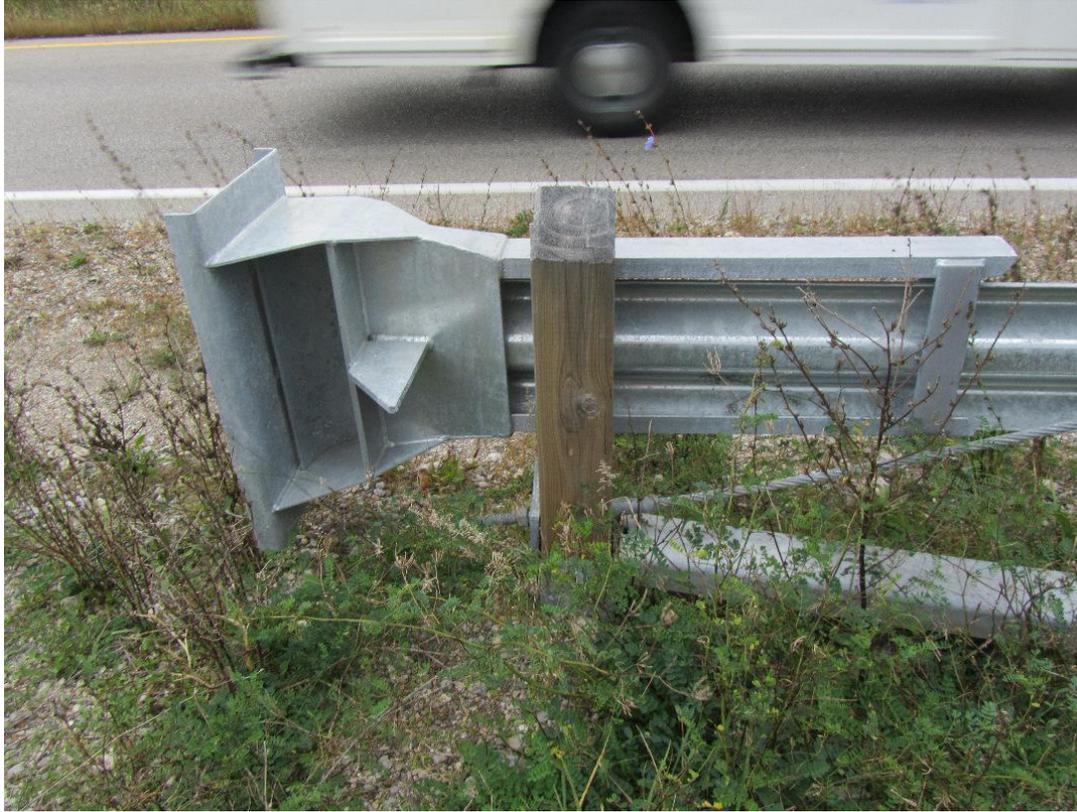
Figure 3: Eastward view of end plate, channel and "W" rail.

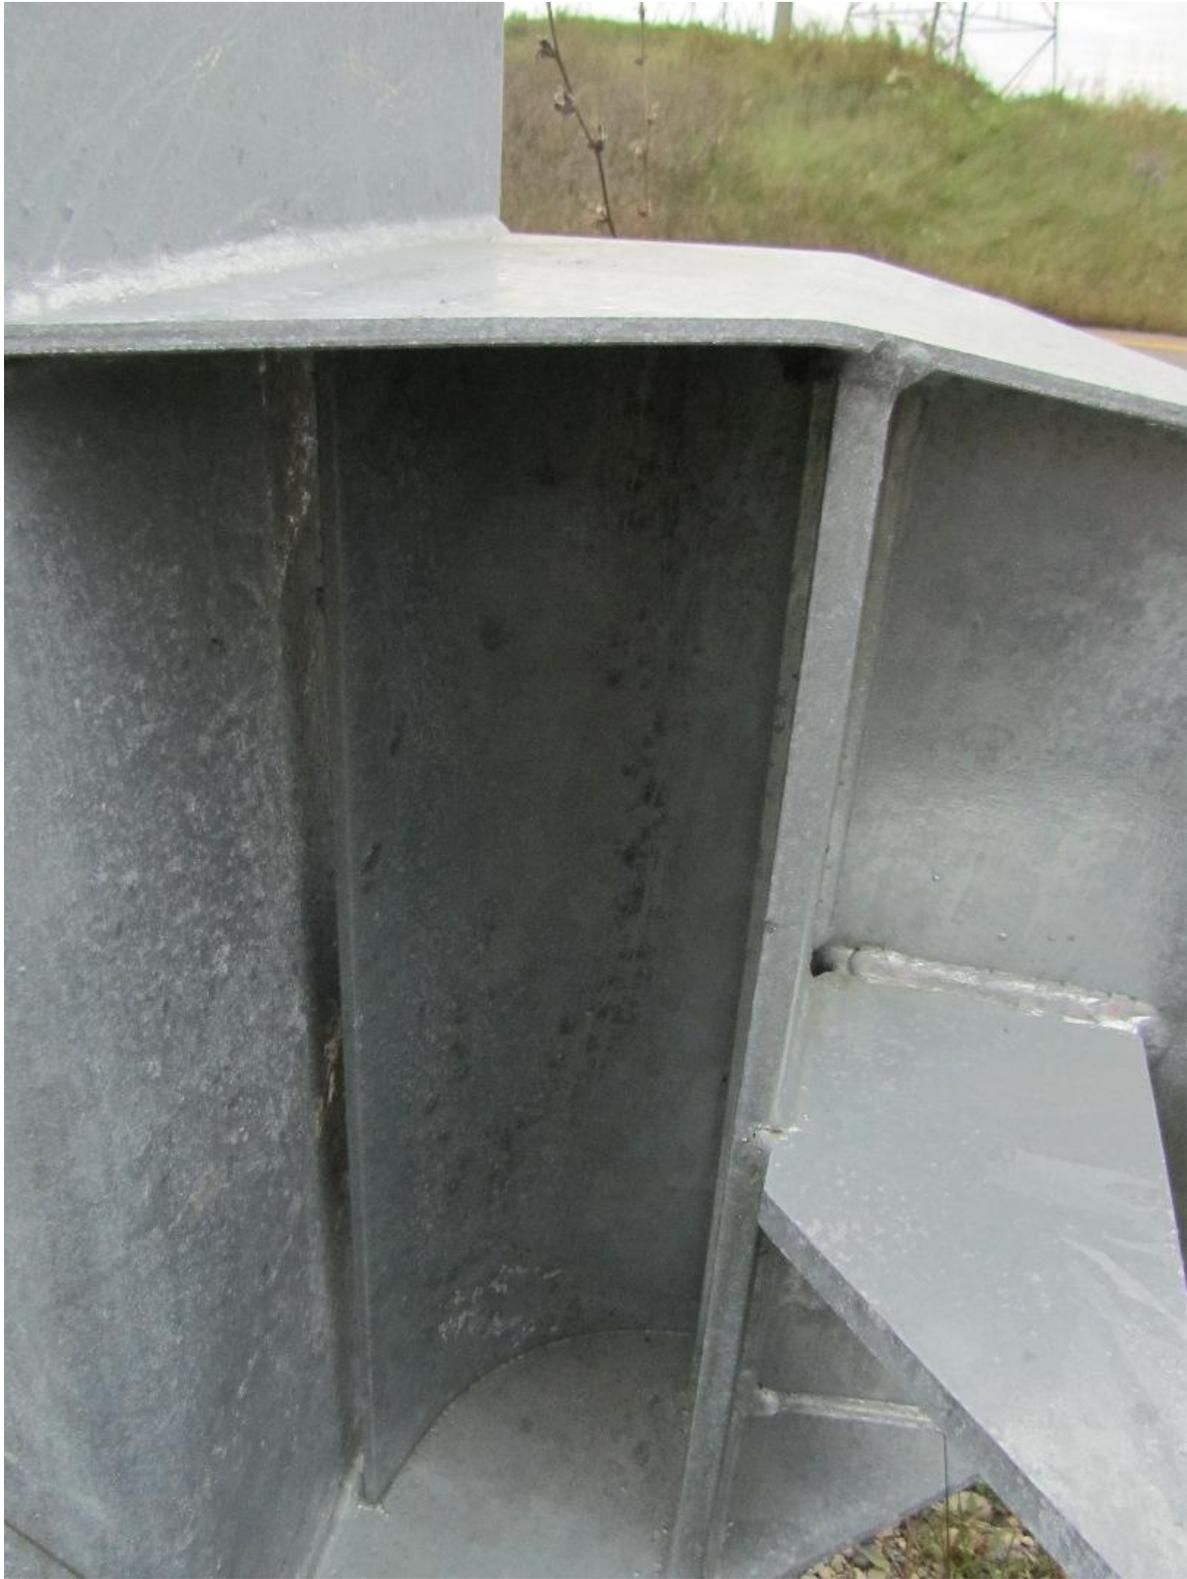
Figure 4 provides a close-up view of the backside of the end plate showing a vertical, curved fabrication which is the mechanism that redirects the "W" rail sideways as it exits the channel.

Figure 4: Close-up view of vertical, curved fabrication behind the end plate that redirects the "W" rail into a sideways orientation as the end plate is being driven along the rail.

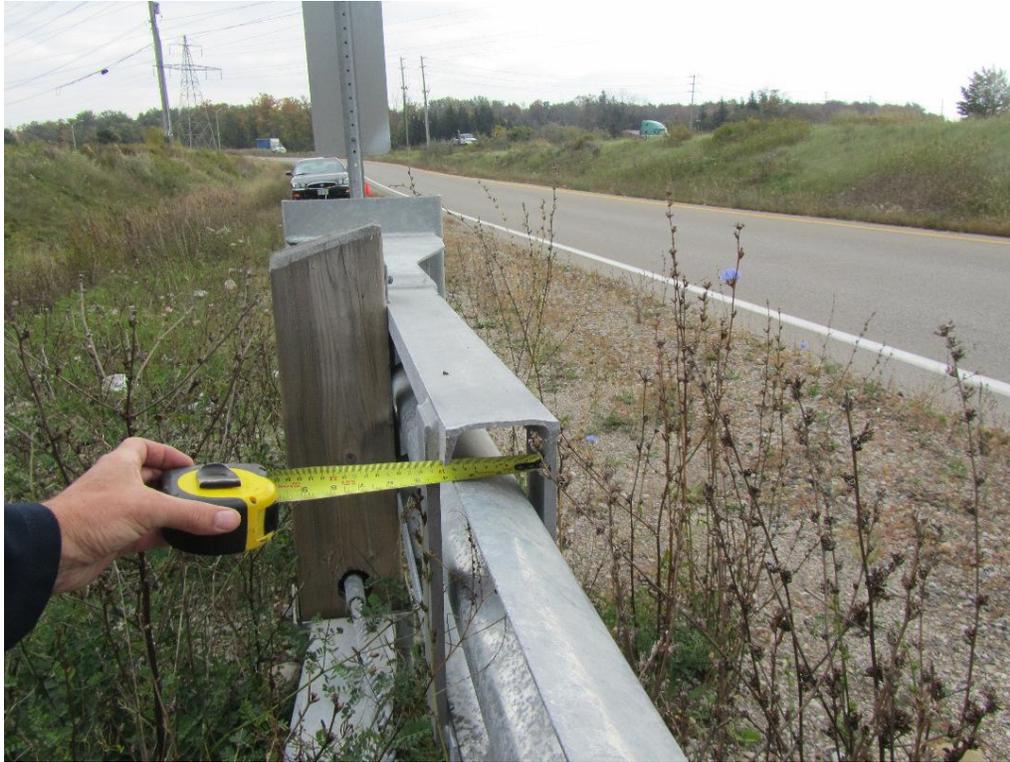
Figure 5 shows a measuring tape spanning the gap of the channel within which the rail is to ride as the end cap and channel are displaced along the rail. We believe it is this gap that is the issue of the defect allegation. As shown in Figure 6 the measured gap of this channel is only 4 inches. So this would appear to be the newly, redesigned channel whose width was reduced from the original 5 inch gap. Yet, we are aware that this guardrail installation is not new. Certainly it existed before 2002 when the channel was allegedly redesigned. So why does it appear that we have the installation of a new end cap and channel?

Figure 5: View showing measurement being taken of the width of the channel.

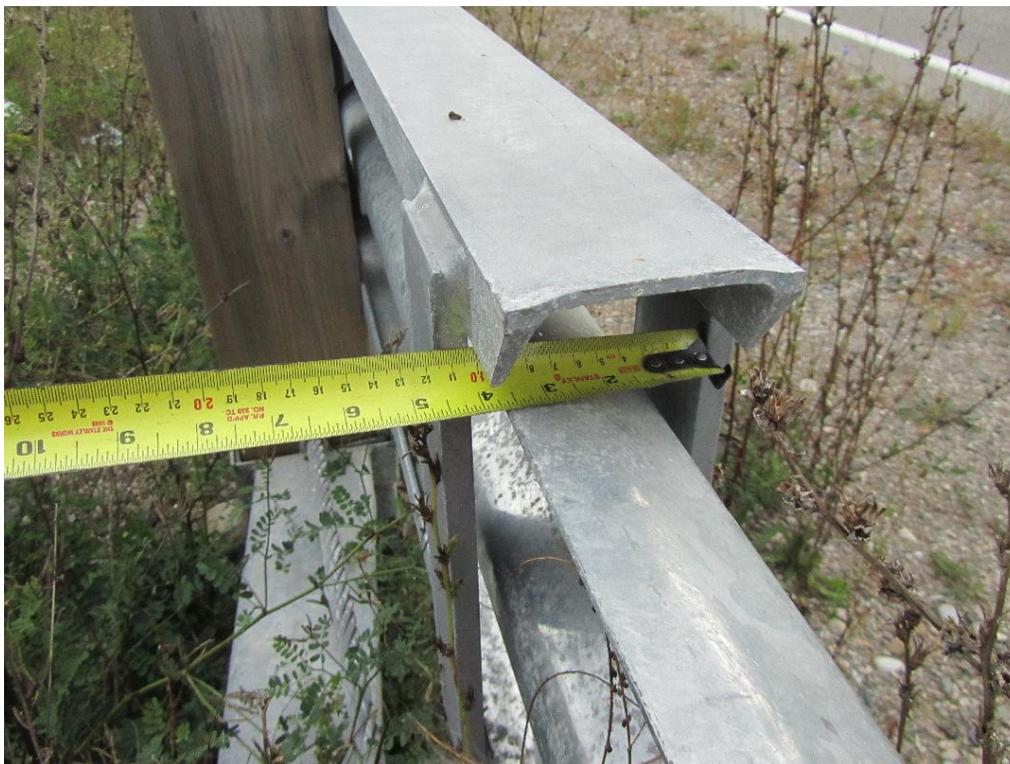
Figure 6: Our measurement indicates that this channel is only 4 inches wide therefore it is the newly re-designed one that is the source of the defect allegation.

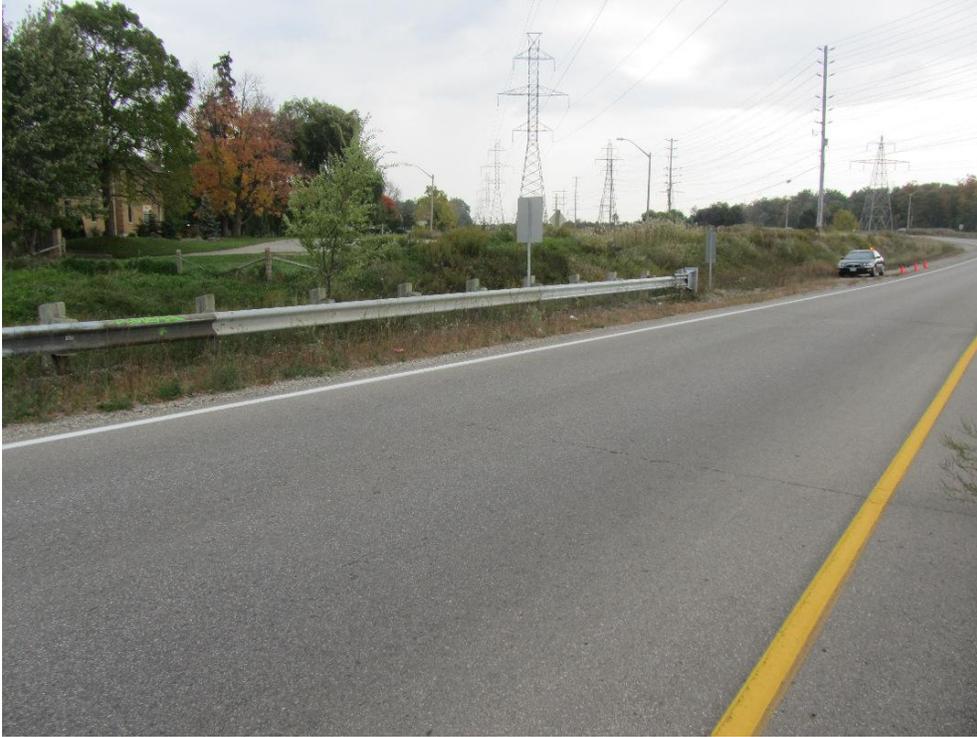
The reason becomes apparent when we look at the length of the guardrail as shown in Figures 7 and 8. Notice that the "W" rail on the left (south) is darker and older looking than the portion to the right (north), near the end of the guardrail. It becomes clear that, over time, the guardrail has been impacted, damaged and replaced. The most recent replacement came at the north end of guardrail, and at that time the end plate was also replaced.

Figure 7: View of west guardrail showing the older section to the left (south) and the newer section to the right (north) indicating that the north portion, including the end plate, had been recently replaced.

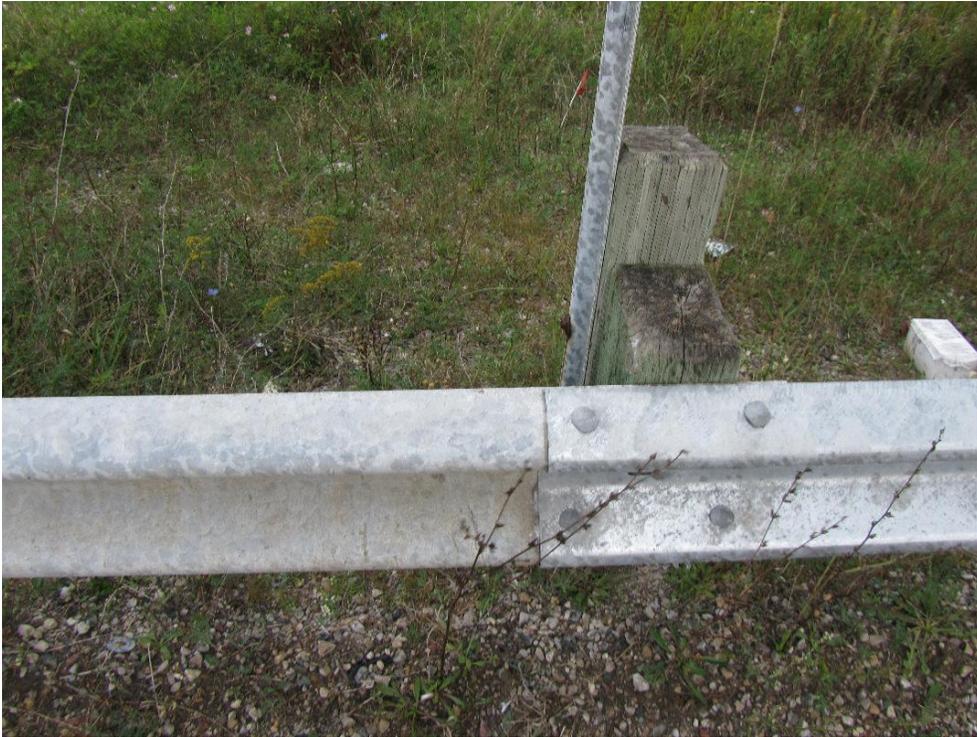
Figure 8: View of the junction between the older and newer "W" rails indicating that the rail had been replaced and this explains why the newer (defective?) end plate was installed on this older system.

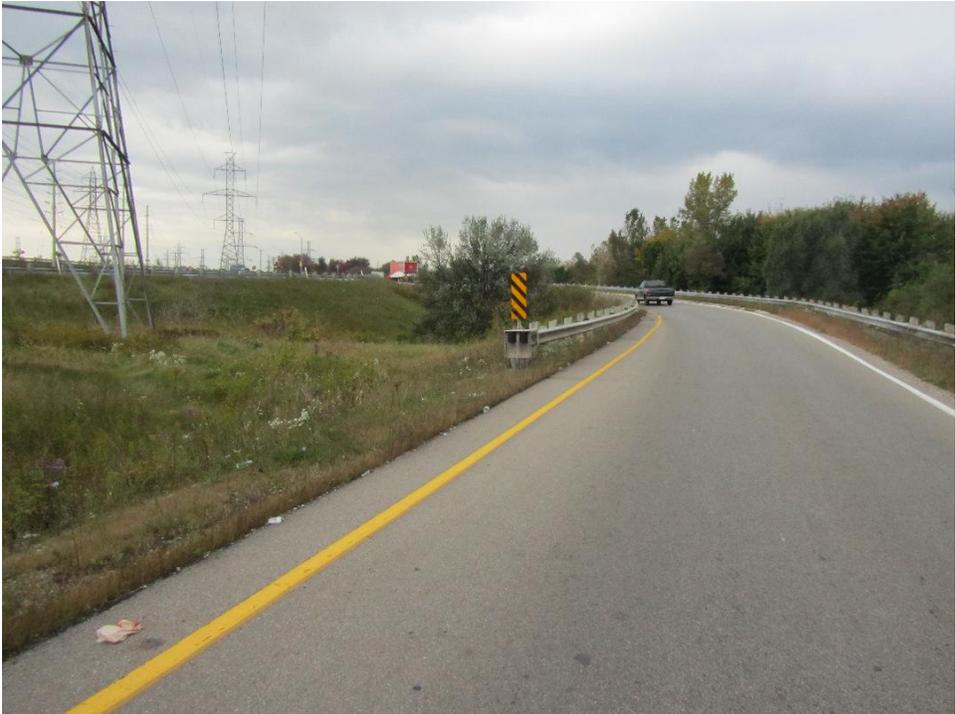
There was an interesting discovery when we turned to look at the east guardrail on the other side of the ramp, as shown in Figures 9 and 10. The immediate observation is that the front face of the end plate appears to be different.

Figure 9: View, looking south, at the east guardrail.

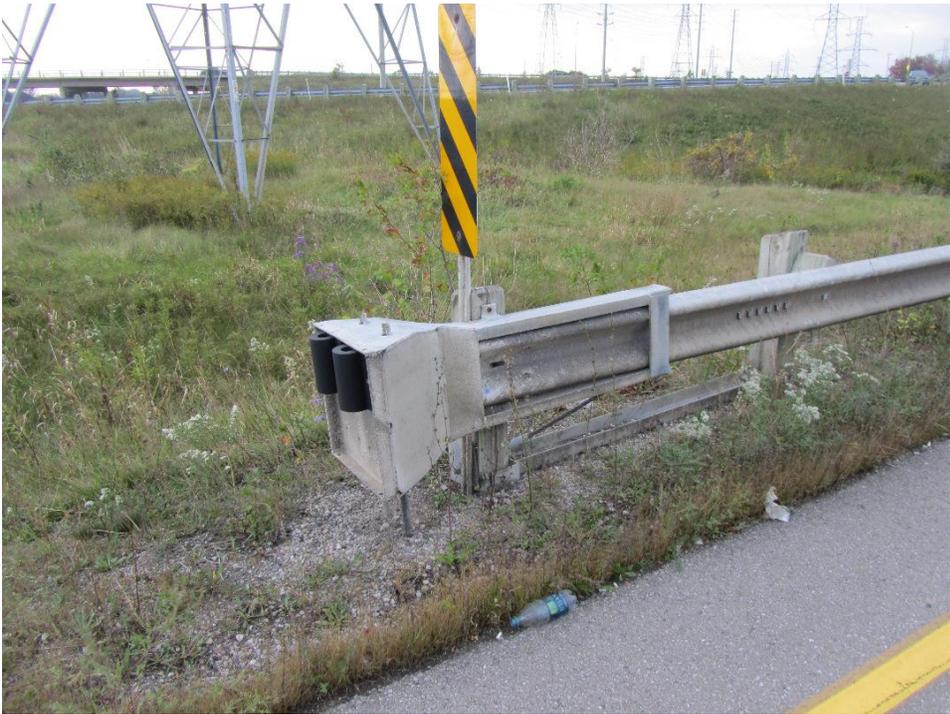
Figure 10: View of a possible missing face of the end plate on the east guardrail.

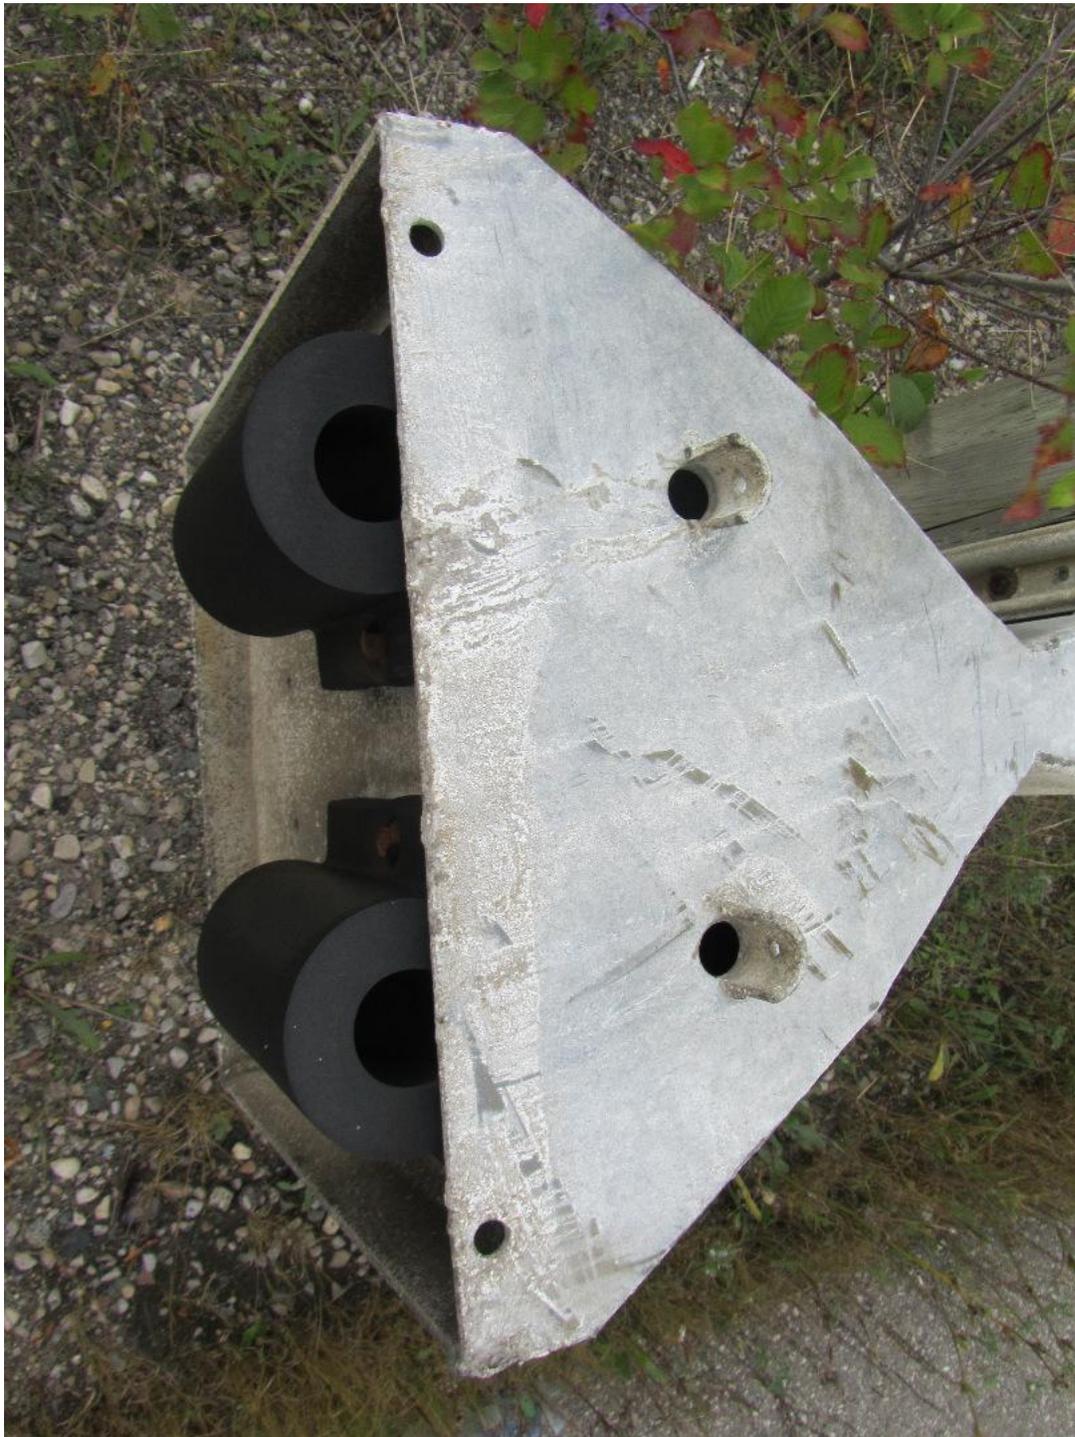
Figure 11 shows some scratches to the top surface of the end plate suggesting that there might have been an impact to it and that, perhaps, some kind of cover should have existed over the front face of the plate that no longer exists.

Figure 11: View of top surface of the end plate indicating some scratches from a possible impact and indications of a possible missing front cover.

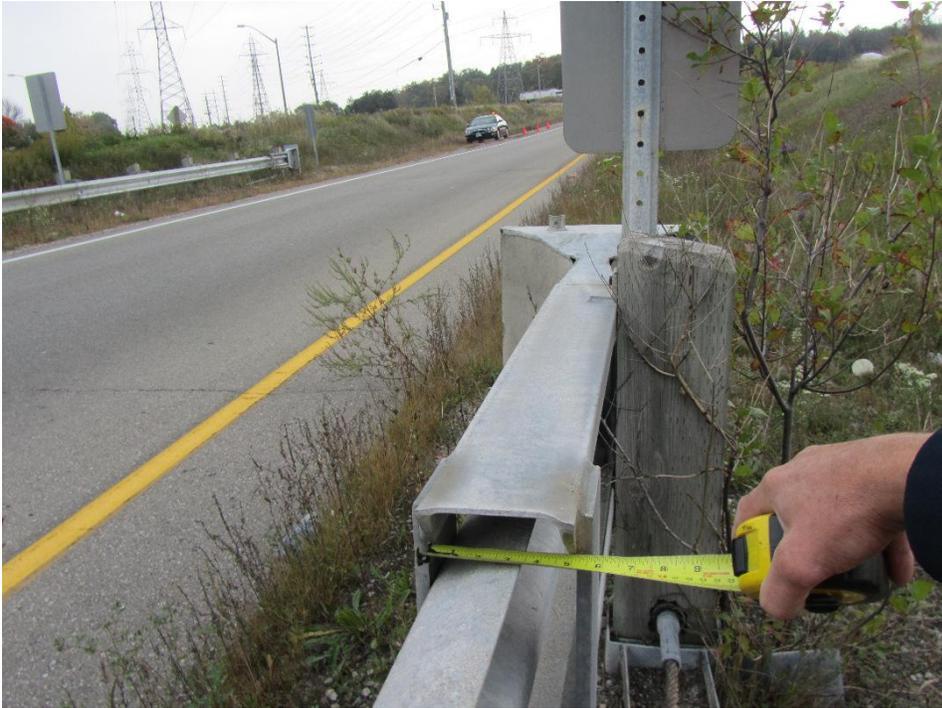
Figure 12 shows how we took the same measurement of the width of the channel of the east guard rail as we did on the west guardrail. Figure 13 shows that the width is 5 inches.

Figure 12: View of measurement being taken of the width of the channel on the east guardrail.

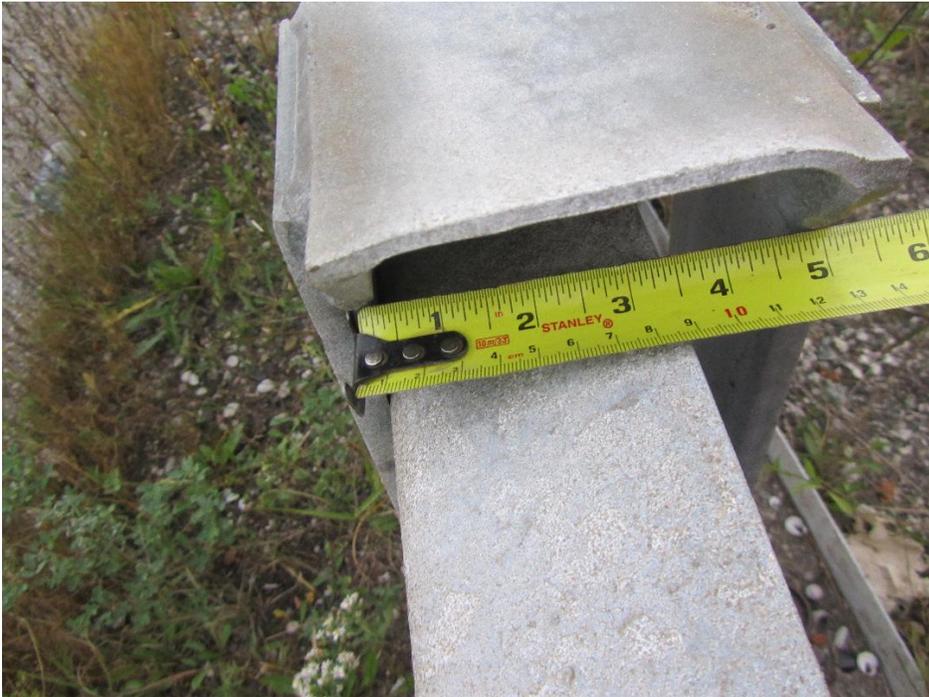
Figure 13: Width of channel on east guardrail is 5 inches.

This suggests that the end plate and channel on the east guardrail are of the older system with the wider channel and that this end plate and channel had not been transferred to the newer (defective?) design.

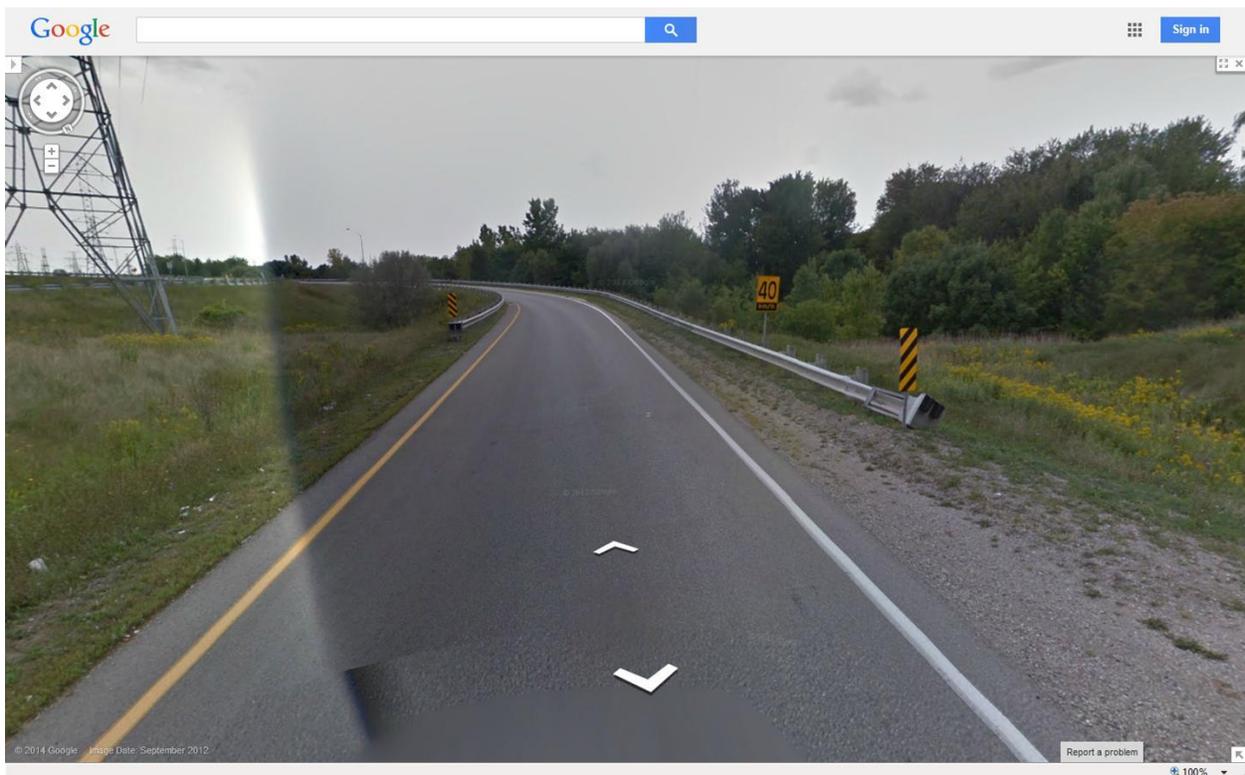
We conducted a further inspection of this site using Google Maps and located an image from September, 2012. Figure 14 shows the Google Street View, looking south along the ramp and we can see the north ends of the east and west guardrails. Surprisingly, it can be seen that the ends of both guardrails are similar to that of the present condition of the east guardrail. From our observation, it would seem that a front face of each end plate is missing.

Figure 14: Google Maps view of the guardrails from September, 2012. Note that the ends of both guardrails may be missing a front cover on their end plates.

Further inquiries need to be made whether the end caps shown in Figures 14 and 15 are missing a front cover that existed in the original design. Even without that information, clearly the deformed angle of the west guardrail could not be expected to function properly and could be a danger to the public.

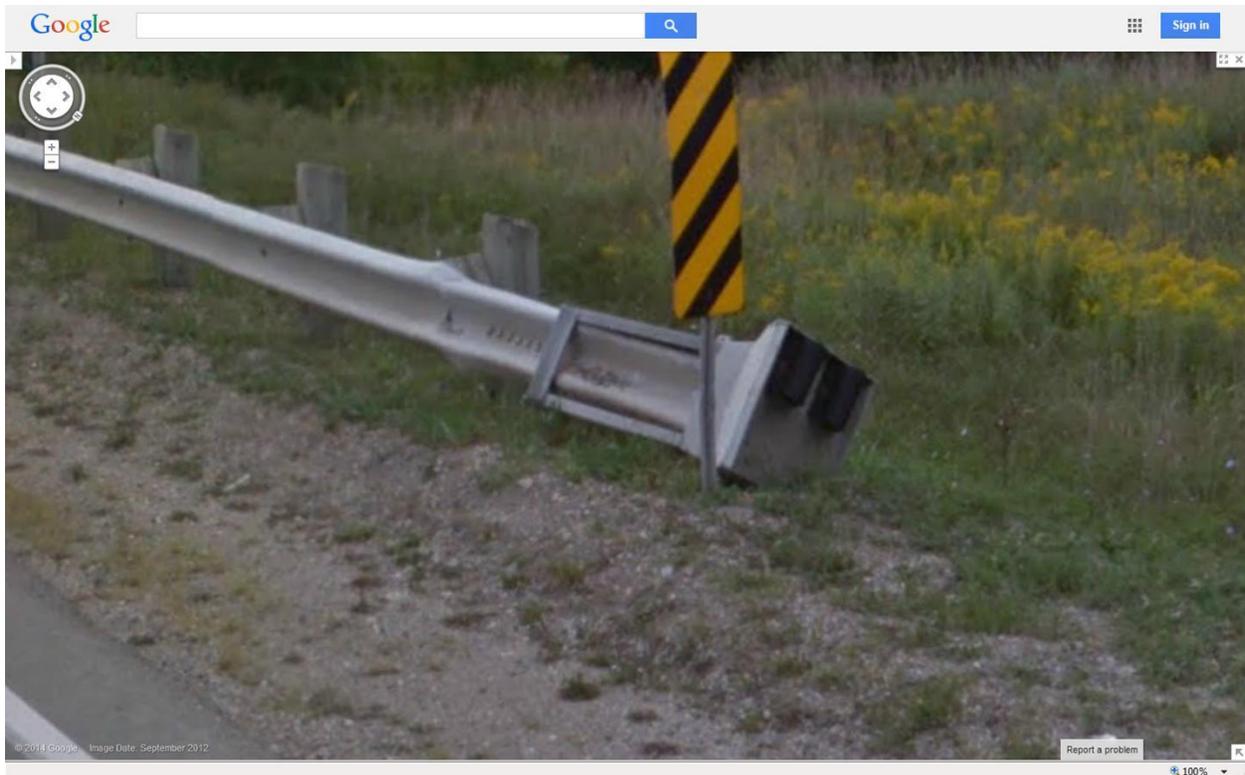
Figure 15 also shows a closer view from Google Maps of the end of the west guardrail and here we see that its end has been displaced and is at a substantial angle such that one corner is dug into the ground.

Figure 15: View of deformed end of the west guardrail from a Google Maps image taken in September, 2012.
