Fatal Loss-of-Control Collision on Oxford County Road 6 North of Brooksdale

Posting Date: 28 Oct 2010

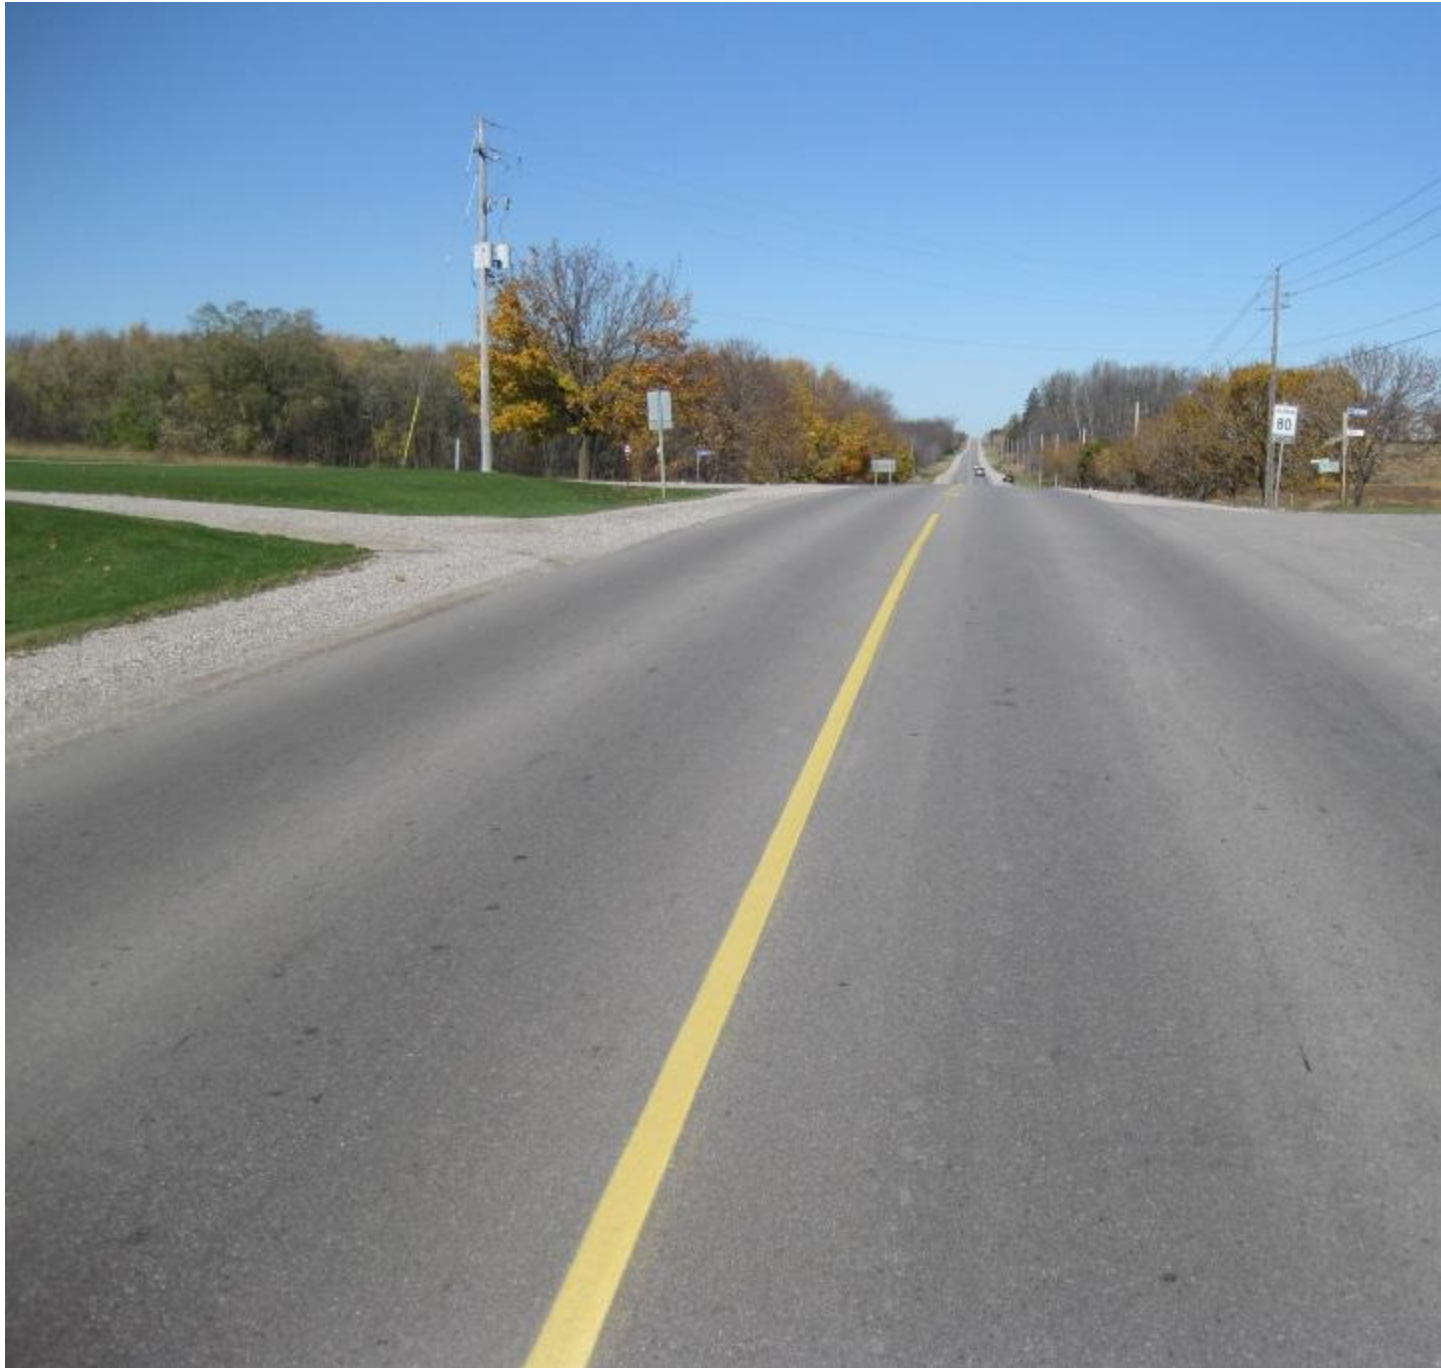
Now, let's look at the accident site from a distance. The tree impact where the vehicle came to rest was about 700 metres north of the intersection with Oxford County Road #92. In this area County Road #6 takes some considerable hills and valleys. The photo below is a northbound view of the roadway just north of the County Road 92 intersection and you are seeing the last hill/valley before the tree impact.

The maximum speed sign that you see on the right side of the road is the beginning of that speed while behind the camera the speed limit was 60 km/h because of some limited visibility due to a steep downgrade and the noted intersection. So basically the vehicle should have been travelling relatively slowly as it passed the intersection and then as it approached the location of the above photo its speed should have increased. If the vehicle went out of control while passing another vehicle then it would appear that this happened near the beginning of the increased speed zone.

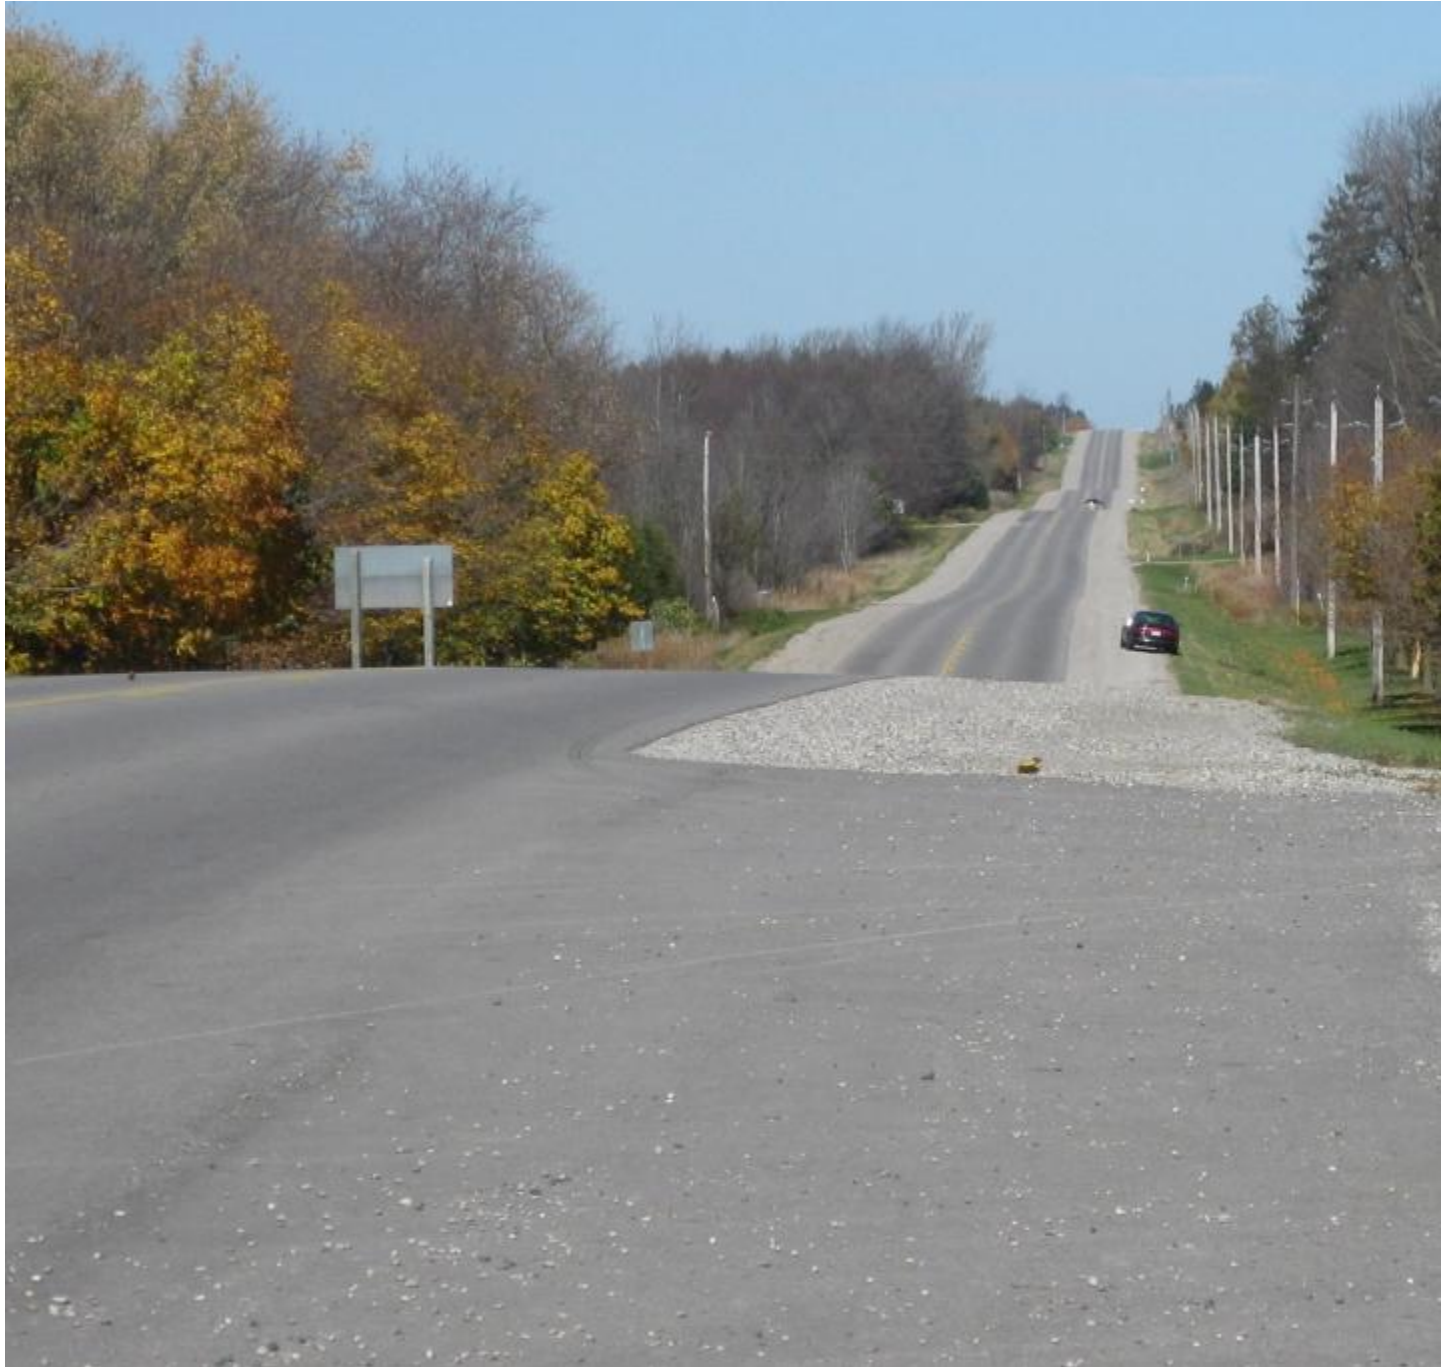
Next, I am going to show you a similar view to the one I just showed you but this time it is closer to the right, or east side of the road, but still looking northward. The black vehicle that you see parked in the distance on the right shoulder is my vehicle and it is adjacent to the tree that was eventually struck by the vehicle.

The above view is somewhat distorted because it is zoomed in so that you can appreciate the contours of the road and the position of my parked vehicle. The distance from the camera to the parked vehicle is still several hundred metres but what I'm trying

to demonstrate is that there is a downslope as the driver lost directional control somewhere in this area.

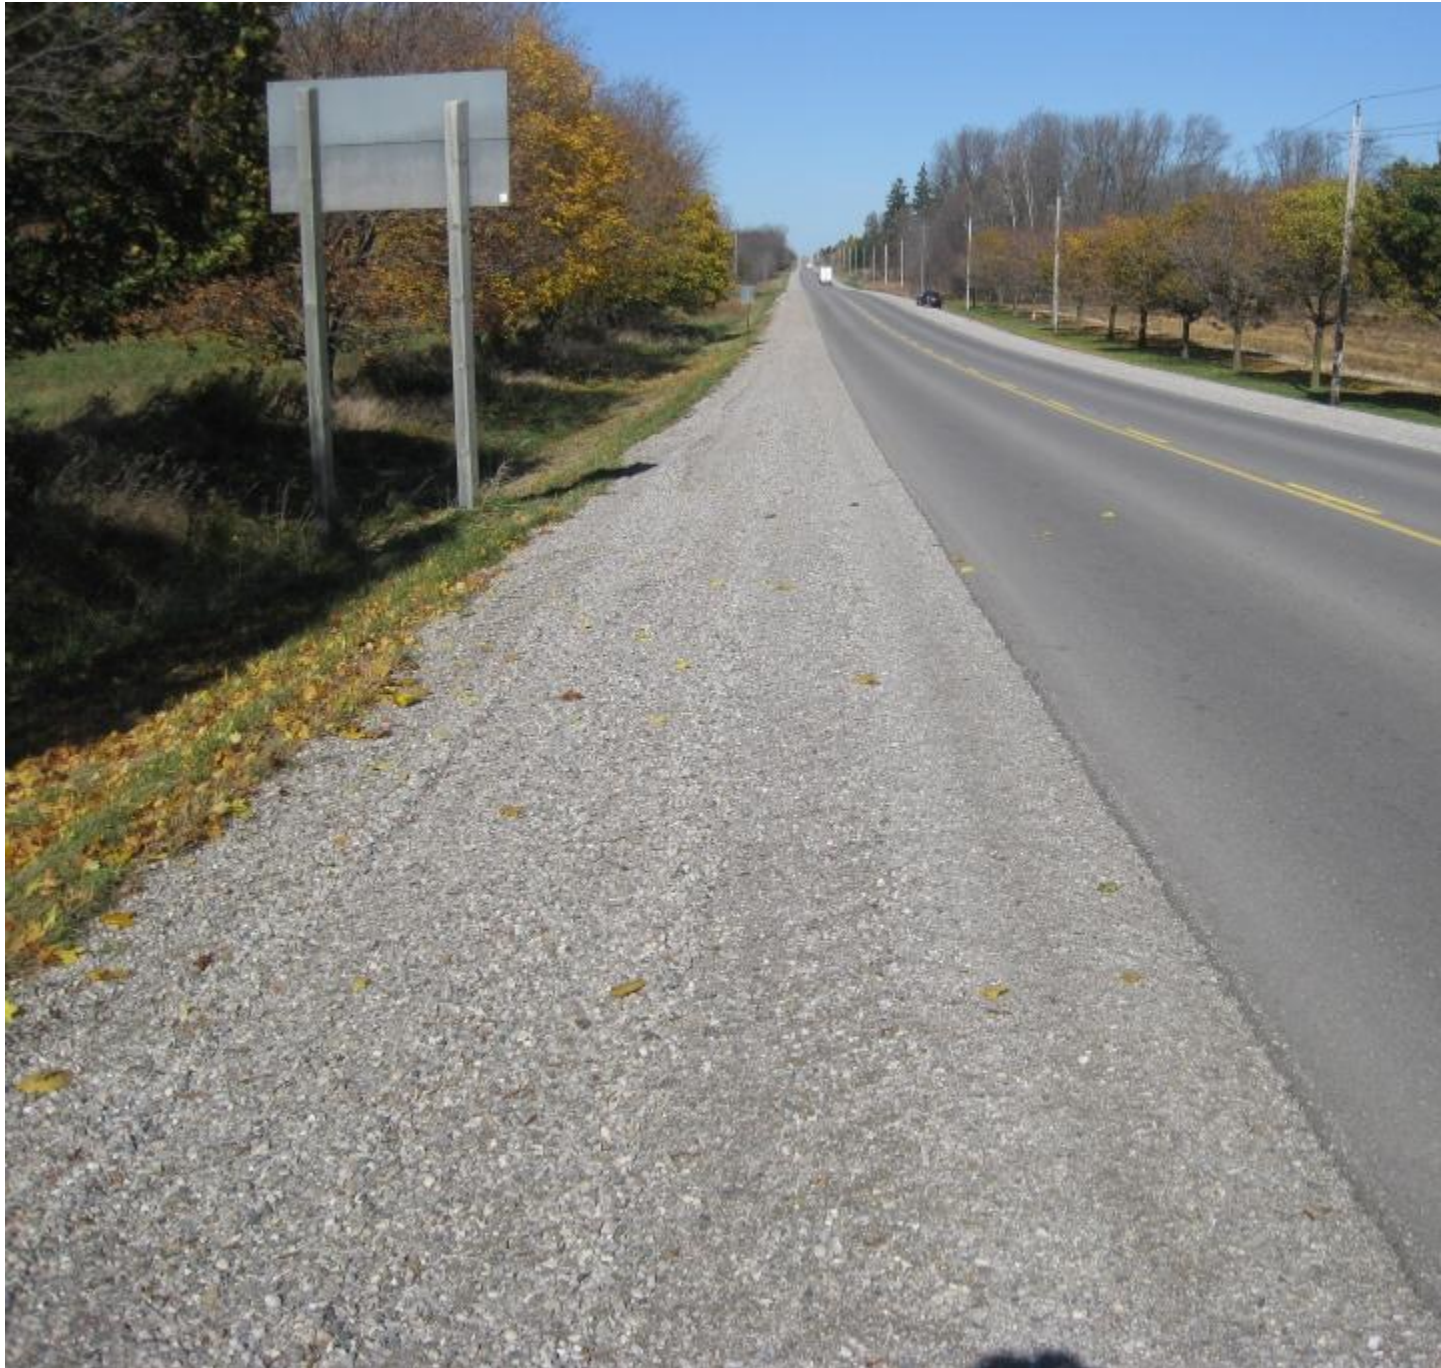
Next, if you are at all a reconstructionist or someone familiar with loss-of-control collisions you will want to know what is on the shoulders of the road because very often we see loss-of-control tire marks in the gravel. Well, I did not notice any tire marks on either shoulder of the road. But just to appease the curious viewer, here is a view of the west shoulder.

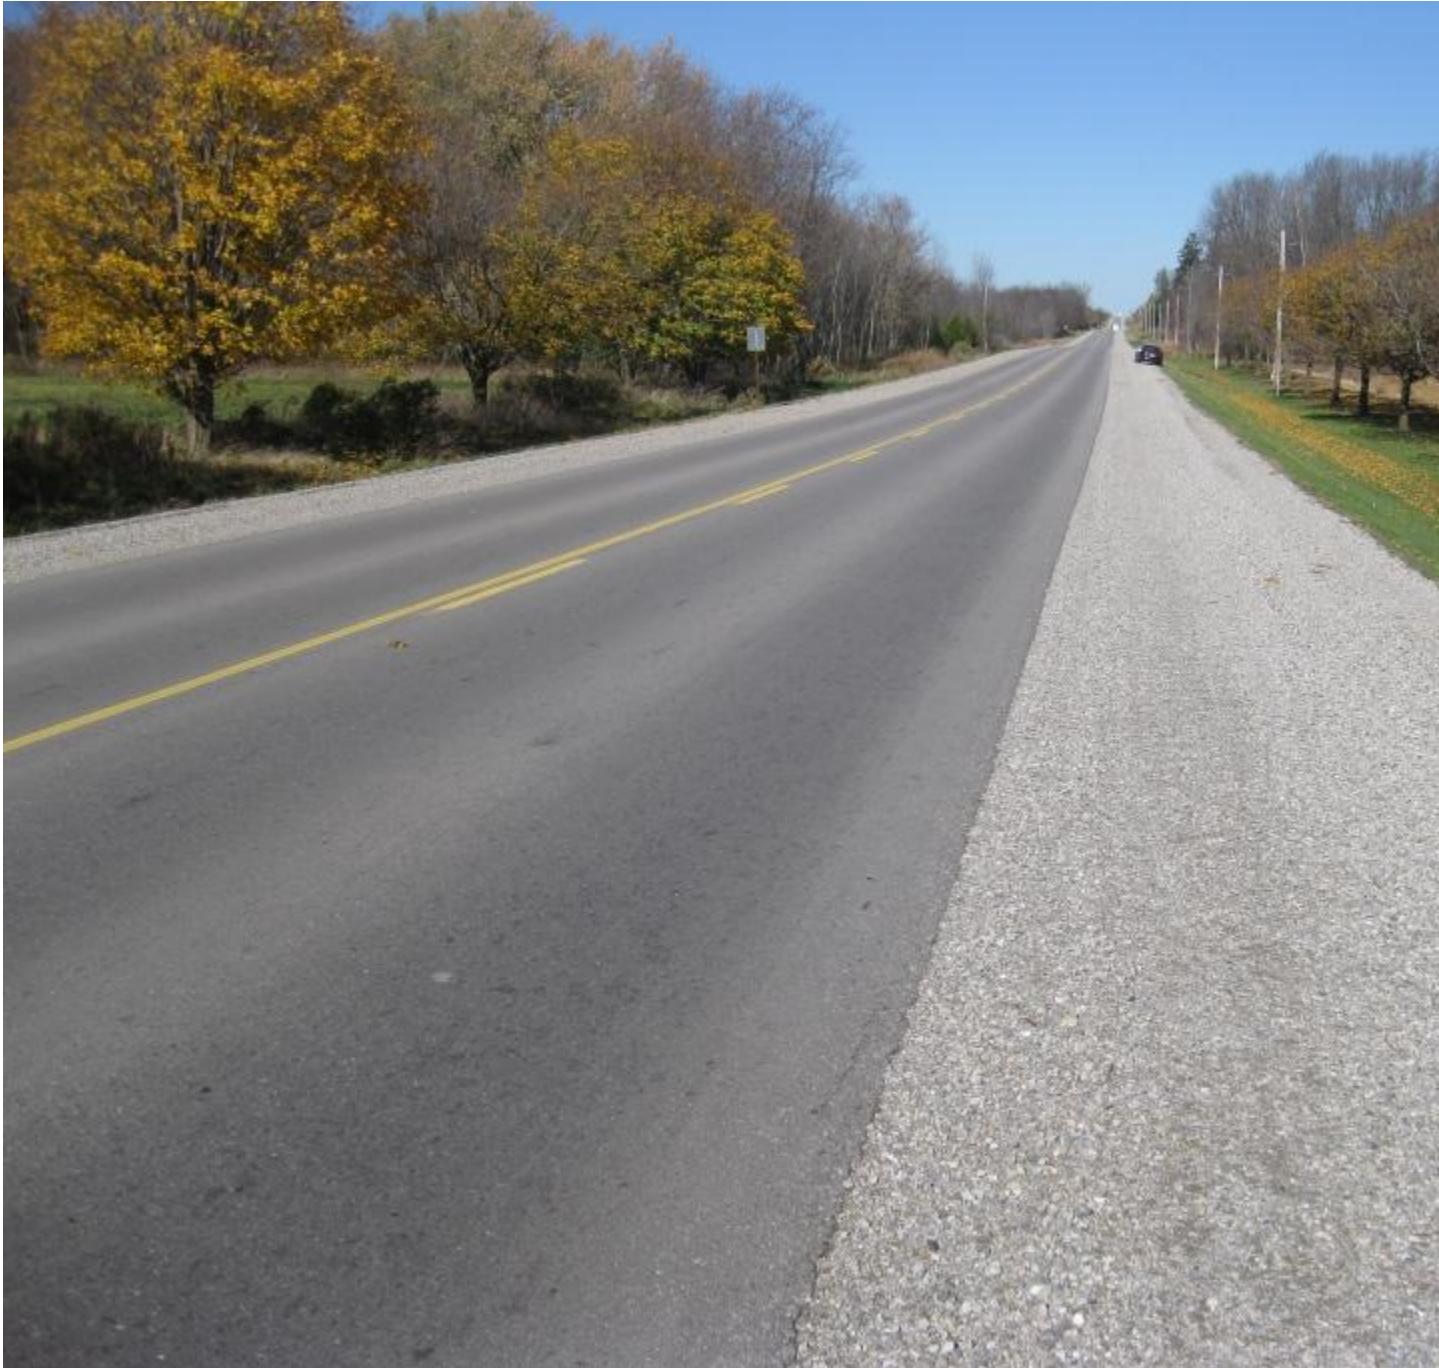
And here is a view of the east shoulder.

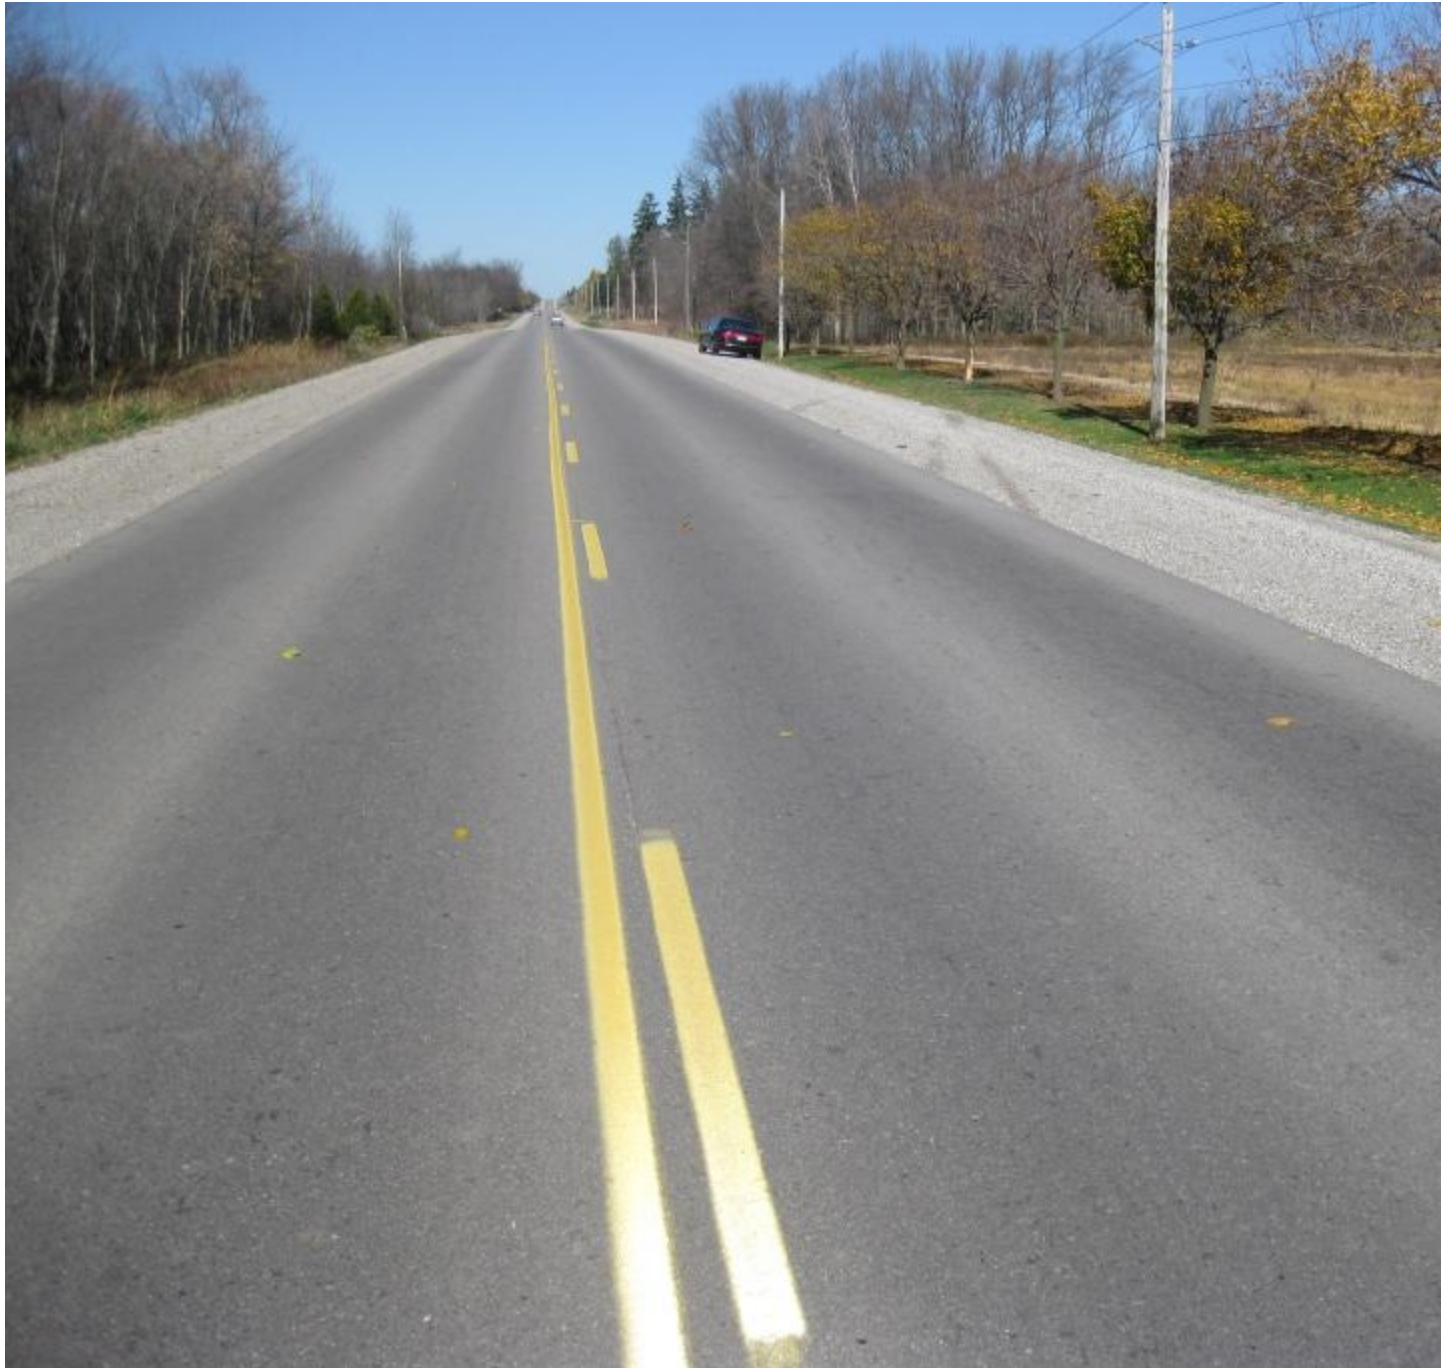
There was no evidence on the road surface and the first sign of any tire marks was at the east gravel shoulder after the vehicle was already in an advanced stage of rotation. Here is a view of the road near the beginning of the tire marks on the east shoulder.

Now it should be fairly evident in the above photo exactly where the loss-of-control tire marks reside on the shoulder and the lack of tire mark evidence on the road. I have no doubt that if I had arrived at the collision scene within a short time after the collision, in the role of an investigating police officer, I would have found additional tire marks on the pavement and likely other marks perhaps on one of the shoulders. Of course the critical factor is rain and wetness. If the road surface was wet then the chance of finding a tire mark on the surface, even minutes after the crash, drop dramatically. Certainly I would

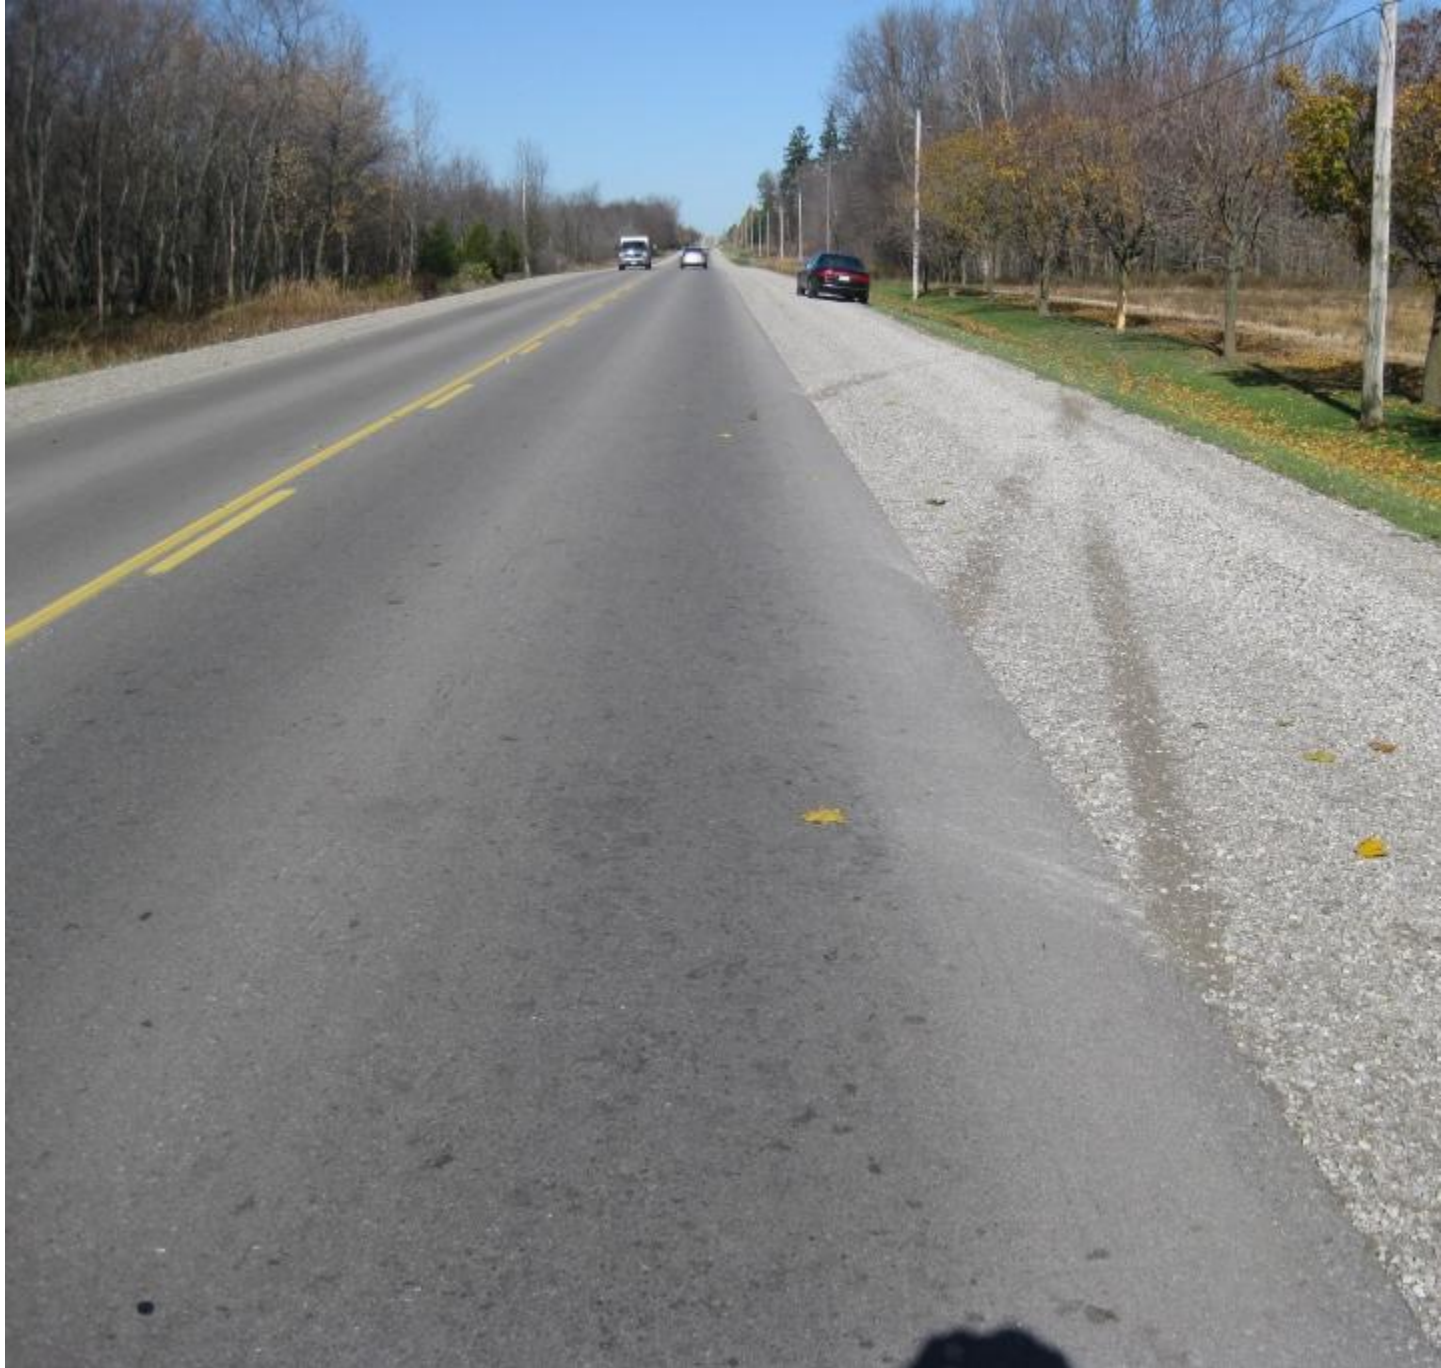
Now, below, I will show you the tire marks as they come off the pavement and onto the east shoulder.

It is not surprising that we would find the typical evidence of tire marks that are converging and diverging. And the tire marks appear fairly straight. This is an indication

of high speed. If you are uncertain then go back and take a look at the photos of the tire marks I showed in the recent article of the fatal collision that occurred on Kent Bridge Road. The tire marks in that case were swarming all over the road, in a lateral sense, because the vehicle was travelling relatively slow (so far as loss-of-control collisions are concerned). The tire marks in the present case are so straight because the vehicle is travelling so quickly and it cannot change its lateral position very much in the visible distance because it is travelling through that distance in very little time. Let's move on.

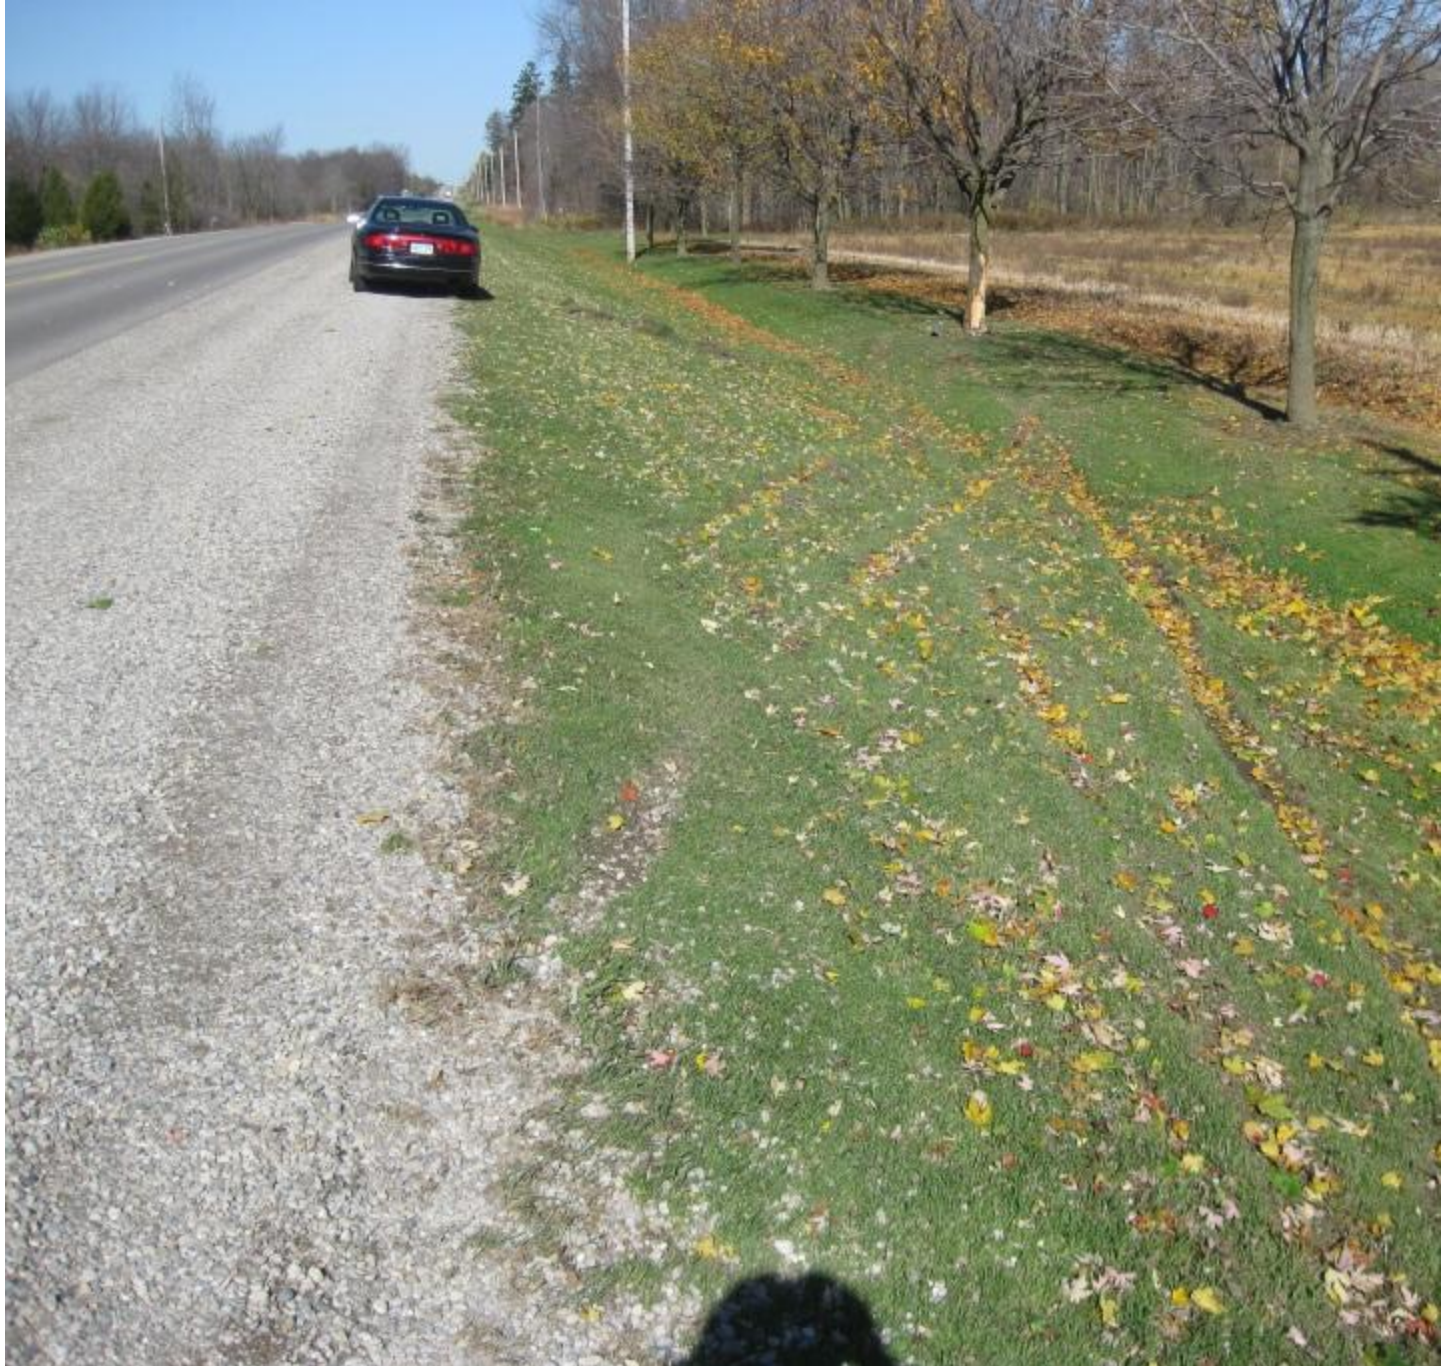
Now let's look at the tire marks as they move through the east roadside and toward the tree, as shown in the photo below.

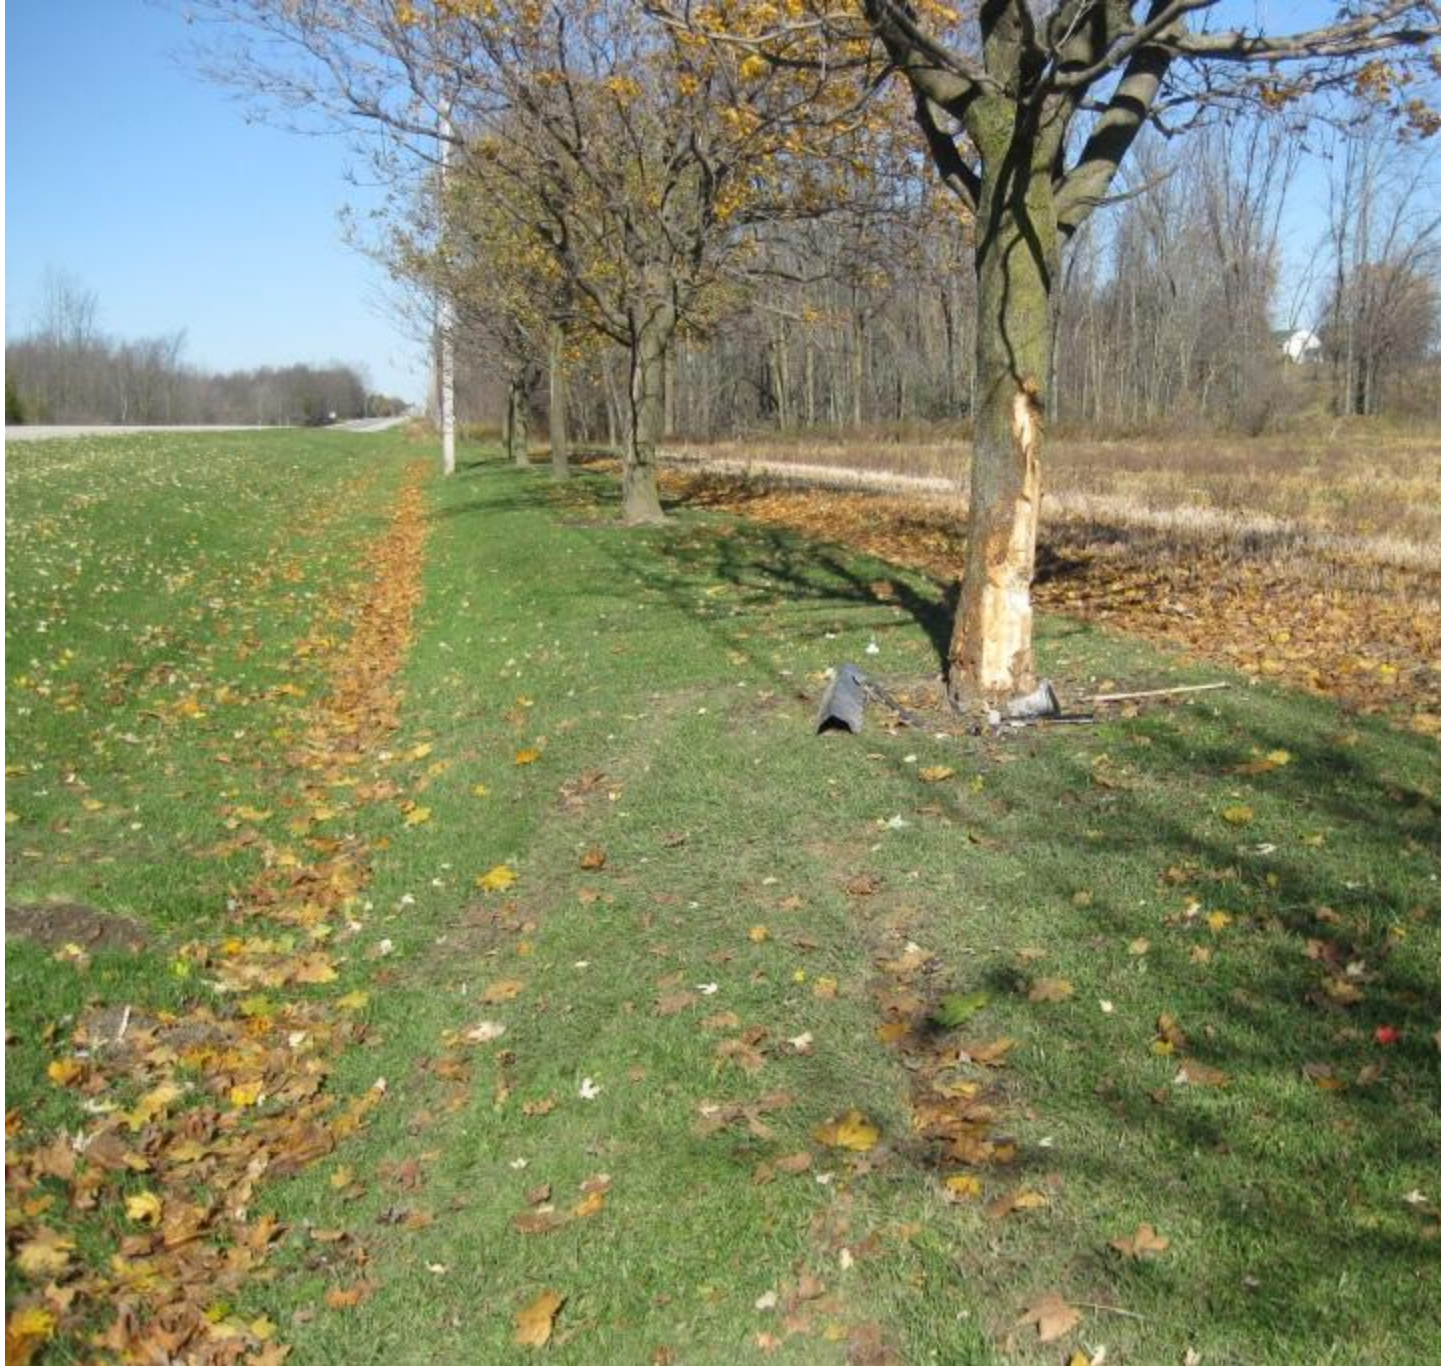
And below you will see the evidence of impact with the tree.

This was a fairly violent impact so far as impacts with trees are concerned and this is evidenced by the amount of bark and wood that has been removed from the trunk. One can study these events further by placing a tape measure vertically along the trunk and examining what evidence exists from the base to the highest point. The photo below shows the tape measure that I placed against the noted tree.

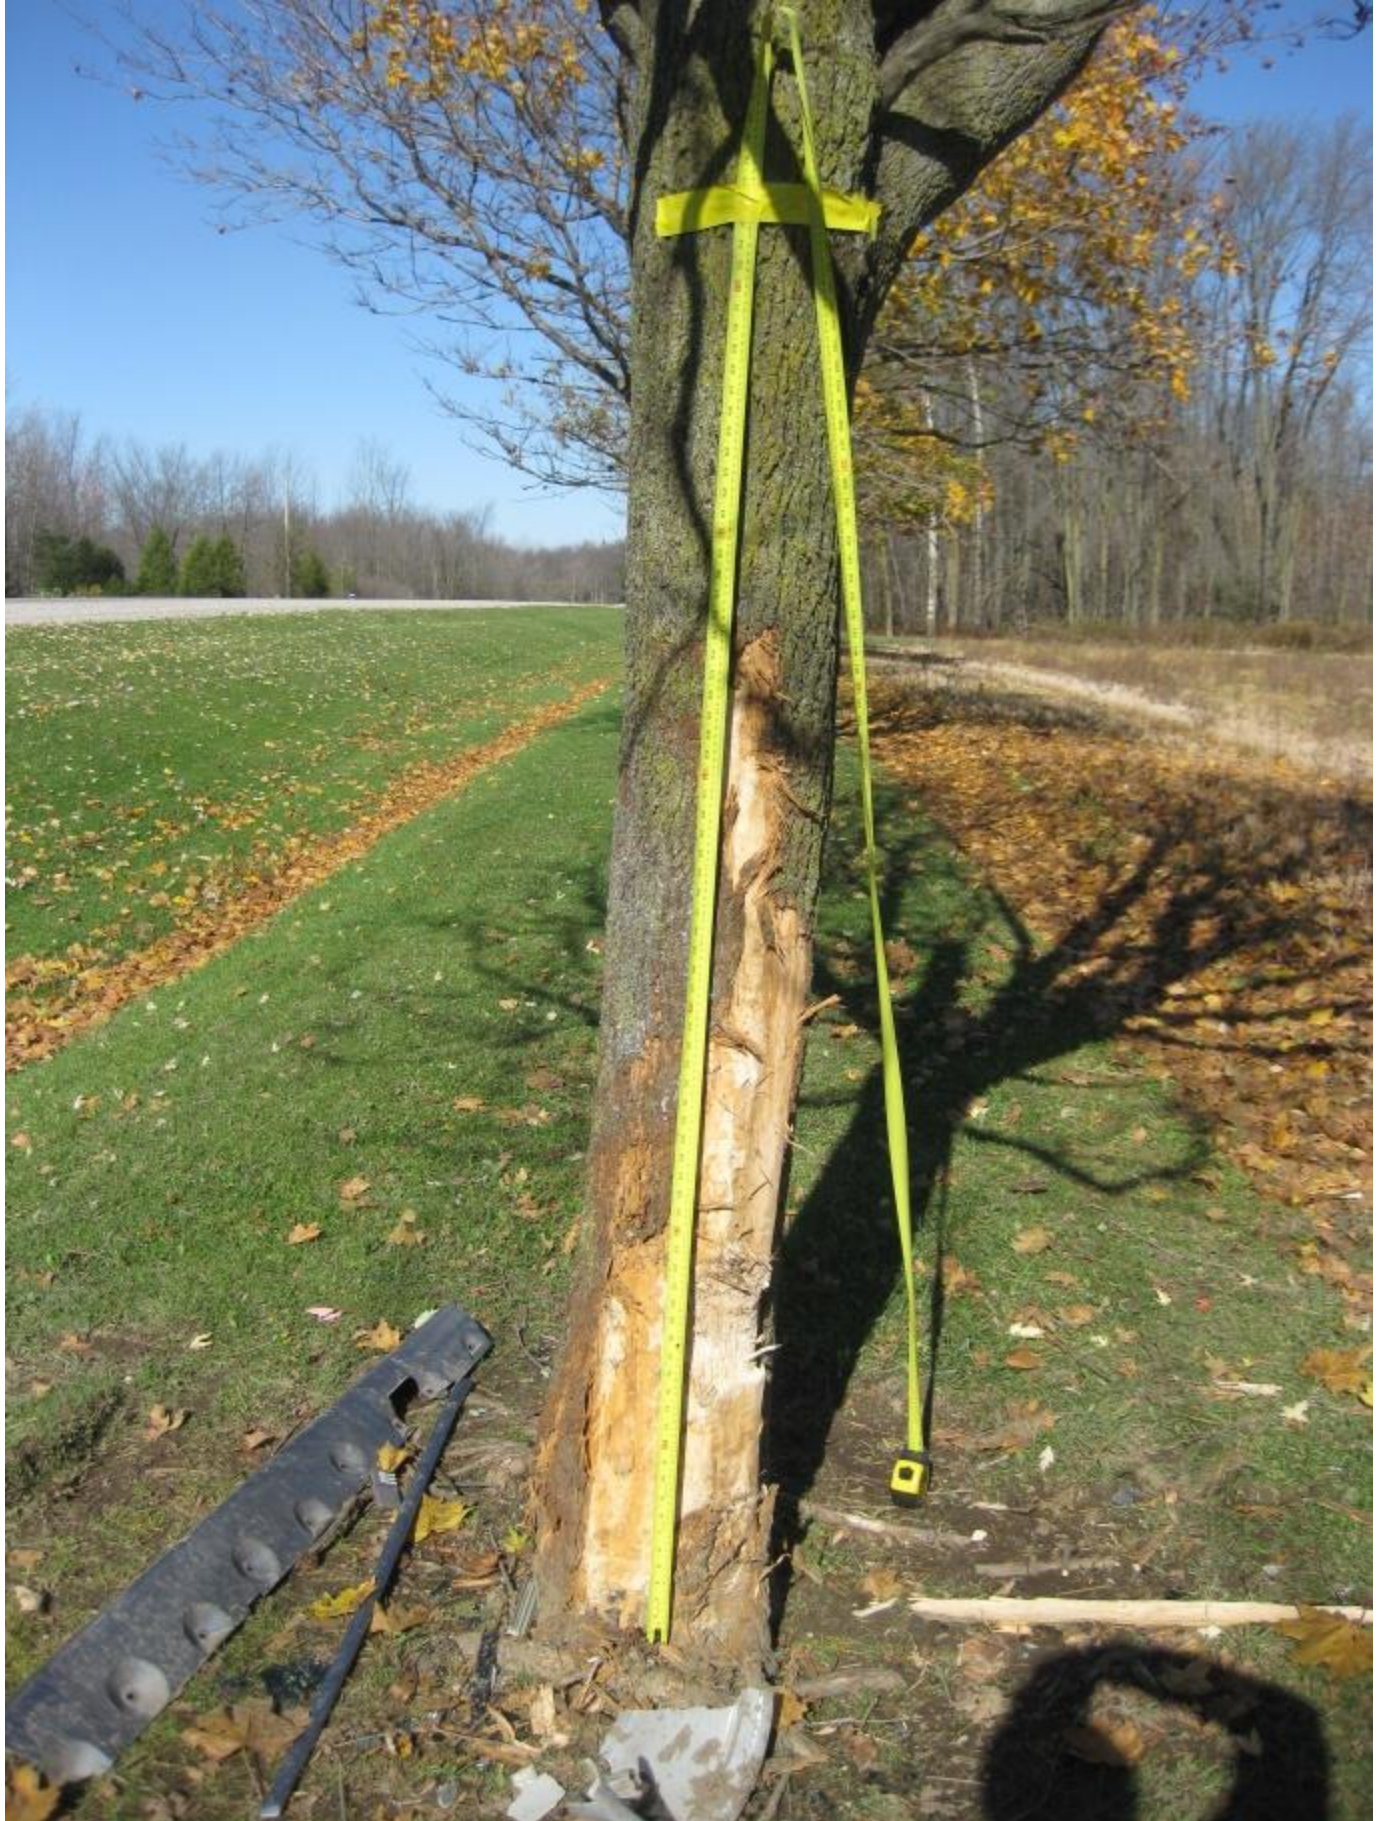
By noting what is visible and then comparing the evidence to similar events you can gain a better understanding of such events.

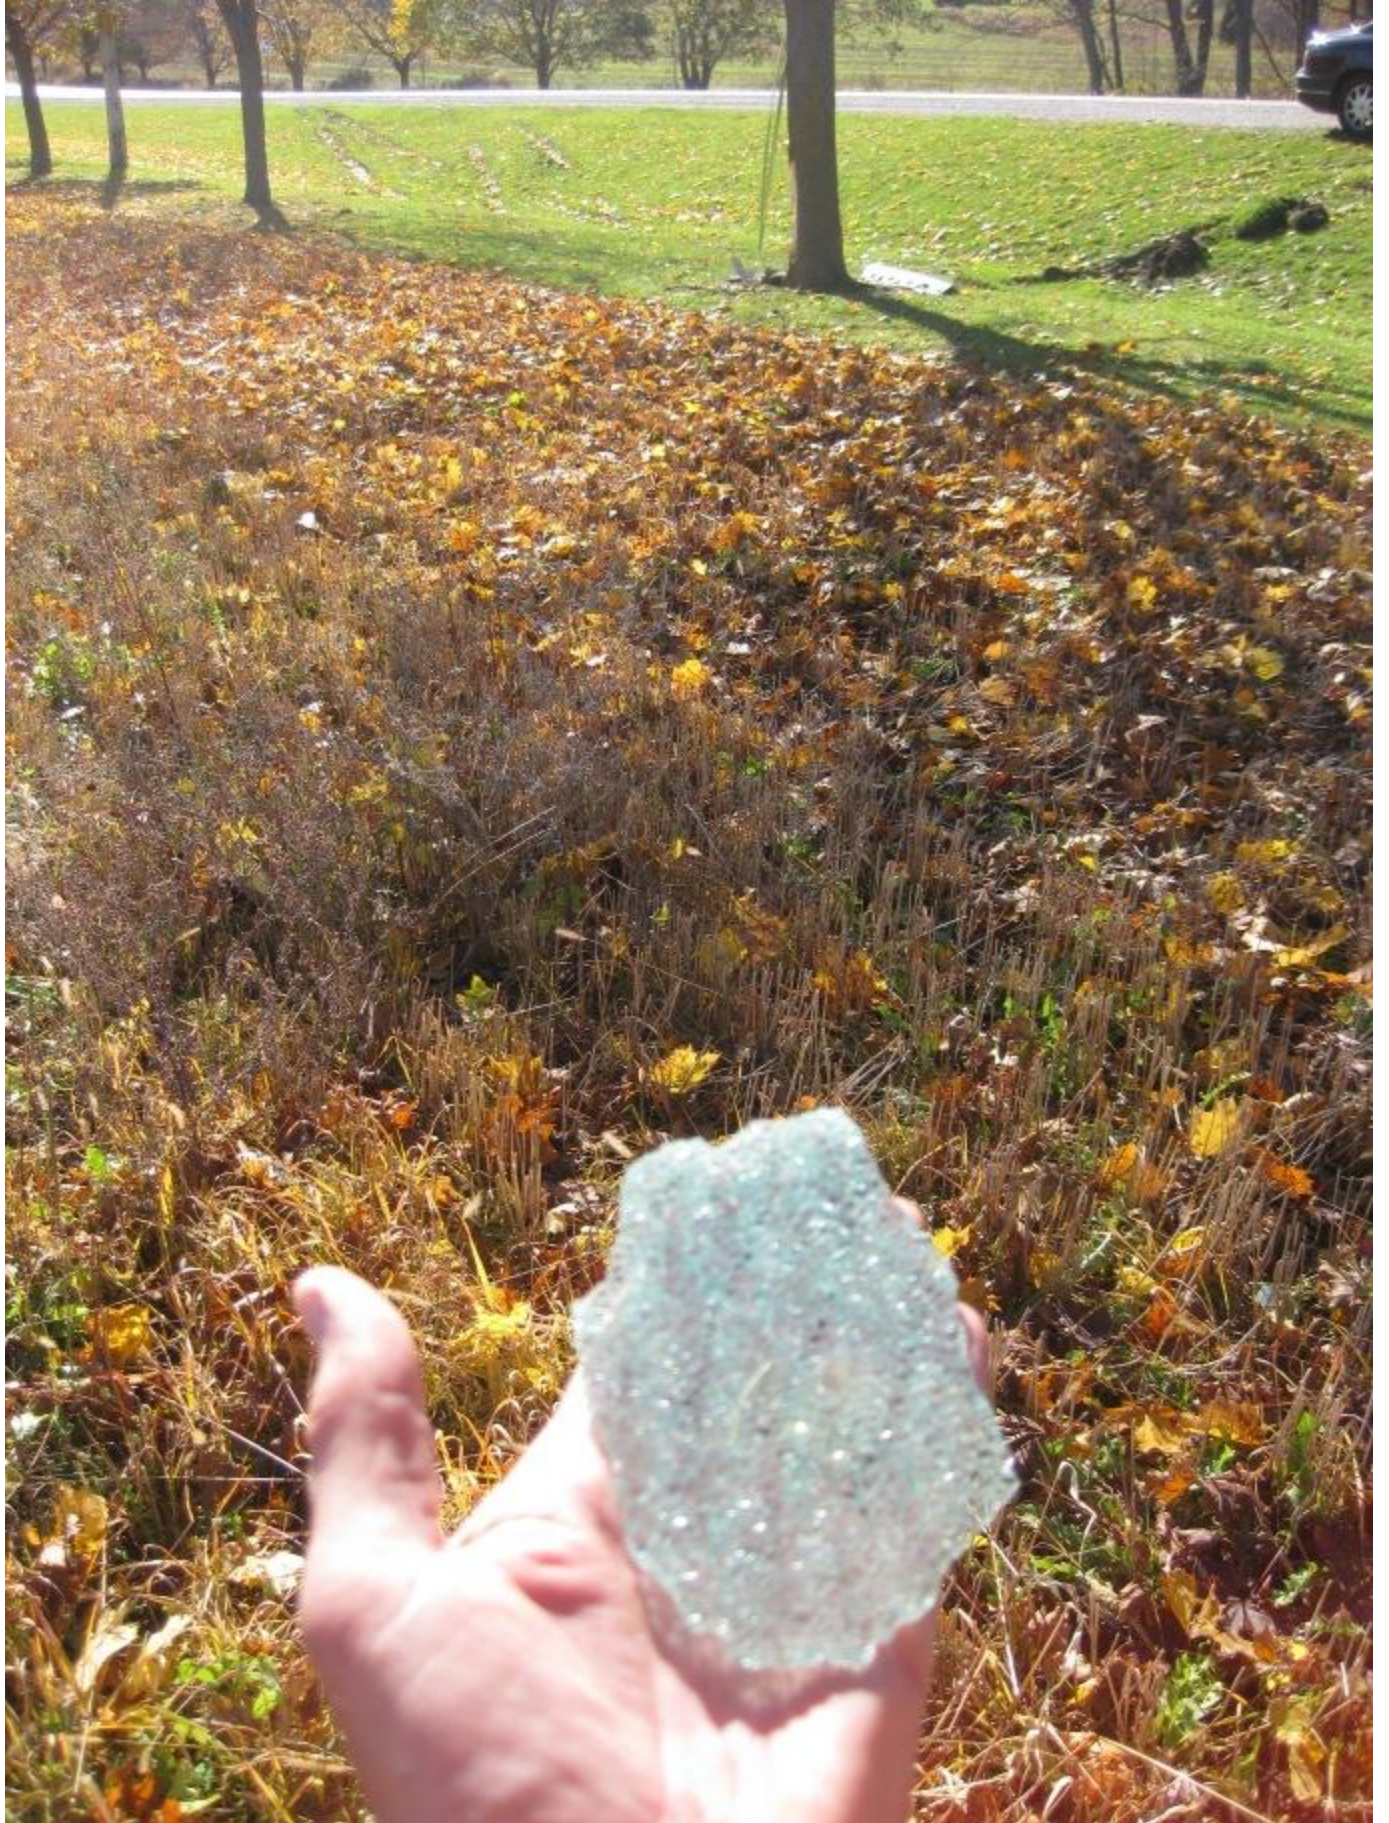
It is worthwhile to note that evidence from such an impact can become thrown a long distance past the point where the vehicle came to rest. Below is an example of some tempered glass that was found lying in the field past the tree impact.

Normally such tempered glass is broken into much finer crystals thus finding such larger pieces might indicate that the glass was shattered due to the contact occurring at a more distant location of the vehicle.
