Calvin William Gogo Charged: Double Fatal On Pressey Line, Malahide, March 26th, 2011

It has been reported that at approximately 10:35 P.M. on Saturday, March 26, 2011, an eastbound GMC Pick-up truck, carrying a driver and four passengers collided with the south concrete bridge abutment on Pressey Line just west of Carter Road, just north-east of Aylmer, Ontario. I was out at the accident site this afternoon and have the following to report.

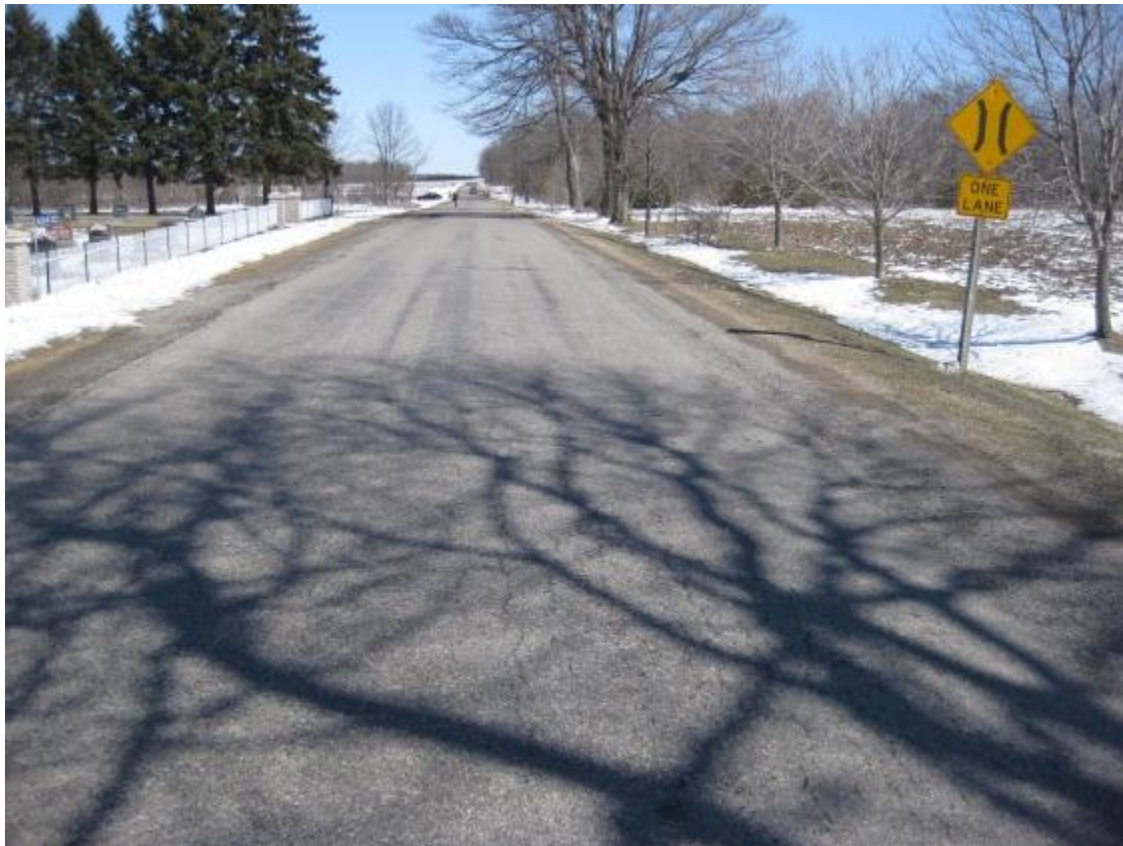
First, we begin by looking eastward along Pressey Line from a distance of 200 metres west of the point of impact (POI) with the concrete bridge abutment.

On the right side of this photo you should see a warning sign indicating that there is a "Single Lane Bridge" ahead. This sign is posted about 188 metres west of the bridge. If you look carefully you will find my black Buick Regal parked on the north roadside just past (east of) the point where the bridge was struck.

As you can see this is a very straight and somewhat level road although there might be a minimal downgrade. Being a rural area and this not being a main road one would think

The road near this 200 metre location is about 6.0 metres wide so it is quite narrow and is at the limit allowable for a two-way roadway. If you look carefully you might observe on the right side of the road that I have placed small orange cones at 25 metre intervals progressing westward to a location 150 metres west of the POI. This is to help you appreciate the distances being shown in the photos.

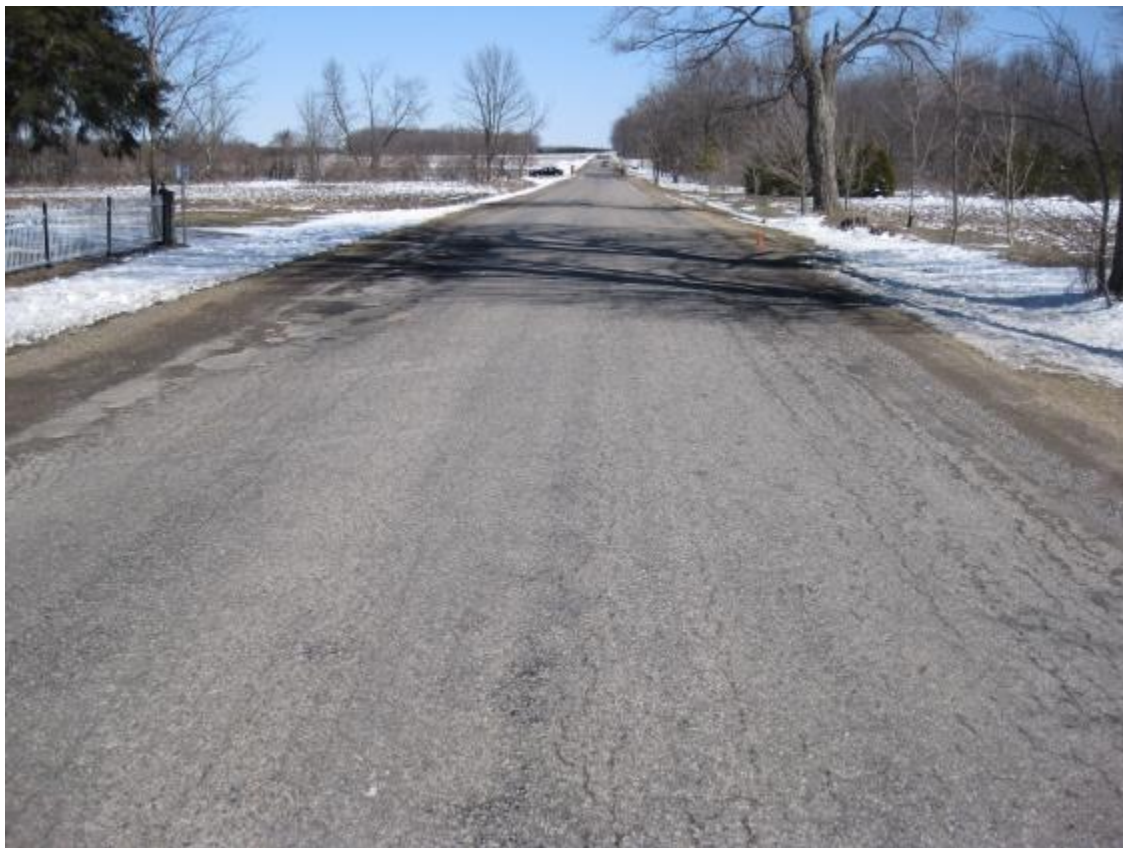
Below is a view looking east from 150 metres west of the POI.

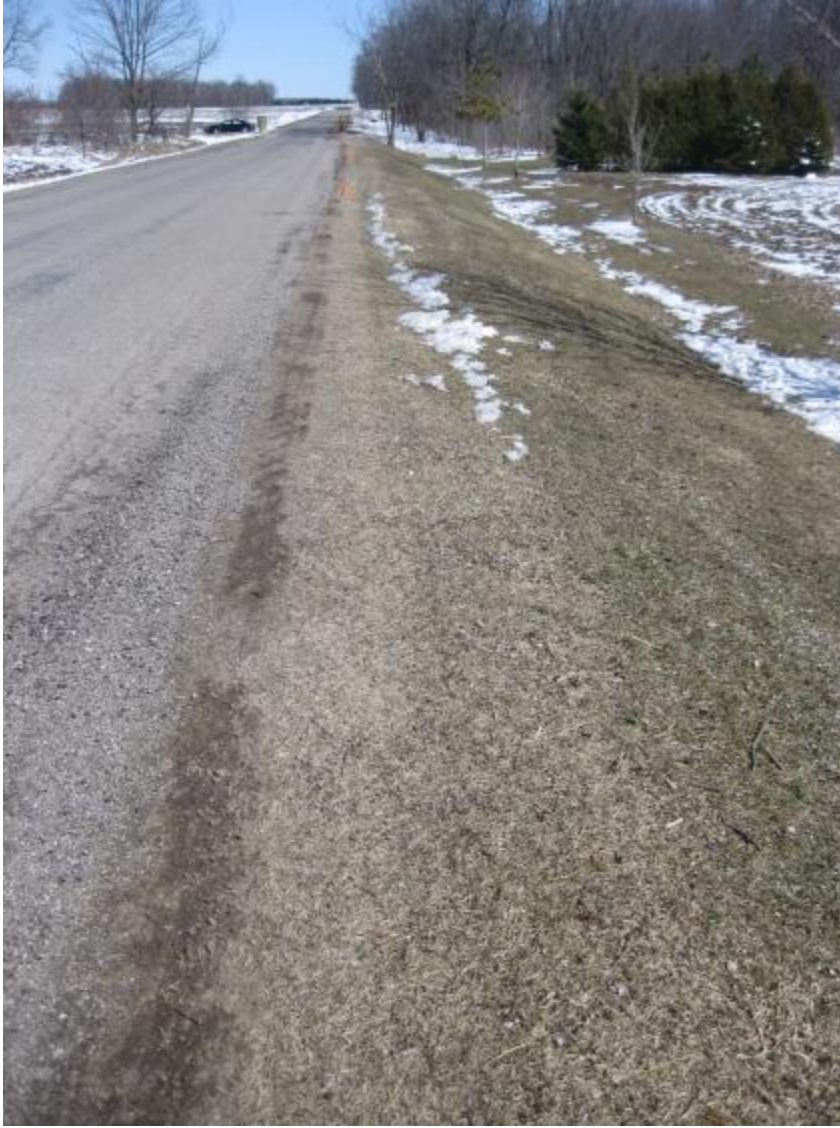
You should now begin to see the small bridge and its concrete abutments which are exposed to traffic without any guardrails. Below is another view looking eastward but now 100 metres west of the bridge (POI). But now the view is taken along the south edge of the road so that you can start looking for any tire marks that would indicate that the vehicle travelled off the roadway before encountering the bridge abutment.

In my opinion there are no visible tire marks on the south roadside. Next is a view looking east from 50 metres west of the bridge. Again, this view was taken along the south edge of the road so that you can examine if there is any evidence of tire marks on the south roadside.

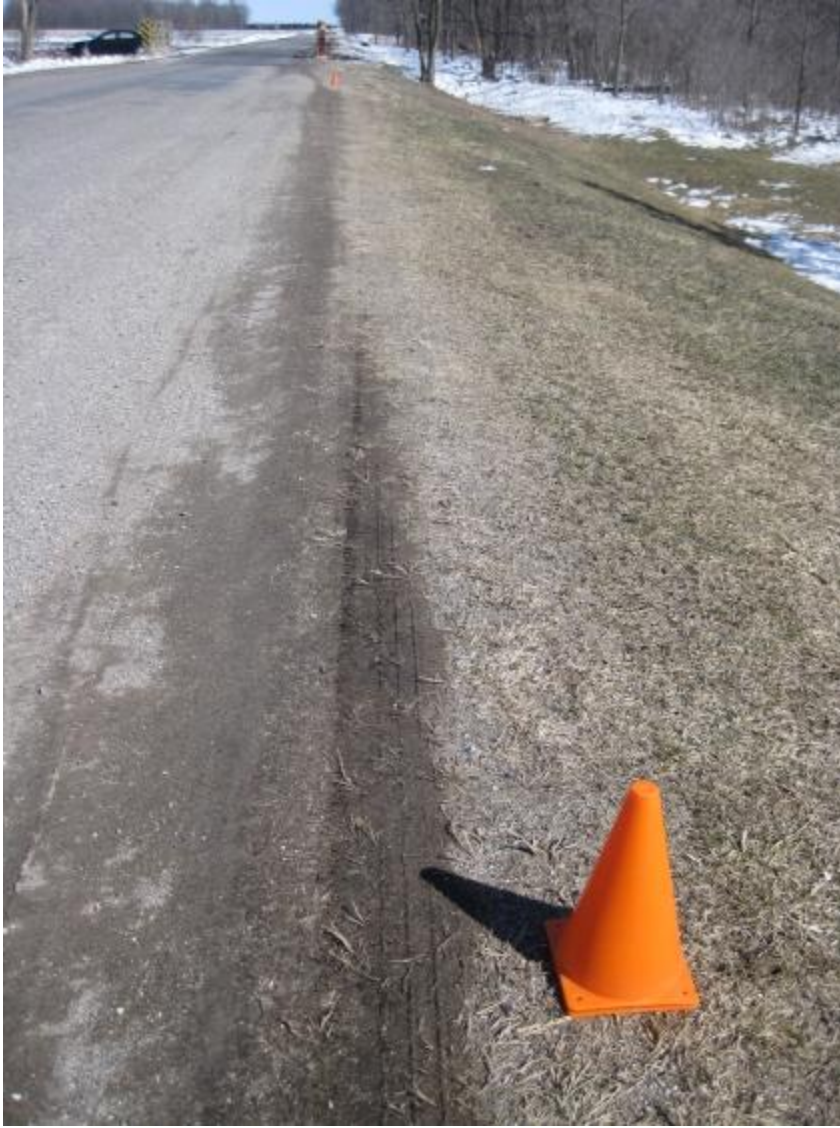
I might comment that there are tire marks near the edge of the road but we would be unable to distinguish those from passersby or emergency vehicles. All I can say is that there are no obvious tire marks along this south edge.

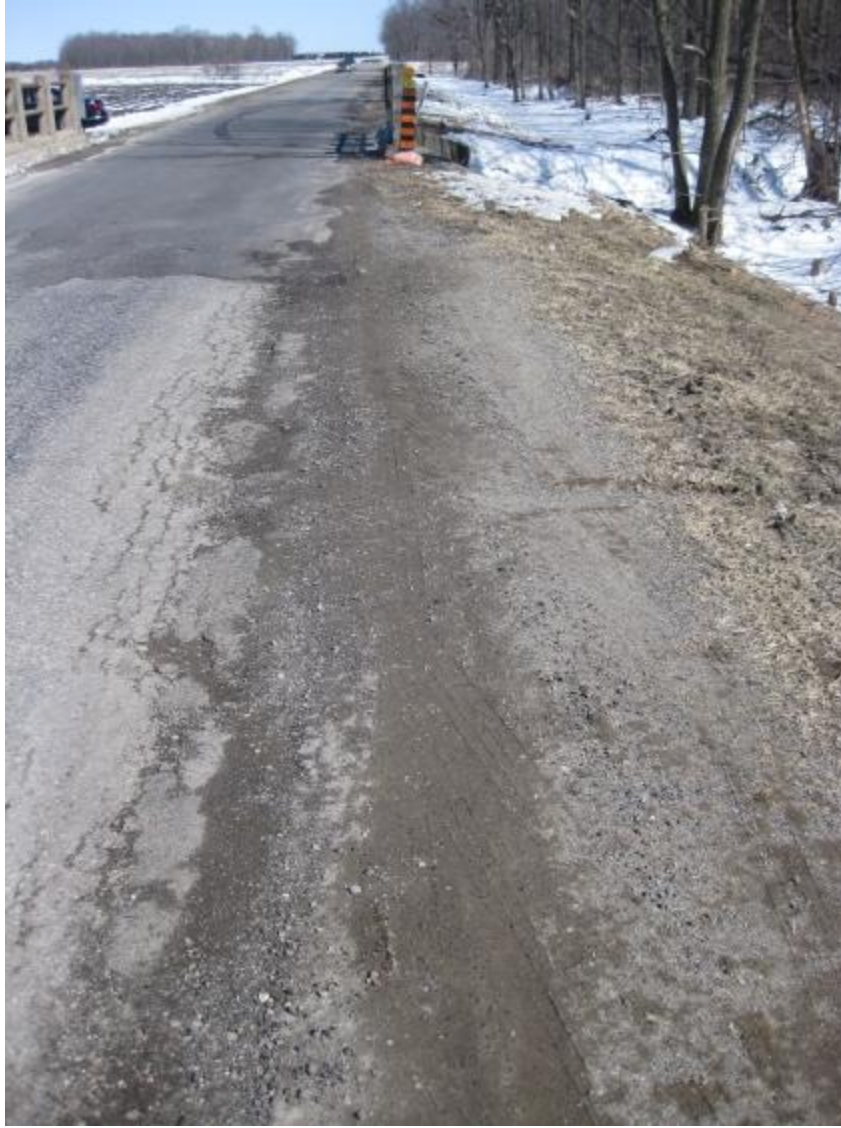
Next is a view from just 15 metres west of the bridge and still looking along that south edge of the road. I see no obvious tire marks.

If you look at this photo and the one previous it should become apparent that the bridge is quite narrow and that traffic approaching it has a good likelihood of getting close to the concrete abutments because the width between the abutments is only 6.2 metres. No wonder there was the sign indicating this was a "Single Lane Bridge". For example below is a photo, zoomed in from 150 metres west where we see two vehicles passing each other near the bridge. Yes, two vehicles could make it through but just barely.

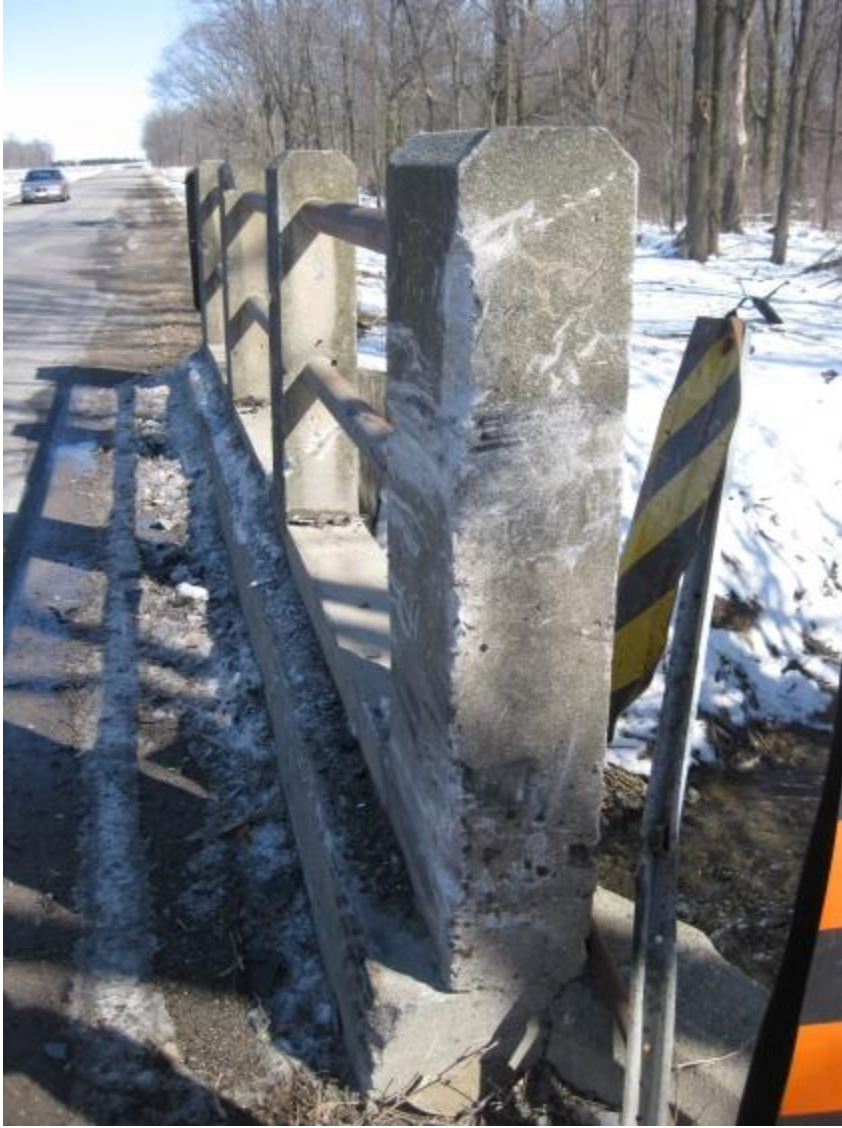
Anyway, below is a view of the actual impact point to the west end of the south abutment of the bridge.

One might say this abutment "never shed a leaf". These things are very stiff and immovable. You can see there was a hazard sign posted in front of the bridge but my inspection revealed that it was very old and was likely of very low reflectance. See the close-up of the sign below.

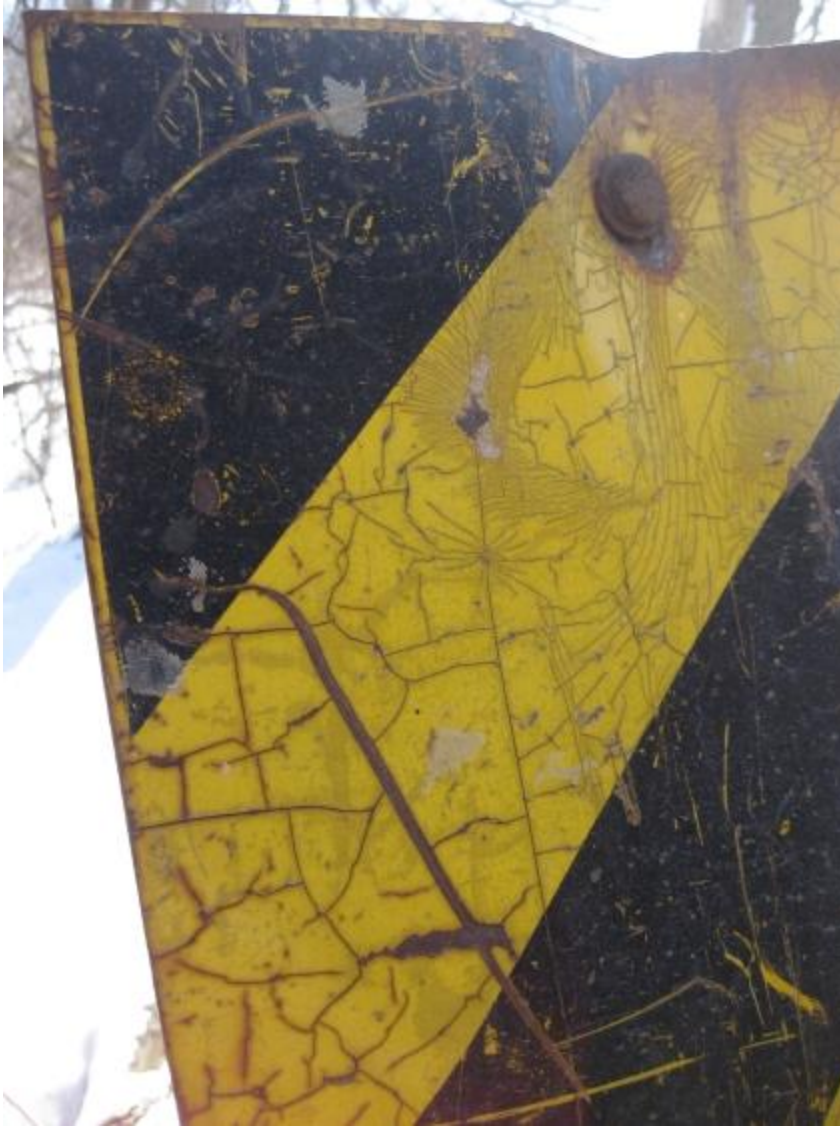
With so many roads that a small municipality like this has to deal with there is eventually a neglect to replace such signs until something like this occurs and the issue becomes "Was the driver given sufficient warning by the sign" due to its age and lack of reflectance"?

Yes, the news media quote police as saying that the driver may have been alcohol impaired and, if so, that would be a factor. But this was a night-time collision. If the hazard sign did not provide proper reflectance then it too was a factor. But this factor is not mentioned. Let's move on.

On the other hand no comments have been made about the other possible causation of the accident - an improperly reflective, hazard warning sign that may have made the bridge abutment difficult to detect until it was too late. I have shown you photographs of that sign, its advanced age, and the poor condition of its reflective surface. No one has asked why this sign existed in the condition that it did.

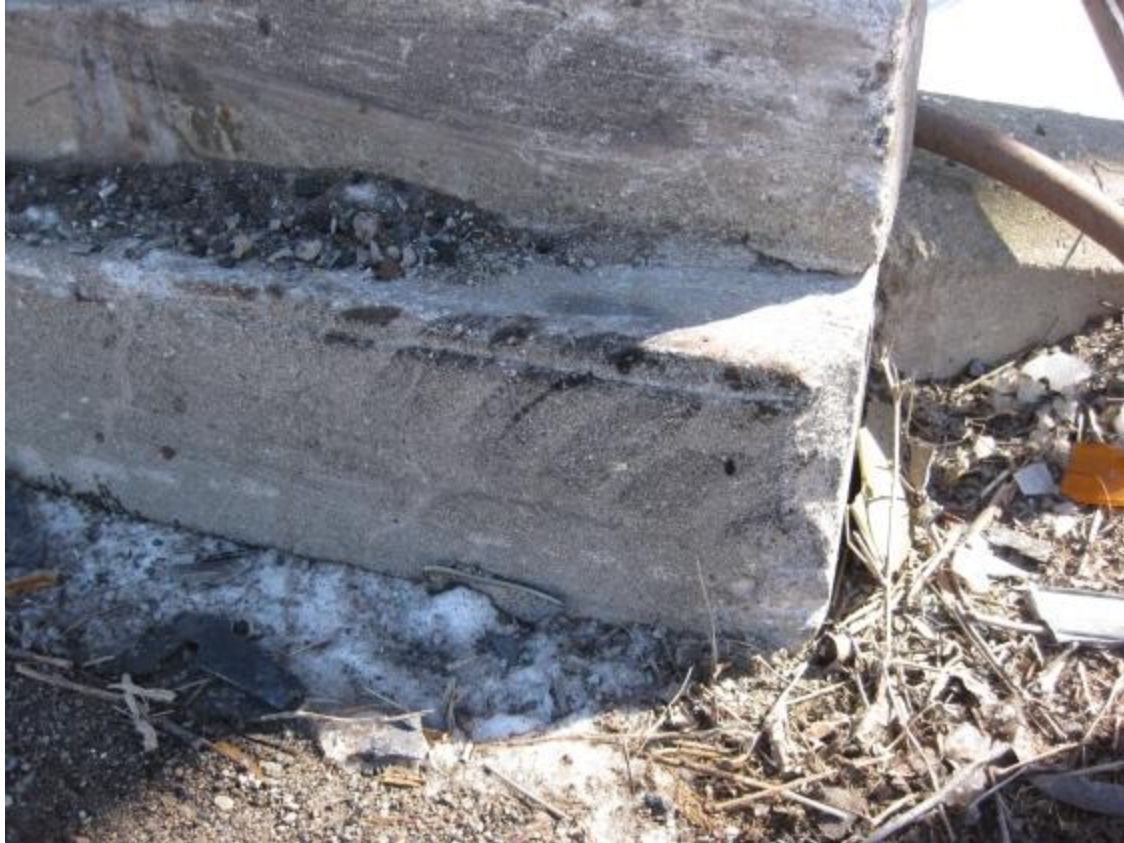
The extent of overlap between the GMC Pick-up and the abutment can be appreciated by noting the rotational rubber transfer on the bottom of the abutment. What you should be recognizing is the curved black marks on the concrete which are from the rotating, right-front tire of the vehicle.

In order for the sidewall of the tire to have scraped the abutment in this fashion the truck would have to impact the abutment in a narrow fashion with a small overlap. Secondly, the fact that the marks are curved indicates that the tire is rotating. This is important because it does not indicate, for example, that the driver applied maximum braking before impact and therefore locked up the right front wheel (or nearly locked it with ABS). So we might expect that the truck struck the abutment at essentially the original speed that it was travelling, or close to it.

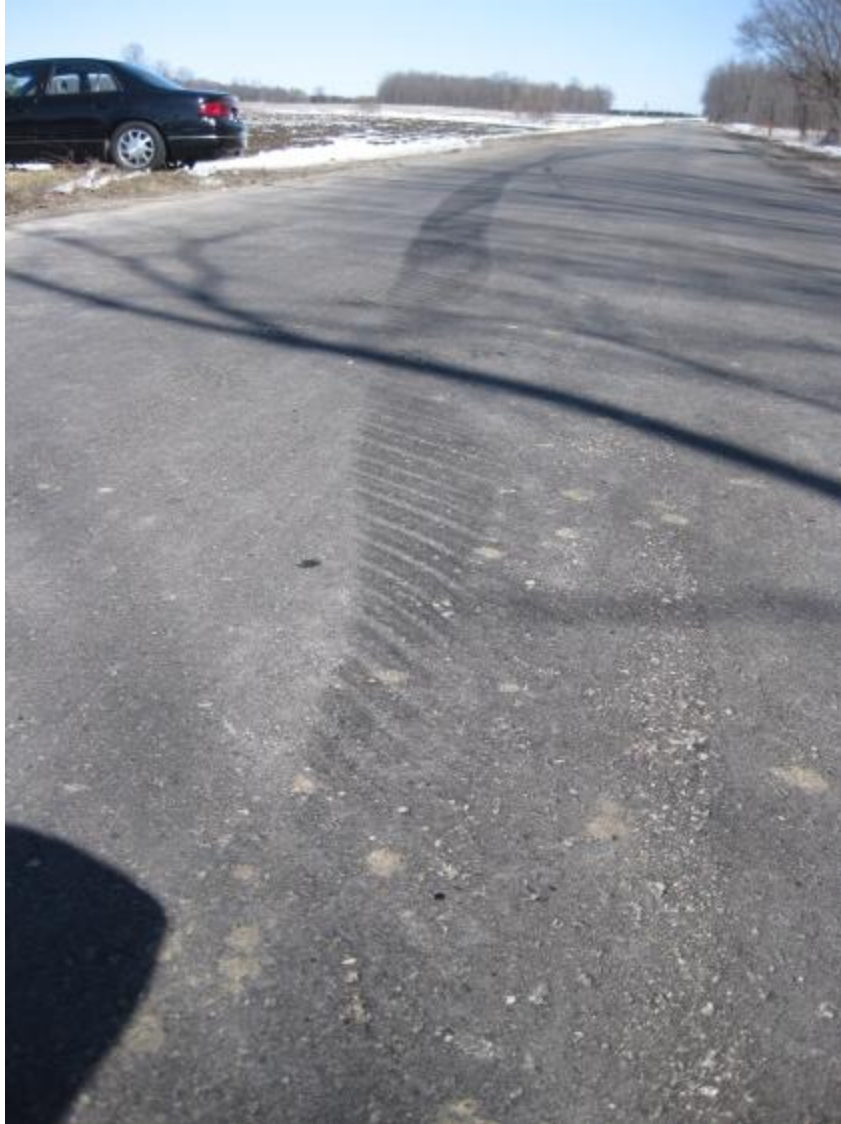
Below you will see the result, just after impact, as the rear of the vehicle rotates clockwise about the abutment and the left-rear wheel produces the dark, yaw, tire mark that you see in this view.

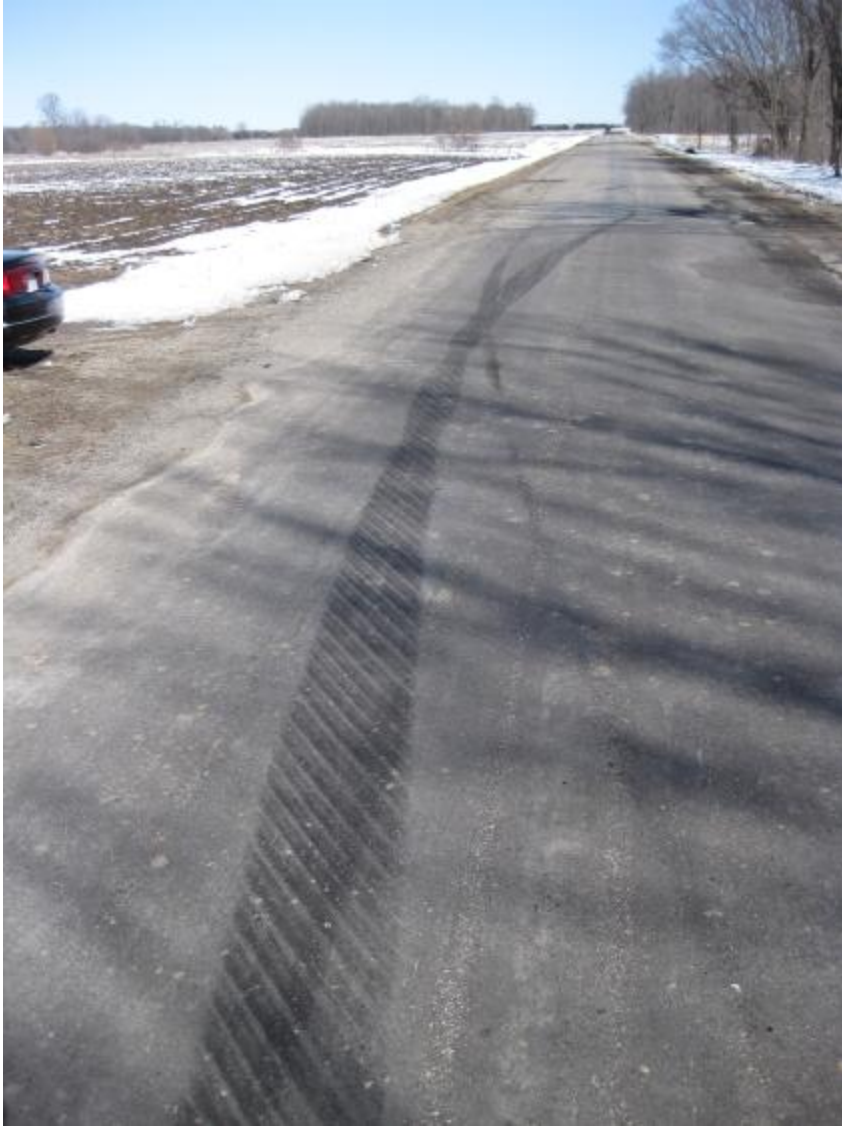
This is further evidenced in the photo below where you should see two tire marks: the darker tire mark on the left is from the left rear and the light mark on the right is from the right rear. Note that as the tire marks cross each other in the background this is the point where the GMC Pick-up is travelling essentially sideways, leading with its driver's side, as it spins towards its final rest position (FRP).

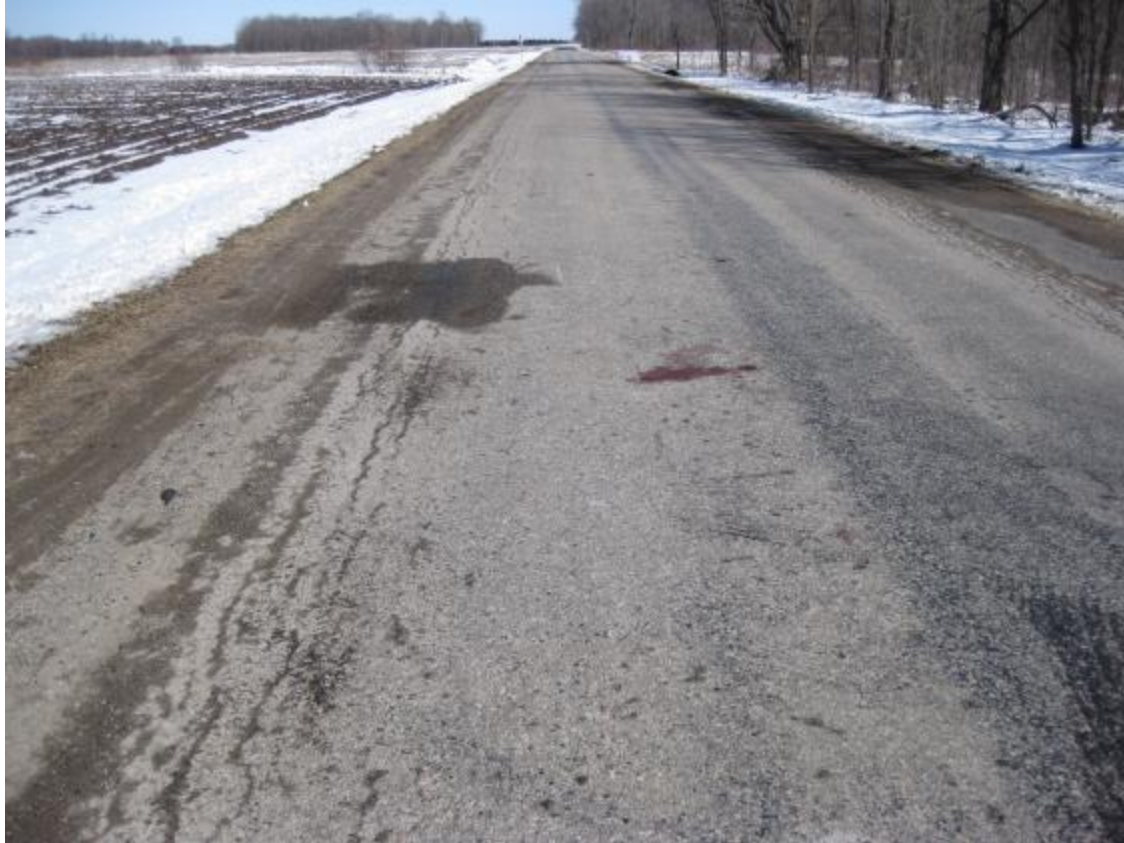
The vehicle continues to rotate clockwise in this fashion until it reaches its final rest position as shown in the photo below.

Note that we always look for a dark stain, whether it be from engine oil, coolant, or some other substance which always indicates where the front end of the vehicle came to rest.

It can be noted that the GMC Pick-up came to rest about 47 metres east of where the initial impact occurred. Using a conservative drag factor of 0.4g this would result in a speed loss of about 70 km/h. This is conservative because the right front suspension of the vehicle was dragging and the right front wheel was likely jammed by the deformation at that location. So any speed loss from the impact with the abutment would be "combined", not added, to the speed loss from post-impact spin-out. I'm not going to discuss the speed calculation details for now only to say that even if the speed lost from the abutment impact was 70 km/h (which is highly doubtful), the calculated impact speed would only be about 99 km/h. What I would say is that the speed was likely less than 99 km/h and therefore high speed was likely not a factor in this collision.

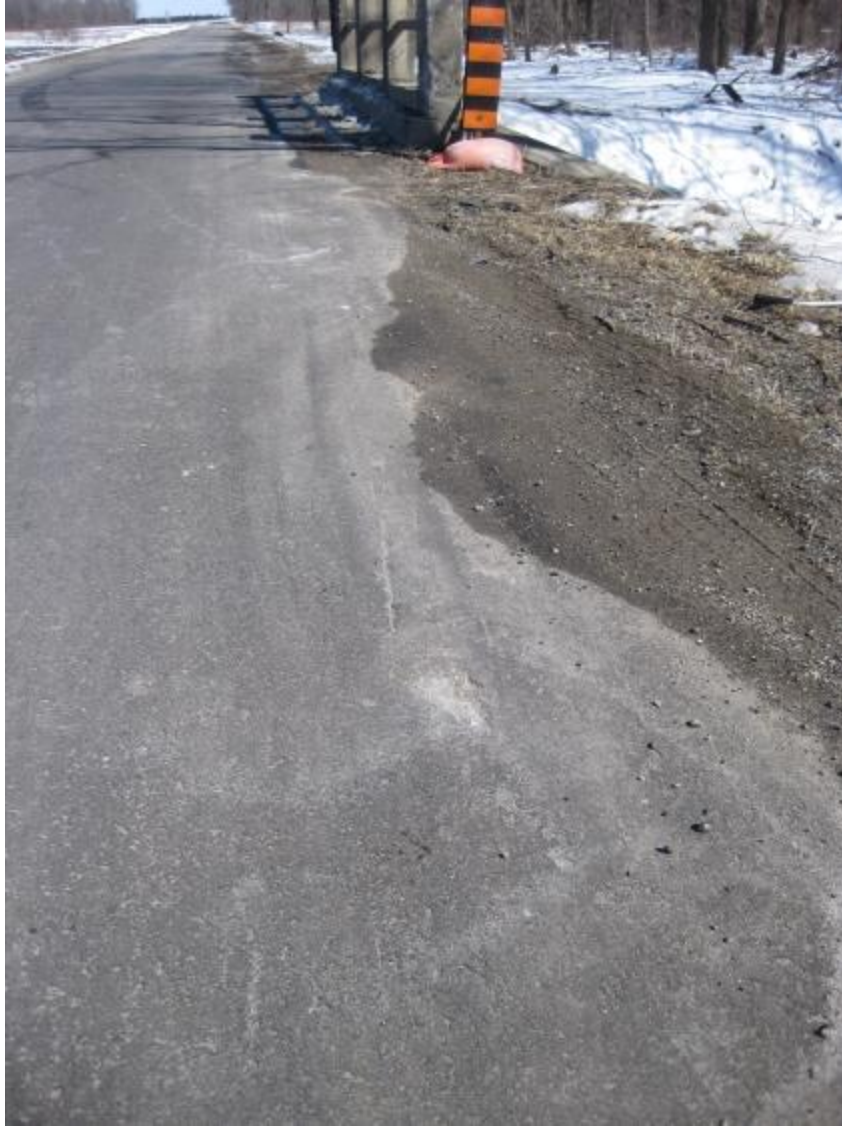
Never-the-less, look at the evidence in the photo below taken from about 10 metres west of the bridge, looking eastward.

If you look carefully at the photo above you should see a "whitish" scrape in the pavement near the right edge of the road. Such "whitish" markings indicate that they are fresh. Let me show you a closer view below.

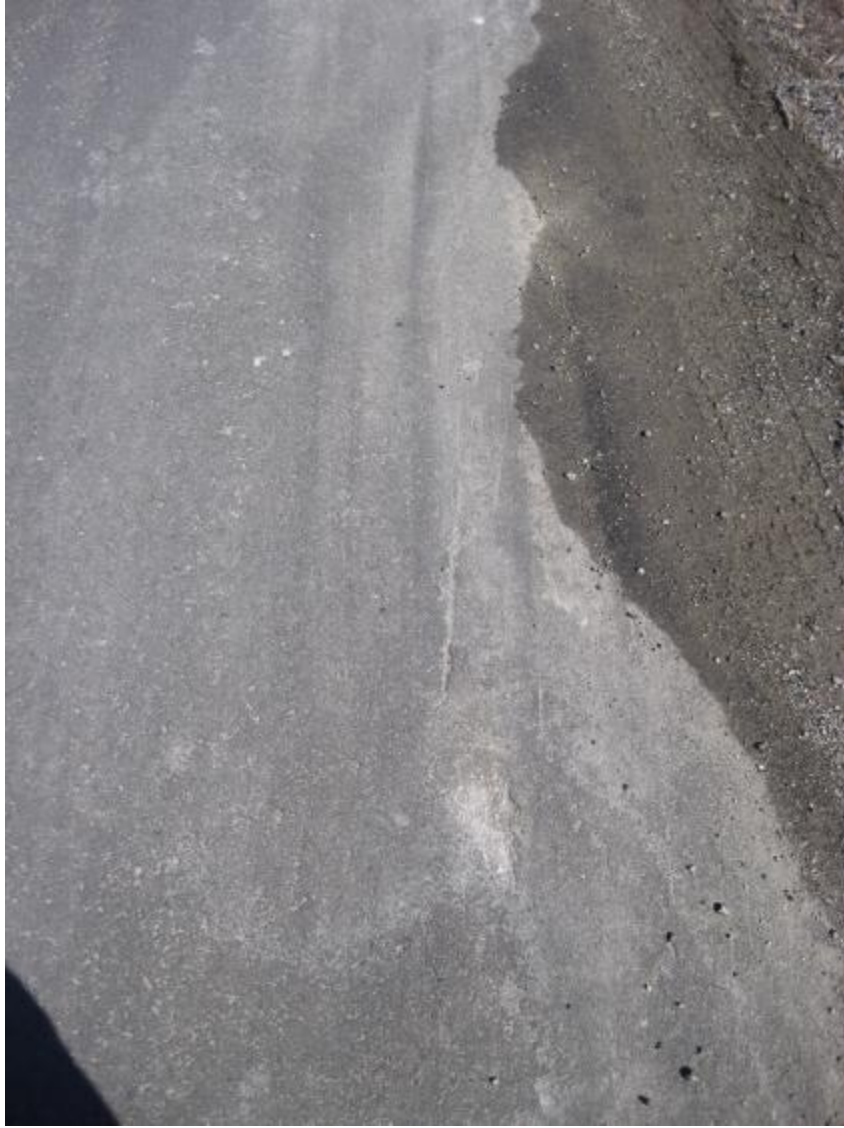
Extending eastward from this mark is a darker mark similar to a tire mark that would be created after an impact. Look more closely at the scrape in the close-up view below.

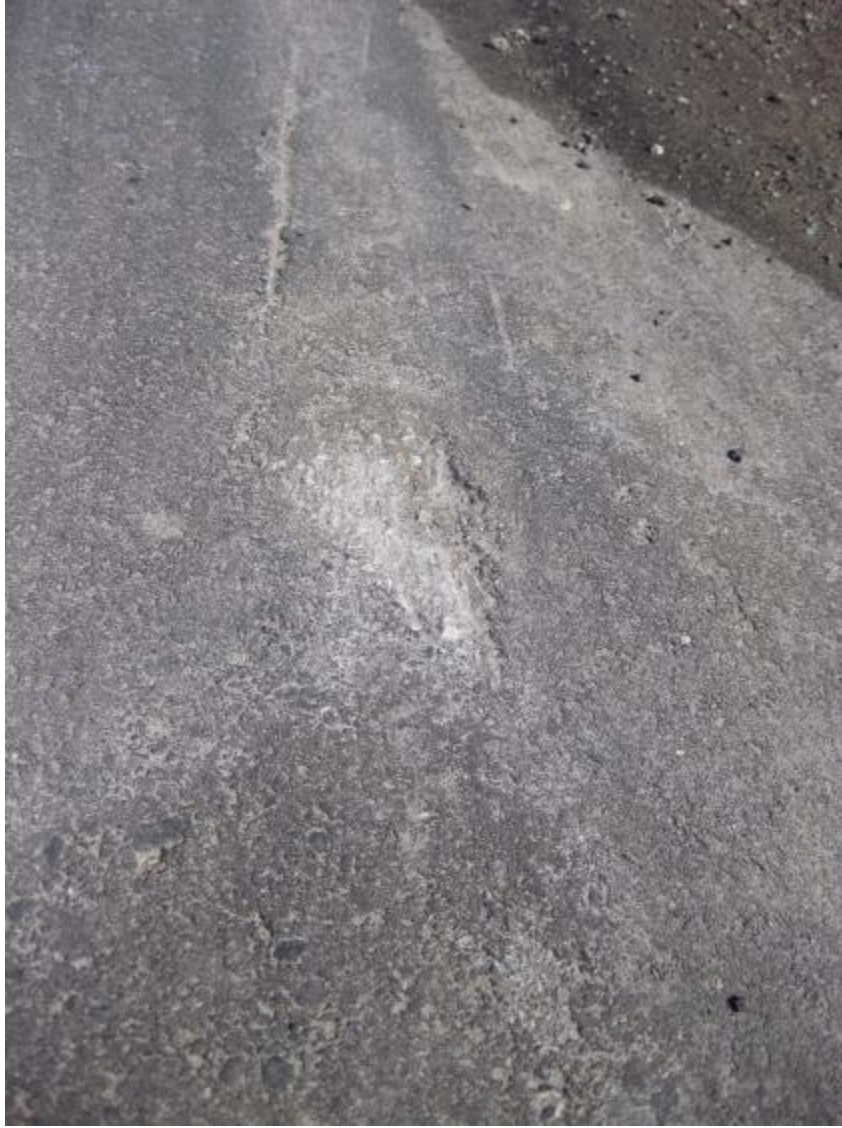
Now, it is common for vehicles that hit non-yielding abutments like this for the underside of the vehicle to bottom out and produce a gouge. But such a gouge would be located near the front end of the vehicle where the impact occurred. The scrape I am showing you is located 6.5 metres west of the abutment. Note that a full size GMC Pick-up like this would not be more than 6.0 metres long. Therefore something caused a gouge behind the Pick-up. It cannot be from the Pick-up at impact. Now that is unusual. But here is more. Take a look at the next photo. Can you see the white acid drip on the road that leads from that scrape to the rear tire marks in the background?

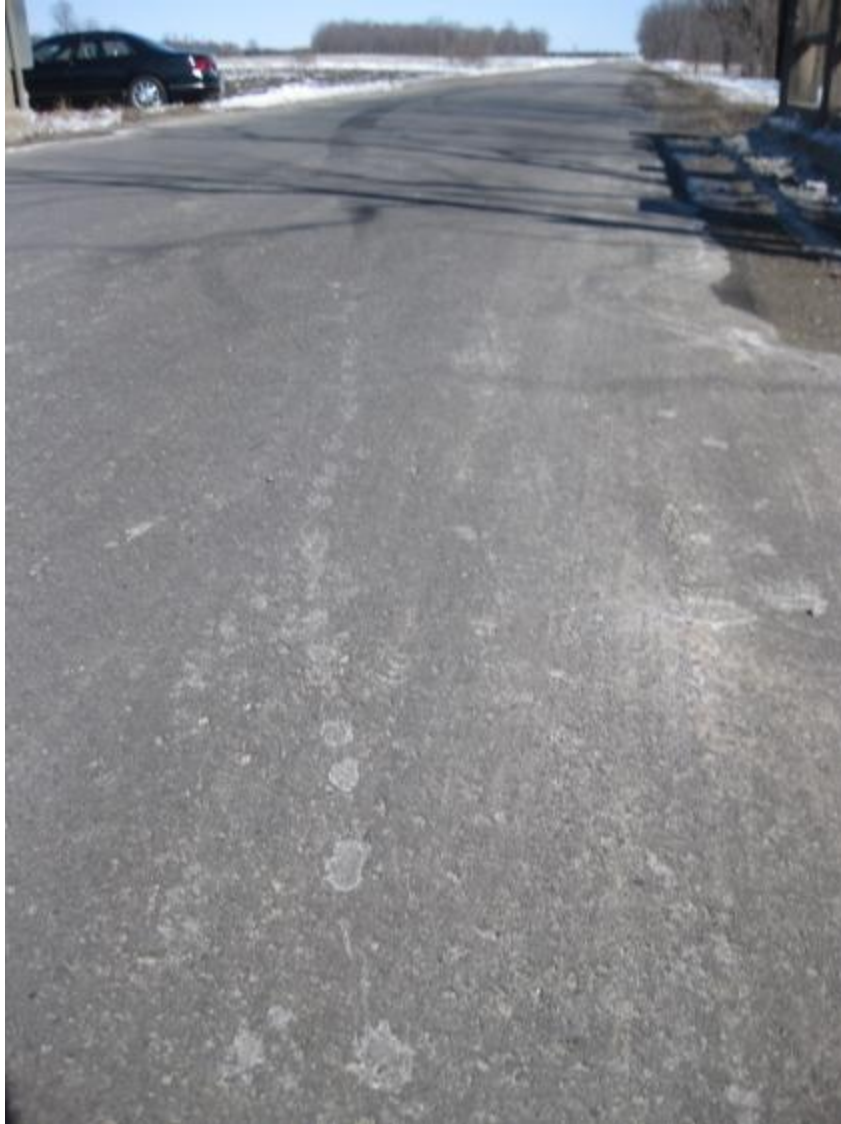
This is curious if it is by coincidence because this information would suggest there was another impact, about 6.5 metres west of the impact to the abutment. Strange. Coincidence, possibly. Caused by emergency personnel - not likely. Caused by another recent collision, yes, possibly. But very strange particularly since the acid trail travels to match with the rear tire marks of the Pick-up.

One explanation could be that the GMC Pick-up was hauling something like a small trailer and the tongue of the trailer made the noted scrape. I don't know since I was not there. But it will be interesting to follow through with any additional info that may be provided through the news media.

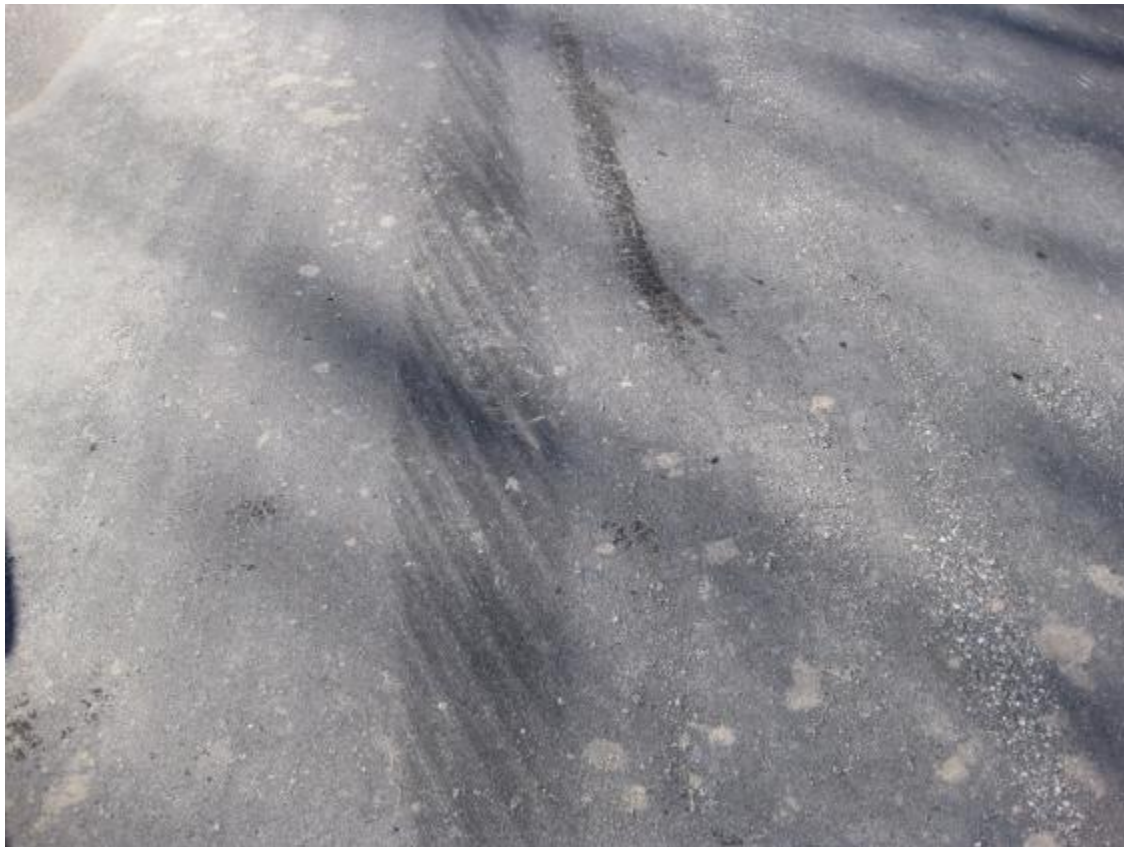
First let me show you some additional photos of some strange marks just after the Chevrolet Silverado (that is what I'm being told it was) struck the bridge abutment. First an overall view of the yaw marks after the impact.

Now, if you look at the above photo you should be able to recognize the very typical markings of a yaw mark to the left and a somewhat less typical tire mark on the right as the two converge. As I mentioned before these are tire marks from the two rear tires of the Silverado. But look closely at the fatter mark on the left which is supposed to be the mark caused by the left-rear tire. Do you see anything peculiar? Let me show you a close-up of the area of interest in the photo below.

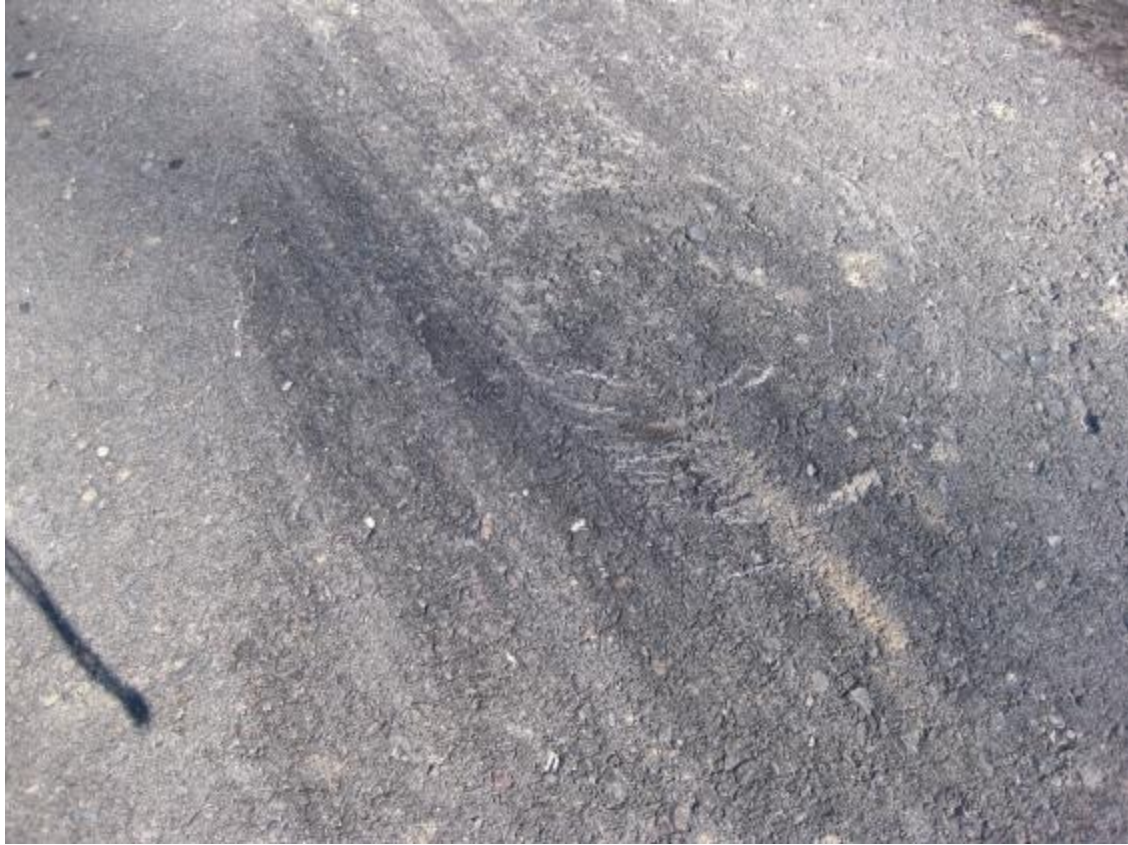
What you should recognize in the above photo is a circular scraping of the pavement within the yaw mark. Let me show you another close-up view below.

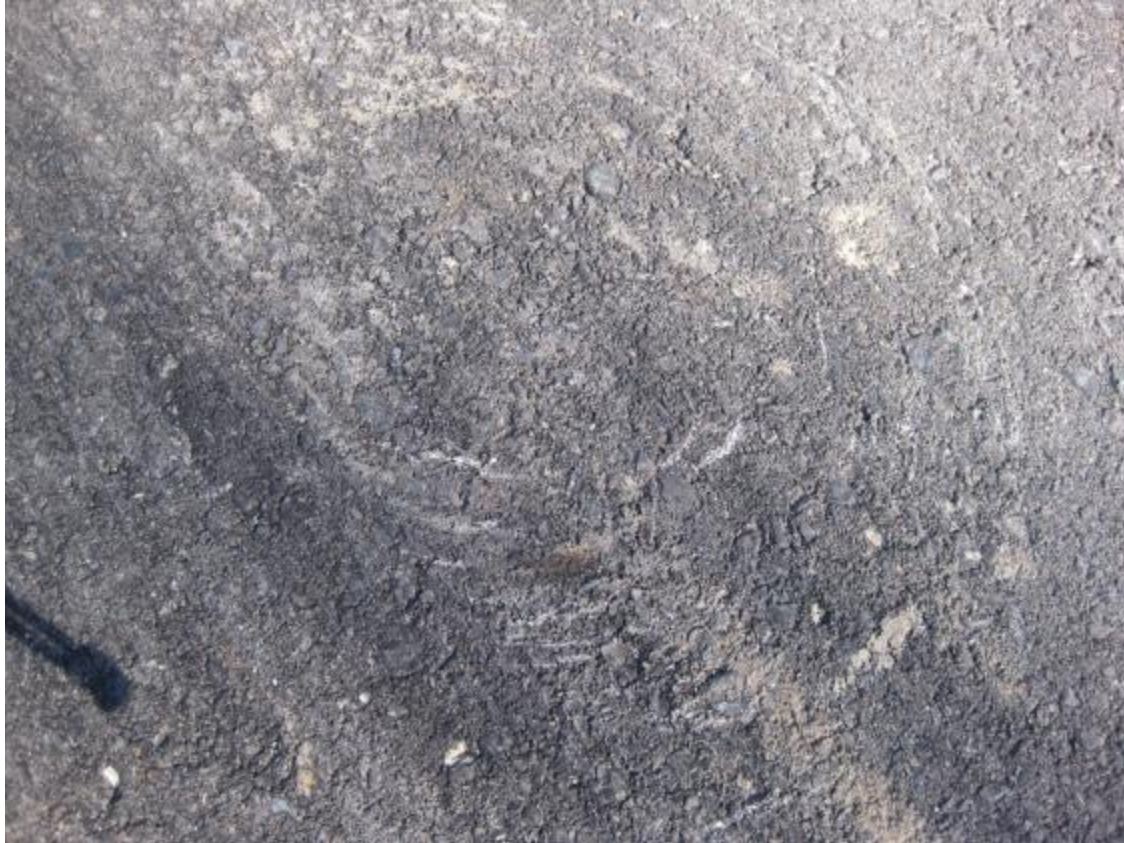
I can tell you that this circular marking that you are looking at is fresh. So why is it there?

Oh, by the way, that circular scrape - very often a vehicle is stopped on the road and the driver performs a "dry steer". In other words the driver turns the steering wheel sharply while stopped because the confined space does not allow the driver to make a wider turn. If you looked at the road surface where the front tires were located at that dry steer you would see circular markings such as what I showed. Yeah, I know, I have not proven anything but I'm just giving you further things to think about.

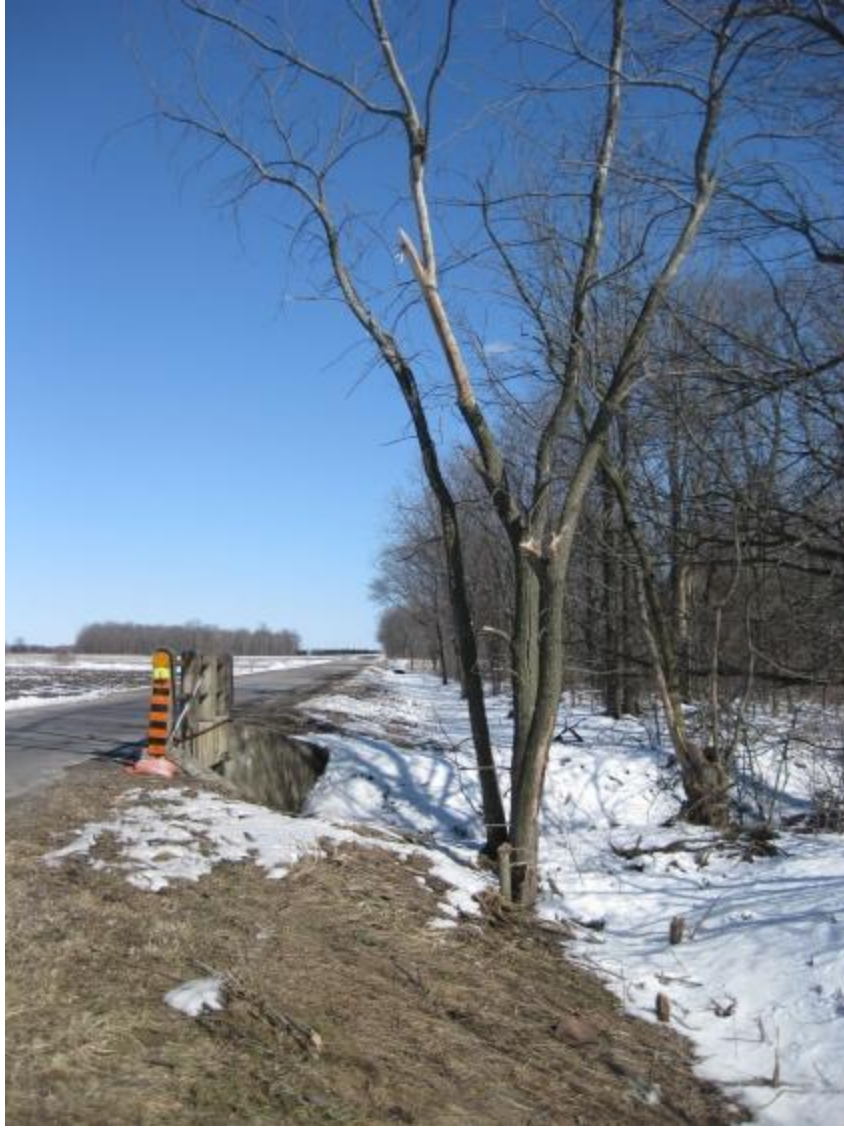
Ok, I know I have had visitors wondering what these markings are and I will give you my opinion. But again, before I do, I want to give you just a couple of more photos of a tree on the south side of the struck abutment. Below is the view of the tree.

If you look up into this tree you will see several branches that have broken and in particular there is a fresh break as shown in the photo below.

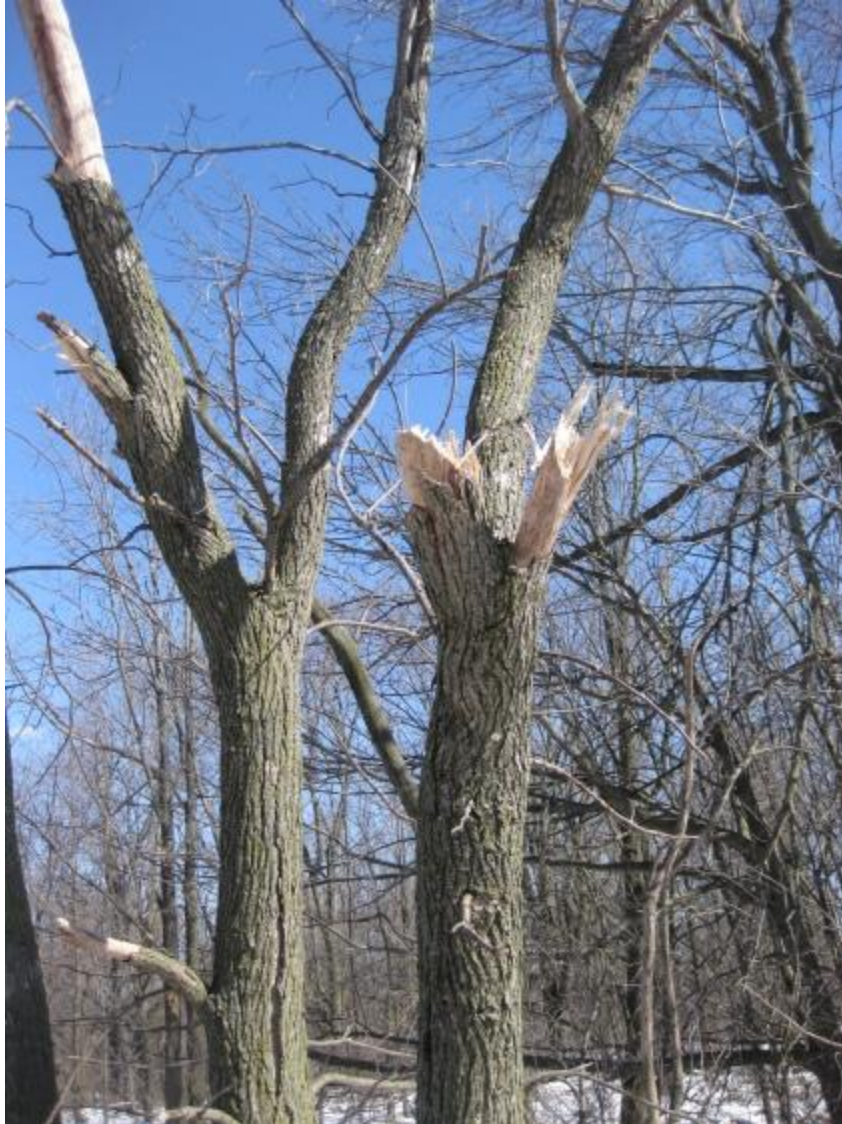
Pieces of such branches can fall onto the road and cause problems.

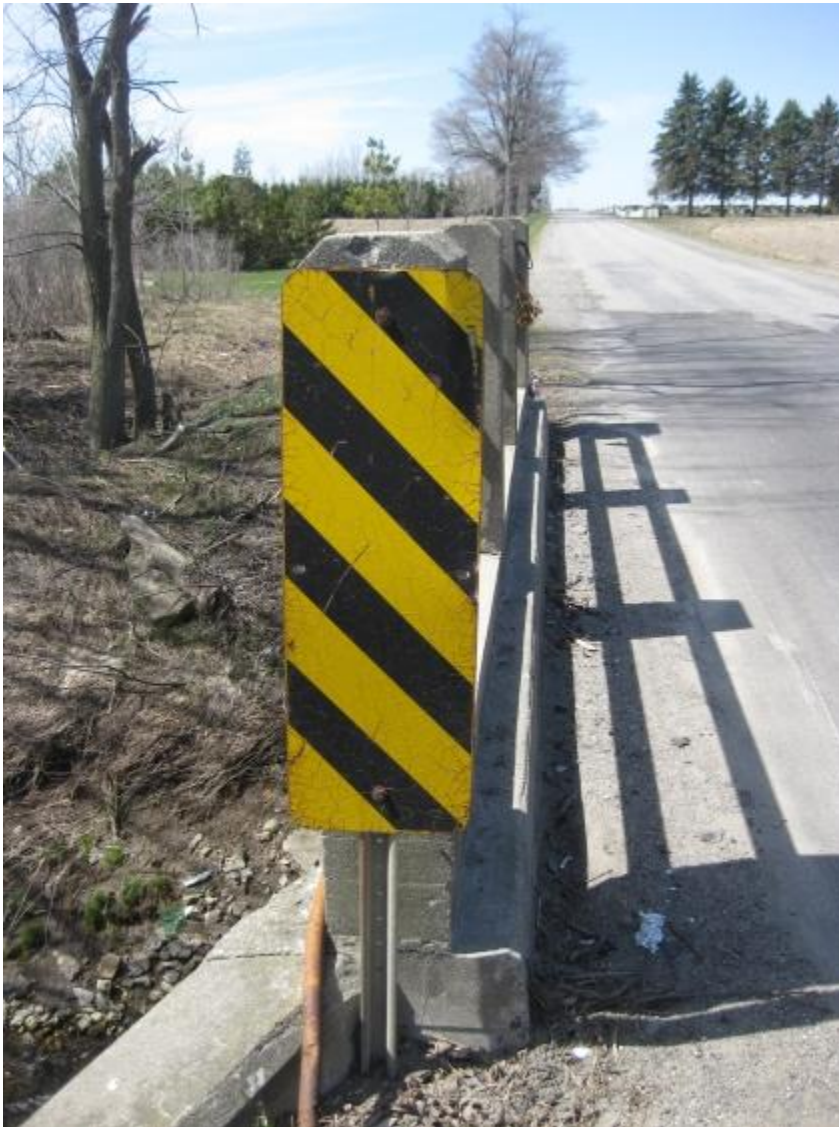
Even now, an aged sign still exists on the south side of the bridge facing westbound traffic. Here are some views of that sign from April 12th, 2011. First an overall view below.
