Calvin William Gogo Charged: Double Fatal On Pressey Line, Malahide, March 26th, 2011

It has been reported that at approximately 10:35 P.M. on Saturday, March 26, 2011, an eastbound GMC Pick-up truck, carrying a driver and four passengers collided with the south concrete bridge abutment on Pressey Line just west of Carter Road, just north-east of Aylmer, Ontario. I was out at the accident site this afternoon and have the following to report.

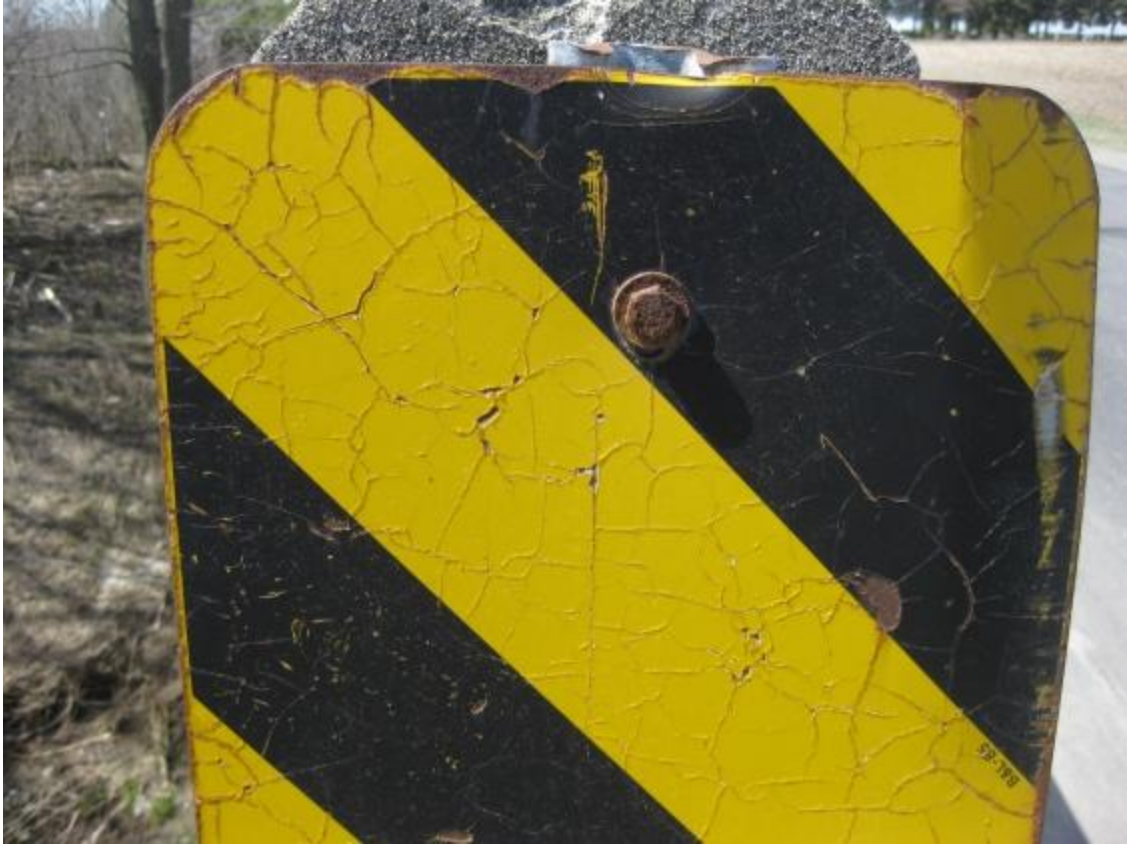
And the view below is a closer view of the front face of that sign.

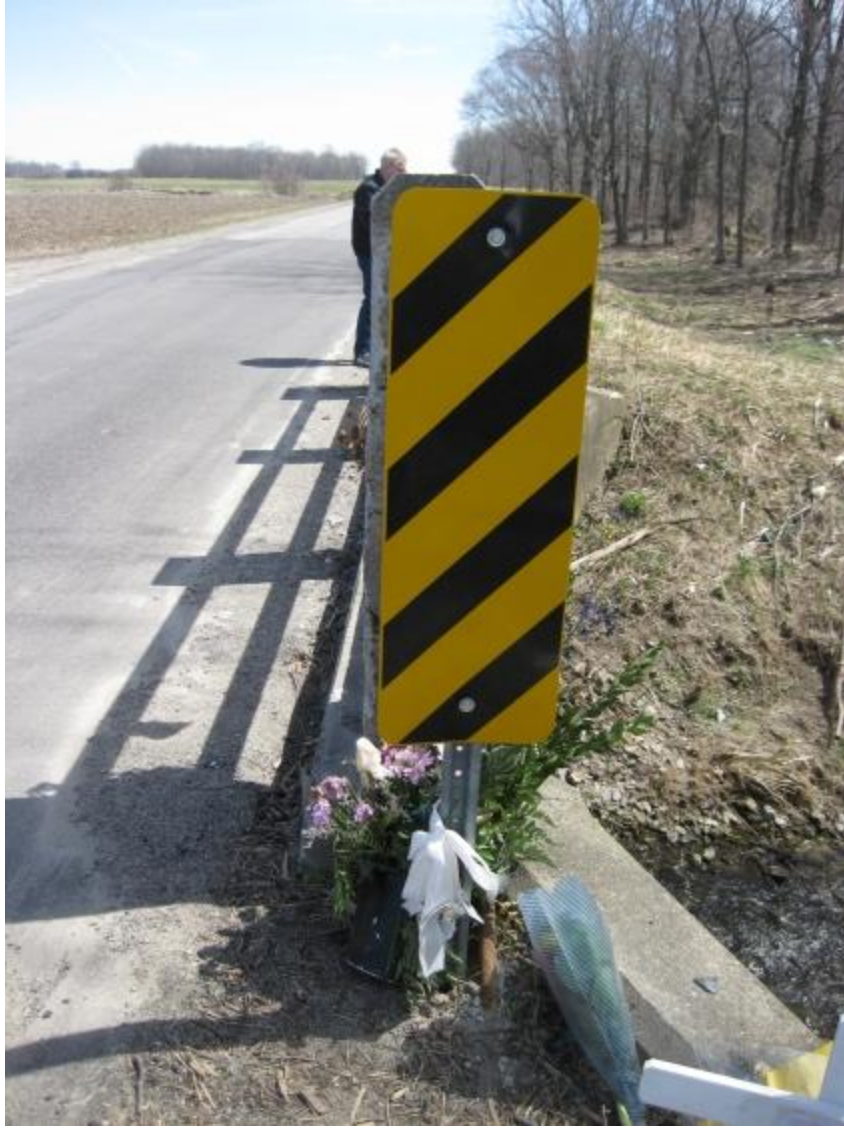
In comparison we can look at the sign that was freshly erected for eastbound traffic as shown below.

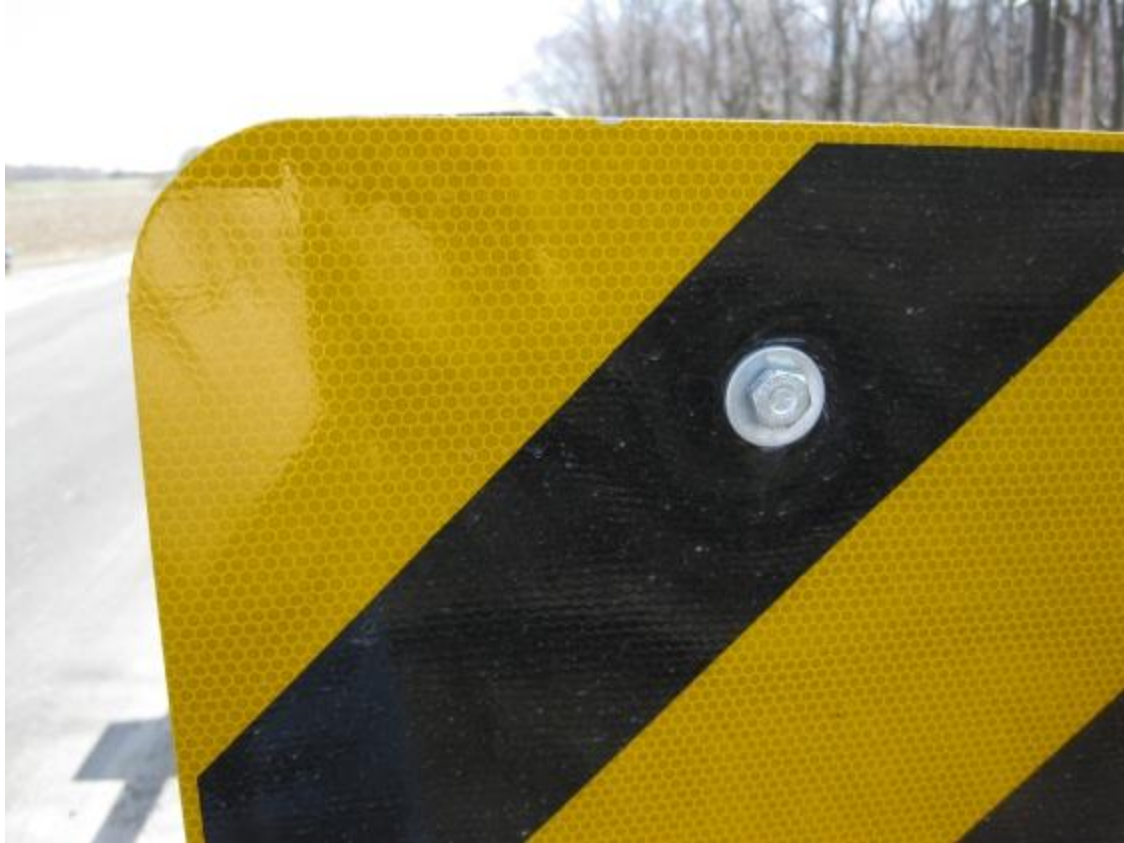
And now a close-up of the reflective surface of that new sign is shown in the photo below.

Would there have been a difference in reflectivity between this new sign and the sign above or the old sign that was struck at the time of the accident (see my previous photos)? I should think so. But none of this evidence has been discussed in the media nor has it been released to the media via the police investigation. If such evidence is not revealed or identified how can we expect corrections to be made? If we are truly interested in public safety we cannot go on ignoring factors such as these when they contribute to the collision consequences.
