## **Camlachie Fatal Rollover at Low Speed Was Result of No Seat-Belt Use**

*Posting Date: 5 Aug 2011*

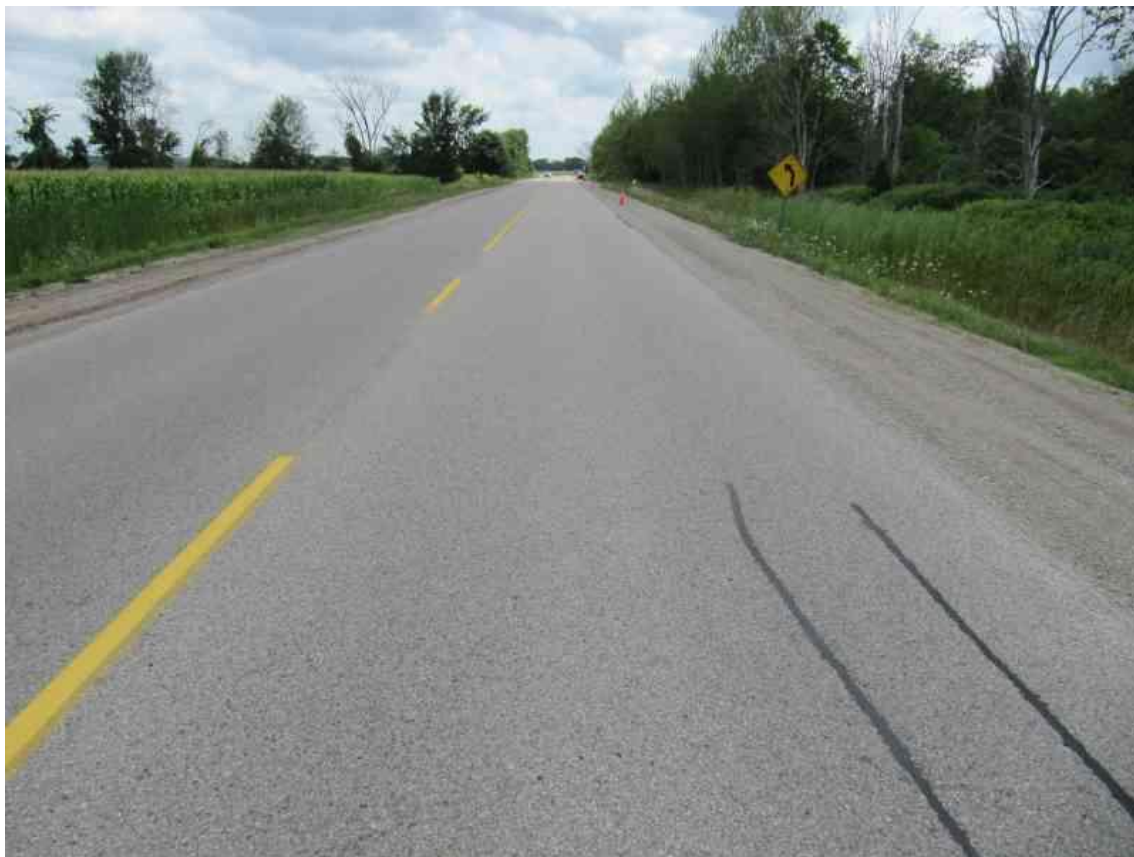
The photo below is a view, looking northbound, from about 250 metres south of the area where the Hyundai Accent came to rest.

As you can see, this is a straight and level roadway that is approaching a left curve, as indicated by the advisory sign on the right roadside. The pavement surface was in good

condition and there was no evidence of any excessive edge drop off on either side of the paved road.

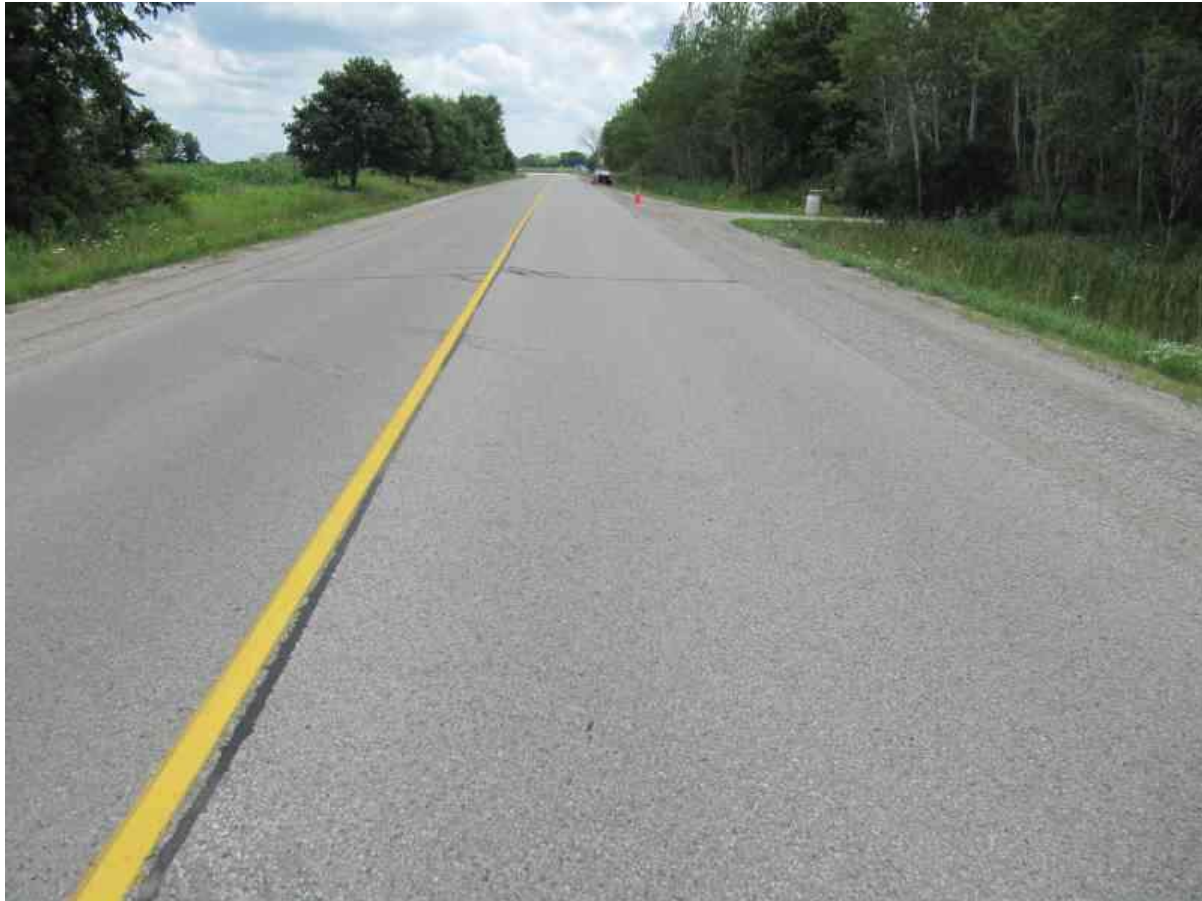
Below is another view, looking north, from about 100 metres from the vehicle rest position.

If you look at some of my previous website articles on loss-of-control collisions you will have noticed that by the time we reach a location that is 100 metres from the rest position of a vehicle there should be evidence of loss-of-control (yaw) tire marks. It should be evident to you by looking closely at the above photo that no such marks exist.

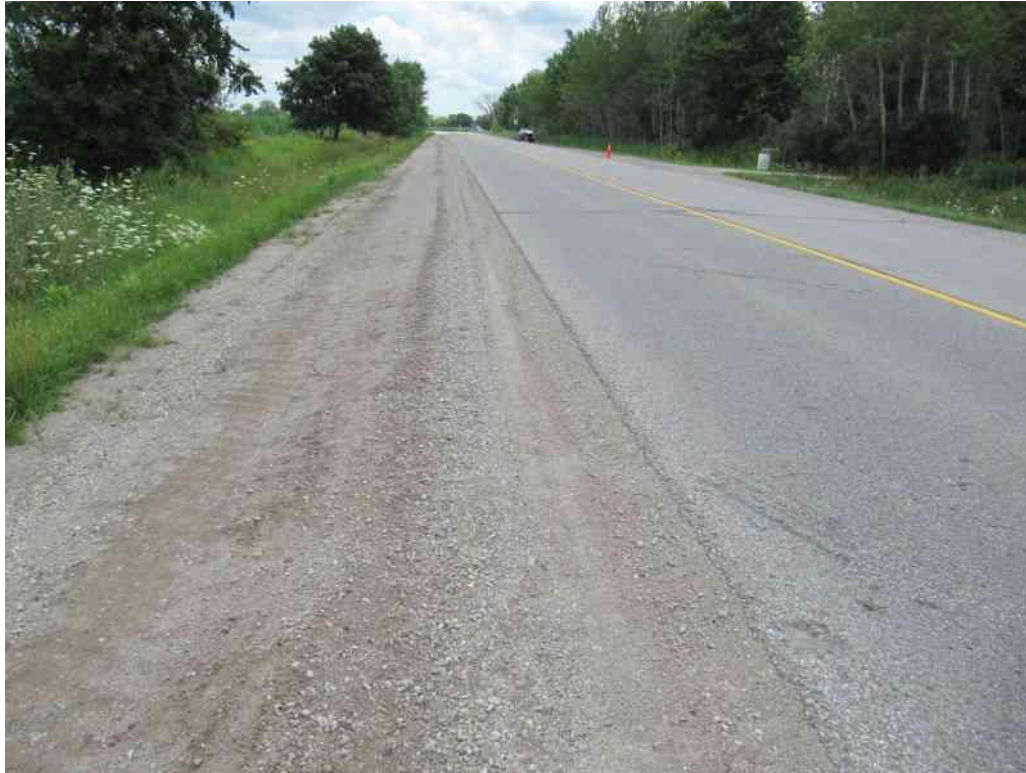
Being educated from my previous discussions you would then say that I should be showing a view of either the right or left shoulders of the road because that is usually where these loss-of-control tire marks are found. So let me show you those shoulders. First the left (or west) shoulder, from 100 metres, is shown in the view below.

Unless you are far more gifted than I am, you should conclude that no such tire marks exist. And now let us look at the right (east) shoulder, still from 100 metres away, as seen in the photo below.

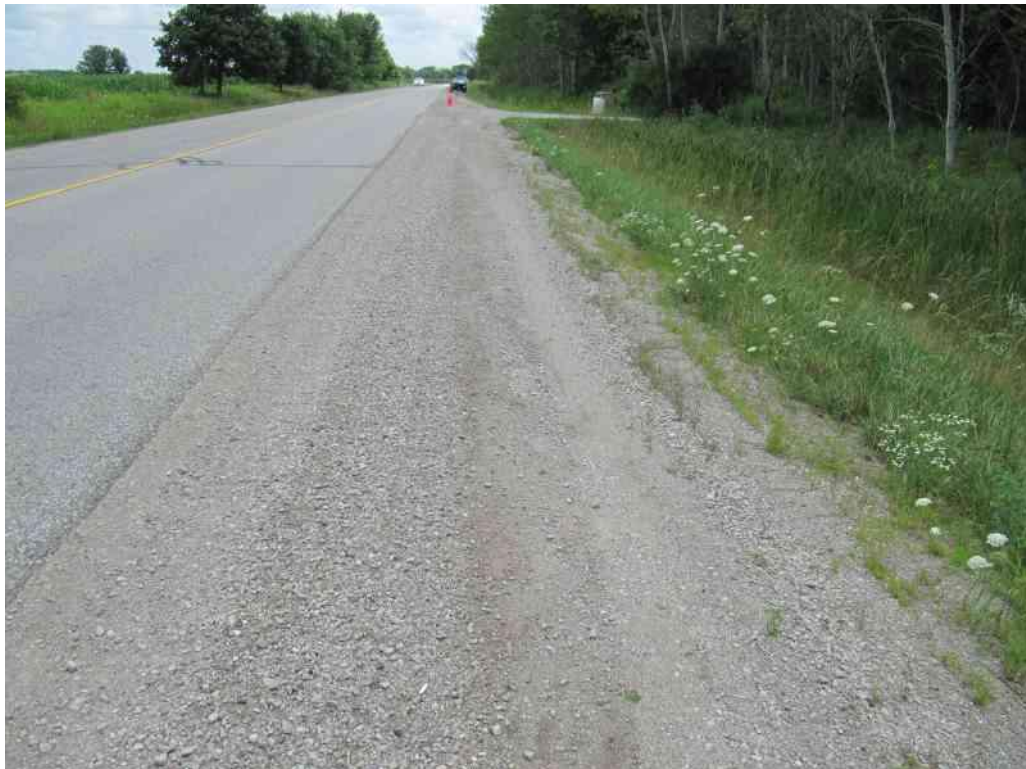
Still no visible tire marks, right?

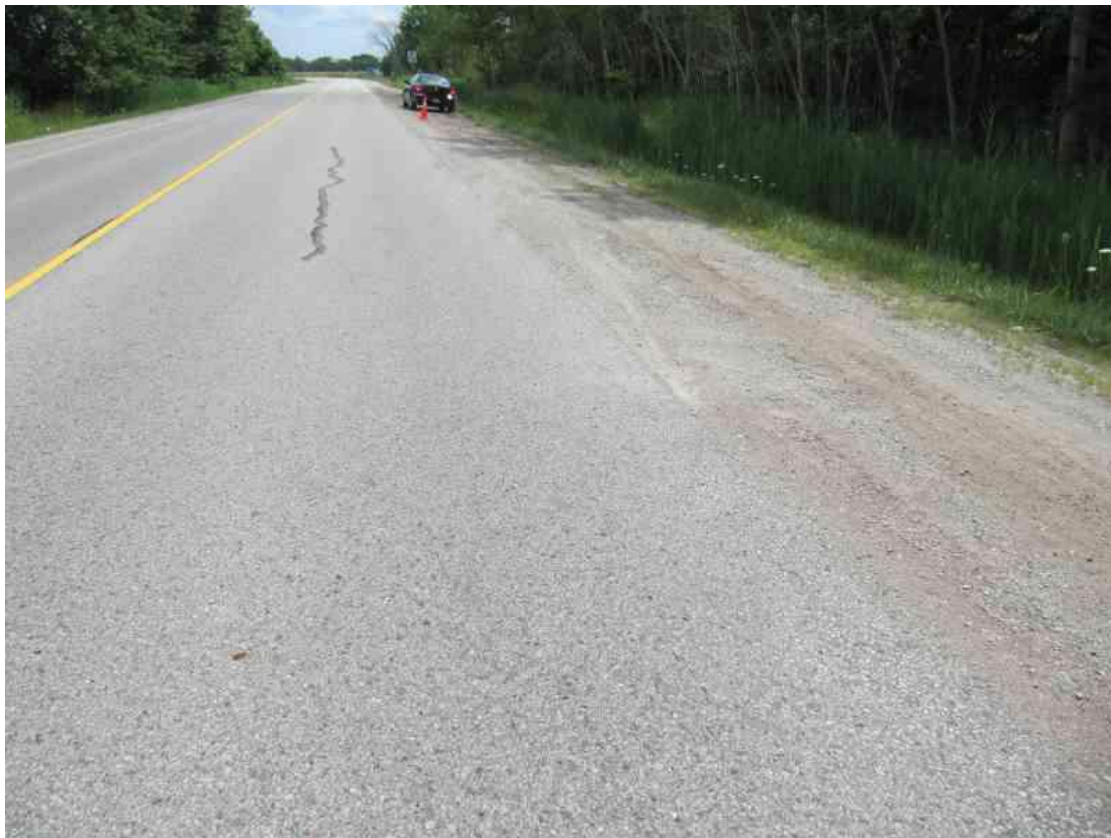
Eventually there was physical evidence the vehicle going into the east ditch, but that was well short of 50 metres from the vehicle's rest position and this evidence was in the form of tire-marks on the gravel shoulder. You might be able to recognize some of those tire marks in the photo below.

To clarify any confusion, the final rest position of the Hyundai Accent was adjacent to the large orange cone that can be seen just behind the back of my vehicle parked on the east shoulder. What you should be looking for are the typical curved yaw marks in the shoulder that indicate the vehicle is rotating, clock-wise and out-of-control, toward the ditch on the right (east) side of the road. But I hope you will agree with me that any marks on the road are not visible. But we know that the vehicle was in an advanced stage of loss-of-control as it exited the road so surely visible yaw marks must be expected since there would be so much sliding involved between the rubber of the tires and the pavement. So why are there no tire marks on the pavement?

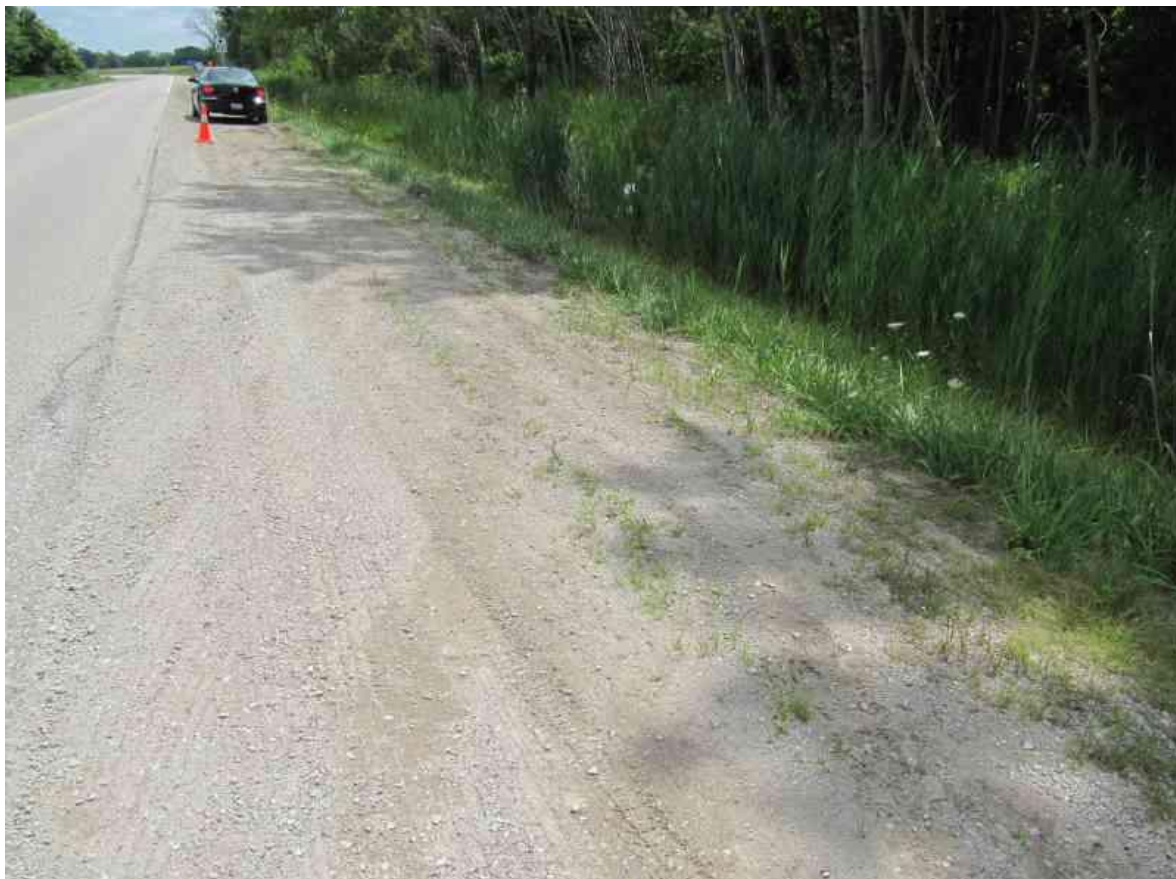
But what we do know is that the angle at which vehicles depart from the road is an indication of their speed or whether or not they had fallen asleep or suffered from some kind of medical condition. Recall that drivers who fall asleep leave the road a very shallow angles, less than 4 degrees with respect to the straight length of the road. Also very fast moving vehicles also tend to leave the road at rather shallower angles, although not quite as shallow as 4 degrees. But as a vehicle's speed slows down it has the opportunity to effect a greater change in lateral position with respect to the road length. And so when we look at the yaw marks, the larger the angle the slower the speed. So look at the angle of the yaw marks in the shoulder in the photo below.

My measurements indicate that the angle was about 18 degrees and that is substantial. The fact that it indicates a slow speed of the vehicle is further emphasized when we look at what happened as the vehicle slid into the east ditch. Leading with its left side you can see in the photo below how the tire marks to the right were produced by the front wheels while those to the left were produced by the rear wheels.

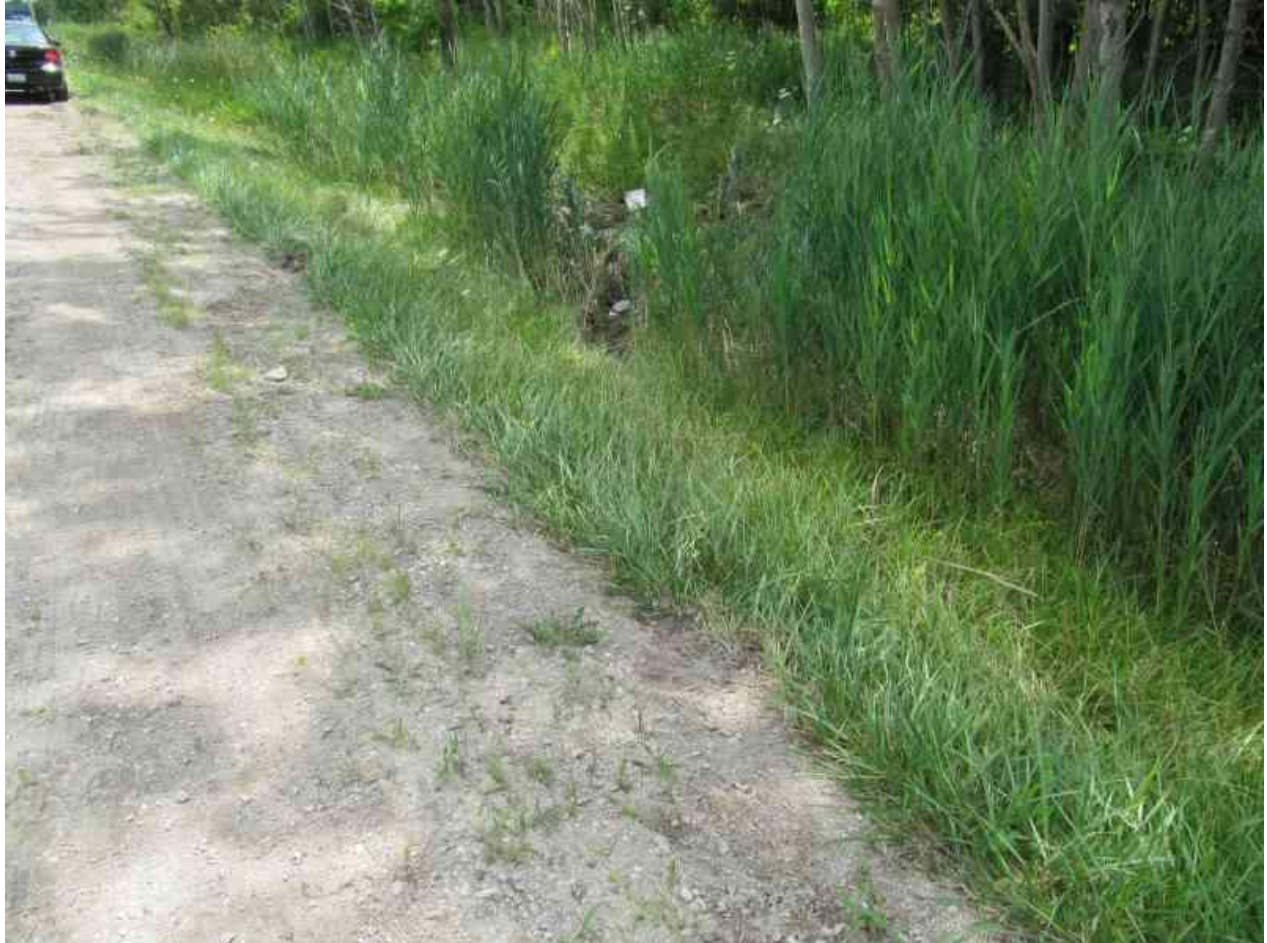
You should already note from the position of my car, shown in the extreme left corner of the photo that the final rest position of the Hyundai Accent must be relatively close to where it entered the ditch.

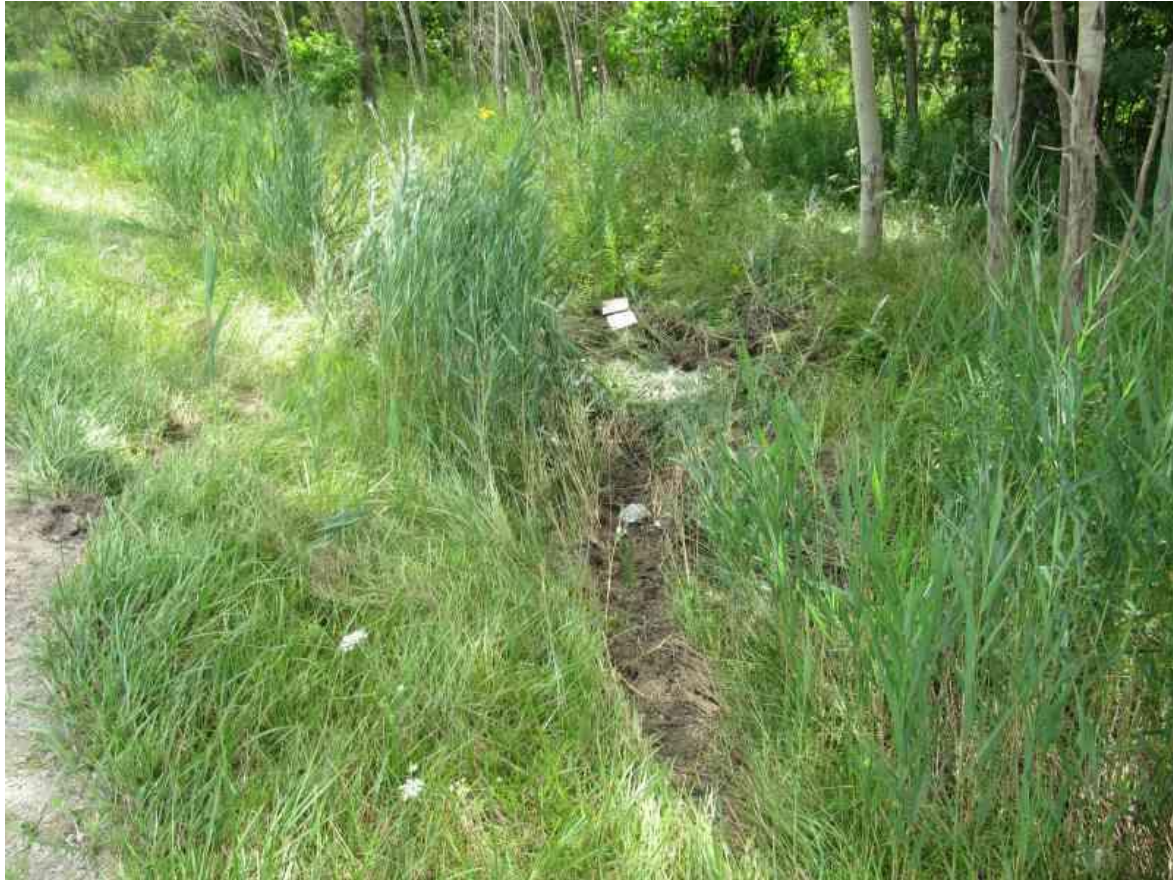
And as is typical, the vehicle's front end reaches the maximum depth of the ditch and there the underside of the left front also begins to plow into the earth. This can be seen if we follow the tire path on the right side of the photo below. You may be able to detect evidence where the front underside tore up the earth.

When the front underside dug in this accentuated the rate of clock-wise rotation that was already present and this is why we see that the path of the rear tire mark begins a greater change in direction, or the arc carved out by that rear tire has a smaller radius. It is precisely because of this accentuated rotation. So the vehicle wants to rollover onto its left side but it is also rotating rapidly in a clockwise direction. This rotation is what prevents the vehicle's full rollover and this is why the vehicle begins to slide backwards along the ditch.

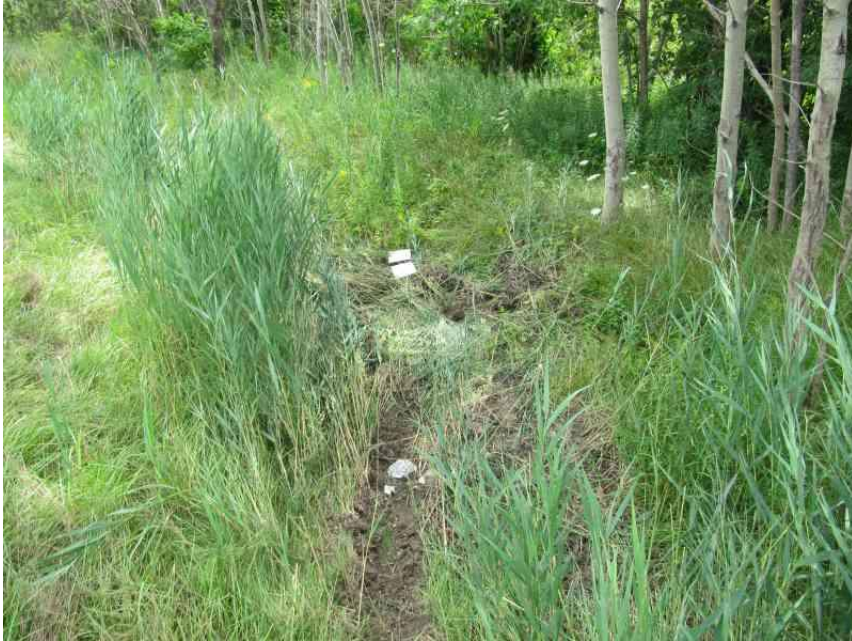
The photo below is a view looking north along the ditch from the end point of the tire marks and toward the rest position of the vehicle in the background.

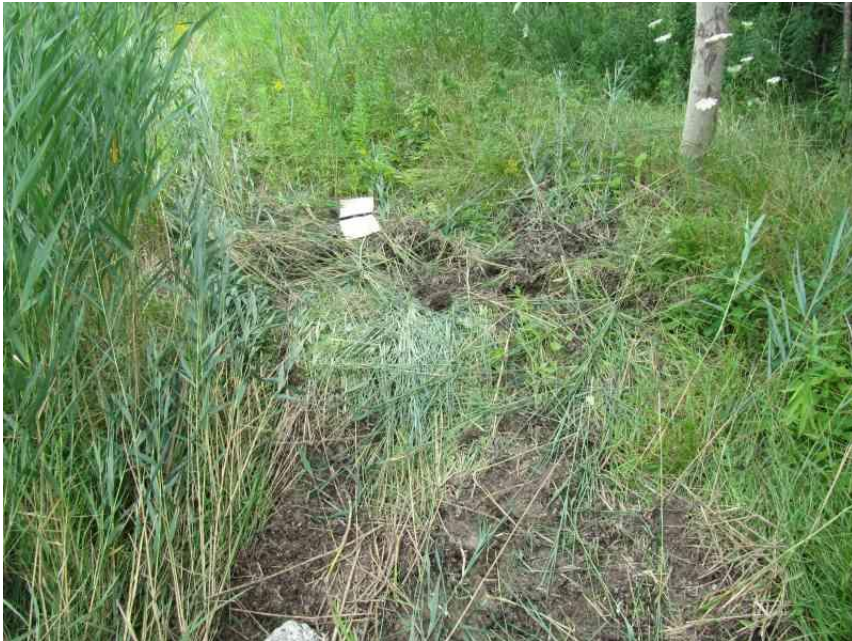
And again, the photo below is a view looking further north along that ditch and closer to the vehicle's rest position

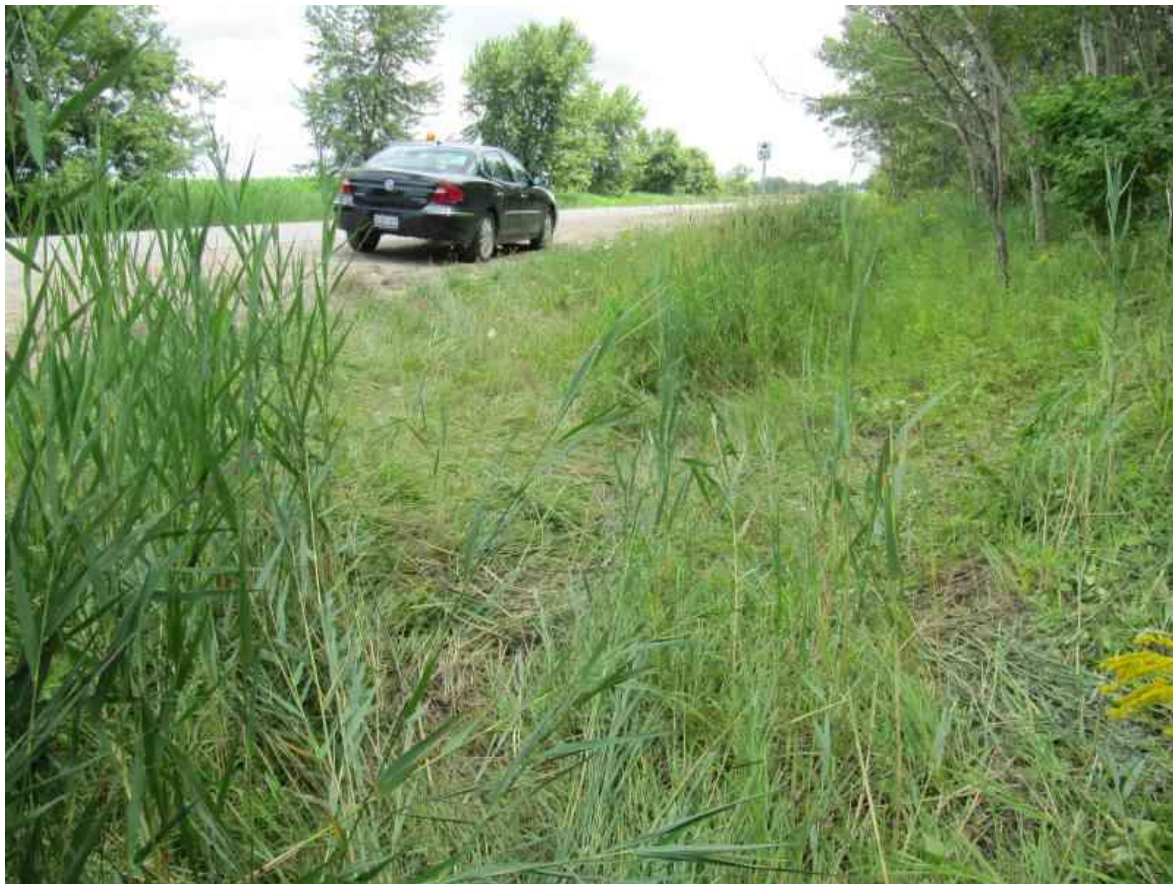
And as we progress further east we can see by the area of trampled grass that the vehicle came to rest in the ditch. The position of my car parked on the shoulder should give you some perspective as to the short distance of rollover that we are talking about.
