Narrow Head-On Impact Results In Fatality on Plank Line (Highway 19) North of Tillsonburg Ontario

Posting Date: 20 Feb 2012

Gorski Consulting
London, Ontario, Canada

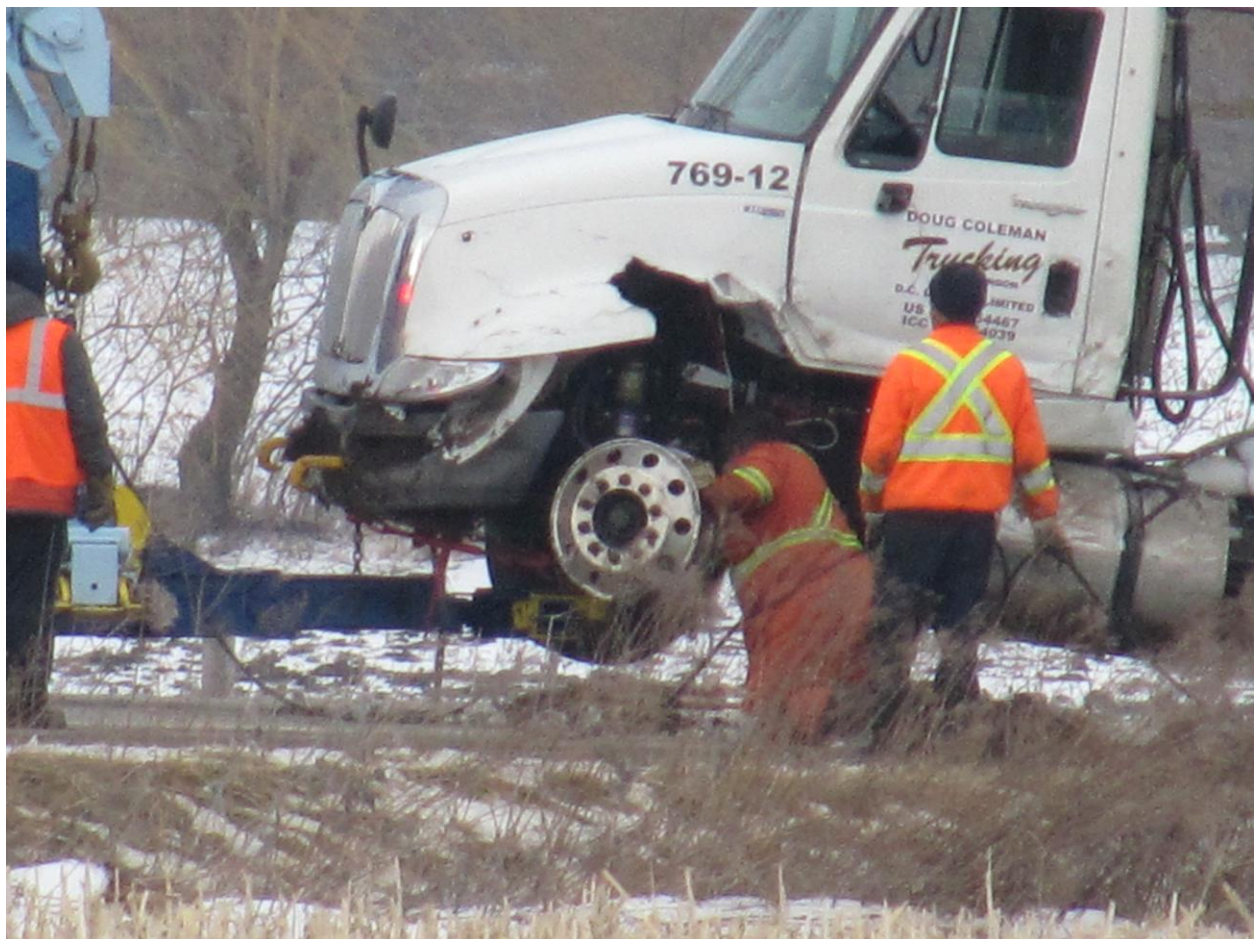
The Transport truck was still at the collision site in the late afternoon of February 15th and damage to the left side of the tractor and trailer were noted. Below is a view of the Tractor.

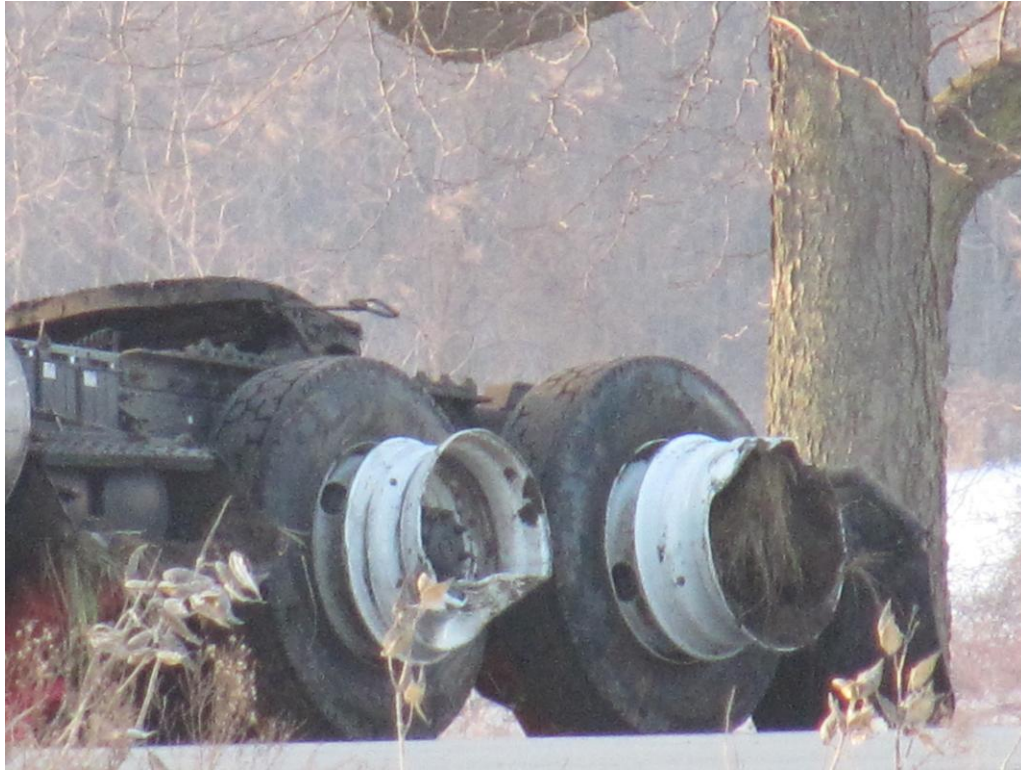
The direct contact damage is evident at its left -front corner and it progresses rearward toward the trailer. The left drive wheels sustained heavy damage as shown below.

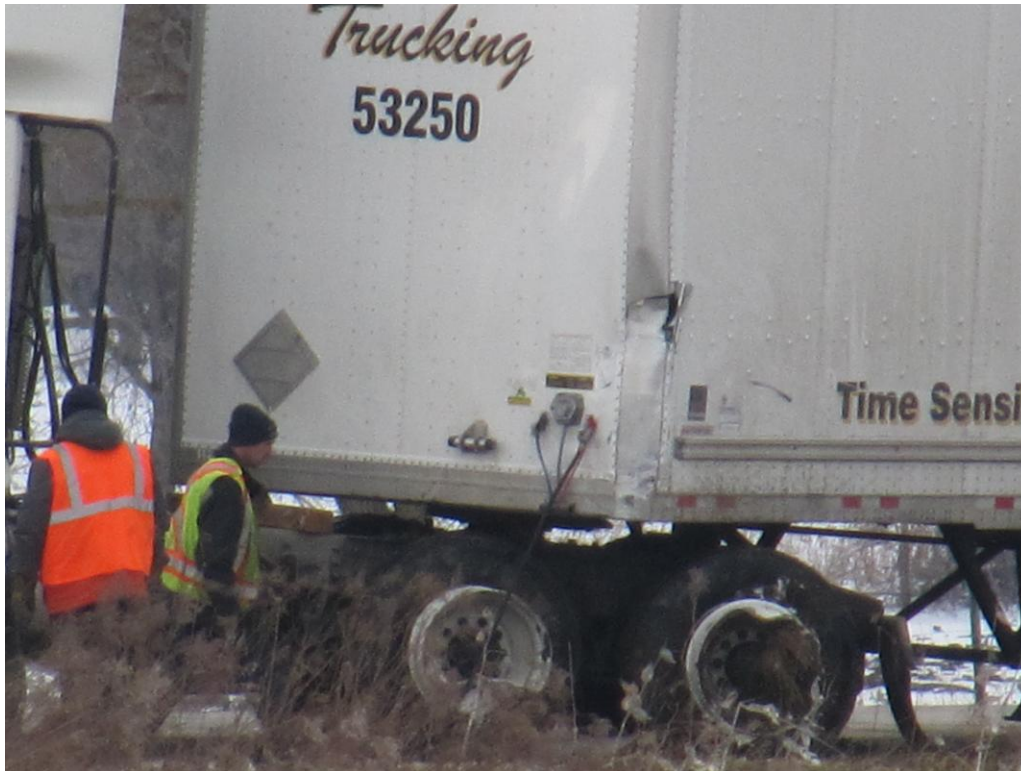
There was also damage evident to the front corner of the trailer as noted below.

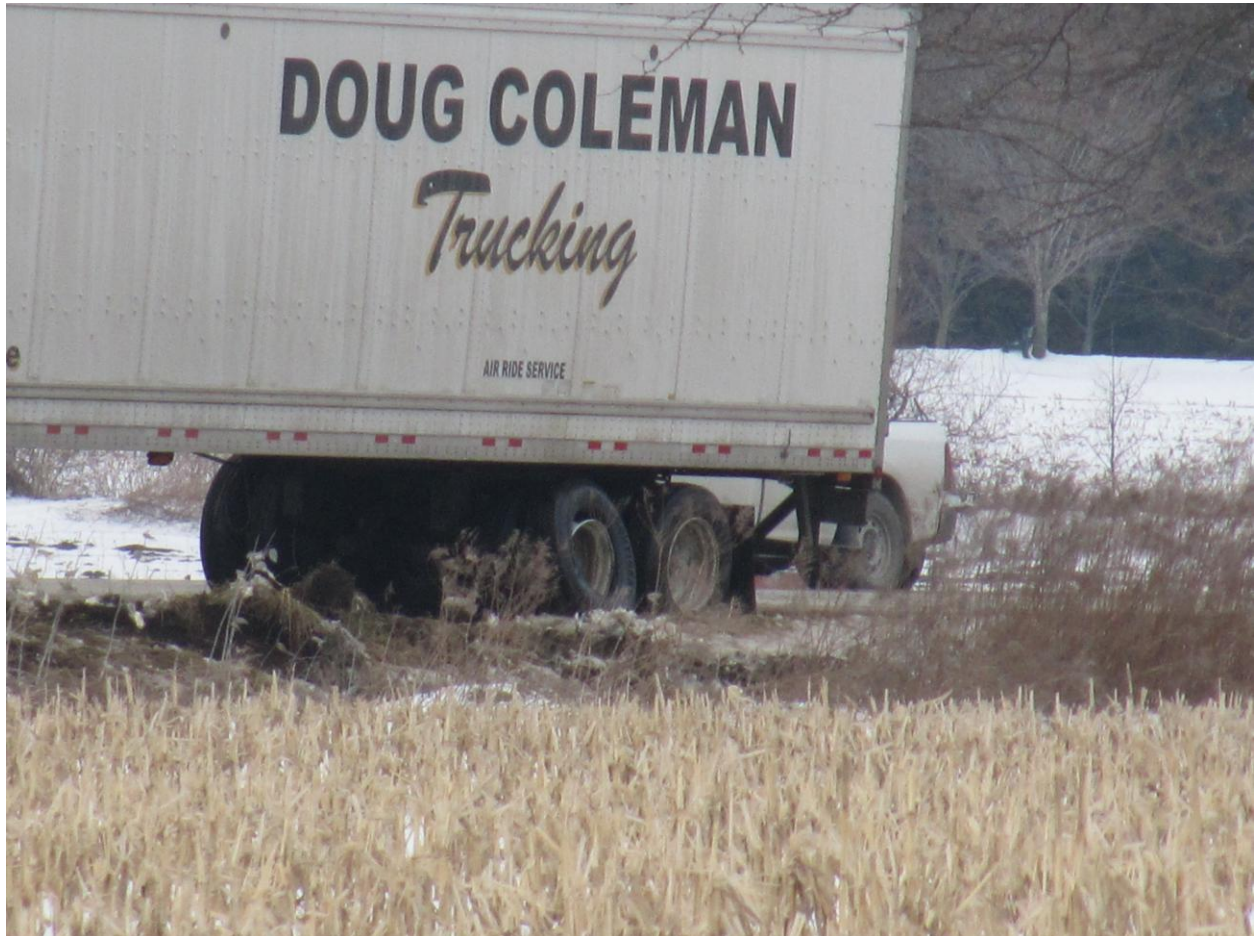
The damage also extended toward the rear of the left side of the trailer, as noted below.

The damage on the Doug Coleman truck would occur from a narrow frontal impact involving the left portions of both vehicles. Such an impact would cause both vehicles to pass by each other and come to rest on opposite sides of the area of impact. This is evident when we examine the physical evidence at the site.

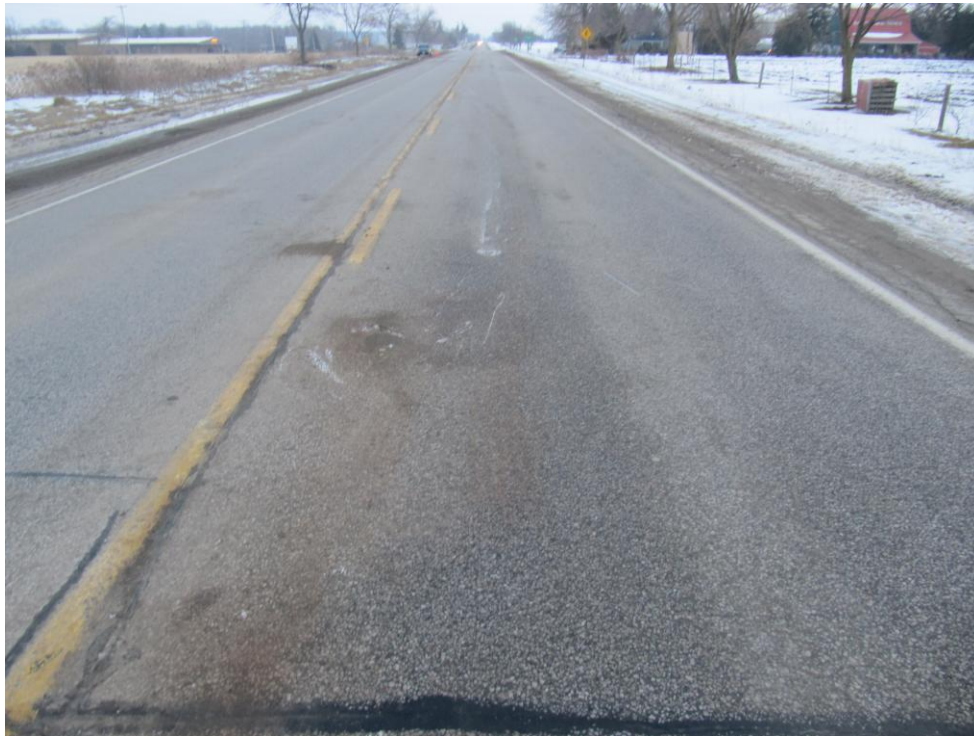
The photo at the top of the following page shows a view, looking south in the southbound lane of Plank Line, just a few hundred metres north of Airport Road. So this view is looking toward the Town of Tillsonburg. In the foreground you should recognize a number of markings in the southbound lane. In particular you should recognize the white-coloured markings which are indicative of recent gouging of the pavement as a result of the impact. These gouges exist in the southbound lane consistent with the location of the Doug Coleman truck which was likely travelling southbound. It would appear that the northbound Howe Cube van travelled into the southbound lane where the impact occurred. Due to the much larger mass of the Coleman truck it travelled further for some distance before coming to rest on the east roadside just north of the area of our parked car in the background.

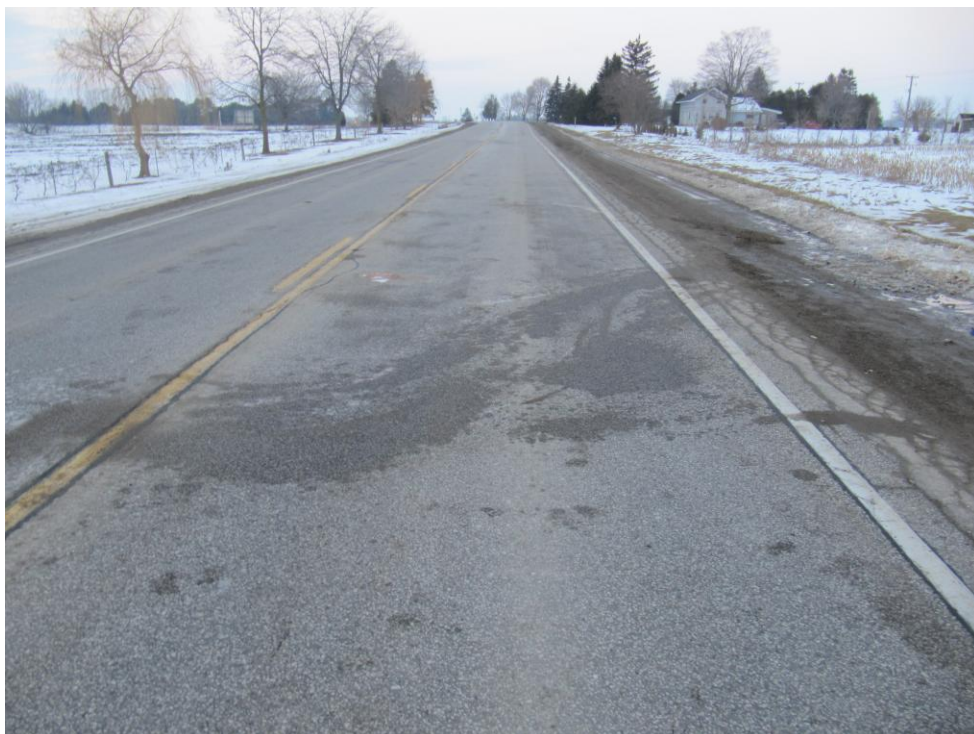
The photo below shows a view looking northbound in the northbound lane where the gouges are just behind the camera. The darker fluid stains indicate the Cube van's travel to final rest onto the east shoulder.

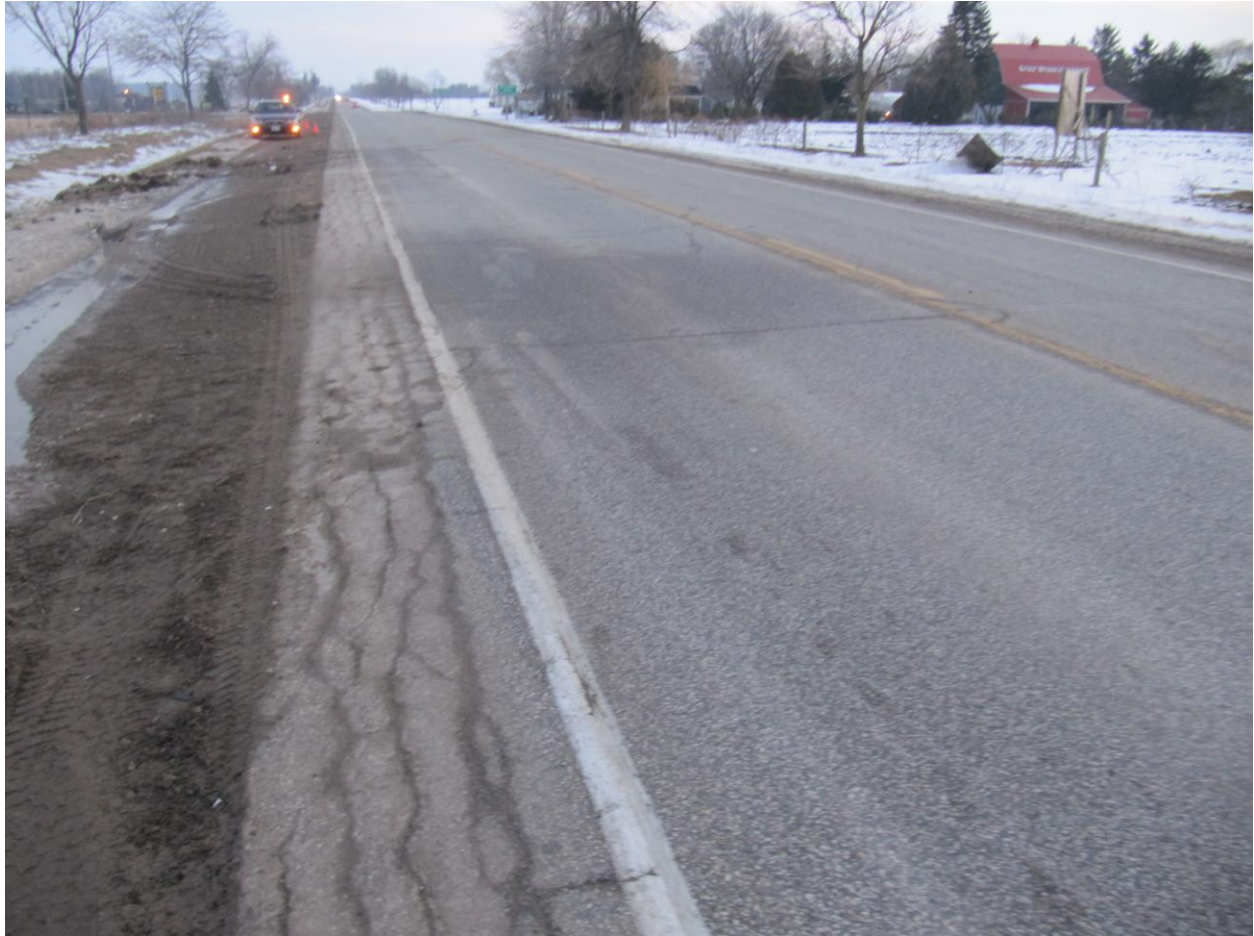
Below is a view looking southward toward the final rest position of the Coleman truck in the east ditch. Due to the damage caused at the left wheels of the vehicle this caused greater drag to the left of its centre of gravity and this is what caused the vehicle to be dragged toward the left (east) following the impact. Such a motion is sometimes confused by investigators as an indication that the truck driver steered toward the east but that is generally not the case.

In trying to understand why the Howe Cube van travelled into the opposing lane we would want to make a close study of the northbound lane in the vicinity shown in the above photo. Sometimes a pavement edge drop off is a common culprit but we can see in the photo that there is not significant edge drop off. The white, painted edge line of the lane is also located a substantial distance from the actual pavement edge so this is also a good safety factor.

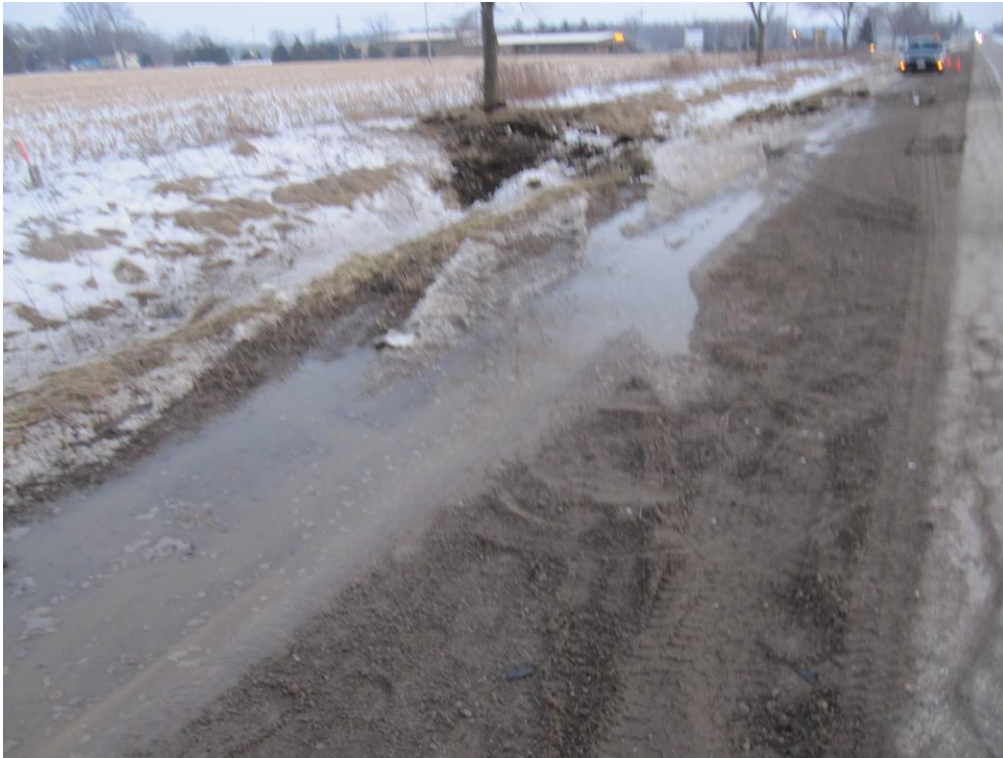
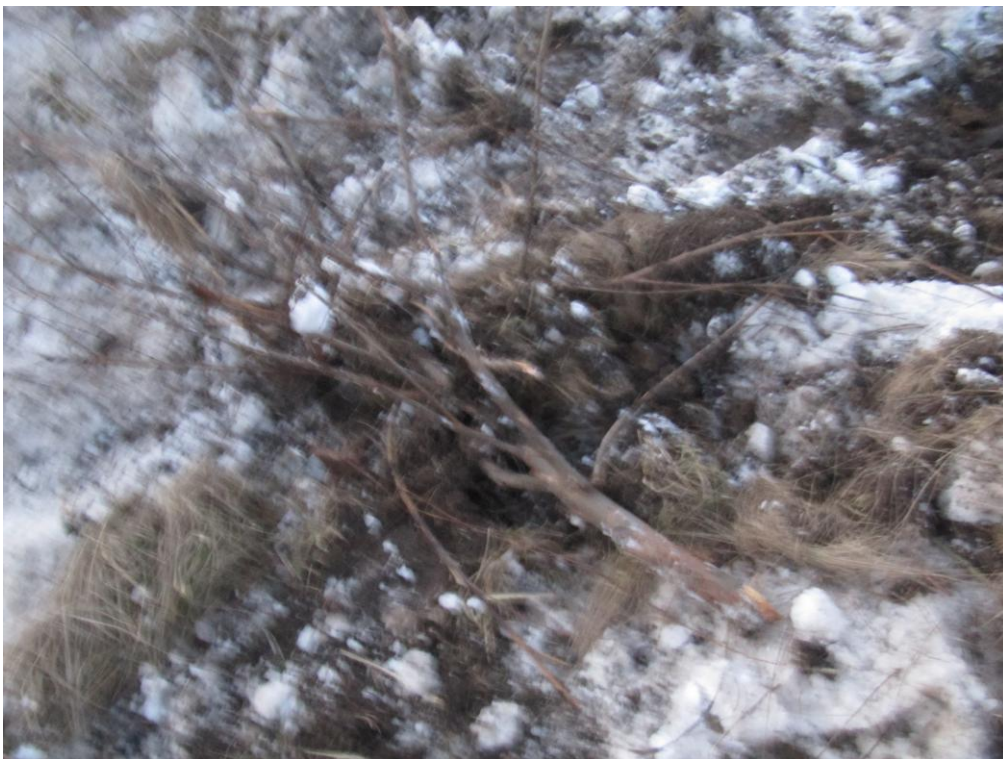
The photo below shows a view looking south-east, toward the final rest position of the Coleman truck. Curiously, there was a broken branch lying amongst the debris at the truck's rest location as shown in the bottom photo of this page.

We checked the condition of the tree at the final rest position of the truck and confirmed that the branch did not come from any breakage on that tree. Our scan of the vicinity around the accident site also indicated that there were no trees close enough to the road to explain how the branch could have been deposited at this location.

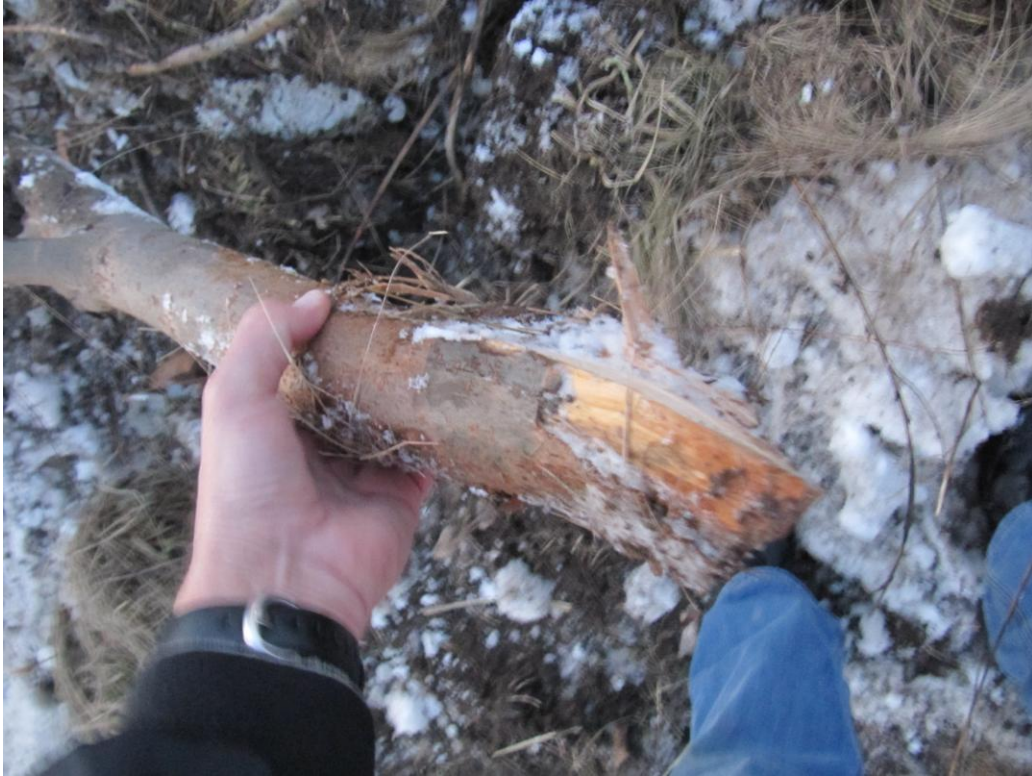
A view of the end of the branch suggests that the breakage occurred recently as shown in the photo below.
