# Characteristics of Tire Marks During Braking and Acceleration During a U-turn on Gravel Shoulders - Part 3

*Posting Date: 29 Feb-2016*

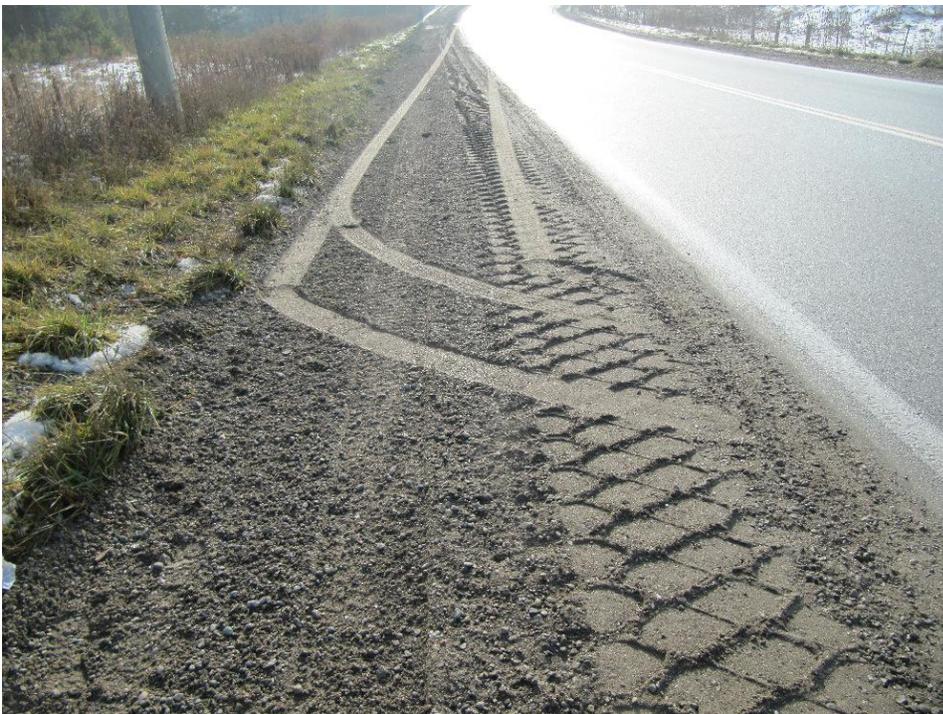
The original tire marks were discovered on December 4, 2013. Figure 2 shows a southerly view of the east shoulder of Clarke Road at the north end of the S-curve. For those readers who have examined the previous two articles the content of what is visible in Figure 2 should be familiar. It shows the tire marks of a northbound vehicle that travelled onto the shoulder (toward the camera). It is likely that the vehicle came to a stop and the driver turned the steering wheel hard to the left to commence a U-turn. Thus we see the typical curved tire marks as the turn takes place.

**Figure 2: View, looking south, along the east shoulder of Clarke Road at the north end of the S-curve. This view shows the tire marks of a northbound vehicle that travelled on the shoulder and then made a sharp left turn that continued onto the opposite (west) shoulder where it completed a U-turn.**

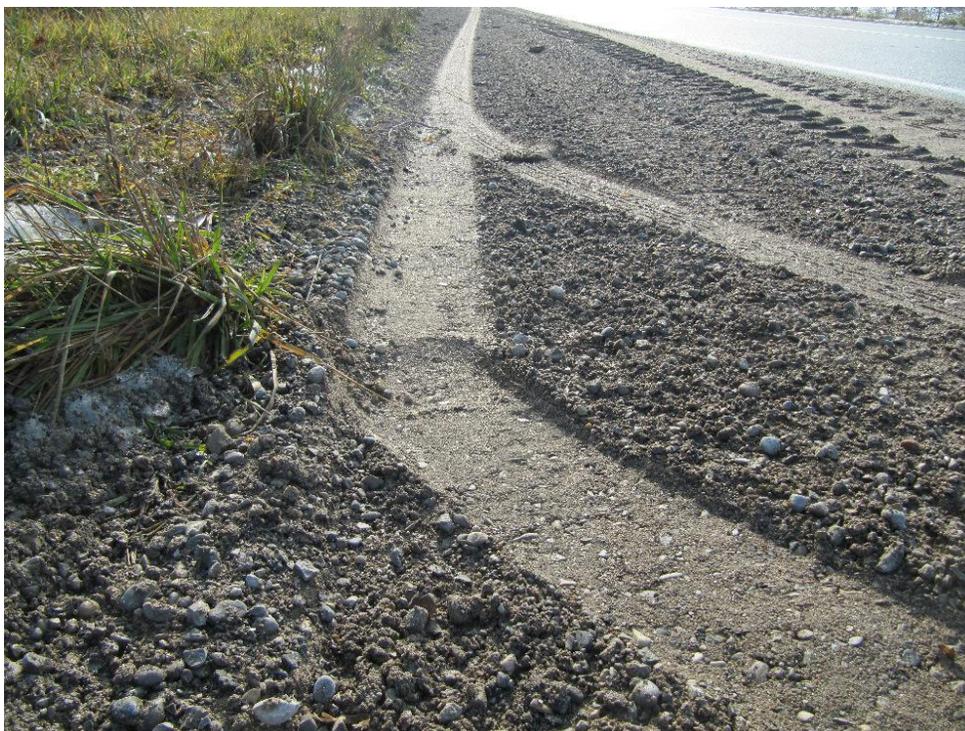
Figure 3 shows the tire mark created by the right front tire. As one would expect, the straight portion of the tire mark was created as the vehicle was slowing while approaching the camera. The tire then stopped at the point where the tire mark changes direction. This abrupt change in direction can only occur when the tire is stopped, or almost stopped, because time is needed to change the tire's pointing direction during steering.

In the background of Figure 3 is the curved tire mark created by the right rear tire. As discussed in the previous articles, as the right front tire moves toward the new direction, the right rear tire follows along but in a more gradual change in direction. Thus we have the typical sweeping curve of the rear tire mark which is inboard of the right front tire mark.

Figure 3: View of tire mark created by the right front tire of the unknown vehicle.

Figure 3 shows an interesting feature of the unknown vehicle. The right front tire mark does not display any tire tread. This is likely because the front tires of the vehicle were "bald" or did not contain a tire tread. This is an uncommon finding.

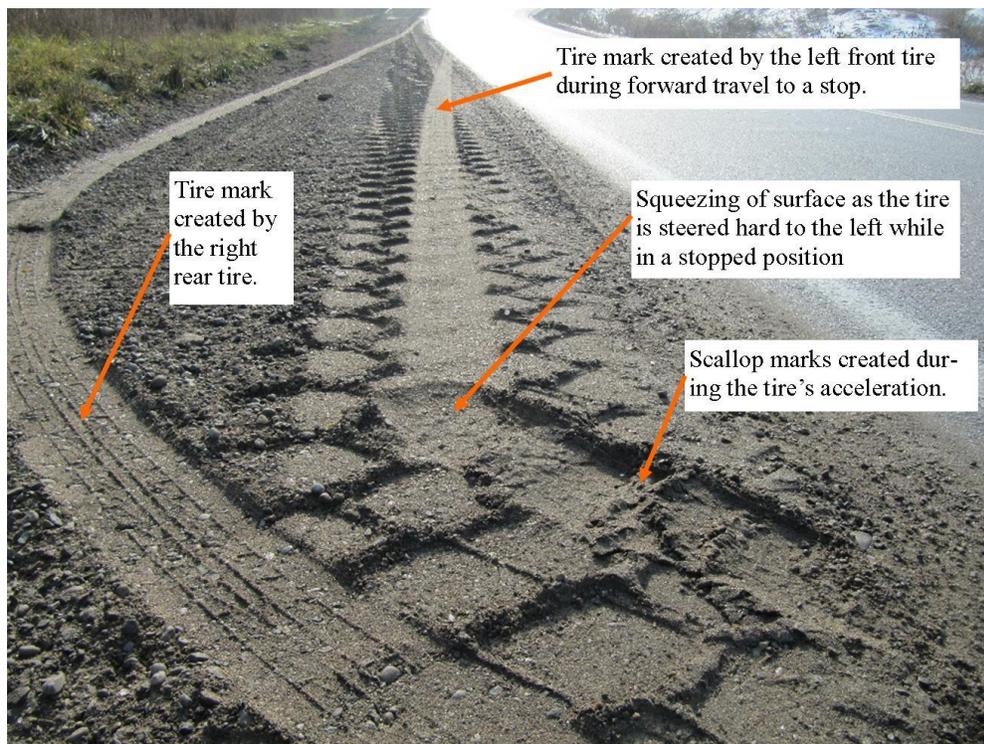
Figure 4: View of the tire marks with their explanations.

Figure 4 shows the tire marks caused by the left side tires of the unknown vehicle. It shows a close-up view of the "scallop" markings within the left front tire mark at the point where the unknown vehicle began to accelerate forward from its stopped position. As noted previously, such scallop markings are an indication of acceleration.

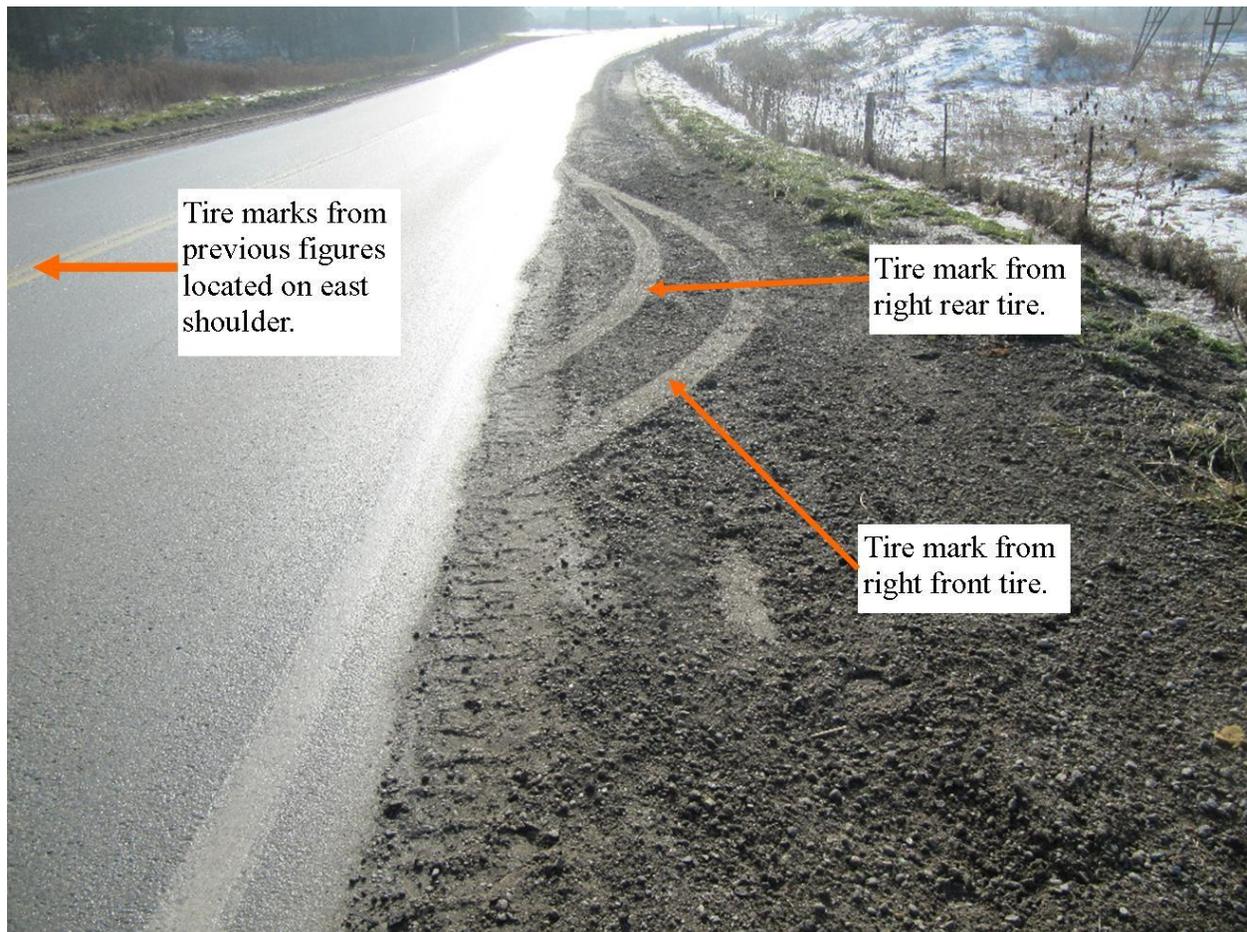
As the unknown vehicle accelerated into the U-turn it crossed the road such that the right side tires travelled onto the west shoulder, as shown in Figure 5.

Figure 5: View, looking south, along the west shoulder of Clarke Road where the right side tires of the unknown vehicle created visible tire marks and the vehicle subsequently moved off into the background after completing the U-turn.

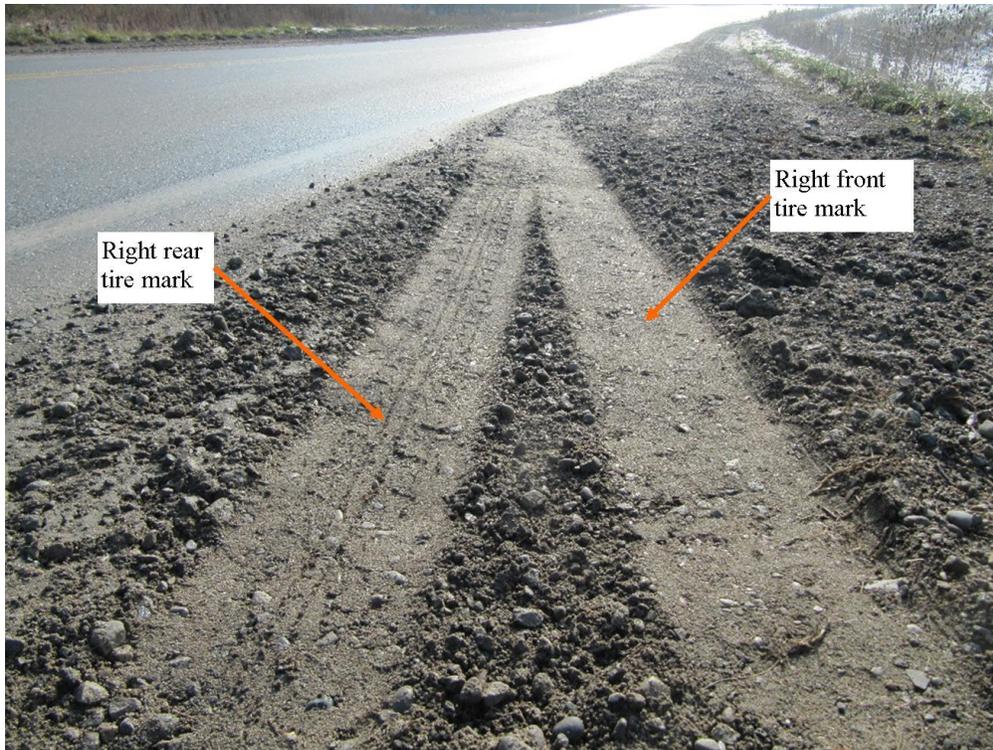
Figure 6 shows the two right side tire marks of the unknown vehicle on the west shoulder near the point where they converge and the vehicle reenters the paved road. Here we can appreciate the difference in the tire tread that is visible in the right rear tire mark but not in the right front tire mark. Again, this is a sign that the right front tire is bald.

Figure 6: View of the characteristics of the tire marks caused by the right side tires of the unknown vehicle.

It is unlikely that many vehicles would be riding the roads with two bald front tires and two rear tires with tread in them. Although uncommon it is these kinds of unique features of a vehicle or its tires which can help to solidify an opinion that a particular tire mark was caused by a particular vehicle. Obviously the pattern of the tread imprint can also be used to establish a vehicle's identity.

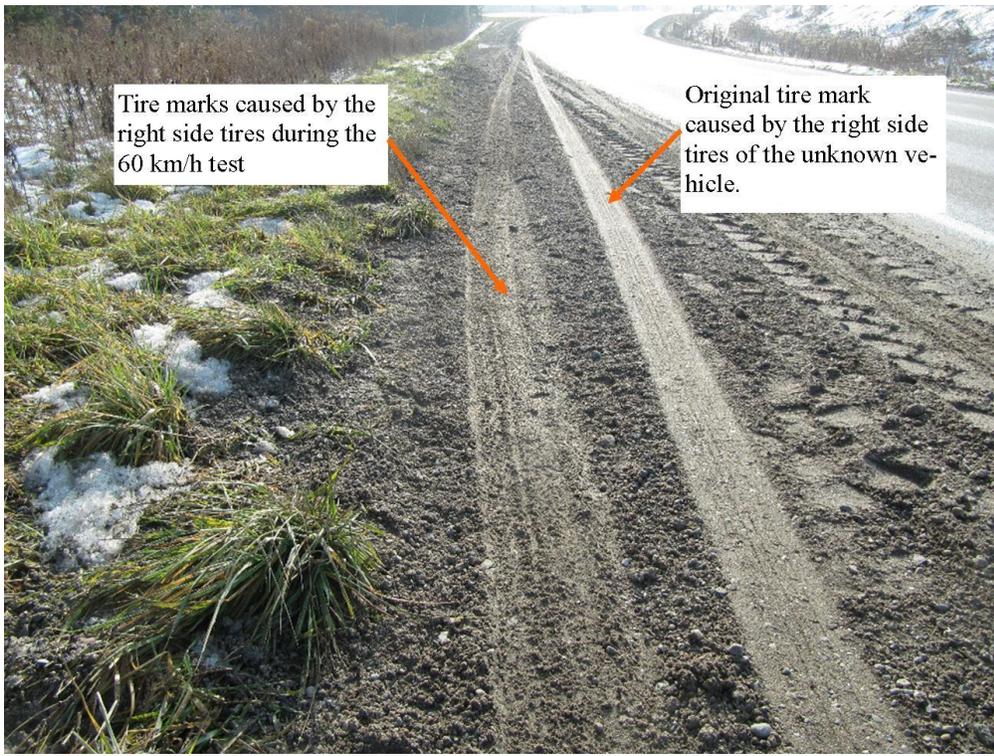
Figure 10 is a view looking south at the tire marks produced by the right side tires of the unknown vehicle and the subsequent test vehicle. Obvious differences include the difference in apparent roughness of the surface within each tire. Although, at this location, the tread is visible within the original tire mark because the rear tire rode over the front, there is still a level of smoothness apparent within that is not duplicated in the roughness of the tire mark produced in the test. We know that the test involved significant braking and we suggest that this is the reason for the difference as well as the fact that the right front tire of the unknown vehicle was likely bald.

Figure 10: View, looking south, at the tire marks produced by the original, unknown vehicle and that produced in the test.

A second difference in the tire marks shown in Figure 10 is the extent of "straightness" or lack of straightness between the two. The original tire mark is very straight whereas the tire mark from the test is curved. We suggest that this is another indication of the difference in speed at which the two tire marks were produced. At a speed of 60 km/h our test required that the driver get onto the shoulder in hurry, straighten the vehicle's path and then apply hard braking, thus the reason for the lack of straightness. In contrast we suggest that the unknown vehicle rolled along at a gently, slow speed in a scenario where the mystery driver was in no hurry or in need to adjust the vehicle's motion other than bring it to a gradual halt prior to steering the wheels hard to the left to commence the U-turn. Thus information about the path of the tire mark can may also help in determining how a tire mark was created.

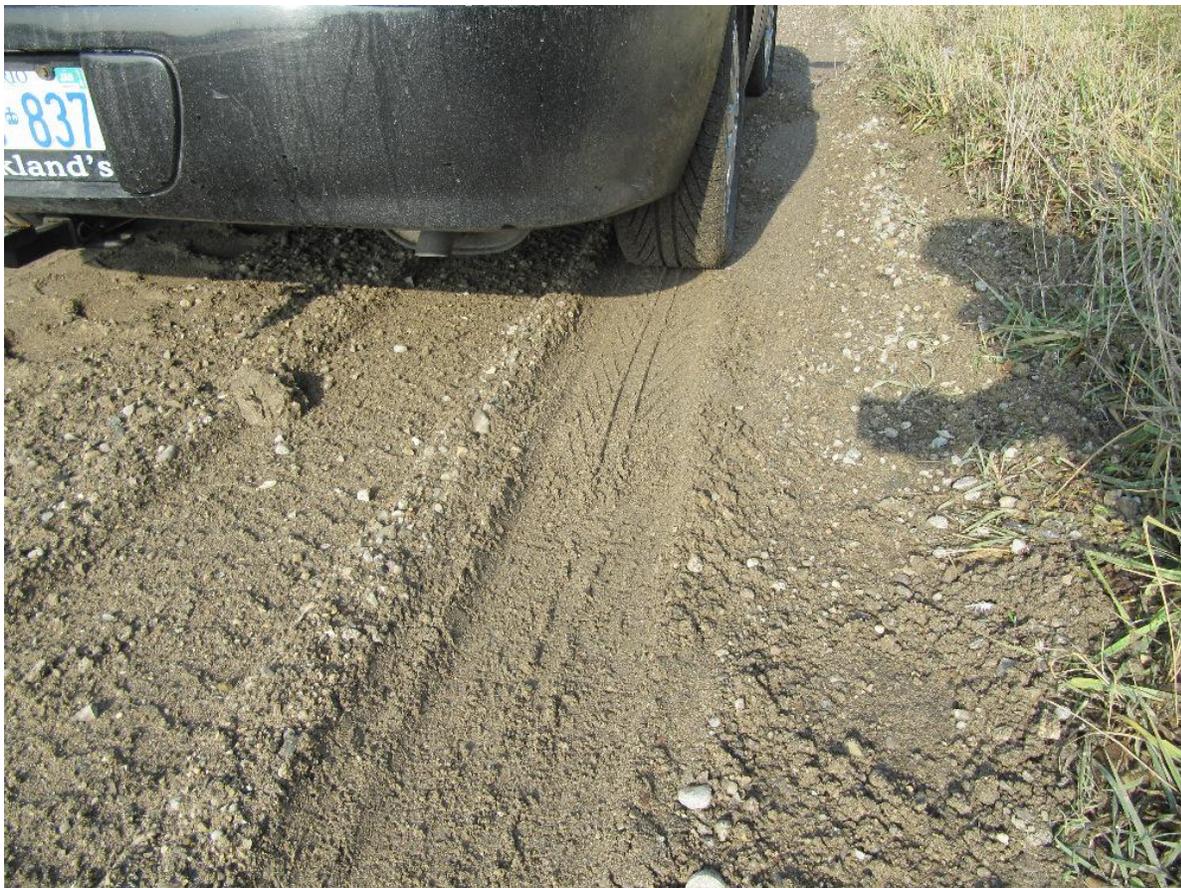
Evidence of high levels of braking may also show up if there are indications that the anti-locking braking was engaged. In Figure 11 we see the last portion of the tire mark created by the right side tires and just behind the right rear tire we can see a clear tire tread whereas closer to the bottom of the view we can see that the tread has been disorganized and disturbed. This difference can be a sign that the ABS system was cycling on and off and changing the rate of rotation of the tire.

**Figure 11: View, looking north, toward the right rear tire of the test vehicle at its rest position. The characteristics of the tire mark produced by the right side tires can be seen in the foreground.**

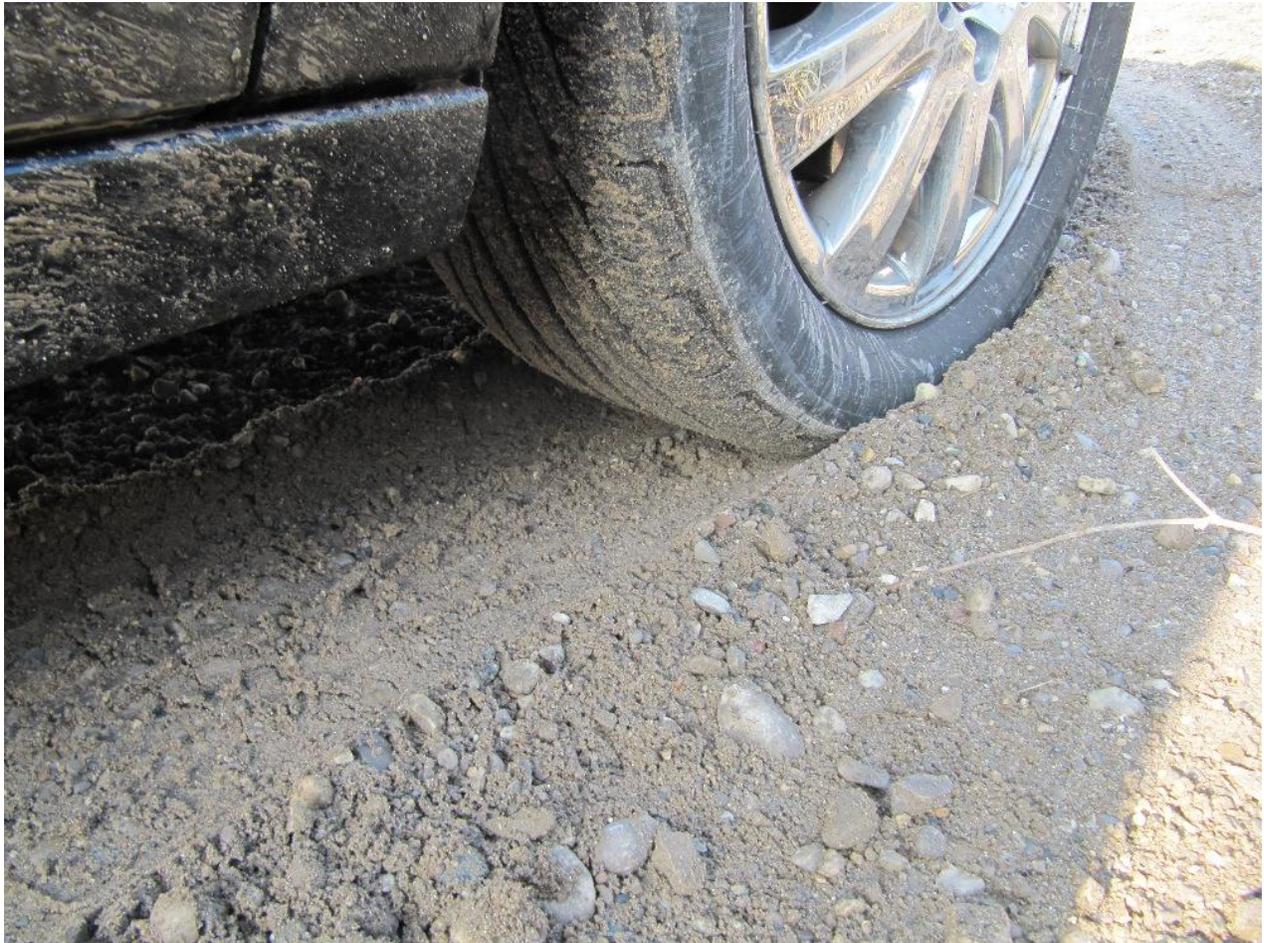
In Figure 12 we see the degree to which the gravel/soil has been pushed to the sides of the tire producing the wall similar to what is created during acceleration. At the top right corner of photo, in the shadows just in front of the tire, one might be able to pick-up the curving tire mark caused by the right rear tire of the unknown vehicle.

**Figure 12: View of the right front tire of the test vehicle at its rest position after the test was completed.**

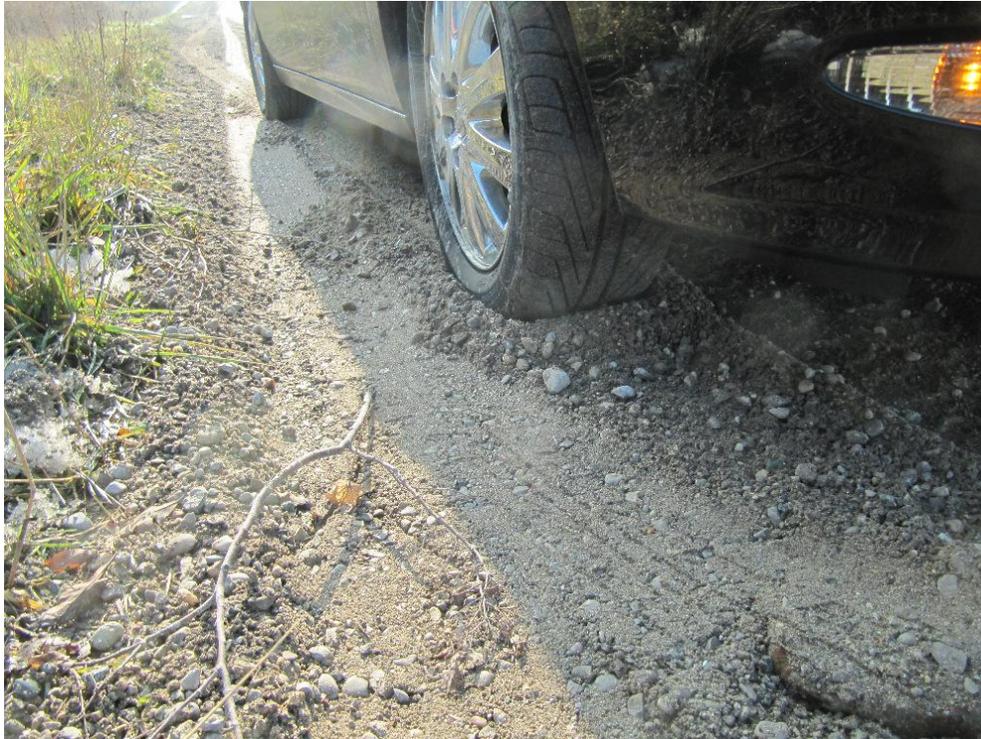
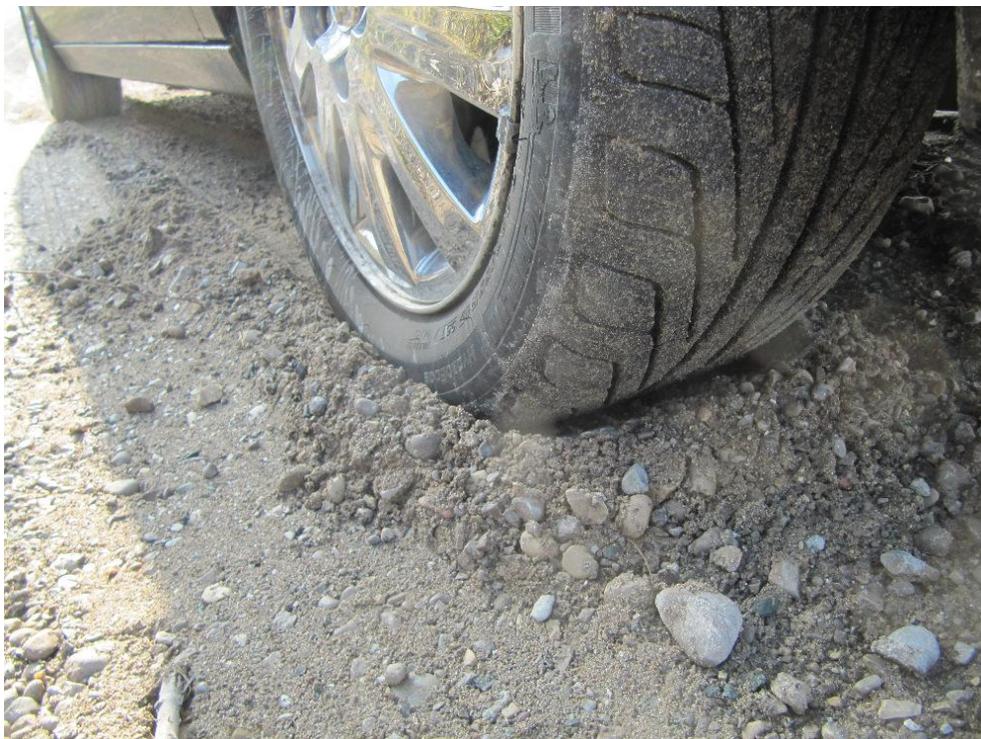
Figures 13 and 14 show the extent to which the gravel/soil has been built up in front of the stopped right front tire. One can imagine how this build up of loose material would be moved when the tire is stopped but the driver turns the steering wheel hard to the left to begin the U-turn.

Figure 13: View of the shoulder conditions around the stopped position of the right front tire of the test vehicle.

Figure 14: View of wall of gravel/soil on the sides and in front of the right front tire at its rest position.

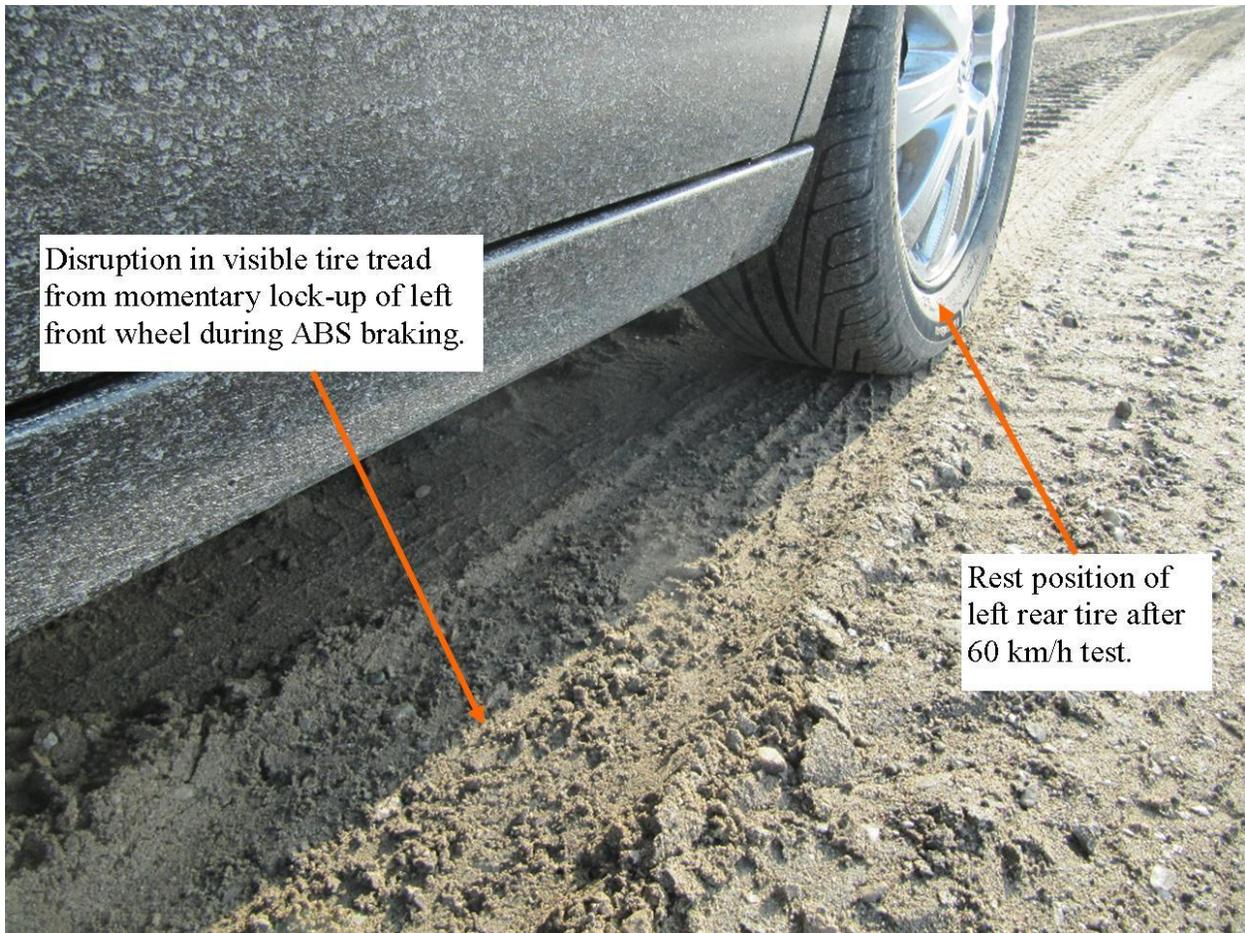
On the left side of the test vehicle Figure 15 shows the tire mark of the left front tire that is just in front of the left rear tire. Here we can see another area of disturbed tire tread within the mark indicative of the activation of the ABS system.

Figure 15: View of the tire mark along the left side of the test vehicle.

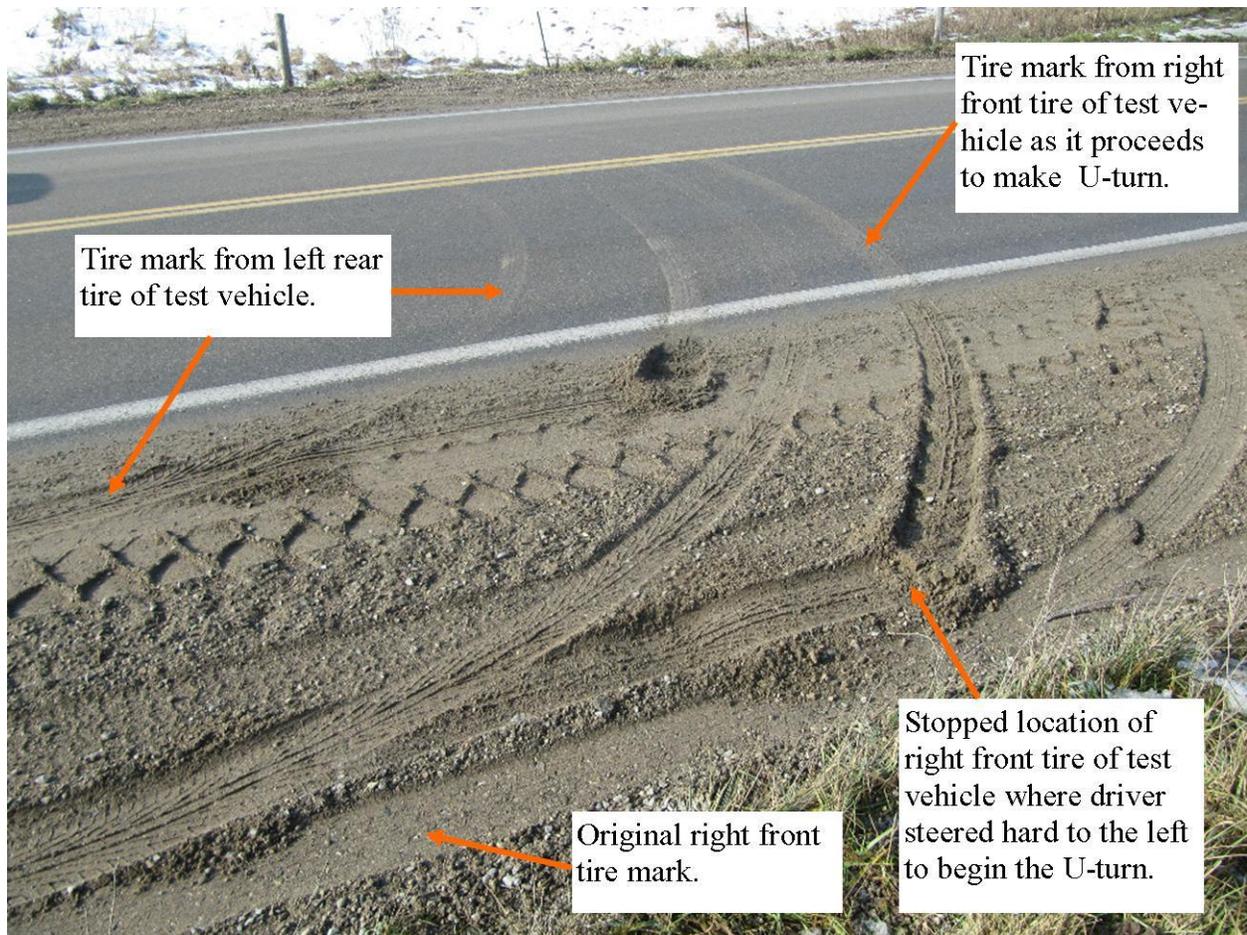
Before reviewing the marks on the west shoulder we first examine what evidence was present on the east shoulder after the test vehicle vacated that area. Figure 16 provides a view, looking west, at the location where the test vehicle came to its stop and then started its U-turn. The labels of the tire marks show that this is also where the unknown vehicle came to a stop although the unknown vehicle's stop position was slightly further north. A label at the bottom of Figure 16 identified the original, right-front tire mark of the unknown vehicle. At the extreme right edge of Figure 16 one can also see the curved tire mark of the right-rear tire of the unknown vehicle.

Figure 16: View of the stopped location of the test vehicle after it vacated the east shoulder.

One can clearly see the sharp change in direction of the paths of the front tires of the test vehicle as the driver steering hard to the left. Although not labelled one should also be able to detect the more gradual, curved path of the right rear tire of the test vehicle as its path separates from that of the right front tire. Thus there are various obvious differences in the paths and characteristics of the tire marks produced by the two right tires. These differences have now been demonstrated in several examples of in the three articles that have been written so far.

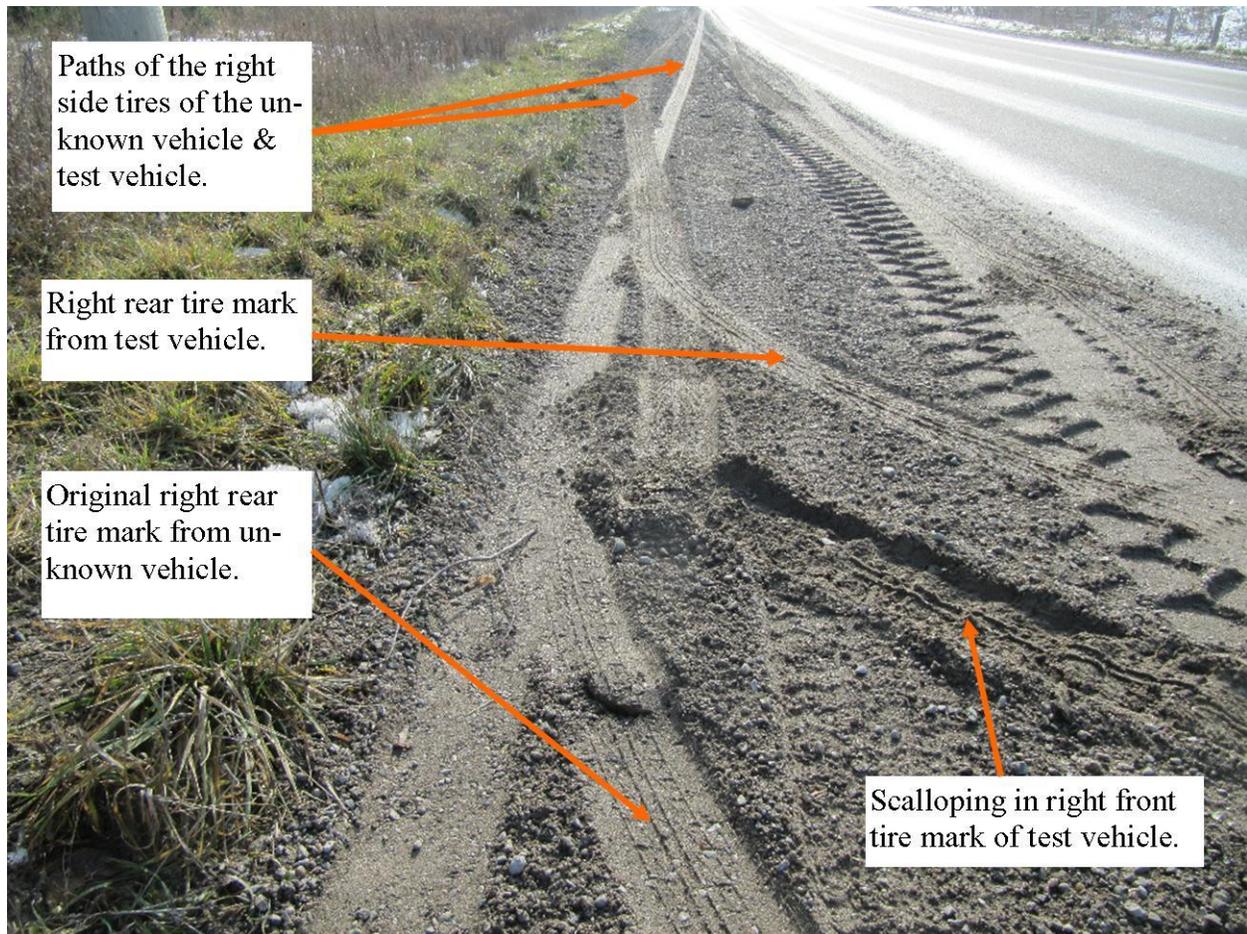
Figure 17: View, looking south, along the tire marks on the east shoulder of Clarke Road.

Looking onto the background of Figure 17, one can re-examine the paths of the right front tires of the two vehicles. It can be observed that the unknown vehicle has followed a very "straight line" path without changes in direction. Alternatively, our test vehicle demonstrates a prominent change in direction. First, the test vehicle exits the pavement at a sharper angle, then it straightens out to travel somewhat parallel to the shoulder. Again, these are signs of the differences in speed of the two vehicles.

As mentioned a number of times in previous examples, one can see the typical scalloping marks in the acceleration of the right front tire of the test vehicle as it begins its forward motion into the U-turn.

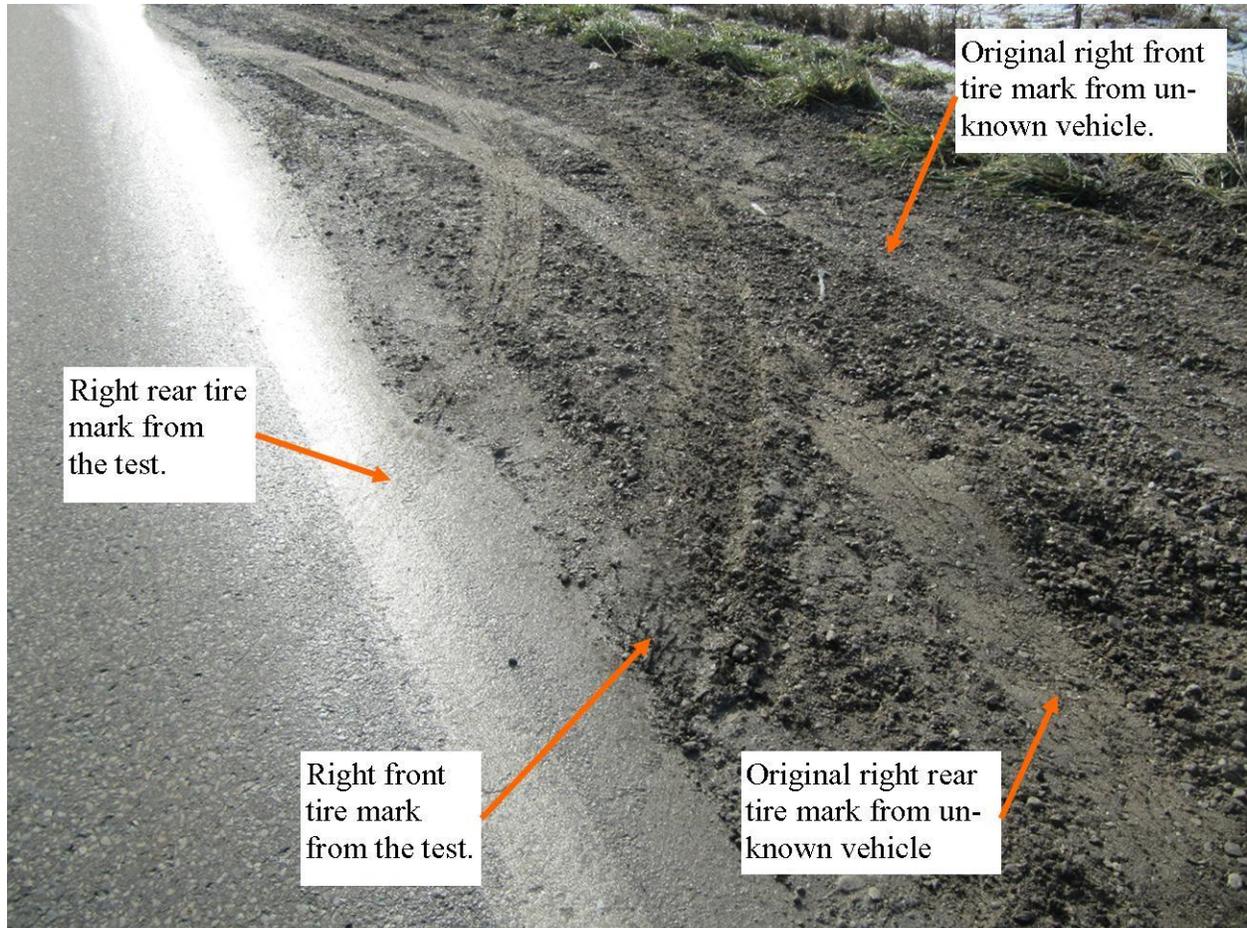
The tire marks on the west shoulder caused by the unidentified vehicle during the completion of its U-turn were previously shown in Figure 5. Now in Figure 18 the result can be seen after the test vehicle made a similar U-turn which created the two additional tire marks from its right side tires.

**Figure 18: View of the right side tire marks of the test vehicle on the west shoulder superimposed over the marks of the unidentified vehicle.**

We see the same general paths of two vehicles although the turn made by the unknown vehicle was a few metres north of the one made by the test vehicle. One might also recognize the slight roughening of the surface within the right front tire mark of the test vehicle. There is also a ridge on the outside edge of the right front tire of the test vehicle. The ridge is not visible on the inside edge of the mark. We also see the tread in the right rear tire mark of the test vehicle suggesting a lack of accelerative power being applied, in contrast to the acceleration indications of the right front tire mark. These observations are carried through to the southward view of the marks shown in Figure 19.

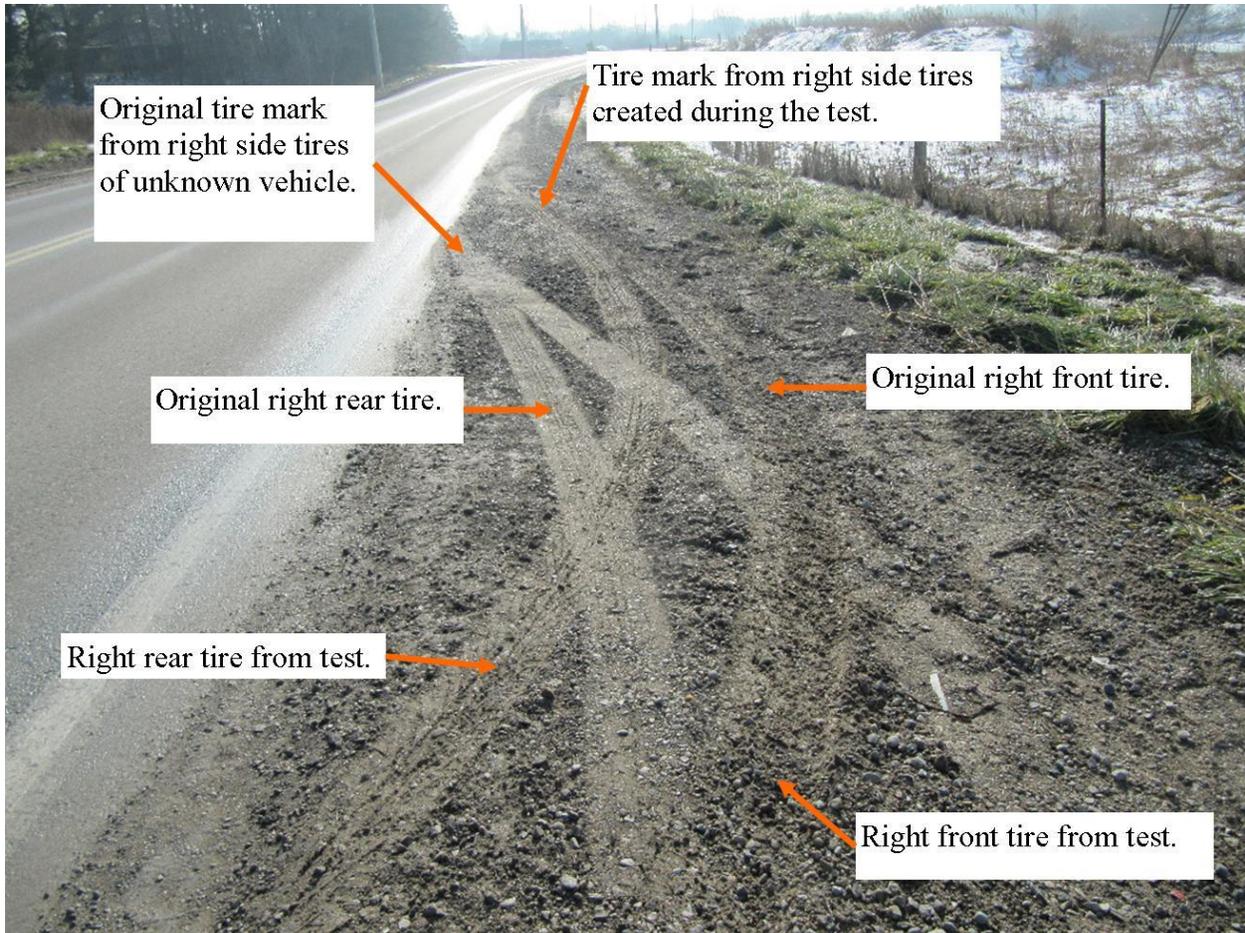
Figure 19: Figure 19: View, looking south along the west shoulder of Clarke Road showing the U-turn tire marks of the two vehicles.
