Clarke Road - Seven Years of Independent Research into Loss-of-Control Events

Posting Date: 21-Aug 2016

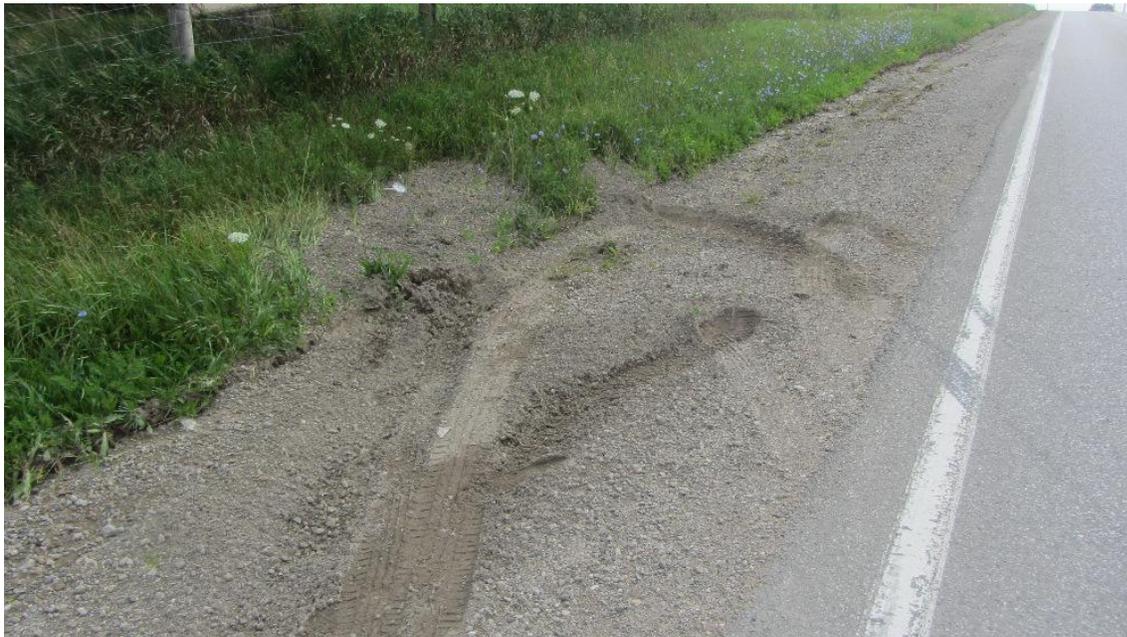
In these last seven years we have maintained a regular inspection of the S-curve for evidence of loss-of-control events. Figures 1 through 3 show an example of loss-of-control event that did not result in a collision however it commenced when the vehicle entered the east gravel shoulder and crossed into the west roadside.

Figure 1: View of loss-of-control tire marks from a northbound vehicle and its rest position from an incident on August 5, 2014.

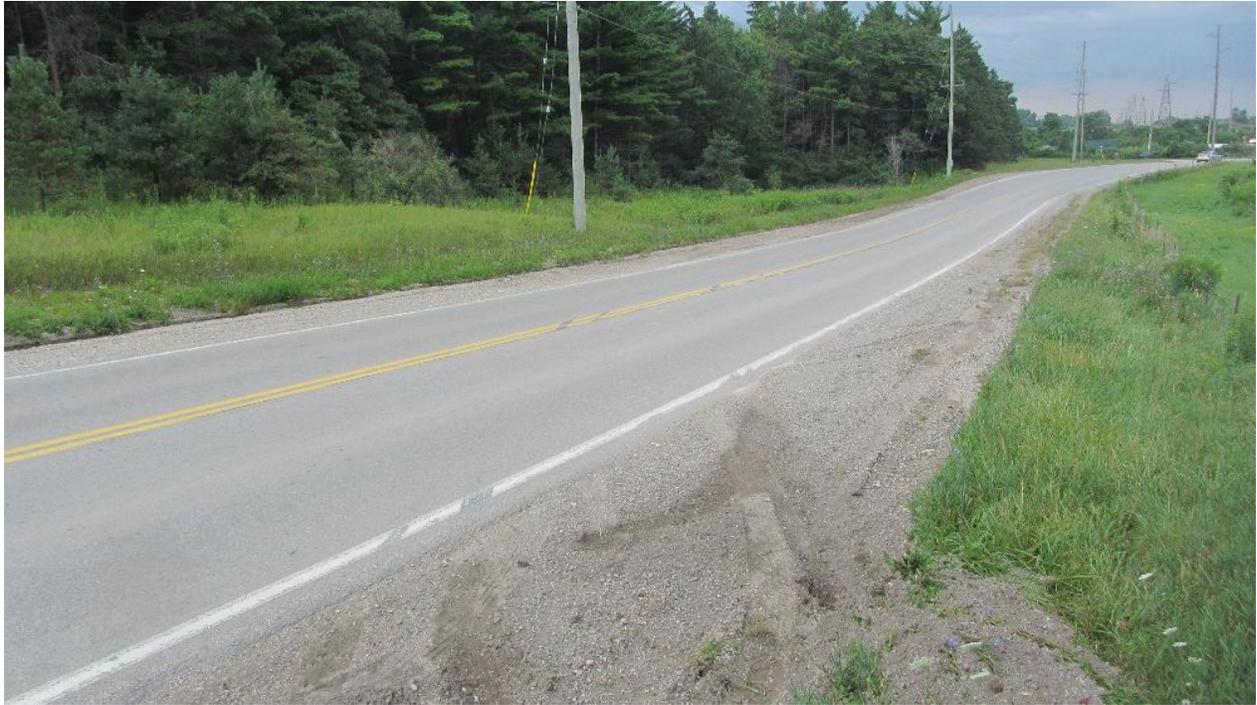
Figure 2: View, looking south from the west shoulder of the S-curve showing the rest position of the loss-of-control vehicle in the foreground and the yaw marks on the road surface.

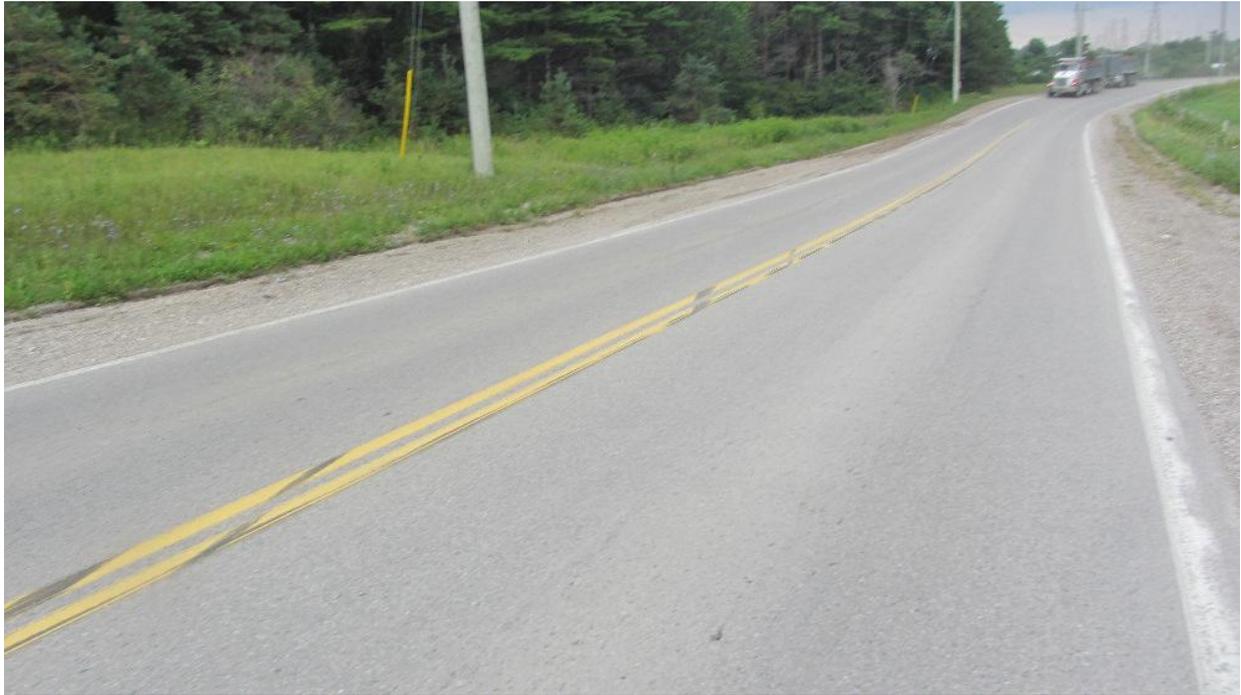
Figure 3: View of black yaw marks on the roadway centre-line suggesting the loss-of-control event occurred when the road surface was wet.

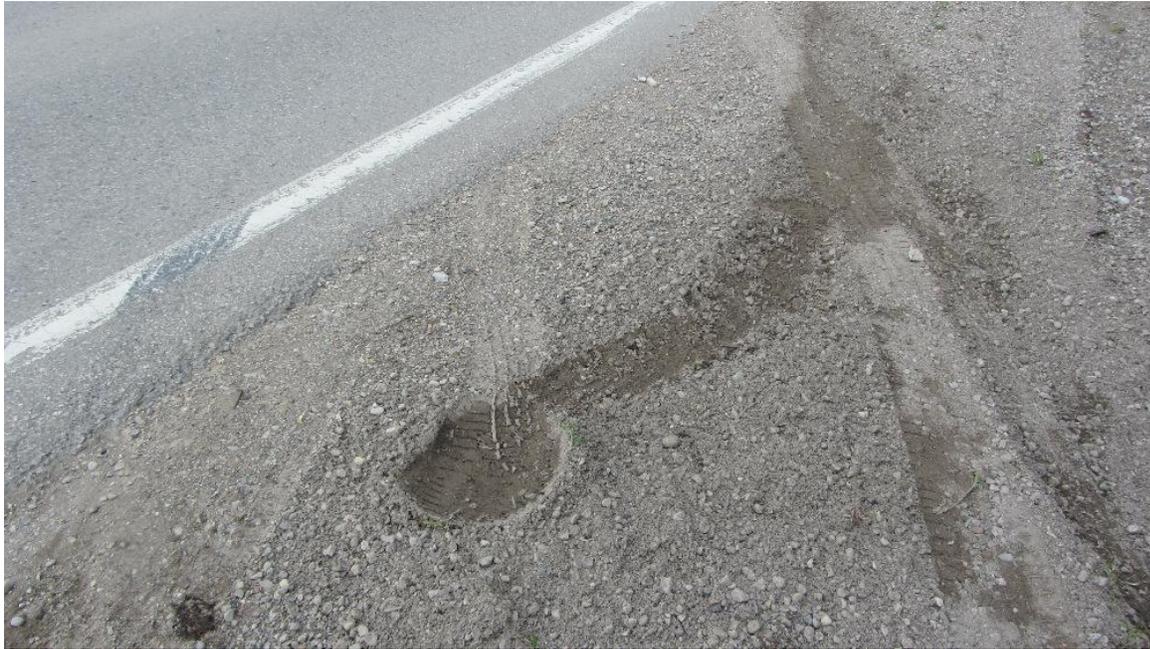
This event was most certainly not documented in any official records, such as a police report. This fact is clear when we take a close examination of the tire marks at the vehicle's rest position, as shown in Figures 4 and 5.

Figure 4: View at the final rest position of the vehicle showing the loss-of control tire marks and those produced subsequently as the vehicle left the site under its own power.

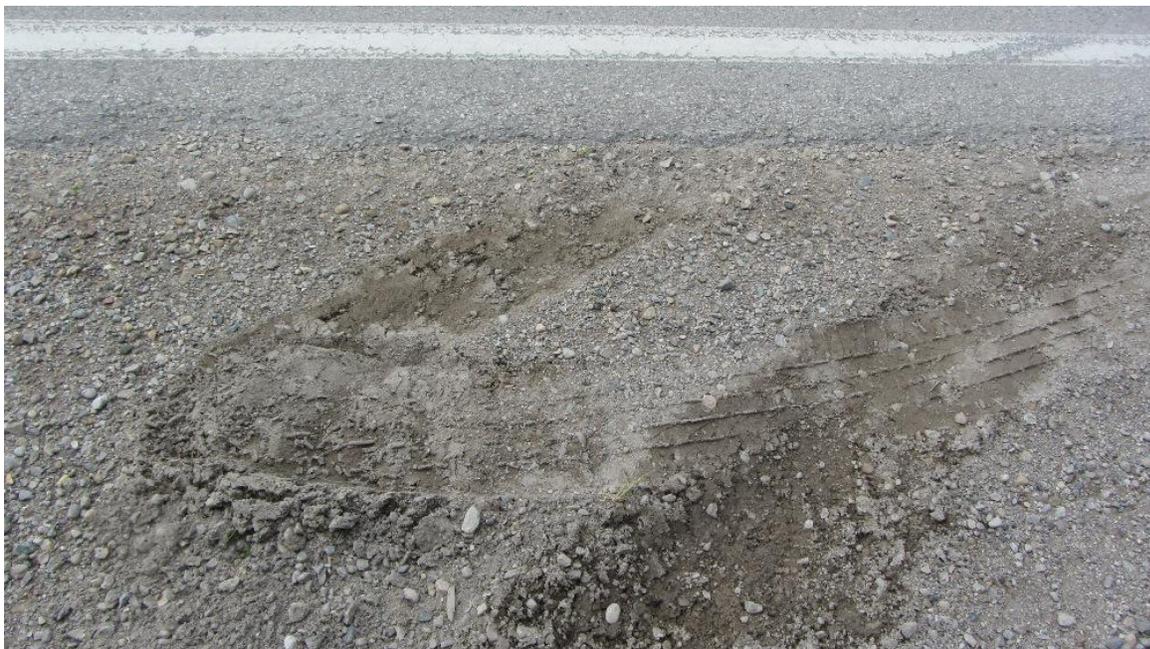
Figure 5: Close-up view of tire marks at rest position, showing the mark produced during loss-of-control and the mark produced afterwards when the vehicle left the site.

Experience in the interpretation of tire marks on gravel can clearly separate the loss-of-control tire marks from the subsequent marks produced by the vehicle as it left the site, under its own power, after sliding to a stop on the roadside. The reason why this event did not result in a collision has nothing to do with the severity of the event or its potential consequences. It just so happened that, as the vehicle slid across the road, there was no other vehicle travelling in the opposing lane. If the vehicle had been occupied by four persons and was struck by a large truck the results could easily have produced multiple fatalities. Therefore the suggestion that this event is unimportant or unworthy of official documentation must be false. There are many incidents like these that have occurred during the five year period of our study.

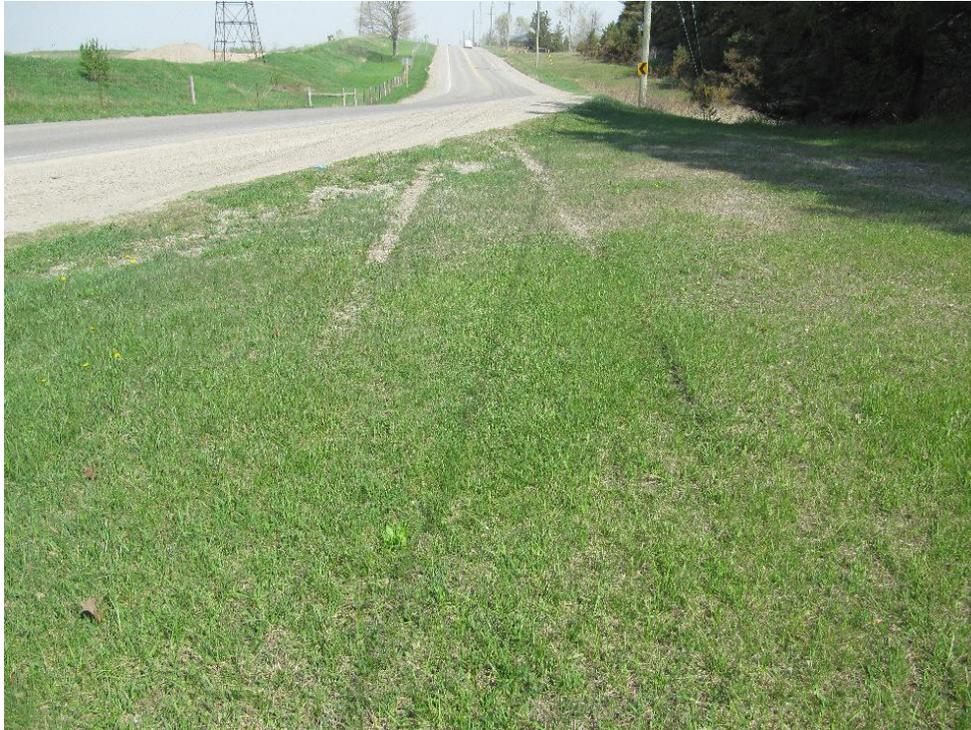
As an example, in May of 2015, a southbound vehicle travelling extremely quickly exited the east side of the road just south of the north portion the S-Curve. Figure 6 shows the view of the tire marks as the vehicle approaches the camera. One can see that the tire marks are straight and parallel and not curved. These are characteristics of a vehicle that is plowing straight ahead without yaw. This is what would be expected if ESC was in effect. Thus although the egress from the road was not prevented, at least the vehicle was pointing in the direction it was travelling.

Figure 6: View of non-yawing vehicle that left the S-Curve in May of 2015.

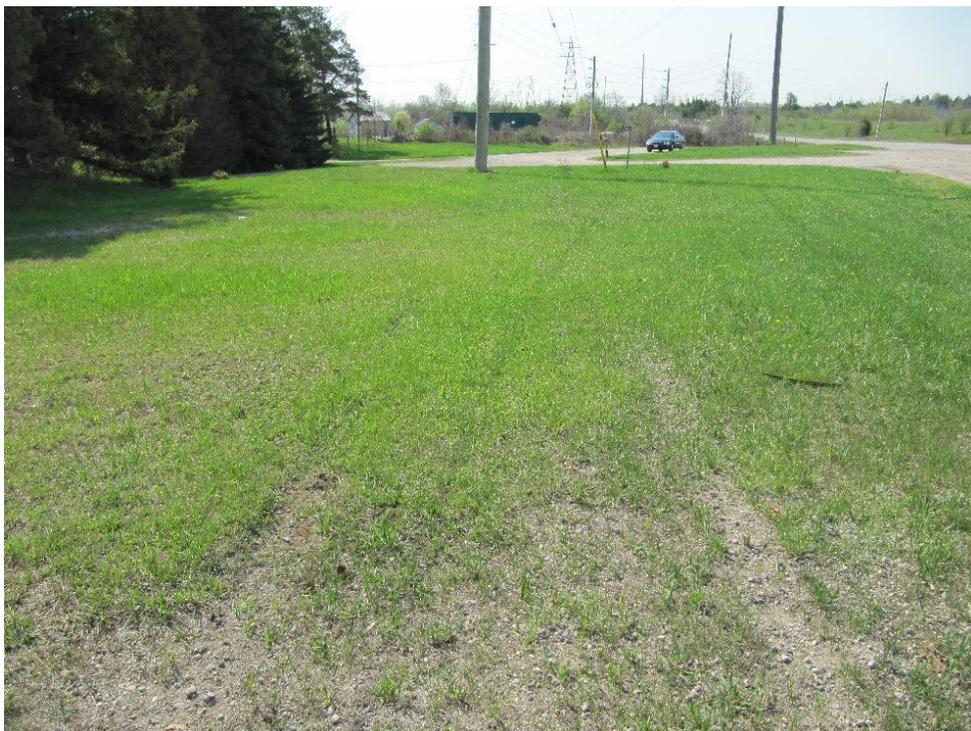
Figure 7 is a view looking the opposite way (southward) where the speeding vehicle just grazed by a utility pole (see Figure 8) and then struck an earth embankment in the distant background. The tire marks become very faint and became invisible to the investigator.

Figure 7: View of tire marks of the non-yawing vehicle that become "invisible" as the vehicle passes by a utility pole in the background.

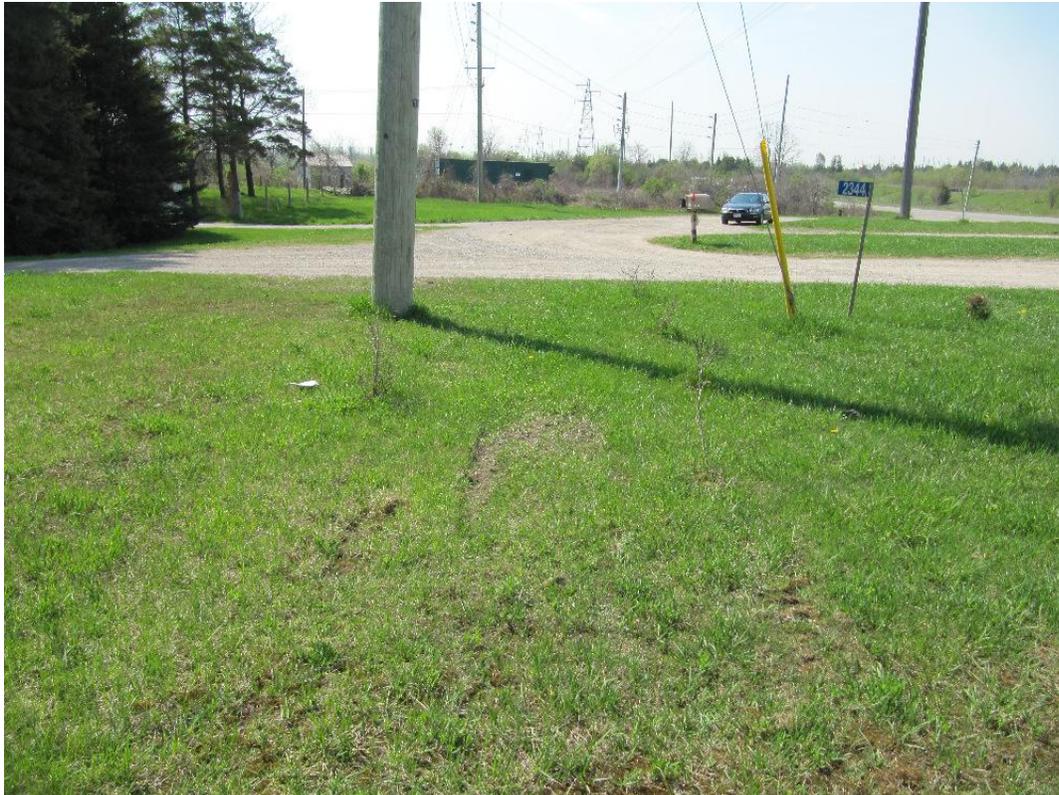
Figure 8: View of some minor disturbances in the grass as the speeding vehicle just grazes past the utility pole and then strikes an earth embankment in the background.

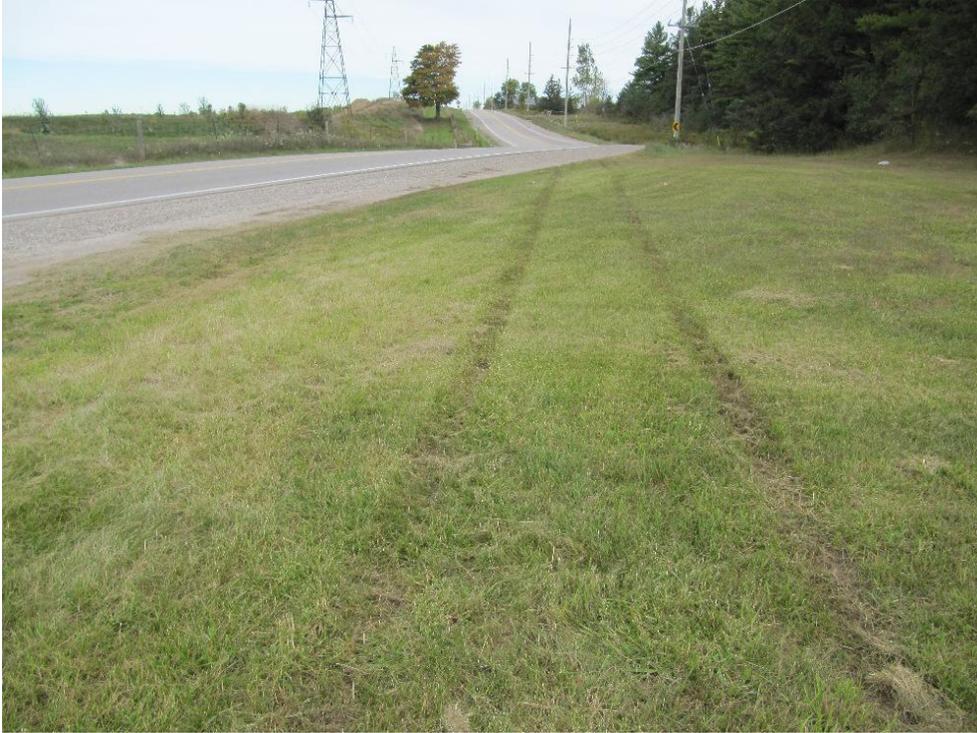
Similarly, in October of 2015, another southbound vehicle travelled almost the same path as the one in May. Figure 9 shows its tire marks that are very well defined as the grass has been torn by likely hard braking. Interestingly, one can observe in Figure 10 that, as the vehicle was exiting the roadway there is evidence of some yawing but then the vehicle straightens out. This is a classic indication that ESC could be in effect.

Figure 9: Tire marks from October, 2015, from a southbound vehicle that shows no evidence of yaw as it travels toward the camera.

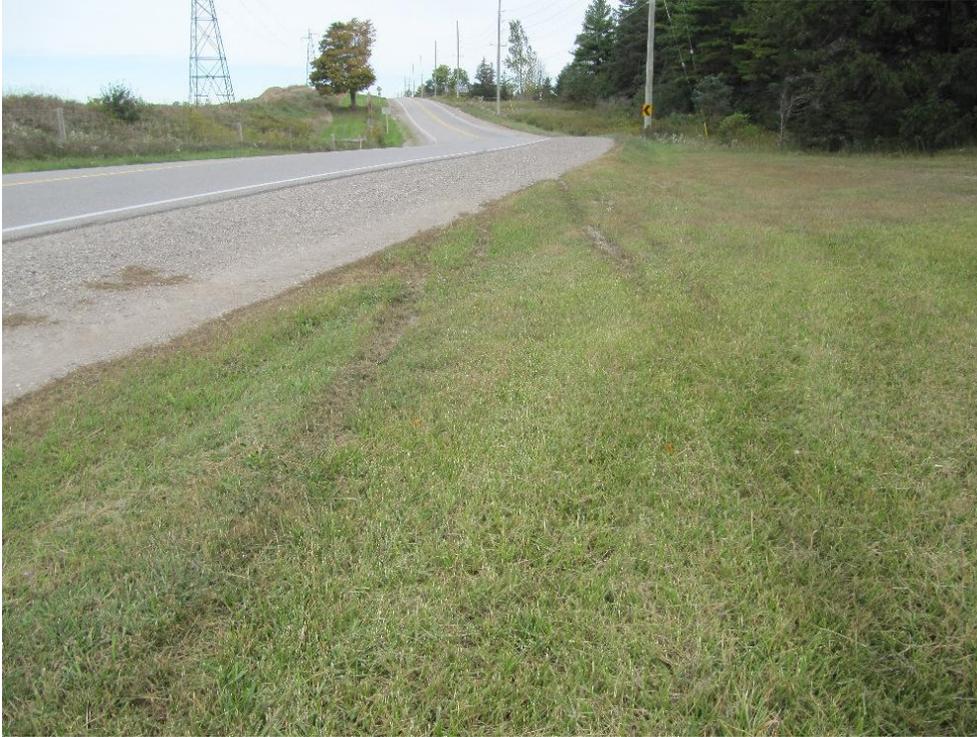
Figure 10: View of a slight separation in the travel paths of the tire marks indicating that there is a slight amount of yawing before the vehicle straightens out.

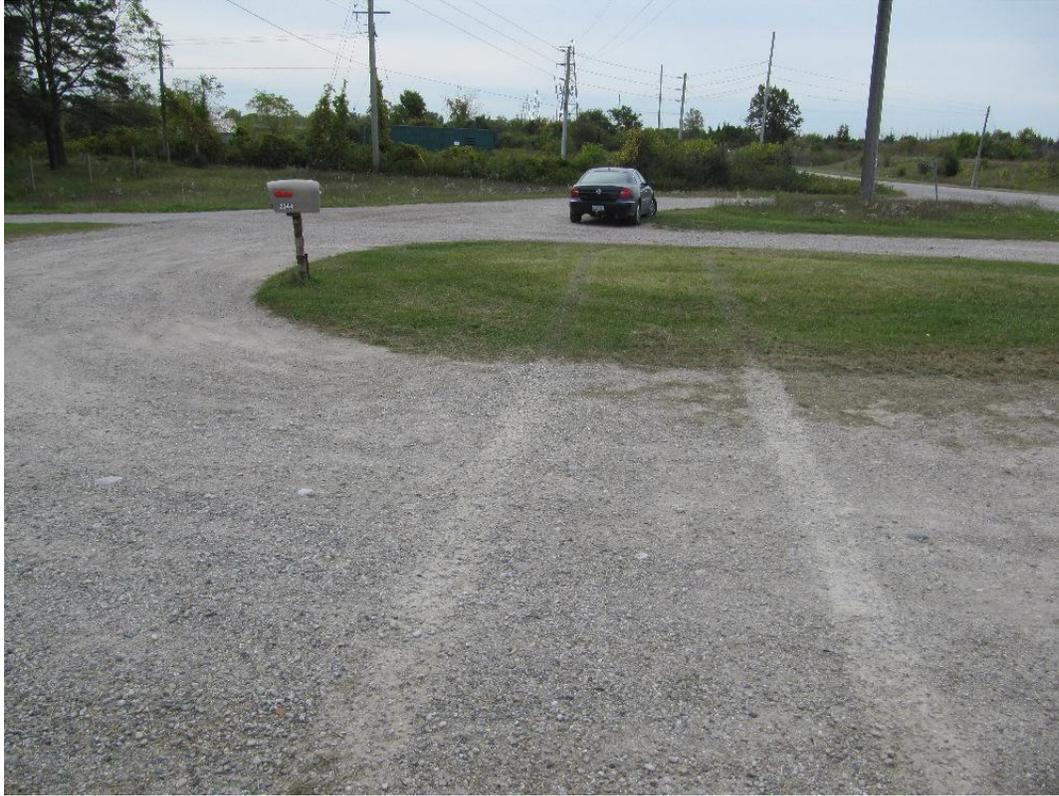
Figure 11 shows that the vehicle comes to rest in the grass just before the parked vehicle shown in the background. Thus the vehicle in October did not travel anywhere near as far as the one from May.

Figure 11: View of the tire marks from the incident in October where the vehicle came to rest just before reaching the location of the parked car. The vehicle in the May incident travelled well past this location as it struck the earth embankment shown in the background of this photo.
