Preliminary Comparison of City of London and South-Western Ontario Road Surface Conditions

Posting Date: 28-Feb 2014

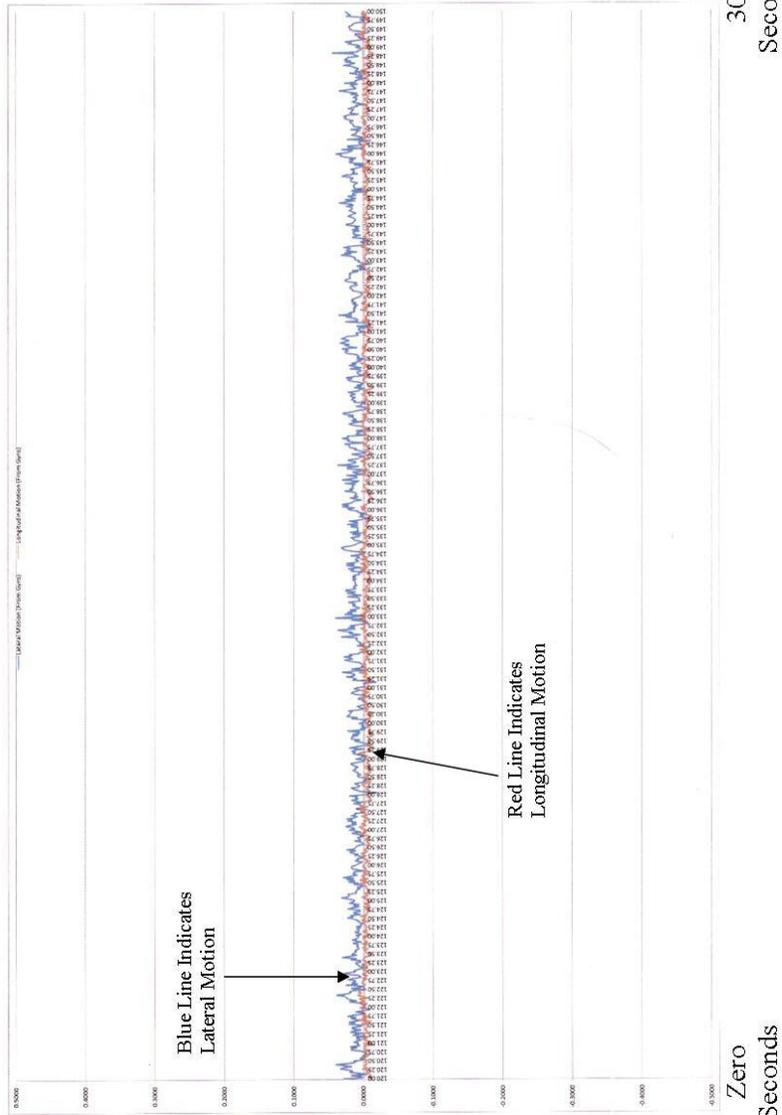
Motions of Test Vehicle Travelling 105 km/h, Westbound, Along Highway 401

Figure 2: iPhone data from WB Highway 401

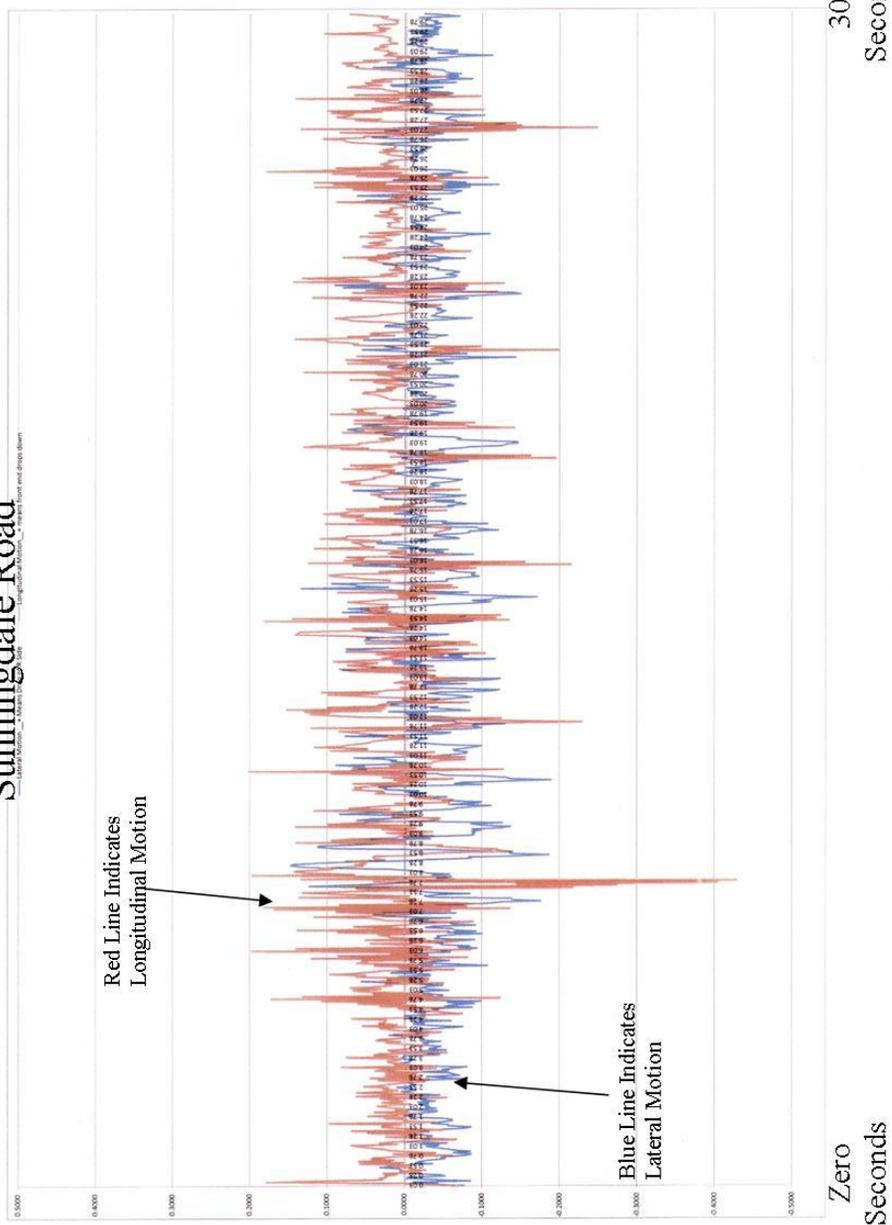
Motions of Test Vehicle Travelling 70 km/h, Westbound On Sunningdale Road

Figure 3: iPhone data from Sunningdale Road Site (1st 30 seconds of testing)

So the site numbered "3" is that portion that contains the first 30 seconds of data along the worst portion of the road. The site numbered "4" is the portion from 20 to 40.5 seconds which contains slightly better conditions. At 40.5 seconds the test vehicle crossed over to the newly paved section of the road so that the site numbered "5" shows about 9.5 seconds of data on that newer section of road.

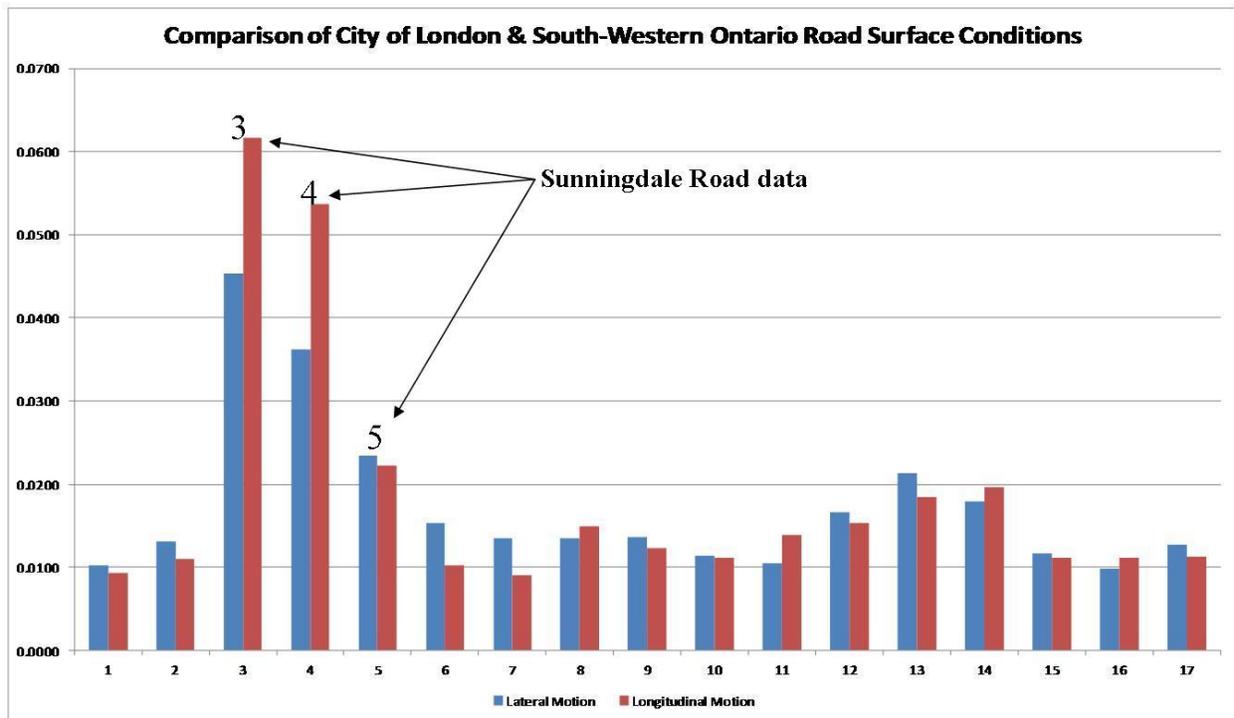
The chart (below) provides the quickest way to recognize that the data from Sunningdale Road truly is exceptional, as we expected. As discussed in the previous article, the Sunningdale data was separated into three "sites" so that that we could demonstrate the difference between the eastern portion of the road which was in worse condition and the portion further to the west which had been re-paved and was in better condition.

Obviously, the Sunningdale site contains a surface which causes much more lateral and longitudinal motion than any of the other 14 remaining sites.

Figure 6: Chart comparing the data from all the sites.

In particular, the longitudinal motion of the test vehicle was much more pronounced at the Sunningdale site. The red columns of longitudinal motion are much taller than the blue columns of the lateral motion and this difference is starkly greater than any of the other sites.

Site "5" was the portion of Sunningdale Road which contained the re-paved surface. It can be seen that the height of the red column has been greatly reduced and the relationship between the longitudinal motion and lateral motion (relationship between red and blue columns) is similar to the other sites. Yet the overall motion on the re-paved surface is still higher than any of the other sites. This is unusual because the other sites contain aged surfaces that would be expected to cause greater motion than the newer surface of Sunningdale Road. As we alluded to in our previous article, we suspect there are problems in the road bed of Sunningdale Road which is causing the upheaval of the newly paved road which is evident from the data.
