Creation of Braking & Acceleration Tire Marks on a Gravel Shoulder to Replicate Marks Caused by An Unknown Vehicle

Posting Date: 29-Mar 2014

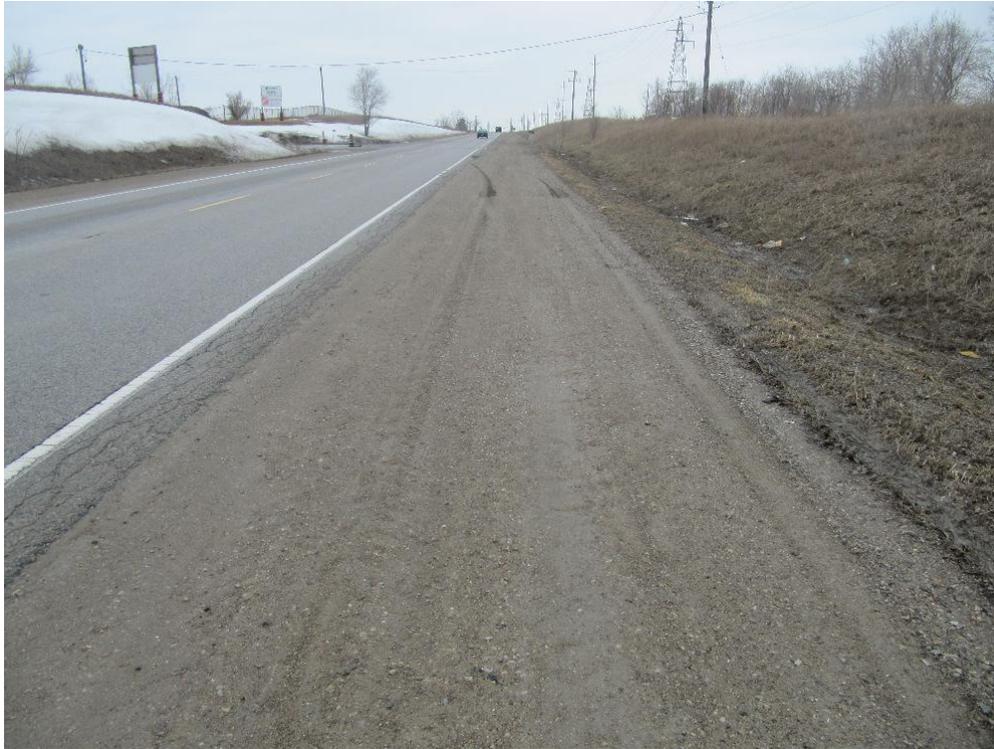
Figure 1: View, looking northward, along the east shoulder of Clarke Road in London, Ontario where a set of tire marks is visible in the background of the gravel shoulder.

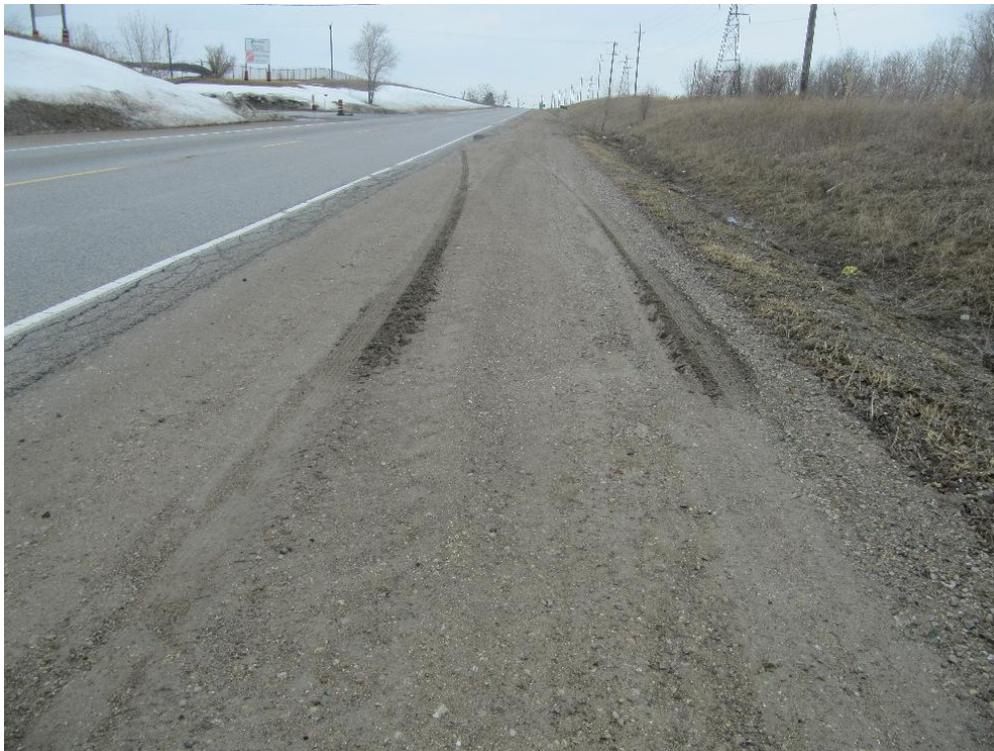
Figure 2: View, looking north, along the east shoulder of Clarke Road close to the location where an unknown vehicle made an abrupt acceleration back onto the paved road surface.

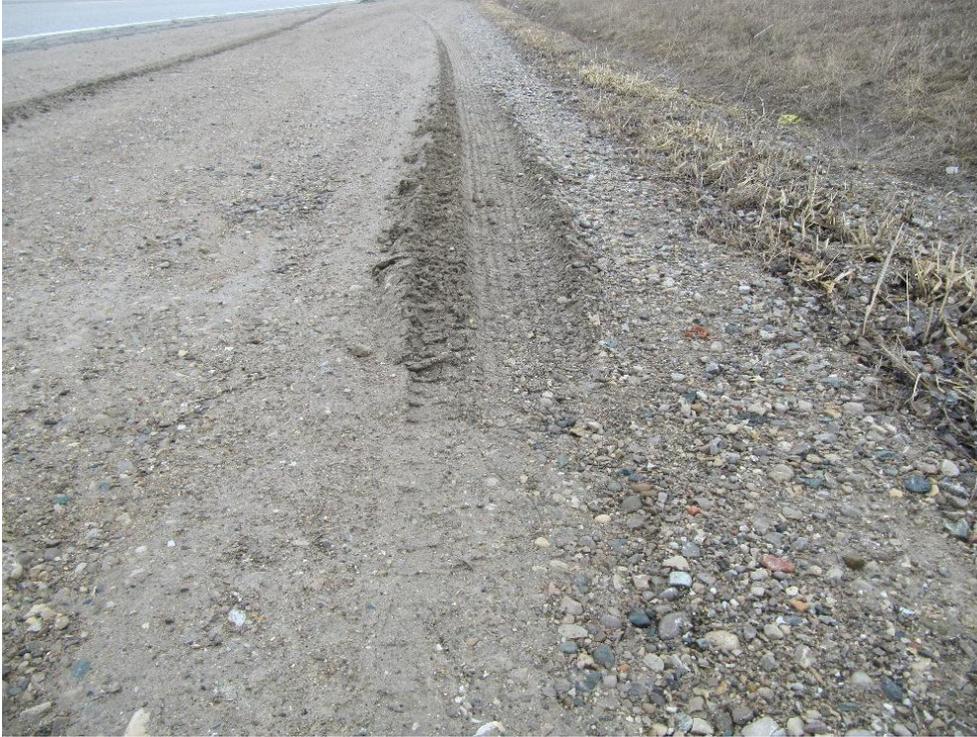
Figure 3: View of right tire mark at commencement of acceleration

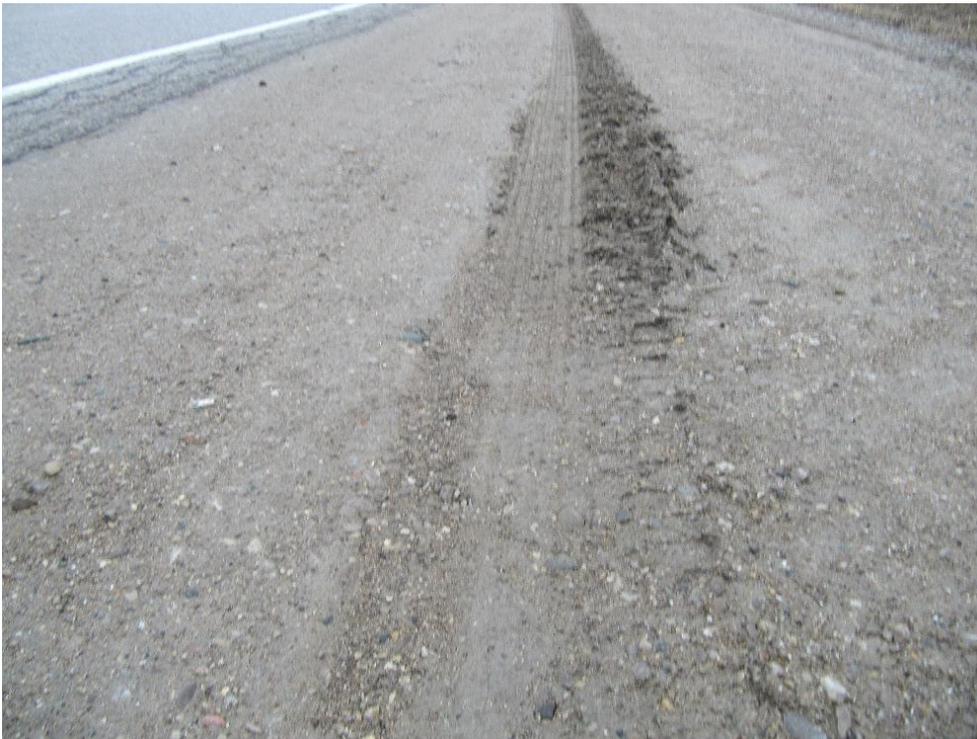
Figure 4: View of left tire mark at commencement of acceleration

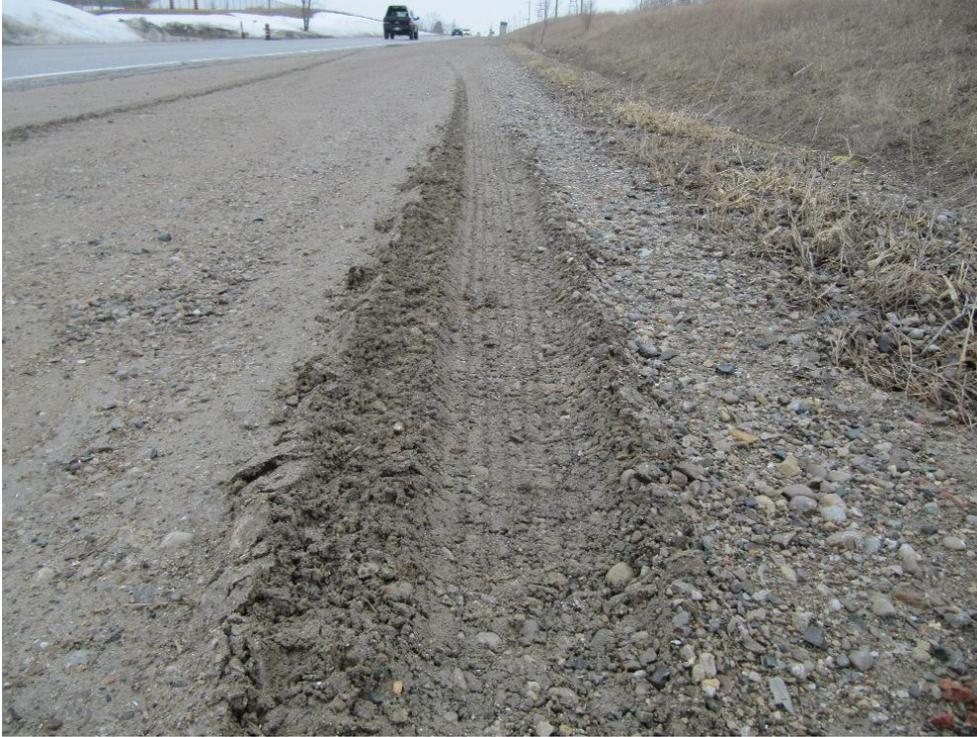
Figure 5: View of right tire mark past the commencement of acceleration.

A curious occurrence is visible in the unknown vehicle's tire marks after the point of initial acceleration, as shown in Figure 5 (right tires) and Figure 6 (left tires). It would appear that the upheaval of the gravel caused by the front tires is located on the outboard side of the imprints caused by the rolling rear tires. It is as if the track width of the front tires was smaller than that of the rear tires. In contrast, when we look at the tire marks produced by our test vehicle, the upheaval of the gravel caused by the test vehicle's front tires is dispersed approximately equally to the right and left of the rear tire tracks. In other words, the rear tires of the test vehicle simply follow the path of the front tires, but also, those rear tires are neither outboard or inboard of the front tires.

One could believe that this curiosity was from the occurrence of a slight bit of yaw by the unknown vehicle. In other words, as a result of the acceleration, the unknown vehicle rotated slightly about its vertical axis. However that would not explain the evidence. If yaw occurred then **both** of the front tires would either be located outboard or inboard of the rear tires. However that is not what is visible in the above figures. In the above figures it appears that, during acceleration, both of the front tires were pulled inboard, or at least existed inboard of both of the rear tires. This could be explained if the weight of the vehicle was rolled off the front end slightly due to high acceleration. However we are not concluding that this occurred. We offer this comment as a way to promote further discussion.

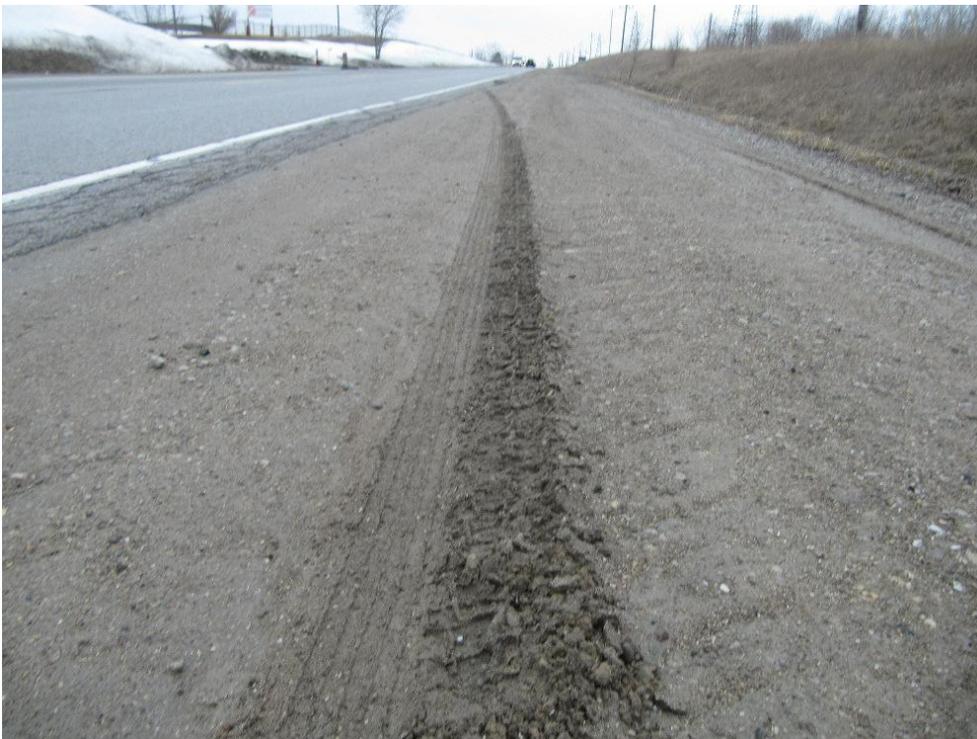
Figure 6: View of left tire mark past the commencement of acceleration.

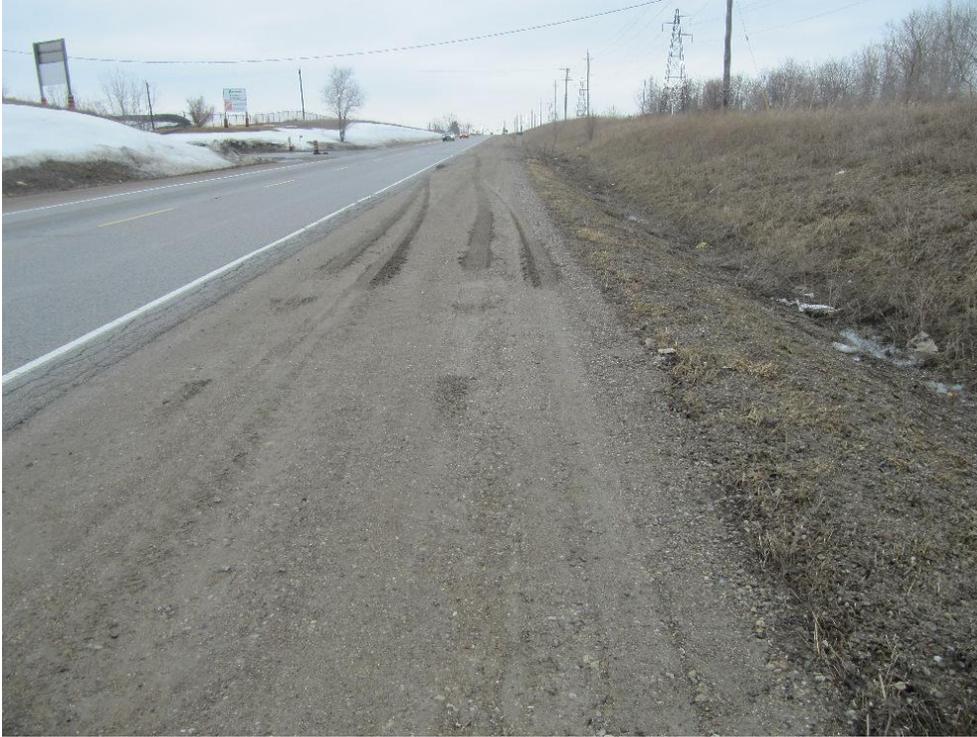
Figure 7: Overall view, looking north, at the new set of tire marks produced by our test vehicle, alongside the original tire marks produced by the unknown vehicle.

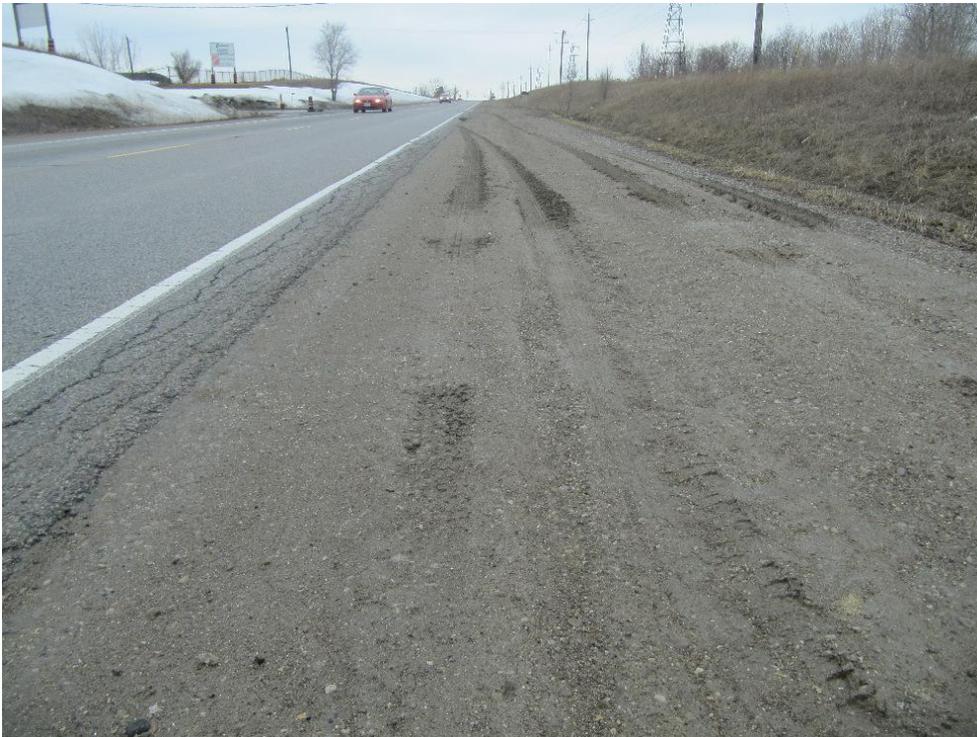
Figure 8: View looking along the left side tire mark produced by the test vehicle.

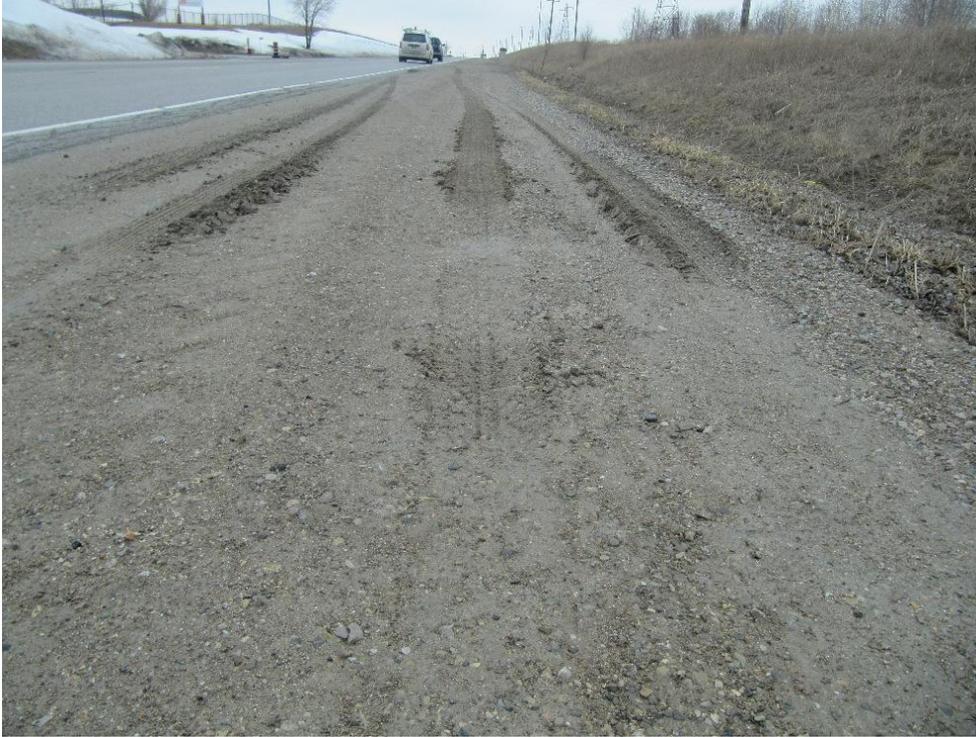
Figure 9: View, looking along the right side tire mark produced by the test vehicle.

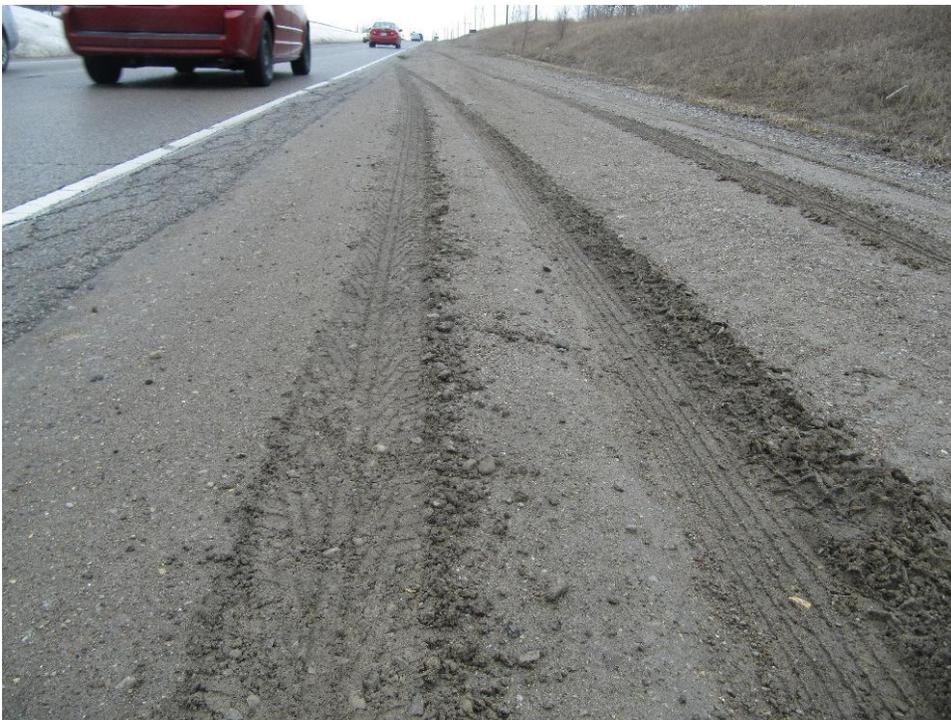
Figure 10: View of the left side tire marks produced by the test (left of view) and unknown (right of view) vehicle.

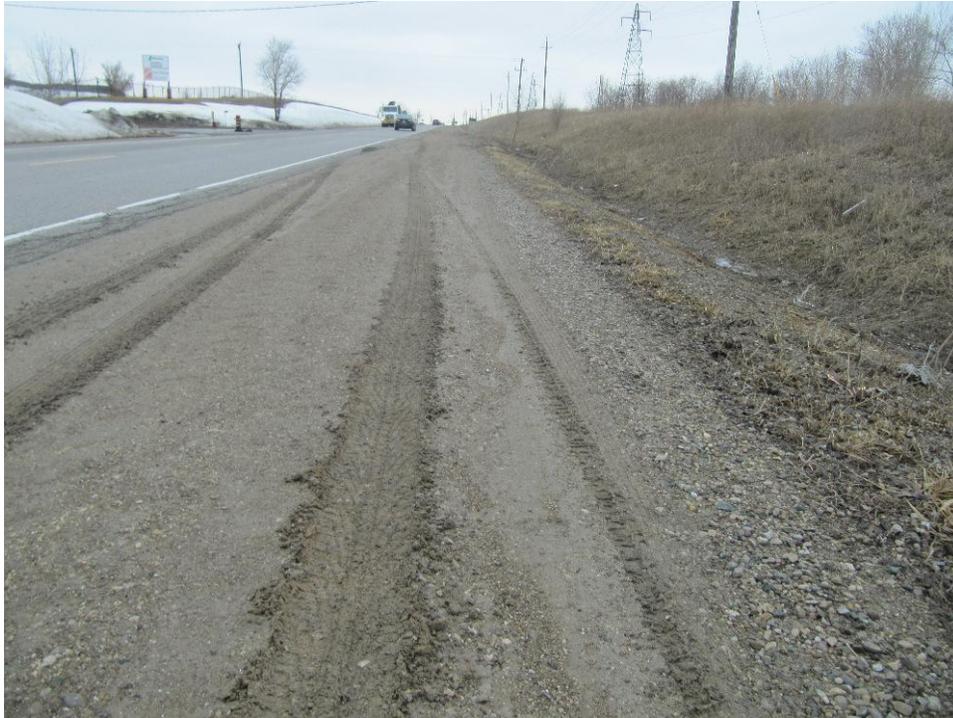
Figure 11: View of right side tire marks produced by the test (left of view) and unknown (right of view) vehicle.

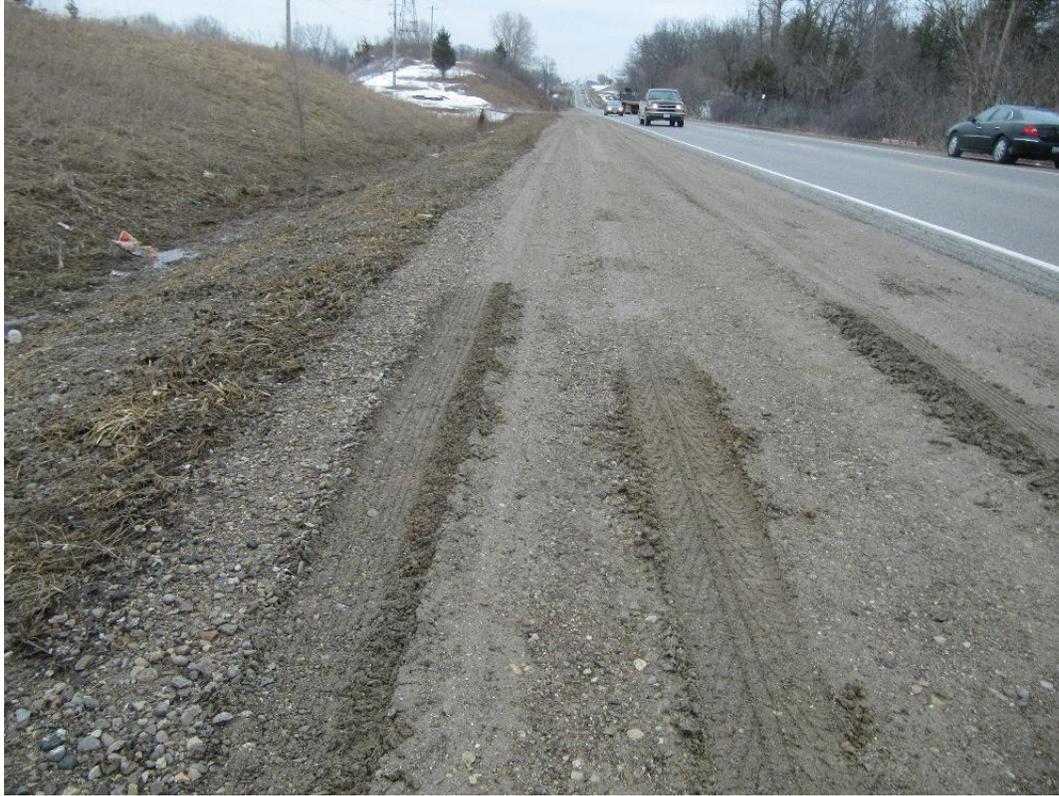
The gravel shoulder where the tire marks exist is on an upgrade as directly to south there is a bridge to the north branch of the Thames River, as shown in southerly view of Figure 12 below.

Figure 12: View, looking south, showing that the shoulder is on a northward upgrade due to Thames River bridge in the background.
