Details of Small Evidence Can Say Big Things

Posting Date: 27- July 2013

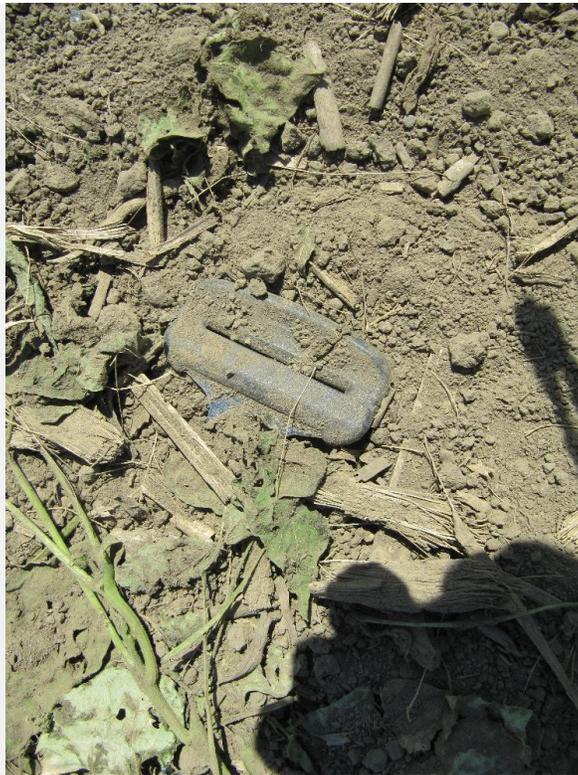
View of sliding tongue from a seat belt system lying on the ground at the final rest position of a collision-involved vehicle.

Because the final rest positions of the two vehicles were substantial distance apart it is reasonable to believe that this piece of evidence was from the particular vehicle at this rest position and not from the other one.

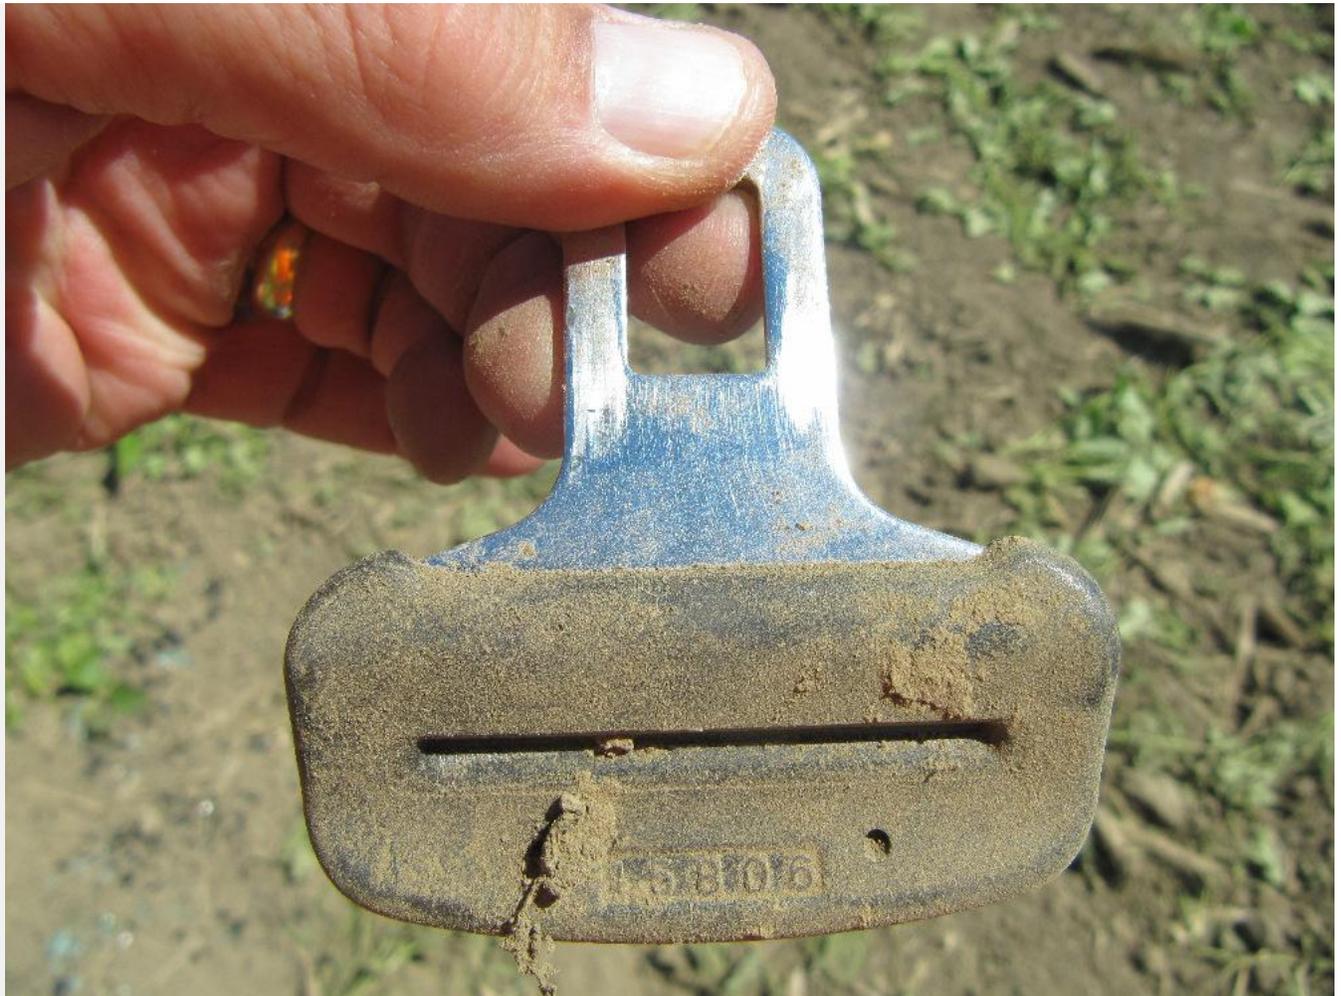
Closer view of sliding tongue.

We might wonder how this evidence came to be located here. For example, such a tongue does not just fall off a restraint system because its webbing passes through the access hole of the tongue. Thus, in order for the separation to occur there has to be somekind of separation of the seatbelt webbing. This separation could be from the collision forces but that would be rare. It takes tremendous force to cause a separation,

or there could be a sharp exposed piece of metal that could cause it, but those are extremely rare in the vicinity of a vehicle occupant where modern safety standards would prohibit such a happening. So, it is far more likely that the separation occurred because emergency personnel used their knife or scissors to cut the webbing to gain access to an injured occupant for transportation to an ambulance.

It is also highly likely that collision forces did not cause the webbing separation because this extreme force would exhibit itself in markings on the restraint system and particularly on this sliding tongue. And this leads us to the next area of discussion...loading marks on restraint systems from collisions forces.

But before that, look at the condition of this sliding tongue. It has dirt caked all over it. We can state that we examined this site only a few hours after the occurrence. So the evidence should be fresh. However, if you are aware of collision evidence you will be aware that, as this evidence sits for longer periods of time weathering occurs in the form of debris and dirt progressively lying over the evidence. So why is this tongue so caked with dirt? A likely conclusion is that, after cutting the seatbelt webbing emergency personnel spent some time at this location, tramping on the earth and stepping on this sliding tongue. So there was some concentrated action going on in the vicinity.

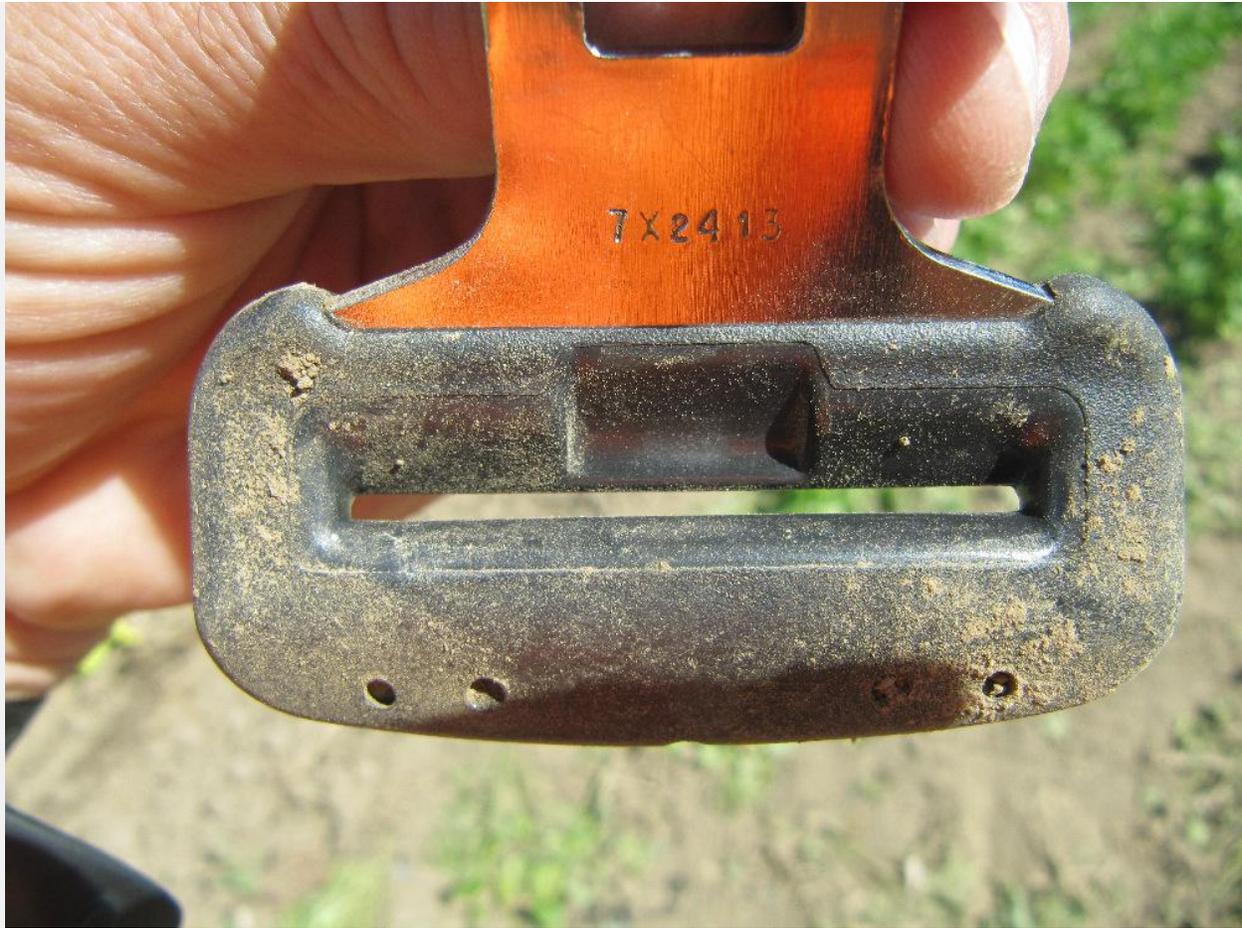
View of front surface of sliding tongue.

Many years ago someone with little understanding of loading marks made reference to the metal portion of the tongue which is inserted into the buckle as the location where one should look for loading marks. This fairy-tale was bounced back and forth in the community of reconstructists for many years until further research papers in the 1990s began to appear from researchers who actually had some reasonable experience and began to set the record straight. The place to look for loading evidence on a sliding tongue is at the rectangular access hole through which the seatbelt webbing passes. What you should be looking for are diagonal striations in the melted plastic of the tongue which occur when the loaded seatbelt webbing applied a large force through that access hole during the impact.

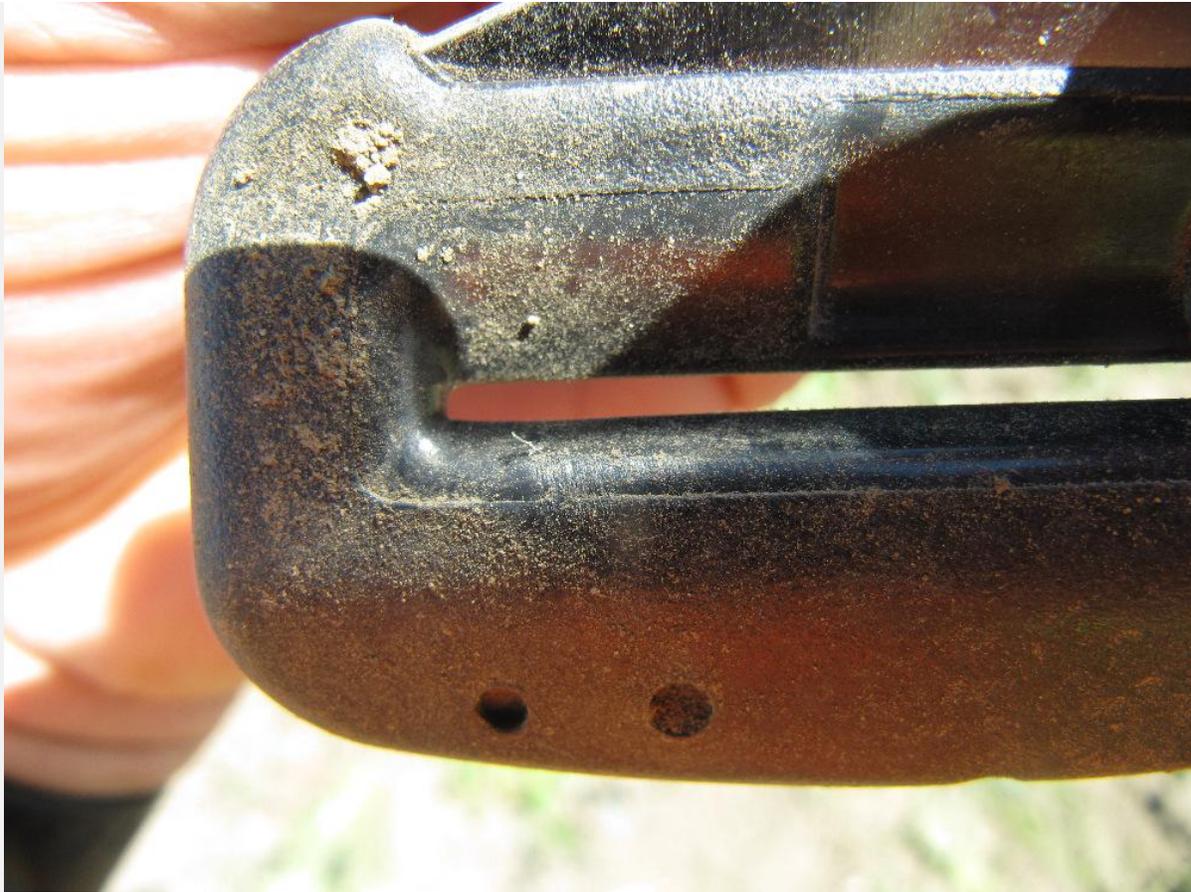
View of loading mark on the bottom corner of the front face of the sliding tongue.

The reason why there the striations in the loading mark on the front face of the sliding tongue are at a diagonal are several, but the most common reason is that the loaded torso (shoulder) belt comes to the access hole at an angle as it travels from the D-ring and across the occupant's torso. One can tell whether the tongue is from the driver versus the right front occupant by noting the angle of the striations because they will be (generally) at 90 degrees to each other. But there are many caveats.

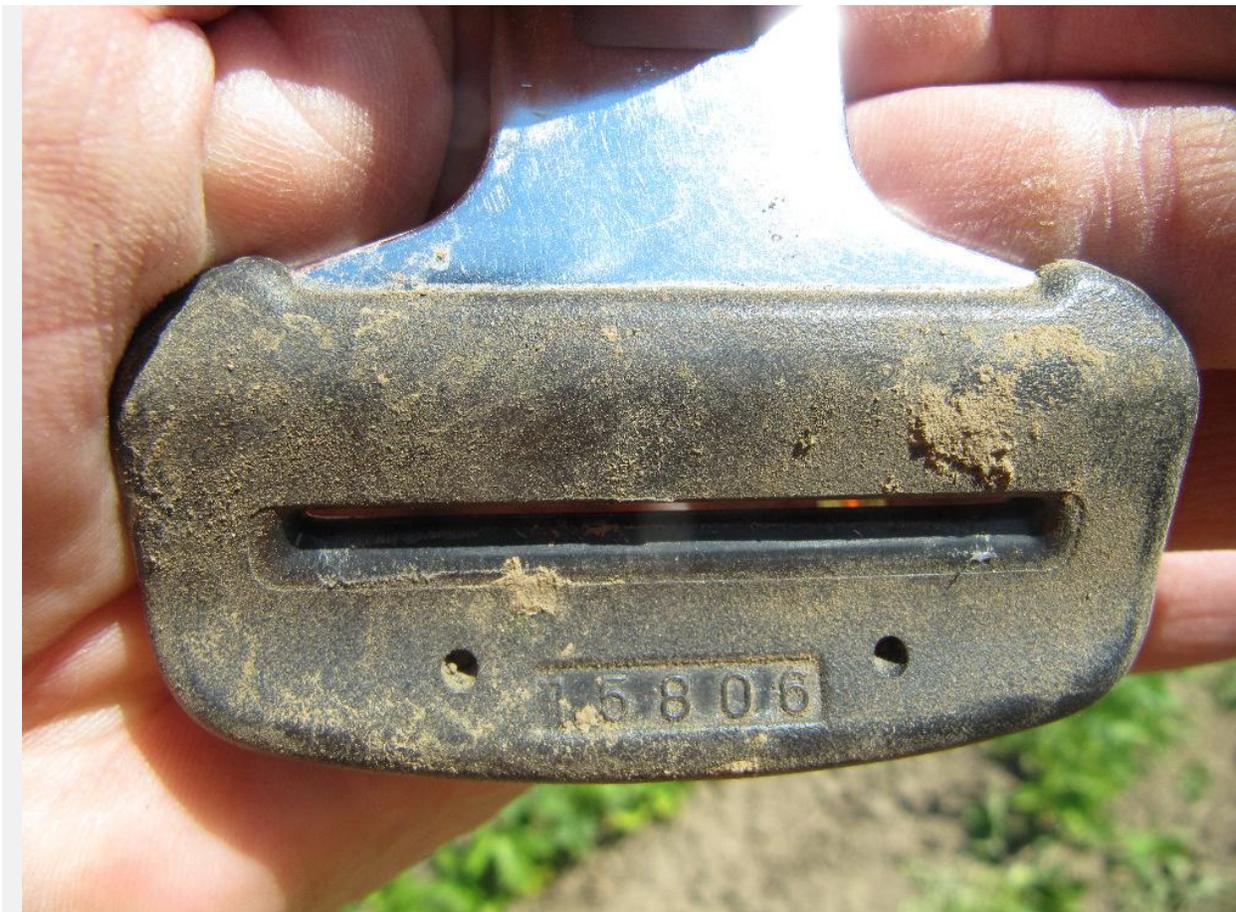
View of backside of sliding tongue.

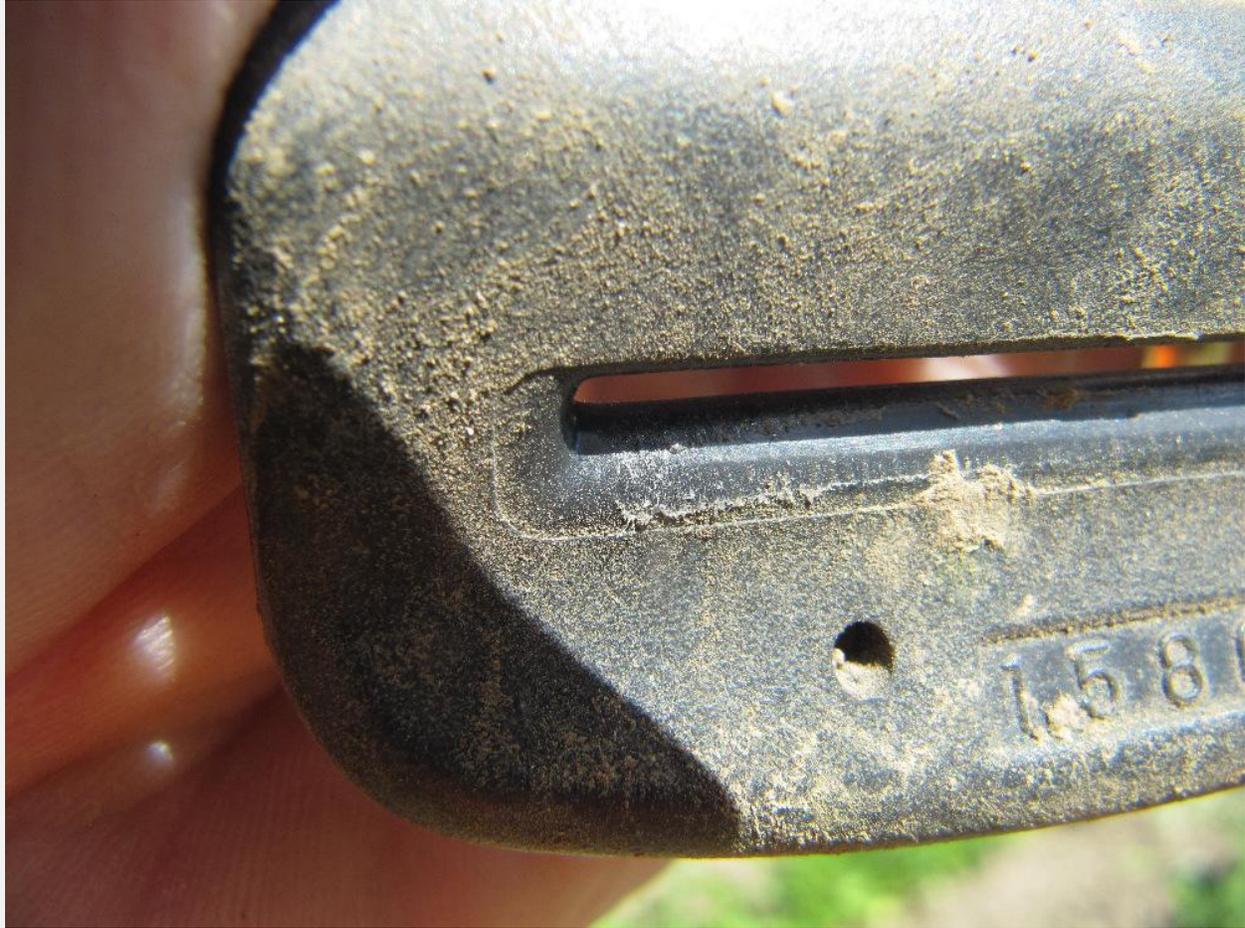
Closer view of the loading mark visible on the backside of the sliding tongue.

We do not want to prolong the discussion but, for the time-being, you should recognize that the loading mark you see in the above photos is from the driver's restraint system. But it would be difficult to recognize that it came from a vehicle that was struck in its side. Partly because this vehicle had a substantial forward speed producing a substantial deceleration along its longitudinal axis, thereby mimicking the conditions of a vehicle struck in its front end.
