Double Fatal On La Salette Road North of Delhi Ontario Prompts Question Why A Roadside Barrier Was Not Installed

Posting Date: 25-Mar 2013

Gorski Consulting London, Ontario, Canada

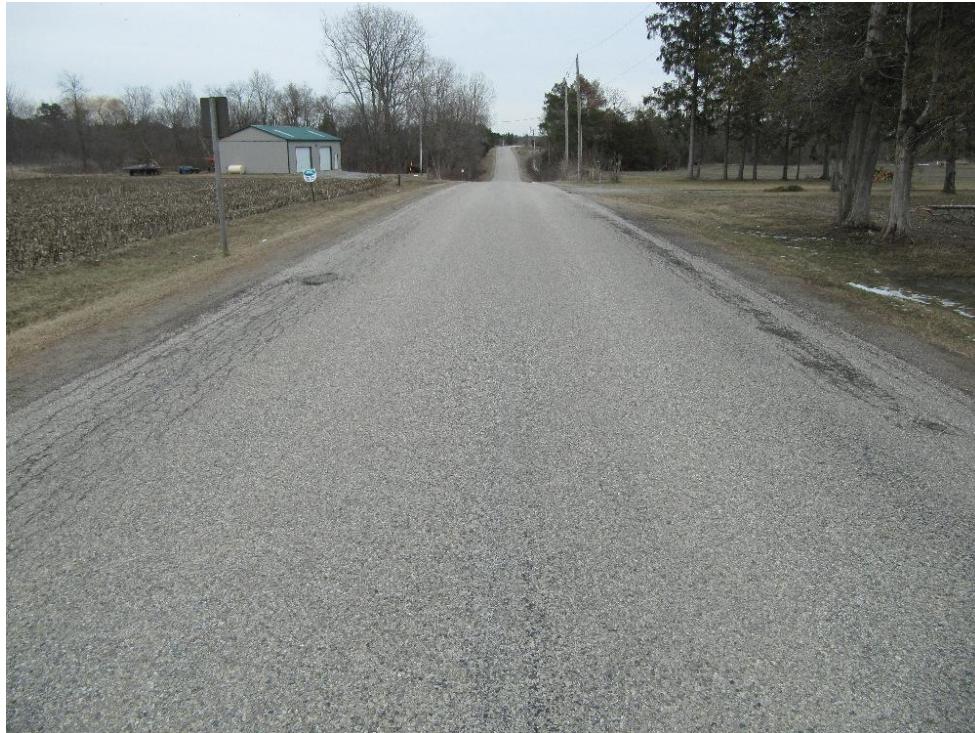
Figure 1 on Page 2 is a view looking east along La Salette Road from a few hundred metres west of the collision site. As can be seen by observing the right and left edges of this road its surface is aged and there is some sagging of the pavement taking place near those right and left edges.

In the background of Figure 1 it is possible to distinguish a sag in the roadway and this is where the eastbound vehicle left the roadway and struck a tree. From this vantage point one can recognize that the road surface cannot be seen in this sag but that it reappears on the other side. So one can appreciate that this is a significant, local, elevation change that is often experienced in the vicinity of a creek or river. Such sags are not unique but exist all over Southern Ontario and throughout North America such that those responsible for the road maintenance must be aware of what signage, roadside protections and surface maintenance are typically required. It is not a unique circumstance that vehicles travelling along such roadways might travel at a speed that is higher than the posted speed. On typical rural roads where the speed limit is 80 km/h it is not unusual for average speeds to be in the range of 90 km/h. At the same time, encountering a steep down-slope has been known to be associated with loss-of-control events as the additional force of the acceleration due to gravity prevents a vehicle from travelling at a constant speed and braking may sometimes be needed to prevent acceleration to a higher speed. Also, maintenance personnel should also be aware that such sags will contain steep grades on the roadsides as the level of the creek is often

Figure 1: View, looking east, from just west of a sag in the La Salette Road where an eastbound vehicle travelled off the north roadside and struck a tree.

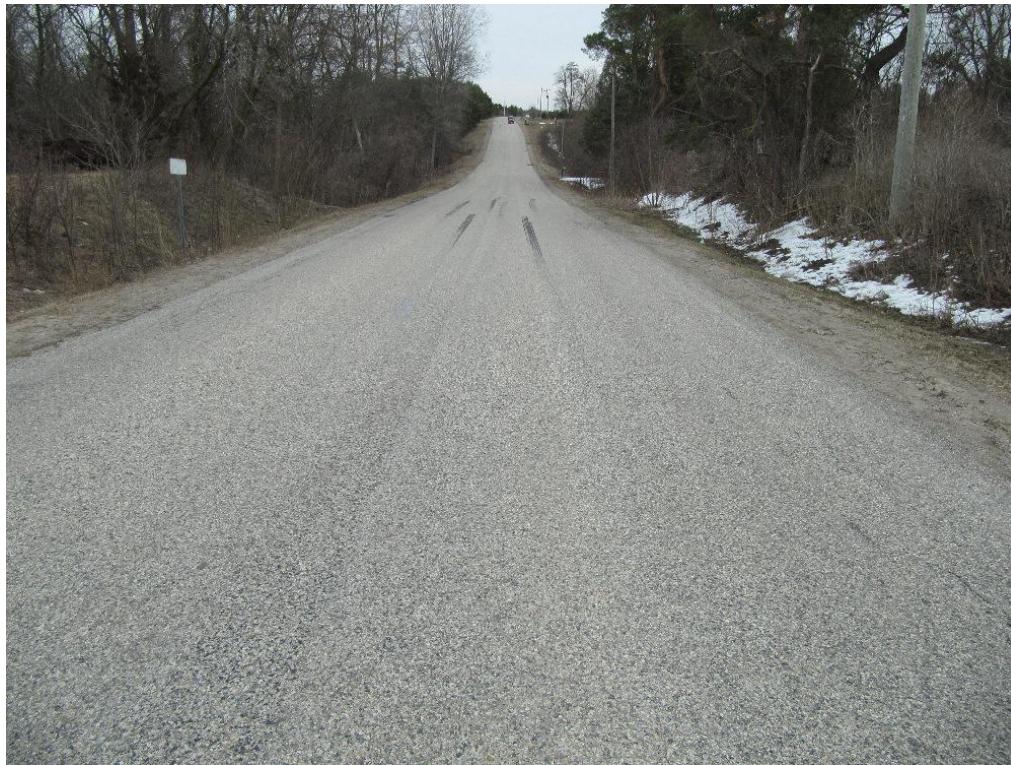
Figure 2 is another view looking eastbound after we have crested the edge of the sag and have progressed partway down into it. There are a number of straight, black tire marks on the road surface in the background and these are typically caused by police investigators as they attempt to determine the "co-efficient of friction" of the surface. Typically police may have an accelerometer on board the test vehicle (often a Vericom) which provides a reading of the average "aggressiveness" of the surface or what tire force it is able to generate which might keep the vehicle stable or give the vehicle an ability to slow down or speed up.

Those black skid marks were produced precisely in the area where we first detected the typical "yaw" marks of the collision-involved vehicle. So it would make some sense for police to conduct the testing in the region where the vehicle laid down the first tire mark evidence of its loss-of-control. In reality most events that generate a loss-of-control are often well prior to the point where such visible yaw marks are produced so the police testing would be of limited usefulness.

Figure 2: View, looking east, on the downslope of the sag, looking at some skid marks likely produced during the police investigation.

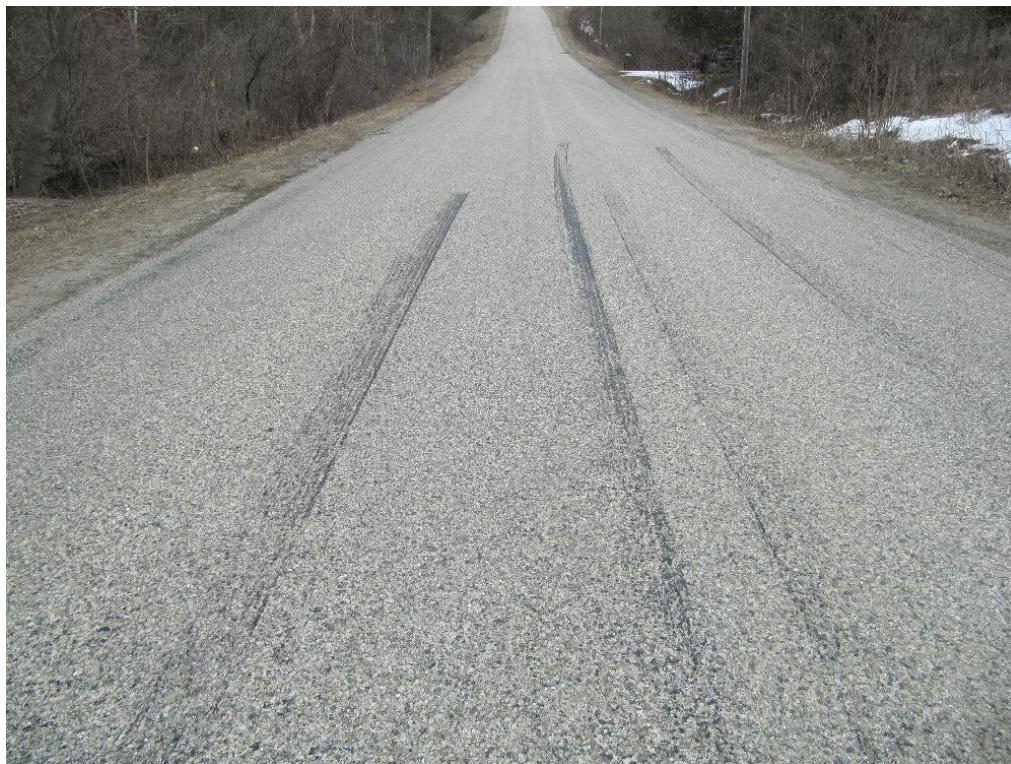
Figure 3: Eastward view of the police skid marks where the first evidence of yaw tire marks was found.

Figure 3 shows a closer, eastward view of the area within the police skid marks. It is within this area that we observed the first evidence of yaw tire marks which were generated by the collision-involved vehicle. This evidence is quite faint but it indicated that the vehicle was rotating clock-wise approximately in the middle of the road.

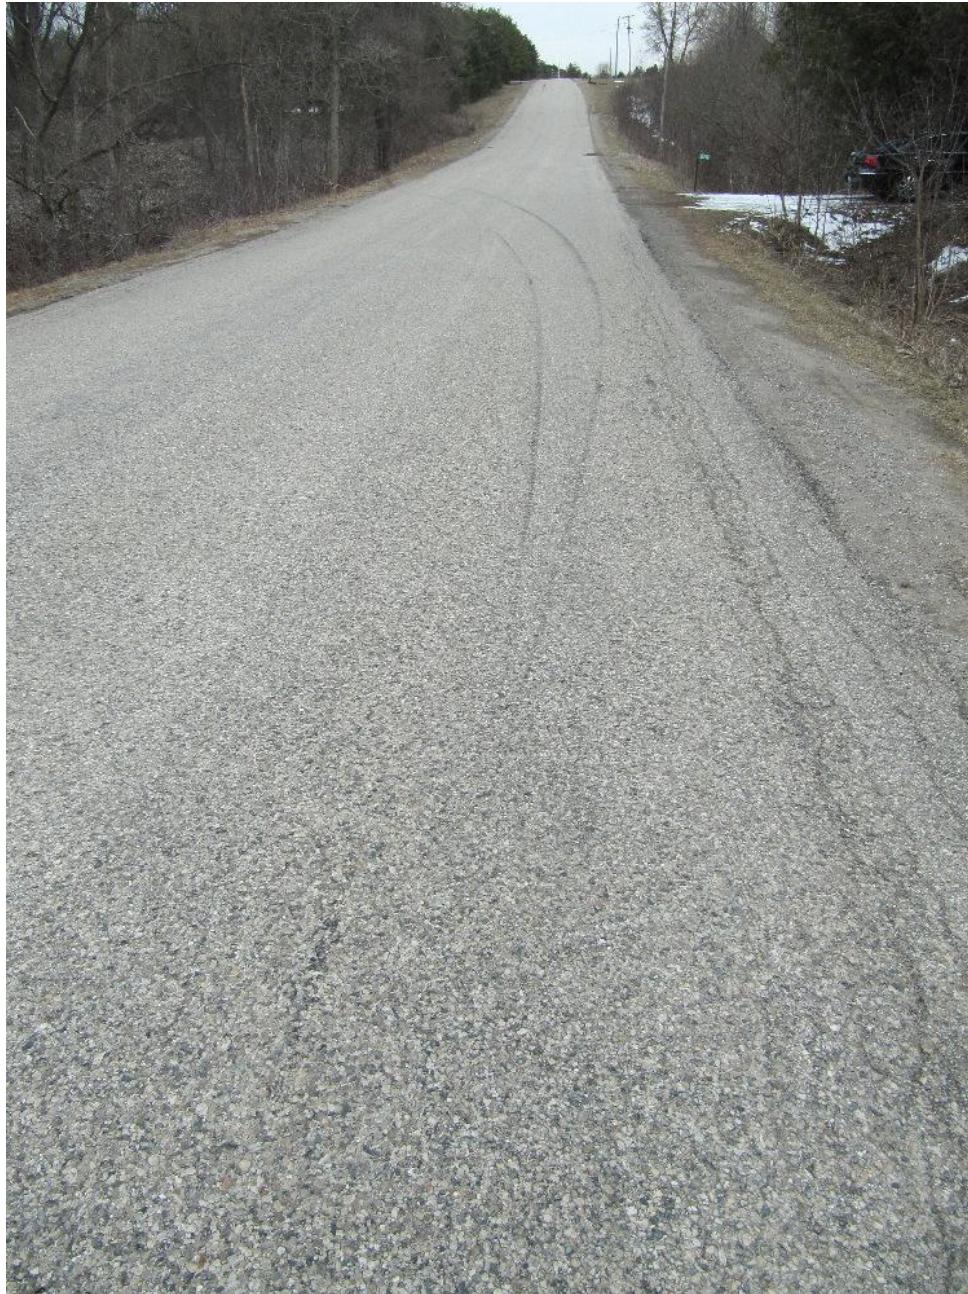
As we move further eastward, past the police skid marks, it is possible to see in Figure 4 the darker yaw marks as the vehicle then began to rotate counter-clockwise from the south lane toward the north roadside in the background.

Figure 4: Eastward view of counter-clockwise yaw marks caused as the vehicle travelled from the eastbound lane toward the north roadside.

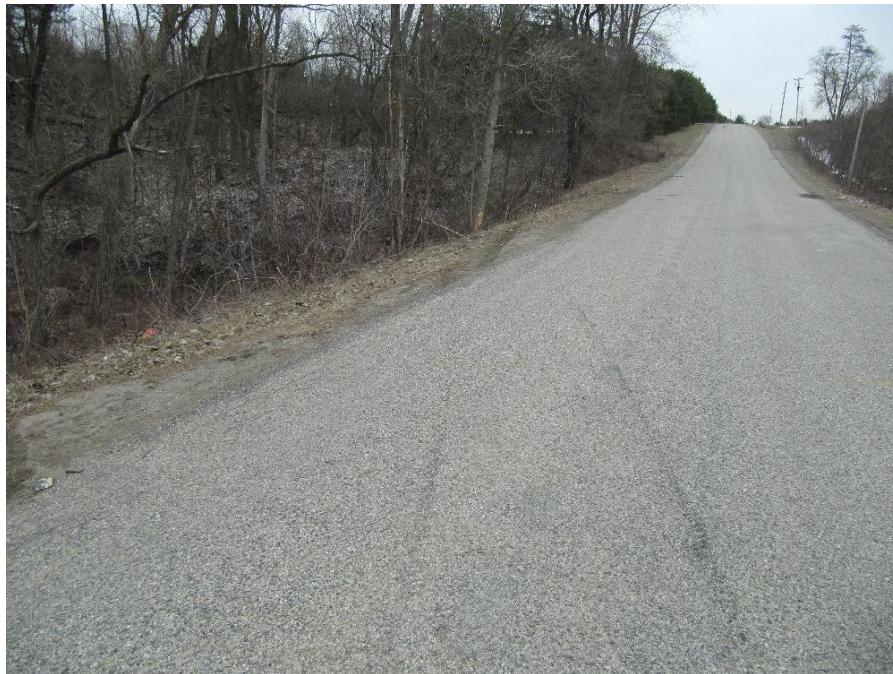
In Figure 5, we see how the yaw marks continue to travel across the roadway and toward the north roadside.

Figure 5: View looking at the yaw marks travelling toward the north roadside.

The issue that should be apparent from observing Figures 5 and 6 is that there no barrier to prevent a vehicle from exiting over the steep embankment on the north side of the road. Figure 6 shows the extent of the drop and the severity of the slope. These characteristics are no different than any roadside next to a bridge that might span a similar creek or small river.

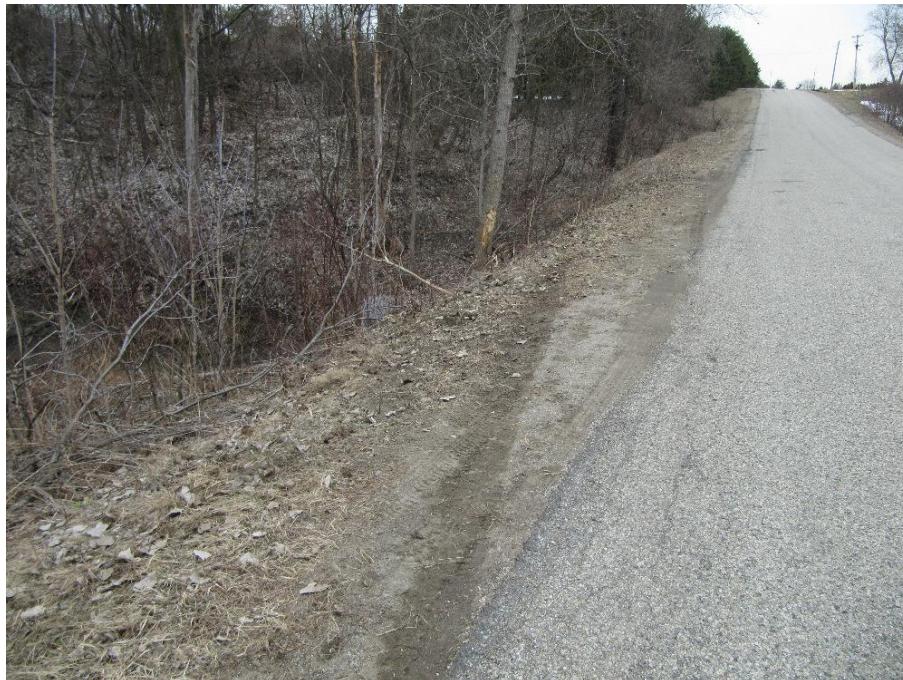
In Figure 6 we see how the tire marks exit the north roadside and we can see the evidence of an impact to a tree in the background.

Figure 6: View of yaw marks exiting into the north roadside.

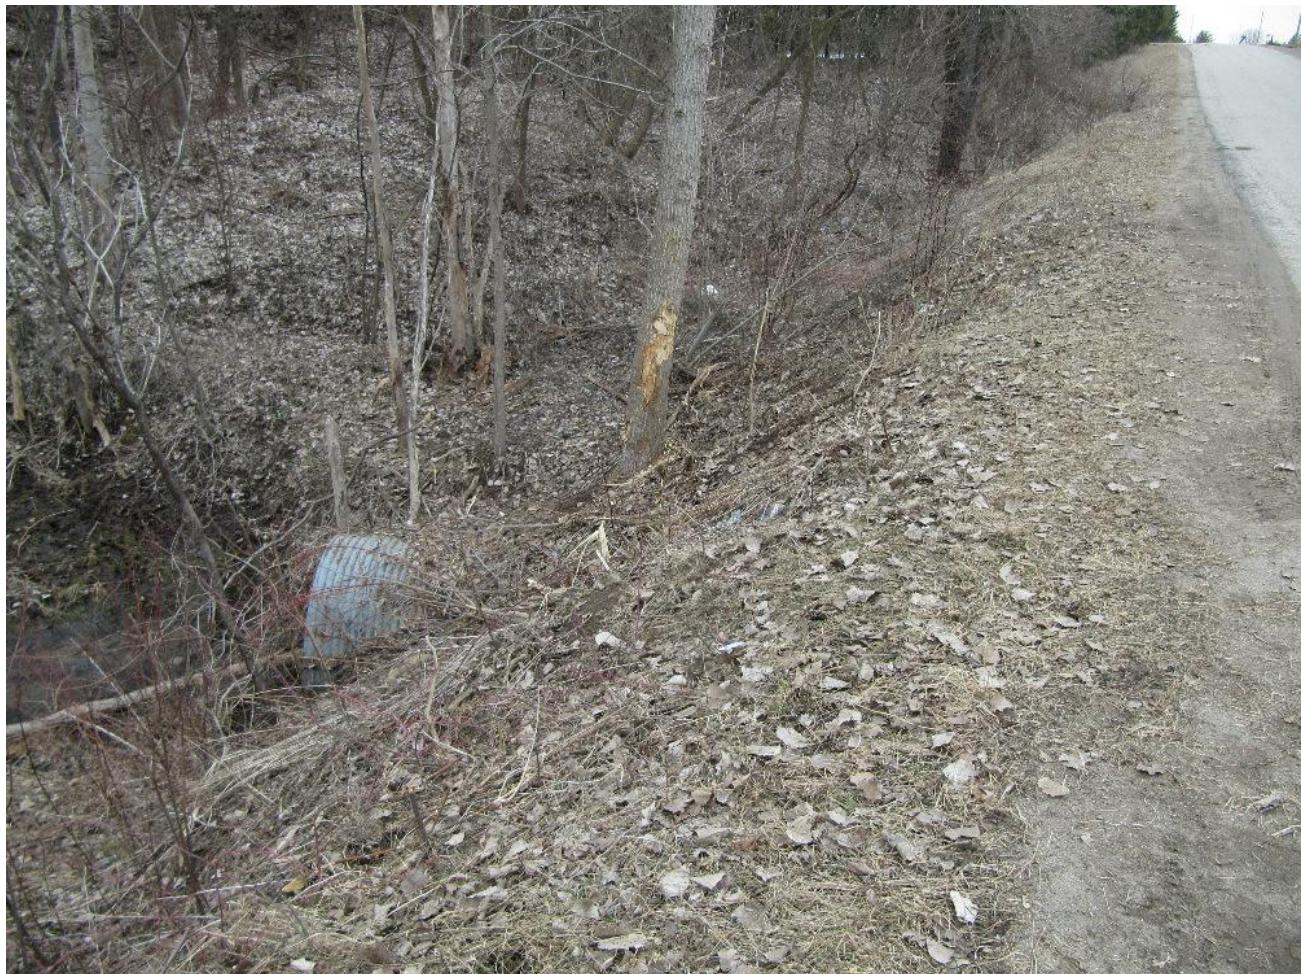
Figure 7: View of north roadside and struck tree.

Looking at the level portion of the roadside next to the hard top road surface there would appear to be sufficient lateral width on which to erect a guardrail or similar barrier to prevent vehicles from this deep drop.

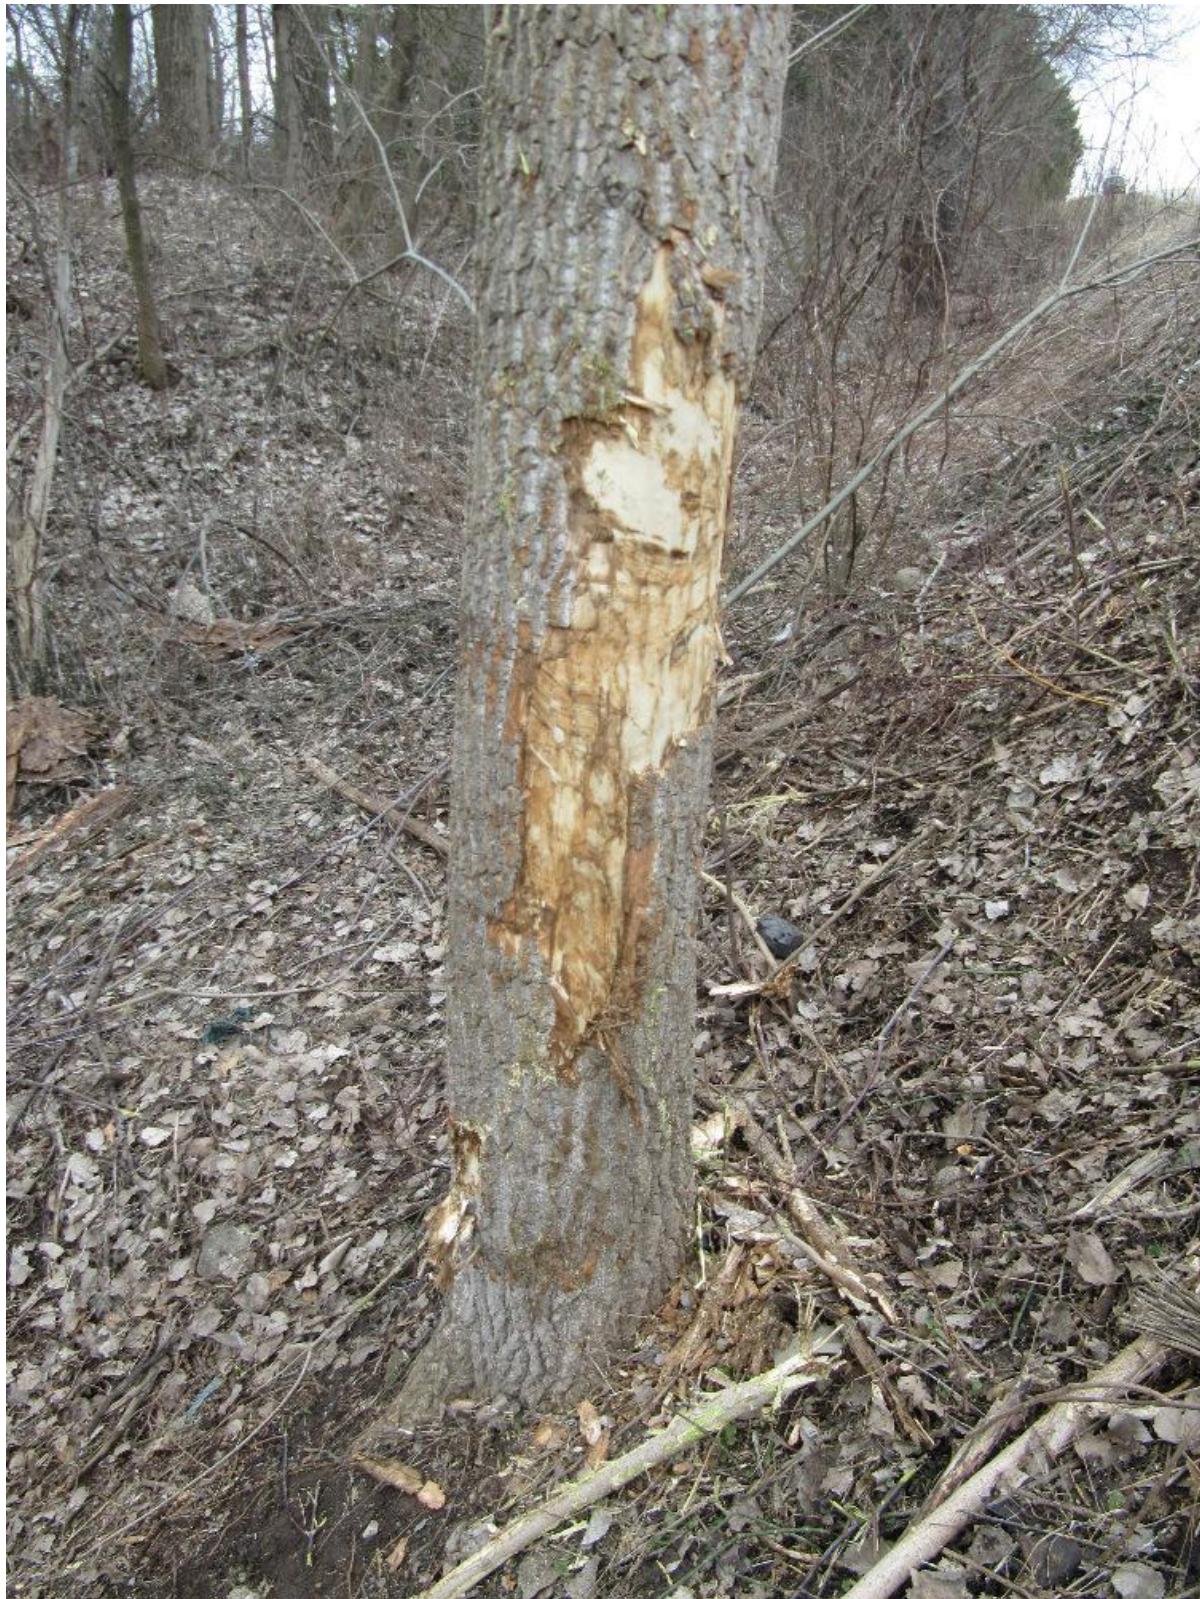
Figure 8 shows a view of the struck tree. Evidence at the site confirmed that the vehicle travelled only a short couple of metres past this tree therefore almost all of the vehicle's speed was lost from this impact and therefore the impact force was applied close to its centre of gravity. This would indicate a higher severity of impact than if the vehicle was able to be deflected from impact with some residual velocity. Since the two occupants would be seated close to the vehicle's centre-of-gravity it is less surprising that both sustained fatal injuries.

Figure 8: View of struck tree.

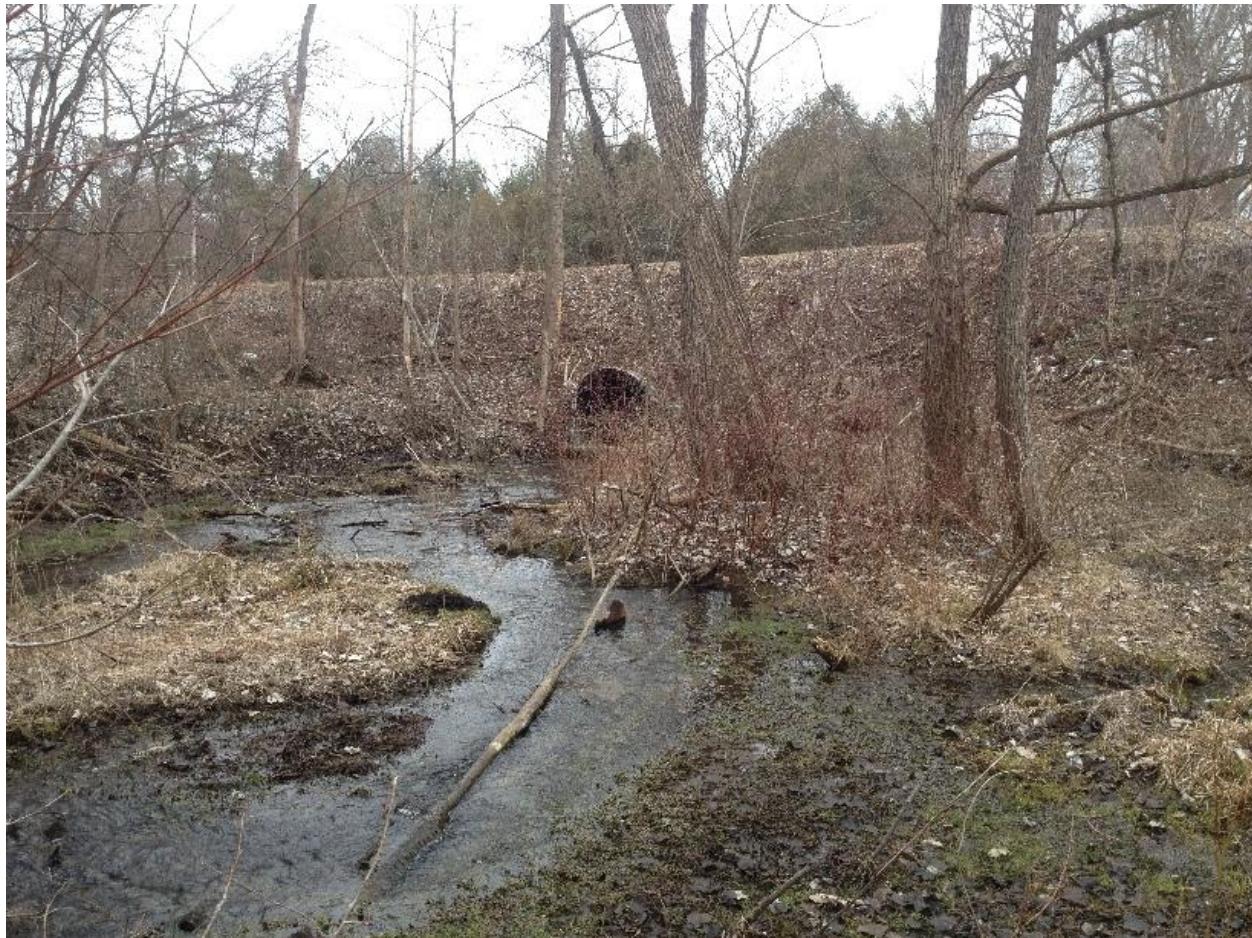
However, it must be questioned why a barrier was not installed to prevent such an impact. Figure 9 shows a view looking from the north toward the roadway and we can see the extent of the steep slope above the bed of the stream. The stuck tree is located at the left centre of this view.

Figure 9: View, looking south, from the north roadside of La Salette Road, demonstrating the large vertical drop and the steepness of the embankment where the collision occurred.

If there had been a barrier erected at this site the collision could have resulted in minor injuries or no injuries at all. It can be understood that not all roadways can receive the same level of service and that level must be increased on roadways with a high traffic volume so that the expenses benefit the greatest number of road users. However, during the time that we examined the site on a Sunday afternoon we were cognizant of the number of vehicles passing the location and it would not be surprising to us if the Average Daily Traffic Volume (ADTV) for this road segment was above 1000 vehicles.
