Dr. Kelly Shaughnessy of Ingersoll Reportedly Fatally Injured in Head-On Collision

Posting Date: 01 Nov 2010

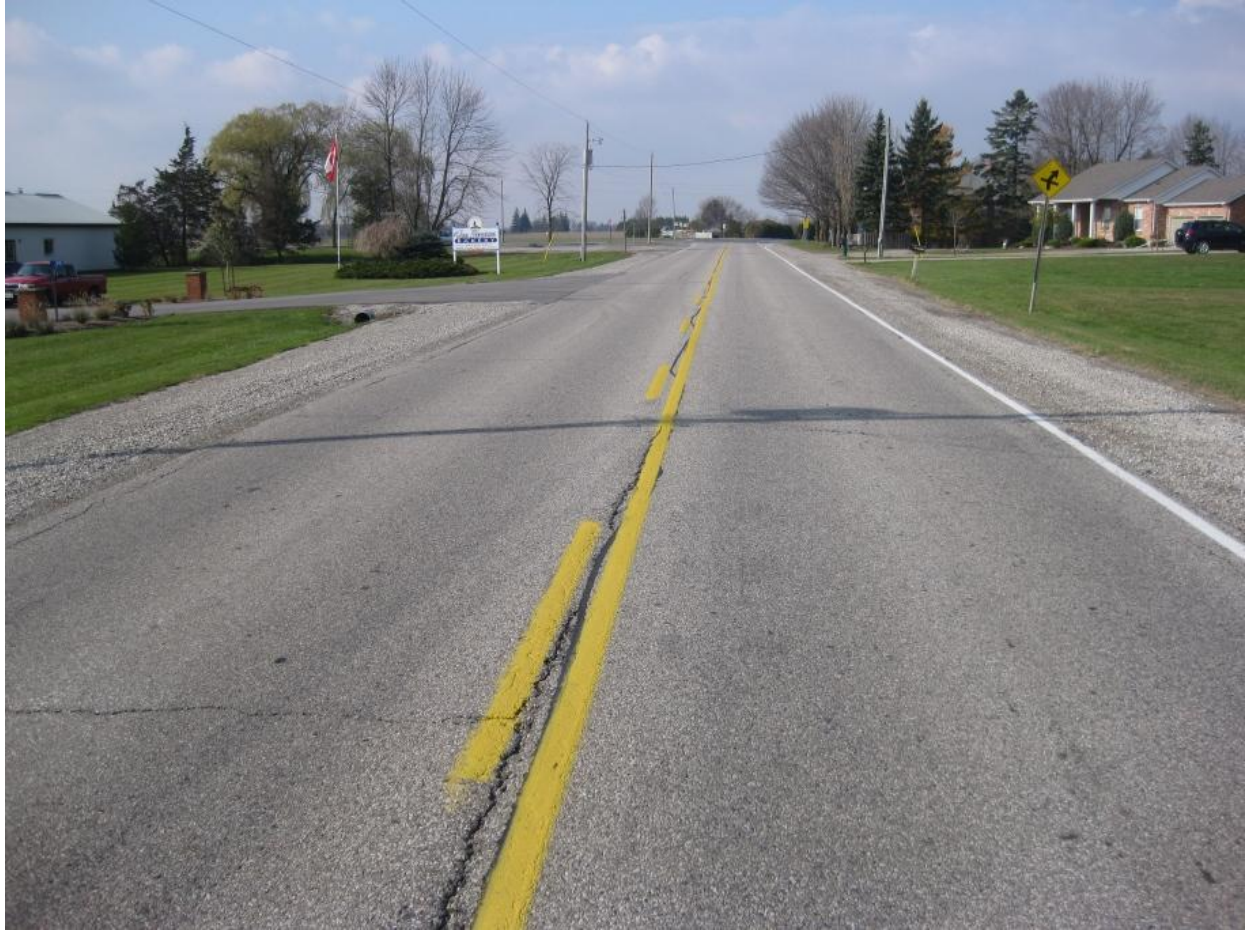
First I want to show you a photo of Oxford County Road #55 from several hundred metres east of the accident site, and looking west or the direction that Dr. Shaughnessy was travelling.

The photo was taken while standing in Brant County and the border with Oxford County is at the intersection in front of us, which is at the hamlet of Muir. You can see that on the Brant County side of County Rd #55 the road surface is a little aged but as we approach the intersection at the border with Oxford County the roadway has been freshly paved. You will also note that the roadway is straight and level but the centre-line marking indicates that passing by westbound vehicles is not allowed. Obviously because we are approaching an intersection but also because there is a right curve at that intersection. The layout of the upcoming road is evidenced by the yellow warning sign on the right roadside in the photo below.

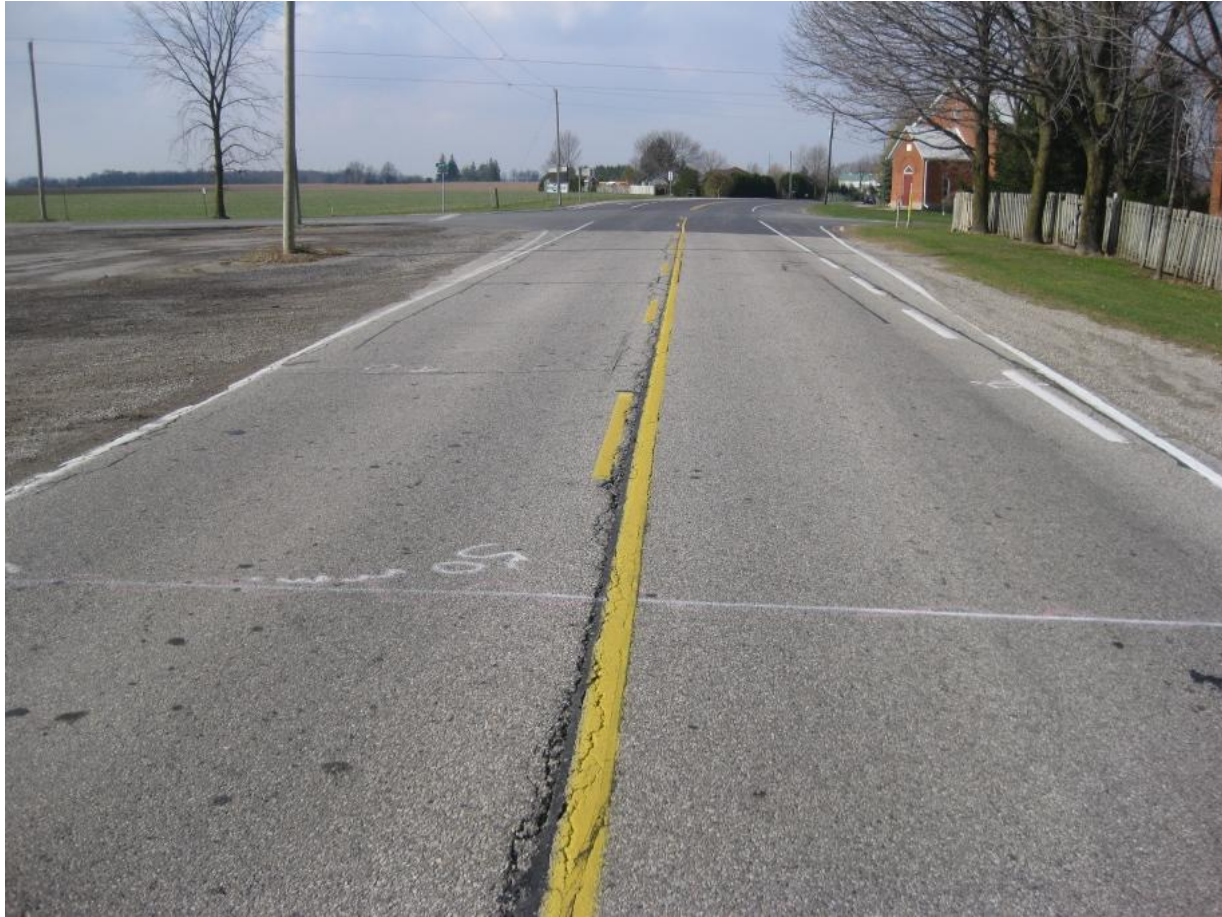
As we get closer to the intersection in the photo below you start to see how the roadway widens out to accommodate turning vehicles. In particular you should be able to recognize the small, red-bricked building on the right that looks like an old church. You should also now begin to see the newly paved surface of the road.

A resident indicated that the road construction was performed this past summer and it was completed only about one month ago.

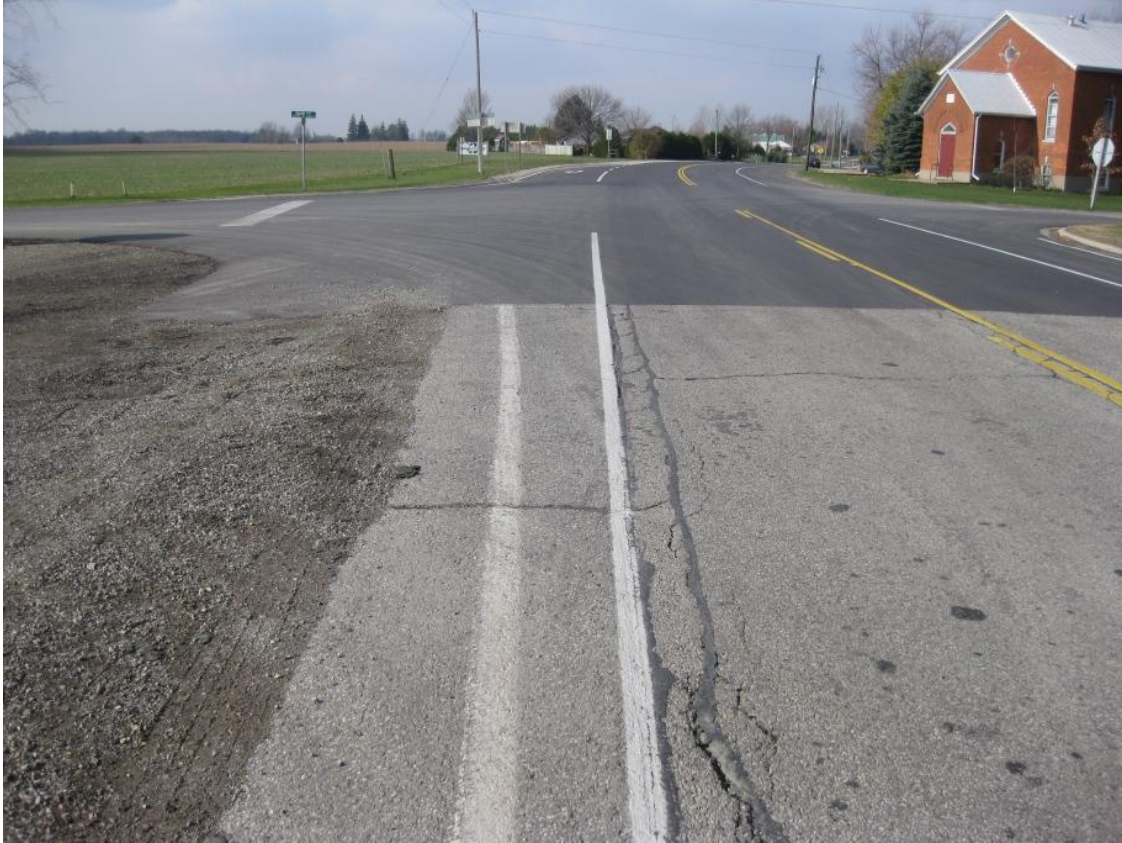
Below is a photo taken from the south side of the road looking toward the intersection and you should be able to recognize that there is a right curve immediately beyond this intersection. You will find in additional photos that Dr. Shaughnessy's Honda SUV travelled onto the south or left shoulder before impact and the evidence of that will be just past this intersection.

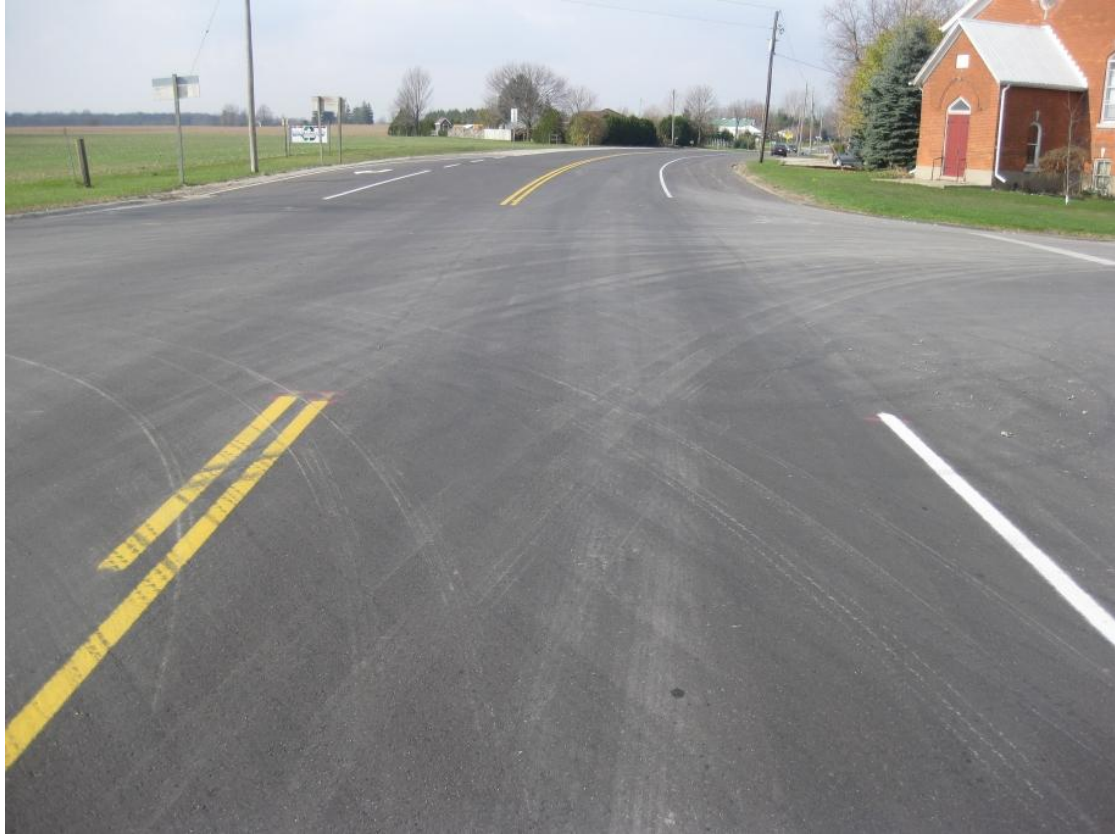
Now, below is a view of the intersection but from a more northerly position where we can see along the westbound lane.

What I am trying to demonstrate with the previous two photos is that the intersection is fairly wide. You can see additional lanes have been included for vehicles turning off the main road. And there, to the right, is that red-bricked church.

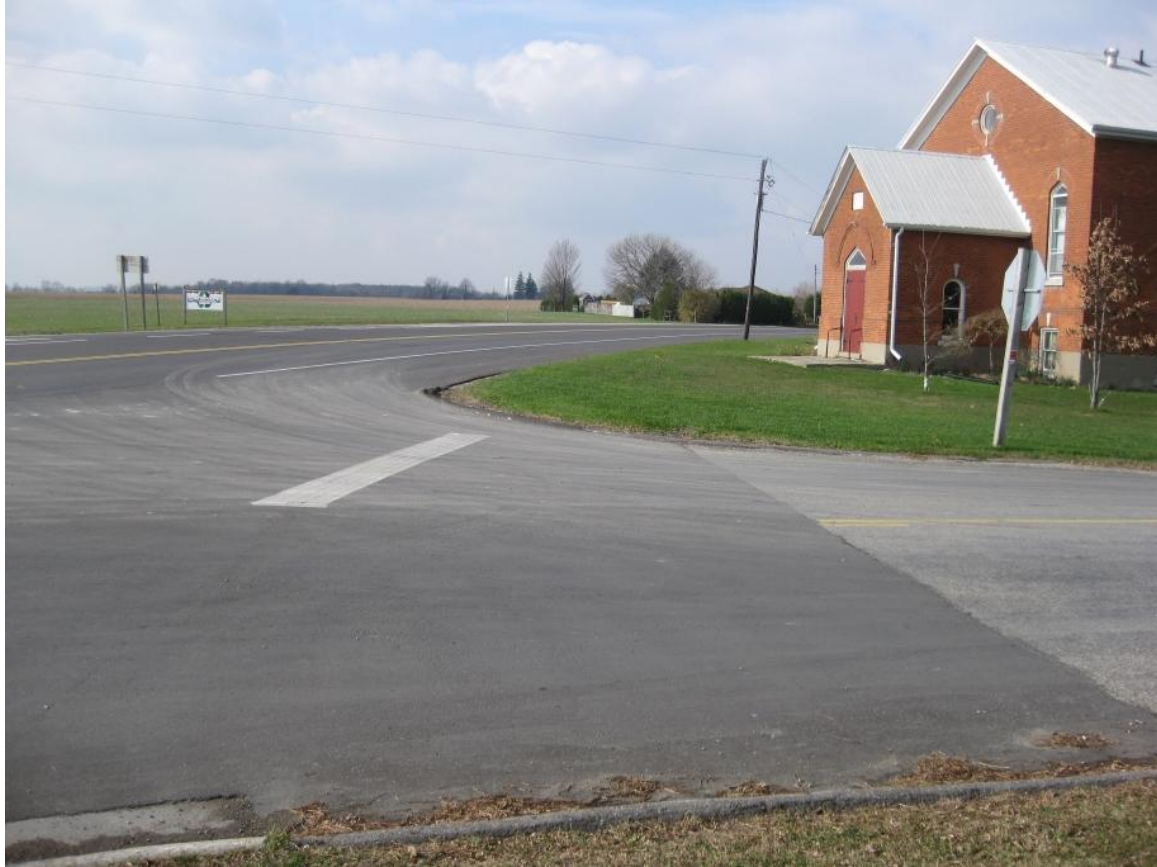
Below is a photo taken from the east side of the intersection looking west but standing at the north-east quadrant. What I want you to consider is the painted traffic stop bar that is in the middle of the view. This stop bar is where southbound vehicles on the minor road (governed by the stop sign) are supposed to stop the front end of their vehicles to scan the main road and determine whether it is safe to cross.

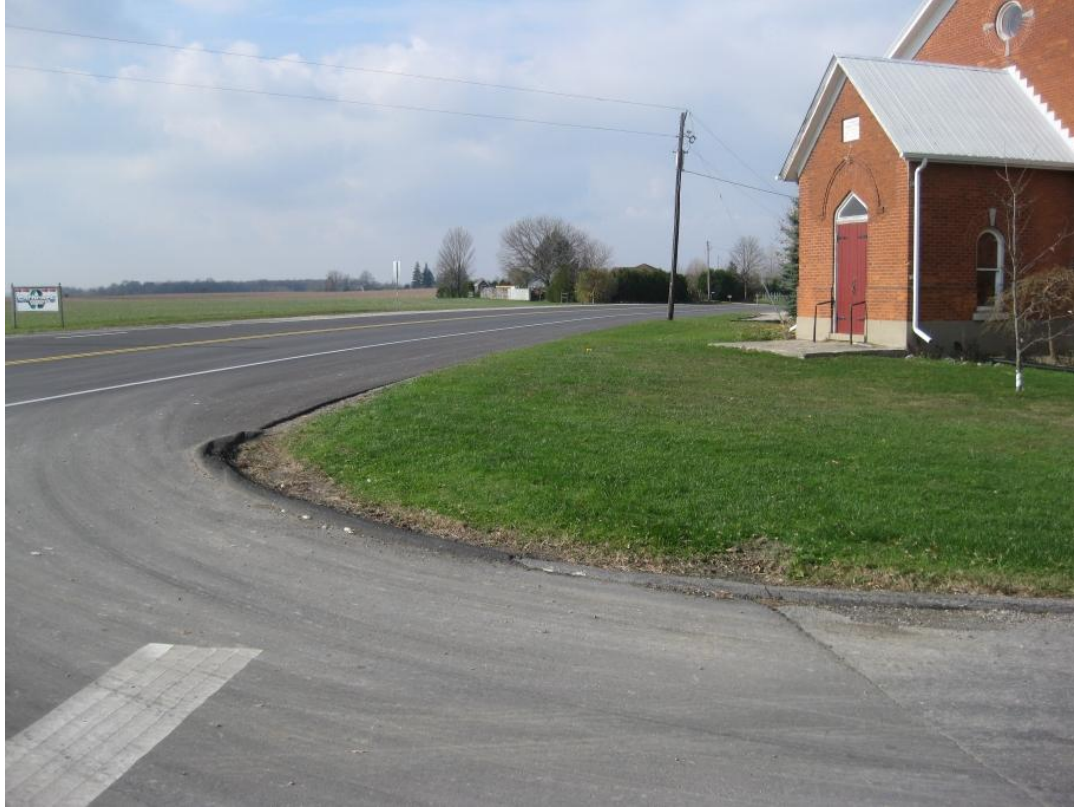
I took the above photo from a distance so that you could get an idea of the layout before I bring the camera to the eye position of a southbound driver. That eye position is shown below.

Now for some background for why I'm showing this. Roadway Geometric Design Standards are fairly similar throughout North America and they help to provide a consistent application of roadway layout so that drivers are given a certain amount of vision into critical areas of the road so they can avoid being struck. At an intersection, where a driver faces a stop sign, there is a certain amount of distance that the driver must be able to see along the main road so a decision can be made whether it is safe to commence a crossing. The standard basically gives the driver a time of two seconds to scan the opposing roadway and then, using a reasonable rate of acceleration, a certain time is allowed for the crossing vehicle to travel from the stop bar all the way across the road up to a point where the rear end of the crossing vehicle passes the far edge of the travelled portion of the intersecting road. So basically the crossing vehicle is given enough time to fully cross without being struck. How is this done? Well, the roadway designer observes the average speed of vehicles on the main road and this "Operating Speed" becomes the bench mark. If the average speed is 90 km/h then the vehicle is travelling 25 metres every second. And if the crossing vehicle requires 7 seconds to safely cross the road then there must be sufficient visibility such that the vehicle on the main road is visible for at least 7 seconds at the Operating Speed. So we multiply 7 seconds by 25 metres per second and arrive at a distance of 175 metres. So the vehicle on the main road must be visible for a distance of 175 metres from the point where the crossing driver is stopped, or else the roadway condition is in violation of the standard.

Frankly, I don't need to take any measurements or observations here. Clearly if you look at the above photo you can judge for yourself that there is not much visibility here. And

we simply consider that the widened intersection means that the vehicle on the side road needs to travel further than usual to clear the intersection. But there is more.

When a driver has to look at an oncoming vehicle travelling on a curve it is more difficult for the observing driver to recognize the approaching vehicle's speed and location, so more time is needed for the driver to consider what is safe. So I think we have a problem here.

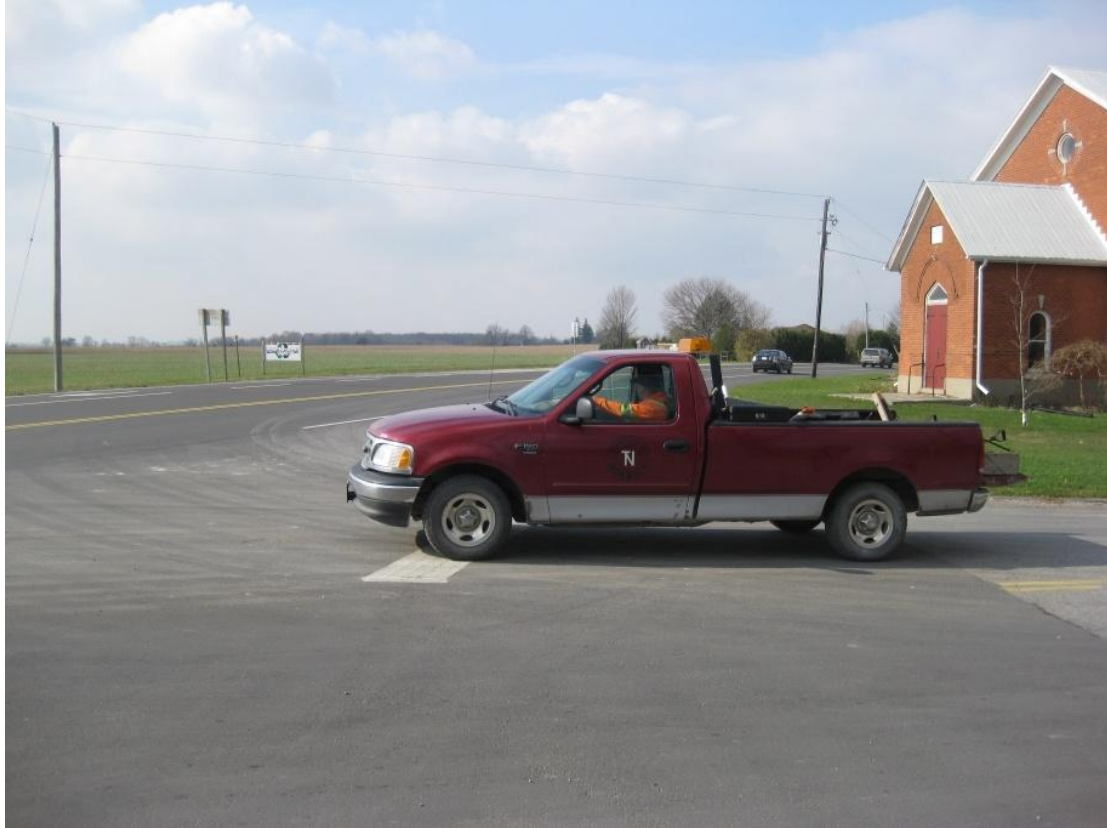
Before I put the visibility issue to rest I want to show you just one more photo (below) of a southbound driver stopped near the stop bar and how he has to creep out past the stop bar to be able to see past the church.

He also has to crank his head somewhat behind him to see because of the curve. I saw several drivers creeping out into the intersection well past the stop bar while focusing on what is to the right because that is where the visibility obstruction is located, but paying less attention to the left for approaching westbound vehicles. So when a collision occurs with a westbound vehicle the official agencies say "well there was no visibility problem because the westbound vehicle could have been seen from a mile away". Things are sometimes more complicated.

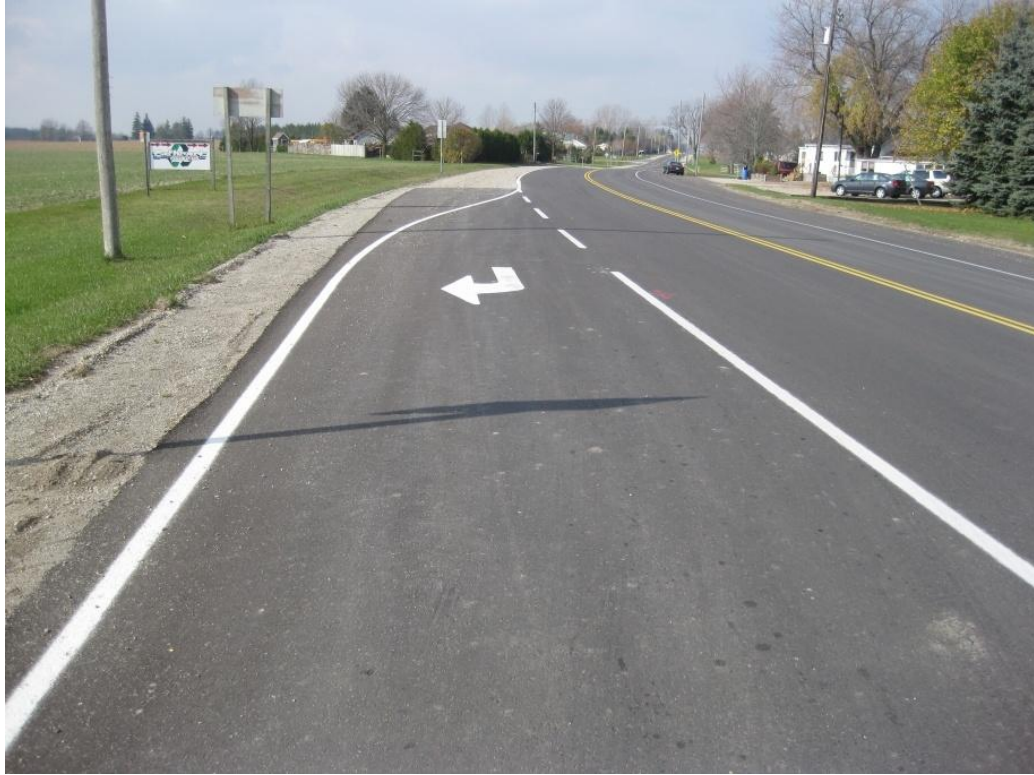
I now want to show you the layout just past (west) of the intersection. The photo below is taken looking west from the south side of County Road 55.

In the background, on the north (right) shoulder you can see my black car which is parked near the area of impact. Dr. Shaughnessy's Honda travelled onto the south shoulder somewhere near this location and then was coming back onto the paved road when the collision occurred. One can appreciate that collisions can occur for a number of reasons but the travel onto this shoulder just past the intersection makes one wonder if the event was related to the intersection. I will put it to rest.

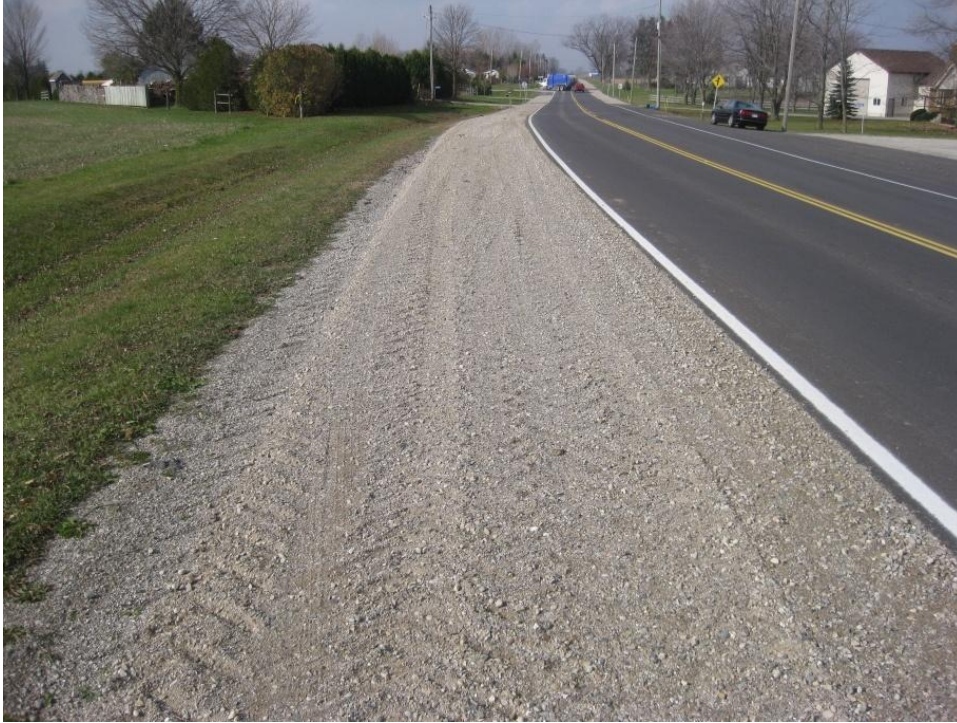
Below is a photo closer to the area of impact and I want you to recognize that the gravel is soft due to the new construction. Again, more difficult to get through at highway speed.

If we were the first police officers to arrive at the accident site we would want to protect this shoulder because it would contain the tire marks of Dr. Shaughnessy's vehicle and it would help to clarify how the collision occurred. Since I am examining the site some 5 or 6 days after the event any tire-marks in the shoulder are long gone. In fact, they are often long gone before any official investigation can be carried out because persons responding the emergency place their vehicles on the shoulder and destroy the evidence. I have heard police reconstructionists refer to the fire rescue people as the "evidence eradication team". Only kidding of course but it high-lights the point that people at an accident scene are there for different reasons and some interfere with the work of others. Towing personnel are a real difficulty for post-accident, civil reconstructionists because of the confusing evidence that they can deposit, sometimes directly over top of the accident evidence. There is an example of this at this site and if I have time I will describe it.

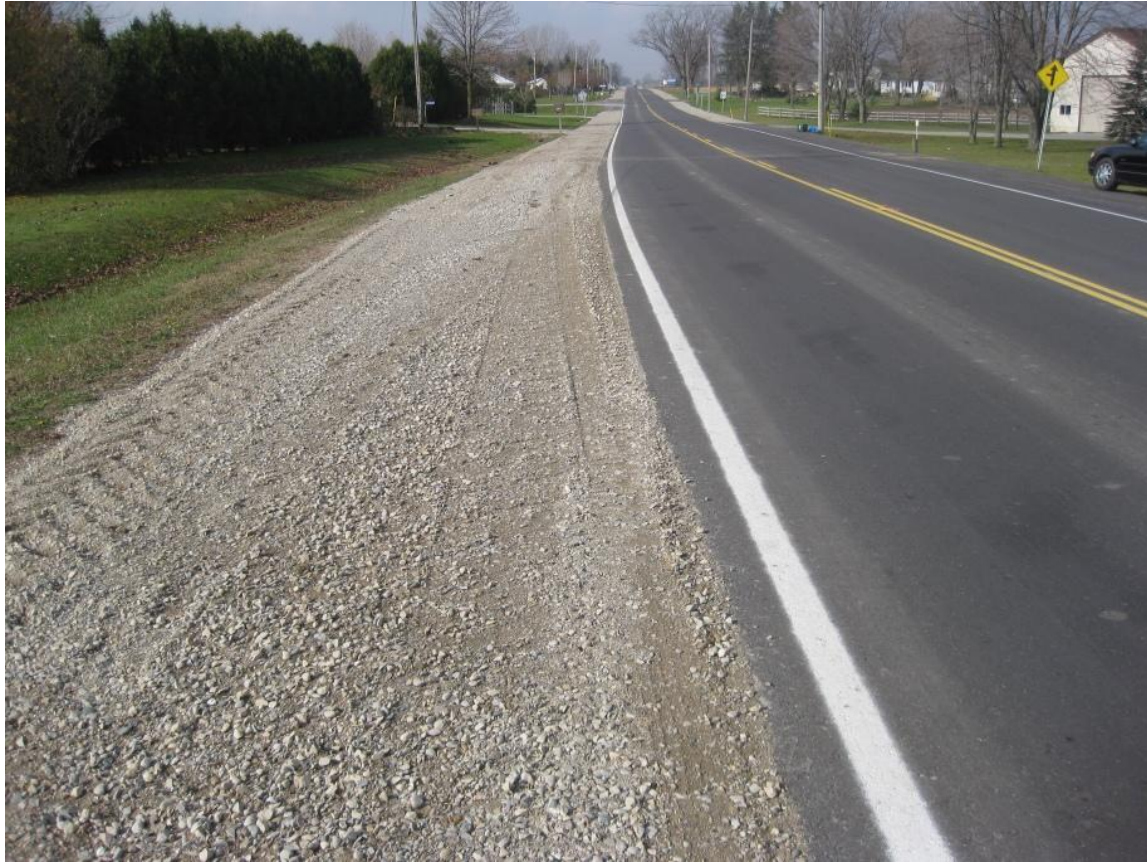
Now as we start to get close to the area of impact you can look at the photo below and try to locate the "yaw" tire mark near the asphalt edge as it exits the gravel shoulder and enters onto the paved roadway.

This is the pre-impact tire mark caused by Dr. Shaughnessy's Honda. And if we were here shortly after the event we would have seen the mark on the gravel shoulder as well. If you cannot see the yaw mark in the above photo then you should certainly see it in the photo below.

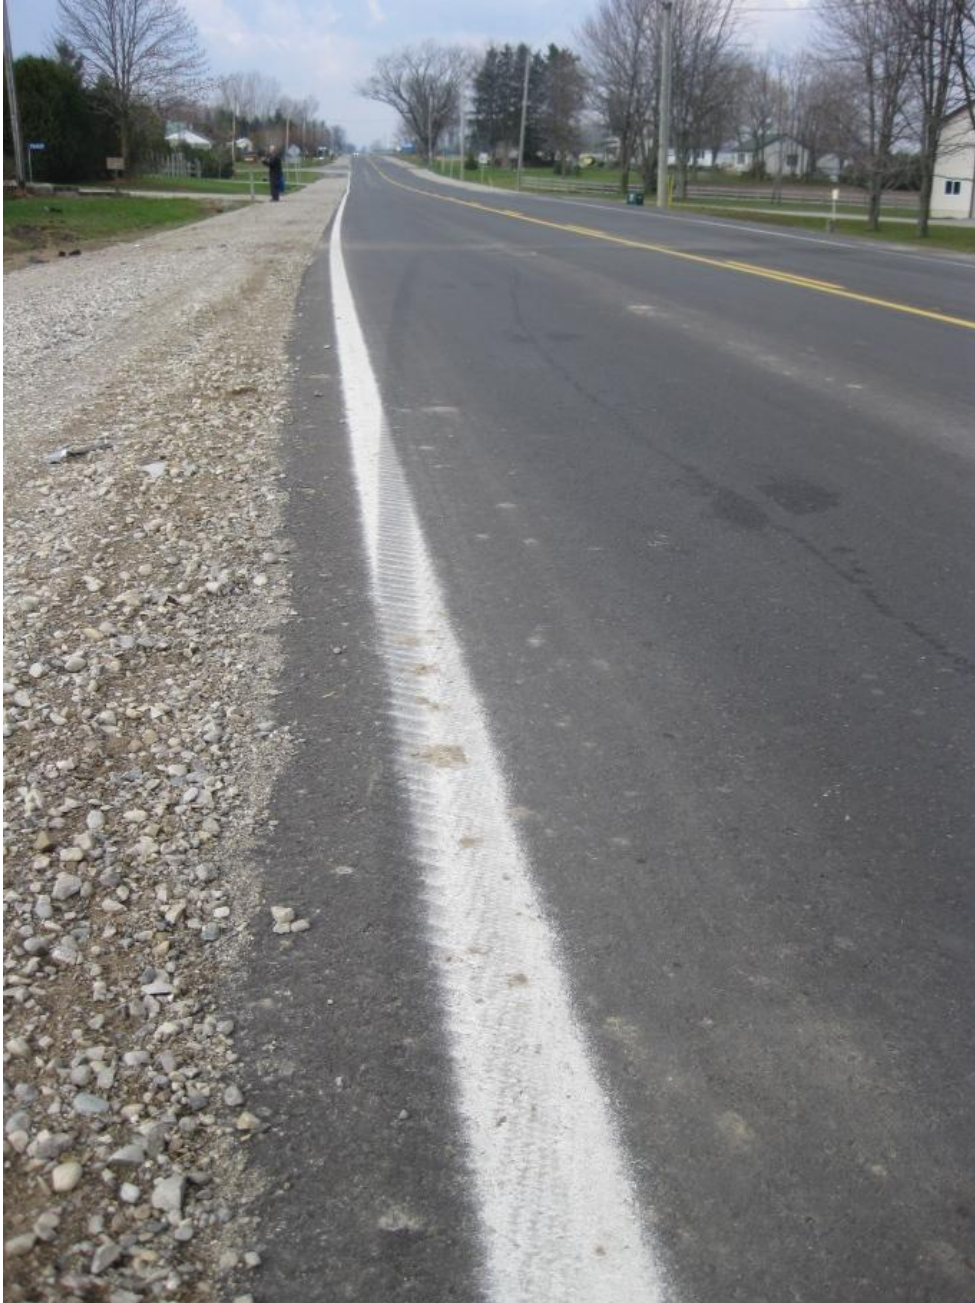
The striations in the mark are very visible when the tire mark crosses the white line. The tire mark ends at the point of impact in the background. Note that the angle of the striations within the yaw mark can tell the investigator whether there was acceleration or braking taking place while the mark was being created. For example the striations of most yaw marks are at a significant diagonal to the length of the mark while the striations in the present mark run almost perpendicular to the length of the mark. I will not comment further than that at this time.

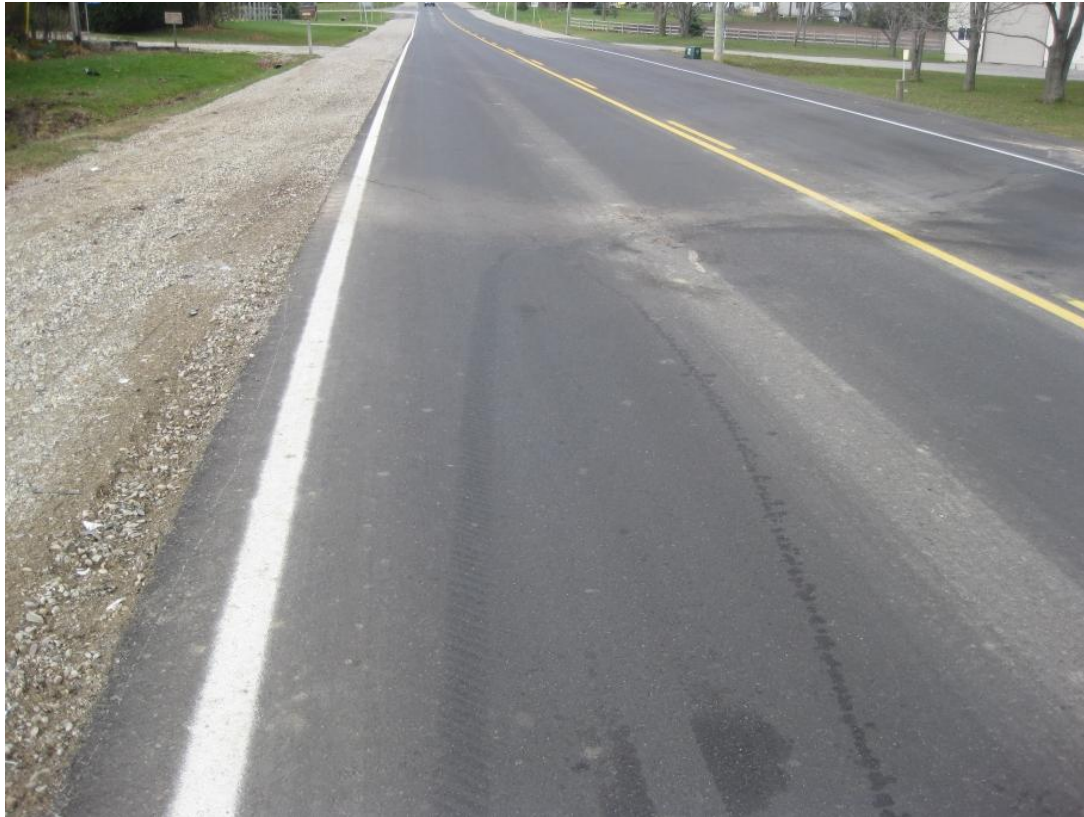
In the photo below you should be able to follow the yaw mark to the point where it ends and that is where the impact occurred.

In my opening remarks I mentioned my review of the news article and I discussed probabilities and how head-on collisions typically occur. I indicated a large majority of head-on collisions occur with about 50% or less of over-lap of the left portions of the front ends. Well the scenario here is quite different. I discussed how unusual it would be for the driver of the Dodge Pick-up to have survived with minimal injury unless the impact was to the right portions of the front ends. I also stated that for right-to-right contact the Honda would have to be in the opposing lane for a substantial time and distance. Well I was right to a degree except that the Honda was "even more" to the left (wrong) side of the road than I stated. It had gone off the travelled portion of the road and was coming back when the impact occurred.

Without even looking at the damage to the vehicles we can know simply by looking at the yaw mark in relation to the gouges in the centre of the eastbound lane and this should tell us that there must have been a lot of crush at the left front of the Honda and possibly further back along the left front fender. There would also be a lot of crush to the right front of the Dodge Pick-up truck where the right front occupant was fatally injured. So now all the facts from the media report make sense.

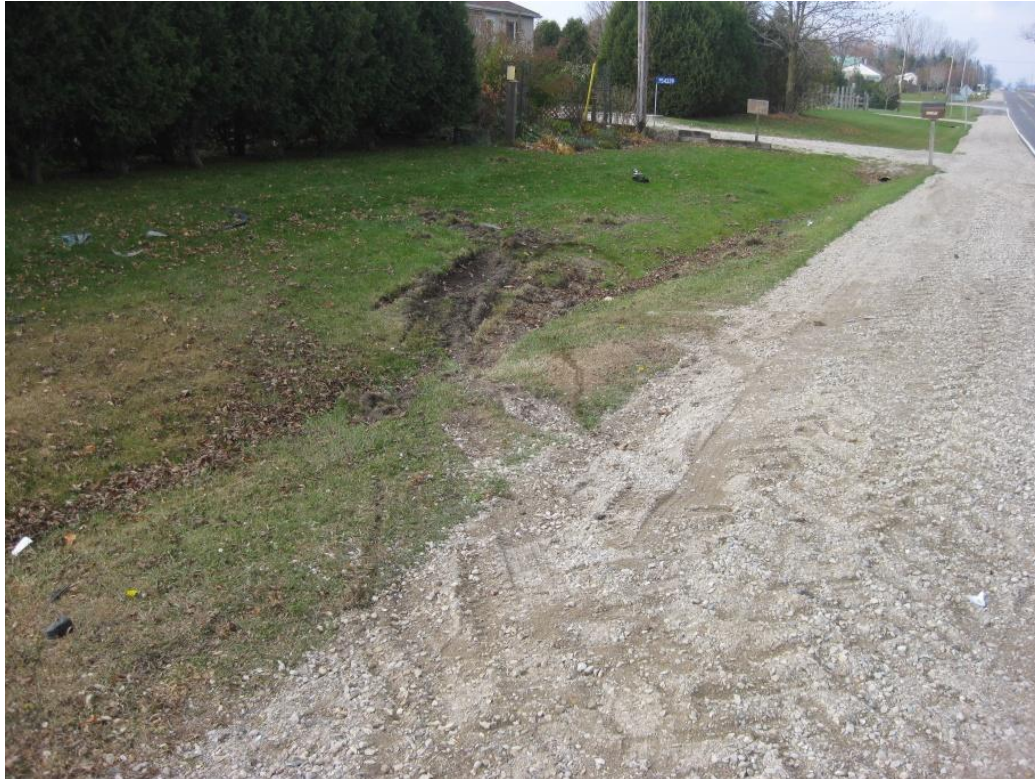
As a result of the impact the Honda was displaced to the south roadside as shown in the photo below.

Evidence that the left front of the Honda was demolished is demonstrated by the evidence of plowing of the earth in comparison to where the oil stain is located. Generally the oil stain at the final rest position of a vehicle identifies the centre front of the vehicle. Because the plowing of the earth is to the left of the oil stain in confirms where all the deformation occurred on the vehicle.

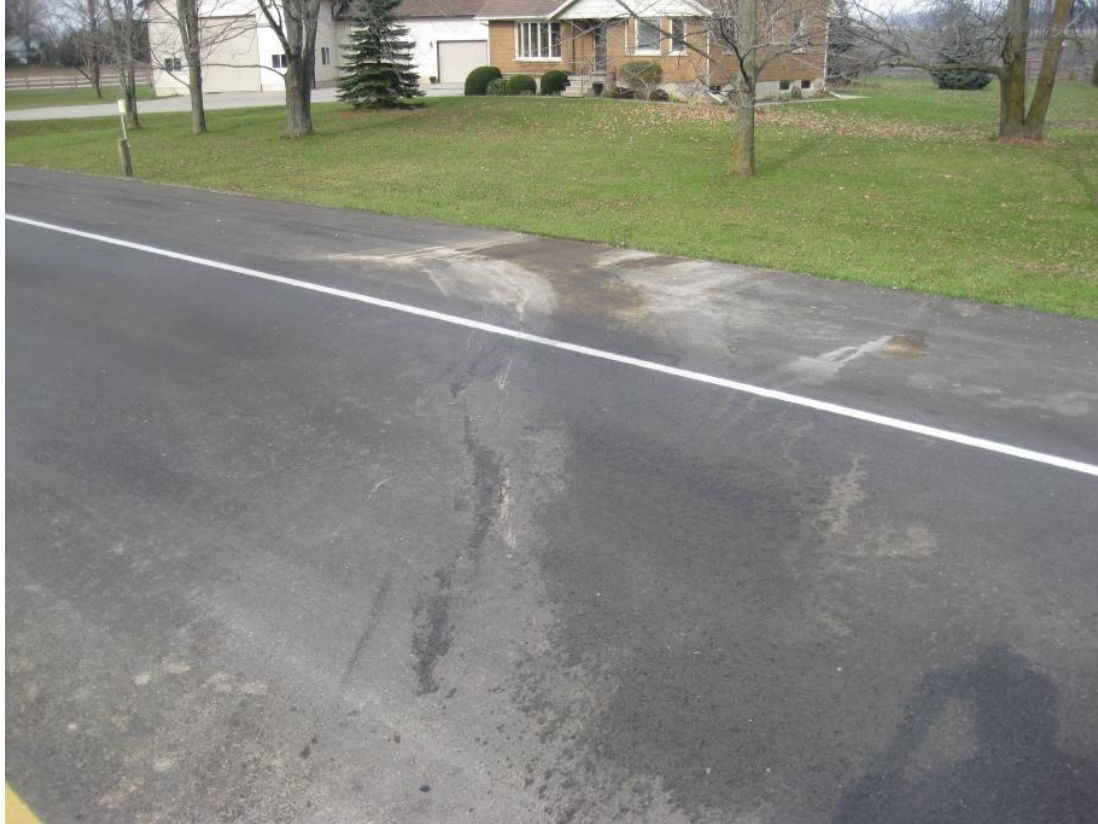
Also because of the unusual manner in which the impact occurred the eastbound Dodge Pick-up truck was thrown to the north side of the road as evidenced by the photo below.
