# Fatal Rollover on Eastbound Highway 401 East of Colonel Talbot Road, South-West Outskirts of London, Ontario

*Posting Date: 21-July 2013*

Gorski Consulting  
London, Ontario, Canada

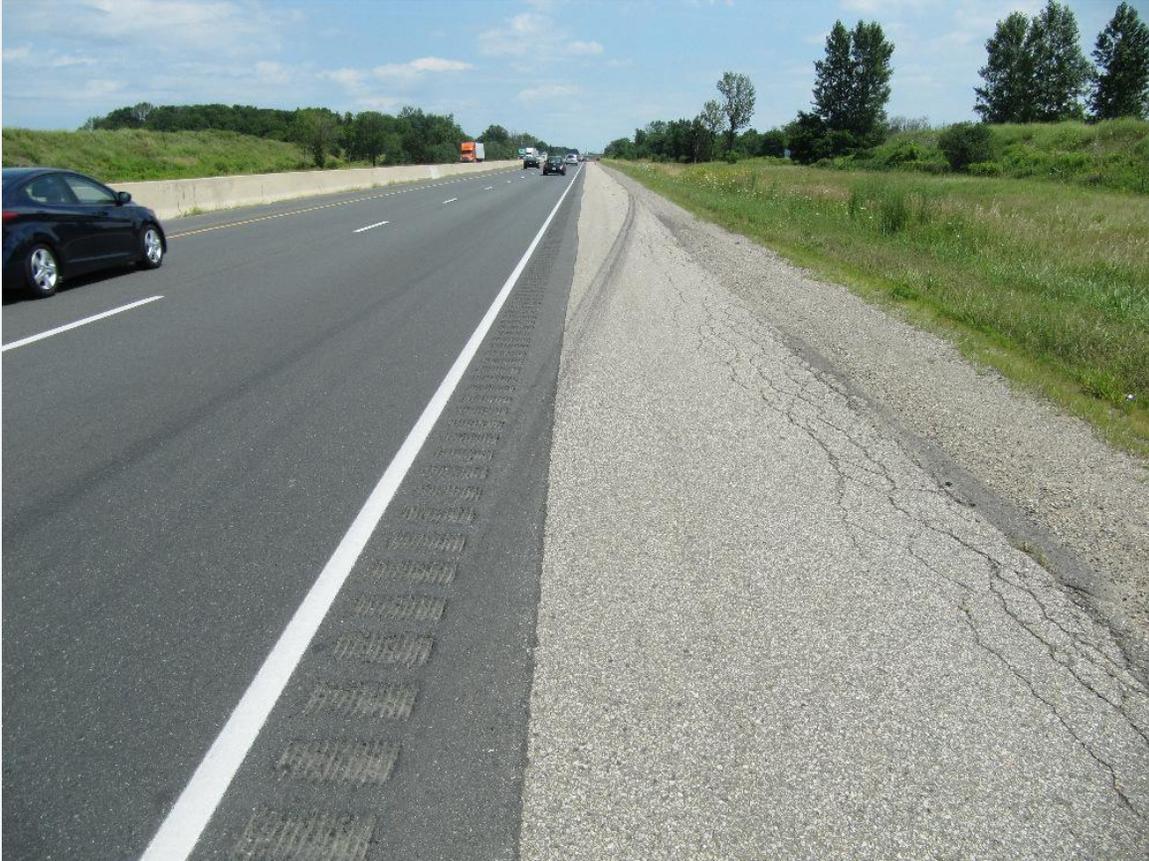
Tire mark located several hundred metres west of the rollover site indicating a vehicle had rapidly moved off the highway and onto the south shoulder.

Of course, this could have occurred when the eastbound driving lane was already shut down by police and some un-observant driver performed this action due to not recognizing stopped or slowed traffic – this is very common. Or it could be completely unrelated. You can appreciate, when we only have the site evidence to examine, these details must be kept in mind until resolved.

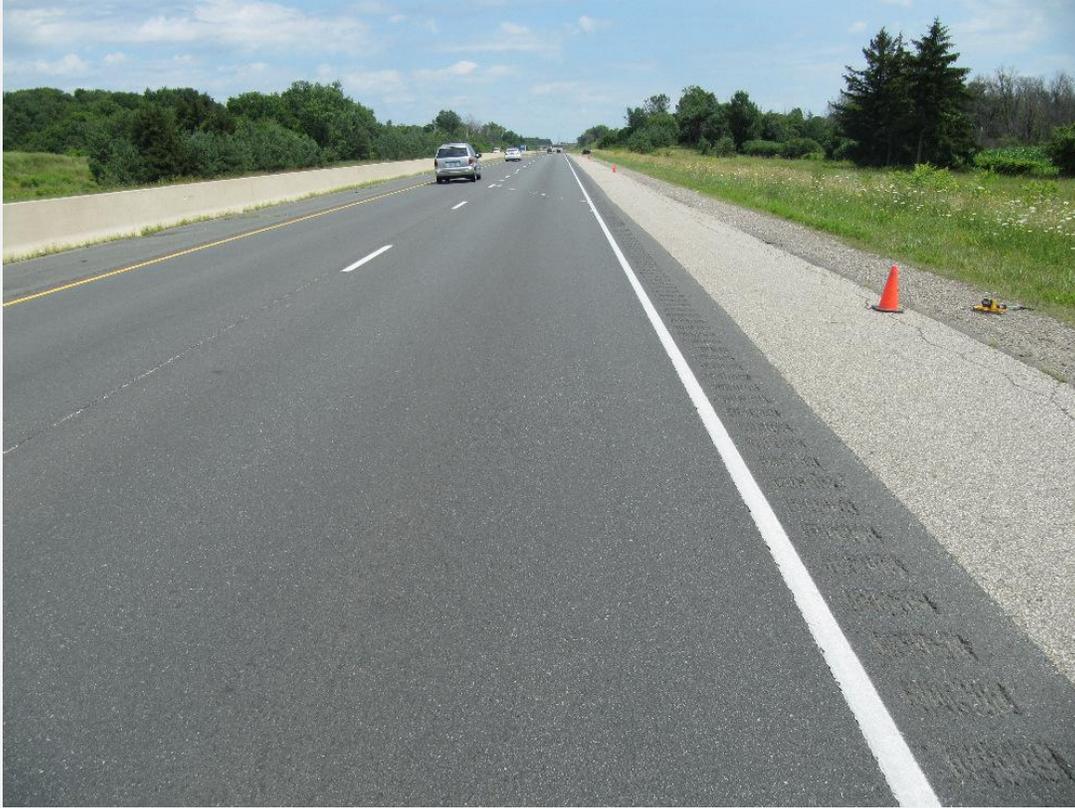
View, looking east, from about 200 metres west of the final rest position (FRP) of the Chevrolet Equinox.

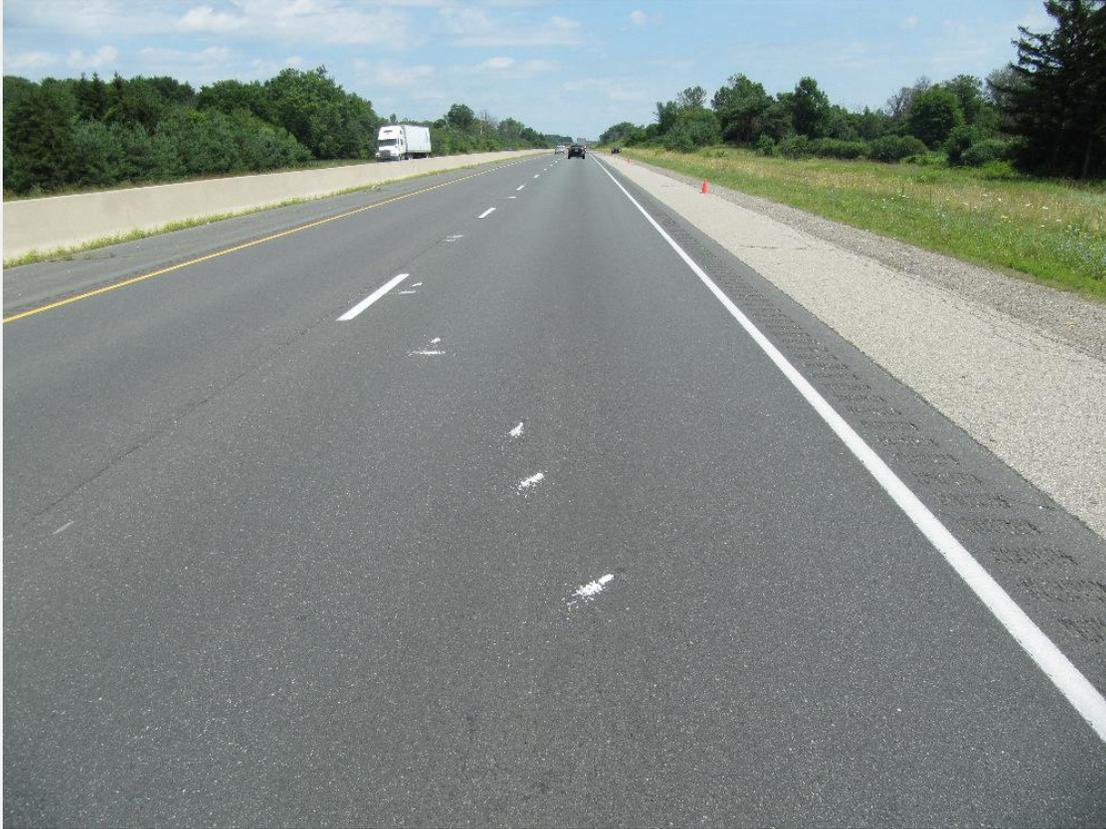
Closer view of white deposits in the eastbound driving lane of Highway 401 demonstrating where the police blocked off the road for their investigation.

Attention to these deposits is helpful in that they help to establish where the police determined the edge of the relevant, visible evidence. For example, if they had found tire marks or other evidence west of that 200 metre distance then they certainly would not allow traffic to drive over the evidence and the line of flares would have been set up further to the west.

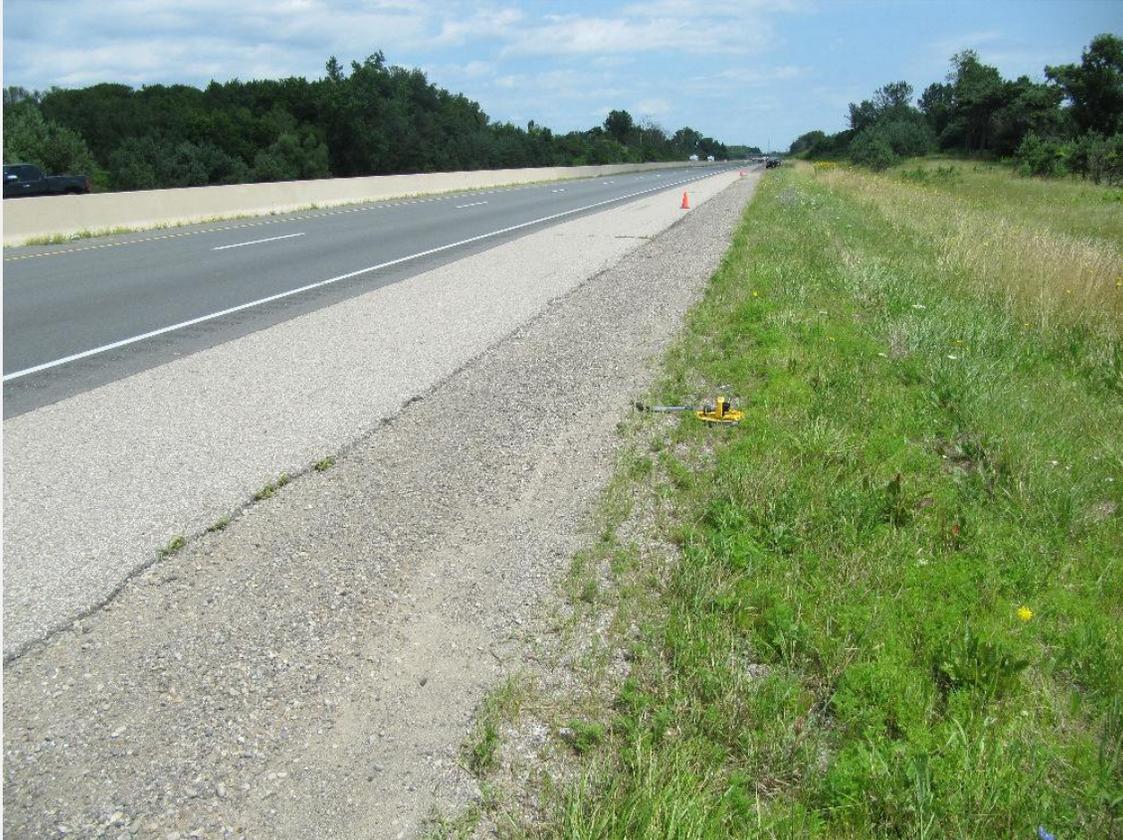
View of measurement wheel referencing the location of the first small piece of red taillight lens found the south shoulder.

This measurement wheel references the location where we found the most-westerly piece of red, taillight lens on the south shoulder. There were many more pieces of this red lens material scattered further eastward from this location within the south shoulder and edge of the south ditch. Why we mention this is because the lens material looked like it had been deposited there very recently. Furthermore we will see shortly that the Chevrolet Equinox was likely, at least, partly in the driving lane in this approximate location. If you look in the background of the above photo you should be able to count that there are two orange cones visible and, since the cones are spaced 50 metres apart, the measurement wheel and the first deposit of red lens material are about 125 metres west of the FRP of the Equinox.

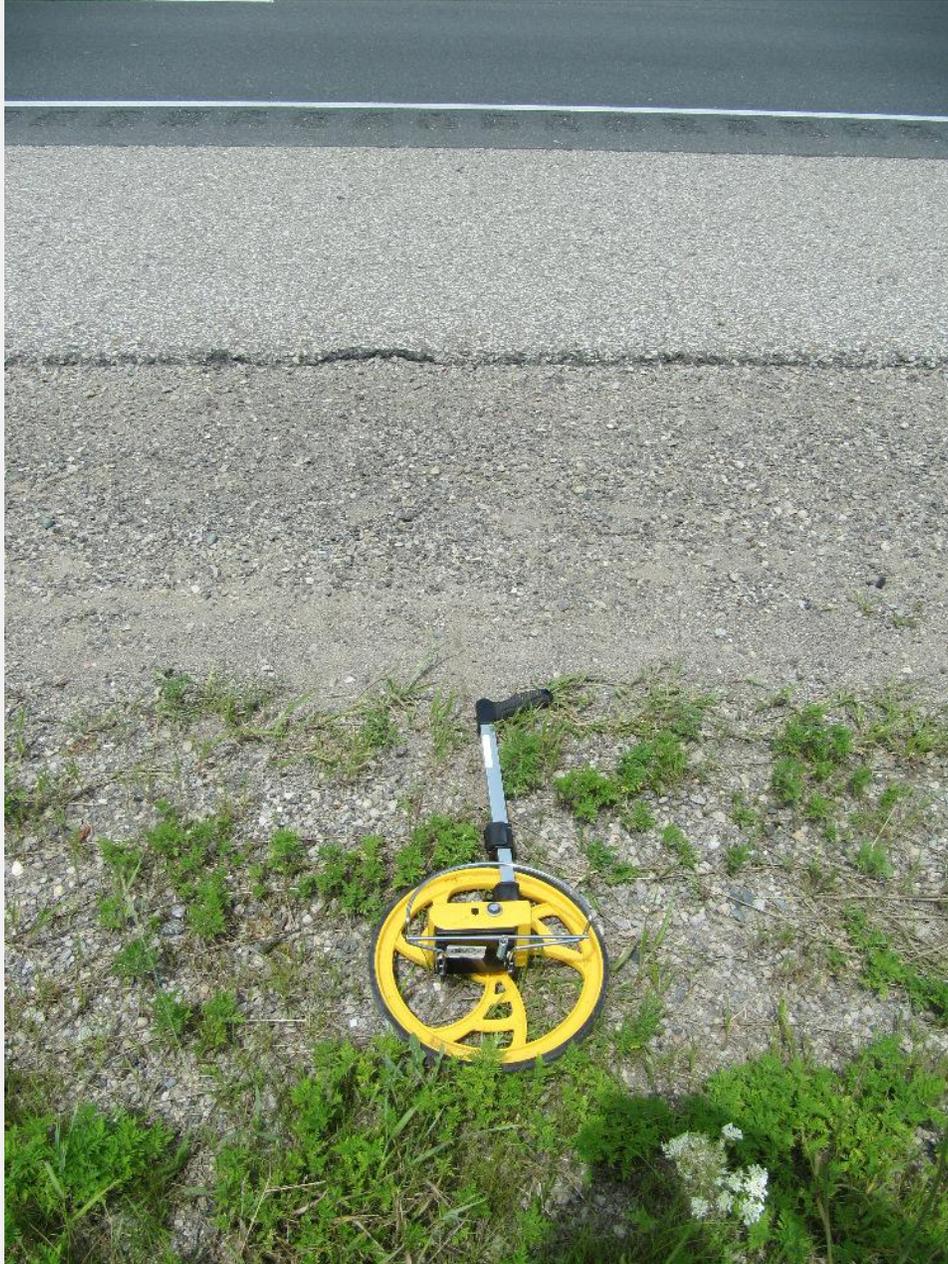
View, looking north, from the position of the measurement wheel out to the south pavement edge where the first piece of lens red material is located.

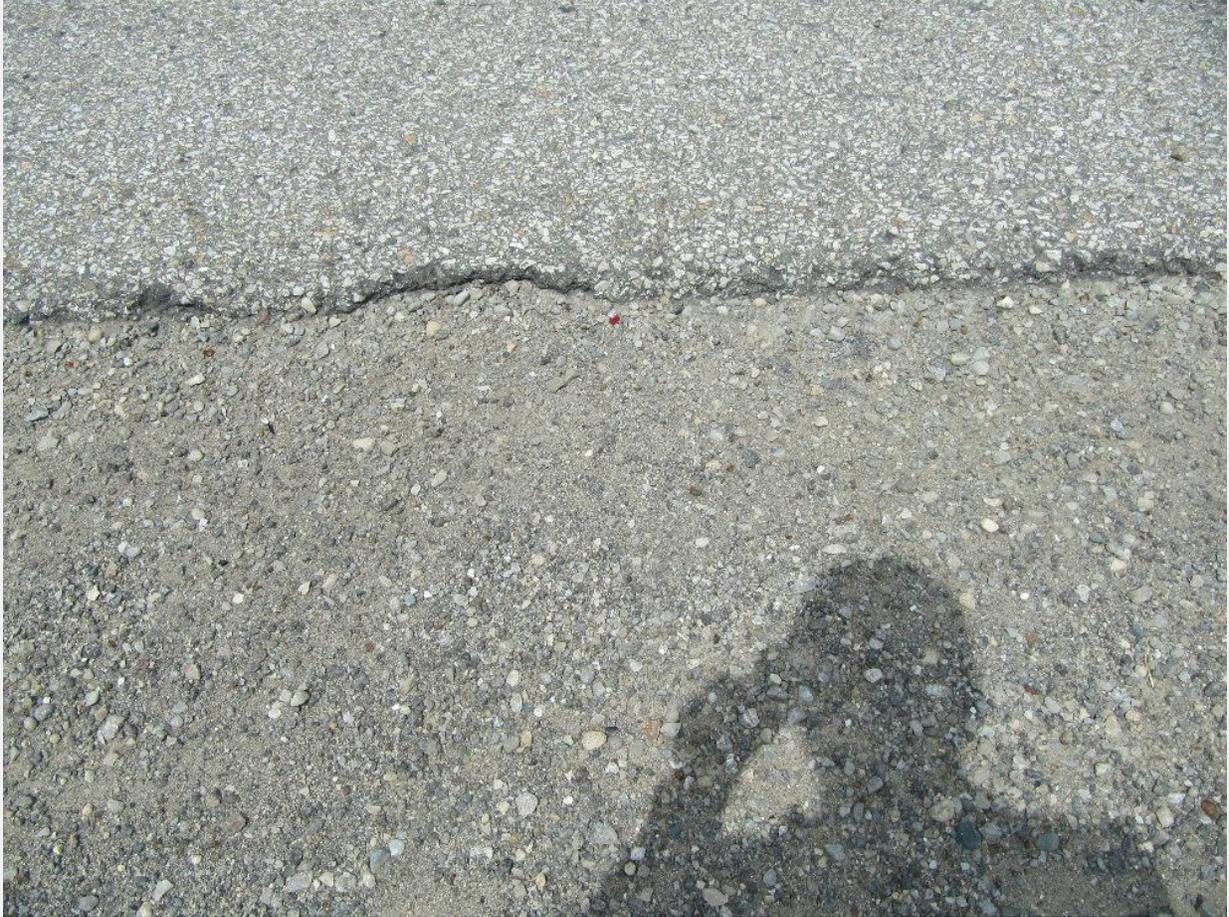
Closer view of south asphalt edge where the first piece of red lens material was located.

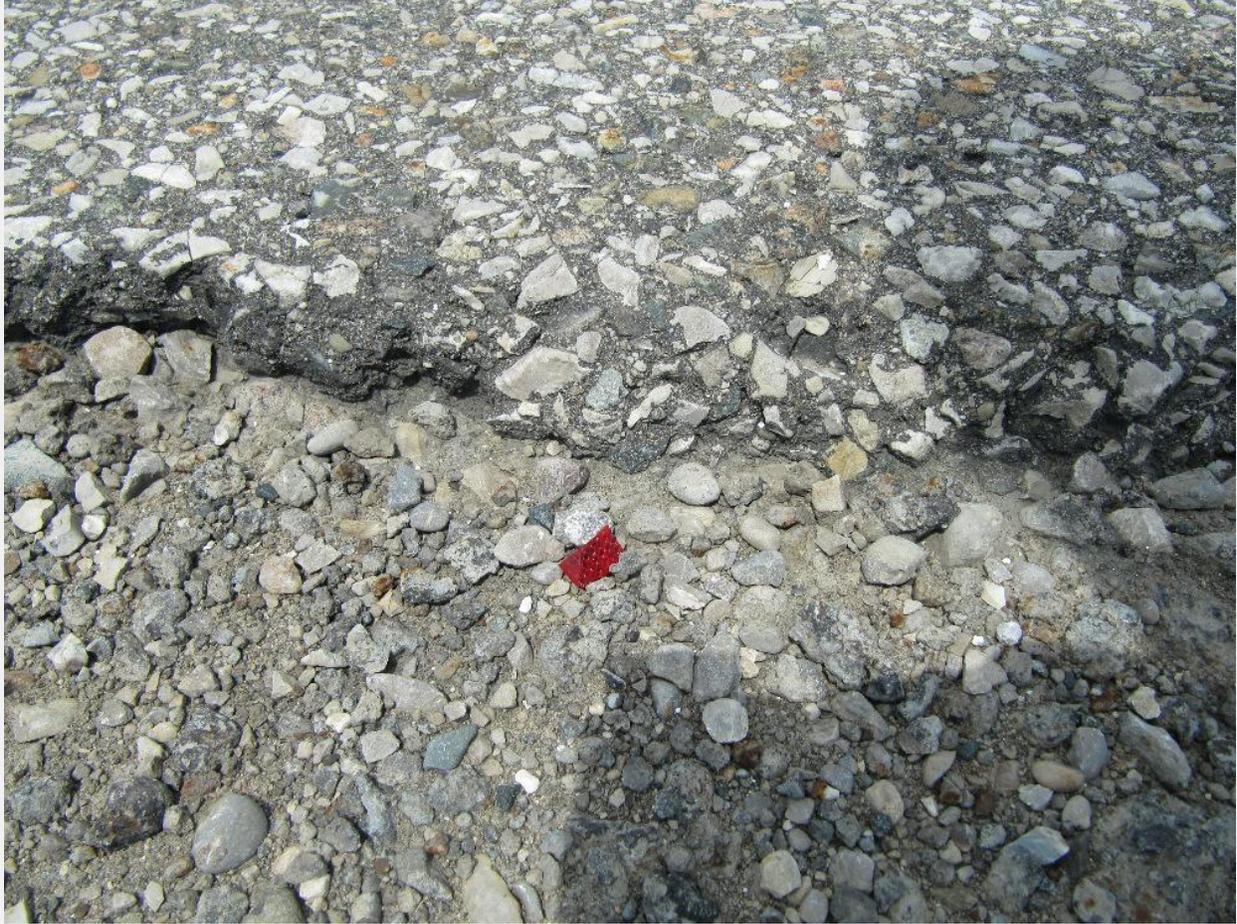
Close-up view of the most-westerly deposit of red lens material.

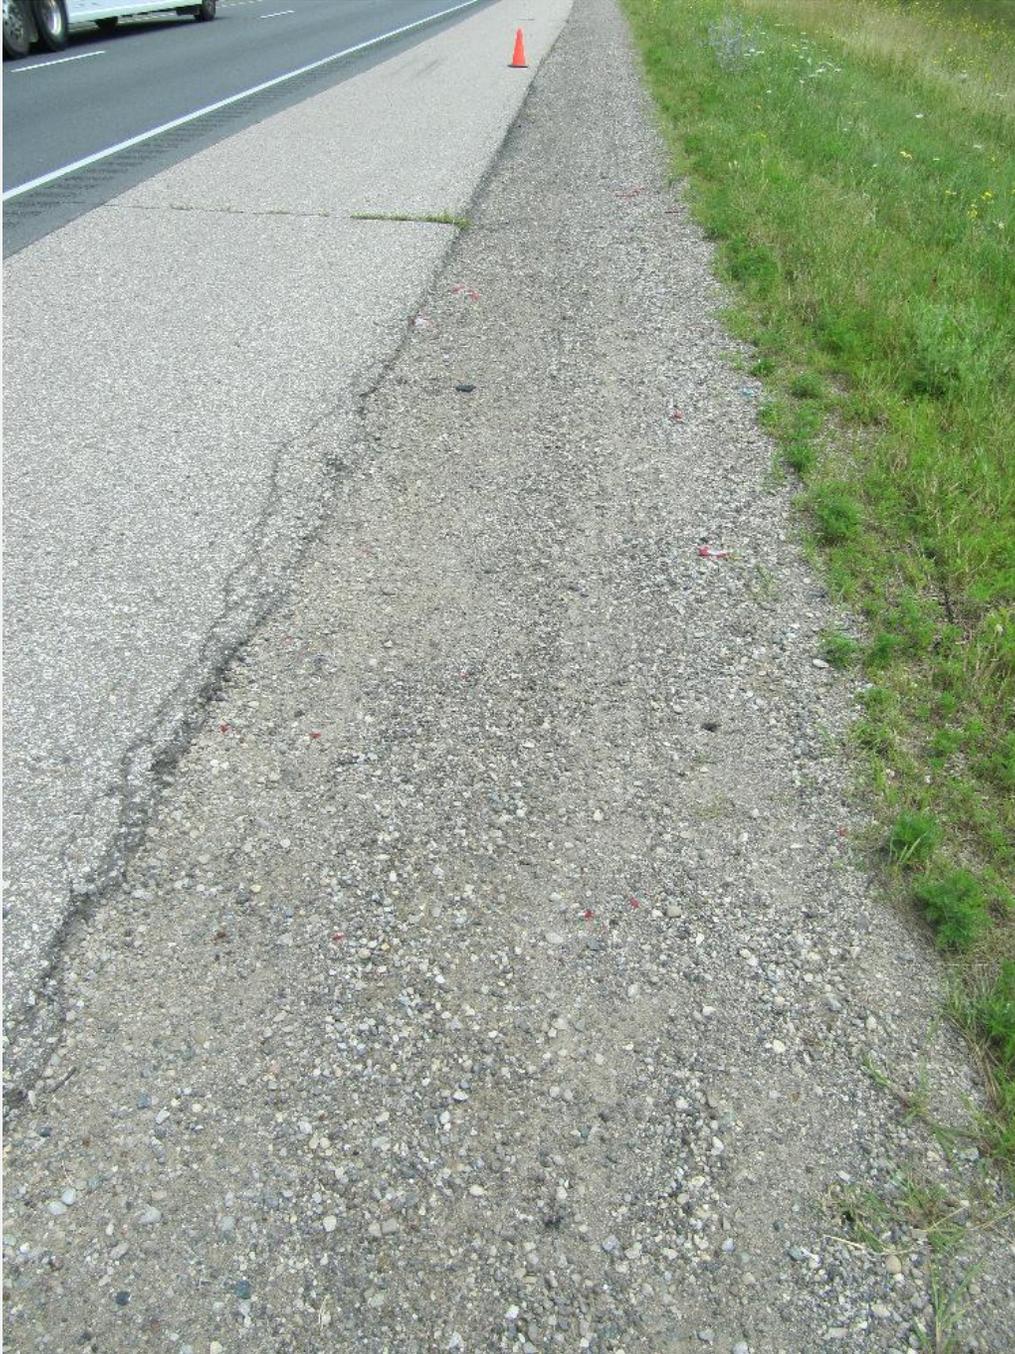
View, looking east, with the 100 metre cone visible in the background, showing the larger deposits of red taillight lens material lying on the south shoulder.

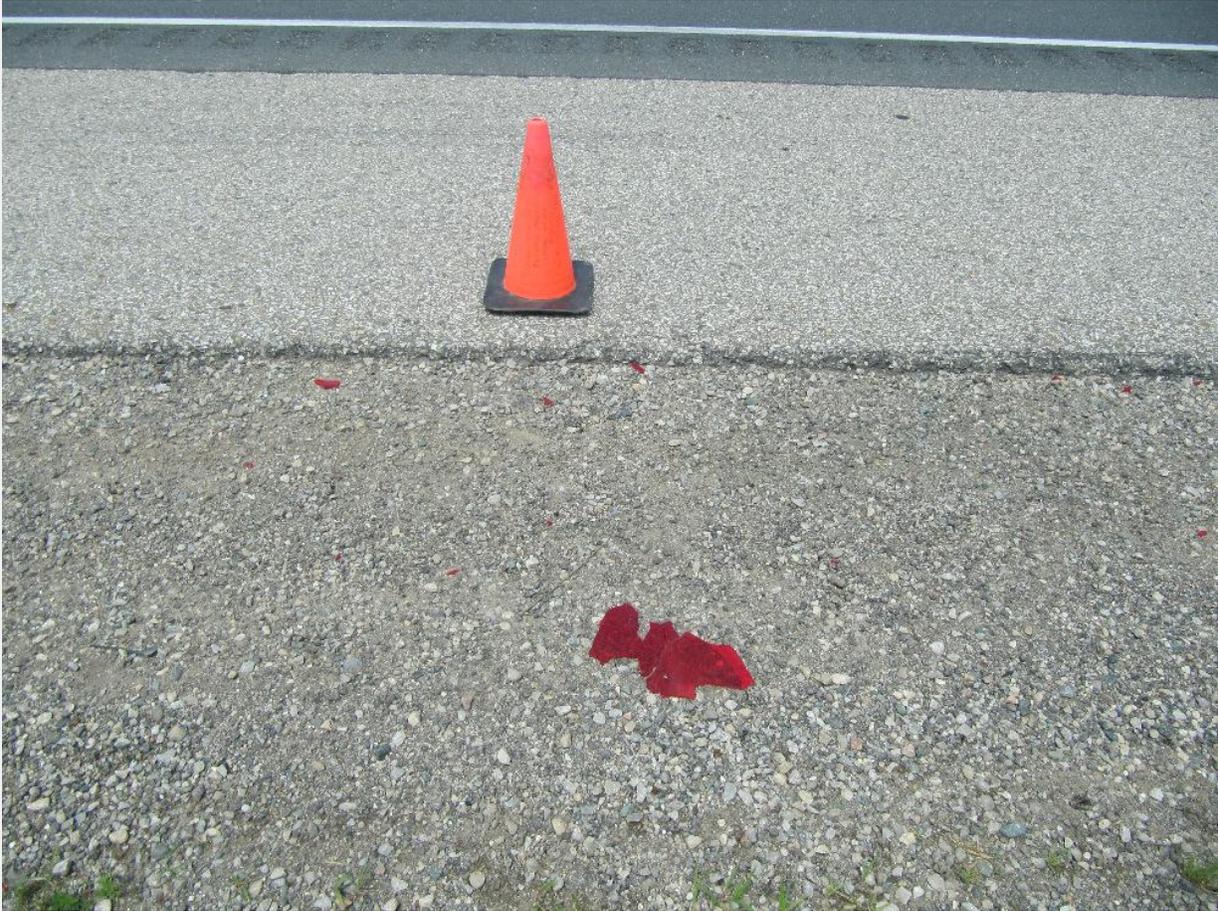
View of larger deposit of red lens material located immediately at the 100 metre cone.

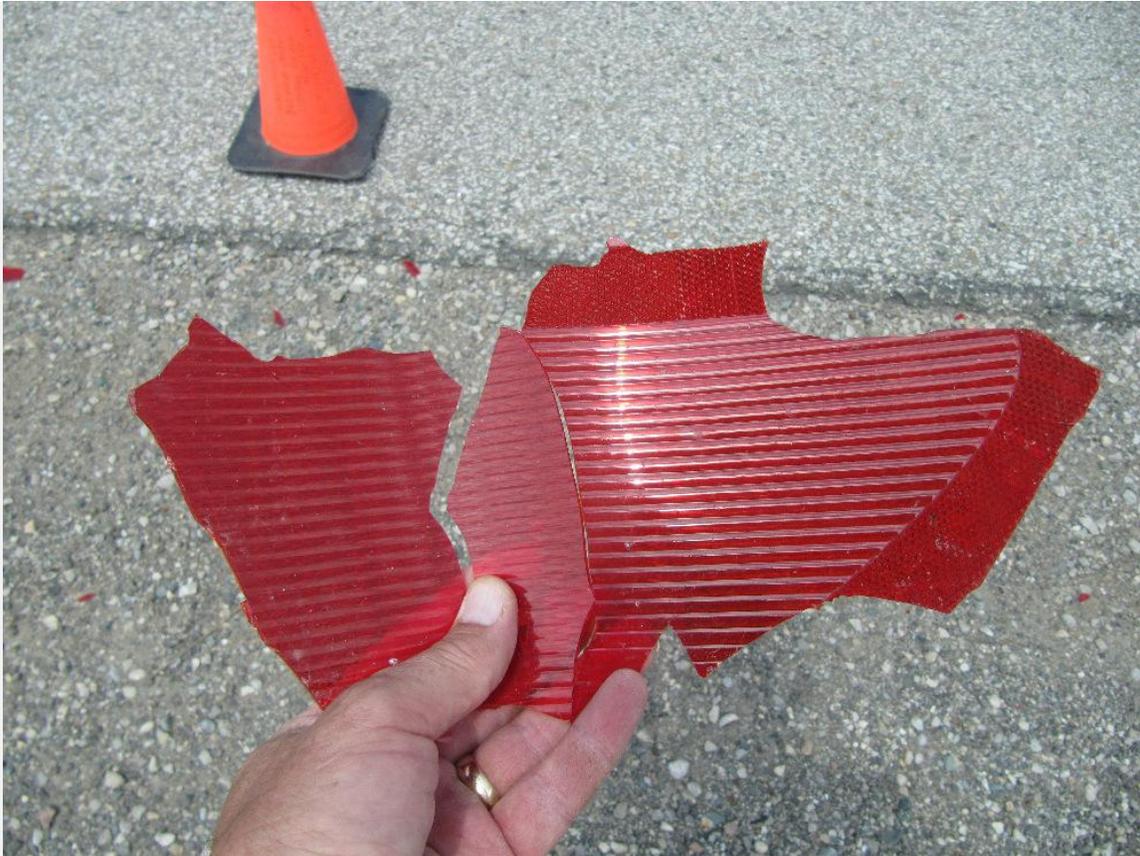
View, showing partial reconstruction of broken lens fragments.

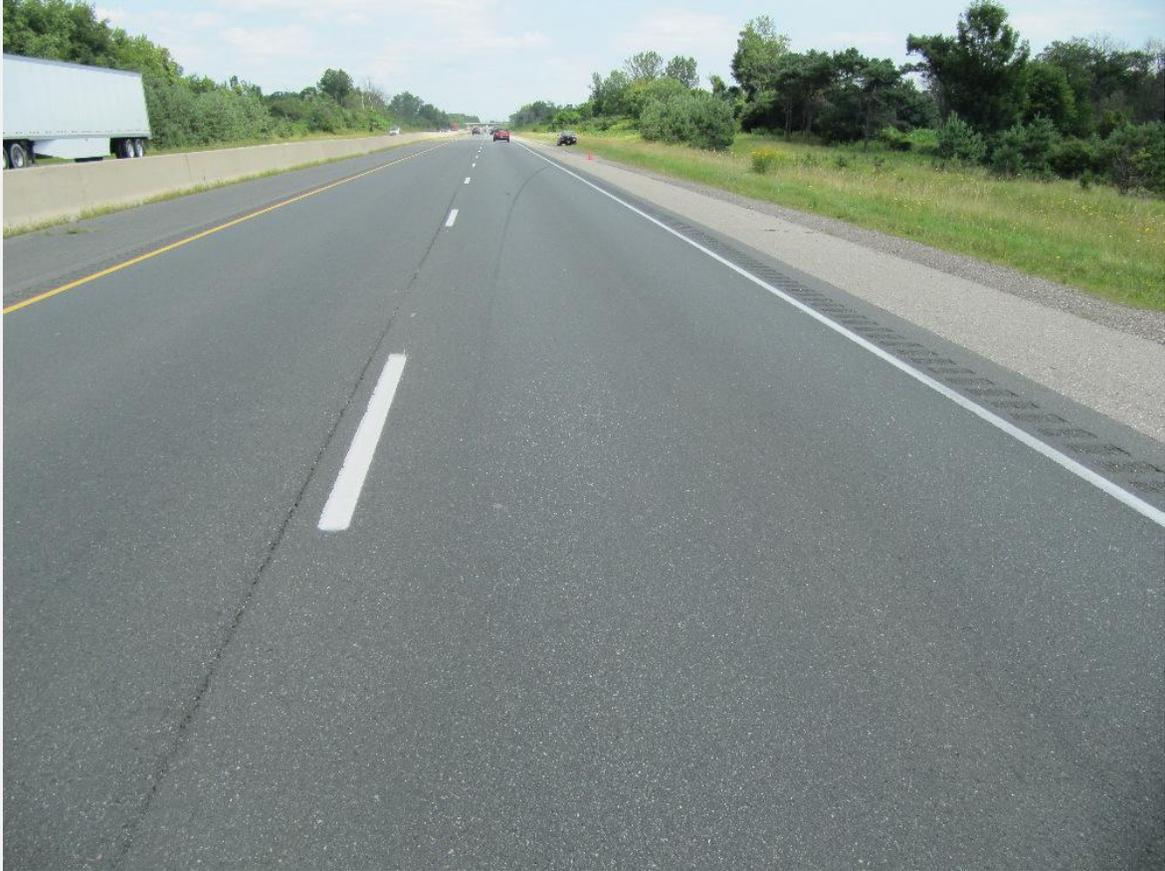
The photo below shows the first evidence of a yaw mark in the eastbound driving lane which provides the first evidence of the motion of the Equinox as it began to rotate clockwise to its eventual departure into the south roadside. If you look you can see only one cone in the view so the tire mark must have commenced before at 50 metre cone.

View, looking east, showing the first evidence of yaw mark in the driving lane.

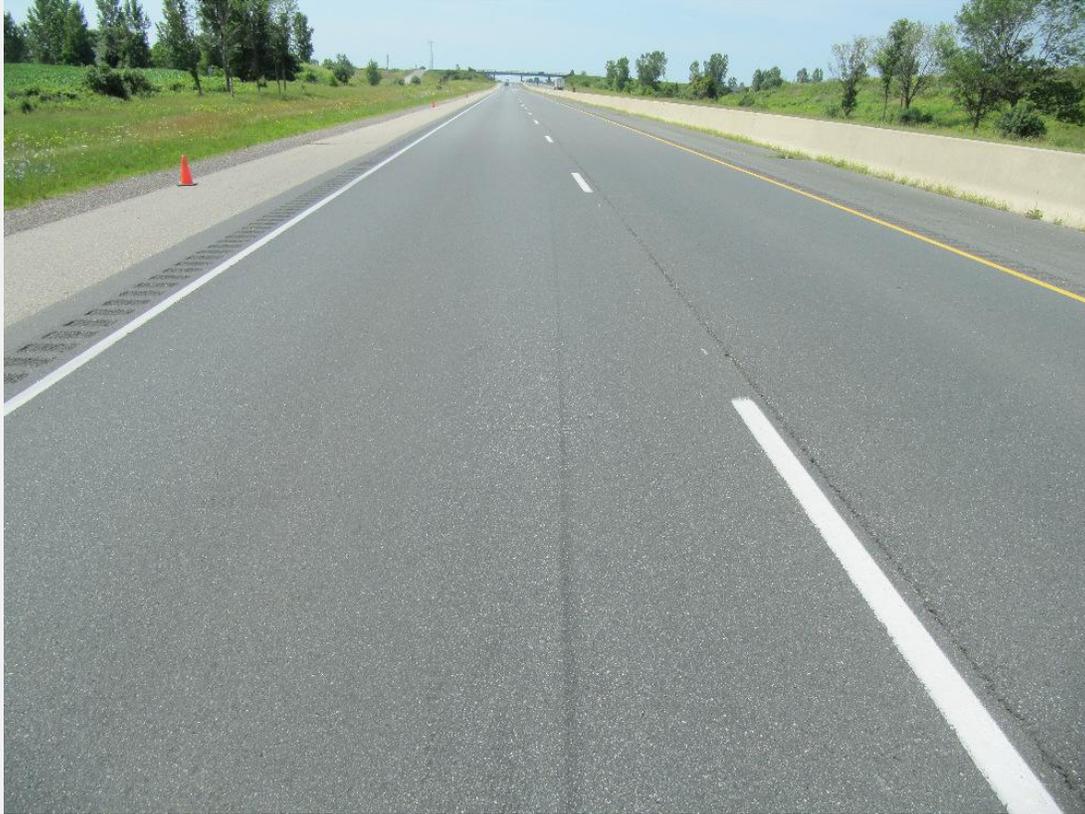
View, looking west, showing the beginning of the yaw mark in the foreground and the 100 metre cone on the extreme left edge of the photo.

And, if we recall, the first evidence of red taillight lens was at about the 125 metre location. So, is this a coincidence? Well obviously we have no other evidence to say yes or no other than what we see on this site. But in our opinion, the freshness of the evidence and its location suggests that this could all be related.

So we are prepared to state the following: It is possible that a rear end impact occurred on Highway 401 where the front end or right side of the Equinox came into contact with the left rear of a vehicle in the driving lane, or perhaps mid-way between the two lanes. This impact could have occurred in the vicinity 125 to 150 metres west of the final rest position of the Equinox. Obviously, this is a hypothesis, and it cannot be proven without further information. If we were officially retained on this matter we would have that “further information” but as we are simply performing this work as an educational exercise we are unlikely to be able to state anything further as to the cause of this collision.

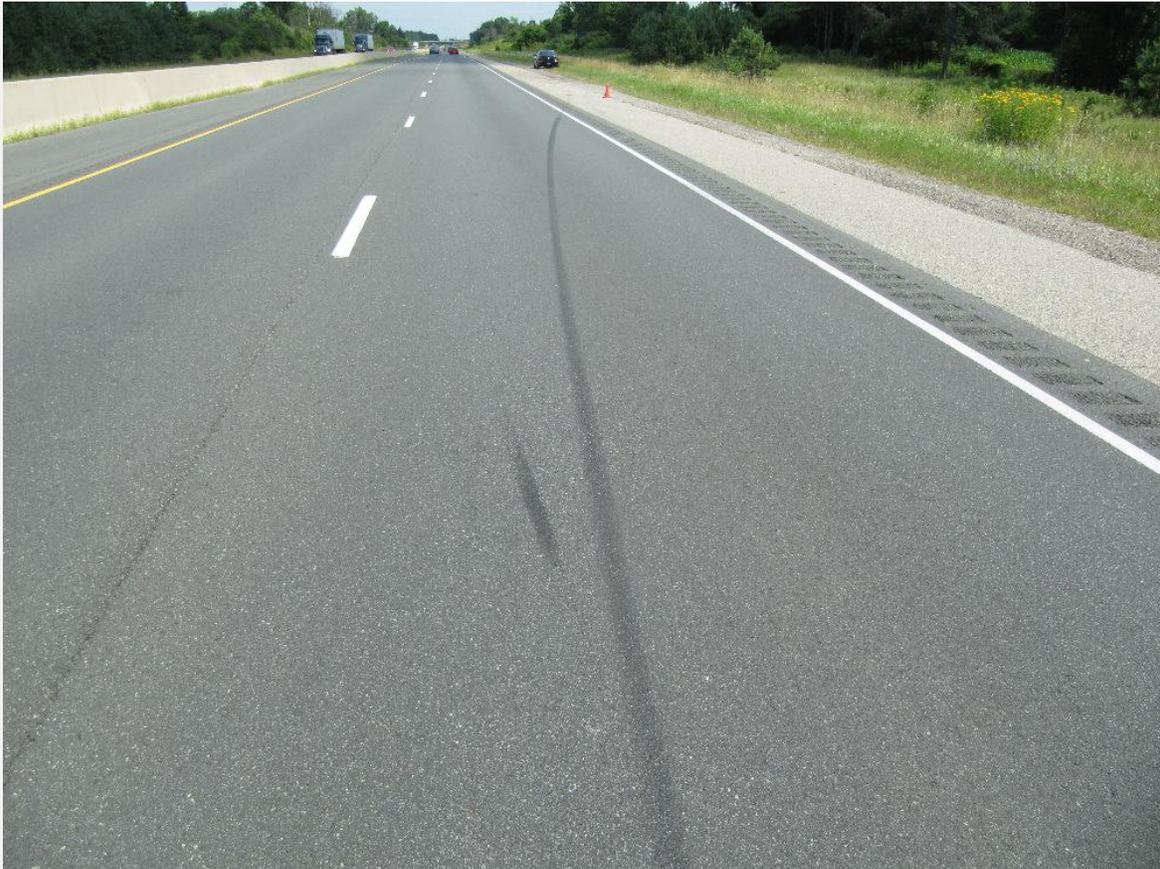
View, looking east, along the yaw mark as the vehicle rotates toward the south roadside.

We would want to be careful at this point because, although the tire mark evidence indicates that the vehicle is rotating clockwise, the evidence is not exactly typical of what you would see. Typically, you would see at least three, curved, yaw marks and perhaps a faint fourth coming from the right rear tire. But that is not the case. There is only one prominent mark and there is also a very short tire mark along side the prominent one as shown in the above photo.

site. And obviously, our examination of the collision-involved vehicle would provide much valuable evidence. But that is not the case. So we have to be careful when we see evidence like this that is not exactly typical of a single-vehicle, loss-of-control event. Obviously, the unusual evidence could be explained if there indeed was a rear-end impact which then caused the Equinox loss-of-control.

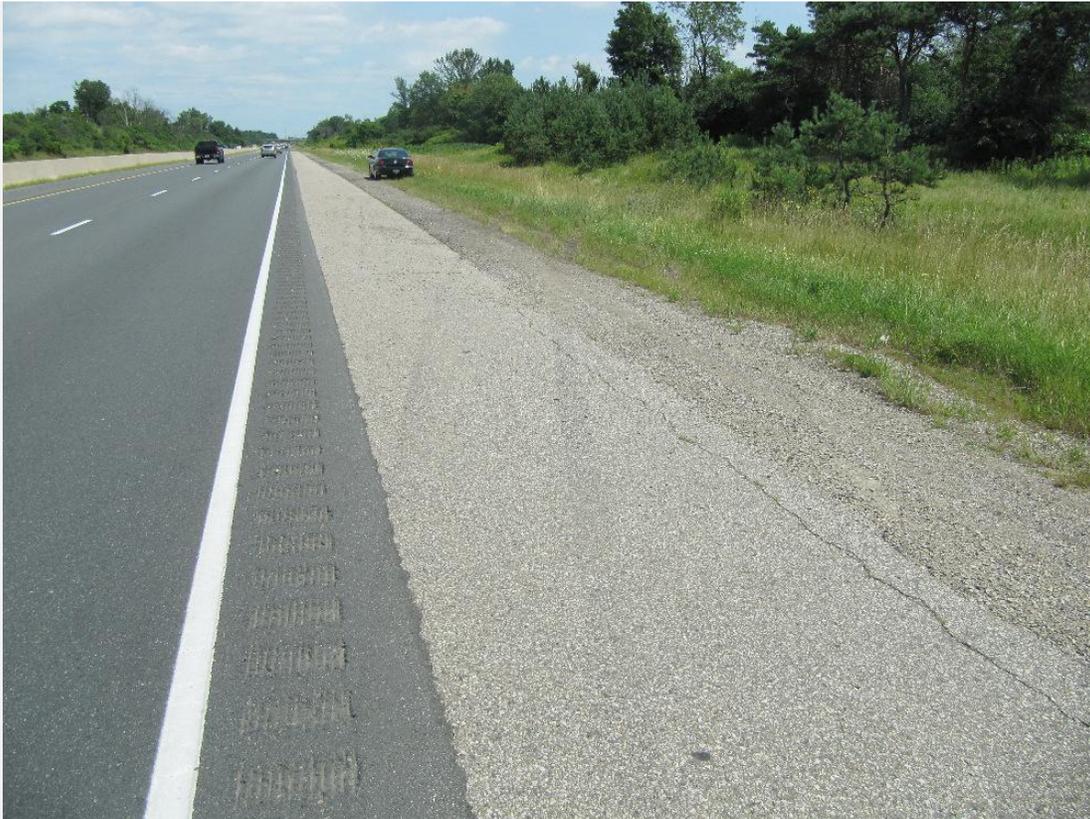
View of tire marks as they exit the pavement and enter the south roadside.

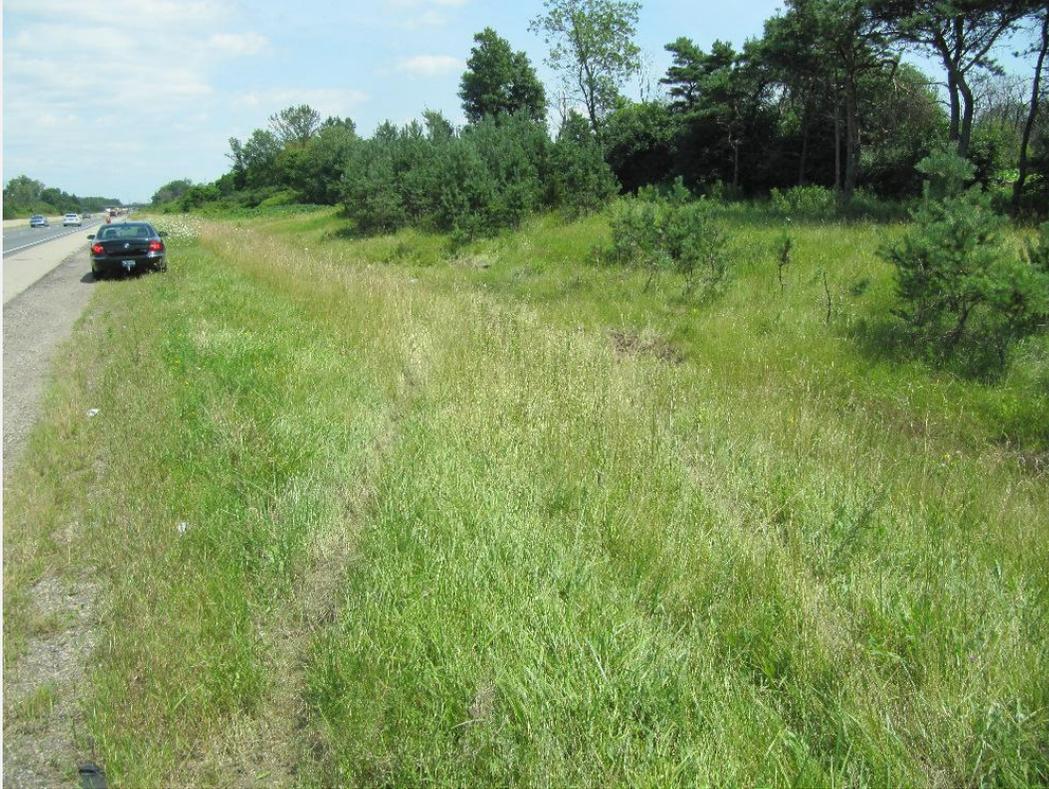
View of loss-of-control tire marks in the grass of the south roadside.

But as is typical, once the vehicle reaching the bottom of the ditch and the tires dig into the earth the vehicle is tripped and it begins to roll. One might detect the location of the initial gouging of the earth in the above photo although is it not particularly clear.

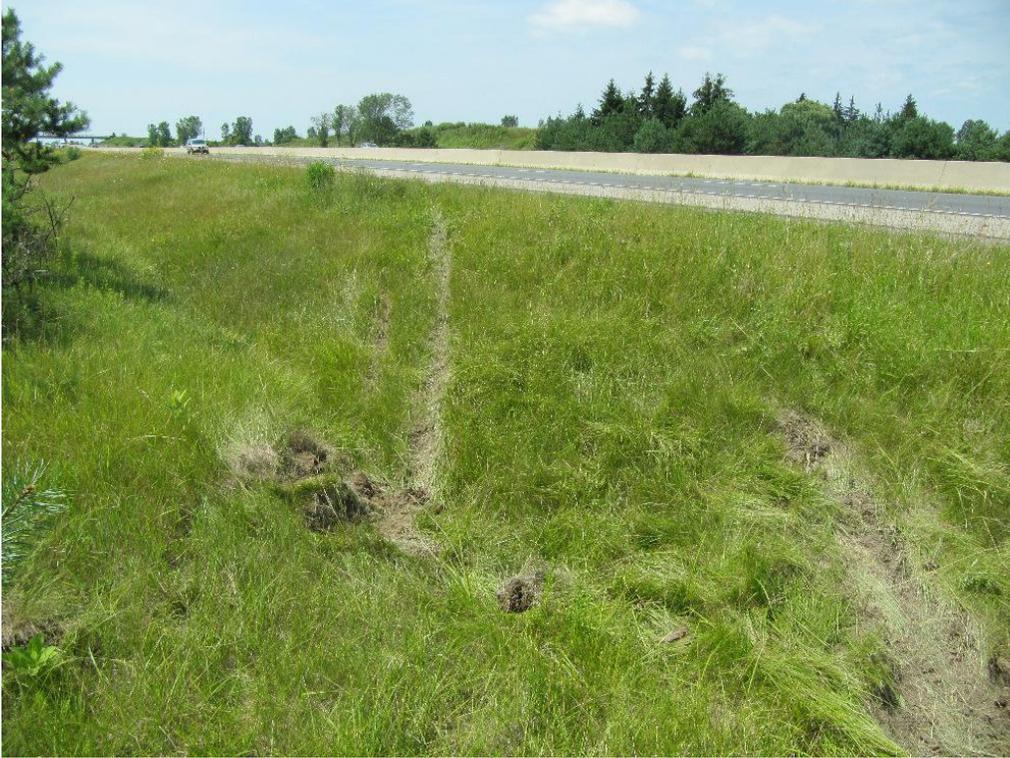
View, looking north-west at the gouging of the earth at the end of the tire marks where the vehicle began to rollover at the bottom of the south ditch.

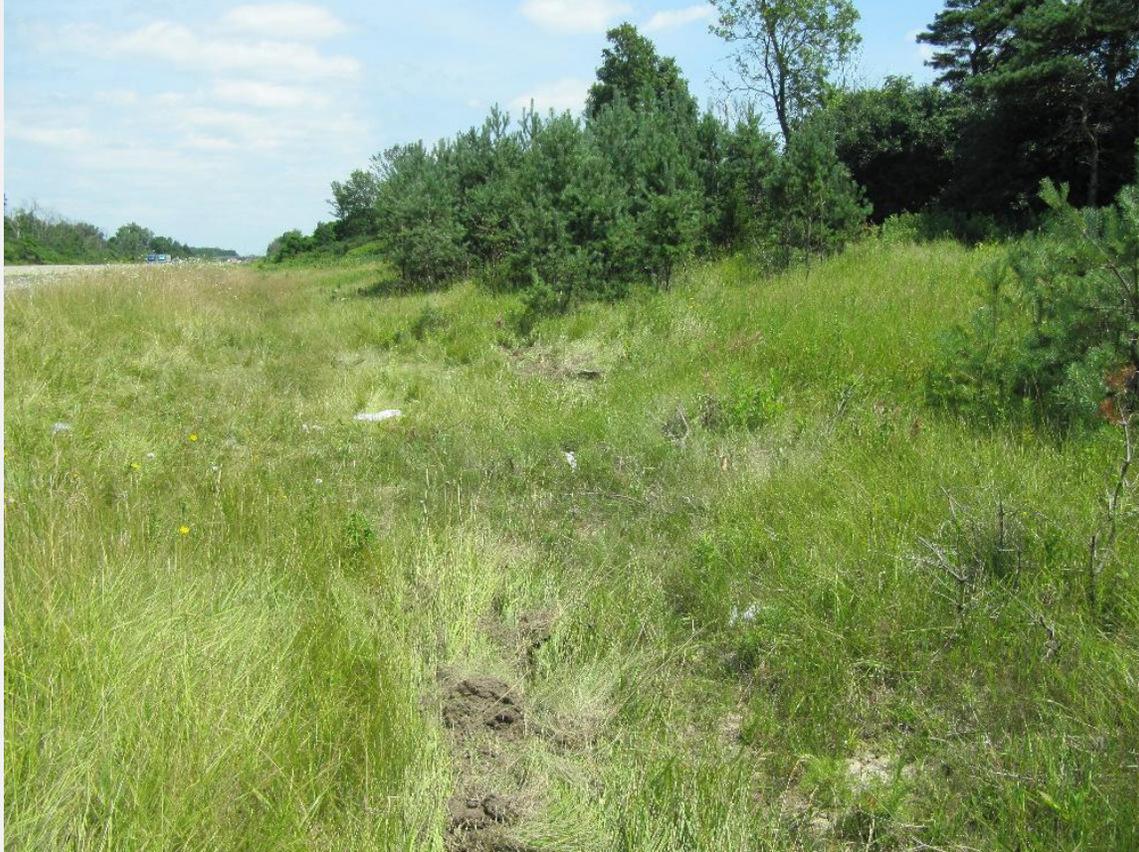
View, looking east, along the trampled grass of the south ditch where the Equinox rolled and then came to a halt.

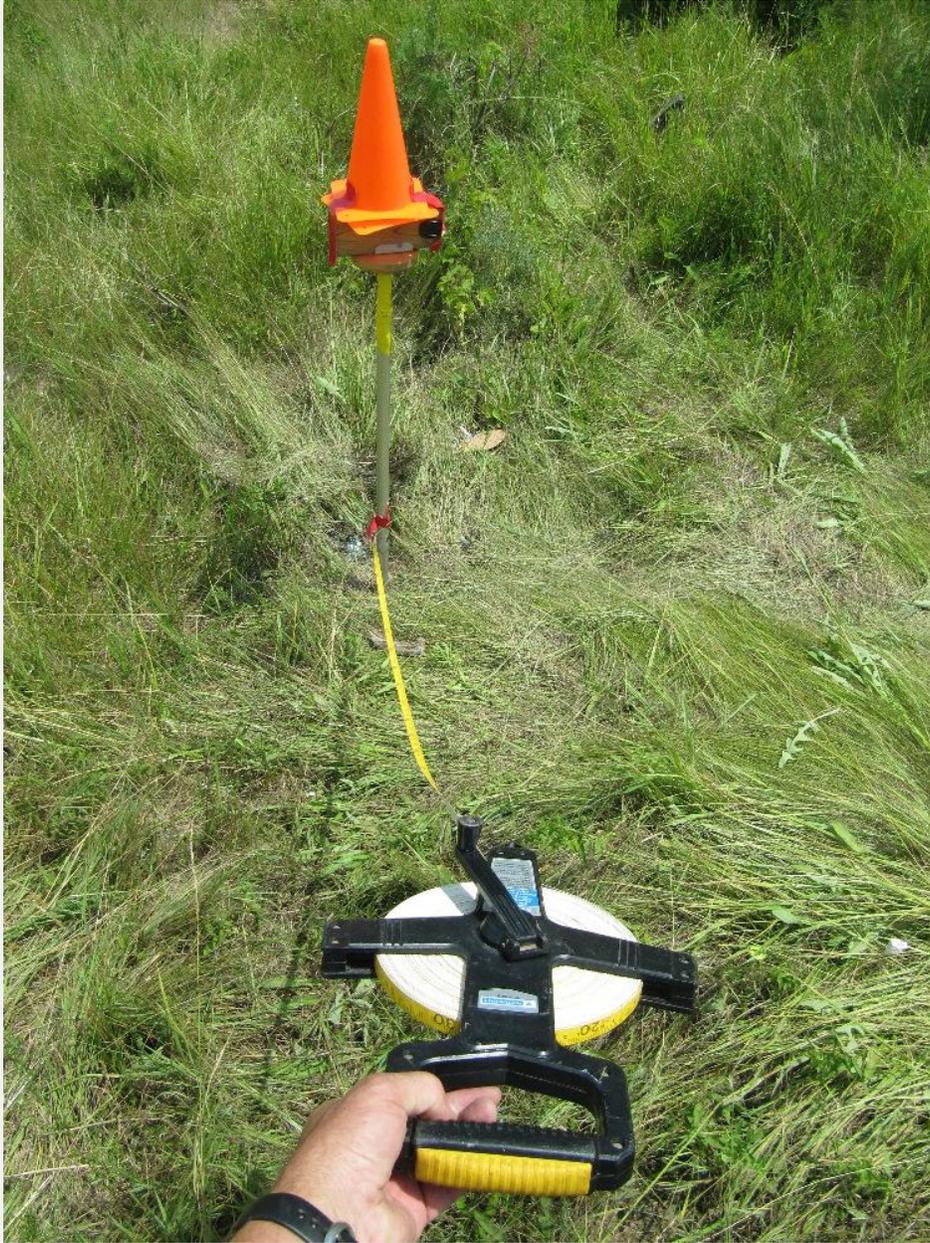
Measurement tape anchored to post at FRP of Equinox so that measurements can be taken to various points of interest.

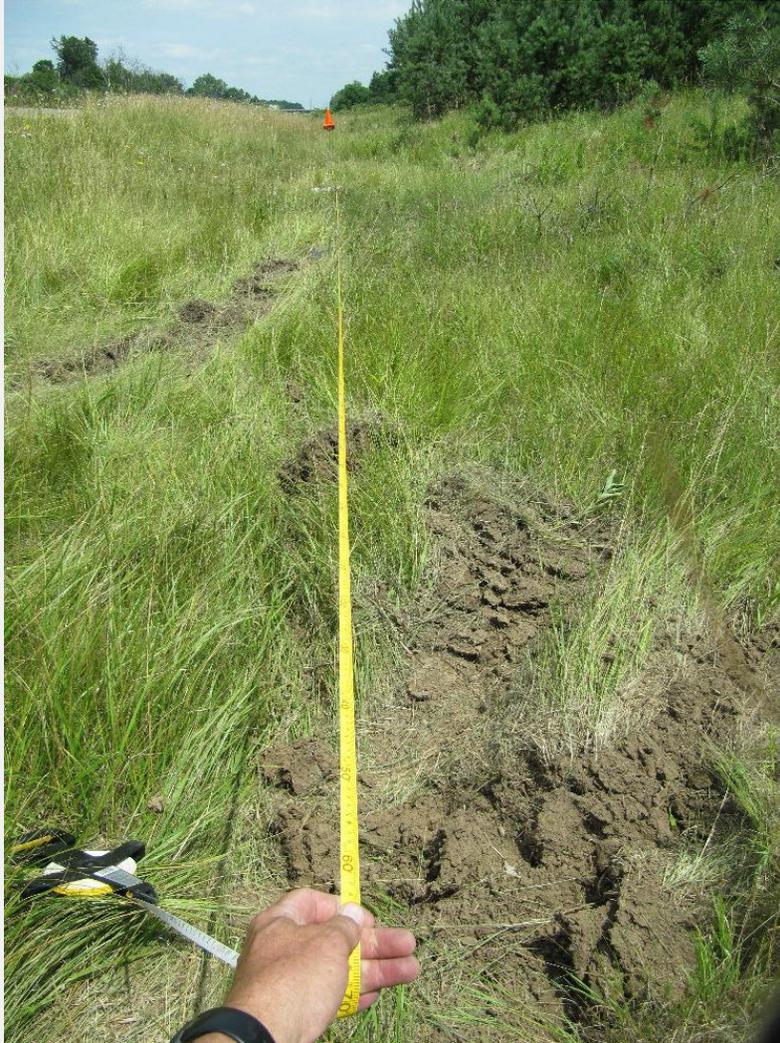
View, showing how the distance was measured from the Equinox final rest position to the gouges in the earth where it first began to rollover.

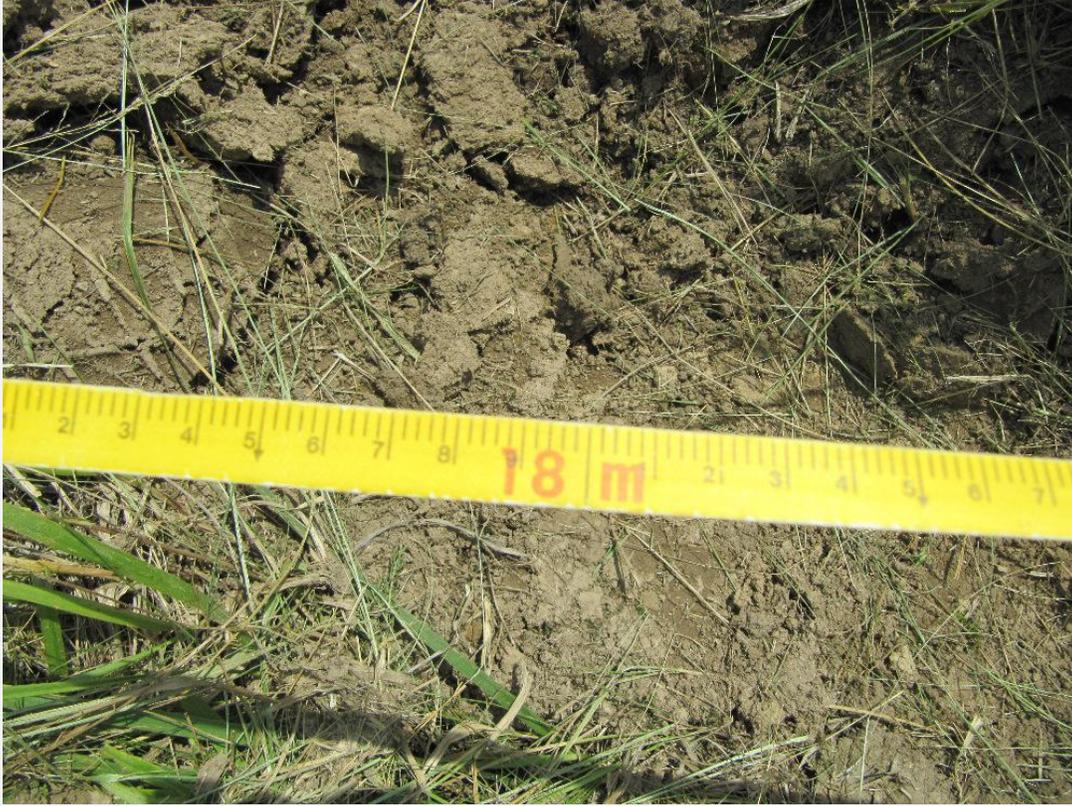
View showing a reading of 18 metres on the measurement tape when measuring from the Equinox FRP to the point where it began its rollover.

If we used a tumble number (0.5g) to represent the rate of deceleration of a soft roll over the distance of 18 metres then we could say that the vehicle's speed was approximately 48 km/h when it began to roll. In fact this is an exaggeration since we took the measurement to the furthest eastward evidence for the FRP and other measurements were taken of other gouges which would place them in the range of 15 to 18 metres. So, overall, the vehicle's speed would certainly be less than 48 km/h when it began to roll. Not a low speed rollover but certainly not a high speed rollover either.
