# Fatal Rollover on Eastbound Highway 401 East of Colonel Talbot Road, South-West Outskirts of London, Ontario

*Posting Date: 21-July 2013*

Gorski Consulting  
London, Ontario, Canada

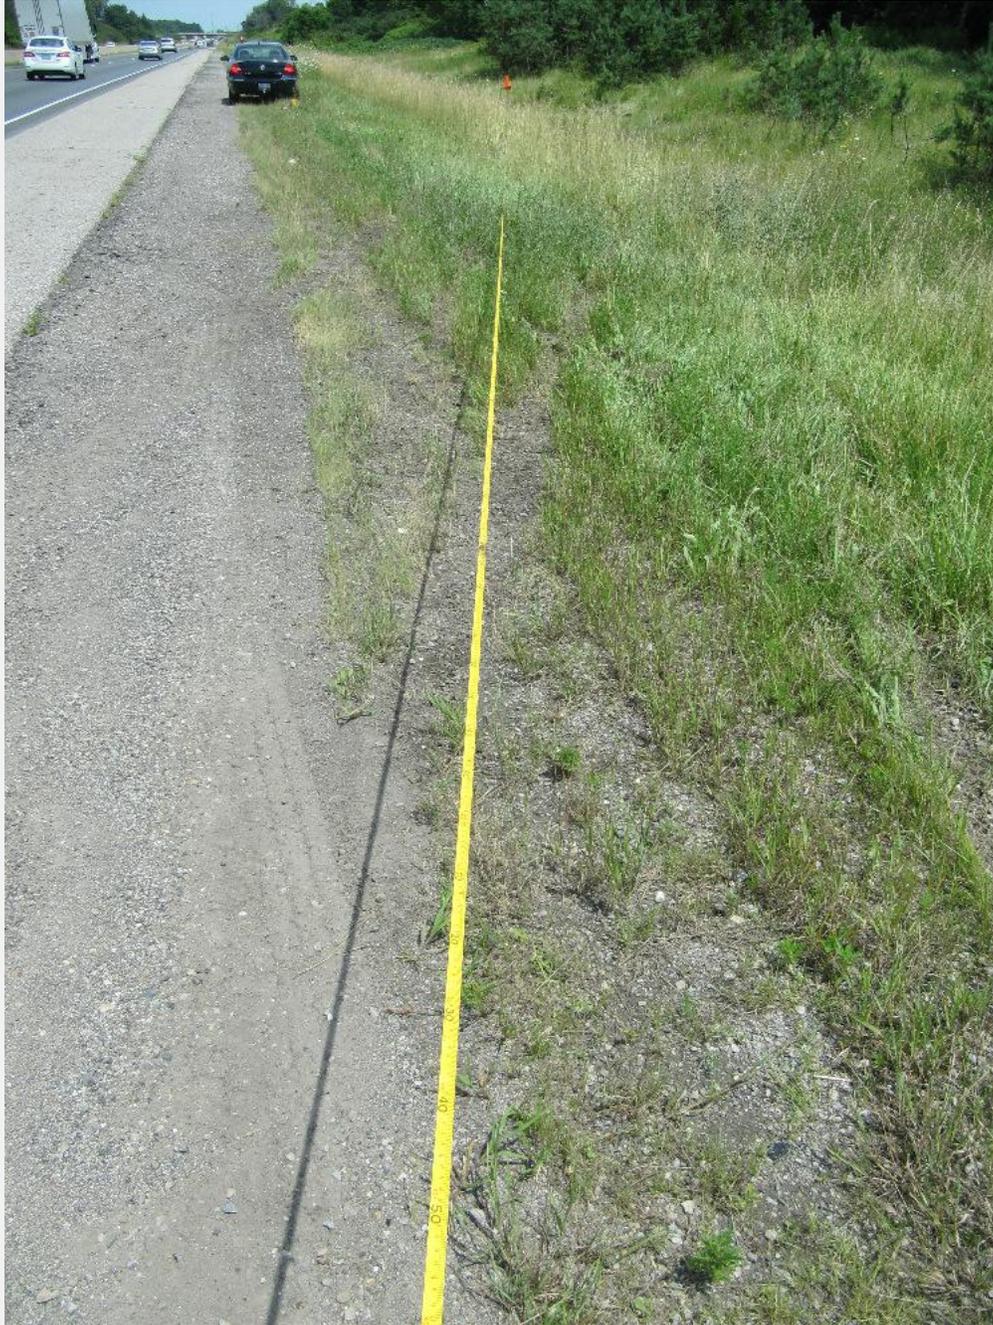
View of measurement tape stretched from the Equinox FRP to the tire marks at the edge of the grass of the south ditch.

If we applied an overall deceleration rate of  $0.4g$  over that entire distance we would obtain a speed of about  $63 \text{ km/h}$  for the vehicle as it entered the grass ditch.

And if we applied an overall deceleration rate of 0.3g for the entire distance from the beginning of the yaw mark at 100 metres from the Equinox FRP then we would get an initial speed of about 87 km/h. This approximation is rather crude but it demonstrates that the vehicle speed in the vicinity of where it produced the initial yaw marking on the road was not unusually high. That does not negate the possibility that it was speeding much faster somewhere prior to the production of those visible yaw marks.

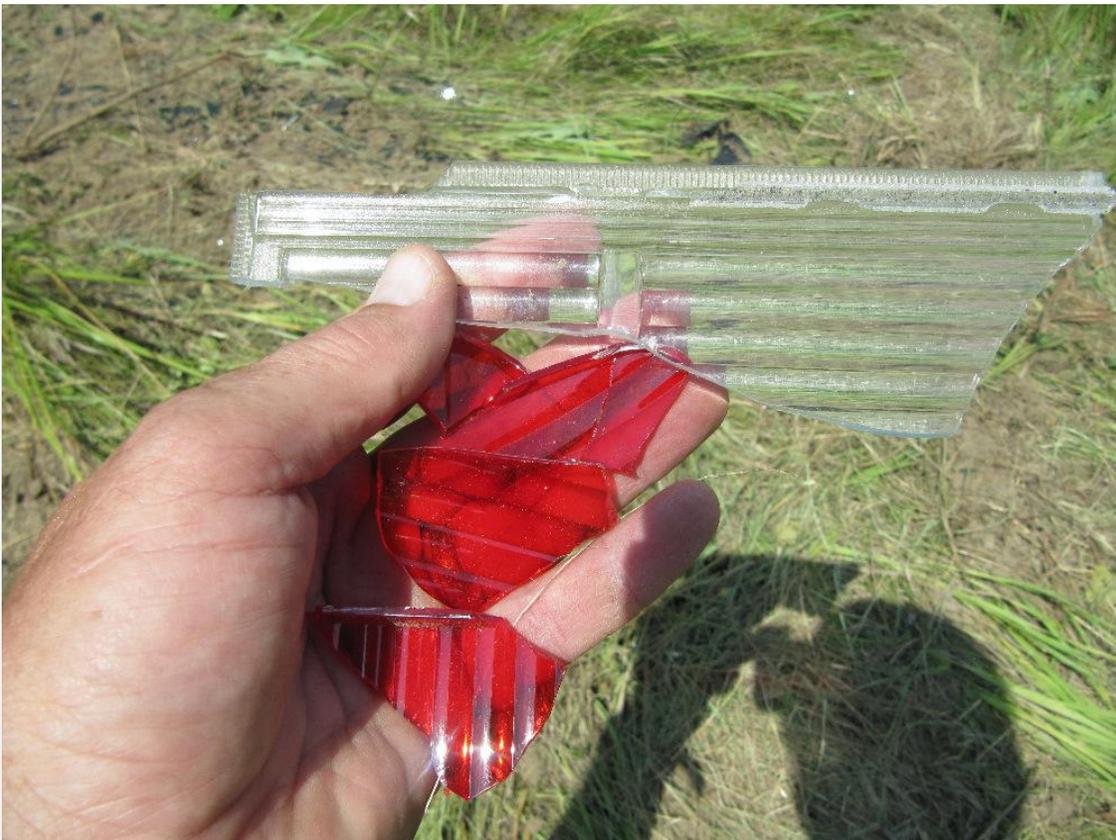
View of broken taillight lens debris obtained near the Equinox FRP.

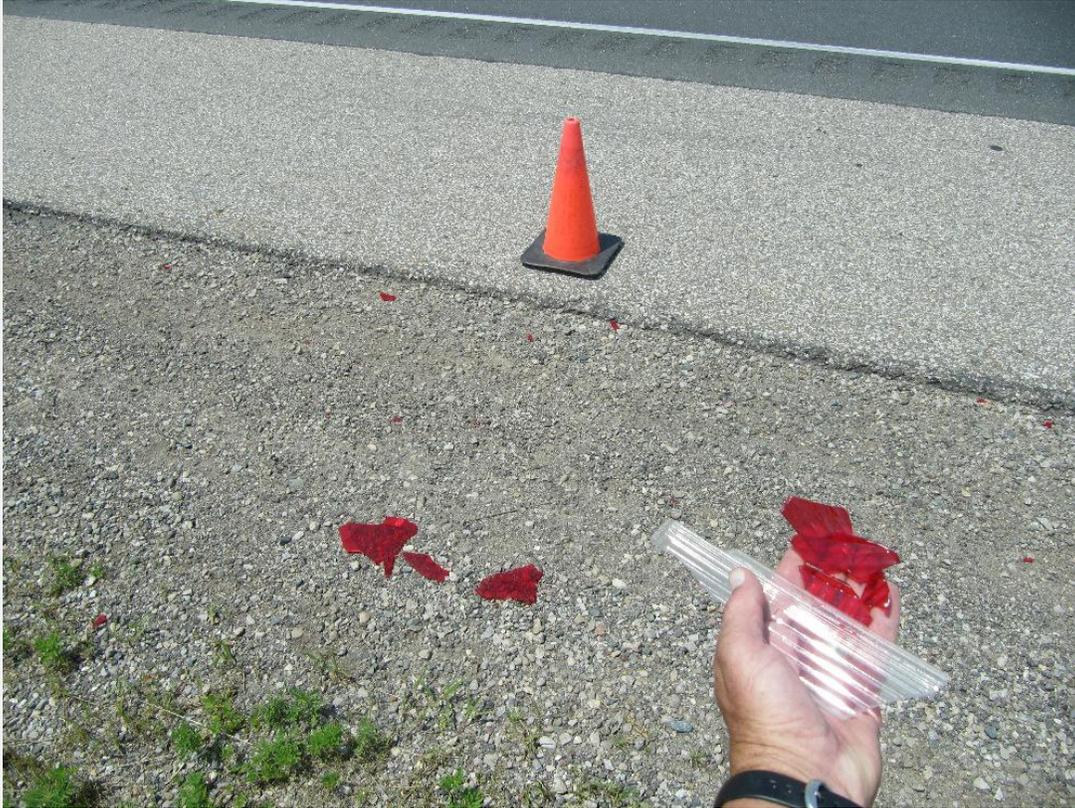
View of lens material taken from Equinox FRP being taken over to the lens material at the 100 metre cone to make a comparison.

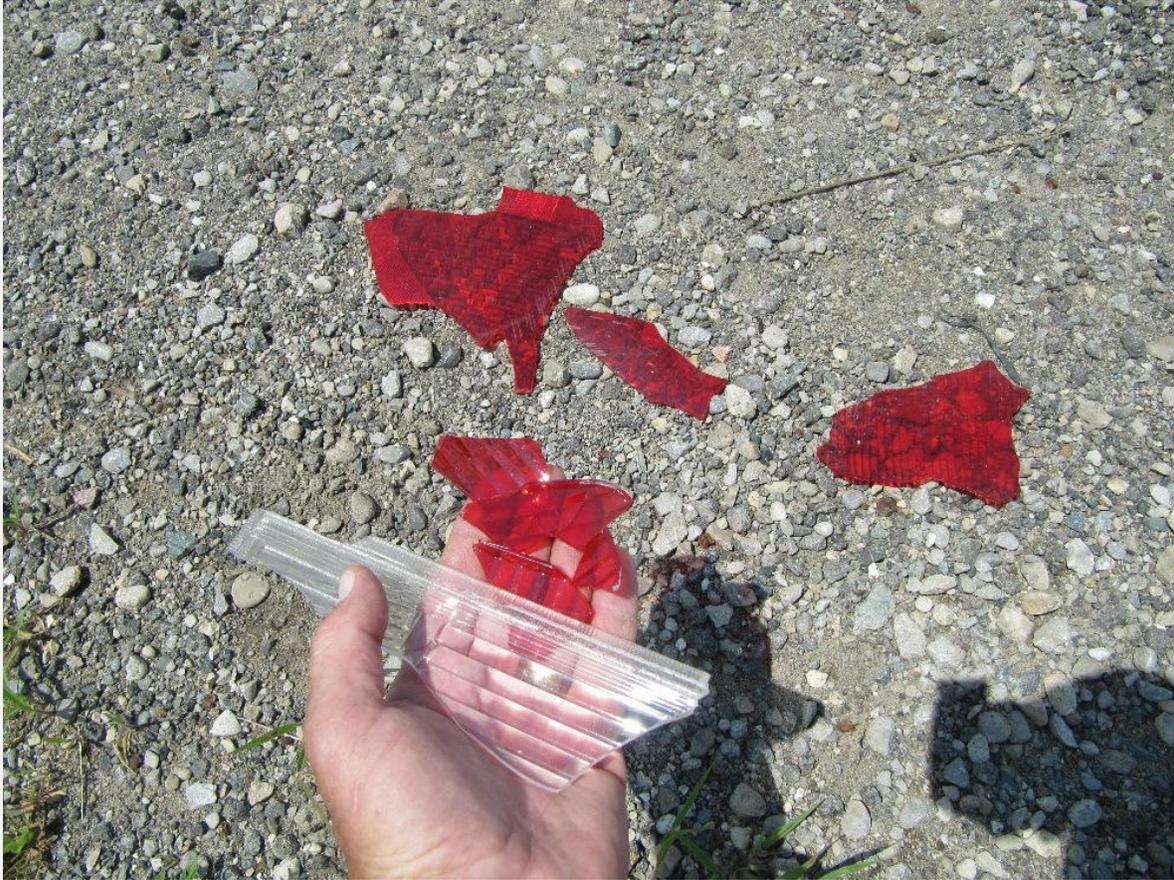
View of comparison between two lens samples.

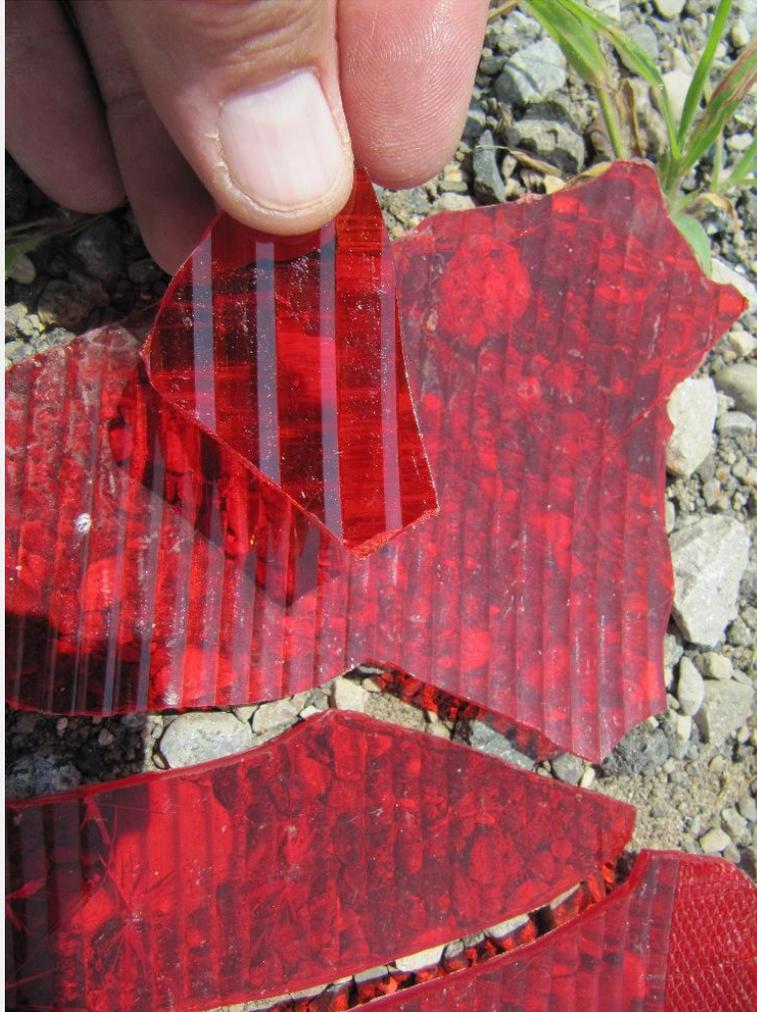
Close up view of comparison being made between the two samples of red lens material indicating that they do not match.

So whatever caused the red lens material to be strewn across the south shoulder of the highway is not known but we know that it did not come from the taillights of the Equinox. Obviously there could be numerous explanations for the existence of this evidence but we hope this is an interesting exercise to demonstrate what can be done to reconstruct motor vehicle collisions.
