Fatal School Bus Collision North of London Ontario

Posting Date: 11-Oct-2016

Gorski Consulting
London, Ontario, Canada

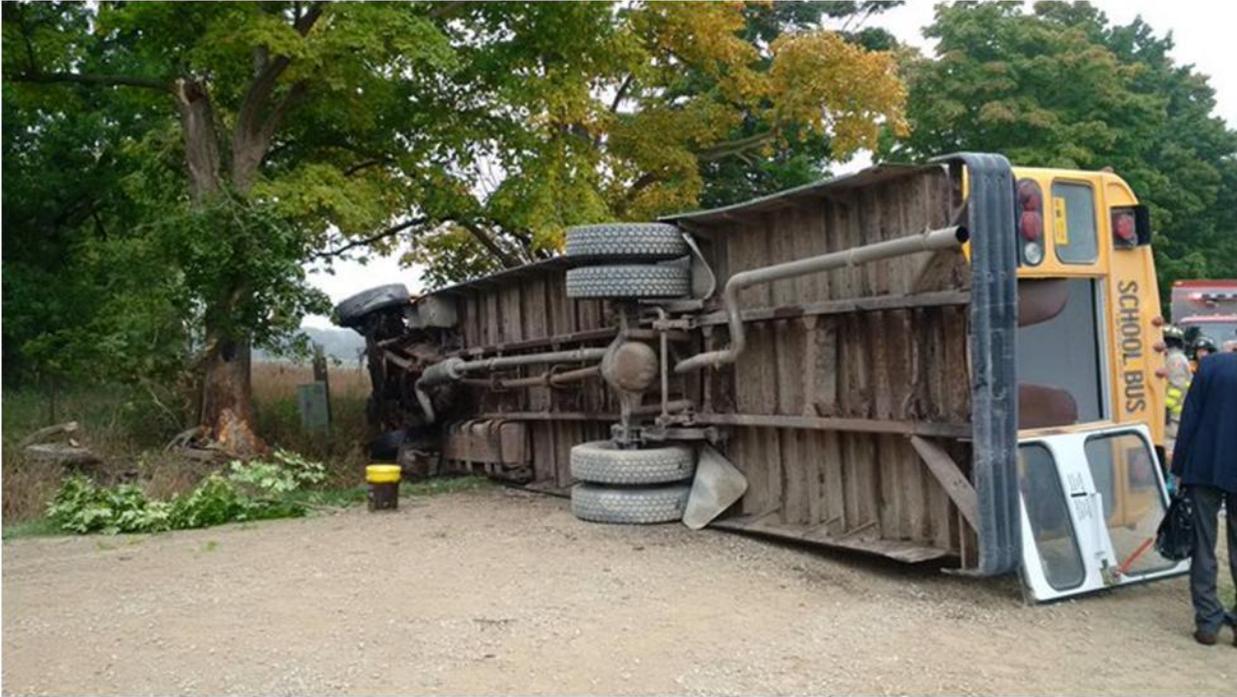
The collision was being investigated by the Ontario Provincial Police (OPP) who released the photo of the crash site seen in Figure 1. In the photo it can be seen that the bus is lying on its passenger side and the struck tree is located in the background. The curiosity about this view is that the road surface is gravel. One would wonder why a full size school would be travelling along this gravel road when the driver's destination was still about an hour away. Travel on gravel roads might seem reasonable if the bus was picking up students at their rural residences which might often be located on local, gravel roads. But at the time of the collision the bus was empty and it would not be picking up students. Furthermore, travelling between London and Clinton would be expected to take certain well-established routes, over paved highways. Twelve Mile Road would not be a primary choice for long distance travel because not paved but contains a gravel surface.

Figure 1: Photo of the collision site released by the OPP.

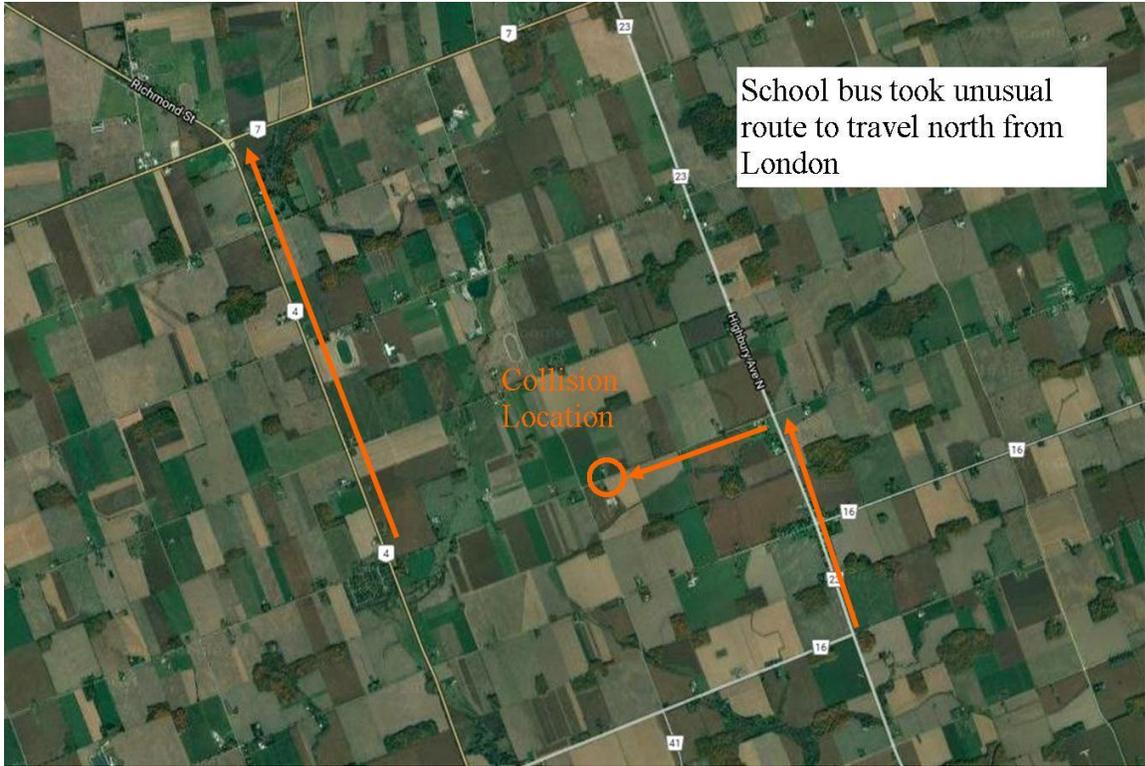
As shown in Figure 4, the school bus took an unusual route by exiting from Middlesex County Road 23 at Bryanston, and turning left onto Twelve Mile Road.

Figure 4: School bus turned left at Bryanston onto Twelve Mile Road , possibly to connect to Highway 4 to the west.

One possibility is that the bus driver made the turn to reach Highway 4 to the west thus she could proceed north on Highway 4 directly toward Clinton. But that would be unusual as there were several paved roadways travelling east/west that could have taken her to reach Highway 4.

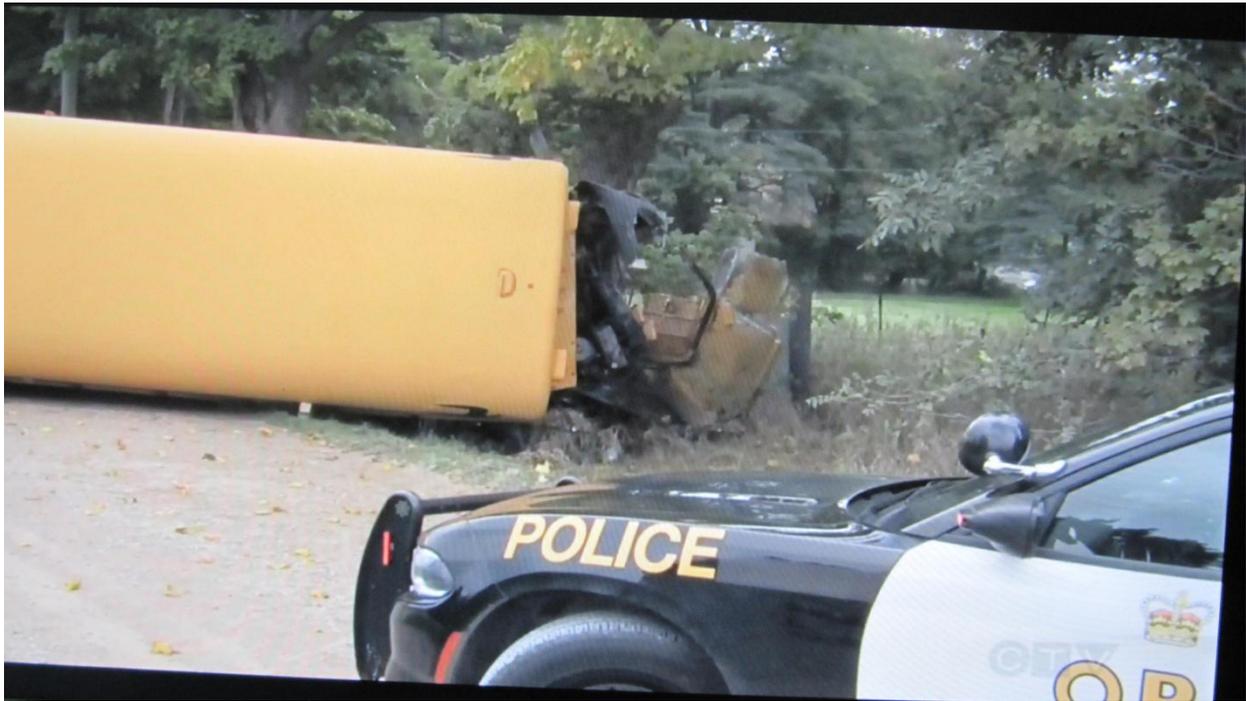
Figure 10: View showing the substantial frontal crush to the bus as a result of the tree impact.

Investigators can become confused when observing substantial crush and make the quick conclusion that there had to be a very large speed involved. However consideration has to be made as to the stiffness of the bus front end. There is not a great deal of data available to determine a bus's stiffness and the crush could be related to a softer structure. Also the fact that that the bus was more massive than a typical light vehicle means that more kinetic energy is available to be dissipated in such a crash. This dissipation of energy should result in more visible "damage". Thus while the frontal crush to the bus was substantial, the evidence would support that survival was likely if the driver had remained in her seat and was restrained by a seatbelt, even if an air bag was not available.

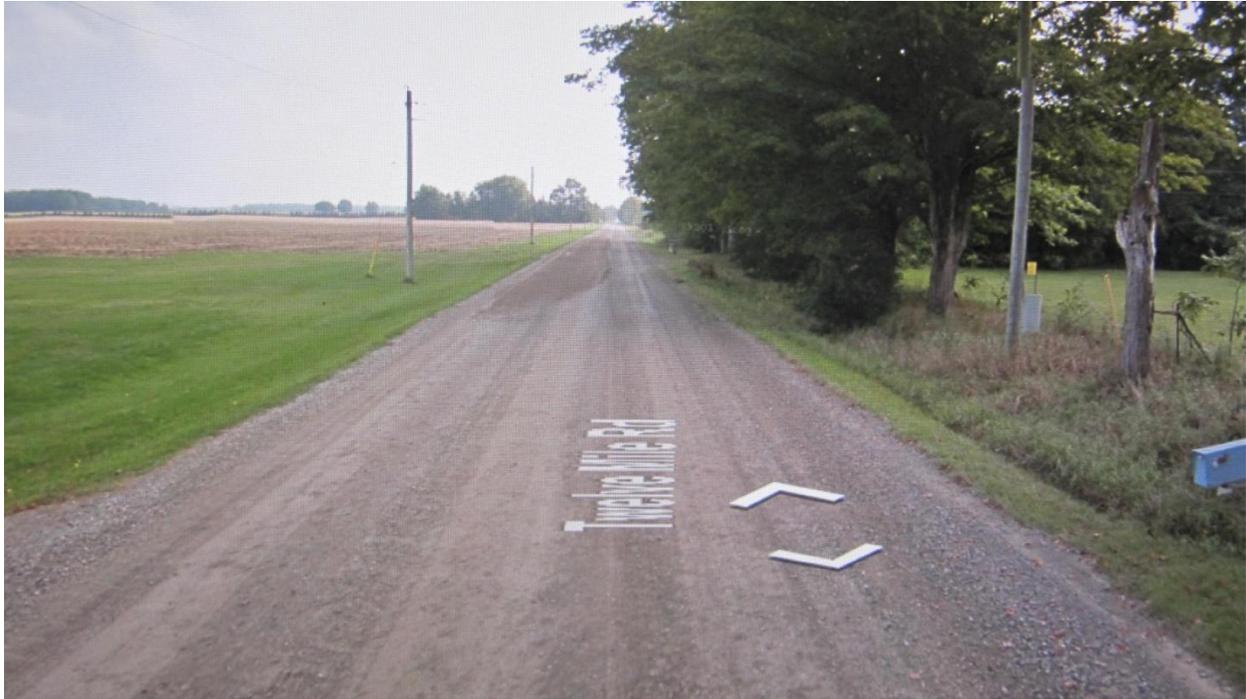
Figure 12: Google Maps view looking east from the area of impact. The shade of the gravel further to the west is different on the north side versus the south side of the road.

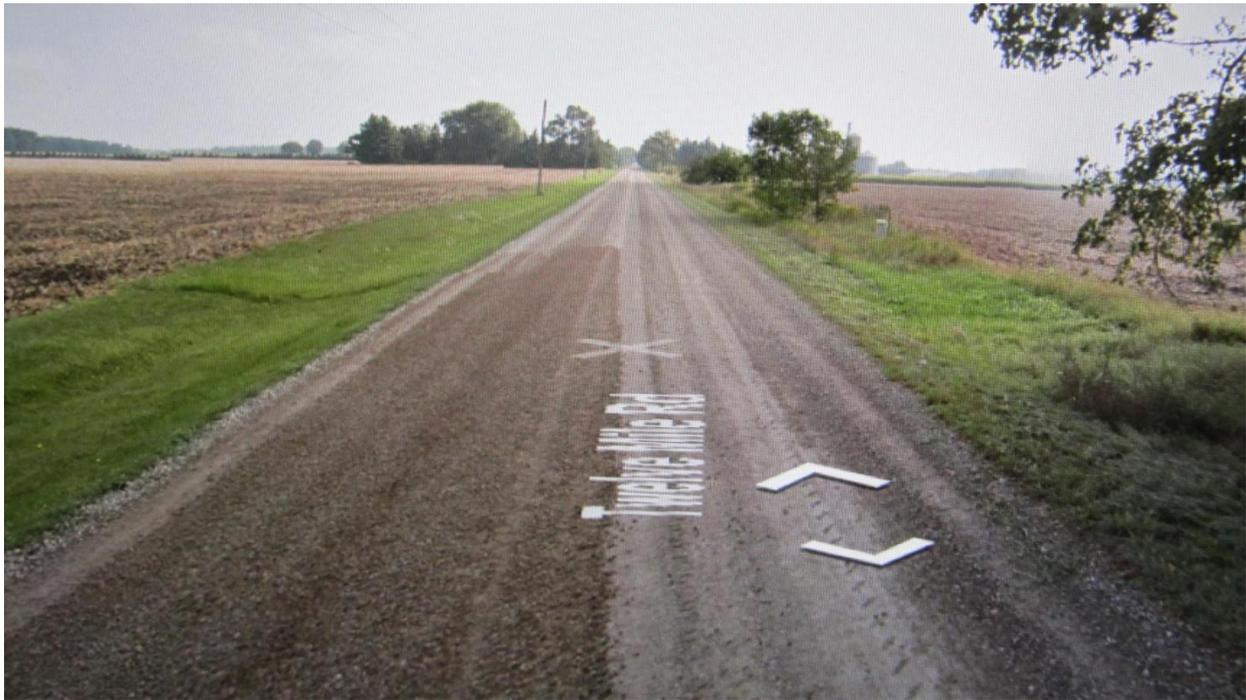
Figure 13: Google Maps view looking east from a short distance east of the area of impact. There is clear evidence that a fresh layer of gravel had been deposited in the westbound lane.

What is clearly visible in Figure 13 is that a fresh layer of gravel has been laid in the westbound lane for a short distance.

This is an unusual occurrence. Gravel surfaces of roadways are often "stirred up" by road graders and sometimes fresh gravel is laid, however this action occurs over a long stretch of roadway and onto both lanes. The problem with application of a small amount of gravel along a short stretch of roadway is that drivers do not receive sufficient warning of the change in surface conditions. Riding on hard-packed gravel is substantially different than riding on loose gravel. For areas where the loose gravel does not exist a vehicle can travel much faster within the packed surface without jeopardy of going out of control. However if the tires on either side of a vehicle encounter loose gravel the situation can become precarious because the tire force can be significantly different. It is undesirable to create a condition where the tire force is different on one side versus the other because this is more likely to lead to a vehicle rotation and loss-of-control.

The conditions shown in the above photos would appear to have existed sometime prior to the fatal collision although it is not known when Google actually captured these views. Yet it is curious that the deposit of loose gravel was in the immediate vicinity of where the school bus ran off the north side of the road before crossing and colliding with

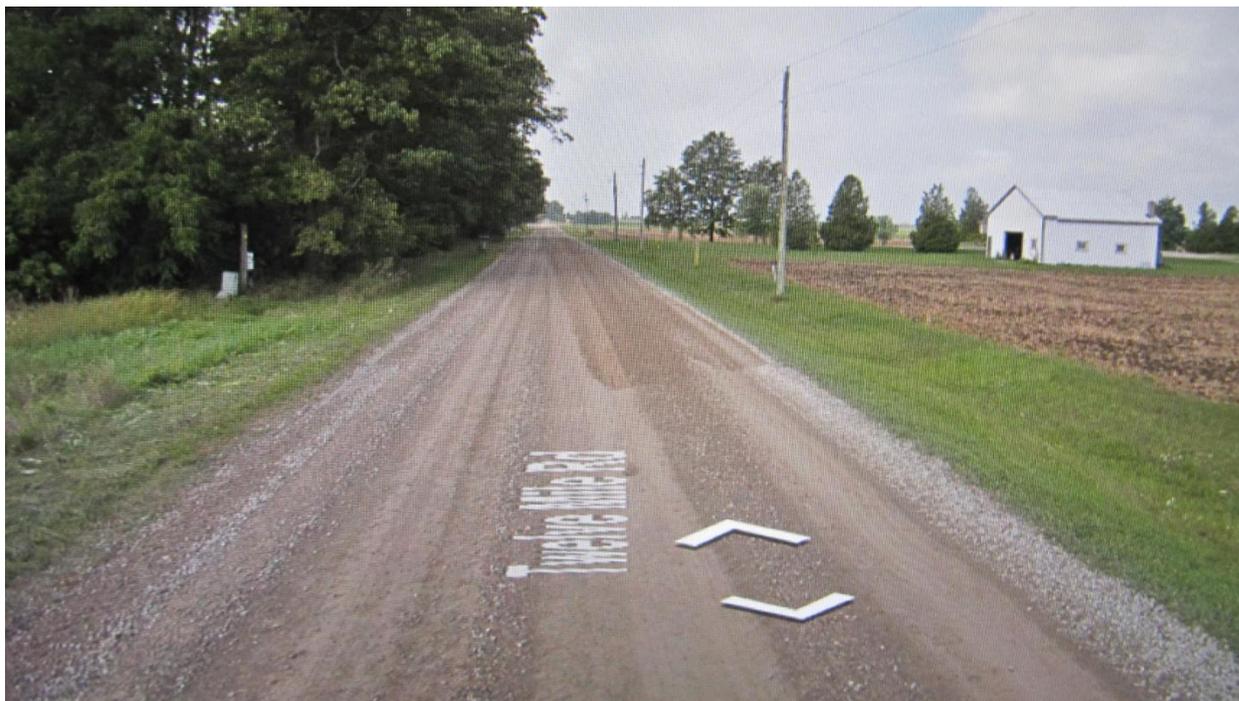
If we rotate around to face westward, Figure 14 shows the same area of the road with the area of impact in the background. Again, what is visible is that a fresh layer of gravel has been laid down for a short distance in the westbound lane.

Figure 14: View looking west, showing the fresh layer of gravel that has been deposited for a short distance of the westbound lane.

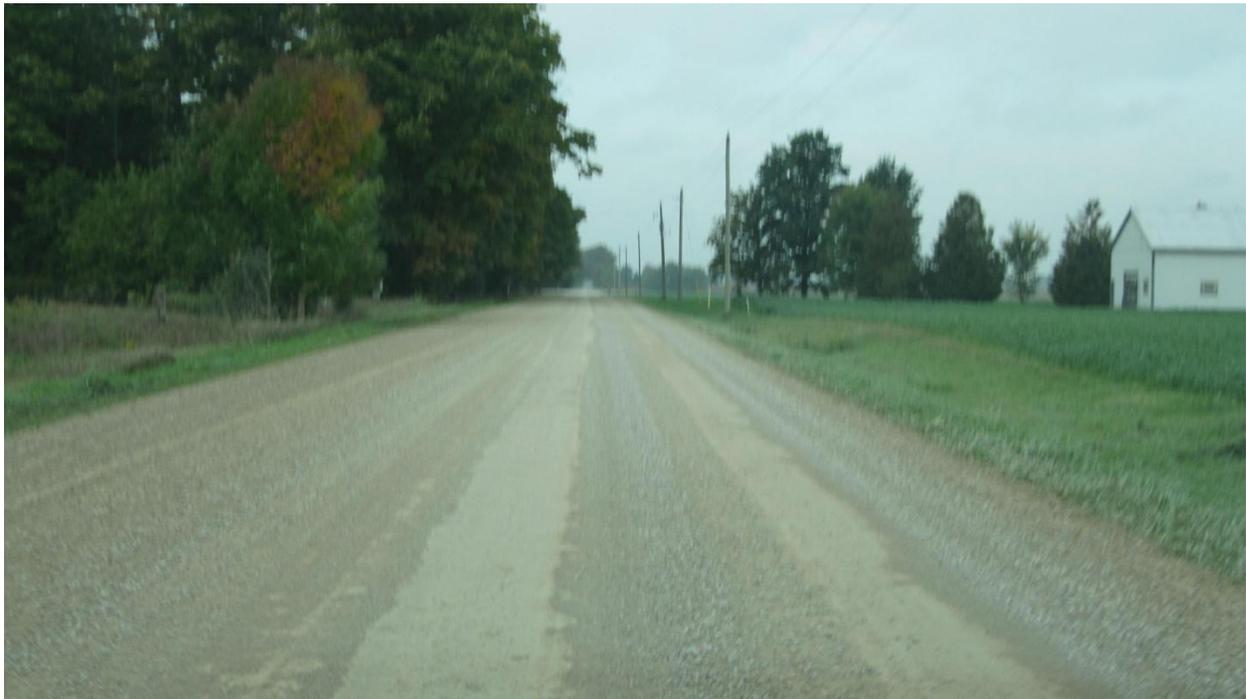
While attending the collision site a day after the collision there was further evidence that caused us concern. For example, Figure 15 shows a view of the collision site during our site visit, looking west, in the direction that the bus was travelling. A typical gravel road will contain three patches of compressed surface that match with the typical travel paths of passing vehicles. Thus, for westbound vehicles such as the bus, the path will be such that the left side tires of the vehicle will travel approximately in the middle of the road. Conversely, for eastbound vehicles, the left side tires will ride within the same centre portion of the road. What is apparent in Figure 15 is that there are only two wheel-tracks and these are in the westbound lane.

Figure 15: View of collision site looking west, taken the day after the collision. There are only two wheel-tracks visible on the road surface when, typically, there are three such tracks.

In fact, we can say that a large amount of traffic made the left turn to travel west along Twelve Mile Road rather than following the detour. This was why there were only two tire-paths visible on Twelve Mile Road. While at the site for a couple of hours we observed no eastbound vehicles using the road yet we saw a steady number of westbound vehicles. It is highly likely that these westbound vehicles had been travelling northbound on the busy County Road 23 and turned west just like the school bus. But Why?

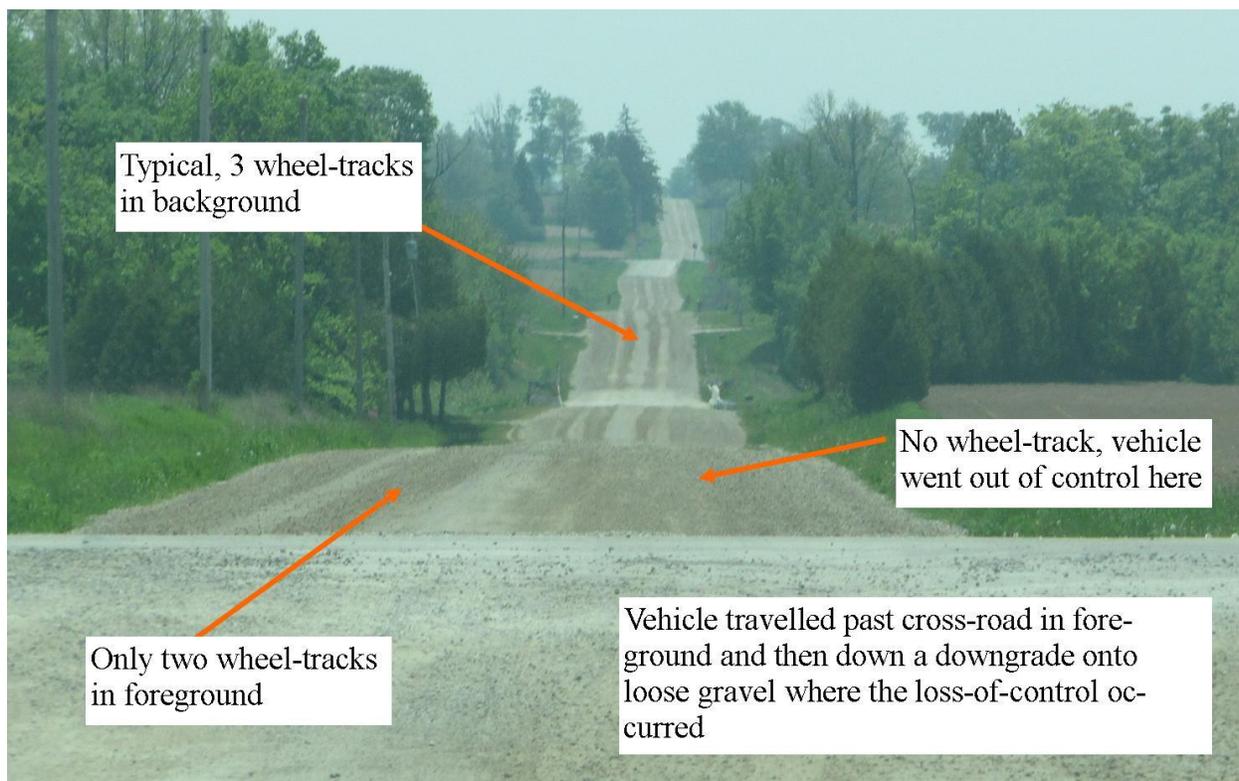
As a comparison, Figure 16 shows a view of another gravel roadway where a pick-up truck went out of control, rolled over, and an occupant was killed. The vehicle passed a cross-road and entered a downgrade. One can see that in the vicinity where the loss-of-control occurred there were only two wheel tracks whereas, in the background, there are typically three such tracks. The presence of loose gravel on the downgrade, in this isolated location likely contributed to the vehicle's loss-of-control.

Figure 16: Example of another fatal collision site where there were only two wheel-tracks in an isolated section of the road.

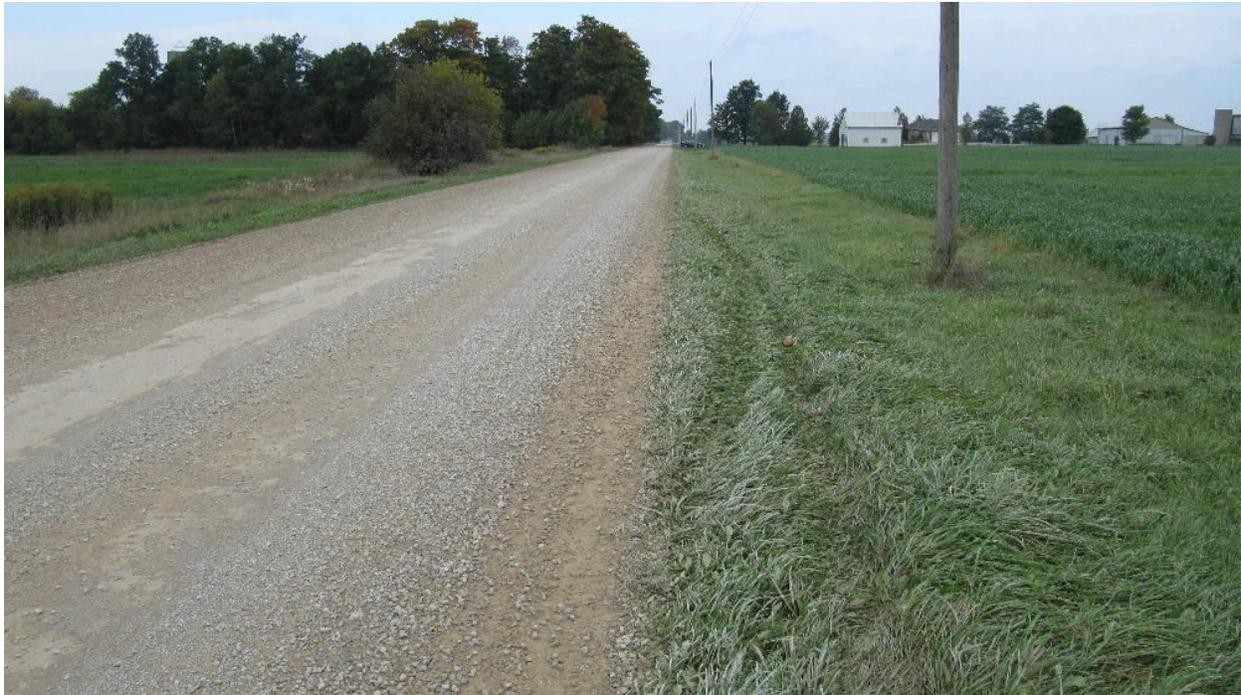
For example, the source pointed to a location well east of the area of impact where there were tire marks on the north road edge and where it was believed that the bus initially exited the road. Figure 18 is a view looking west showing a set of tire marks on the north roadside at a substantial distance east of where the impact occurred.

Figure 18: View, looking west, at a set of tire marks on the north roadside. Investigators may have interpreted that these were some of the marks created by the bus during its loss-of-control.

We offer the caution that the presence of either of these sets of marks may have nothing to do with the motion of the bus. While witnesses may claim that they observed the bus go out of control and travel onto the north roadside, there can be a misunderstanding of where that loss of control occurred. It is conceivable, and quite possible, that the bus only travelled onto the north roadside at a location closer to the tire marks located closer to the area of impact and that the above-noted marks were unrelated to this event. The marks shown above may be related to other westbound vehicles that might have left the roadway but successfully returned and left the area.

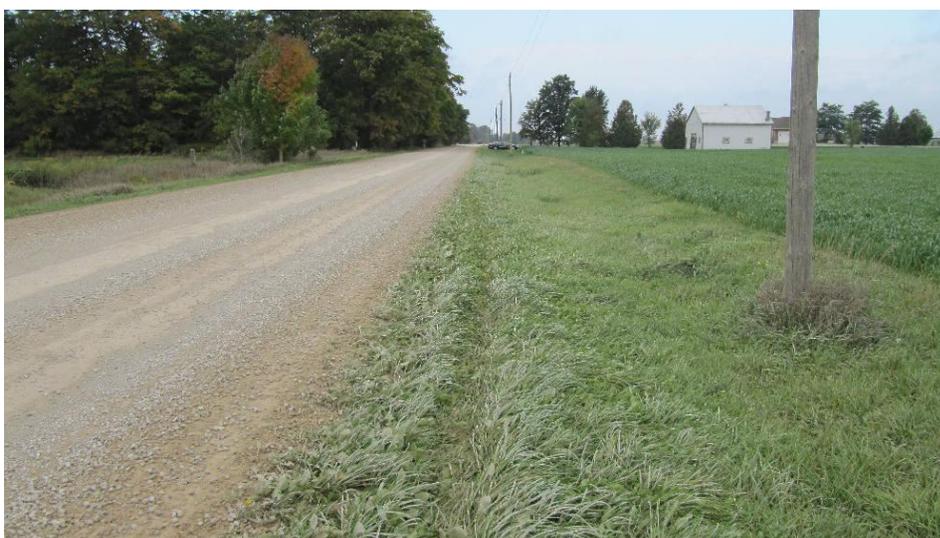
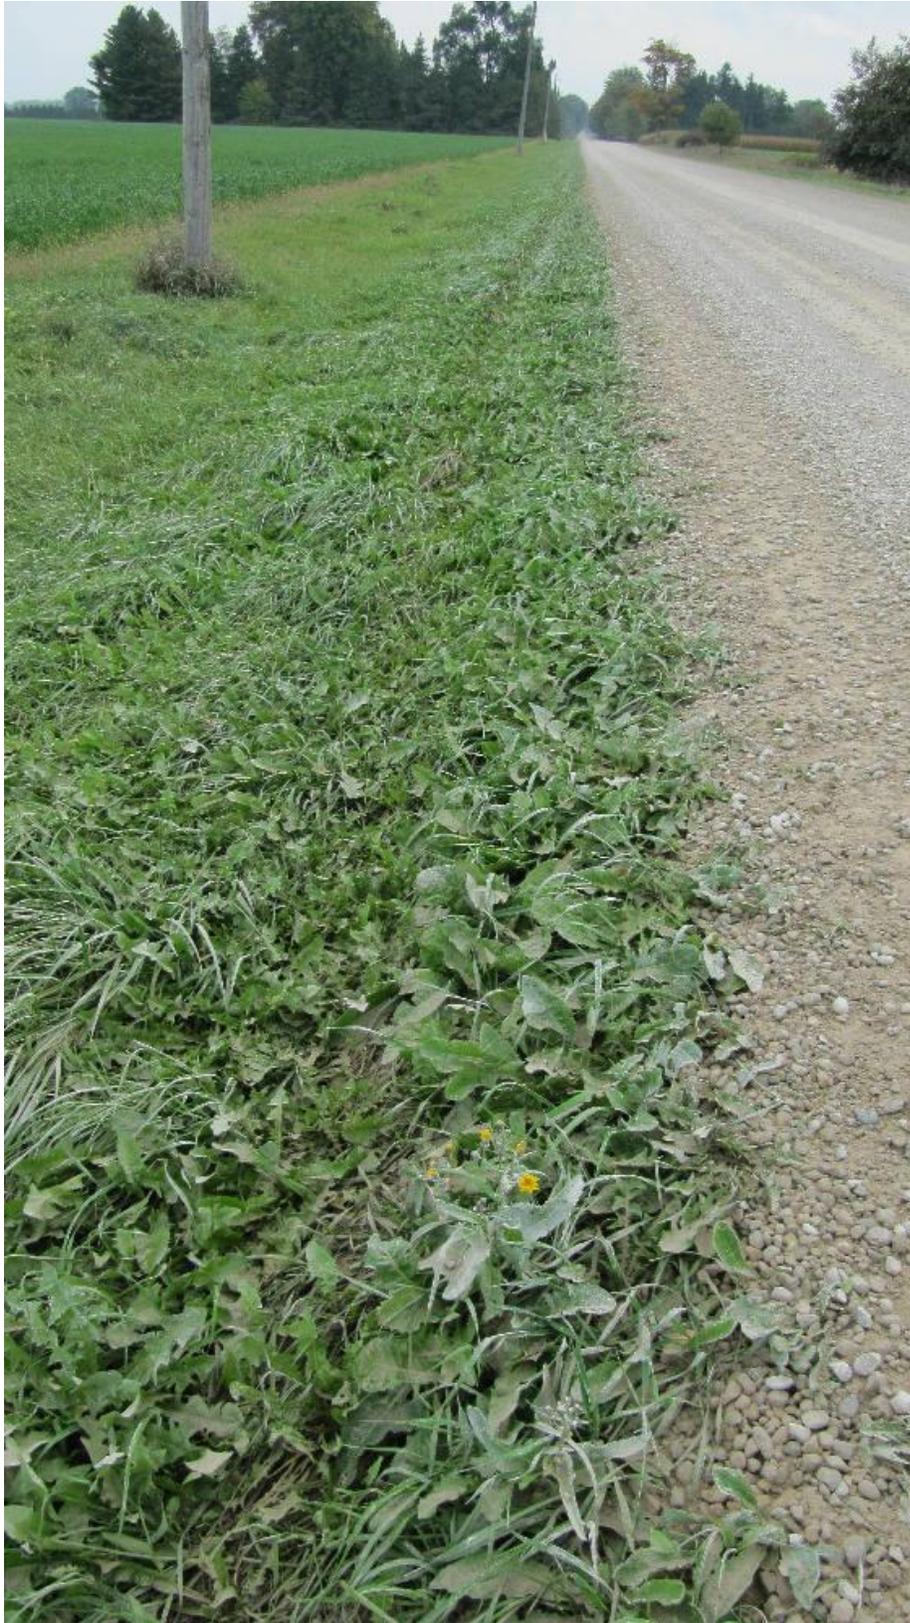
Figure 19: View looking west, showing a set of tire marks on the north roadside at a considerable distance east of the area of impact.

Figure 20: View, looking east showing a set of tire marks in the north roadside at a substantial distance east of the area of impact.

It was not specified by the source which set of marks was being attributed to the bus. However the location of both of these marks were a long distance from the location where the bus eventually crossed the road. Thus this could be the basis used to suggest that the bus driver was not slowing down while the bus was moving off the road.

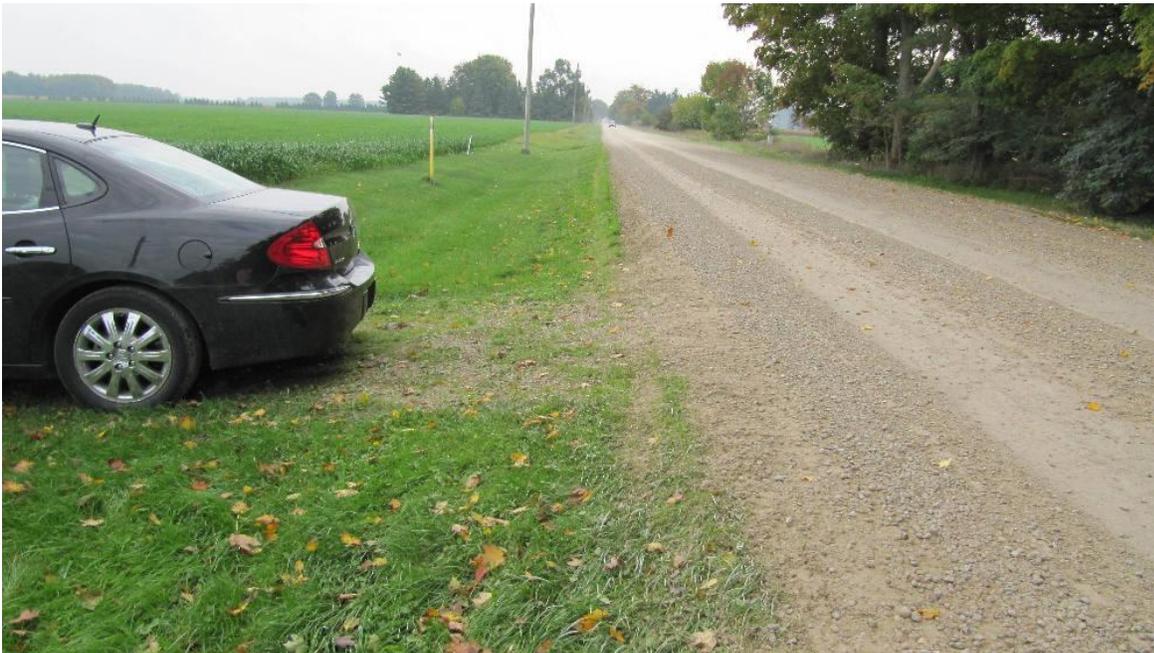
Figure 21: View looking east from just east of the area of impact. Tire marks exist just beyond the parked position of the black car and this were likely caused by the school bus as it initially left the road surface.

These markings indicate that the bus travelled only a short distance off the road surface. However there was a substantial vertical drop of the earth immediately adjacent to the gravel of the road. This vertical drop caused the greater difficulty for the bus to regain the road. A harder steering action to the left would be required to exit out of this vertical drop and this could have led to the sudden veering of the bus across the road.

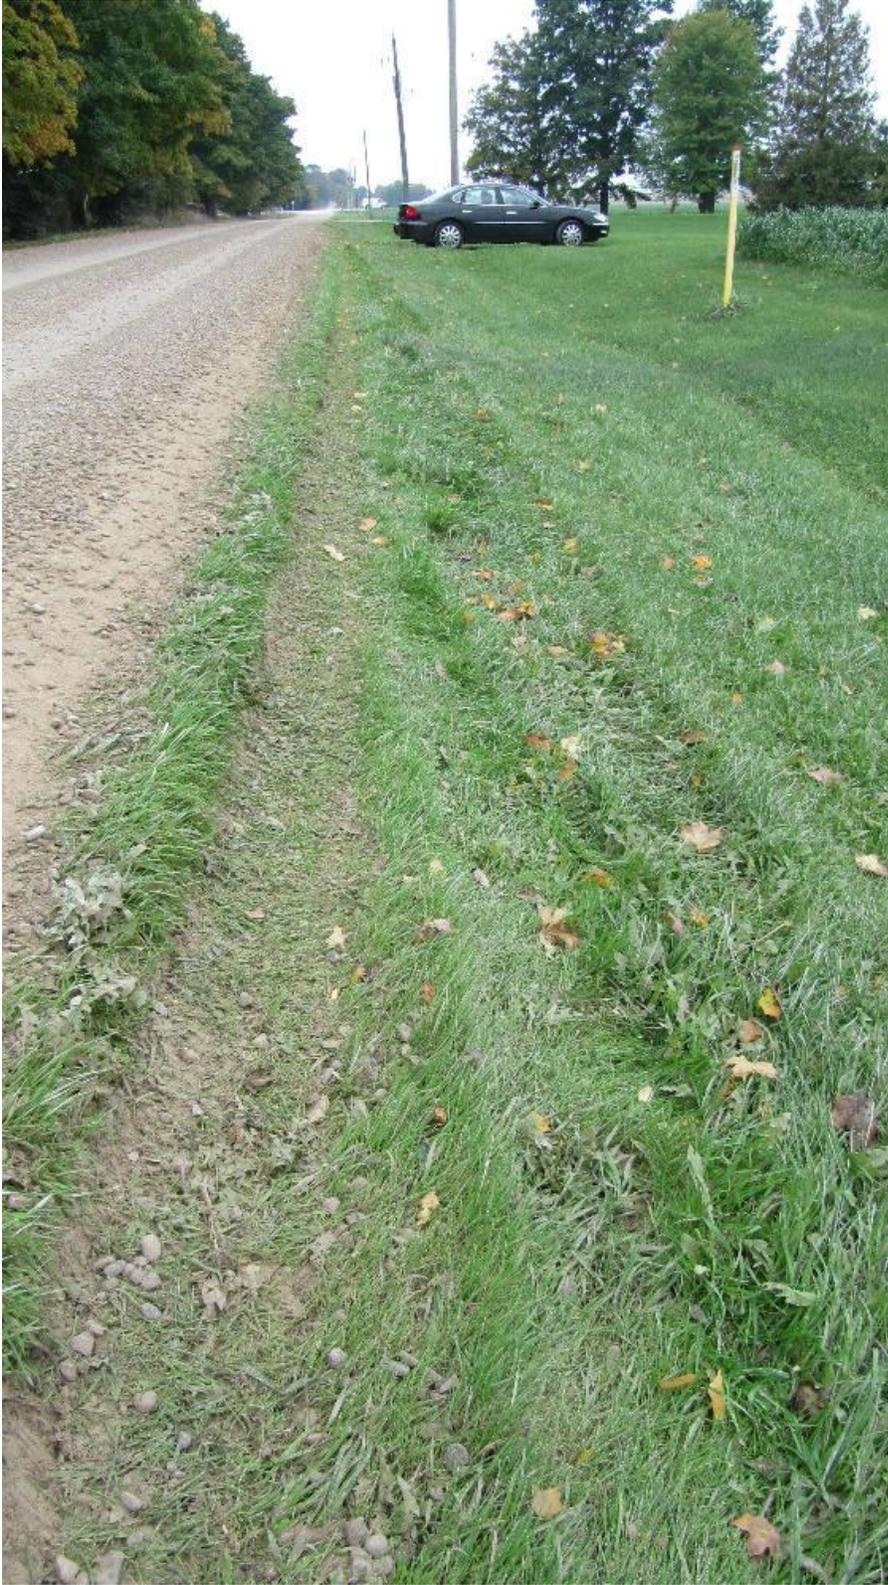
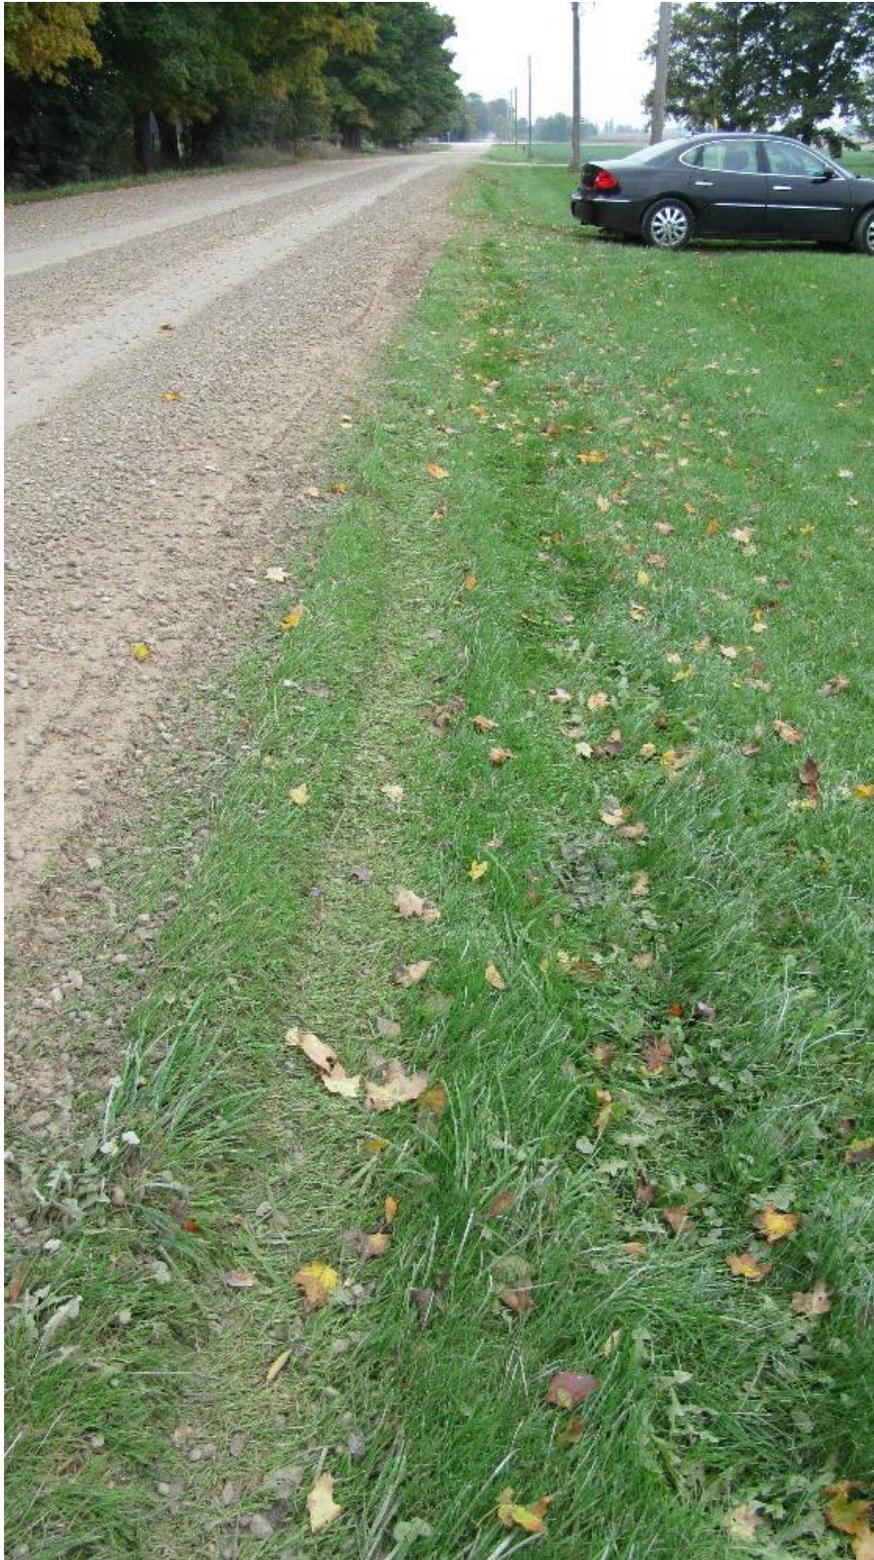
Figure 22: View, looking west, at the tire marks near the edge of the grass that can be firmly attributed to the pre-crash motion of the school bus.

Figure 23: View, looking west, at the tire marks near the edge of the grass that can be firmly attributed to the pre-crash motion of the school bus.

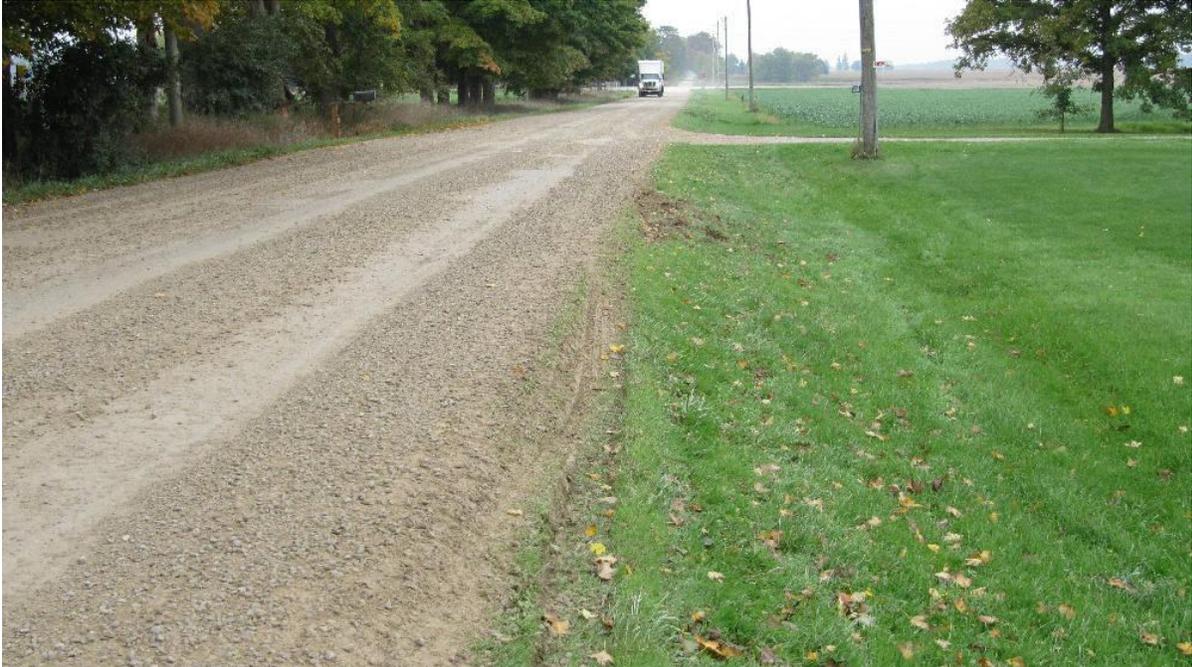
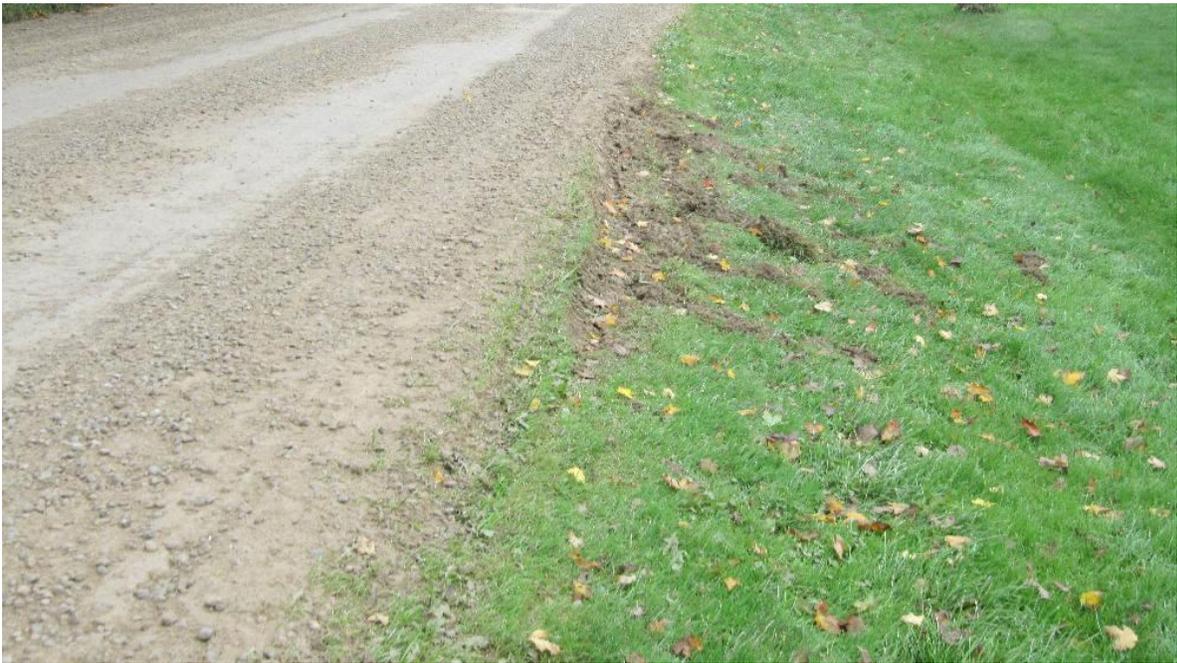
Figure 24: View, looking west, at the tire marks at the edge of the north grass roadside that were caused by the school bus.

Figure 25: View, looking west, at the tire marks on the north roadside that were caused by the school bus just before in crossed to the south side of the road.

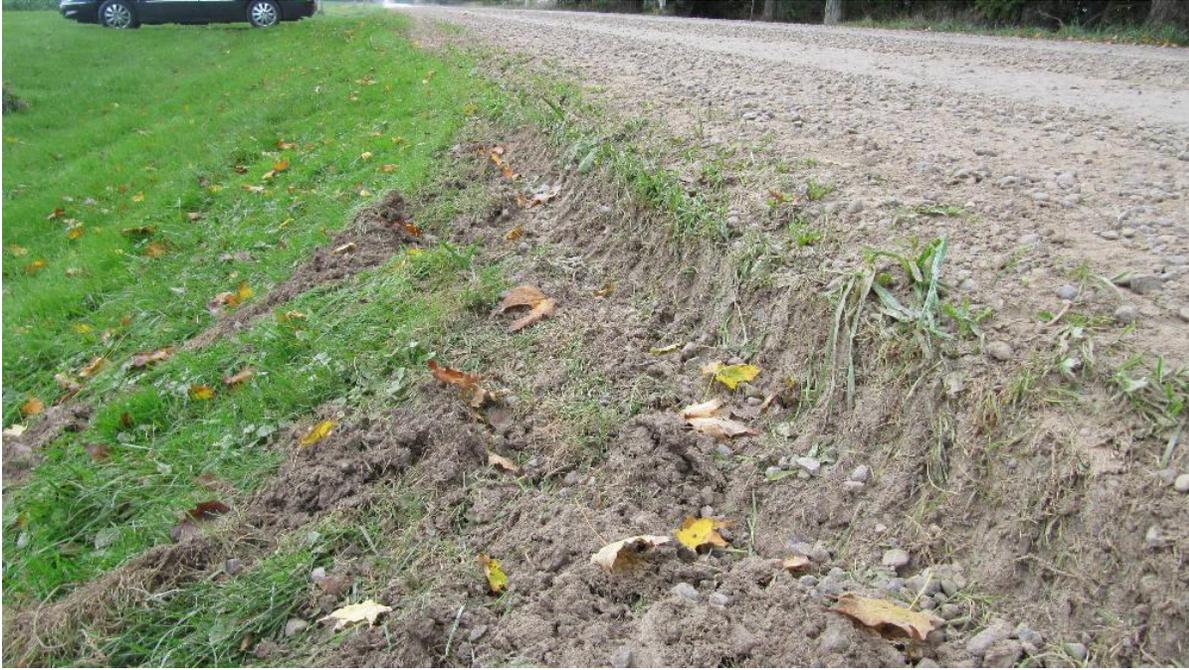
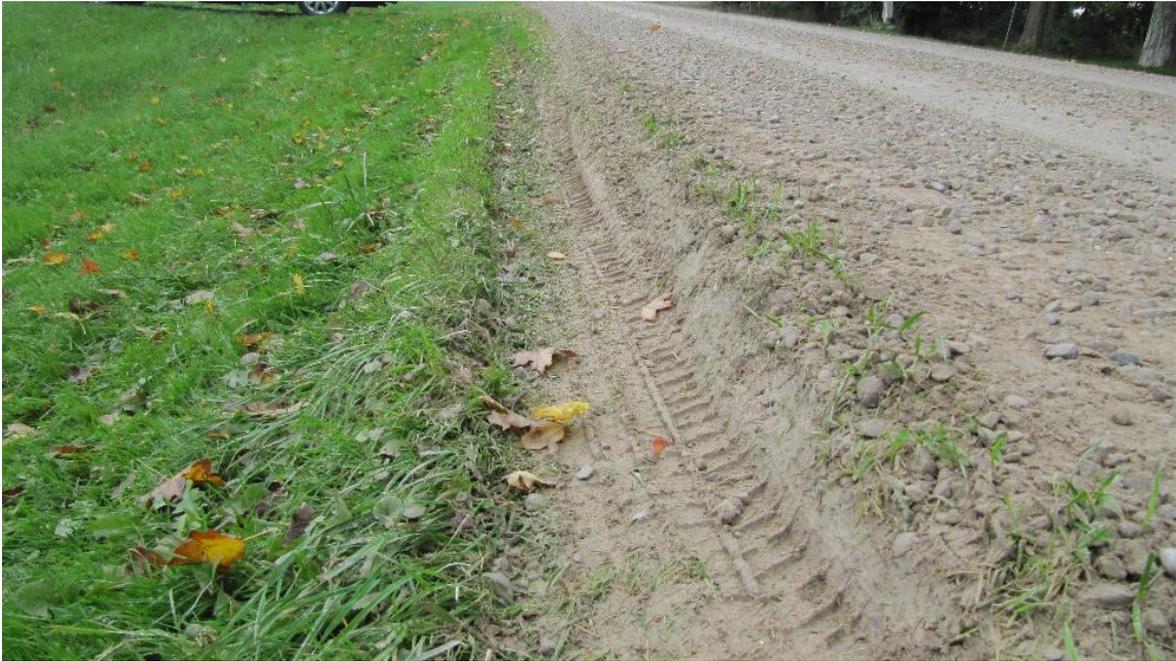
Figure 26: View, looking east, of the tire marks caused by the school bus just before it crossed to the south side of the road.

Figure 27: View, looking east, of the tire marks caused by the school bus just before it crossed to the south side of the road.

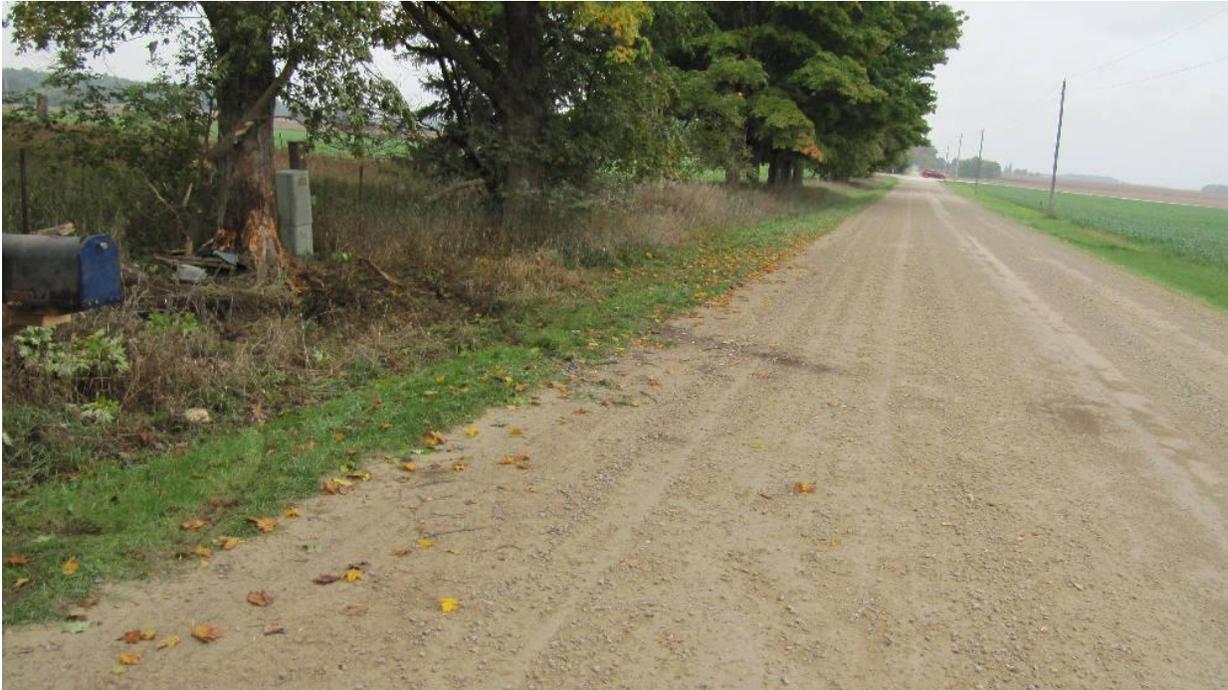
Figure 28: View of the struck tree where the school bus came to rest.

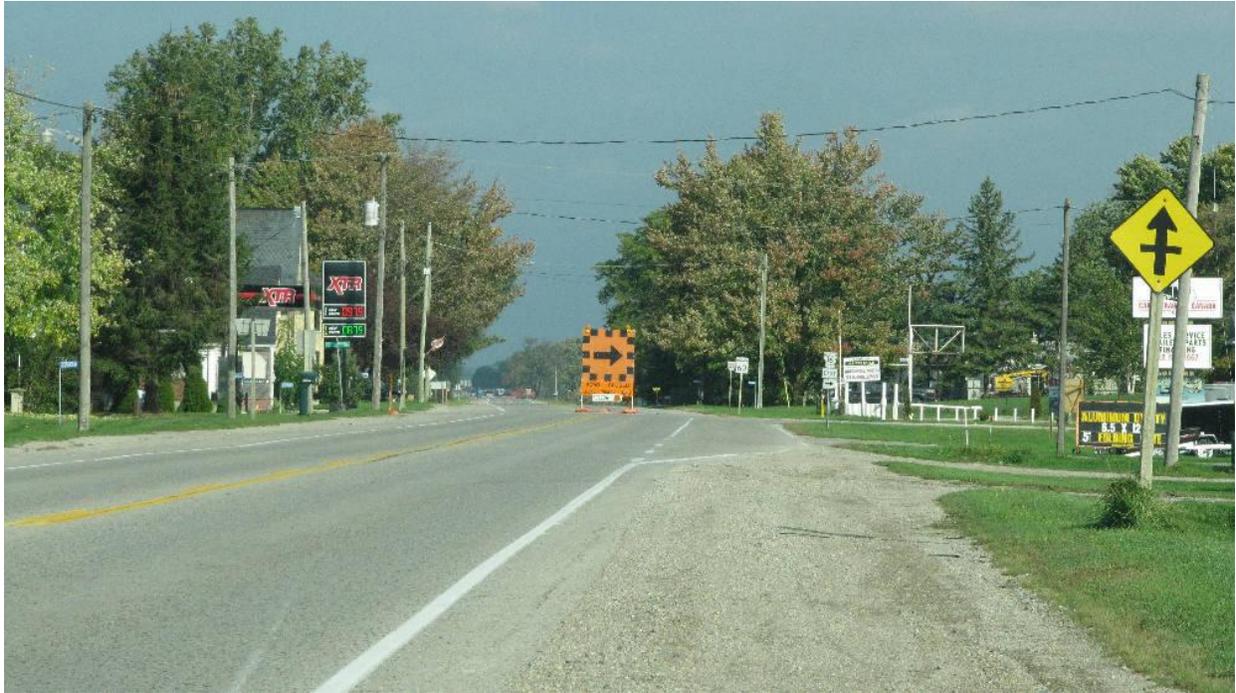
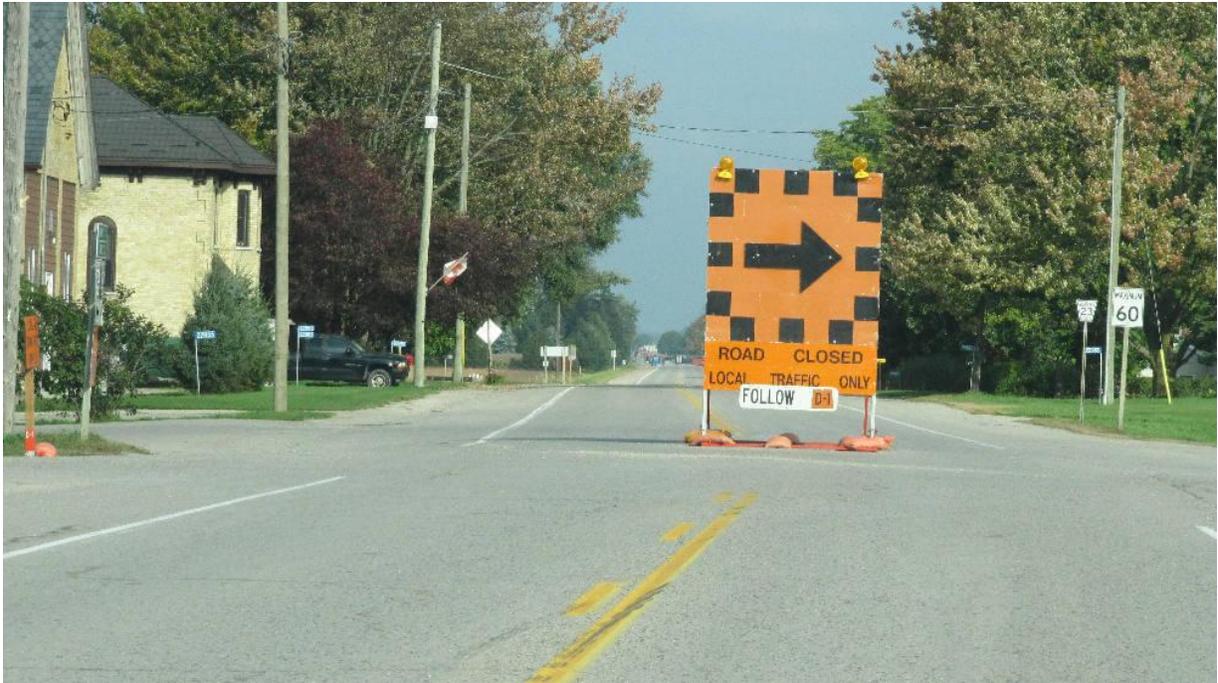
Upon completing our assessment of the site we travelled eastward on Twelve Mile Road toward Middlesex County Road 23 (Highbury Ave). It was at this intersection where the driver would have turned left onto Twelve Mile Road. Figures 29 and 30 show that there is a road closure sign at the intersection and an arrow pointing traffic to the east. Yet the bus travelled to the west, in opposition to the advisement.

Figure 29: View, looking north along Middlesex County Road 23 (Highbury Ave) toward its intersection with Twelve Mile Road. A road closure sign exists at the intersection.

Figure 30: View of road closure sign advising drivers to turn left (east) to follow the detour.

The reason why there was a right turn arrow on the road closure is that to the east Twelve Mile Road is a hard surfaced road and is renamed County Road 16 (Plover Mills Road). Thus the Middlesex County employees wanted to direct traffic onto this paved road which would be in better condition to handle such traffic. However, it should have been obvious to them that a large percentage of traffic on Middlesex Road 23 (Highbury Ave) was intending to travel north and drivers would be wanting to travel west. It should have been obvious to them also that many drivers would ignore the advisement on the sign to turn right and that most traffic would turn left, and this obviously occurred.
