Fatal Acura Impact On Hwy 53 West of Burford April 8th, 2011

Posting Date: 08 Apr 2011

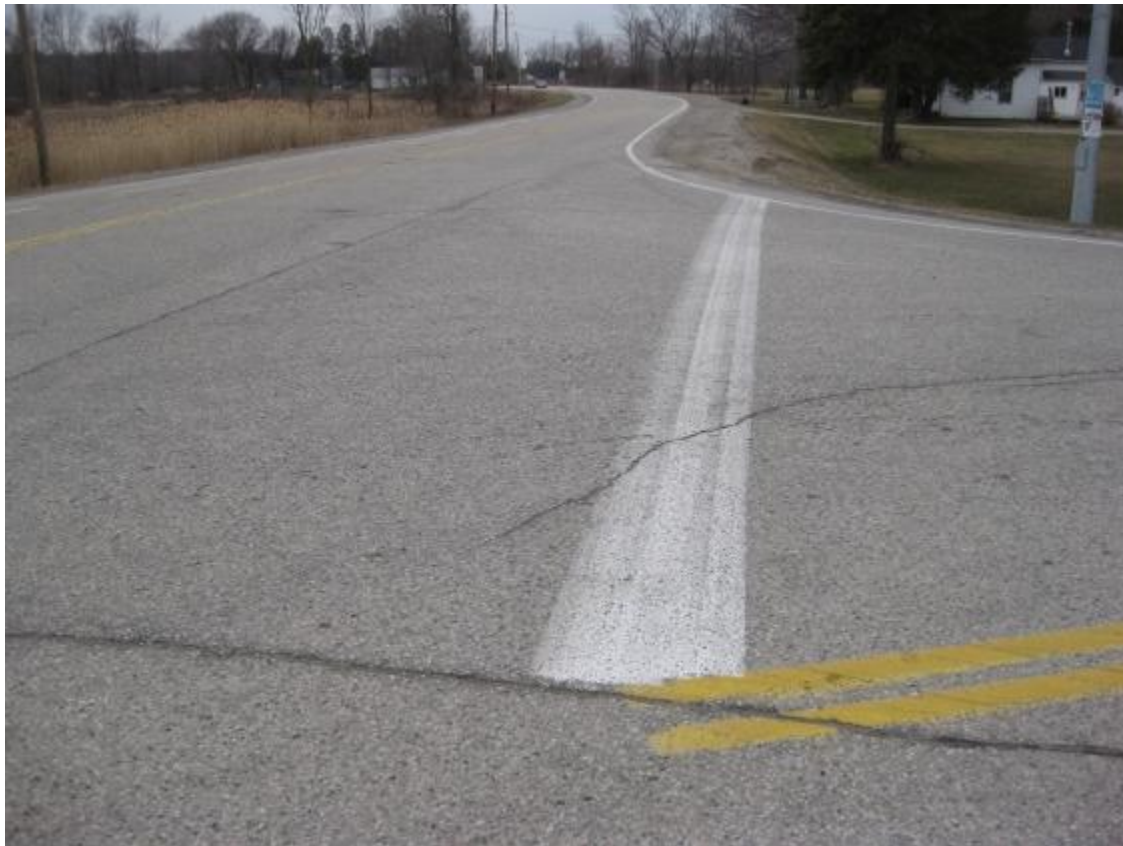
OK, I have gathered up a selection of photos and will now give you some details. First, a view from the intersecting Road (Middletown line) looking west toward the accident site, The Acura's impact with the trees was located about 400 metres west of this location around the curve that you see in the distance.

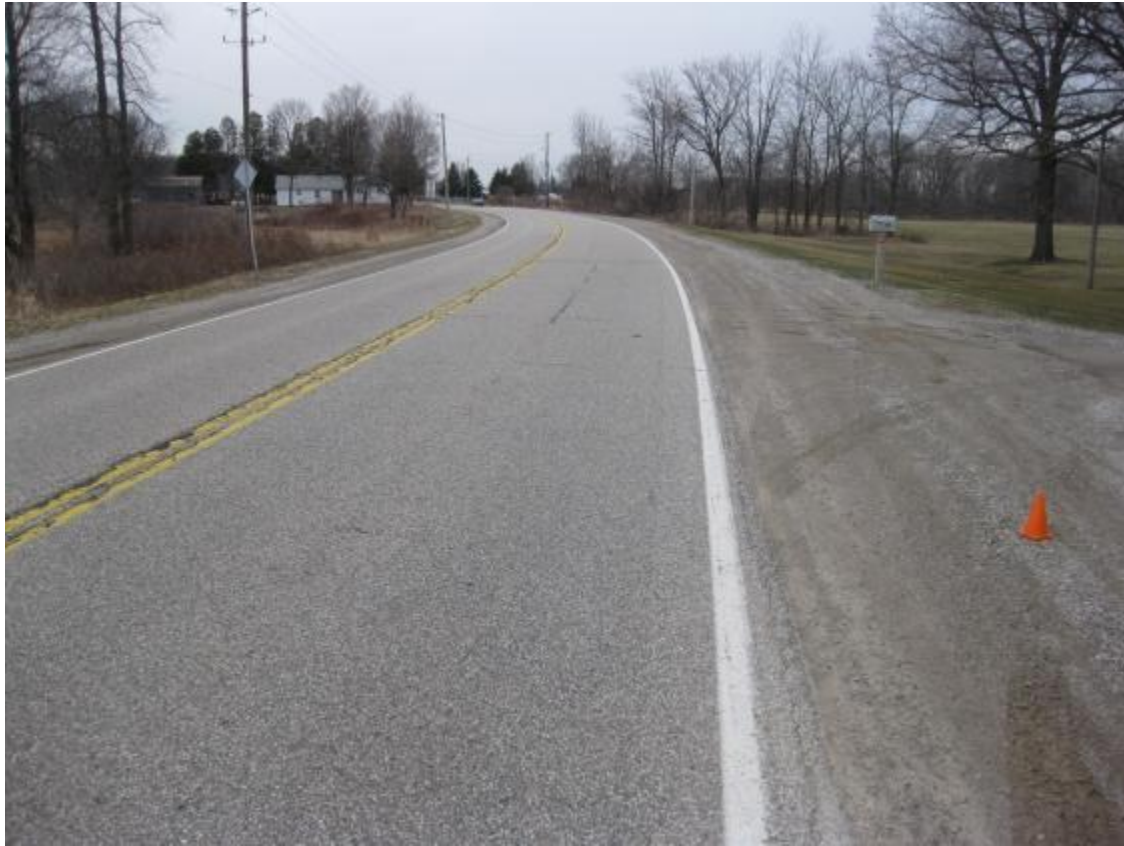
Now a view from 300 metres east of the point of impact (POI) still looking west along the curve of Highway #53.

The small orange cones that I usually set up on the roadside are positioned 50 metres apart this time because of the longer distance of road that I want to show. The most westerly cone is 50 metres east of the POI at the trees. My black Regal is positioned on the north roadside close the area of impact.

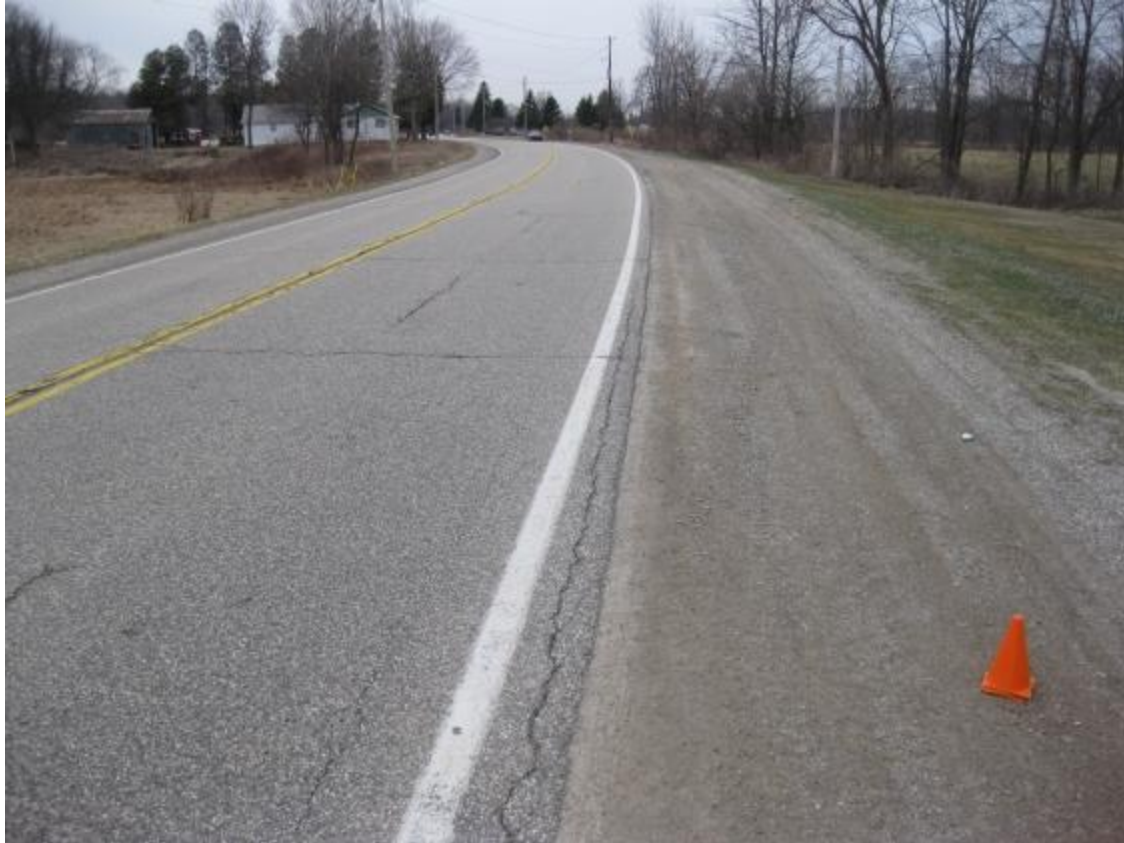
Now the view below is taken from 200 metres east, still looking west. If you are observant you will see the commencement of the yaw marks on the north gravel shoulder in the vicinity of about 160 metres east.

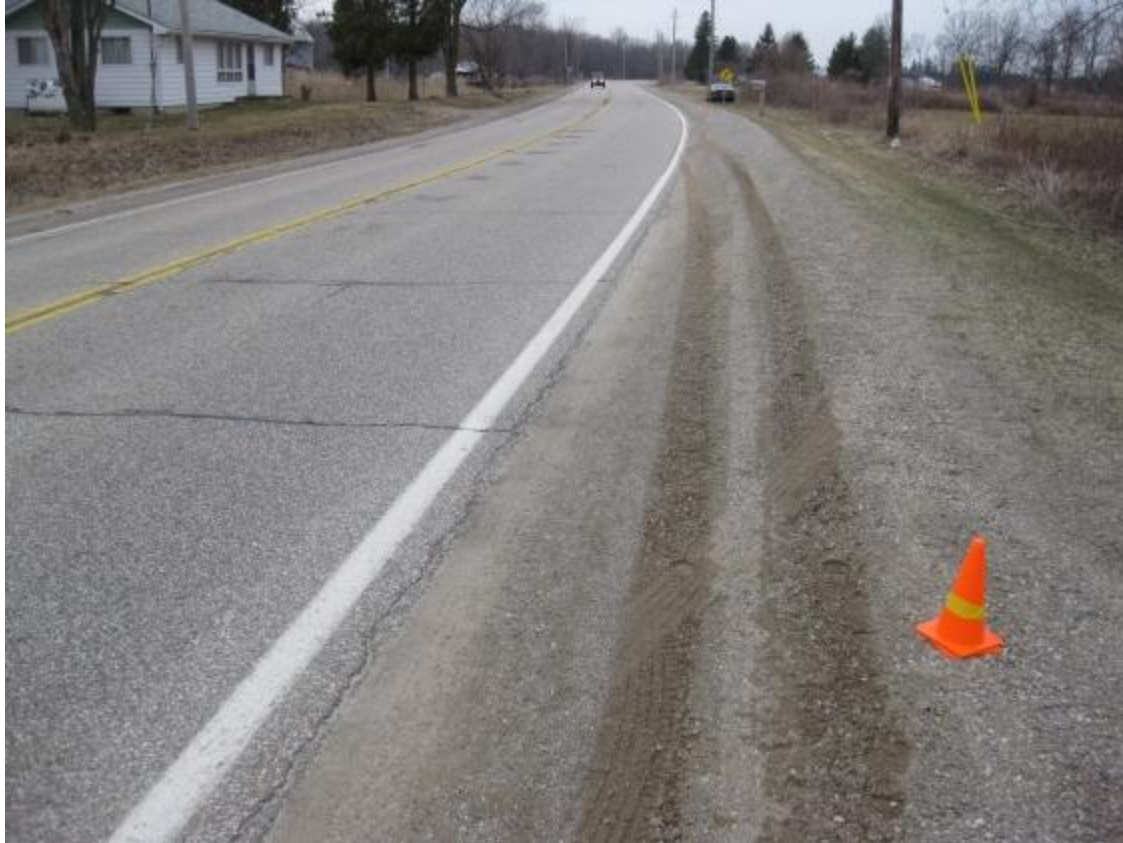
Although I have numerous photos of the start of the yaw marks I am not going to bother with them for now. I want to get closer to the area of impact where I want to show you some details. So below is a view from 100 metres east of the area of impact.

In the photo above you can see that the right side tires (front and rear) have already split off from each other means that the vehicle is in a state of yaw.

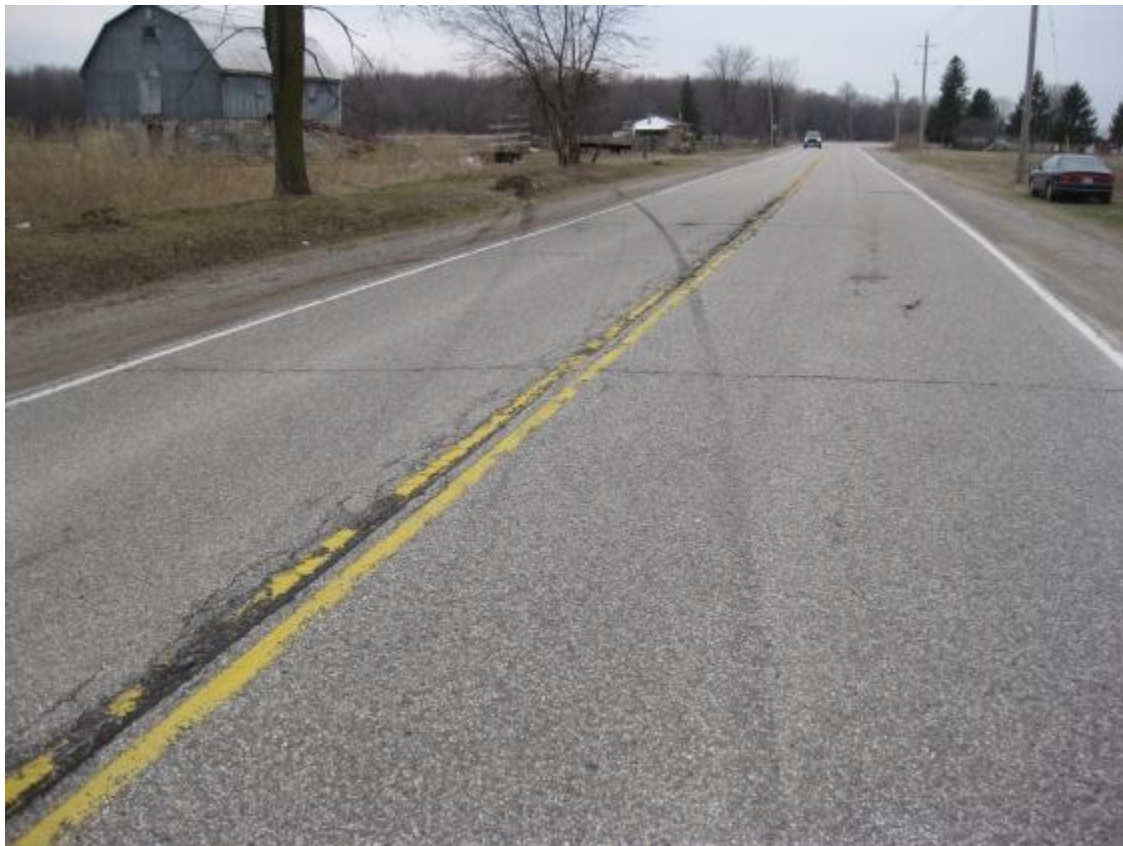
Below I'm now taking to the position where the vehicle has already crossed to the south side of the roadway and you can see in the background where it struck a number of small trees. The left side yaw marks are from the front of the vehicle and the right side marks are from the rear of the vehicle and the vehicle is rotating counter-clockwise.

You can see in the above photo that shortly after the vehicle enters the south gravel shoulder the two front wheel marks and the two rear wheel marks converge meaning that the vehicle is now sliding sideways and leading with it right side.

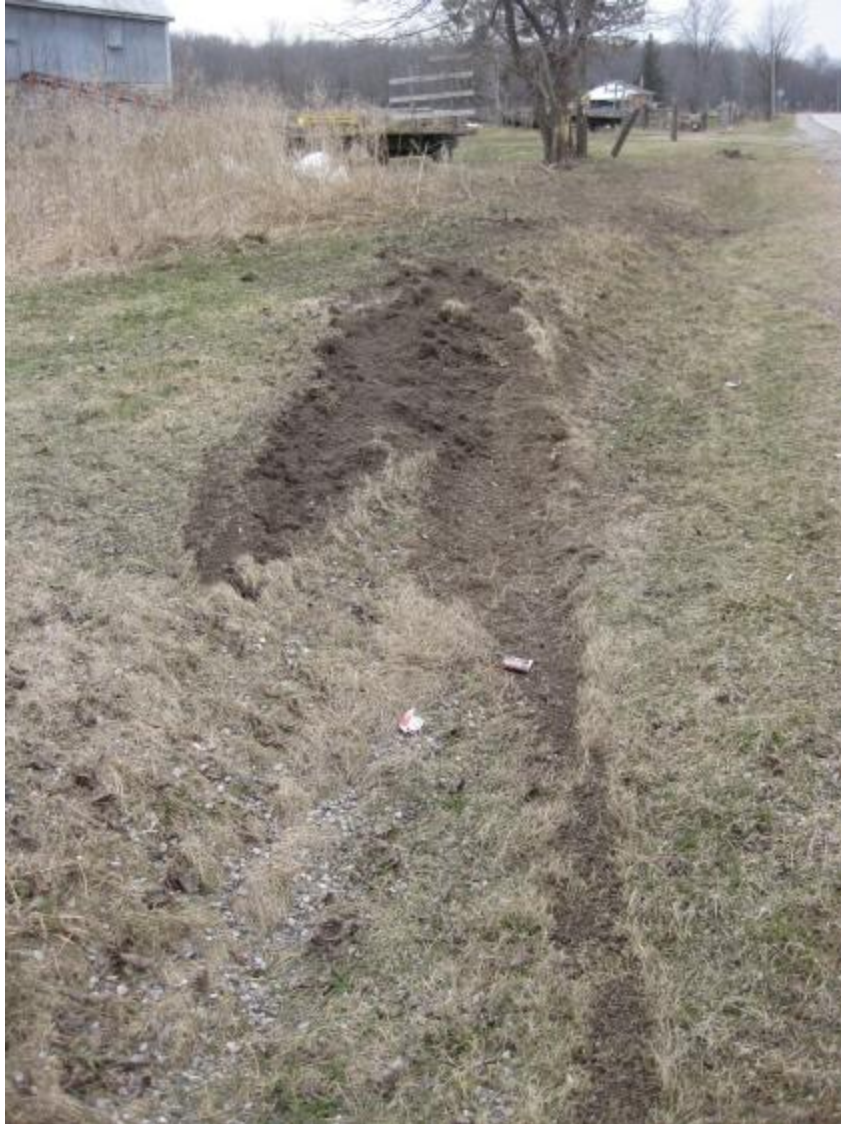
Note in the photo below how the right corner of the front bumper digs into the up-raised slope here at the south roadside and this causes the an increase in counter-clockwise rotation of the vehicle.

In the above photo, the gouging of the earth on the right is caused by the right front wheel and the short burst of gouging at the left is where the right corner of the bumper dug in. So although the media reports indicated this was a rollover it was not really. I mean the vehicle is very close to striking the trees in the background when its right front corner is suddenly arrested by plowing into this earth and this has increased the rotation such that we will see shortly that likely the right rear corner of the vehicle struck the first tree. Before that however, let's look backwards, to the east, in the photo below to examine how the rotation was accentuated.

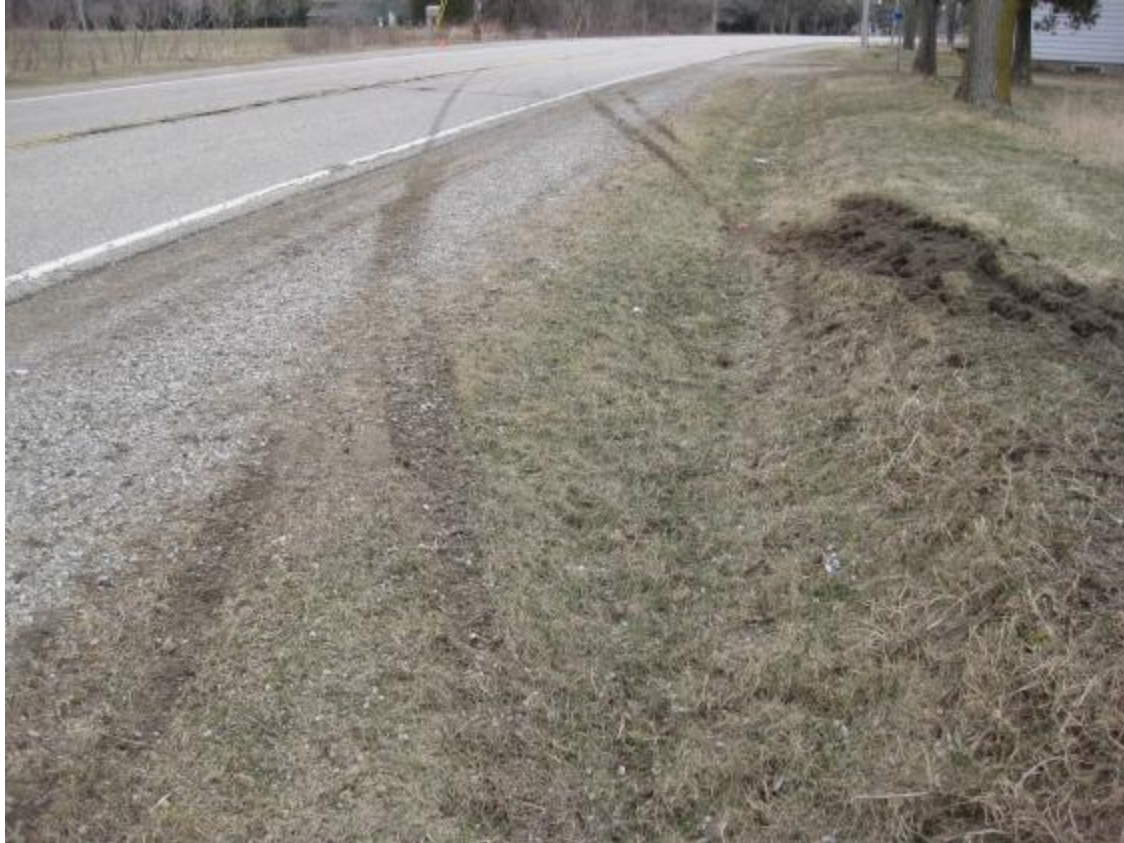
In the photo above we are looking back to the north east from where the Acura came from and we are just beyond the point where the front end of the vehicle dug into the earth. Look at the two tire marks caused by the rear wheels and note how they suddenly diverge very quickly in the short distance at about the point where the front end was arrested. This is an indication of the increased counter-clockwise rotation that I mentioned.

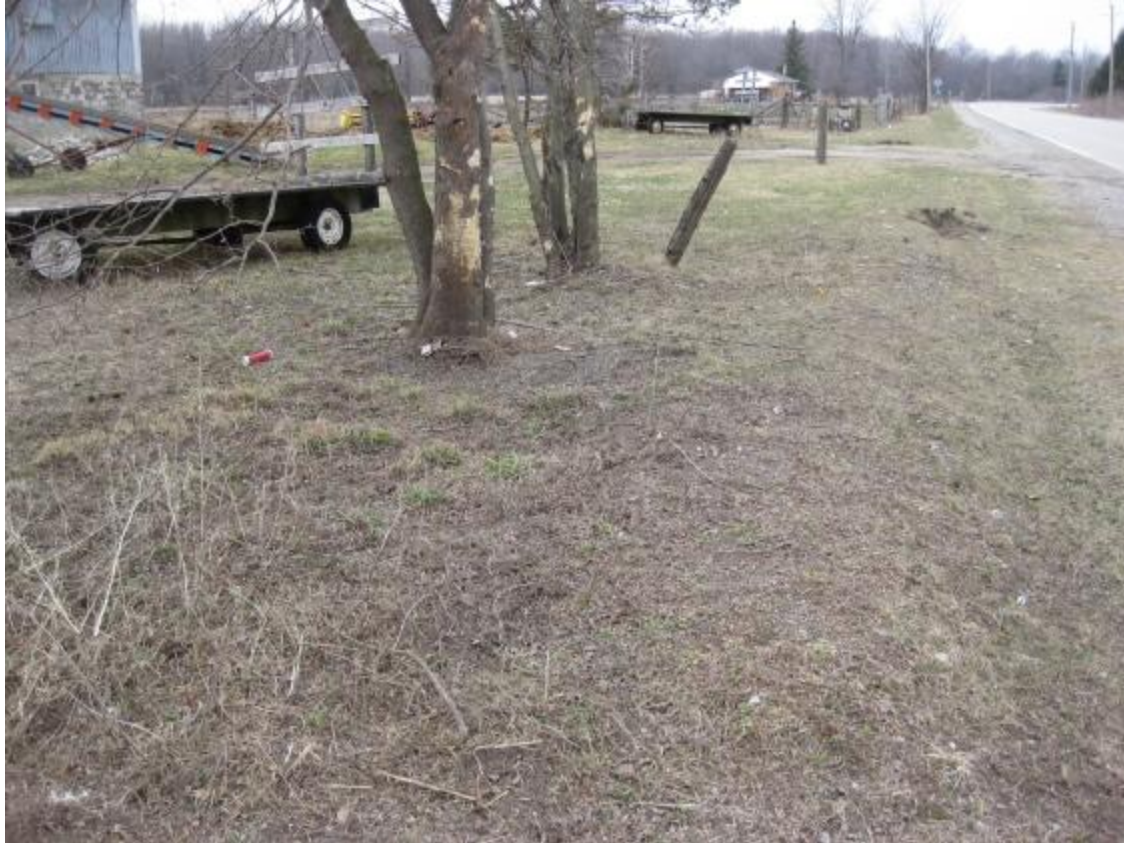
Now let's look more closely at the impact with the trees. The photo below shows an overall view of the area of impact between two clumps of small trees. The primary impact was with the trees in the foreground and then, following rotation, I suspect the trees at the second grouping were struck.

Following this impact the vehicle was deflected back onto the roadway and likely came to rest in the eastbound lane of Highway #53 a few metres west of the trees.

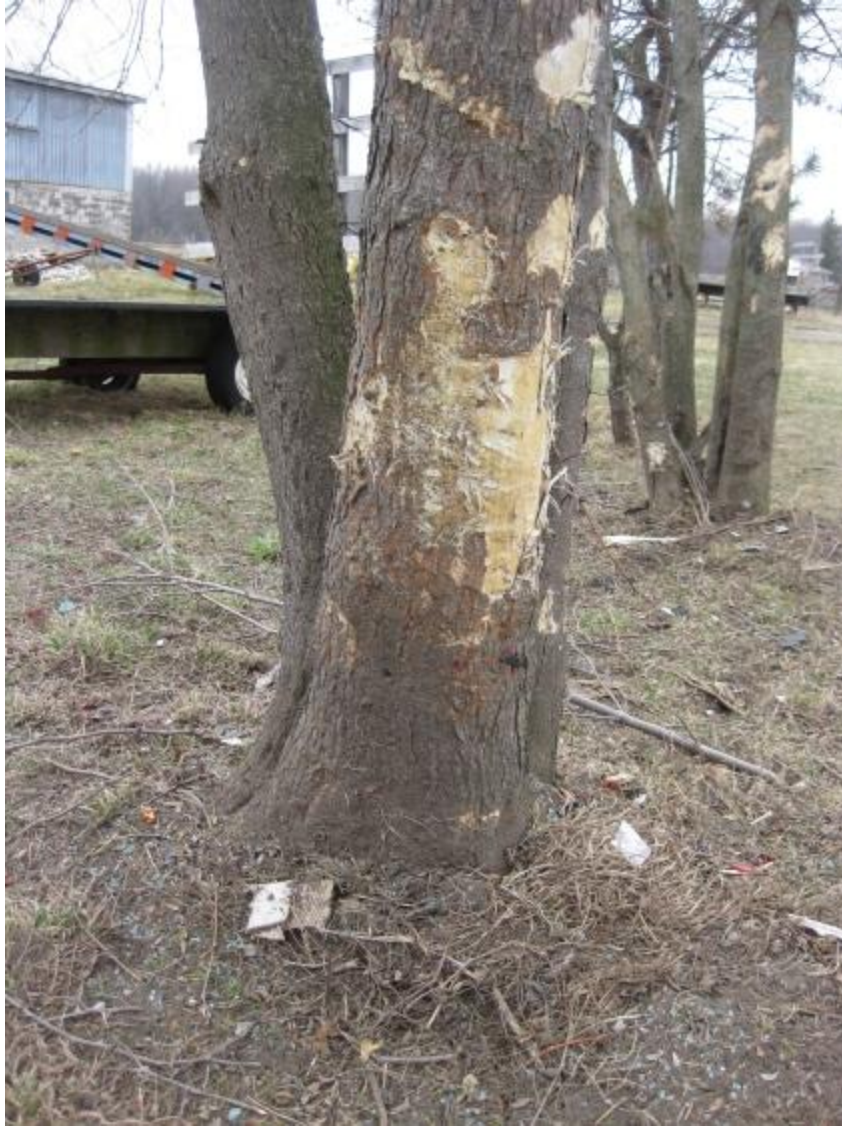
Although I have not seen the damaged vehicle, study of the markings on the trees and what has been imbedded in them can give us clues as to what portion of the vehicle made contact and how the occupants might have incurred their injuries. Let us look at the damage to the first tree as shown in the photo below.

As I have mentioned in previous articles, a tape measure can be placed against the tree trunk and photos can be taken to locate the various evidence at different heights for comparison to other similar collisions. I think the manner in which this Acura struck the trees is rather unique and does not bode well for comparison to other cases so I have not used the tape measure technique. But we can still look closely at some of the markings and imbedded materials. For example, near the base of the tree we can see the materials imbedded in the wood as shown in the photo below.

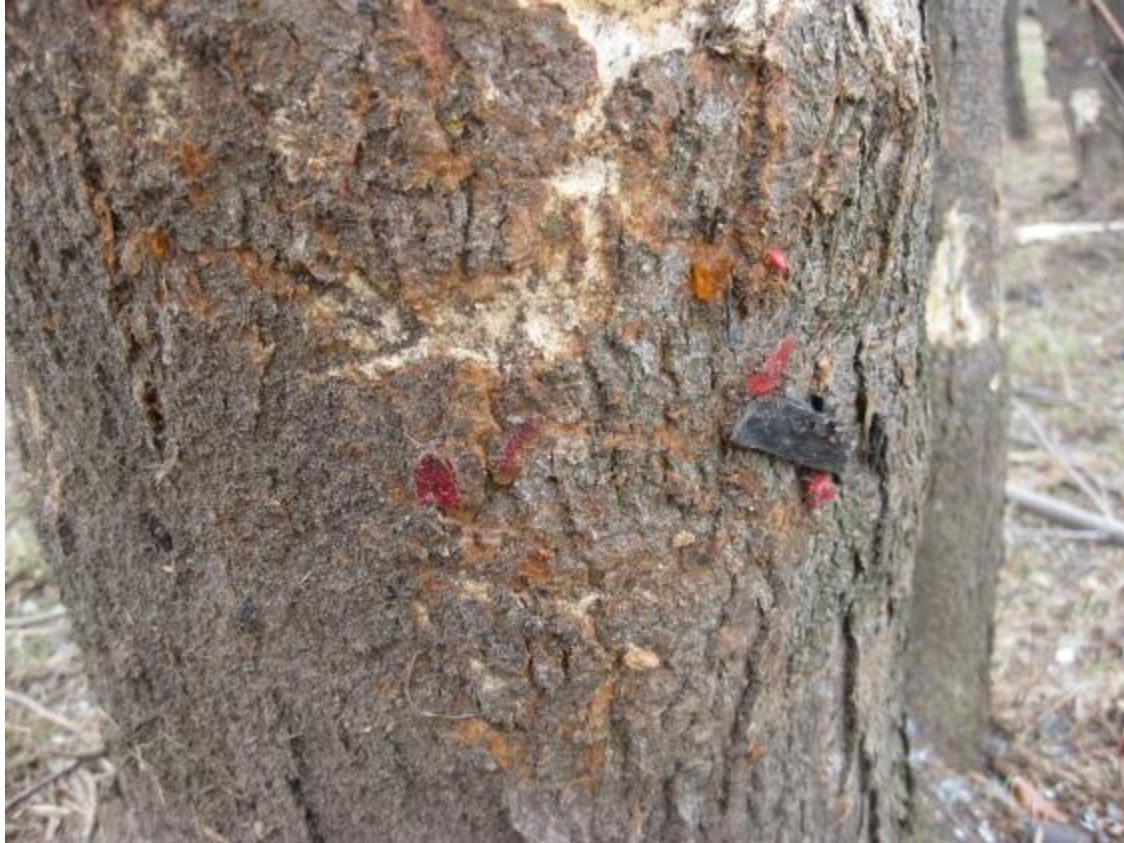
The red lens material is often associated with tail-lights while orange lens material is often associated with frontal corners of a vehicle. So it may be perplexing to find both red and orange lens material imbedded in this wood. This may be so until we look around and find some of the lens material as shown below.

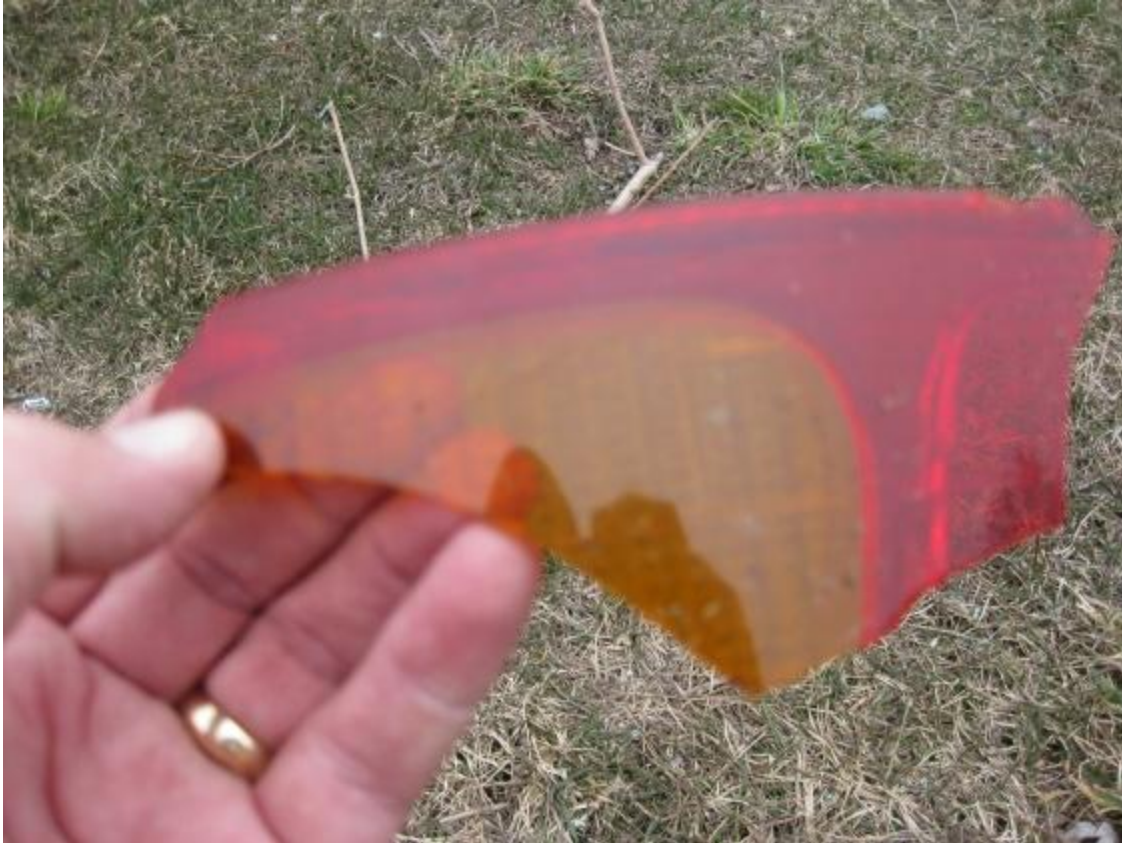
So the Acura manufacturer has incorporated a lens with both red and orange lens material at the rear tail-lights. So that explains it. We can study other imbedded material such as patterns in the tempered glass as shown in the photo below.

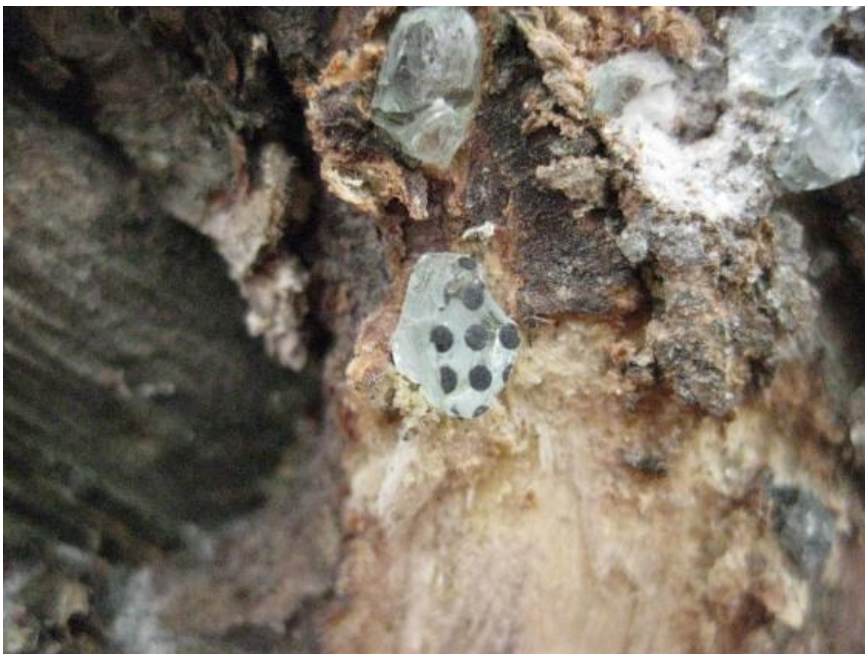
The black spotted material on this imbedded glass is generally not found on side window glass but one could examine an Acura and confirm precisely from where it originated. This gives us some idea of how the vehicle interacted with the trees.

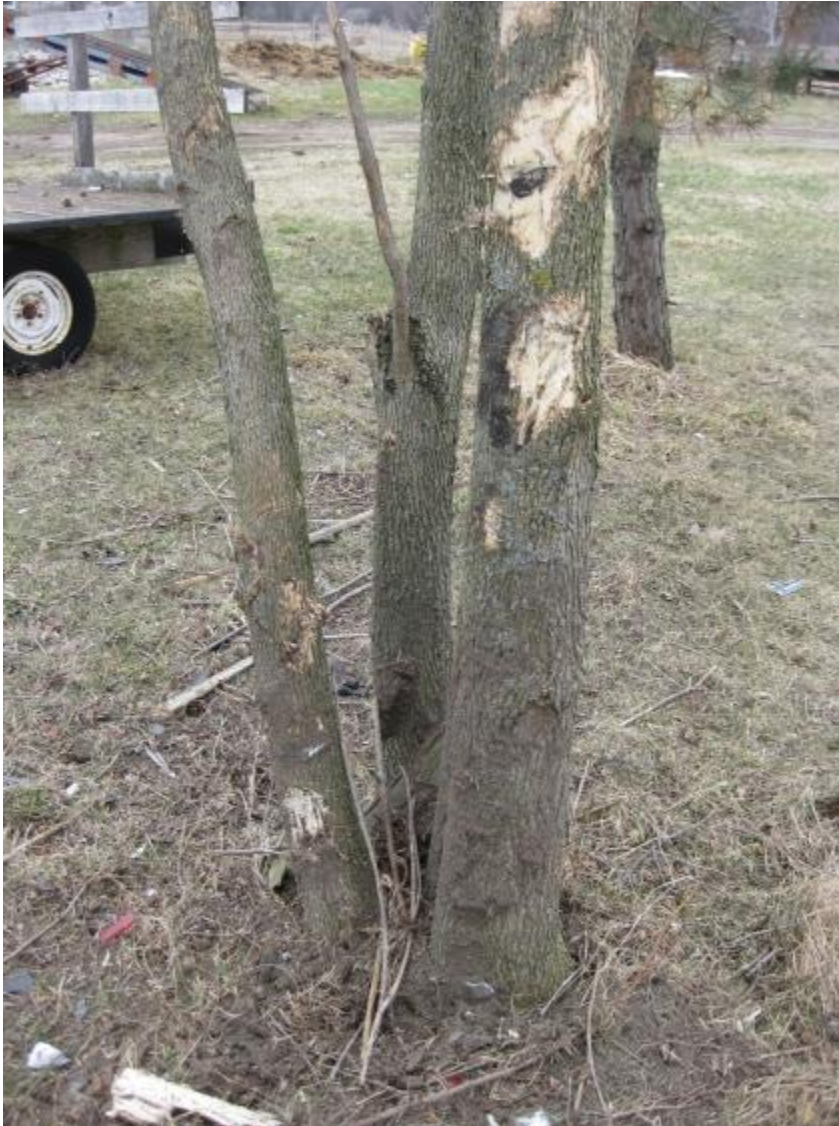
We may find black, greasy substances such as what exists at the second clump of trees shown in the photo below.

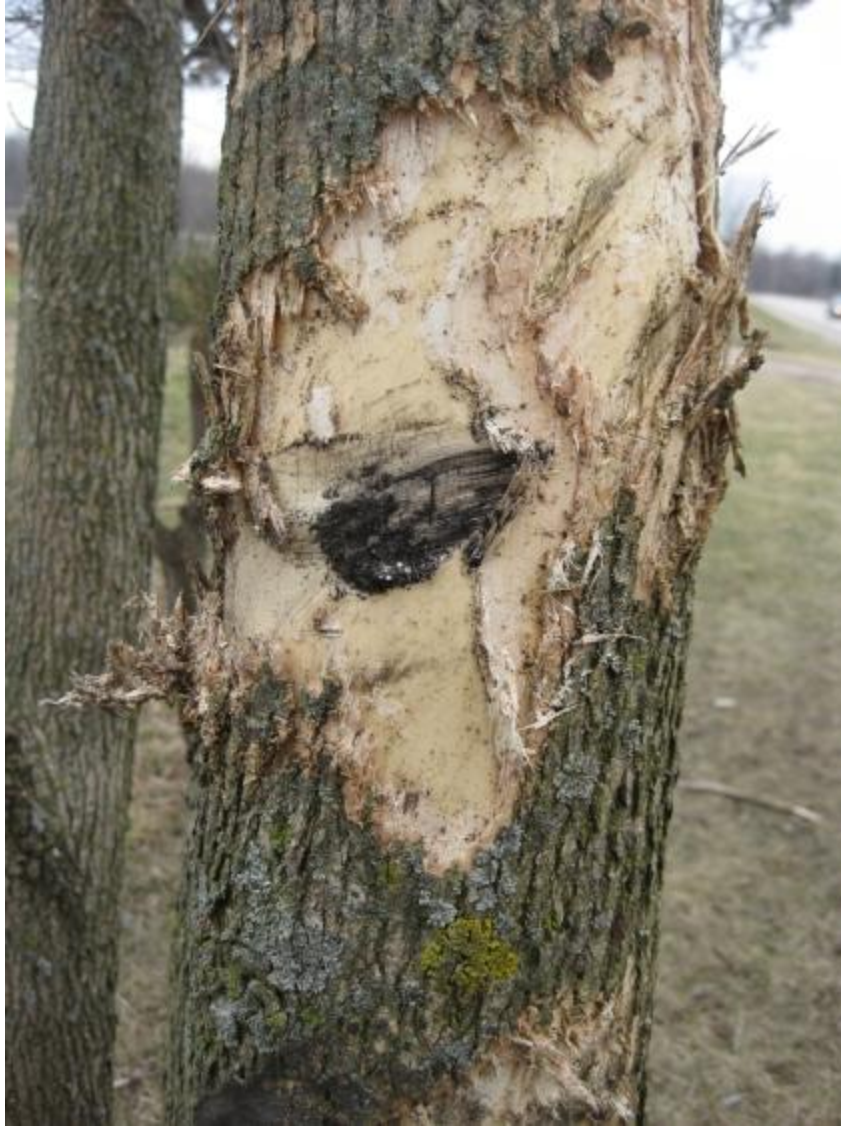
The close-up view of the black substance is shown below.

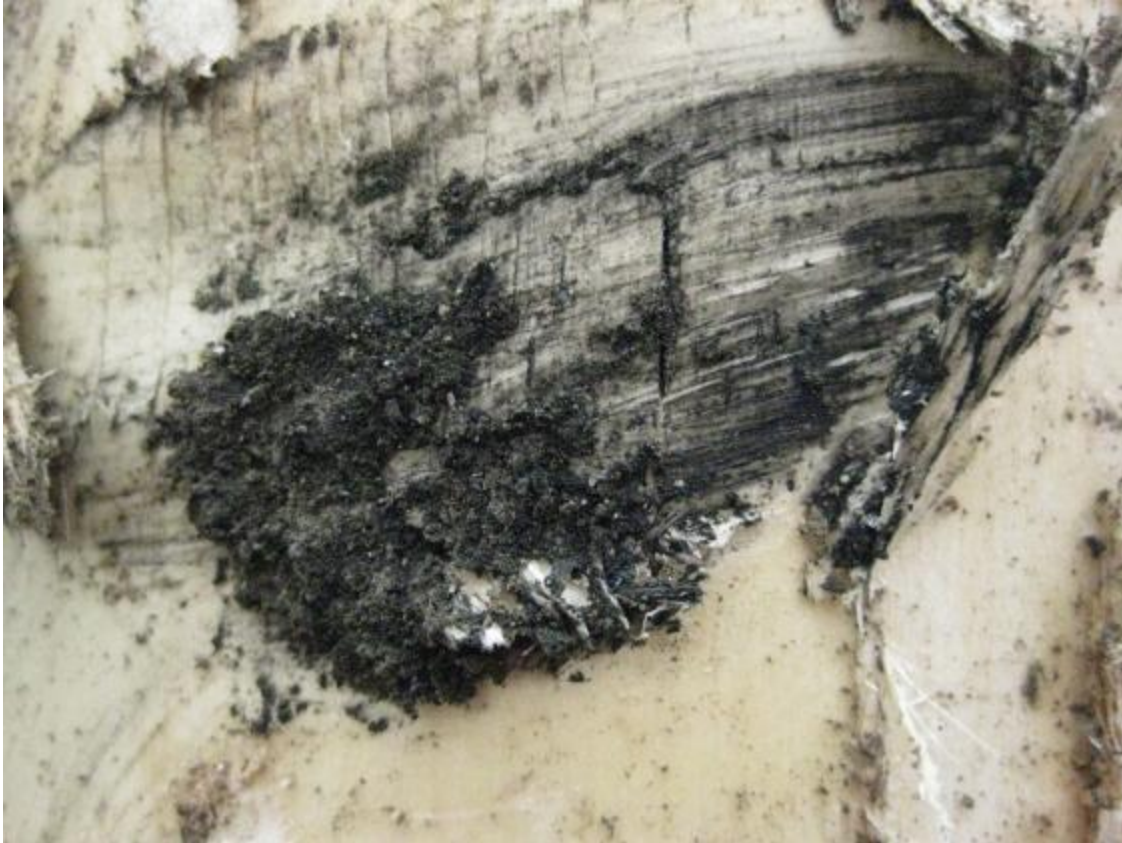
And we may take a macro photo of the substance as shown below to examine in which direction the material was transferred onto the wood and therefore how that portion of the vehicle was travelling during the impact.

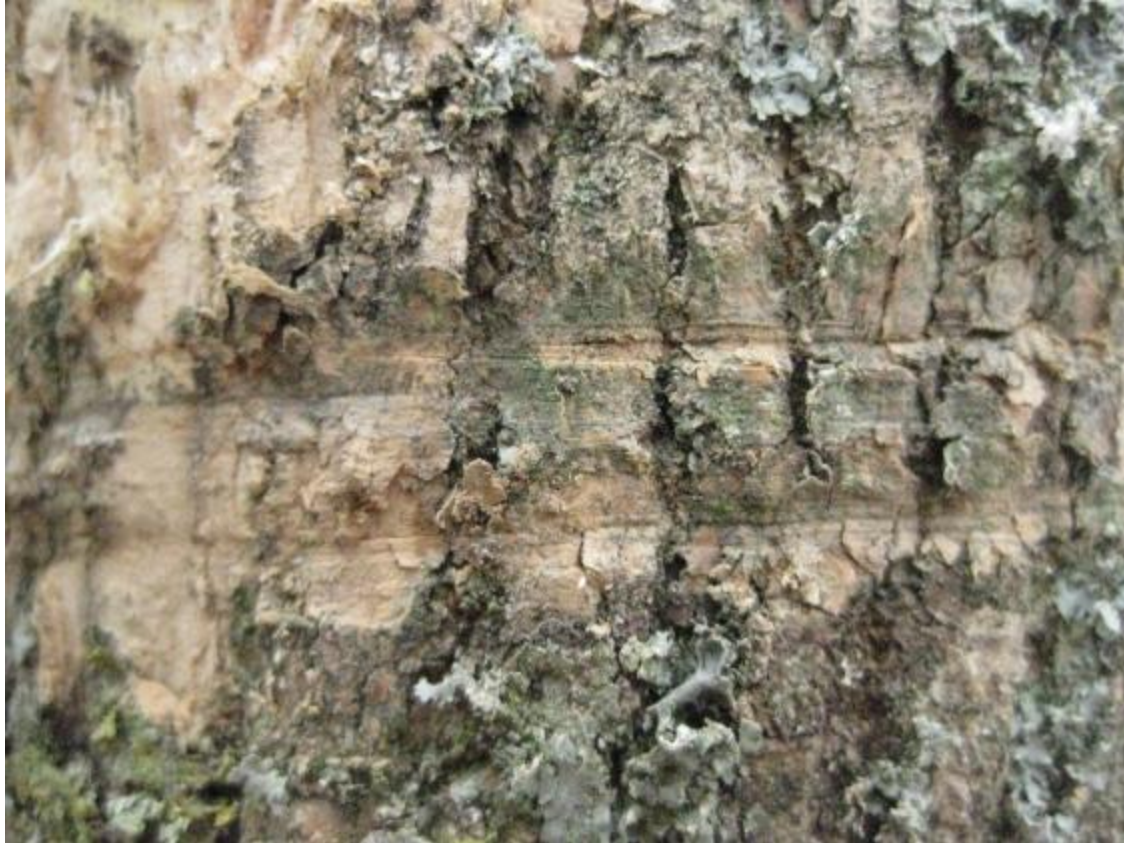
For example the photo below provides a macro view of a horizontal imprint into the bark of one of the trees.

This imprint has a very specific dimension and could be traced to a specific portion of the vehicle. This very specific imprint can provide you with very specific information about the interaction between the vehicle and the tree. If you did not recognize it and you did not document it you would have lost an opportunity to understand something very detailed about the crash. Unfortunately many reconstructions are based on the absence of such detailed study and documentation. Sometimes it seems that if you have a multitude of degrees and many years of experience you can be exempt from providing proof of your opinion, or so it sometimes seems in the court room. But I digress.

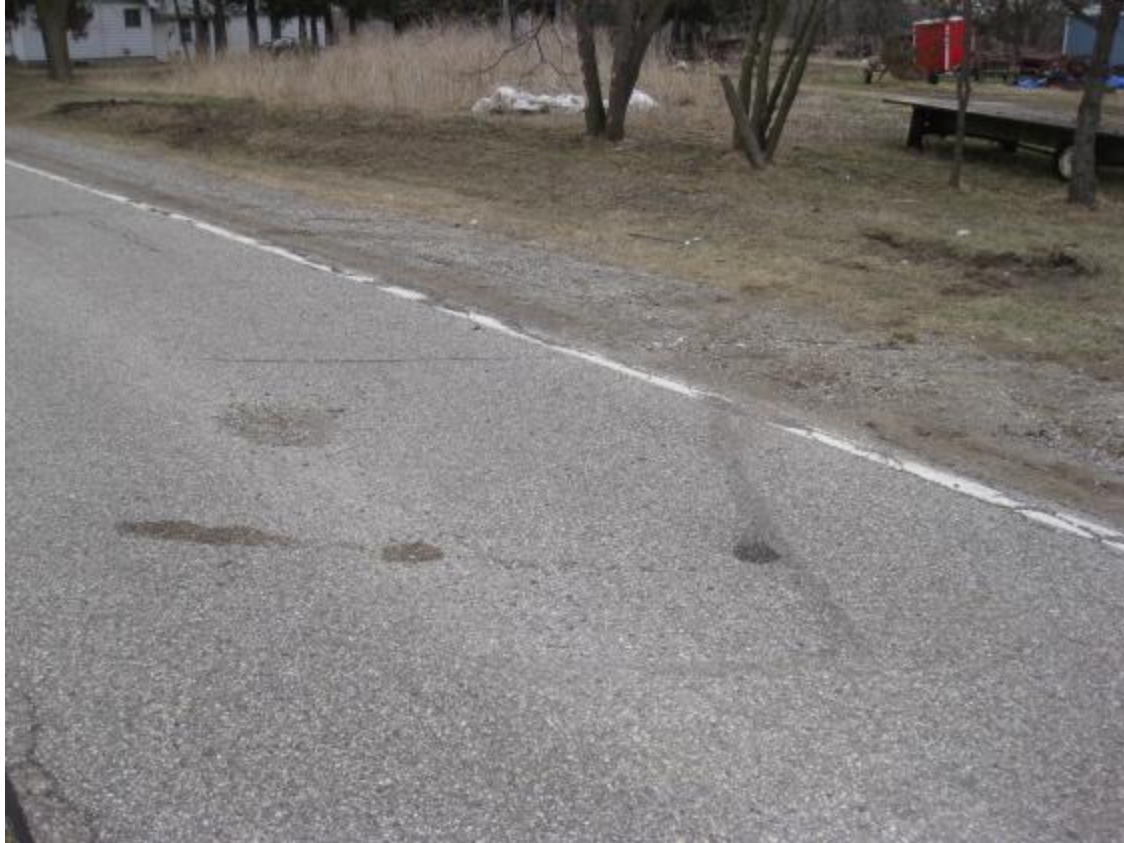
Before closing my comments let me give you some idea of where this vehicle travelled to its rest position as noted in the photo below.

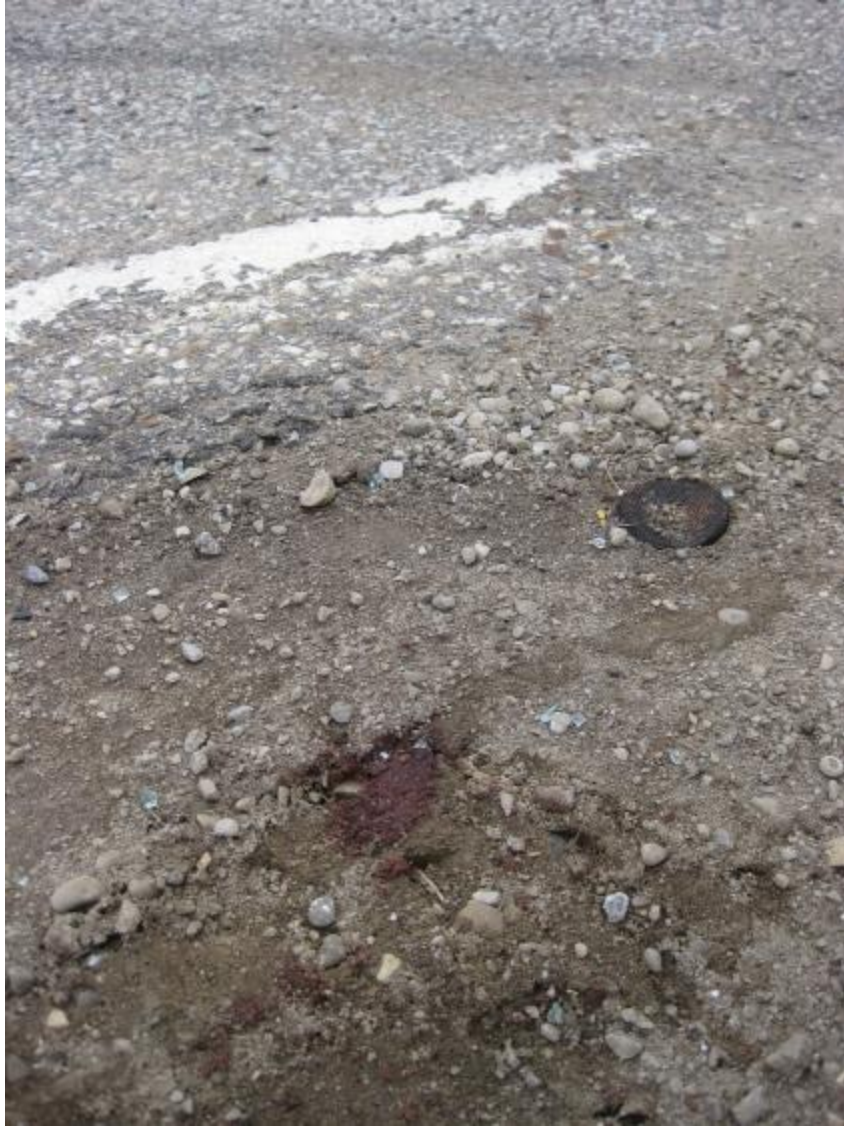
As always you have to be careful about evidence caused by emergency personnel, towing and previous investigations. Particularly at final rest positions, obviously the vehicle would have to be visited by various people and equipment to remove the occupants or to remove the vehicle. So you also have to be familiar with what evidence is created by all these entities. If I was involved in a real accident reconstruction I would have many more details to rely upon. But when I come out to an accident site like this without the benefit of other information, evidence can sometimes be mysterious. In fact, at almost every accident site there is always a multitude of suspicious evidence left behind. Before I close out I will give you one example as shown below.

Larger areas of blood are often indications of the rest positions of the victims. So the photo below would suggest such a rest position. But in the background of this photo is a trail of blood out onto the pavement. The photo below shows that trail a little more closely.

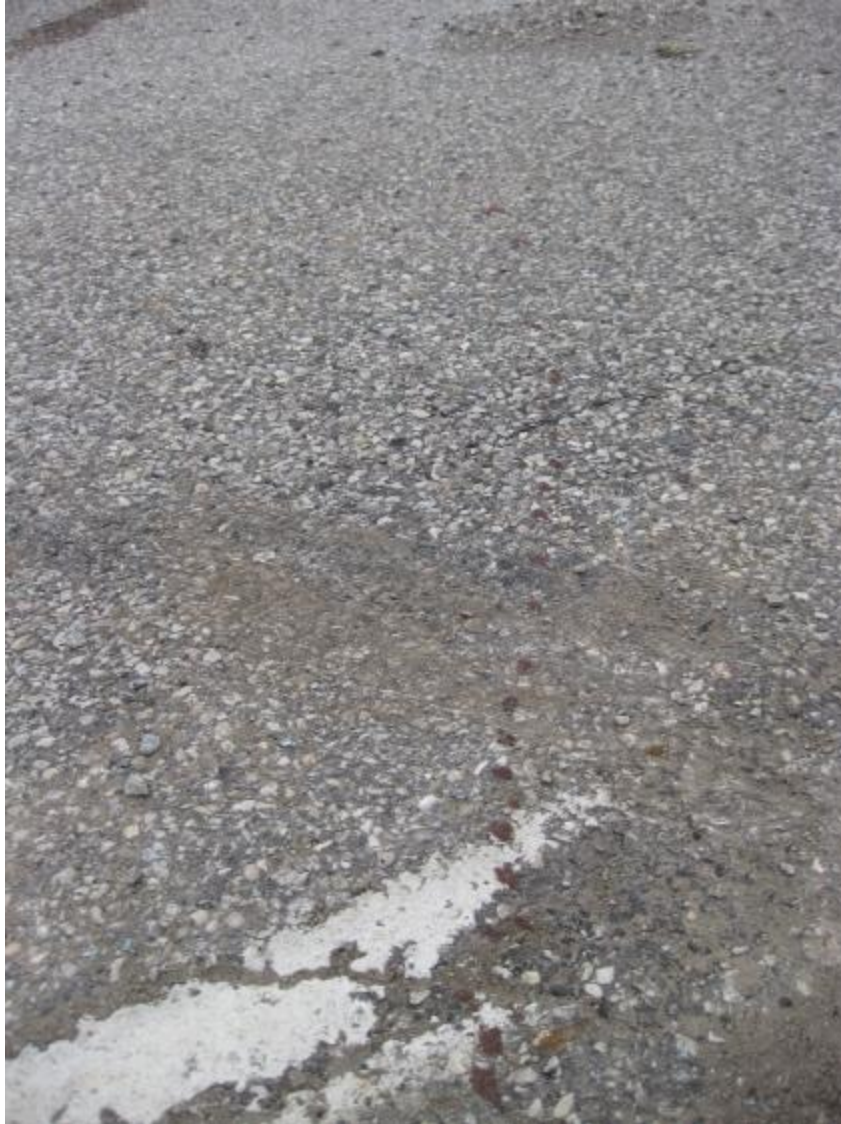
This trail leads from the south shoulder back onto the roadway where there is evidence of a possible rest position of the vehicle. Now, was this trail related to one of the victims or was it deposited when the vehicle was moved, or did something else happen? I won't know but in a real investigation I could find out because there would be much more information available. It is evidence like this which exists all over almost every site where a collision occurs and often this provides a road map of what persons were doing after a collision.
