Fatal Collision on Highway 8 South of Cambridge, May 30th, 2010 - Review of Evidence

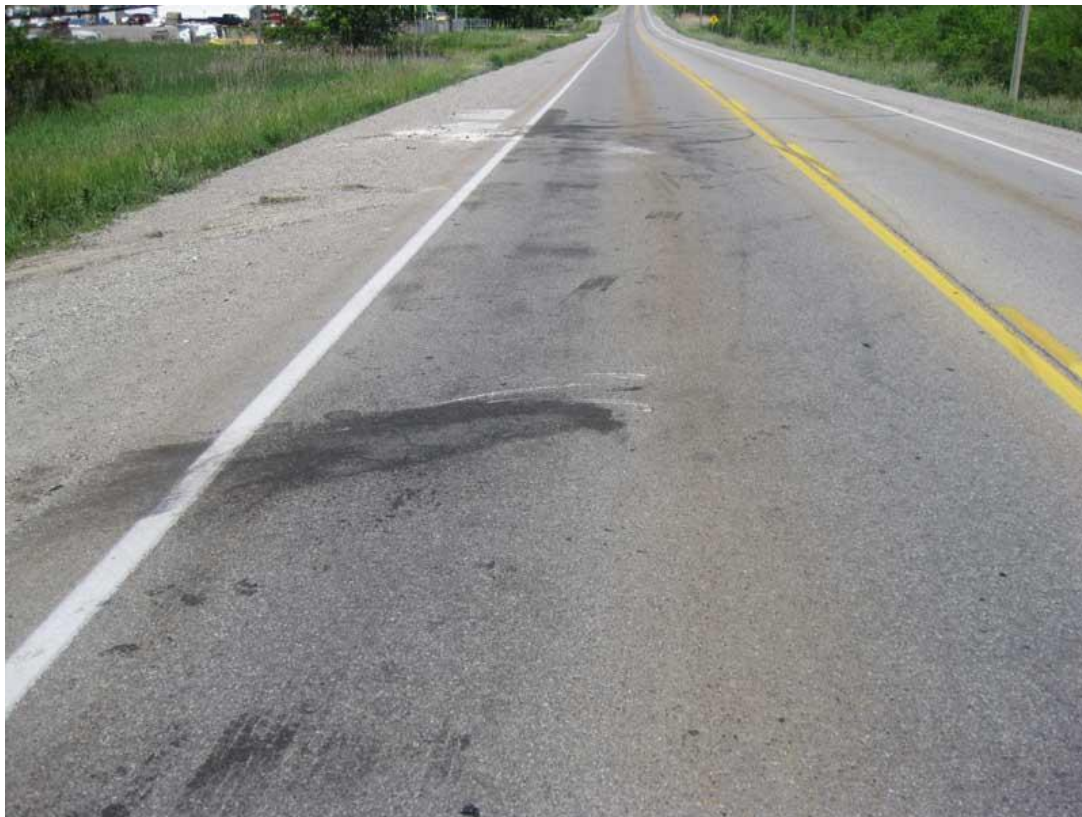
First, here is a view looking westbound at the area of impact in the eastbound lane of Highway 8. The photo was taken on May 31st or just less than 24 hours after the occurrence.

You will note an area of prominent gouges in the eastbound lane in the foreground indicating the point of impact. You will also see a variety of fluid stains in the background where the Mercedes came to rest.

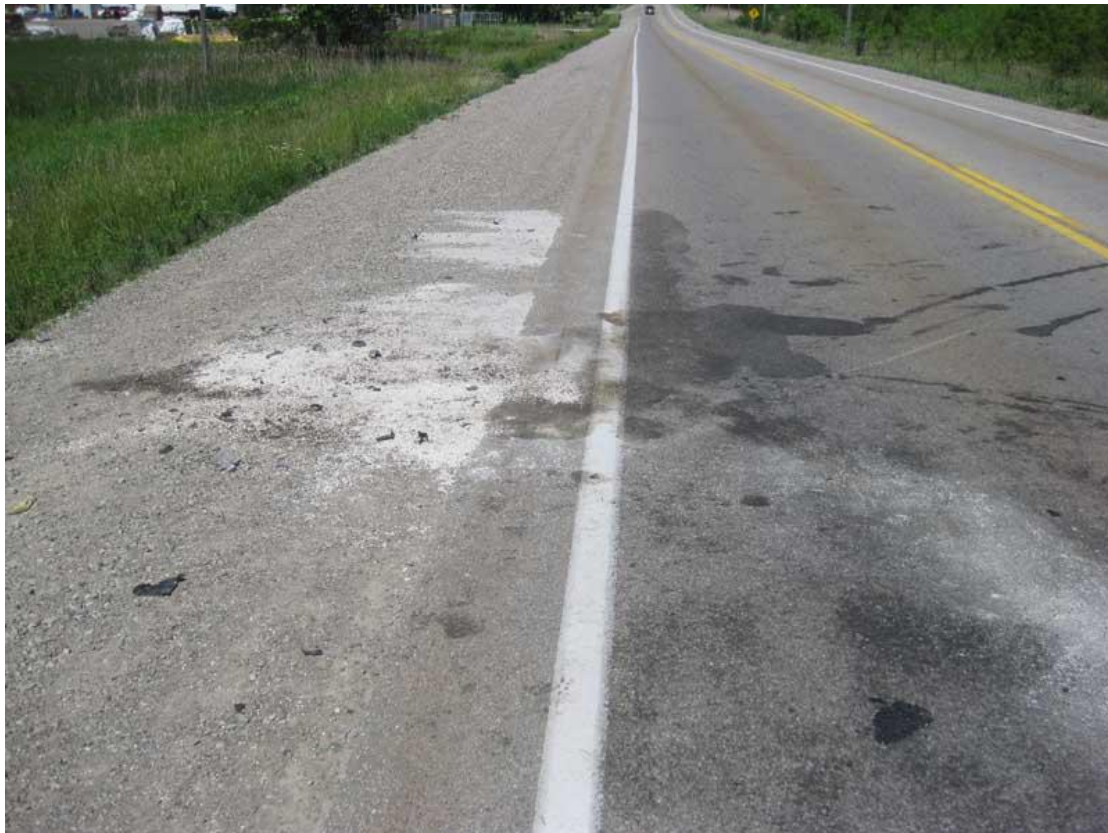
Below is a view looking westward at the evidence at the final rest position of the Mercedes in the eastbound lane.

When examining this evidence the investigator must come to understand what was created as a result of the impact versus what was created by emergency or towing personnel. Sometimes that is not easy. But here it is fairly obvious that the Mercedes came to rest in the eastbound lane and the tow truck then pulled the vehicle across into the westbound lane and then westbound. The white colour material you see is often an absorbent that is placed by emergency or towing personnel to soak up any greasy or oily substances that could be slippery.

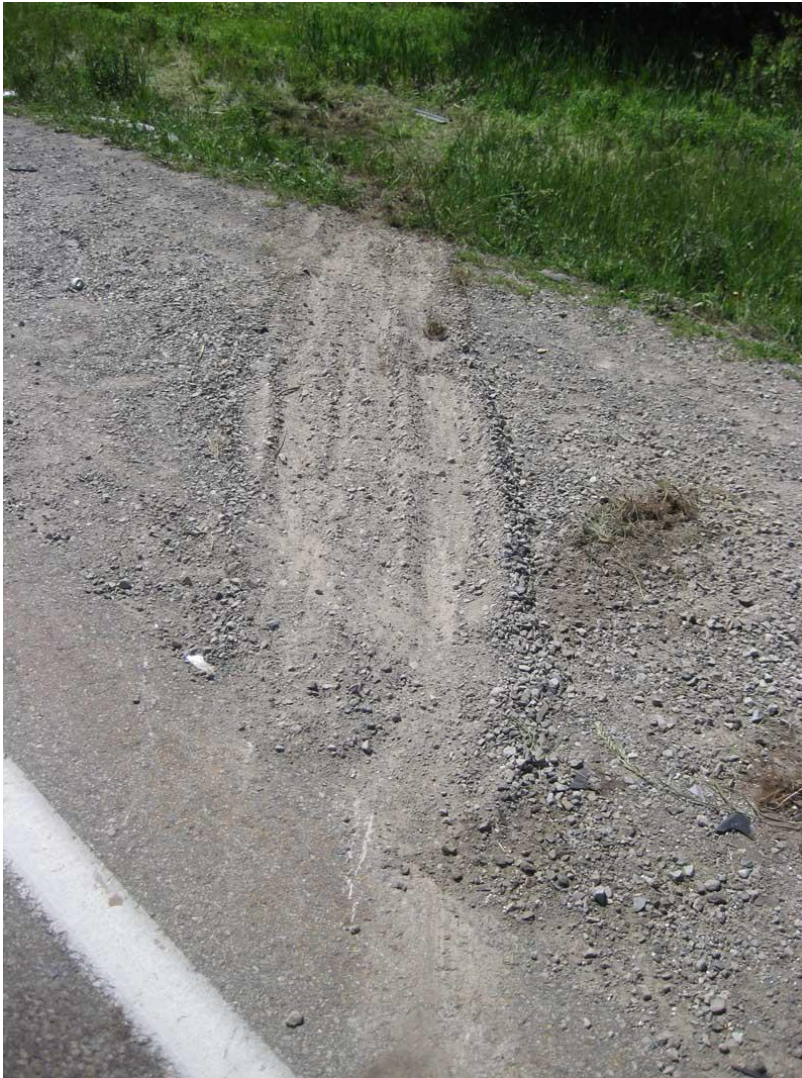
Below is another view, looking toward the south shoulder where the Hyundai came to rest.

The scraping that you see in the gravel of this south shoulder is from towing personnel as they pulled the Hyundai out of the ditch. This is fairly typical of what you would expect to see.

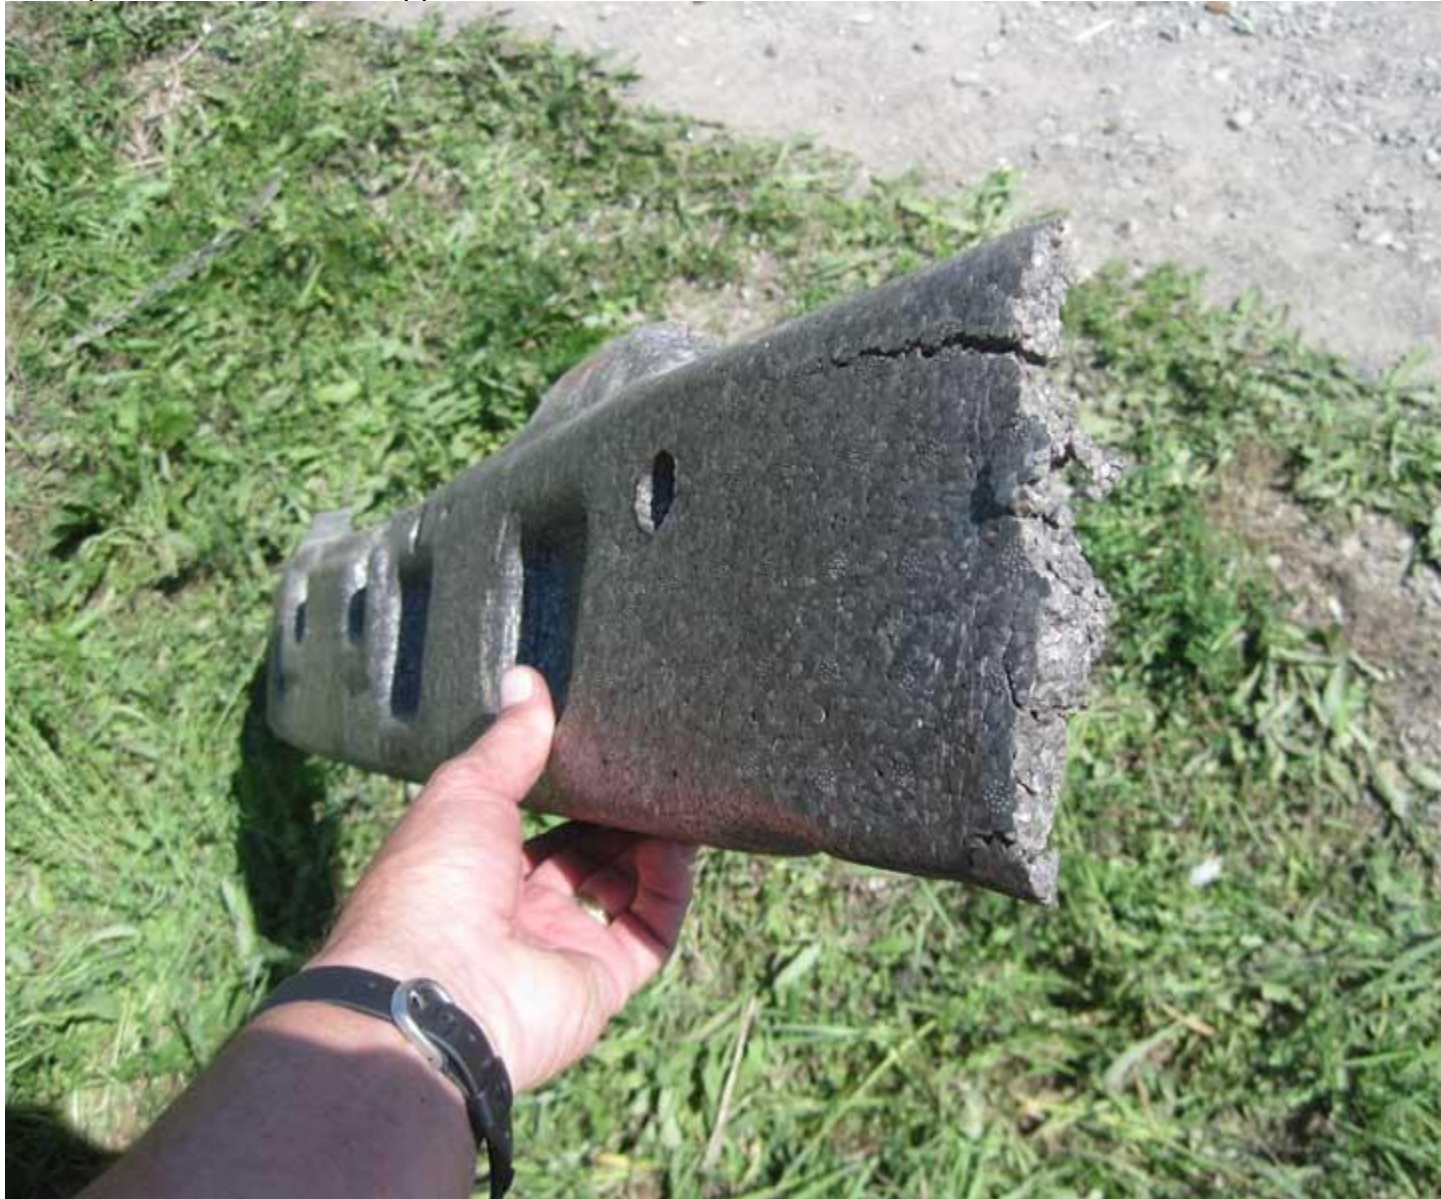
The more educational evidence is revealed when we look at some of the debris that was left scattered on the ground. For example, below is the energy absorbing filler (foam core) that forms part of the front bumper of the Hyundai. This would be the foam-like material that would be located just behind the plastic fascia of the front bumper. What should attract you is that this energy-absorbing material is essentially intact.

Now recall that this is supposed to be a head-on collision that resulted in fatal injuries to the driver of the Hyundai. So the front of the Hyundai should be receiving the brunt of the impact force. Yet there appears to be no deformation/fracture of this material.

Alas, after careful study you discover that indeed there is some damage to the left end of this foam core. But is it consistent with a major frontal impact that would cause the death of a young driver? Let's look at the backside of this foam core, as shown below.

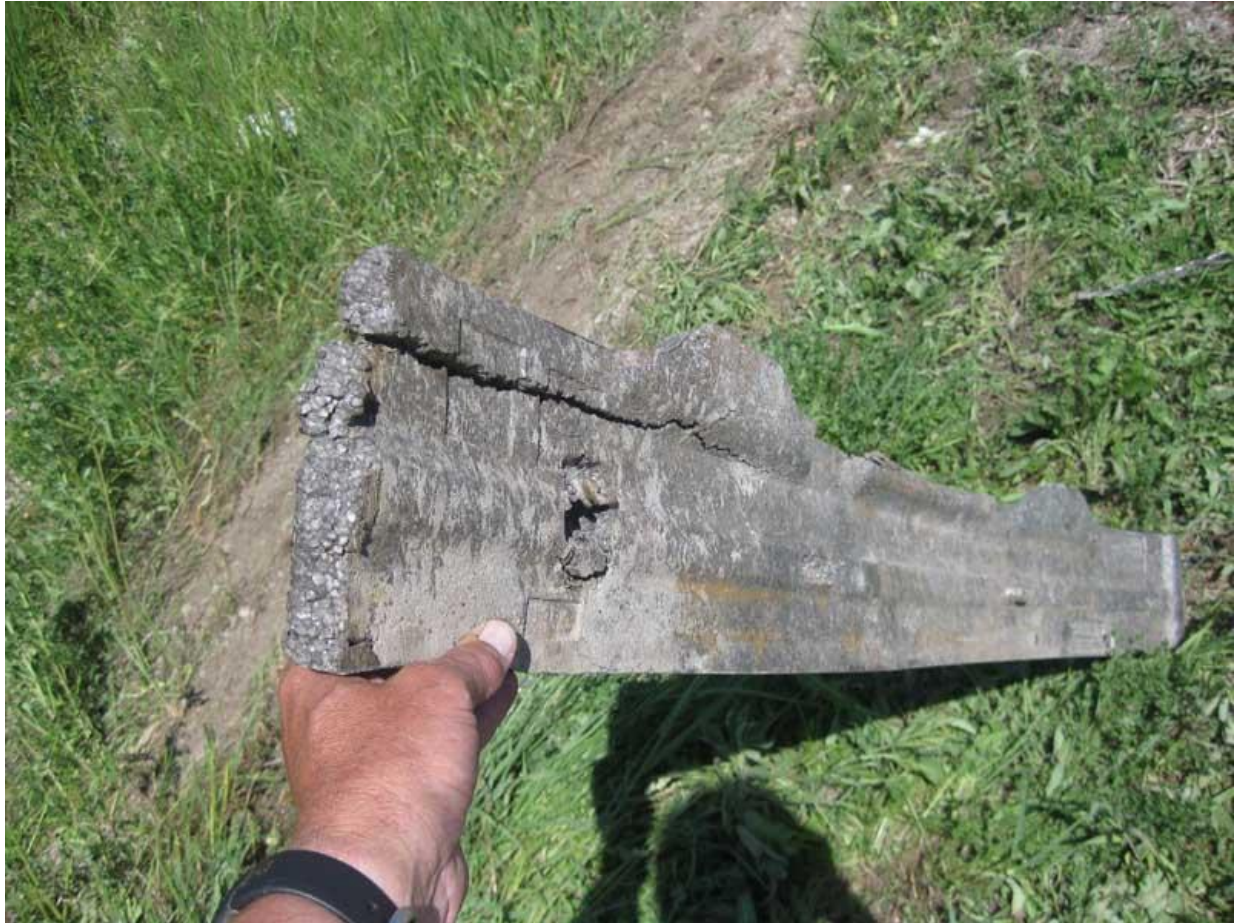
Above we are showing the backside of the left end of the foam core. Again, some damage is visible at the left end, but not much. I would think you should be questioning why this is so.

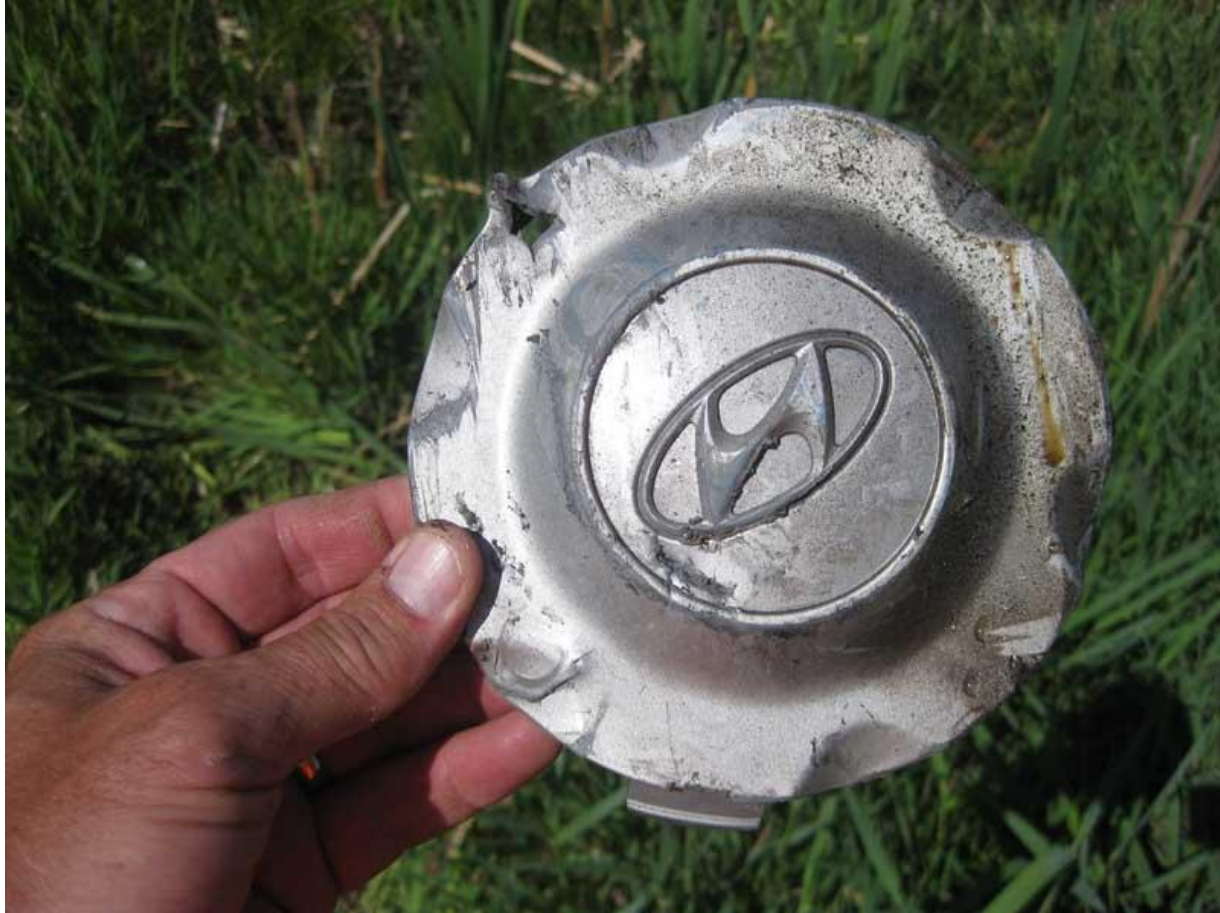
If you look closely at the transfers onto this plastic you will likely observe a distinctive blue colour of some of those transfers. Investigators in Ontario recognize this blue colour because it comes from the blue colour of Ontario license plates. Ah, the plot thickens.

Why are there blue license plate transfers on the hub cover of the Hyundai left front wheel? This can only come from the centre of the front end of the Mercedes. But why is the centre of the front end of the Mercedes located at the left front wheel of the Hyundai in this severe head-on collision? Let me give you a likely explanation that matches what has been observed at the foam core of the Hyundai.

The young driver of the Hyundai attempted to avoid the Mercedes by steering toward the right, or toward the south shoulder. This caused the Hyundai to be pointing at a slight angle toward the right shoulder. The two vehicles made initial contact such that only a small portion of the Mercedes left-front end made direct contact with a small portion of the Hyundai's left-front end. This was a very narrow zone of direct contact that would likely be coded something like 12FLEE-? in the Collision Deformation Classification (CDC). I use the "?" mark in the deformation extent zone because the rearward displacement of the direct contact along the Hyundai's front left side could be substantial and could result in structural intrusion into the driver's space.
