Fatal Pick-up Truck Collision on Perth County Rd 112 on July 29, 2010 - Was Visibility A Factor?

Posting Date: 29 Jul 2010

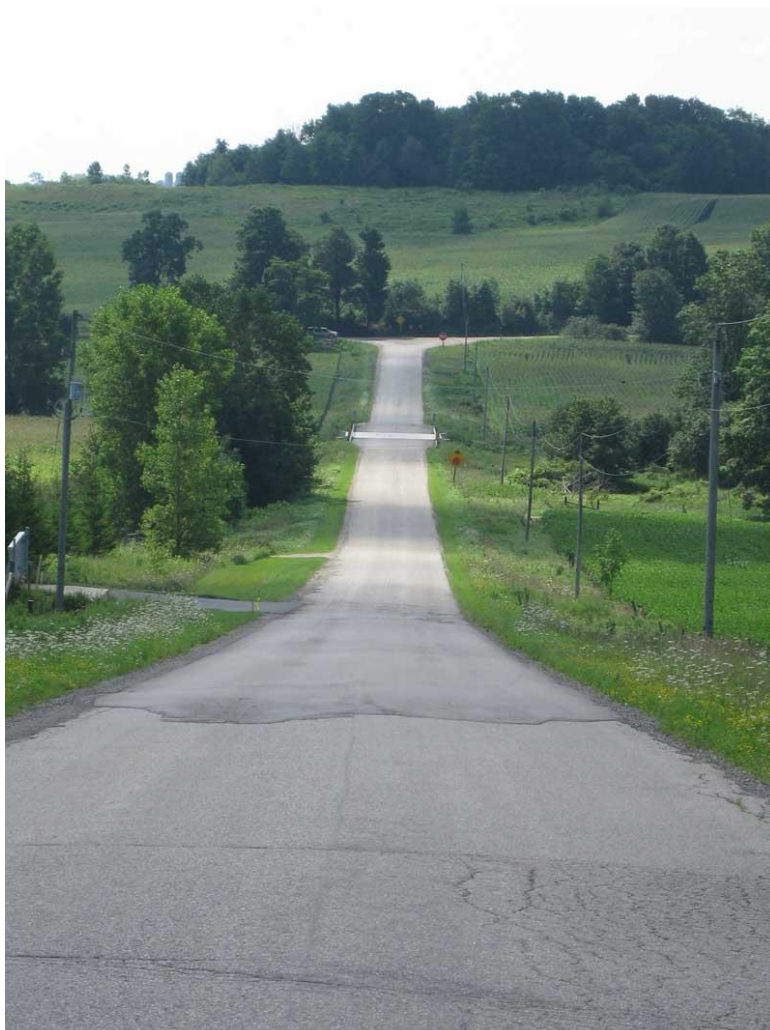
You can see how the vehicle travelled along a down-slope of the road and crashed at the T-intersection in the background. Next we present an intermediate-distance view which is closer to the intersection:

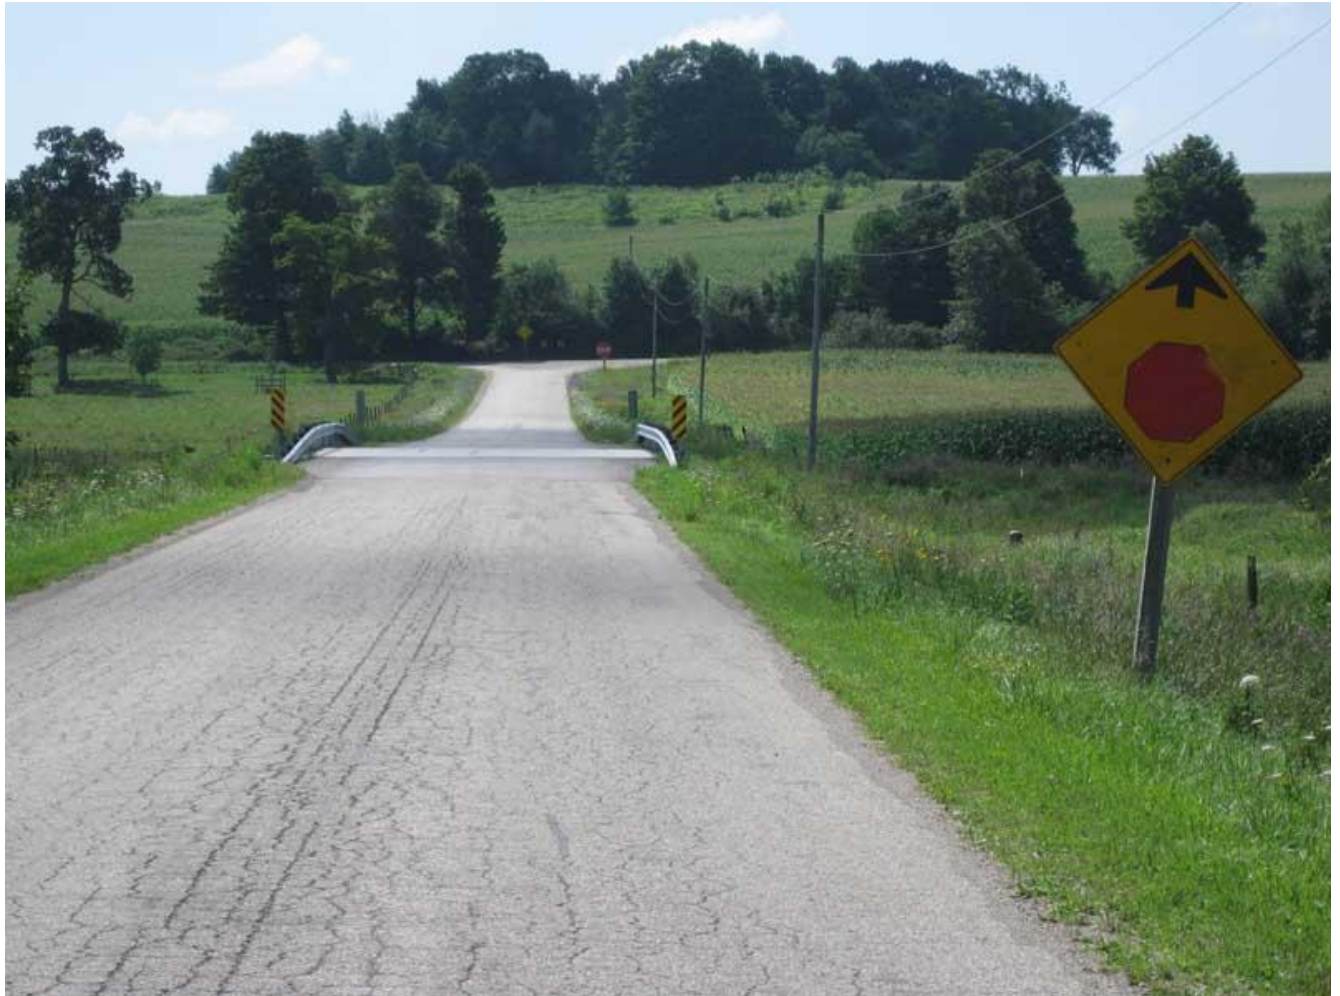
You should now be able to see the Checkered warning sign and yellow Chevron signs indicating the termination of the road.

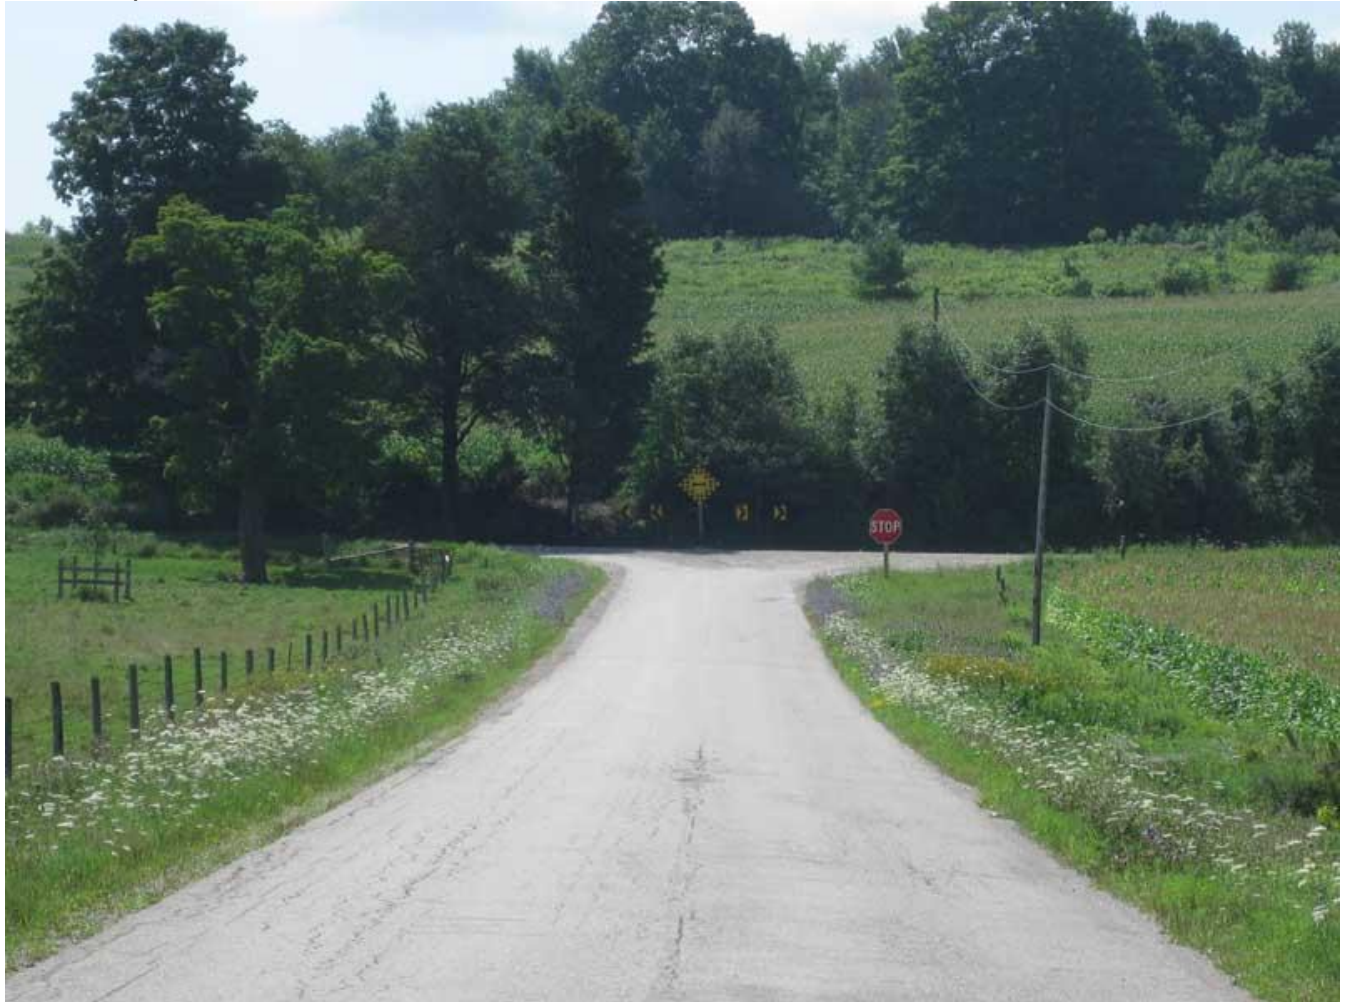
You should be able to note two trees located to the left (east) of the signs and this is where the vehicle came to rest and became engulfed in flames. The tree closest to the signage is the one that the Pick-up truck struck before it rotated to a position between the two trees. Looking at this last photo you should recognize that the truck did not simply travel straight down the road to impact but that it moved to the left (east) by several metres as it approached the impact. This would suggest that the driver attempted to steer to the left before impact.

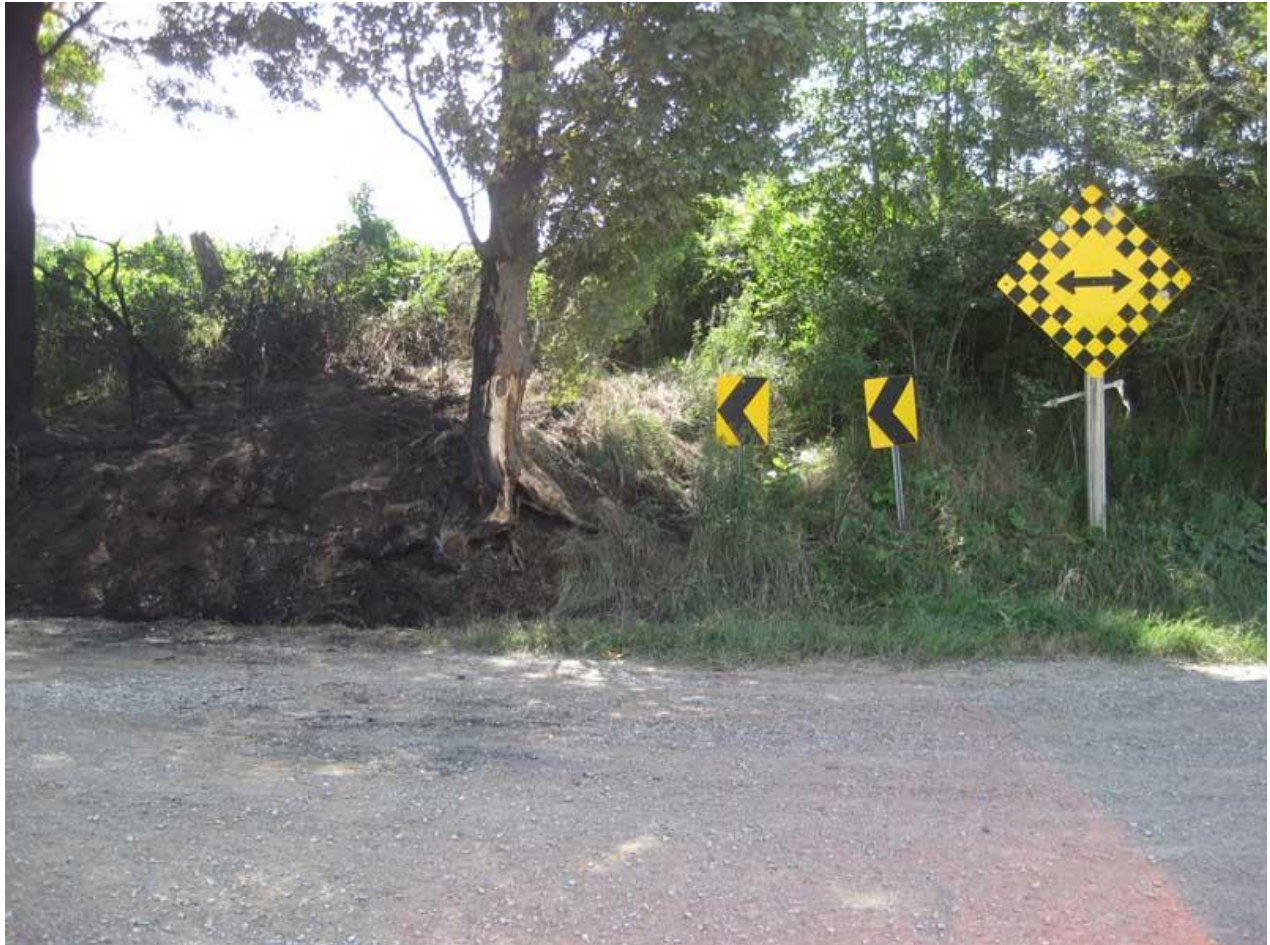
Below is a southbound view showing the signage and the struck tree located just to the left (east) of the signs. Further to left (east) you should recognize the blackened area where the vehicle burned.

The extent of damage to the struck tree is evident from the amount of bark that has been removed and from the amount of scarring to the wood beneath it. Even without seeing the vehicle this evidence would tell us that the impact was at highway speed. One would tend to question at this point why such a high speed impact would occur when the site photos would suggest that the signage was quite visible.

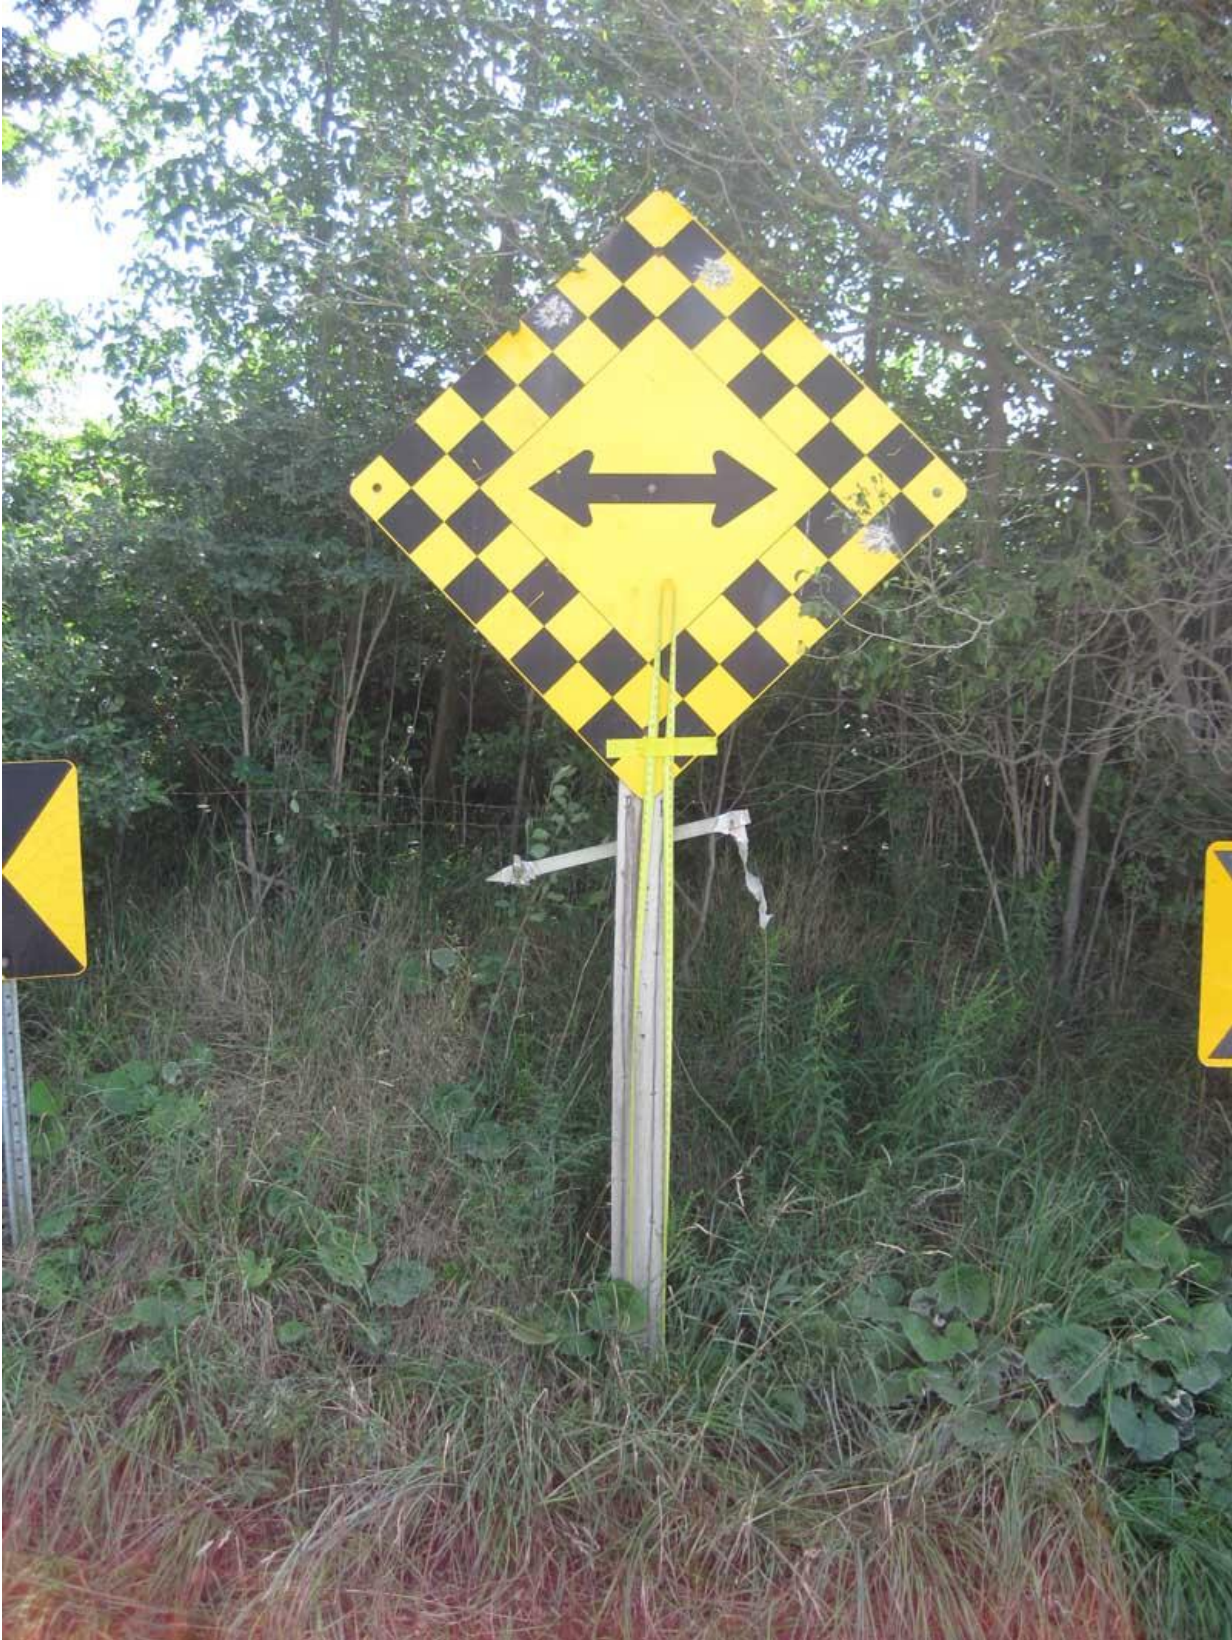
nearby roadway. The photo below shows a measurement tape being placed at the sign to note how high it is relative to the ground around it.

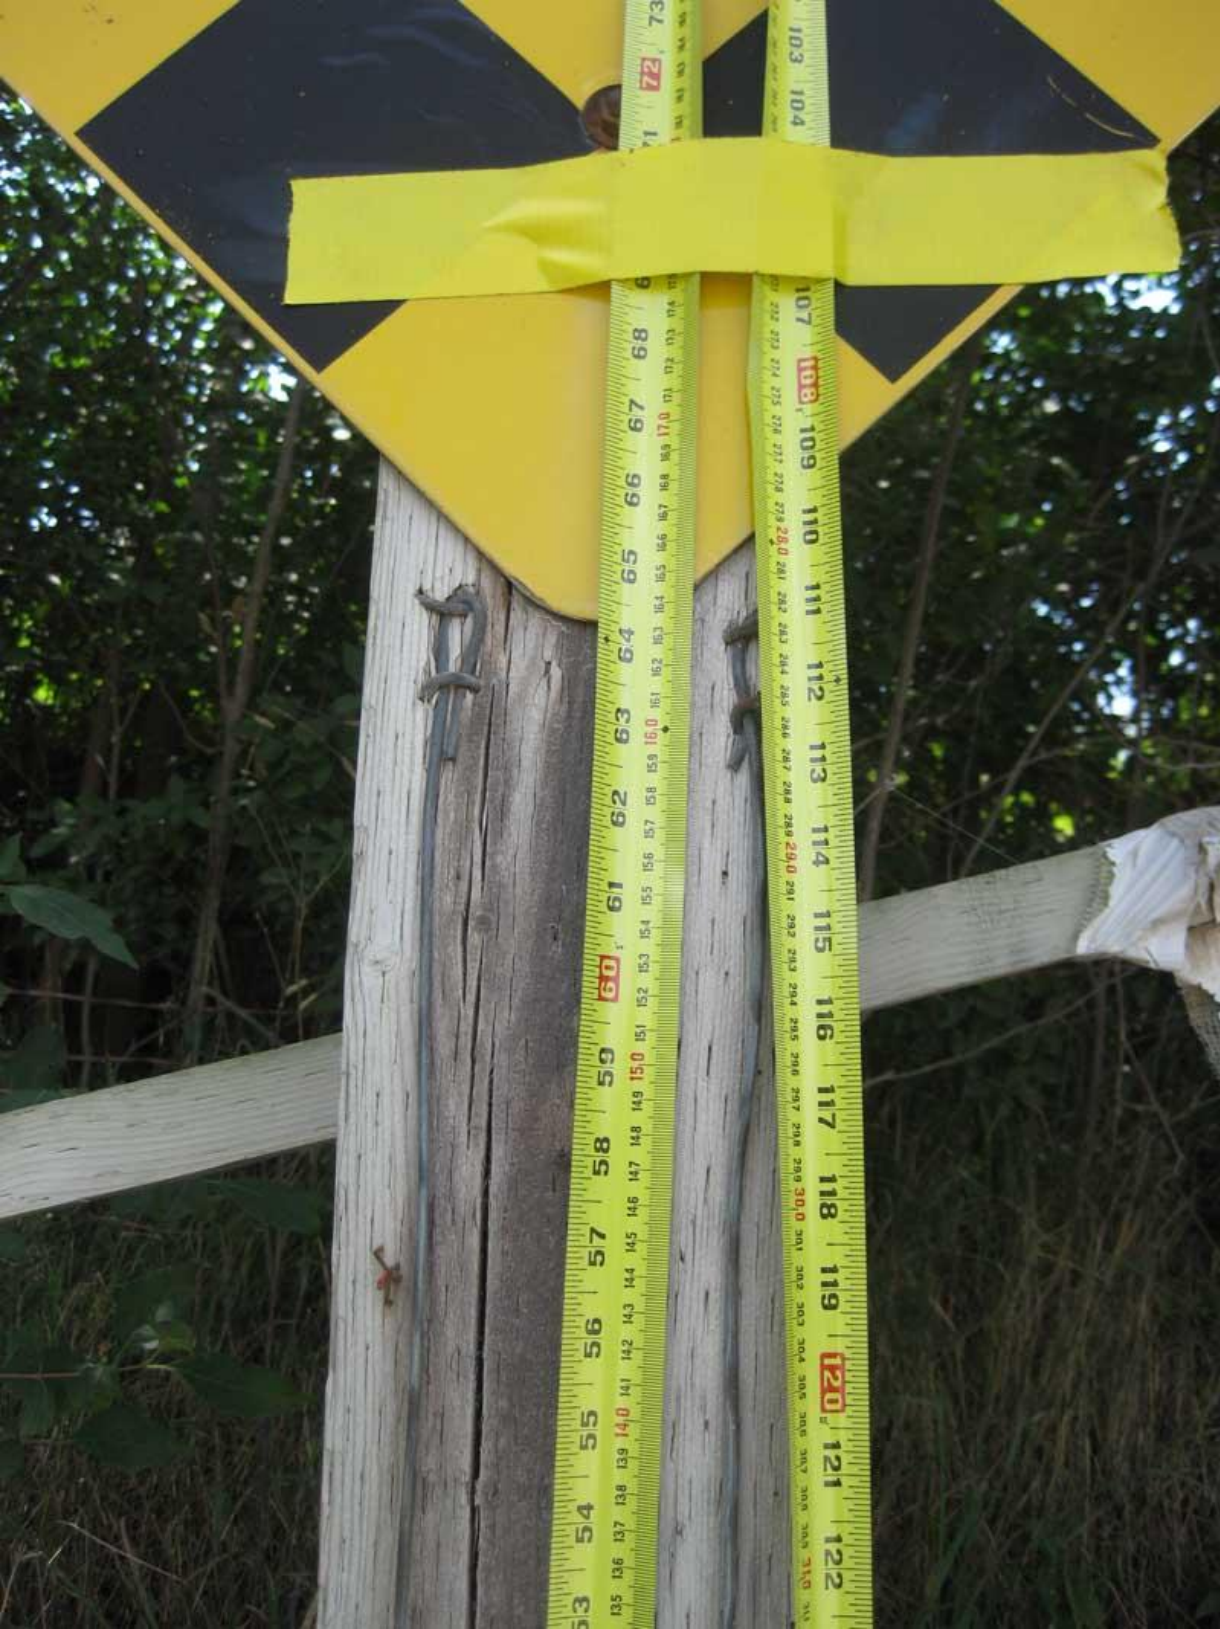
Below is a closer view of the tape showing a height of 163 centimetres to the bottom of the sign.

Obviously this measurement is not sufficient because we still do not know the actual vertical position of the sign with respect to the aim of the vehicle's headlight as the vehicle is approaching the sign. Total Station data should reveal this but a photo like the one above helps to explain matters that might come up at a trial. An investigator might attend the site at night and place a vehicle at several locations along the road with its headlights on, preferably on high beam. The investigator could then use two procedures involving reading from a light meter. First he could stand at the position of the vehicle and take spot-meter readings. Spot readings are ones that measure the amount of reflected light coming back to the observer. Measurements can be taken of the sign but also of the background to consider the difference in contrast. A second procedure might involve the investigator standing in the vicinity of the signs and taking illumination readings. Readings of illumination would tell the investigator how much light is reaching the area at the signs. Light readings should be taken at differing heights because the amount of light thrown onto an area will differ such that the headlights might provide sufficient illumination of the ground just below the sign but not the sign itself.

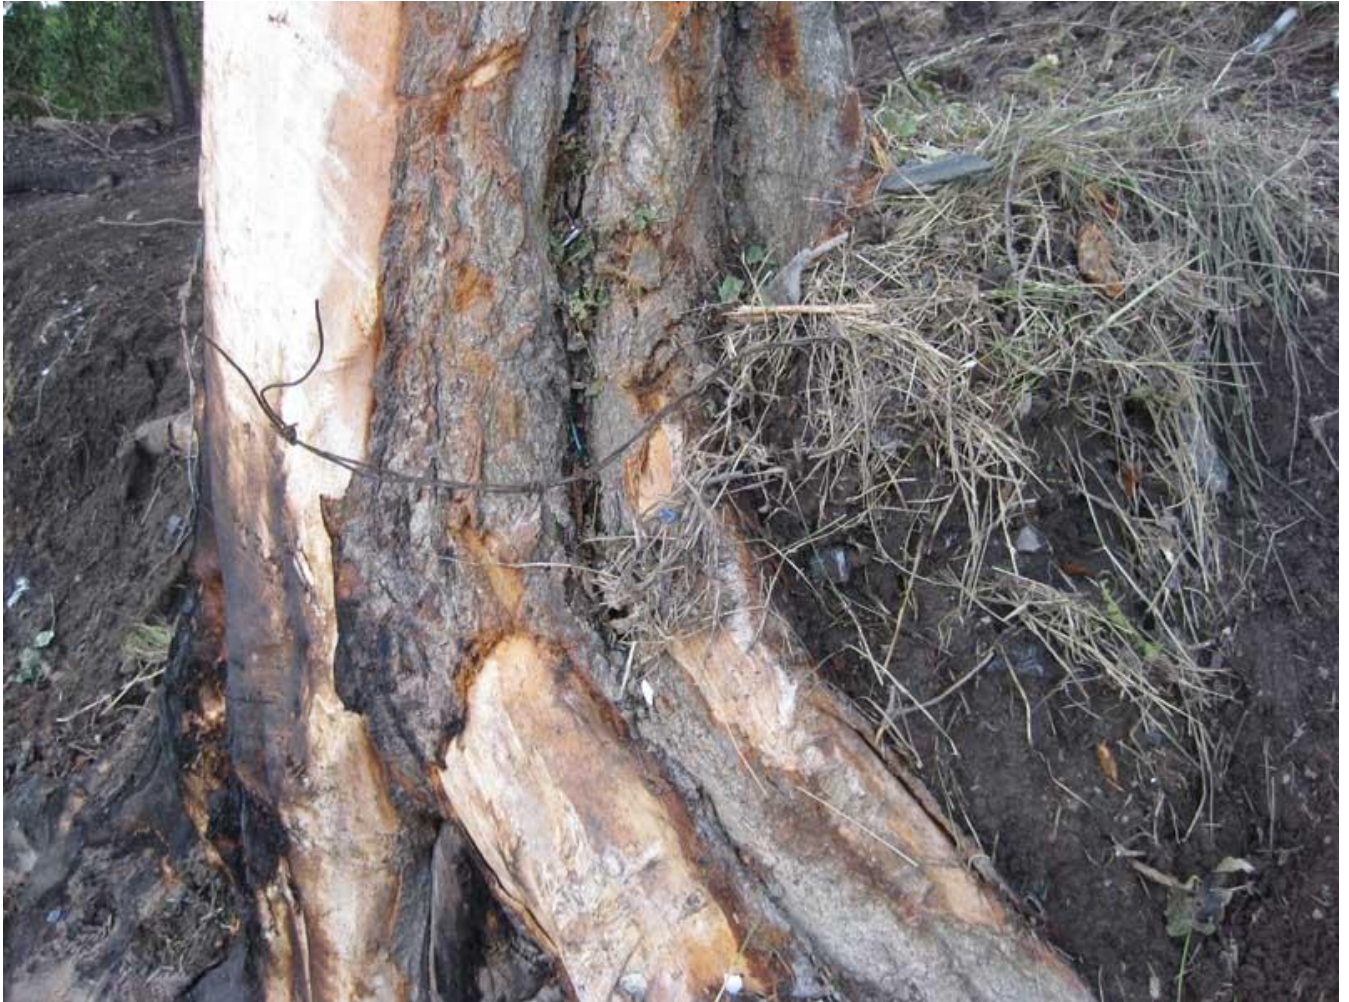
Look closely below and see if you can find the metal reflector from a headlight that is imbedded in the embankment.

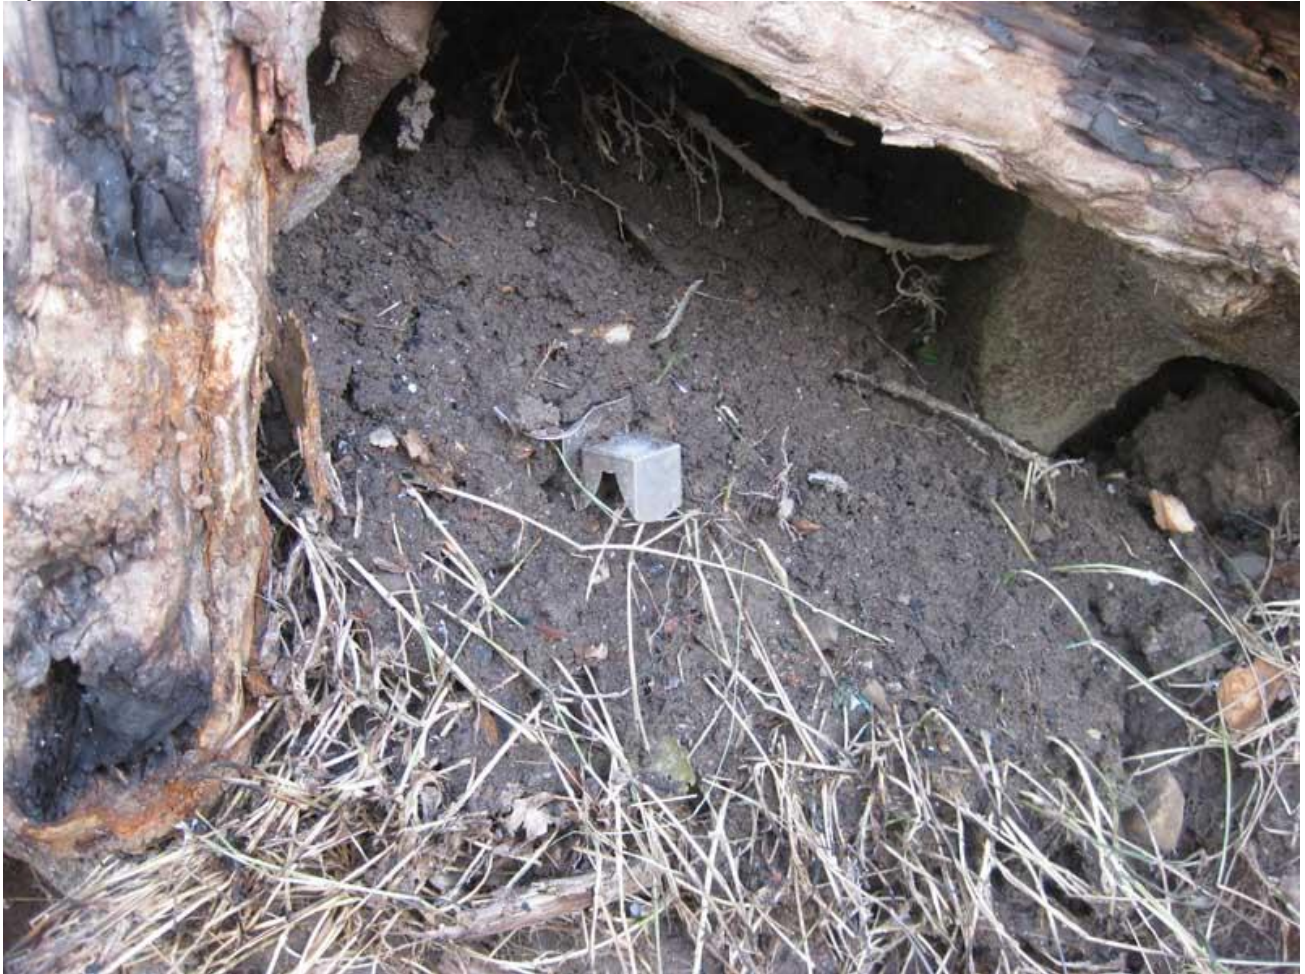
Once you see that this reflector is imbedded in this location then you know that other parts of the headlight must be somewhere nearby. It is apparent that the police investigators in this case did not look closely enough because they did not find the helpful evidence. Slightly higher and to the right of the reflector we can see the housing of the filament imbedded in the earth as shown below:

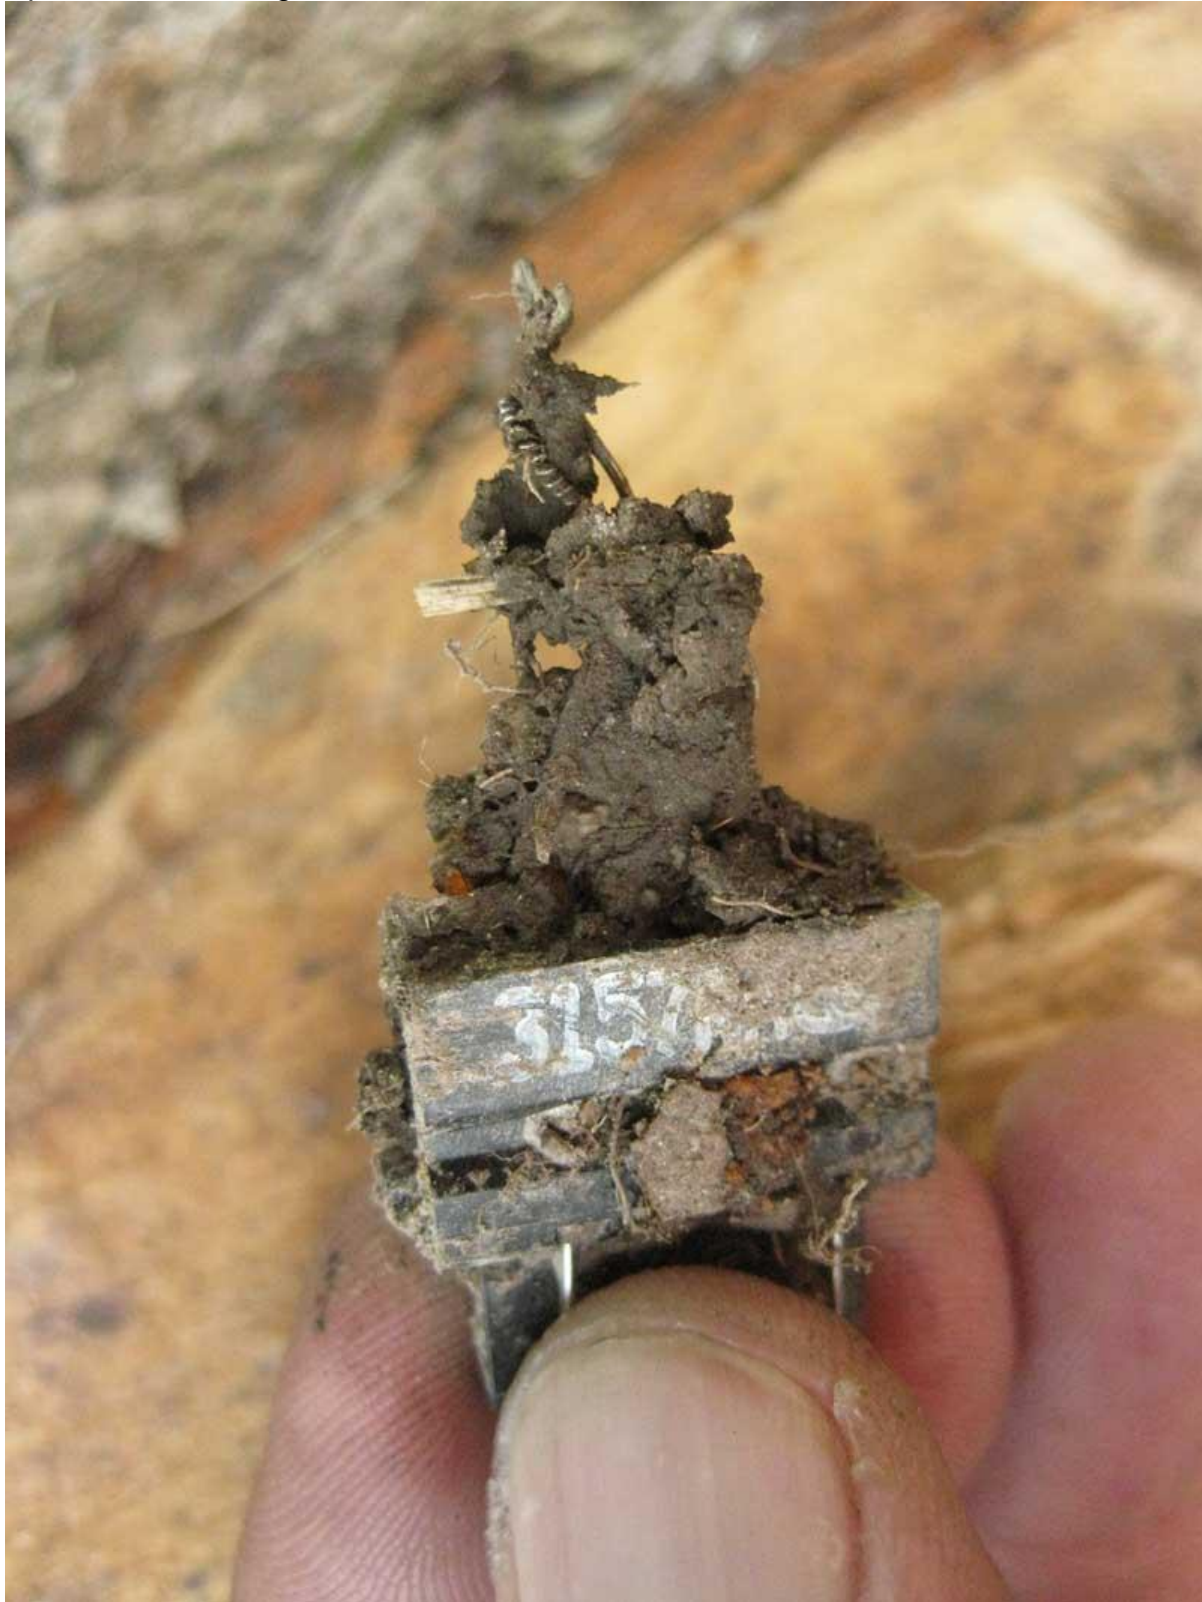
I pulled this housing out of its imbedded location and we can see it below.

You should be able to see the coils of the filament.

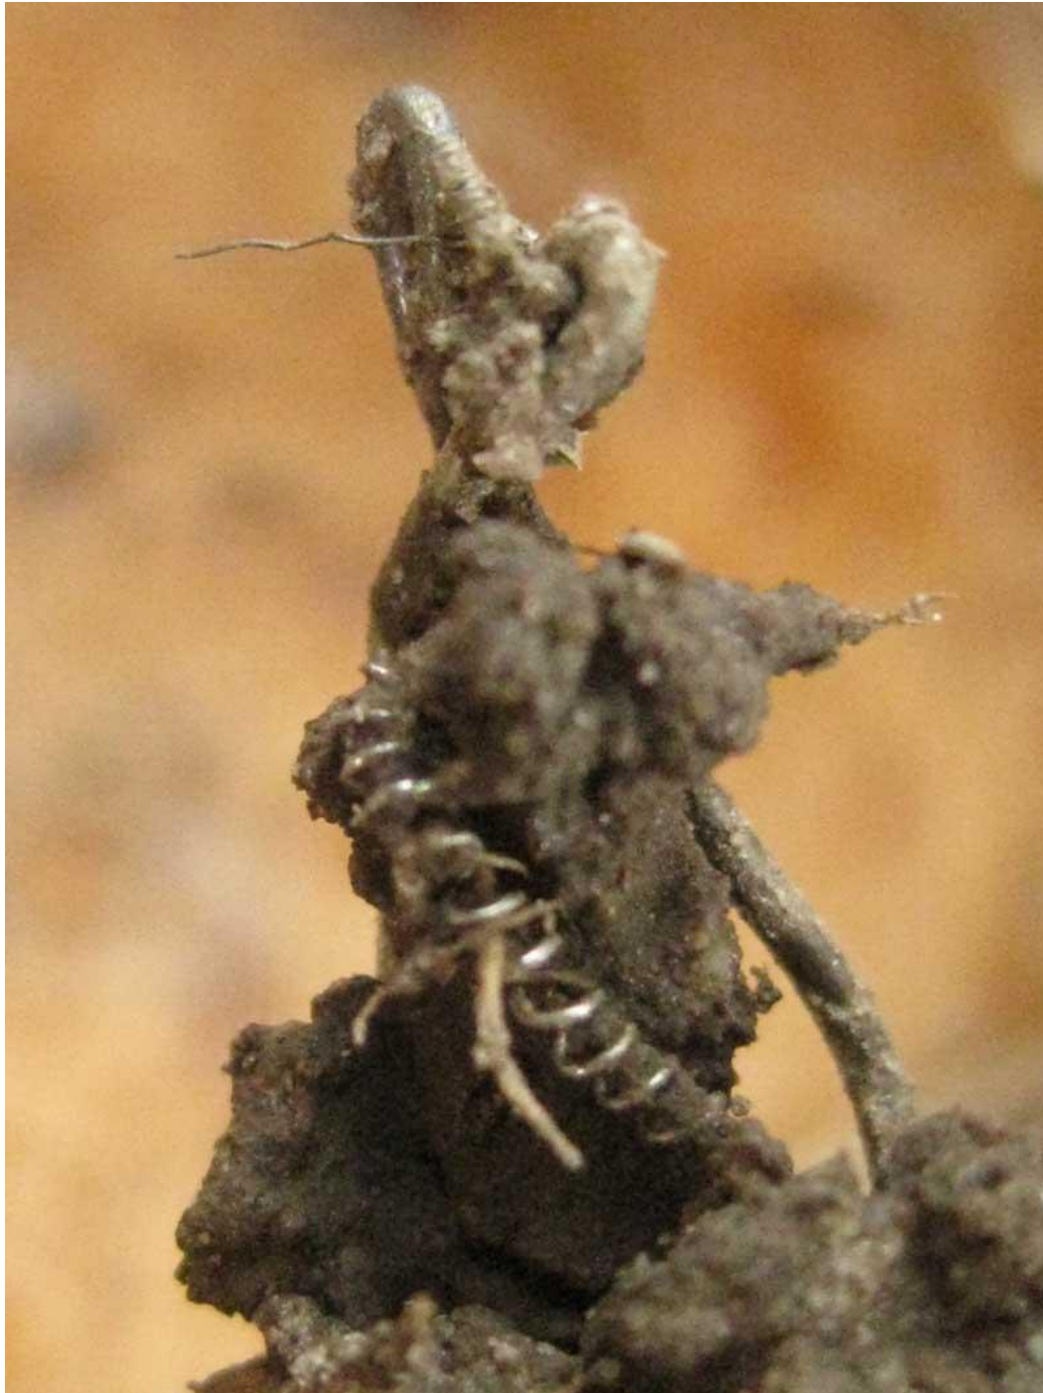
Now for all you budding CSI experts, tell me what you see. Are the filaments stretched indicating hot shock (headlight was on) or are the filaments perfectly wound in their pre-crash condition? Send me your opinion.
