## **Fatal Angle Collision Embro Road & Perth Road 26 South West of Stratford, Ontario, August 13, 2011**

*Posting Date: 141 Aug 2011*

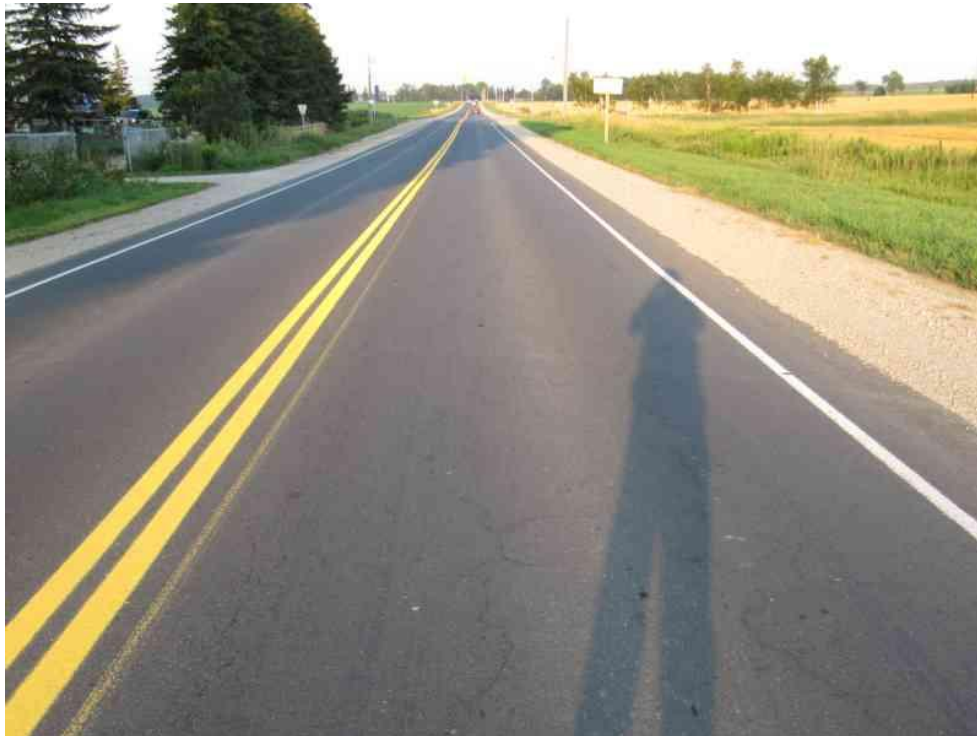
First we see a view looking eastward along Perth Road 26 and this is the view that the eastbound Cruze driver would have seen as he approached Embro Road.

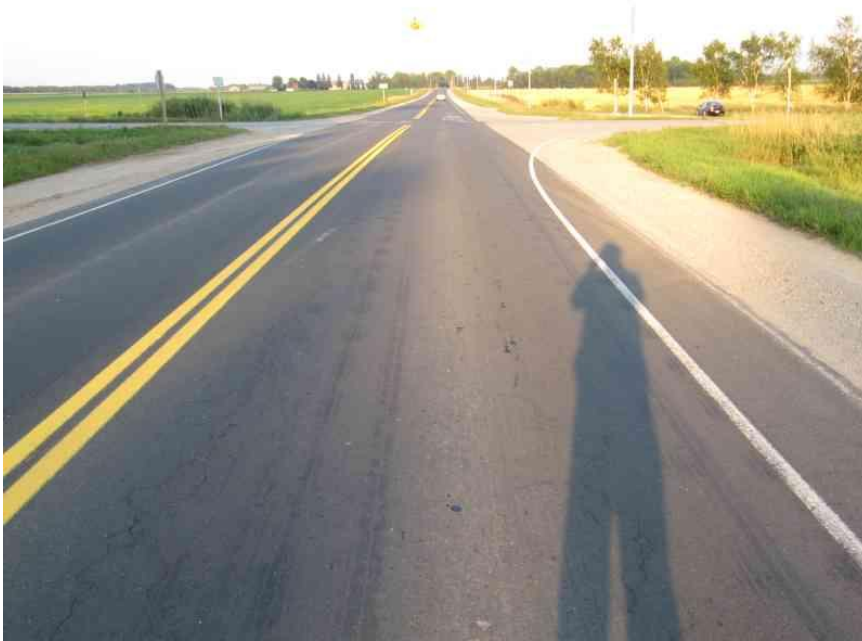
As we get closer to the intersection we can begin to see the Embro Road. Mr. Fildes was crossing from the right to the left in this view.

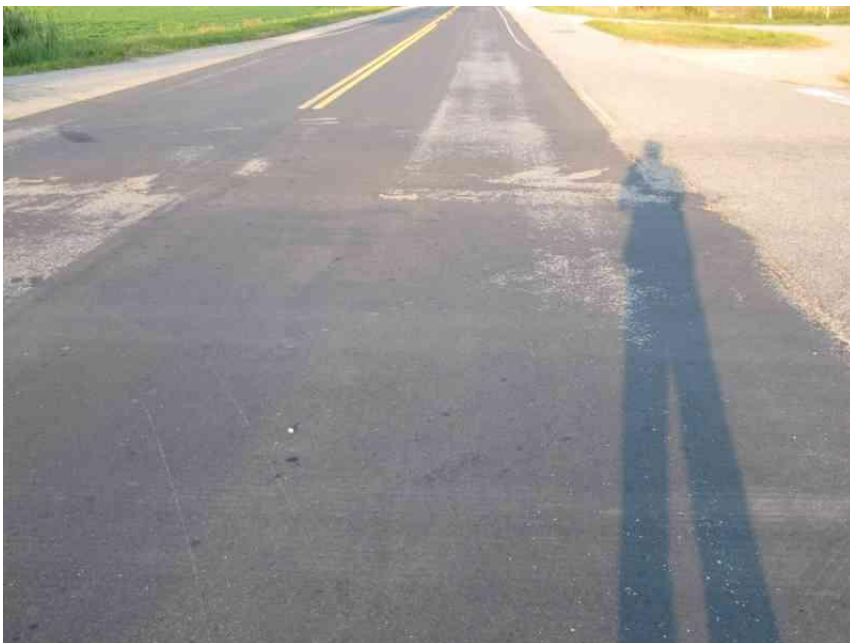
As we approach the intersection of the two roads you can note that there are no visible skid marks from the Cruze but also note that this vehicle is, at most, likely more than a year old and its more modern technology might have influenced the evidence of any pre-crash braking. What you should also observe is that there is no physical evidence of an impact within the eastbound lane of Perth Road 26.

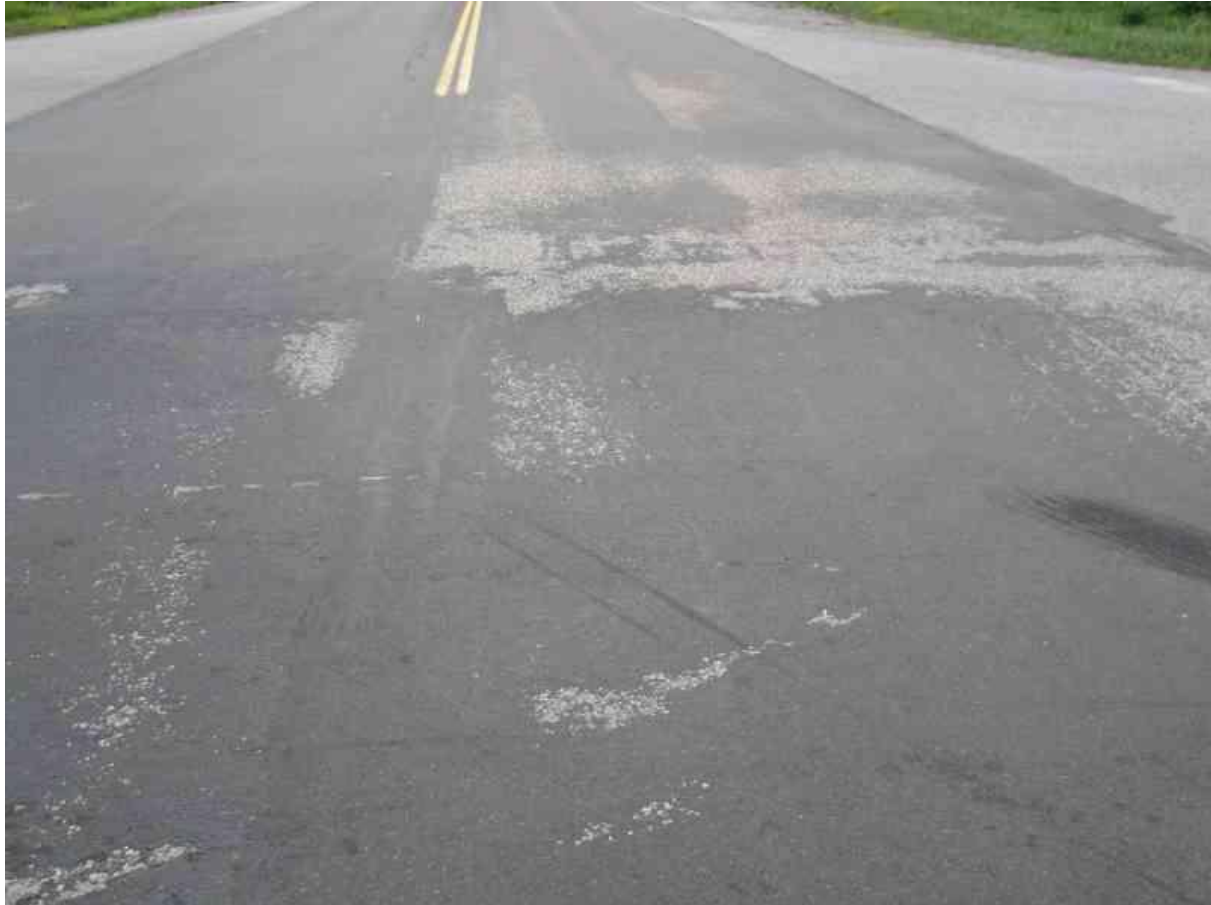
But as we approach closer we can see some tire marks on the other side of the roadway centre-line. This viewed better rotating around 180 degrees and looking back westbound as noted in the photo below. So in the photo below the Cruze is approaching the camera and you should see two tire marks to the north or right side of the roadway centre-line.

If you have followed any of my previous articles you should be expecting fresh gouges in the pavement in the vicinity of where the vehicles struck. But there are no gouges. This is a little un-common but not terribly so.

But the above photo shows that the two tire marks start to show up a fair distance to the north and this is beyond what we would expect if the Cruze was simply travelling within its own lane at impact. Instead the evidence would be better explained if the driver of the Cruze steering left just before impact in an attempt to avoid the collision.

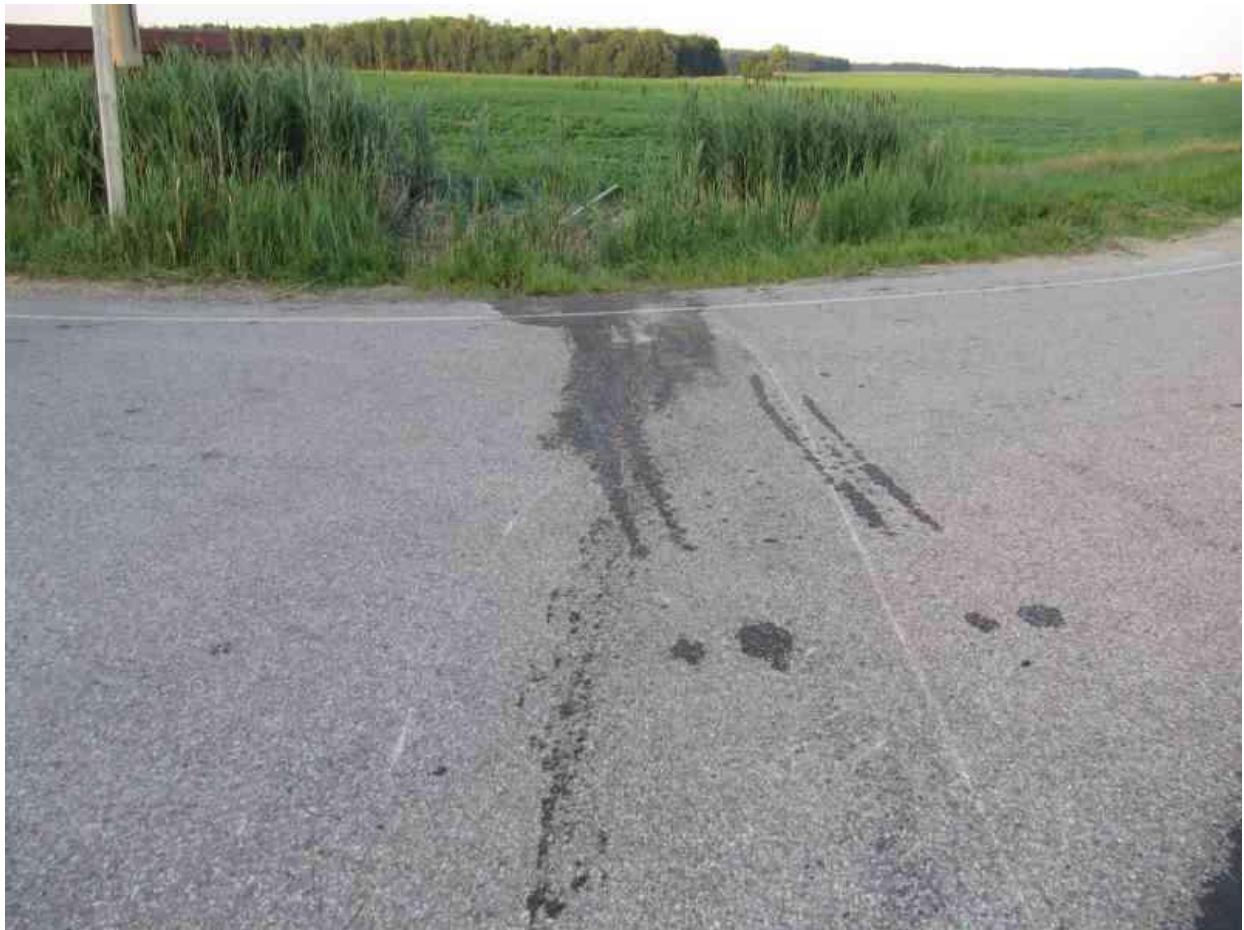
But there is an indication that the severity of this impact was reduced, either by the Cruze driver driving at a reasonable speed or because he or she applied the brakes before impact. I say this because of the final rest positions of the vehicles. Below is a view looking north east from the area of impact and looking toward those rest positions.

As is typical, you see the usual scrapes and scratches in the pavement and the spray of dark fluid as the front end of the "front-impacting" vehicle spills its engine fluids. You will note the large stain of dark fluid and that will be the final rest position of the front end of the Cruze. So the Cruze did not travel very far after impact and that should be an indication to you of its speed, regardless of any calculations. The other thing that

should catch your attention is the angle at which both vehicles departed the impact. The travel path of the Cruze was re-directed substantially as result of the impact and that is an indication of its moderate impact speed. Look at it this way, if the Cruze was just flying down the road at tremendous speed it would knock the Toyota out of the way and then it would continue to travel along a similar travel path to the path it took just before impact. Think about Momentum: Velocity X Mass.

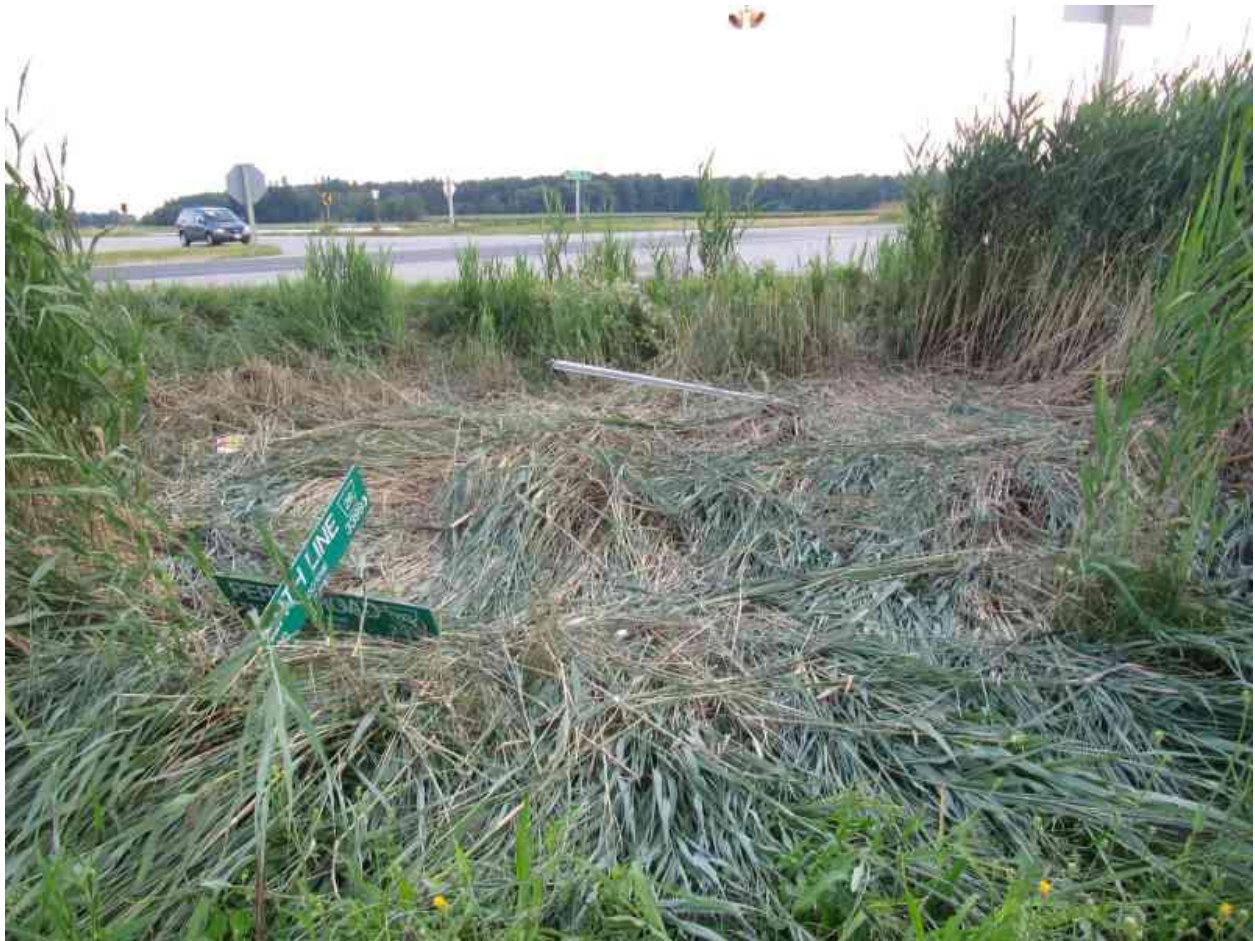
Below is a view from the north east looking back toward the area of impact.

Yes, there is evidence that the Toyota travelled some distance into the tall grass after impact, but that is mostly the case in fatal angle collisions. But when we compare this travel distance to other fatal collisions we will see that this distance is not large. So the Toyota was also not travelling "very quickly" after impact and it matches the belief that it had come to a stop and then pulled out just before impact as opposed to simply driving through the stop sign without stopping.
