Fleeing Police On Glanworth Curve Likely Involved Ice and Loss of Control Impact Into Tree

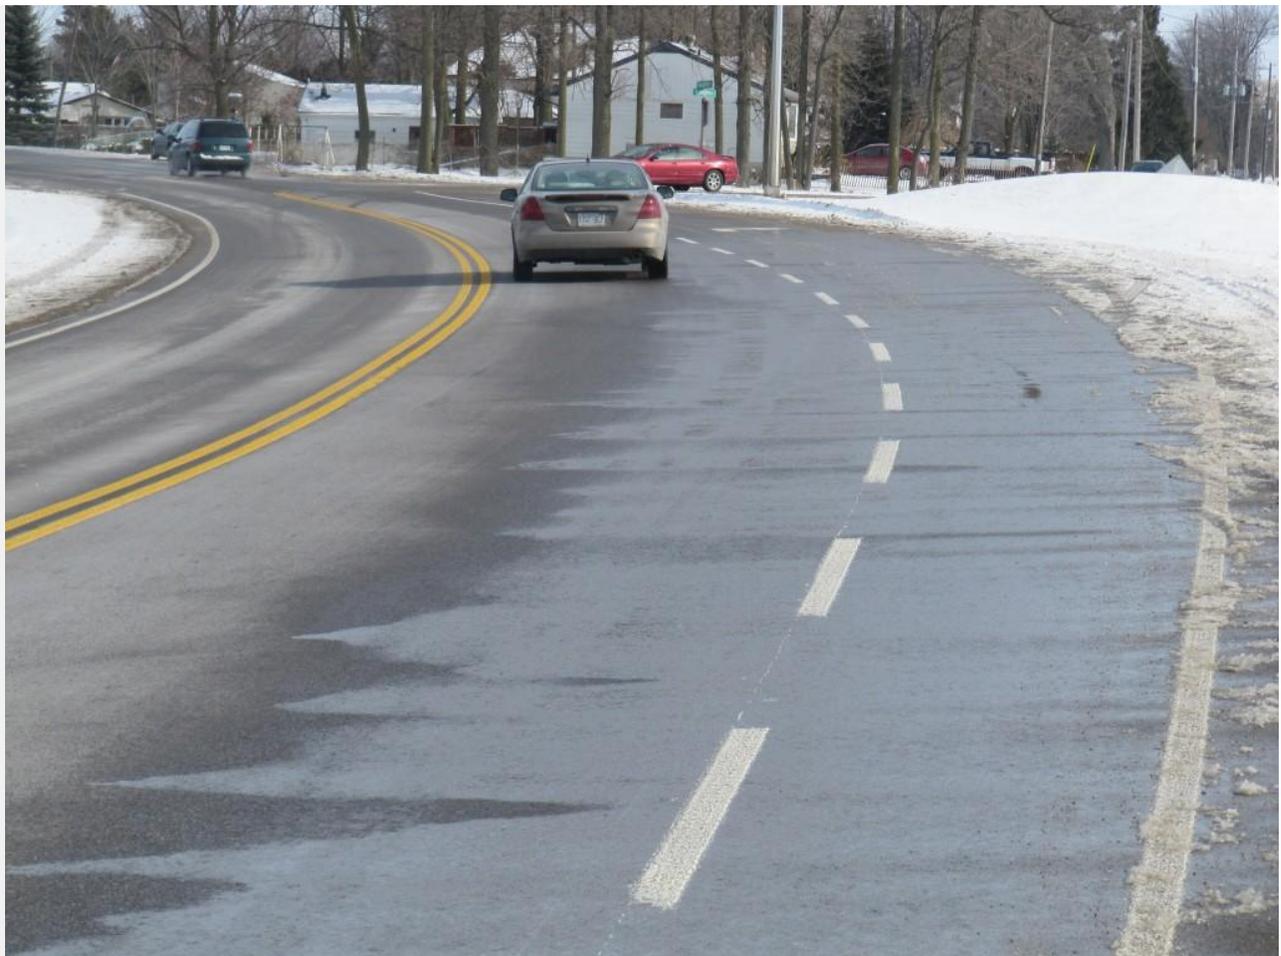
View of Melting Snow/Ice that flows onto the northbound lane of Wellington Road at the Glanworth Curve. The crash occurred several hundred metres in the background.

The left curve contains a significant superelevation to help drivers travel around the bend. But in creating the superelevation there is always a concern that melting snow and

ice will slide onto the travel lane and then freeze in colder conditions. Looking at the present conditions in this photo that was taken just before noon on January 22nd, 2012, we can see how the ice and snow on the south (right) side of the curve is melting and then the water is flowing onto the northbound lane. These are similar conditions to what occurred yesterday when the sun was out and providing ideal melting conditions.

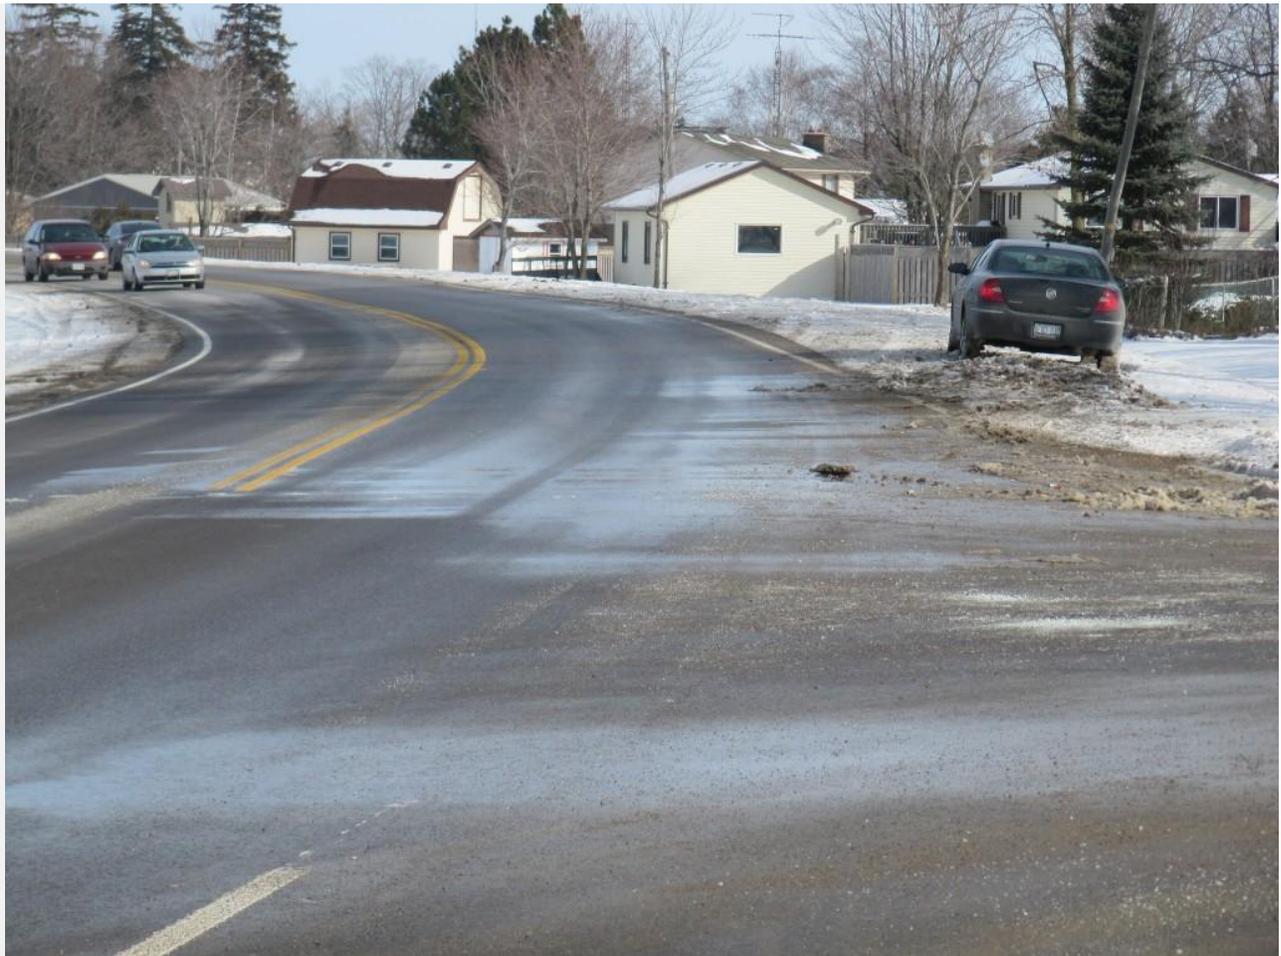
View looking north on Glanworth Curve Showing Moisture on Northbound Lane at Location Where Fleeing Vehicle Left the Roadway

We would be less inclined to focus on this issue if the vehicle had performed a typical, yawing motion before leaving the roadway. Instead the tire marks suggest that the vehicle may have left the roadway while sliding almost rearwards and that is not a common scenario.

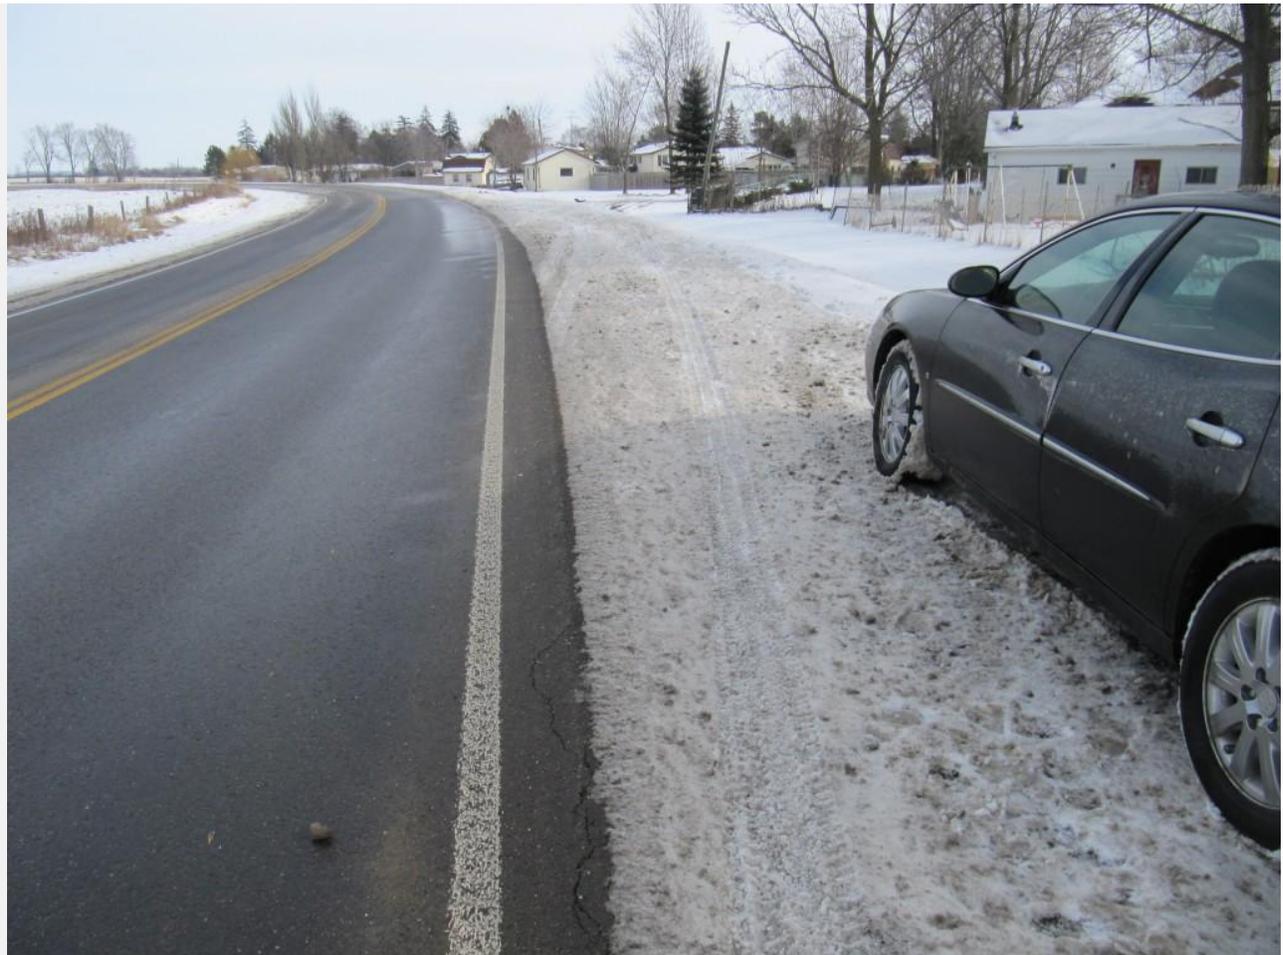
View, Looking North, Along the Right Side of the Northbound Lane of Wellington Road
Just South of the Location Where the Fleeing Vehicle Left the Roadway.

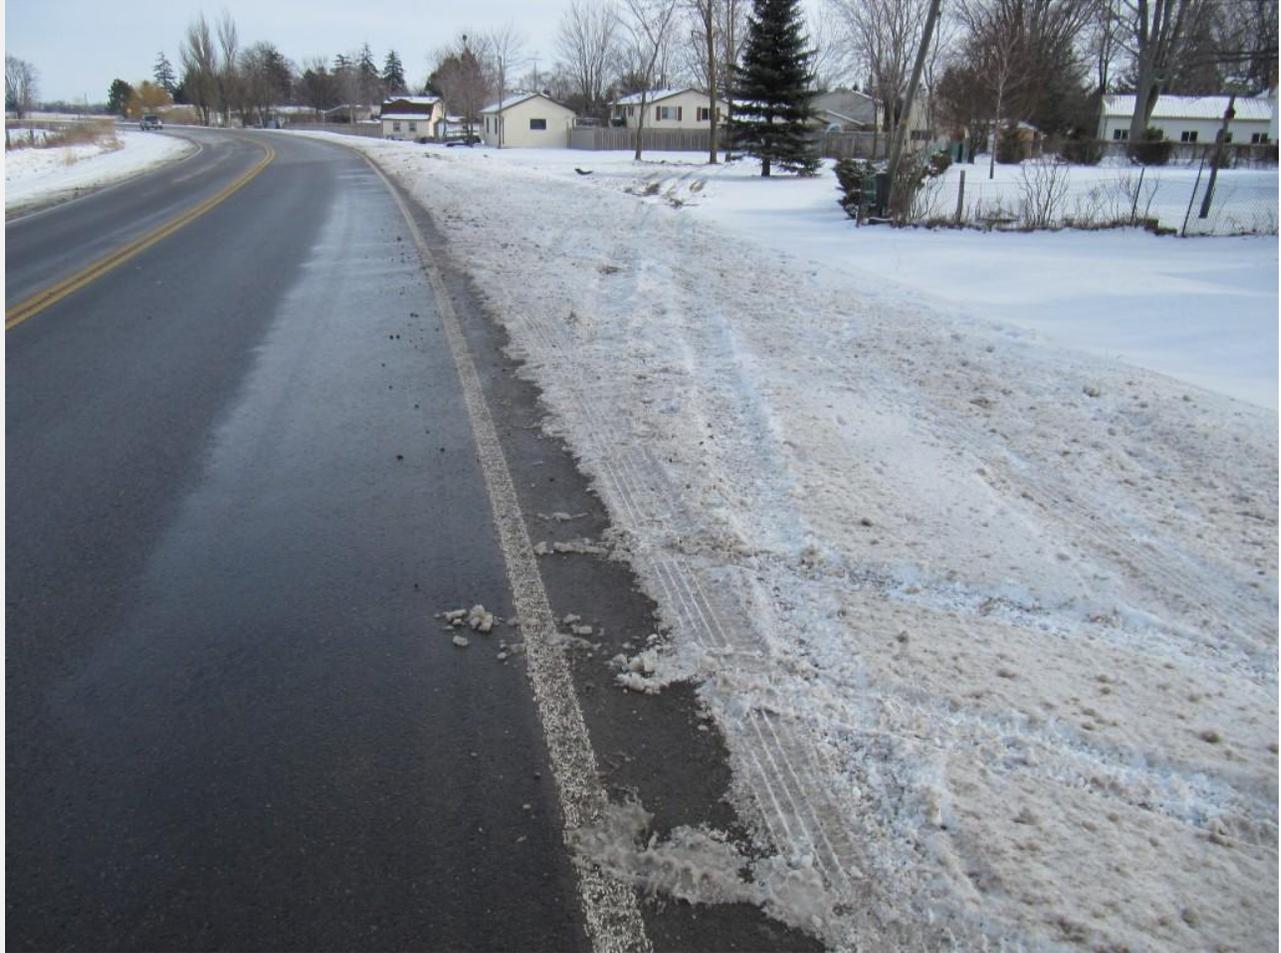
View, Looking North, at the Beginning of the Tire Marks in the Snow, Caused by the Fleeing Vehicle That Struck a Tree in the Background.

What you should recognize from these tire marks is that there is little evidence of rotation of the vehicle about its vertical axis, or there is minimal evidence of yaw. Sometimes such little evidence of yaw may signify a very high speed. But regardless, the other important point is that the vehicle was likely sliding almost backwards as it left the road and produced these tire marks.

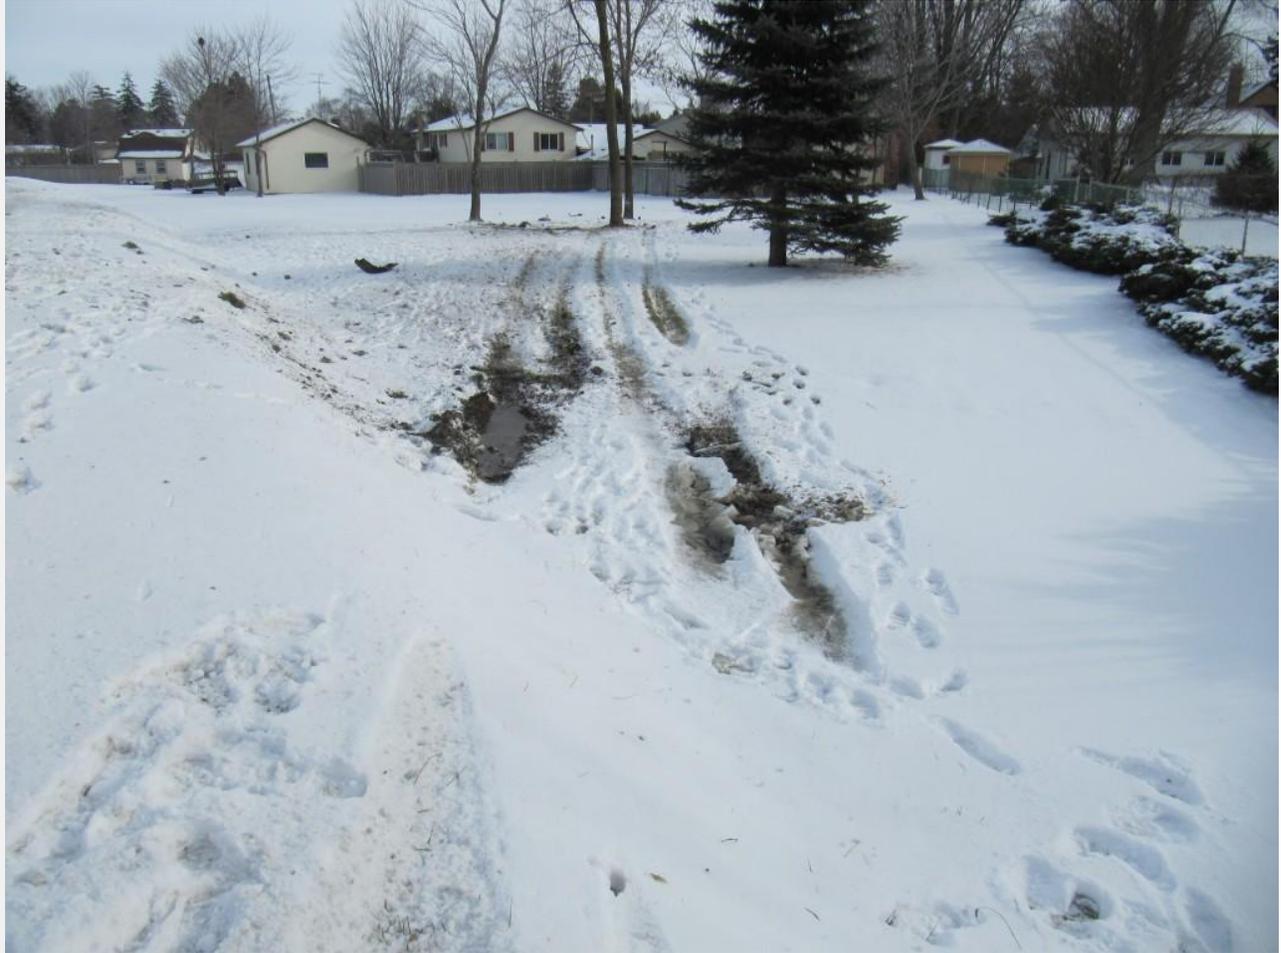
Below is a further view of the tire marks and you should now be able to recognize the tree where the impact occurred. Note how the tire marks are not crossing each other or diverging or converging. So the vehicle is essentially sliding rearwards into the tree with little rotation. The reason for the short discontinuity in the tire marks is because the vehicle has travelled over short down-slope so it was momentarily airborne.

View of Tire Marks as They Approach the Tree Impact.

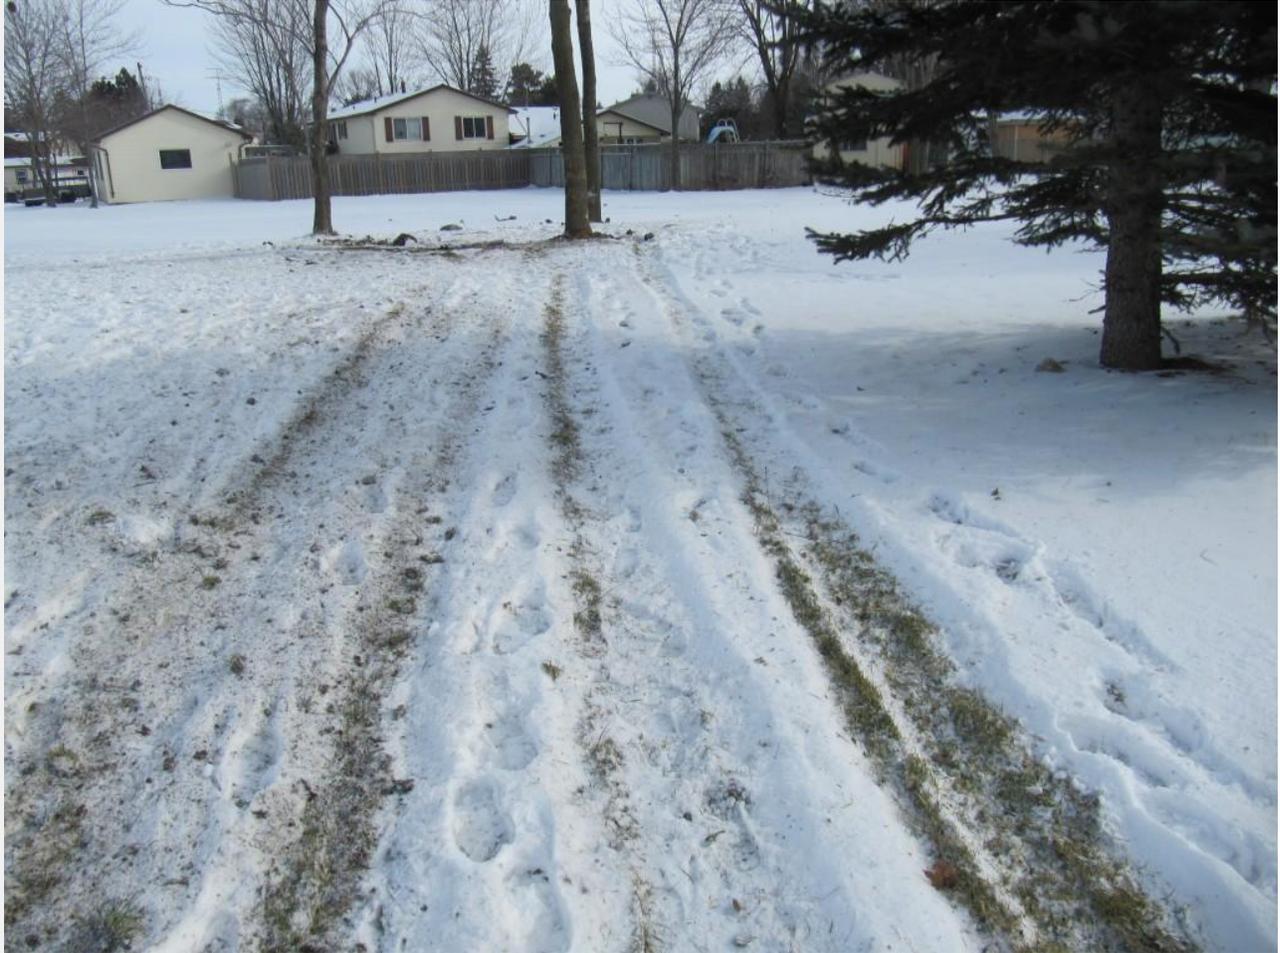
The photo below shows how the tire marks continue to be straight as they approach the tree impact.

View of Straight Tire Marks as They Approach the Tree Impact.

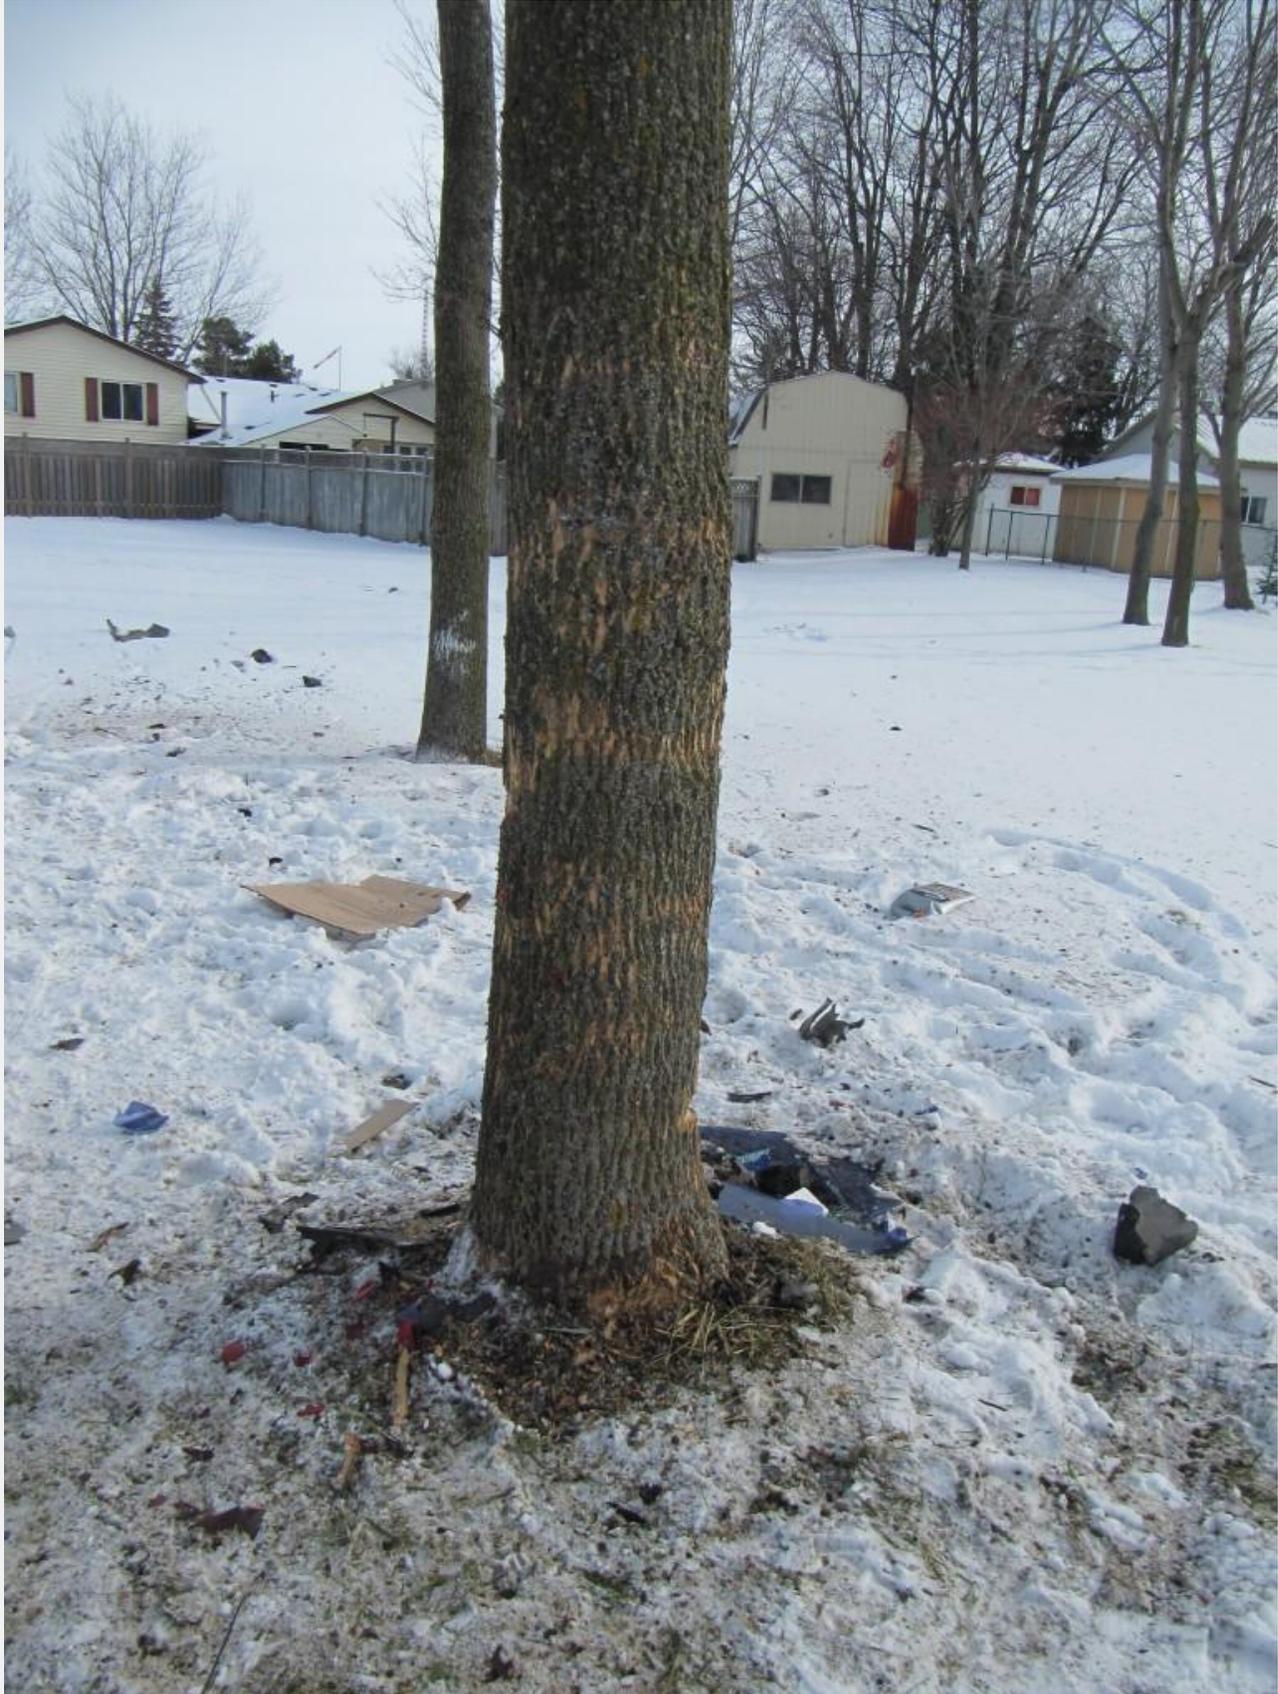
Below is a view of the damage caused to the struck tree. By examining the damage, as well as the particles that are imbedded in it, it is possible to obtain further information about how the impact occurred. This why we state that the vehicle probably struck the tree at least partially with its rear surface. There is also evidence that there was penetration into the occupant compartment and thus intrusion, possibly into the area where the driver was seated.

View of Damage to Struck Tree

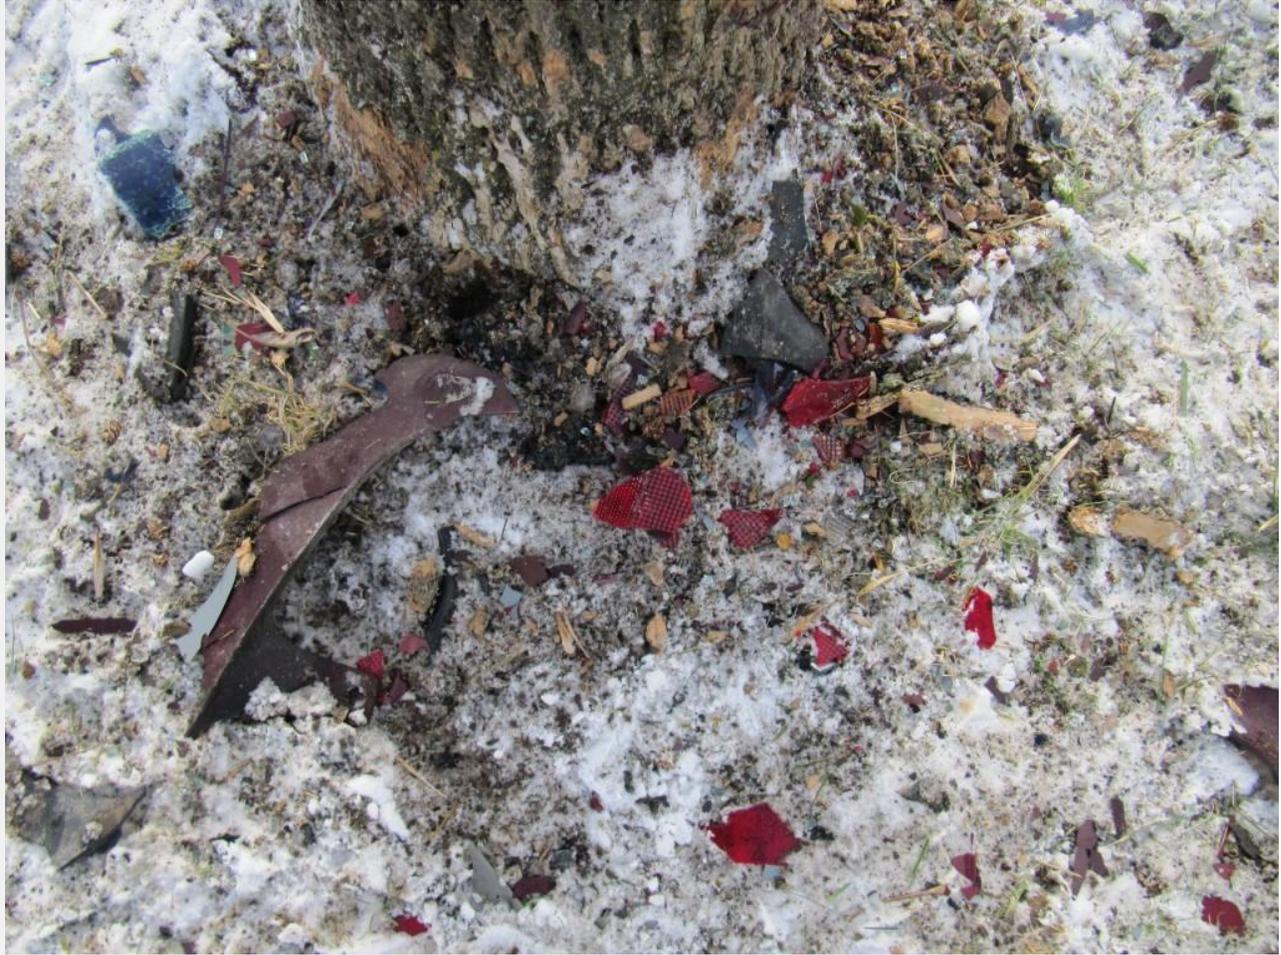
Close-up View of Red Lens Material Lying at the Base of the Struck Tree

When we see red lens material, such as shown in the above photo, and it is concentrated in small particles like it is, then it commonly suggests that the rear tail-light was in contact with the tree. Other debris from the rear of the vehicle also suggests to us that there was damage to the rear of the vehicle, hence our reasoning for the vehicle orientation.

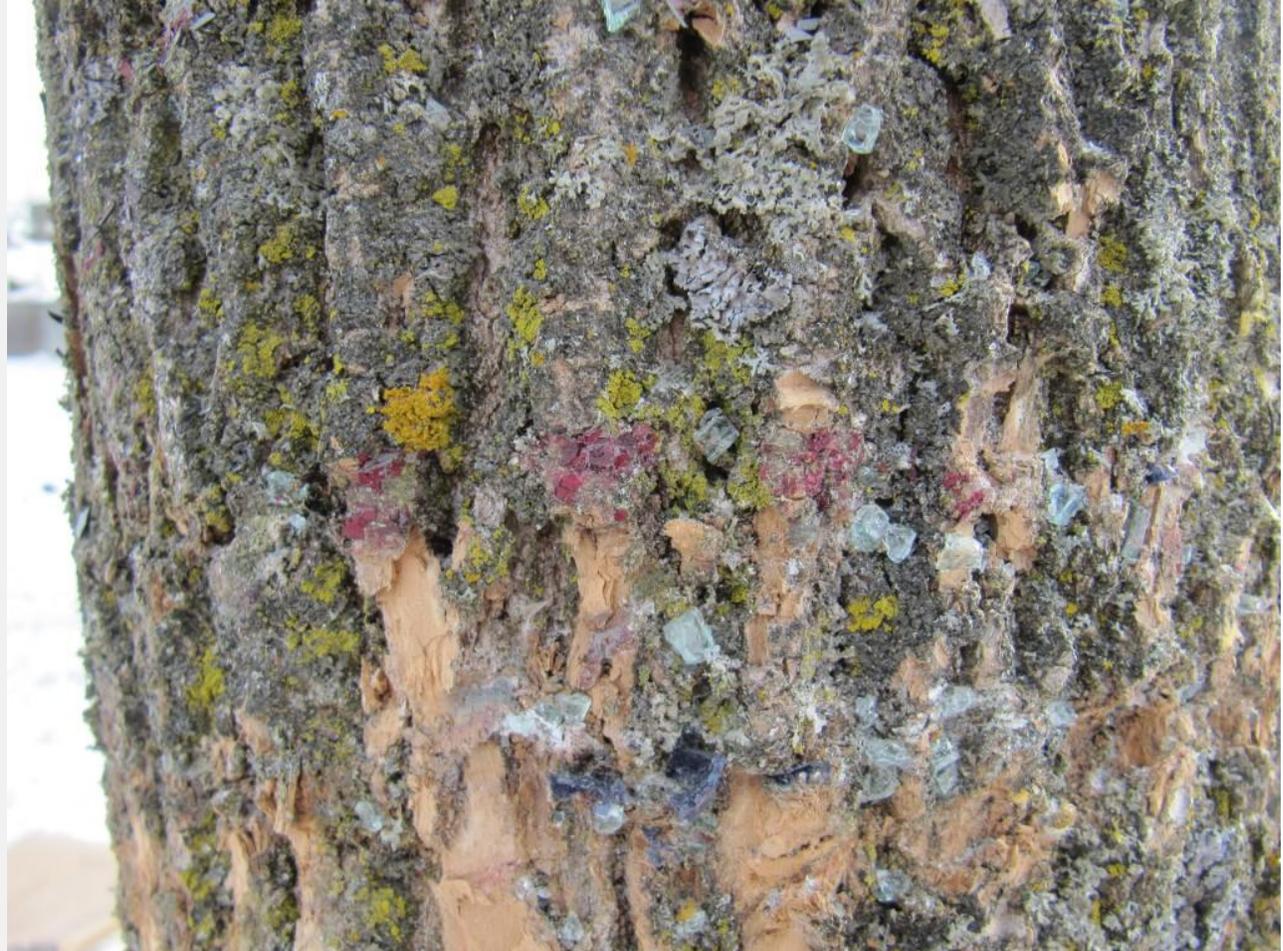
We want to add further that, an impact of a tree by the rear end of a vehicle makes it difficult for penetration and intrusion to occur into the occupant compartment simply because there is so much structure to get through before reaching that occupant compartment. Yet we see that there is evidence of glass imbedded in the tree which is very commonly associated with penetration into the occupant compartment. Note the imbedded glass in the photo below.

View of Glass Particles Imbedded in Struck Tree Indicative of Occupant Compartment Involvement

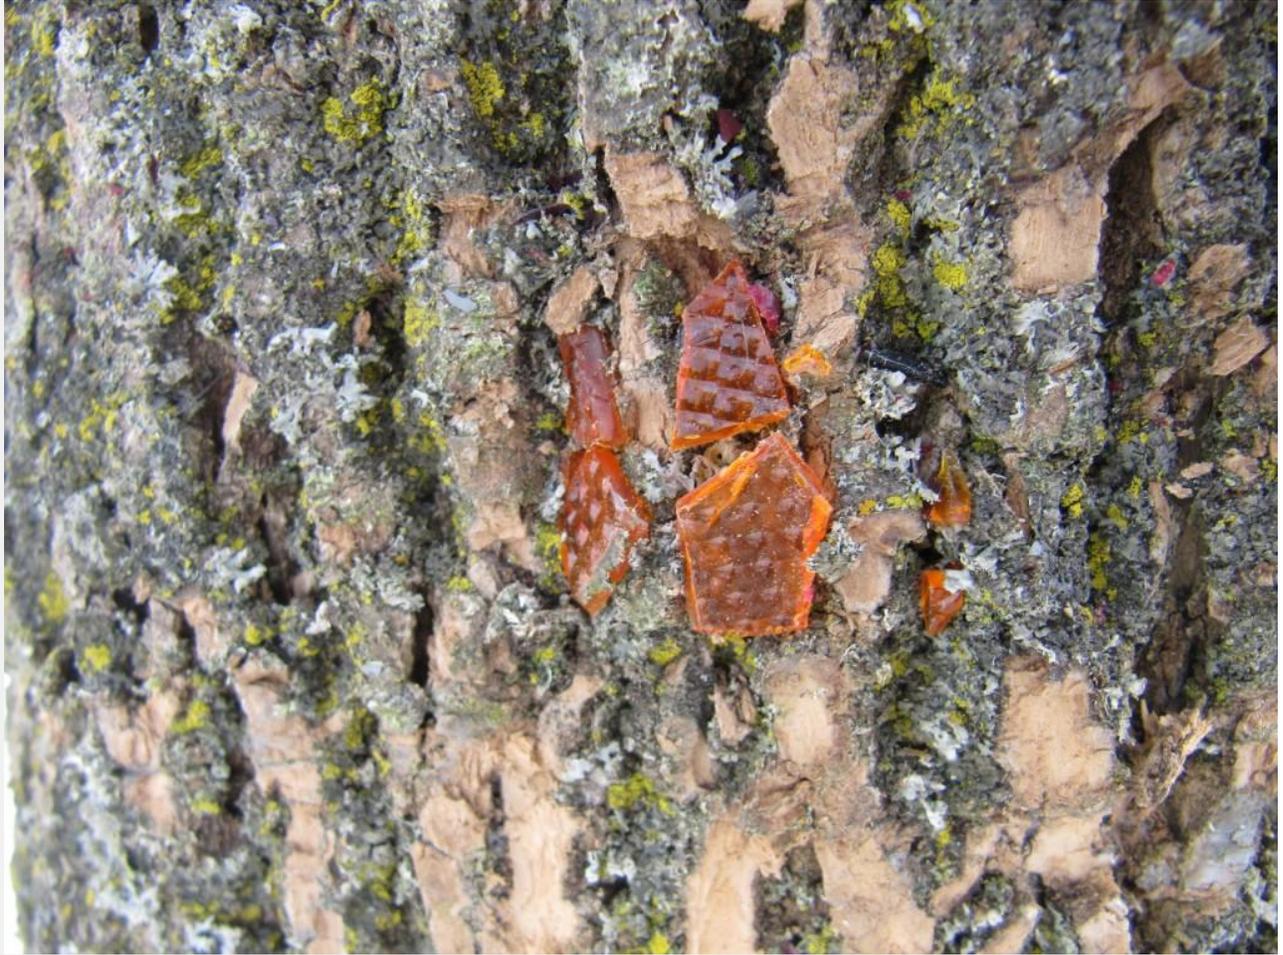
Additionally, there is also orange lens material clinging to the bark and that is more associated with impact of the front end of the vehicle. In the photo below is a close-up view of that orange lens material.

View of Orange Lens Material Clinging to the Bark of the Struck Tree.
