## **Fleeing Police On Glanworth Curve Likely Involved Ice and Loss of Control Impact Into Tree**

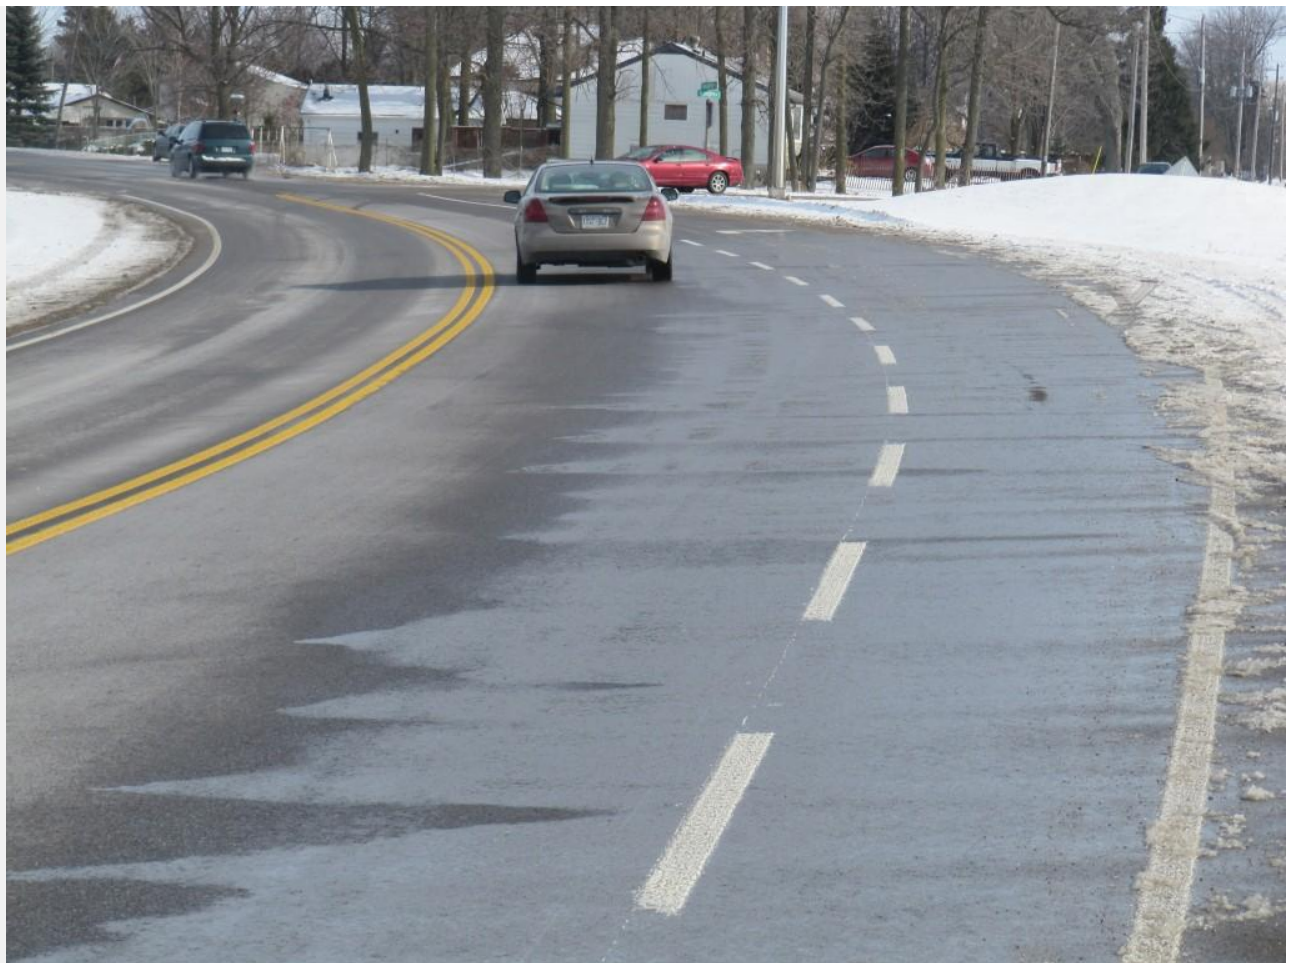
View of Melting Snow/Ice that flows onto the northbound lane of Wellington Road at the Glanworth Curve. The crash occurred several hundred metres in the background.

The left curve contains a significant superelevation to help drivers travel around the bend. But in creating the superelevation there is always a concern that melting snow and

ice will slide onto the travel lane and then freeze in colder conditions. Looking at the present conditions in this photo that was taken just before noon on January 22nd, 2012, we can see how the ice and snow on the south (right) side of the curve is melting and then the water is flowing onto the northbound lane. These are similar conditions to what occurred yesterday when the sun was out and providing ideal melting conditions.

The actual collision occurred around 2120 hours. But previous to that, the sun had gone down and the moisture that was present likely began to freeze. When you add a little speed to the mix bad things happen.

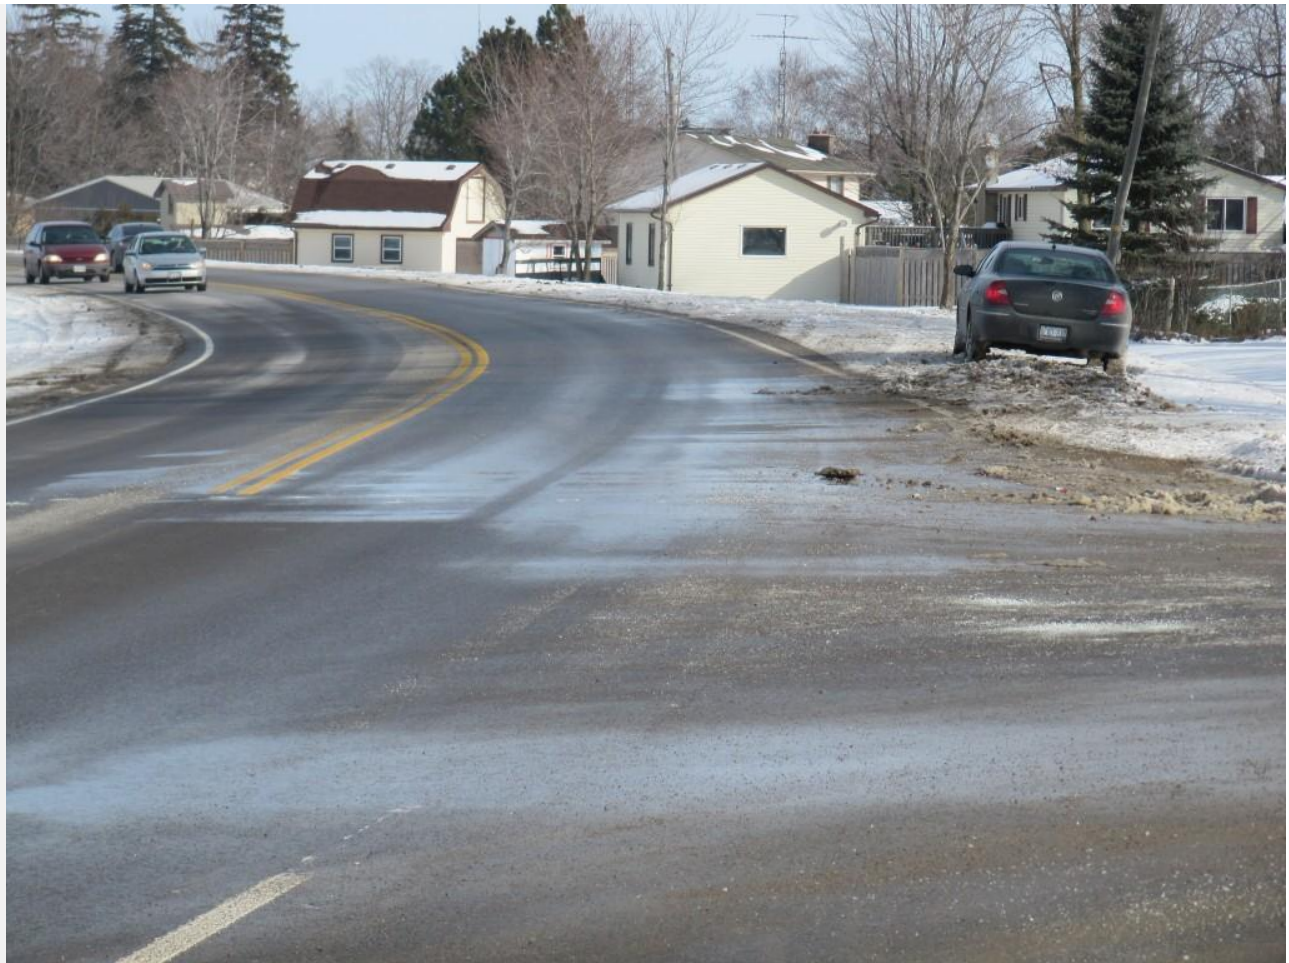
View looking north on Glanworth Curve Showing Moisture on Northbound Lane at Location Where Fleeing Vehicle Left the Roadway

We would be less inclined to focus on this issue if the vehicle had performed a typical, yawing motion before leaving the roadway. Instead the tire marks suggest that the vehicle may have left the roadway while sliding almost rearwards and that is not a common scenario.

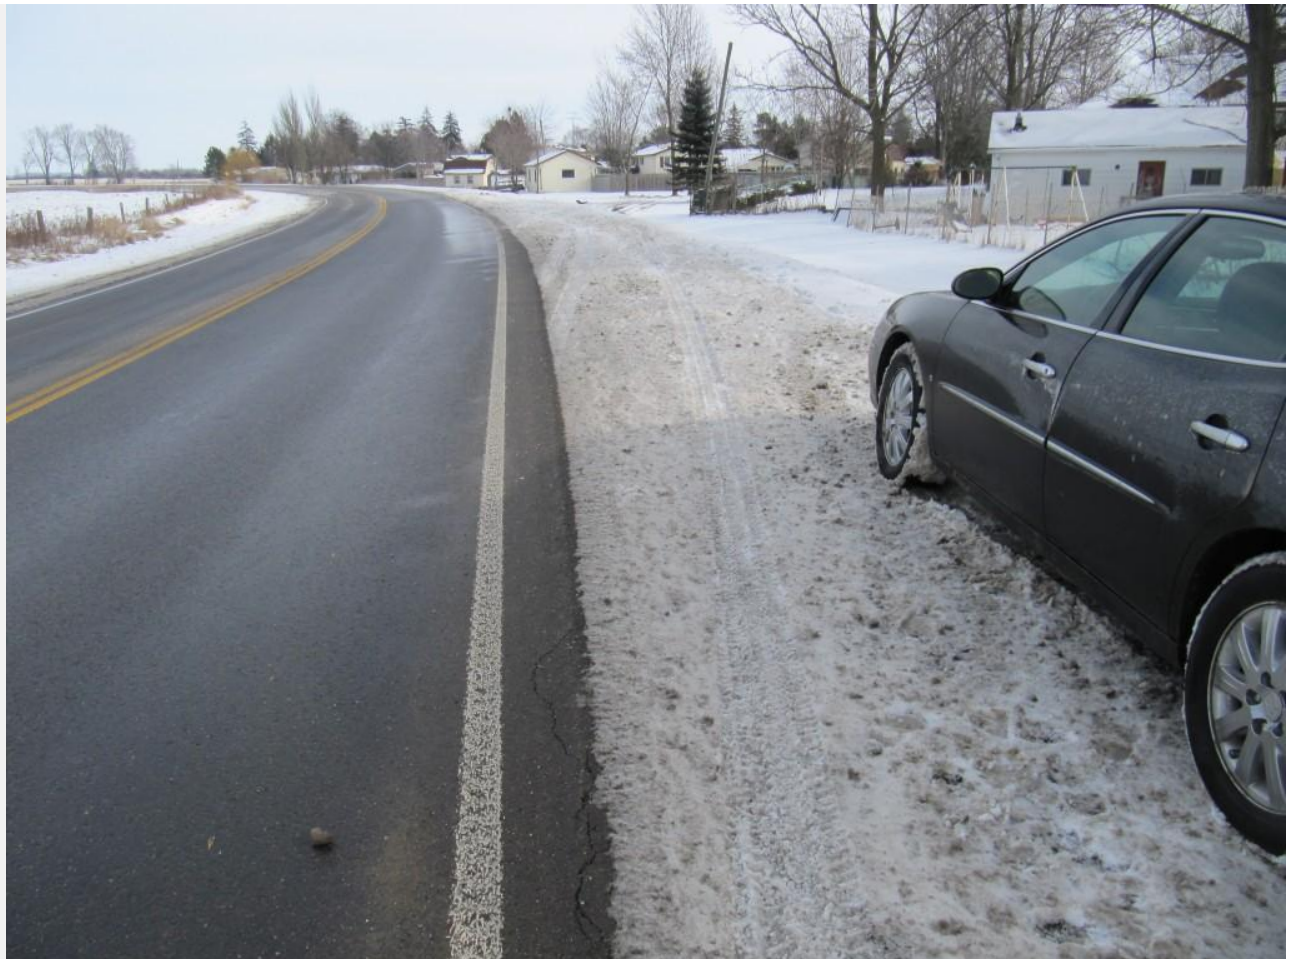
View, Looking North, Along the Right Side of the Northbound Lane of Wellington Road  
Just South of the Location Where the Fleeing Vehicle Left the Roadway.

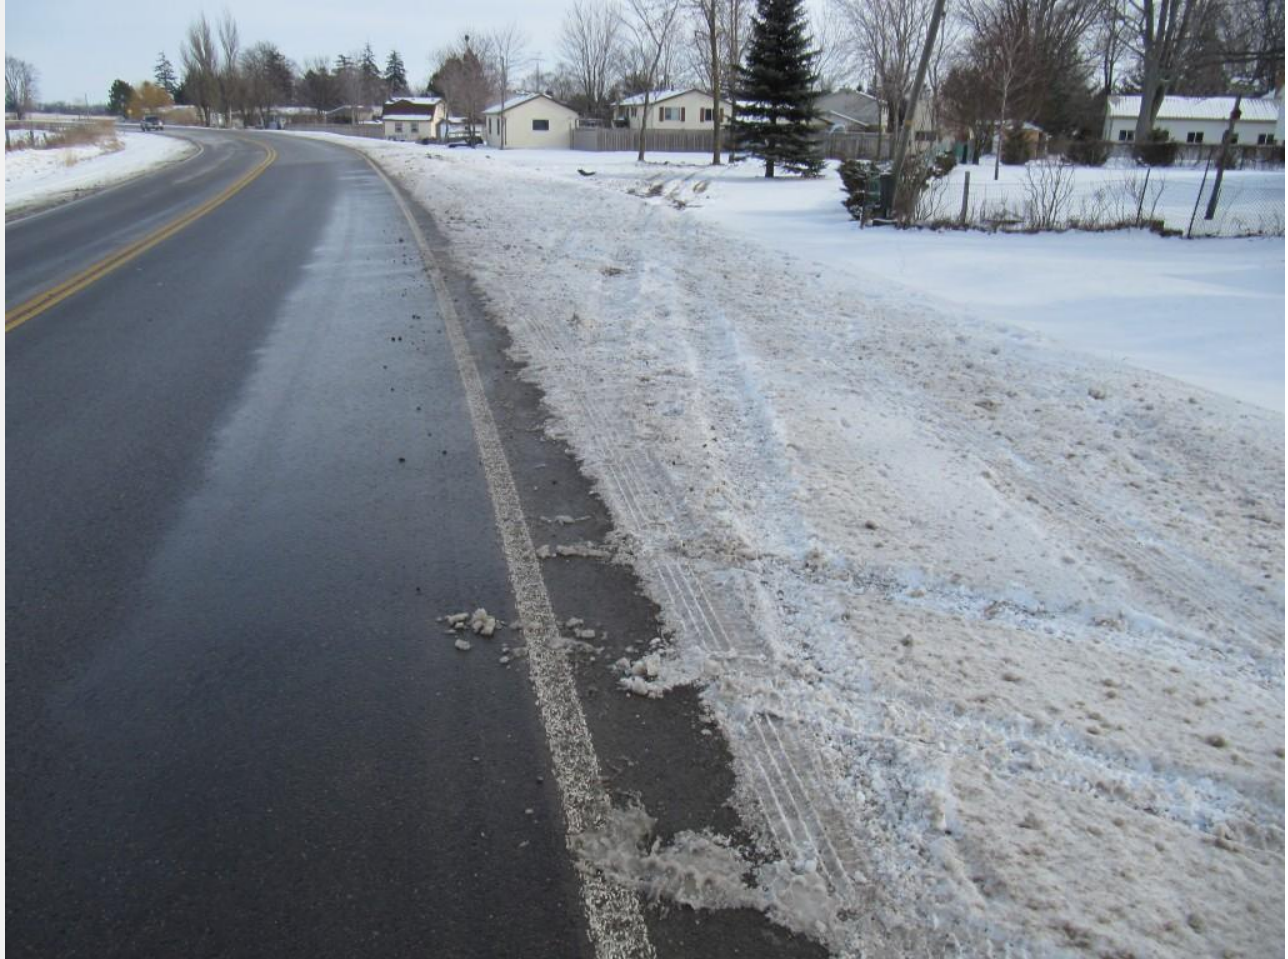
View, Looking North, at the Beginning of the Tire Marks in the Snow, Caused by the Fleeing Vehicle That Struck a Tree in the Background.

What you should recognize from these tire marks is that there is little evidence of rotation of the vehicle about its vertical axis, or there is minimal evidence of yaw. Sometimes such little evidence of yaw may signify a very high speed. But regardless, the other important point is that the vehicle was likely sliding almost backwards as it left the road and produced these tire marks.

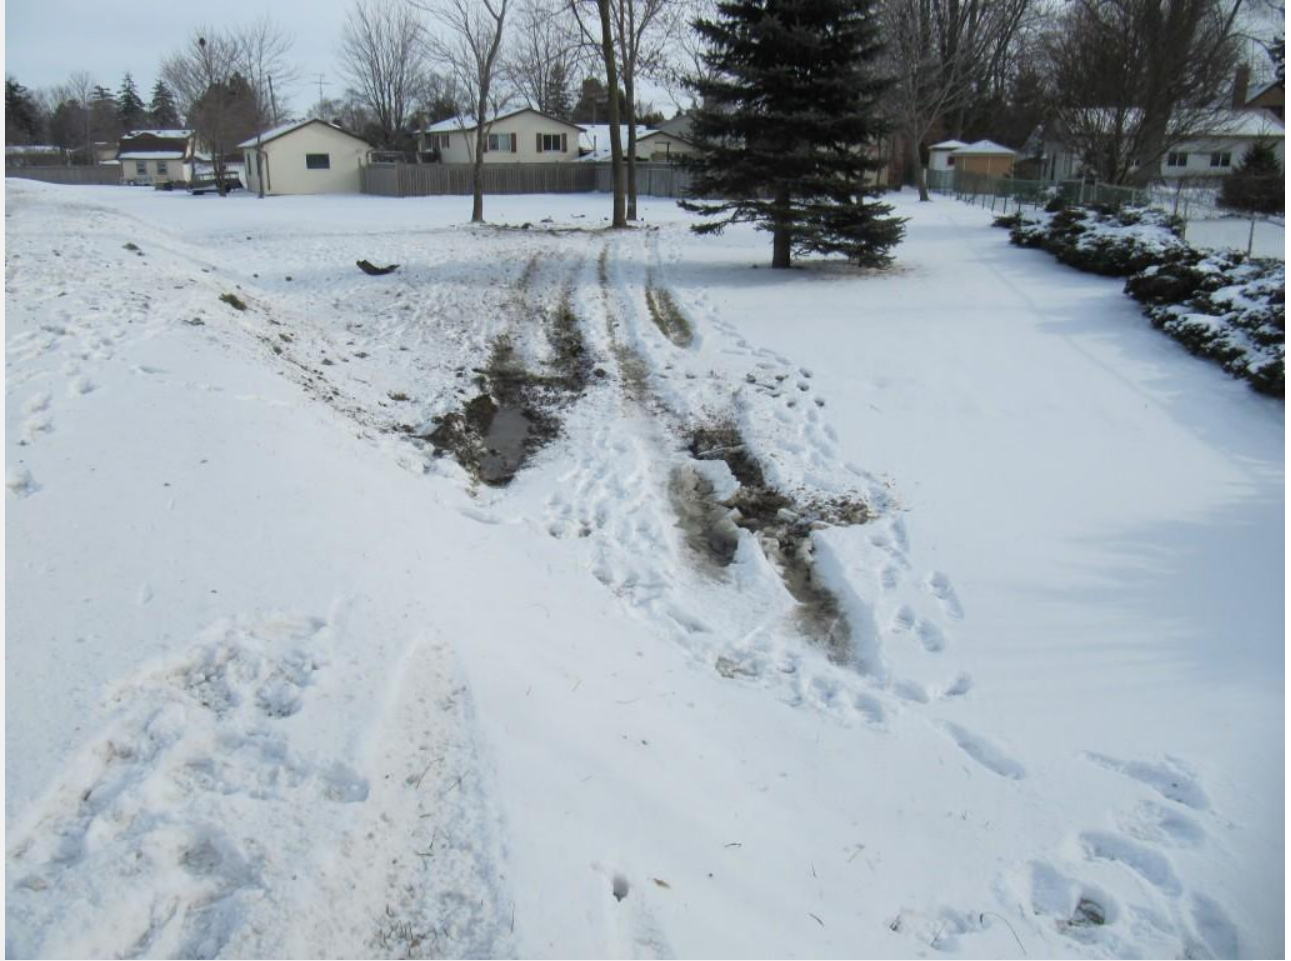
Below is a further view of the tire marks and you should now be able to recognize the tree where the impact occurred. Note how the tire marks are not crossing each other or diverging or converging. So the vehicle is essentially sliding rearwards into the tree with little rotation. The reason for the short discontinuity in the tire marks is because the vehicle has travelled over short down-slope so it was momentarily airborne.

View of Tire Marks as They Approach the Tree Impact.

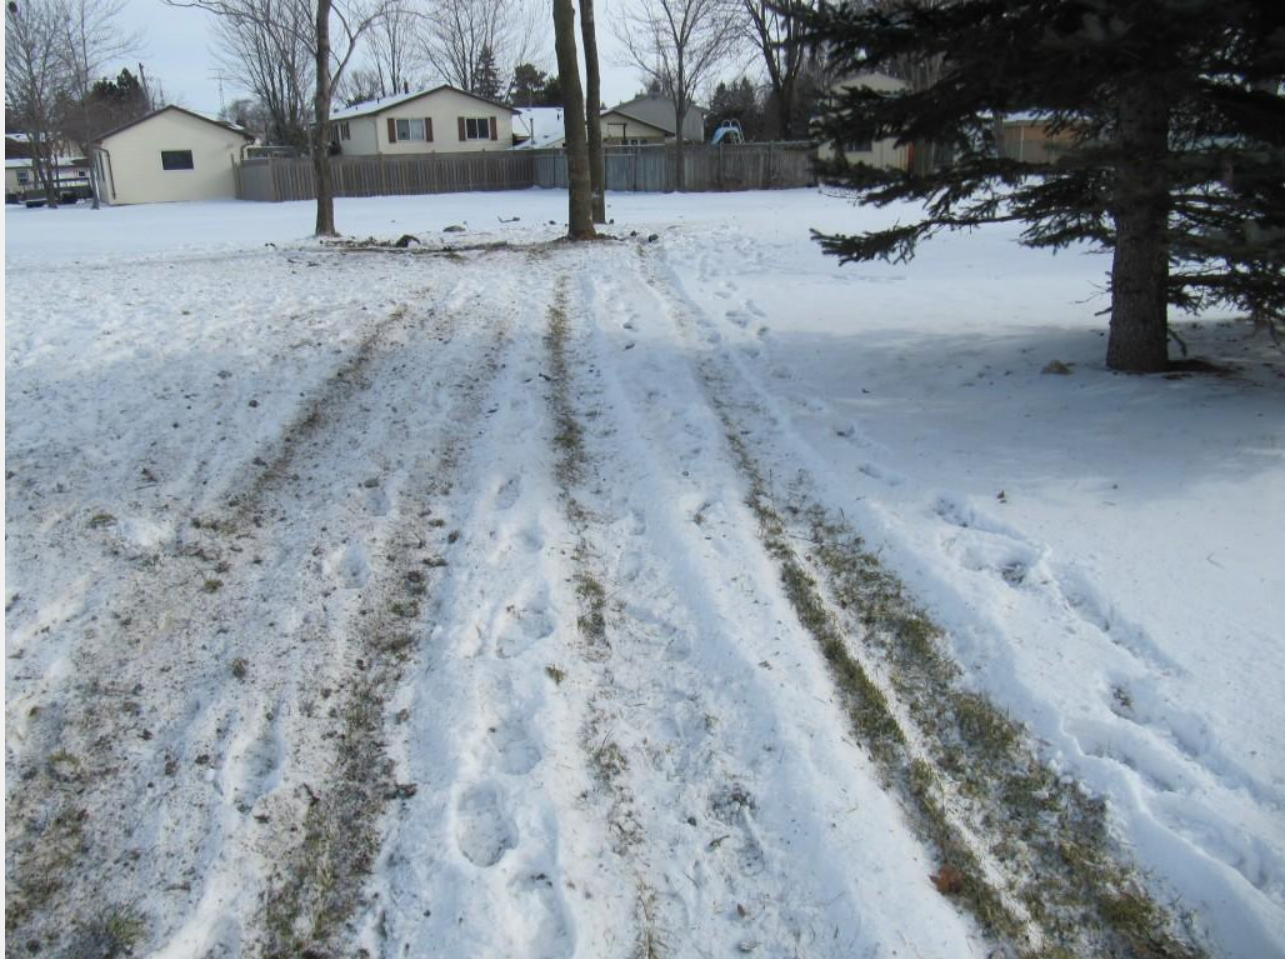
The photo below shows how the tire marks continue to be straight as they approach the tree impact.

View of Straight Tire Marks as They Approach the Tree Impact.

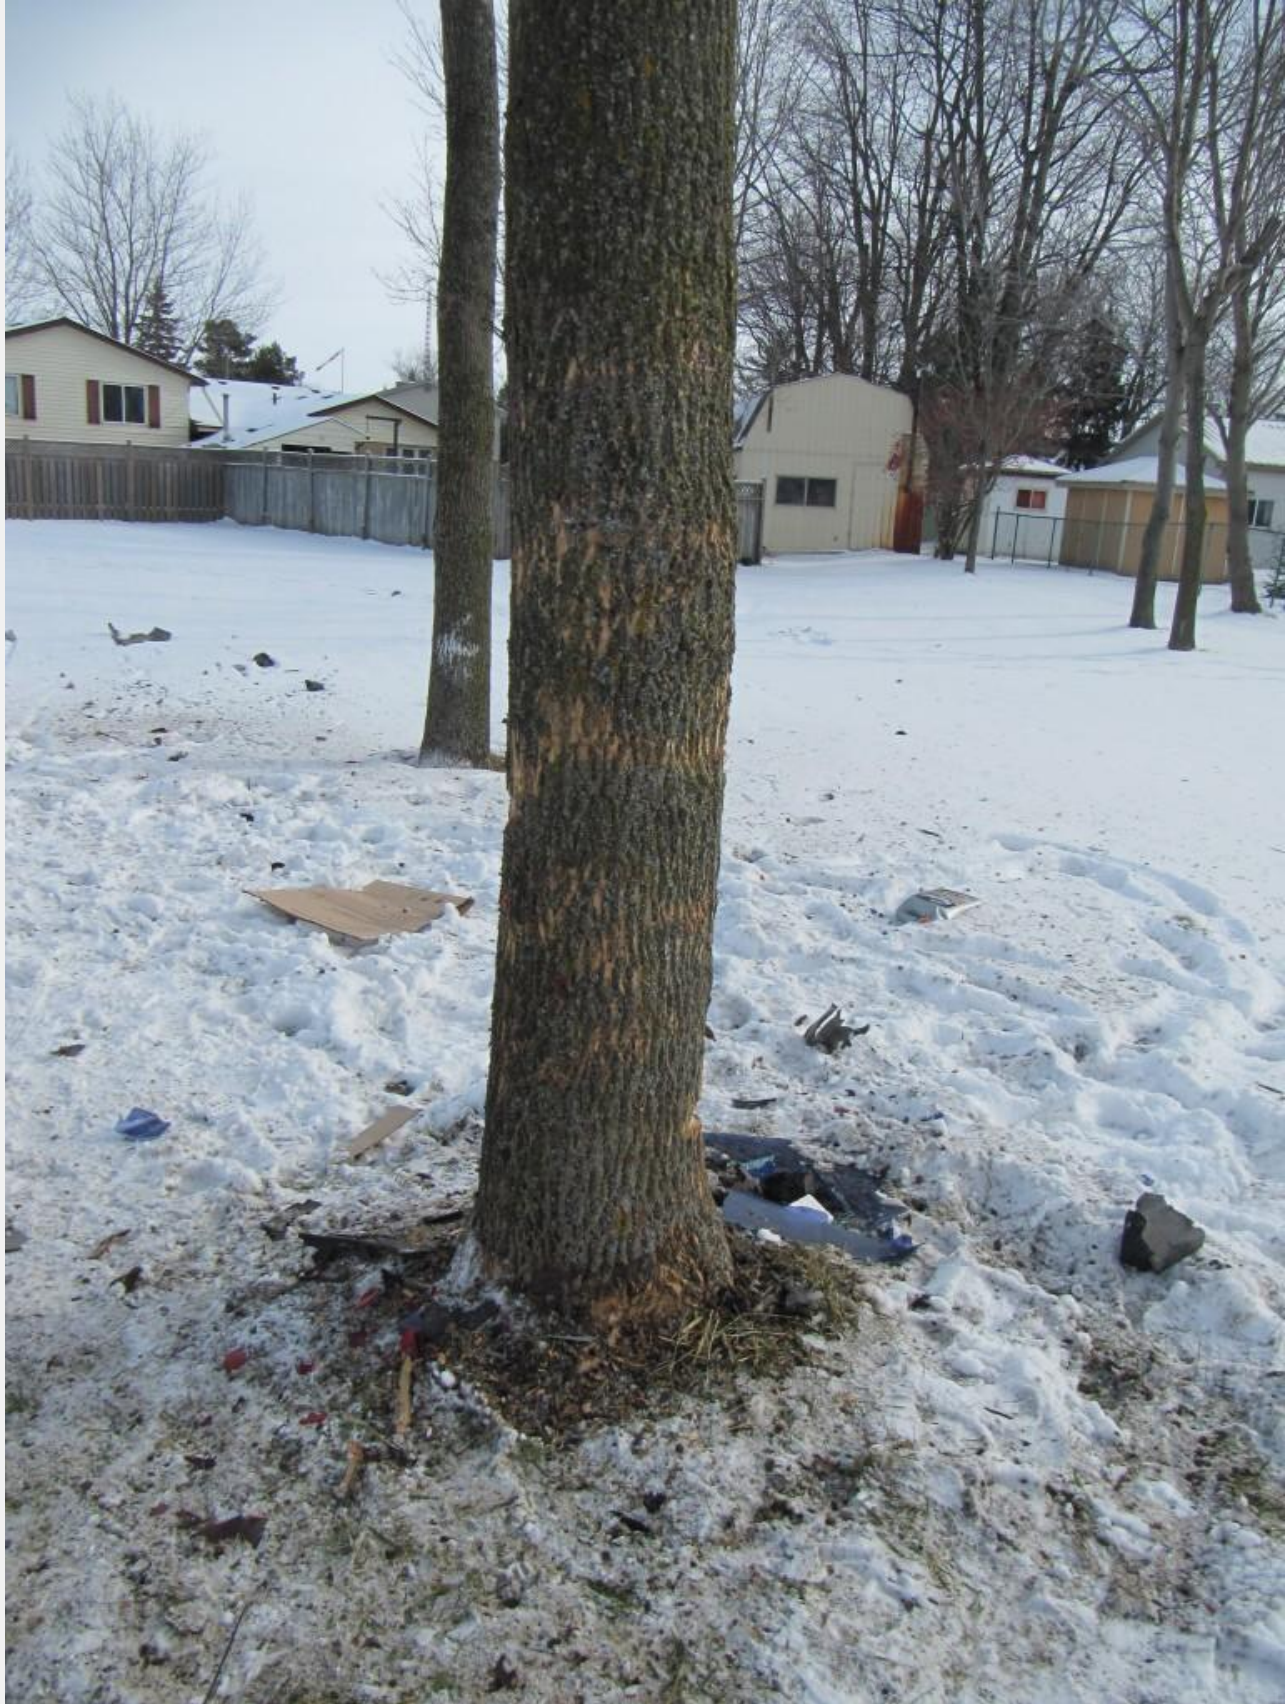
Below is a view of the damage caused to the struck tree. By examining the damage, as well as the particles that are imbedded in it, it is possible to obtain further information about how the impact occurred. This why we state that the vehicle probably struck the tree at least partially with its rear surface. There is also evidence that there was penetration into the occupant compartment and thus intrusion, possibly into the area where the driver was seated.

## View of Damage to Struck Tree

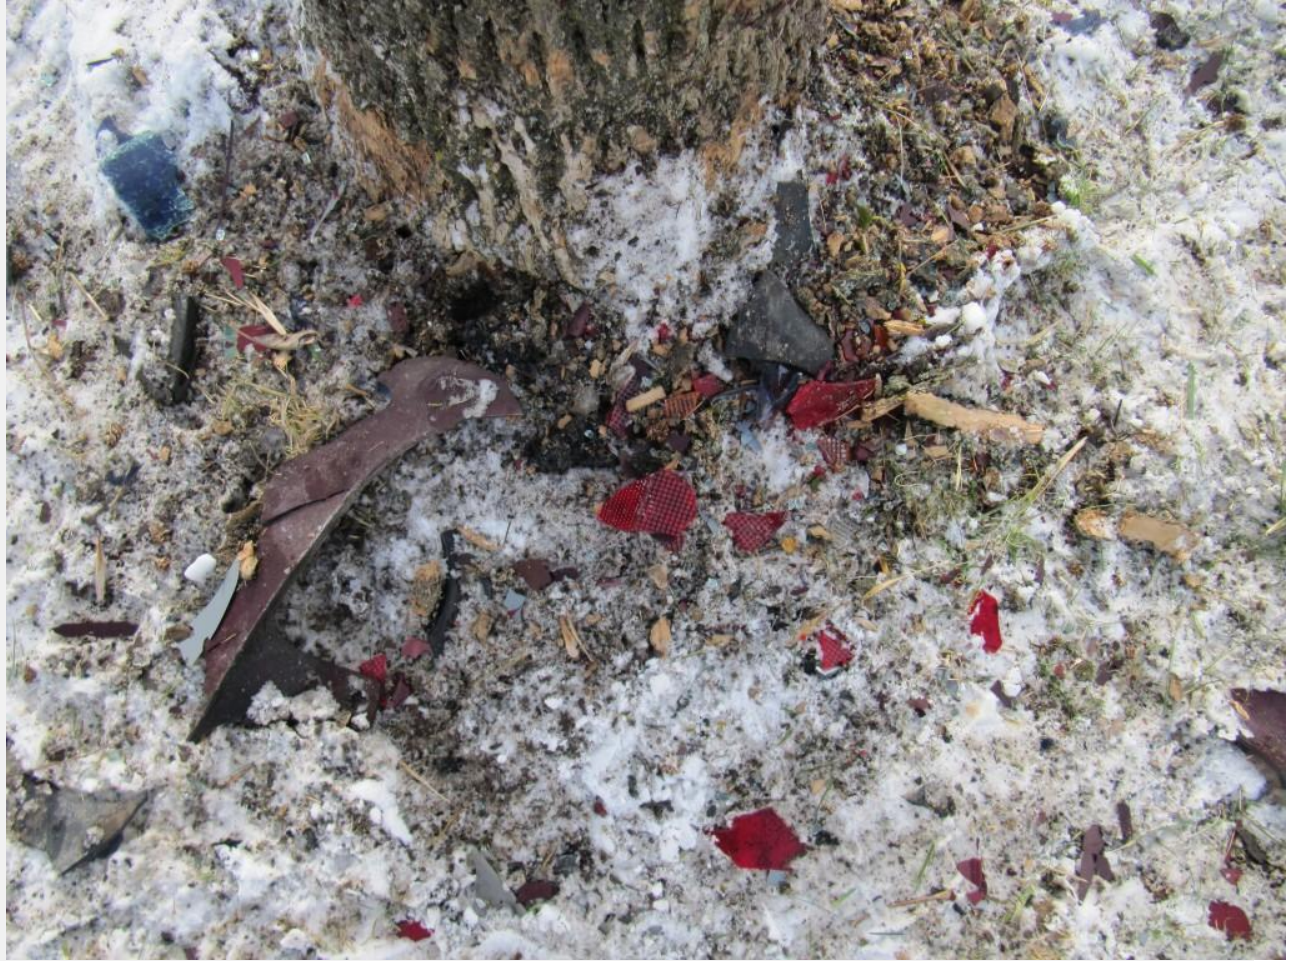
Close-up View of Red Lens Material Lying at the Base of the Struck Tree

When we see red lens material, such as shown in the above photo, and it is concentrated in small particles like it is, then it commonly suggests that the rear tail-light was in contact with the tree. Other debris from the rear of the vehicle also suggests to us that there was damage to the rear of the vehicle, hence our reasoning for the vehicle orientation.

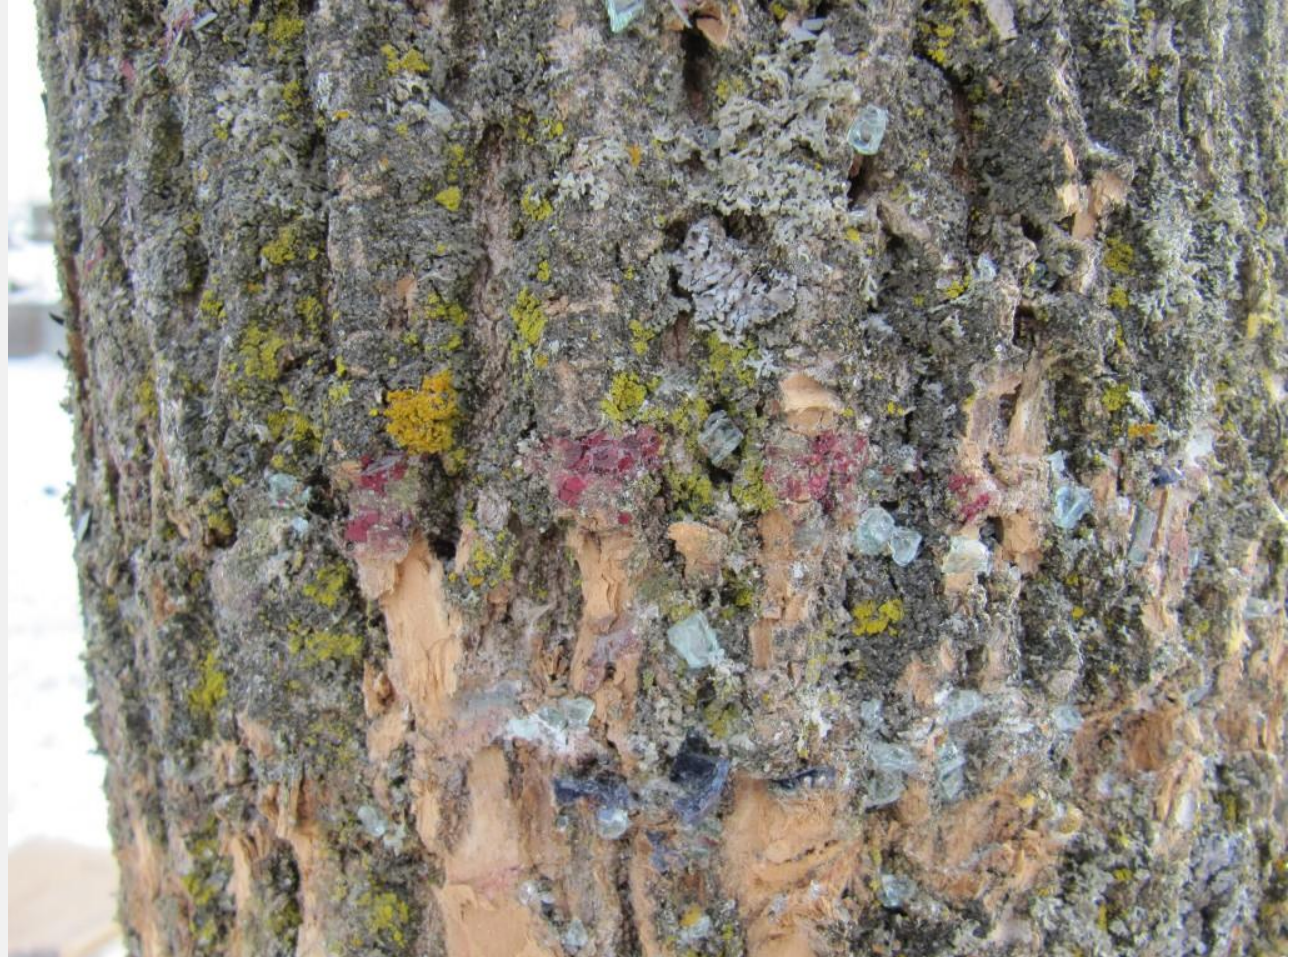
We want to add further that, an impact of a tree by the rear end of a vehicle makes it difficult for penetration and intrusion to occur into the occupant compartment simply because there is so much structure to get through before reaching that occupant compartment. Yet we see that there is evidence of glass imbedded in the tree which is very commonly associated with penetration into the occupant compartment. Note the imbedded glass in the photo below.

View of Glass Particles Imbedded in Struck Tree Indicative of Occupant Compartment Involvement

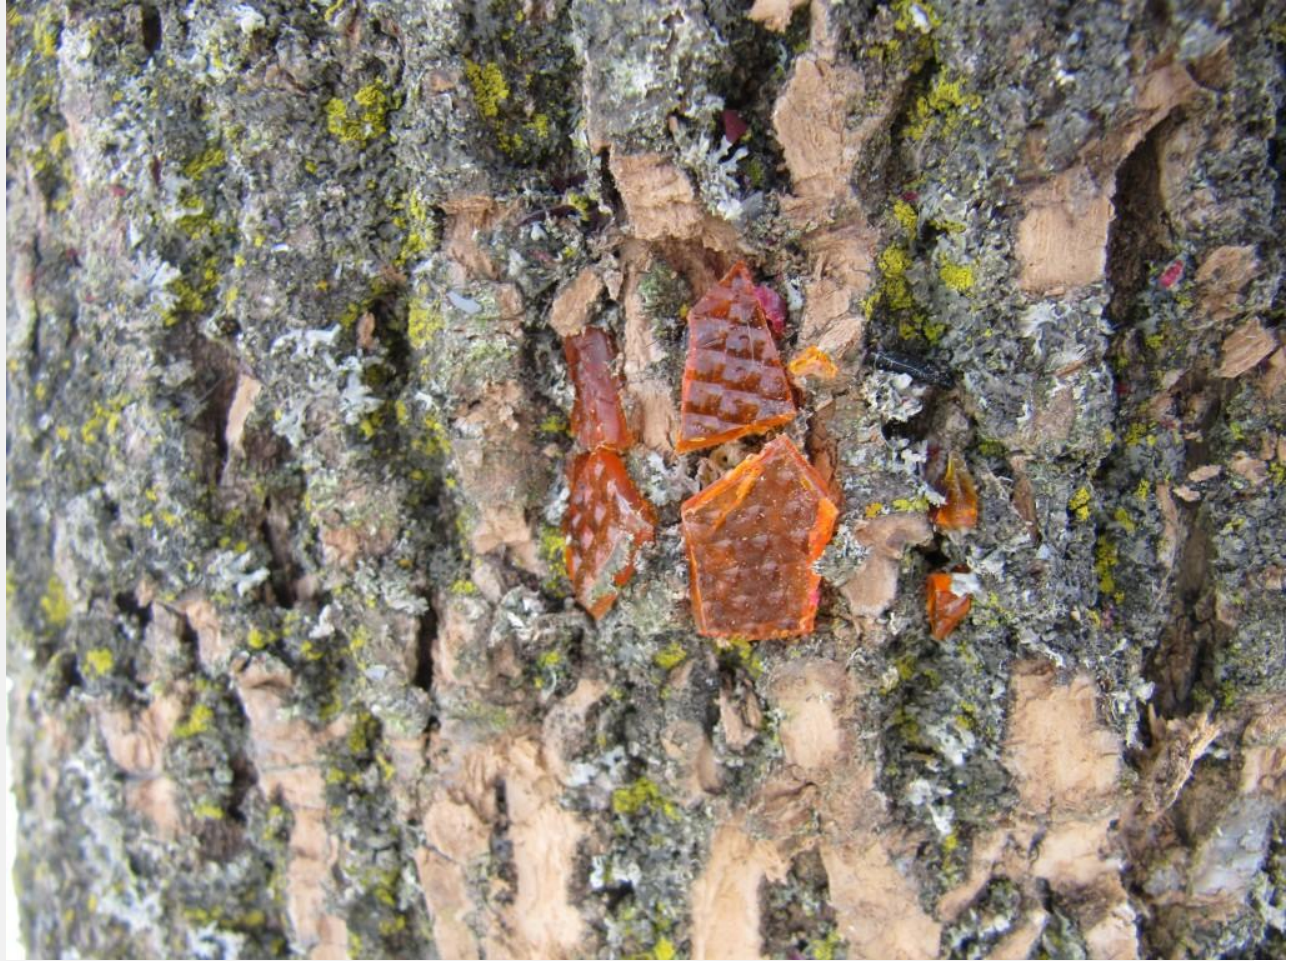
Additionally, there is also orange lens material clinging to the bark and that is more associated with impact of the front end of the vehicle. In the photo below is a close-up view of that orange lens material.

View of Orange Lens Material Clinging to the Bark of the Struck Tree.
