# Further Differentiation Between Good and Bad Road Surface Characteristics From Instrumented Vehicle Testing

Posting Date: 04-Mar 2014

Gorski Consulting  
London, Ontario, Canada

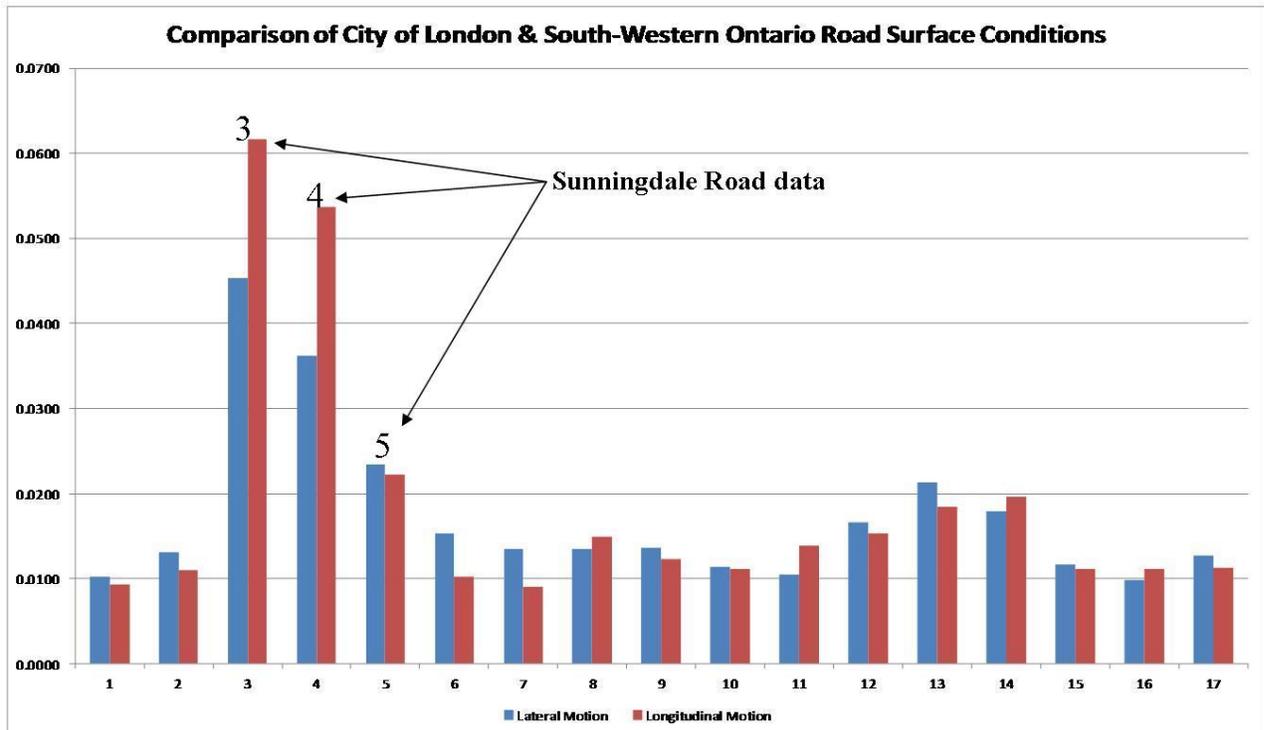
Figure 1: 17 results from testing conducted on roads in the City of London, Ontario and its vicinity.

demonstrated there was much more lateral (blue bar) and longitudinal (red bar) motion of the vehicle when travelling on Sunningdale Road than when the same vehicle travelled on the other roadways, as shown in the above chart. In particular the high height of the red bars in the chart indicated that Sunningdale Road caused an exceptional amount of longitudinal motion of the test vehicle.

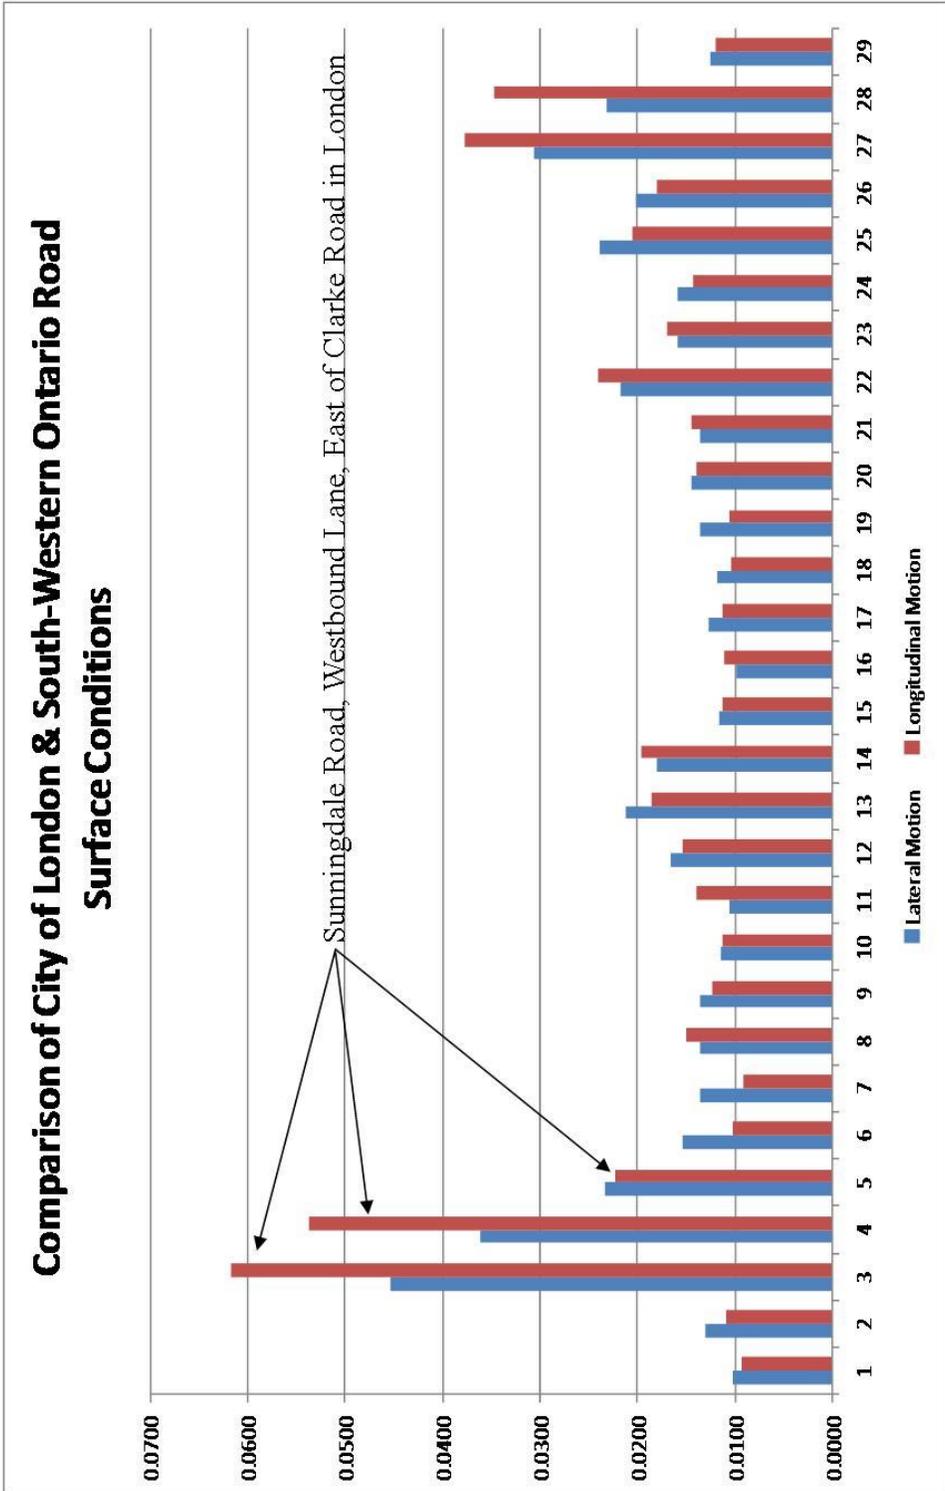
Figure 3.

It can be seen in Figure 3 that Sunningdale Road still contains the most extreme surface conditions. However, near the latter portion of the chart (sites 22 through to 29) the data seems to indicate worsening conditions. In particular Sites 27 and 28 caused substantial motions of the test vehicle. Part of this difference is that packed snow was encountered on the road surface of these latter sites.

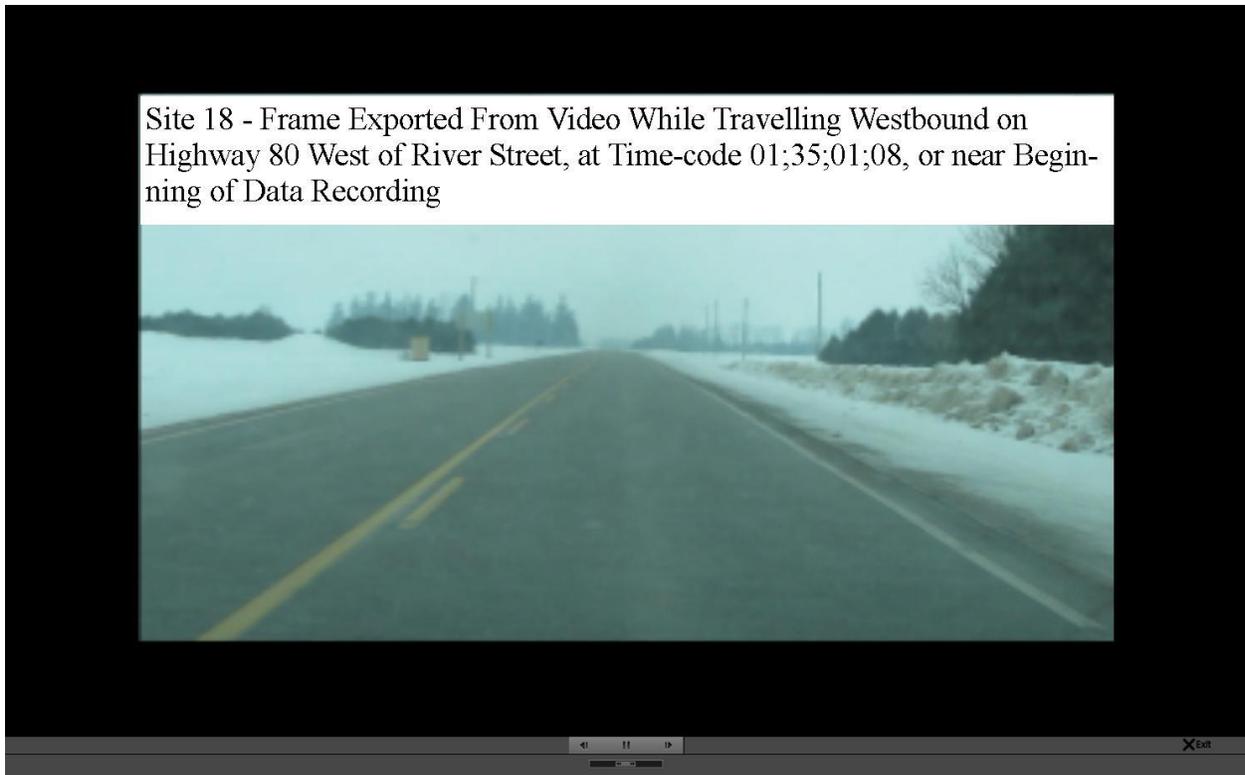
Figure 5.

Better surface conditions were sensed at Site 18, which was on Highway 80. The conditions at this site are shown from the frame in Figure 5 which was exported from the video camera that was pointing forward through the windshield of the test vehicle.

As can be seen in Figure 5 the road surface is asphalt, it is bare and contains little evidence of any cracking or unevenness.

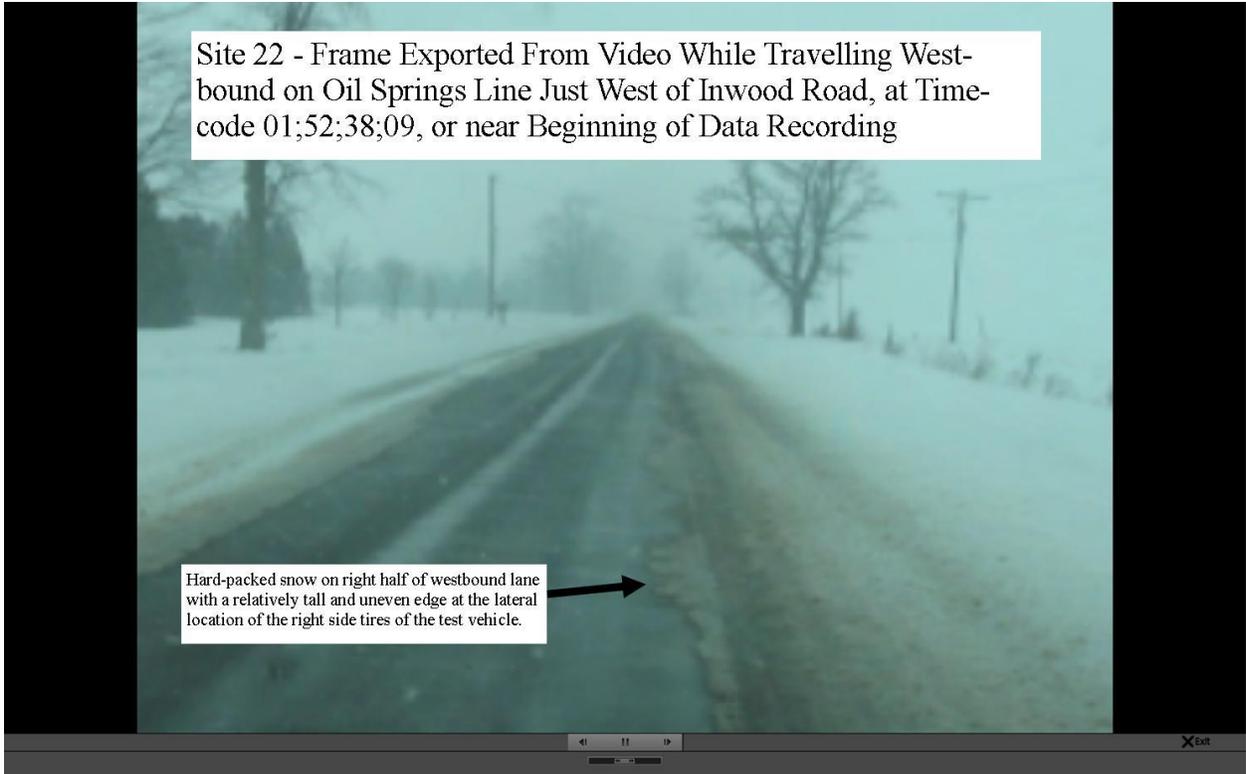
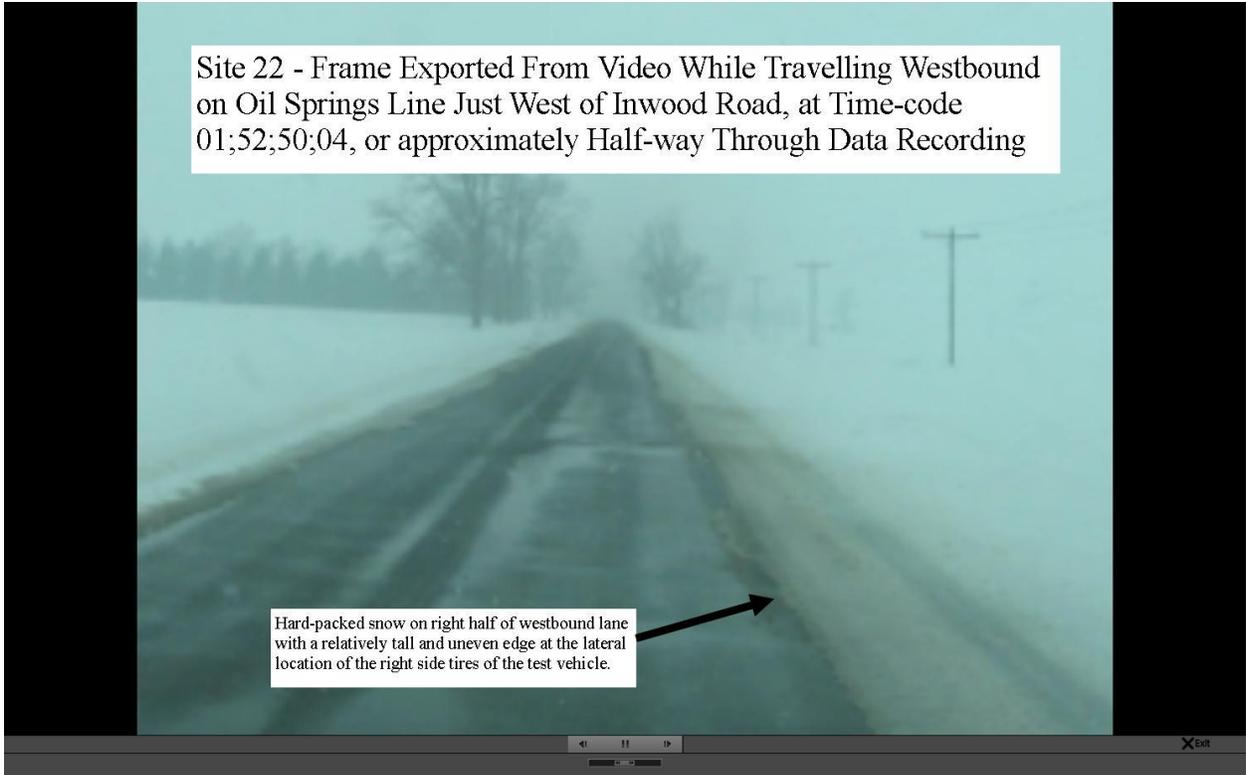
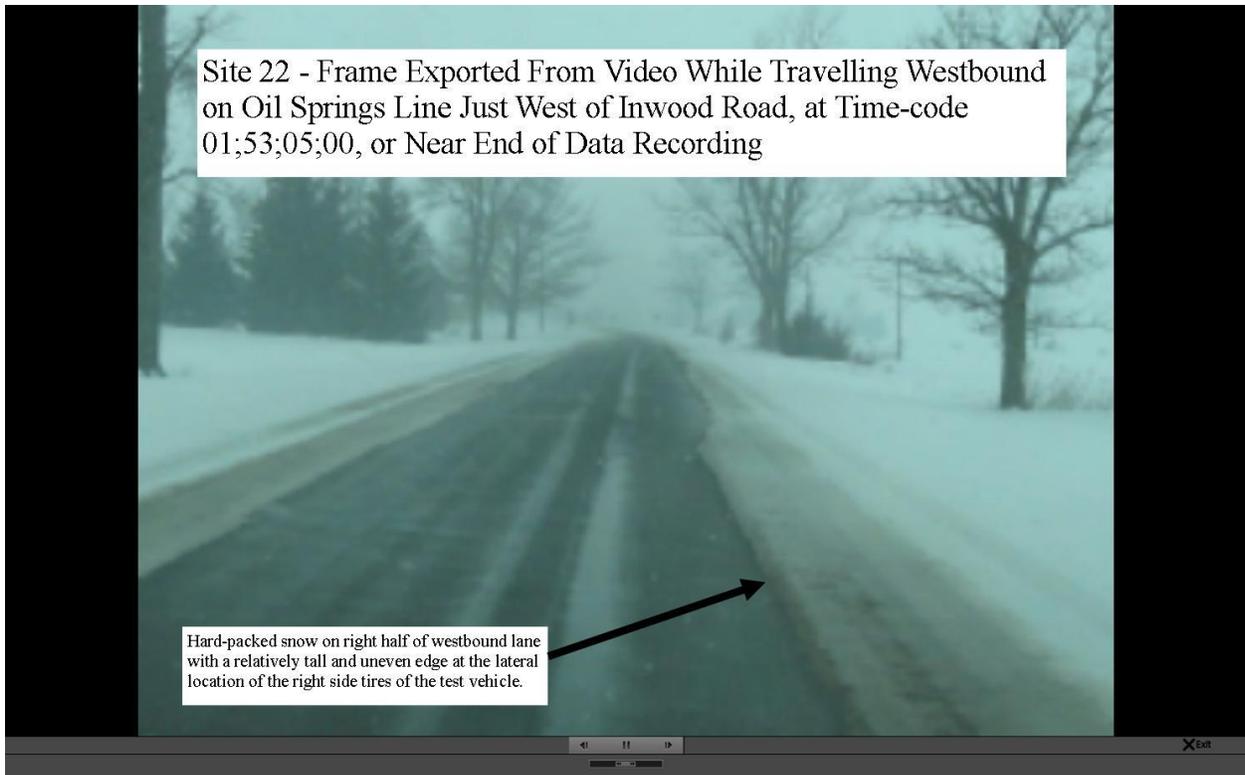
For example, we started recording for Site 22 just after we entered onto Oil Springs Line, just west of Inwood Road. While travelling along Oil Springs Line the test vehicle encountered hard packed snow/ice on the right half of the westbound lane while the left half was bare and wet. This was a potentially unsafe condition because of the difference in tire force that could be experienced by the two sides of the vehicle.

Figure 6 shows the road conditions on Oil Springs Line near the beginning of the recording for Site 22. Figure 7 shows the conditions about halfway through the recording and Figure 8 shows the conditions near the end of the recording. In all three of these figures we can see how hardened snow and ice were compacted onto the right half of the westbound lane. If one were to drive properly within the westbound lane then the right side wheels of the vehicle would have to travel near the edge of that hardened snow and ice. Note how the edge of the hardened snow and ice is irregular so the right side wheels of the vehicle would be continually travelling onto that snow/ice and travelling off it, back and forth. This is the type of condition that caused excessive motion of the test vehicle.

Note however, that the snow and ice were not the only problem. The surface of the road was also uneven and this can be seen in the irregular pooling of water on the surface from time to time in those areas where there were depressions and the water could not drain away.

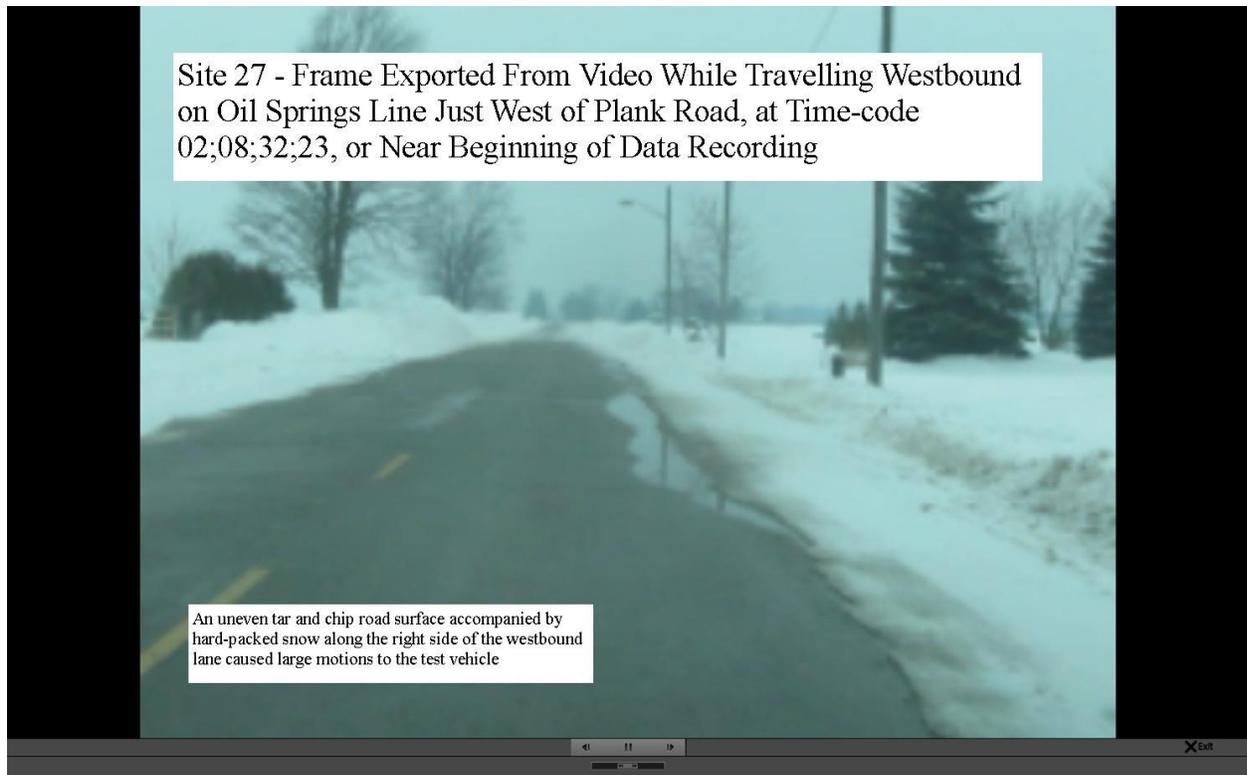
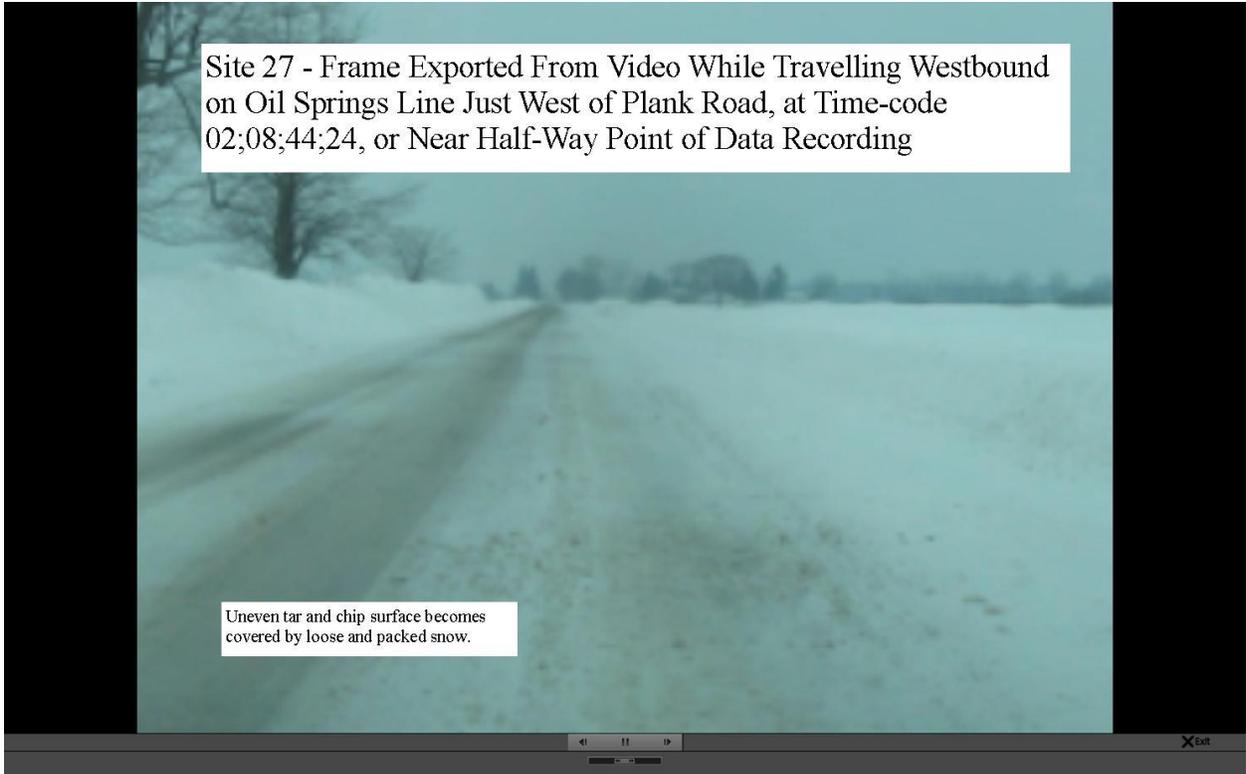
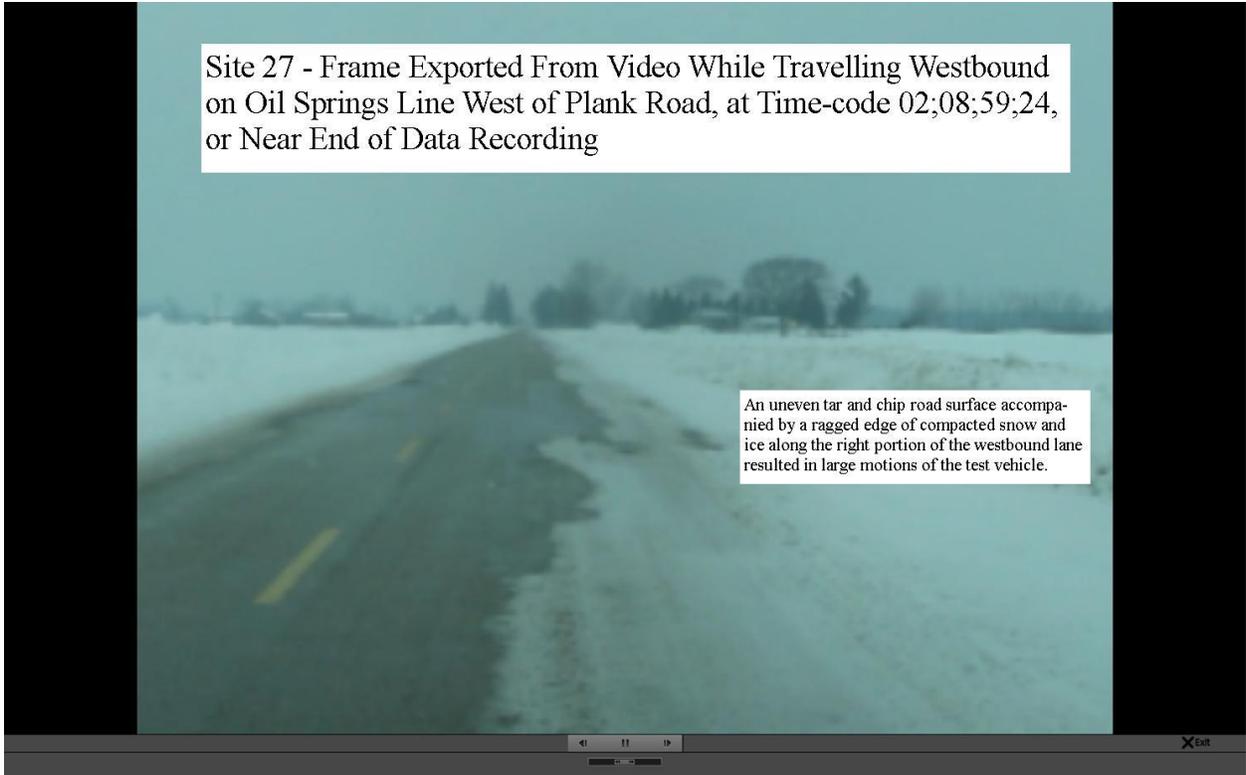
Figure 9 shows the condition of the road at the beginning of the recording of Site 27, Figure 10 shows the conditions mid-way through the recording and Figure 11 shows the conditions near the end of the recording.

Similar to the conditions at Site 22, the uneven tar and chip road surface was intermittently covered in snow and ice.

While being impaired by alcohol and driving too fast are obvious factors that lead to many serious and fatal collisions, the presence of road deficiencies is rarely discussed or identified even when those deficiencies exist. Given the road conditions shown in these figures and the motion data that was recorded by our test vehicle, the poor road conditions at the site of the loss-of-control rollover collision were likely a factor that could have contributed to the event.
