Further Interpretations of Loss-of-Control Tire Marks on a Gravel Shoulder

Posting Date: 14-Oct 2013

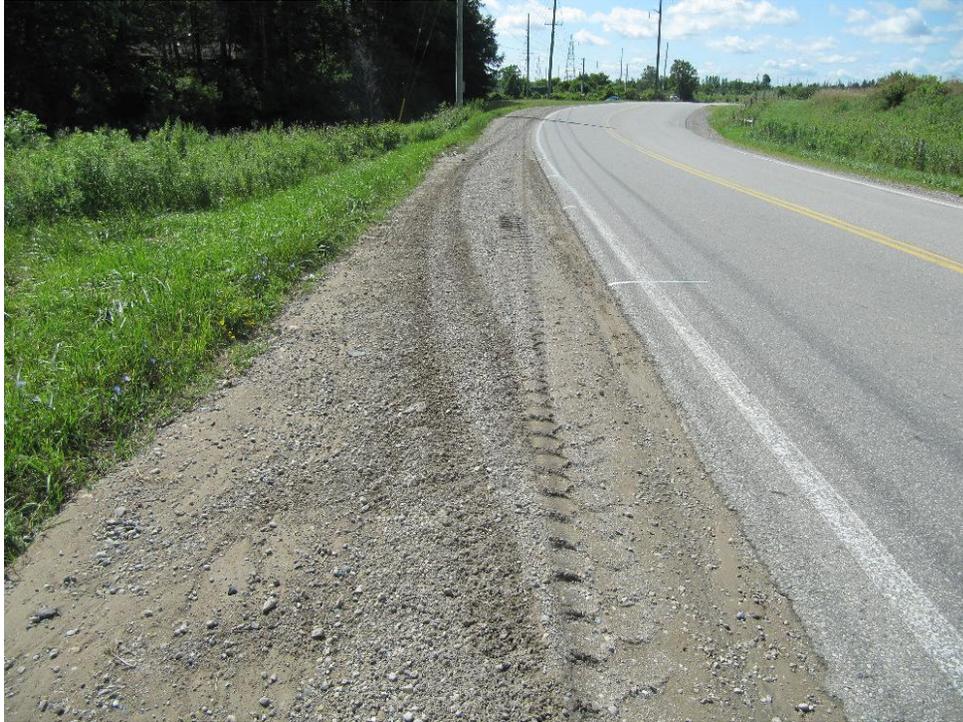
Figure 1: Southbound view of tire marks on east shoulder of Clarke Road that were discussed in Figure 7 of our August, 2013 article.

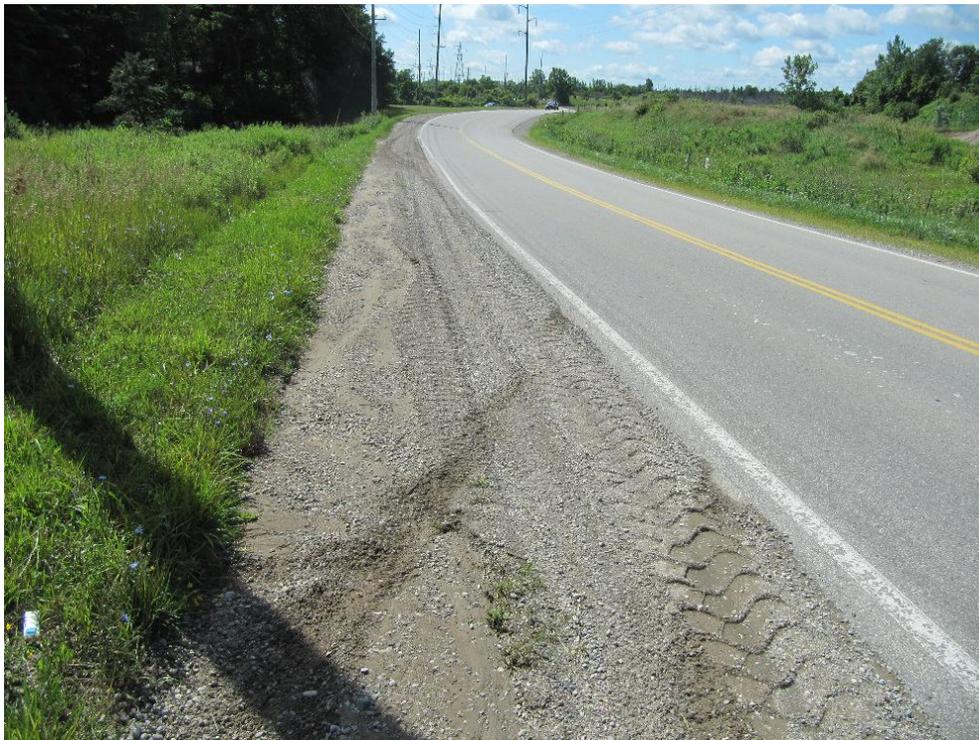
Figure 2: View, looking south, of tire marks from Figure 1 visible in the background and showing how the vehicle returned to the east gravel shoulder in the foreground. This was Figure 8 in our August, 2013 article.

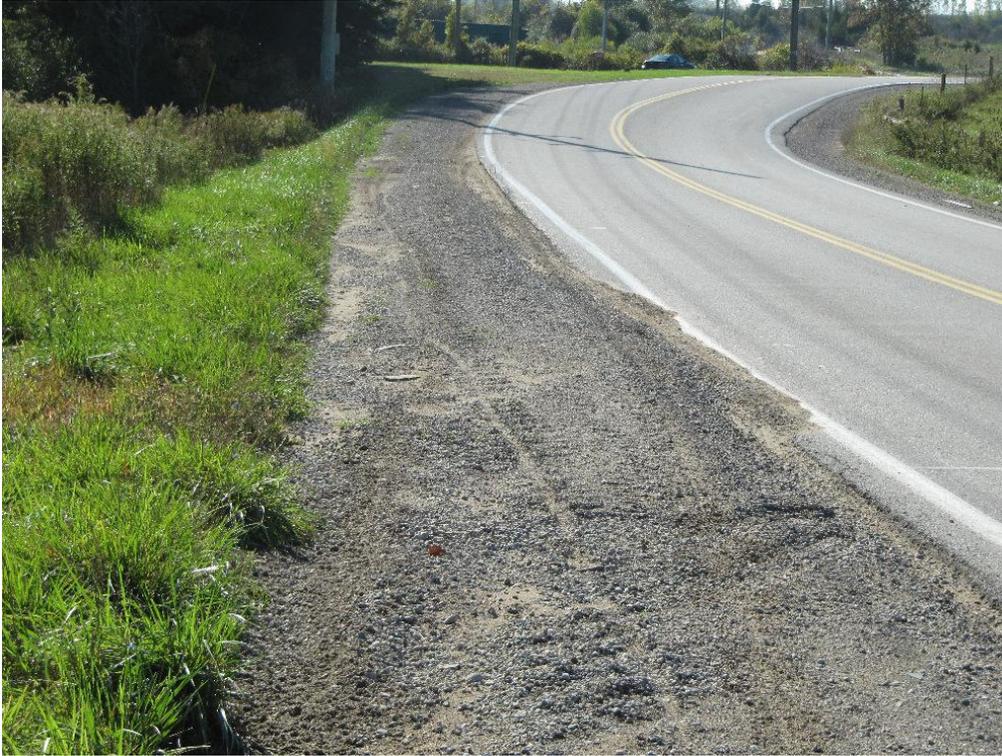
Figure 3: View, looking south, along the east shoulder of Clarke Road, at a set of loss-of-control tire marks caused by a northbound vehicle.

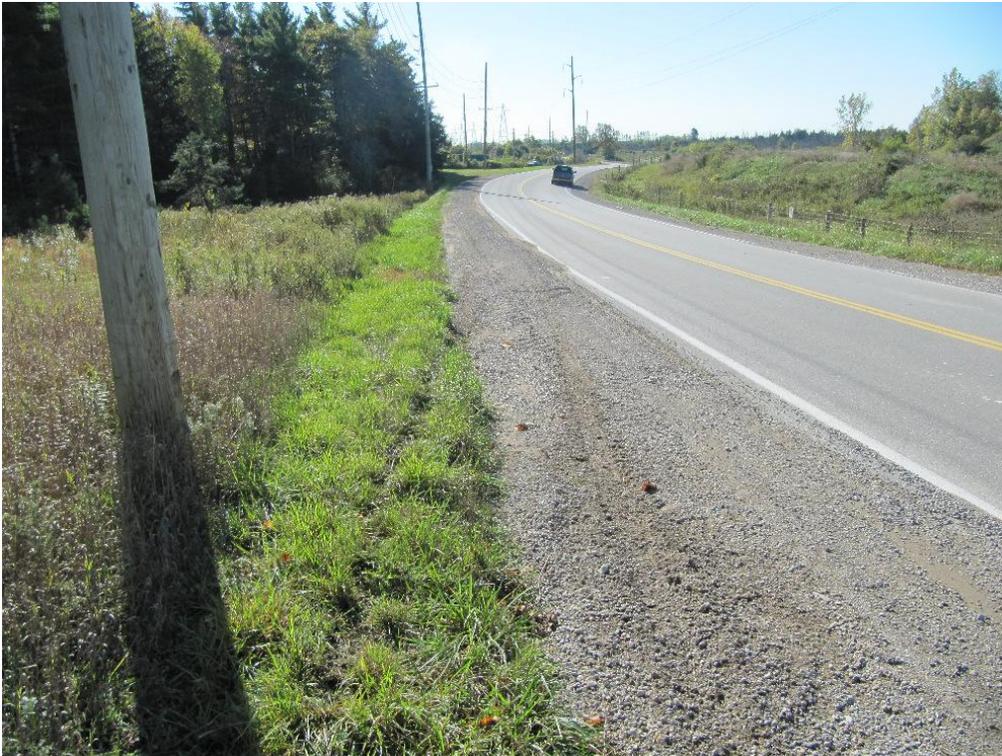
Figure 4: View, looking south, of the tire marks produced by a northbound vehicle as it returns into the east gravel shoulder and partially on the grass roadside.

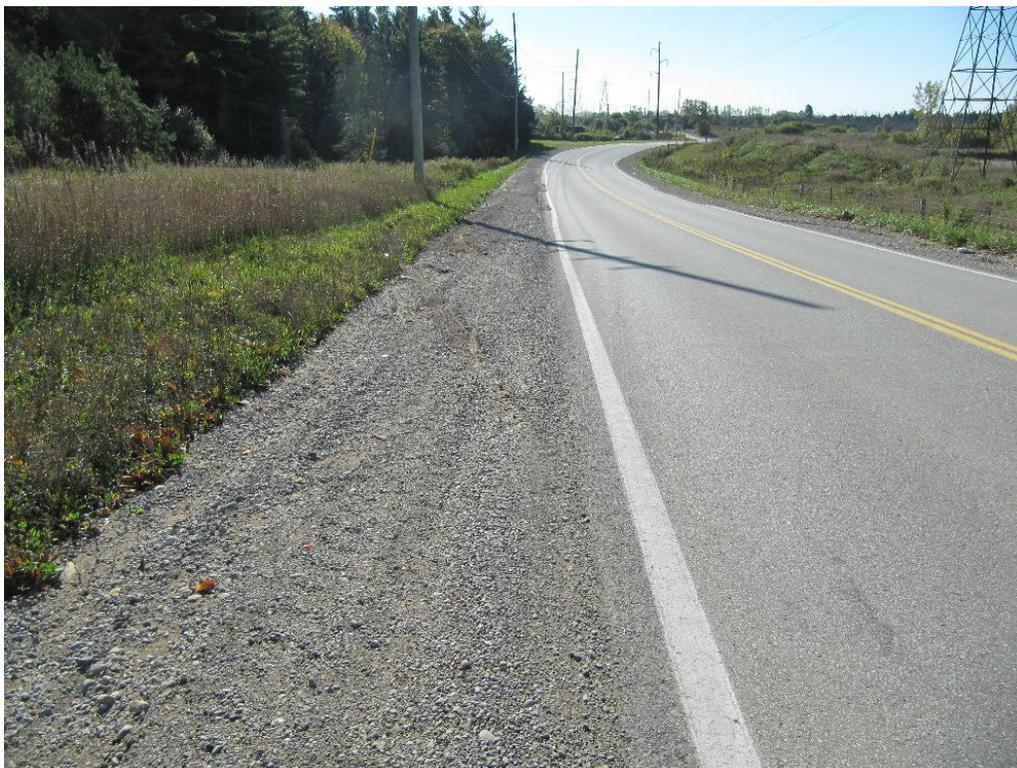
Figure 5: View, looking south, from north of the point where the northbound vehicle reenters the pavement and continues on its way.

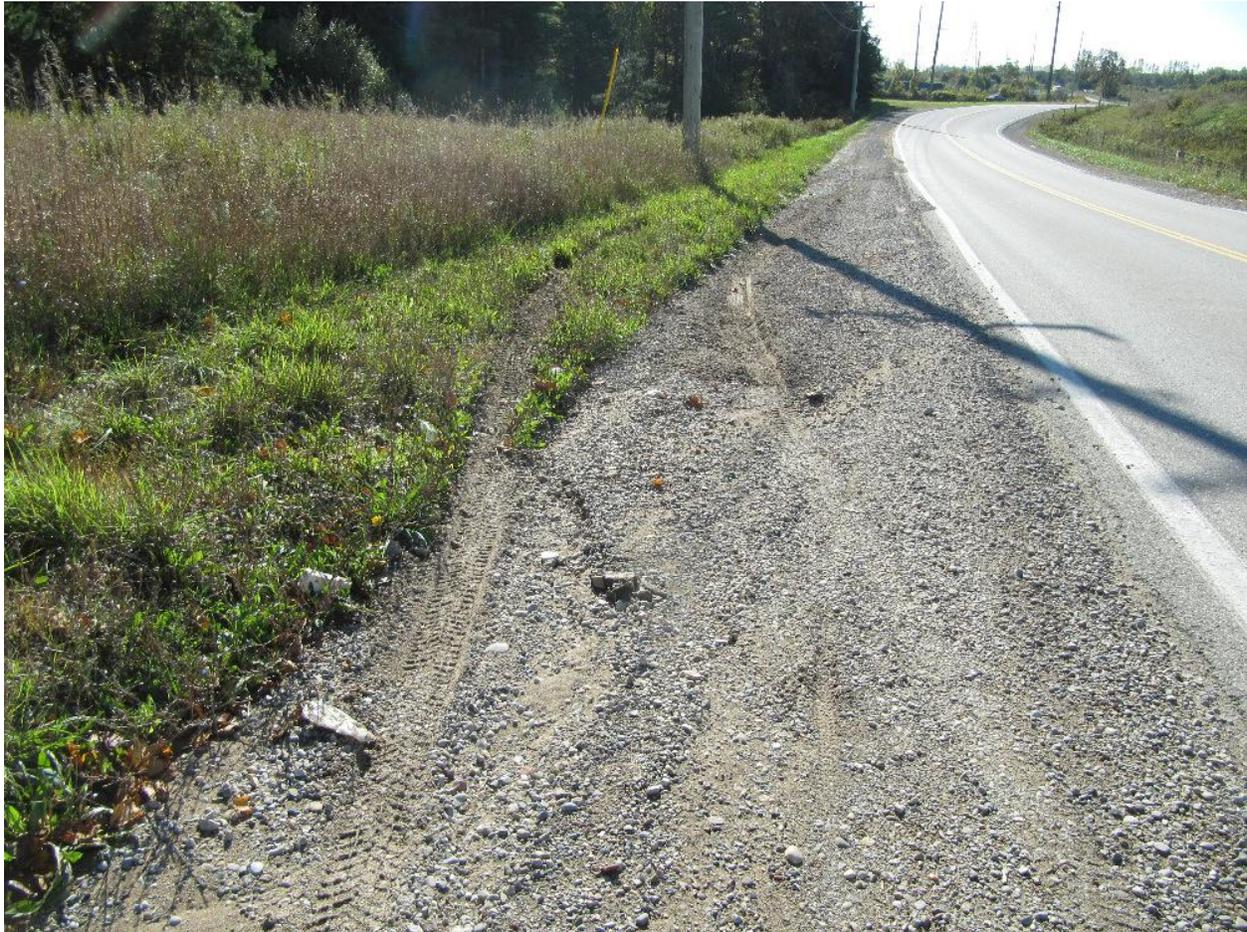
Figure 6: View, looking south, at the tire marks as they exit the grass road side and travel toward the point where they return to the pavement.

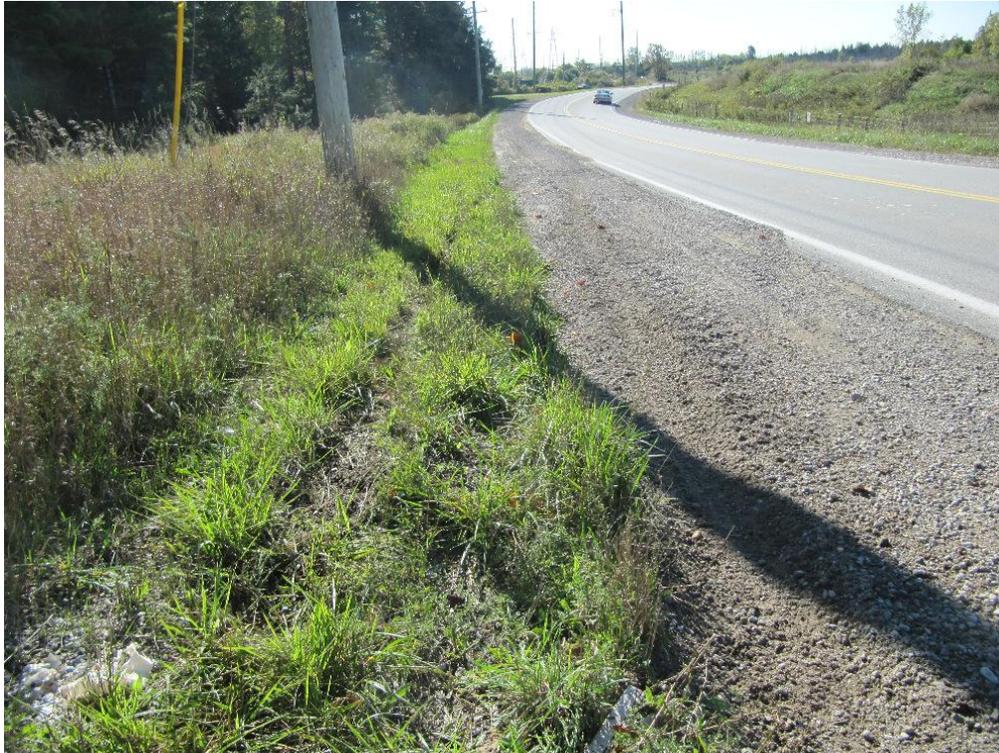
Figure 7: View, looking south at the tire marks as they pass through the east, grass, roadside.

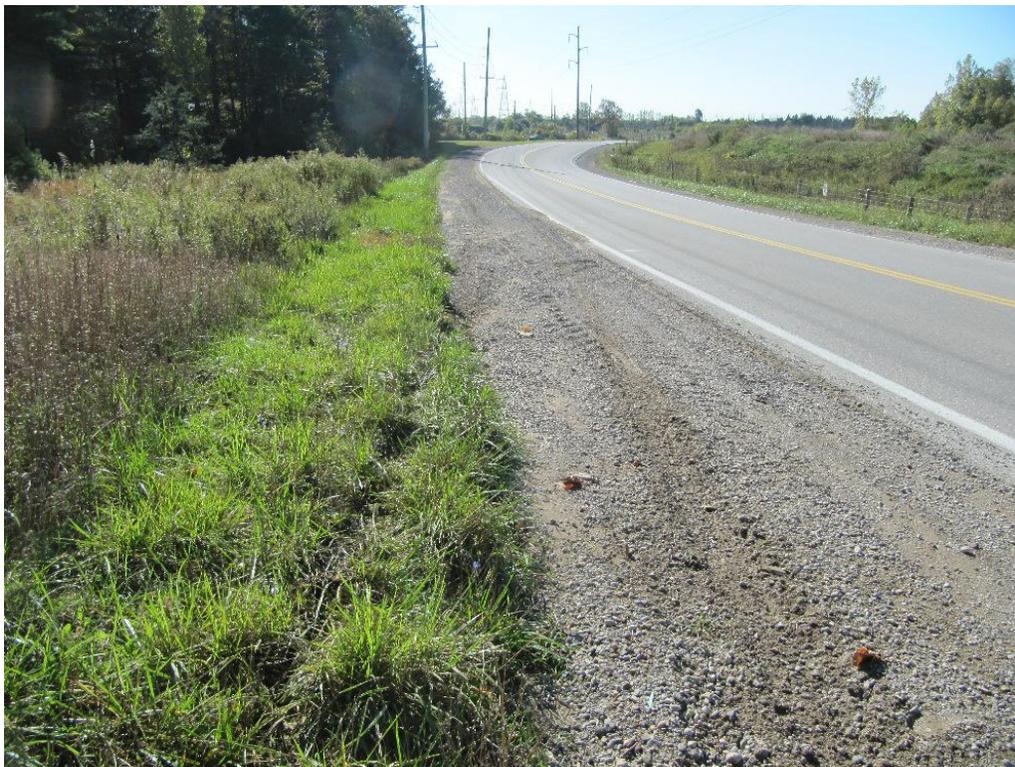
Figure 8: View, looking south showing the point where vehicle enters the east grass roadside.

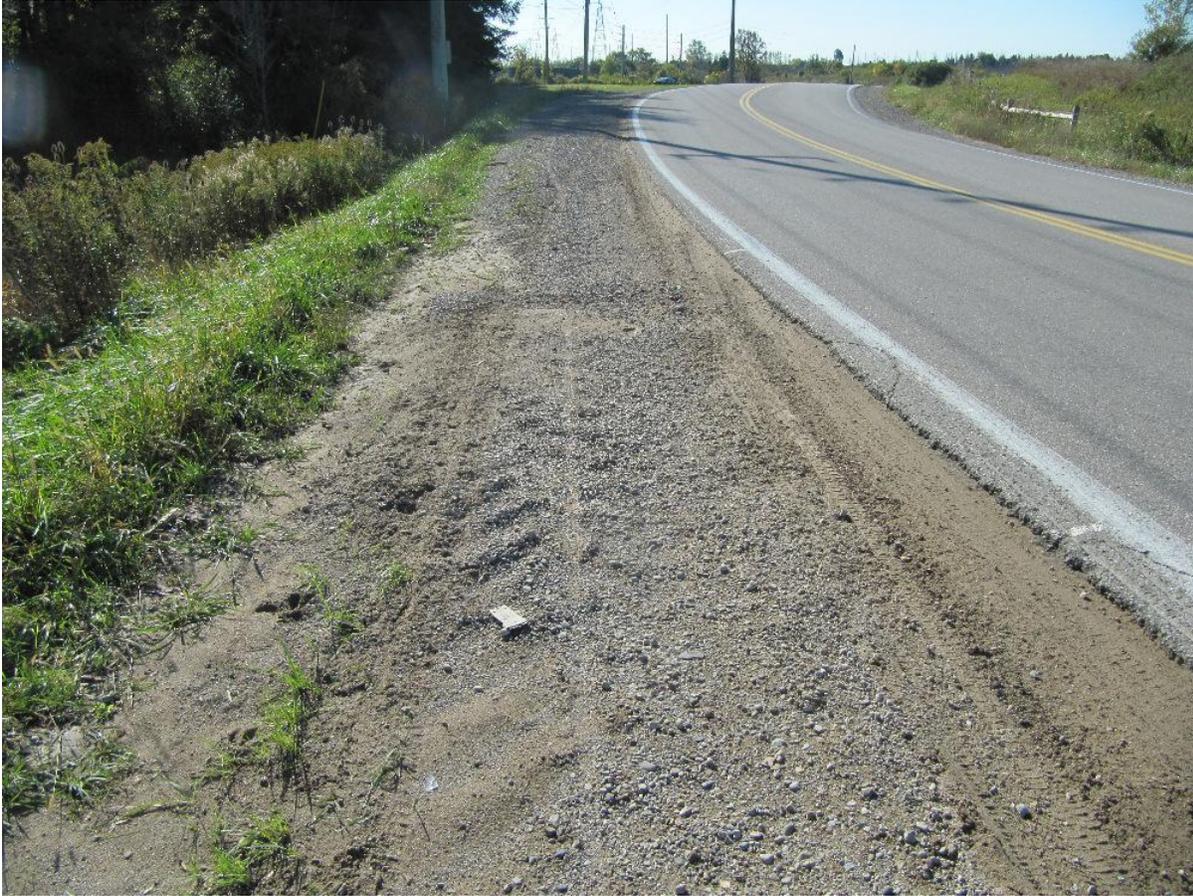
Figure 9: View, looking south, along the tire marks as the vehicle comes off the pavement and is at the limit of the available centripetal force.

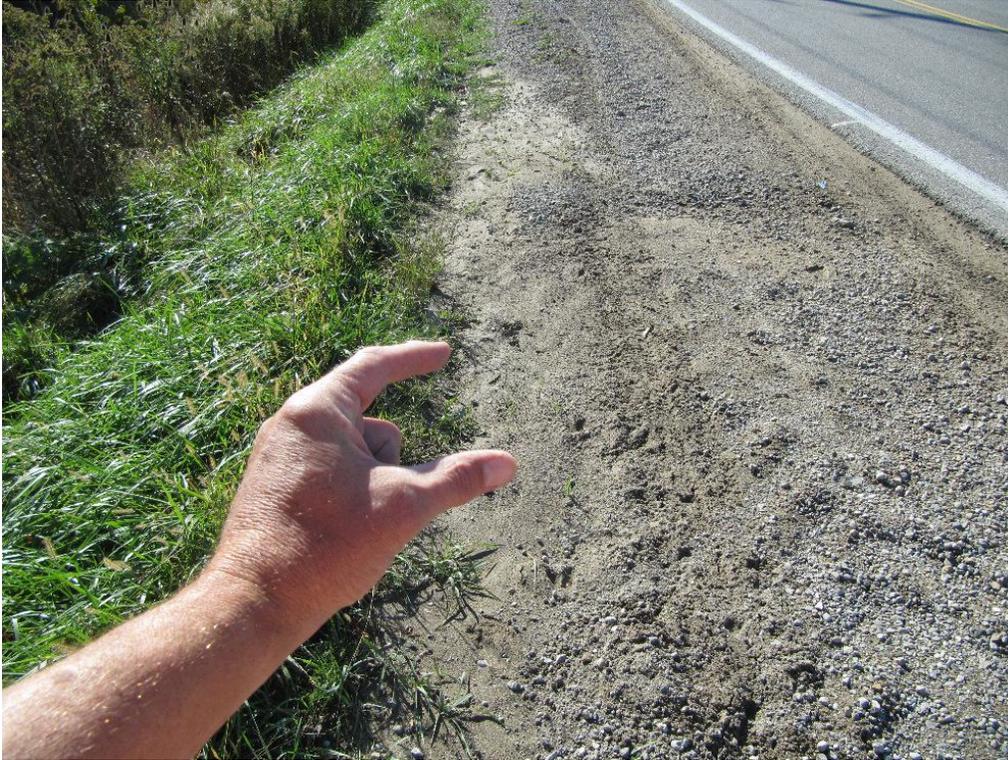
Figure 10 gives us the first evidence of concern. The investigator's fingers are pointing to an area of the shoulder next to the tire marks and closer views of this area are shown in Figures 11 and 12. In Figure 12 the evidence is obviously a deer hoof mark.

Figure 10: View of investigator's fingers pointing to some evidence on the east shoulder next to the loss-of-control tire marks.

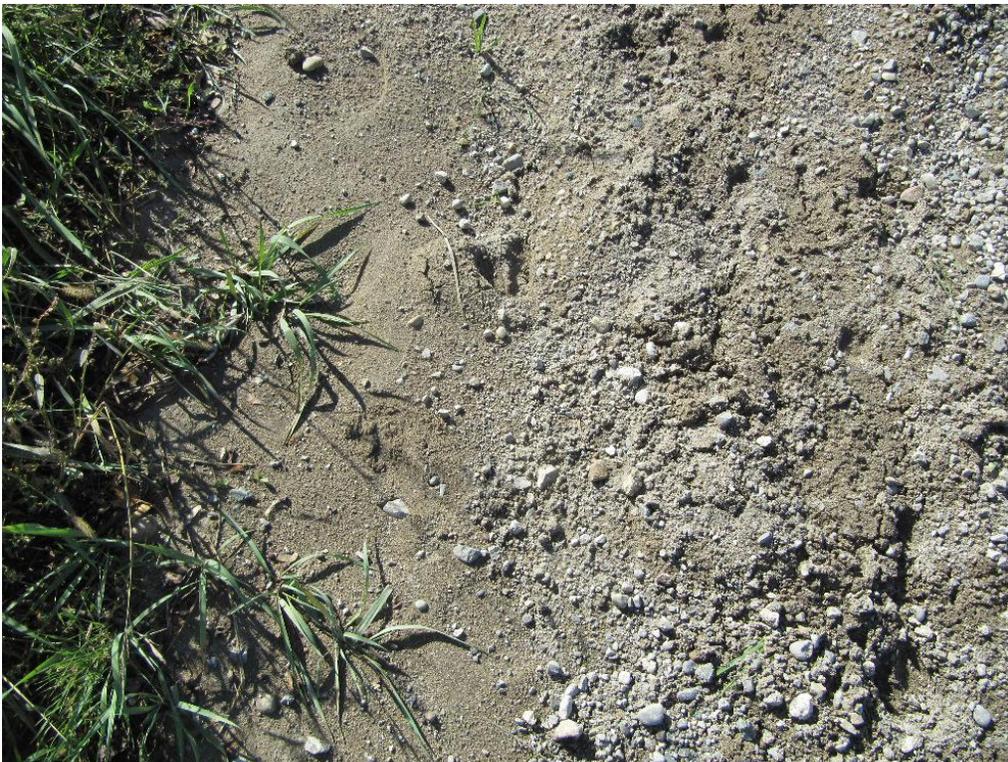
Figure 11: Closer view of the area shown in Figure 10.

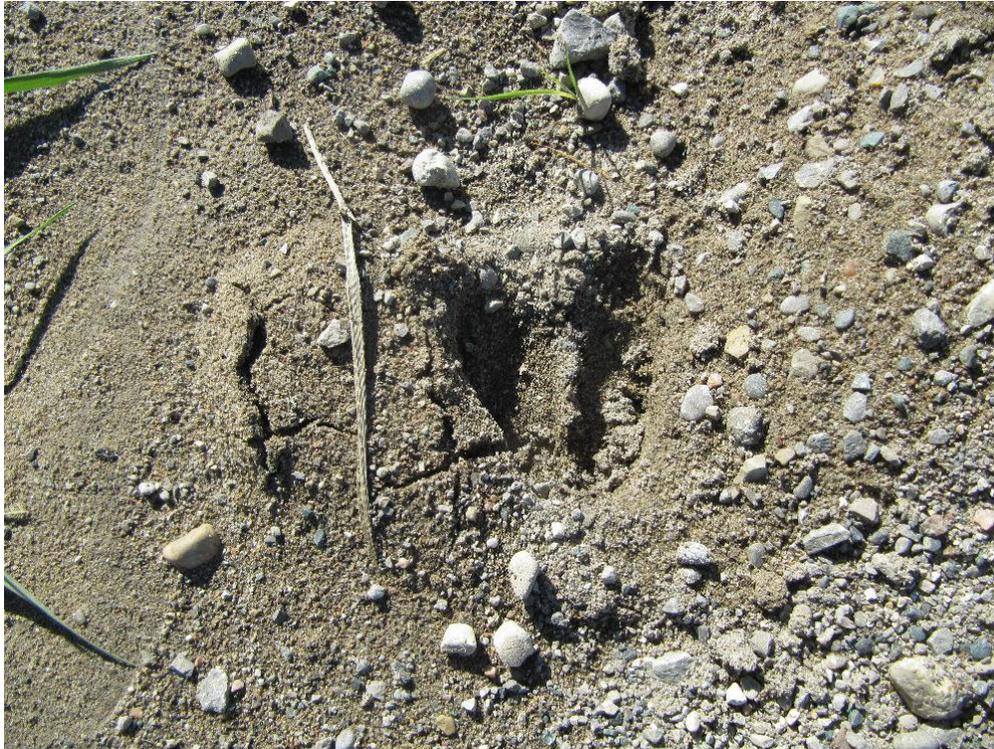
Figure 12: Close-up view of deer hoof print in the area shown in Figures 10 and 11.

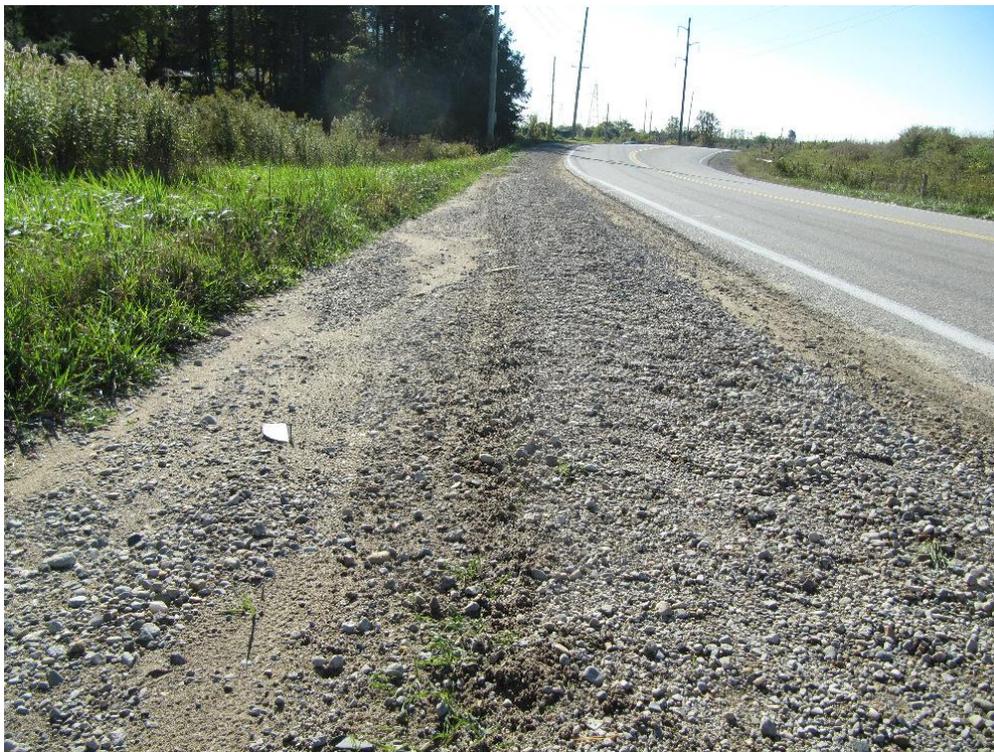
Figure 13 shows some other suspicious evidence. If you look closely just to the left of the left side tire marks of the vehicle, there is another fresh imprint of a wiggly, narrow tire. Is this a mark that is produced by a bicycle? Certainly it has those characteristics. So did the driver lose control because he/she encountered a bicycle on this curve? So the plots thickens even further. To evaluate these concerns we need to look at the rest of the physical evidence.

Figure 13: View of a narrow, wiggly tire print just to the left (east) of the tire mark produced by our subject vehicle.

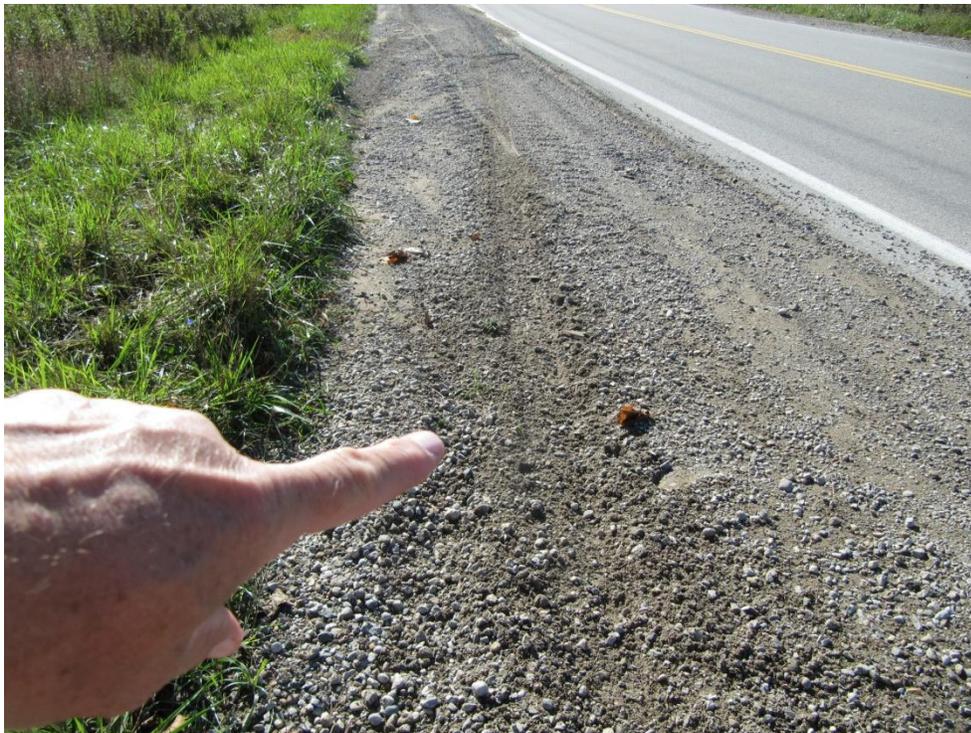
Figure 14: Southward view with finger pointing to the area of an interesting overlap of an imprint on top of the left side tire marks.

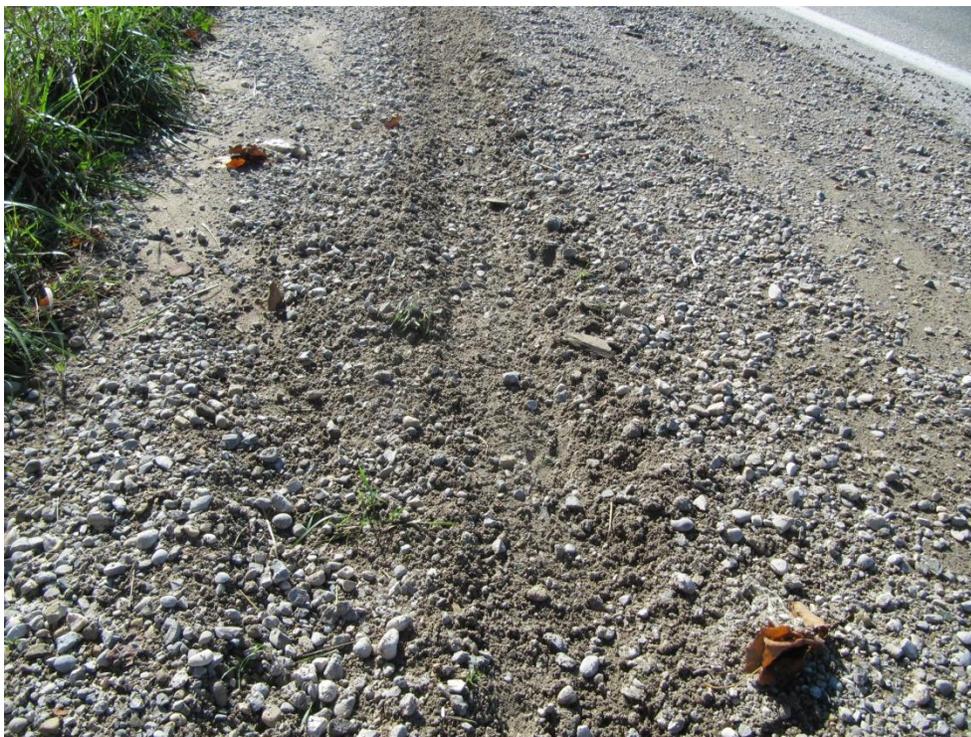
Figure 15: Closer view of portion of left side tire marks containing an interesting imprint.

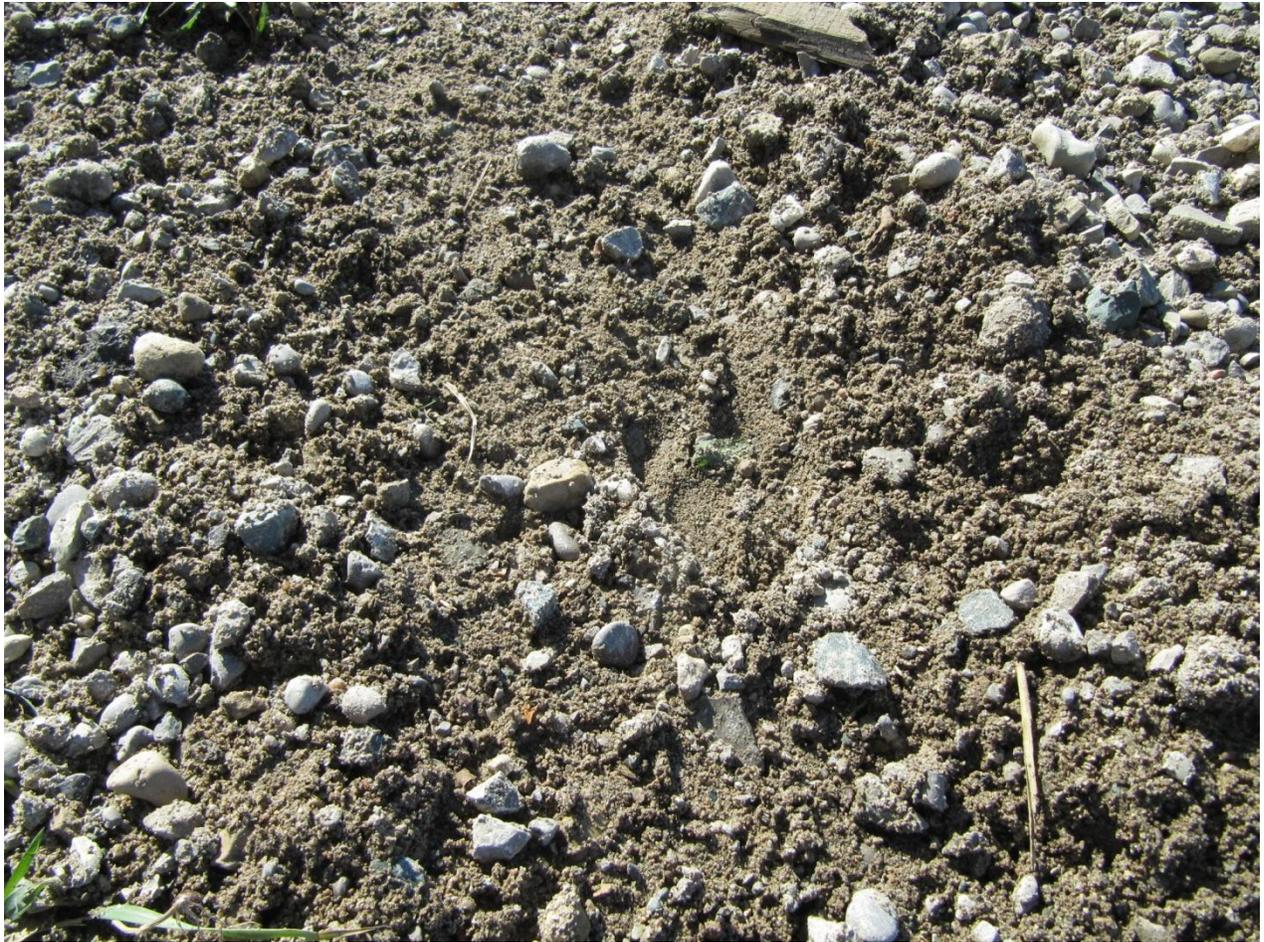
When we look further along the tire marks we come across an interesting, overlapping imprint on top of the left tires as shown in Figure 14. Close-up views of the area are shown in Figures 15 and 16. A close inspection of the centre of Figure 16 shows a deer hoof imprint on top of the tire marks produced by the left side tires of the vehicle.

Figure 16: A close-up inspection of the centre of this photo shows deer hoof imprint on top of the tire marks produced by the left side tires of the vehicle.

The finding of the deer hoof imprint on top of the tire mark indicates that the deer travelled over this mark after it was created. Although this does not eliminate the possibility that the deer may still somehow have been involved in these events, it demonstrates that the finding of evidence on top of other evidence can help one to understand how the events unfolded.

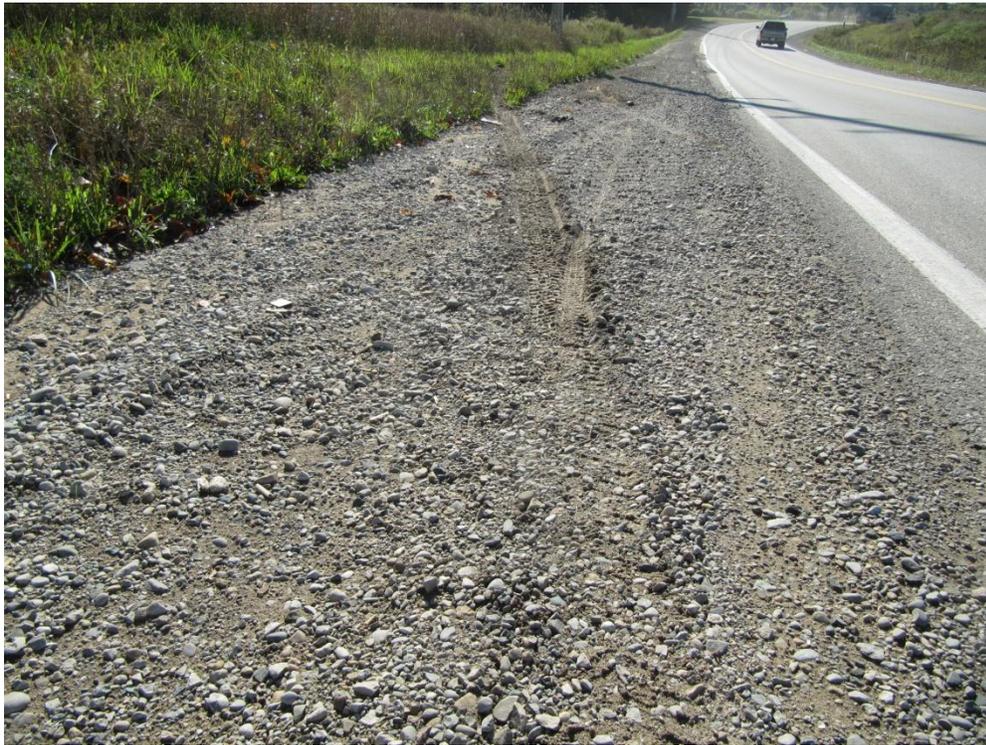
Similarly, we can study of bicycle tire mark. Figure 17 shows an area where the motor vehicle has come off the east roadside and is headed back onto the pavement and we are looking at the mark produced by the left side tires. If you look closely you can also see the narrow tire mark produced by the bicycle and the two marks converge. And Figure 18 provides a closer view of that convergence. One should be able to detect that the bicycle tire mark is overlapping the mark from the motor vehicle, just like the deer hoof imprint discussed earlier. Figure 19 provides an even closer view of that convergence.

Figure 17: Southward view showing area where the bicycle tire mark converges with the motor vehicle tire mark.

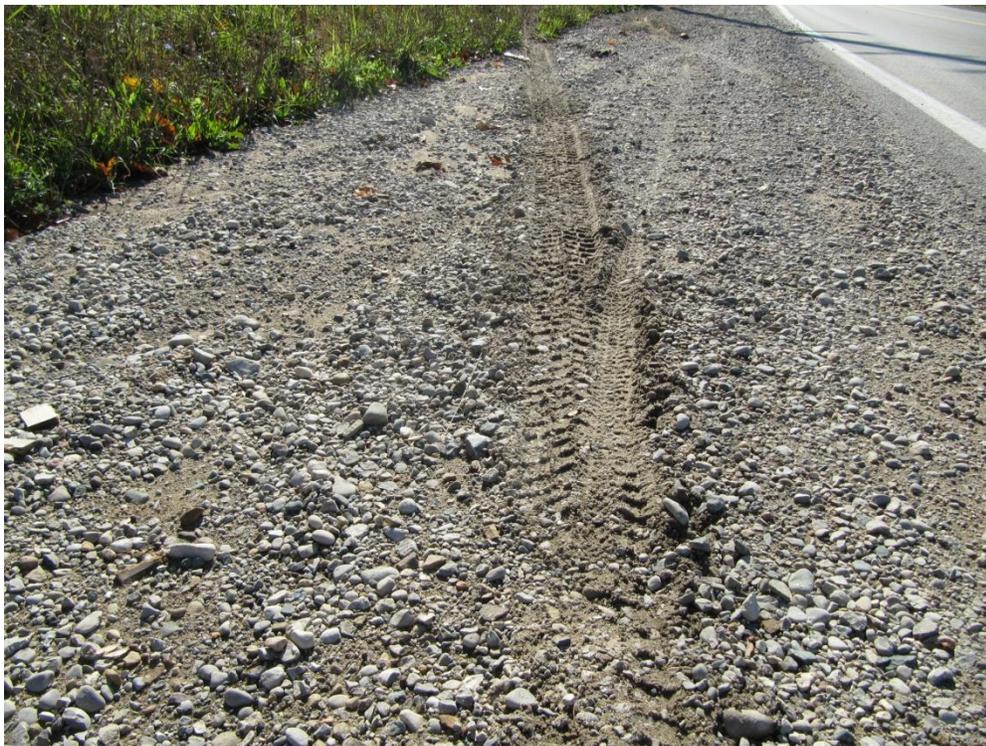
Figure 18: Closer view of the convergence between the bicycle and motor vehicle tire marks.

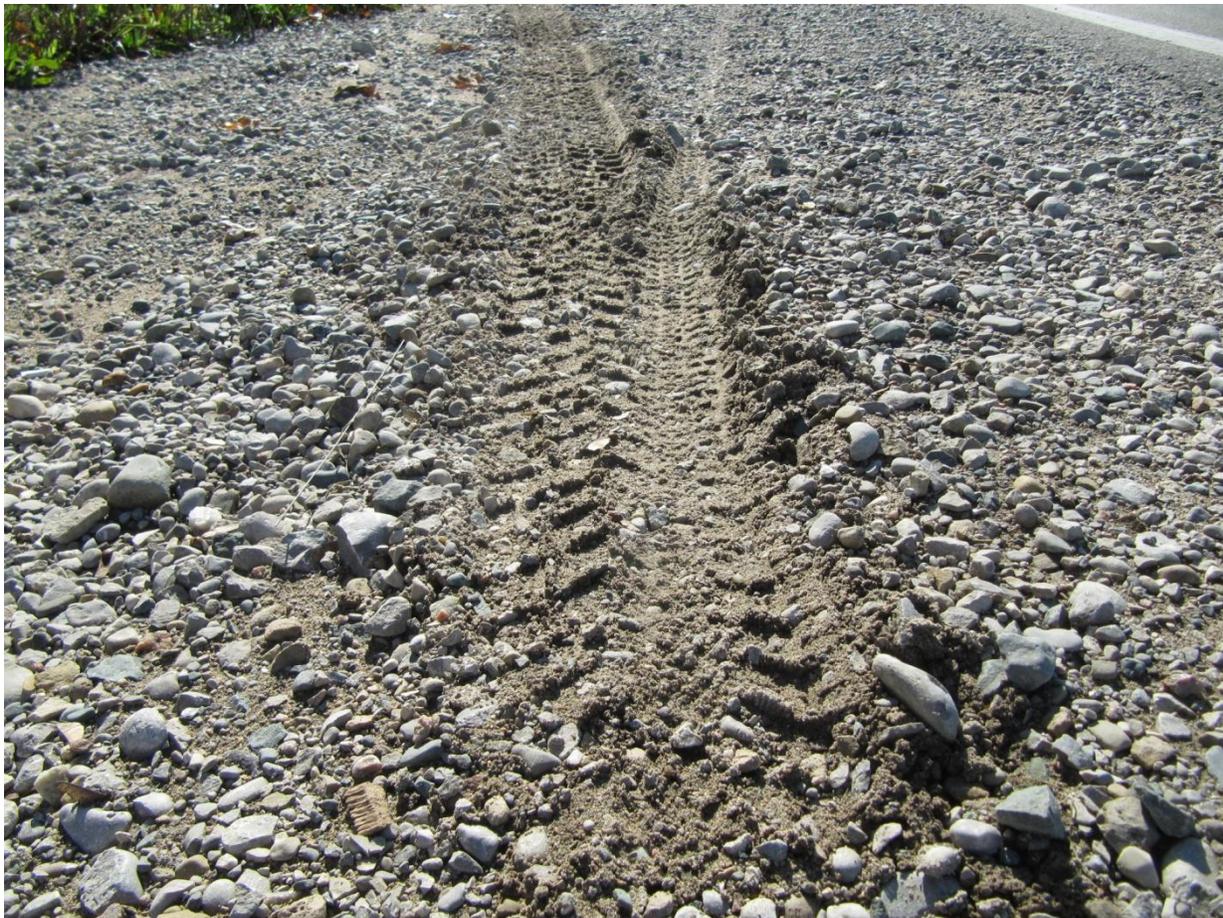
Figure 19: Close-up view of convergence between bicycle and motor vehicle tire marks.

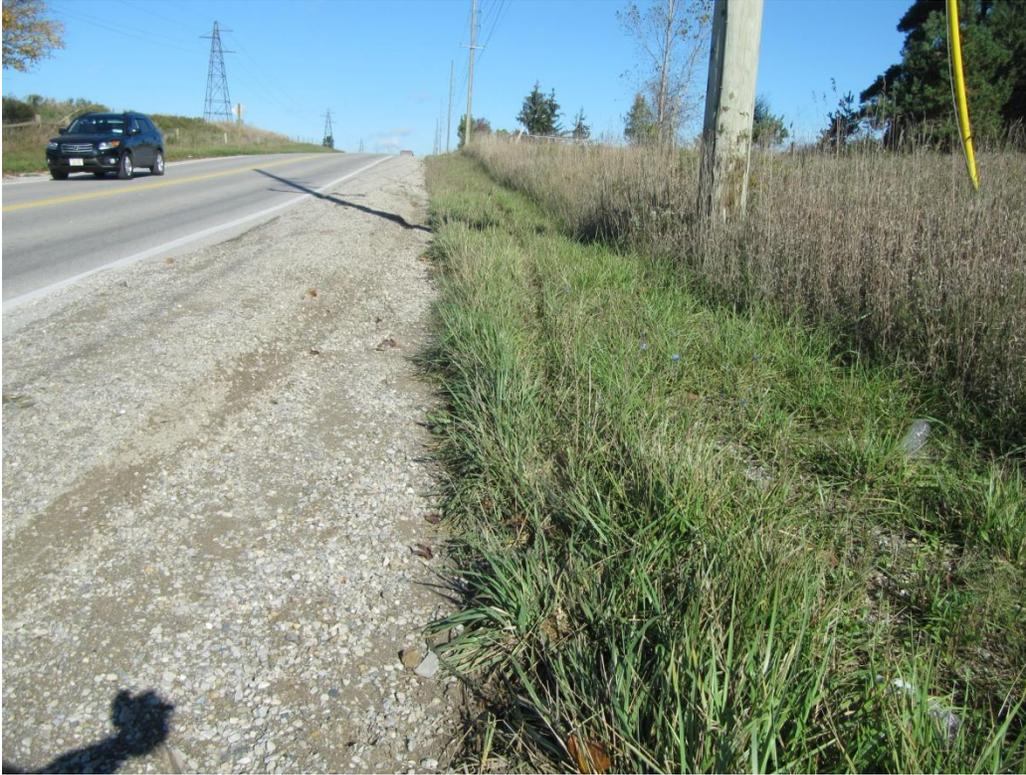
As shown in Figure 22, in the present case, our vehicle does not enter the grassy roadside as abruptly as evidenced by the more shallow angle of entrance of the left side tires into the grass. We follow those tire marks in Figures 23 and 24 and then as those tire marks exit the grassy roadside in Figure 25.

Figure 22: Northward view of the tire marks from the present scenario where the tire marks enter the grassy roadside.

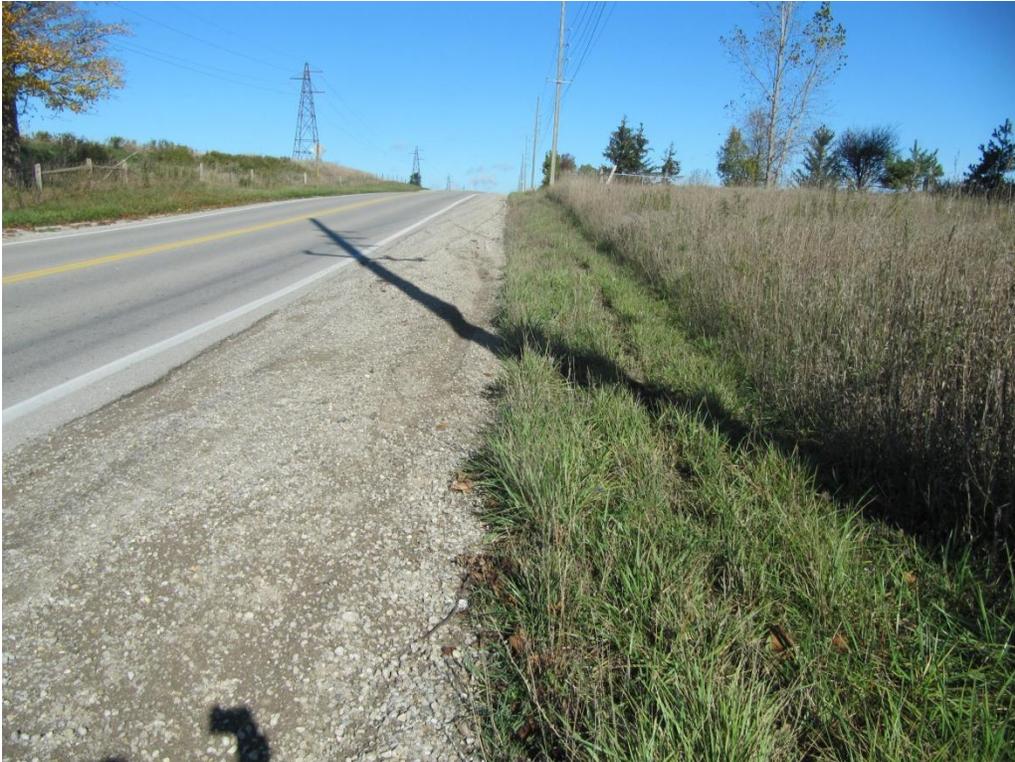
Figure 23: Northward view as we follow the tire marks in the east grassy roadside.

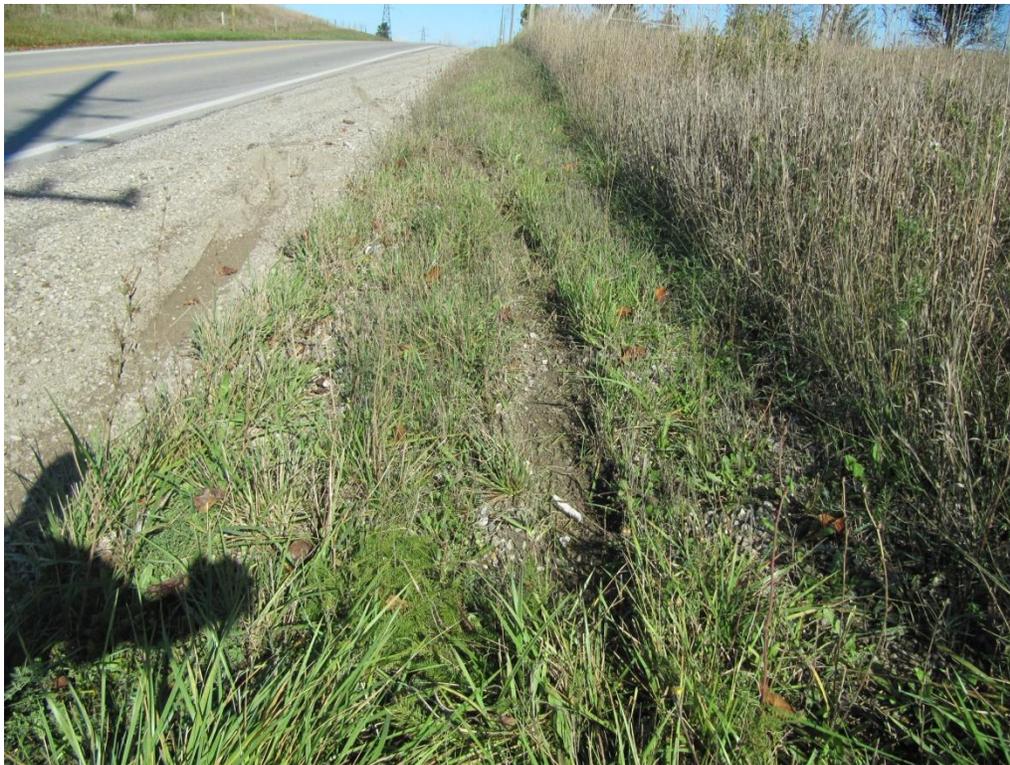
Figure 24: Northward view of tire marks on east grassy roadside.

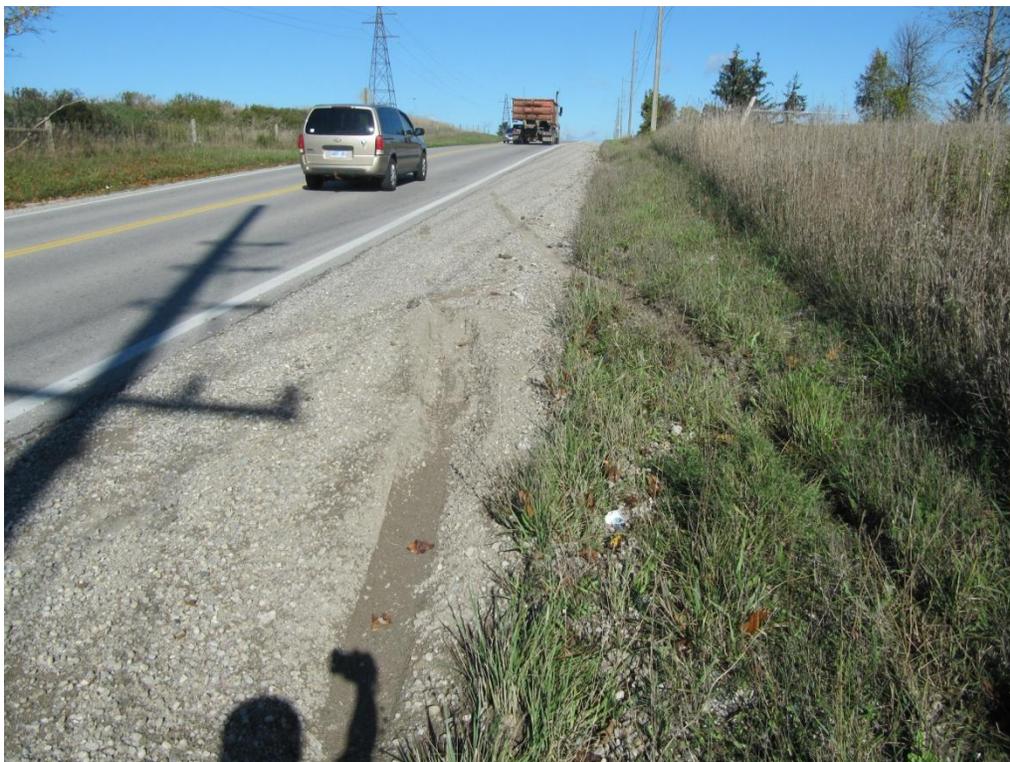
Figure 25: Northward view of tire marks as they exit the grassy roadside.

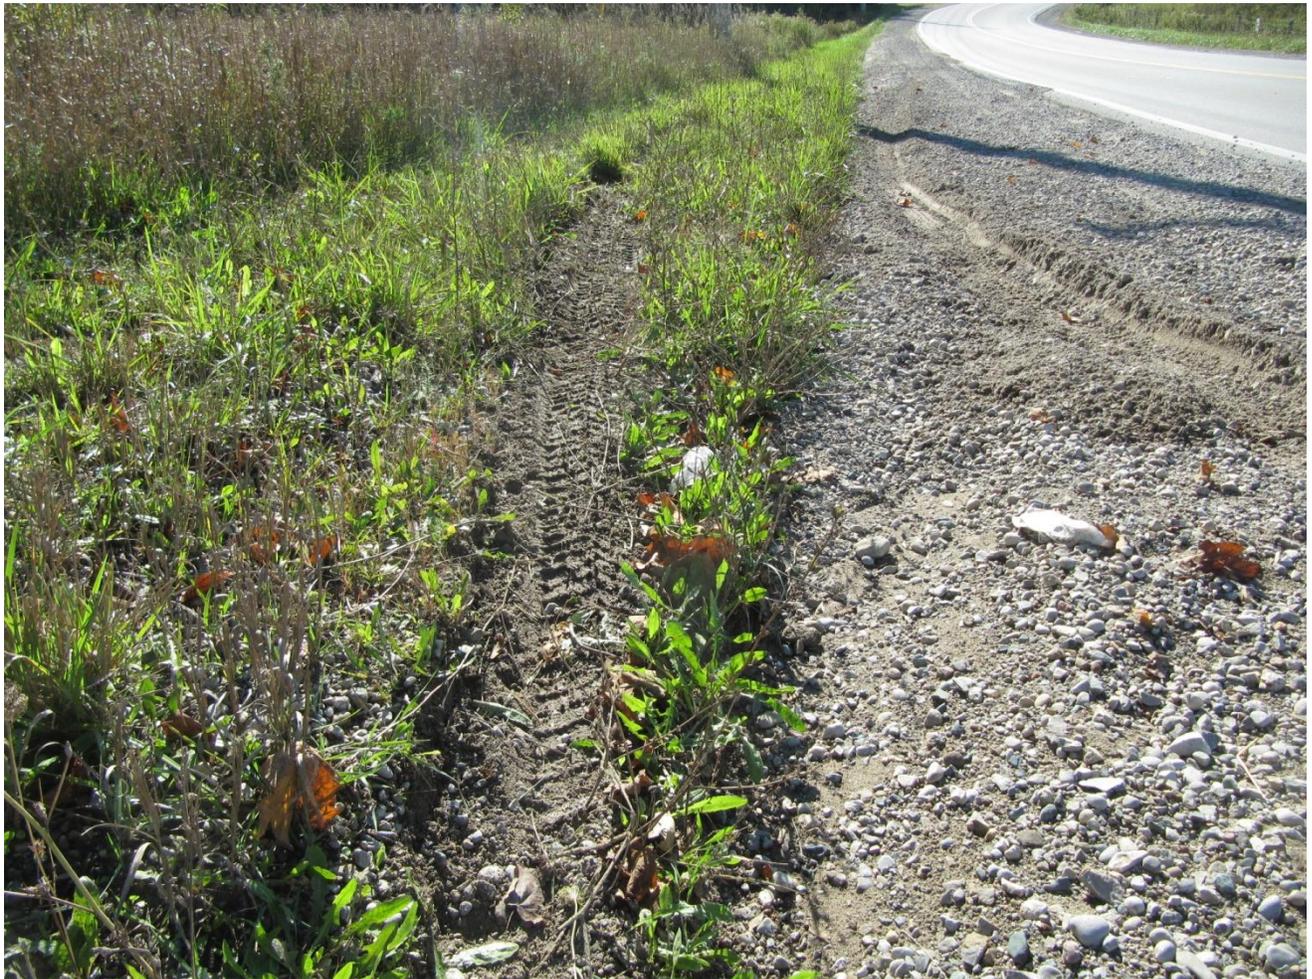
Figure 26 provides a closer view of the tire marks produced by the left side tires of the vehicle. You should be able to detect the pattern of the tread of the tire mark in the foreground as that tire mark is just exiting the grass.

Figure 26: Southward view of left side tire mark exiting the grass.

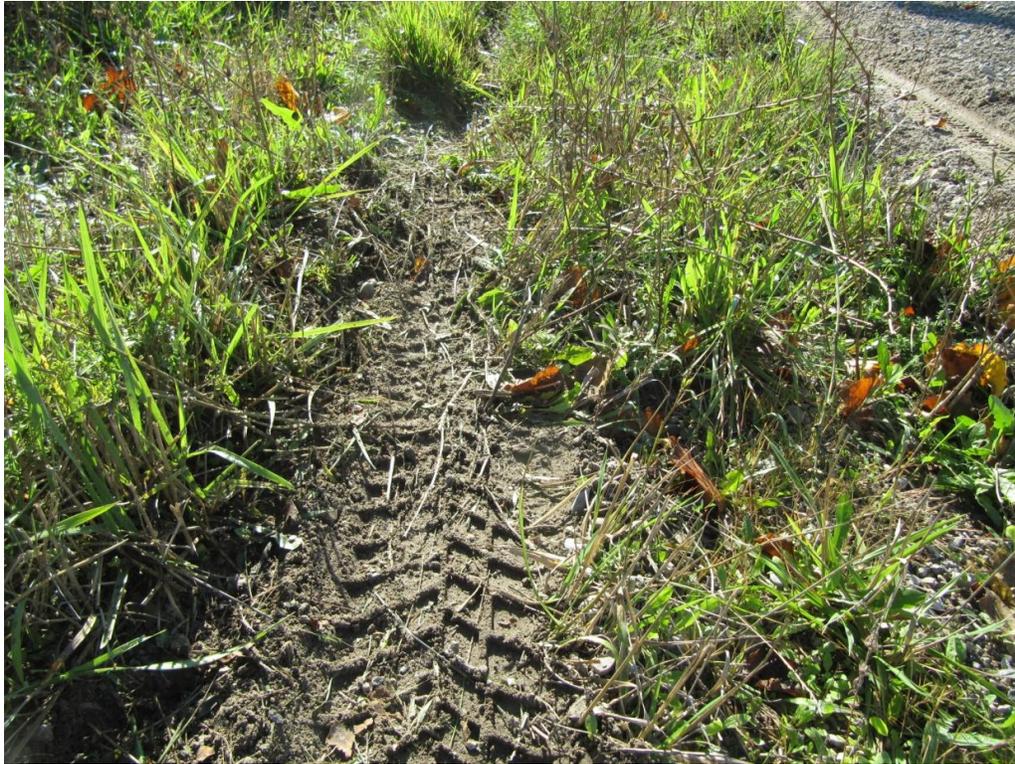
That tread pattern is more clearly visible in the closer view of Figure 27. However there is a point further to the south where that tire mark does not exhibit that visible tread mark but that characteristic is difficult to show because it is masked by the grass. The status of the vehicle's motion is more clear by looking at the right side tires that are still on the gravel shoulder, as shown in Figure 28.

Figure 27: Closer view showing the visible tread pattern in the left side tire mark as it passes through the grass.
