Further Interpretations of Loss-of-Control Tire Marks on a Gravel Shoulder

Posting Date: 14-Oct 2013

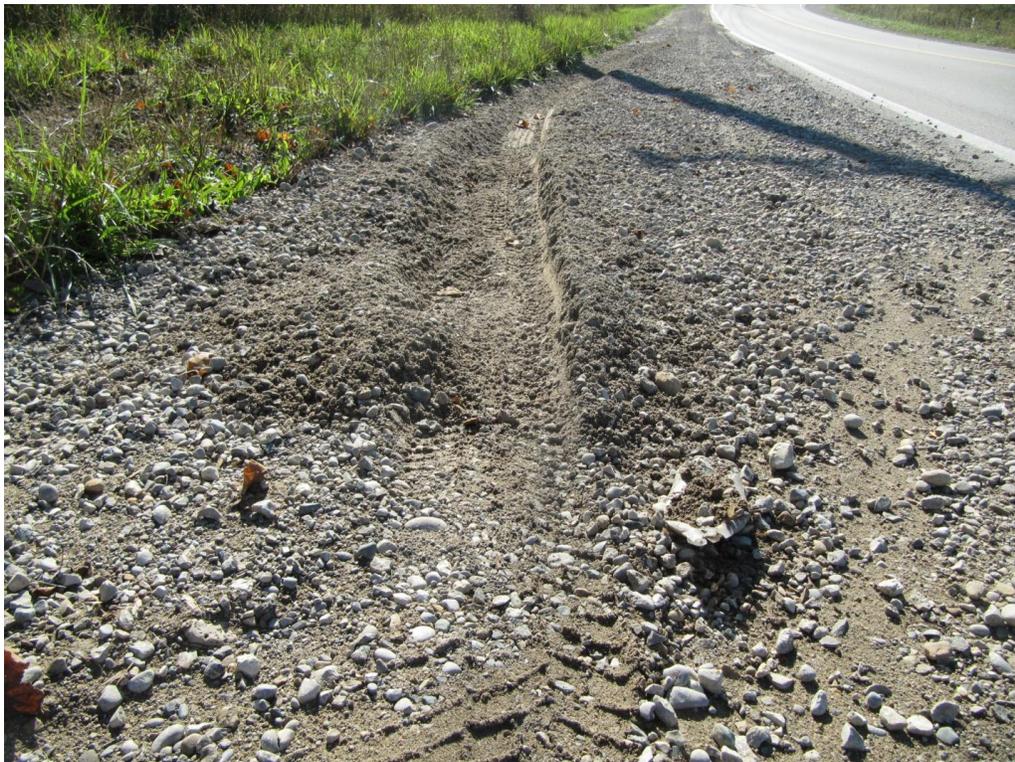
One can easily distinguish between the tracking tire in the foreground and the upheaval visible in the background that is indicative of the tire sliding with respect to gravel surface. Recall that the "sliding" can take place either from positive acceleration (throttle application) or from negative acceleration (applying the brake pedal), so we need to discern what is the actual case. Certainly, Figure 28 shows a fairly deep furrow where the tire has dug deeply into the gravel however that depth can also be a function of the softness/looseness of the surface and not necessarily indicative of maximum acceleration. Also the tire with the least load may be the first to "spin".

Figure 28: View of right side tire mark with a visible tread pattern in the foreground and an upheaval of the gravel in the background.

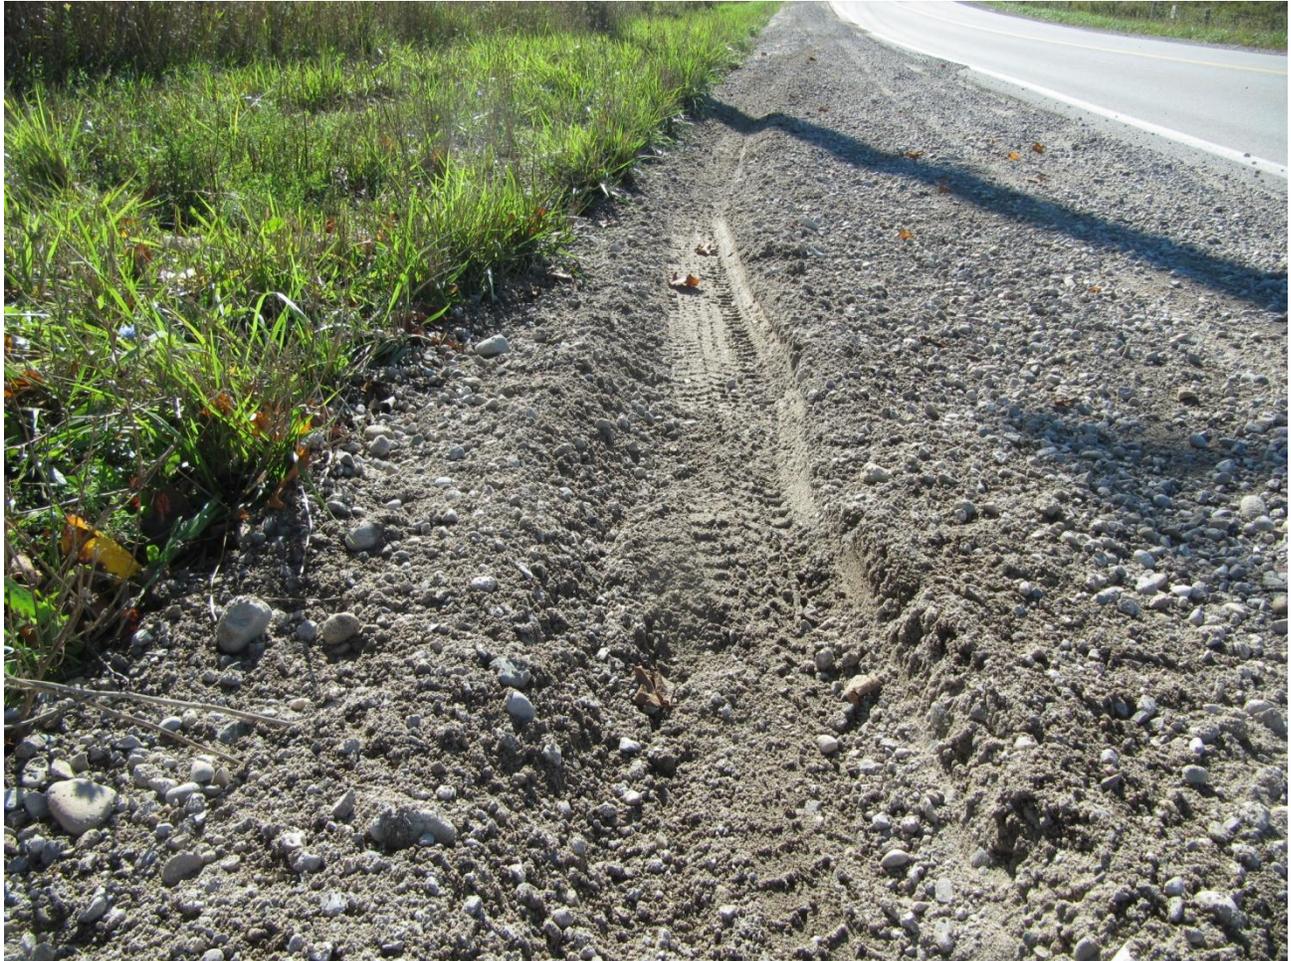
As we look slightly south of the view shown in Figure 28, we see a curious characteristics in the right side tire mark as shown in Figure 29. There appears to be a patch of tire mark that has its tread mark visible.

Figure 29: View, looking south at a portion of the right side tire mark containing a visible tread.

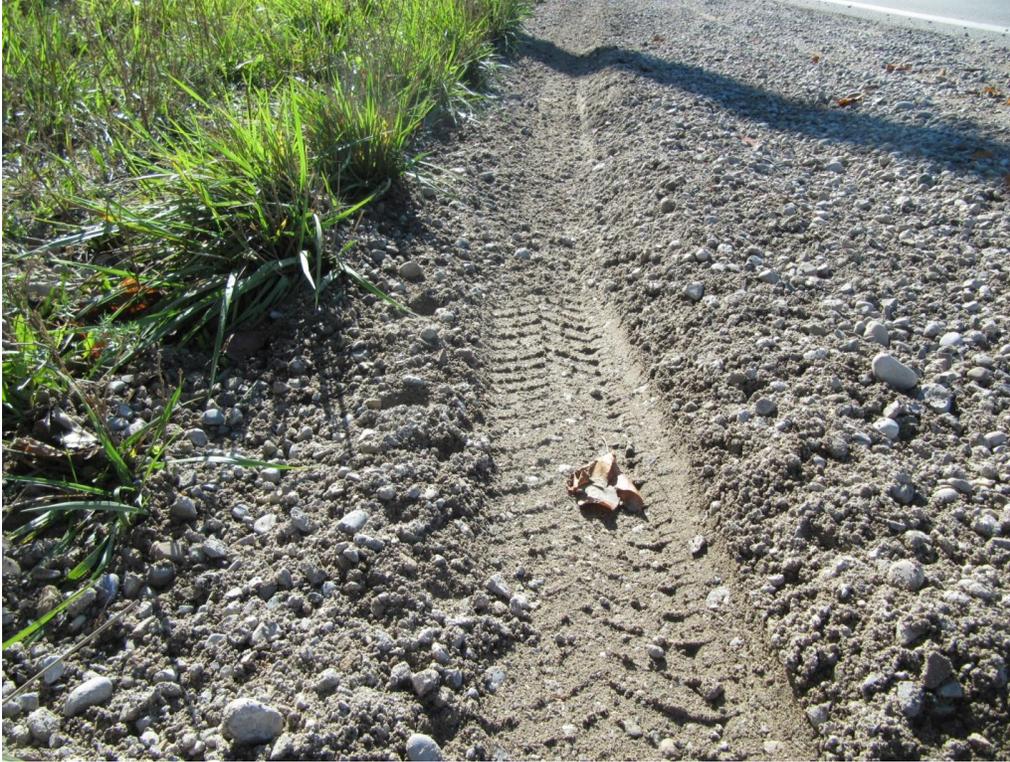
Figure 30 shows a closer view of that area. Is this the point where the driver regained control of his/her vehicle? It is an interesting argument that we will allow the reader to consider.

Figure 30: Closer view of area of visible tread in the right tire mark.

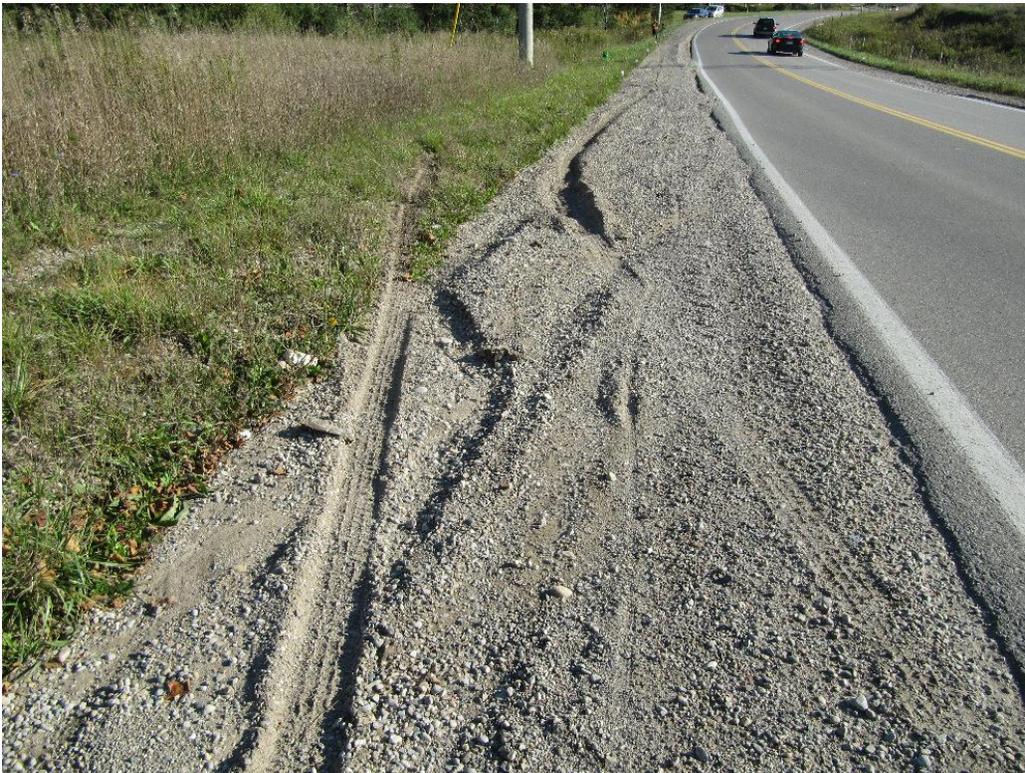
Figure 31: Southward view taken in the late afternoon, demonstrating the difference in the visibility of the characteristics of the tire marks.

Figure 31 is showing a similar view to that of Figure 6 but note how the characteristics of the tire marks are more vivid. Because the sun is low on the horizon it accentuates the character of vertical height differences so that ridges in the tire mark edges are more pronounced. Note in Figure 32 how the existence of shadows helps to define areas of vertical changes such as the ridges of the tread pattern and the depth of the hollow where the tire dug into the gravel.

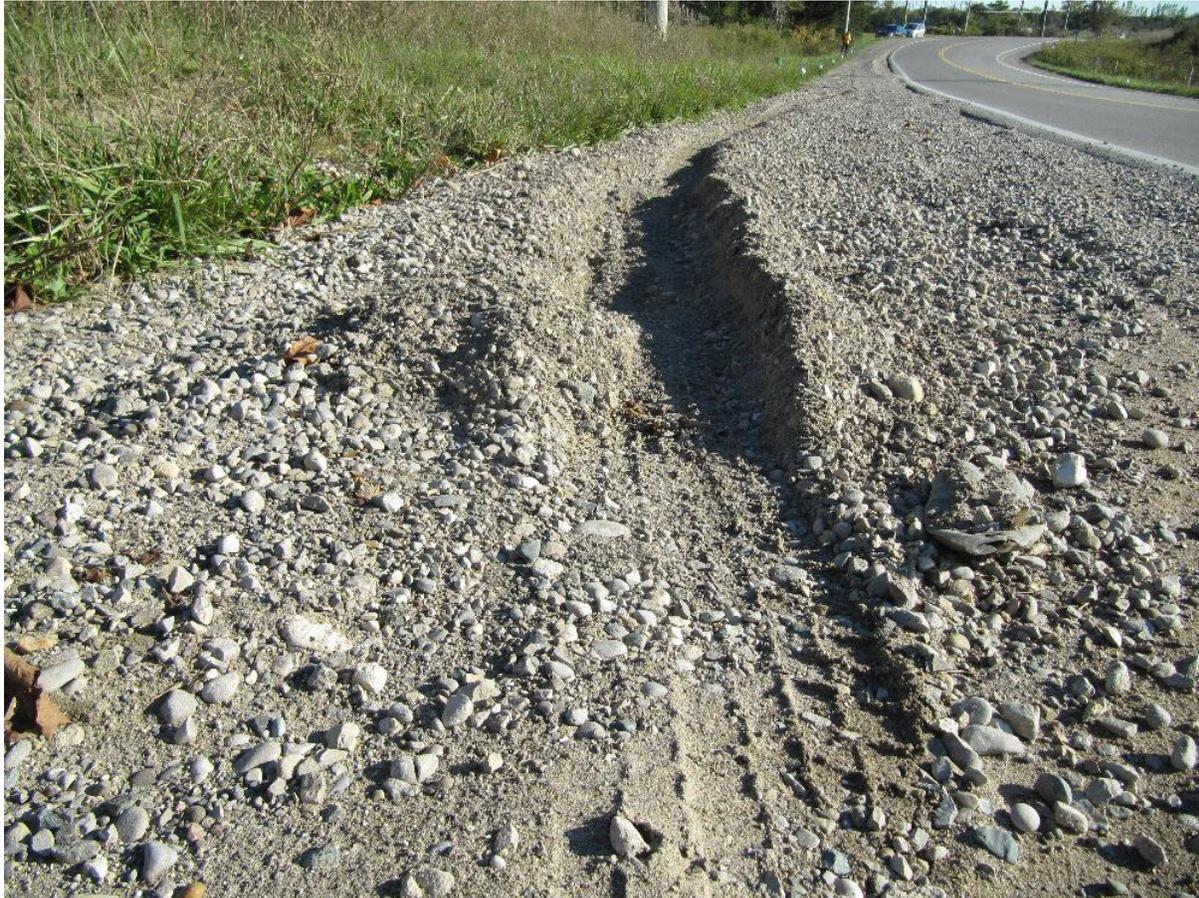
Figure 32: View of right tire mark taken in the late afternoon when the shadows help to define the vertical changes in the tire mark.

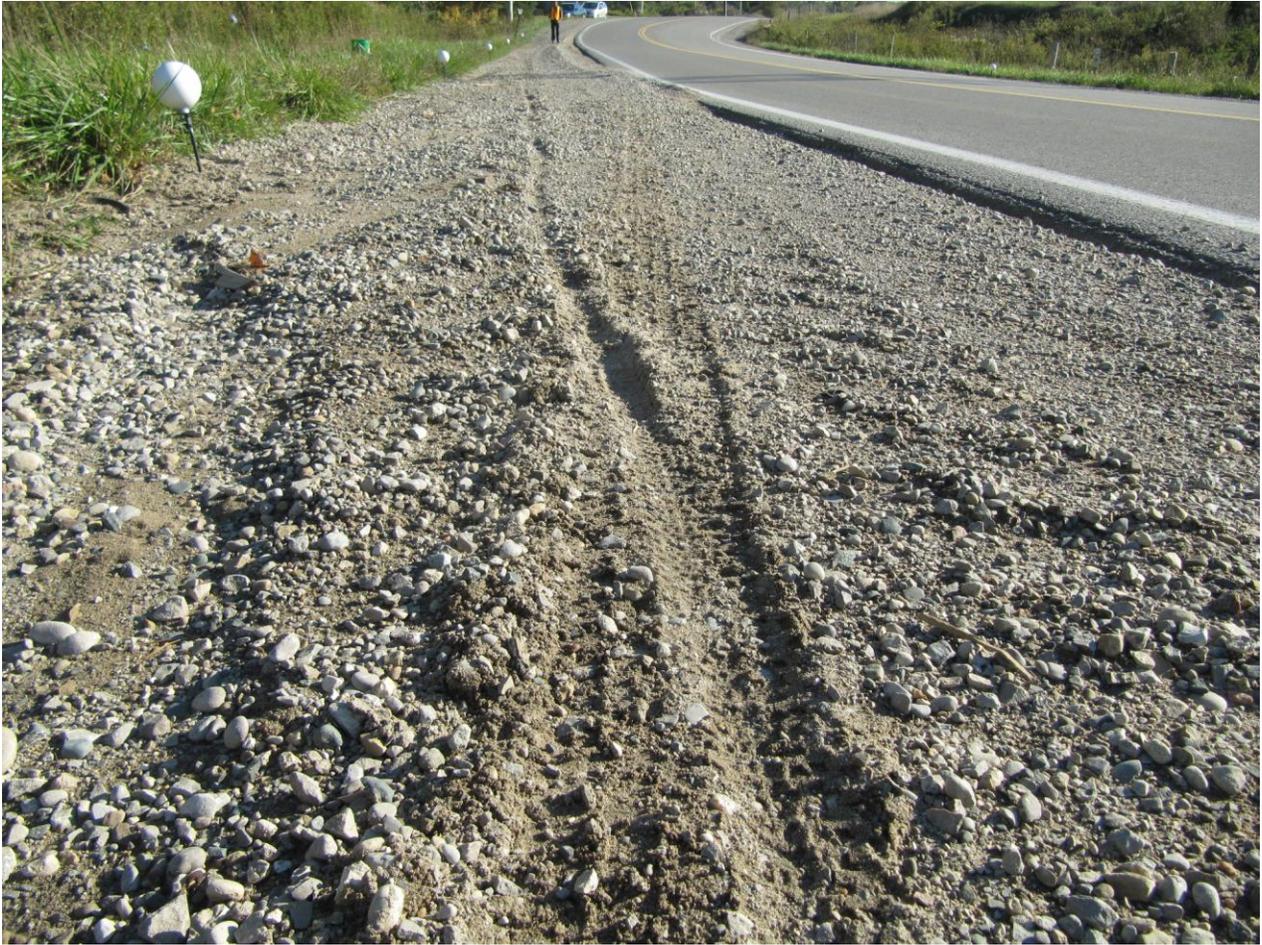
Figure 33 also shows a southward view of the east shoulder and we can see how much more visible the bicycle tire mark is because the depth of the impression causes the shadows to become contrasted against the monotone shade of the gravel,

Figure 33: Southward view of bicycle tire mark demonstrating its increased visibility when the sun is low on the horizon.
