Glanworth Curve Double Fatality - Further Analysis

Posting Date: 17 Feb 2012

Gorski Consulting
London, Ontario, Canada

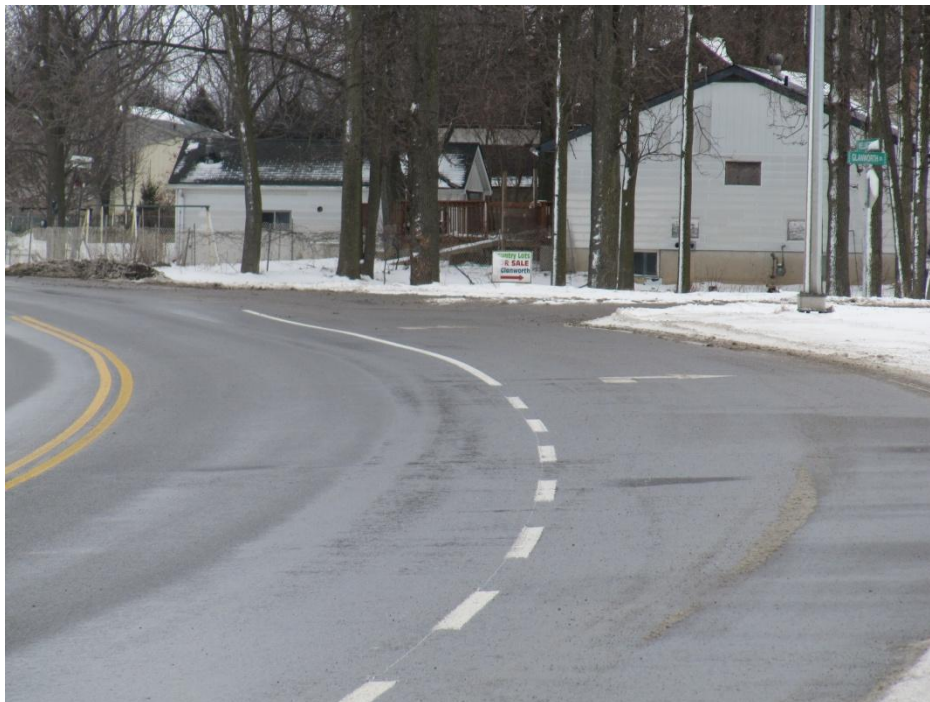
Upon our initial arrival at the site, slightly more than 24-hours after the occurrence a substantial amount of additional snow had fallen and some of the snow that might have been present at the time of the collision was most likely altered. Below is the view of the site taken on February 12th, 2012.

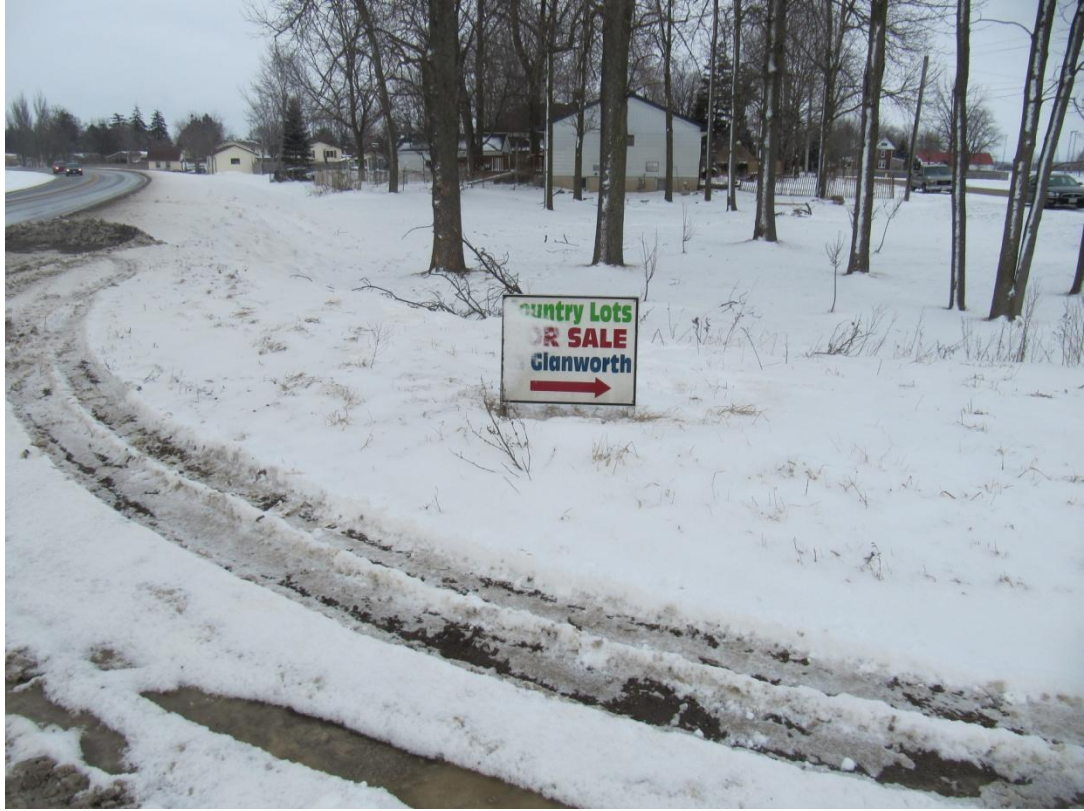
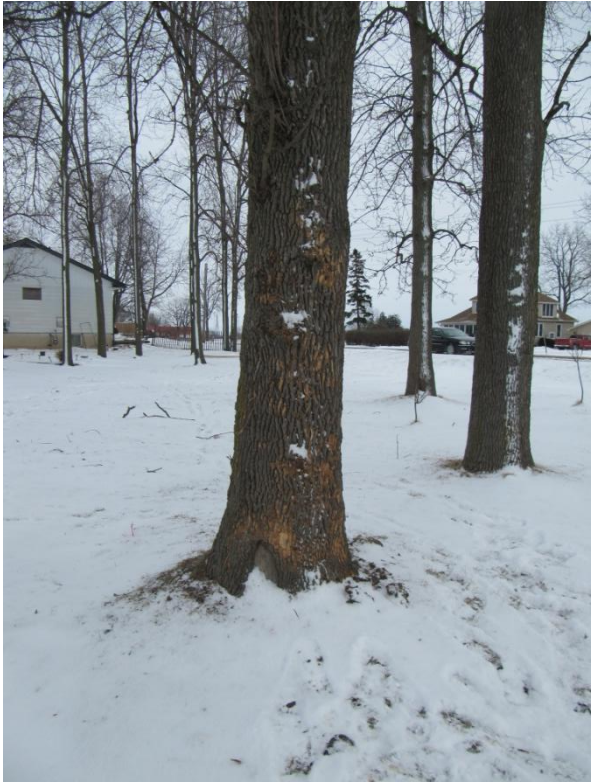
The two photos on the following page show the area where the vehicle struck the tree.

As can be seen, the ground around the roadside was covered by snow and this made it difficult to accomplish some investigative tasks. Due to the snow fall after the accident it was not possible to examine the collision evidence, such as the debris, any possible tire marks and gouges. It was reported that the investigating police were also interested in knowing at what location the vehicle left the roadway. This suggests that they did not obtain good evidence on the roadway that would identify the vehicle's path.

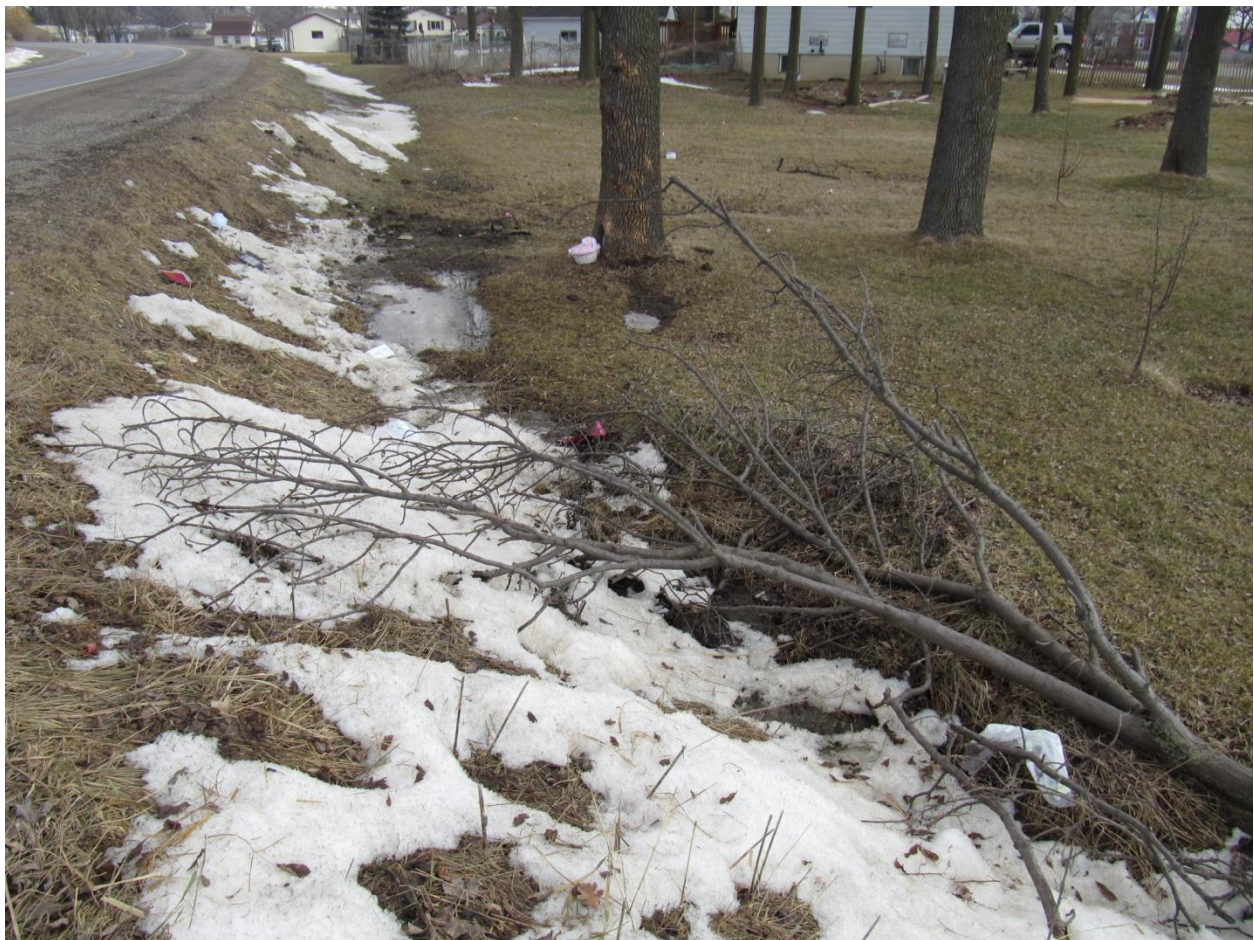
In these circumstances, as well as others, it is beneficial to return to an accident site to obtain additional information once the environmental conditions changed. In this case, we returned to the site on February 17th or about six days after the collision, when warmer weather caused some of the snow to melt and expose some of the markings and debris. Below is a view of the same roadside at the tree impact, upon or re-attendance at the site.

With the snow melted away it was possible to note where the vehicle made contact with the roadside on its way to the tree impact. In this case there was a large tree limb lying on the ground and study of its branches made it possible to estimate the height at which the vehicle passed over the fallen limb. Additionally there was a gouge in the earth just before the tree impact and this was not visible during our initial visit. The angle

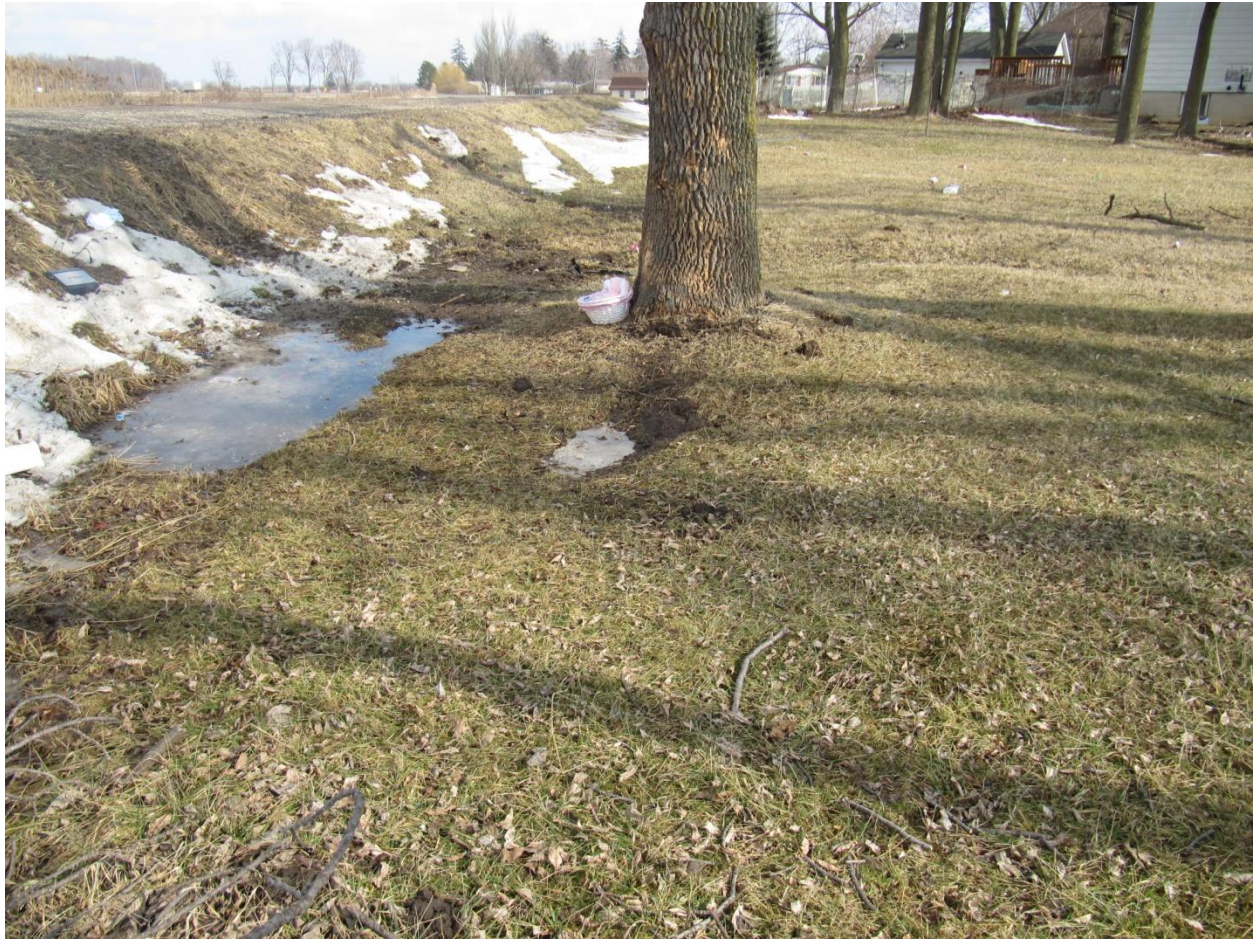
of that gouge in the earth also helped to establish the angle at which the vehicle came into the tree impact. The gouge can be seen in the photo below.

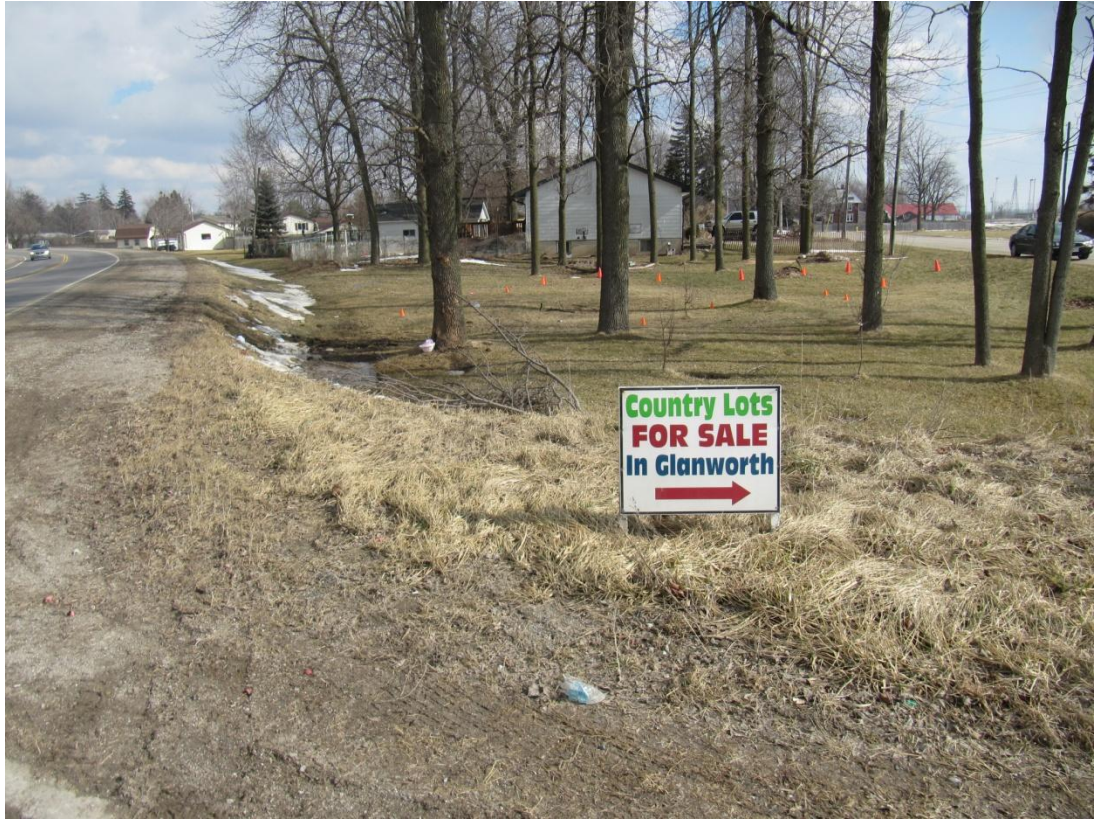
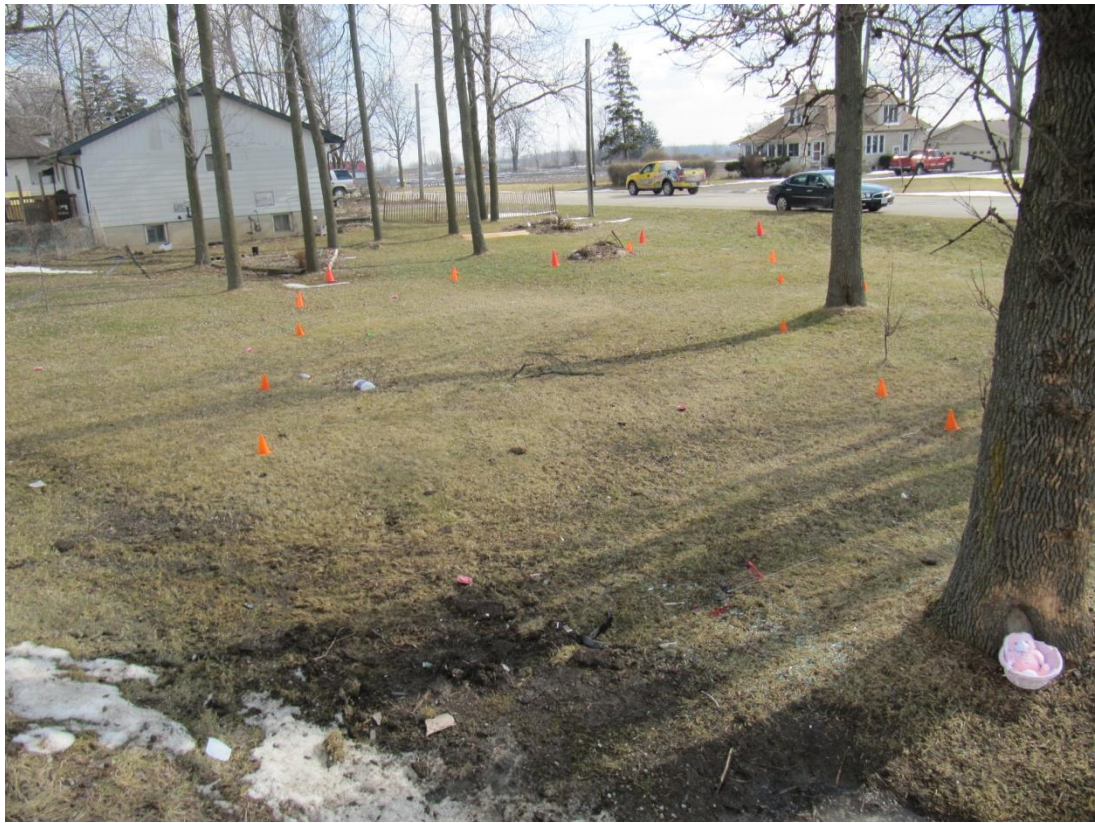
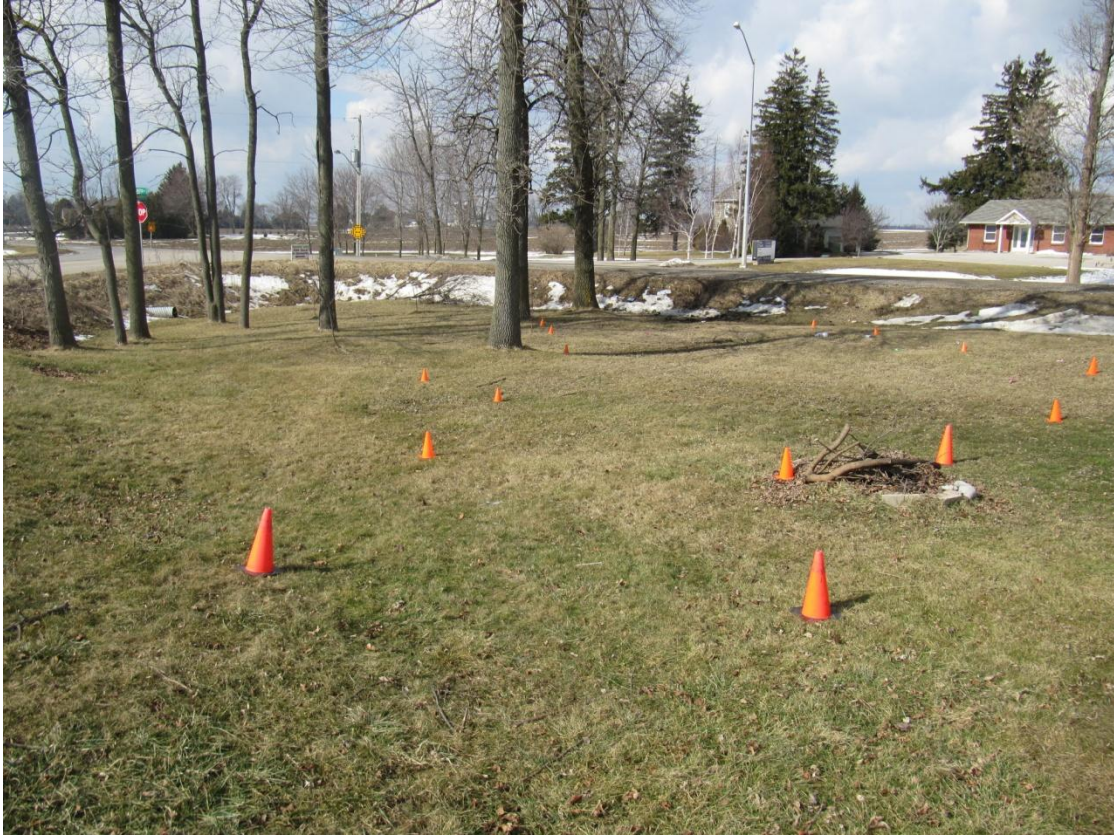
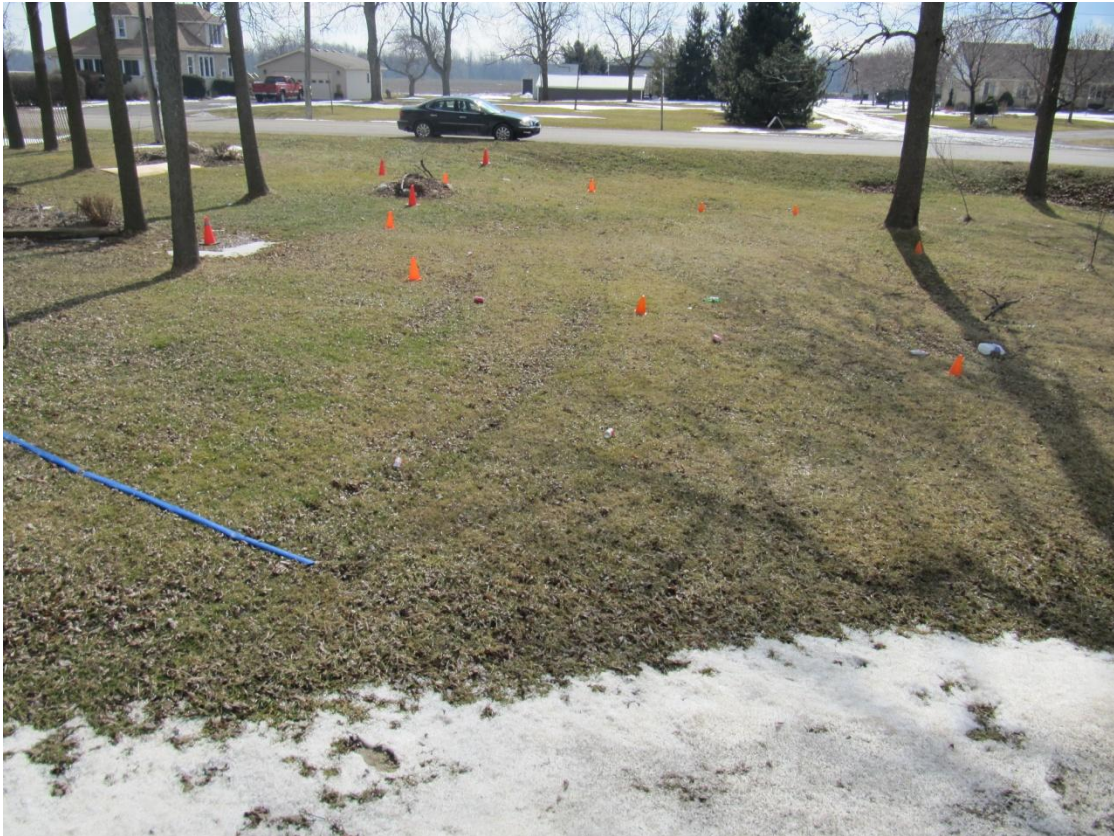
In this case we made a study a some black glass which we suspect originated from the rear lift-gate of the Escape. This black glass was scattered throughout the grass beyond the tree impact. We documented the field of this debris by placing cones at the perimeter of it. Larger cones were placed at the locations which were furthest from the point of impact to indicate the higher velocity of the projectiles. This activity caused an irregular, circular formation created by the cones. The photos on the following pages show that irregular formation from various angles around its perimeter.

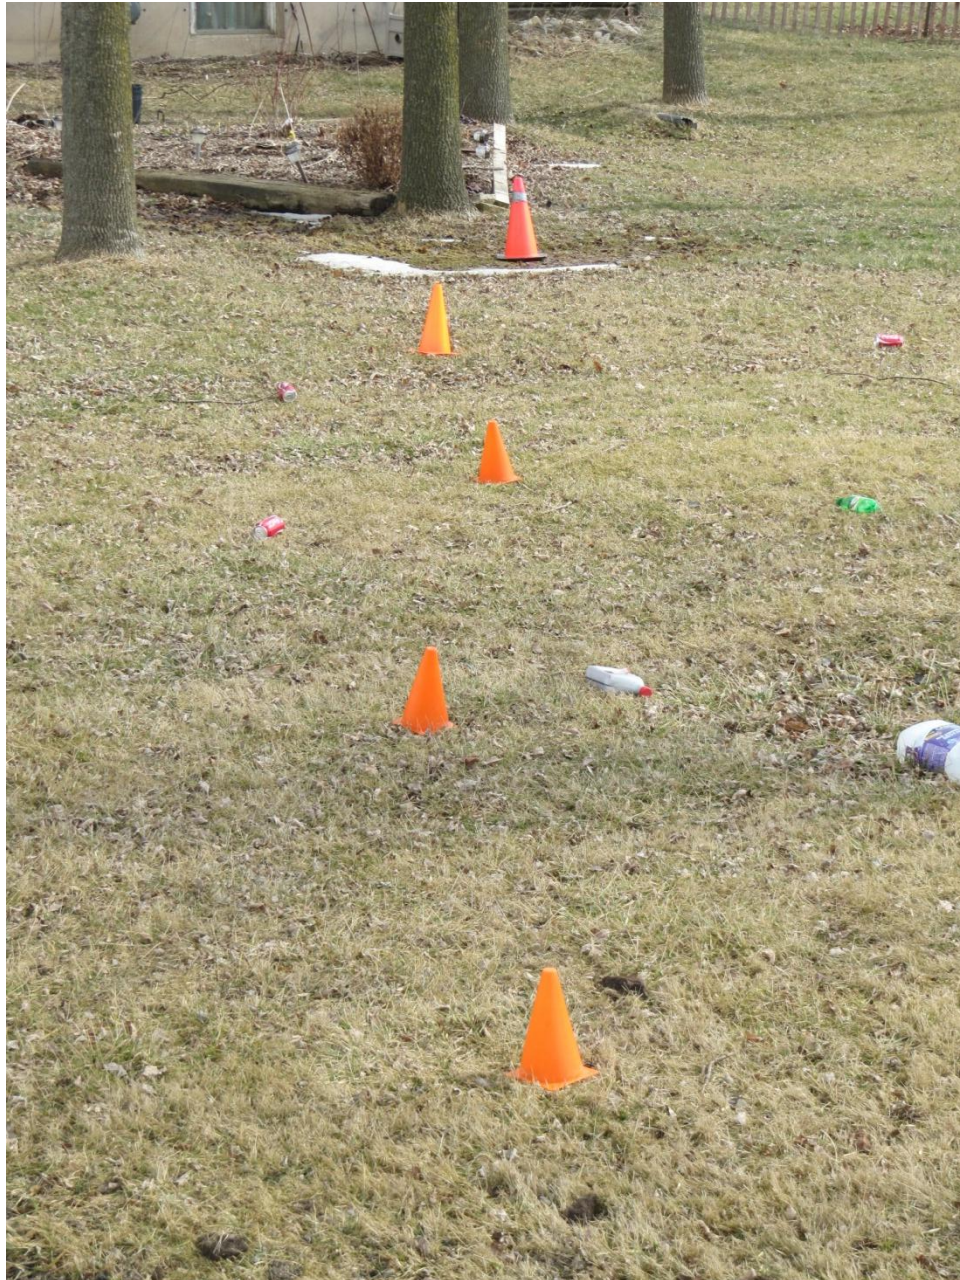
In a real investigation we would set up a high tripod or similar instrument so that the irregular formation could be better visualized for court purposes. However it is still possible to get an idea of the shape from studying the above photos. of Interest is the general position of the debris that has been thrown the furthest from the tree as well as the left and right boundaries of the debris. This helps in the estimation of the general angle at which the vehicle came toward the tree impact. For example, looking away from the tree, along the left side of the debris trail the cones were fairly consistent in describing the left edge of the debris field as the cones in the photo below show a general line with a gentle curve.

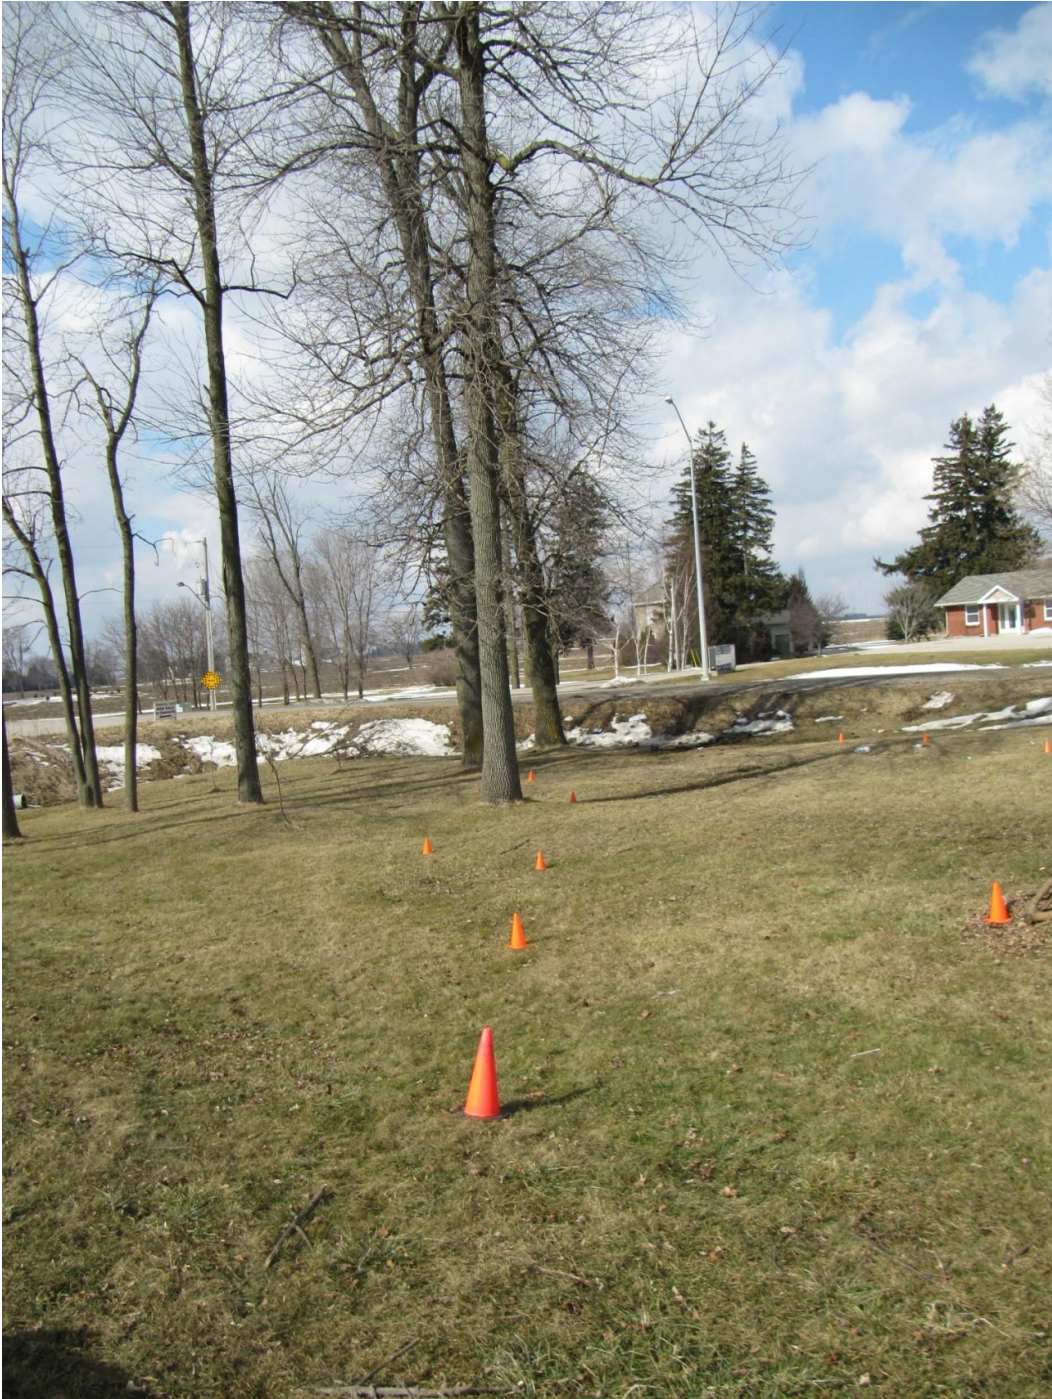
Similarly, the photo below shows a view looking toward the tree impact along the right portion of the debris field and the line of cones also provides a generally straight line for where the debris exists versus where it does not.

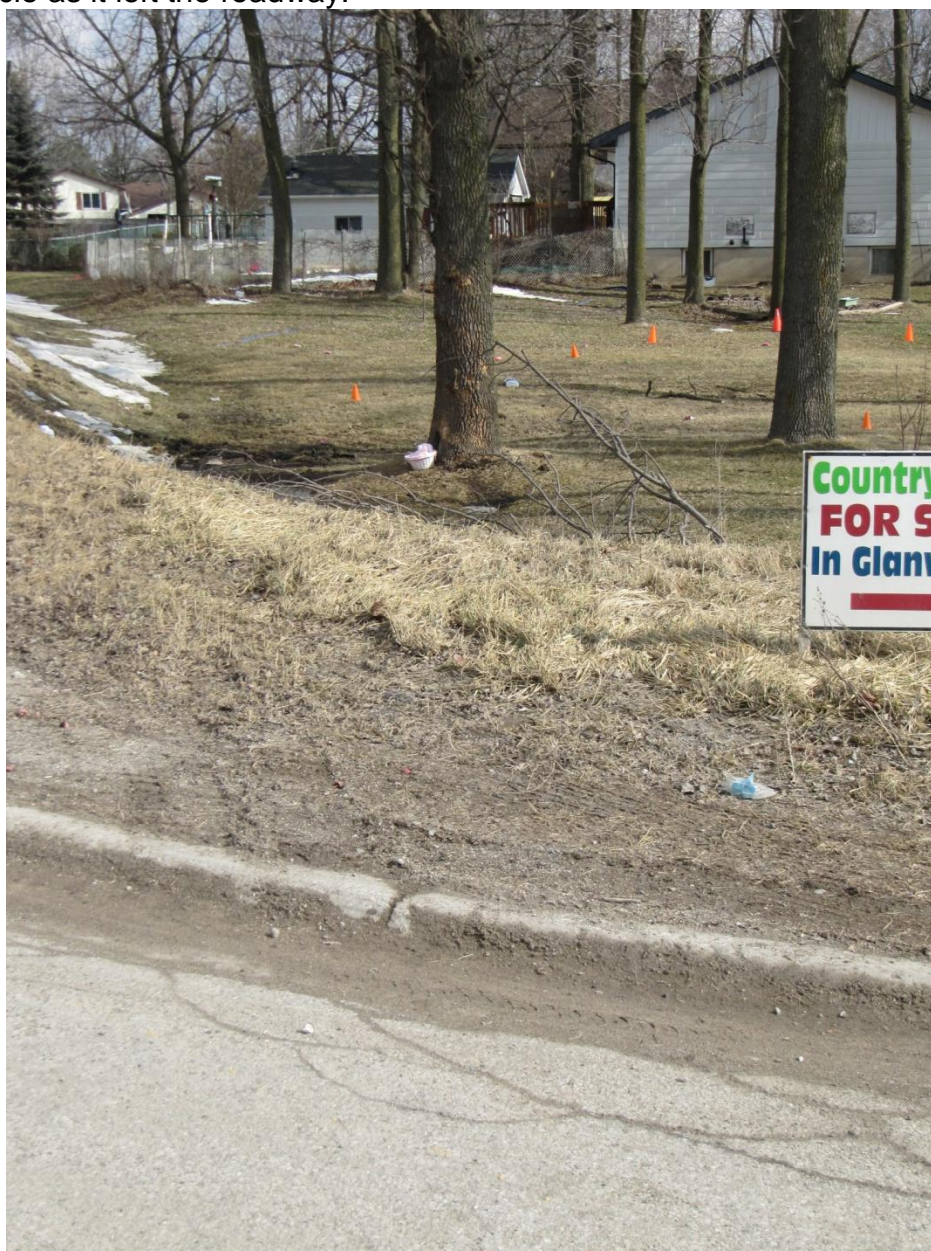
For example, looking at the photo below, we can see that the vehicle did not knock over the real estate sign in the foreground therefore we suspect the path of the vehicle was to the left the sign. We can also examine the fallen limb and recognize that this matches well with the angle of the gouge at the base of the tree. So we would expect that the vehicle entered the roadside just to the left of the real estate sign. Yet, when we looking in the background almost all of the cones are located to the right of that suspected travel path. Yet, if we look closely onto the road edge and dirt in front of the grass we might be able to distinguish some disturbance that could suggest the path of the wheels of the vehicle as it left the roadway.

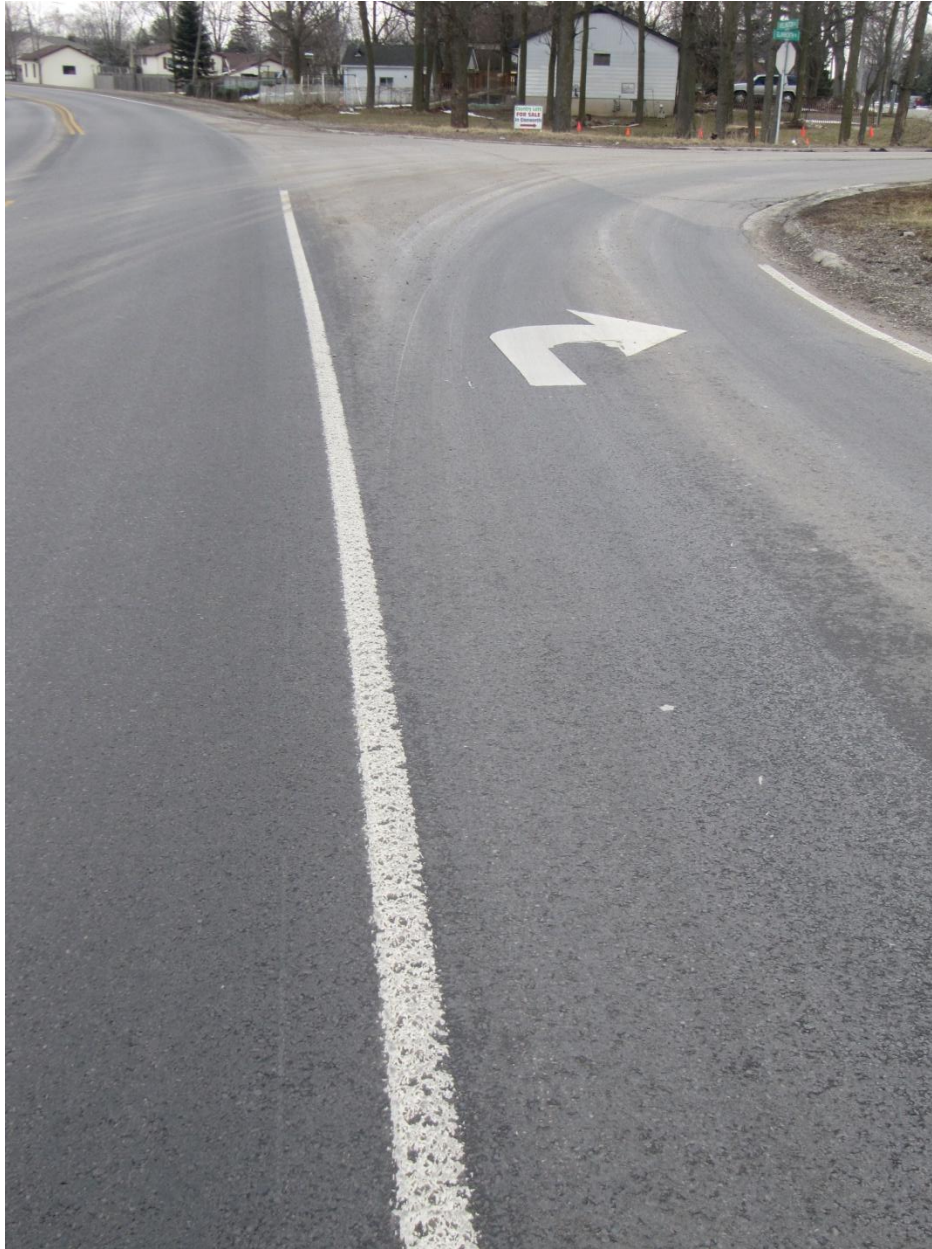
We can back up further while lining up the evidence to estimate where the vehicle left the roadway. As demonstrated in the photo below.

This suggests that the vehicle was travelling out of its lane at about the location of the road in the foreground.

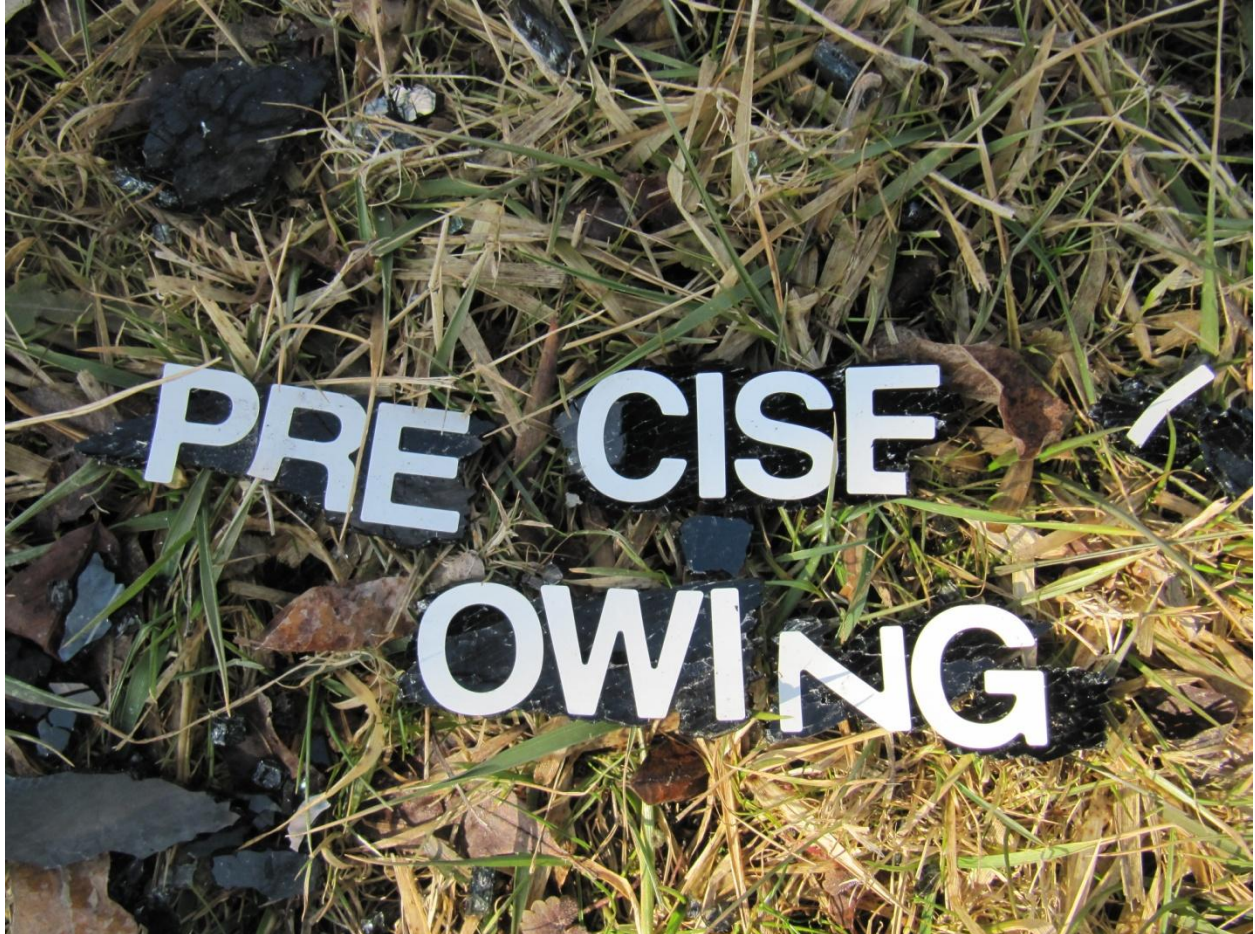
It is also possible to explore the contents of the debris to get idea about where it was located on the vehicle. As shown below, the evidence can be assembled very much like a jig saw puzzle to reveal some form of identifier that can lead to the a specific part of a vehicle.
