Intersection Collision of Oxford Cty Rd 74 and 43 April 6th, 2011

Posting Date: 07 Apr 2011

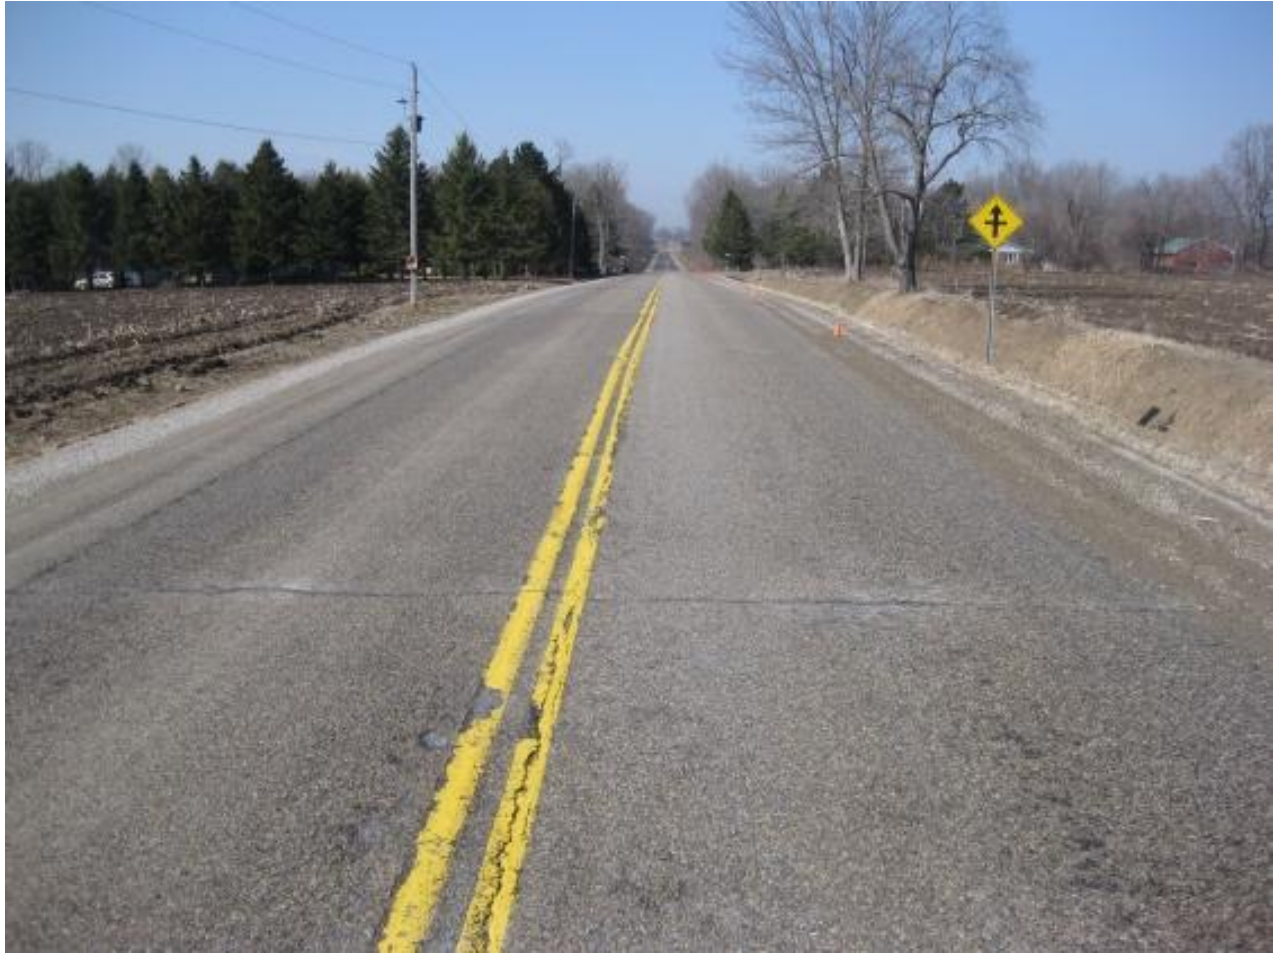
Ok, I have assembled a number of photos from the site for discussion. First (below) is a view looking west from 175 metres east of the point of impact. This is a view looking along Zorra Road 74 which the direction driven by the Durango driver who had the right of way.

As usual my small orange cones are placed along the north roadside at 25 metre intervals. Note the slight high-crest on this (#74) road. The northbound Hyundai pulled out from a stop sign at the group of fir trees on the left side of the view.

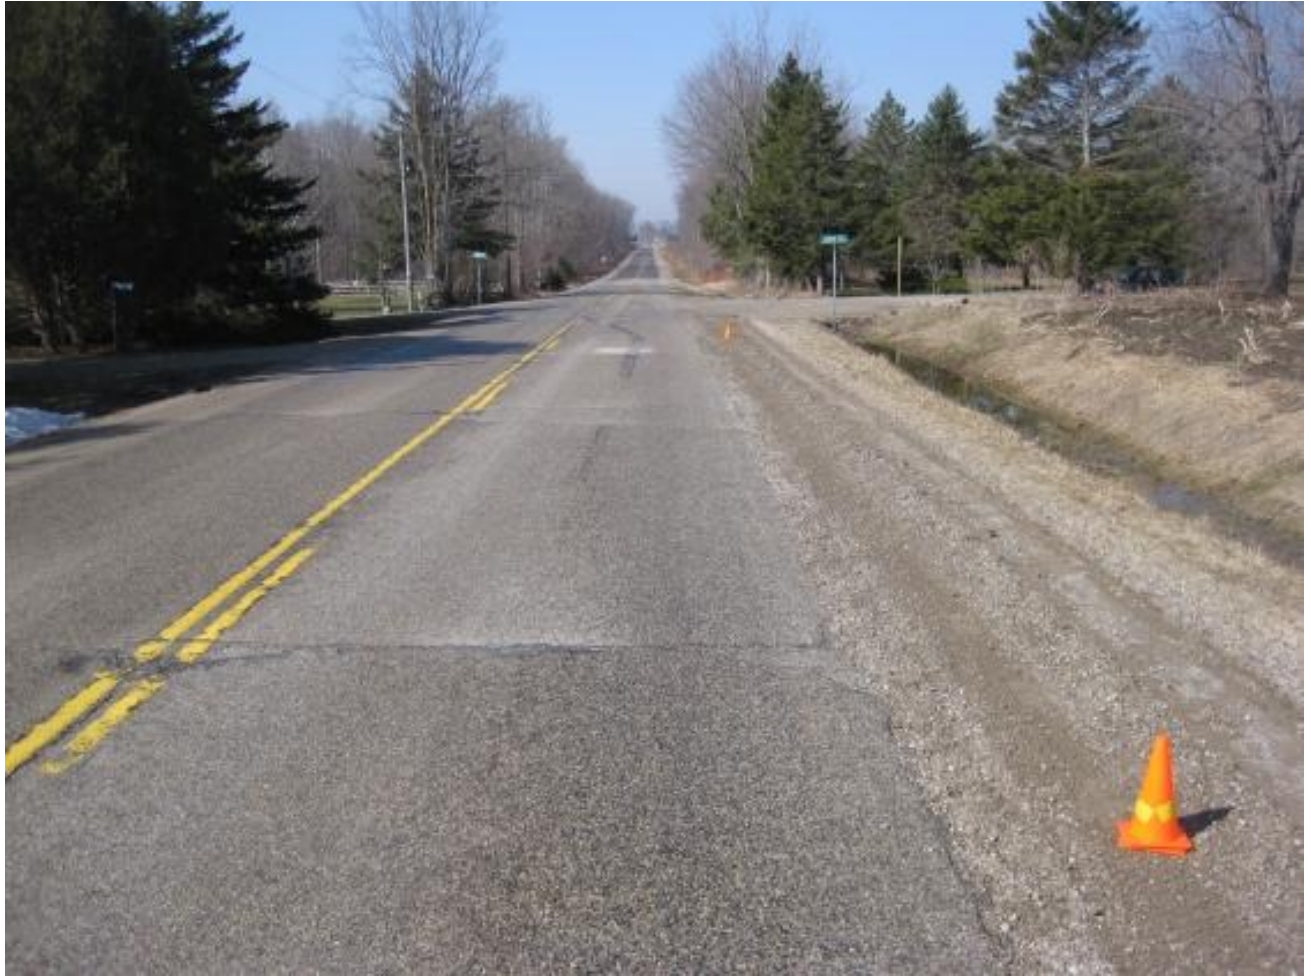
Now below is a view from 50 metres east of the POI, still looking west, as we approach the intersecting roadway. After impact both vehicles travelled to the north east of the intersection and into the ditch running along the north side of Road #74.

Note to the left what kind of limited visibility is provided to the Hyundai driver past the grouping of fir trees.

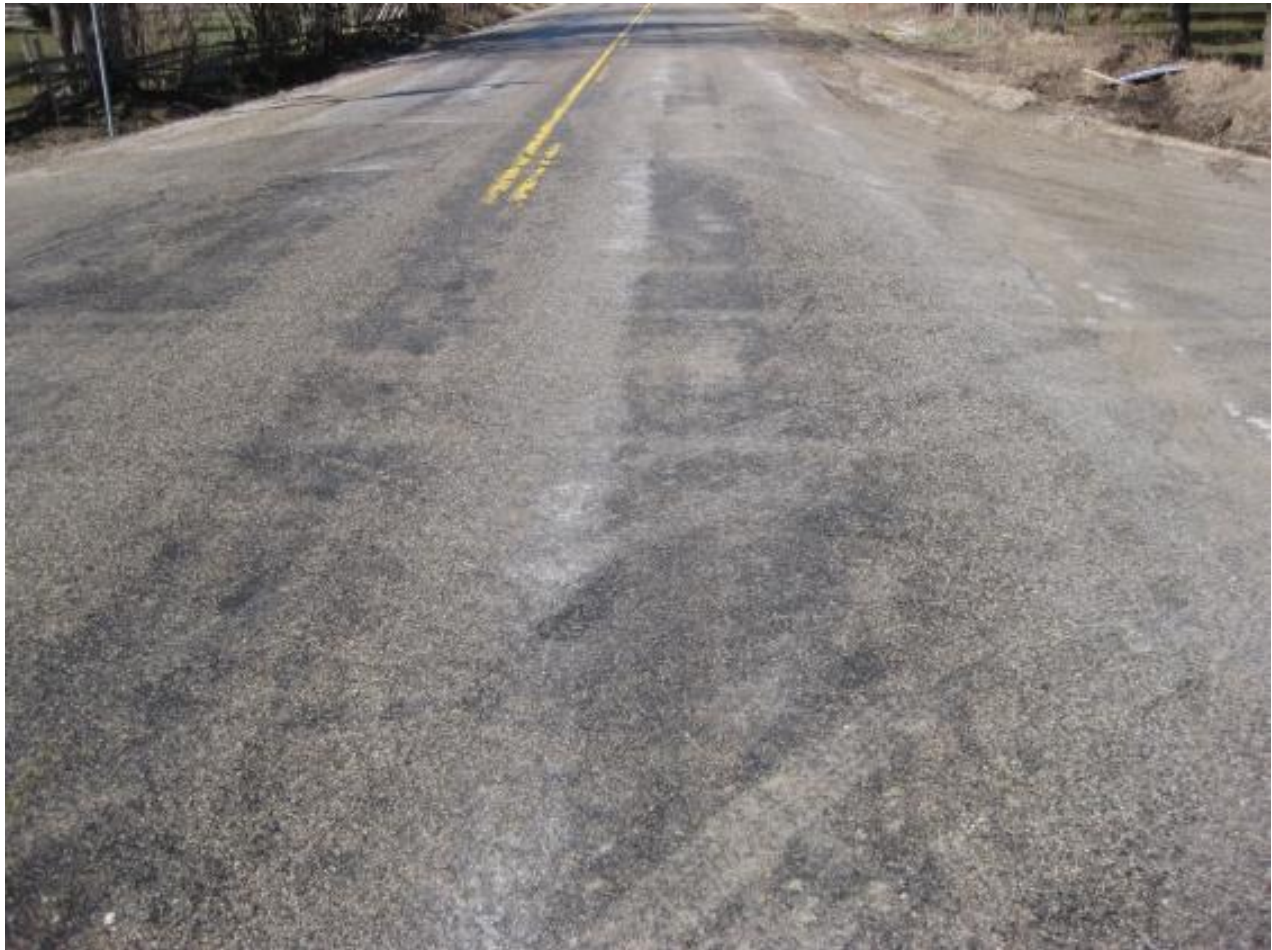
Now below is a view of the middle of the intersection, still looking west. If you look closely in the middle of the westbound lane you should see a diagonal scrape that is oriented in a south-east to north-east direction. This scrape was caused at the point of impact (POI) between the vehicles and then they progressed into the north-east ditch in the background. The fact to observe is the eastward direction in which both vehicles travelled after impact. For example, if both vehicles had the same mass (weight) and speed then we would expect them to leave the area of impact at a 45 degree angle, assuming of course that they were originally travelling in their pre-crash directions.

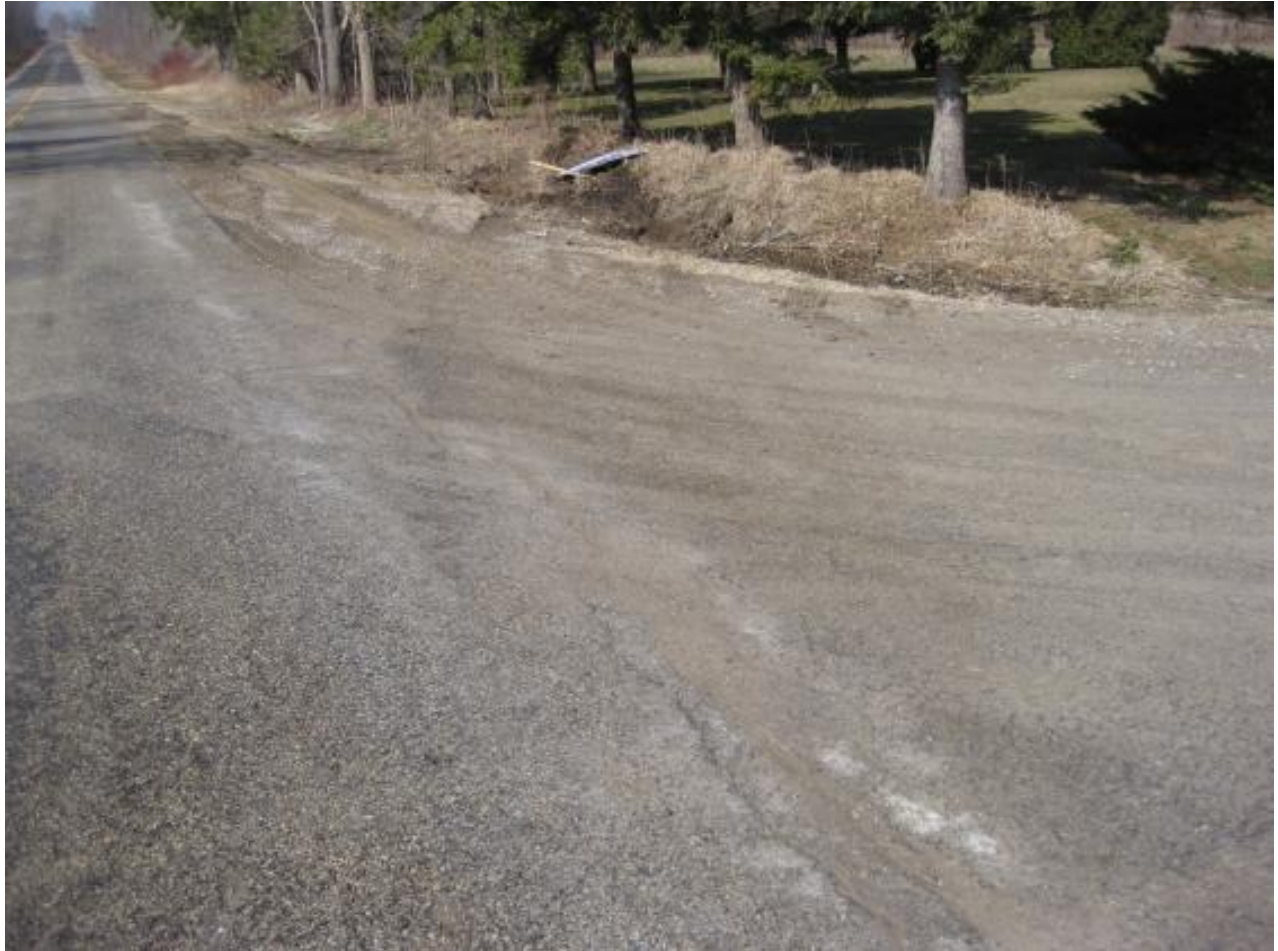
The view below now takes us looking northeast from the centre of the intersection and we can see the trail of damage as both vehicles enter the northeast ditch. Note however that neither vehicle stuck any of the trees. If the Hyundai had been travelling any faster the result could have been different.

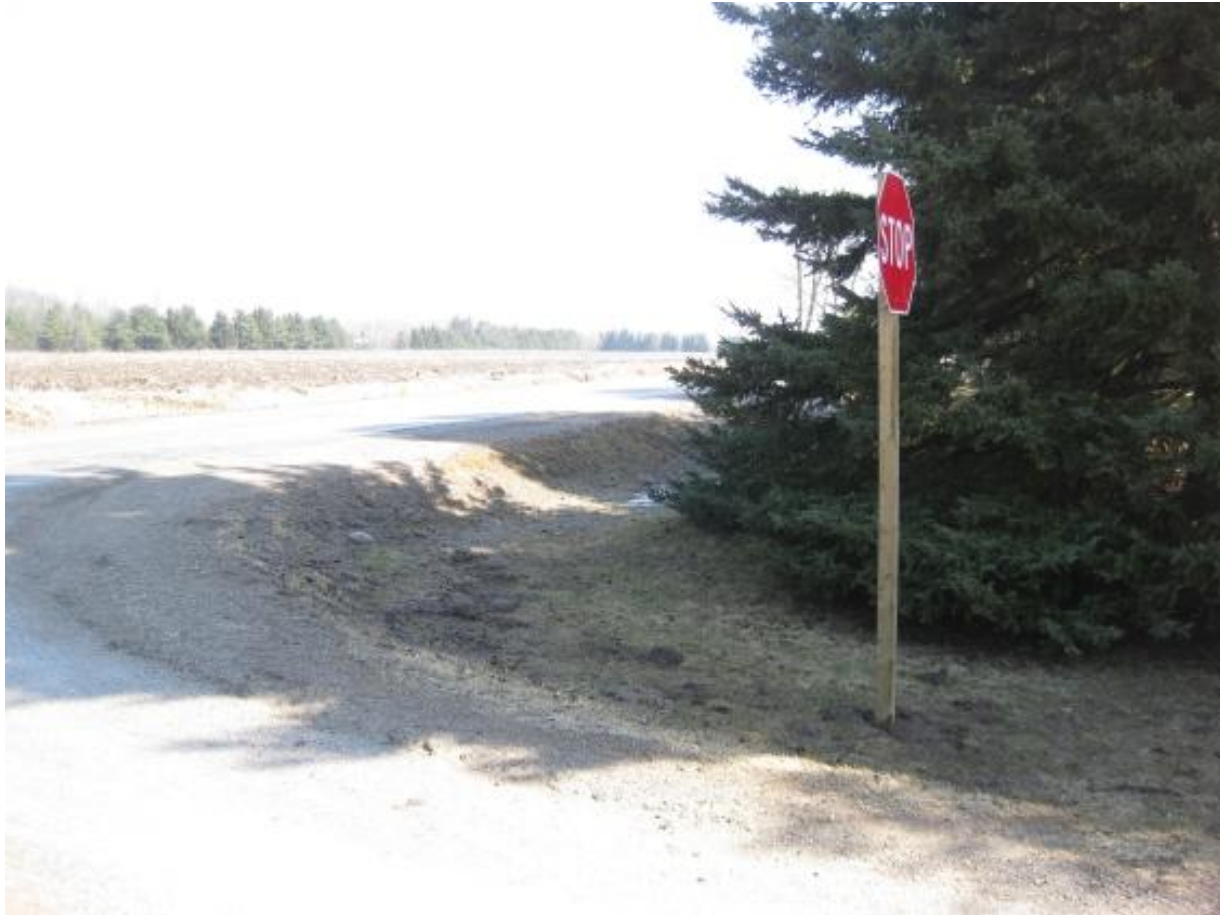
Before moving on to look at the post impact debris I want to show you (below) the limited line of sight afforded to the Hyundai driver.

We might look closer at the possibility that the driver was not afforded a reasonable change to view the road due to the trees shown above but that is not guaranteed. For example one should not stop "at the stop sign" as is often said. If there is a painted traffic stop bar then the front of the a vehicle should come to stop there. And if there is no painted stop bar then the front of the vehicle should approach the edge of the lane of the intersecting roadway. In the photo above I am simply showing you what a problem you create if you do not pull up to a position where you can see far enough along the intersecting road.

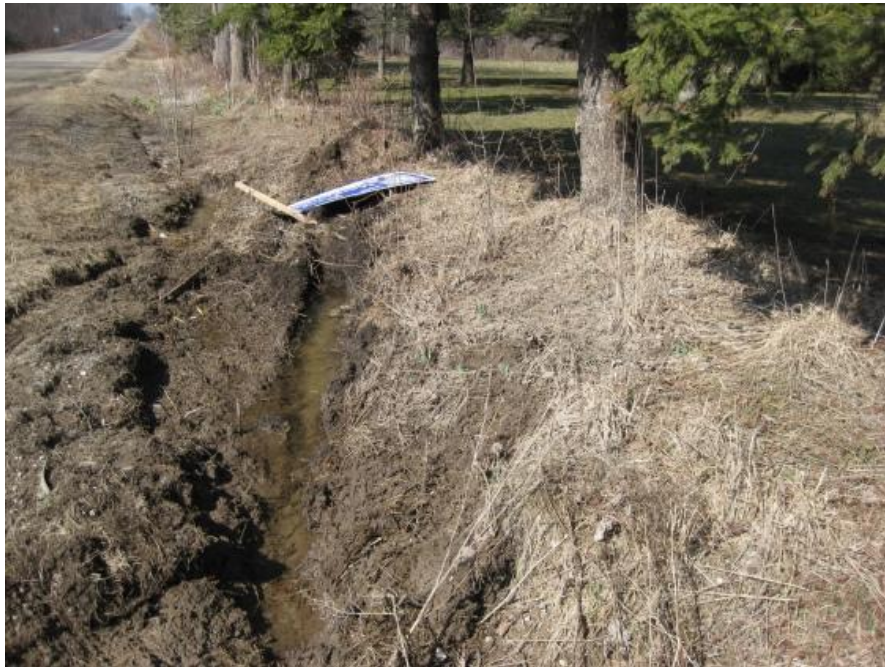
Below is a view of some of the tire marks and gouges.

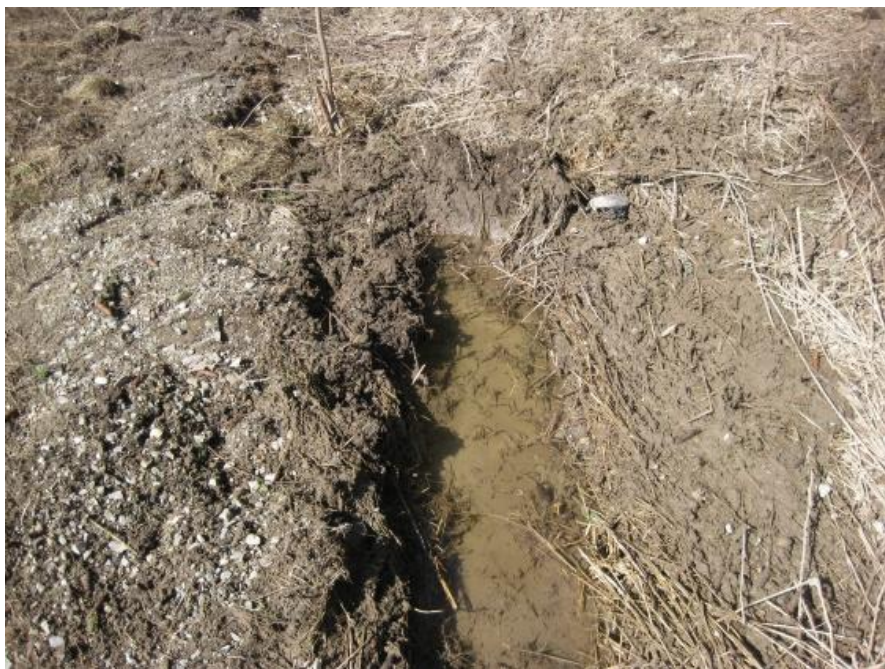
The Durango came to rest just past the small blue sign that was knocked over while the Hyundai carried on further westward. The final rest position of the Durango is exemplified by the sudden stop of the deep gouges in the earth caused by the wheels of the vehicle. At the end of the gouge you can see how the earth has been built up as it was pushed forward. This is typical evidence of what you would see as a vehicle slides to rest in mud like this.

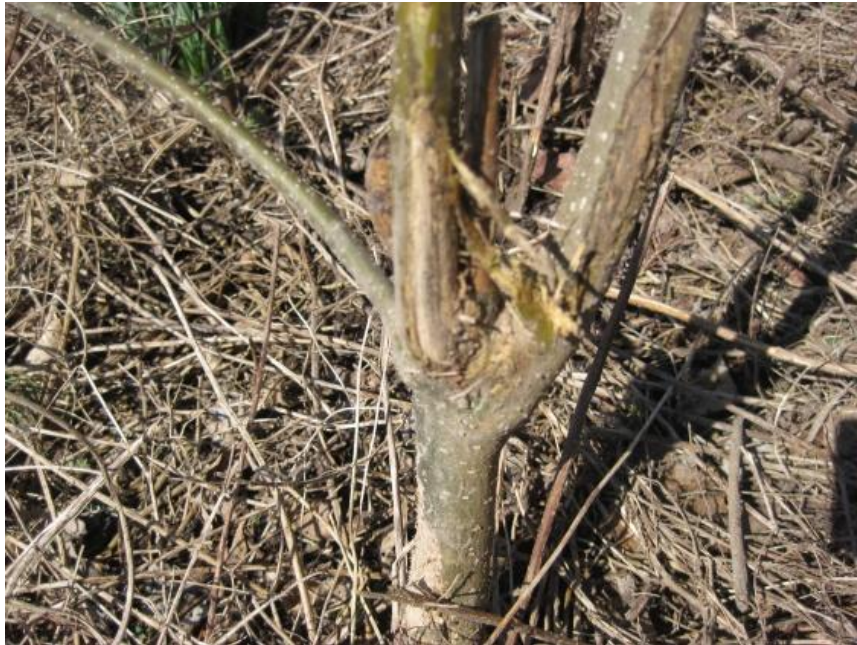
In many instances the travel path of a vehicle is not outlined by gouges from wheels and we must identify more subtle markings such as what is shown in the photo below.

Much like a woodsman following a trail you have to recognize fresh evidence of motion by way of disturbances in the natural layout of things. In the above case there are some fresh breaks to some twigs of a bush. Following such evidence leads us to the final rest position of the Hyundai as shown in the photo below.

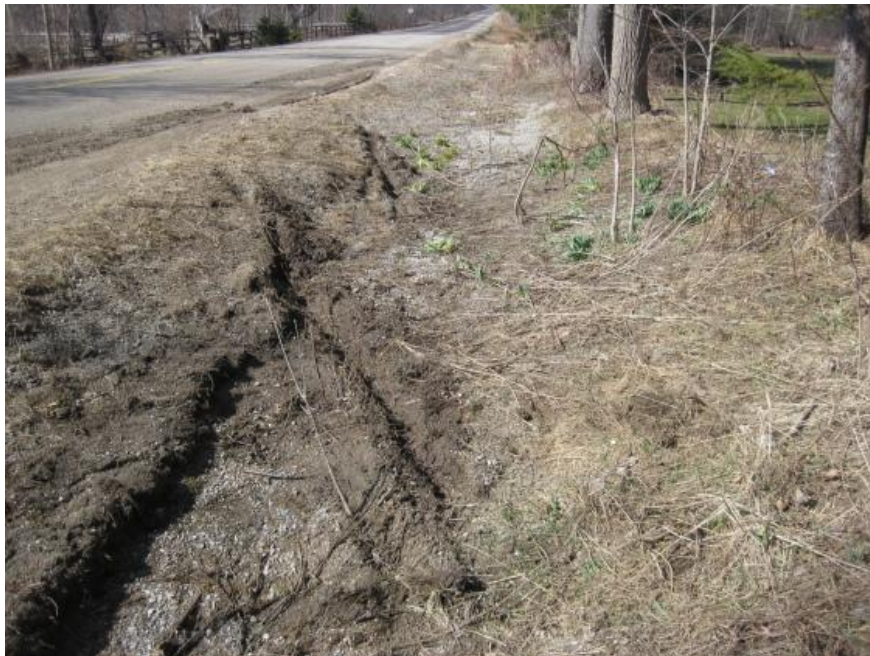
As always you have to sort out what is evidence of final rest and what is evidence of towing or emergency personnel.
