# Irony of Selective Road Safety Enforcement

*Posting Date: 28-Apr 2013*

Gorski Consulting  
London, Ontario, Canada

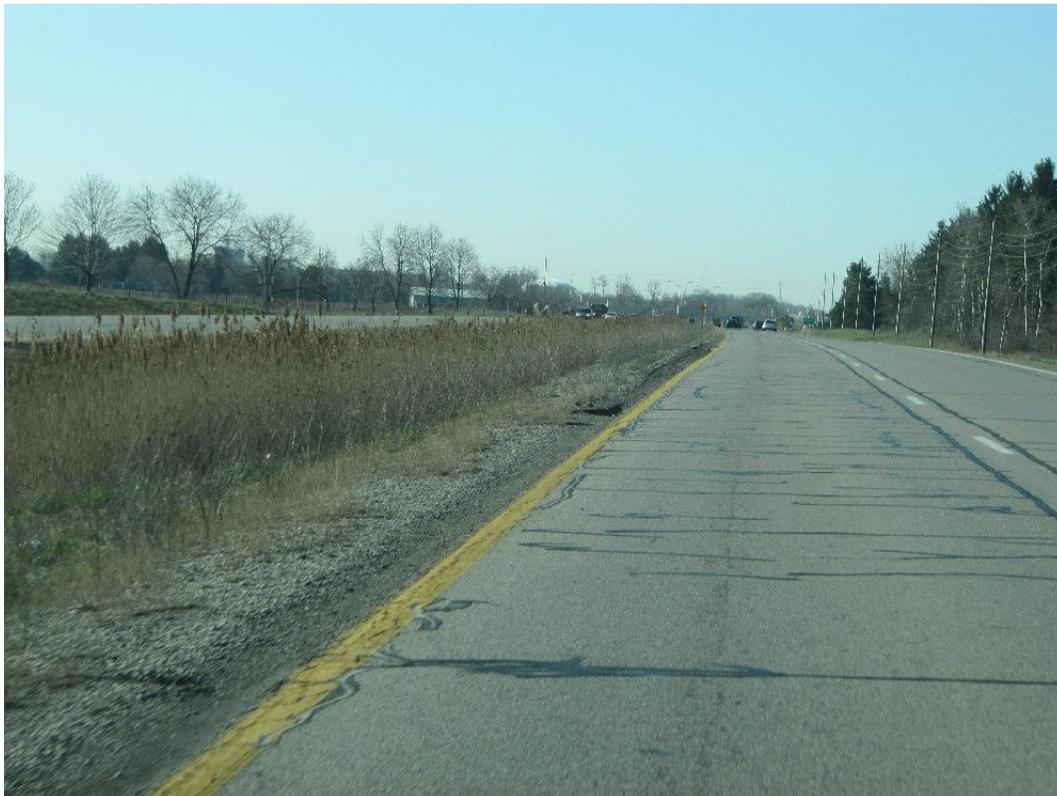
**Figure 1:** View, looking southbound on Veterans Memorial Parkway in London, Ontario showing an unmistakable, large crevice in the gravel of the centre median.

Someone familiar with searching for roadway problems would not mistaken the evidence on the left edge of the pavement, in the median, which indicated a deep drop-off of the gravel. So how could this evidence not be detected by anyone responsible for the safety of the travelling public?

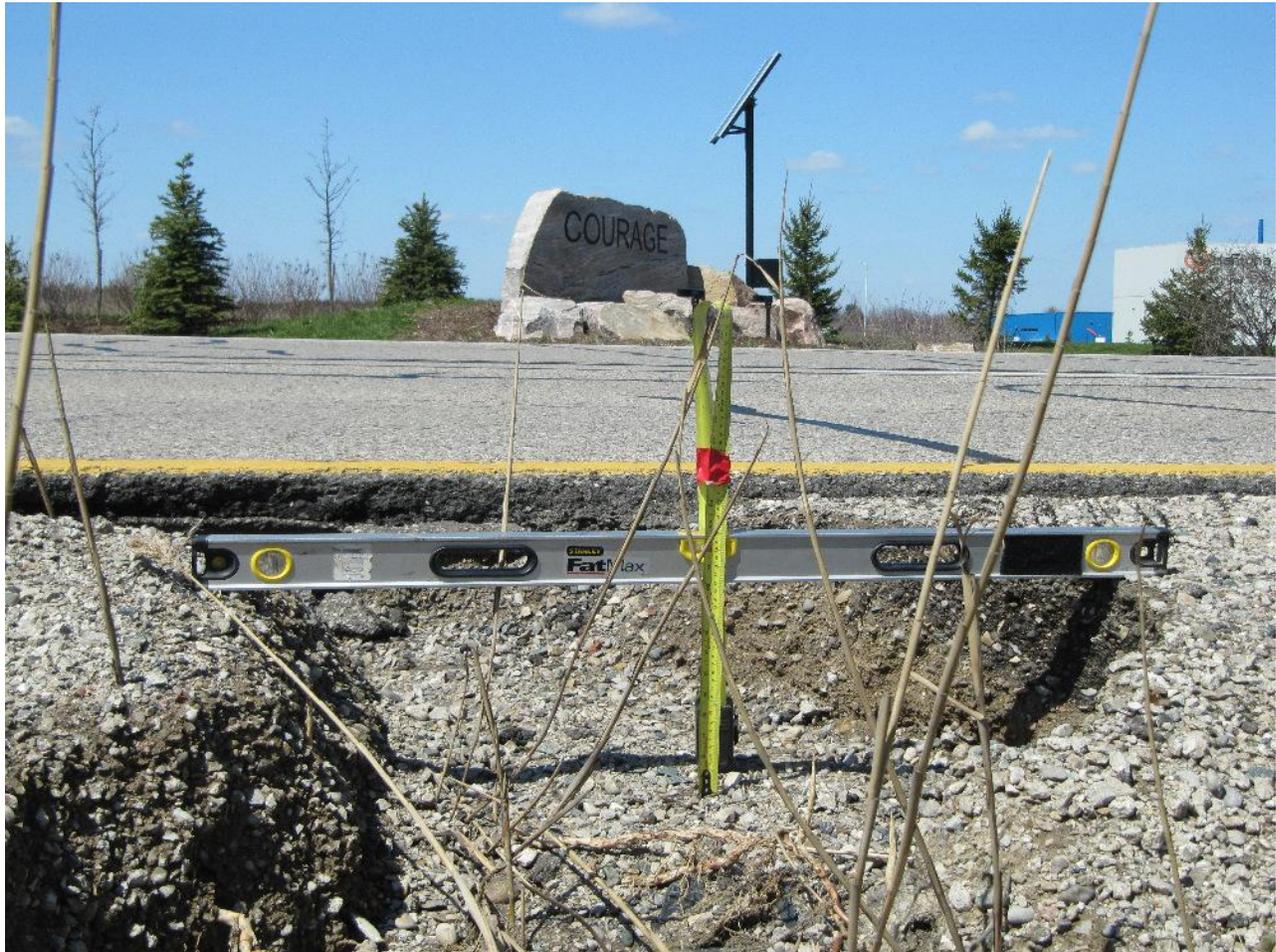
Figure 2: View of apparatus used to document the extent of the crevice in the gravel shoulder at pavement edge of the centre-median while the "Courage" monument is visible in the background.

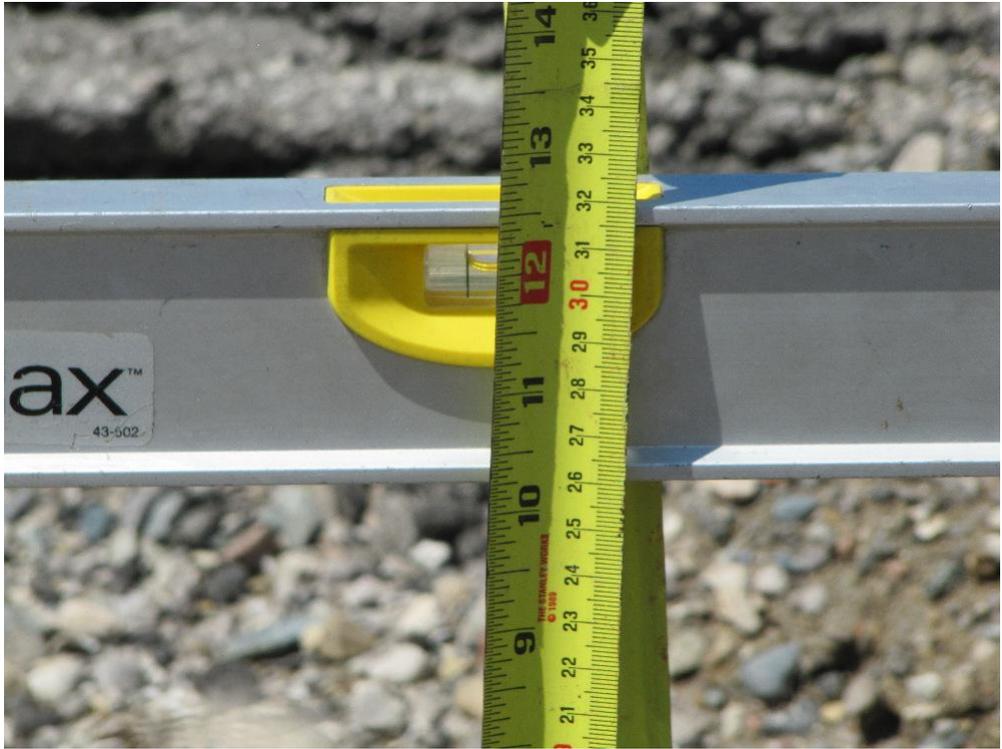
As shown in Figures 3 and 4 this crevice was over 10 inches deep and it extended for several metres along the asphalt edge.

Figure 3: Crevice depth of April 26, 2013 was over 10 inches.

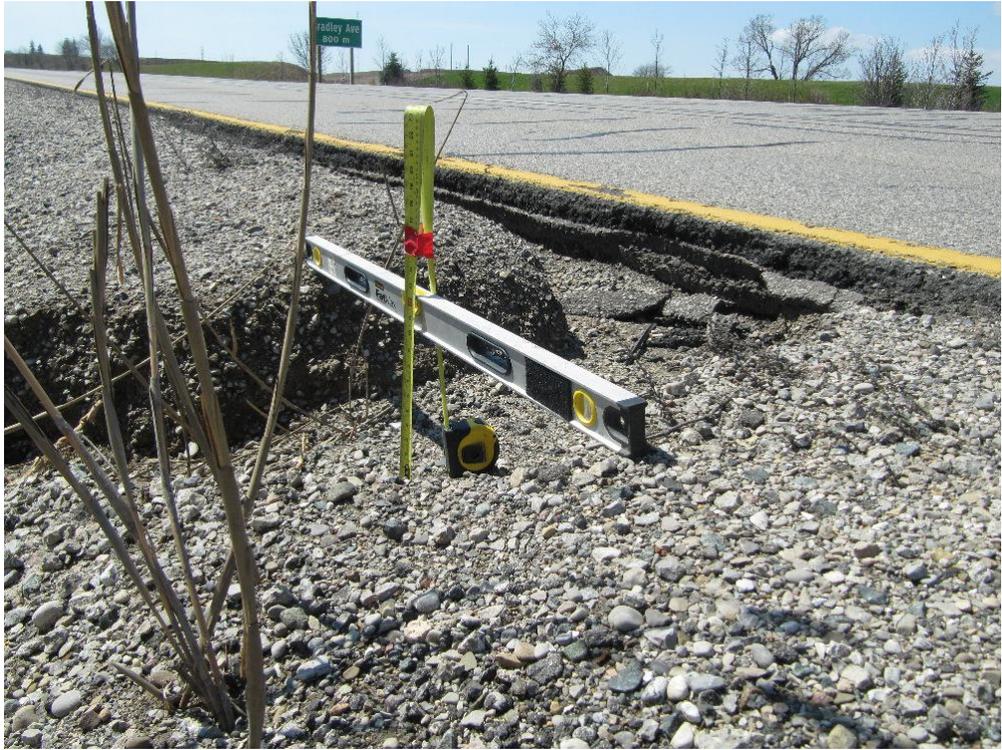
Figure 4: Crevice extending along pavement edge of southbound lanes at centre median on April 26, 2013

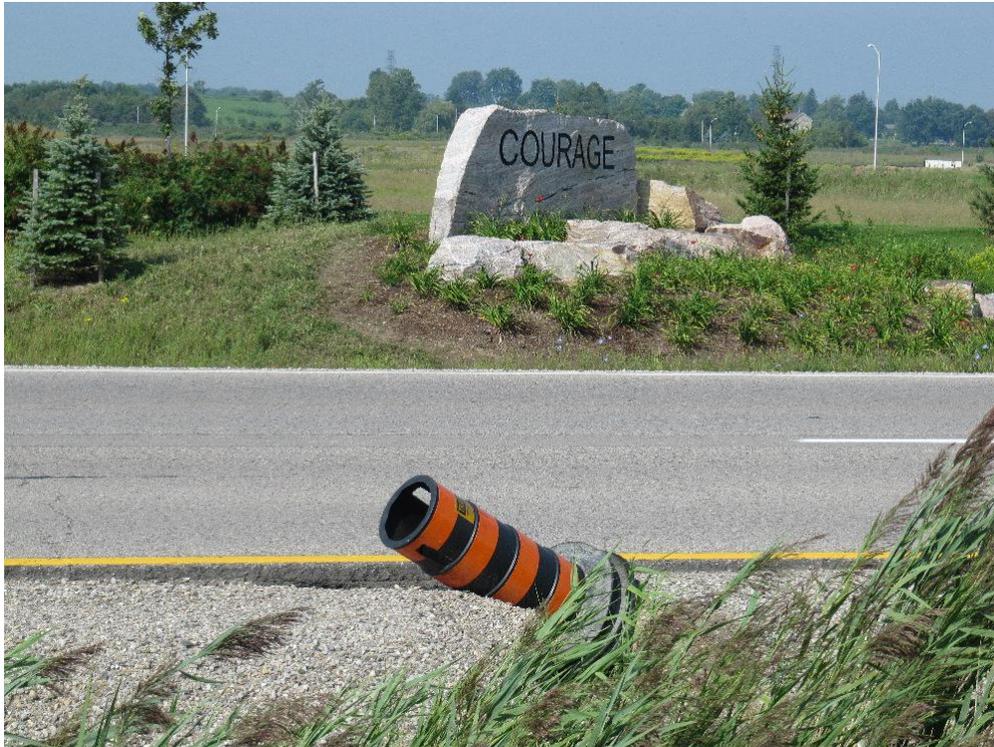
But this action also caught our attention as we had a feeling that we had been here before. Yes, on September 2, 2011, we documented a very similar set of evidence as shown in Figures 5 and 6. At that time the problem was apparently recognized by someone because a large traffic cone had been placed at the crevice, only to be partially swallowed up by it. The further irony is what we found at the base of the traffic cone, as shown in Figures 7 - a "funeral" marker likely lost by some passing motorcade.

Figure 5: Crevice at same location photographed on September 2, 2011.

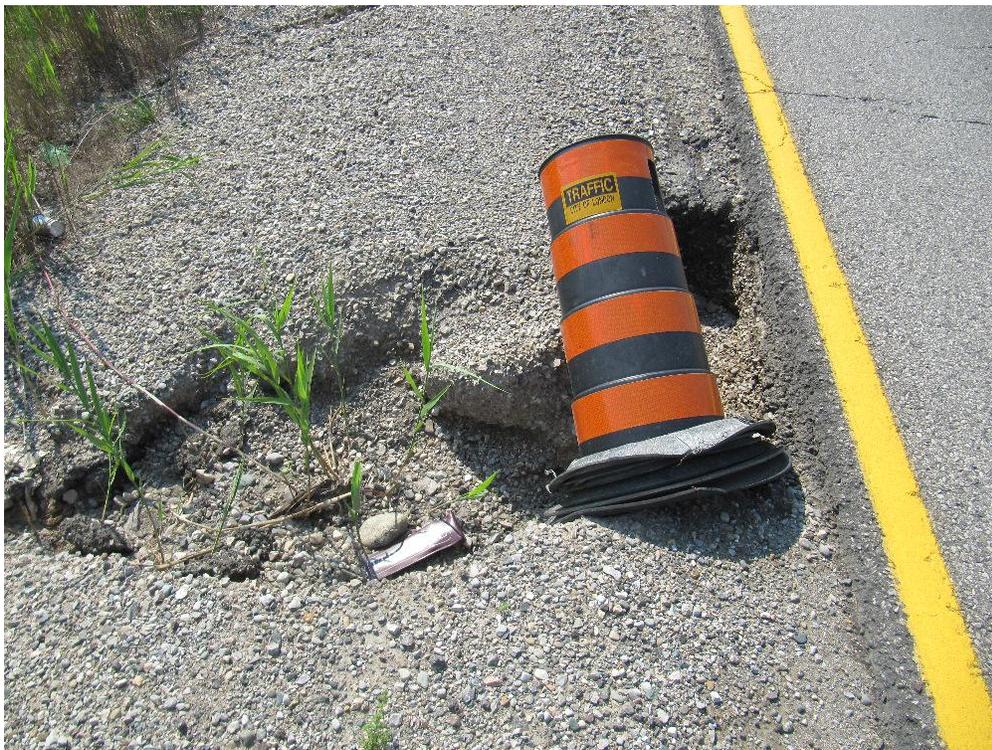
Figure 6: Crevice at same location photographed on September 2, 2011.

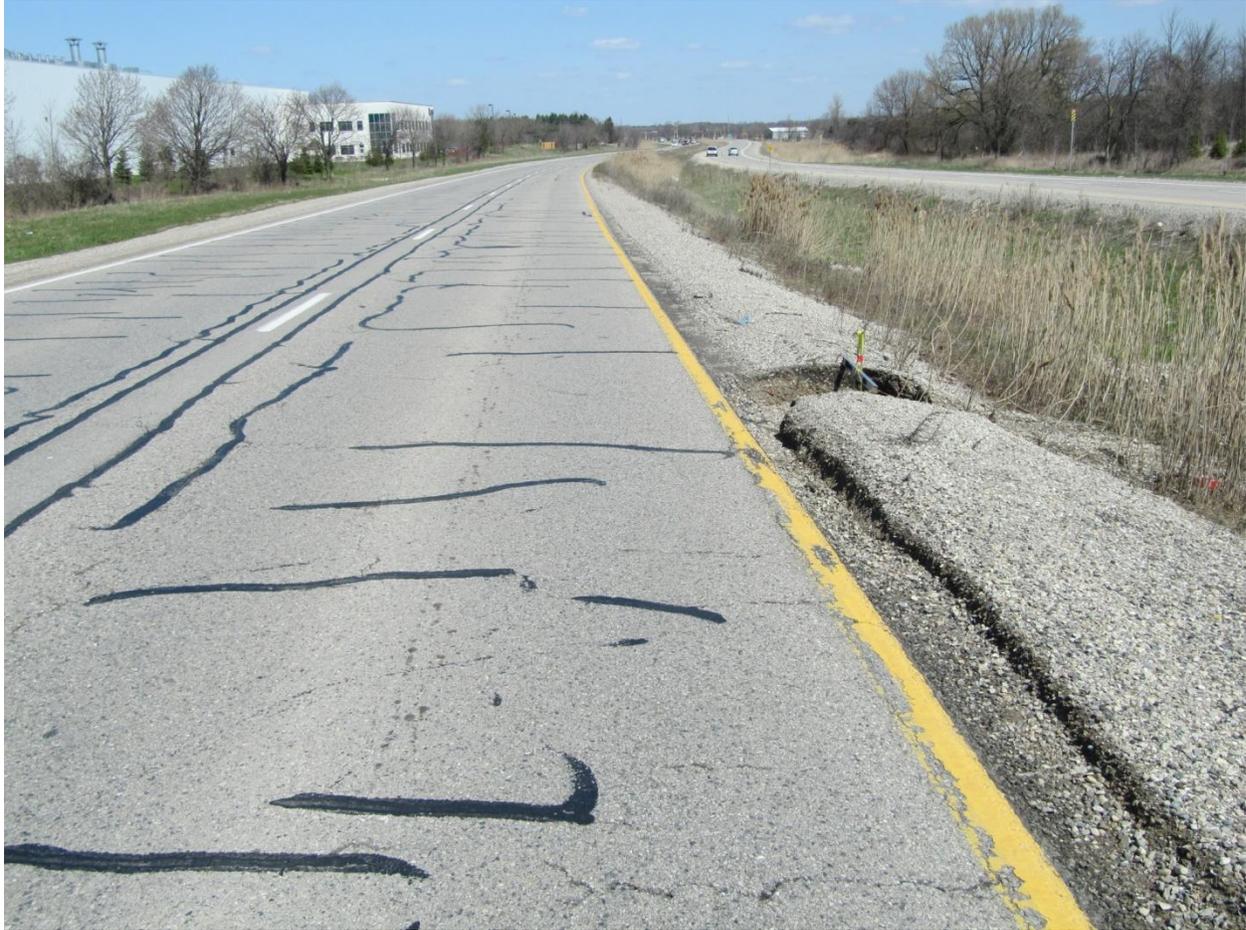
The result of those efforts was what was visible to us on April 26, 2013 as we surveyed the surface of the southbound lanes as shown in Figure 11.

Figure 11: Northbound view along the southbound lanes of Veterans Memorial Parkway, near the location of the deep crevice, showing the fine patching of the pavement that had been completed in August of 2012.

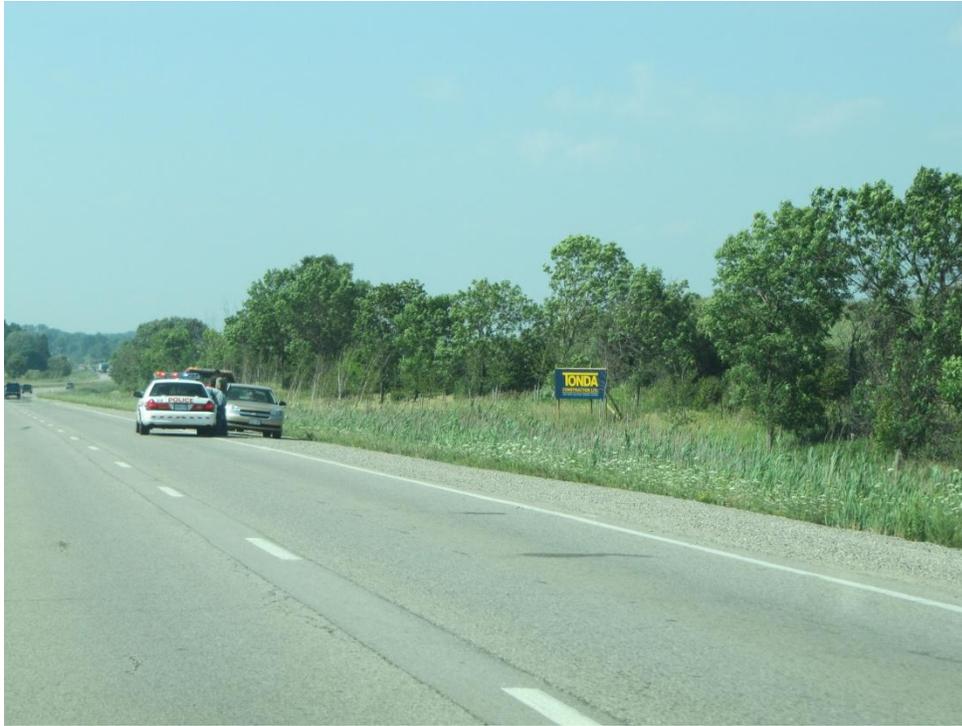
In some instances a passing vehicle need not stray into the stopped cruiser as some police officers actually park their cruisers partly onto the paved lane - a very very dangerous act. For example this is the very thing we observed on the Veterans Memorial Parkway on July 23, 2012 as shown in Figures 15 and 16.

Figure 15: View, looking northbound on Veterans Memorial Parkway showing a London City Police cruiser positioned dangerously in the live curb lane of Veterans Memorial Parkway to perform a traffic stop.

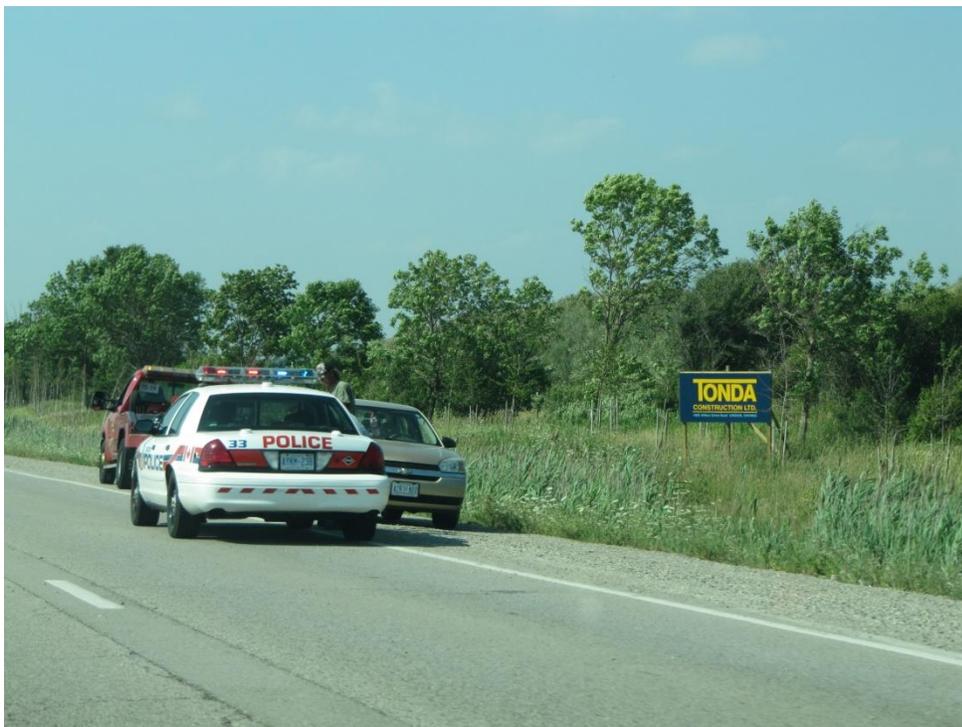
Figure 16: View of police cruiser stopped in a live lane of Veterans Memorial Parkway on July 23, 2012.

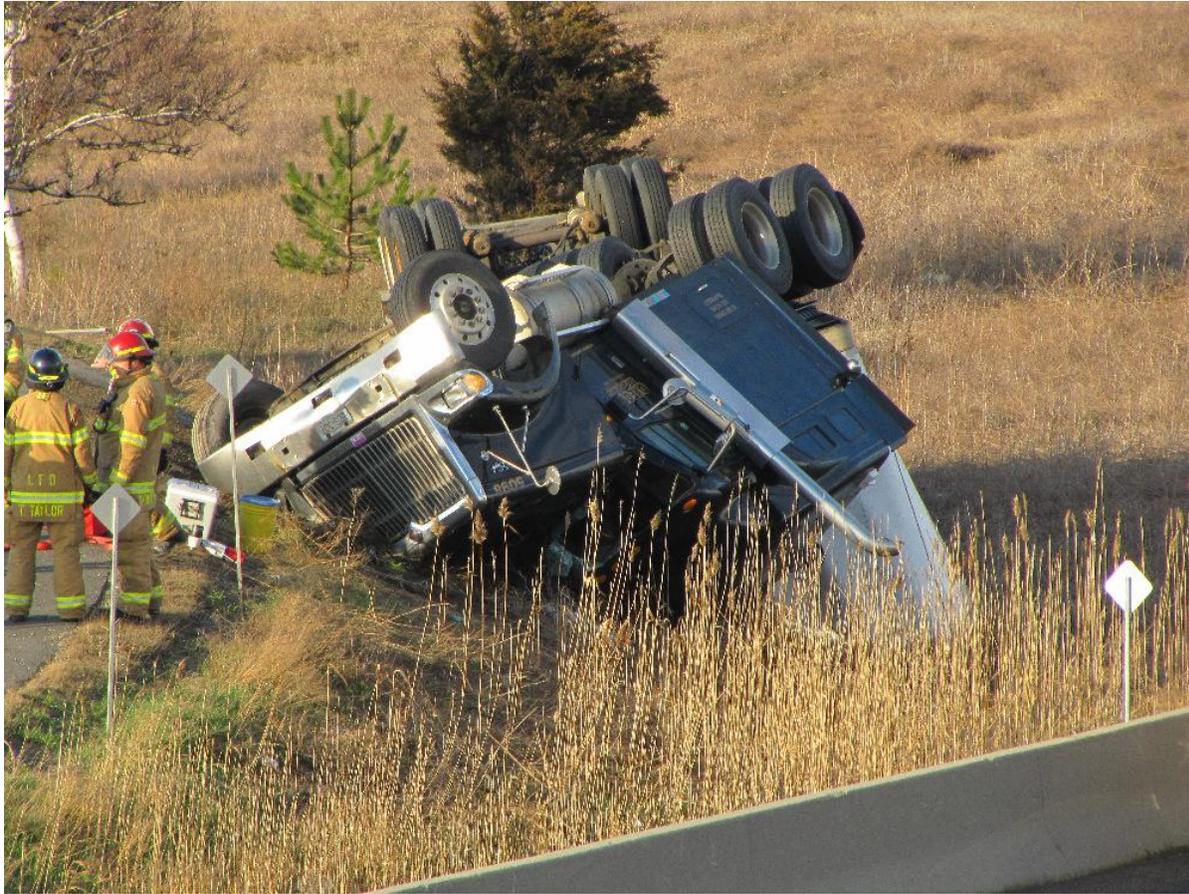
The driver of this transport truck reportedly sustained injuries but these were not serious. But the scenario could have been much worse. The truck cab was crushed above the driver and these drivers are more likely to be unrestrained in the mistaken belief that the mass of their trucks would prevent the large velocity changes that are experienced by smaller vehicles. Without wearing a seatbelt this driver could have been in a precarious situation, and even if he was restrained the collapse of the cab roof could have made the consequences unpredictable.

Figure 18: View of driver's side of cab of road tractor showing how it was crushed by the landing onto the bank of the entrance ramp.

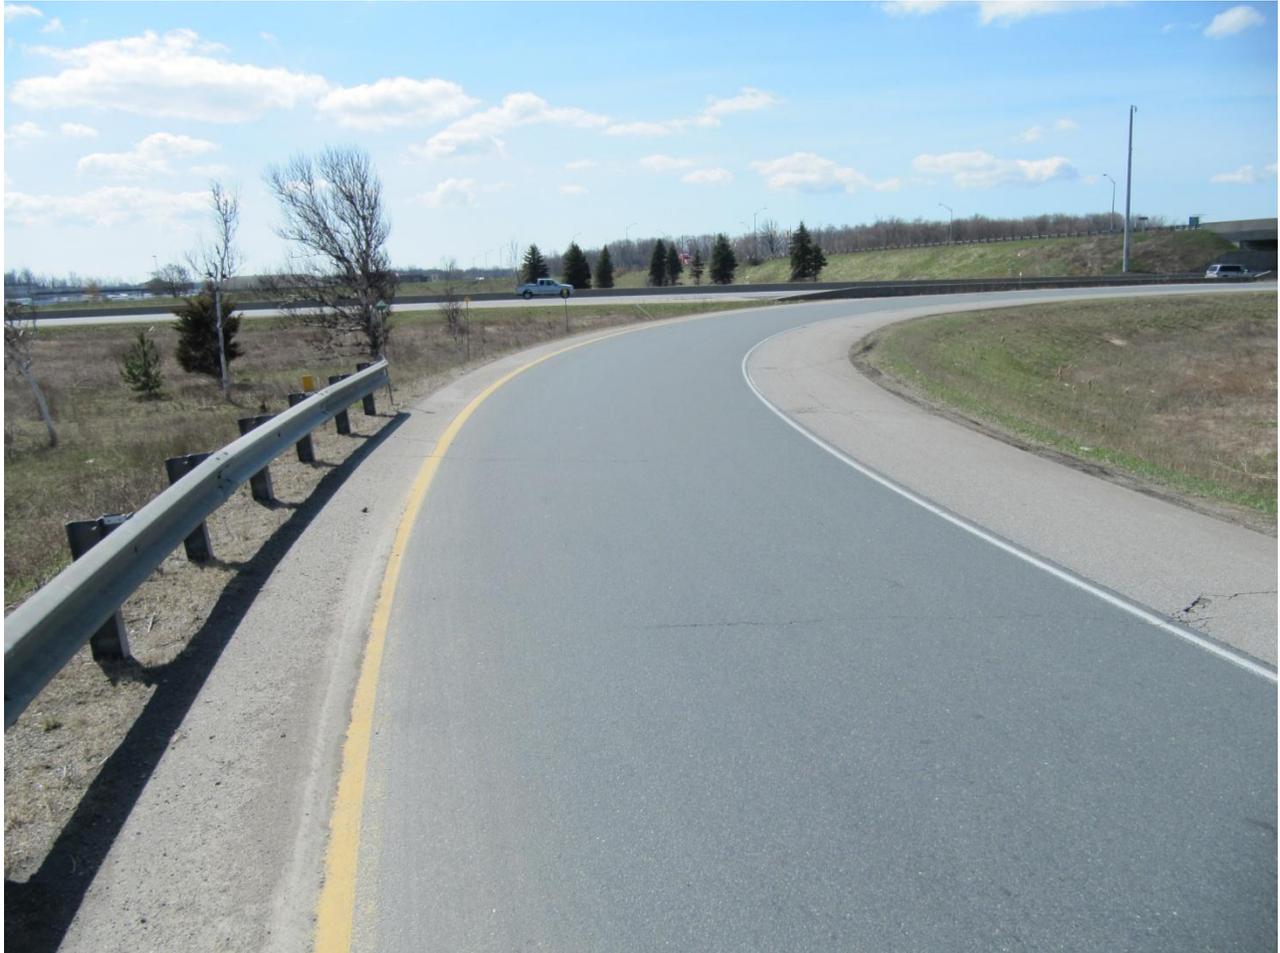
What we observed from examining the guardrail is what good condition it was in. No evidence of any previous impacts, not even any minor dents. That could be a good thing and it could also be bad. As we came to the end of the guardrail, as shown in Figure 21, we observed that the transport truck had not made any contact to it. In fact, several of the fragile, diamond shaped, curve-delineation, marker posts marking the outside of the ramp were still standing erect at the end of the rail as shown in Figures 22 and 23.

Figure 21: View of conditions at the end of the guardrail.

So the position where the transport truck left the ramp surface was well past the point where the outside guard rail came to an end. So what benefit did the guardrail provide to this driver?

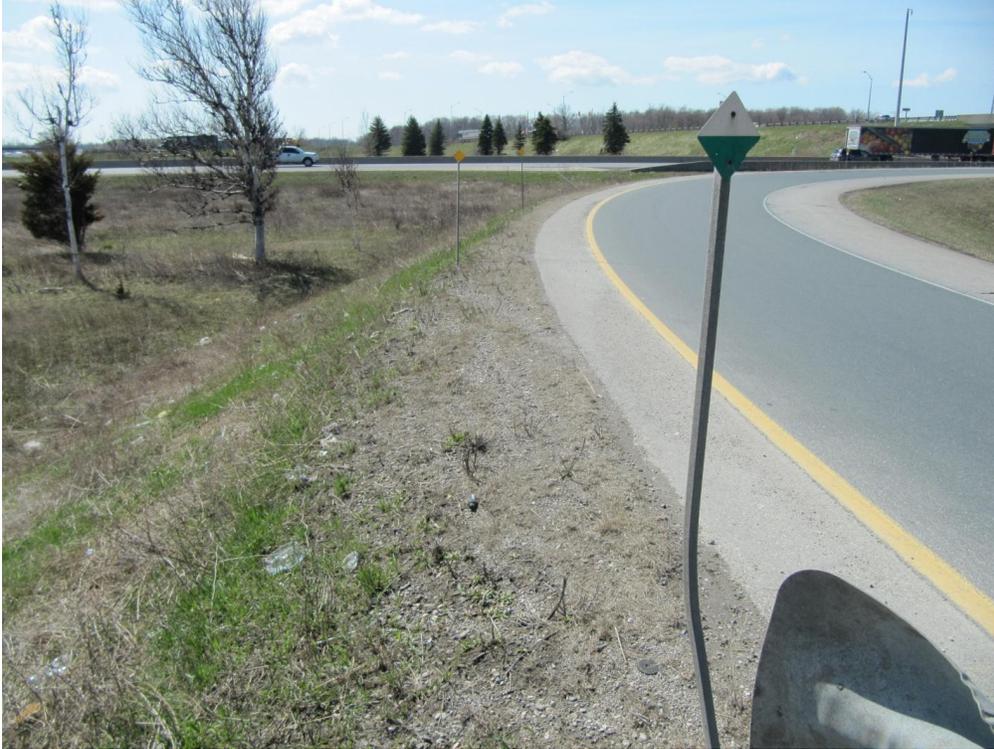
In fact, we have argued that the height of such guardrails, and their strength, would provide very little benefit to re-directing a large truck like this. In fact, such a low rail would make matters worse as it would increase the likelihood that the truck would trip over this low obstacle. The truck driver might stand a better chance to just fall down an embankment and hope that the truck stays upright rather than accept the heightened chance of being tripped by such a low guard rail.

Figure 22: View at end of the guardrail showing the curve delineation posts that are still standing and indicating that the truck never passed over them.

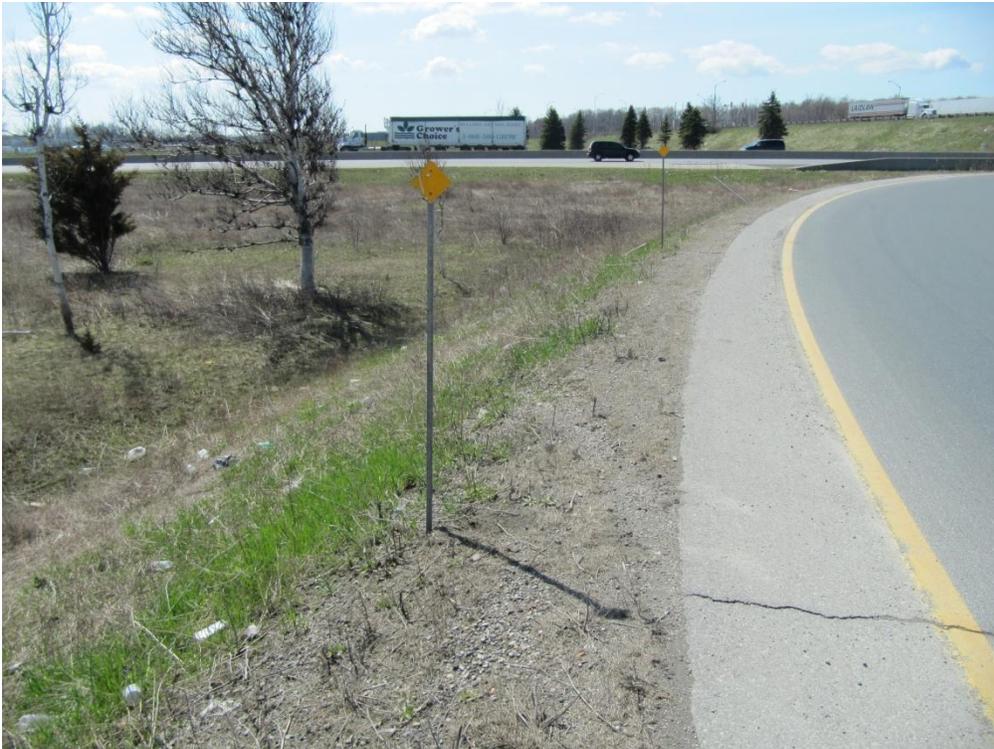
Figure 23: View of the curve delineation posts that are still standing past the end of the guardrail.

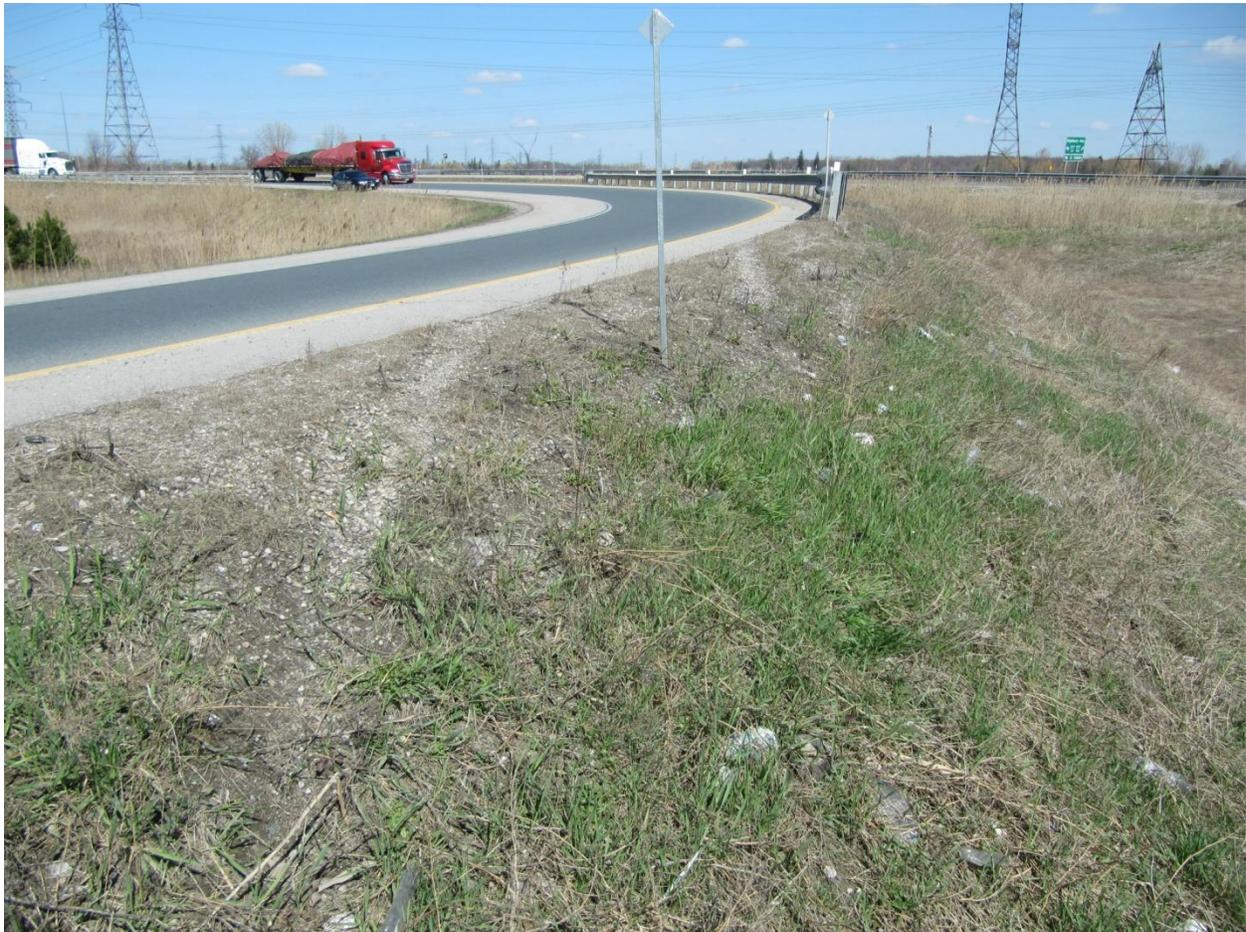
Figure 24: View of older set of loss-of-control tire marks caused by a smaller vehicle, located just past the end of the guardrail.

To those unaccustomed to locating loss-of-control tire marks the view in Figure 24 might not demonstrate an obvious indication of where these tire marks exist. If we look at the curve-delineation post in the centre of Figure 24, there are two loss-of-control tire marks, one on each side of the post, which are noticeable from the "whiteness" of the underlying gravel where the grass has been torn away. This tire marks indicate the counter-clockwise rotation of a smaller vehicle that would be expected in such circumstances.

So we have a beautiful, unmarked guardrail but it fails to be contacted by the tractor trailer that rolled over, as well as by another smaller vehicle which also fell off the outside embankment past the guardrail.

So is the guardrail providing any benefit to smaller vehicles? We don't know. Those responsible for the upkeep of this ramp should maintain a history of all accident events so that they can properly address any safety problems. But you and I will never know details of these collision events unless we sue those persons and therefore request such secret data. But as these entities are in danger of losing a great deal of money if they lose a civil suit it is obvious that such data will otherwise never see the light of day.

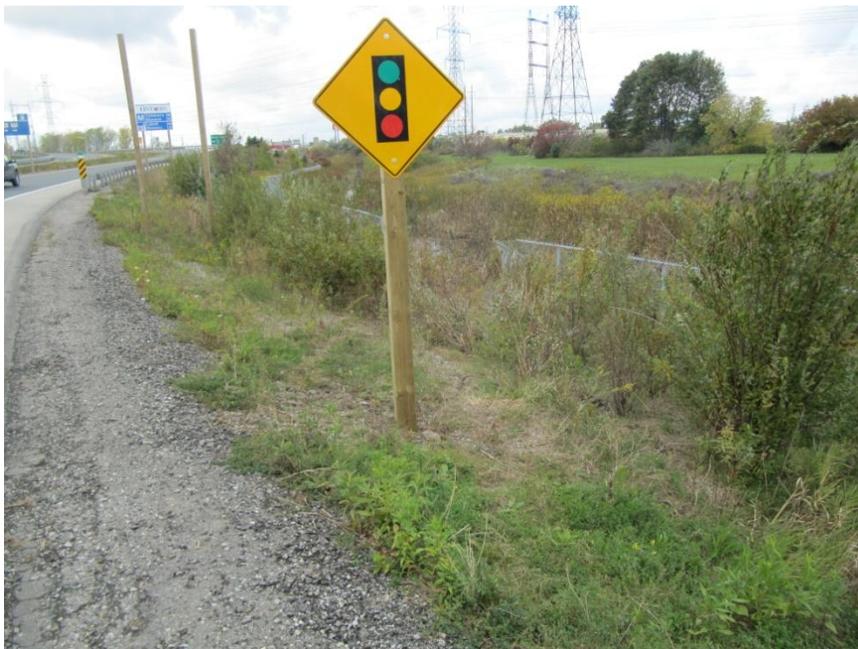
A number of months ago (October, 2012) we posted an article to our website entitled "Loss-of-Control On Highway 401 Exit Ramp - A Lucky Result". This stemmed from our observation of collision evidence on the westbound exit ramp just east of Wellington Road in south London where we observed that a vehicle had crashed through a chain-link fence and came to rest in a pond. Since we did not hear any news about this incident we commented on the luck of the vehicle occupants in surviving a potentially fatal mishap. We have also recently highlighted the number of persons who have drowned in Ontario from exiting a number of roads, some with barrier protections and some not. So we came back to this site on April 18, 2013 because we observed that the fence damage was still unrepaired.

Figure 25: View From October, 2012 showing where a vehicle left the 401 exit ramp, crashed through a chain-link fence and fell into a pond.

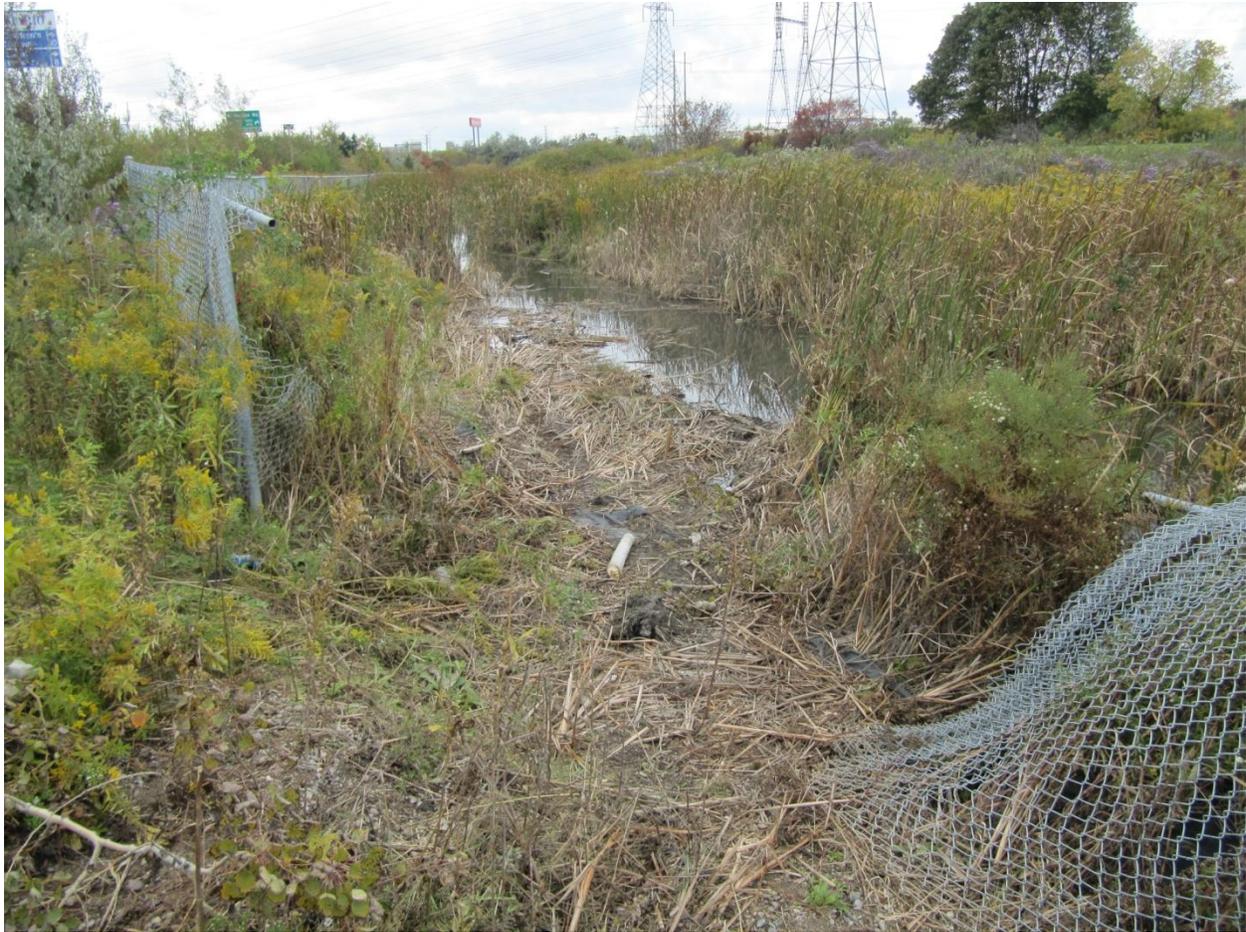
Figure 26: View from October, 2012 where a vehicle crashed through this chain-link fence and came to rest in the pond in the background.

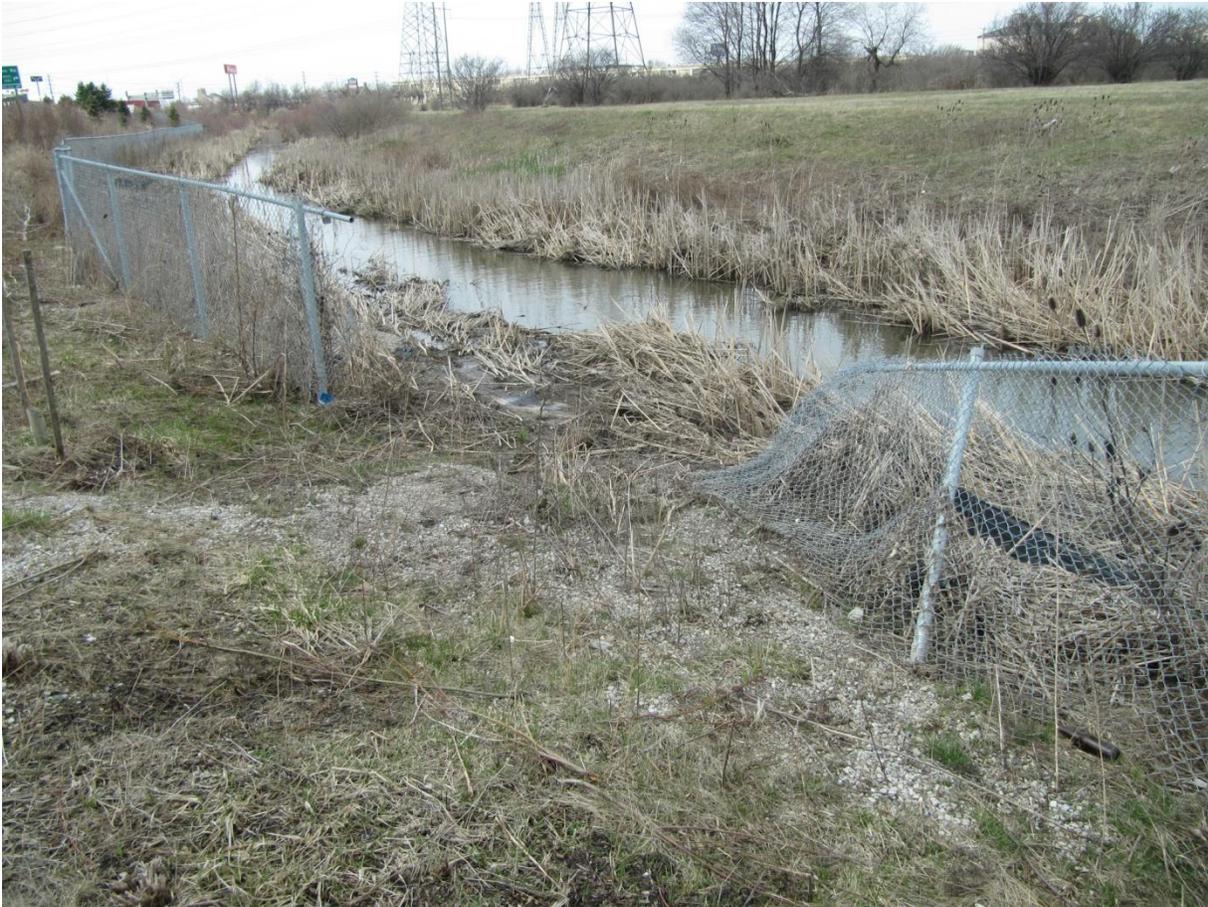
Figure 27 shows that the fence still remains unrepaired. How many months is it from the day we observed the damage, not to mention the delay from the actual collision? The irony reveals itself when we turn around and take a photo (Figure 28) from a slightly different angle, toward the northeast, with the accident site in the foreground and the London OPP Detachment building only a hundred metres away in the background.

Figure 27: View of (still) unrepaired fence on April 18, 2013.

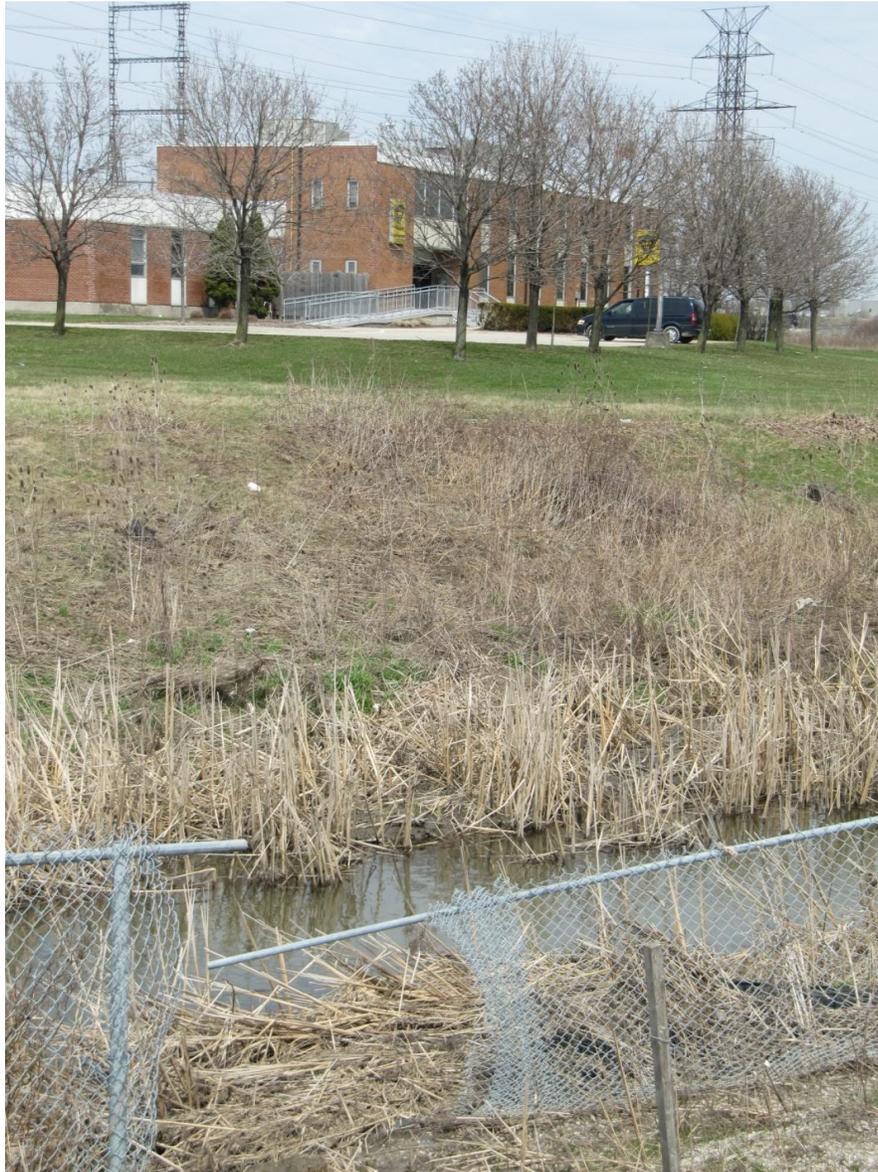
Figure 28: View of London OPP Detachment building in the background of an accident site where the chain link fence has been left unrepaired for months following a collision where the vehicle travelled into the pond in the foreground.
