## Criminal Traffic Charges To OPP Constable Left to Public's Speculation

*Posting Date: 12 January 2012*

Gorski Consulting  
London, Ontario, Canada

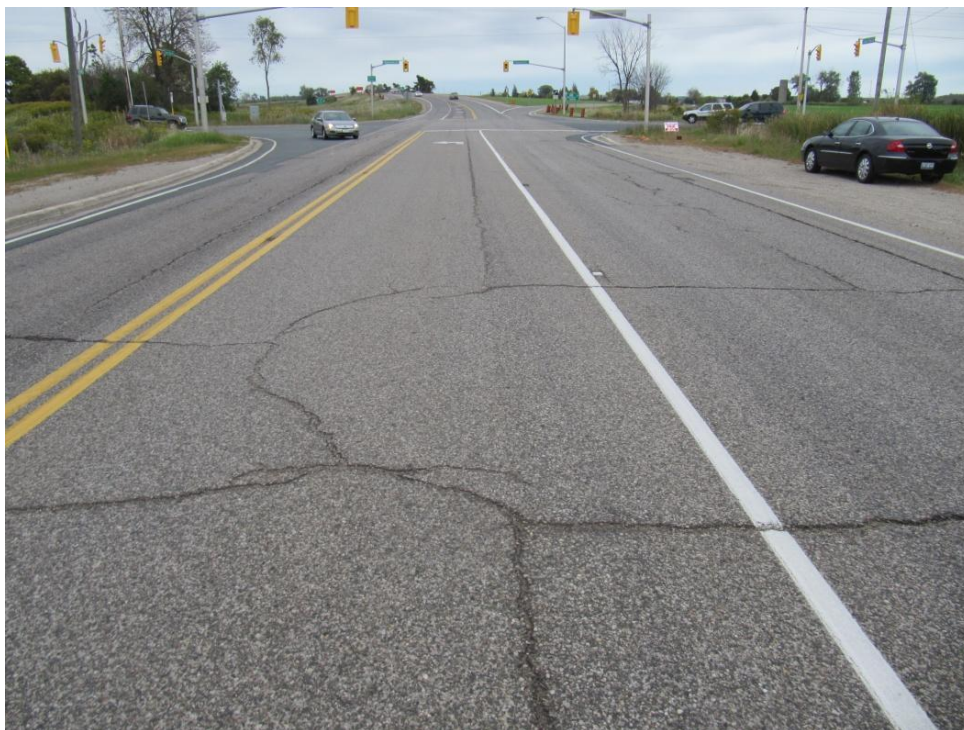
**1** - View looking south along Colonel Talbot Road

After the two vehicles collided it would appear that at least one of the vehicles travelled toward the south west and into a ditch. The orange cones on the south-west portion of

the intersection in the above photo shows the general location where the vehicle exited the road.

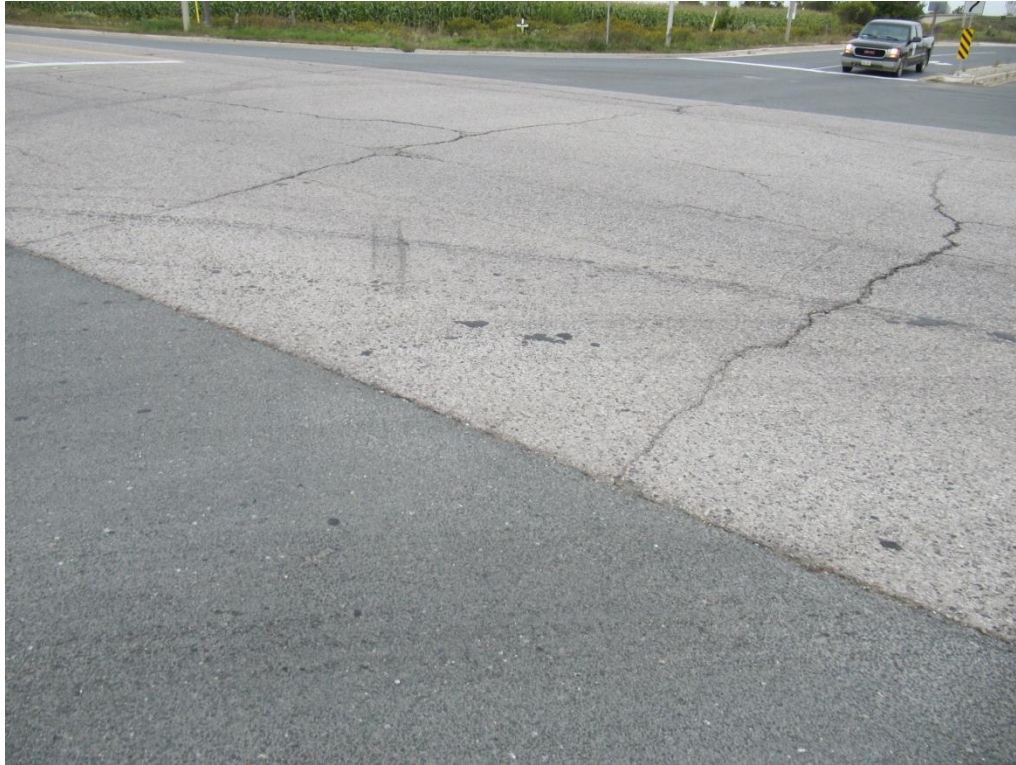
Such a short, scuffing tire mark is often produced in a scenario where two vehicles meet in an intersection collision. The angle of that tire mark would suggest that the vehicles were headed south and west. But the lack of physical evidence relating to the post impact travel of a second vehicle is somewhat unusual. Typically the post-impact travel of both vehicles is clearly visible as various curved yaw marks and fluid trails would be created. Yet only the single, short tire mark was visible in the present case. As one of the vehicles reached the curb at the southwest quadrant of the intersection there was more typical evidence of the vehicle's motion into the ditch.

3 - View, looking northeast at tire mark at the point of impact

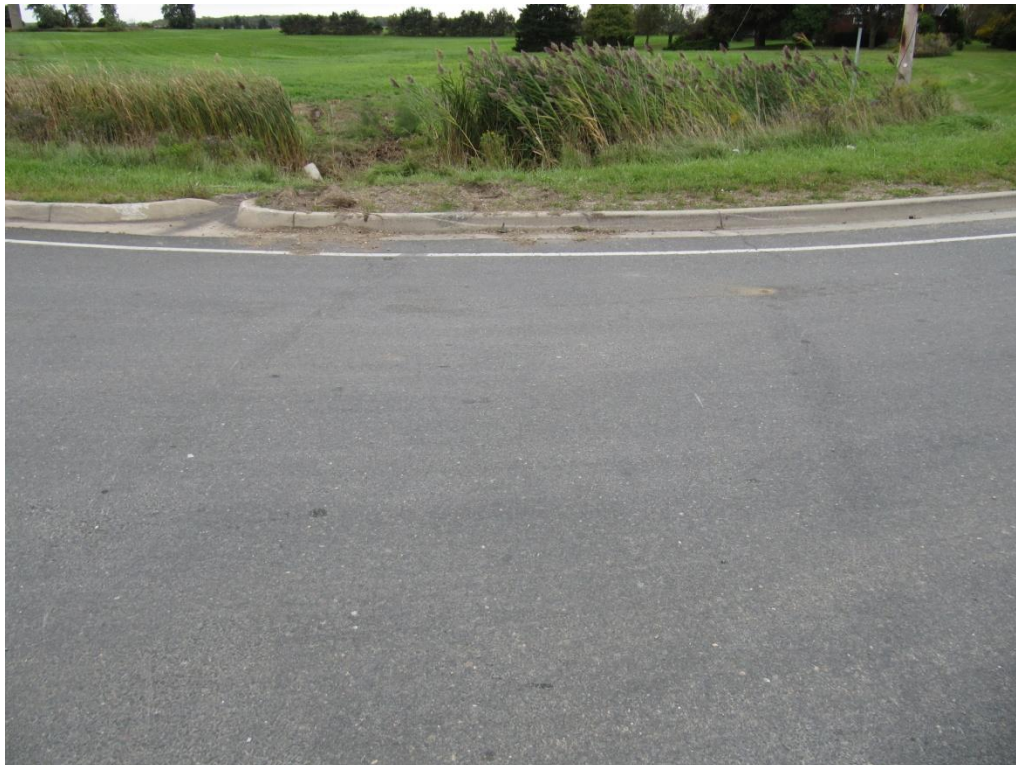
4-View, looking southwest toward the exit location where one of the vehicles entered the ditch
