## Criminal Traffic Charges To OPP Constable Left to Public's Speculation

*Posting Date: 12 January 2012*

Gorski Consulting  
London, Ontario, Canada

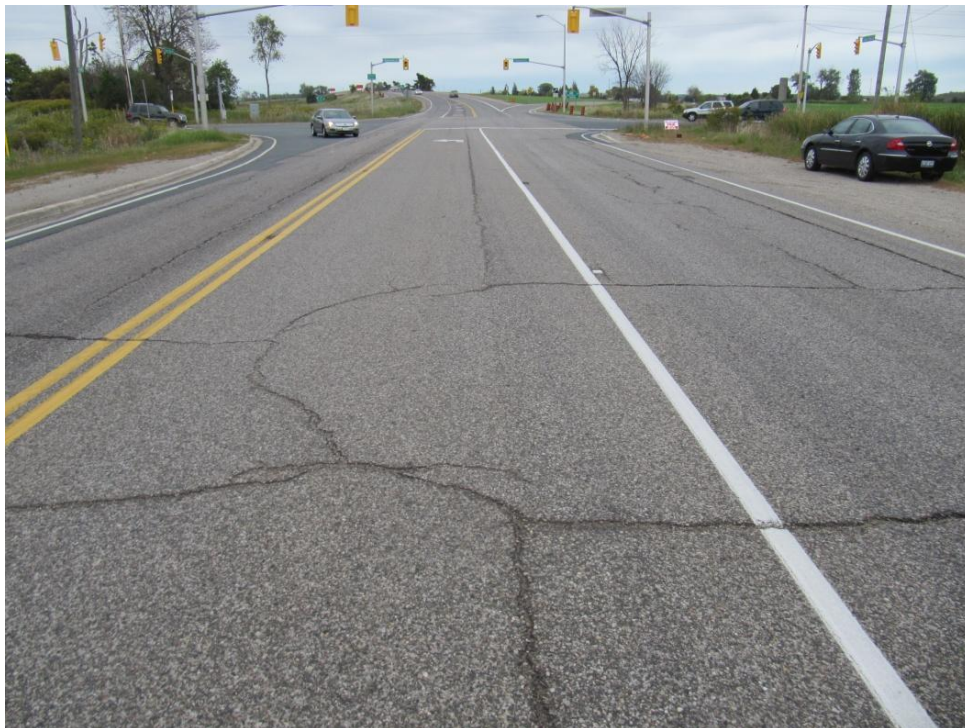
**1** - View looking south along Colonel Talbot Road

After the two vehicles collided it would appear that at least one of the vehicles travelled toward the south west and into a ditch. The orange cones on the south-west portion of

the intersection in the above photo shows the general location where the vehicle exited the road.

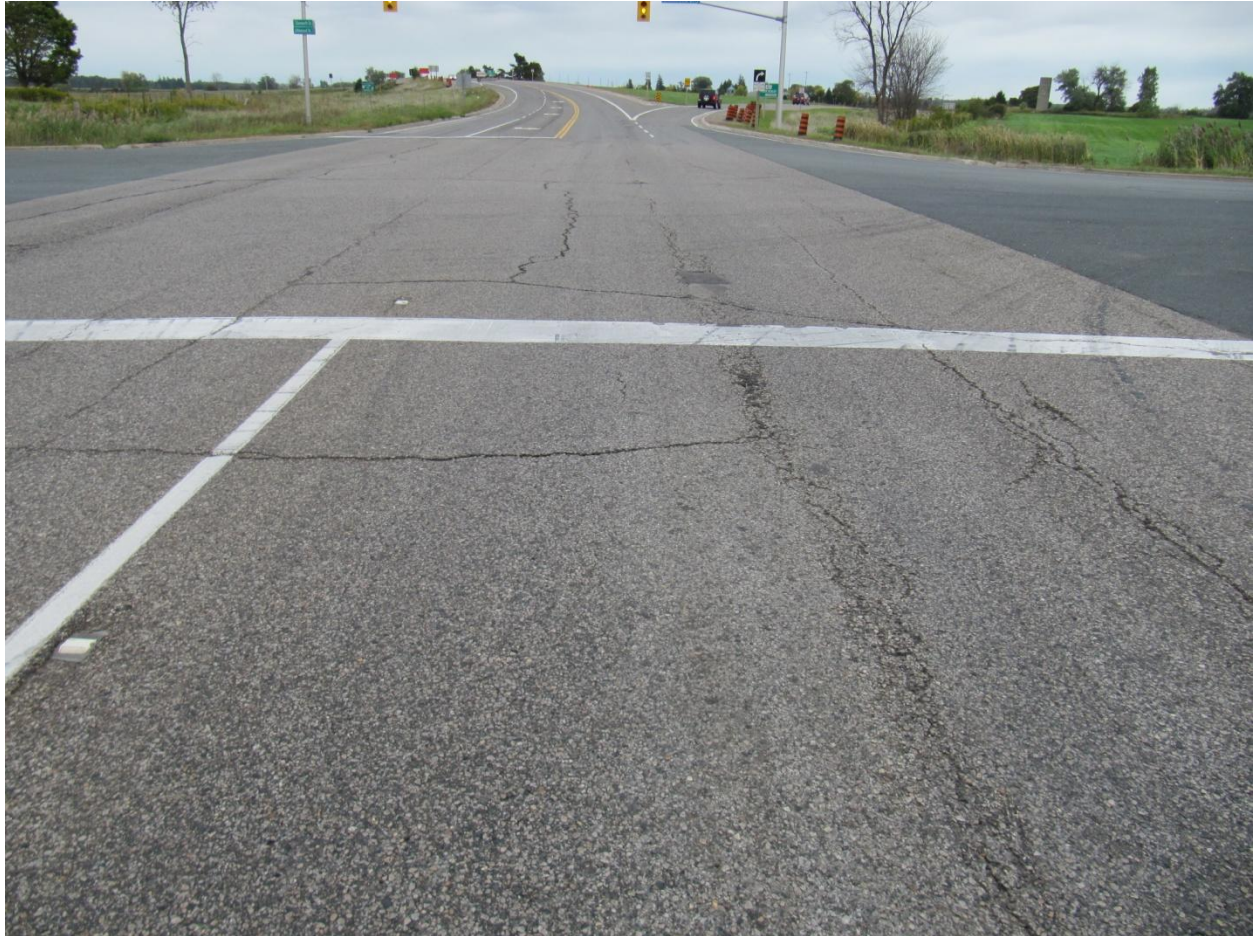
2 - View looking south at north edge of intersection with Glanworth Drive

In the extreme upper right of the above photo you can see a little more clearly where a vehicle travelled off the roadway. If you look at the line of bushes you will see a small area where the bushes are missing and this is the location where a vehicle plowed through those bushes. The actual impact between the two vehicles occurred in the middle of the intersection as evidenced by a tire mark indicating that the tire was scuffing or sliding. A photo of that tire mark is shown on the following page.

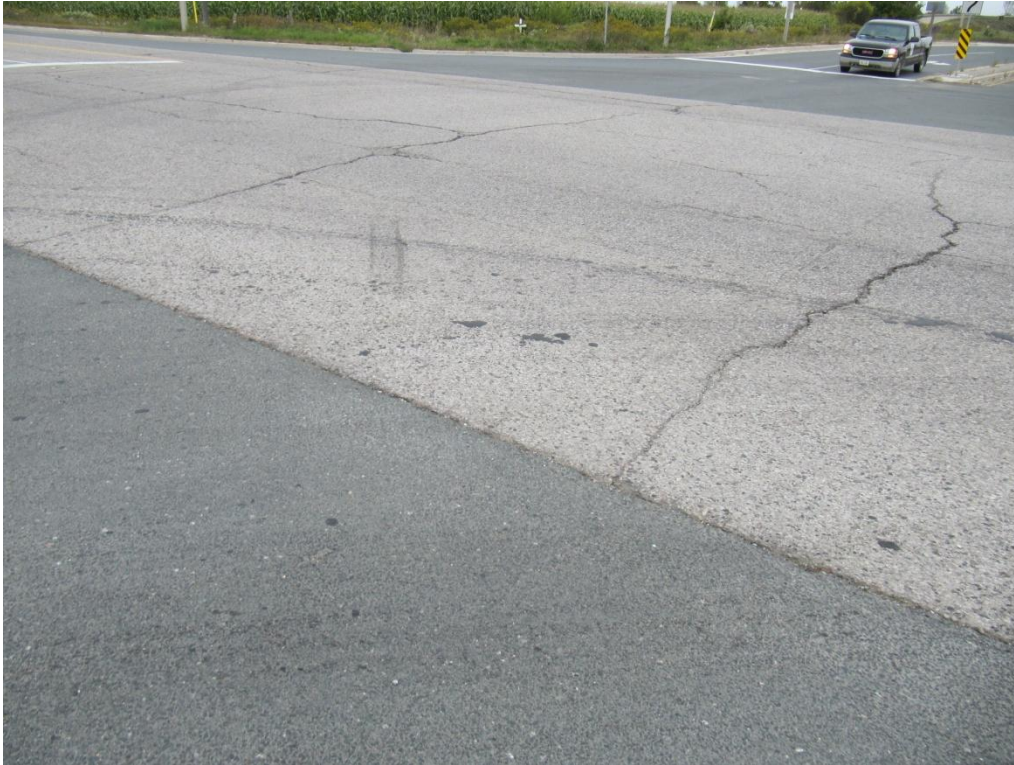
Such a short, scuffing tire mark is often produced in a scenario where two vehicles meet in an intersection collision. The angle of that tire mark would suggest that the vehicles were headed south and west. But the lack of physical evidence relating to the post impact travel of a second vehicle is somewhat unusual. Typically the post-impact travel of both vehicles is clearly visible as various curved yaw marks and fluid trails would be created. Yet only the single, short tire mark was visible in the present case. As one of the vehicles reached the curb at the southwest quadrant of the intersection there was more typical evidence of the vehicle's motion into the ditch.

3 - View, looking northeast at tire mark at the point of impact

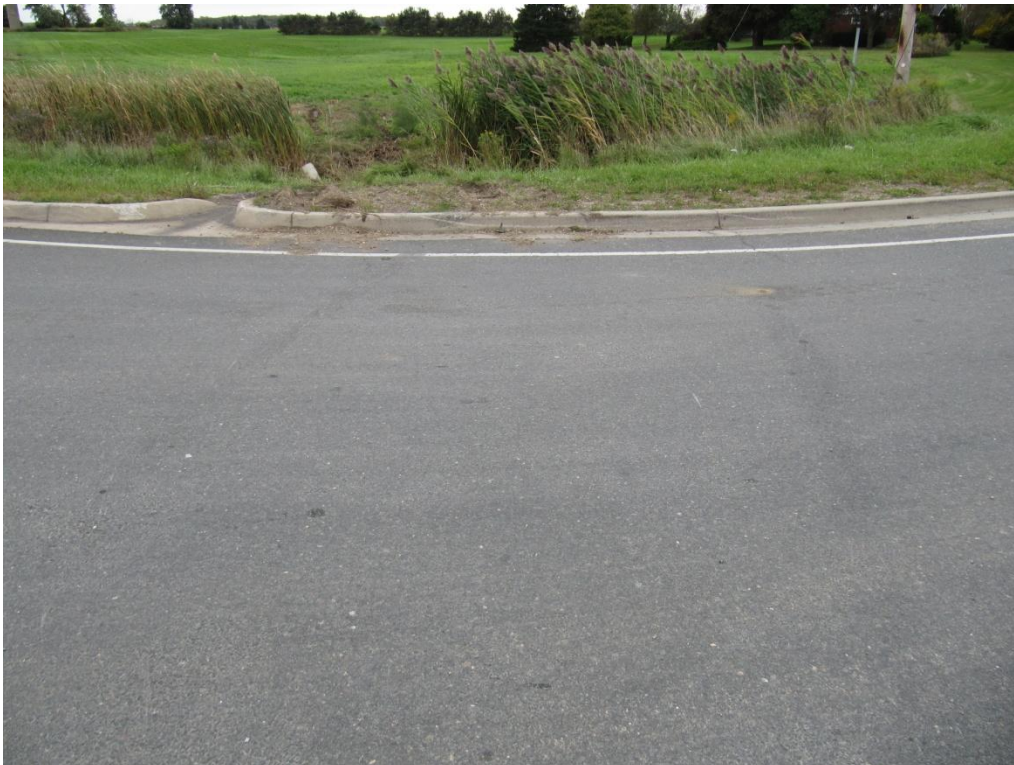
4-View, looking southwest toward the exit location where one of the vehicles entered the ditch

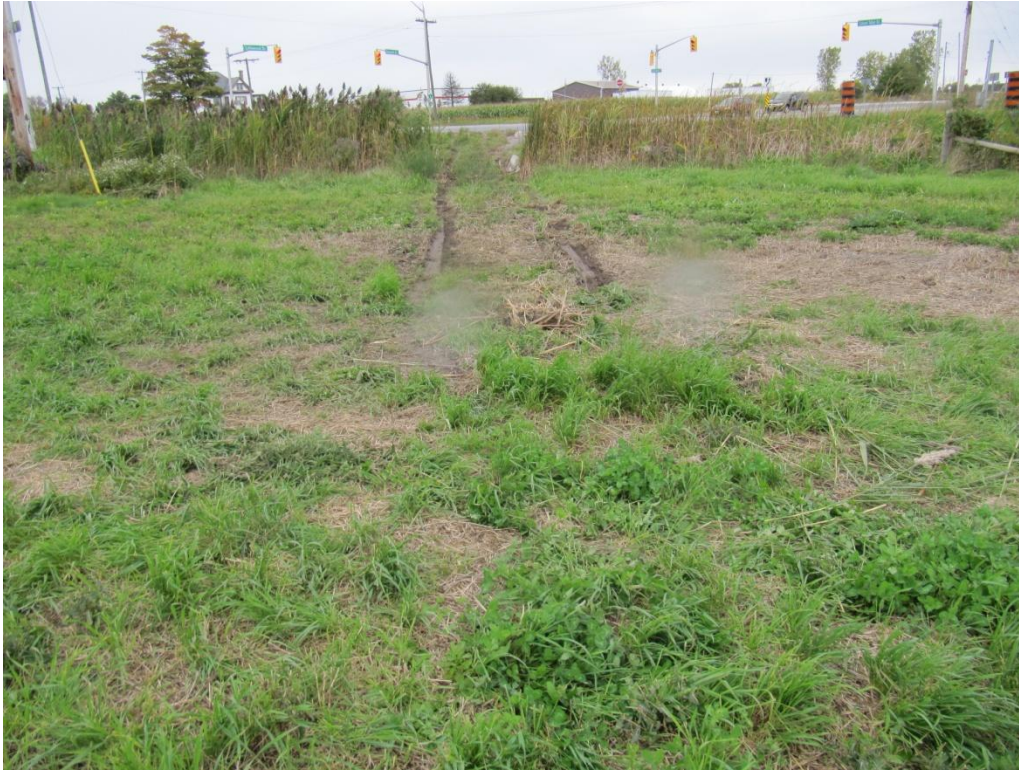
An interesting set of tire marks existed on the back side of the ditch where the vehicle produced some sliding tire marks in the wet earth. The photo below shows this evidence from a distance and then the following photos show closer views of that evidence.

5 - View, looking northeast at the tire marks of one of the vehicles after it passed through the bushes to its final rest position

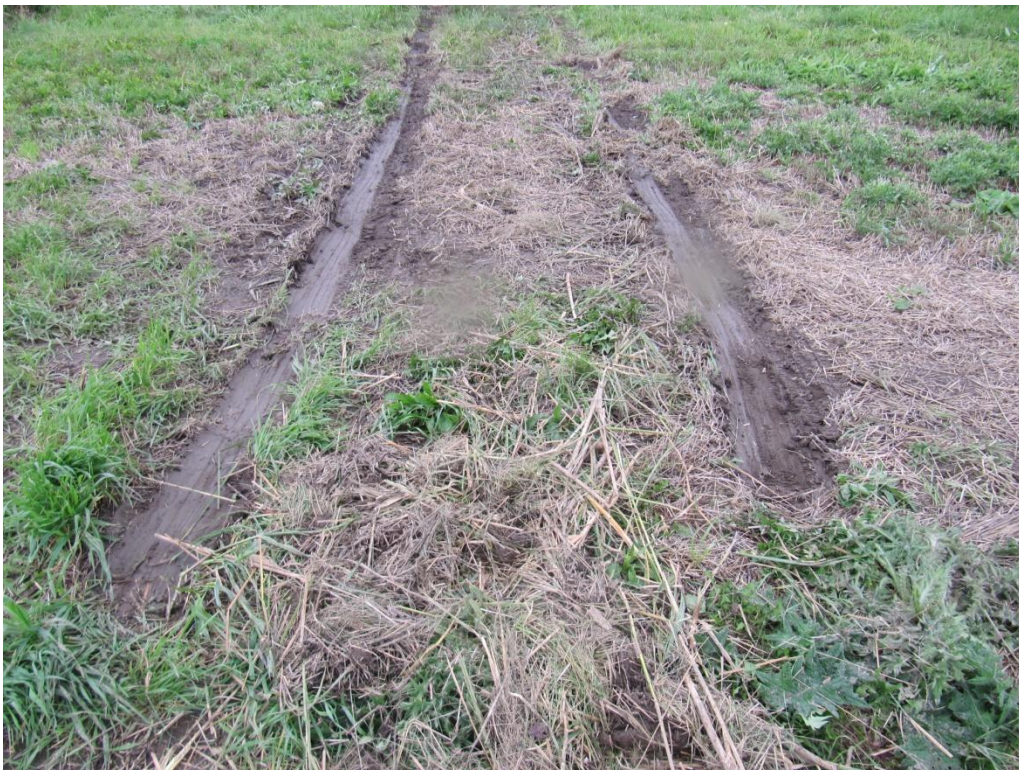
6 - View of tire marks indicating that the vehicle was sliding

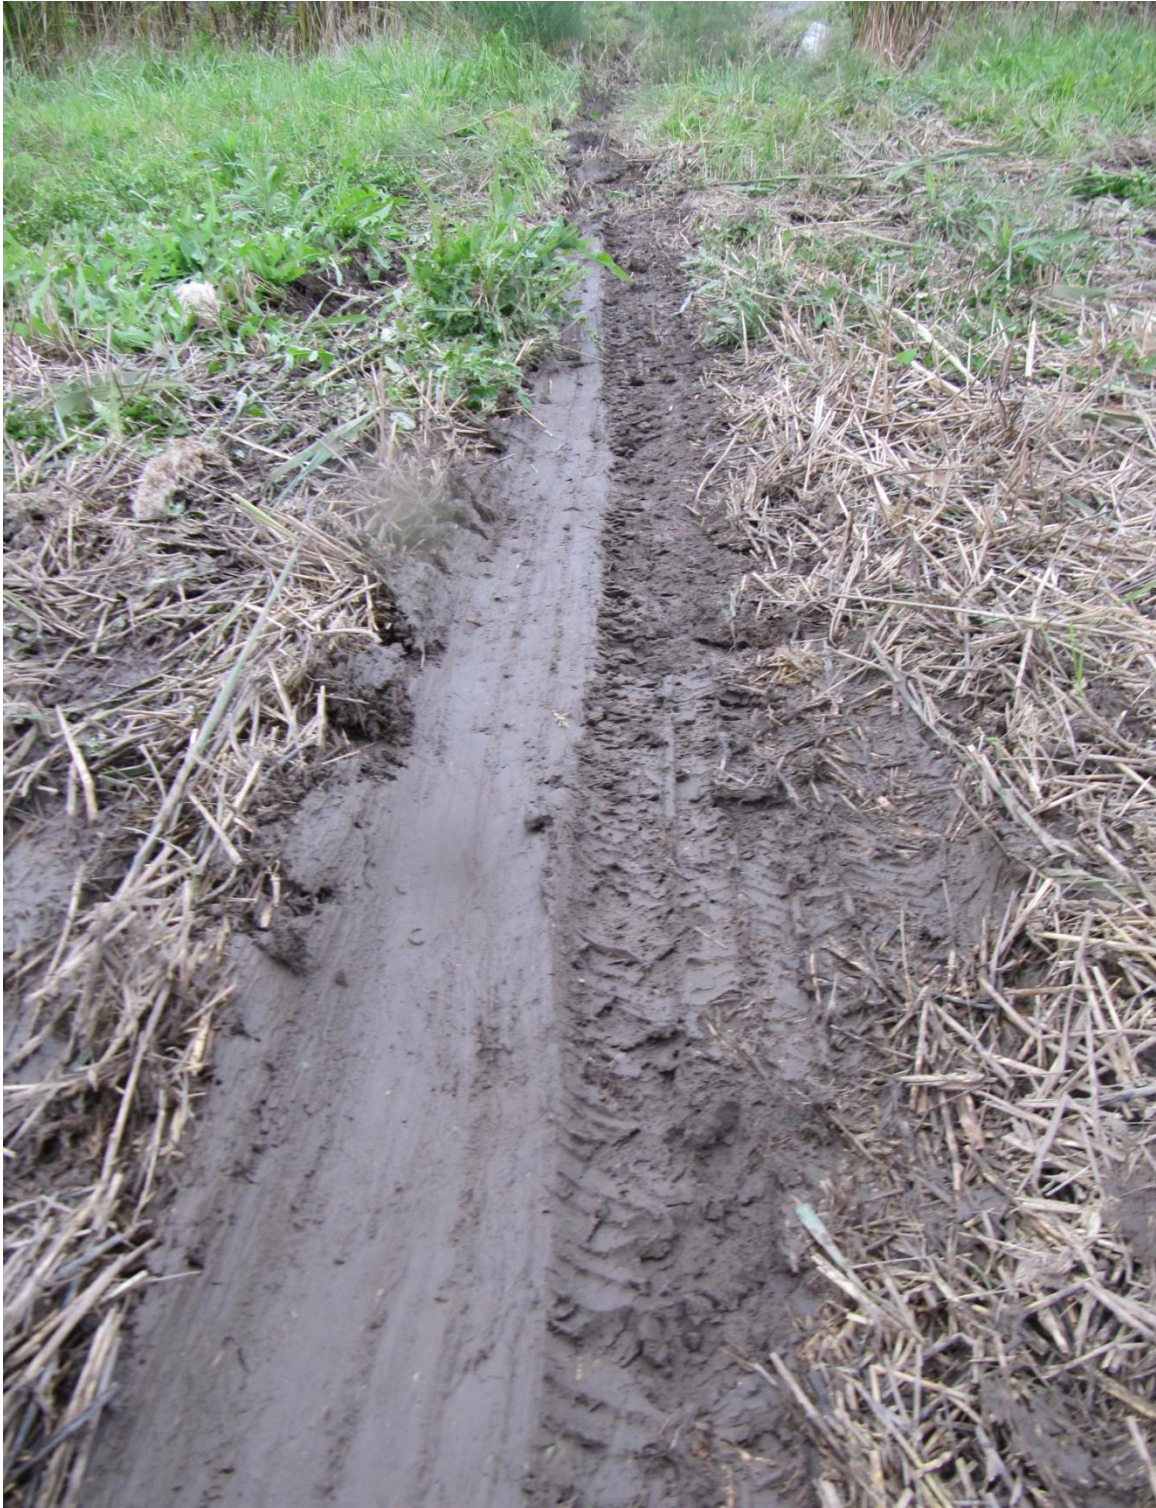
7 - View of sliding character of tire marks

Judging by the tread imprint along side of the sliding marks it would suggest that the sliding evidence might have occurred after the tread marks were created and that

perhaps the sliding evidence is related to towing. Regardless, the evidence is not typical.
