Loss-Of-Control SUV Crash Results in Fatal Injuries to Ingersoll Man - A Review of Evidence at the Accident Site

Posting Date: 10-Oct 2012

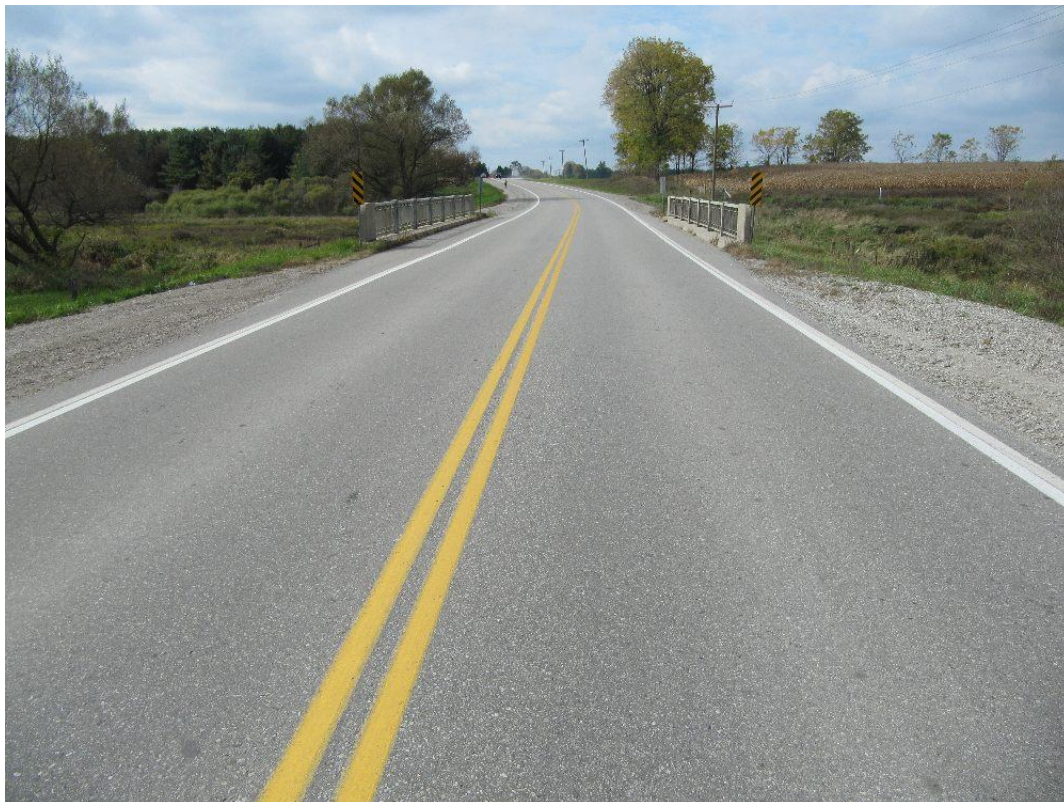
Gorski Consulting examined the collision site on the afternoon of October 9th. Below is a view looking west along Road 88. The impact occurred about 500 metres east of Oxford Rd 6. The west end of the bridge shown in this photo is located about 225 metres east of that area of impact. Thus the present photo is taken from approximately 300 metres east of that area of impact.

You can see in the background, past the bridge, that Road 88 curves to the left. In the vicinity of this left curve the Bader SUV's right wheels travelled onto the right (north) gravel shoulder and this is where the vehicle began to rotate out of control.

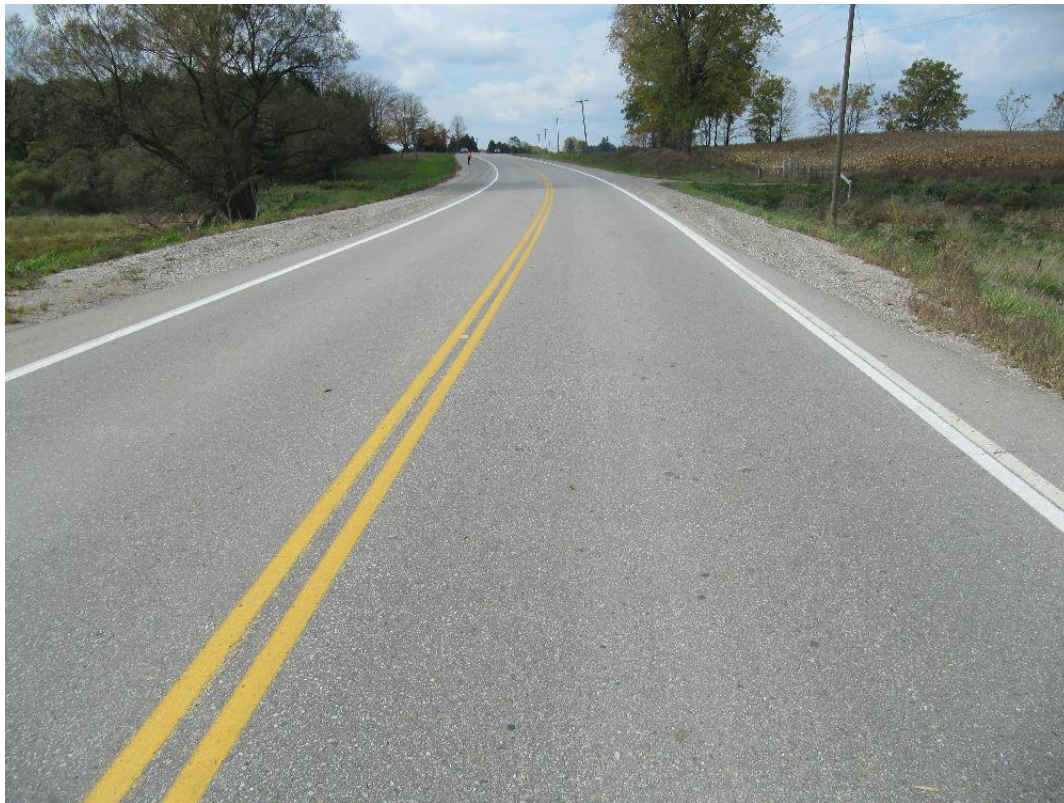
The photo below now takes us just west of the bridge which is now behind the camera. In the far distance there is a man standing on the south shoulder and we will see that same man in several of the following photos. The position of this man can be used to gain an appreciation of the distances shown between the various photos.

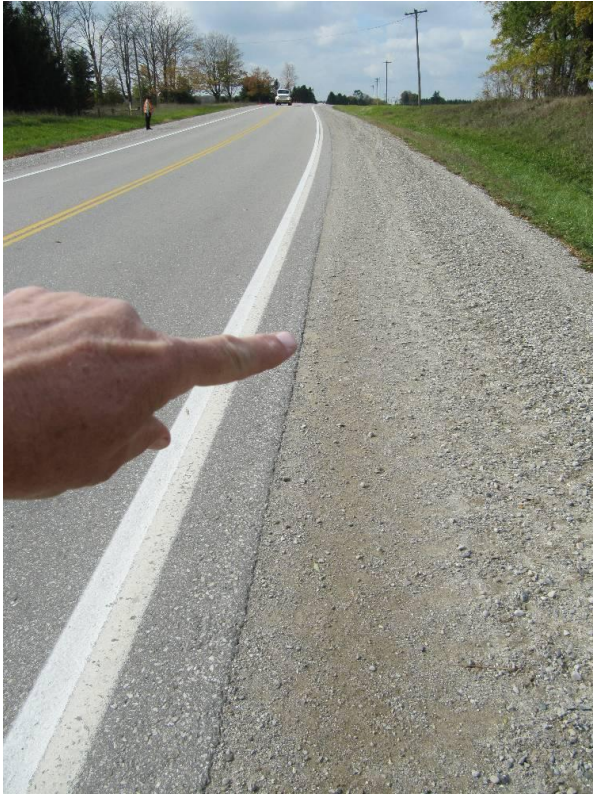
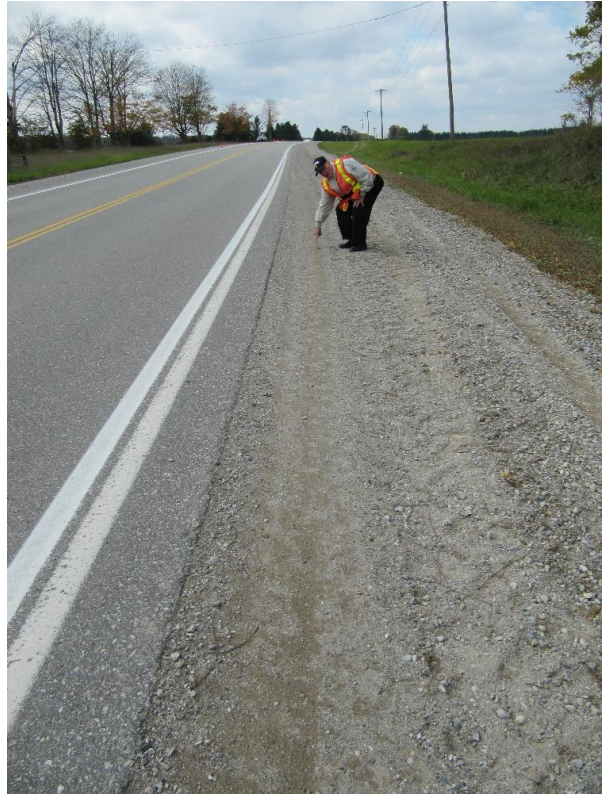
The top left photo on Page 3 shows the location where the SUV first travelled off the road surface and onto the north gravel shoulder. You can see the man standing on the south shoulder in the background and he is at the same position as he was in the previous photo. We noted that the vehicle first exited onto this north shoulder at a distance of approximately 142 metres east of the eventual area of impact. The top right photo shows an assistant pointing to the location of the tire mark on the north shoulder.

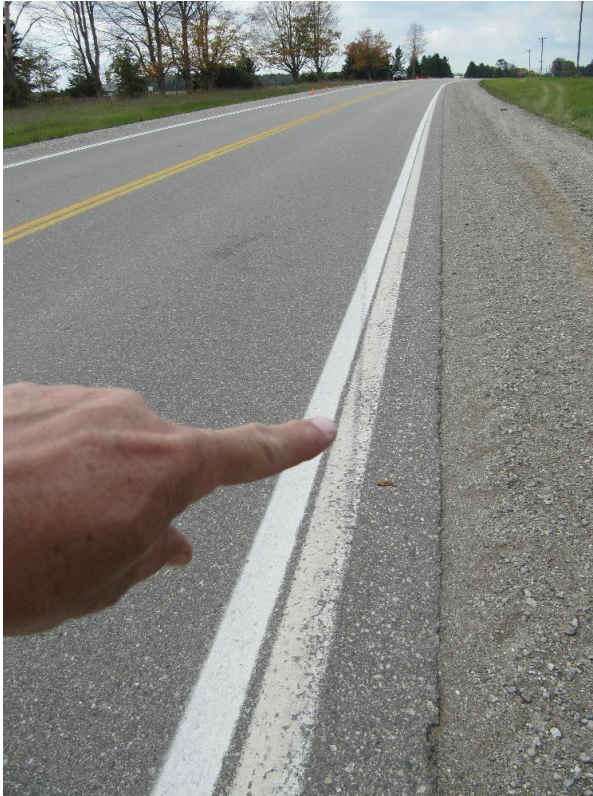
In the bottom left photo on Page 3 the finger is pointing to the tire mark as it is leaving the north shoulder and begins re-entering the road surface.

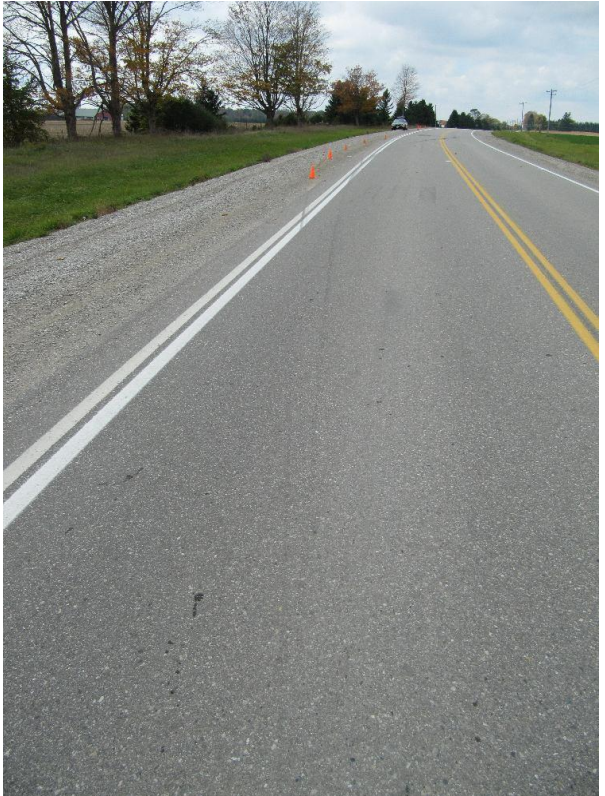
The bottom right photo on this page is looking westbound in the eastbound lane and it

indicates how the SUV crosses the roadway centre-line and travels onto the south gravel shoulder. The tire mark produced on that south shoulder has been outlined by a series of small orange cones placed along its path.

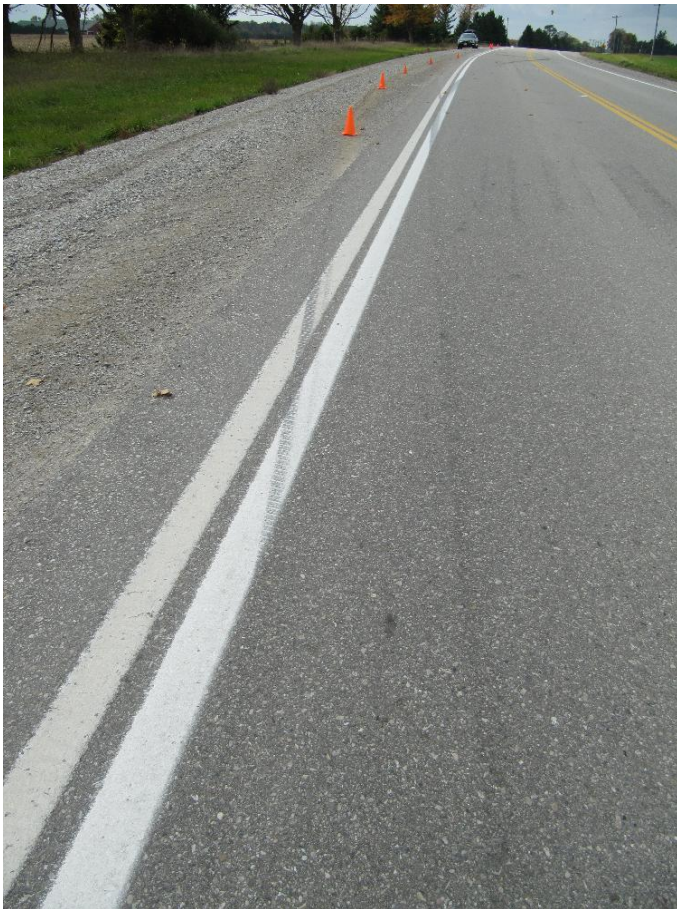
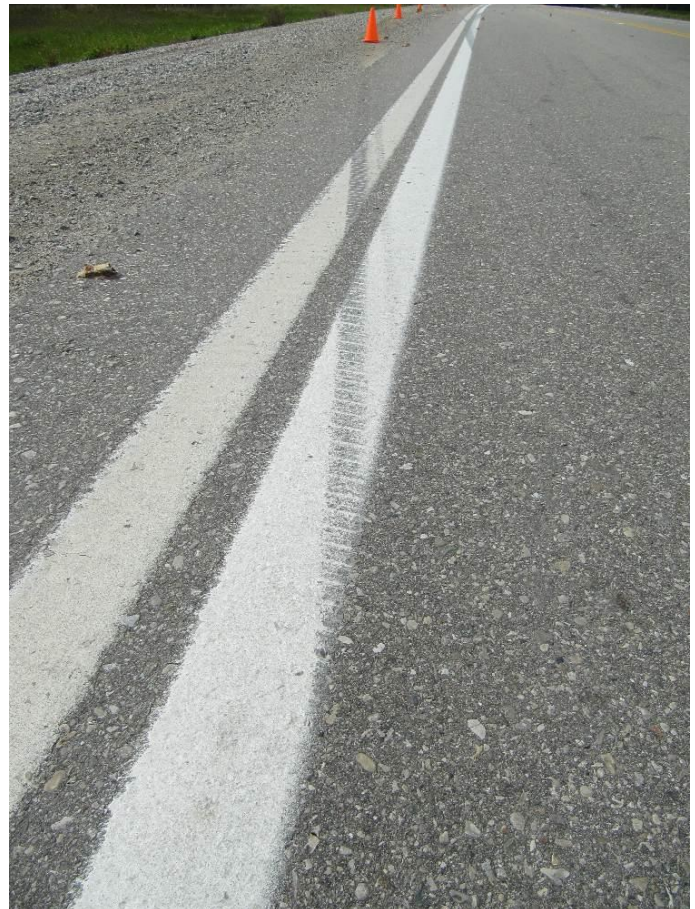
The above-left photo shows a westbound view of the tire marks as the SUV travels across the eastbound lane and enters the south gravel shoulder. The above-right photo shows the diagonal striations that accompany the tire mark as it crosses the white edge lines at the south edge of the eastbound lane.

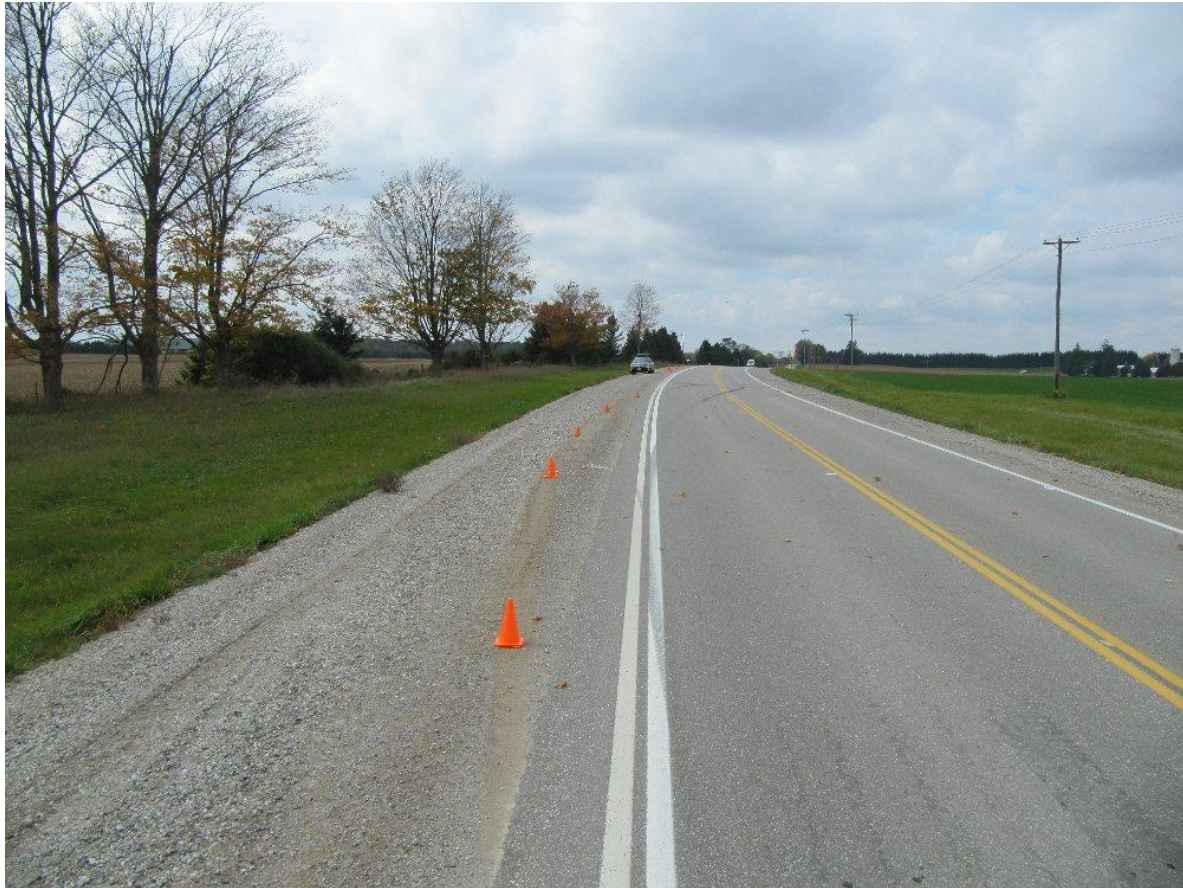
Our measurements indicate that the SUV was on the north shoulder between approximately 100 and 142 metres east of the area of impact and during this distance the vehicle began to rotate counter-clockwise. It then crossed the road and entered the south shoulder at about 56 metres east of the area of impact. While approaching the south shoulder the driver attempted to re-direct the vehicle back toward the road but

induced a clockwise rotation which brought the left rear tire back onto the road at about 19 metres east of the area of impact. The photo below shows the path of the left rear tire of the vehicle (outlined by the orange cones) on the south shoulder as the vehicle's clockwise rotation is in effect.

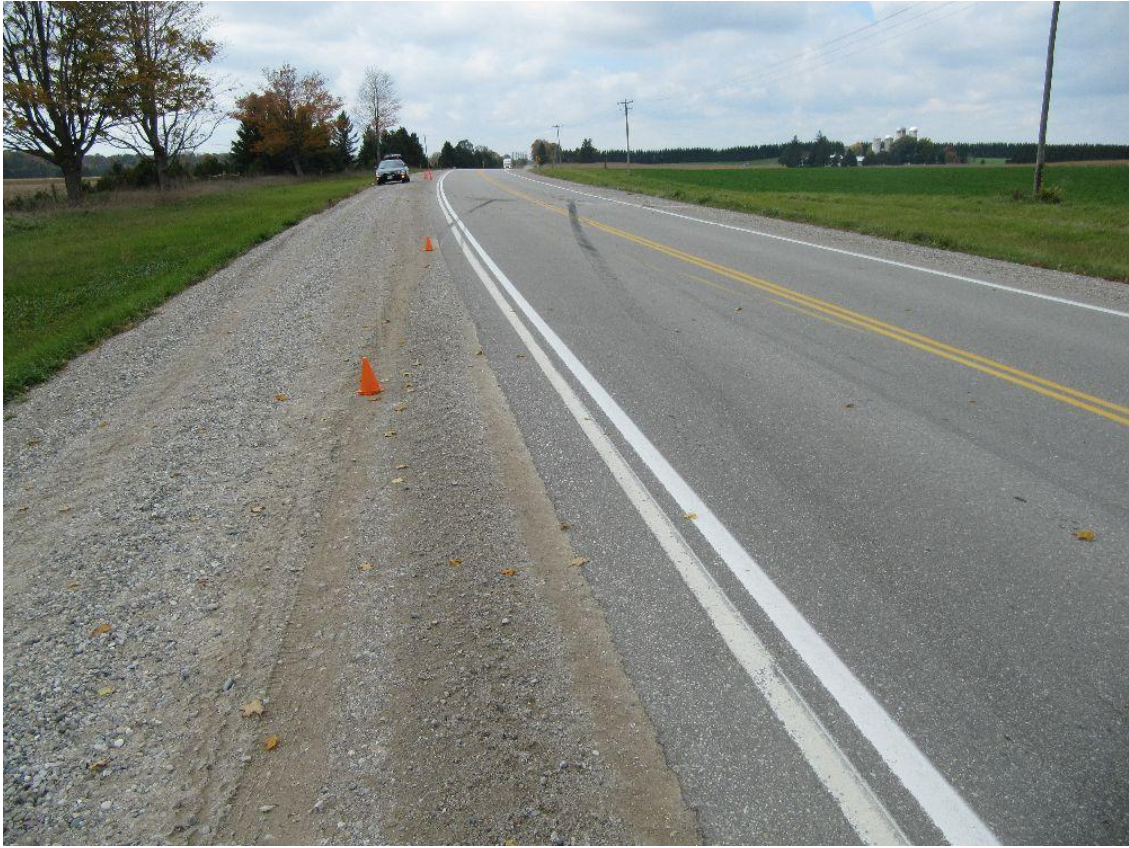
You may note that our vehicle is parked on the south shoulder in the background and the area of impact is closer to the camera than that parked vehicle. The photo at the top of Page 6 brings us further westward along that south shoulder and the orange cones indicate how the left rear tire re-enters the roadway. At this point you might also observe a dark tire mark approximately in the middle of the eastbound lane that was caused by the left front tire of the SUV. This demonstrates that the SUV is progressively rotating into a sideways slide, leading with its left side as it re-enters the roadway.

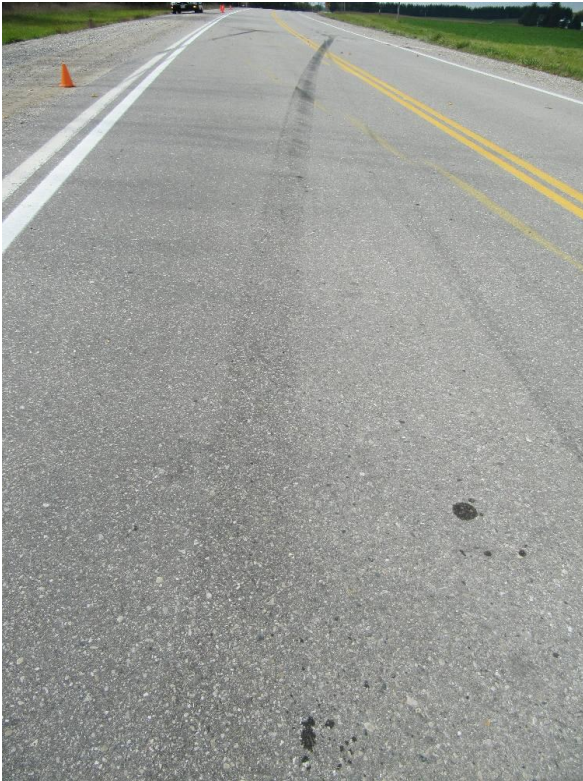
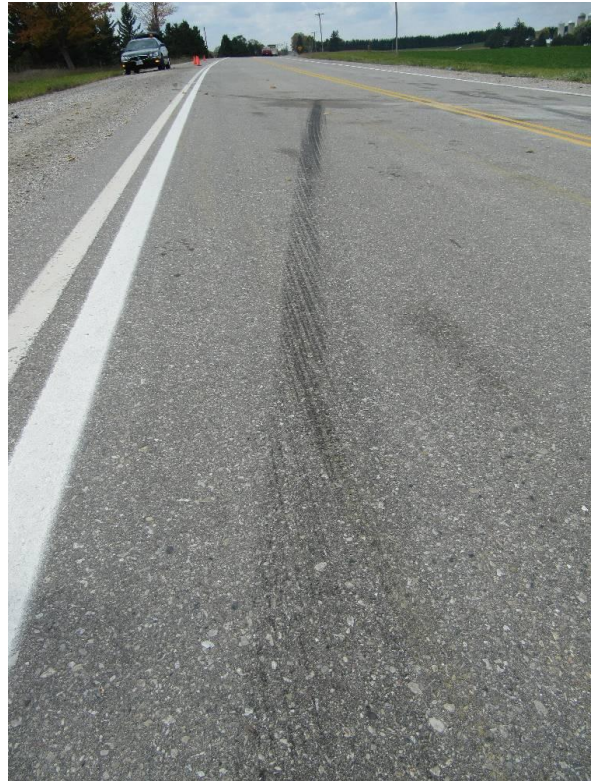
The photo at the bottom left of Page 6 shows the left rear tire mark while the photo at the bottom right shows the left front tire mark as they both travel toward the area of impact in the centre of the road.

We can look at the angle of the striations of the tire mark produced by the left rear tire of the SUV, shown in the bottom right photo on Page 6. The striations near the bottom of the photo are definitely not perpendicular to the length of the mark and, as we look further in the background, those striations appear to become almost parallel to the length of the mark. That interpretation becomes quite obvious when we take a close look at that tire mark near the area of impact, as shown in the large photo on Page 8. Clearly, the striations in the tire mark appear to run parallel to the length of the tire mark.

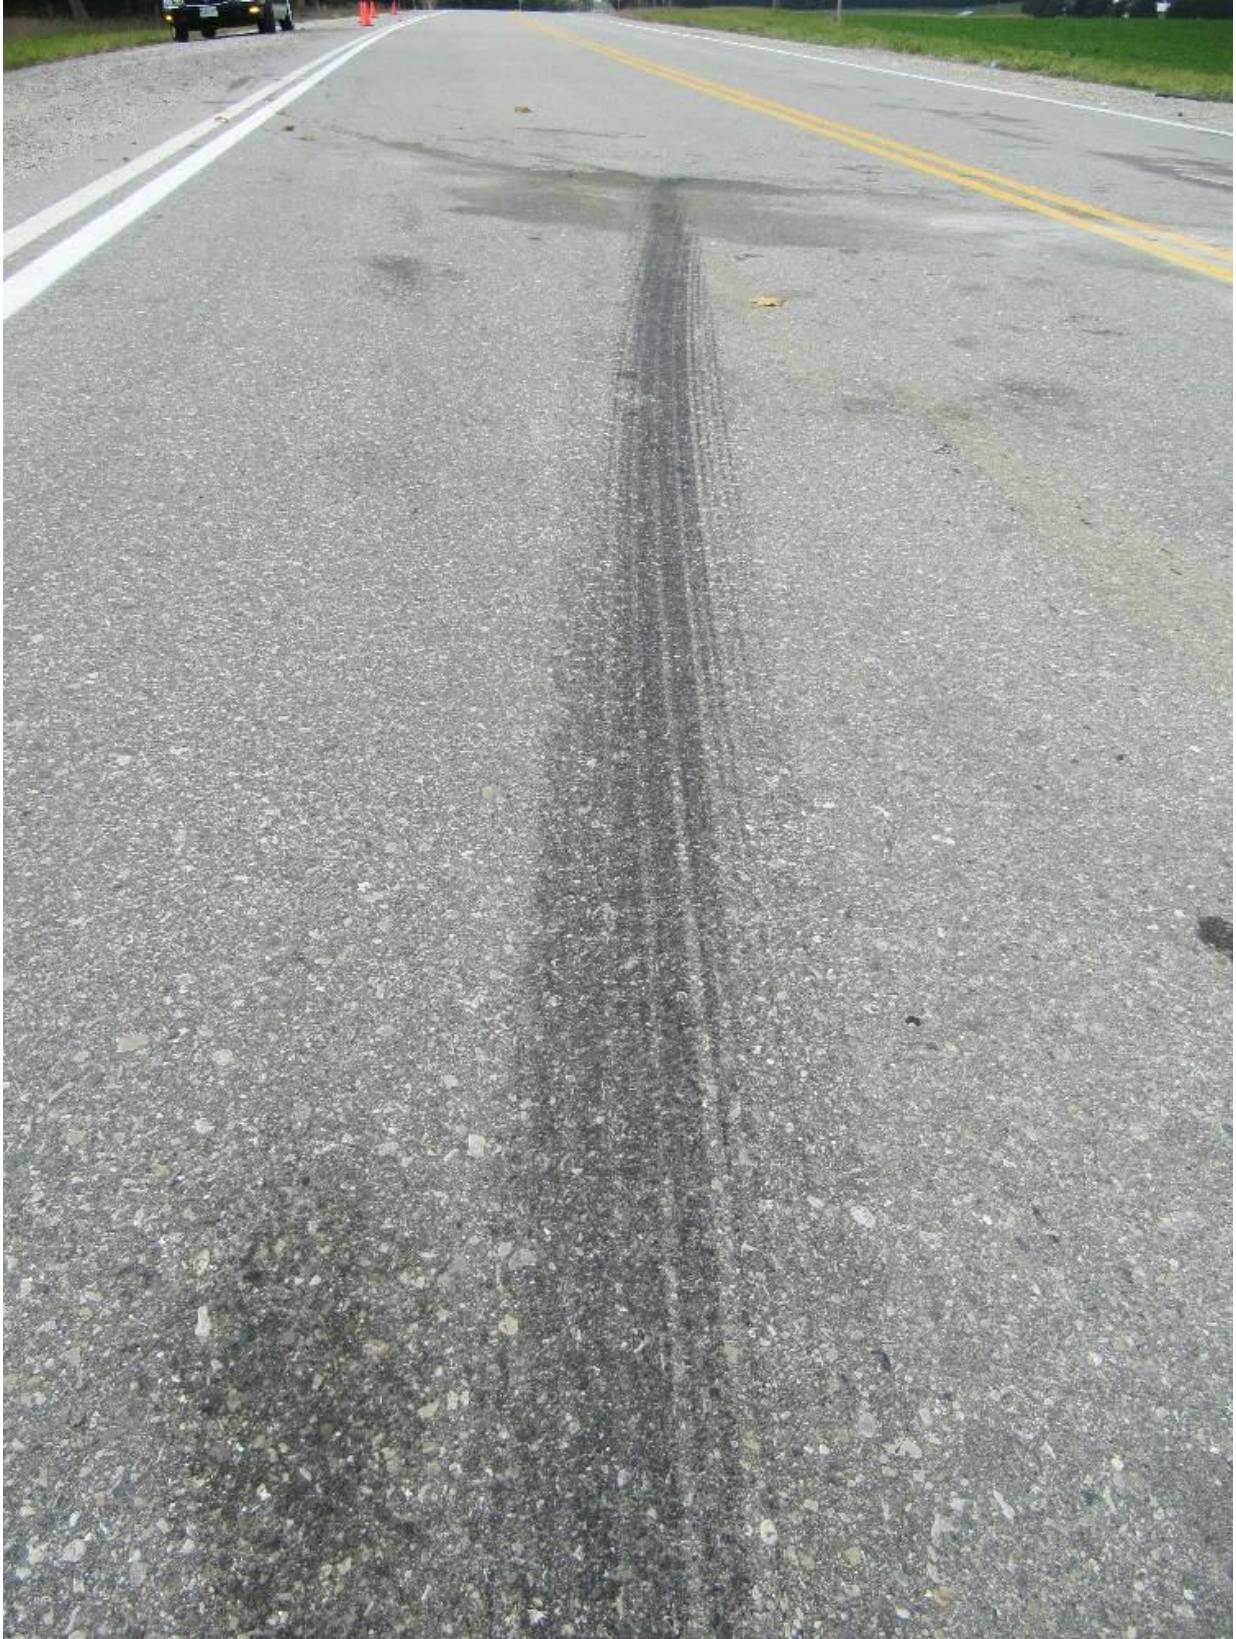
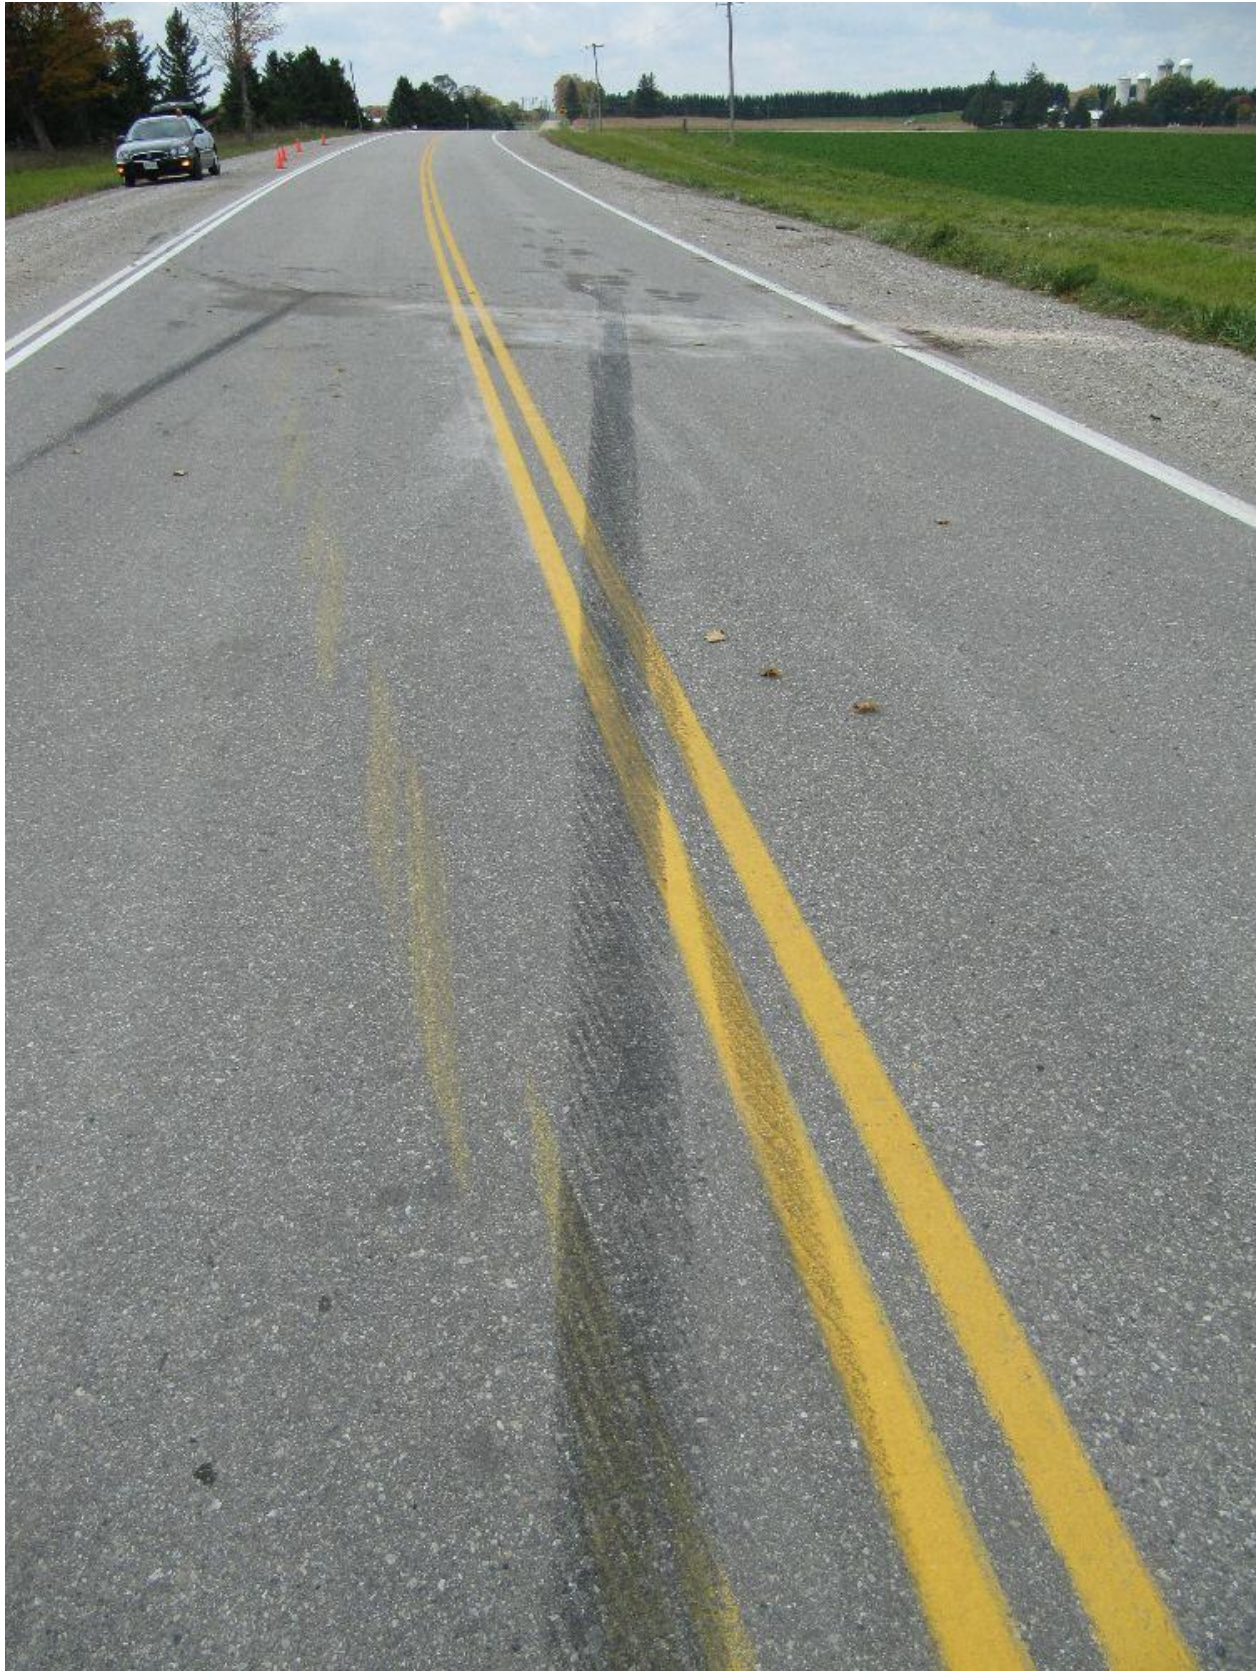
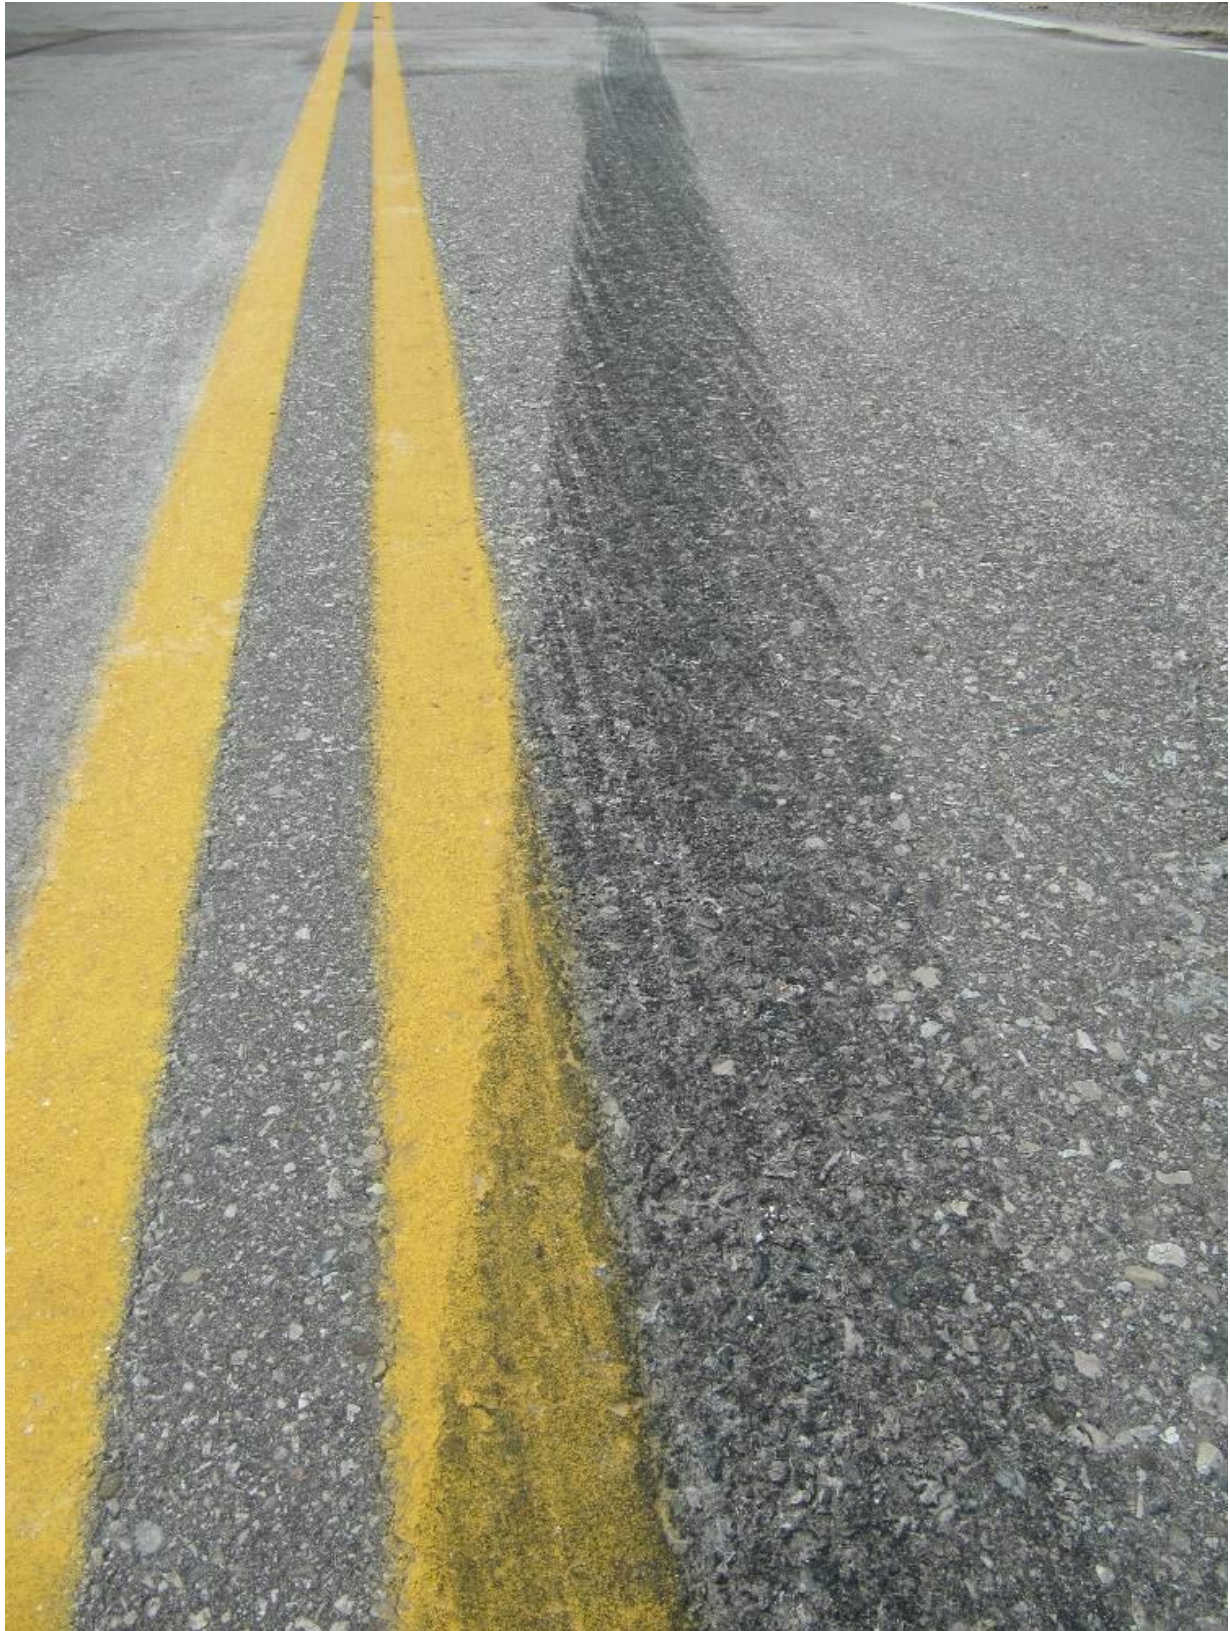
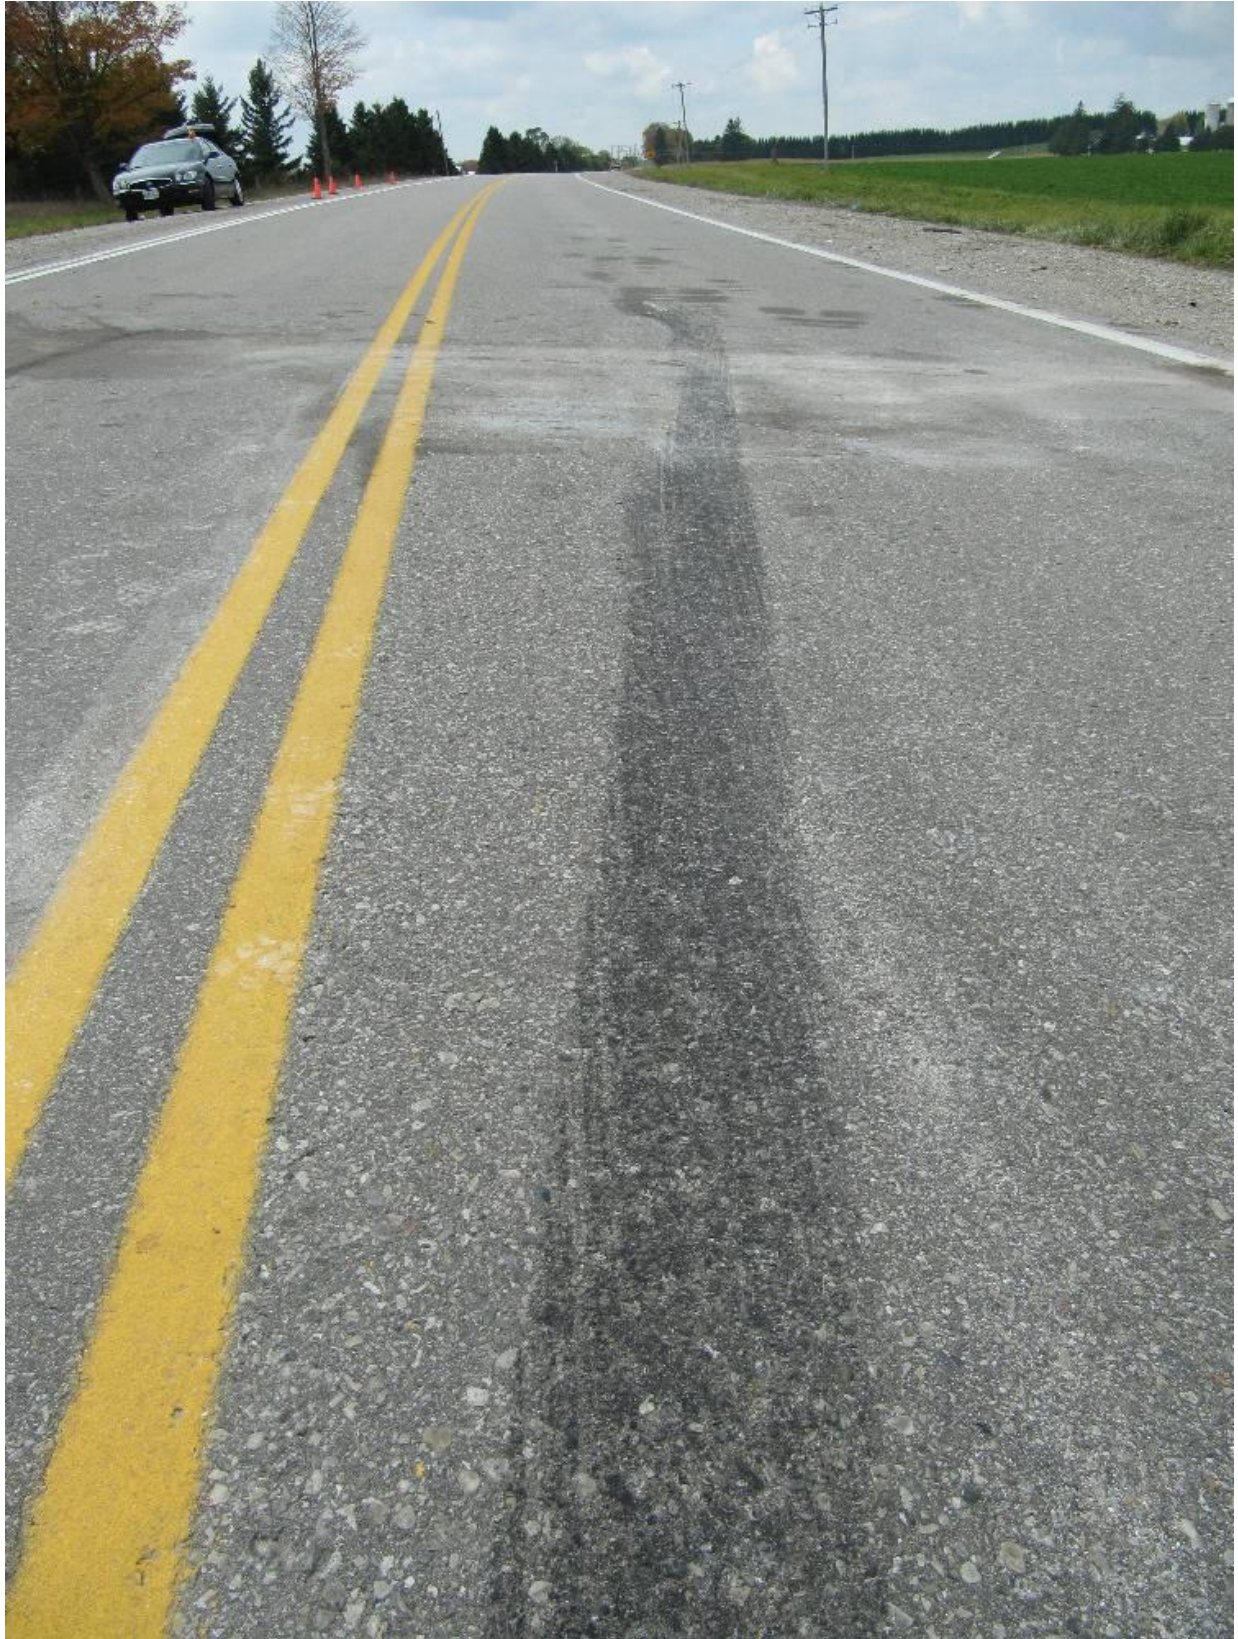
If the theory held true then, if we examined the tire mark caused by the left front tire then it too would show evidence of the striations running parallel to the length of that tire mark. We can see the characteristics of that left front tire mark on Page 9 through 11. These three photos follow the left front tire mark as it approaches the area of impact. Clearly, the striations are already at a substantial angle in the photo on Page 9 and they become essentially parallel to the length of the tire mark in the photo on Page 11. Since the tire marks caused by both of the left side tires show the same pattern it would suggest that Mr. Bader was applying his brakes as his vehicle was on the wrong side of the road and that the brake application was probably near maximum just before impact.

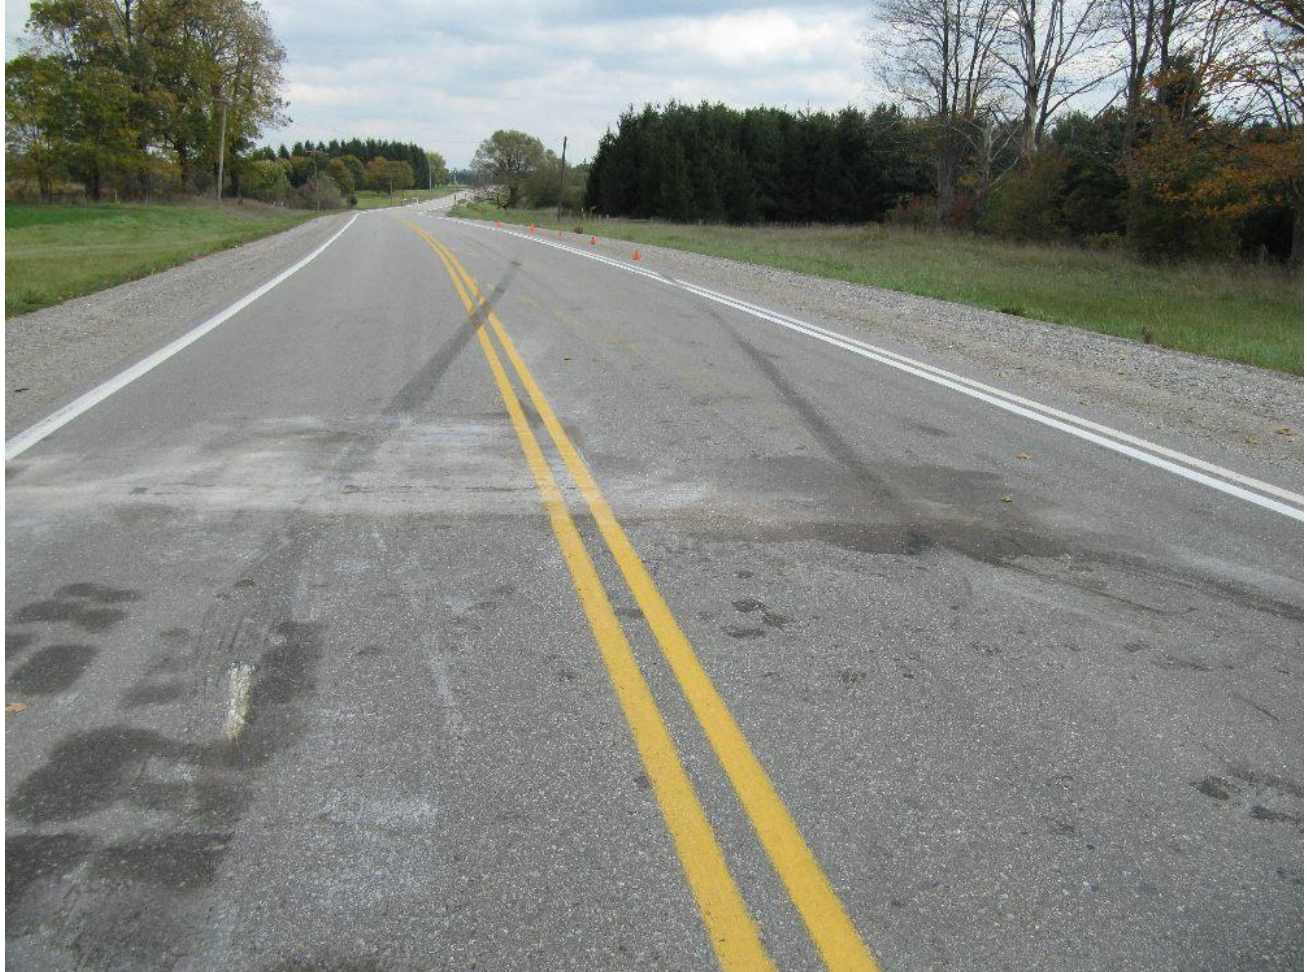
The photo below is a view, looking east, from just west of the area of impact and it is possible to see the two dark tire marks caused by the two left side tires of the SUV as it slid sideways. It is also possible to see the curve of the road in the background which was shown from the opposite direction in the earlier photos.

The evidence in the above photo is quite typical of what you might expect at the area of impact of two vehicles approaching each other from opposite directions. There will be gouges created in the pavement where one of the vehicles, or both, make contact with the pavement. One gouge is quite visible and it is located at the end of the tire mark caused by the left front tire of the SUV. This gouge is visible in the bottom left corner of the above photo.

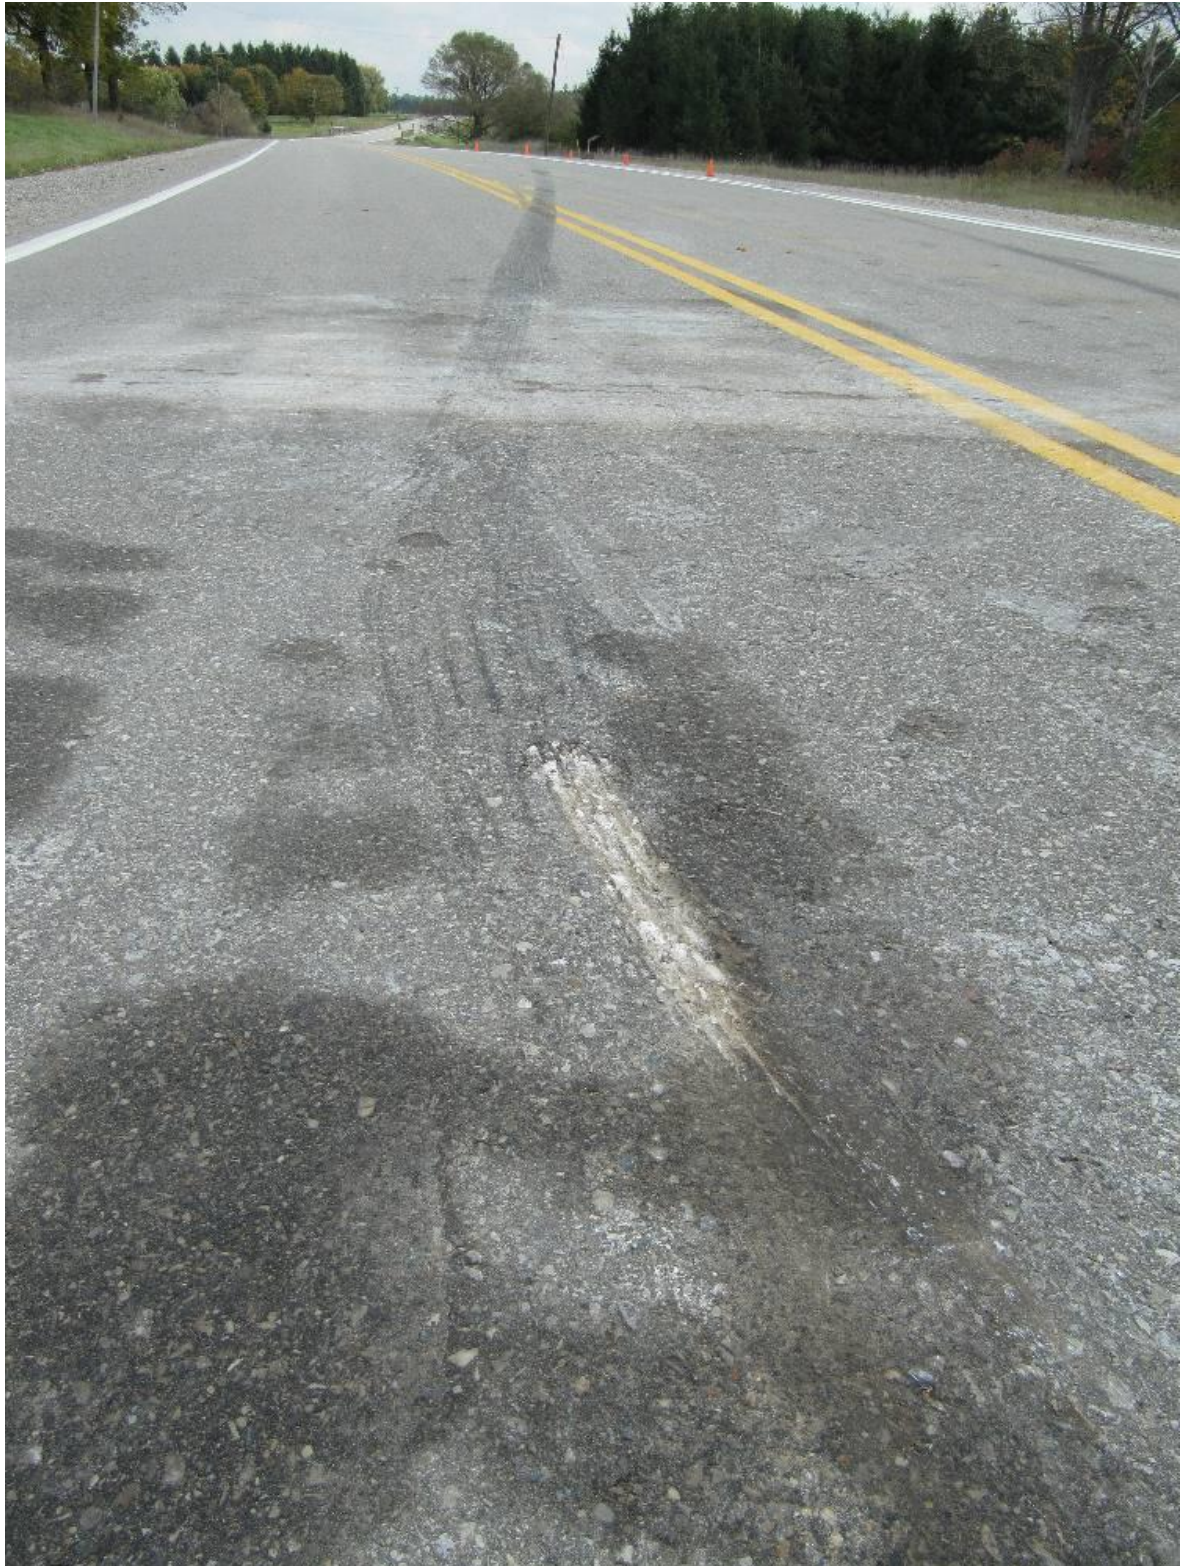
Its characteristics are more visible in the closer view of the gouge shown on Page 13. Note how the angle of the tire mark changes as the impact occurs and then, as further deformation occurs at the left front wheel, the gouge is likely caused by the rim of the left front wheel.
