Loss-Of-Control SUV Crash Results in Fatal Injuries to Ingersoll Man - A Review of Evidence at the Accident Site

Posting Date: 10-Oct 2012

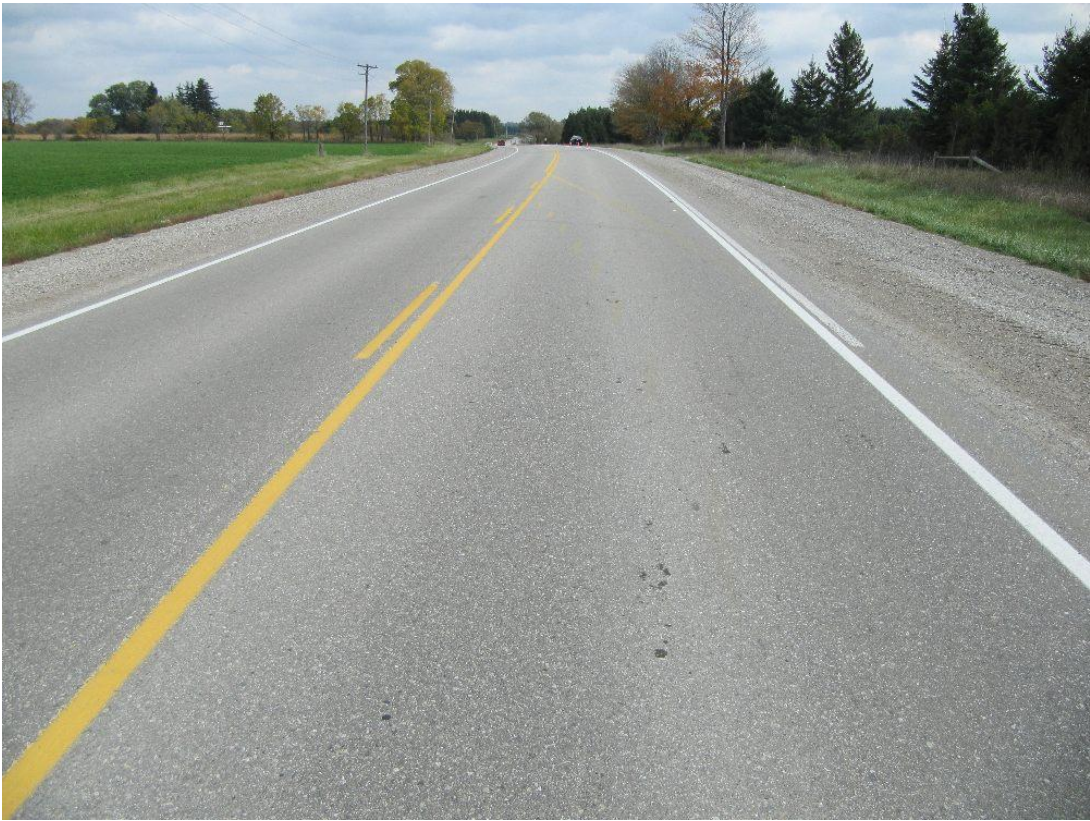
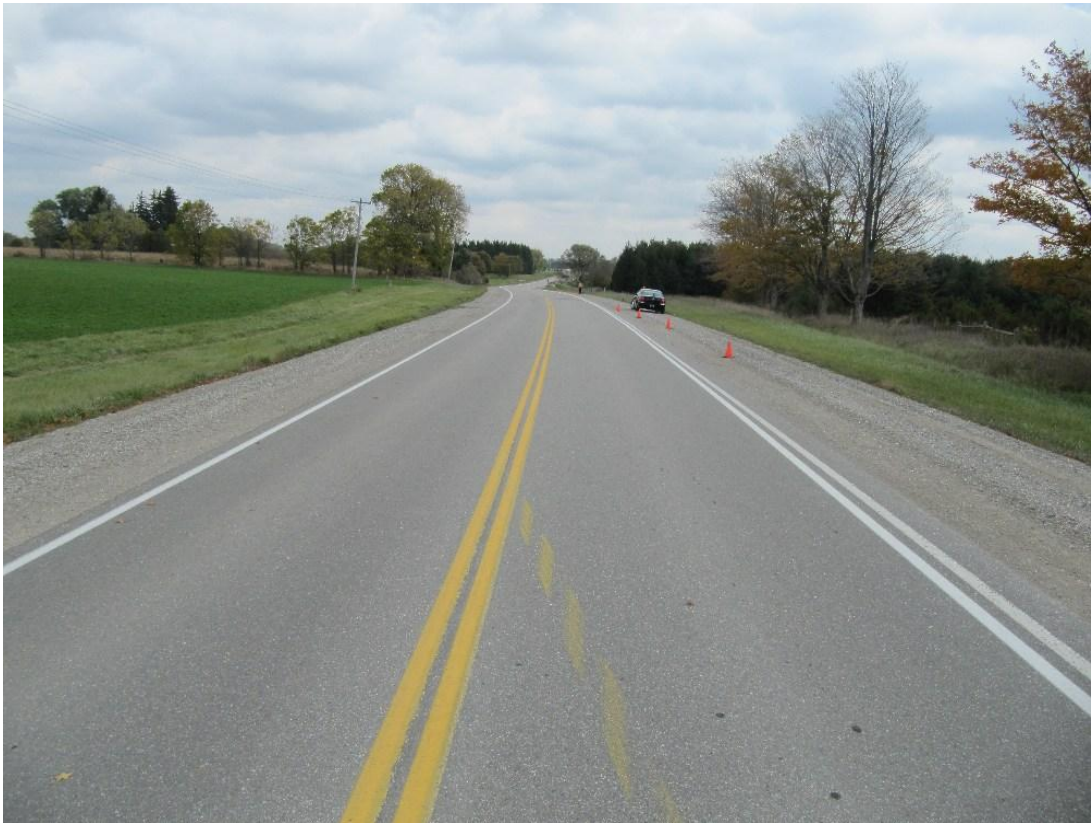
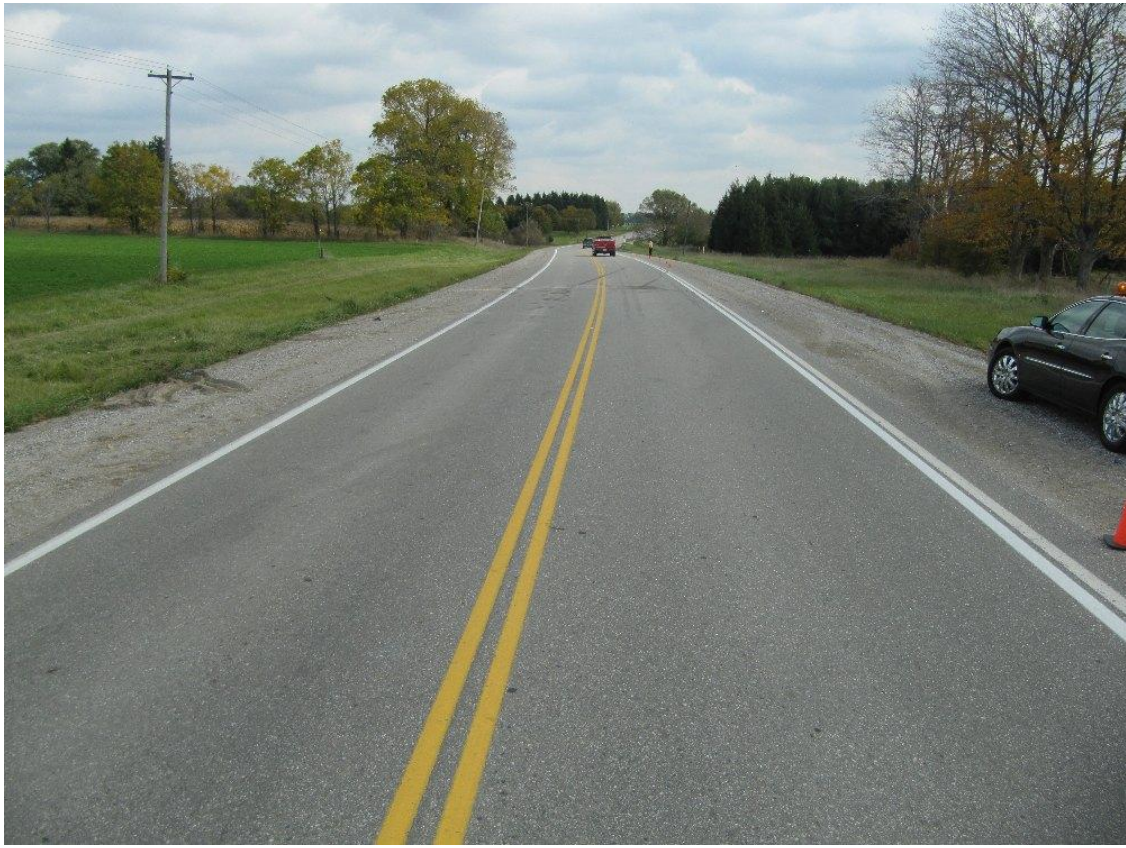
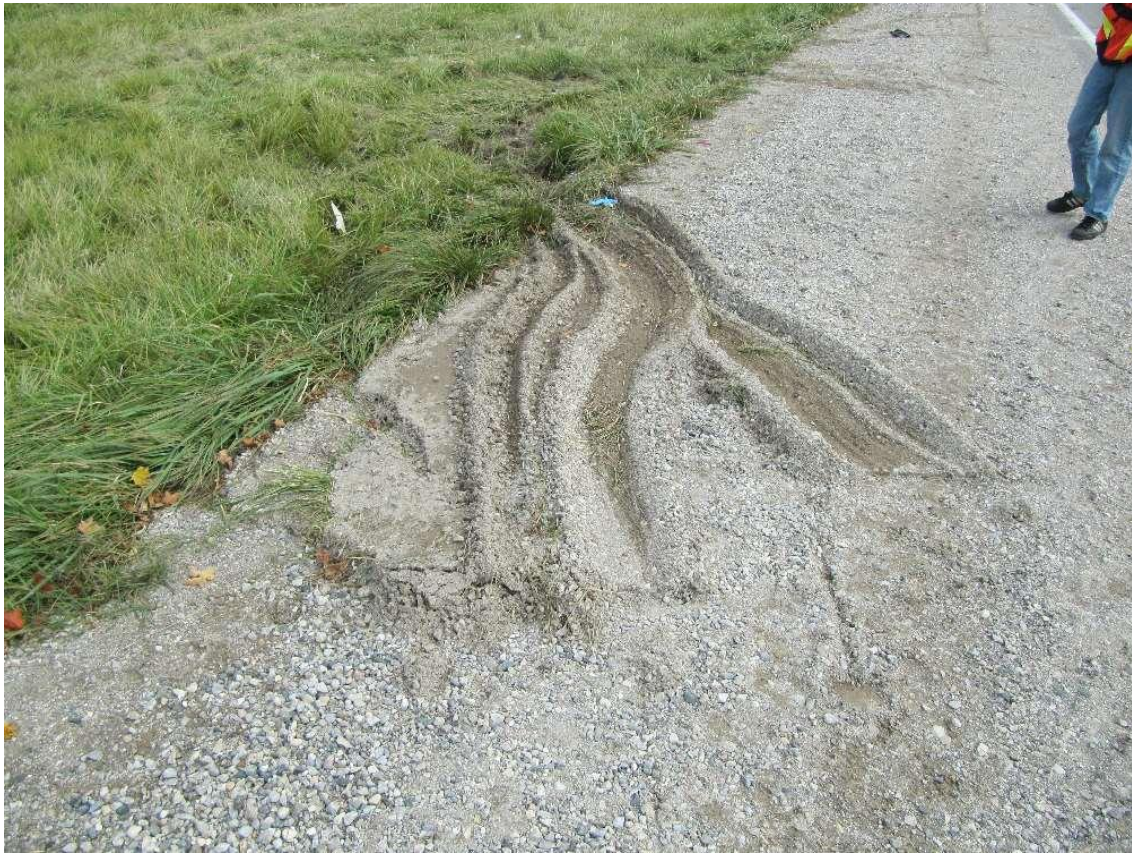
Let us step back westward and examine what the eastbound driver of the minivan might have been able to see in the few seconds of approach toward the impact. The photo at the top of Page 15 shows an eastbound view, looking along Road 88, from several hundred metres west of the area of impact. You might be able to detect the position of our parked vehicle on the south (right) shoulder of the road in the distant background. The 500 metres of this road leading eastward from the intersection with Oxford County Road 6 is straight and relatively level. It is not until the last 100 or so metres prior to the impact the road begins a slight curve to the left.

The gradual nature of that curve is exemplified in the bottom photo of Page 15 which brings us further eastward and closer to the area of impact. One can judge the closer distance by noting how our parked car has come much closer into view.

The photo at the top of Page 16 is almost adjacent to the parked position of our car and now you might begin to distinguish those tire marks and stains in the middle of the road, in the background, where the two vehicles collided. Looking at the left (north) shoulder of the road, across from the parked position of our car, you might see some disturbance in the shoulder and this was caused by the towing personnel as they removed the SUV which came to rest in the north ditch. This disturbance is more clearly visible in the bottom photo of Page 16.

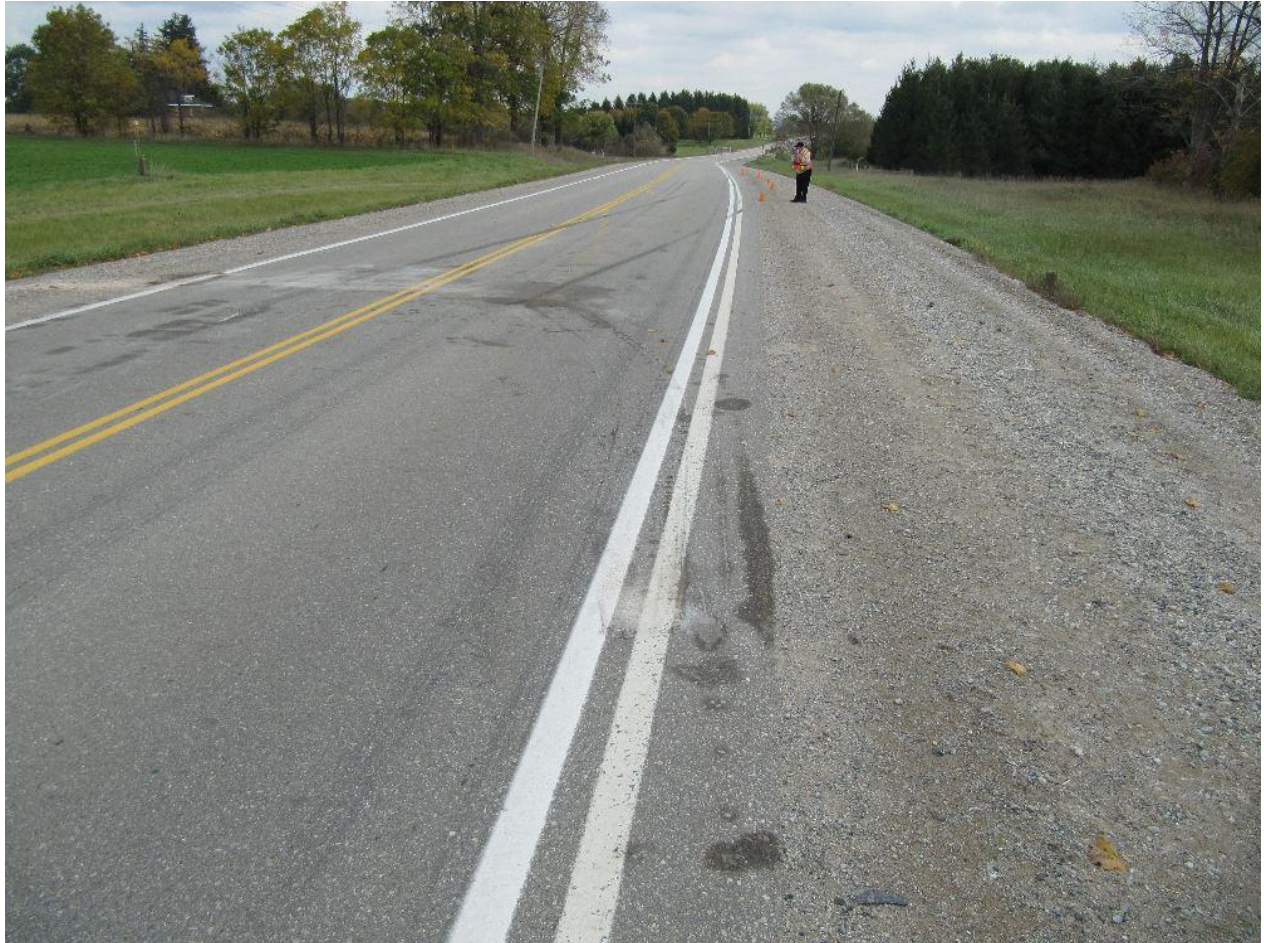
The photo below is a view looking eastward from the south road edge and the area of impact is located approximately in the middle of the view. In the foreground you should see some stains and a trail of markings coming toward the camera and stopping near the south road edge. These markings were likely deposited by the minivan but it is not clear to us that they were created during the impact. This is so because there is a large area of fluid staining at the area of impact and such staining is typically caused at the final rest position of a vehicle that has sustained front end damage. It would also be atypical for the eastbound minivan to be pushed so far backwards as this would suggest that the speed of the SUV at impact was much greater than the speed of the minivan.

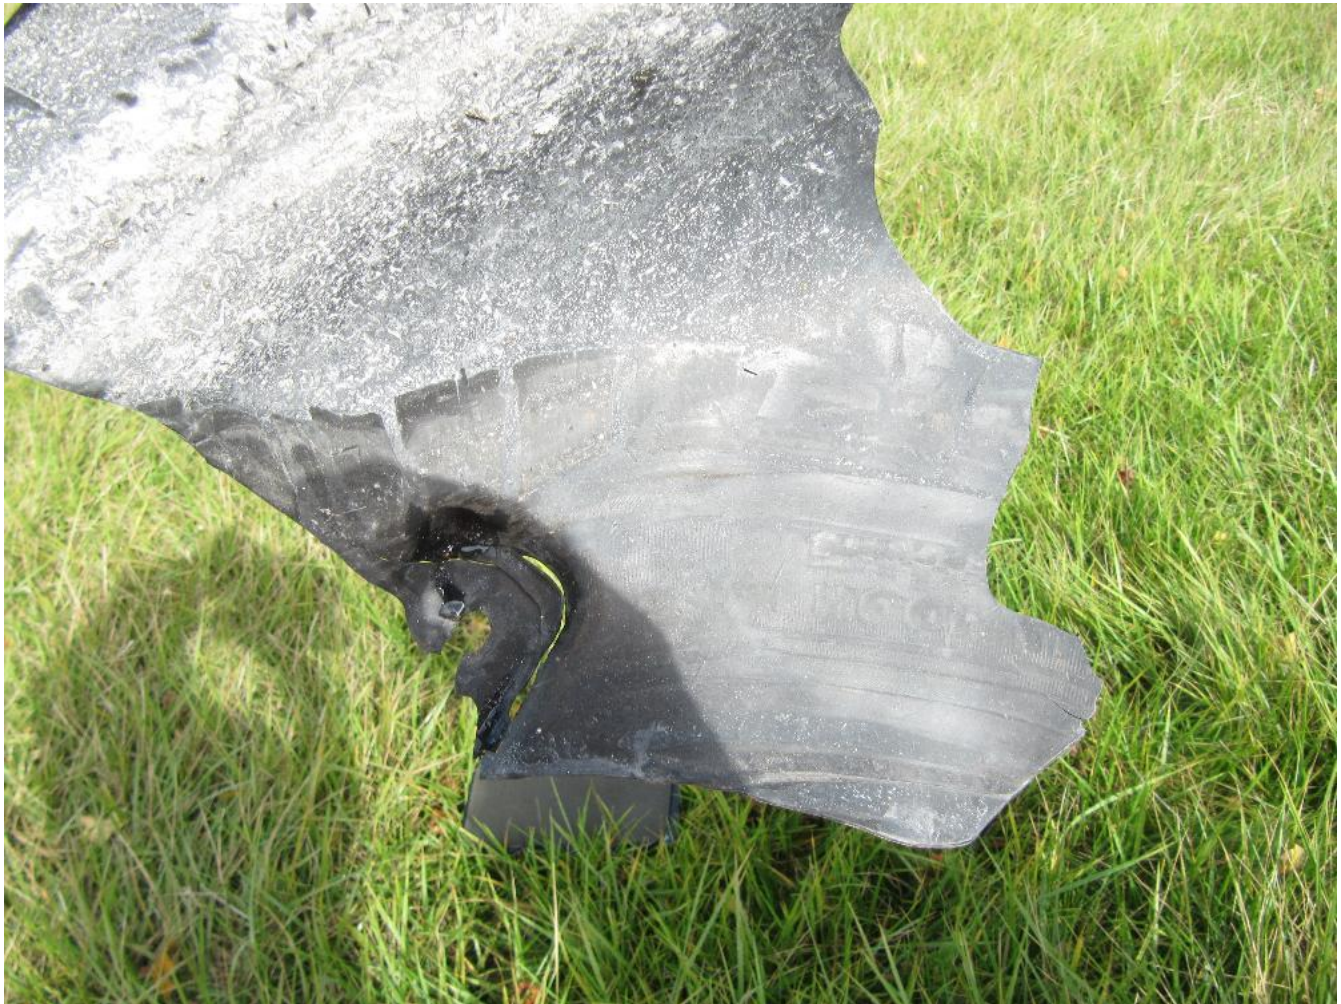
For example, earlier in this article we discussed the striations in the SUV's yaw mark and described research that suggested the driver of the SUV might have been braking at the time of impact. While that conclusion remains open, there is debris at the site that could help provide further information on that issue. The photo below shows a piece of wheel-well liner that came from one of the colliding vehicles. If you look closely at the bottom of that liner you should see an imprint of the sidewall and tread of a tire.

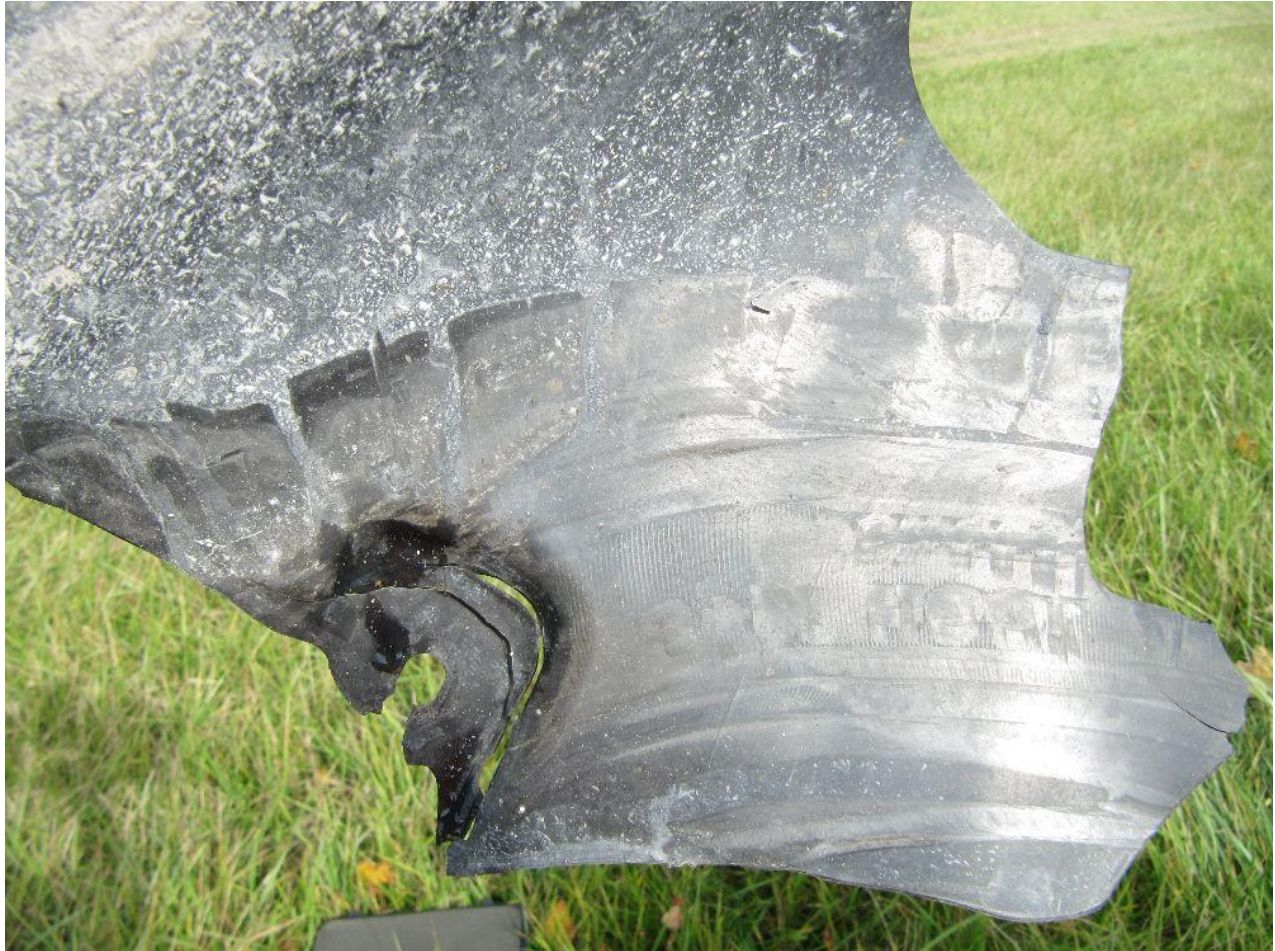
The photo at the top of Page 19 provides another view of that imprint. This evidence indicates that the tire was pushed sideways against this liner. There are distinct outlines of the individual tread blocks of the tire and you might even be able to read some of the labels from the tire. Such well-defined markings occur when a tire is not rotating, or rotating very slowly at the time of impact. A rotating tire would cause smudged, circular scuffs on the liner. So this evidence suggests that one of the vehicles' tires was not rotating at impact. But which vehicle?

Well, based on probability, the minivan might sustain front damage where the impact force would generally be from the front rearwards and this type of force would not cause its tire to be pressed against the wheel well. However we see clear evidence that the SUV was sliding sideways at the time of impact and we also saw a gouge at the end

of the tire mark caused by the left front tire that would suggest that this wheel sustained a substantial impact resulting in the wheel rim making contact with the ground. Such a force at the left front wheel would be expected to push the left front tire against its sidewall. So it is quite possible that this liner came from the left front tire of the SUV and that it supports the yaw mark evidence that the driver of the SUV might have been braking at the time of impact.

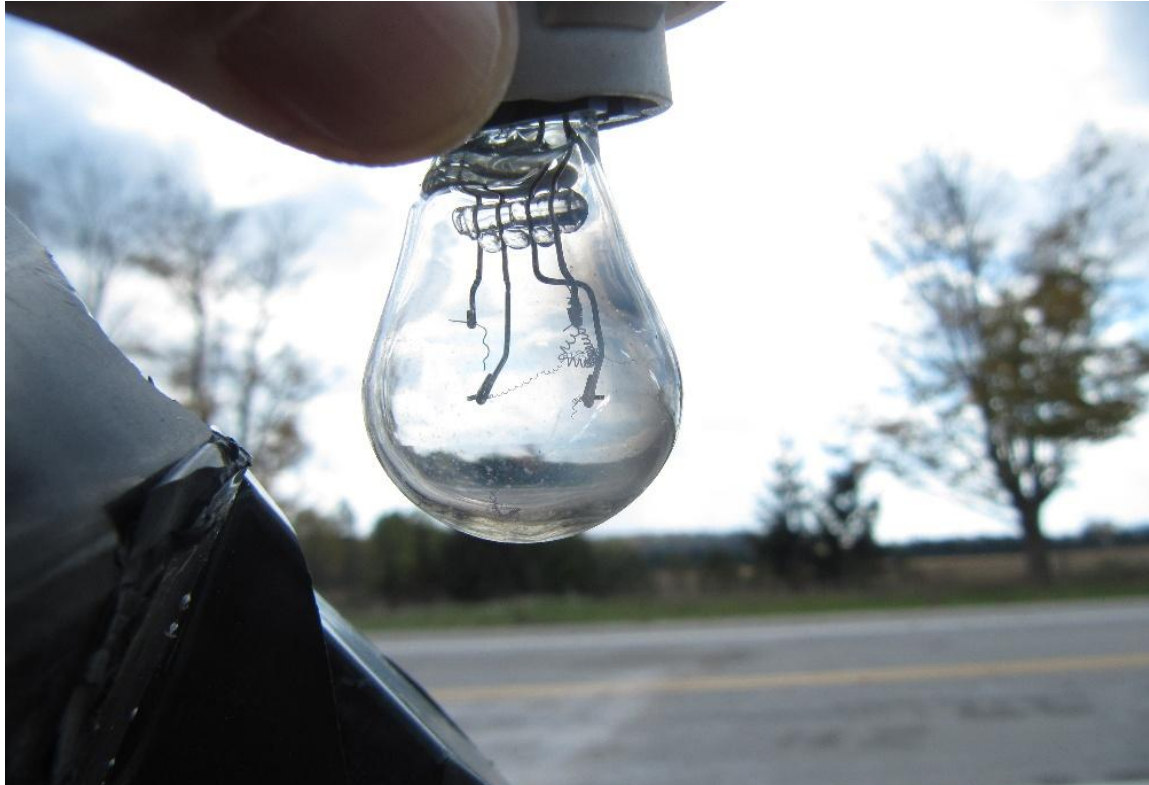
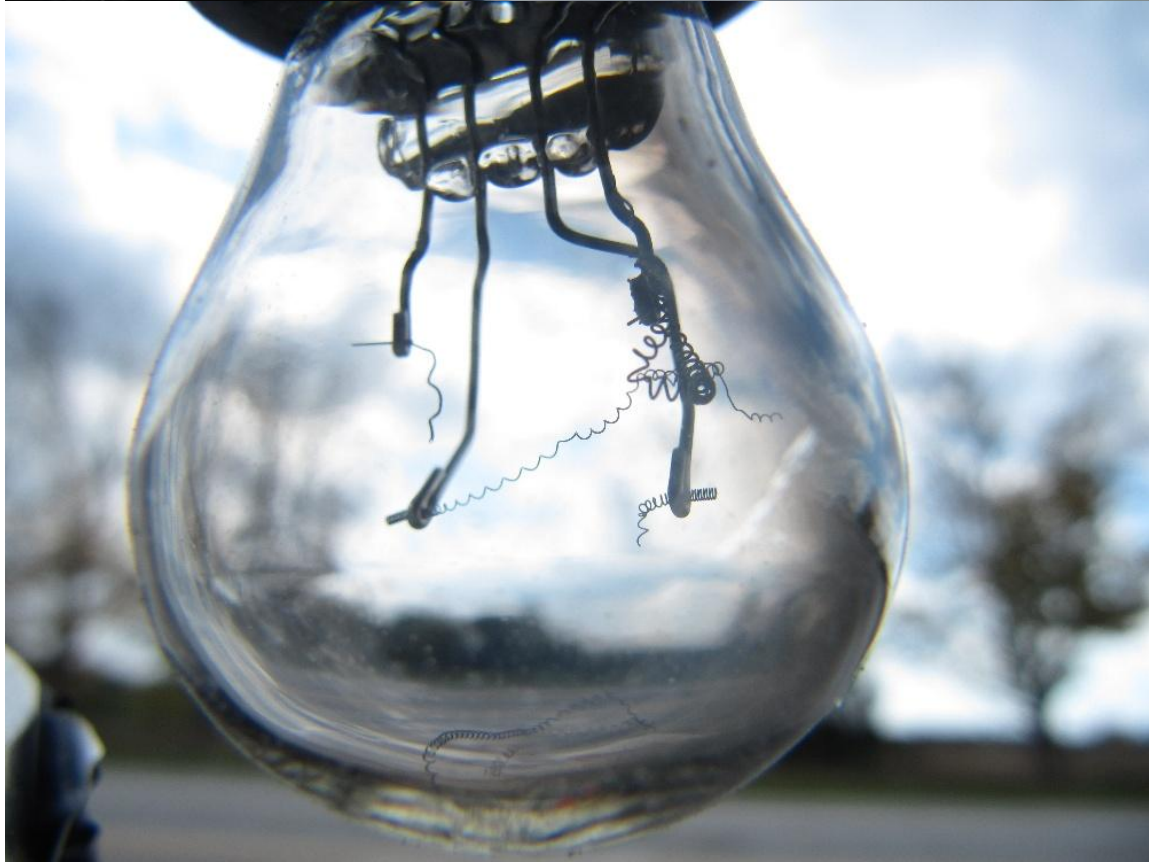
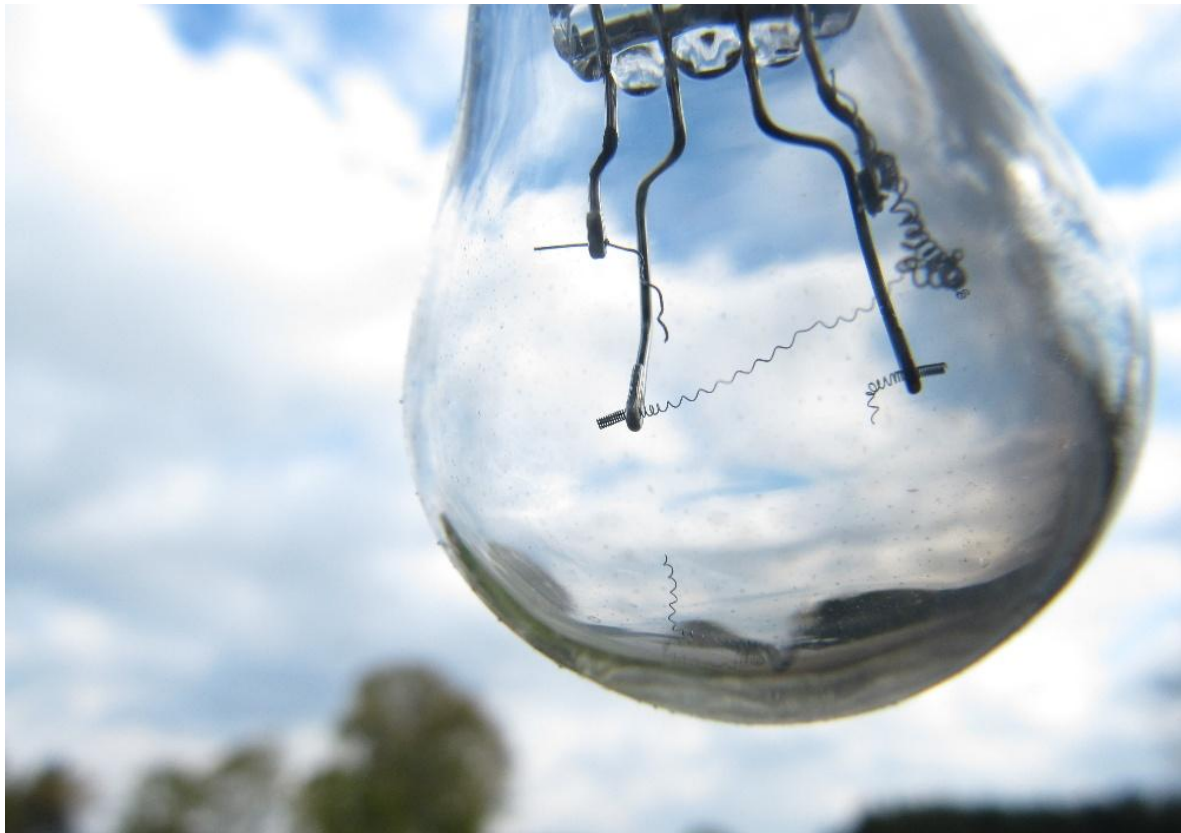
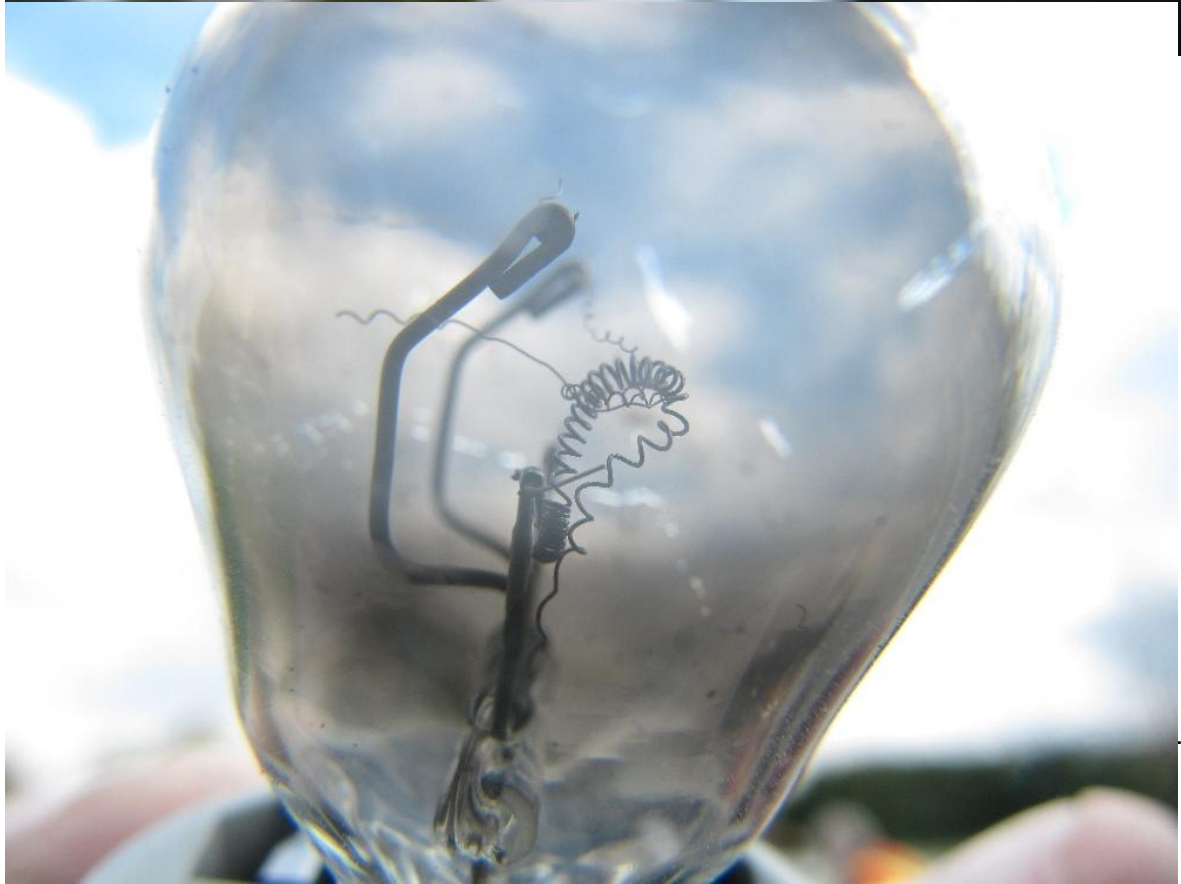
There is further evidence found in the debris at the site that indicates one of the vehicles was braking at the time of impact. In the photos on Pages 20 and 21 we can see a taillight bulb that we removed from a housing that was lying on the ground. Recall that the tungsten filaments of these bulbs will stretch when illuminated and this is a classical way of determining whether a brake, signal or headlight was on at the time of a crash. The current bulb contains two posts for each filament which is stretched across the post. You should see that there are two shorter posts which contain the thicker filament of the brake light and two taller posts that contain the thinner filament of a signal/ident light. By looking at the various views of the filaments you should come to the conclusion that both filaments exhibit "hot shock" deformation and therefore both were illuminated at the time of the crash. So, which vehicle did this filament come from. Again, we have to examine the probabilities.

Generally, filaments do not stretch like this unless they are located close to the area of impact. So we would expect that there was substantial contact to the left rear corner of the SUV. But if we already determined that there must have been major contact to the left front wheel then that suggests that there was a broad area of damage across the left side of the SUV. We say this because a typical SUV might be about 5 metres long depending on its actual size, and the rearward distance from the front bumper to the front wheel hub would likely be somewhere in the range of 1 metre. Thus direct damage would need to occur over a width of about 4 metres of the left side of the SUV. But if the minivan is likely less than 2 metres wide then we need to explain how 4 metres of damage could exist along the SUV when the van is only 2 metres wide.

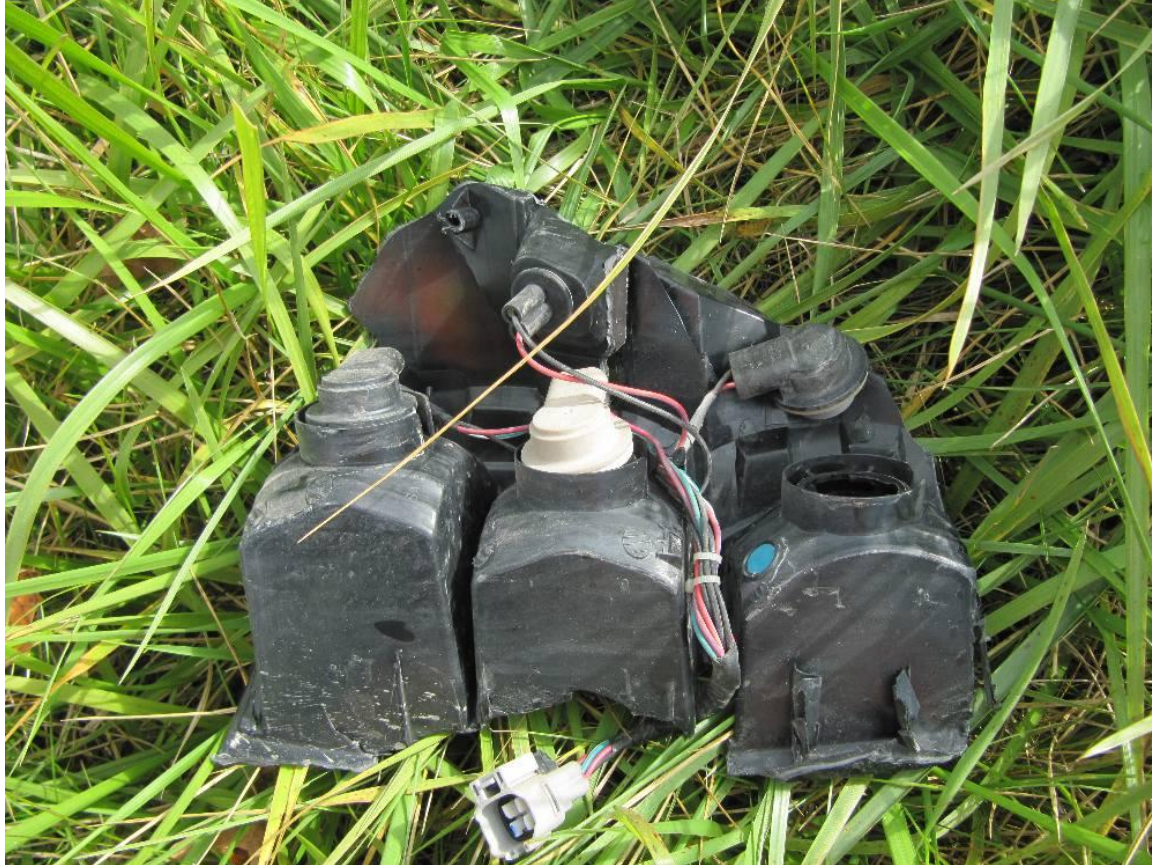
The photo below shows the tail-light housing as it was found lying in the grass.

The probability is low that it came from the minivan because we would expect the major damage on that vehicle to be located at the front end. It is more likely that the housing came from the left rear of the SUV because that vehicle was sliding sideways and leading with its left side as it approached the impact.

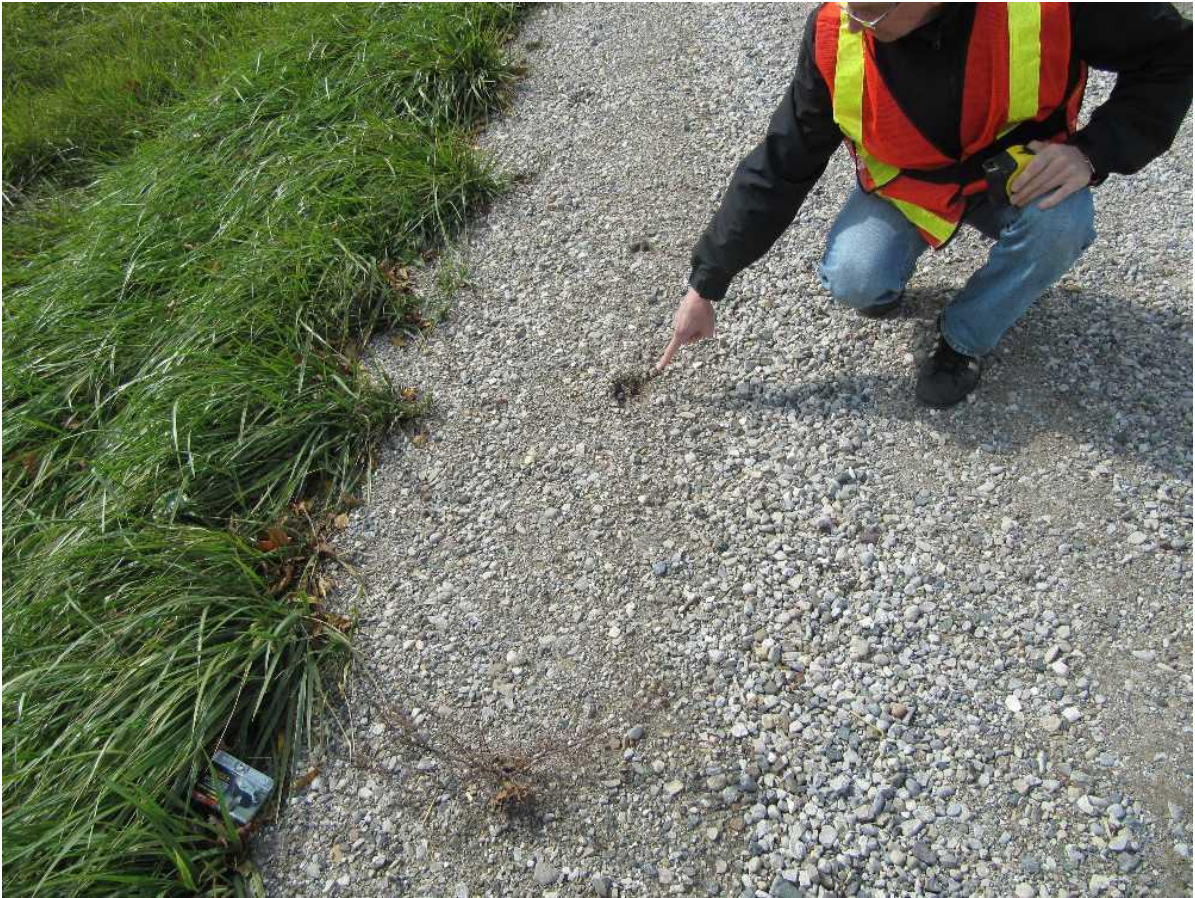
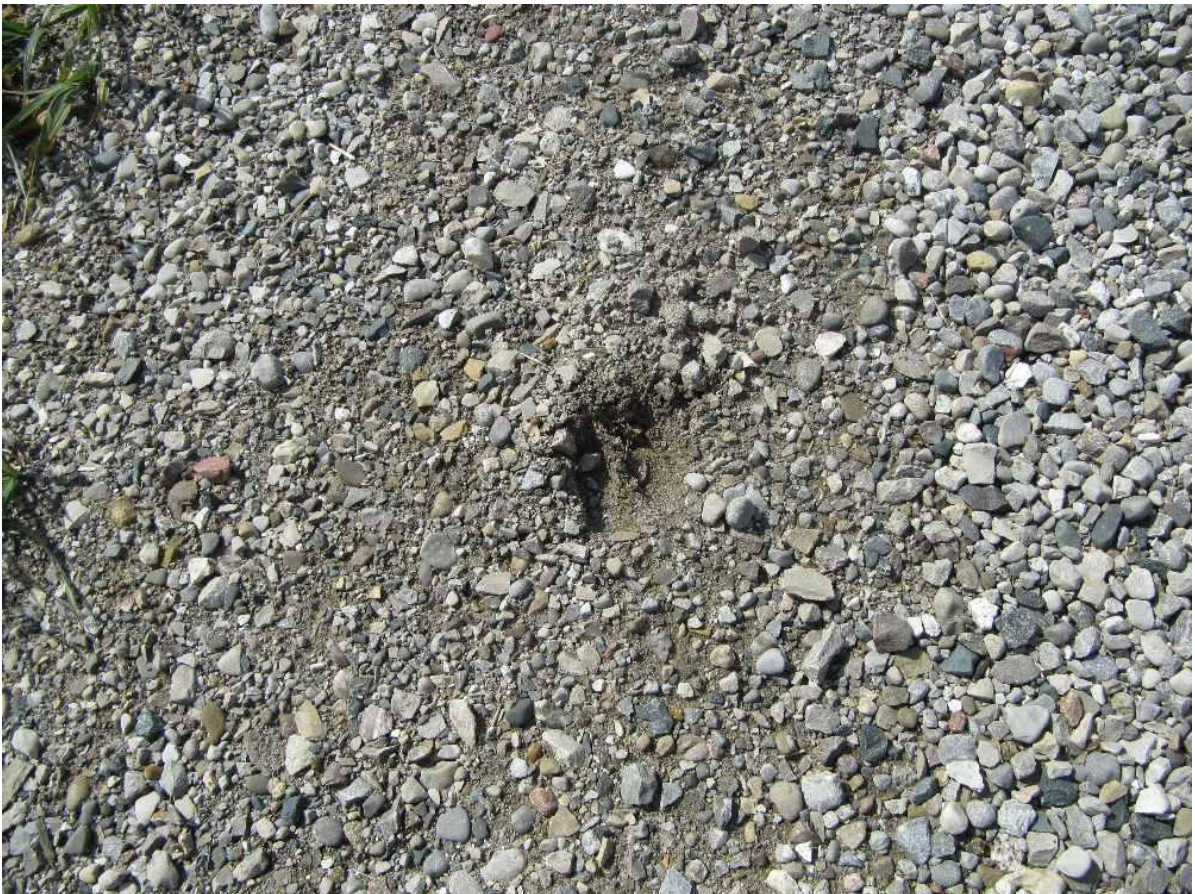
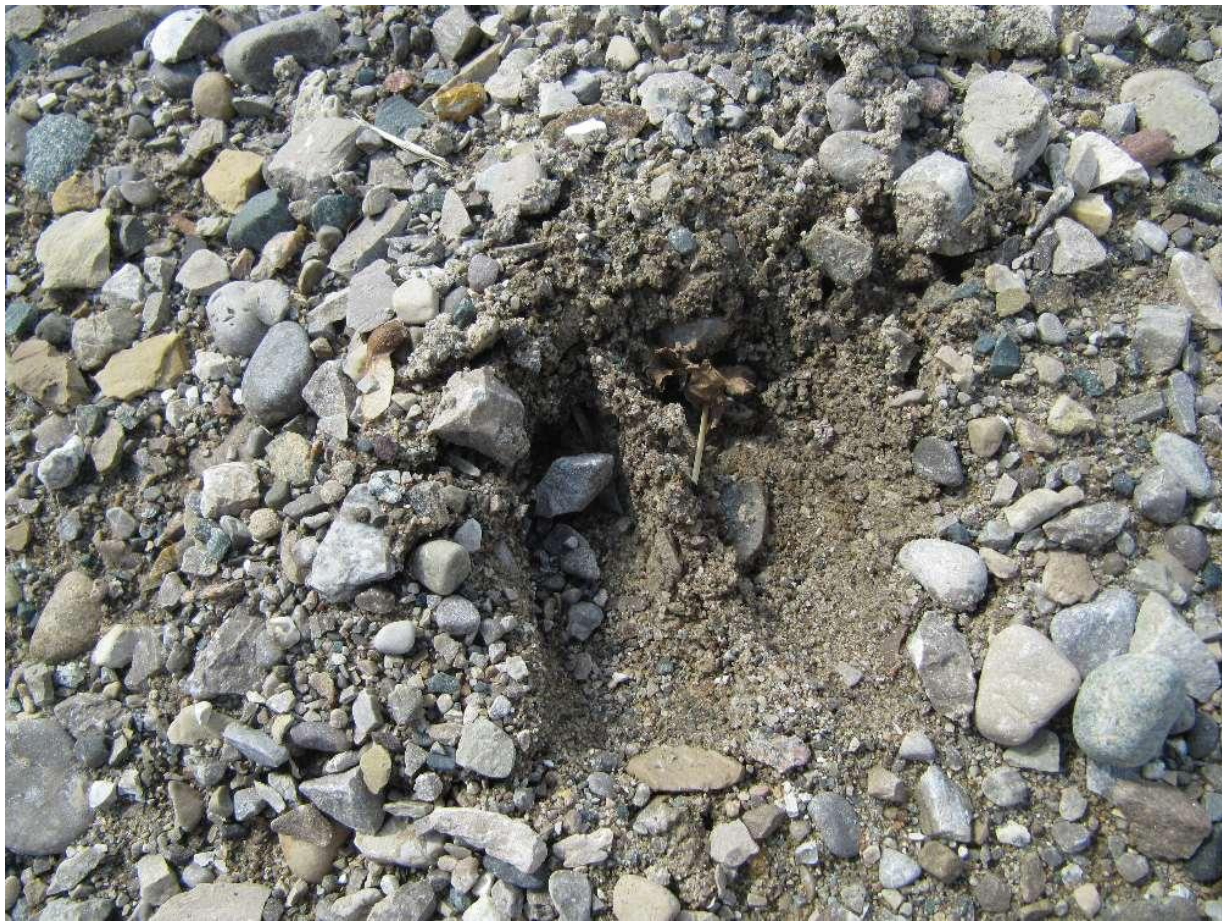
Well, we did a search of the roadsides in the area where the vehicle travelled onto the north shoulder and we came across a discovery in the gravel shoulder as shown in the photos on Page 23. The final photo on Page 24 provides a close up of one of the many fresh imprints in the gravel shoulder.

As you might suspect these imprints are hoof prints caused by deer and they are quite fresh. We had arrived at this accident site at about 1140 hours on October 9th and the collision reportedly occurred at about 2030 hours on the evening of October 8th. So approximately 15 hours had passed since the accident. Since police reconstructionists were likely present because this was a fatal accident they would undoubtedly wait until the sunrise of the morning of October 9th so they could get a good look at all the evidence in daylight. Thus they would likely have not opened the road to the public very much earlier than our arrival. Thus the opportunity for deer to be walking along the shoulder in the 15 hours after the collision is not great.

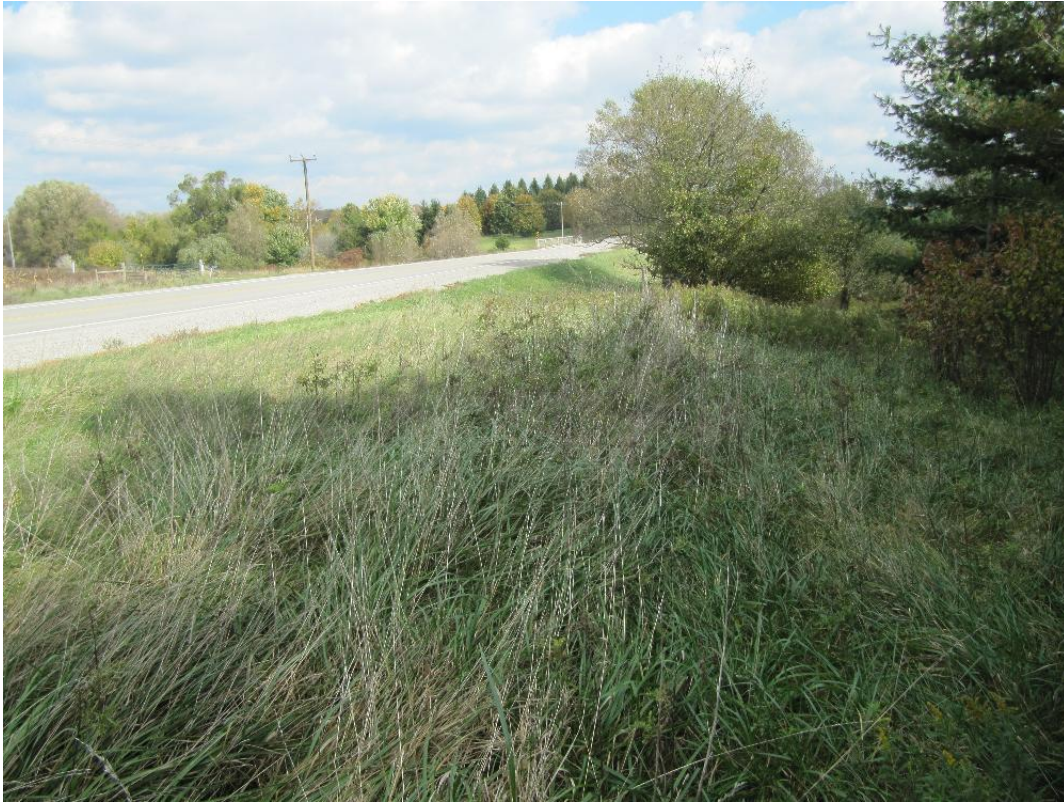
In the photo on Page 26 we show the view that a deer might have made if it had been standing on the south side of the road, near the line of trees and looking toward the east from which the SUV emerged. That view is well blocked by the trees such that the bridge is not even visible from this location. If we consider that the SUV was travelling very quickly it would be a considerable distance away to the east when a deer might decide to venture toward the road. So there is some reason to consider this possibility as a factor.
