# Minor Injuries to Pedestrian Lead to Death - Questions About the Official Investigation

*Posting Date: Nov 4-2015*

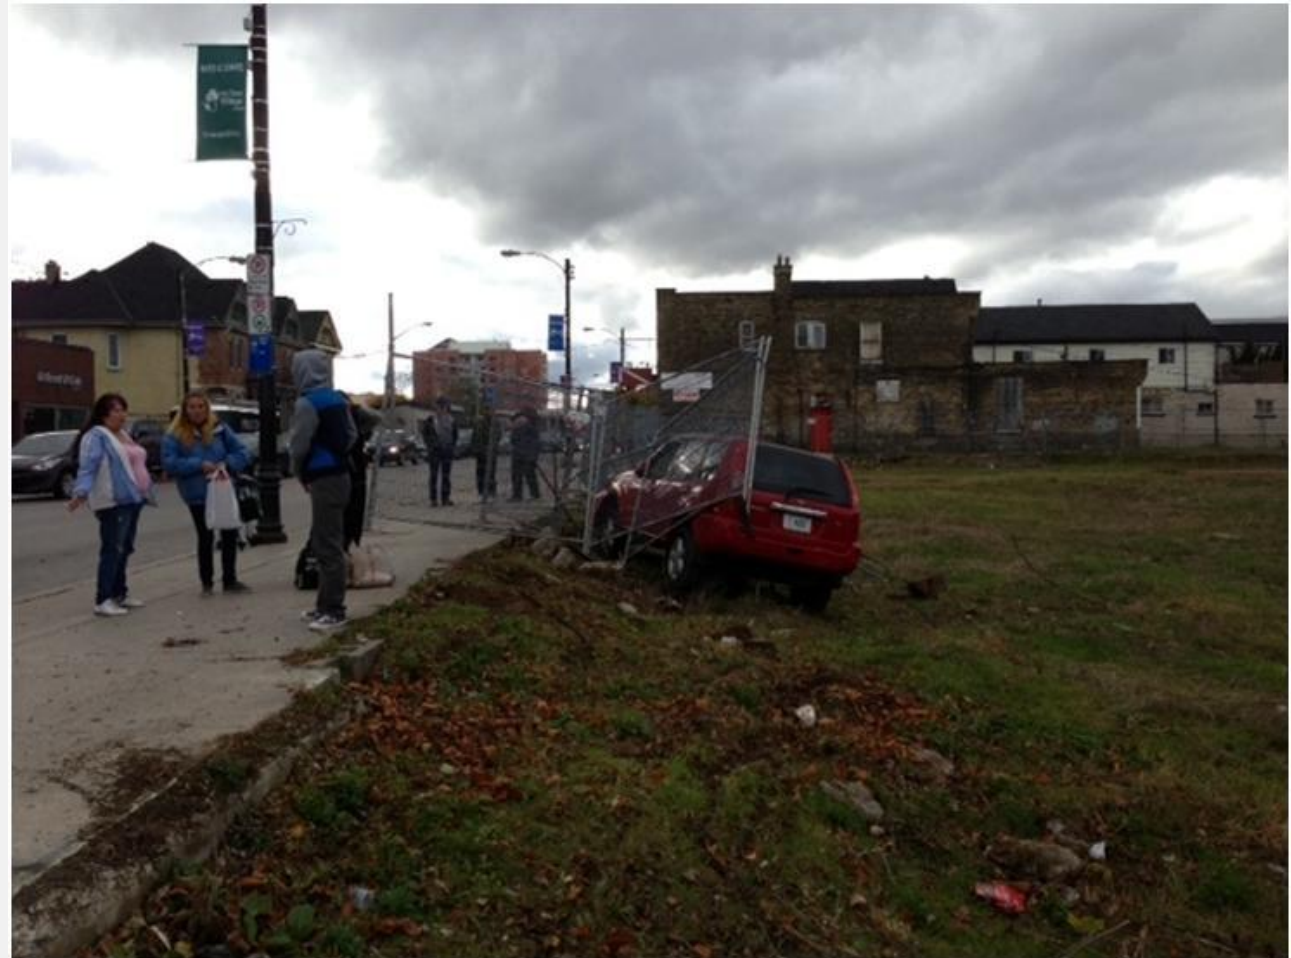
**Figure 1: It was reported that this SUV struck two pedestrians before driving into a metal fence on Dundas Street west of English Street in east London, Ontario, on October 30, 2015. One of those pedestrians later died.**

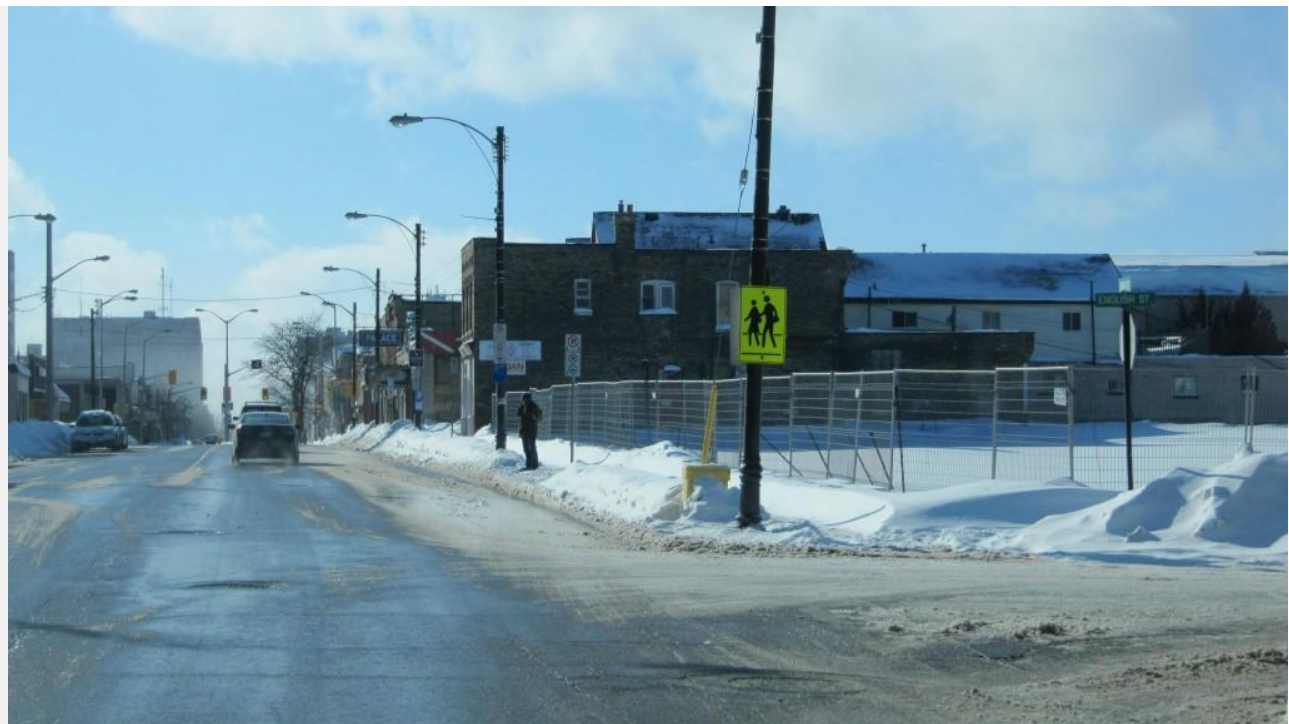
Figure 2: View, looking north-west at the accident site on February 14, 2015.

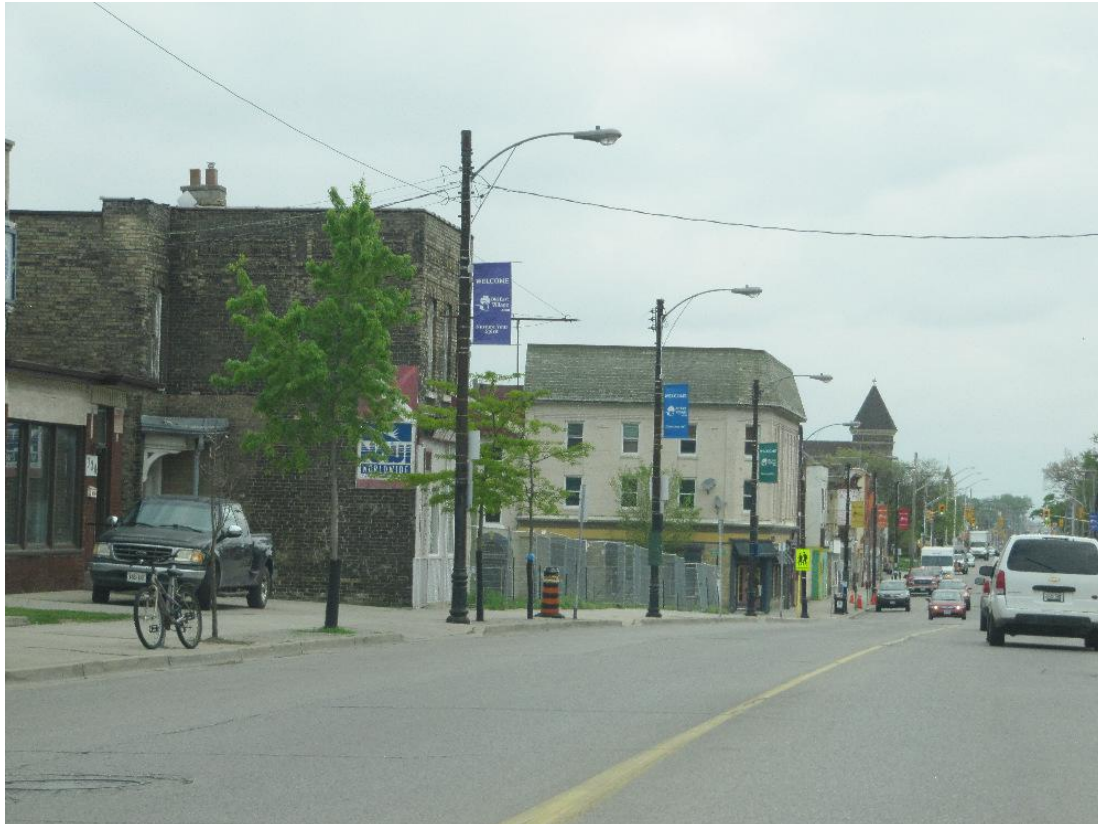
Figure 3: View, looking east, toward the accident site on May 13, 2015.

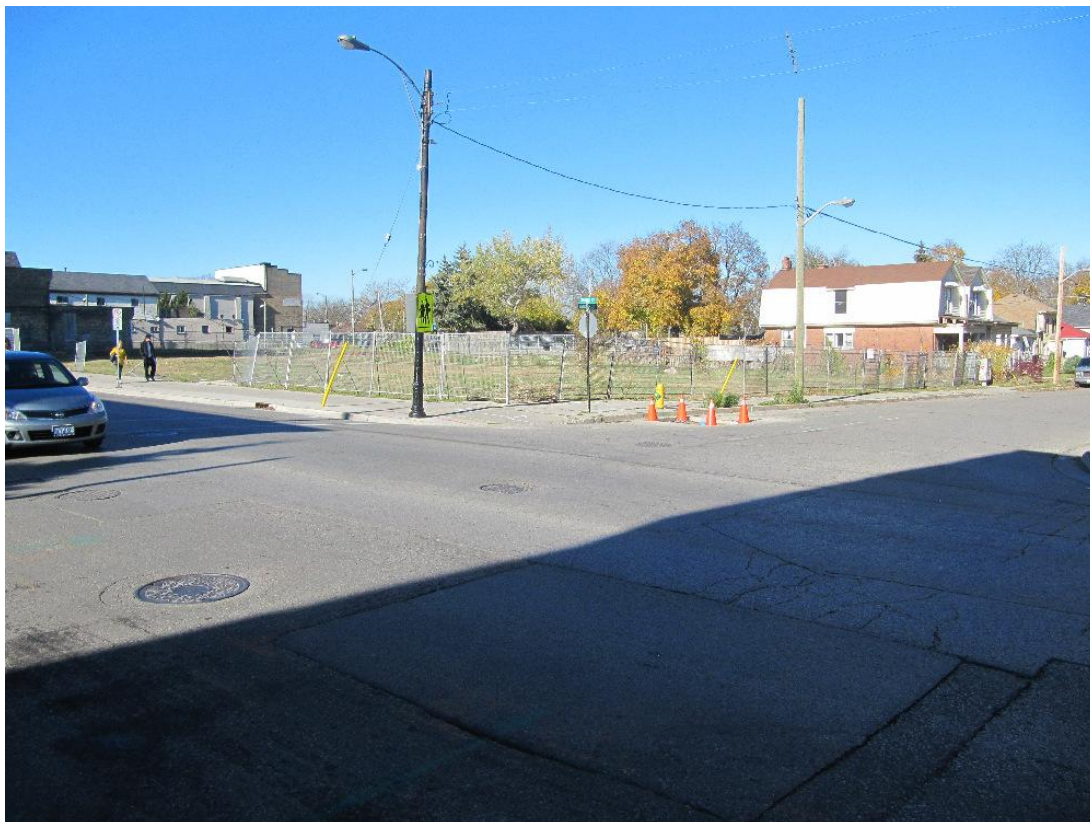
Figure 4: View, looking north-east, at the accident site on November 4, 2015.

The photo in Figure 4 was taken on November 4, 2015, or just a few days after the collision. In Figure 4 one can see a hole in the metal fence where the SUV struck it. It can also be seen that there are some traffic cones at the intersection with English Street and the pavement has been removed in a small rectangle.

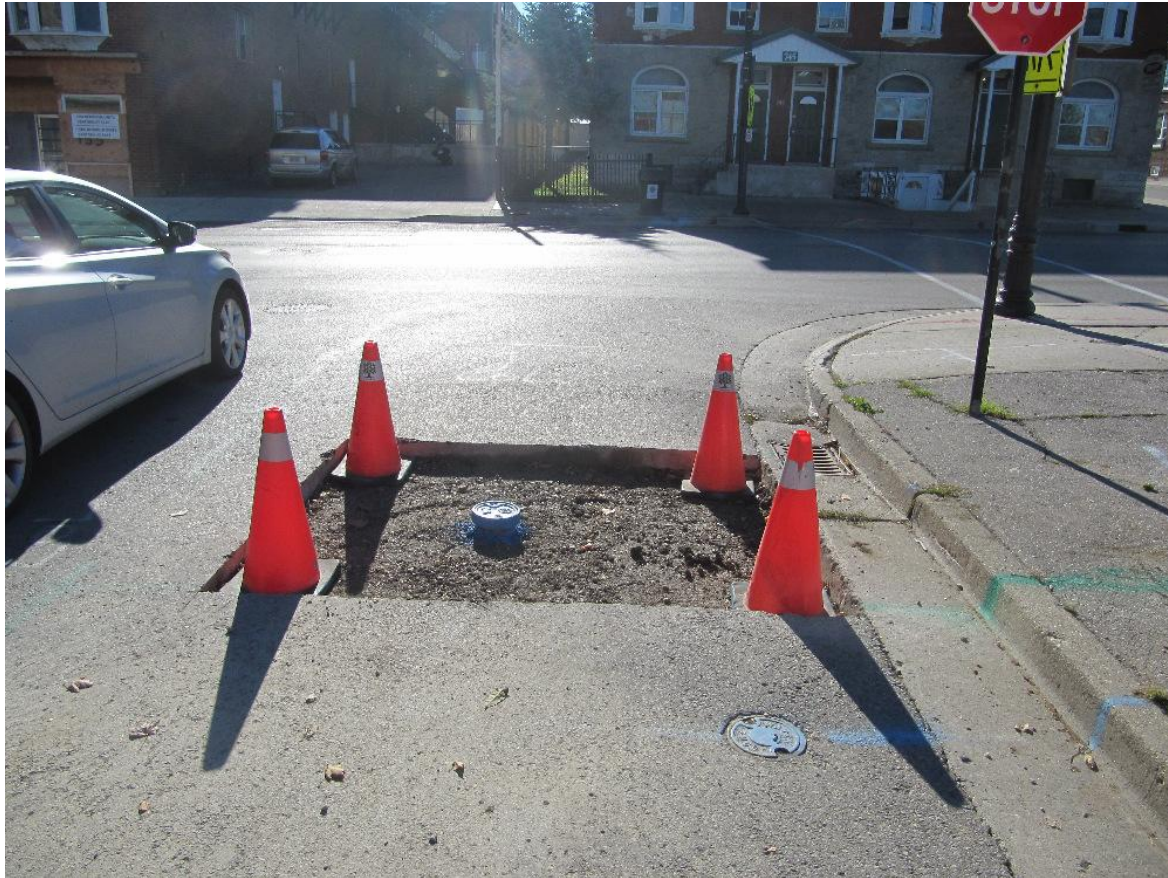
Figure 5: View, looking south, from English Street toward the construction hole in the pavement at Dundas Street.

The photo in Figure 5 above shows a closer view of the construction hole in the pavement on English Street at its intersection with Dundas. It is not known if this hole was present at the time of the collision. However, the collision reportedly occurred at about 1500 hours on Friday, October 30, 2015. It is possible that the pavement was removed in the late afternoon of Friday while the police investigation would have been ongoing but that is highly unlikely.

The other possibility is that the pavement hole was created on either Monday or Tuesday, November 2 or 3, and this is a more likely possibility. However we simply do not know as nothing was reported in the news media about it and there were no photos taken by the news media that showed that area of the site. So this fact remains a mystery.

If this construction hole existed at the time of the collision then the SUV would travel along a similar path to the white car shown at the left edge of Figure 5. So the SUV would stop at this location and then make a right turn where it would commence to go out of control.

If the construction hole was present then we would have to ask whether there were construction vehicles or other equipment near the hole and whether that could be relevant to the collision events. Obviously no one has mentioned anything about this in the official reporting of the incident.

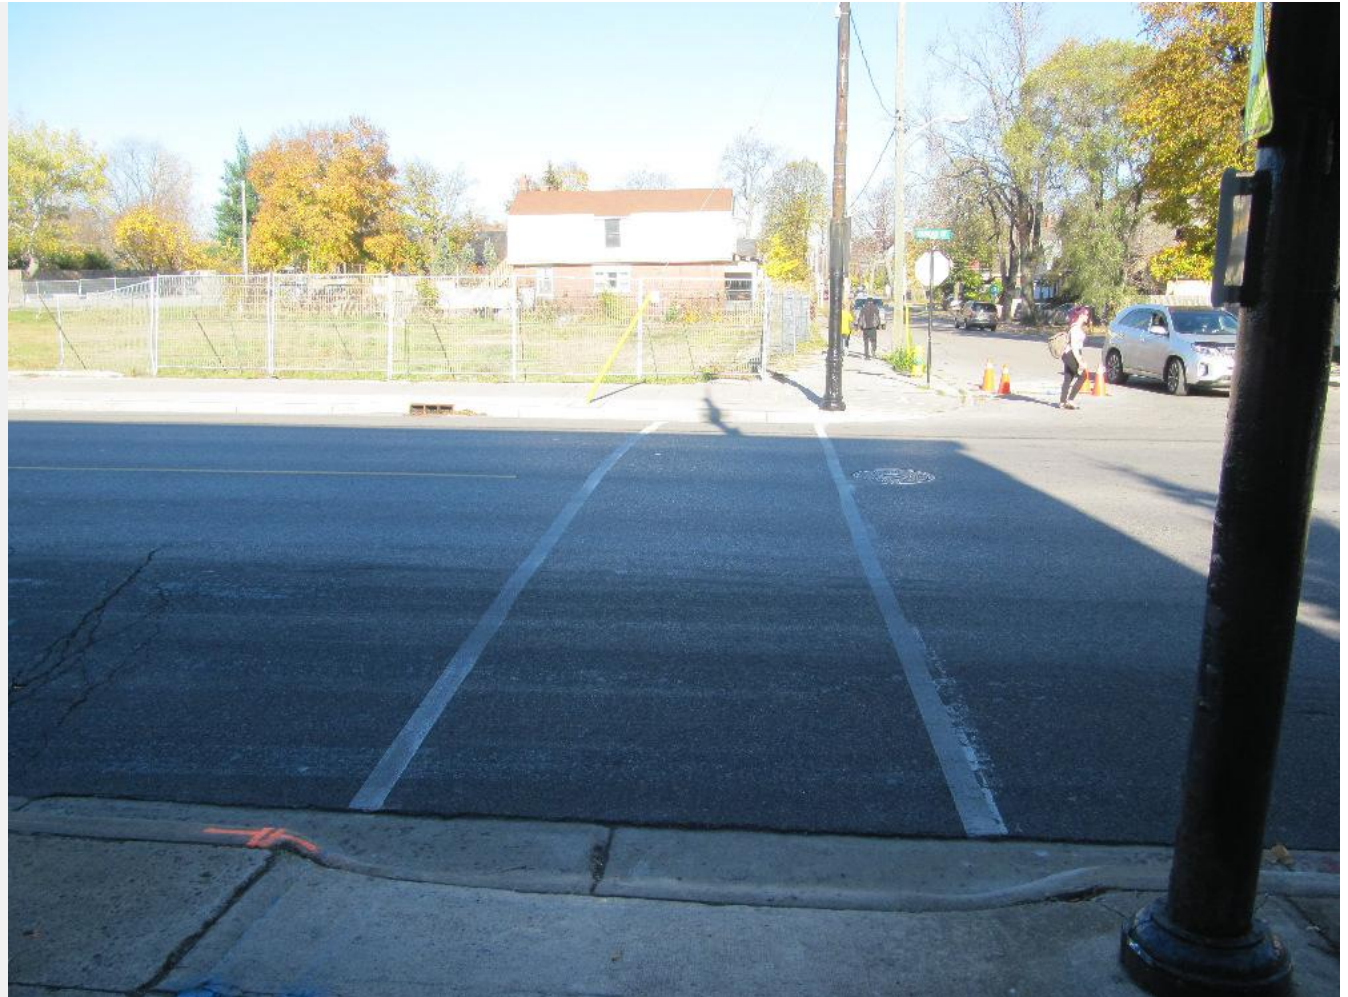
Figure 6: View, looking south, along the pedestrian crossing of Dundas Street near the west edge of the intersection with English Street.

Toward the right portion of Figure 6 one can see a sewer drain that is built into the south curb of Dundas Street and this is where tire marks were found on the curb that likely came from the SUV as it exited the road. But one should examine the short distance between this sewer drain and the intersection of English Street and consider whether the motion of the SUV could be accomplished in this very short distance. Perhaps this could be accomplished if the SUV was travelling very slowly but the evidence does not indicate such a slow speed. We need to look at this evidence more closely.

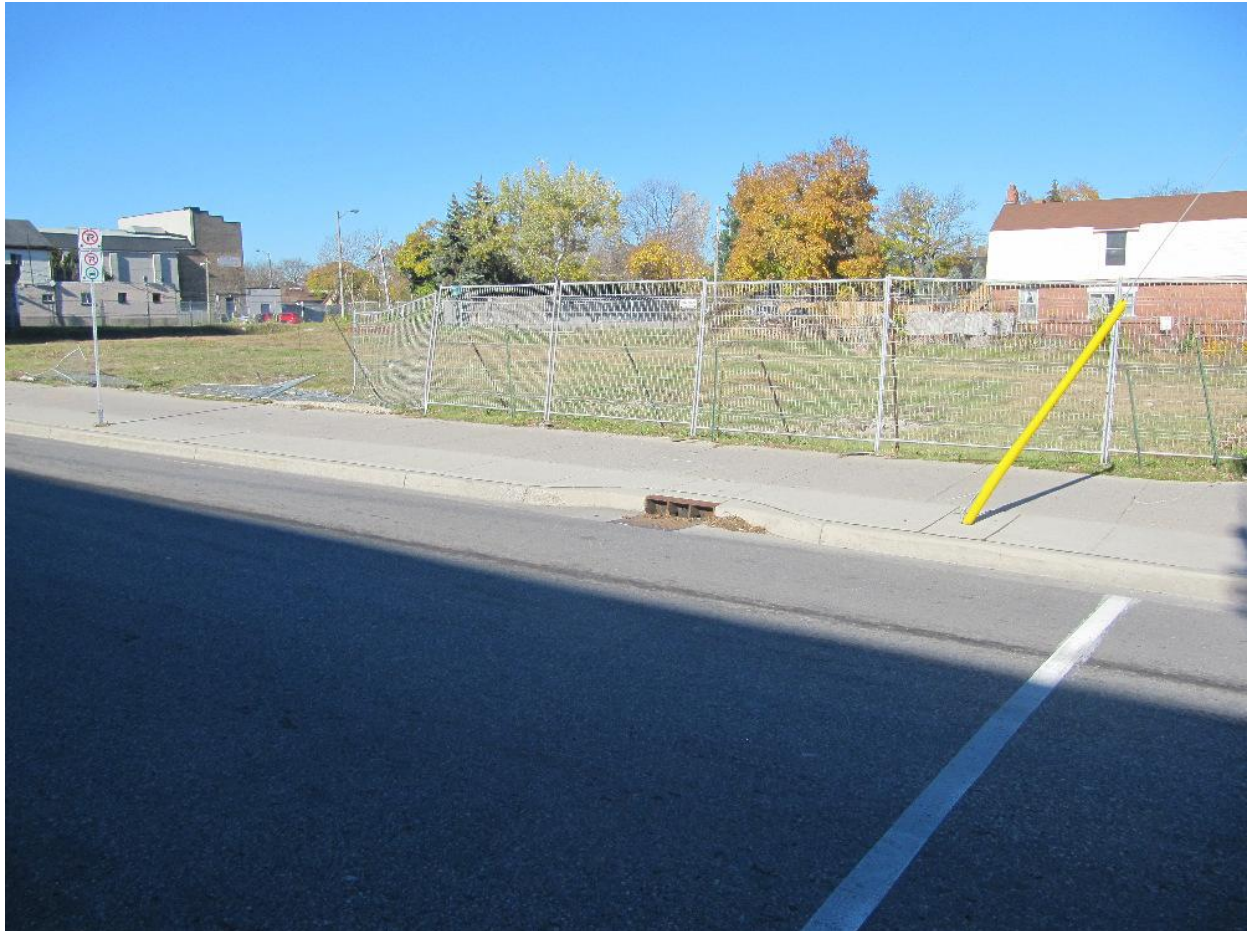
Figure 7 shows a diagonal view looking at the sewer drain with the hole in the fence in the background. Thus we can explore the angle at which the vehicle struck the curb and then carried on to impact with the fence.

Figure 7: Diagonal view looking toward the northwest. We can see the sewer drain in the curb where the tire marks are located and the hole in the fence in the background.

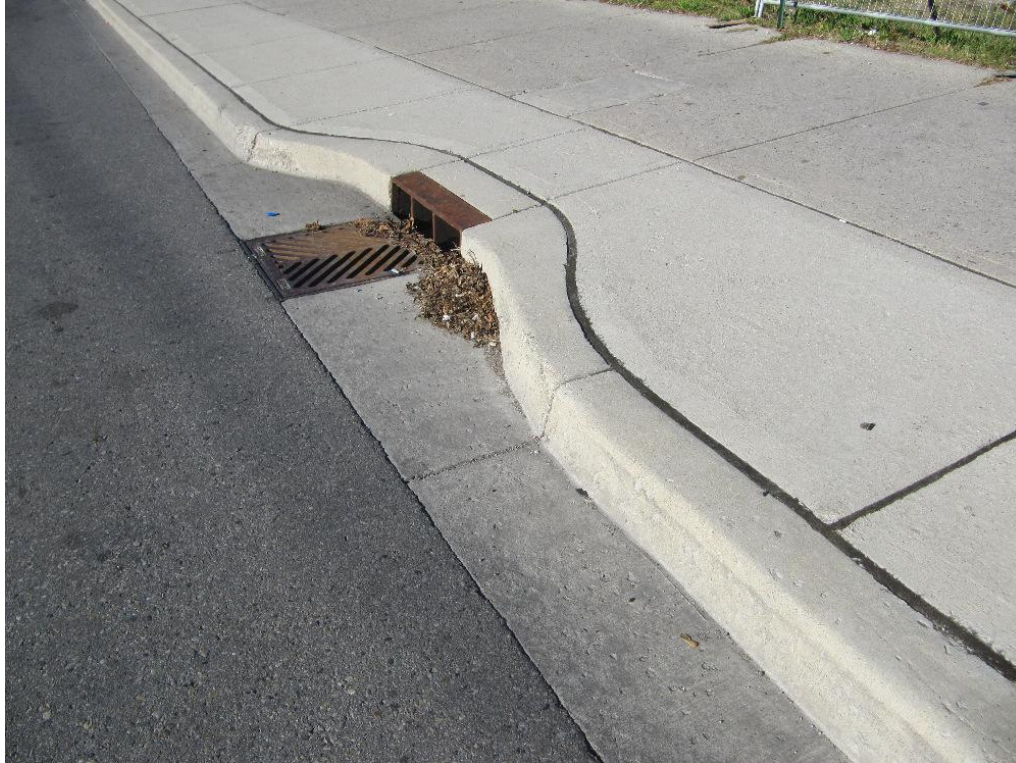
Figure 8 shows a view of the north curb of Dundas Street at the sewer drain. There are tire marks both east and west of the drain. Figure 9 shows the tire mark that is east of the drain and this would likely have been caused by the right side tires of the SUV. Figure 9 shows a close-up of the tire mark.

Figure 8: View of the sewer drain. A tire marks can be seen on curb just east of the drain and a close-up of that mark is shown in Figure 9. This mark would have been caused by one of the right side tires of the SUV.

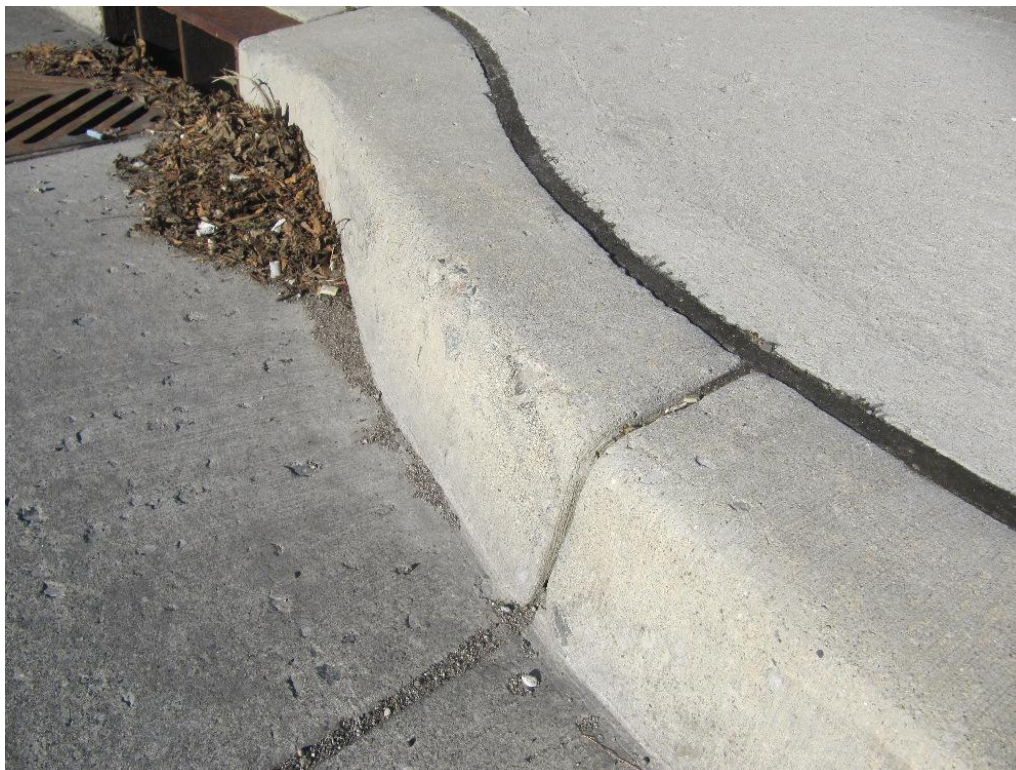
Figure 9: View of the small tire mark located on the north curb approximately at the junction of the concrete in the centre of the photo.

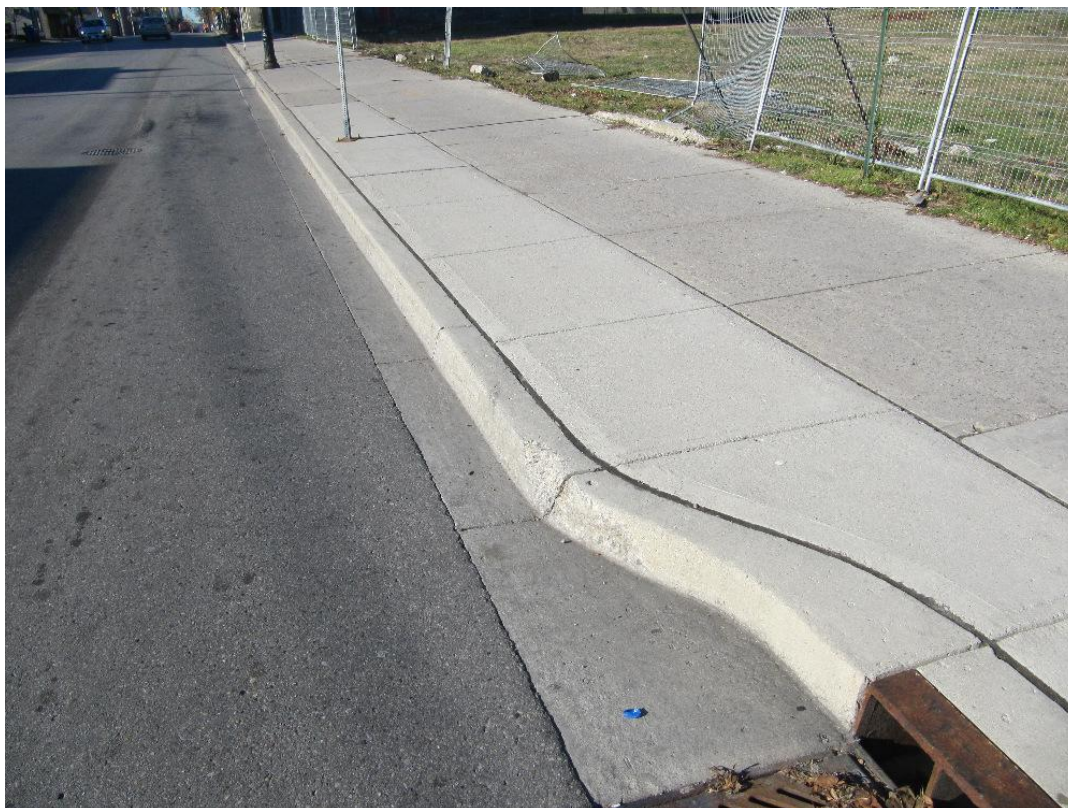
Figure 10 shows the portion of the north curb west of the sewer drain and Figure 11 shows a close-up of the tire mark which was likely caused by one of the left side tires of the SUV.

Figure 10: View of the north curb just west of the sewer drain.

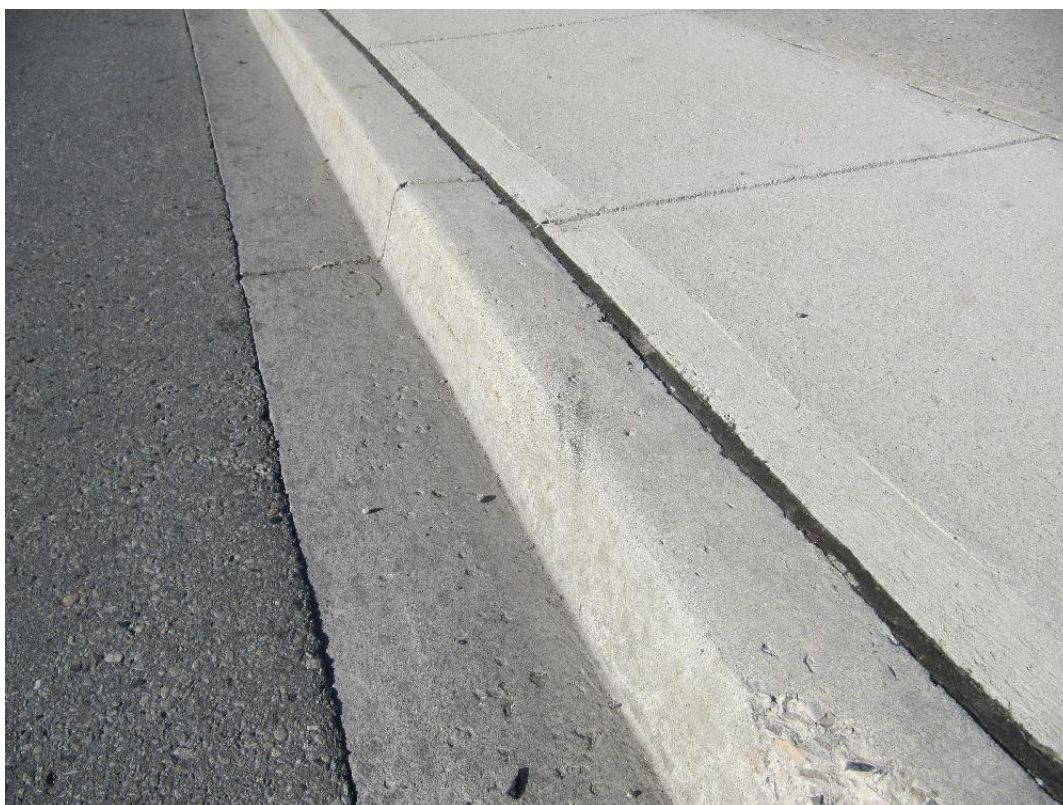
Figure 11: Close-up view of the small black tire mark on the edge of the curb west of the sewer drain.

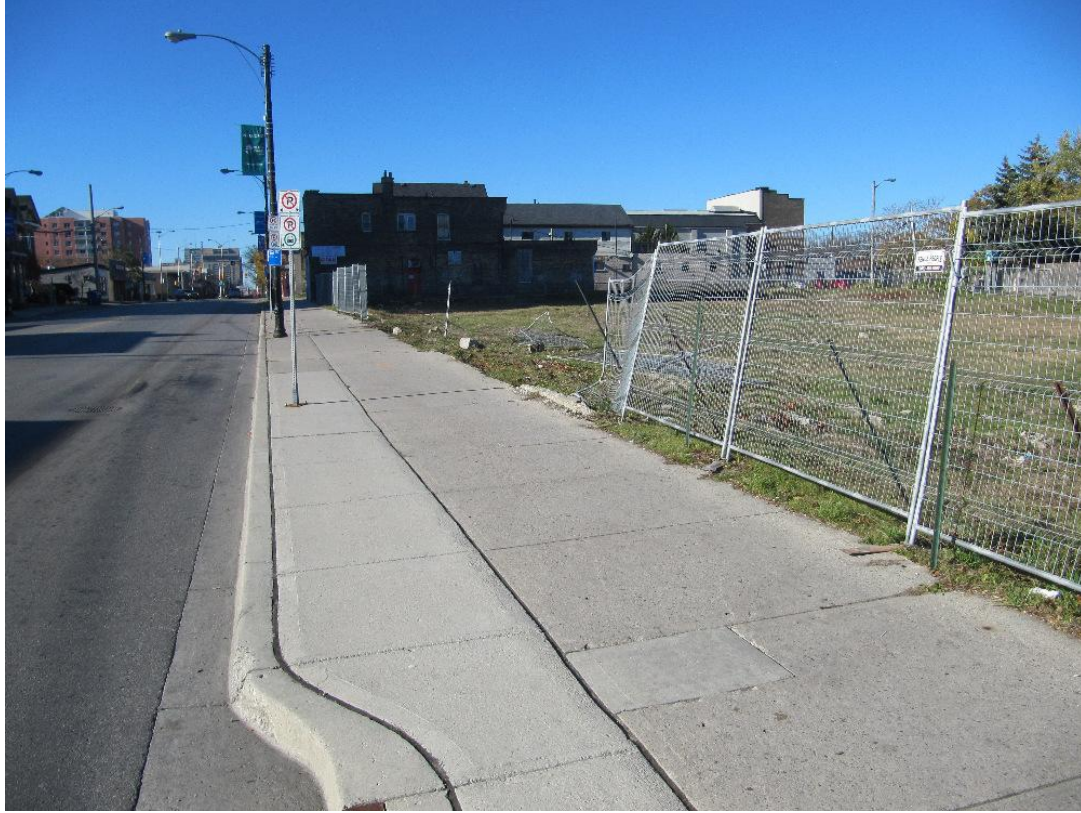
Figure 12: Diagonal view from the tire marks at the sewer drain looking toward the east edge of the hole in the metal fence.

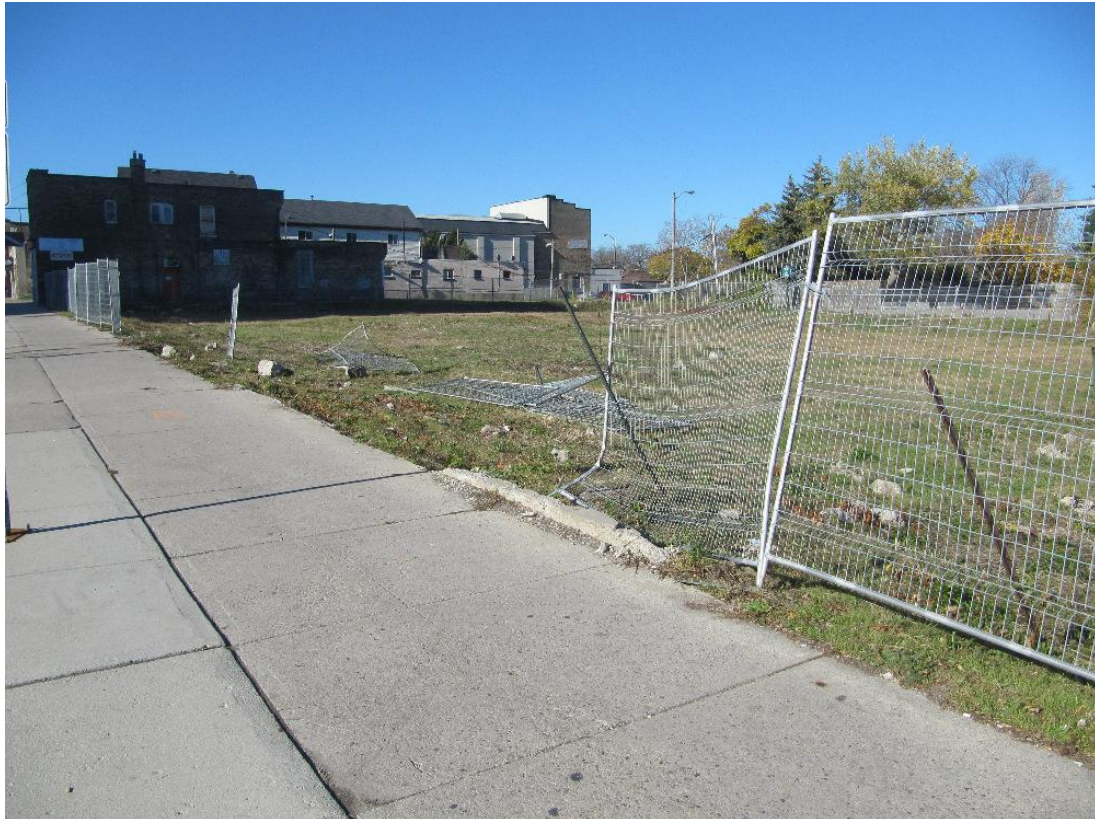
Figure 13: Diagonal view looking toward the east edge of the hole in the metal fence.

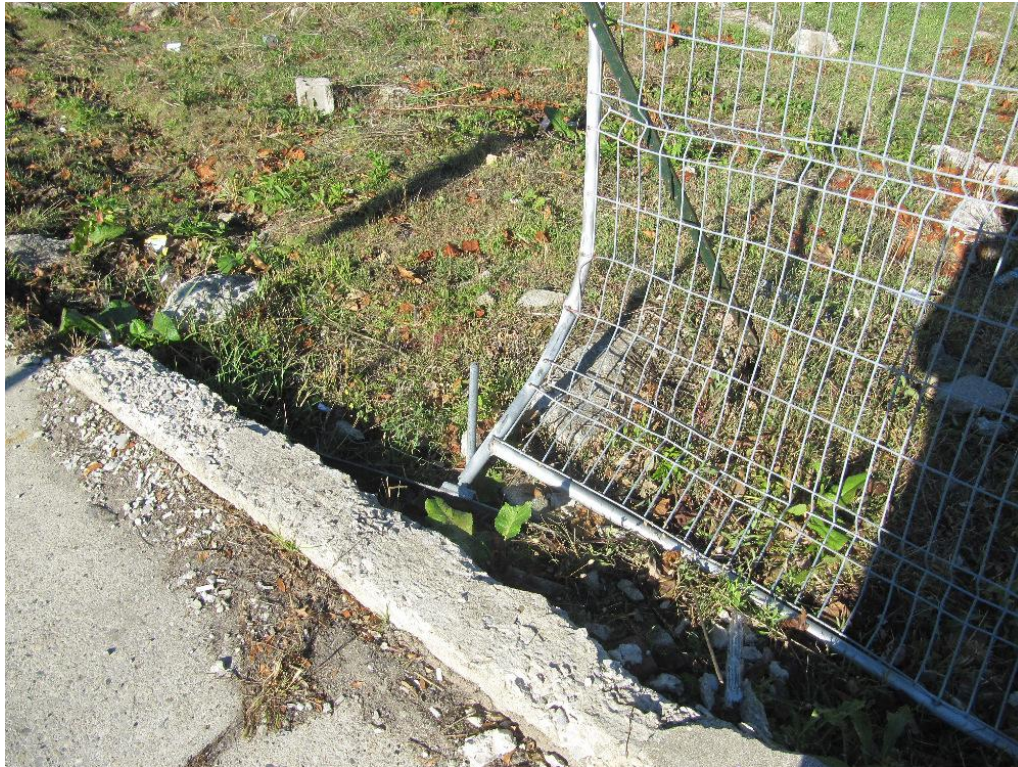
Figure 14: View of the deformed vertical post of the fence at the east end of the hole.

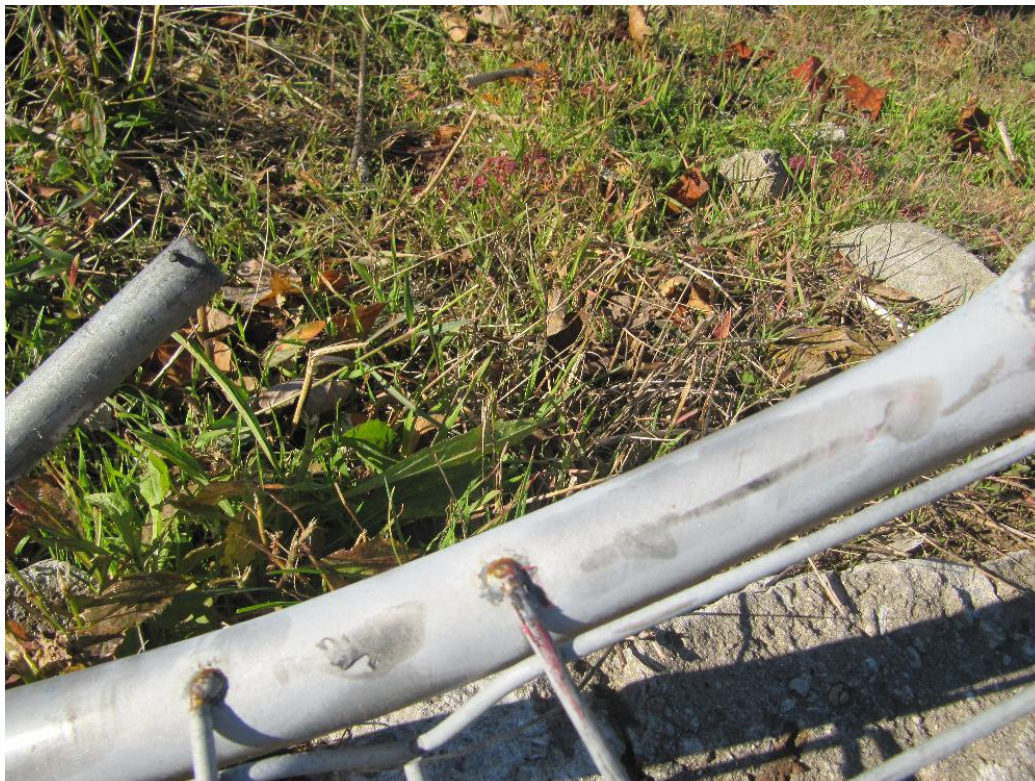
Figure 15: View of the dark transfers on the vertical post of the fence caused from contact by one of the right side tires of the SUV.

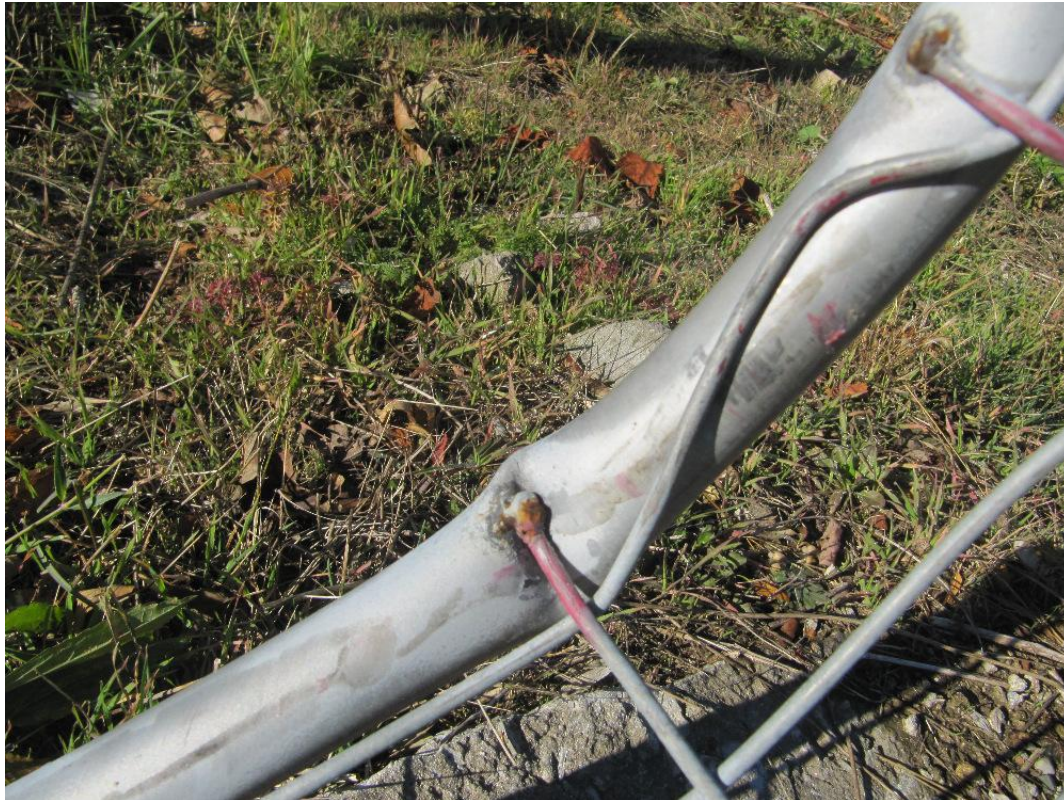
Figure 12 shows a diagonal view from the sewer drain toward the east end of the hole in the metal fence. This view is carried on in Figure 13 as we approach further west toward that hole. There is evidence of red/burgandy paint and black rubber transfers on the fence post at the east edge of the hole. This evidence is shown in Figure 14, 15 and 16.

Figure 16: View of dark rubber transfers and burgandy paint tranfers indicating that contact was made by the SUV to the vertical post of the fence at the east edge of the hole.

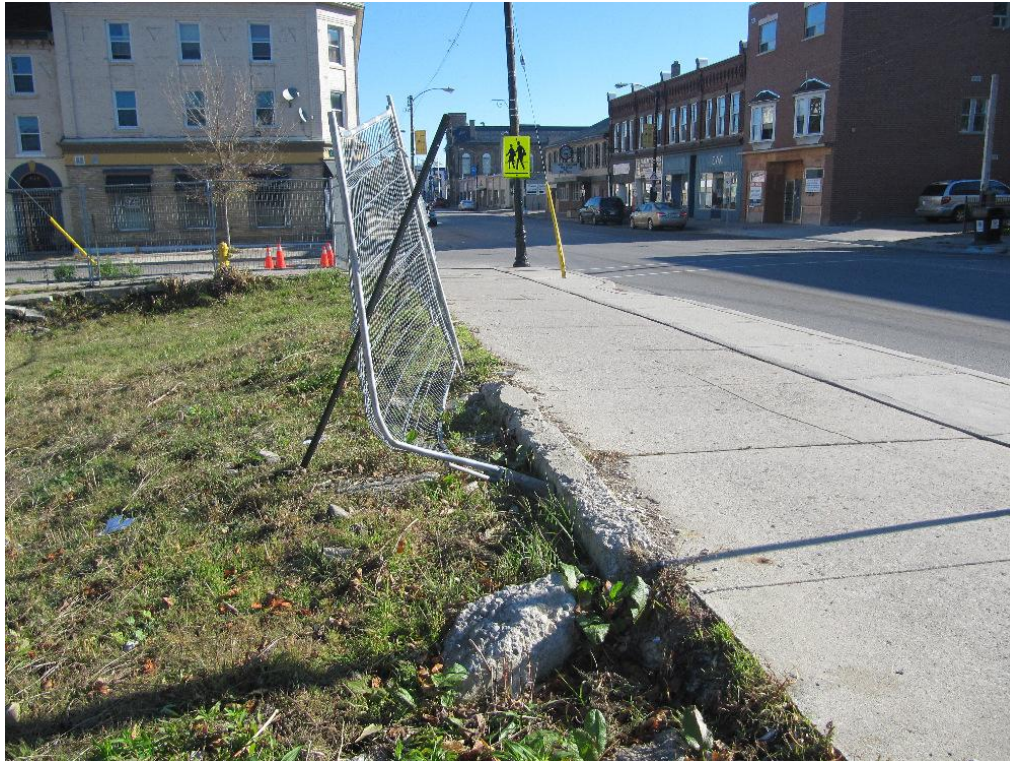
Rotating around to face south-east, the view in Figure 17 shows the east edge of the hole in the fence and we can line up the SUV's travel path by noting that the sewer drain would be located just to the right of anchorage of the yellow-covered guide wire near the north curb. So this gives us a general appreciation of the shallow travel path of the SUV as it leaves the road.

Again, we must consider what the claim of the official reports of how this collision occurred. The SUV was southbound and made a right turn onto Dundas and then when into an immediate state of loss-of-control that propelled it on the shallow travel path shown in Figure 17. In this assessment we must keep in mind that the driver's steering wheel must be turned sharply to the right during the vehicles' right turn and then, immediately afterward the steering wheel must be turned very sharply to the left in order to cause the vehicle to travel on this shallow and straight path shown in Figure17. Does that make sense?

Figure 17: View, looking south-east to establish the travel path of the SUV is was travelling toward the camera.

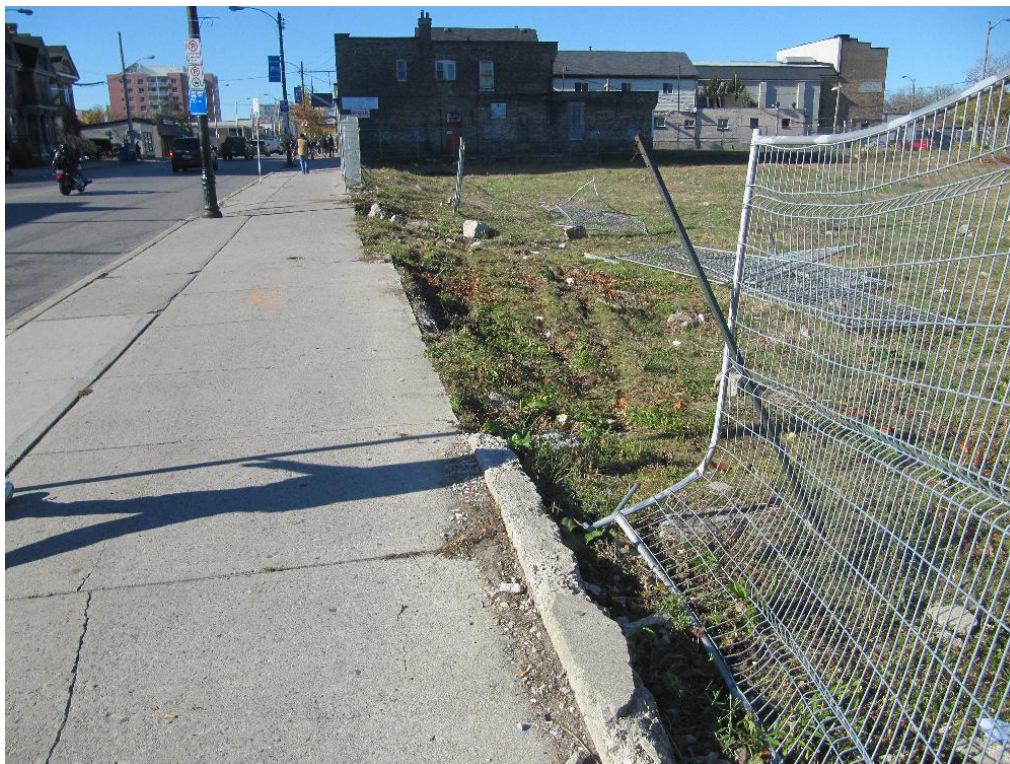
As we indicated earlier, the official explanation might be possible if the SUV was travelling very slowly so that these steering wheel inputs would have time to be carried out. But that is not the case. The SUV was not travelling very slowly as evidenced by the distance that it travelled through the fence and through the various concrete blocks and other debris in the empty lot.

Figure 18 helps to illuminate the distance that the SUV travelled from the instant that it struck the metal fence and as it stumbled over the uneven surface of rocks and concrete blocks.

Figure 18: View, looking from the point where the SUV crashed into the metal fence and the evidence in the background where the SUV travelled to final rest.

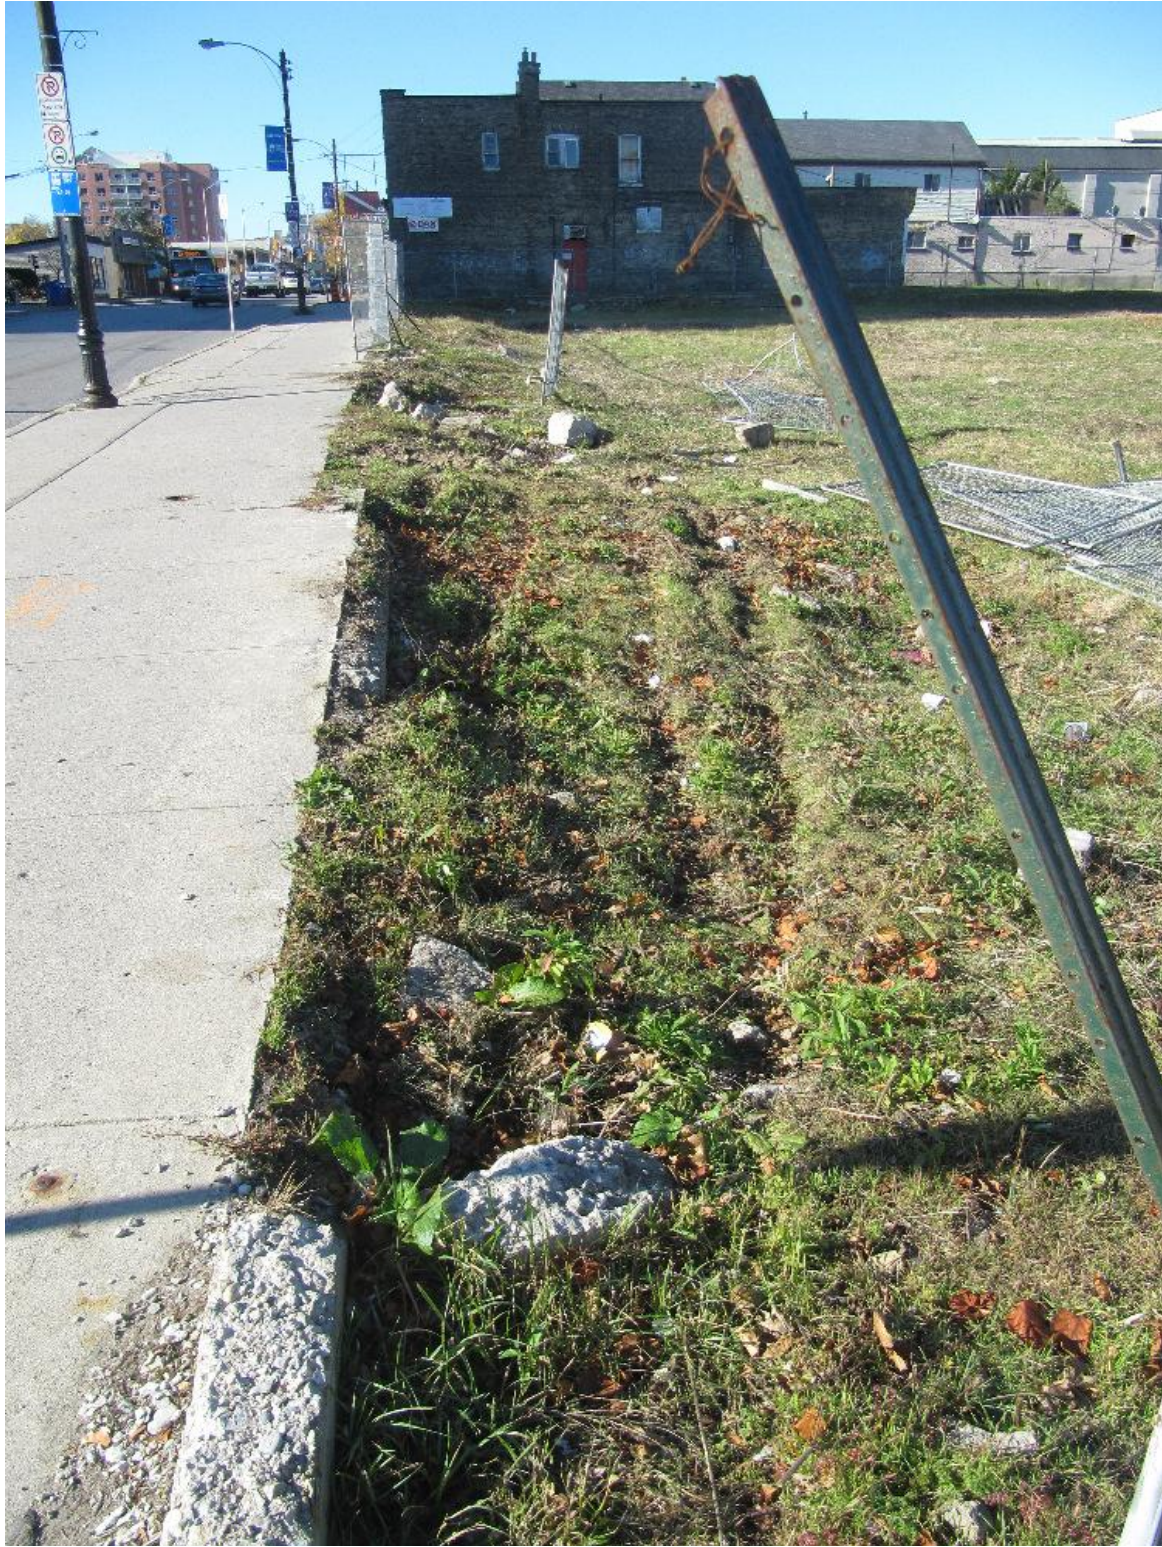
Figure 19: View, of the tire marks of the SUV as it stumbled through the uneven surface after crashing through the metal fence.

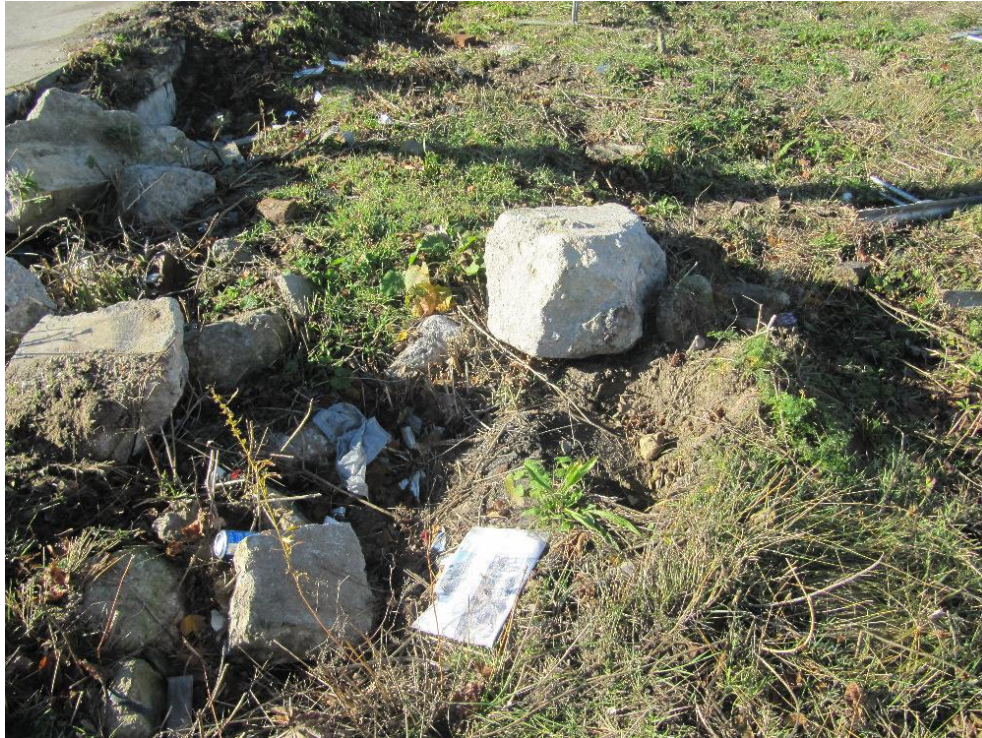
Figure 20: View of a large concrete boulder in the centre of the view that was pushed out of its resting position by the impact of the SUV.

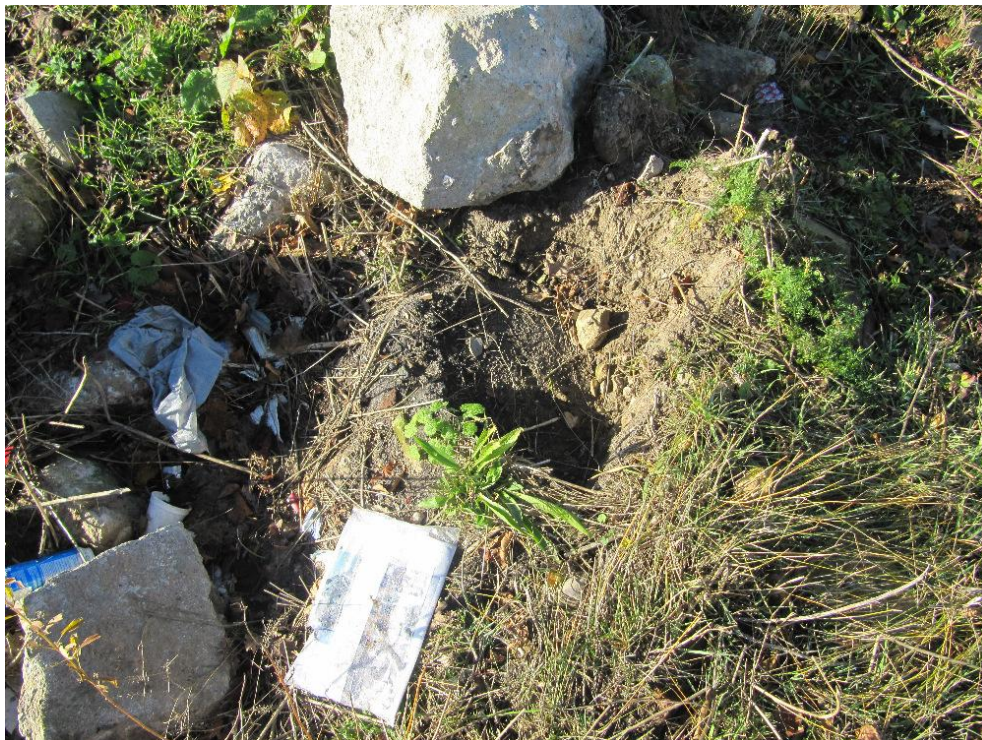
Figure 21: View of the hole in the ground where the concrete block had been sitting before it was displaced by the impact of the SUV.

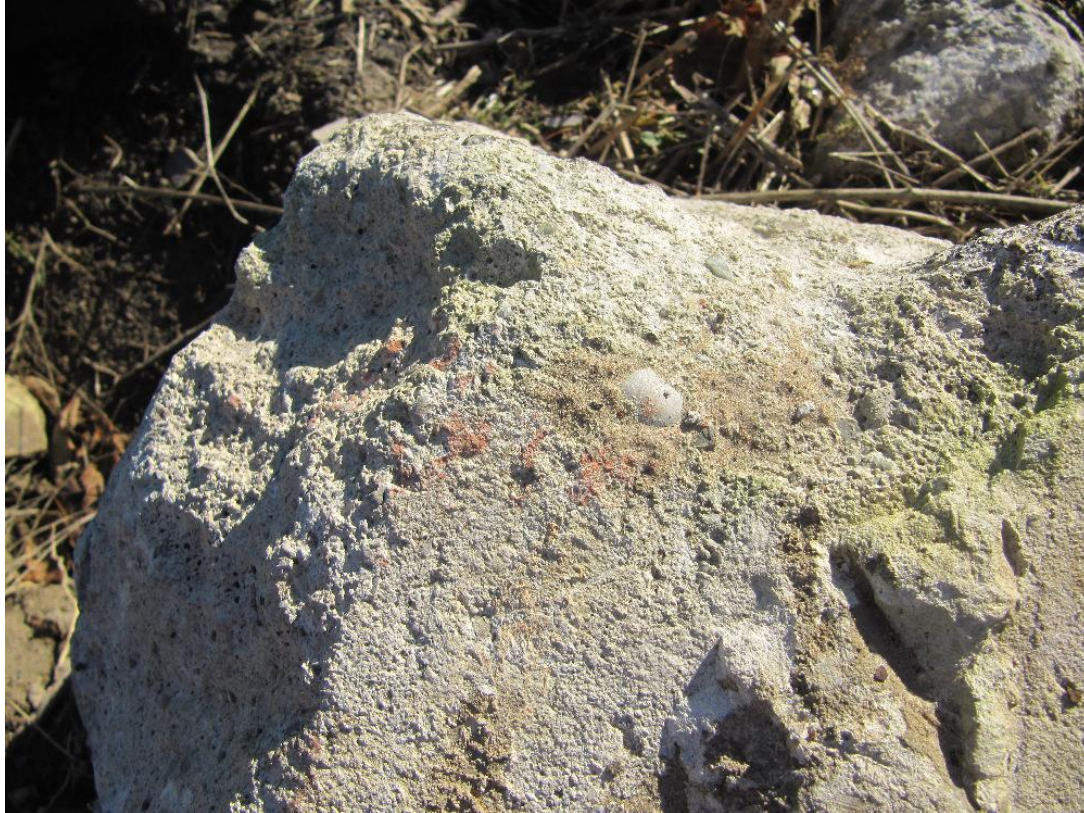
Figure 22: View of the reddish paint transfers on the concrete boulder confirming the SUV's impact with it.
