# Minor Injuries to Pedestrian Lead to Death - Questions About the Official Investigation

*Posting Date: Nov 4-2015*

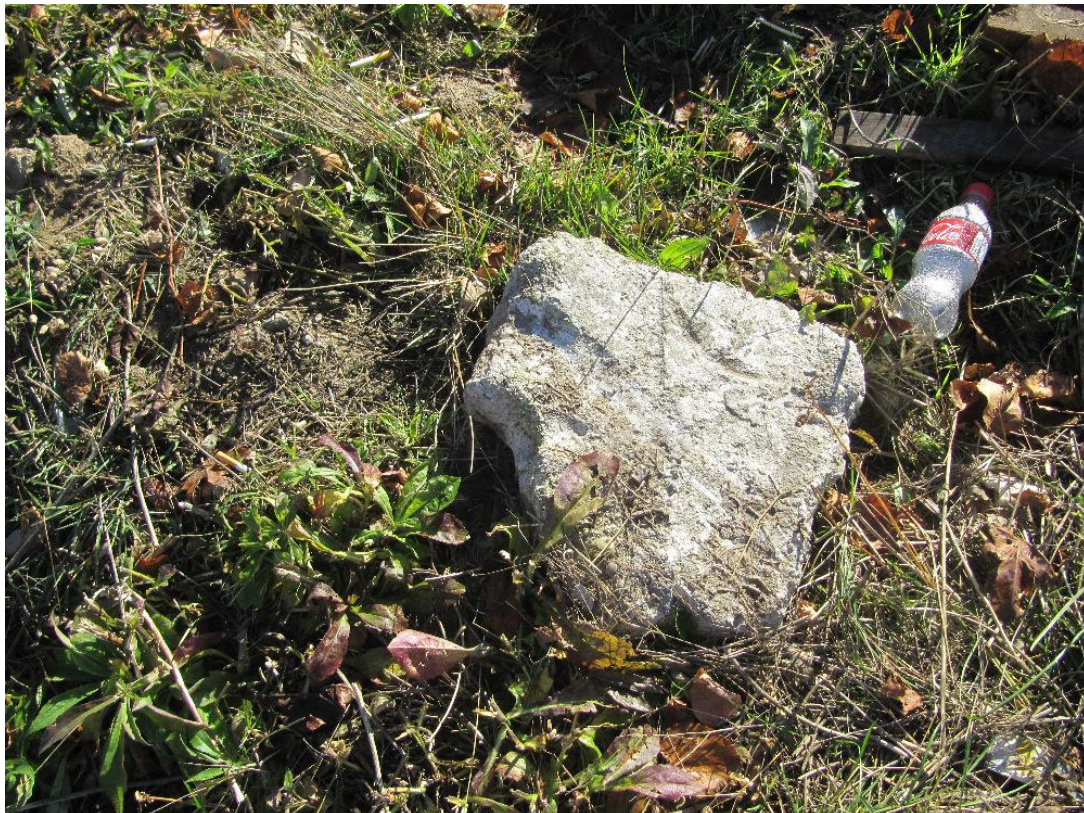
Figure 23: View of a boulder containing a linear scar from scraping contact of the SUV.

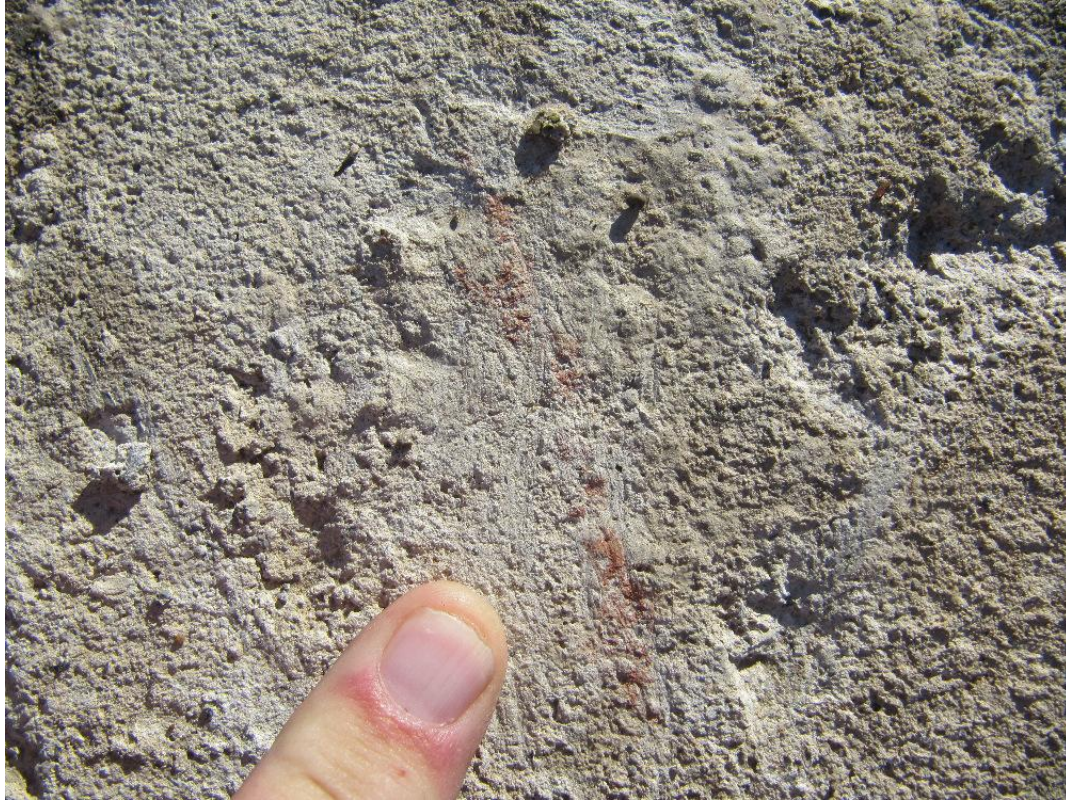
Figure 24: Close-up view of linear scrape and reddish paint transfers to a boulder that was struck by the SUV.
