## Petrolia Line Fatal Collision with Tree

*Posting Date: 26-Oct 2012*

Gorski Consulting  
London, Ontario, Canada

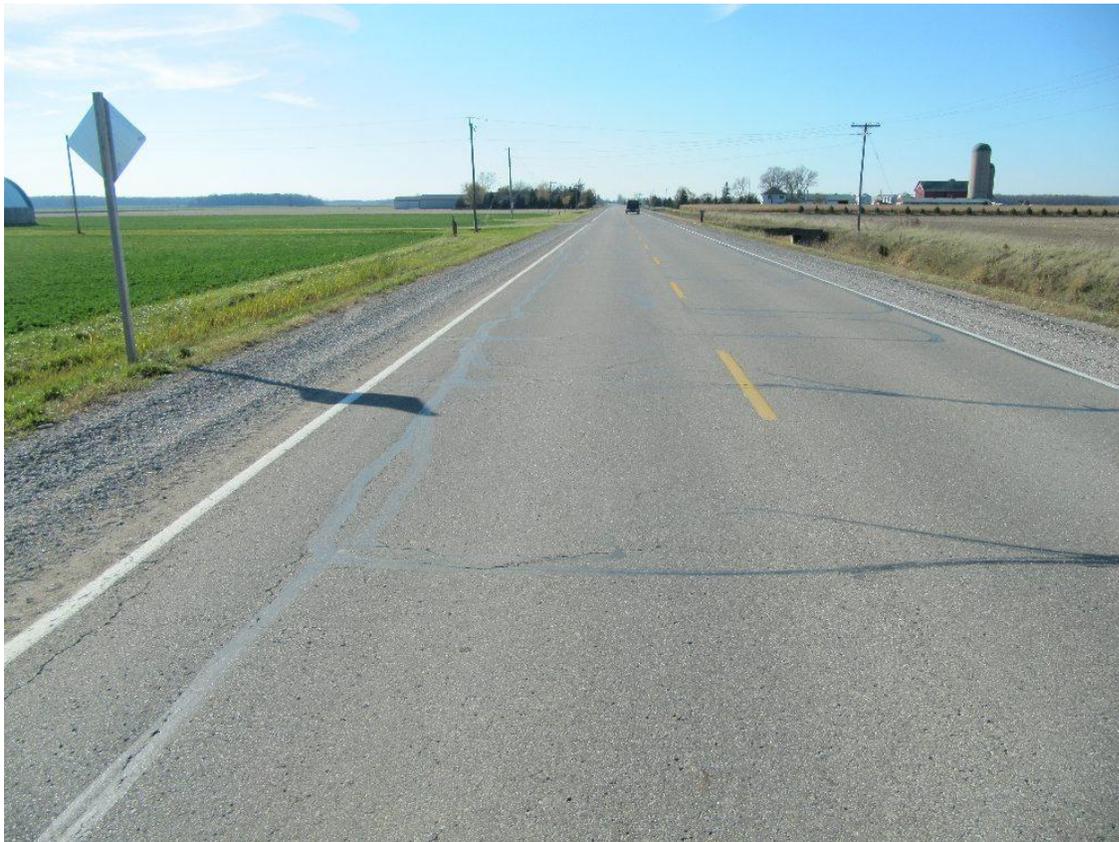
The photo below is taken from several hundred meters west of the tree impact and we are looking westbound on Petrolia Line. Thus the Chevrolet would be approaching toward the camera.

Note that the highway is straight and level. You can see the backside of warning sign on the left side of this view and that is the same sign that is shown the next photo below,

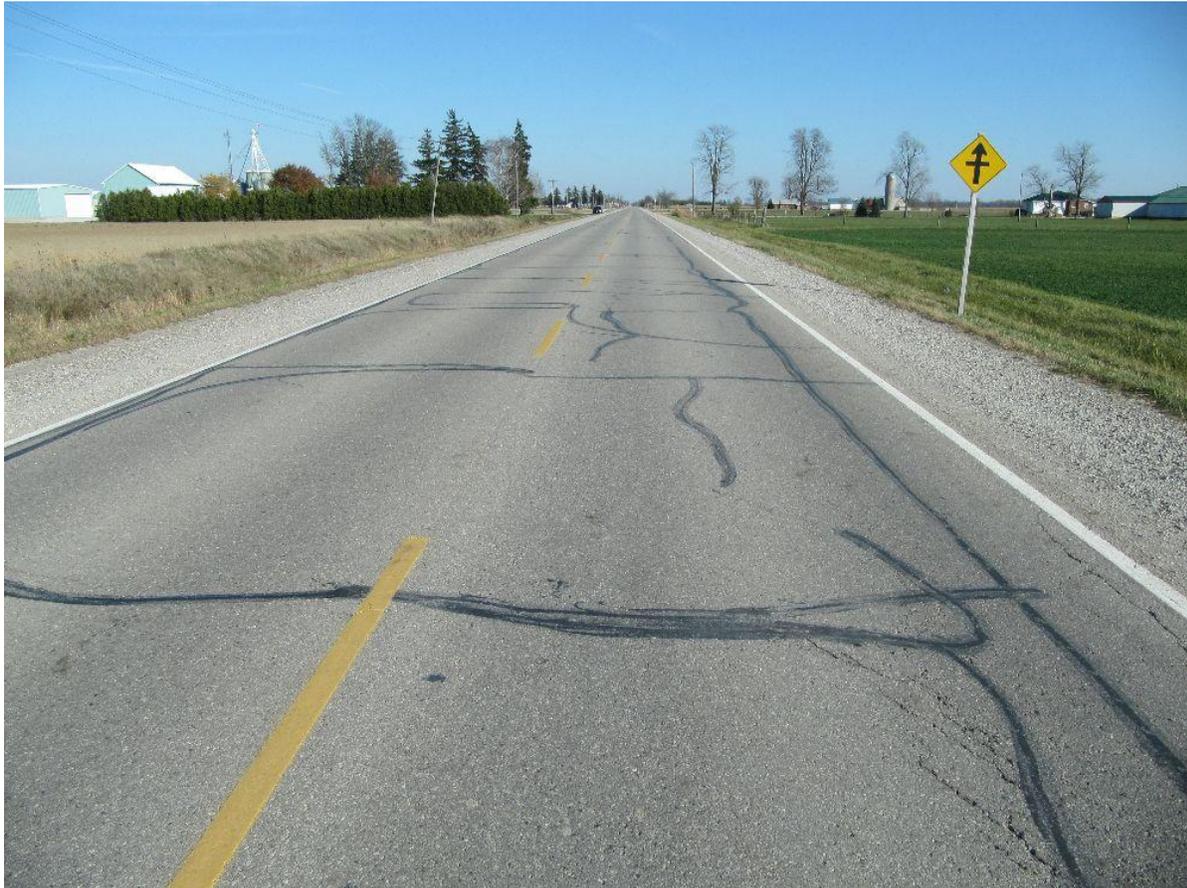
which is a view looking eastbound on Petrolia Line but now looking toward the area of the tree impact in the far distance.

If you look in the far distance, on the left side of the road, you may be able to detect our black car which is positioned near the tree impact. Throughout this distance you can see that the road surface is straight and level. There are lines of tar in the pavement where work crews have filled an cracks that could lead to deterioration of the road. So the road has been properly maintained. Having walked on the surface we can also indicate that there were no areas of unusual sagging, depression or upheaval. There was also no significant edge drop off.

The typical scenario is that vehicles travelling at highway speeds usually encounter problems several hundred metres prior their eventual collision and rest position. So the above photo is a good point to evaluate what might have caused the driver to lose control of her vehicle. One option is that some type of animal could have entered the roadway and the driver attempted to avoid it.

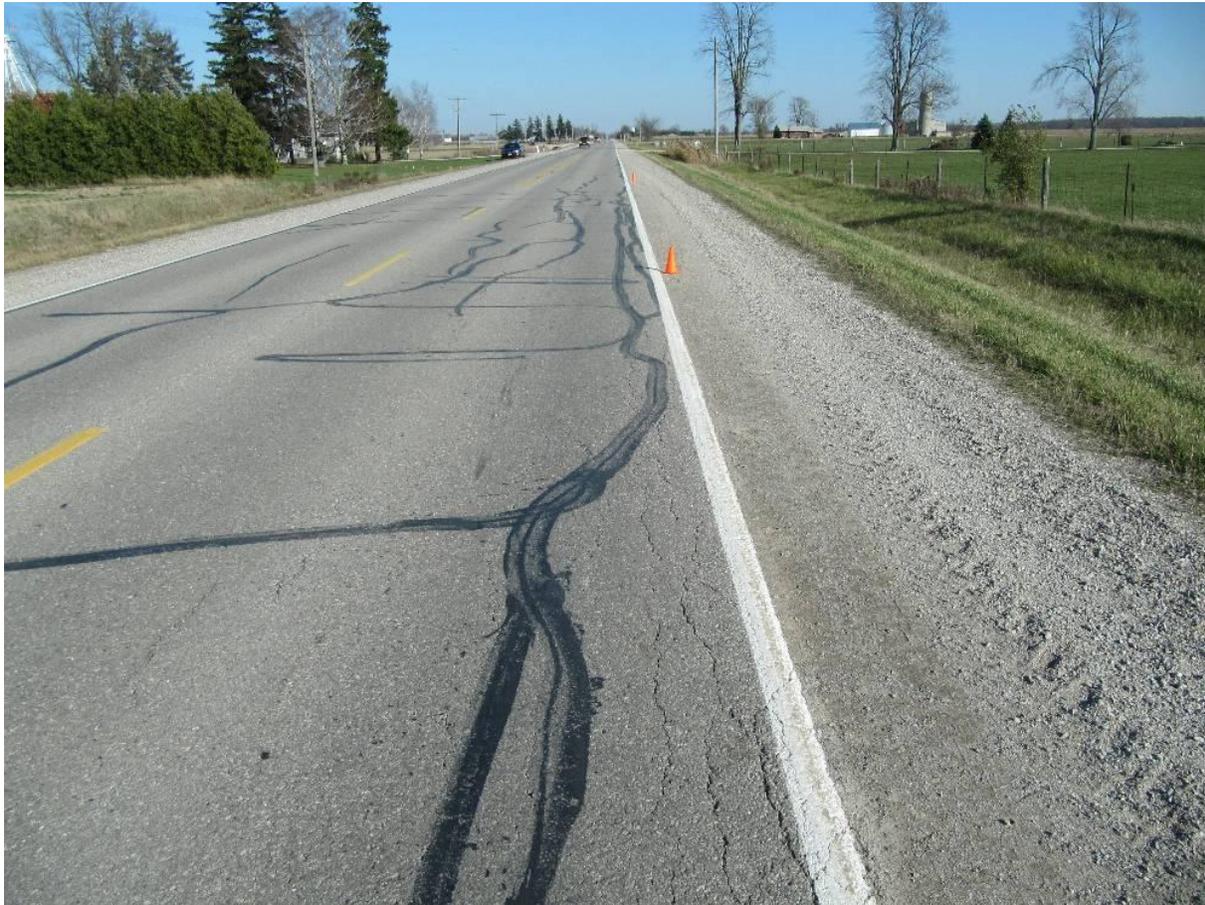
The photo below now takes us several hundred metres eastward to the area just west of where we detected some fresh tire marks on the right (south) roadside. We placed two orange cones on the right shoulder, near the asphalt edge, to demonstrate where the vehicle came onto the shoulder and then where it returned back onto the road surface before finally departing toward the north roadside.

Although there are many tire marks visible on the right shoulder, the tell-tale signs of a fresh, loss-of-control, set of tire marks on a gravel shoulder are not difficult to detect. In this case, part of those tire marks have already been demolished by vehicles travelling onto the shoulder but the marks are still capable of being seen.

The evidence in those tire marks on the shoulder indicates a divergence in the two marks and this indicates that the vehicle is rotating, typically counter-clockwise. With respect to the length of the road, the vehicle entered the right (south) shoulder about 102 metres west of where it eventually struck the tree. It travelled on that gravel shoulder for about 45 metres before it came back onto the road surface, at which point it was already at a substantial angle fully out of control.

In the 102 metres of evidence that was deposited along the vehicle's path there was evidence that the vehicle was decelerating, primarily by virtue of its tires sliding across the pavement and grass. One might consider some rates of deceleration (0.2 to 0.4 g) that might give us some ballpark number of the speed that could have been lost during that 102 metres. The speed loss could be something in the range of 72 to 102 km/h. But the struck tree was actually positioned about 19 metres north of the north road edge therefore the actual distance that the vehicle travelled was at a substantial diagonal to the road and therefore the actual travel distance was longer than the 102 metres measured along the road. So overall, we have a substantial speed loss even before the vehicle struck the tree.

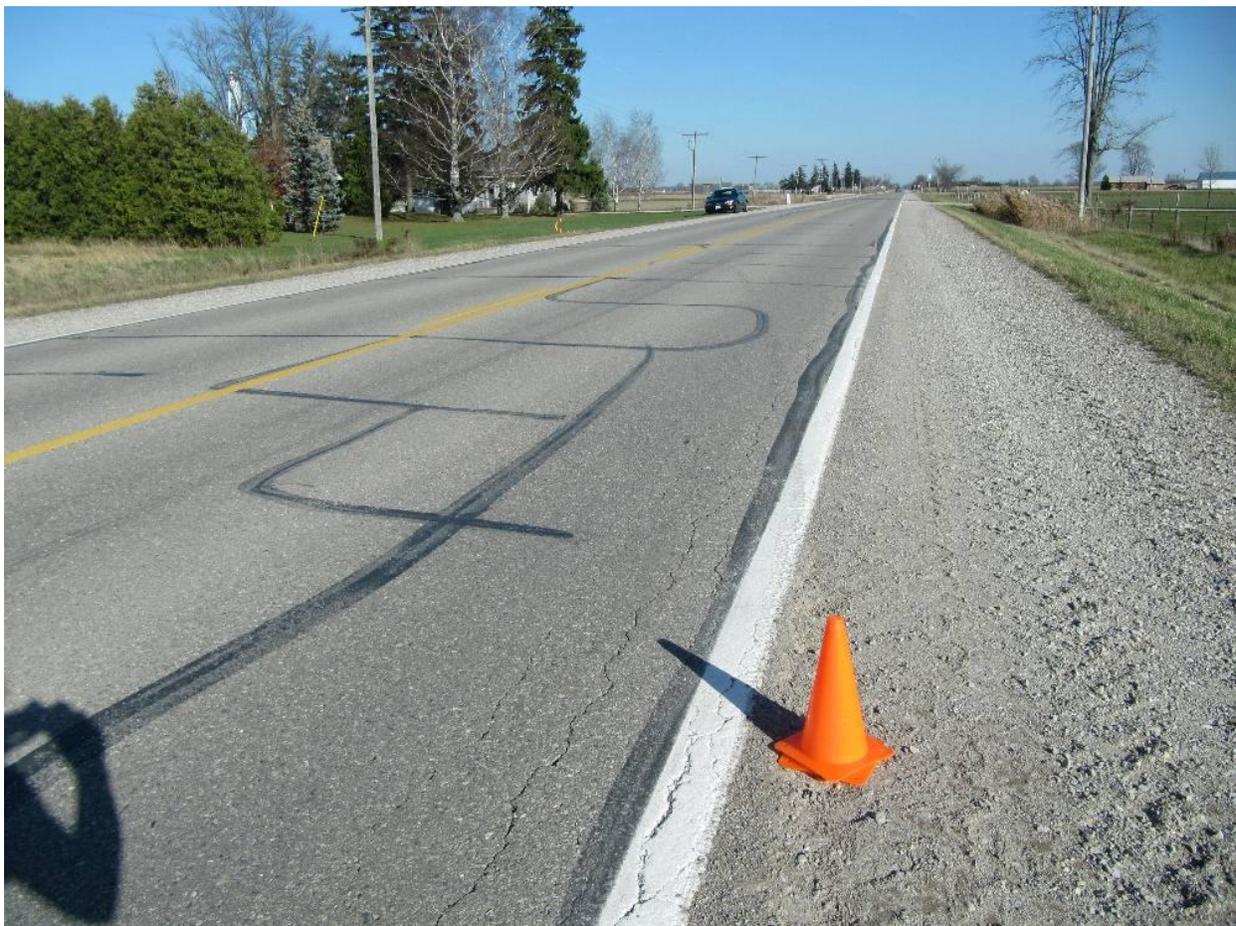
The photo below shows a north-easterly view from the point at the east end of the tire mark as it leaves the south gravel shoulder and the vehicle begins to travel back across the road toward the north roadside. If you look closely at the road surface you should be able to detect the black, curved yaw marks indicating that the vehicle is rotating counter-clockwise. You might also be able to detect a large evergreen tree to the left, and east of our parked car and this is the tree that was struck by the vehicle.

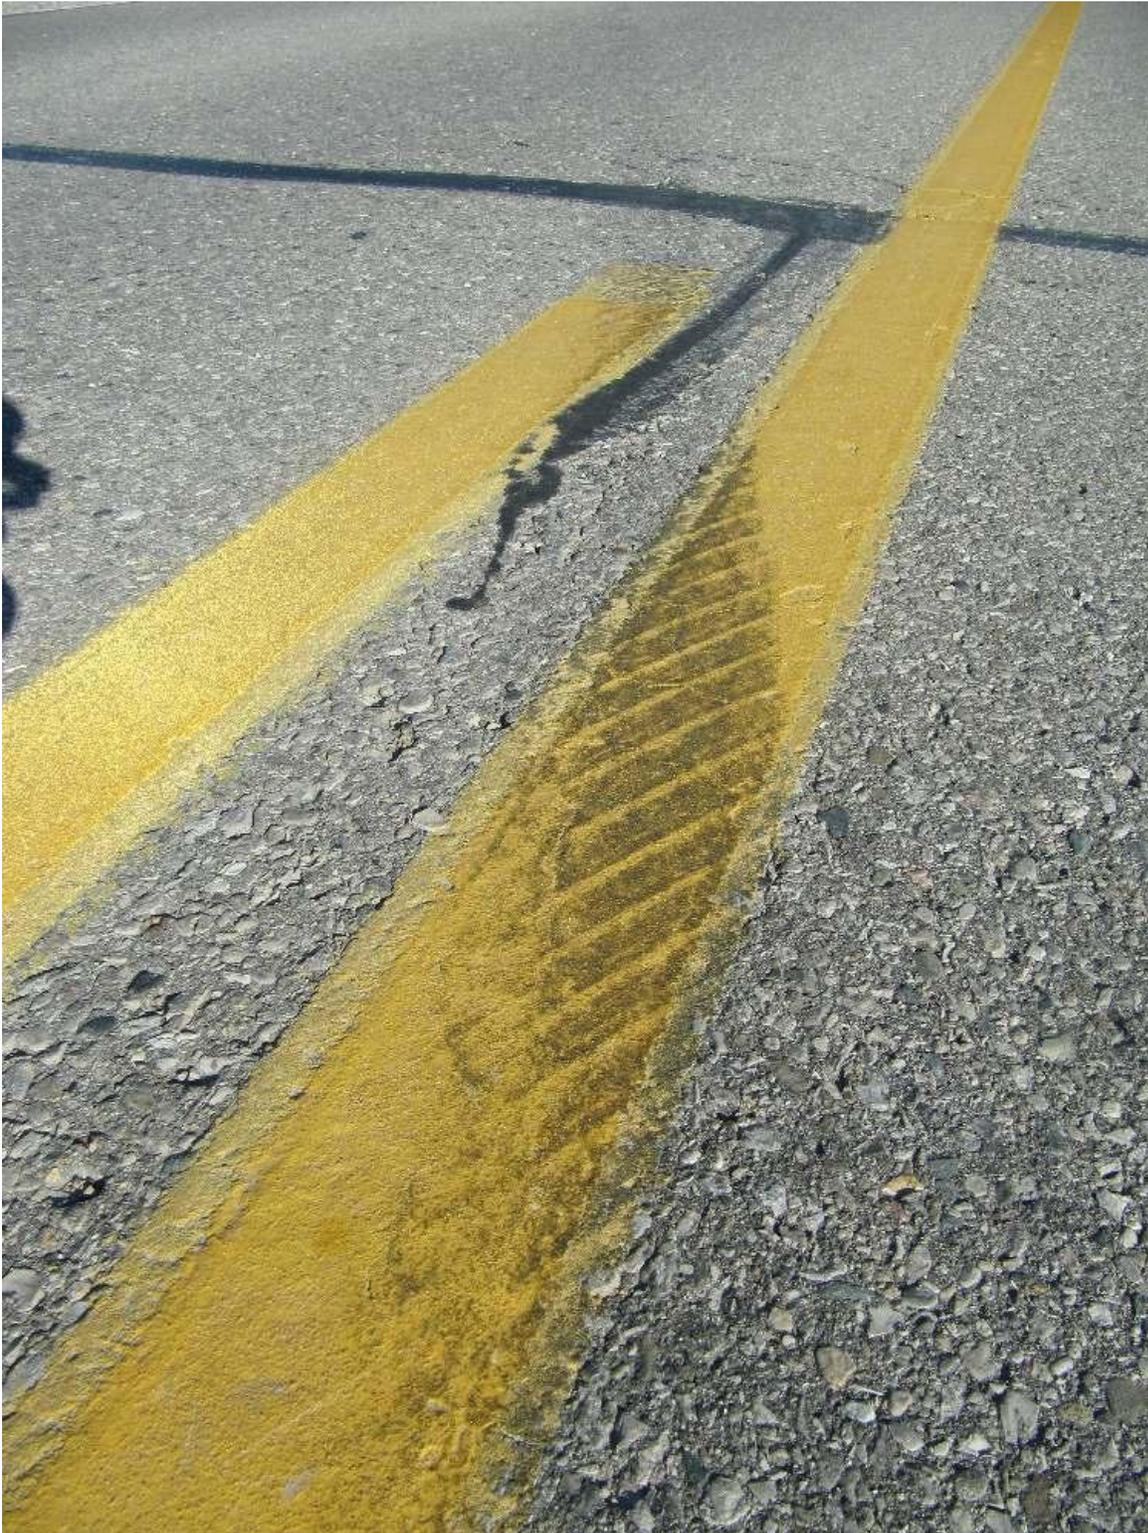
A painted line is often the best location to see the characteristics of a tire mark and the photo on the following page shows a close-up view of one of the yaw marks as it

crossed the yellow centre-line of the road. The angle of the striations in the mark suggest that little or no braking was taking place at this location.

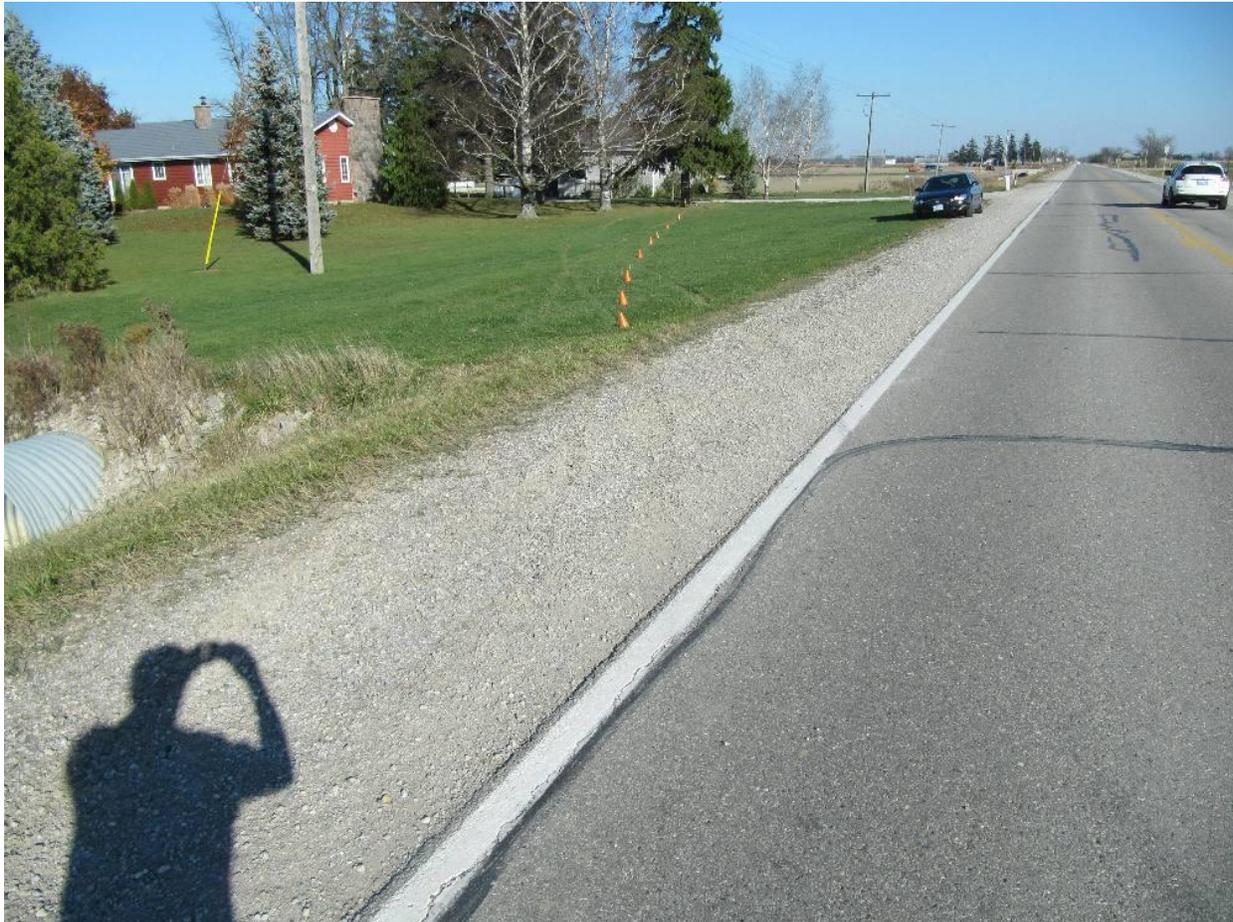
As we cross to the north side of the road we can see in the photo below how the tire marks cross the north shoulder and then travel toward the noted evergreen in the background. For clarity we have placed a line of small orange cones on what we believe to be the left rear tire mark, although we have not studied the evidence in any detail to confirm this.

The various merging and diverging of the tire marks needs proper study to confirm that the tire marks are matched to their proper tires. This would be easier for police or those who were able to see which portion of the vehicle came in contact with the tree. In official investigations we would plot the tire marks on a scale diagram of the site and, using a scale diagram of the representative vehicles we would match the tires to the various tire marks to ensure that our interpretation was correct. As this is not an official investigation we would not perform such studies.

One can generally observe that the extent of rotation is greater in this collision than what we would typically expect. Part of this may be due to the longer distance travelled away from the road and the greater opportunity for the vehicle to proceed with that rotation.

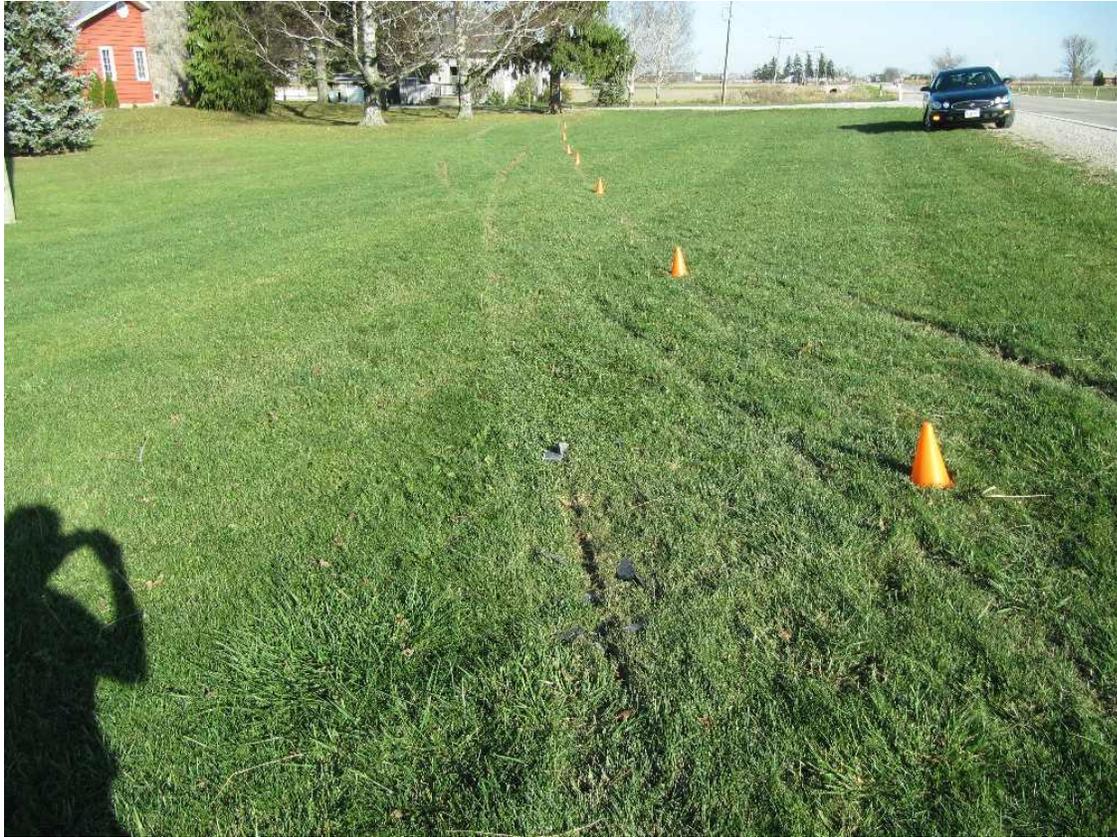
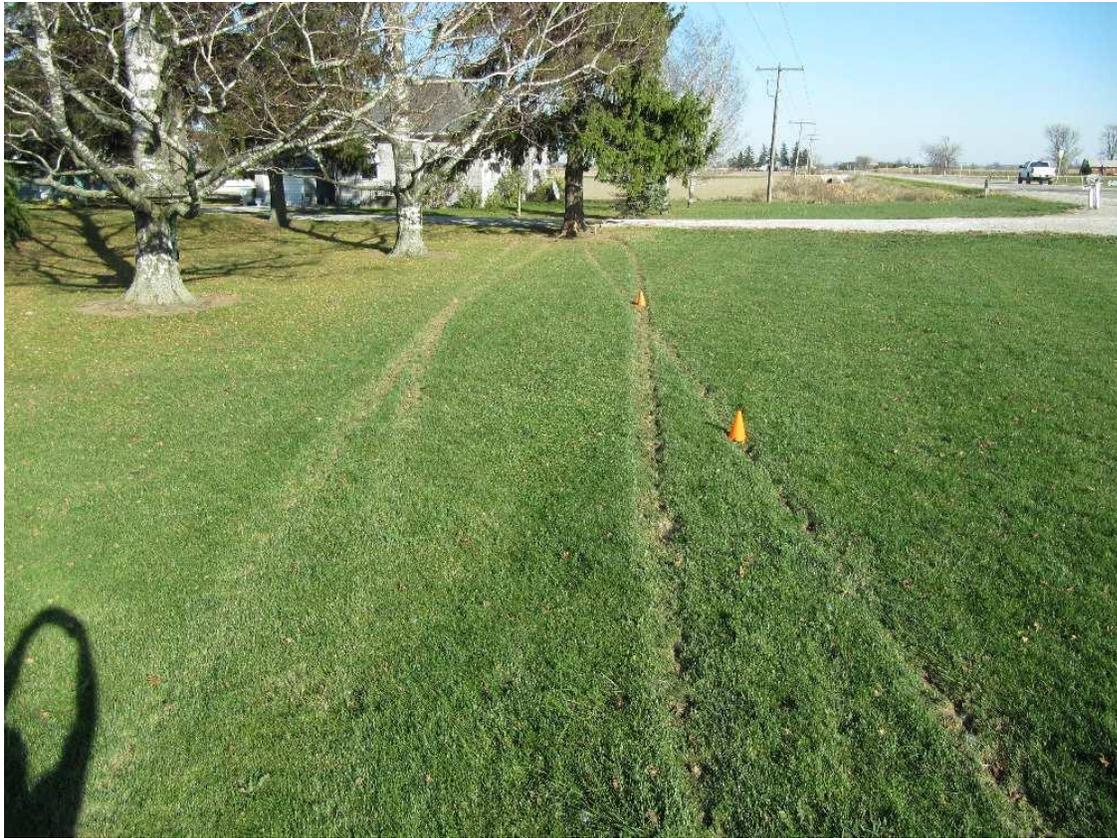
The two photos on the following page take us eastward along the tire marks on the north roadside and toward the noted evergreen tree where the impact occurred.

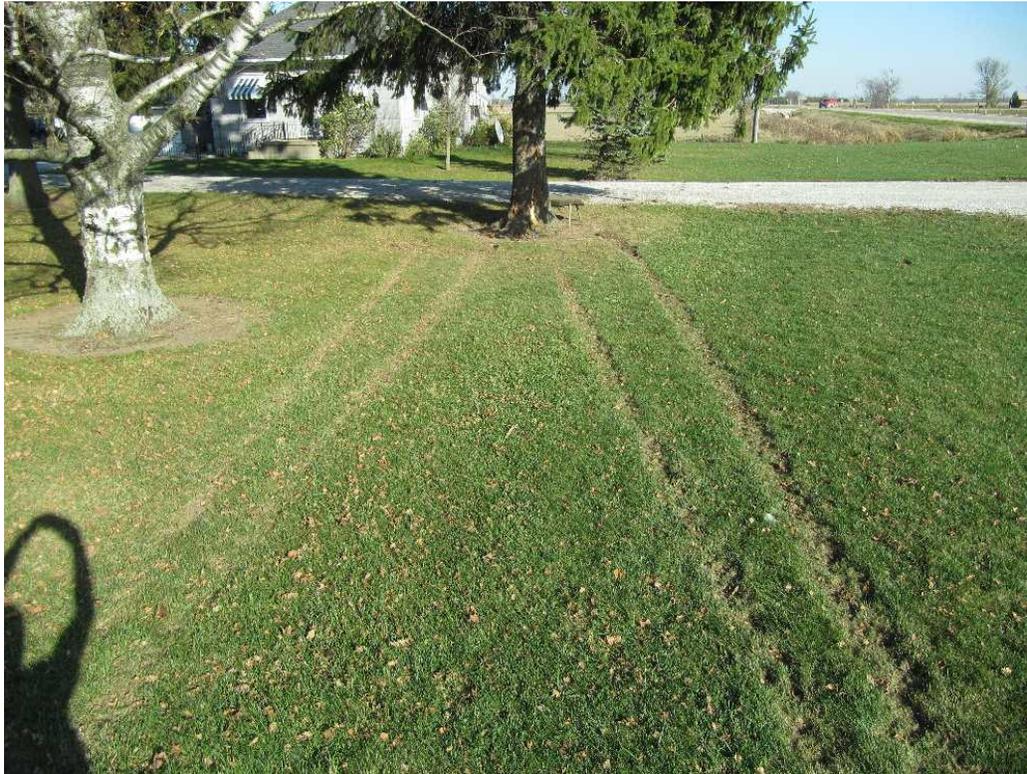
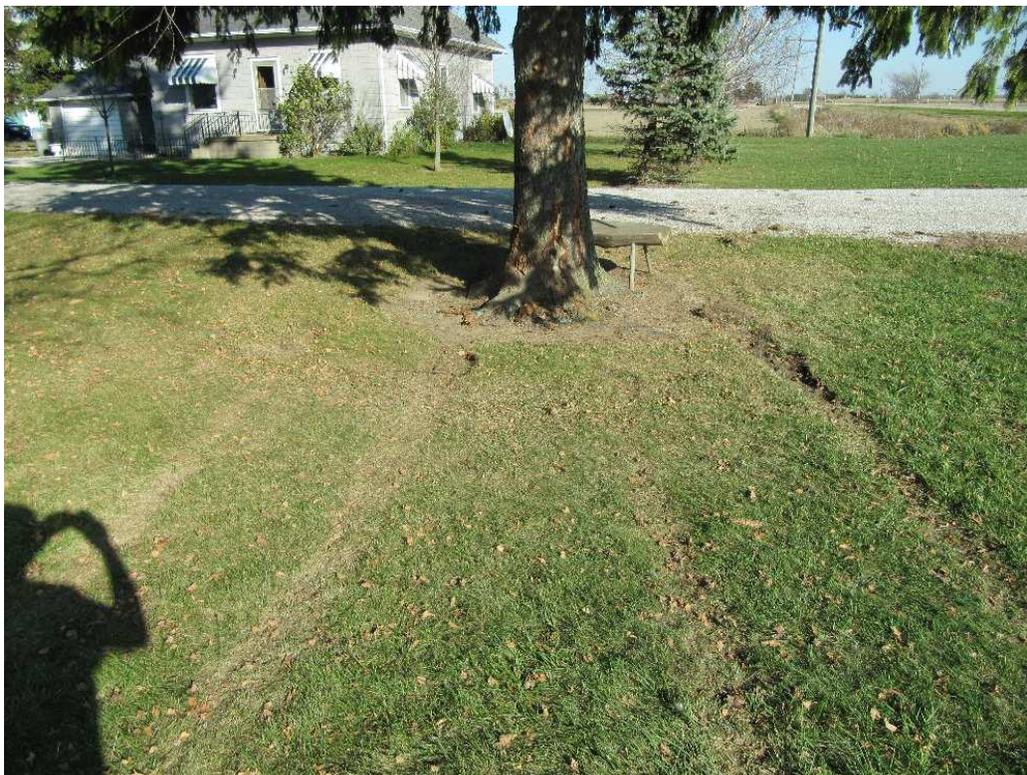
As we approach the tree in the two photos below we can see that the four tire marks from the subject vehicle are clearly outlined in the grass.

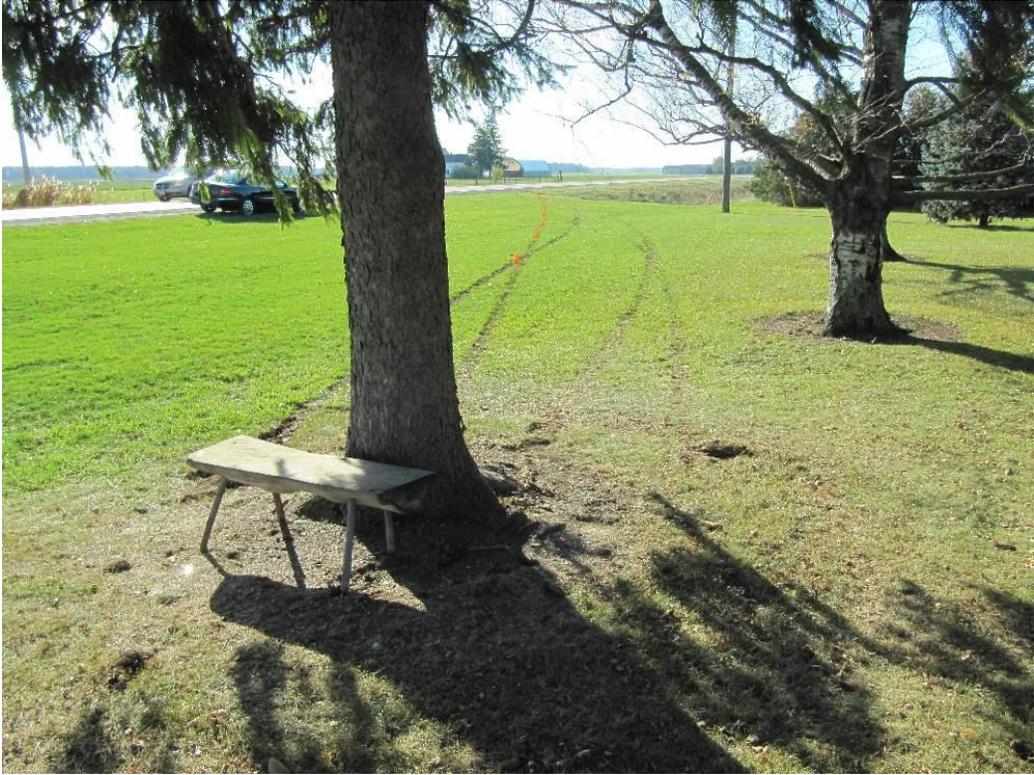
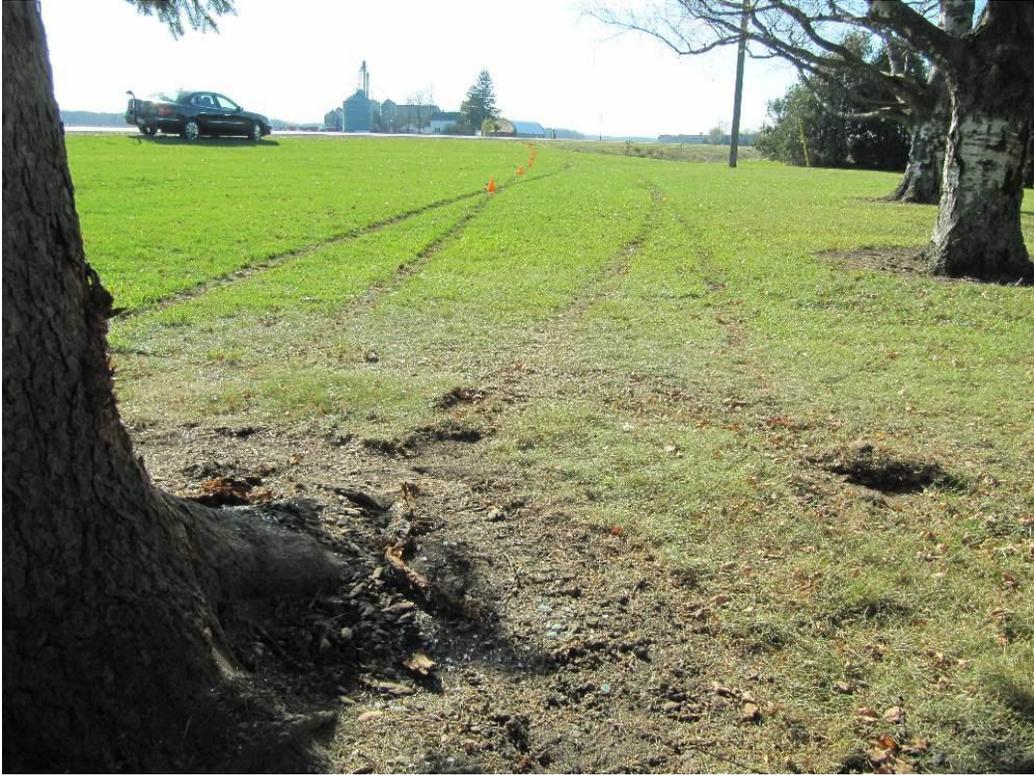
In the two photos below we turn around and view the tire marks from just east of the impacted tree.

It is unfortunate that events unfolded such that the vehicle's impact with the tree was relatively central and that all of the vehicle's remaining speed was lost from the impact. This central impact is evidenced by the fact that the vehicle came to rest at the base of the tree. Had there been some offset from this central impact the vehicle might have rotated, carried on past the tree and this could have resulted in a less severe impact. Often tree impacts result in very localized areas of deep penetration and when that penetration is to the "greenhouse" area of the occupant compartment it is difficult to develop a reliable safety device that can consistently protect that occupant in all cases. But it has been observed that, with non-central impact, and where the occupant's direction of motion is away from the direction of force, injury can be remarkably lessened.
