Photographic Chronology of East Asphalt Edge Breakage at North Curve of Clarke Road North of Fanshawe Park Road

Posting Date: June 7-2015

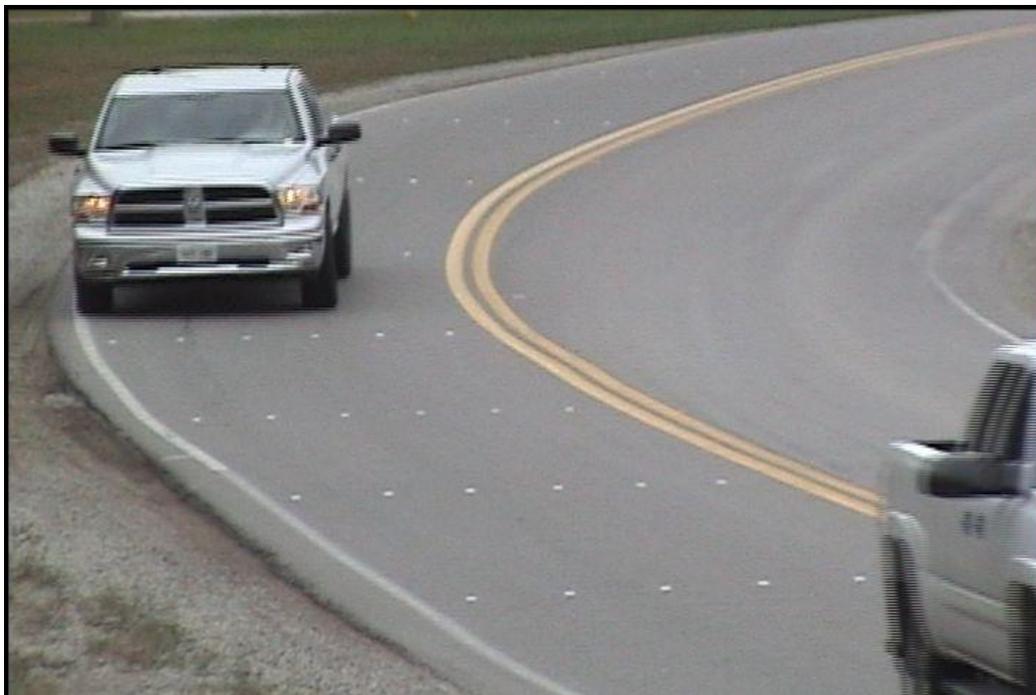
Figure 1: View showing a northbound pick-up truck approaching the north end of the S-Curve on Clarke Road. White markers set up in a grid pattern allowed a detailed assessment of the vehicle's position within the lane.

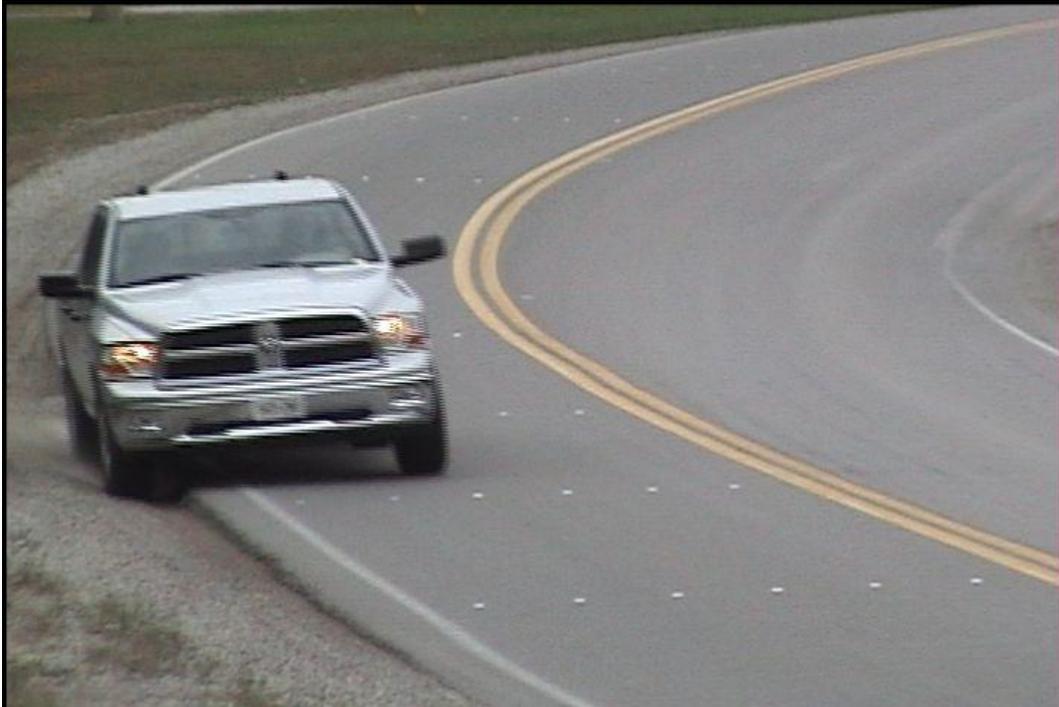
Figure 2: View, 1 second after the view shown in Figure 1. Here the right side wheels of the vehicle have fully fallen off the east asphalt edge.

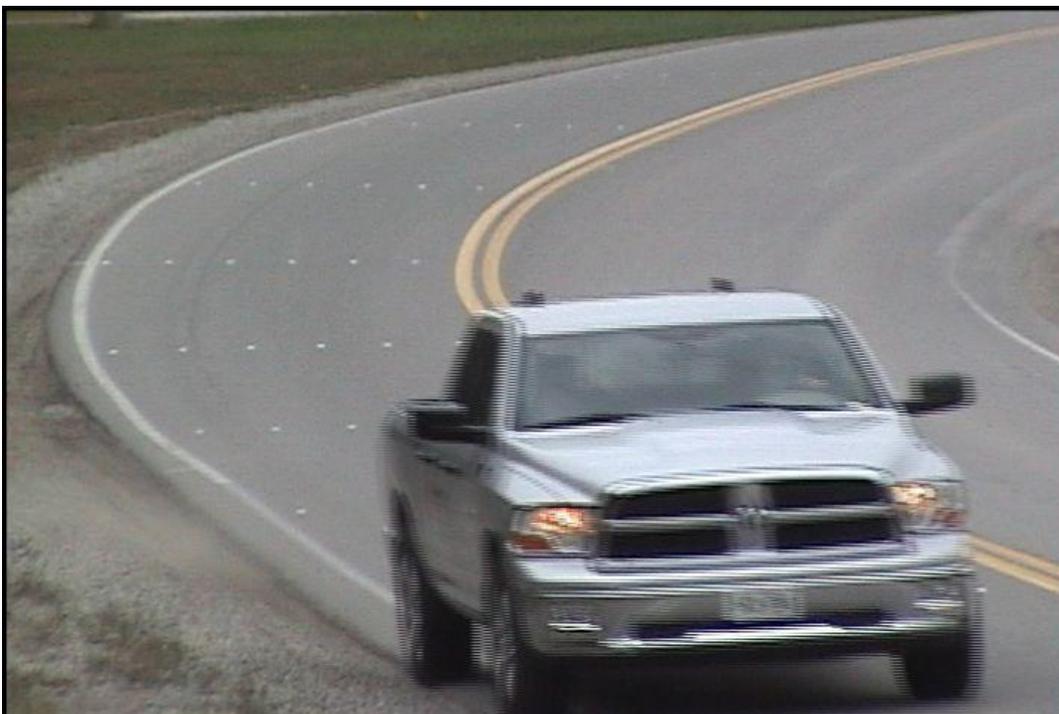
Figure 3: View, 1-second after the view shown in Figure 2. Here the vehicle has almost re-emerged back onto the asphalt road surface.

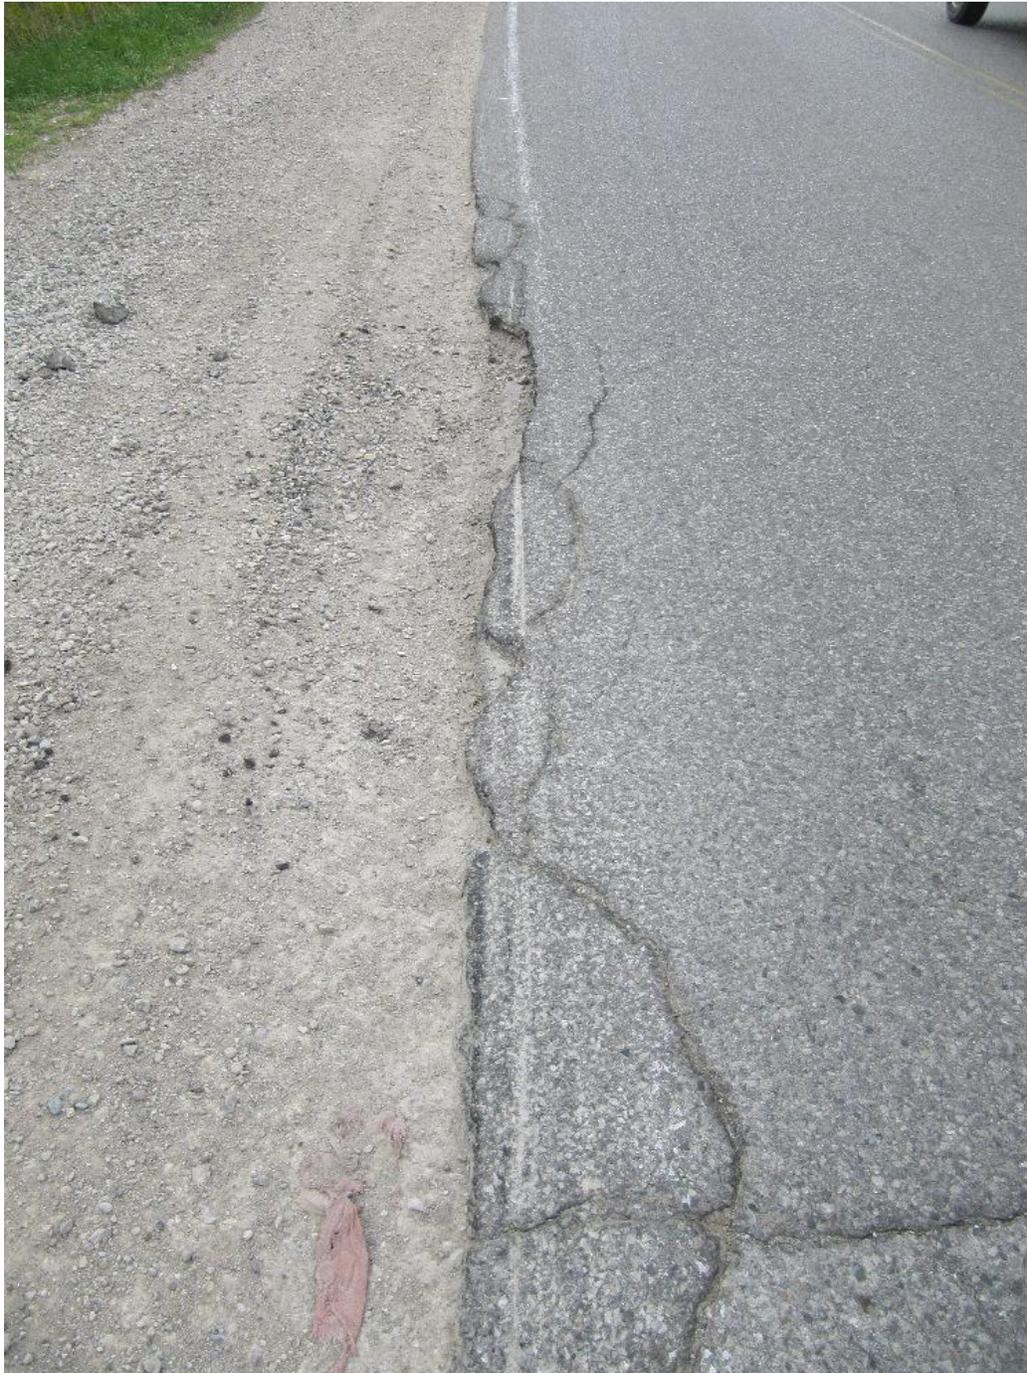
Figure 4: View looking south on May 25, 2015

The testing in the above figures was conducted in the fall of 2009. Figure 4 below shows a southward view of the east edge of the pavement at the location where the Pick-up truck in the above figures slipped off the asphalt edge. This photo was taken on May 25, 2015, or 5 1/2 years later, and we can see that the edge of the pavement has broken away.

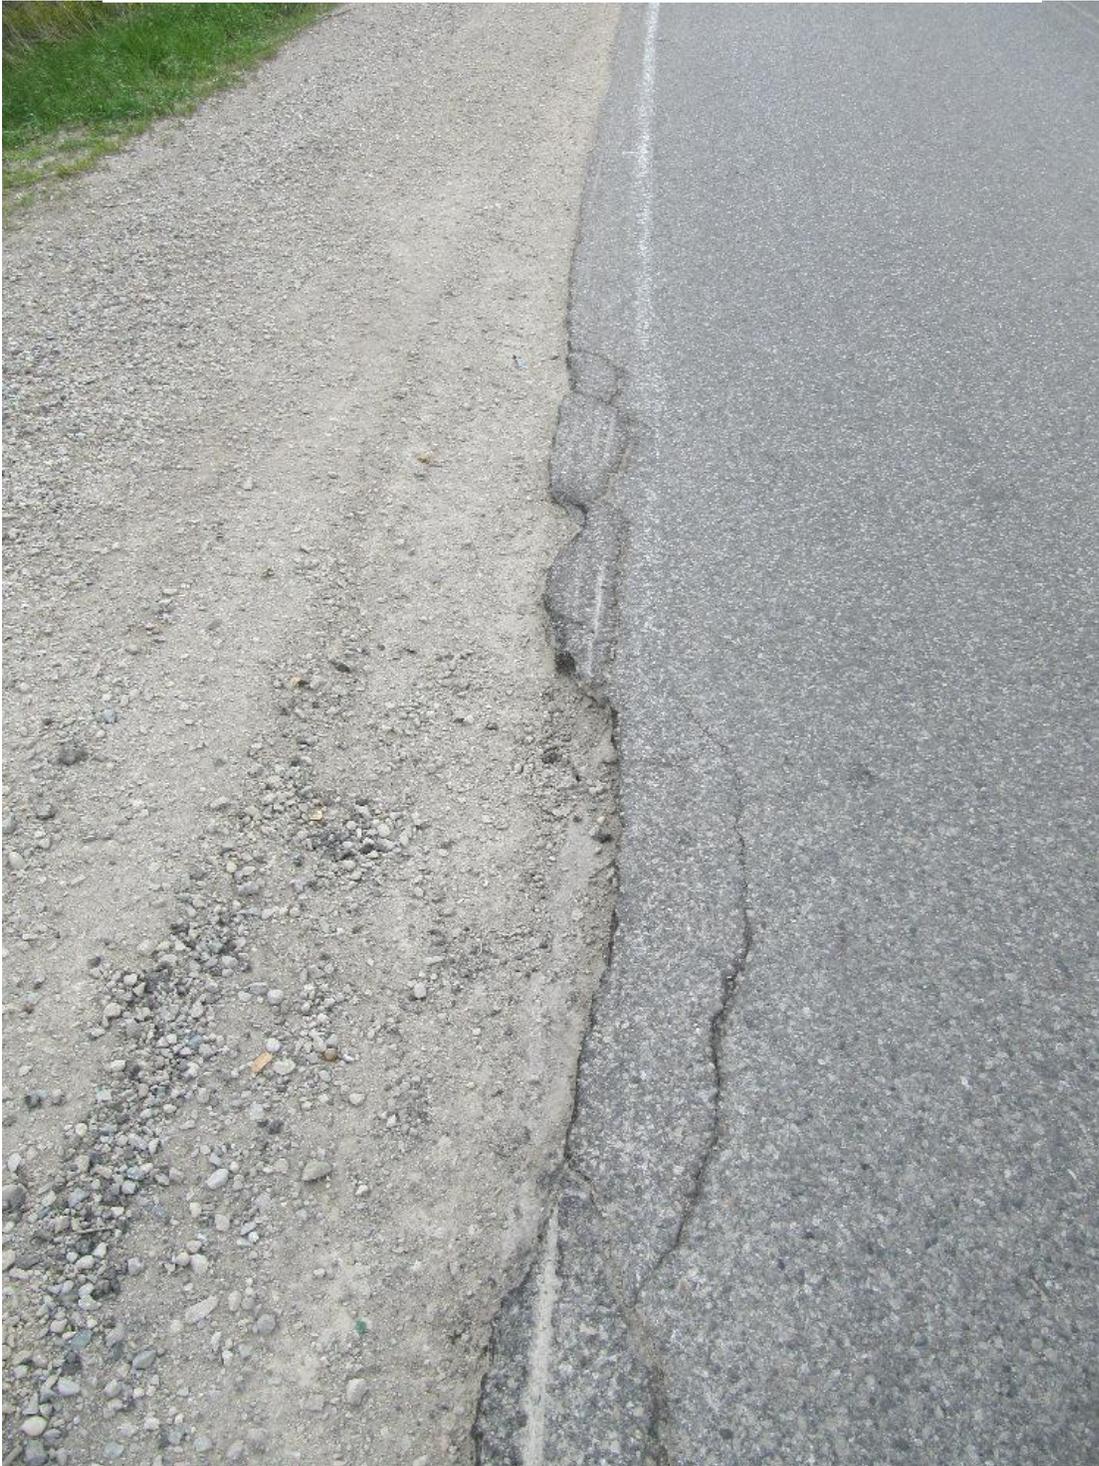
Figure 5: View looking south, of east asphalt edge on May 25, 2015

Figure 5 shows another view of the same location but slightly further south.

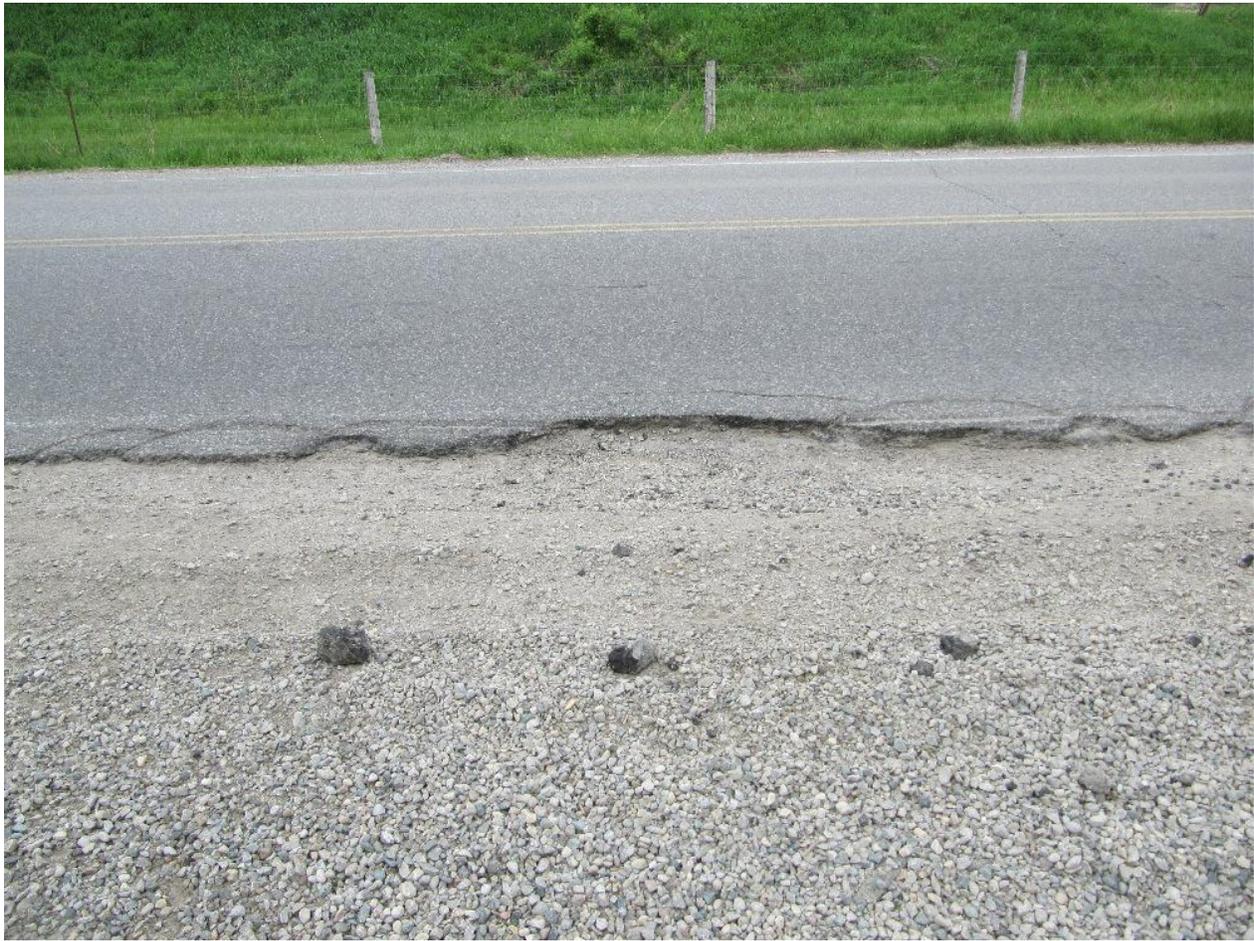
Figure 6: View looking west, of condition of east asphalt edge on May 25, 2015.

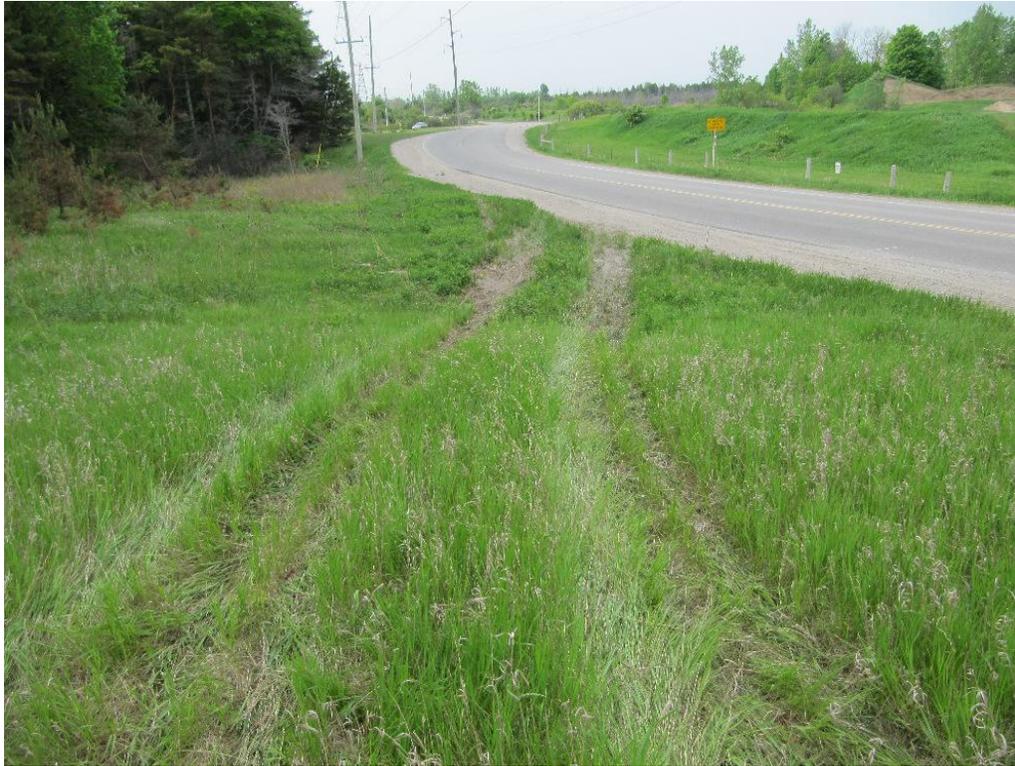
Breakage of the asphalt edge at this location is a concern because, during our examination on May 25, 2015, we identified evidence of fresh collision events on the east roadside, north of the curve. For example, Figure 7 shows fresh tire marks in the east roadside caused by a large, northbound truck. Figures 8 and 9 also show evidence of a vehicle that rolled over after climbing a small embankment on the east roadside.

Figure 7: View of fresh tire marks in the east roadside where a northbound truck travelled off the northbound lane of Clarke Road that the curve.

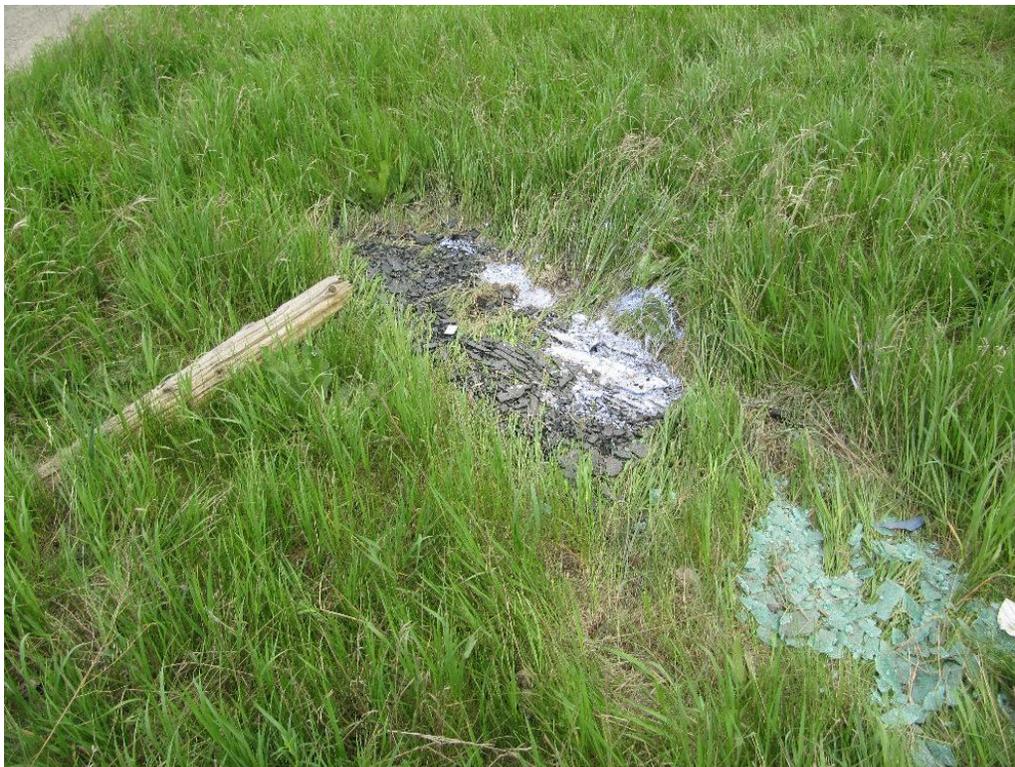
Figure 8: Fresh evidence of broken glass deposited on the east roadside as a result of a vehicle rollover.

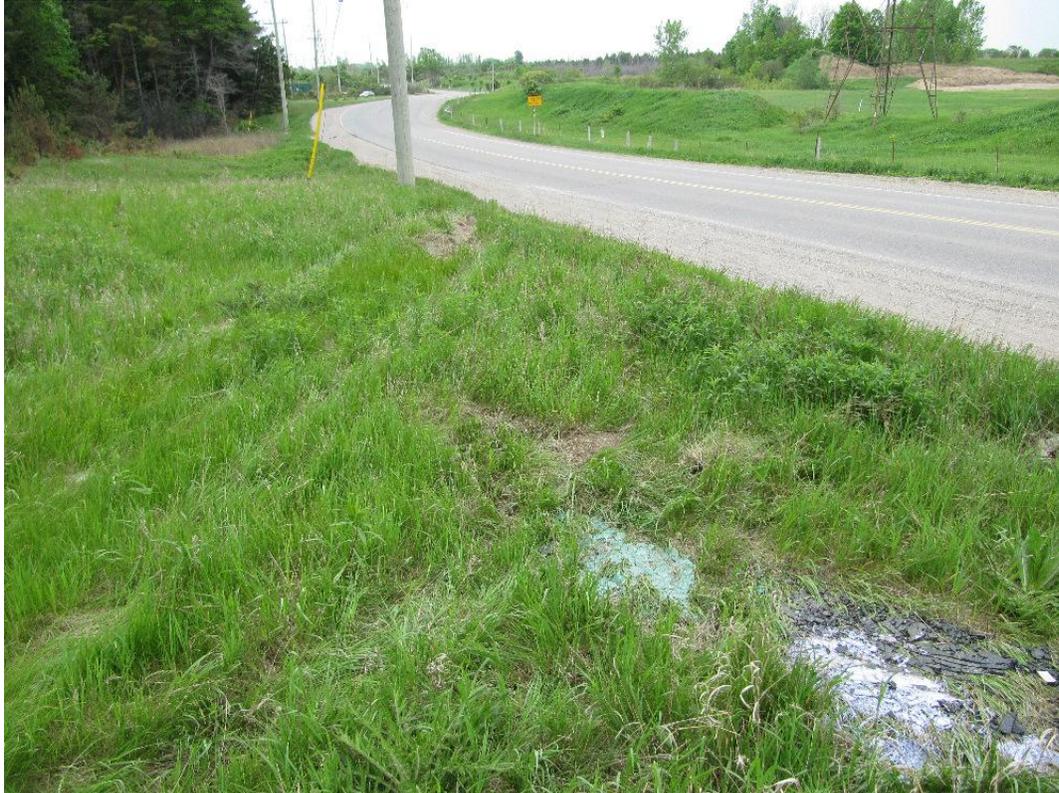
Figure 9: Southward view showing the relationship between the broken glass from the rollover collision the north curve of Clarke Road.

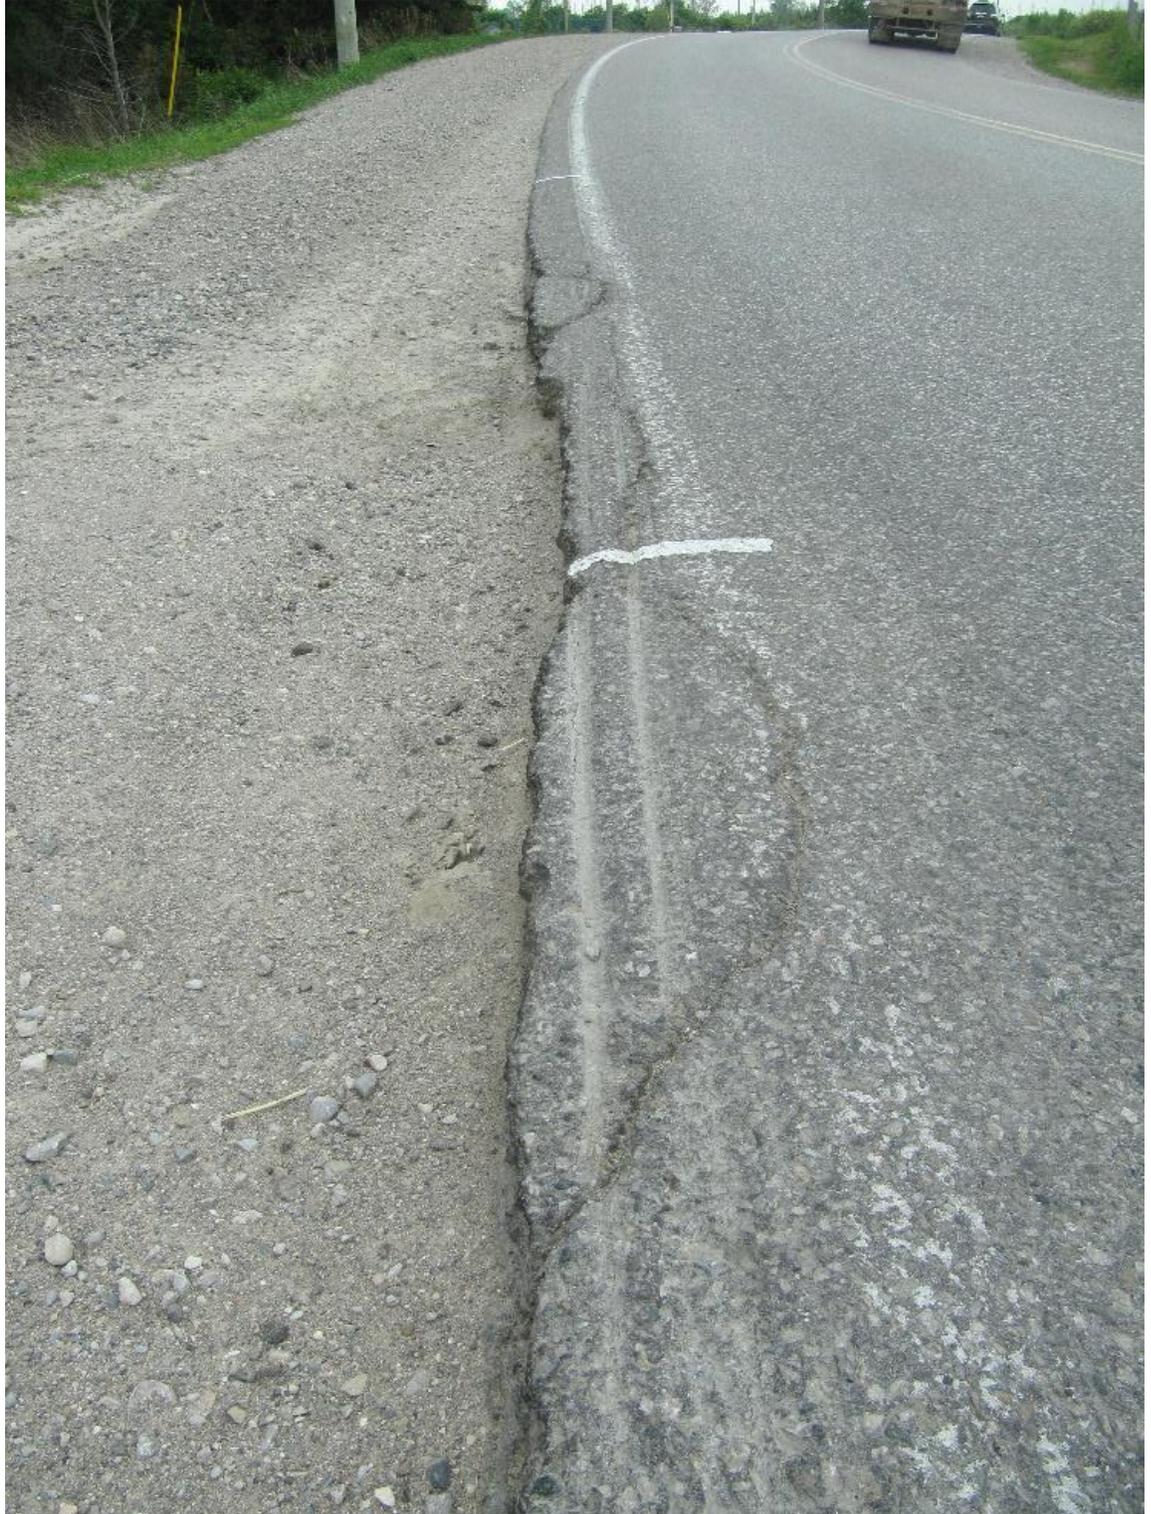
Figure 10: View, looking south, of east asphalt edge on June 2, 2014.

Figure 10 shows a southward view of the east asphalt edge taken on June 2, 2014. We can see that there has been some breakage of the pavement edge and, comparing this to Figures 4 and 5 we can see what portion of the pavement eventually broke off by May 25, 2015.

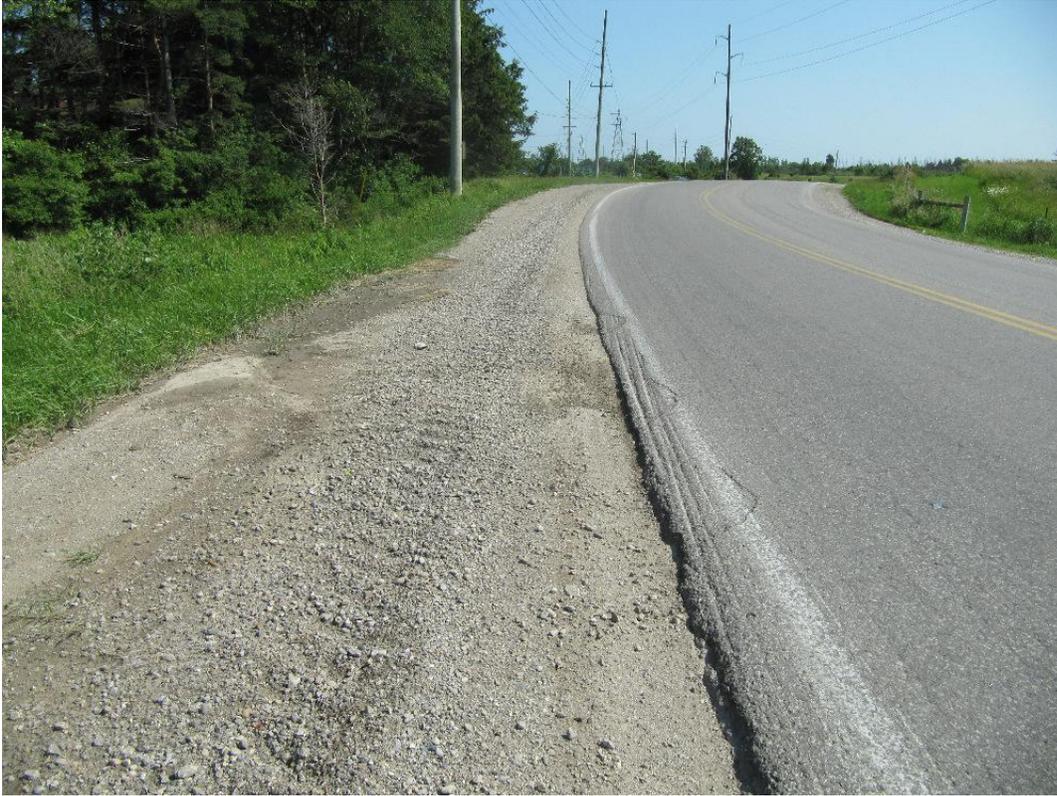
Figure11: Southward view from June 23, 2013.

Figure 11 shows a southward view from June 23, 2013. Here we see some curved cracks have formed but the pavement edge is still relatively intact.

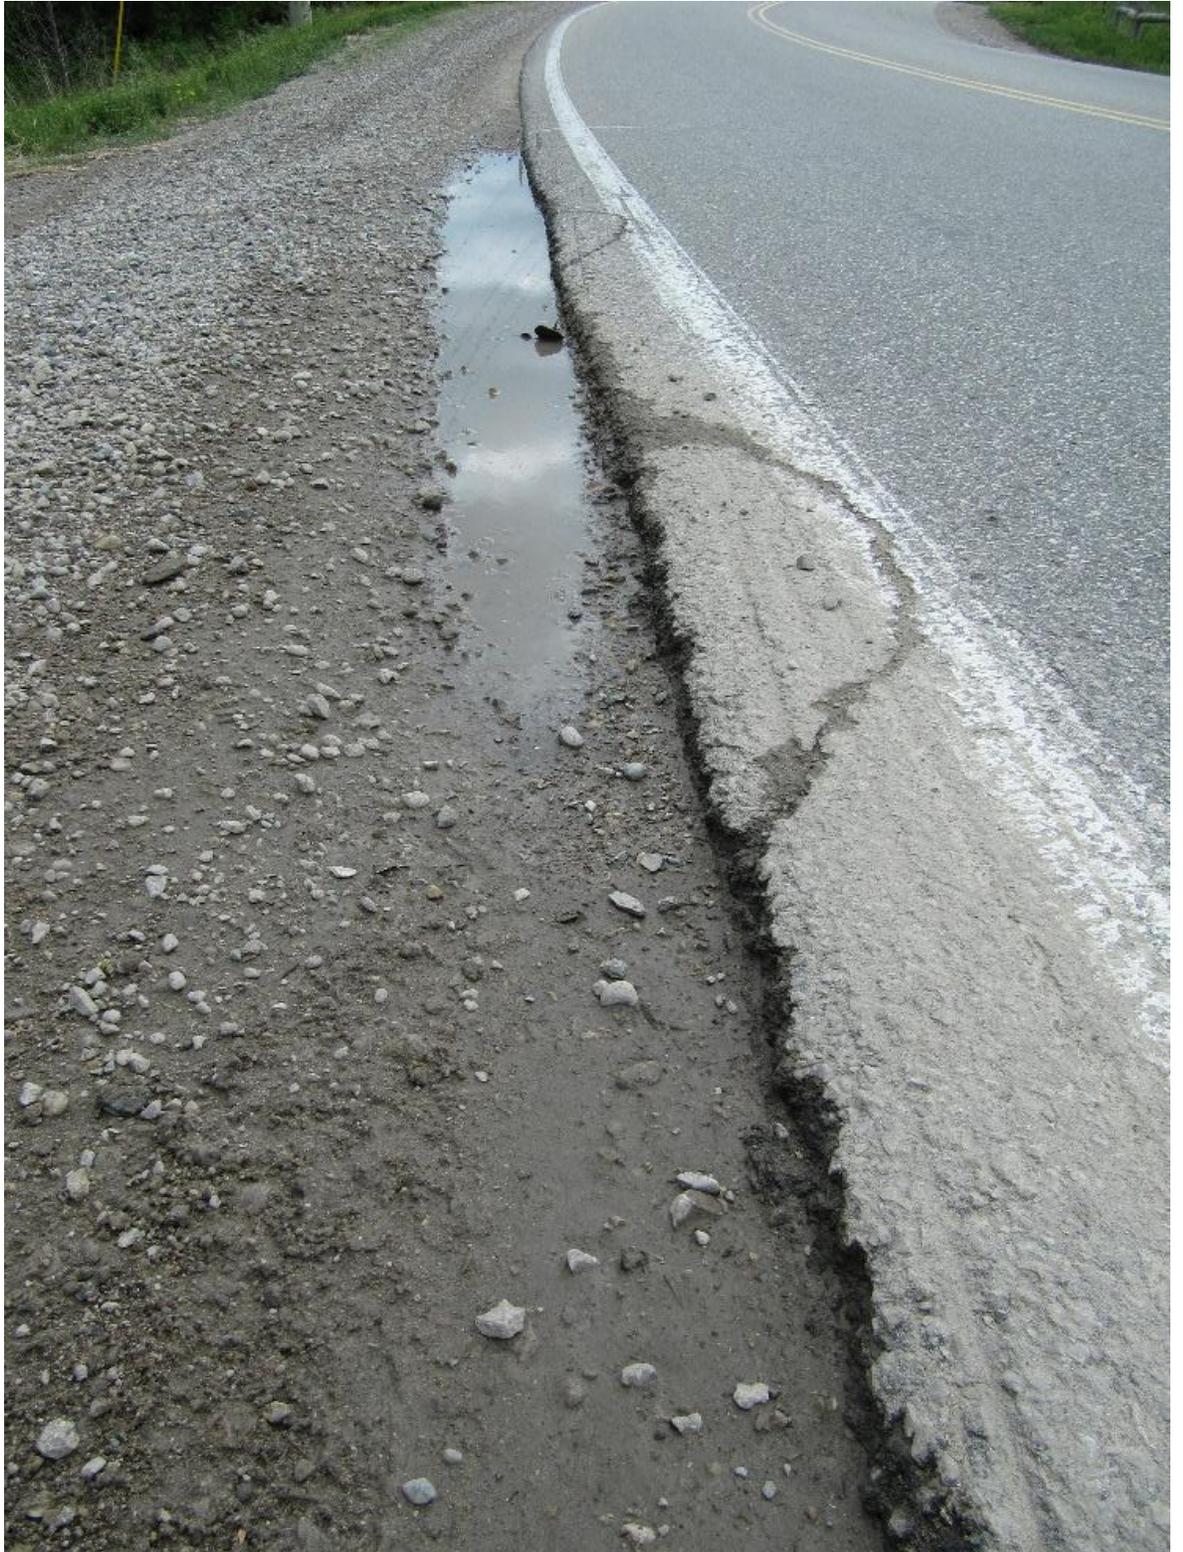
Figure 12: Southward view from June 2, 2012.

Figure 12 takes us to June 2, 2012 and a southward view. Here we see two arcs of cracking in the pavement edge but the edge has not broken away.

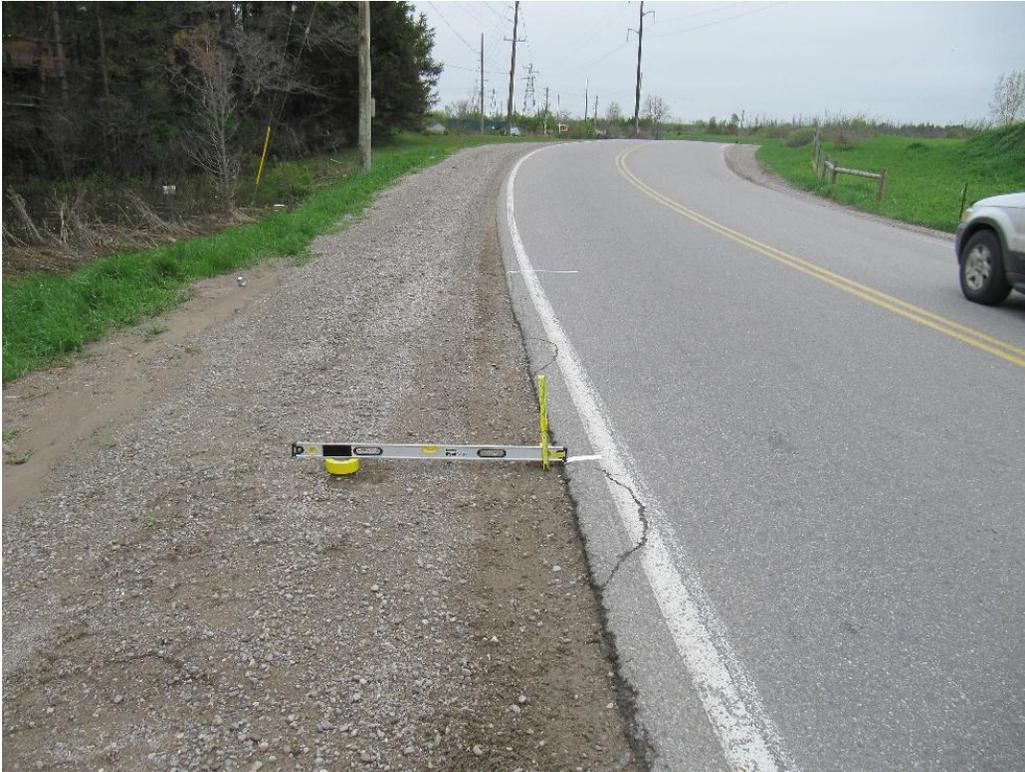
Figure 13: Southward view from May 17, 2011.

Figure 13 is a southward photo taken on May 17, 2011. Two arcs of cracking in the pavement are visible near the east asphalt edge but the edge has not broken away.

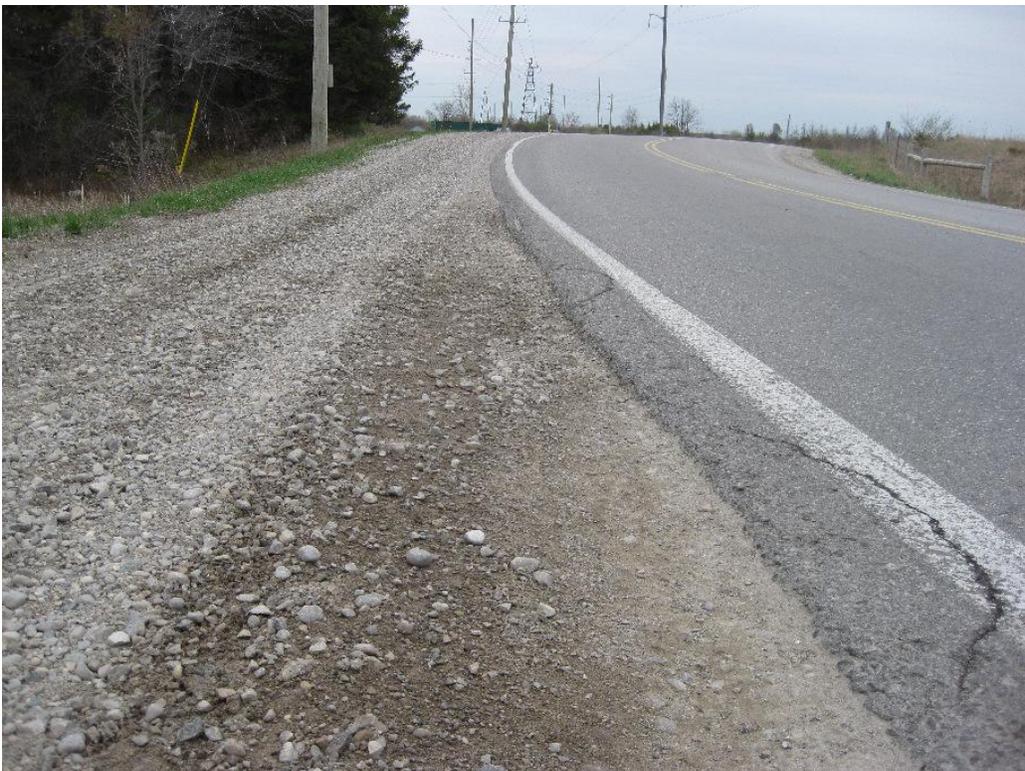
Figure 14: Southward view from April 16, 2010.

Figure 14 shows a southward view from April 16, 2010, showing no evidence of any cracking along the pavement edge.

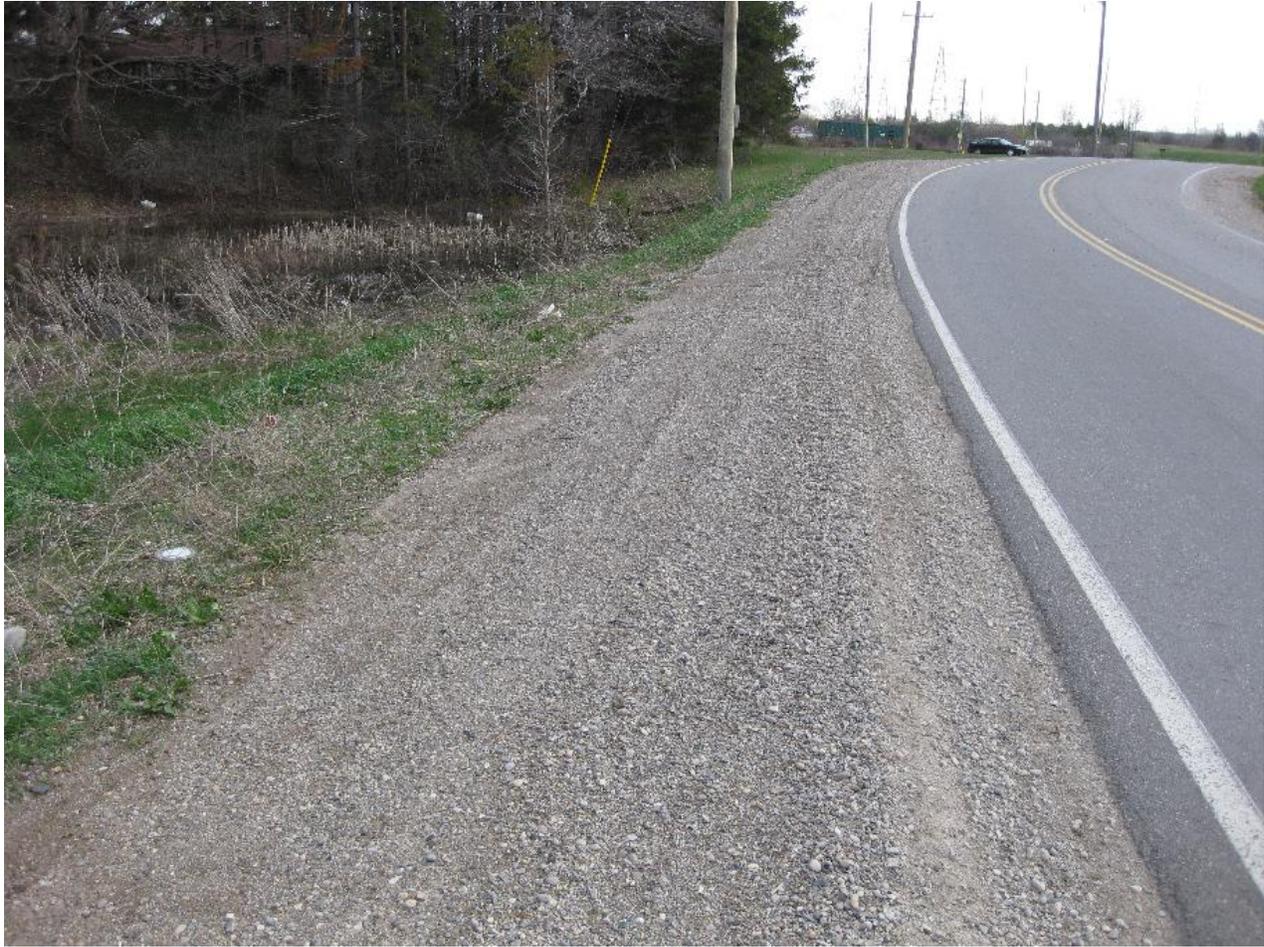
Figure 15: View, looking south on April 28, 2009.

Finally, Figure 15 shows the status of the east asphalt edge on April 28, 2009. There is no cracking of the pavement or breakage of its edge.
