Road Authorities Faced With Difficult Decisions Regarding Replacement of Damaged Guardrail End Terminals

Posting Date: 18-Nov 2014

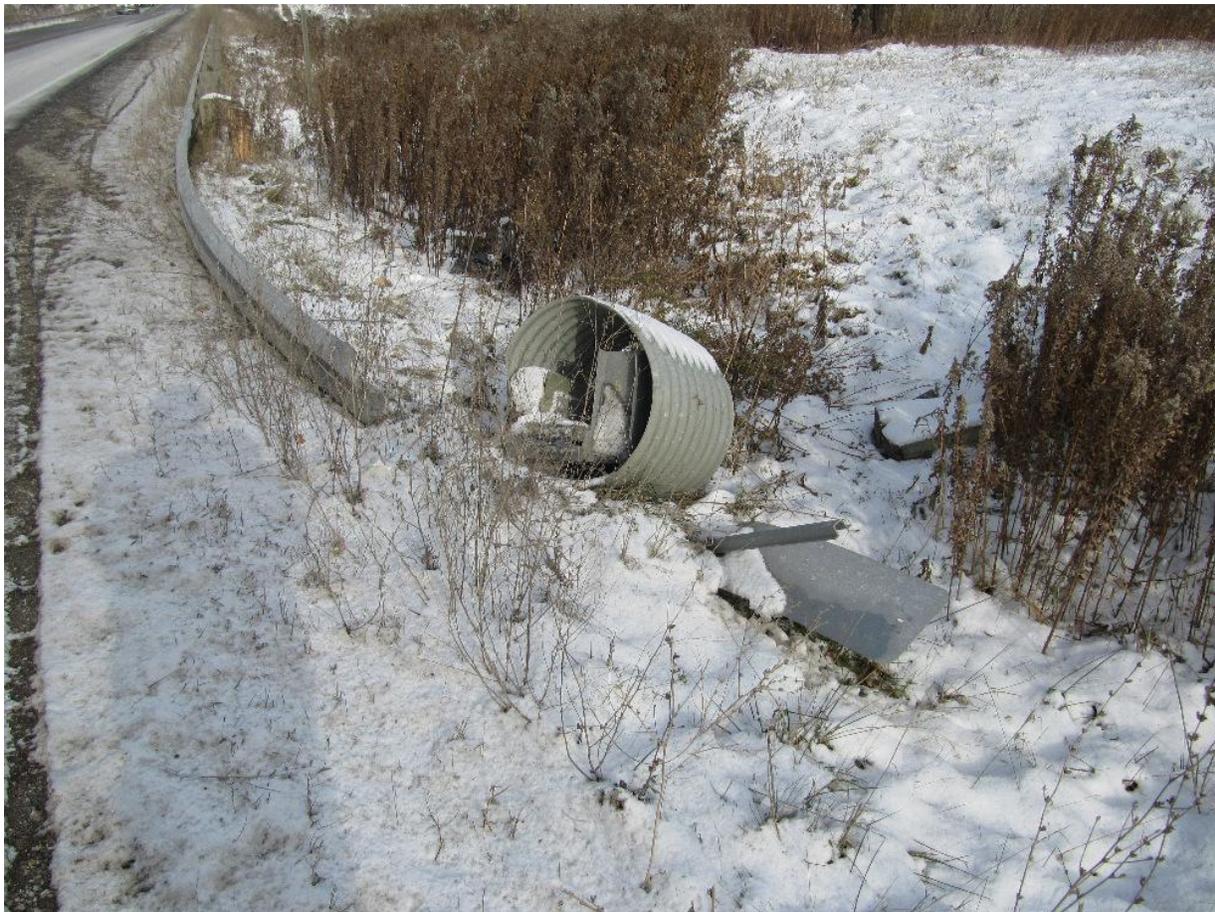
Figure 1: View of older-style guardrail end that was struck on November 17, 2014 on Clarke Road, on the south end of the Thames River, in London, Ontario. This guardrail repair has been made quickly.

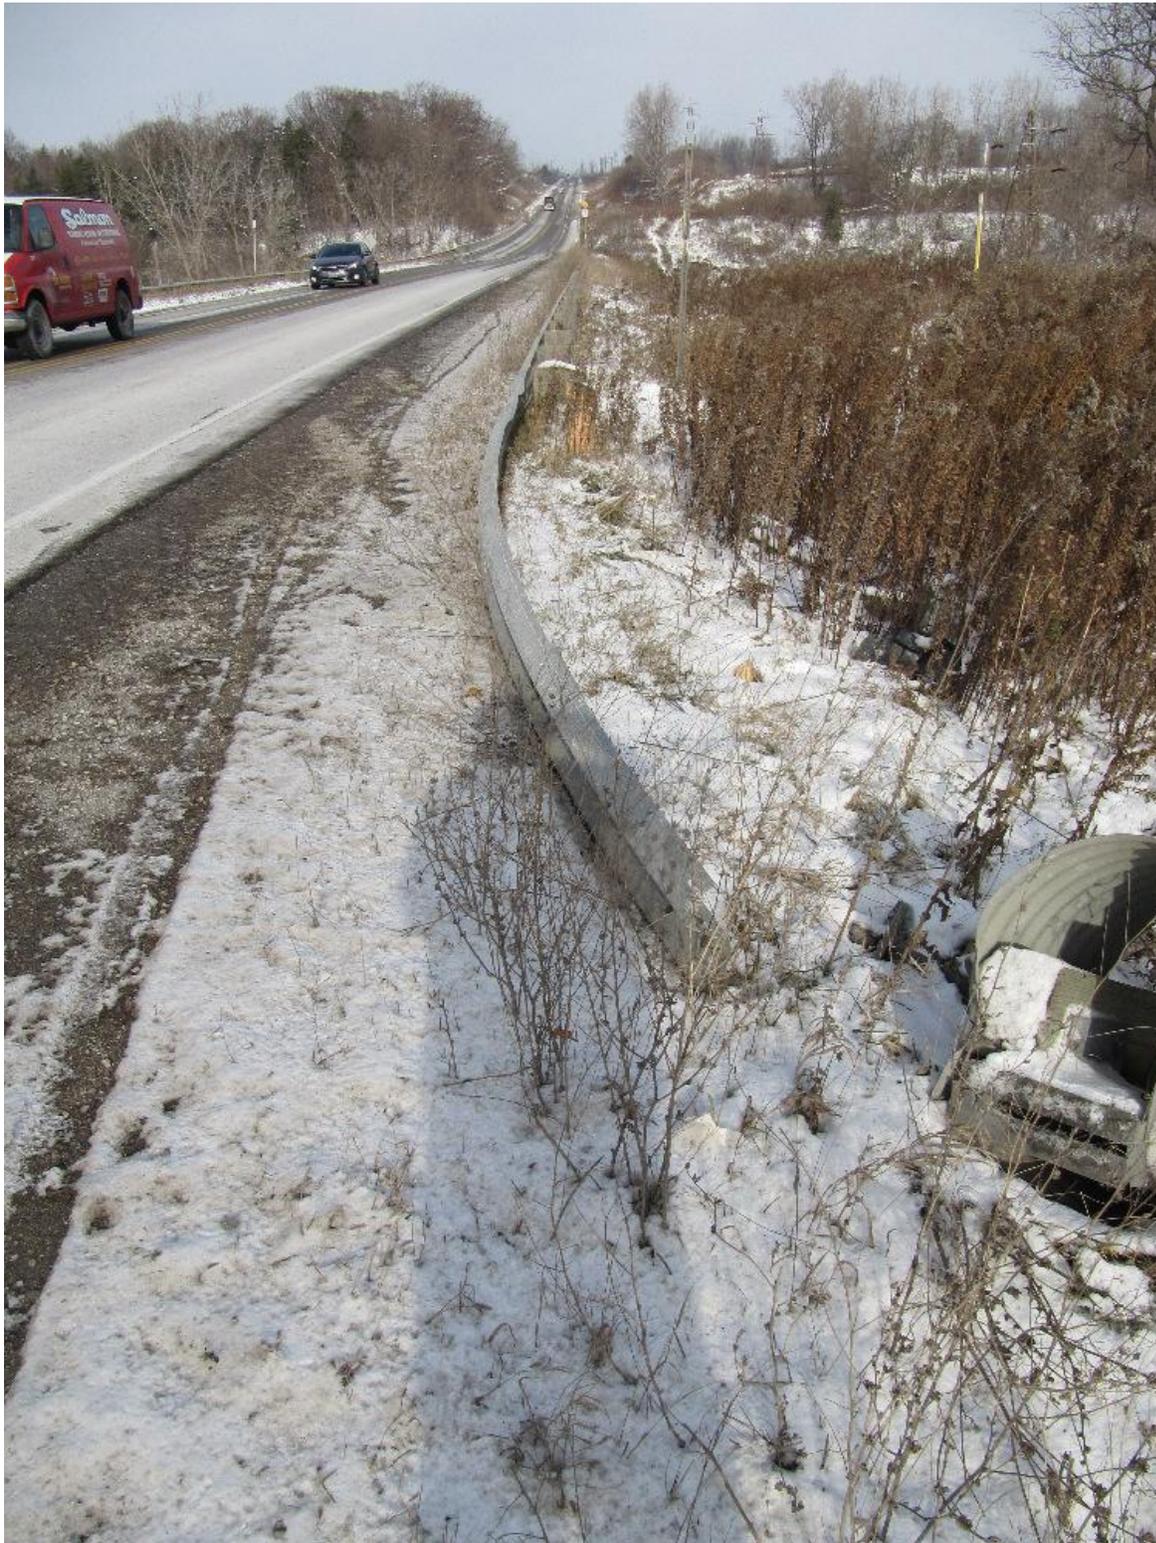
Although we were not present to examine the circumstances of this collision we suspect that the explanation for the damage is quite clear. The guardrail was not struck by a northbound vehicle, but rather, by a southbound vehicle.

Figure 2: In a peculiar result, the barrel terminal of this guardrail appears to have been pushed aside and the guardrail itself appears relatively undamaged and not collapsed.

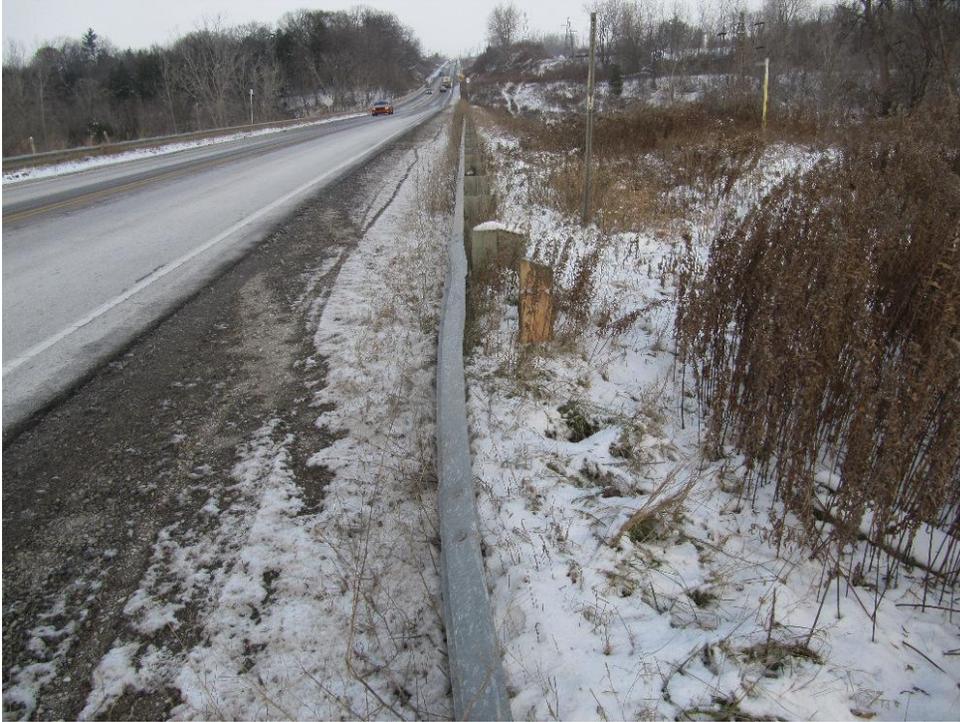
Figure 3: Evidence of tire marks on the gravel shoulder next to the start of the damage to the guardrail suggest that a southbound vehicle crossed over to this east side of the road and struck the guardrail and continued southward.

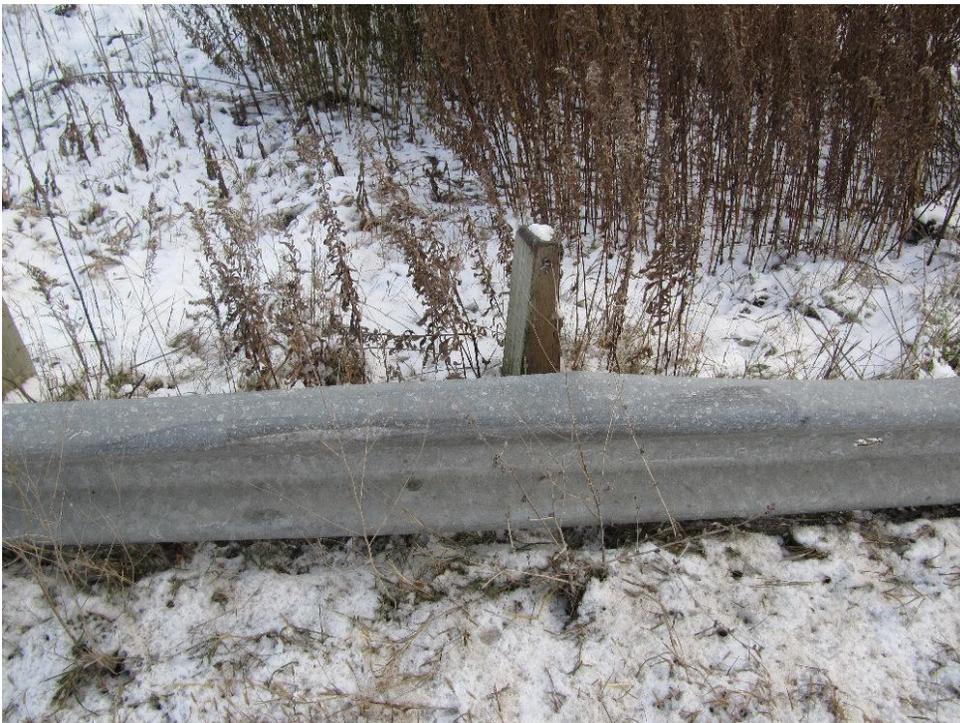
Figure 4: Contact evidence exists along the face of the guardrail that indicates that the striking southbound vehicle was deflected and continued further southward.

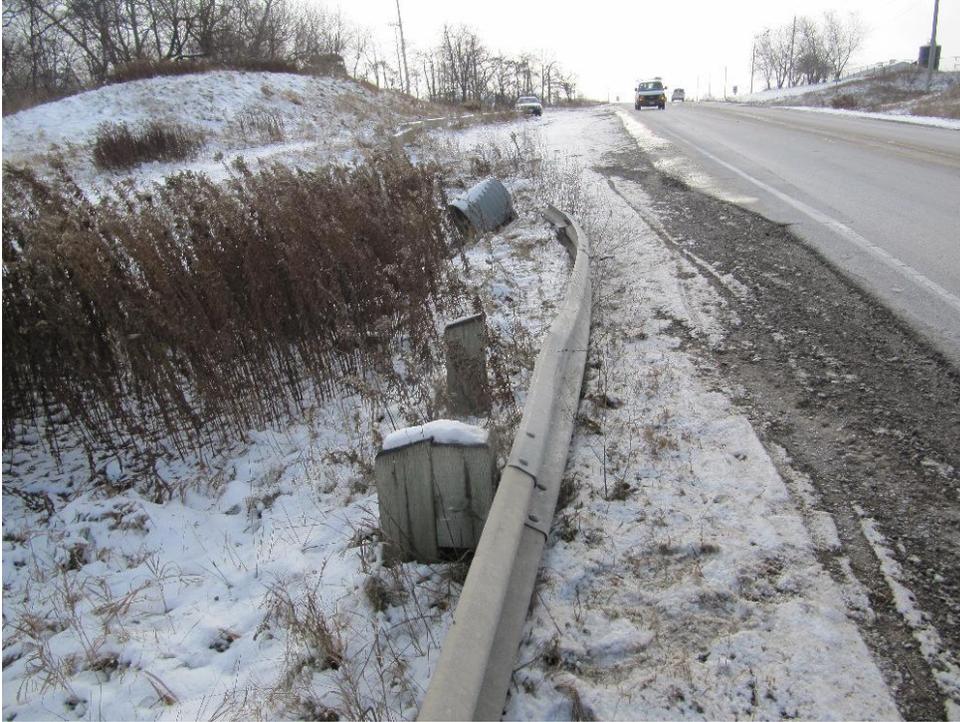
Figure 5: View, looking south, along the east guardrail, showing the damage evidence and eventual impact with the barrel terminal in the background.

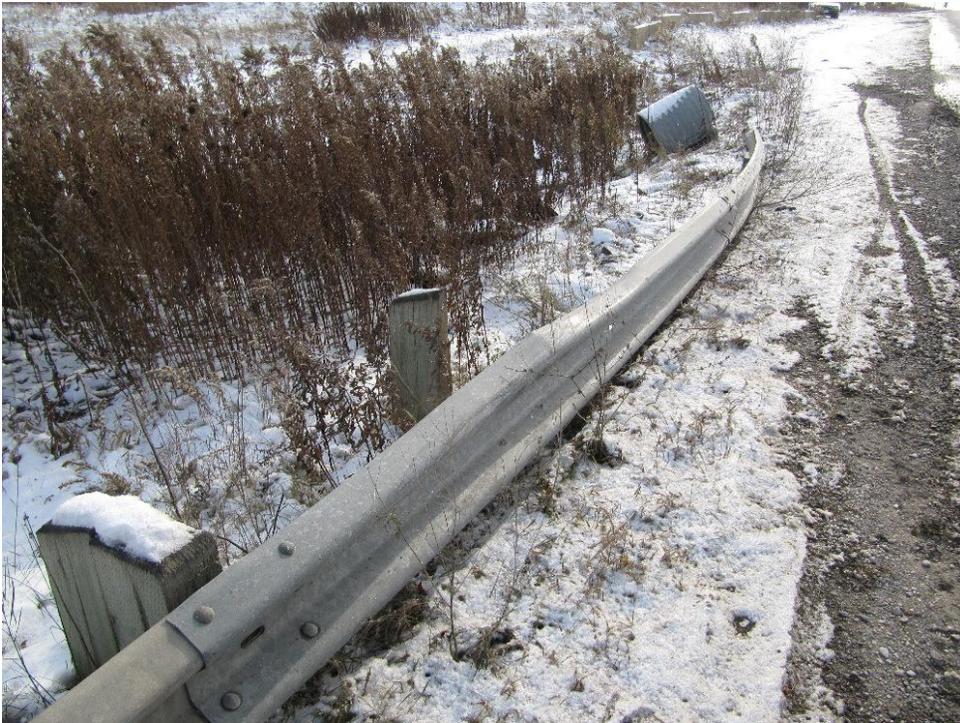
Figure 6: View of contact evidence along the face of the guardrail from impact by a southbound vehicle.

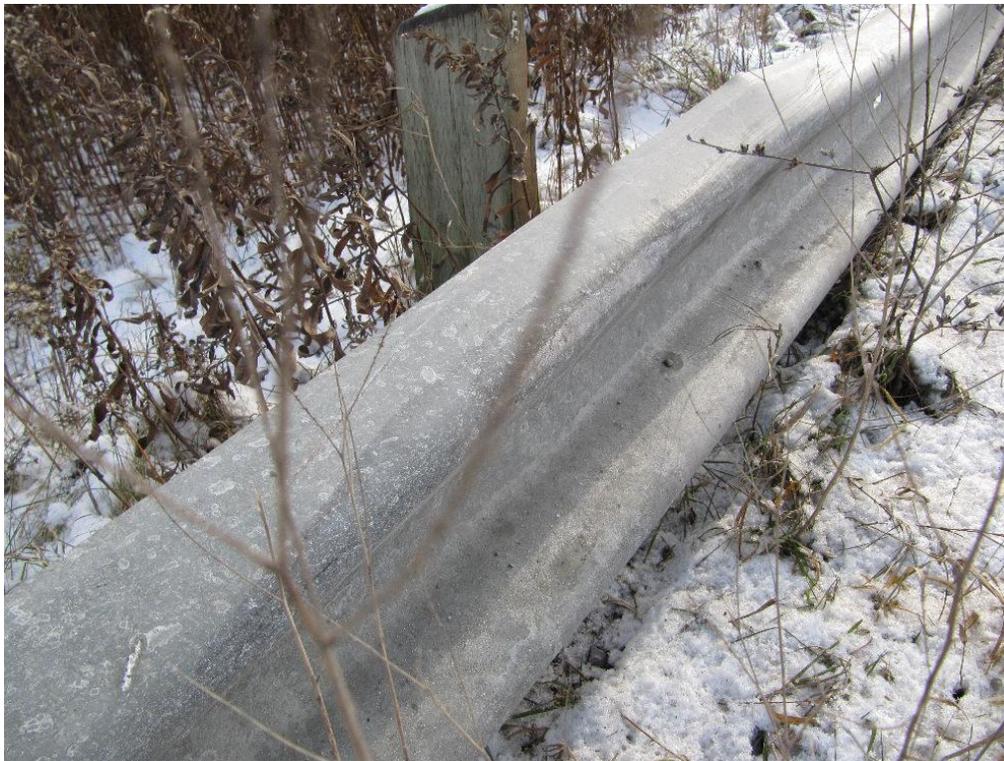
Figure 7: Close-up view of contact evidence on the rail indicating the deflection of the striking, southbound vehicle.

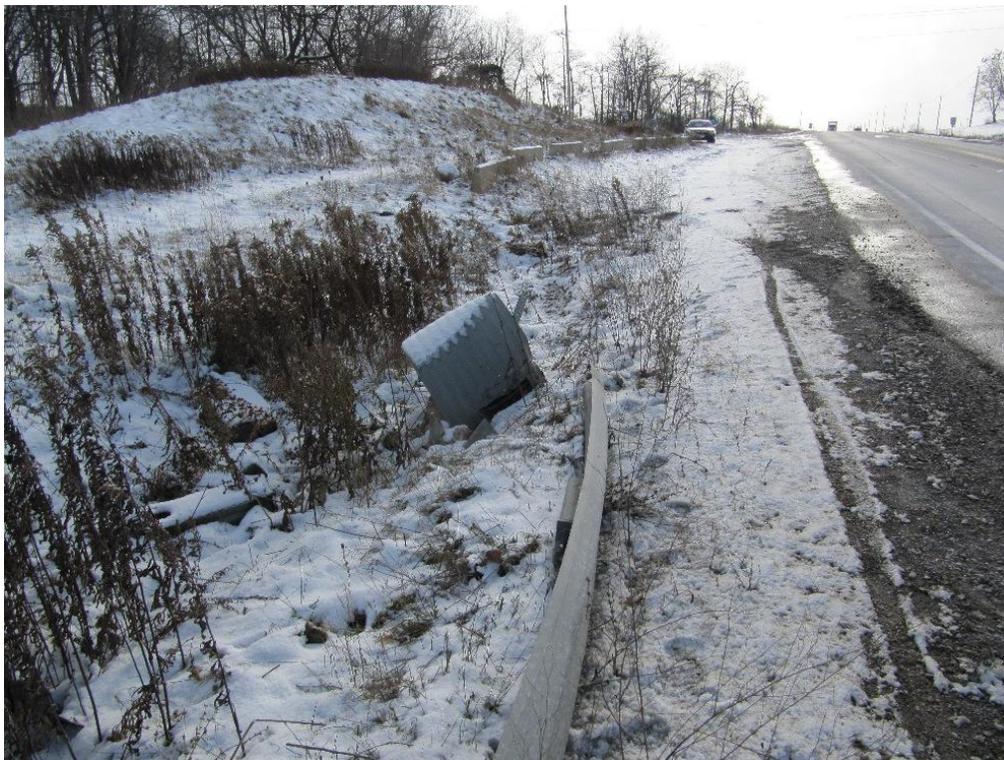
Figure 8: View of the south end of the guardrail where the barrel terminal was ripped off of its anchorage by the striking southbound vehicle.

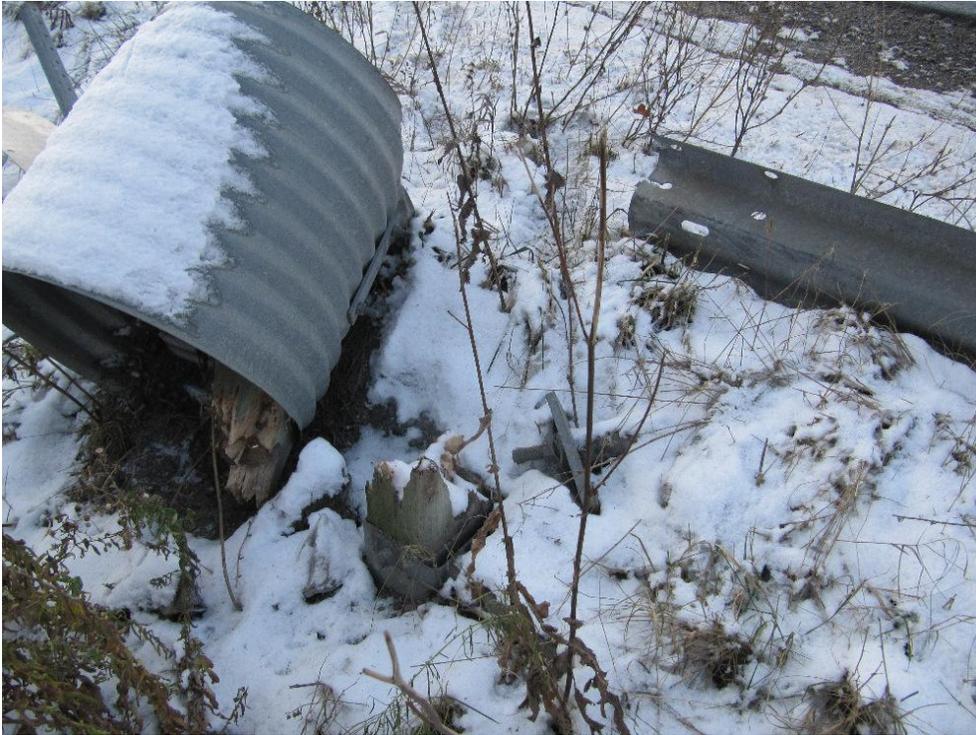
Figure 9: View of the barrel terminal and the south end of the guardrail indicating no compression of the rail thus confirming the southward direction of the impact force.

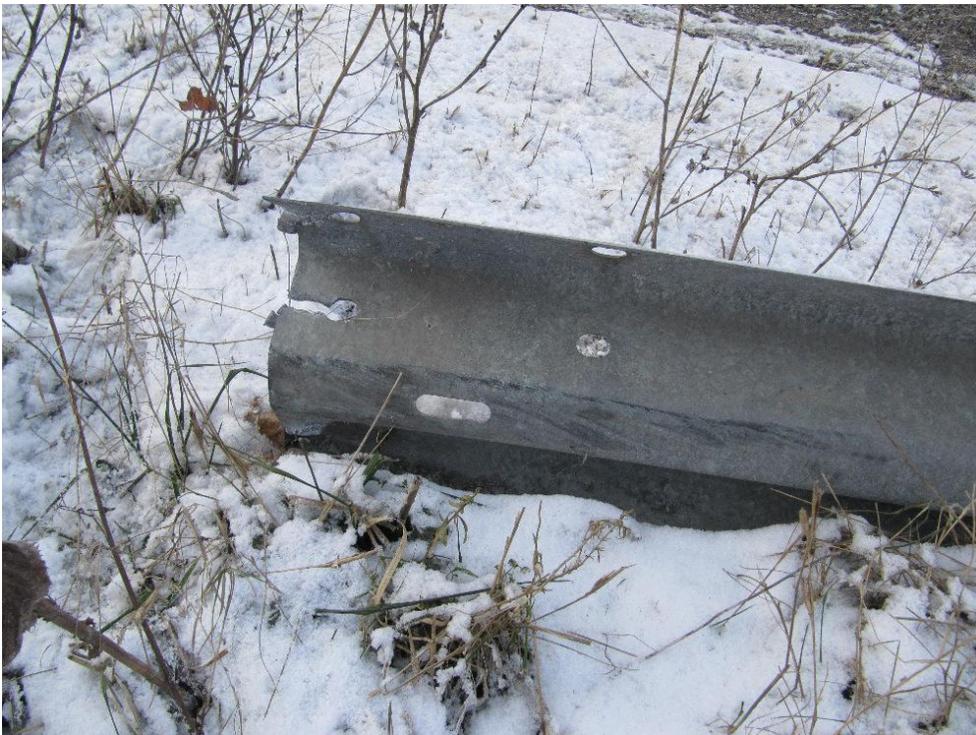
Figure 10: View of south end of the guardrail where the anchor bolts for the barrel terminal were ripped out of the rail by the southward impact force.

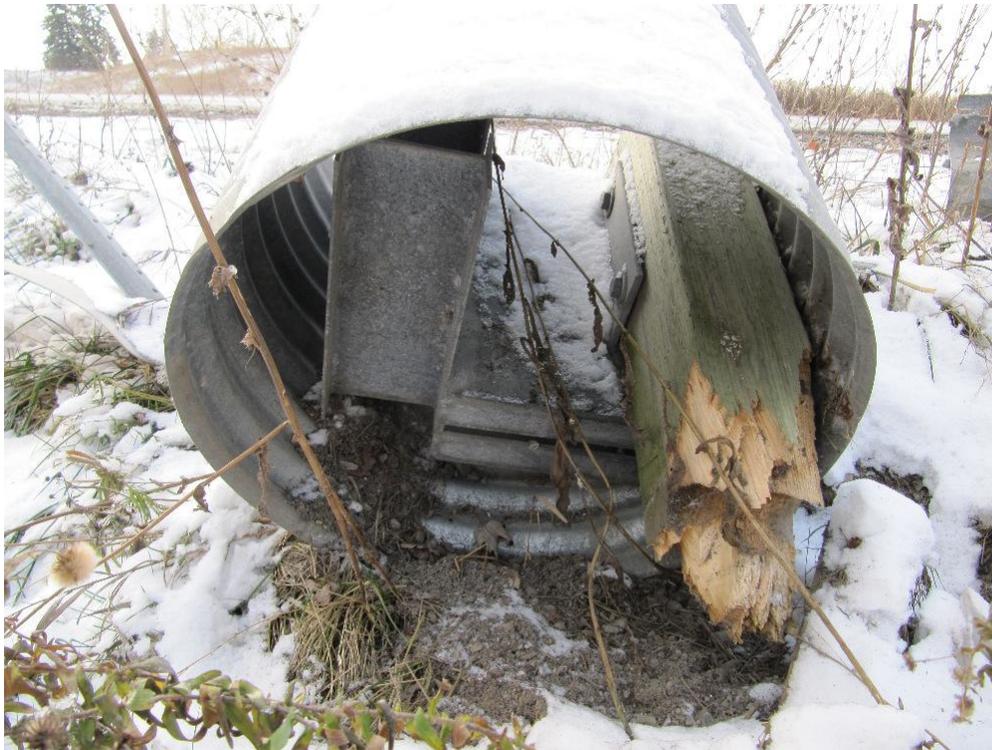
Figure 11: Overall view of the relatively un-deformed shape of the barrel terminal.

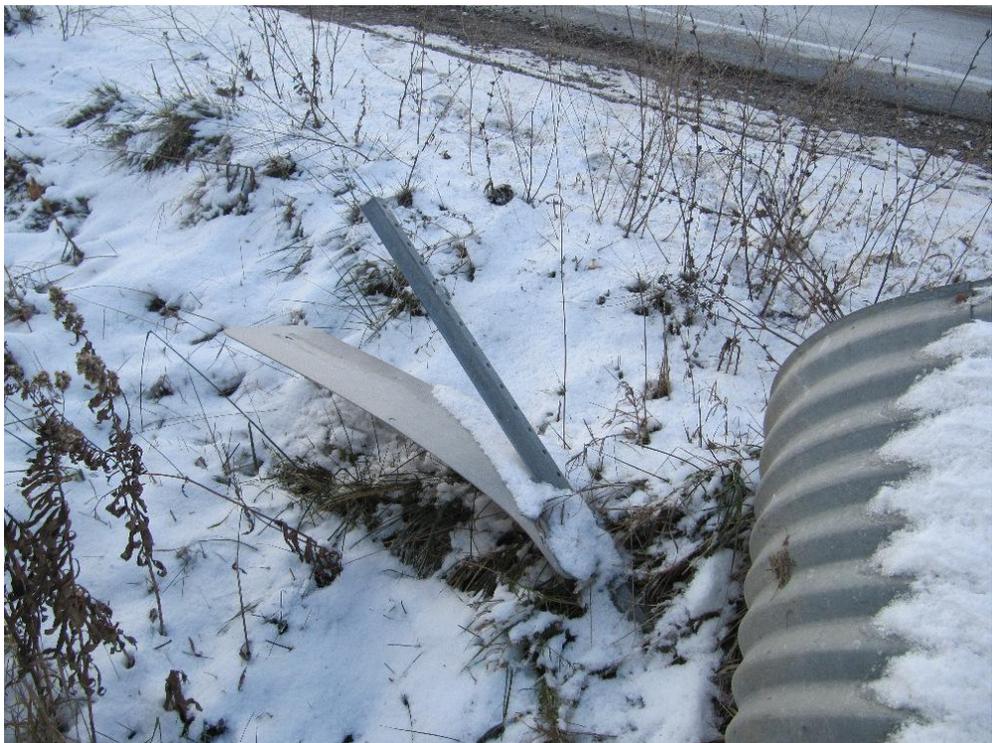
Figure 12: Further evidence of the southward impact force is displayed by the southward deformation of the hazard warning sign.

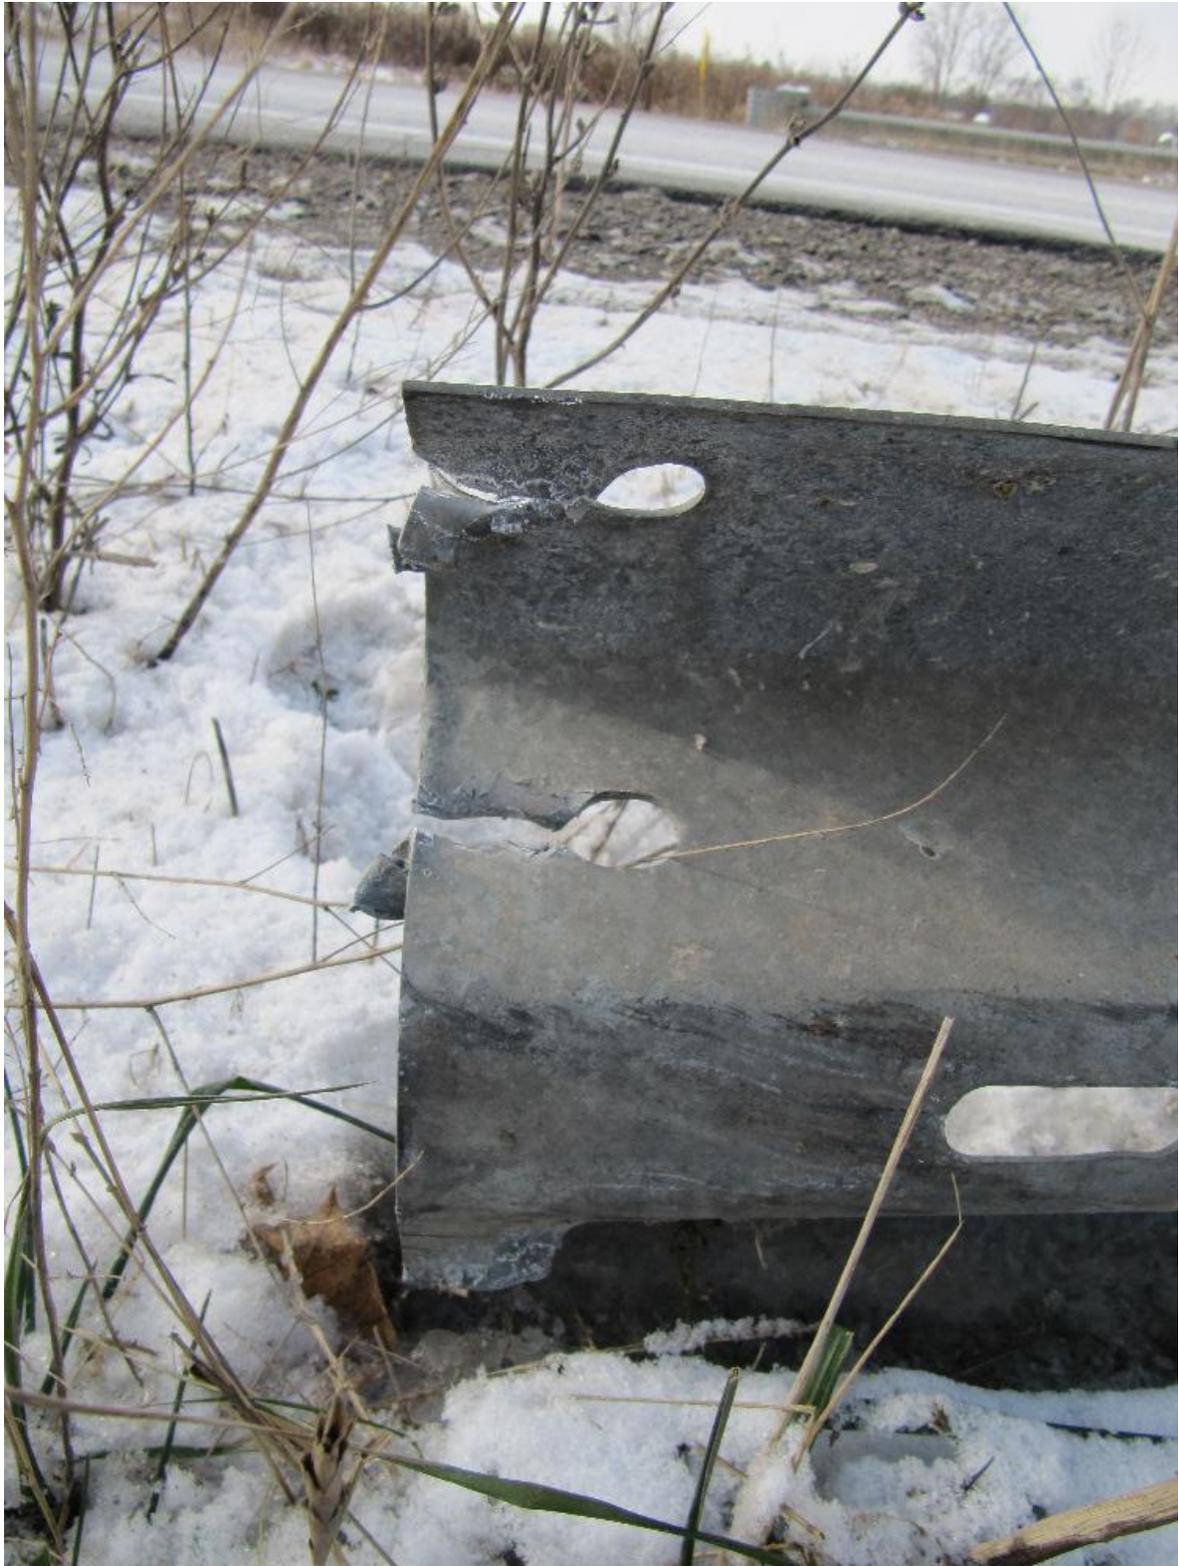
Figure 13: close-up view of the torn south end of the rail where the barrel terminal was ripped away.
