Rollover Fatality On Highway 402 At Colonel Talbot Road

Posting Date: 25-July 2013

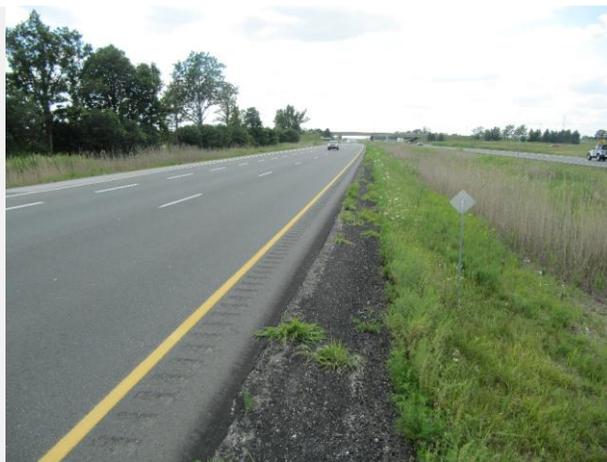
The photo below shows a westward view of the eastbound lanes of Highway 402 from just east of the Colonel Talbot overpass which can be seen in the background. The Suzuki was travelling toward the camera and exited the pavement just in the foreground of this view.

View, looking west, from the median side of the eastbound lanes of Highway 401 at the location where the Suzuki travelled off the pavement surface and into median.

It is noteworthy that the entrance ramp from Colonel Talbot Road onto Highway 402 is located here and therefore there is a strong possibility that a vehicle entering the highway may have contributed to the interference of the Suzuki, causing the driver to take evasive action, resulting the Suzuki entering the median.

Because of the location where the Suzuki entered the median with respect to the entrance ramp from Colonel Talbot Road, it would be advisable for police to research the possibility that another vehicle was involved which might have interfered with the Suzuki's travel and causing the driver to take evasive action to avoid a collision.

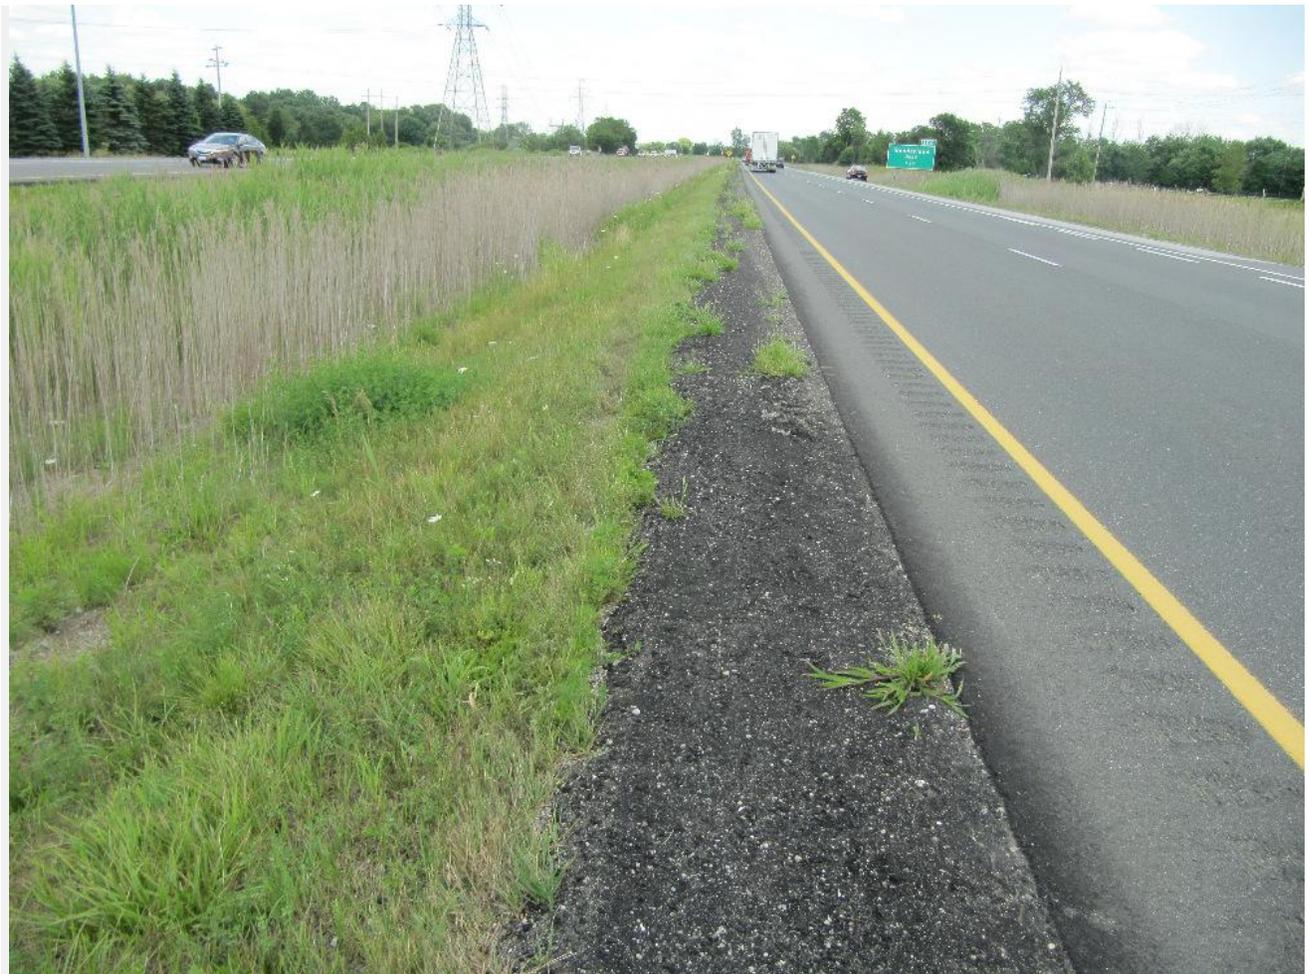
The photo below shows an eastward view along the eastbound lanes of Highway 402 from a similar position as the photo above. The tire marks from the Suzuki are not readily visible at the edge of the median at this location but they will become visible shortly as we move further eastward. Our vehicle is parked on the south roadside in the distant background and the Suzuki travelled into the south roadside just in front of the parked position of our vehicle.

View, looking east, along the median side of the eastbound lanes of Highway 402 at the point where the Suzuki travelled off the pavement surface and into the median.

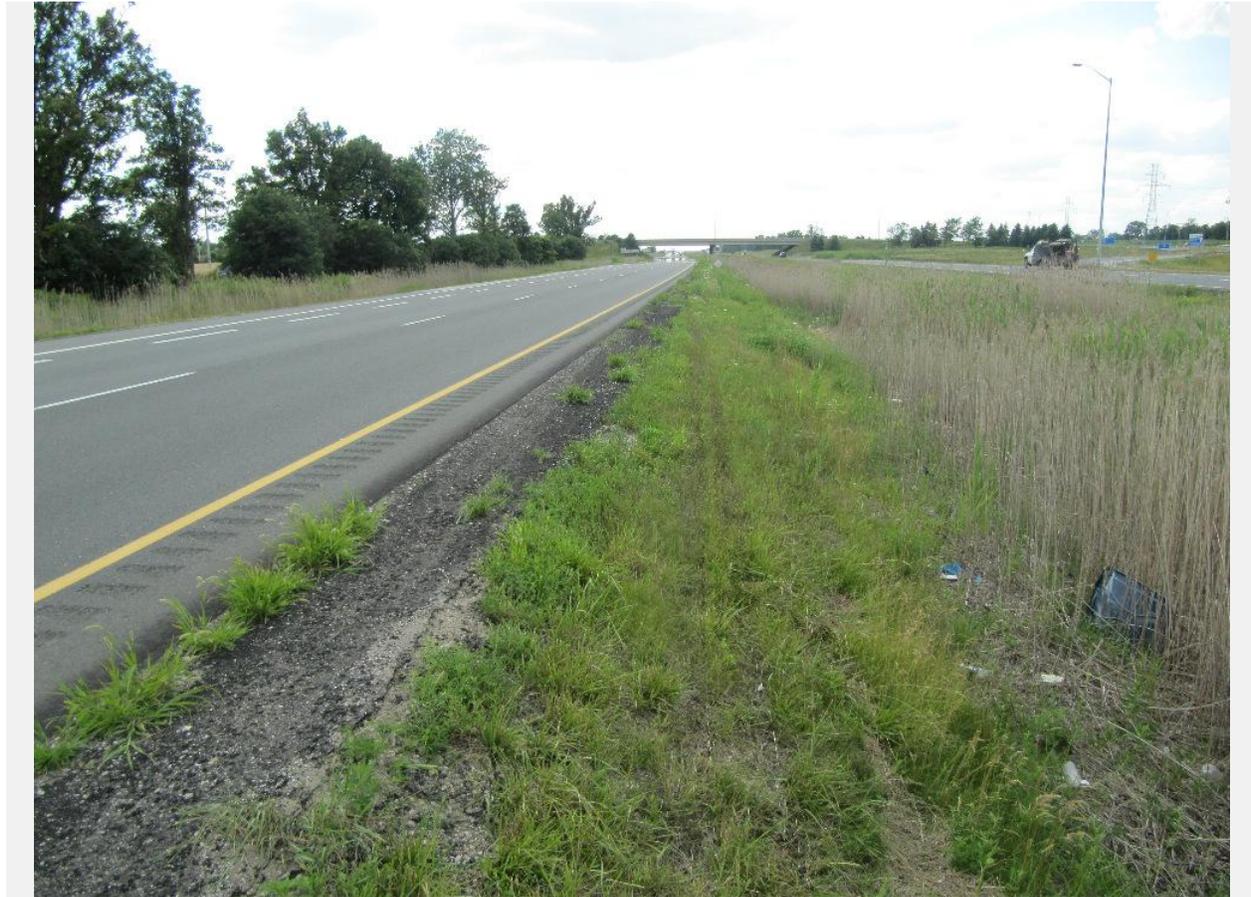
As we move further eastward along the median, the photo below was taken looking back toward the west where now the tire mark from the Suzuki should be visible in the grass. This tire mark is actually widening into two marks from the two left side tires of the Suzuki as it is beginning its clockwise rotation.

View, looking west, along the median next to the eastbound lanes of Highway 402 where a tire mark is visible in the grass indicating the exit of the Suzuki from the road surface.

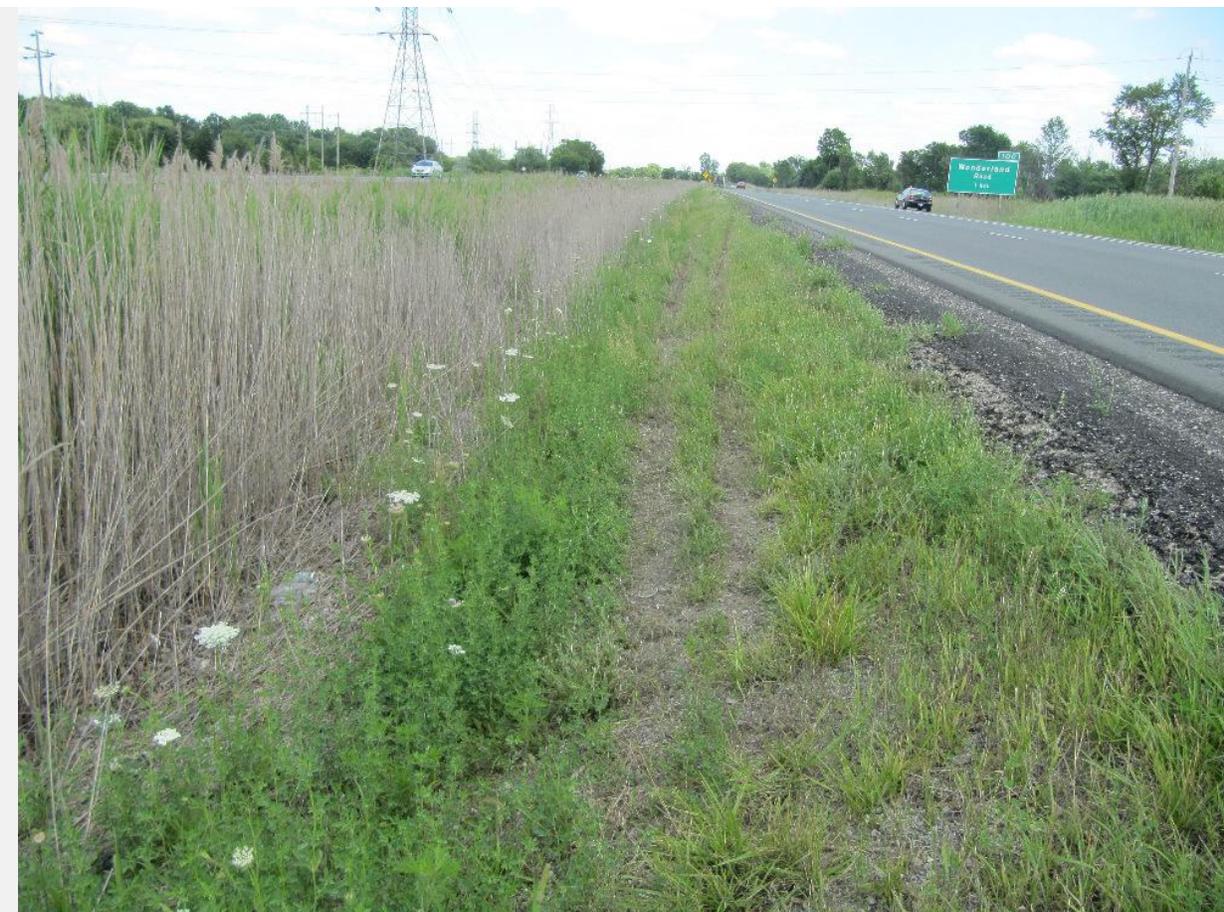
The photo below shows a view looking east just slightly further east from the position shown in the photo above. Now the tire marks from the two left side tires of the Suzuki should be plainly visible in the grass as they diverge, indicating that the vehicle is rotating clockwise.

View, looking east, along the median next to the eastbound lanes of Highway 402 showing the tire marks, from the left side tires of the Suzuki, visible in the grass.

What is not readily apparent in the above photo is that there is a steep slope to the grass median that would normally pull the vehicle into the centre of the median. It is surprising therefore that the driver was capable of bringing the vehicle back out of the steep slope and back toward the road surface while the vehicle continued to rotate clockwise.

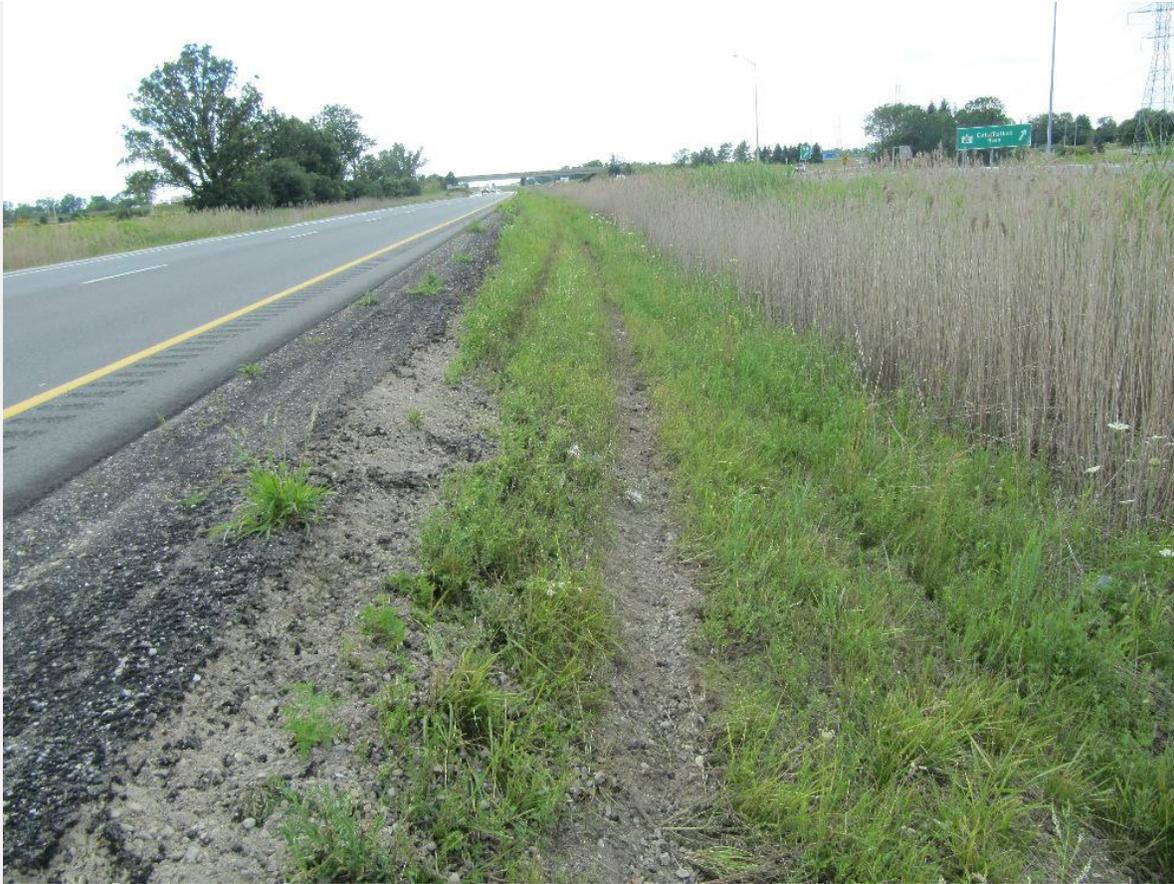
View, looking west, from a distance further east, along the median next to the eastbound lanes of Highway 402. Now the two tire marks from the left side tires have diverged substantially indicating the increased pointing angle of the Suzuki as it is rotating clockwise and out of control back toward the road surface.

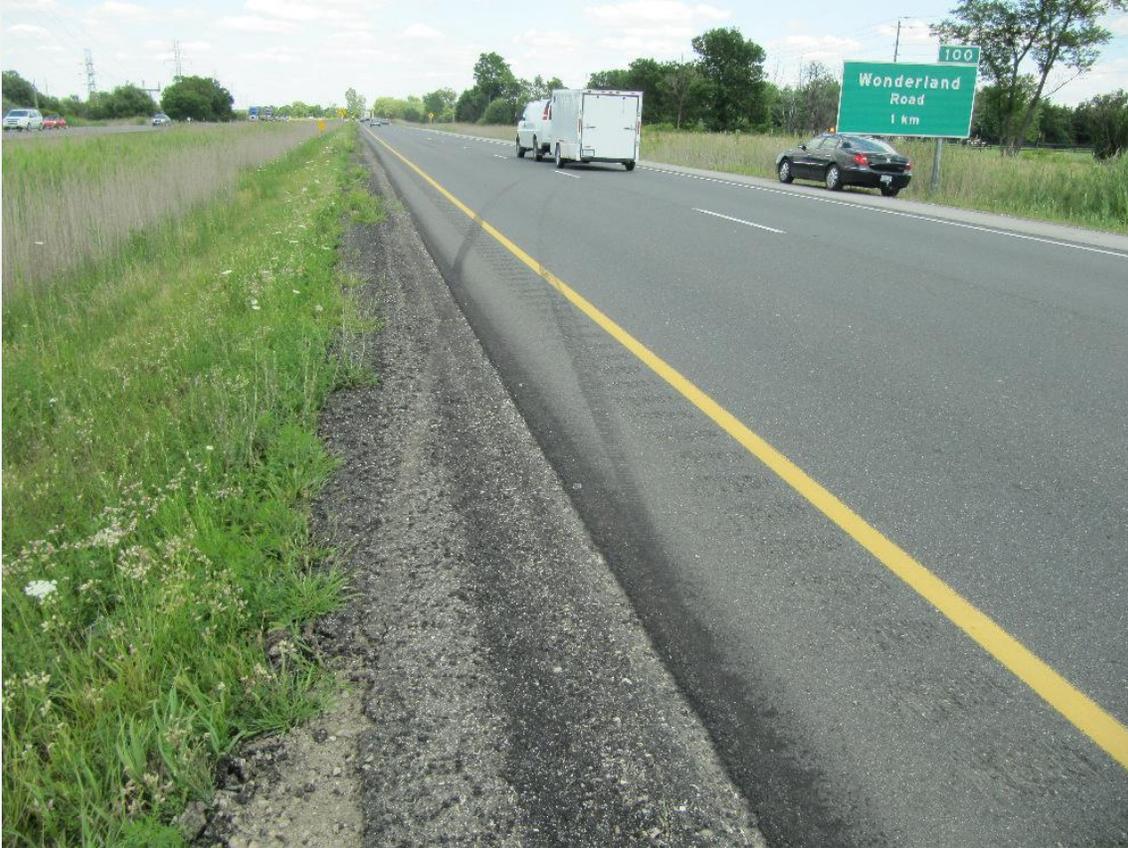
If we turn around again to face eastward the photo below shows how the Suzuki continues its clockwise rotation as indicated by the diverging of the two tire marks caused by the two left side tires, and indicating that the vehicle is now returning toward the eastbound lanes of Highway 402 as it will soon cross the lanes and rollover in the south roadside.

View, looking east, as the two tire marks diverge, indicating the continuing clockwise rotation of the Suzuki as moves back onto the eastbound lanes and heads across the lanes to its point of rollover on the south roadside.

In the above photo you can see the position of our parked vehicle which was visible in the distant background of the previous photos. It is now easy to visualize how the Suzuki's motion toward the south roadside was just in front of our parked vehicle.

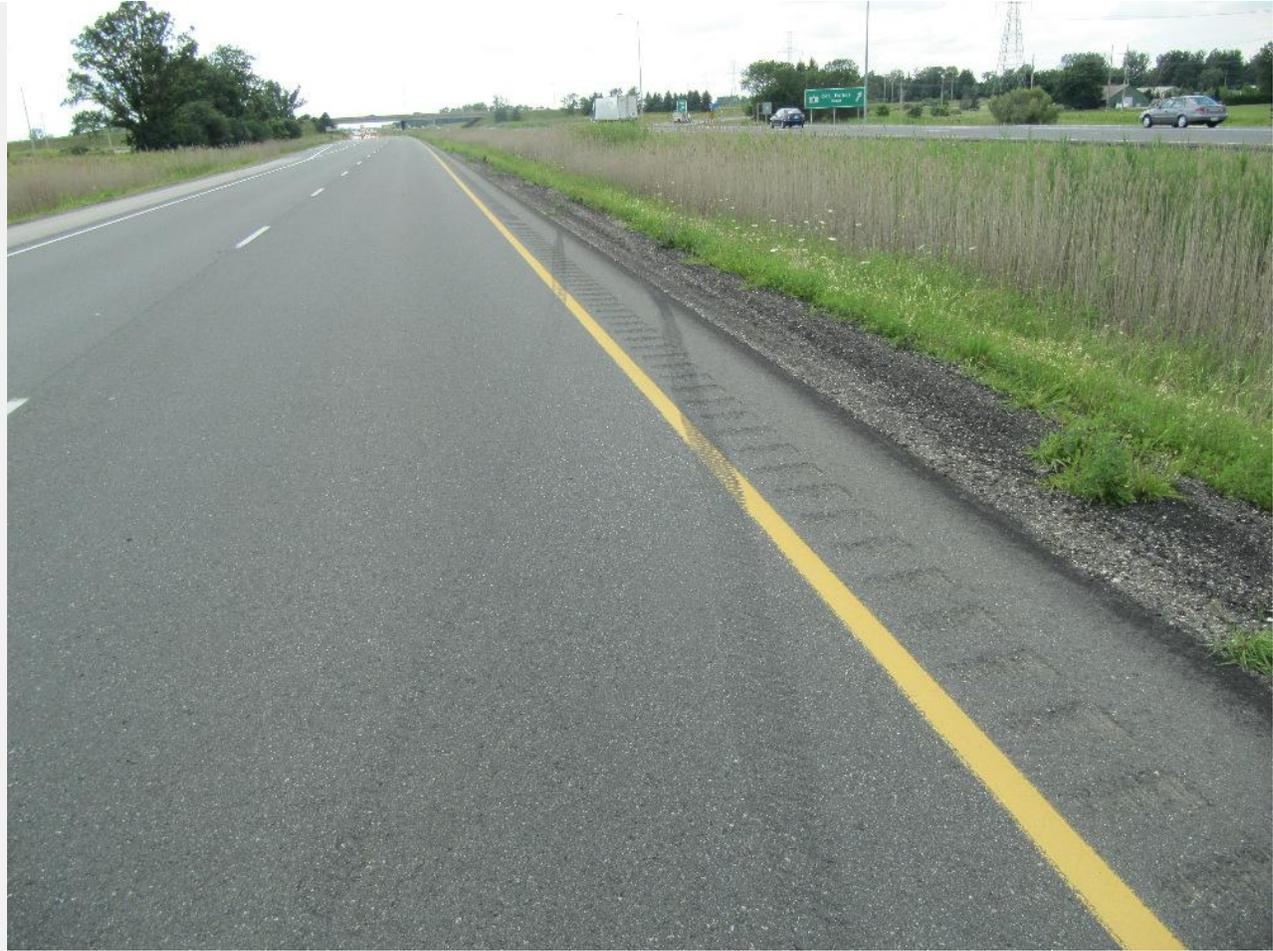
In the photo below we show another westward view taken from a position where the tire marks from the Suzuki can be seen crossing back onto the road surface as the vehicle heads toward the south roadside.

View, looking westward, as the tire marks from the Suzuki are crossing the eastbound lanes of Highway 402 and approaching the camera as the Suzuki is rotating clockwise and travelling toward the south roadside.

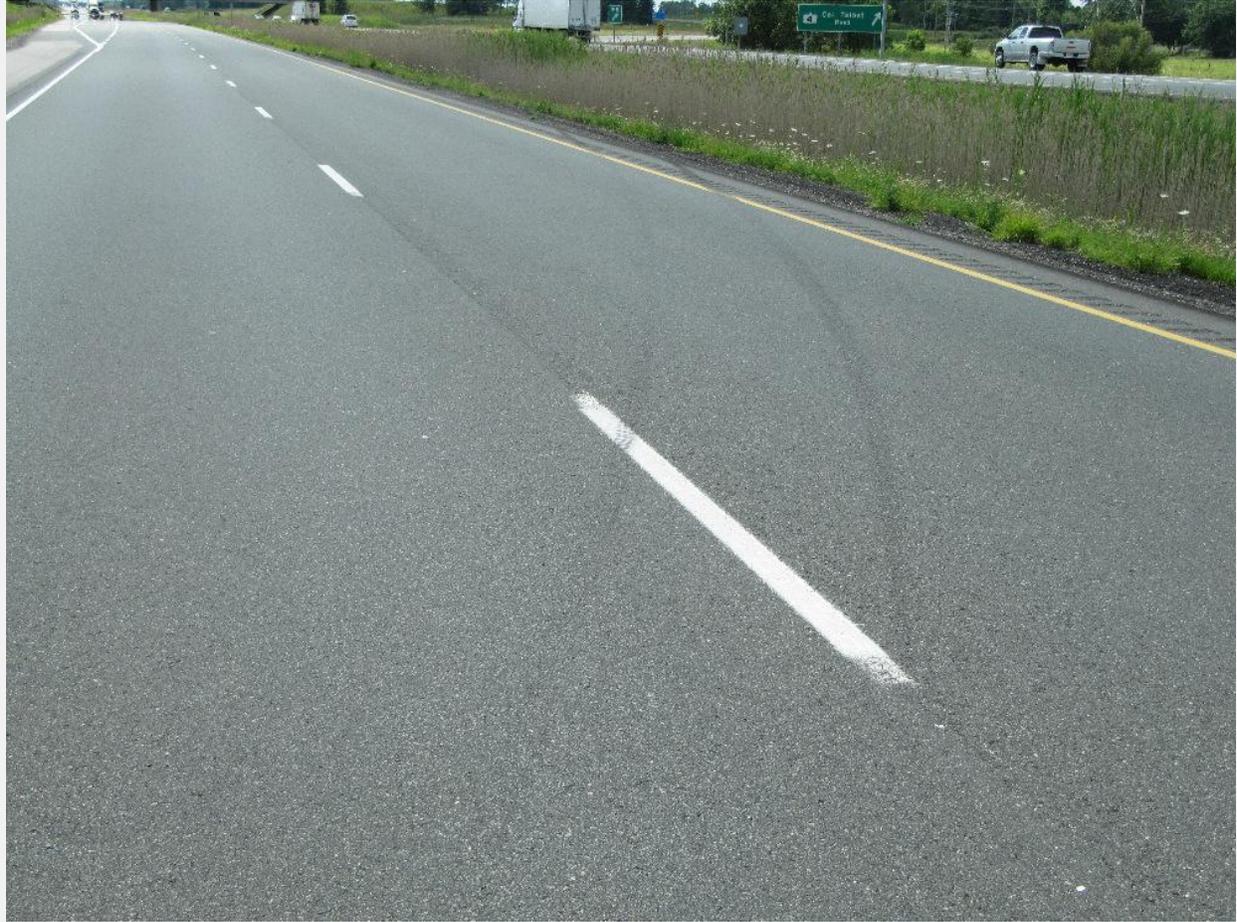
And the view in the photo below shows how the tire marks continue to cross the eastbound lanes of Highway 402 as the Suzuki heads toward the south roadside where it rolls over.

View, looking northwest, showing the tire marks of the Suzuki as they cross the eastbound lanes of Highway 402 and the vehicle travels toward the camera on its way to rollover in the south roadside.

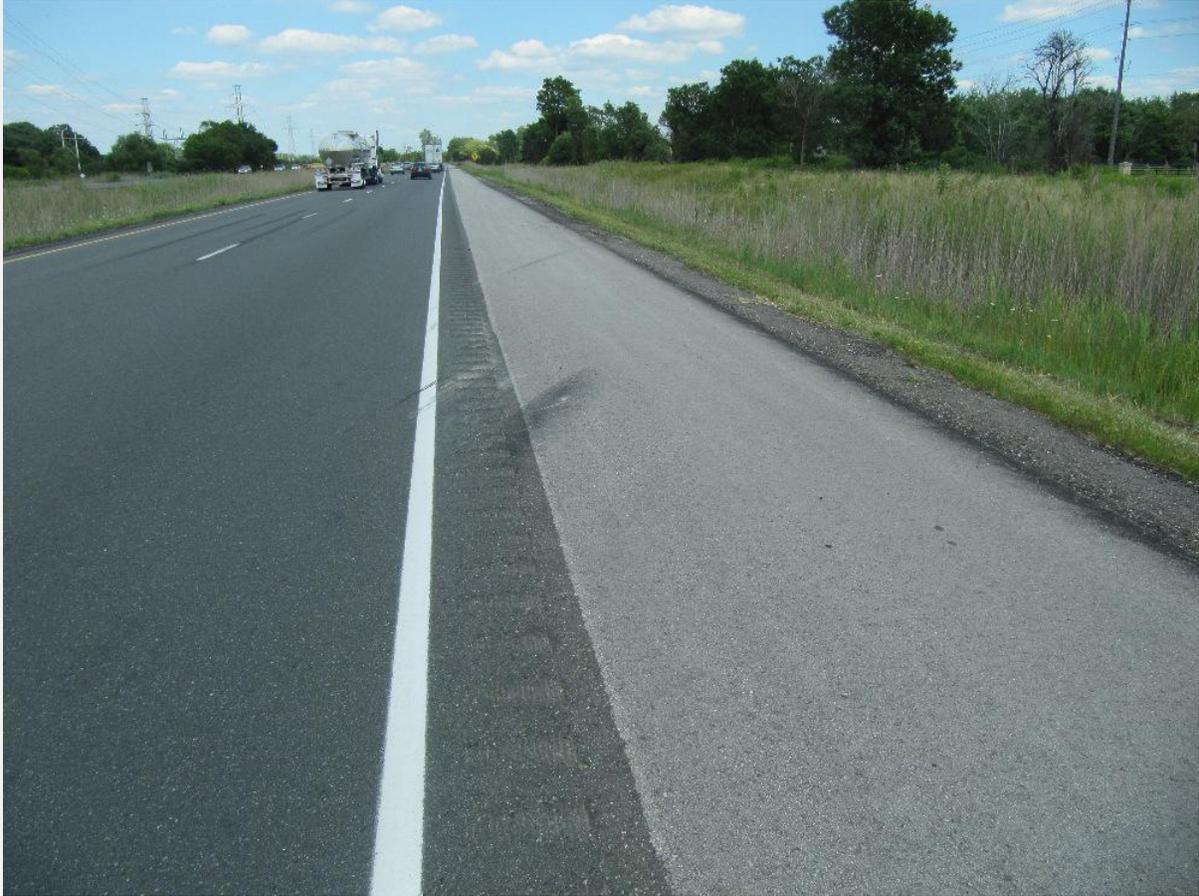
The photo below takes us to the south side of the eastbound lanes where we can see the tire marks exiting the eastbound lanes and heading toward the south roadside.

View, looking east from the south shoulder of Highway 402 showing the tire marks as they exit the road surface and travel toward the south roadside where the Suzuki rolled over.

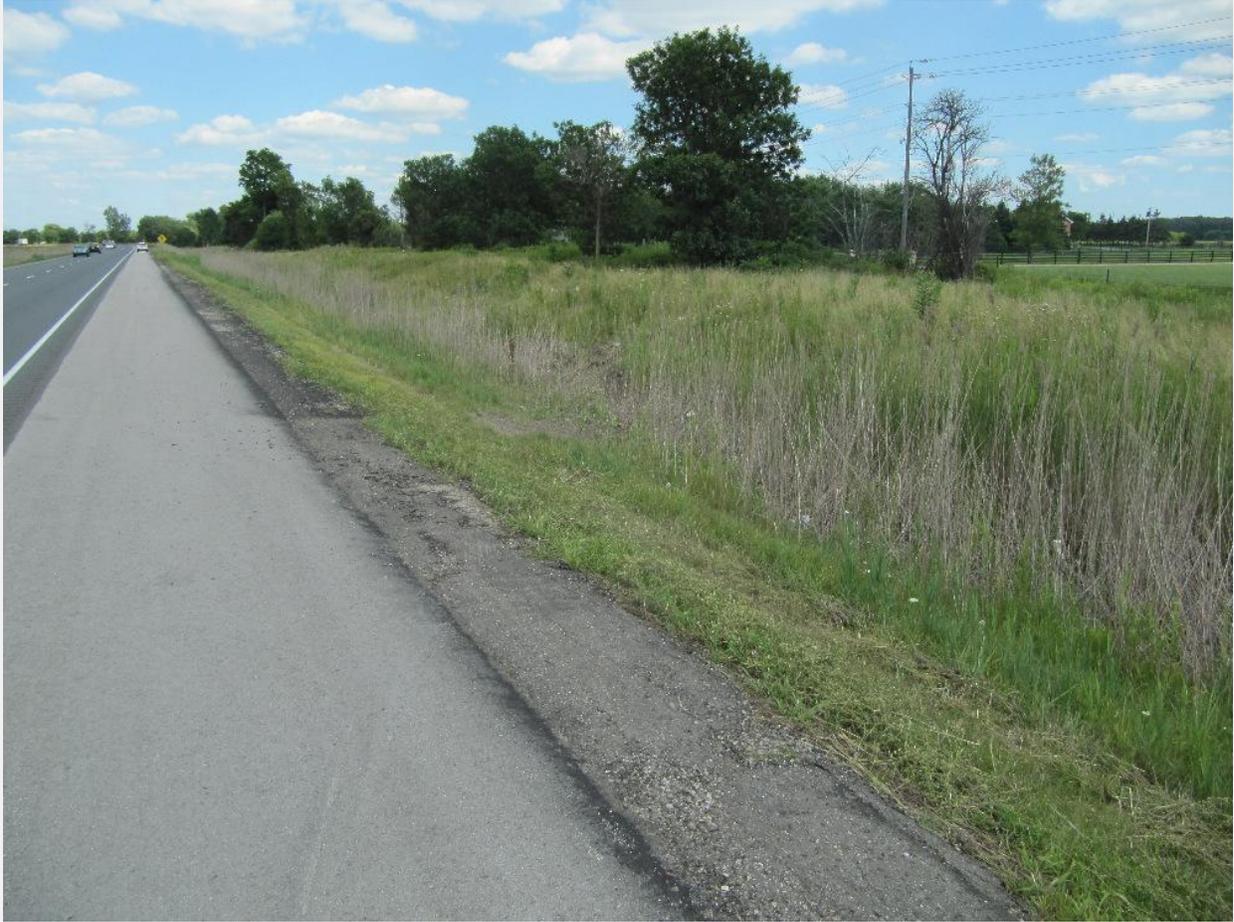
The photo below shows where the Suzuki entered the south ditch and began to roll over just after crossing into the grass area. The Suzuki would have been sliding sideways and leading with the driver's side when this roll began.

View of south roadside where the Suzuki entered the ditch and rolled over.

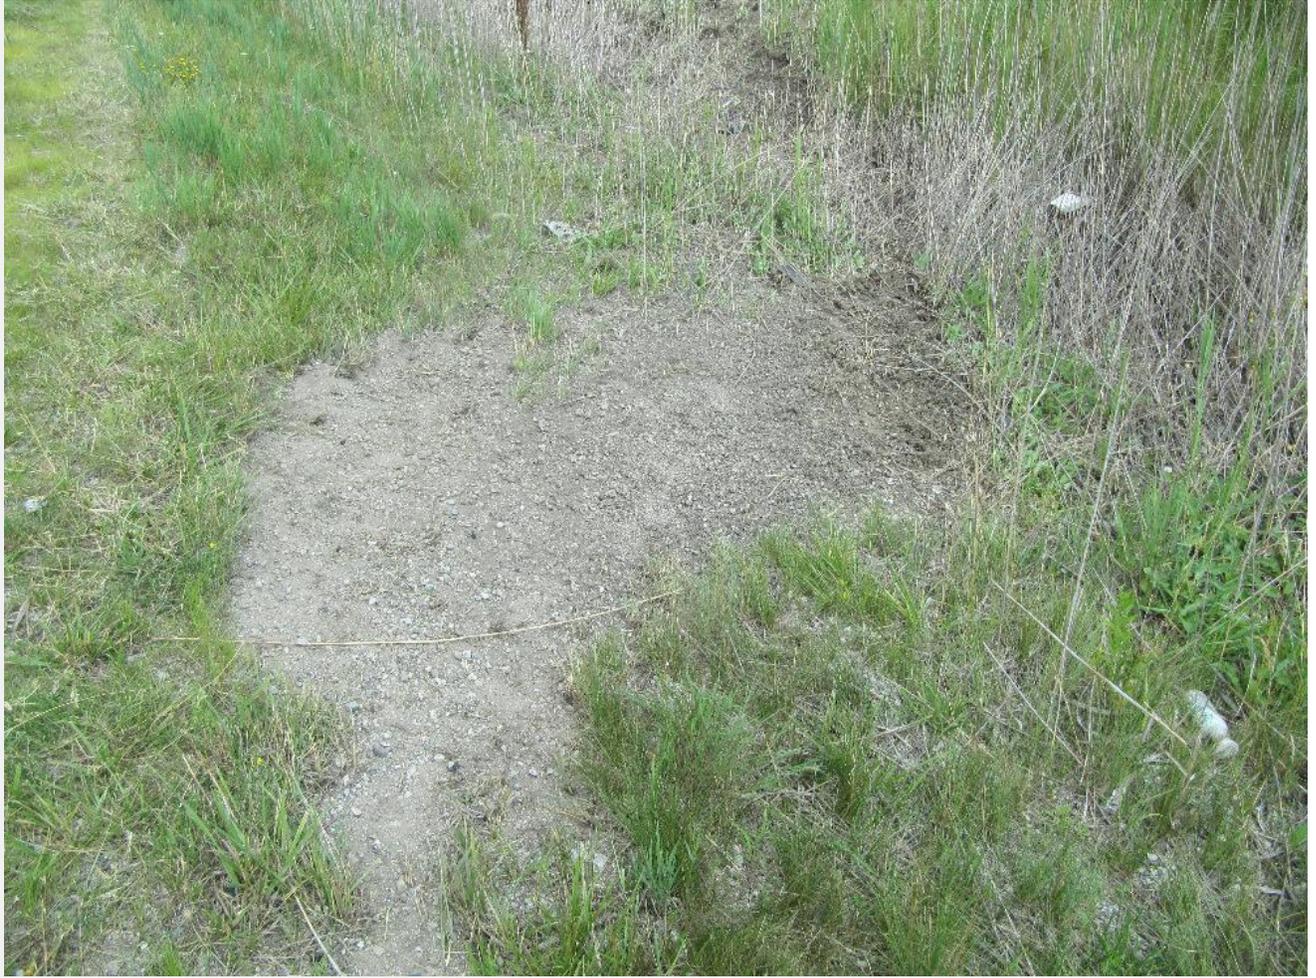
The photo below shows the first of several gouges produced in the earth as the vehicle impacted the rising side of the ditch and then settled on that rising bank.

View of the first of several gouges in the earth where the Suzuki rolled to rest.

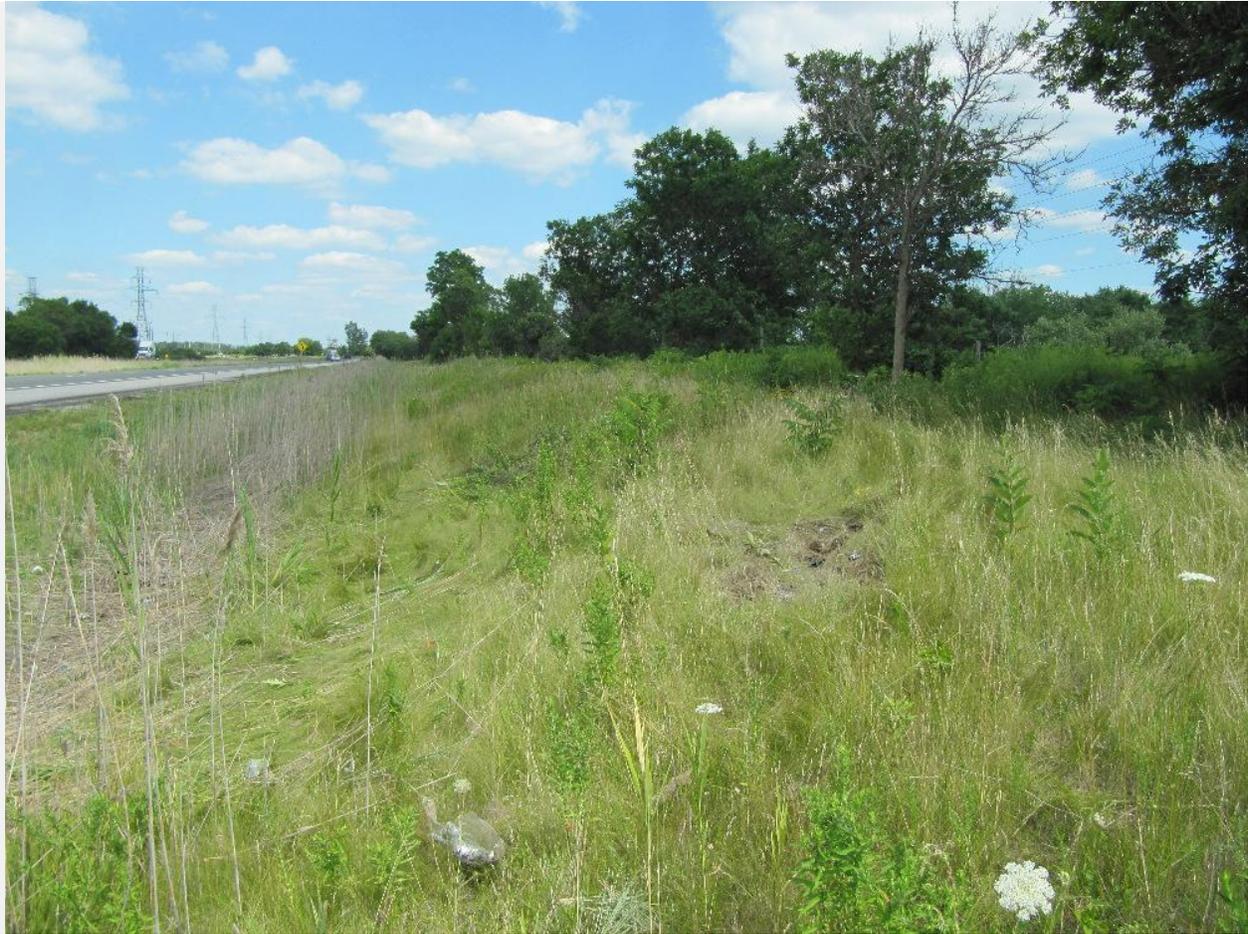
The photo below shows the final rest position of the Suzuki.

View of gouges and debris on the slope of the south ditch at the final rest position of the Suzuki

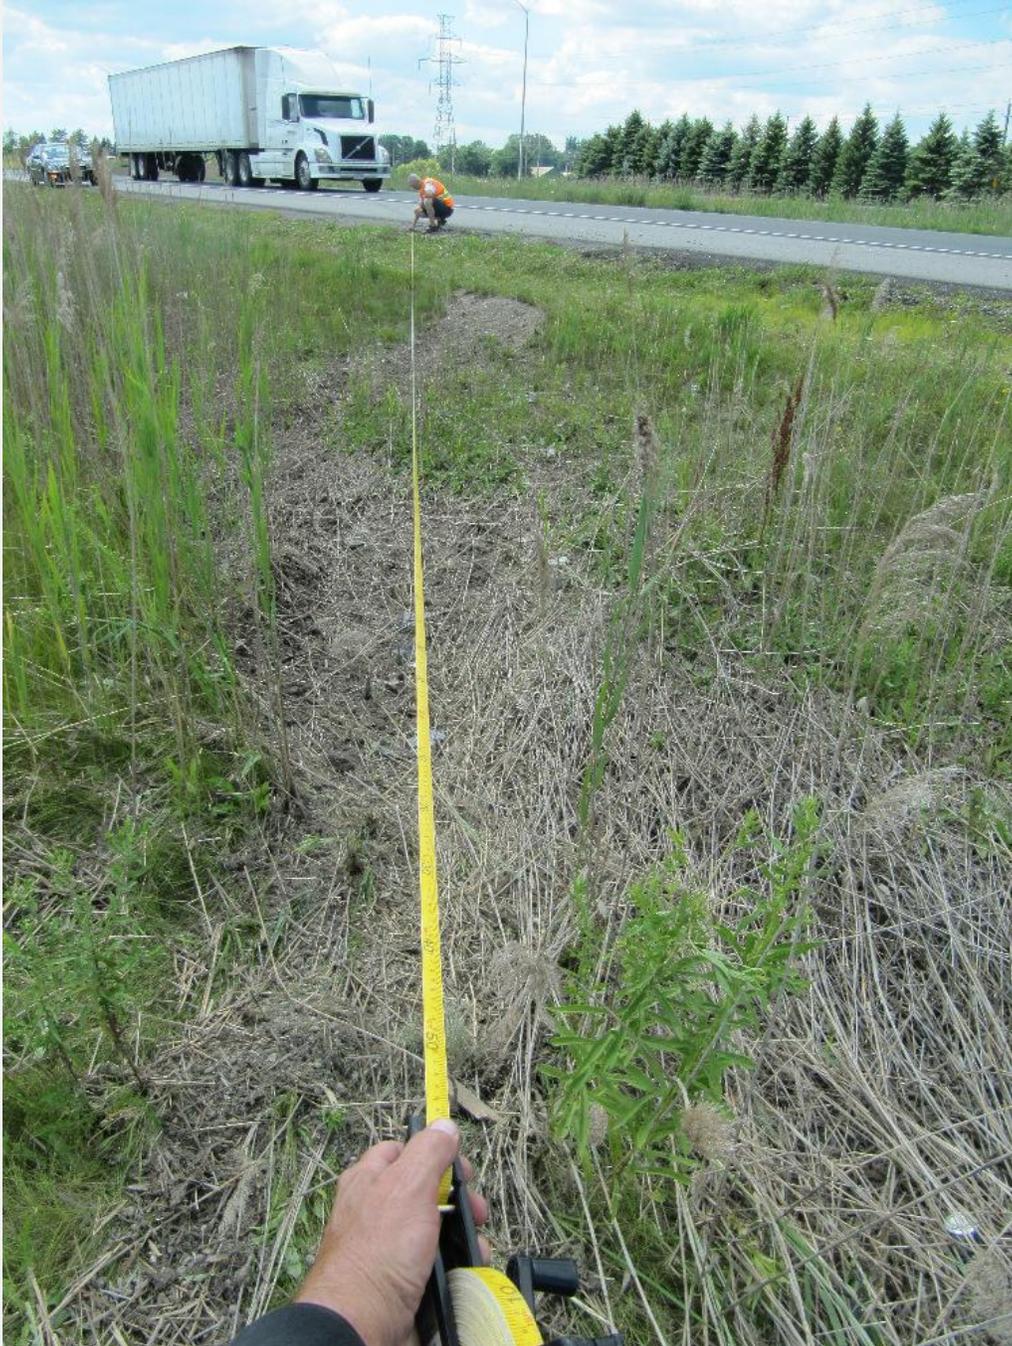
One can obtain a general indication of the speed of the vehicle and the severity of the rollover event by measuring the distance that the vehicle travelled during the rollover. The photo below shows how an assistant holds the zero end of the measurement tape at the end of the visible tire marks at the edge of the grass and we extend the tape to an intermediate point on the slope of the ditch.

View showing measurement taken from the beginning of the rollover to an intermediate point on the sloped bank.

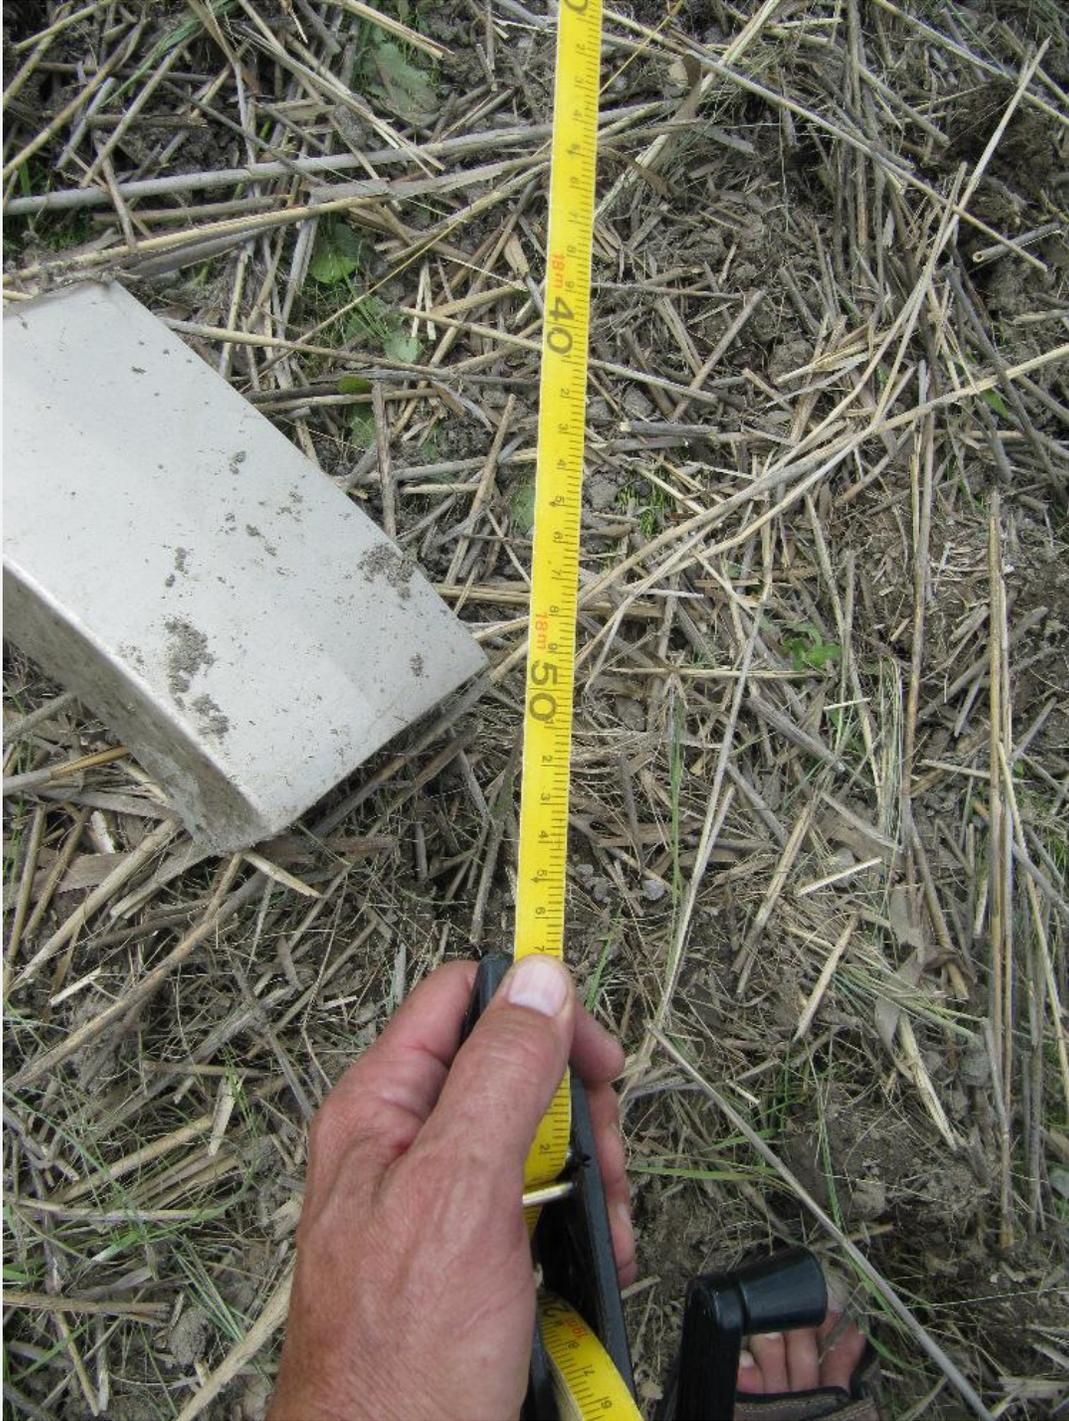
We can see below how the distance to the intermediate point is 18.5 metres.

View showing a distance of 18.5 metres read on the measurement tape at the intermediate point as we measure the distance of the rollover.

Adding the two measured distances ($18.5 + 18.2$) indicates that the vehicle travelled a distance of about 36.7 metres. This is no longer a low speed rollover but gets into the moderate range. Using a tumble number for the deceleration rate would provide a speed of about 68 km/h at the beginning of the roll.

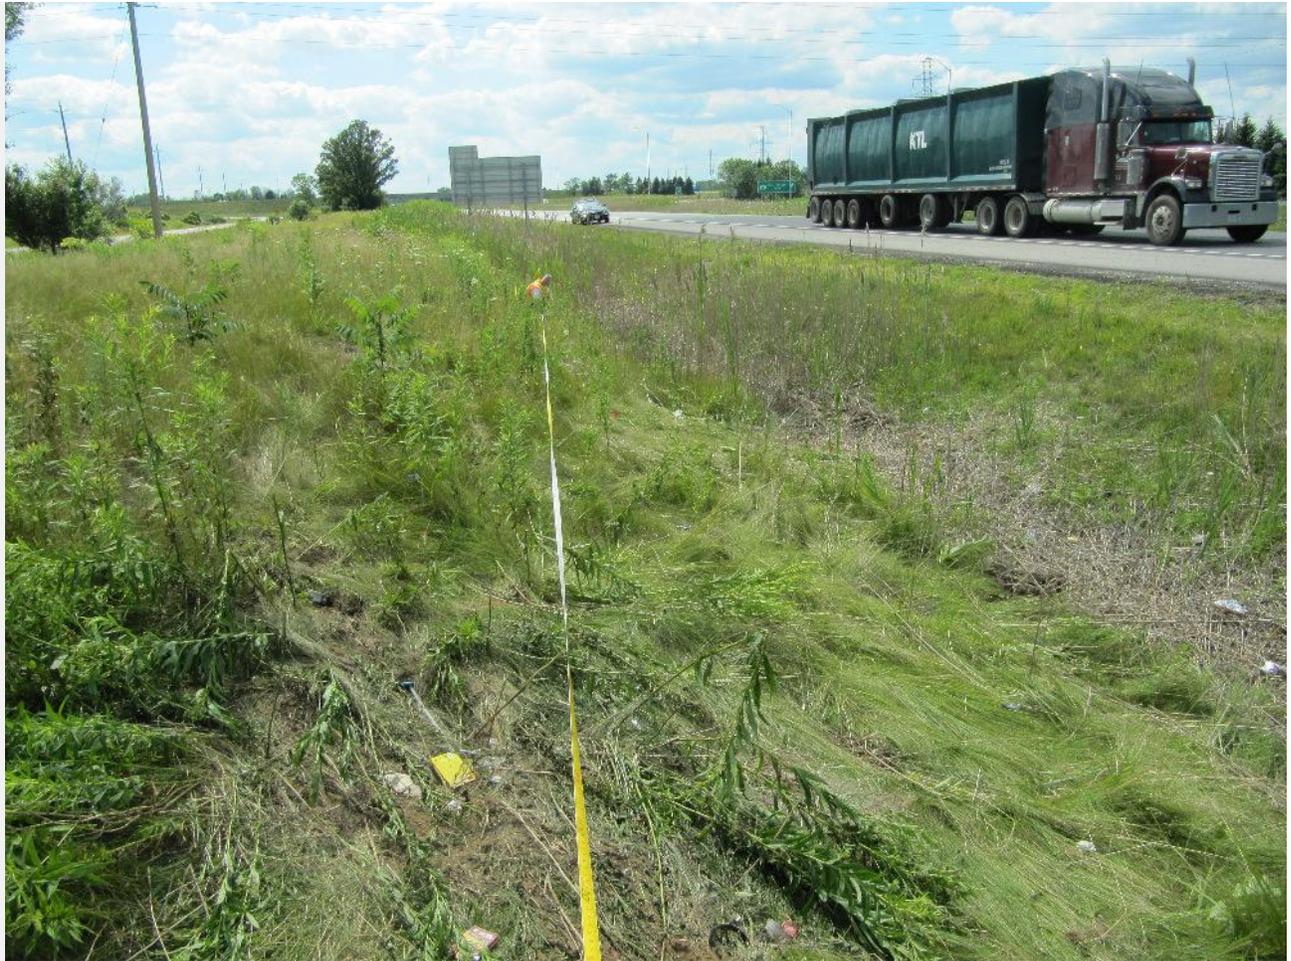
We then take a second measurement from that intermediate point to the final rest position of the vehicle as shown in the photo below.

View showing the assistant holding the zero end of the measurement tape at the intermediate point while the tape is extended to the vehicle final rest position in the foreground.

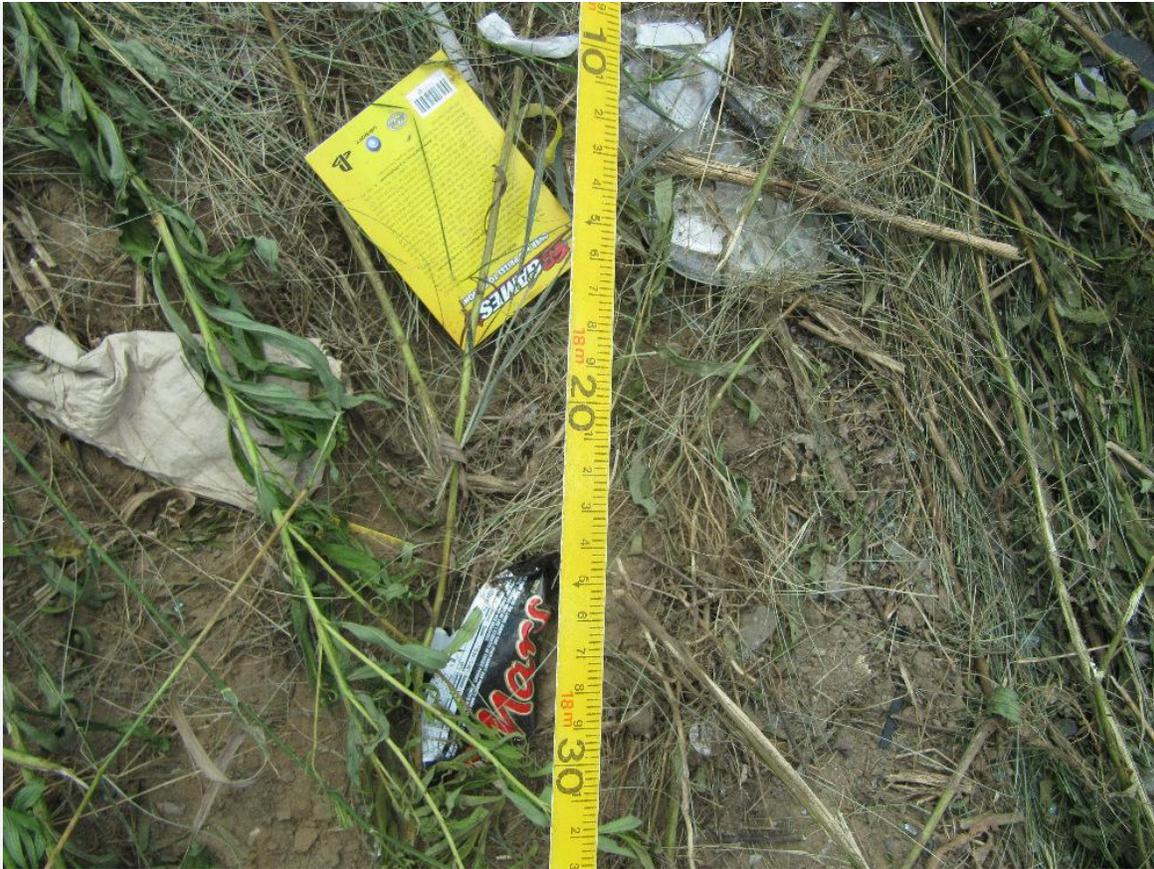
We can see in the photo below that the distance from the intermediate point to the Suzuki final rest position is about 18.2 metres.

View, showing a distance of 18.2 metres from the intermediate point to the Suzuki final rest position.
