Rough Roads, Increasing Speed and Change in Test Vehicle Motion

Posting Date: 06-Mar 2014

On March 3, 2014 testing was conducted on Sunningdale Road to explore the motion of a test vehicle as its speed was increased incrementally from 40 to 90 km/h. The present article will review the test procedure and summarize the test results.

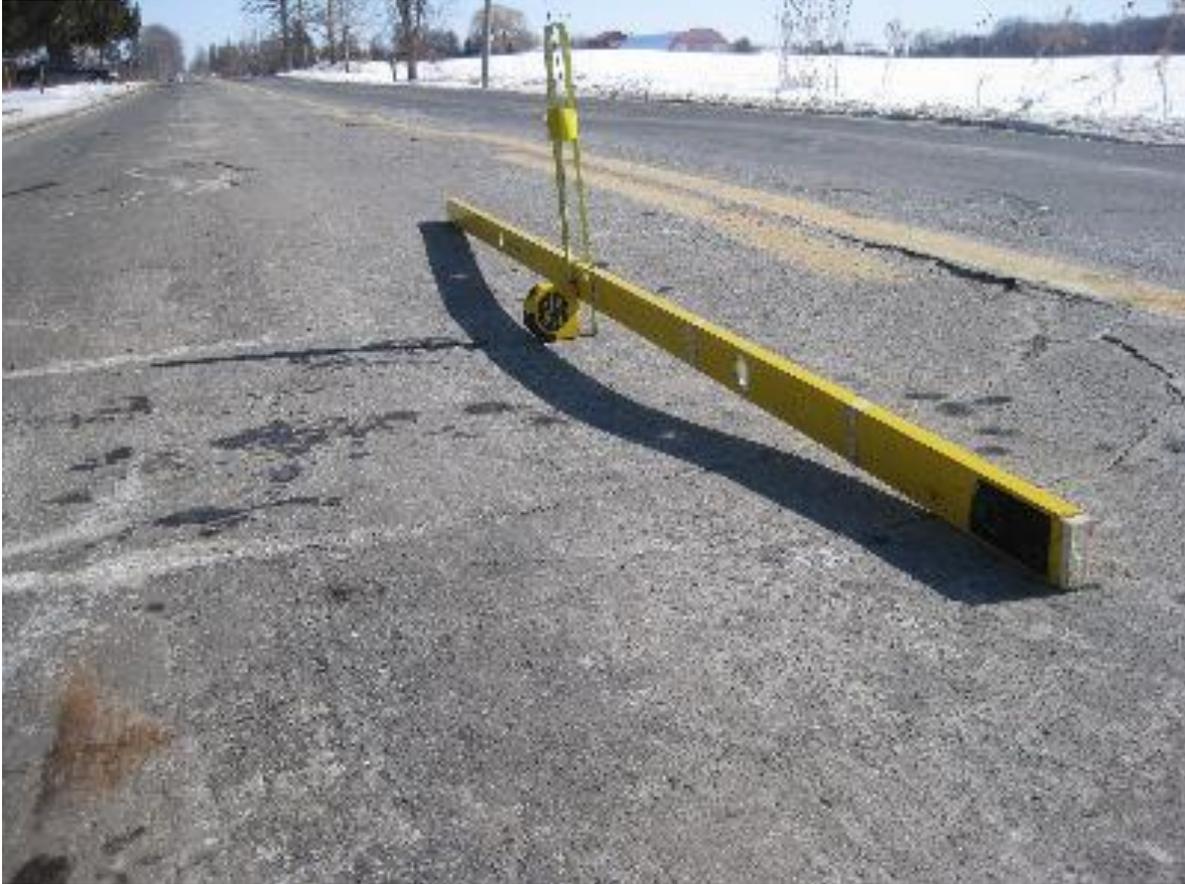
Over the years Sunningdale Road had experienced a variety of road surface problems. It is believed that the water table in the vicinity of the road is high and, over winter months the freezing of the ground caused an upheaval of the road surface.

Figure 2 shows an example of a localized depression in the road surface that was documented in the winter of 2011. The carpenter's level shown in the Figure is 8 feet long and it can be seen that the depression spans the full length of the level. Thus it is possible to note that this depression was not just an insignificant feature. Depressions like these existed throughout the most of the length of Sunningdale between Clarke and Highbury. In the fall of 2011 the City of London re-paved the worst portion of the problems in the middle two-thirds of the road segment. However, portions of the poor surface still remained to the east and west of the ends of the re-paved segment.

Figure 2: View, looking west along Sunningdale Road, at one of numerous depressions that existed in the road surface in 2011. The surface was subsequently re-paved though some portions of poor surface still remained.

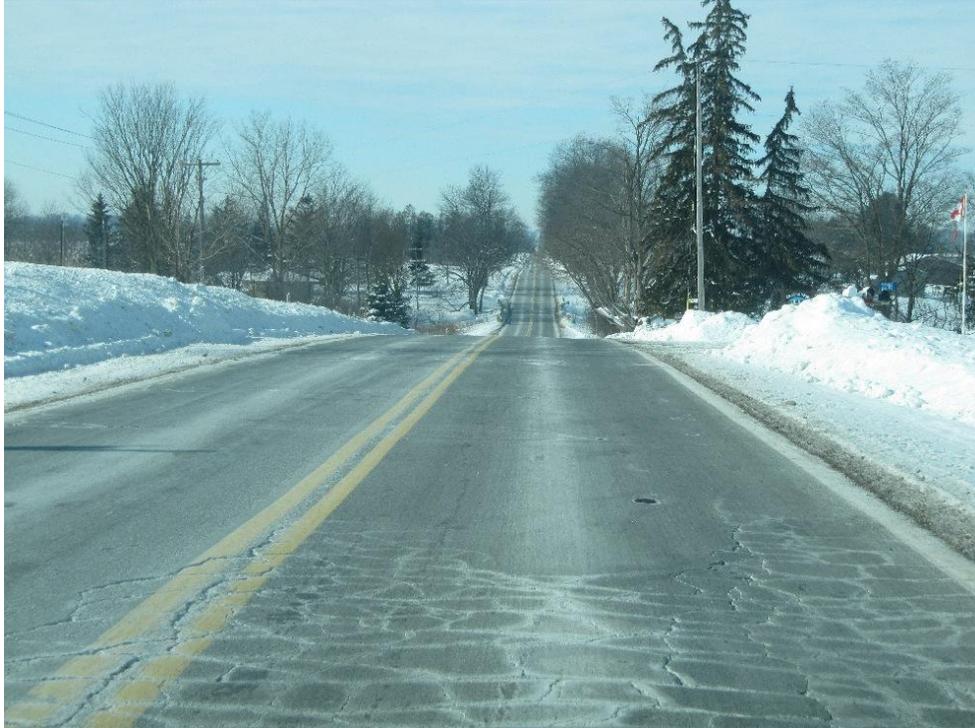
Sunningdale Road was generally straight and level except for a small sag located near its east end. There was a small bridge at the bottom of this sag as shown in the westward view of Figure 3.

Figure 3: View, looking west along Sunningdale Road, near the location where data collection was commenced. In the background is a sag and small bridge which is the only significant elevation change in the road segment.

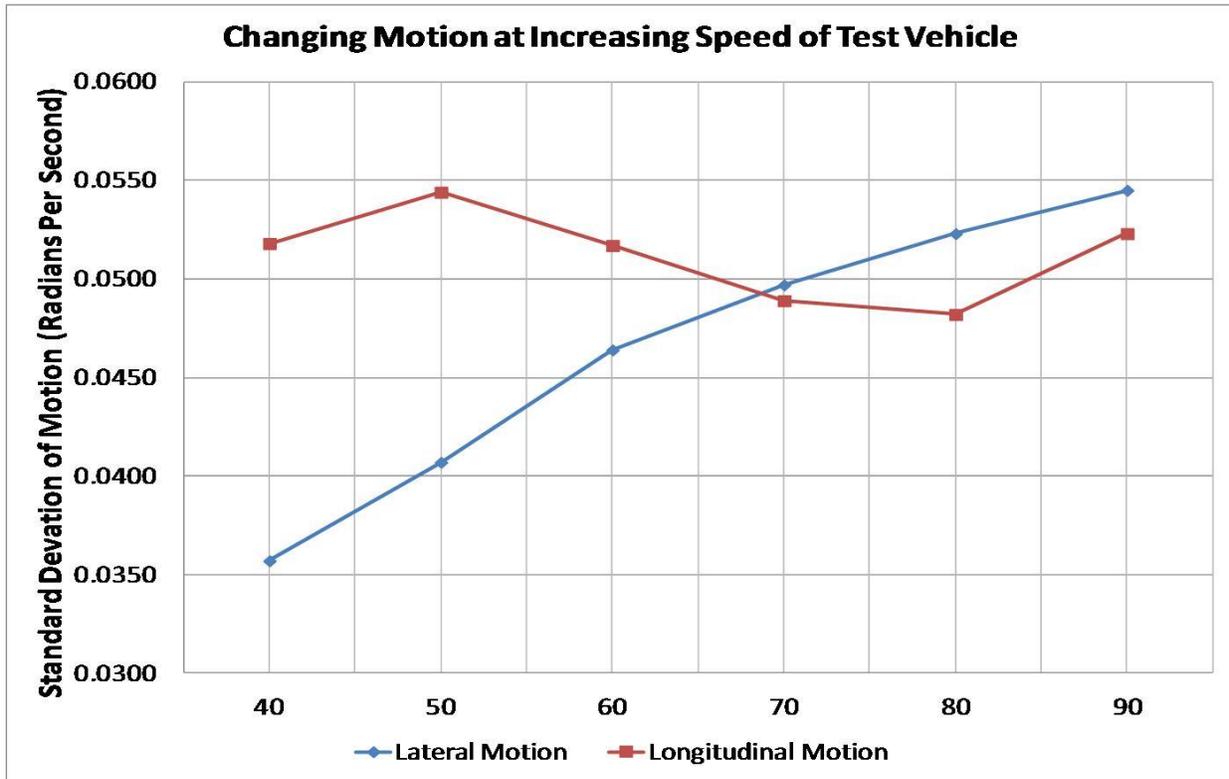
Figure 4.

At the low speed of 40 km/h the rate-of-change in the longitudinal motion was much higher than it was for the lateral motion. However, as the speed was increased, the rate-of-change of the longitudinal motion stayed relatively the same, or perhaps the data might suggest that the rate was being reduced as speed was increased. However, the rate of rate-change in the lateral motion rose significantly as the speed of the test vehicle was increased such that, in the last three highest speeds the lateral motion was higher than the longitudinal motion.

In simple terms, as the vehicle was travelling relatively slowly over the rough road the front and rear ends of the vehicle were being lifted up or dropped toward the pavement, while there was little side-to-side motion. The front and rear end motion was large and was experienced as such by the test driver. As the vehicle's speed was increased, the test driver's perception was that the vehicle's overall motion was increased, and the data supports that perception. However it is the manner in which that overall motion was

increased that is interesting to observe. The increase in the overall motion of the vehicle, as the vehicle speed increased, was achieved via an increase in the lateral, side-to-side, motion, while the longitudinal, front to back, motion either remained the same or might have been reduced slightly.
