# Speed Advisory Sign - A Source of Potential Municipal Liability

*Posting Date: 11-Nov 2014*

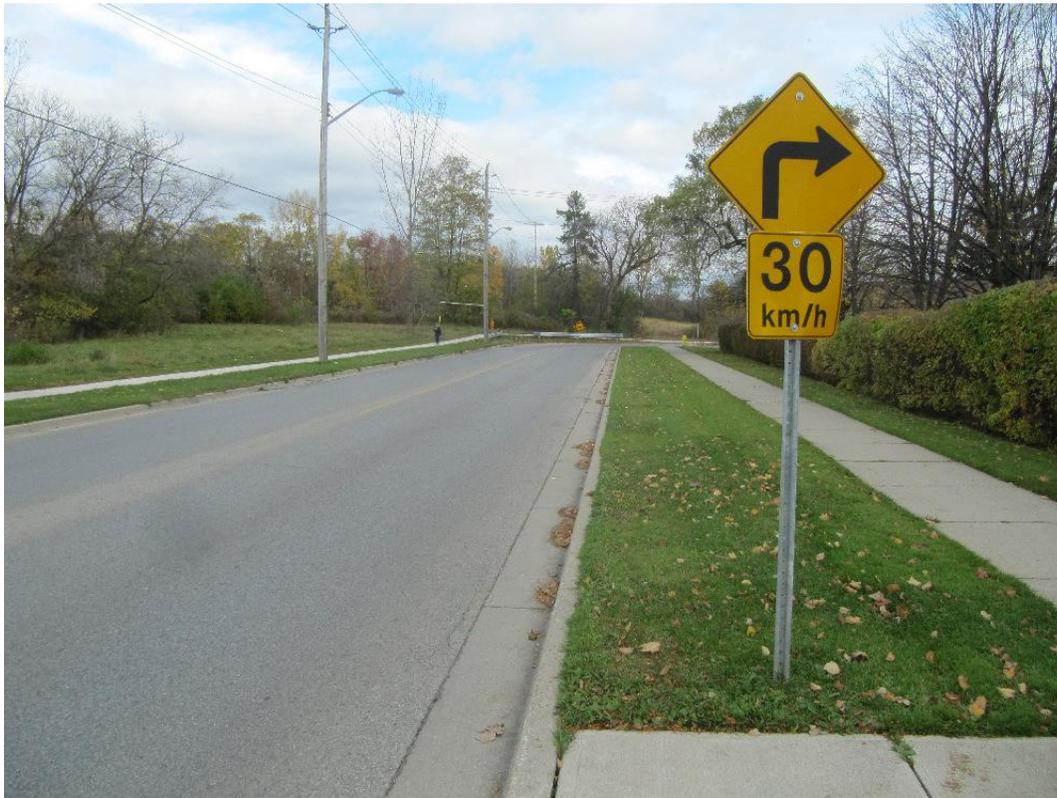
Figure 1: View of Turn sign with a Speed Advisory tab, on eastbound Beaverbrook Road in London, Ontario, indicating the speed at which eastbound vehicles can safely traverse the sharp "curve" at its intersection with Proudfoot Lane.

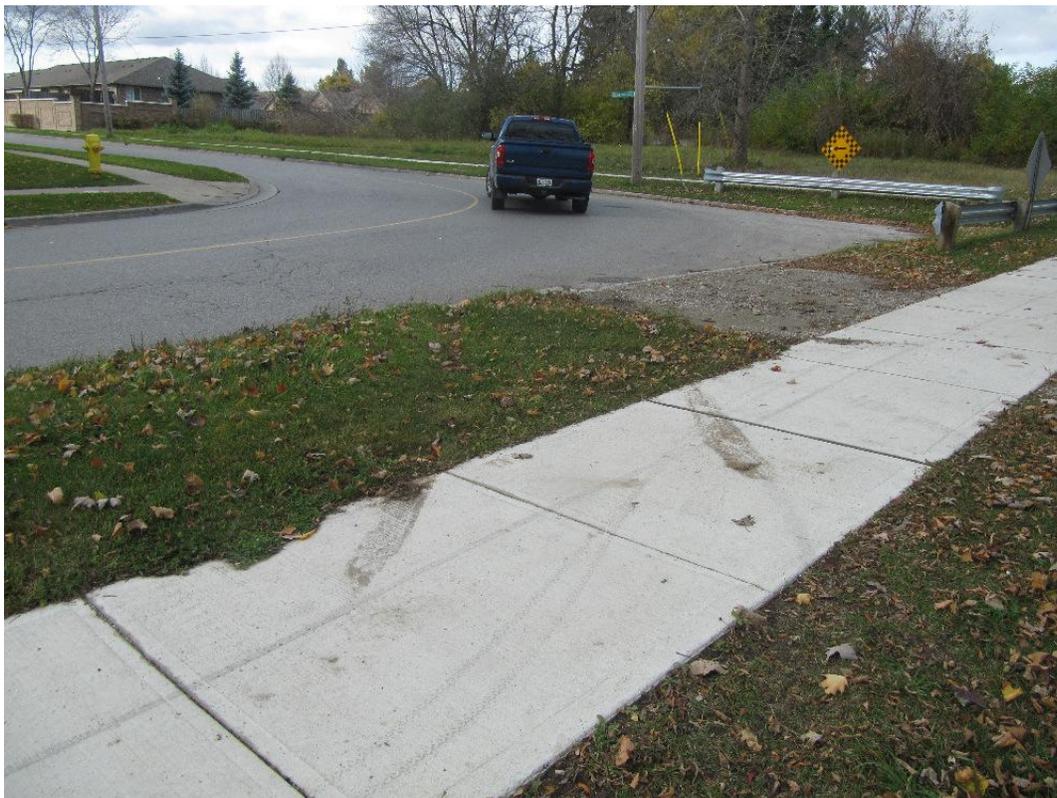
A resident in the area maintained a history of concerns to the City of London that his safety, and that of his fellow pedestrians, was in jeopardy due to the speed and volume of traffic passing through the dramatic curve. Our site examination revealed evidence of various markings at the curve indicating that a number of vehicles were in a state of loss-of-control. As an example, Figure 2 shows some tire marks caused by an eastbound vehicle that attempted to make a right turn to travel southbound onto Proudfoot lane. Unable to maintain its path in the curve the vehicle slid onto the sidewalk.

Figure 2: View, looking north-west, at the sharp "curve" where tire marks on the sidewalk indicate that an eastbound vehicle, approaching the camera, failed to negotiate the curve and slid onto the roadside.

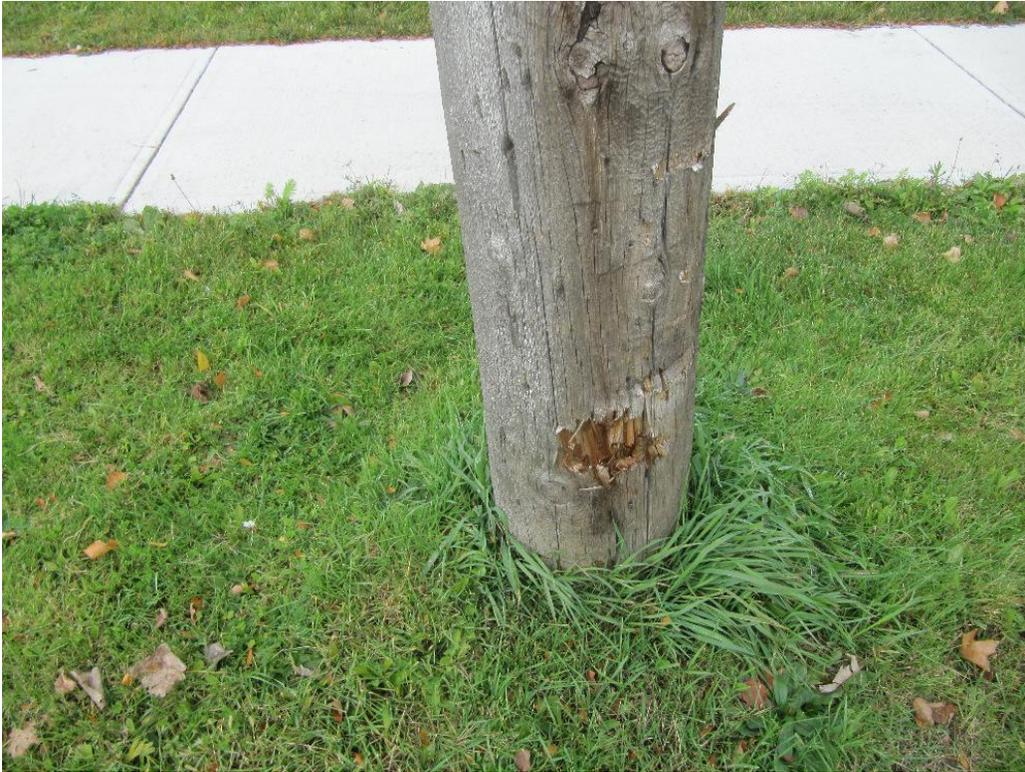
Figure 3: Evidence of a minor impact to a nearby utility pole.

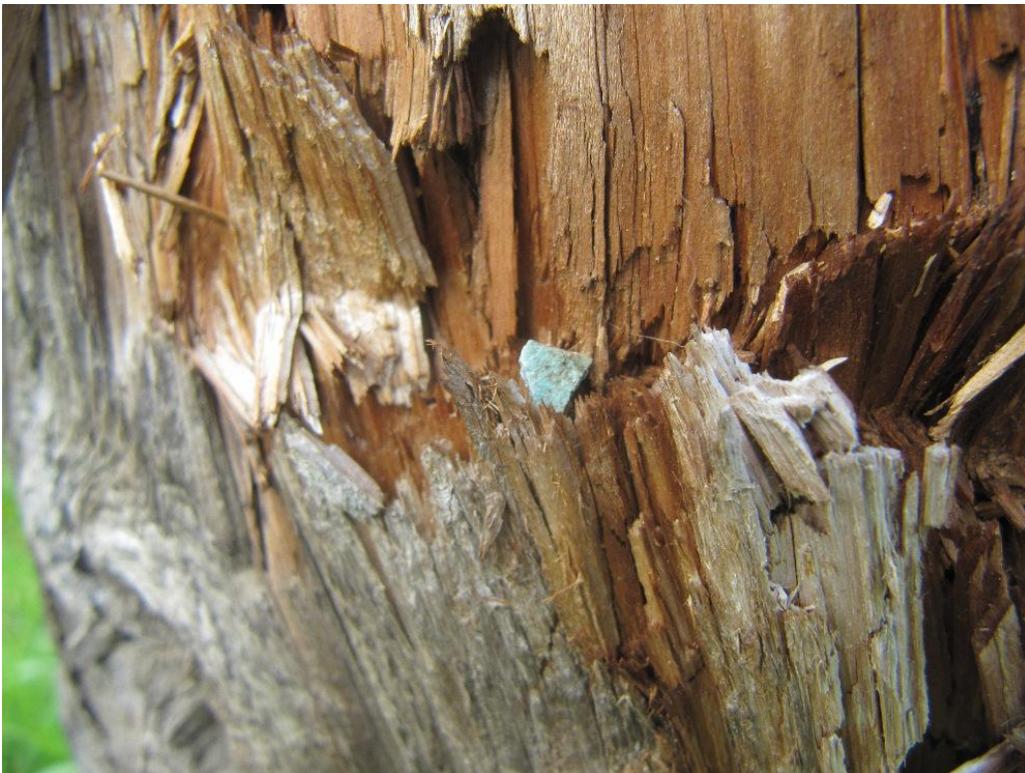
Figure 4: View of minute debris still resting within the damage that could help to identify the source of the impact.

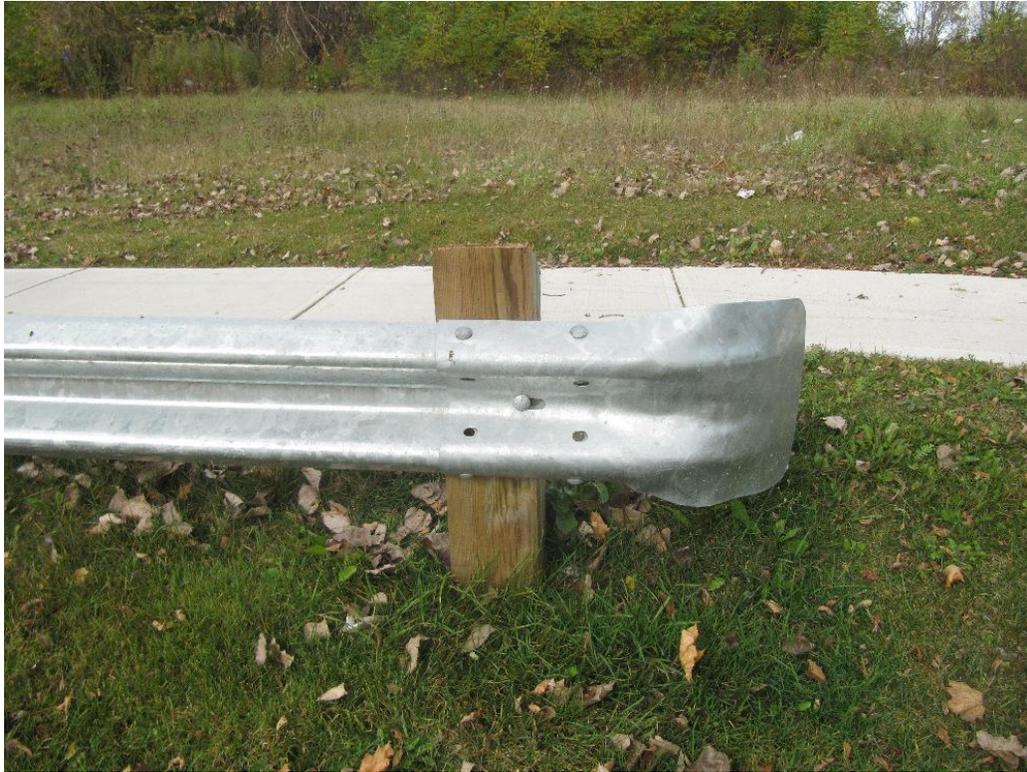
Figure 5: The presence of new guardrails would be another indicator of recent damage to them.

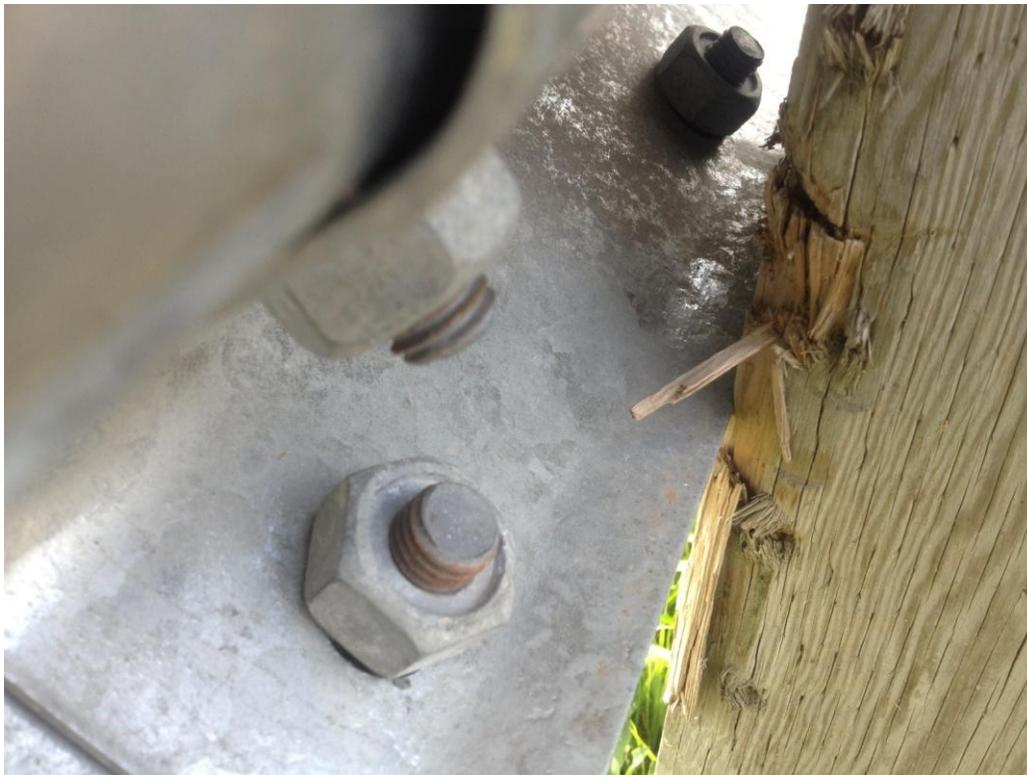
Figure 6: Damage to the wooden anchor post behind the guardrail suggested that previous impacts had occurred.

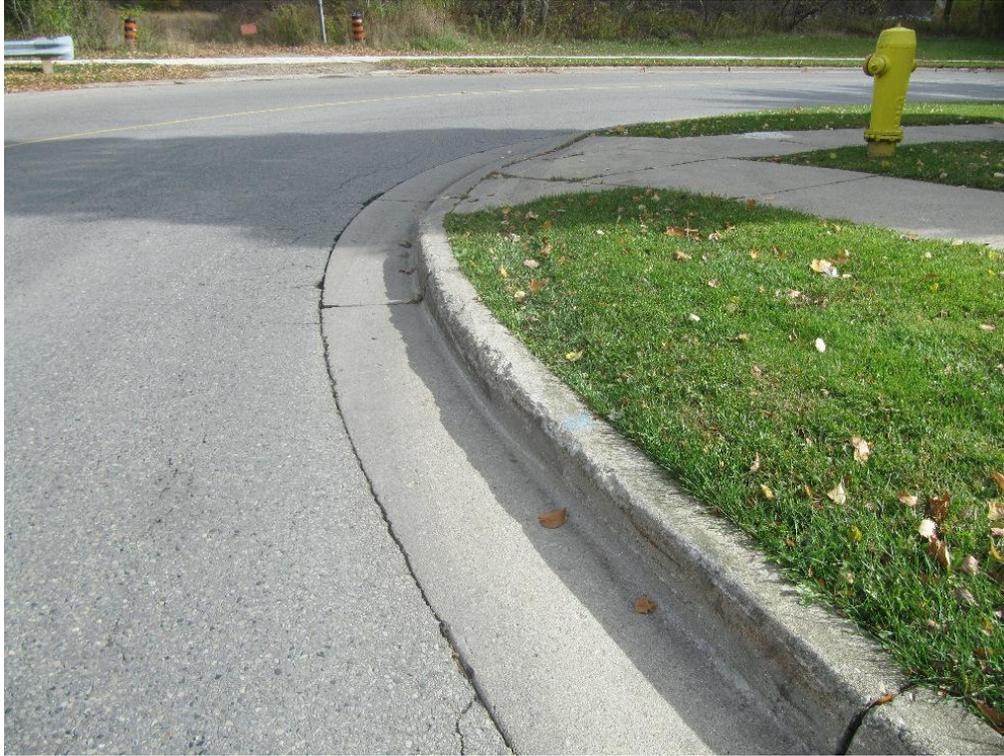
Figure 7: Evidence of scrapes and black tire marks on the edge of the curb indicative of contact by eastbound vehicles.

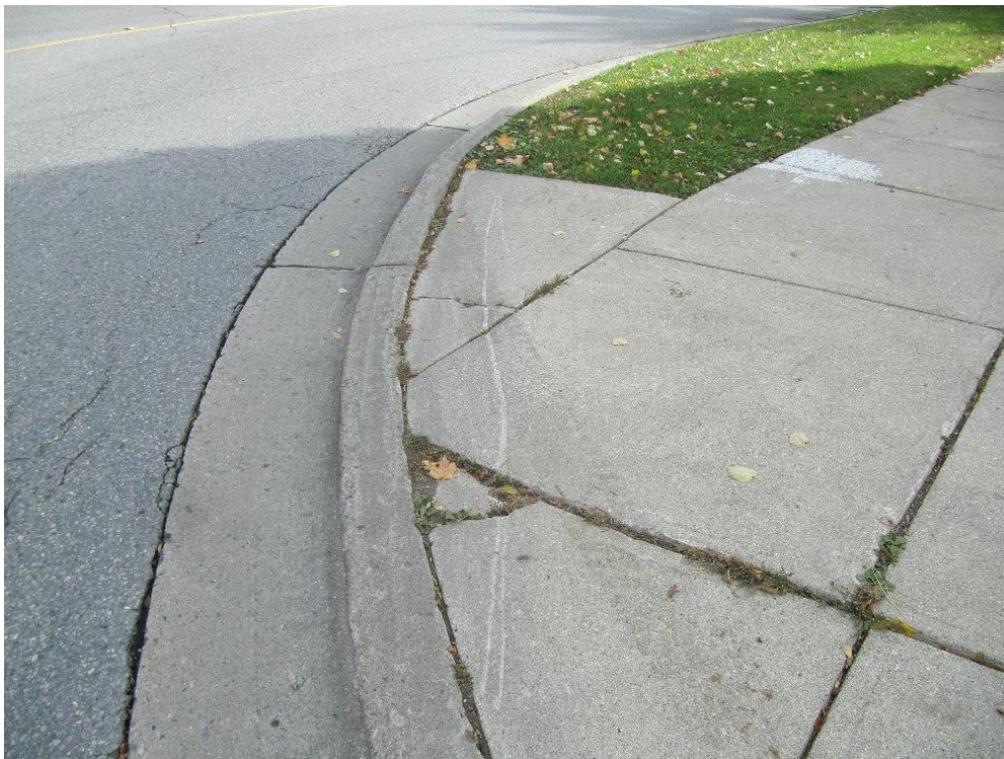
Figure 8: Evidence of scrapes and tire marks on the sidewalk at the edge of the curb indicating the presence of turning vehicles.

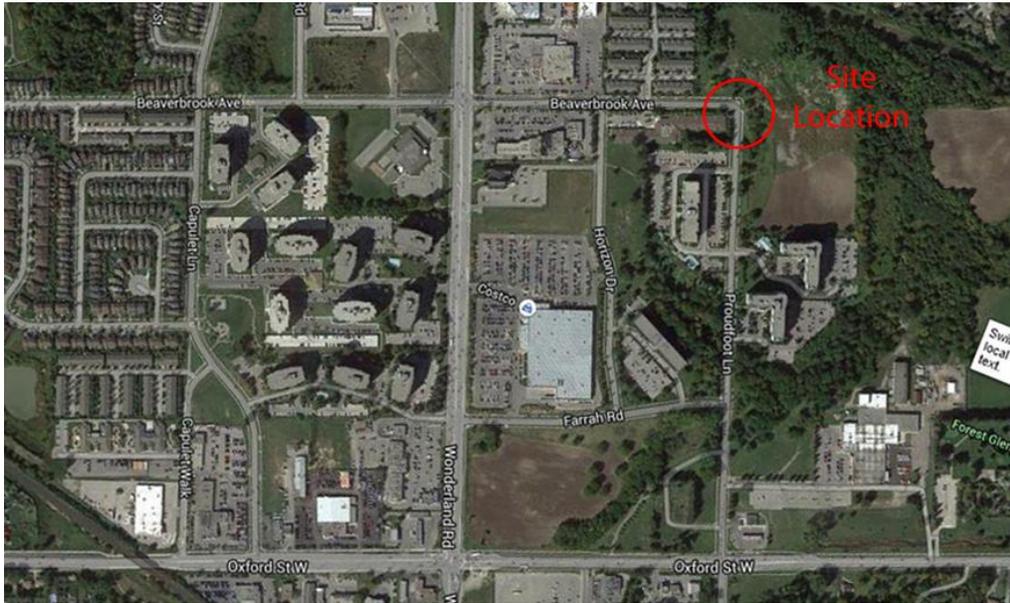
Figure 9: View of 90 degree "curve" and its location as a shortcut between the arterials roads of Wonderland Road and Oxford Street.

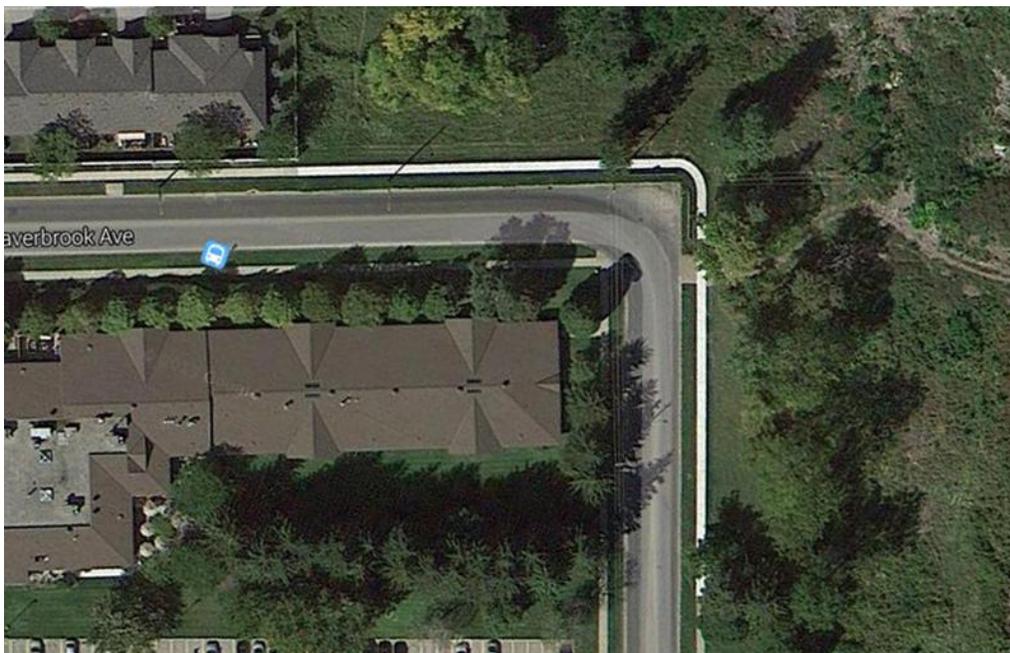
Figure 10: View of 90 degree "curve".

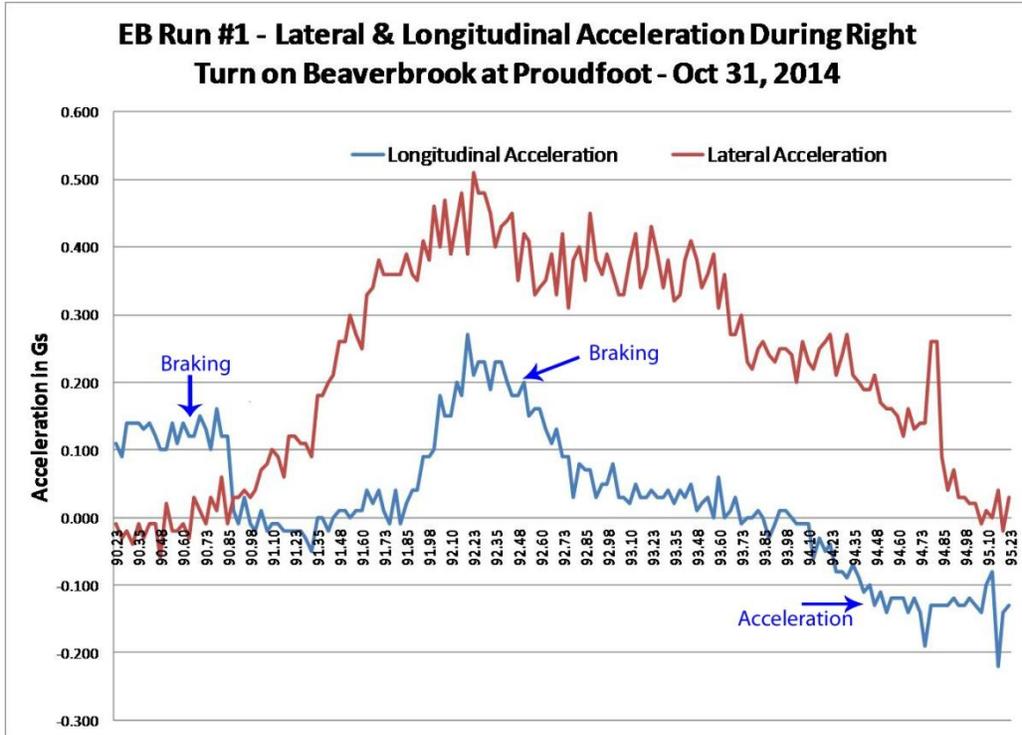
Figure 14: Test #1, eastbound on Beaverbrook.

As an example we can examine the data contained in the first eastbound run in Figure 14. The chart shows a 5 second time interval between 90.2 and 95.2 seconds during which our test vehicle travelled around the curve. At the beginning of the charted values the vehicle's speed was 34 km/h, dropped to 28 km/h in the middle of the turn and at the end it was 28 km/h. The drop in speed was because we had to brake substantially to reduce our speed. This was because we had to assume that the speed advisory of 30 km/h was correct, however, as we approached the turn it was obvious that our speed was too high and we had to apply our brakes resulting in the noted variations in the longitudinal acceleration.

Because of the orientation of the accelerometer in the vehicle the longitudinal acceleration (blue line) had positive values whenever the vehicle slowed down and negative values whenever it sped up. This is explained in the captions shown in Figure 14.

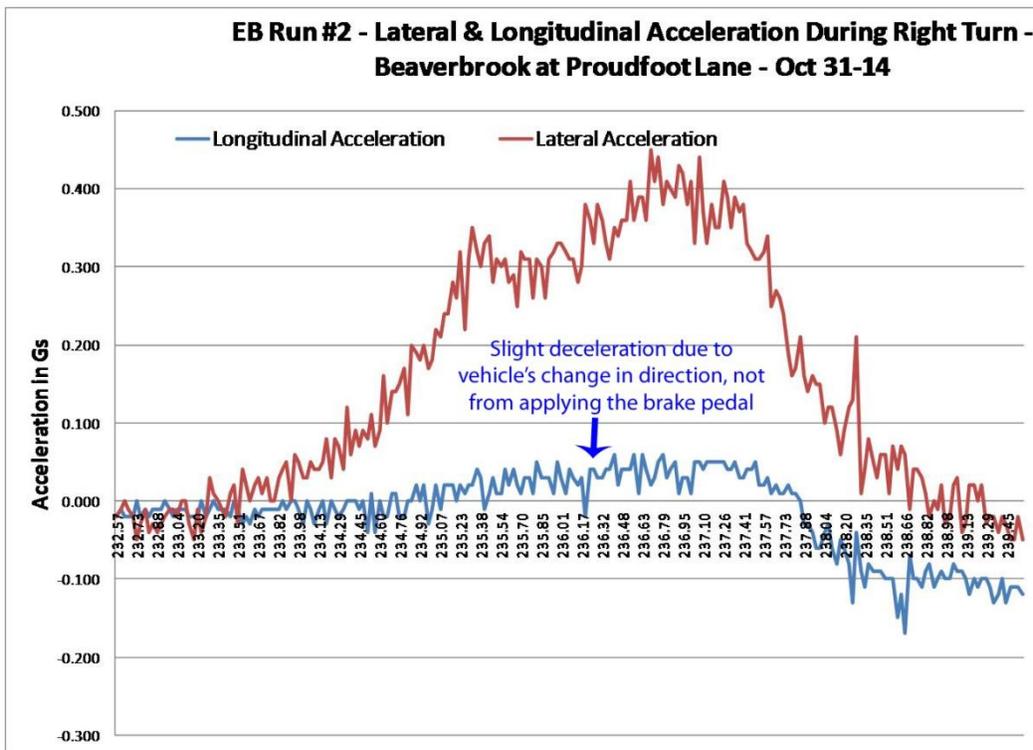
Figure 15: Test #2, eastbound on Beaverbrook.

In Figure 15 we indicate that the longitudinal acceleration contains a slight, natural "bump" in its values indicating that the vehicle slows down, not because the brake pedal is applied, but because, due to the major change in direction, the vehicle's tires scrub along the surface as the tire force is used up to cause the change in direction.
