# Speed Advisory Sign - Additional Testing

*Posting Date: 16-Nov 2014*

This article deals with a specific Speed Advisory tab that exists on the very sharp "curve" of Beaverbrook Road where it intersects with Proudfoot Lane in London, Ontario, as shown in Figure 1.

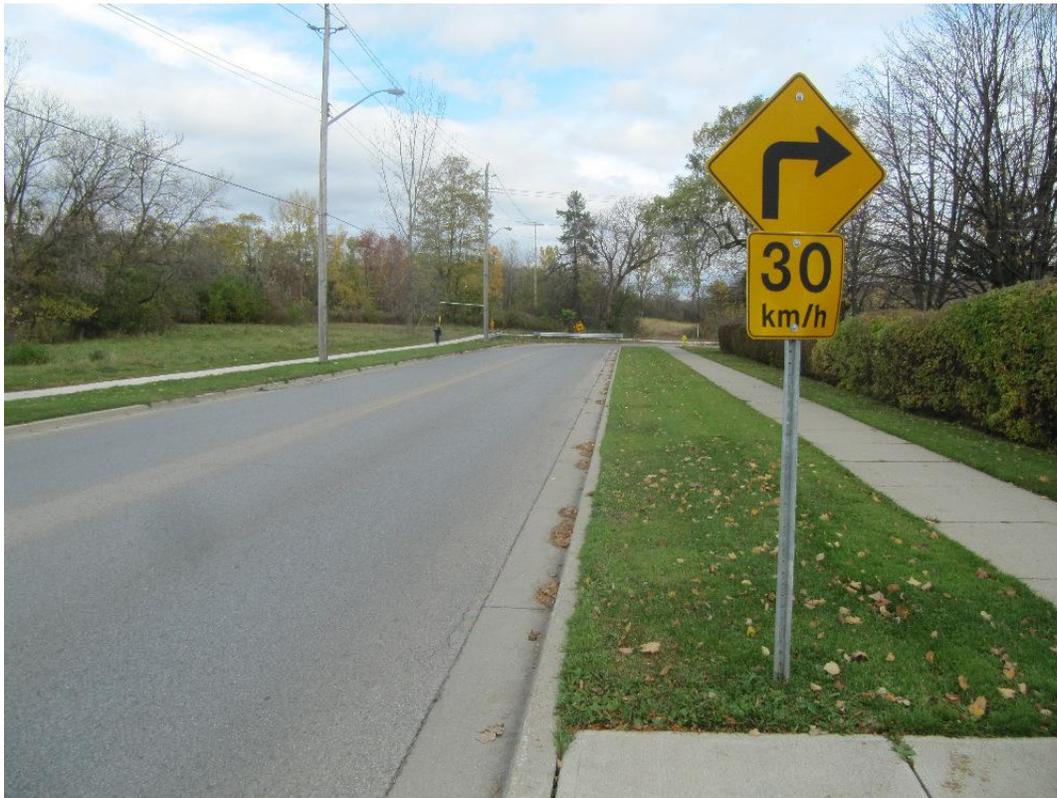
**Figure 1: View of Turn sign with a Speed Advisory tab, on eastbound Beaverbrook Road in London, Ontario, indicating the speed at which eastbound vehicles can safely traverse the sharp "curve" at its intersection with Proudfoot Lane.**

Thus, a side friction factor (lateral acceleration) of 0.21 should have been experienced by our test vehicle if the 30 km/h Speed Advisory was appropriate. Instead, the testing revealed lateral accelerations approaching 0.50g which are well beyond the recommendations.

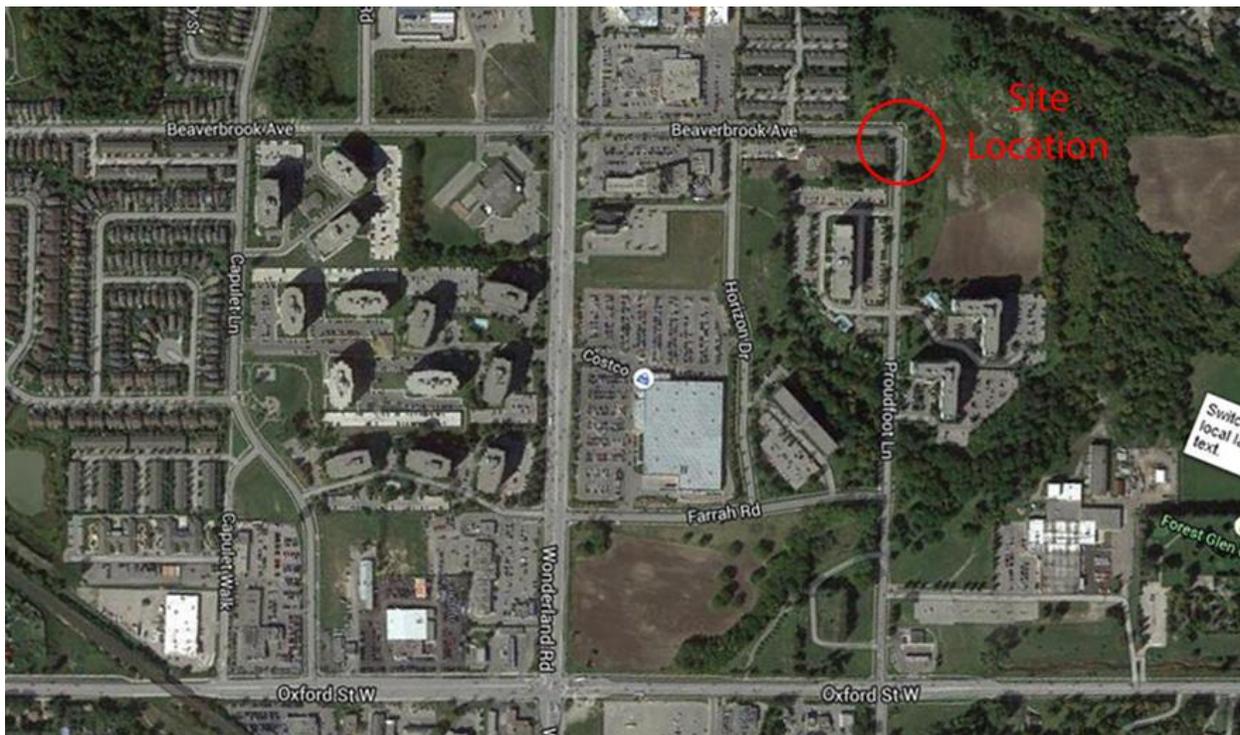
Figure 2: View of 90 degree "curve" and its location as a shortcut between the arterials roads of Wonderland Road and Oxford Street in London, Ontario.

Our general estimate indicates that the right "curve" at this location has a corner radius of approximately 11 metres or 36 feet. This radius is essentially no different than what would be expected at the intersection of low-volume, residential streets in the City.

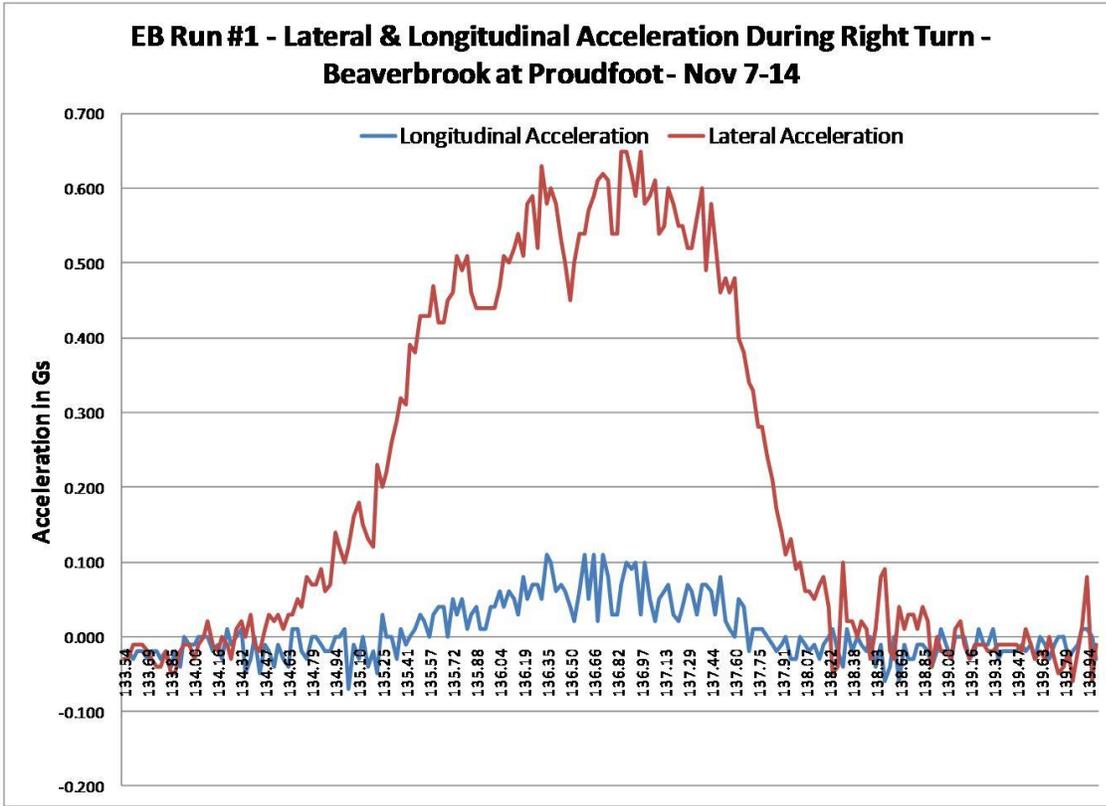
Figure 6: Eastbound Run #1

The view in Figure 10 is taken precisely when we began to steer to the right during our first eastbound run. This is precisely at the beginning of the data displayed in the chart shown in Figure 6. One can see in Figure 6 that both the longitudinal and lateral accelerations are near "zero" at the start of the steering input.

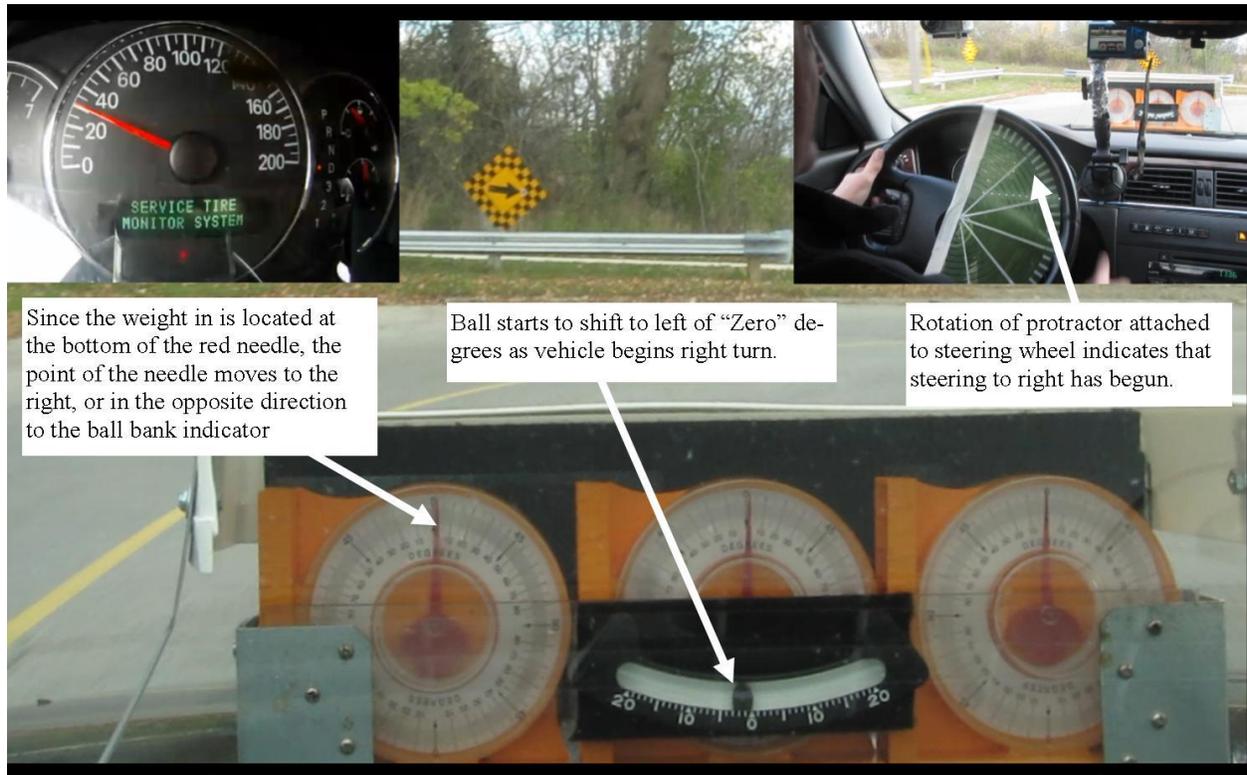
Figure 11 shows the scenario at 1.00 seconds after the steering was commenced. Note that the black ball in the ball bank indicator has started to move to the left of the "zero". The red needles in the three angle-finder gauges also begin to move to the right.

EB Run #1— At one second after start steering to right; Speed still 31 km/h

**Figure 11: Scenario at 1.00 seconds after the steering has commenced.**

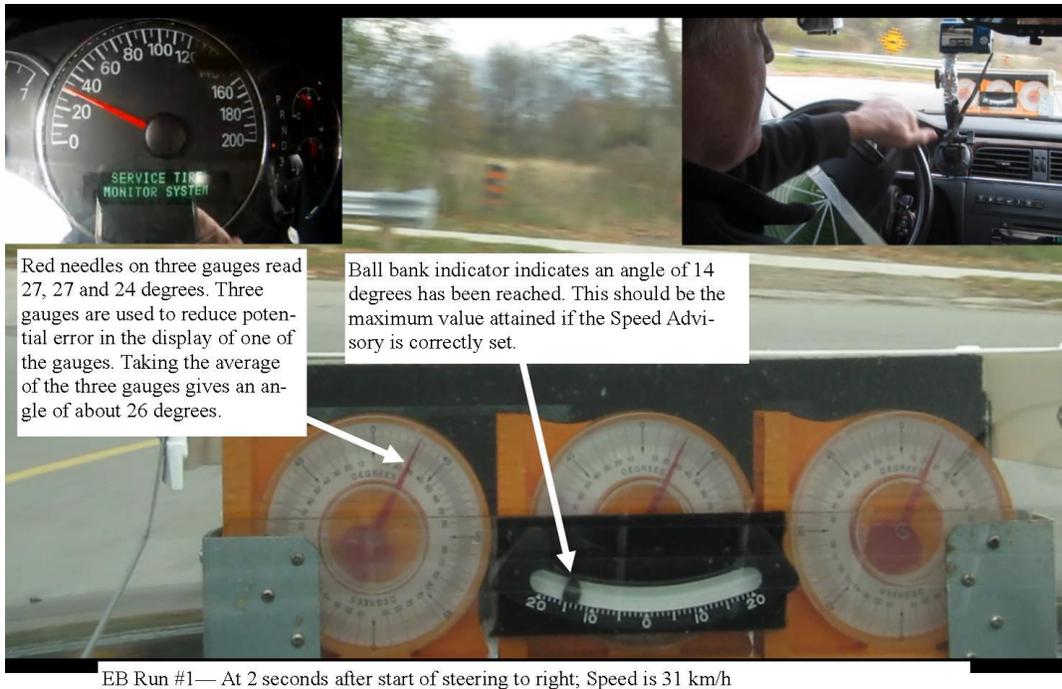
Figure 12 shows the scenario at 2.00 seconds after the steering has commenced. Here the black ball in the ball bank indicator has moved to a position of about 14 degrees. It can be recalled from our previous discussion that this is the maximum angle that the bank indicator should display if the 30 km/h Speed Advisory was set properly. Thus the ball bank indicator should not display a higher value throughout the remainder of the turn. The three angle-finder gauges display an average value of about 26 degrees. However, as can be seen in Figure 13, at 2.33 seconds after the commencement of steering, the black ball in the ball bank indicator has moved to the maximum that it is capable of displaying, or 20 degrees. At this time the three angle-finder gauges display an average value of about 27.7 degrees. Furthermore, Figure 14 shows the scenario 3.00 seconds after the commencement of steering. Here the black ball of the ball bank indicator is at its maximum reading of 20 degrees because it is incapable of displaying a higher value.

Figure 12: Scenario at 2.00 seconds after commencement of steering.

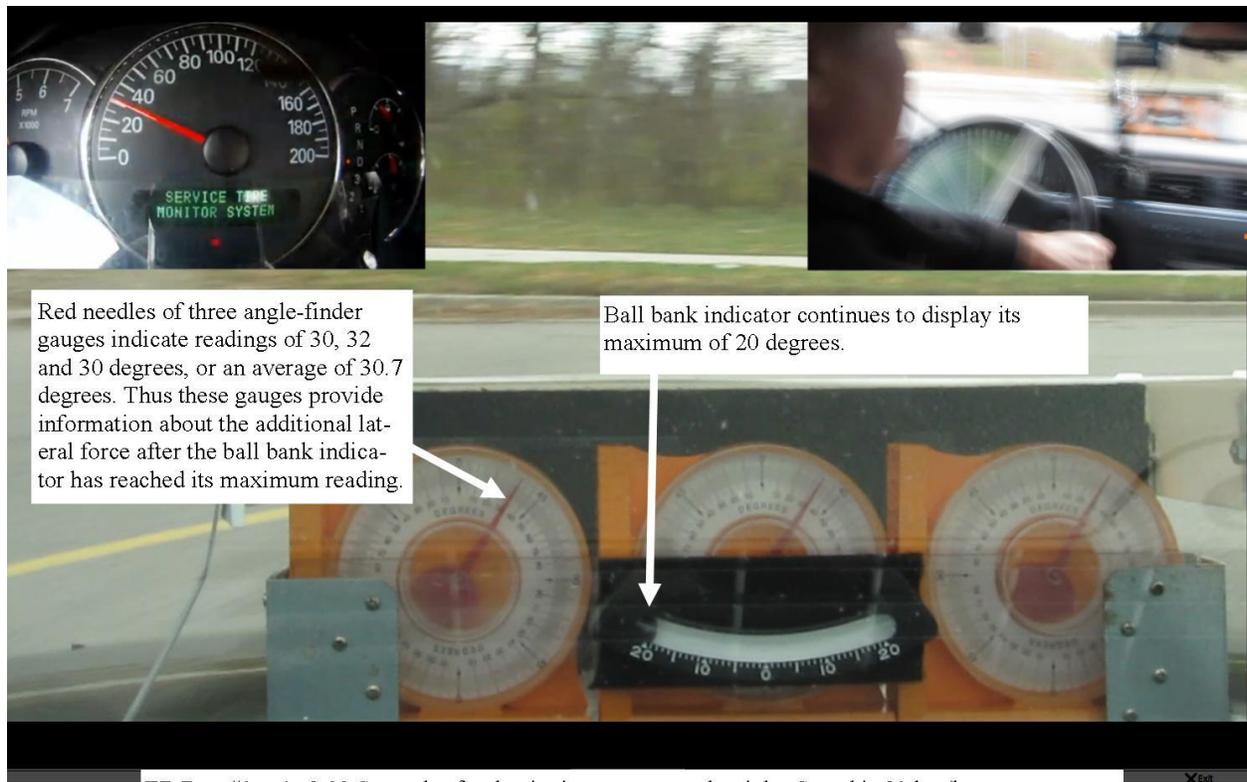
Figure 14: Scenario at 3.00 seconds after commencement of steering.

Thus, even though the ball bank indicator cannot tell us the actual value of the lateral acceleration, the three angle-finder gauges provide us with some guidance. The red needles of these gauges display values of 30, 32 and 30 degrees, or an average of about 30.7 degrees. And we can recall from Figure 12 that their average value when the ball bank indicator reached its maximum of 20 degrees was 27.7 degrees. So this gives us an indication of the additional lateral acceleration that the ball bank indicator could not display because the value was beyond its range of display.

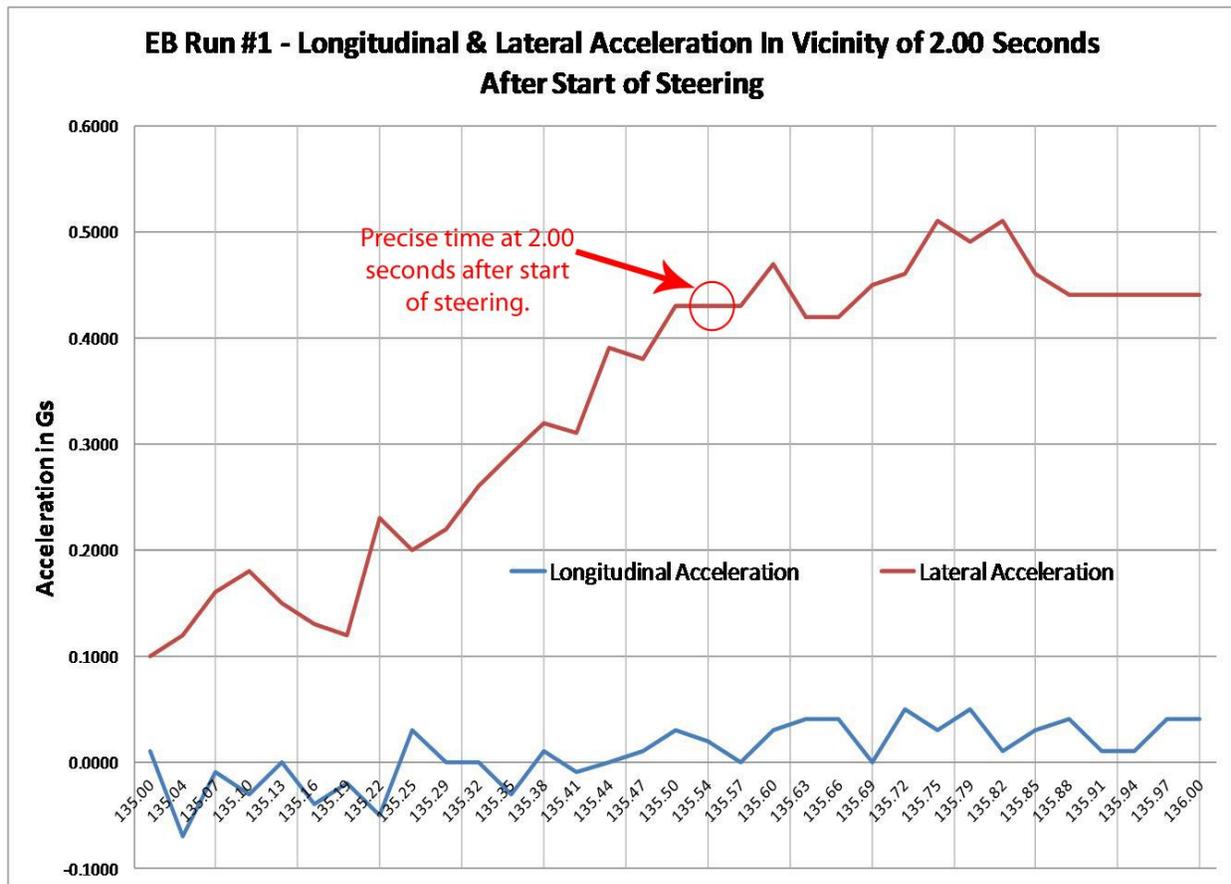
Figure 15: Close-up view of raw data from accelerometer between 135.00 and 136.00 seconds, or 1.50 to 2.50 seconds after the start of steering.

In this 1 second of data, the lateral acceleration rises from about 0.3g to around 0.5g and this is a rapid increase. Yet we know that the motion of the black ball in the ball bank indicator is damped as evidenced by the fluid in the casing where the ball resides. Thus the reaction of the ball to the instantaneous changes in the lateral acceleration is slow, much slower than the changes in value sensed and displayed from the accelerometer, or the less damped motions of the needles of the three angle-finder gauges. So in the present scenario, where the vehicle makes a very quick change in direction over a short time and distance, the ball bank indicator is unlikely to be a good

indicator of the precise lateral acceleration at a specific time. Instead the ball bank indicator is designed to provide an indication of the lateral acceleration over longer curves where the lateral acceleration changes less dramatically. This is a fact that should be kept in mind when comparing the results of the ball bank indicator to the data from an accelerometer or to that of other gauges.
