Springbank Driver Fatal Crash Into Tree - Review of Site Evidence

Posting Date: 26-Mar-12

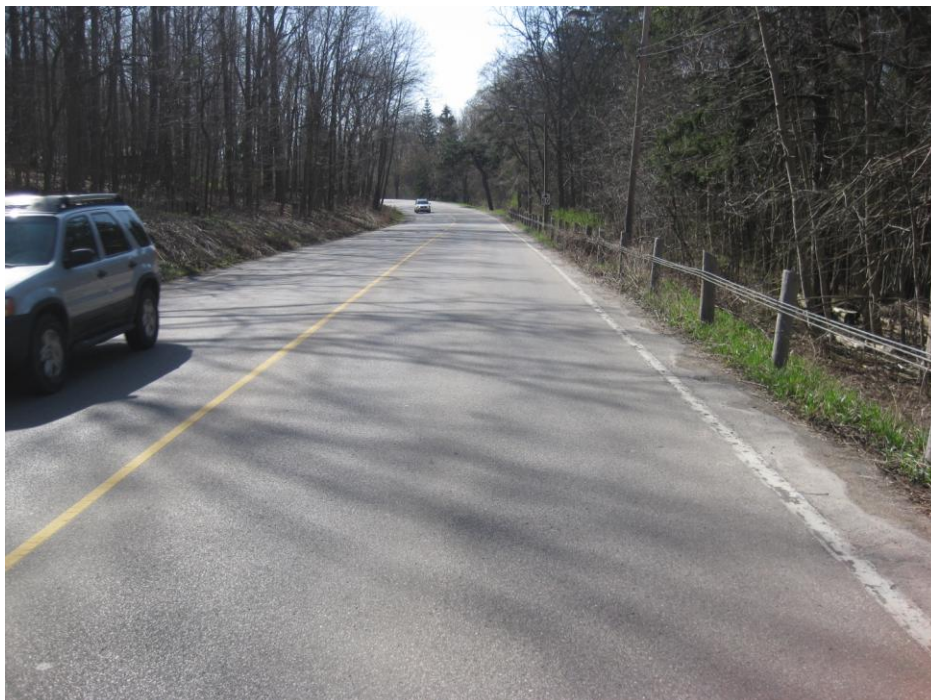
On approach to the crash site Springbank Drive levels off and becomes straight for a distance of a couple hundred metres as shown in the photo (looking westbound) below.

It can be seen in the background of the above photo that the roadway curves to the left. It is at this point of curvature that the subject Pontiac travelled off to the right (north) side of the road. On the south side of the road we observed a fresh tire mark as shown in the photos below.

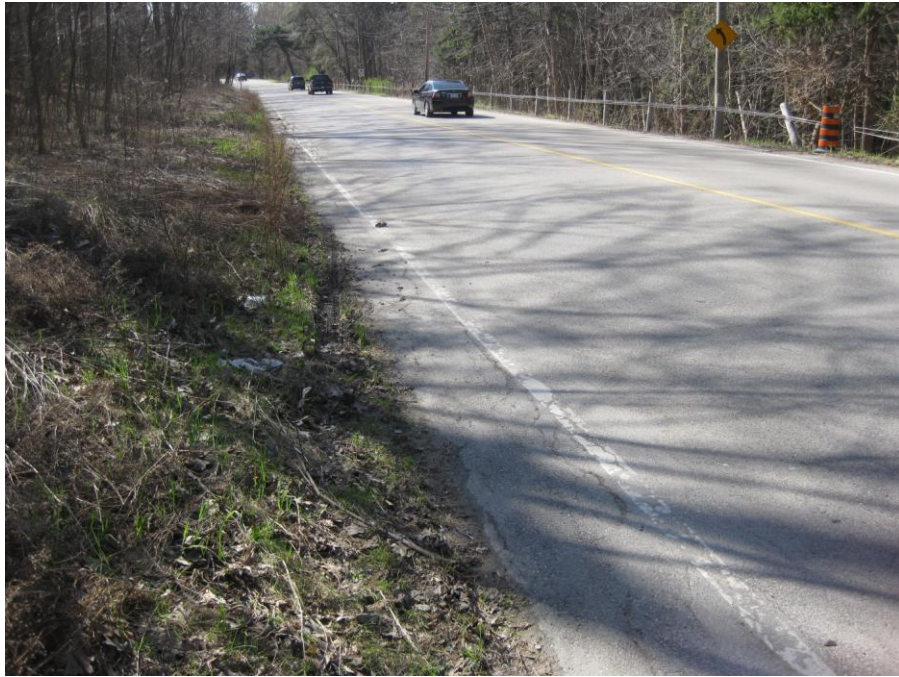
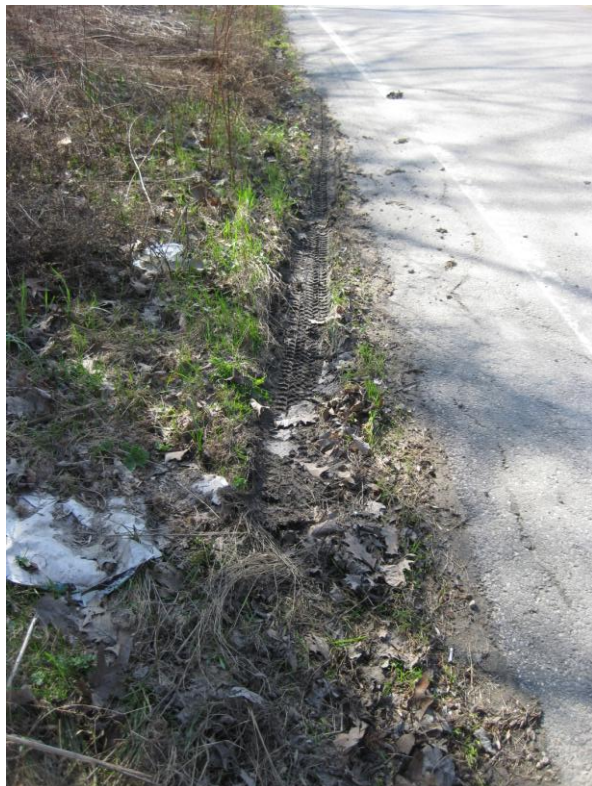
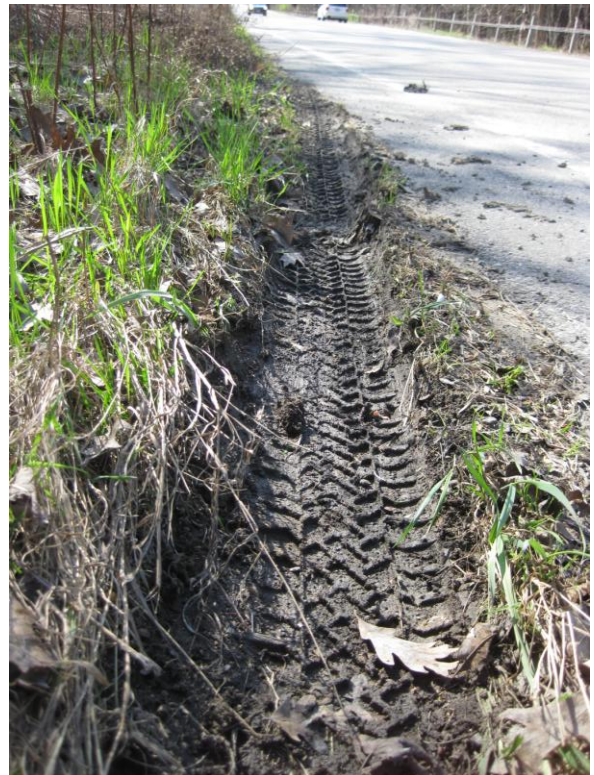
Although this tire mark is several hundred metres east of the area of impact one must be careful with such evidence when considering that at high speed, say 90 km/h, a vehicle can travel 25 metres every second. So it is possible that an eastbound vehicle could interfere with the travel of the Pontiac and then come to a stop several hundred metres east of where the actual crash occurs. We are not suggesting that this evidence is related to the crash but rather, this is an educational exercise, where we comment on general possibilities that investigators should be aware of.

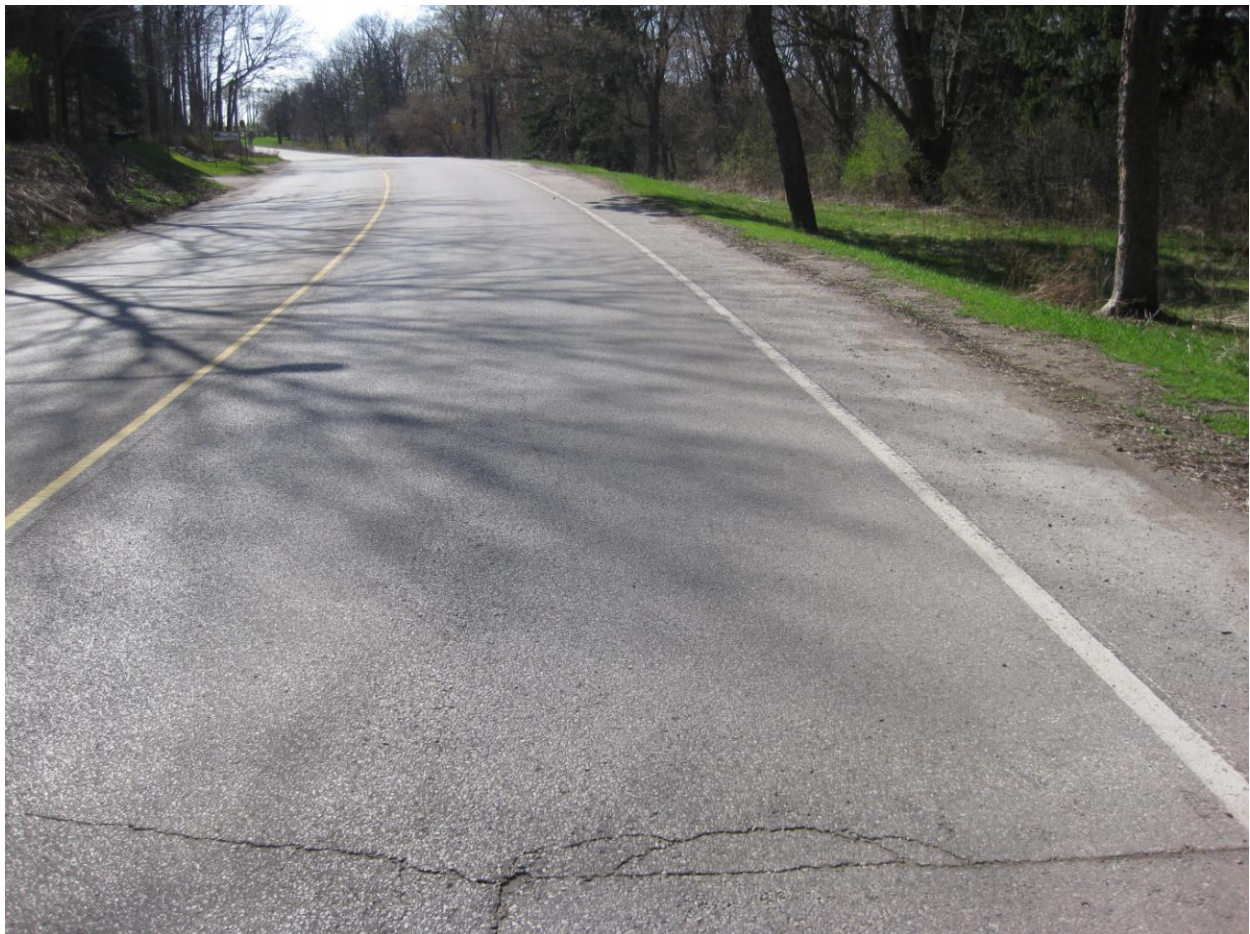
The photo below now takes us further west to the beginning of the curve. Note that there is a slight elevation change at the point where the road curves to the left. This elevation change can be appreciated by noting that you can see the surface of the road fairly well for some distance in the background and then suddenly the surface "disappears". Although the elevation change is small, when it is combine with a high speed and a slippery road surface this small effect on the tire force could make a difference in whether a driver encounters a problem.

We are often concerned with the status of the edge of the paved surface and whether there is any evidence of an edge drop off or if there is a substantial cross-slope. One can see in the above photo that the pavement exists over a wide distance beyond the white fog line therefore this is a fairly safe characteristic. We can also report that there was no evidence of a significant cross-slope in the road. One can also see that the road

surface is in relatively good condition without any evidence of patching, pot holes or depressions.

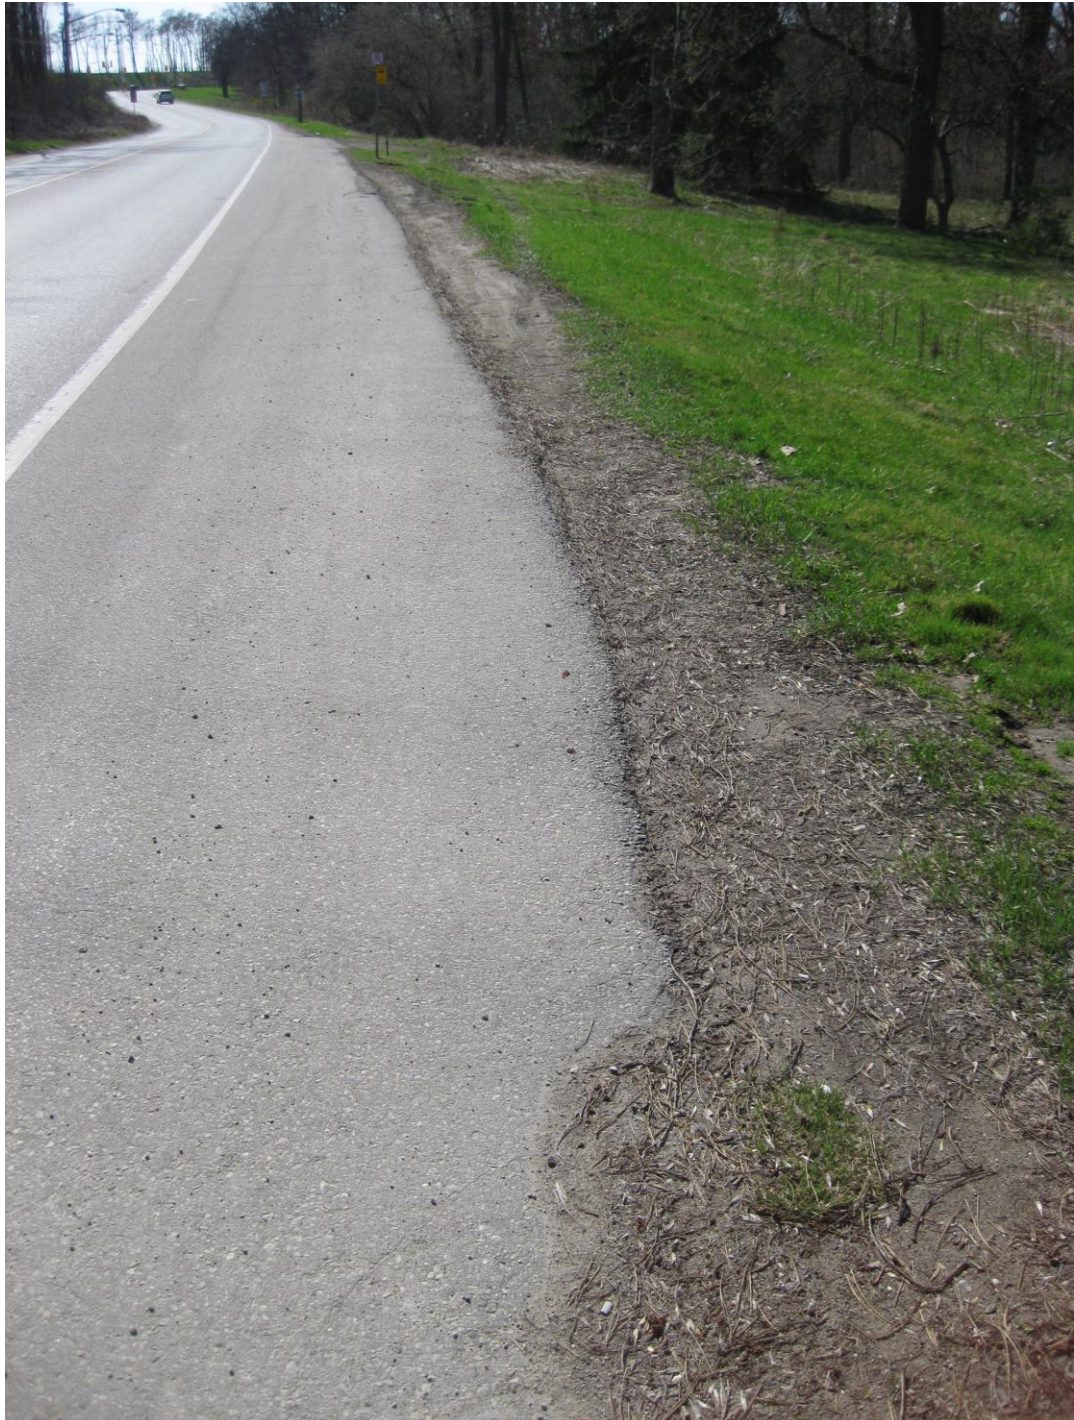
As we approach the area where the vehicle left the road surface we can see in the photo below that the paved surface extends a fair width beyond the white-painted fog-line. One should appreciate the additional safety margins that such a characteristic provides if a driver should encounter difficulties while travelling around the curve.

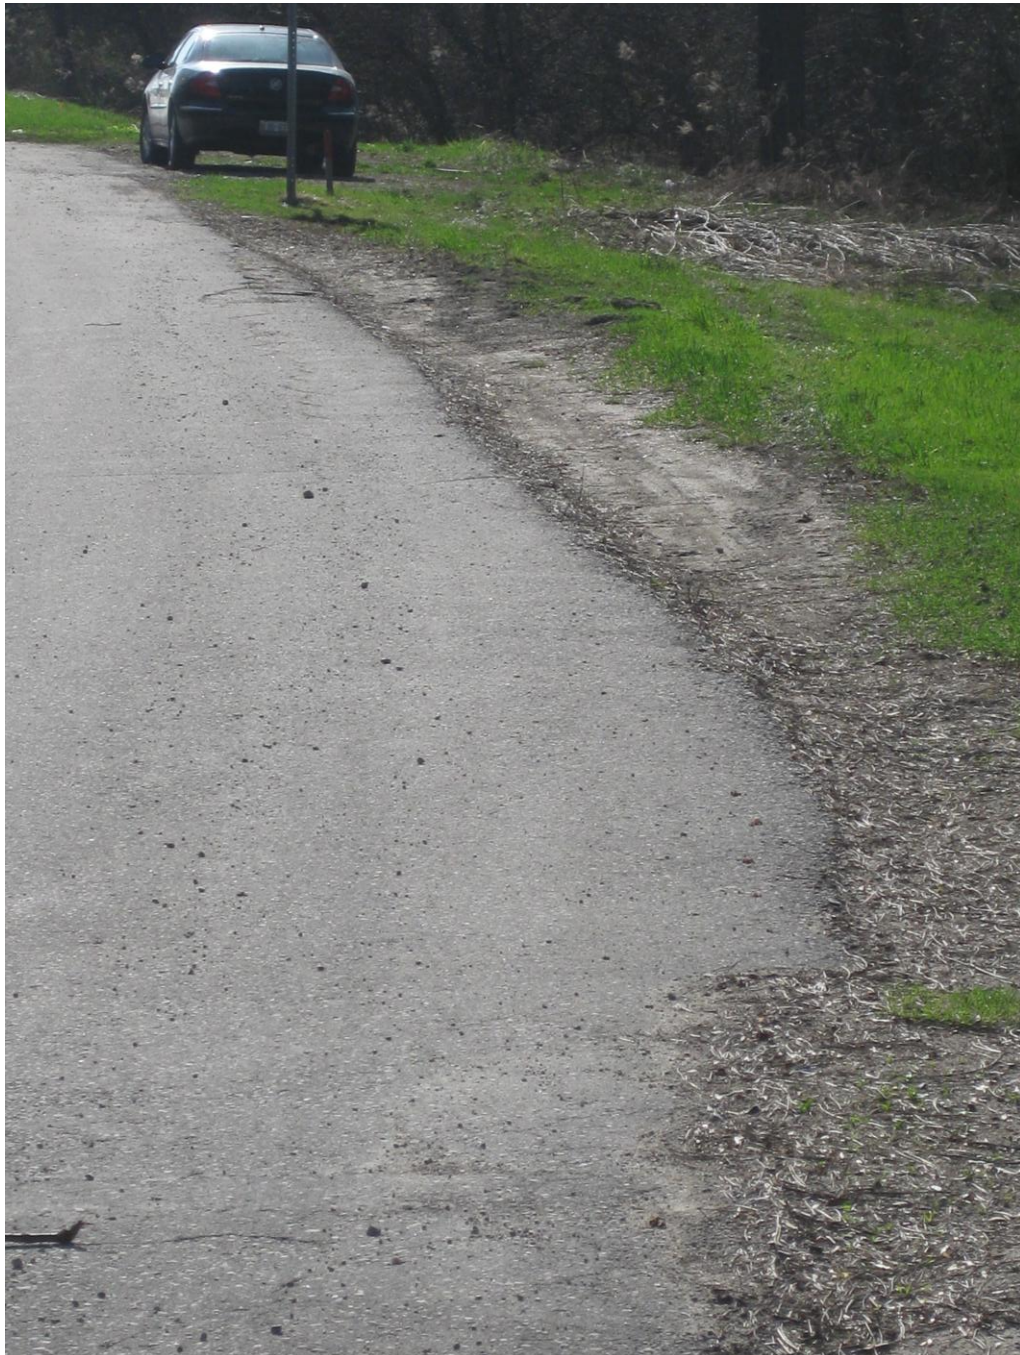
The photo below shows the vicinity of the north roadside where the Pontiac first left the pavement surface. This is a zoomed in view so that the road distances appear much shorter than they truly are. We have parked our vehicle a short distance east of the struck trees that cannot be seen the background due to the dark shadows. The Pontiac's tire marks will eventually be visible just to the right (north) of our parked vehicle. The beginning of the tire marks will be seen in the earth at about the middle of the right side of the photo.

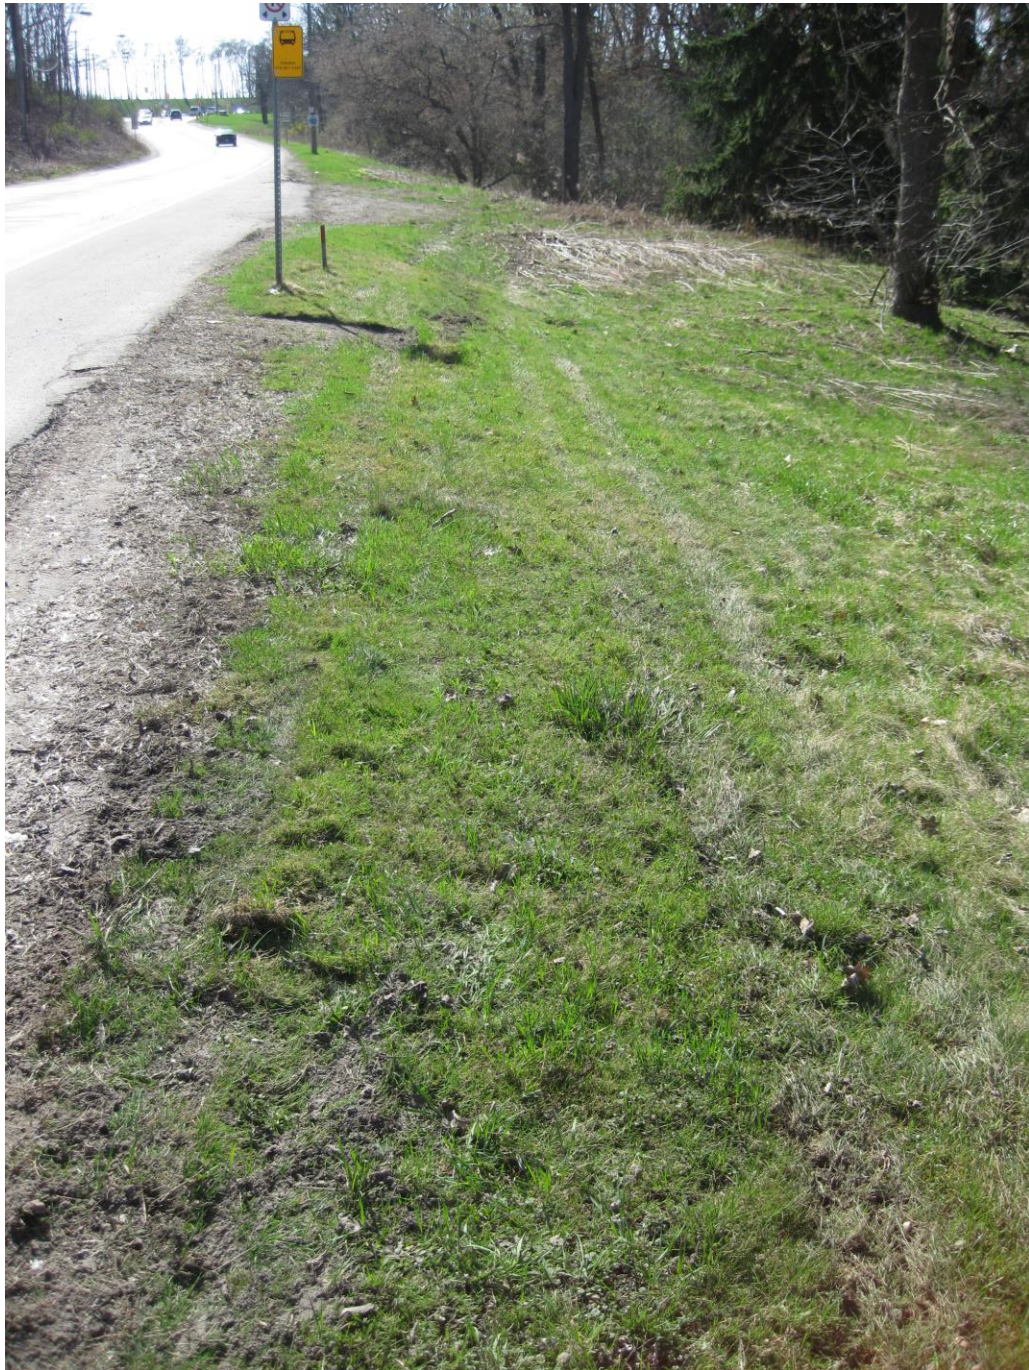
Before discussing the details of those tire marks we first want to take you through the site to the point where the vehicle hit the trees. So below is another view, looking further west, along the tire marks produced by the Pontiac.

The right side tire marks are perhaps more visible than the left and they are located in the grass toward the right side of the above photo. There are two tire marks side-by-side because the two right side tires are not travelling along the same path. The left side tire marks are located just to the right of the bus stop sign in the background. The struck trees can be seen in the background directly in the centre of the upper part of the photo.

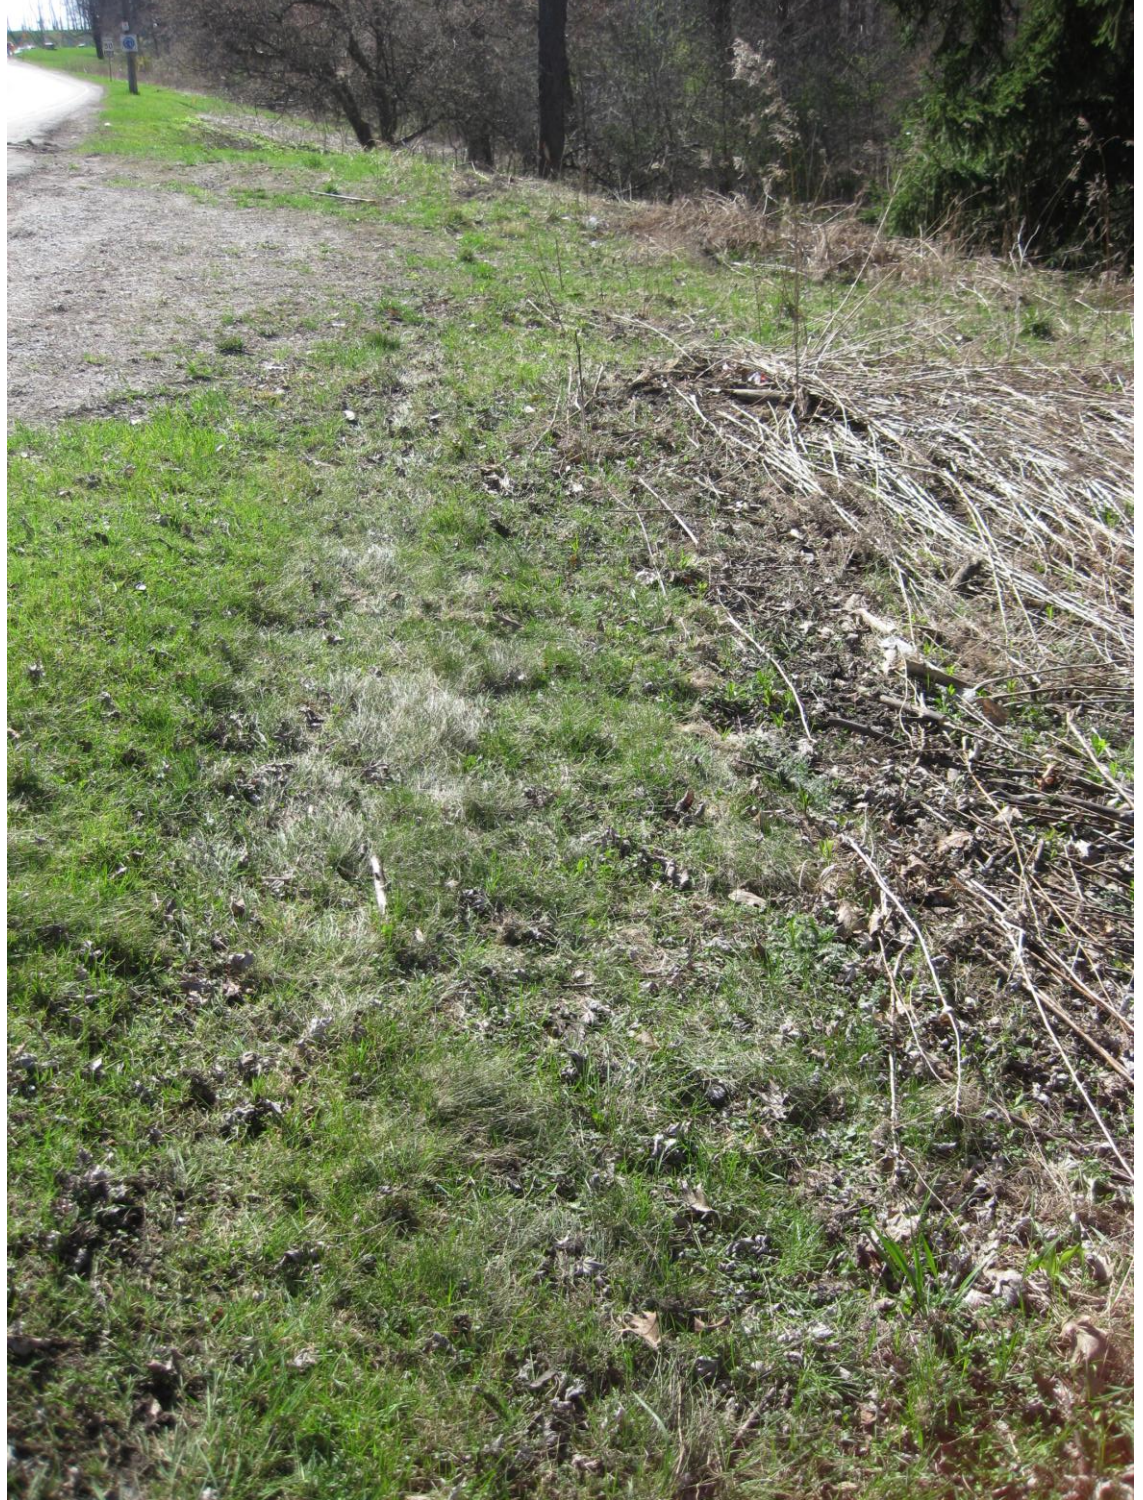
Below is a view, looking further westward toward the trees where the impact occurred. The roadside slopes downward toward the west and toward the trees in the background. You may be able to detect the two sets of tire marks in the grass in the foreground.

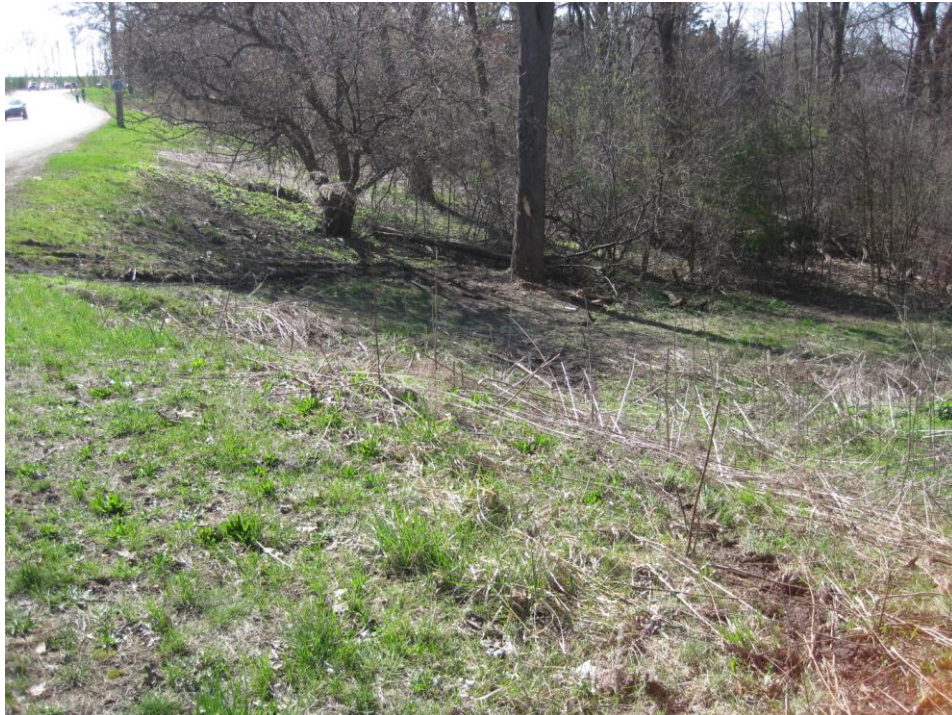
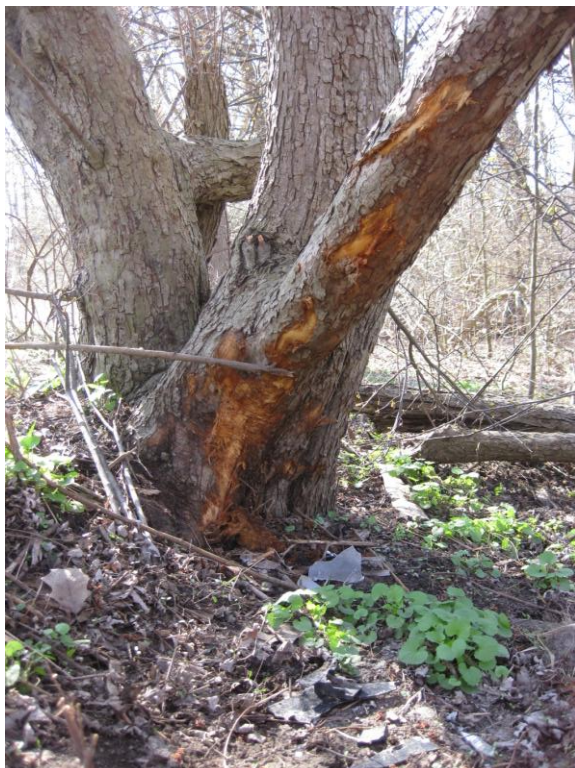
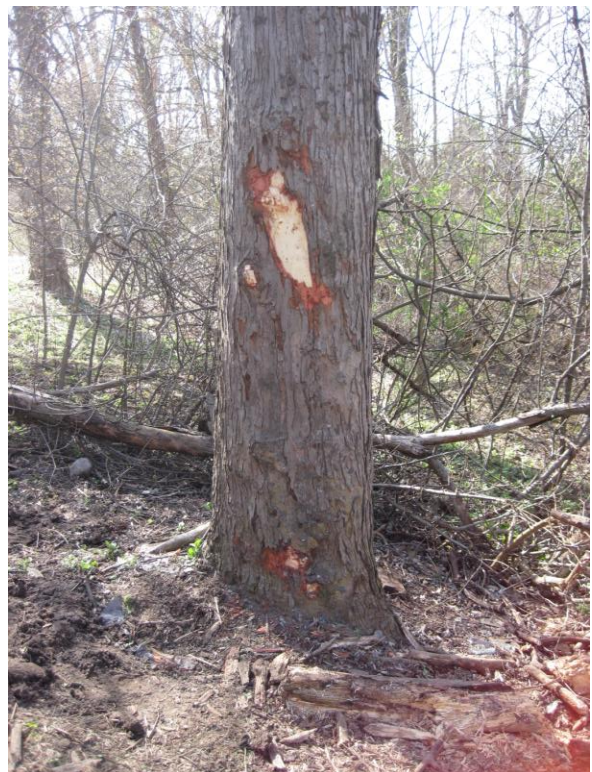
The photo below shows another westward view as we approach the struck trees. There was evidence of contact damage to two trees and those are shown in the two photos at the bottom of this page.

The lateral distance between these two trees is at least 5.0 metres and the total length of the Pontiac would be less than 5.0 metres. Therefore it is unexplainable how contact could have occurred to both trees by the same vehicle.

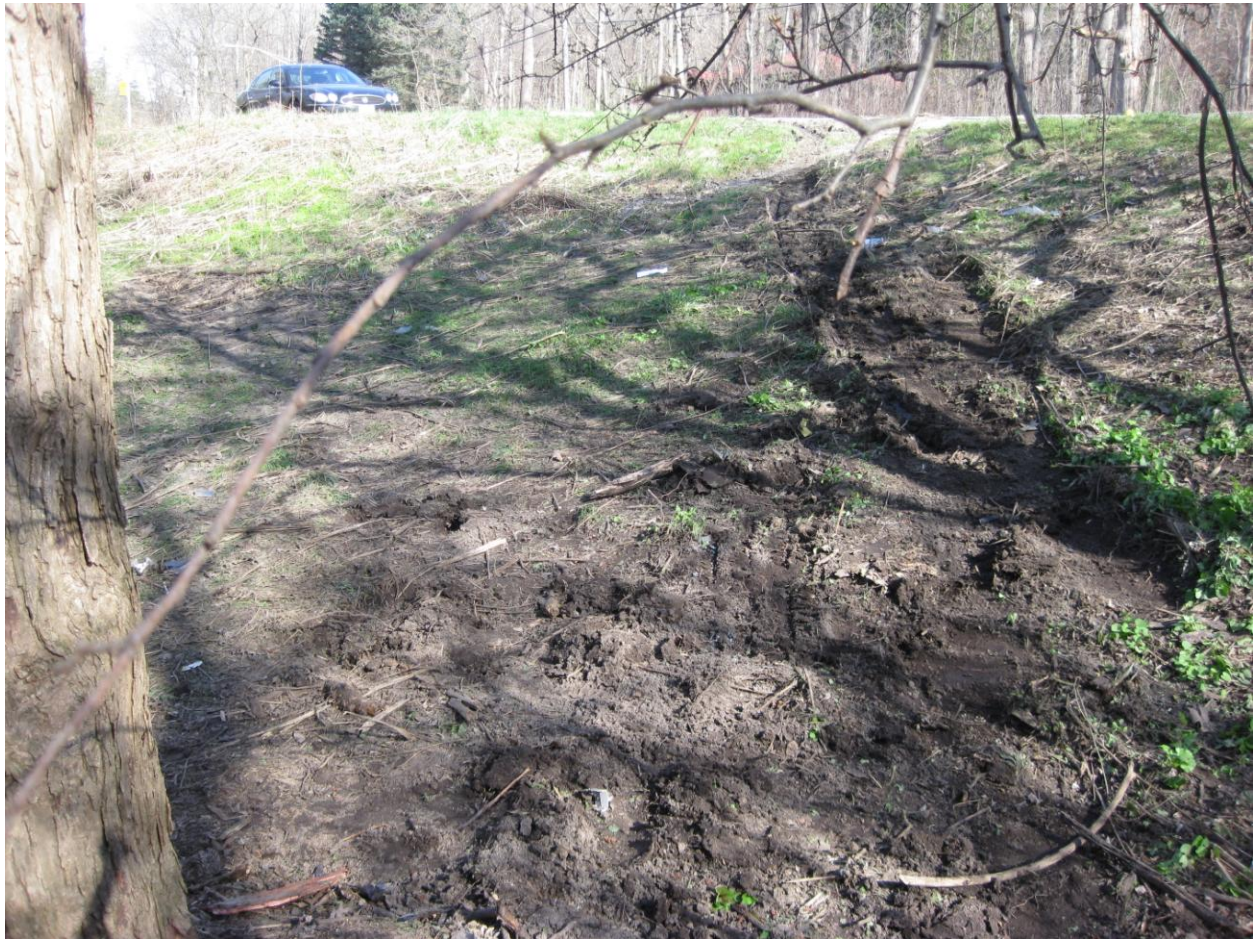
The photo below shows a view looking eastward from the large tree. On the right side of the view you can see gouges in the earth where the tow truck pulled the vehicle back up the slope and onto the roadway. You can also get an appreciation of the road location by noting the position of our parked car that was shown in previous photographs.

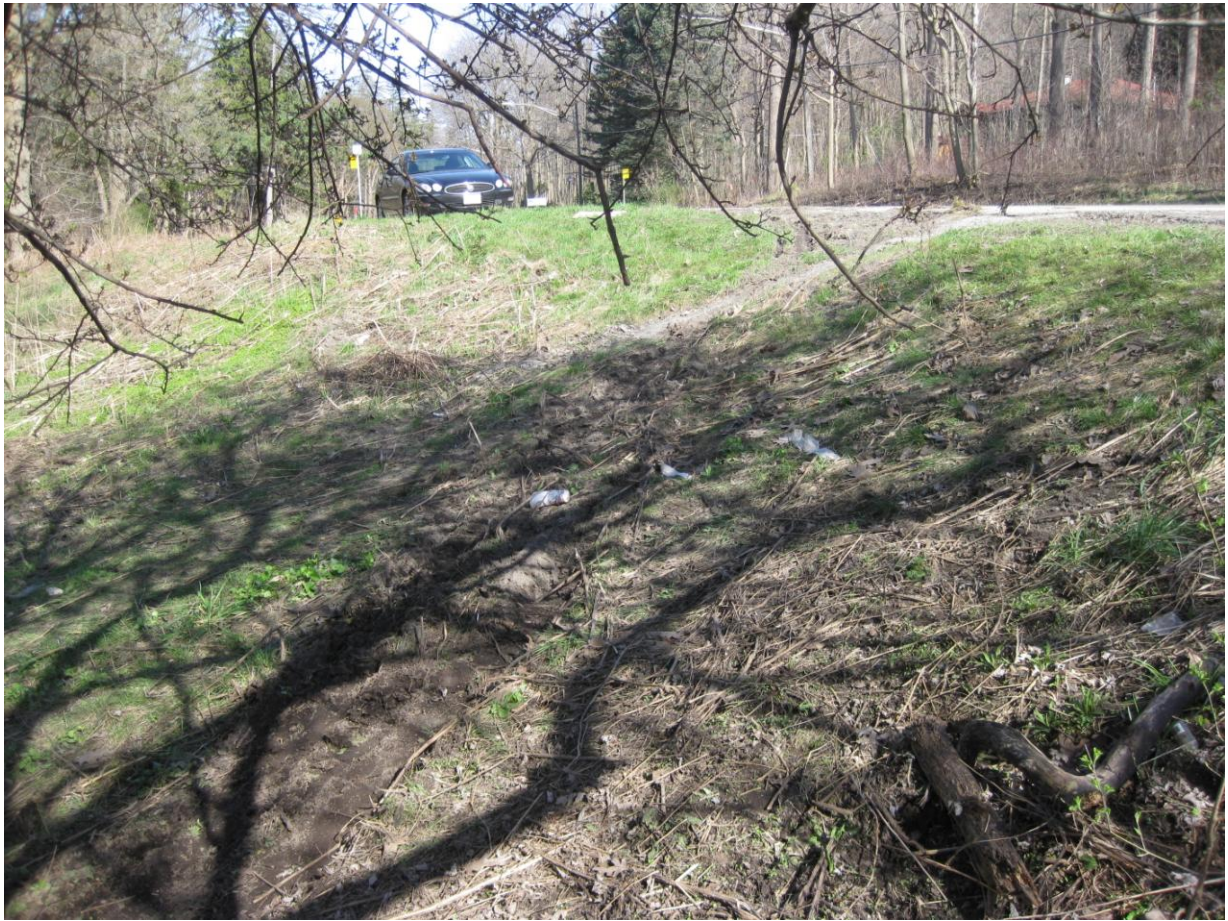
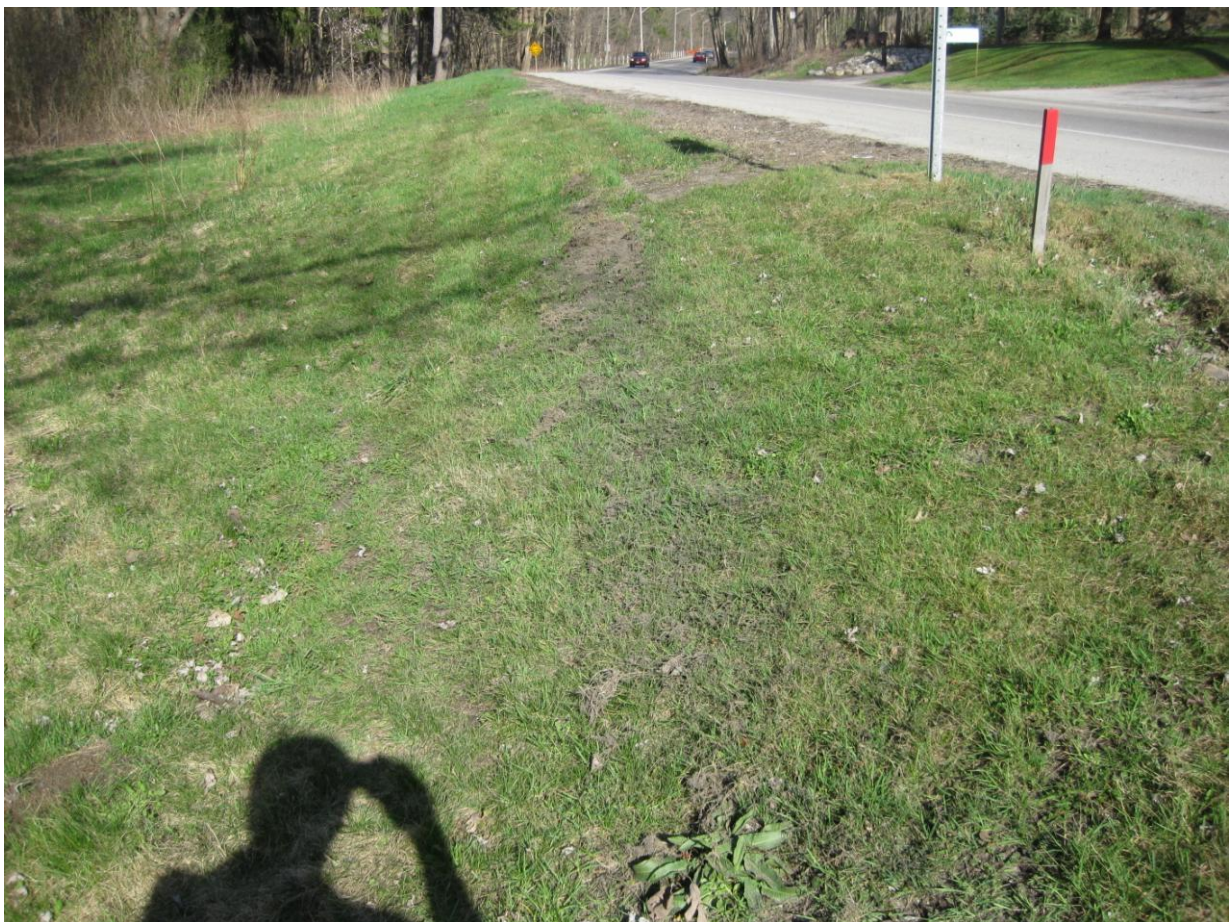
The two photos on the following page take us back up the slope along the tire marks. The bottom photograph was taken from adjacent to our parked car and you can see the tire marks in the grass as the Pontiac came toward the camera. A metal post in the upper right corner of the view is the post that contains the bus stop sign. Just east of that bus stop sign there is a small bare portion of earth where it would appear that a snow-plow had torn out the grass possibly in attempting to clear out the snow around the bus stop. Inside that area of bare earth we were able to see the prints of the two left side tire treads.

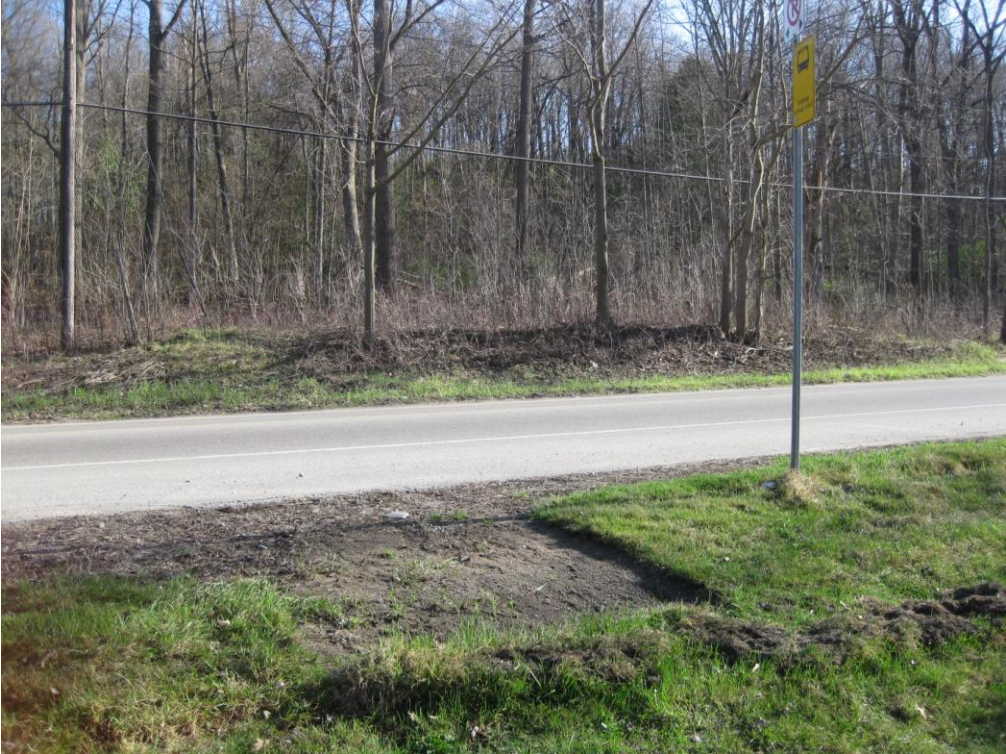
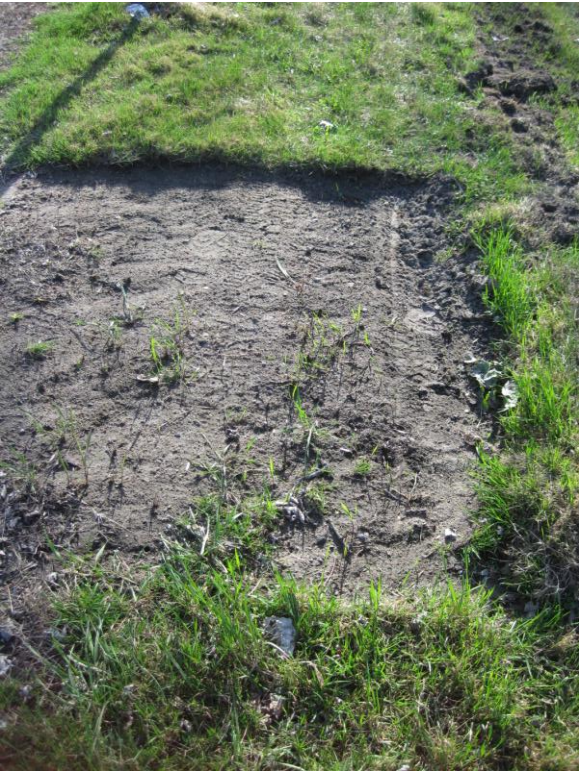
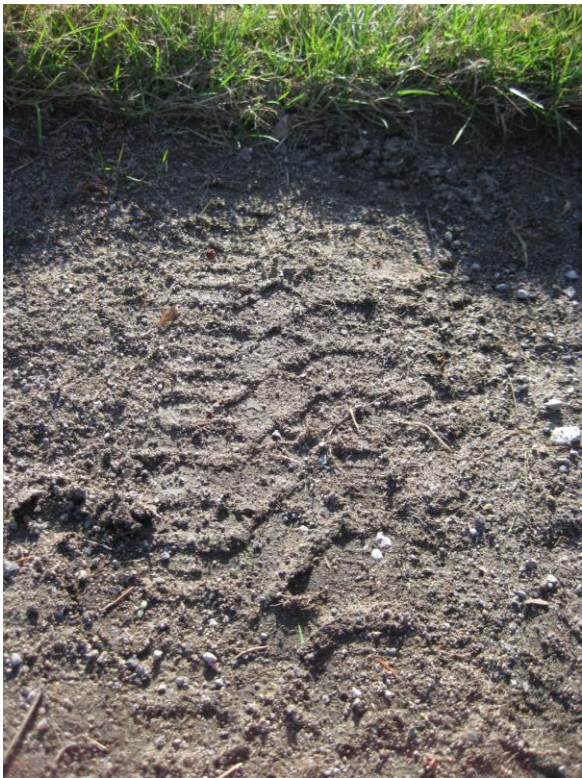
The photos below show the area of bare earth and the prints from the treads of the left tires of the Pontiac. The bottom two photos show the view looking westward.

The presence of a visible print of the tread of a tire often indicates a lack of braking however, with the prevalence of anti-lock braking systems tire tread imprints may still be present but these could be interspersed with the scrubbing of the earth when the tire is near to lock-up.

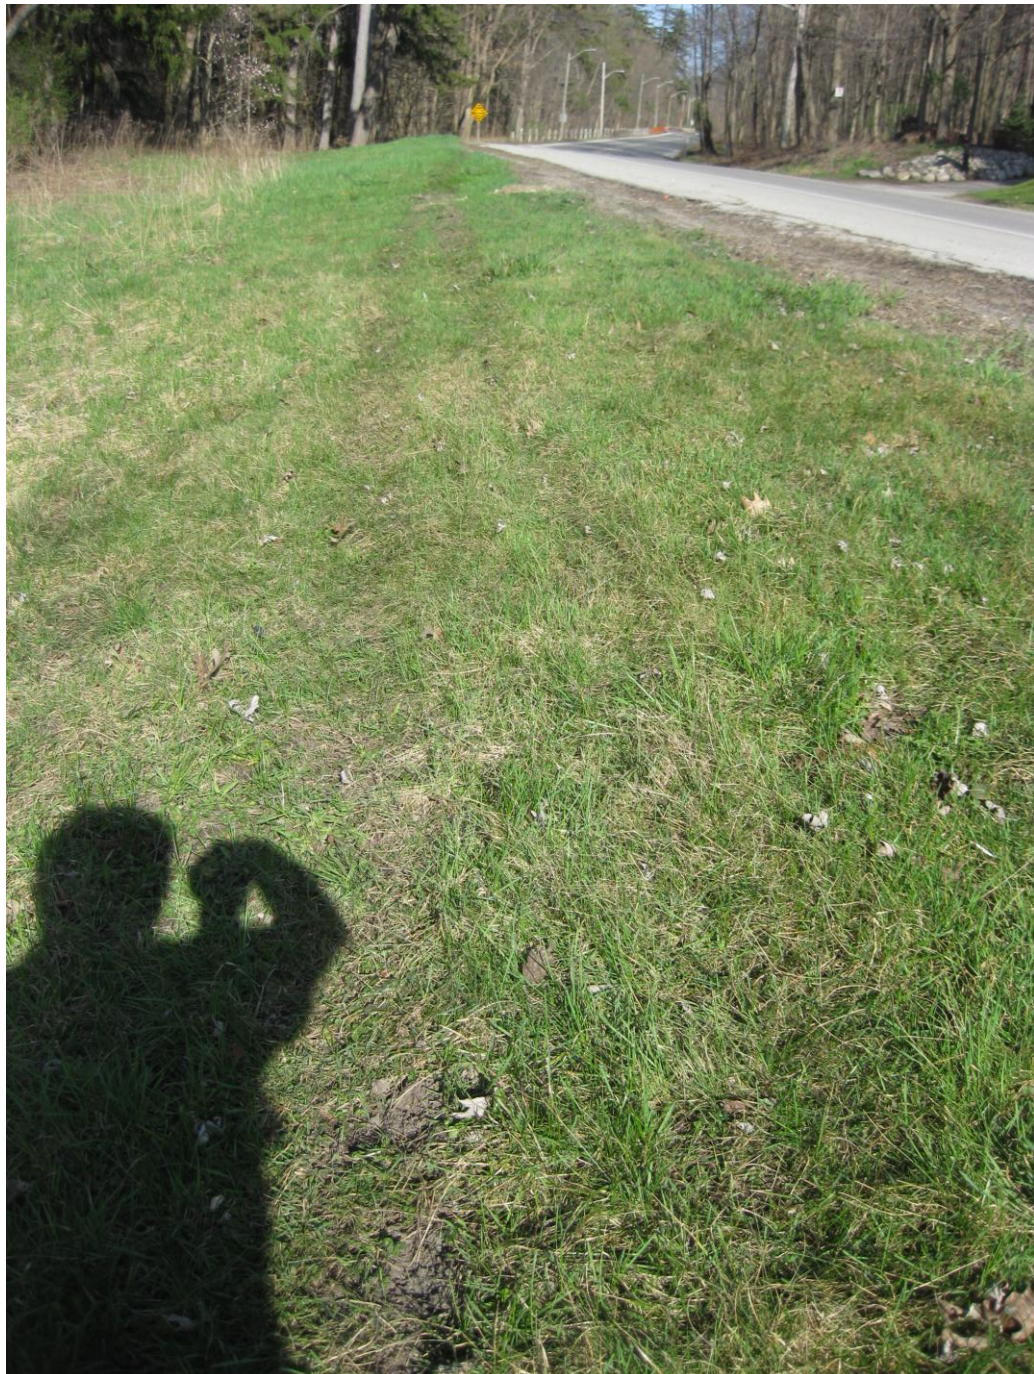
In the photo below we continue to follow the tire marks eastward. You may be able to see the two right tire marks and how they appear to come from the same location in the background but then they diverge as they approach the camera. This is a sign that the vehicle was pointing the same direction as it was travelling in the background and that it rotated counter-clockwise as evidenced by the slight curvature of the tire marks.

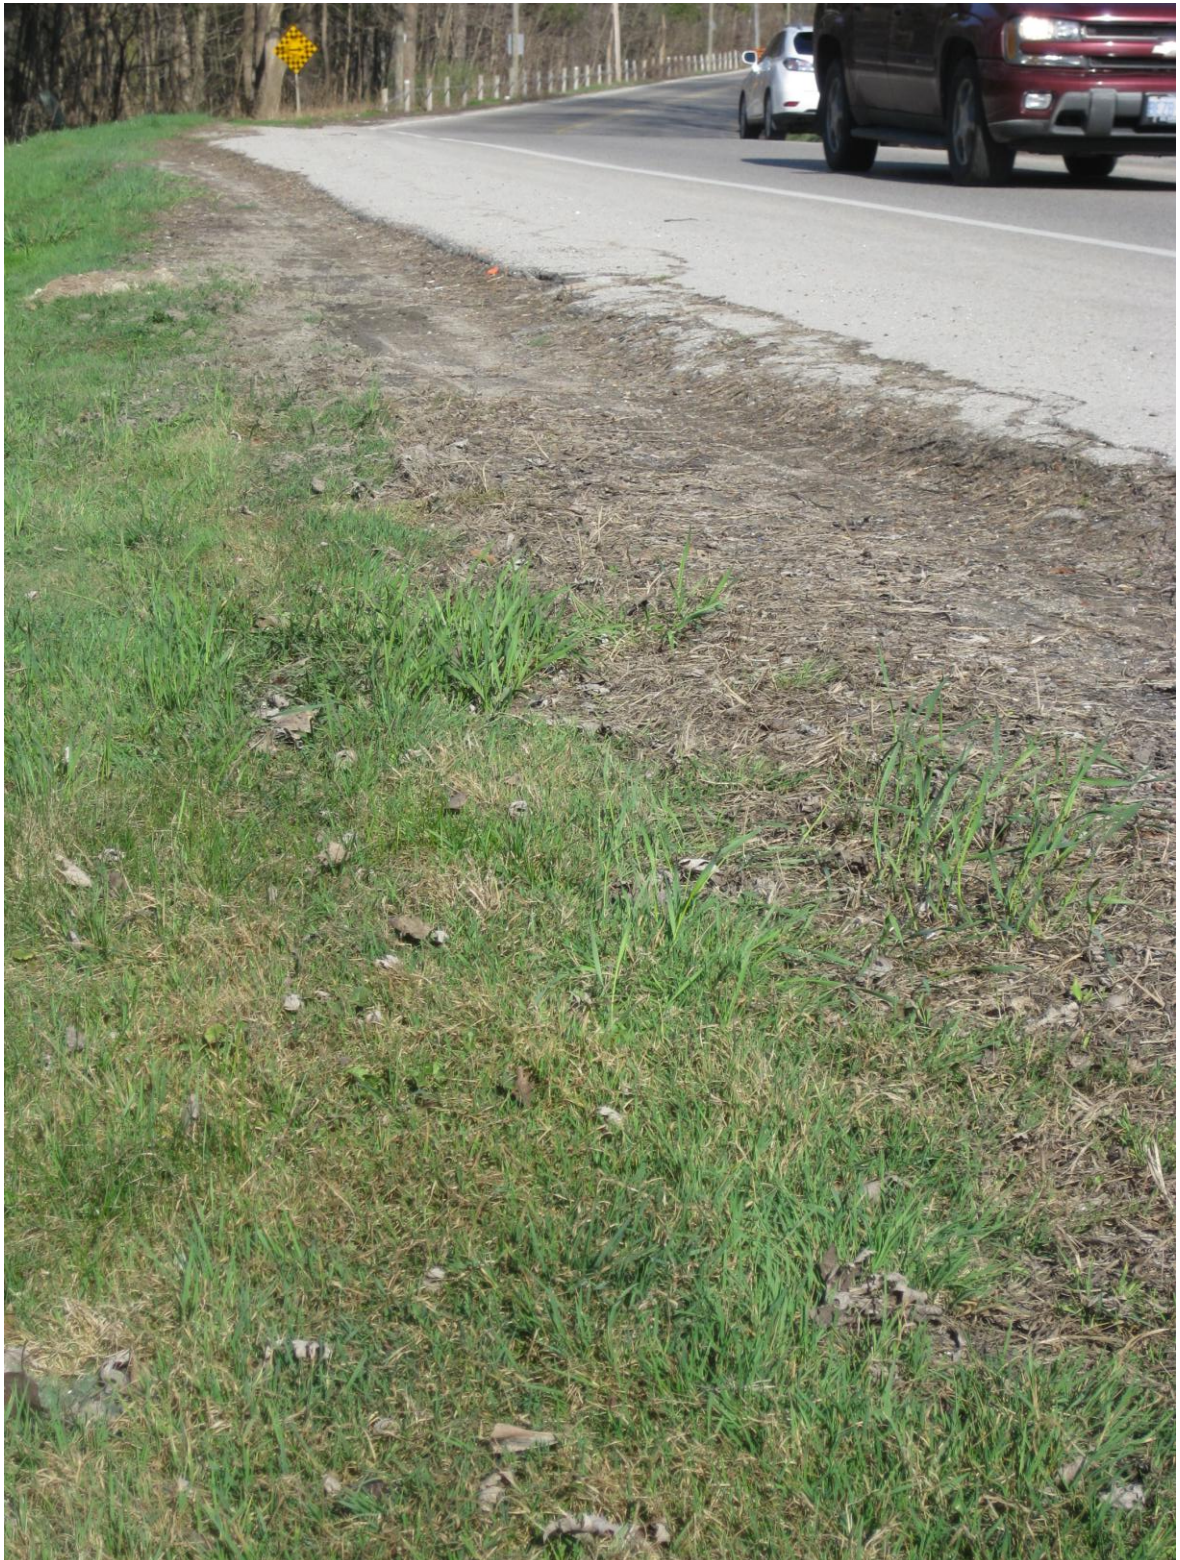
In the photograph below we approach the origin of the visible tire marks. It may no longer be possible to distinguish them from the grass and dirt near the road edge but they were quite obvious when we were making our observations at the site.

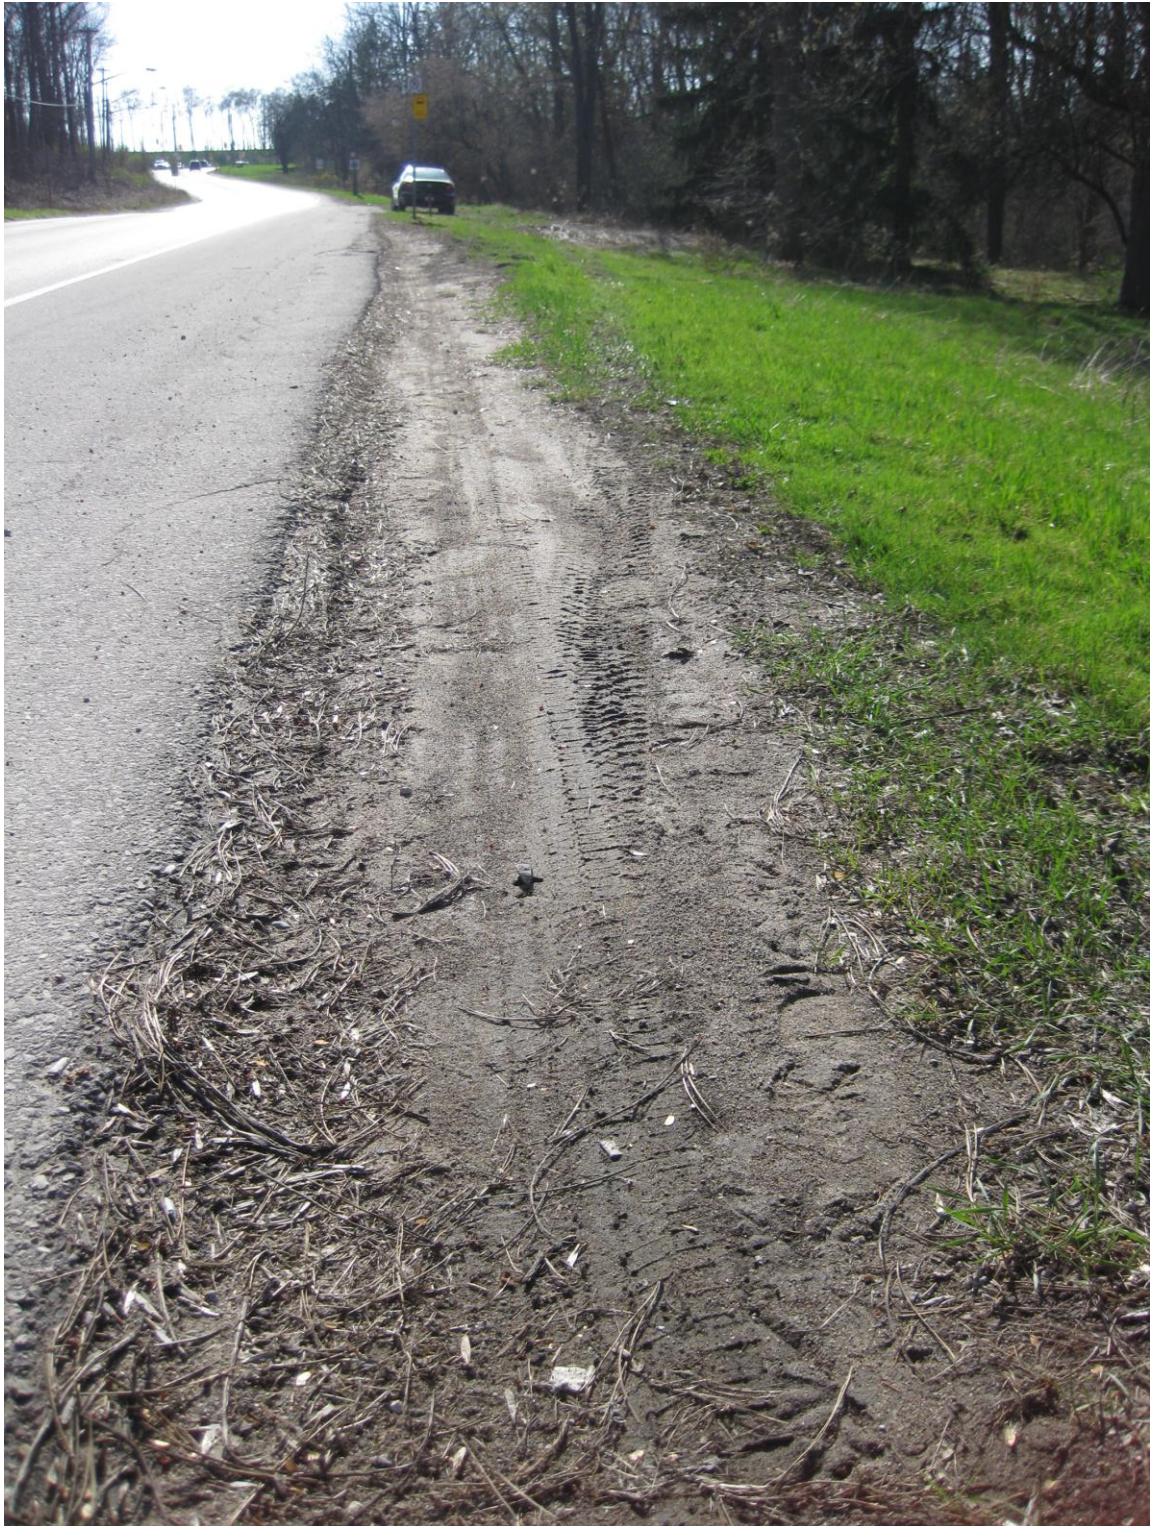
When tire marks are difficult to distinguish from one viewing direction it is possible to obtain a clearer view by viewing them from another direction. This truth is demonstrated in the photo below where we turn around to face westward. Look at the bare earth in the centre of the photograph and see if you can find the tread of the right side tires by matching them to the tire marks on the grass in the background.
