Springbank Driver Fatal Crash Into Tree - Review of Site Evidence

Posting Date: 26-Mar-12

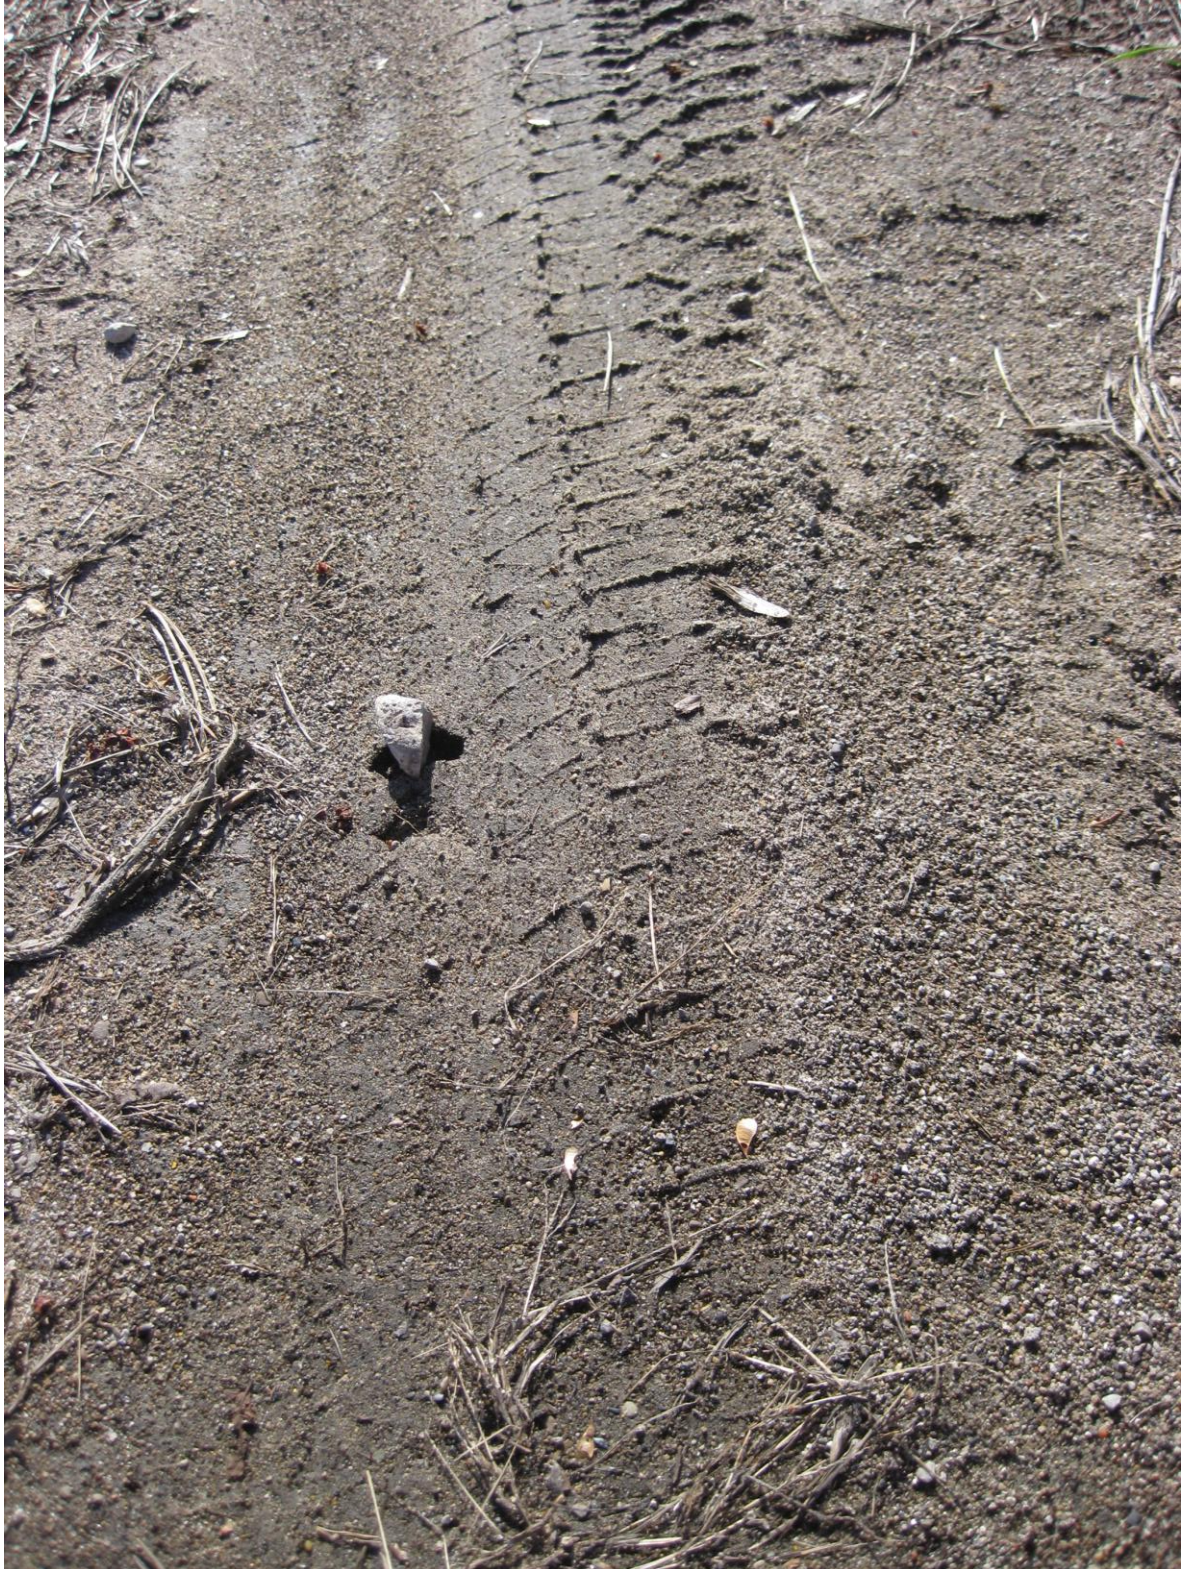
The detection is made a little more difficult because the tire of another vehicle has driven over the collision-involved tire mark, but the photo below provides a closer view of the area where the tread print exists.

In the photograph above (looking west) you should be able to detect two tire prints. The print that is more vertical in the one that was caused after the collision and erased the collision-involved print which can be seen angled slightly toward the right. The collision-involved print is only visible in the upper centre portion of the photograph. Below is a closer view of the two tire prints with the collision-involved print located to the right.

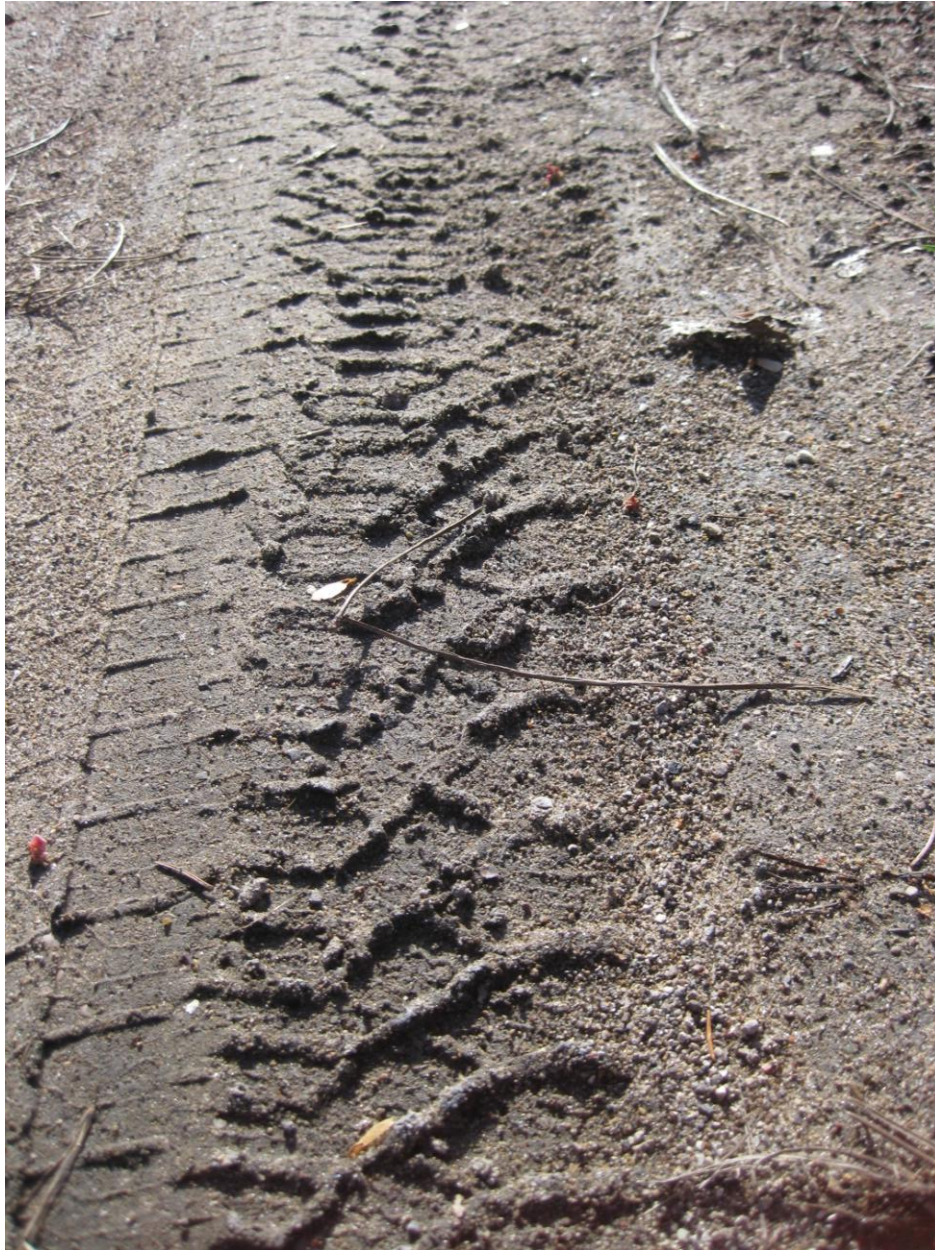
The lack of any evidence of scrubbing of the earth would suggest that the tire of the collision-involved vehicle was not sliding with respect to the surface and therefore there is no evidence of braking. However, as we stated earlier it does not mean that braking did not occur just because there is no evidence of sliding.
