Stephanie Fairweather Identified as Woman Fatally Injured on Third Line East of Iona Road

Posting Date: 03 Dec 2010

The London Free Press has now identified Stephanie Fairweather as the 32-year-old female driver of a Ford Focus that was fatally injured Thursday (December 2, 2010) as a result of a collision with a group of trees. My comments from December 3rd, 2010 follow:

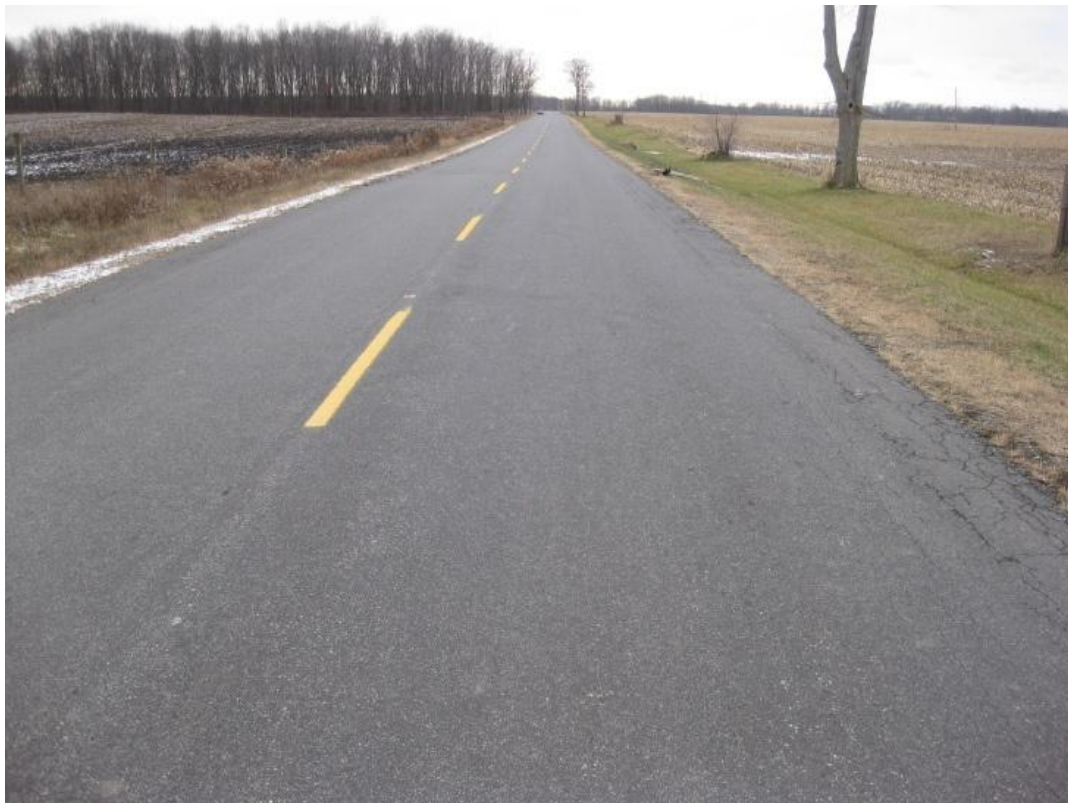
First, the photo below is a view looking west along Third Line from about 300 metres east of the location where the Focus left the roadway.

In the far distance you should be able to see my car, parked on the south side of the road, across from the final rest position of the front half of the Focus. Closer to the camera you should be able to see a large tree on the north roadside. A limb had fallen from this large tree and this limb was found lying near the north edge of the road. This limb is located about 235 metres east of the location where the Focus left the road surface. This is the only evidence I could find on the road that could remotely be associated with any obstruction or roadway defect which could be related to this collision. The photo below shows a view of the broken limb on the north roadside.

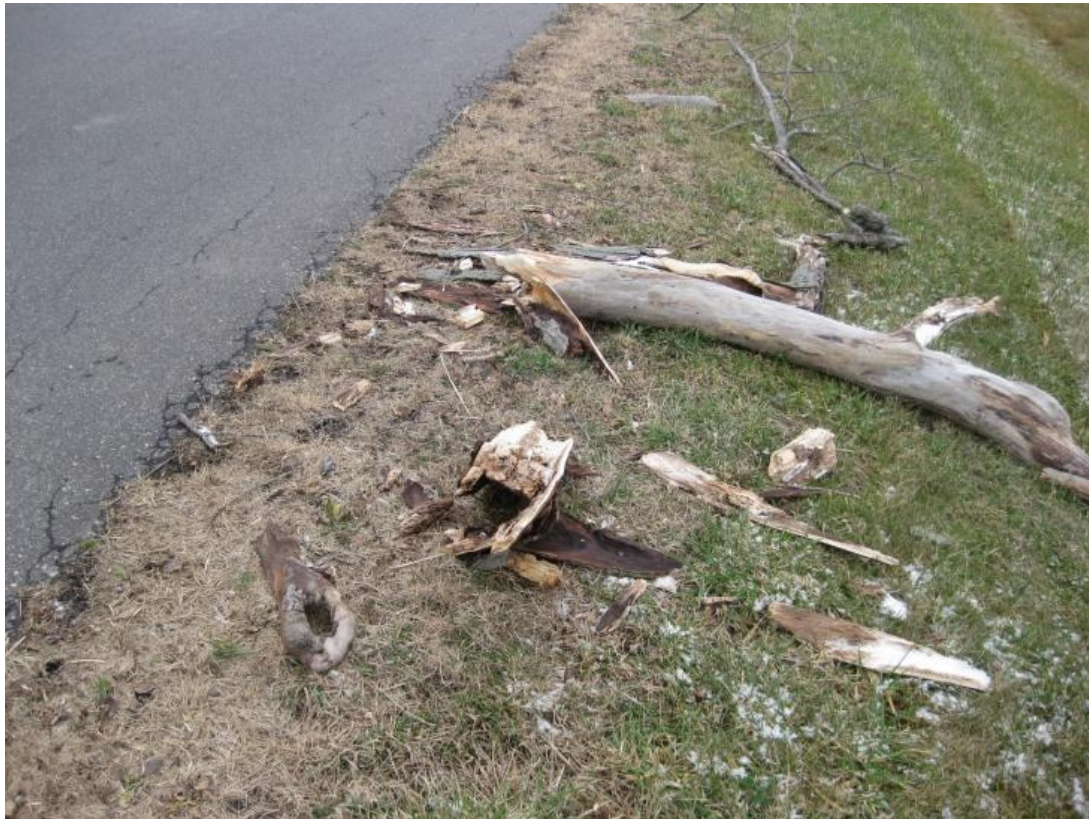
Note that the limb is on the roadside and not on the road so there is no evidence that it ever was on the road surface. The only other issue is that the limb is broken into several pieces and if it had been struck then we could expect it to become broken. But then someone would have to remove the limb from the road to hide its contribution and that seems a bit farfetched to me. Certainly I did not observe any tiny contaminants of wood on the road surface to suggest that the wood was ever on the road. I just mention it because it literally is the only thing in the vicinity that I can see as having an effect on a westbound vehicle's motion. Note that the roadway is straight and level and, considering it is a very low volume road, it is in relatively good condition.

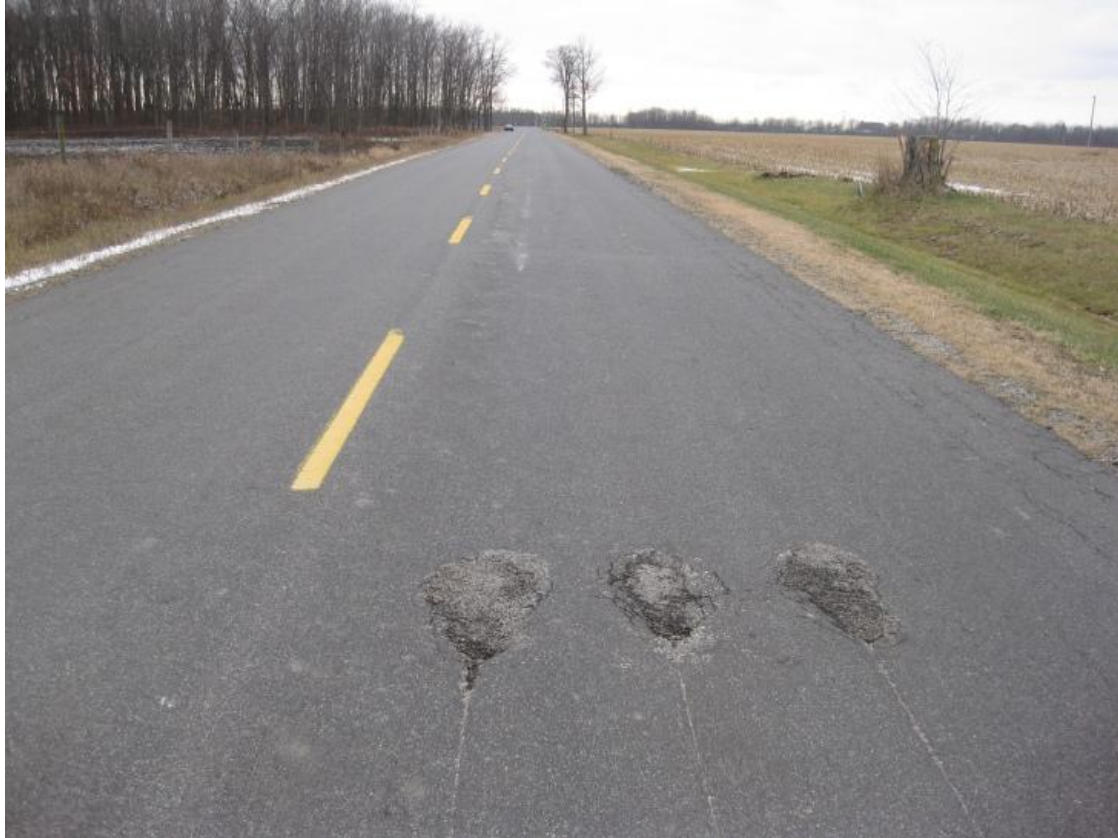
Now you should clearly be able to see my car parked on the south roadside, next to where the front portion of the Focus came to rest. Closer to the foreground you should be able to see the stump of a tree on the north roadside. This stump is located about 108 metres east of the point where the Focus left the roadway. I mention the stump because the angle of the tire marks of the Focus I am about to show you line up with this stump. So if we are going to search for a location on the road from which the Focus began to leave the roadway then the vicinity of the stump is a good place to start.

You will have noticed the markings in the westbound lane in the foreground of the above photo and I'm sure you are already wondering if these have something to do with the collision. They don't have anything to do with this collision. Someone has laid a "cross" monument at the base of the stump and I suspect it has nothing to do with the present collision. My best guess is that there was a previous collision at this site where perhaps someone was fatally injured. The marks in the westbound lane are something similar to what would be caused by towing personnel: often caused by a larger than average tow truck. This is consistent with the aging of the marks. It is rather coincidental if a previous fatal collision occurred within a 100 metres of the present one because this is a very low volume road. So I would be interested to know if my assumption is correct.

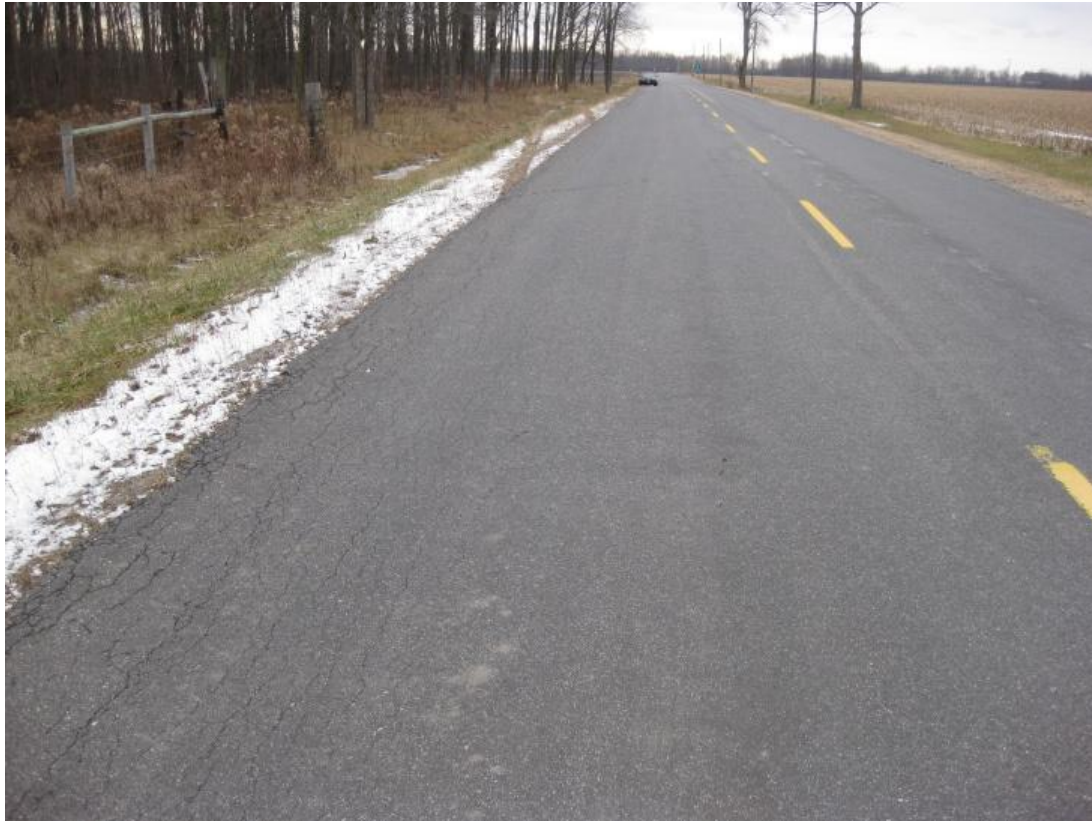
Next we begin to get close to the collision evidence. The photo below is looking westerly and you might begin to see the tire marks of the Focus on the south roadside as they travel toward a group of trees in the background.

because the tire marks do not look like your regular, curved yaw marks. They appear to be quite straight. Certainly I was scratching my head when I first saw them.

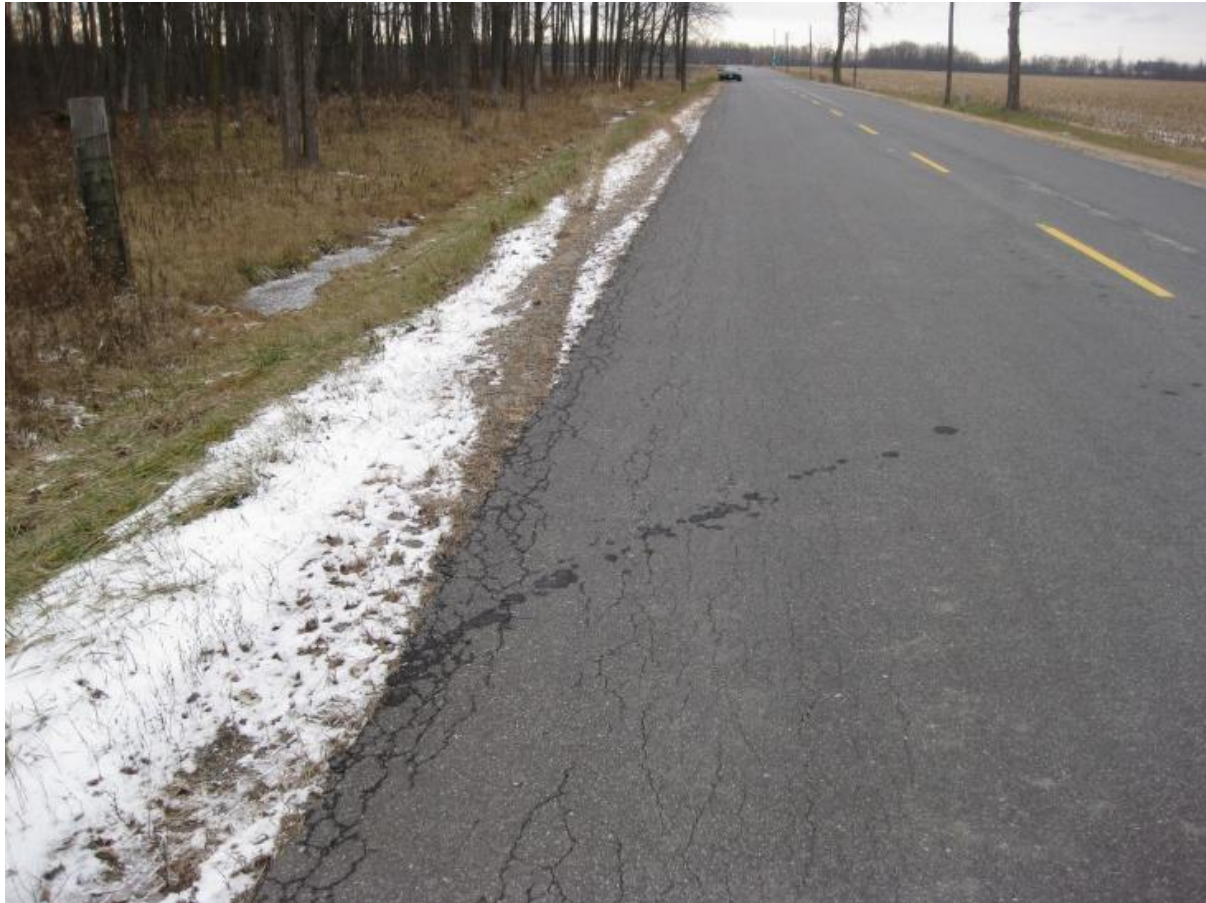
The photo below shows another view of those tire marks near the beginning of where they travel off the road surface.

These marks are essentially parallel to each other. I know the marks in the above photo appear to converge but that is simply because they are entering the small ditch and this distorts their view. Believe me when you are looking at them at the site they look very parallel to each other. But that is not what is supposed to happen. Yaw marks are supposed to be curved and do a lot of converging and diverging.

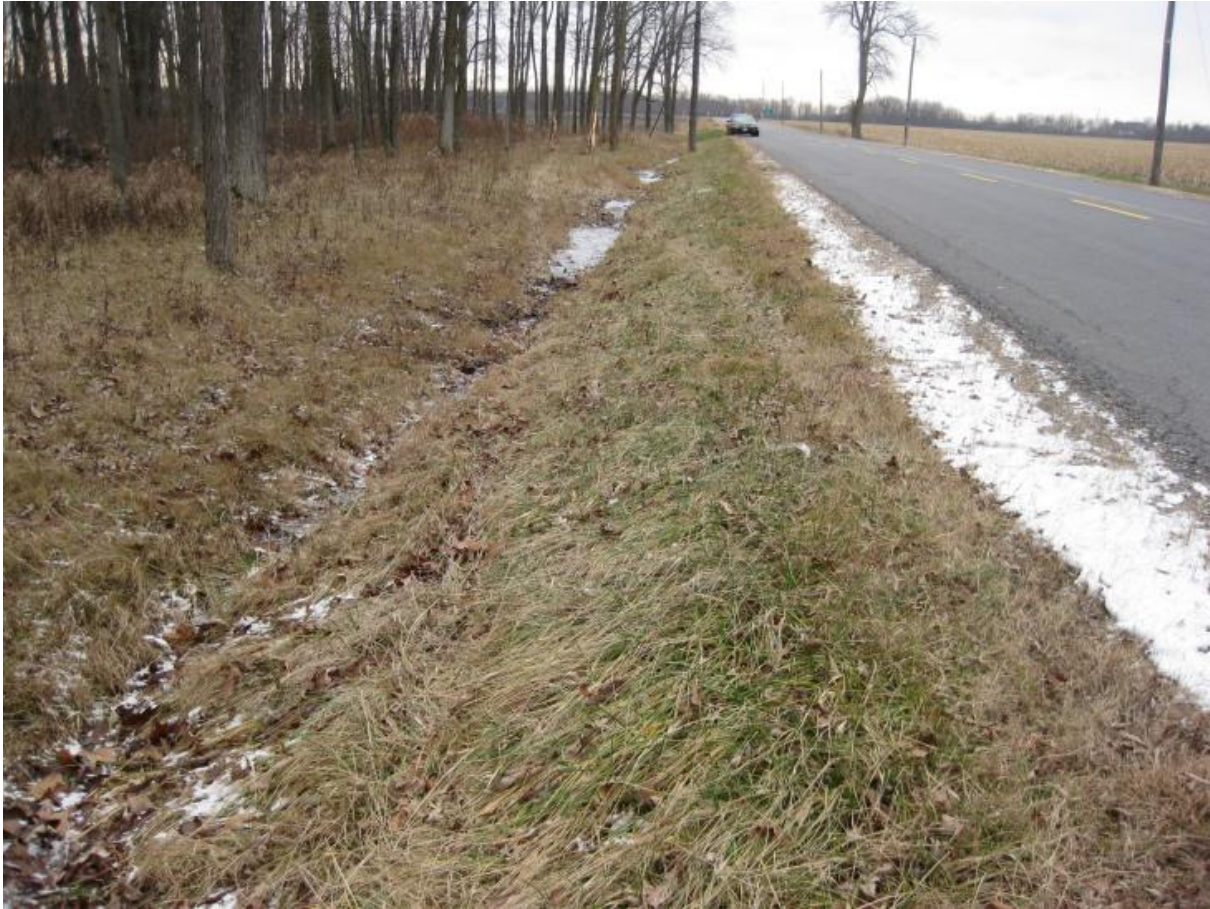
The photo below shows the tire marks as they pass through the small ditch and toward the area of initial impact with the small trees in the background.

If you can follow the path of the tire marks you should be able to recognize that they look very parallel.

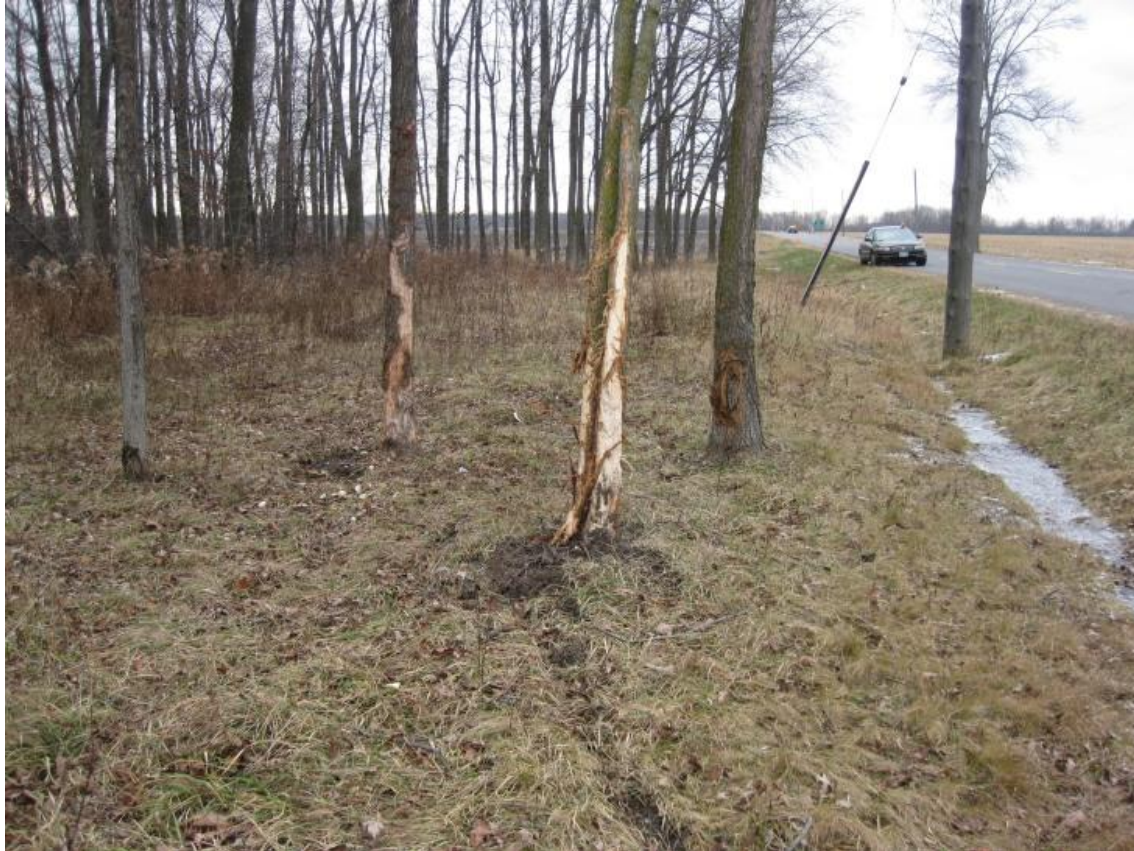
Before continuing this discussion of the tire marks let me continue further west and show you the area of initial impact with the three small trees in the photo below.

Upon striking these trees the vehicle separated into two pieces. One piece remained close to these trees while another portion travelled through them and ended up at another group of trees about 30 metres west of this location.

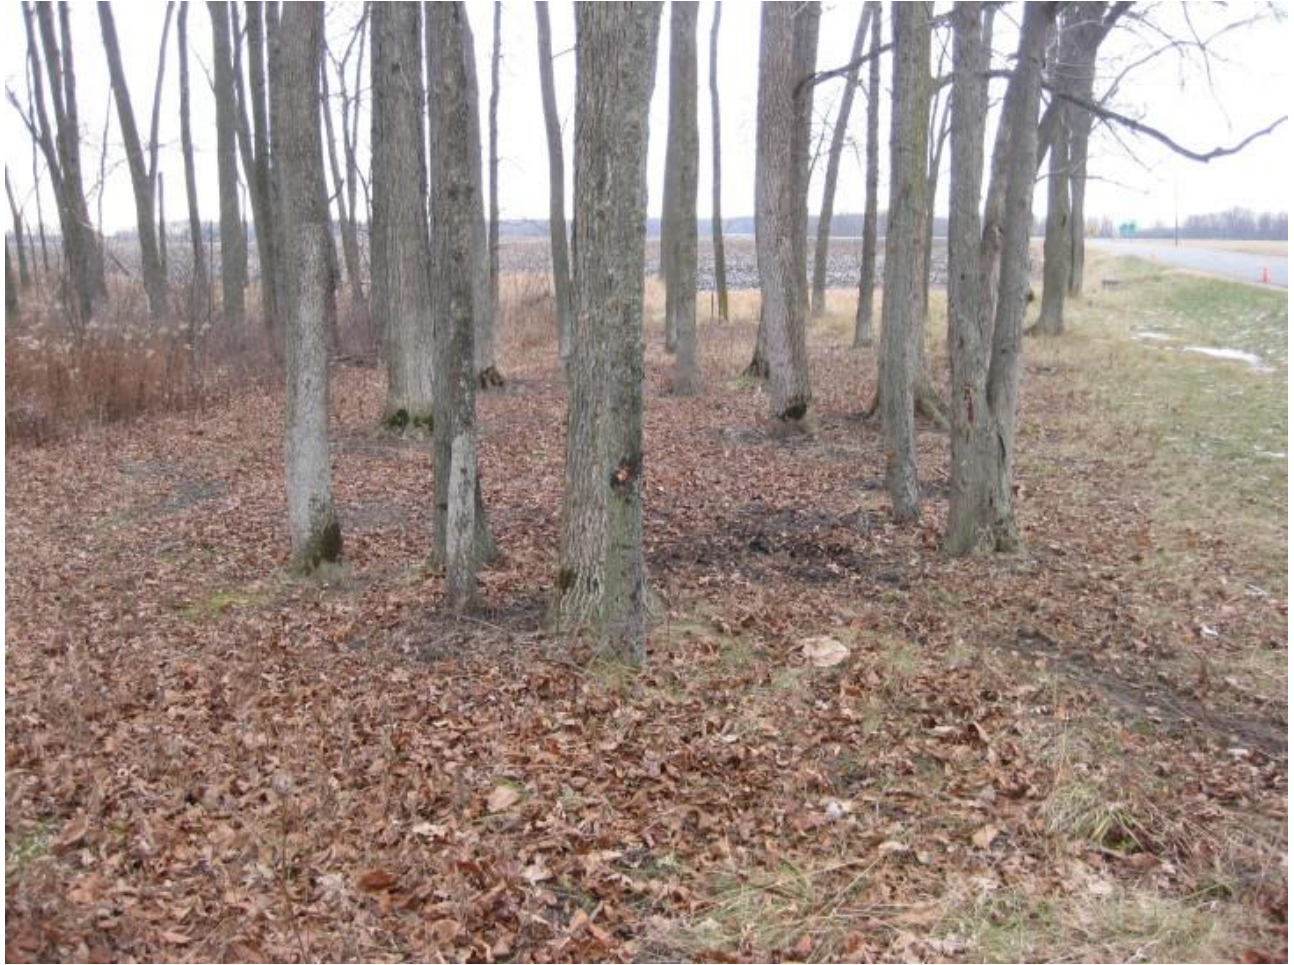
The photo below is a view of the second group of trees where the remaining portion of the vehicle came to rest. This location is adjacent to the parked position of my car. Note that there are some minor markings to the trees at this location but nothing compared to the large damage at the initial area of impact.

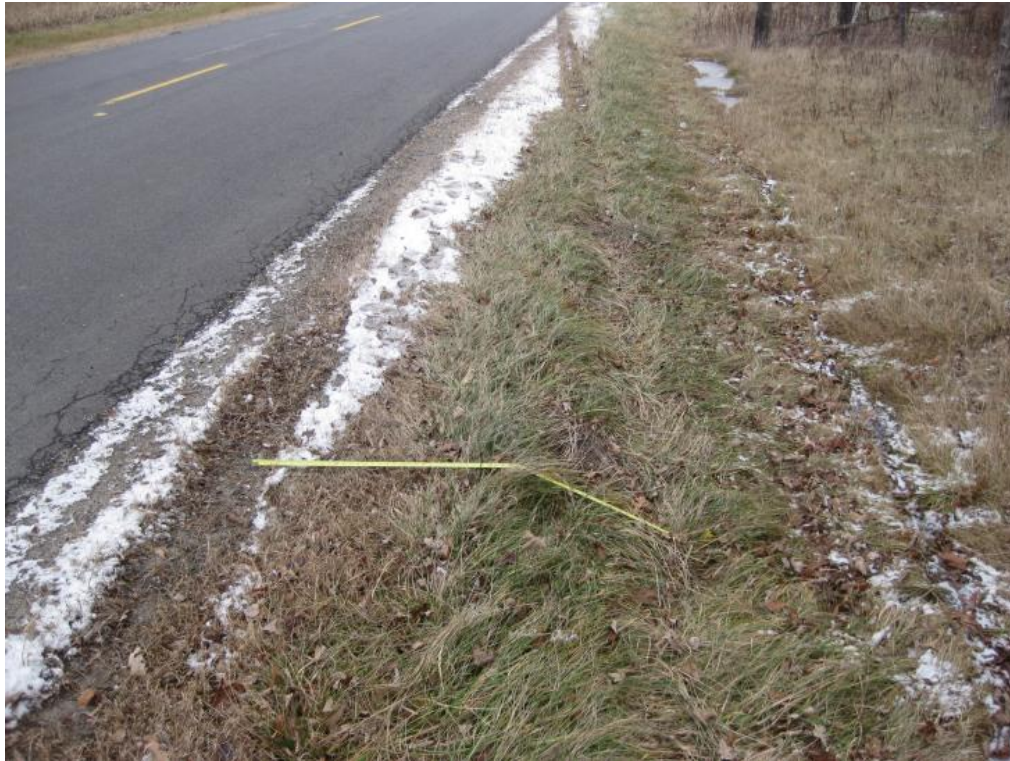
Returning to the issue of the tire marks I took some measurements of the lateral distance between them at two locations. The first measurement location is shown in the photo below. It was taken near the beginning of the visible tire marks. You can see my tape measure placed perpendicular to the marks.

The measured distance was 148 centimetres. And I took a second measurement further to the west as shown in the photo below.

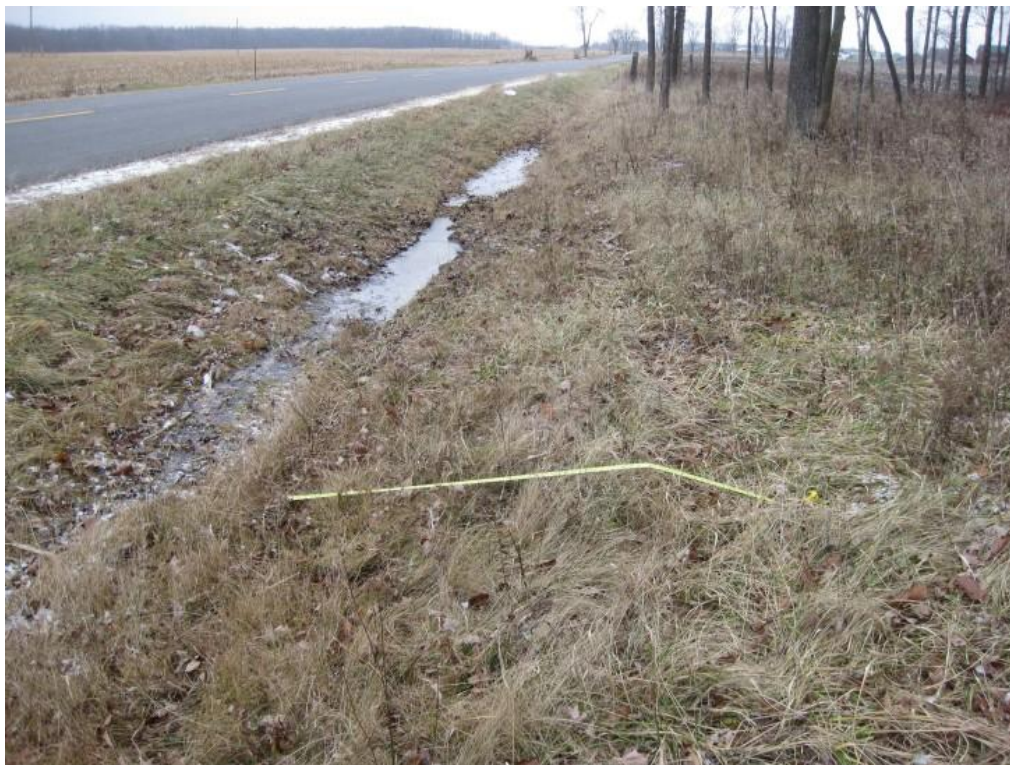
The measurement at the second location was also 148 centimetres. Thus this confirmed what I had observed from looking at the tire marks. They were essentially parallel in the distance that they were visible. The distance from where the tire marks first appeared on the south roadside to the initial impact with the trees was about 67 metres. The distance inboard from the road edge to the first tree was about 5.9 metres. This results in an approximate departure angle of about 5 degrees. Fairly shallow but somewhat outside the range of 1 to 4 degrees that might suggest a sleeping or incapacitated driver.
