Travel Direction of Tanker Truck Mis-Reported in Double Fatal Collision North of Embro Ontario

Posting Date: 27 Feb 2012

Gorski Consulting
London, Ontario, Canada

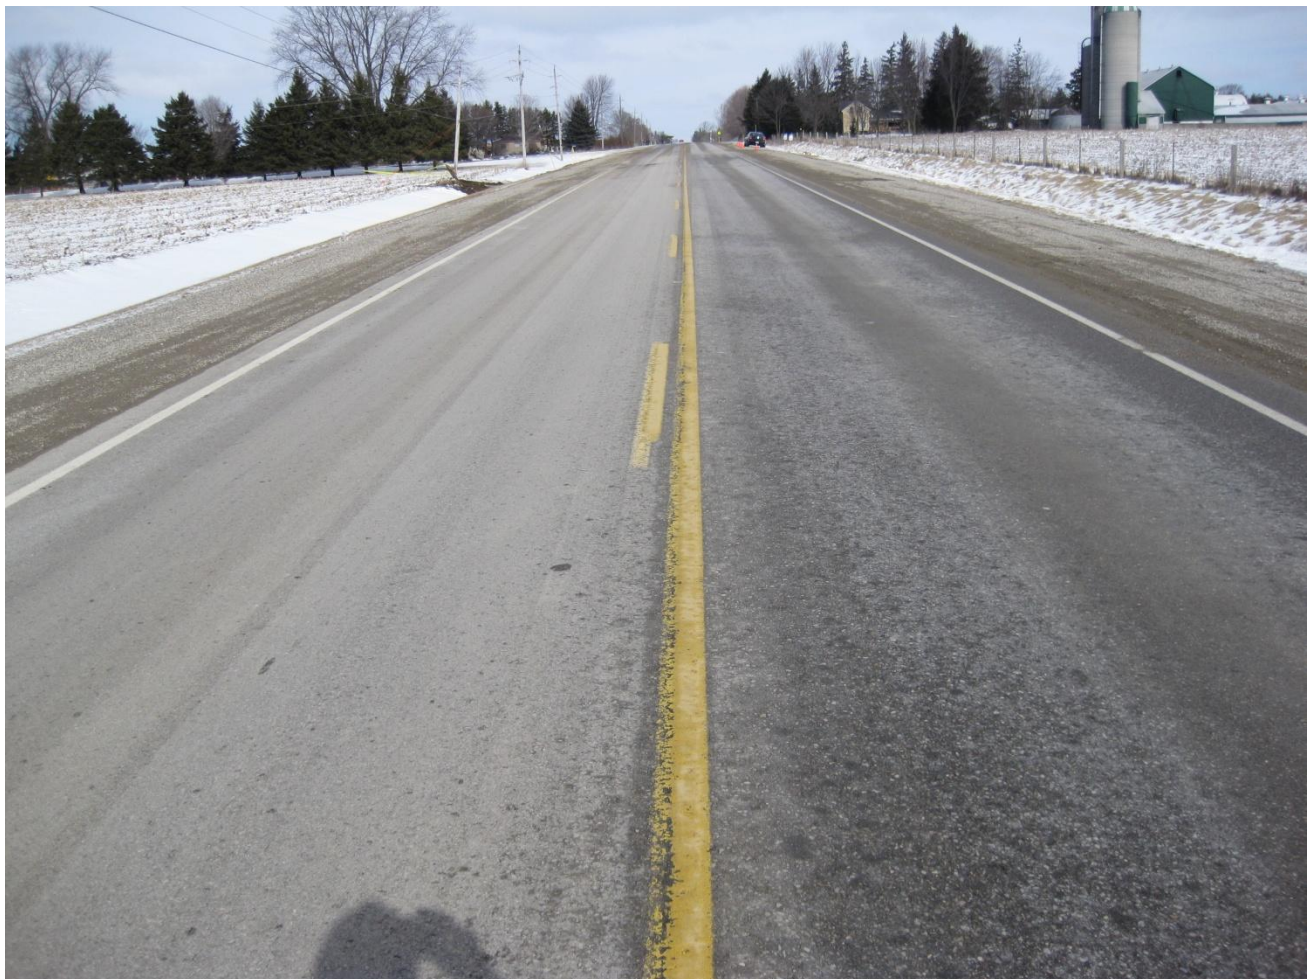
Below is a view of the site looking north from south of the area of impact. The Tanker Truck was travelling toward the camera while the Avalanche was travelling away from the camera. The Tanker truck came to rest on the west (left) side of the road while the Avalanche came to rest on the east (right) side of the road.

Gouges at the west edge of the southbound lane indicate that the Avalanche crossed the road centre-line and that the driver of the Tanker Truck likely steered to the right in an attempt to avoid the collision.

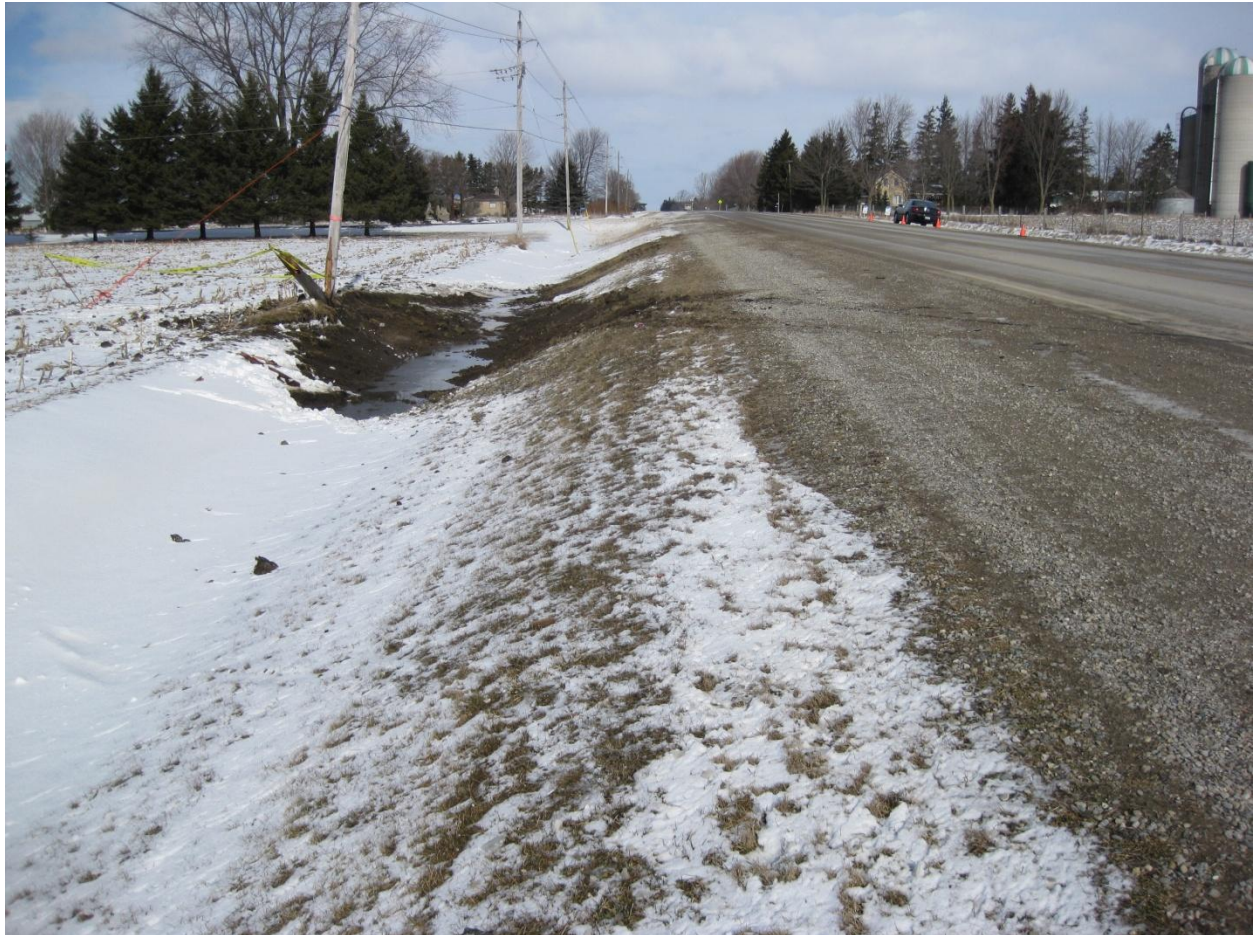
The photo below shows a view looking north taken from the west roadside and south of the final rest position of the Tanker Truck which came to rest in the west ditch.

You might be able to observe in the above photo that the truck struck a utility pole and fractured it. A small amount of diesel fuel escaped from the fuel tank of the truck and this is why some earth was removed around the ditch where the truck came to rest.

In the background of the above photo you should see our car parked on the east shoulder with several orange cones surrounding it and this should provide you with further orientation as to where the photos are taken with respect to that reference. The Avalanche came to rest in the east ditch to the right of this view.

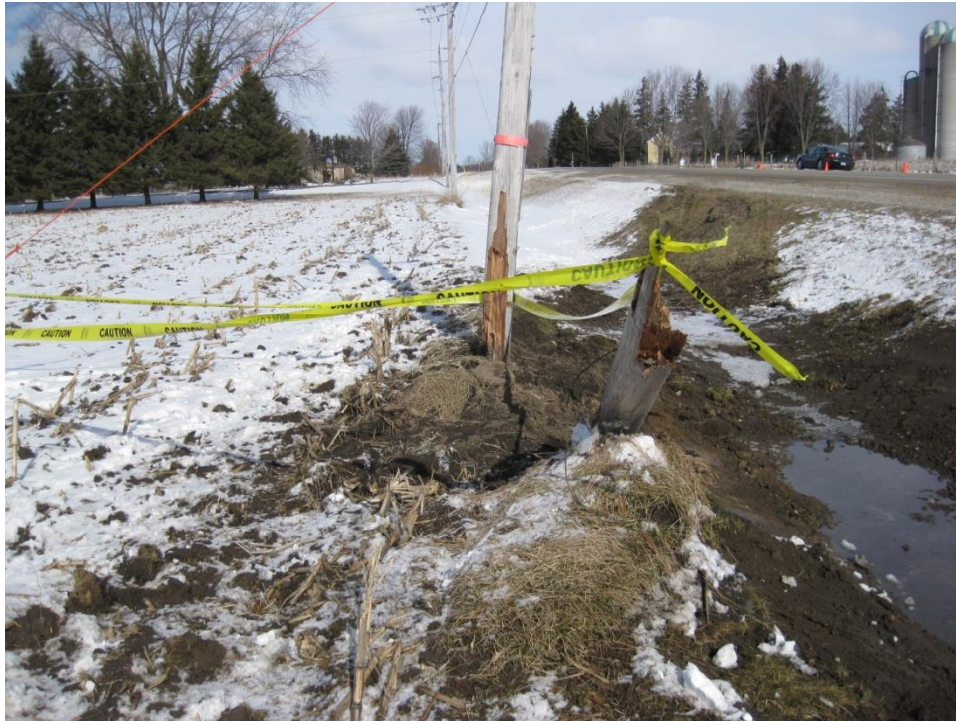
We get closer to the utility pole in the photo on the following page. That view is looking generally northward from the south side of the struck pole. The Tanker Truck came to rest at the struck pole. If you look past the pole you will be able to see an area of the west roadside that is sloped down into the ditch and this sloped area is missing the

snow cover that exists everywhere else. This bare area is where the Tanker Truck left the roadway on its approach to final rest.

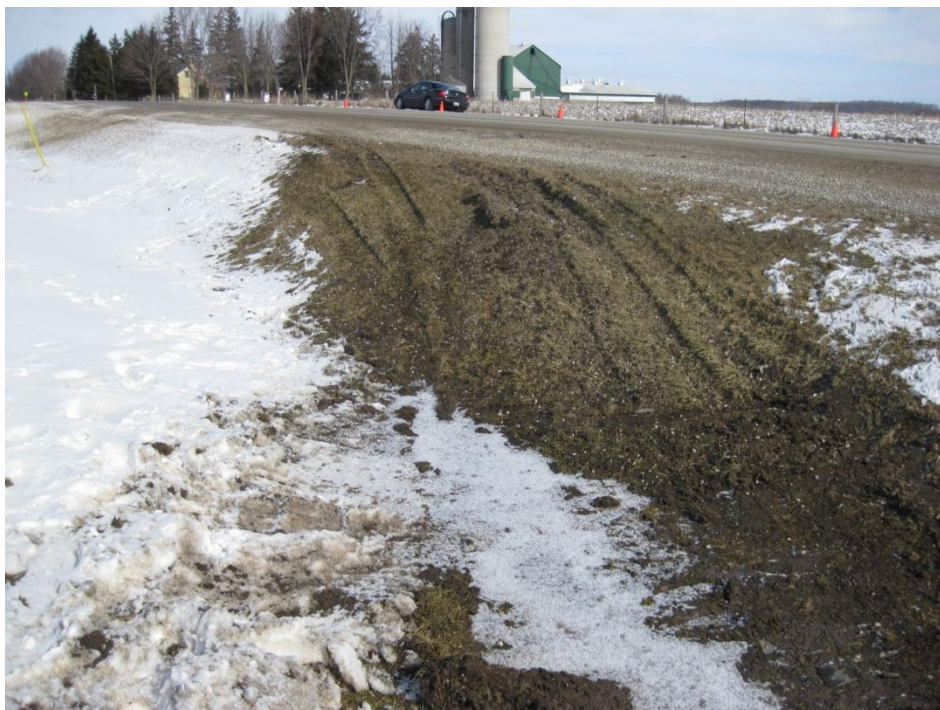
The photo below shows that slope and you can see the tire marks that indicate how the tanker truck moved off the road and toward the impact with the pole. You can also see my vehicle and cones in the background to orientate where this evidence is located.

This evidence should clearly indicate to you that the truck was moving southward as it left the road, not northward, as reported by the news media. For comparison, we can look at the area of the road just south of the pole impact as shown in the photo below.

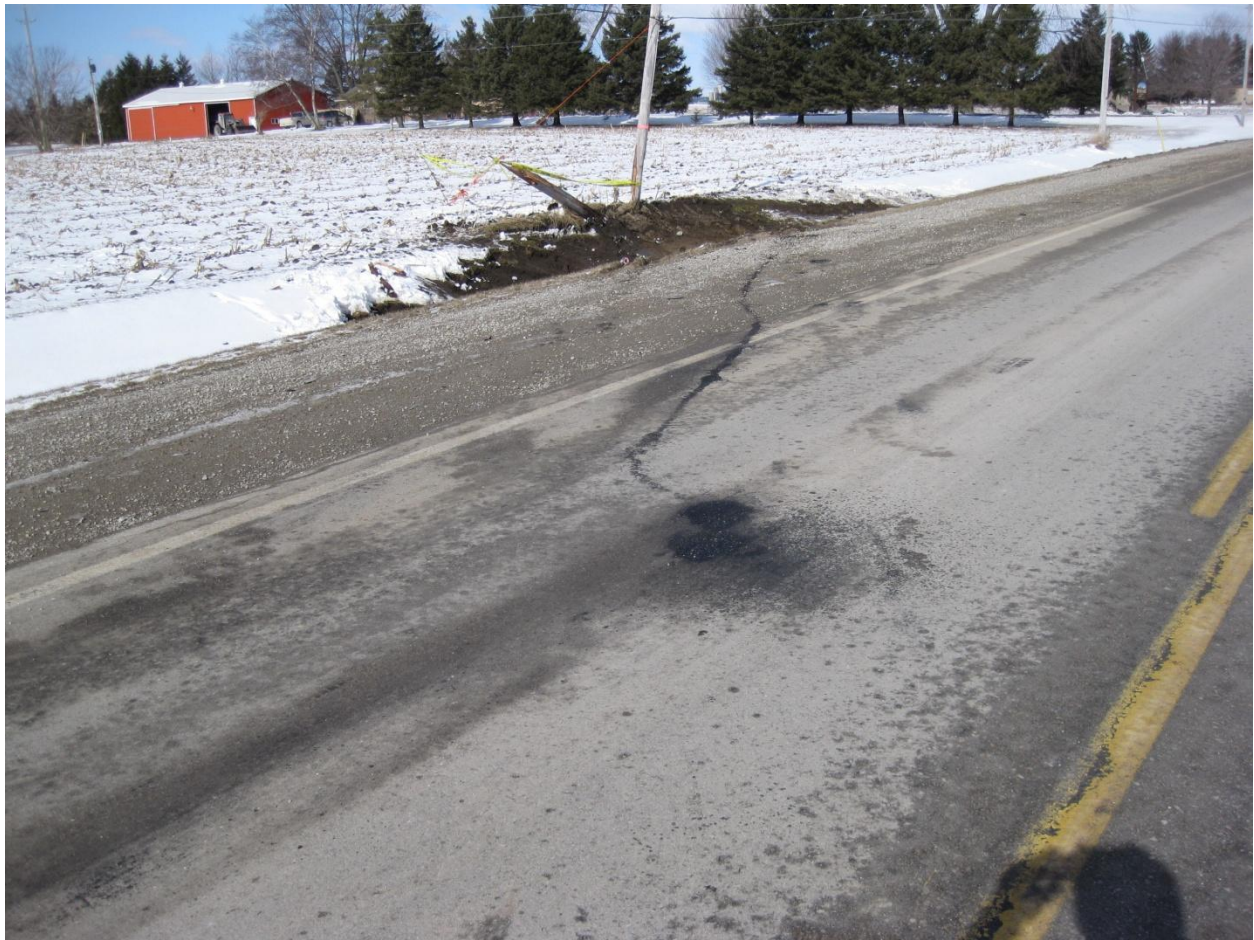
You should recognize in the above photo that the Tanker truck was towed out of its rest position toward the camera and you should see a thin trail of diesel fuel that trickled from the rest position and then formed a black stain in the centre of the southbound lane as the tow truck momentarily stopped pulling the vehicle out, possibly to adjust something. You might also see the tire marks on the west shoulder that were caused through that towing operation. So clearly, this is evidence of towing operations; it is not evidence of pre-crash travel of the Tanker truck into impact.

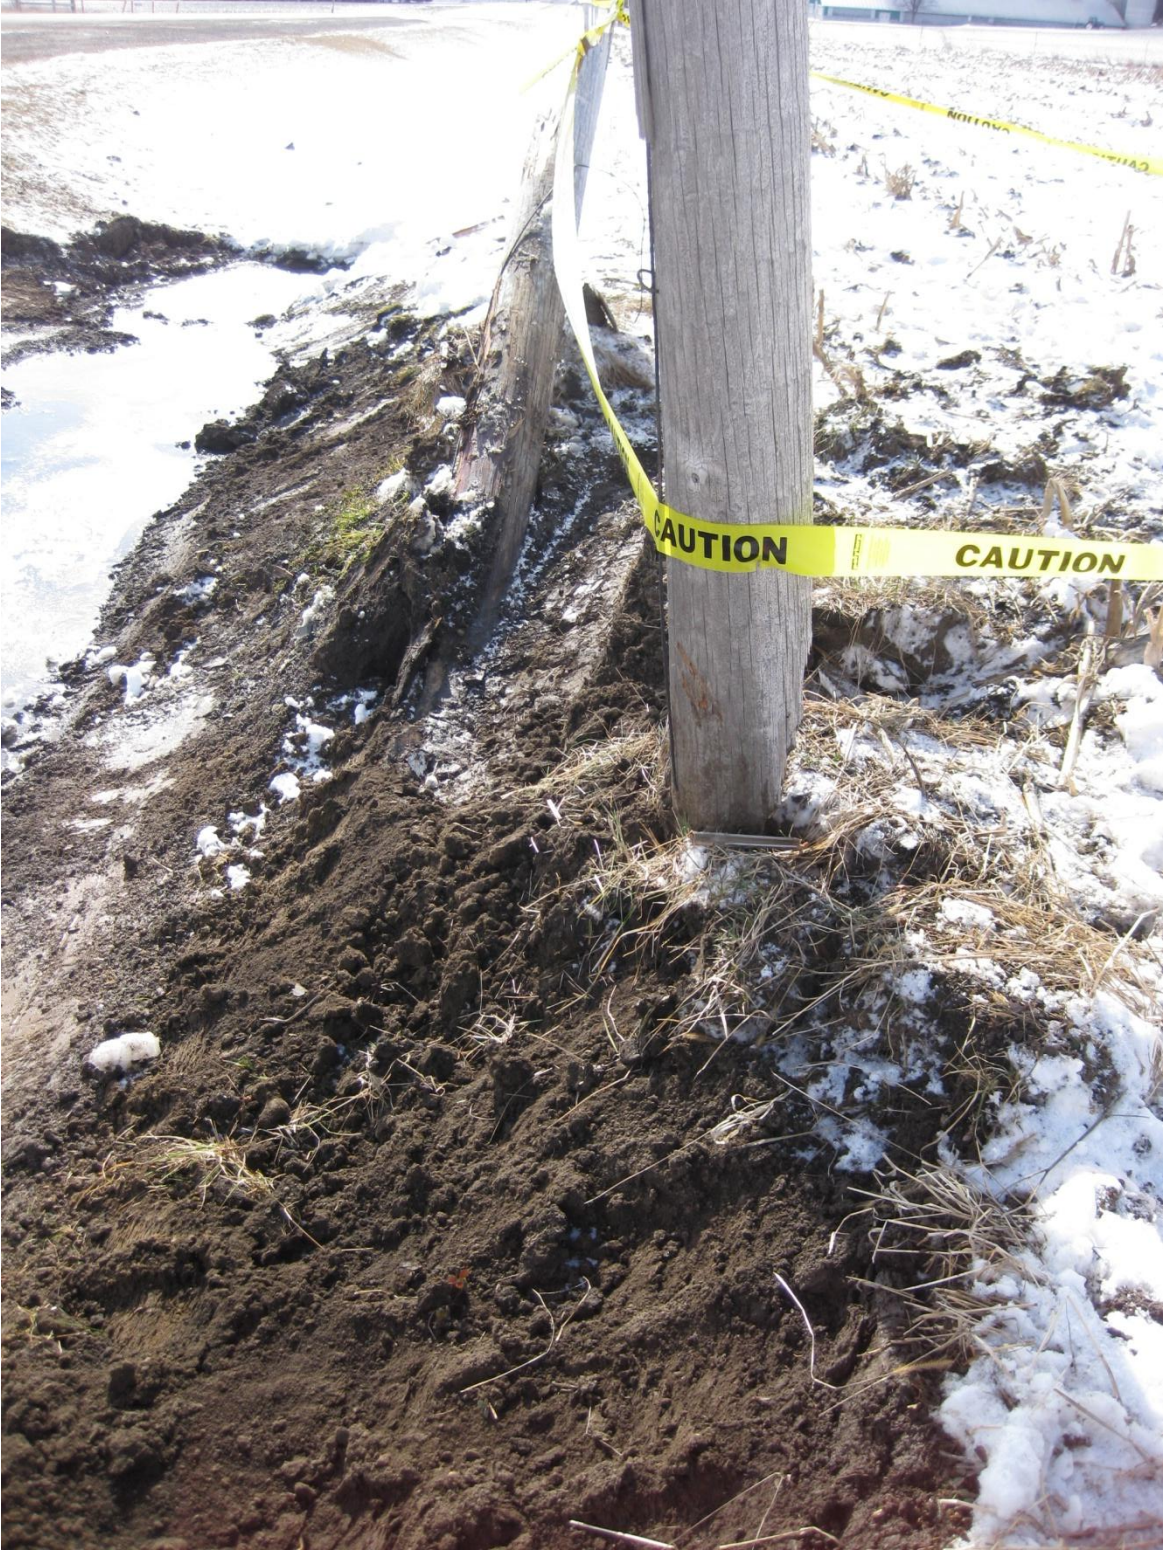
Furthermore, we can look at the resting angle of the stuck pole. as shown in the photo on the following page. The photo below was taken from the north side of the pole, looking south. In the foreground you can see the vertical portion of the pole which is the upper half. The bottom portion of the pole is still anchored in the ground and it can be seen just to the left of the vertical upper half. You should be able to recognize the steep angle of the bottom portion of the pole and how it has been pushed toward the southwest. You might also be able to see a tire mark in the muddy bank caused by the right front tire of the Tractor portion of the Tanker truck. If the Tanker truck had been

travelling northbound it would have pushed the pole toward the northwest, not toward the south west. All this evidence clearly indicates that the Tanker truck was southbound.

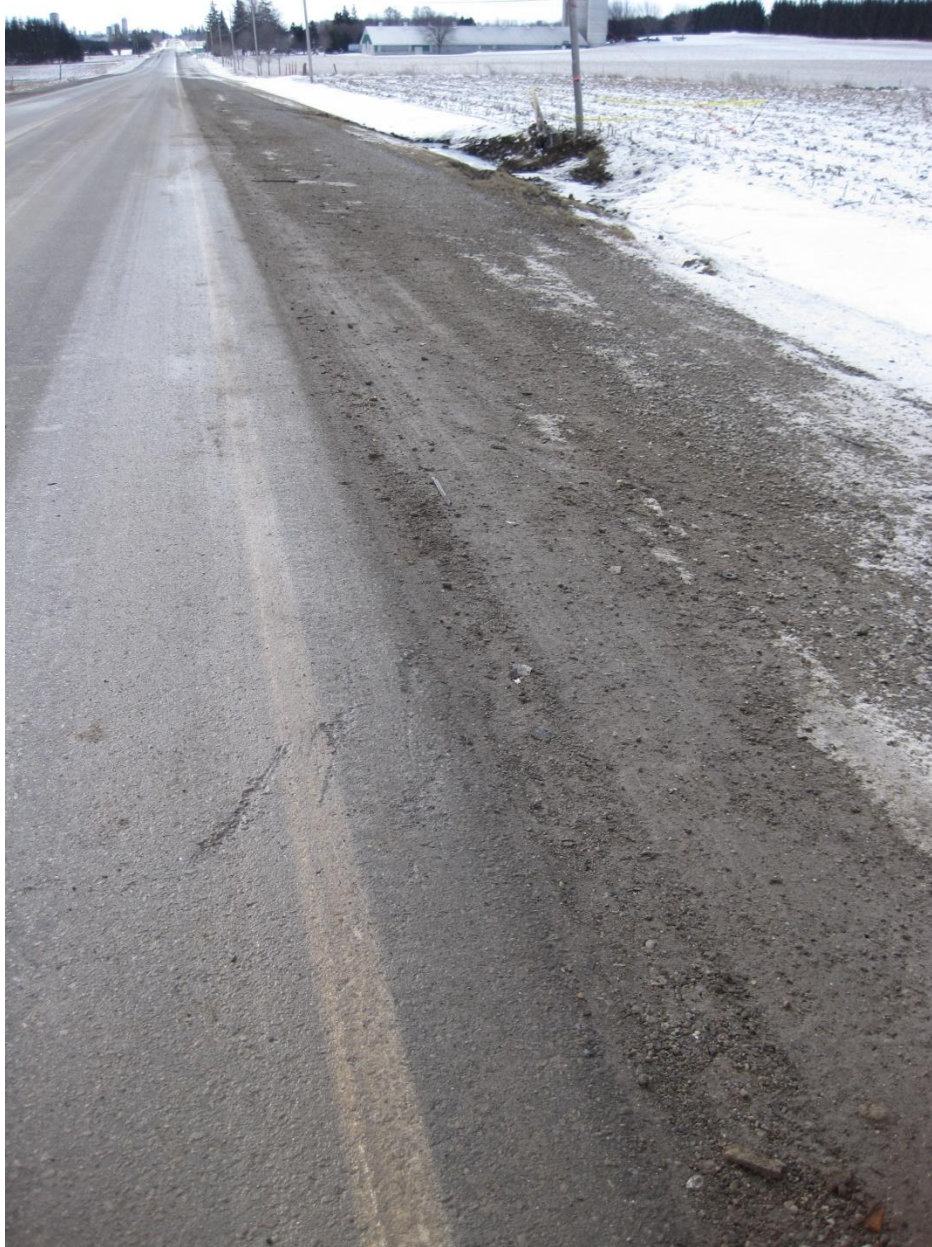
The travel direction of the Tanker truck is further evidenced by the position of the gouges on the pavement which indicate the area of impact. This is shown in the photo below which is looking southward with the gouges in the foreground and the Tanker truck rest position in the background.

The character of these gouges is typical of what you might see at an area of impact. It clearly shows that, after impact, the very large mass of the Tanker truck continued to move southward, off the road surface, and into the west ditch where it struck the utility pole.

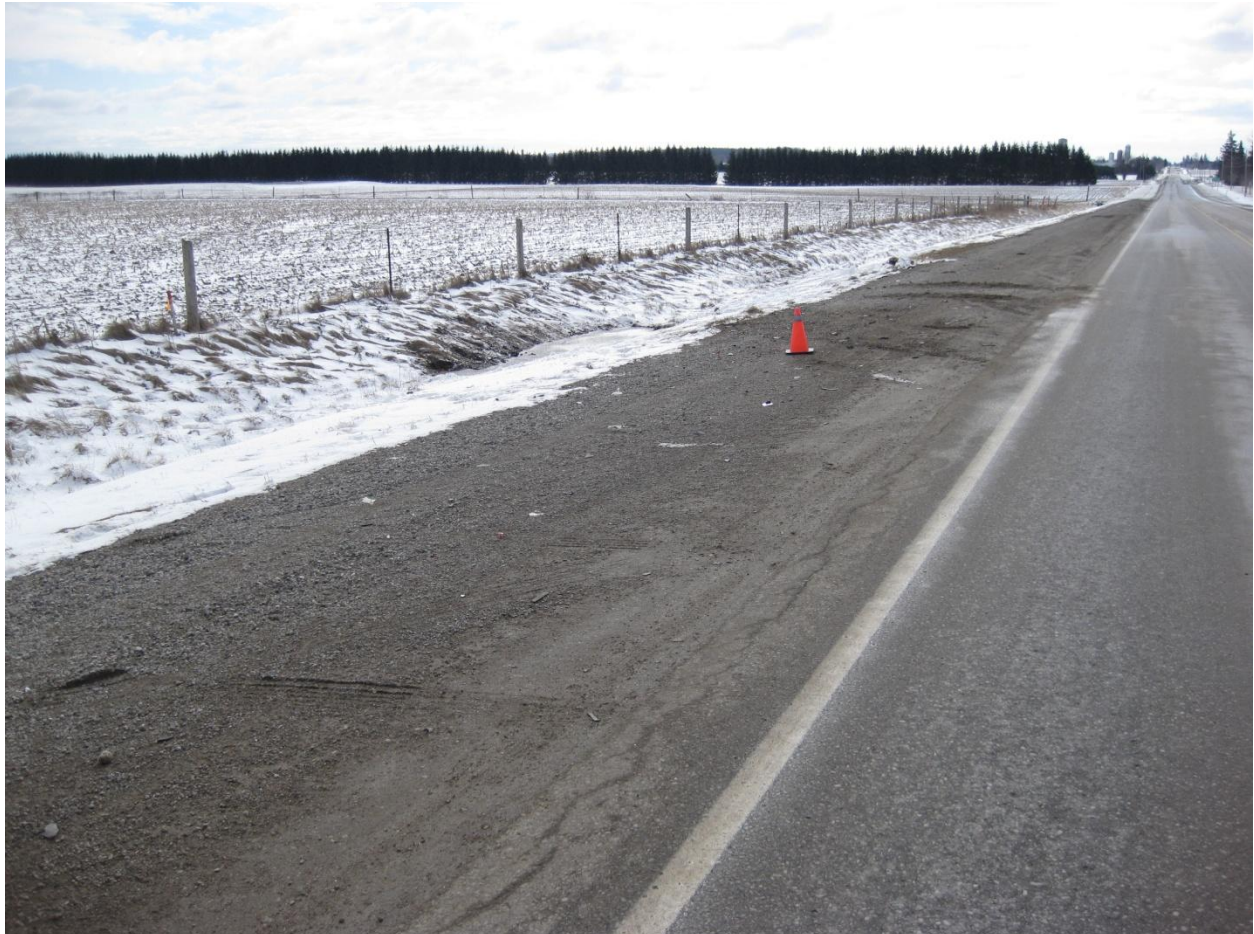
The final rest position of the Avalanche was in the east ditch. The photo below is looking southbound from the northbound lane and toward the west ditch. You can see one of the orange cones on the east shoulder and you can appreciate that my vehicle is parked on the shoulder, directly behind the camera.

To the left of the visible cone is the rest position of an object, likely one of the fuel tanks of the Tanker truck. The actual rest position of the Avalanche is further toward the south in the background of the above photo.

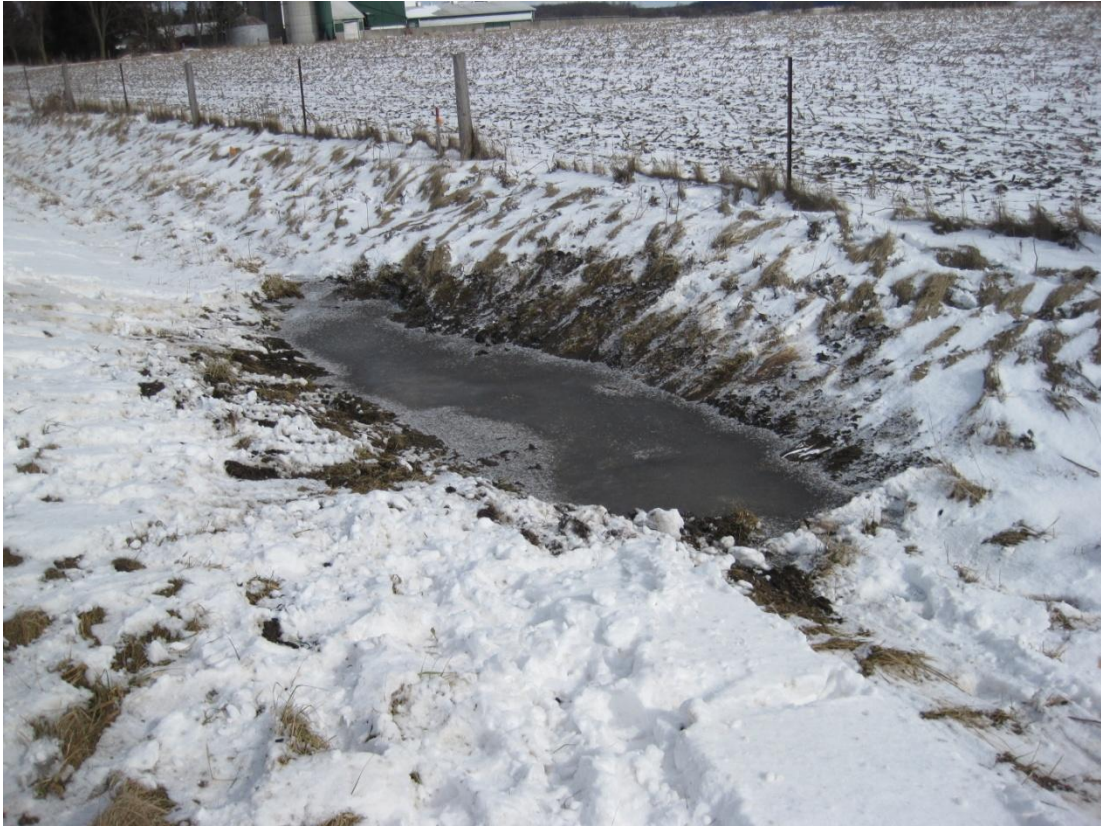
The top photo on the following page shows a hole in the east ditch adjacent to that visible cone. This is a view looking north-east from just south west of the rest position of the object in the ditch. This hole was caused during clean-up of the diesel fuel that spilt into the ditch. At the top left of the photo there are markings which indicate how the object entered the ditch and in the bottom right of the photo you can see the markings in the snow indicating how the object was dragged out of the ditch.

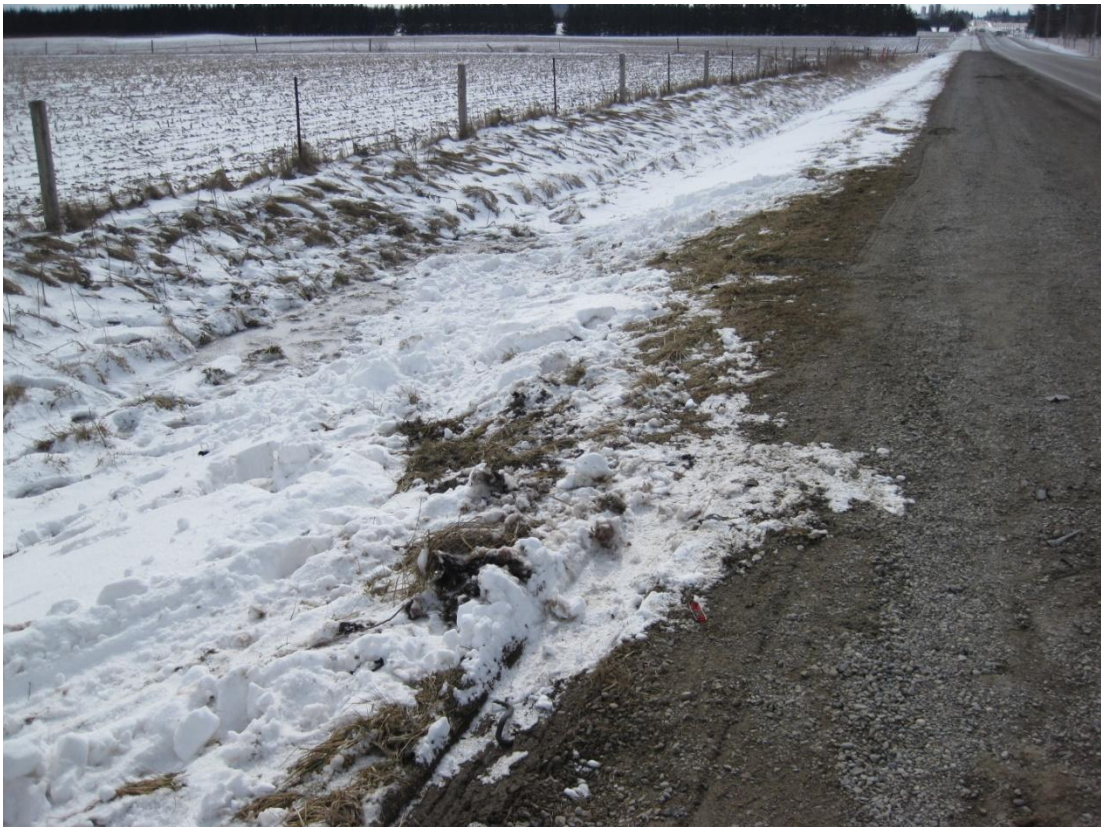
The bottom photo on the following page is a view looking southeast from northwest of the final rest position of the Avalanche. You should be able to recognize the tire marks in the snow as the vehicle slid in a southeast direction through the slope and into the ditch. There were additional markings further to the south indicating how the Avalanche was pulled out of the ditch from its rest position.

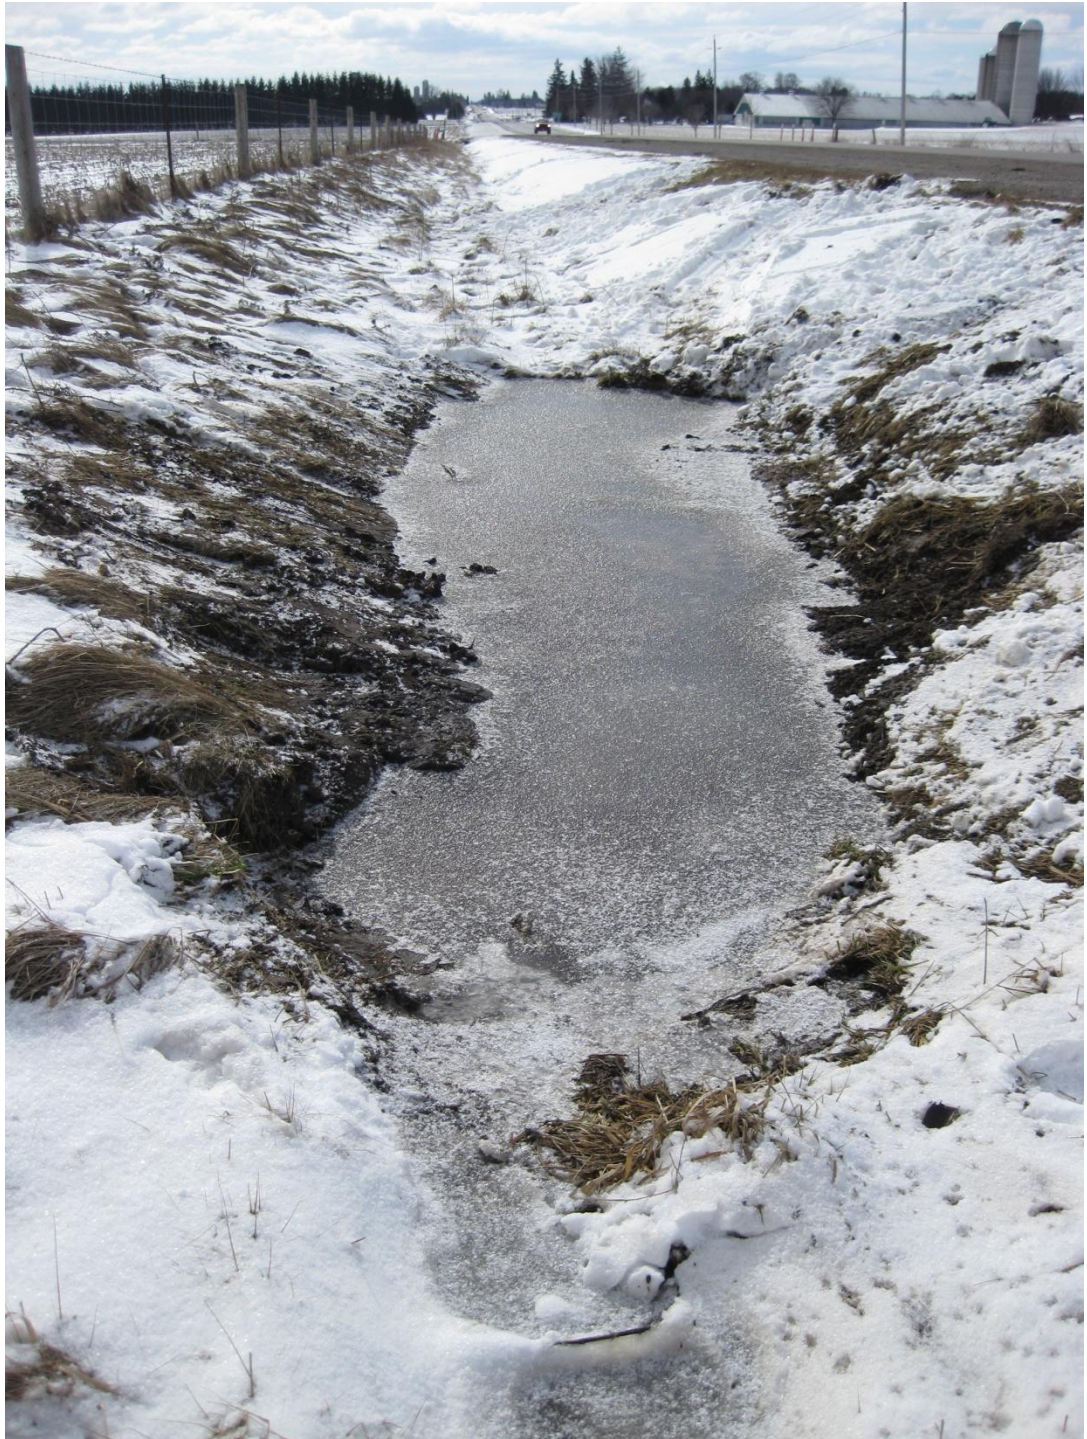
The photo below is a view looking south from the final rest position of the object (fuel tank?) on the east shoulder and in the background you can see the final rest position of the Avalanche.

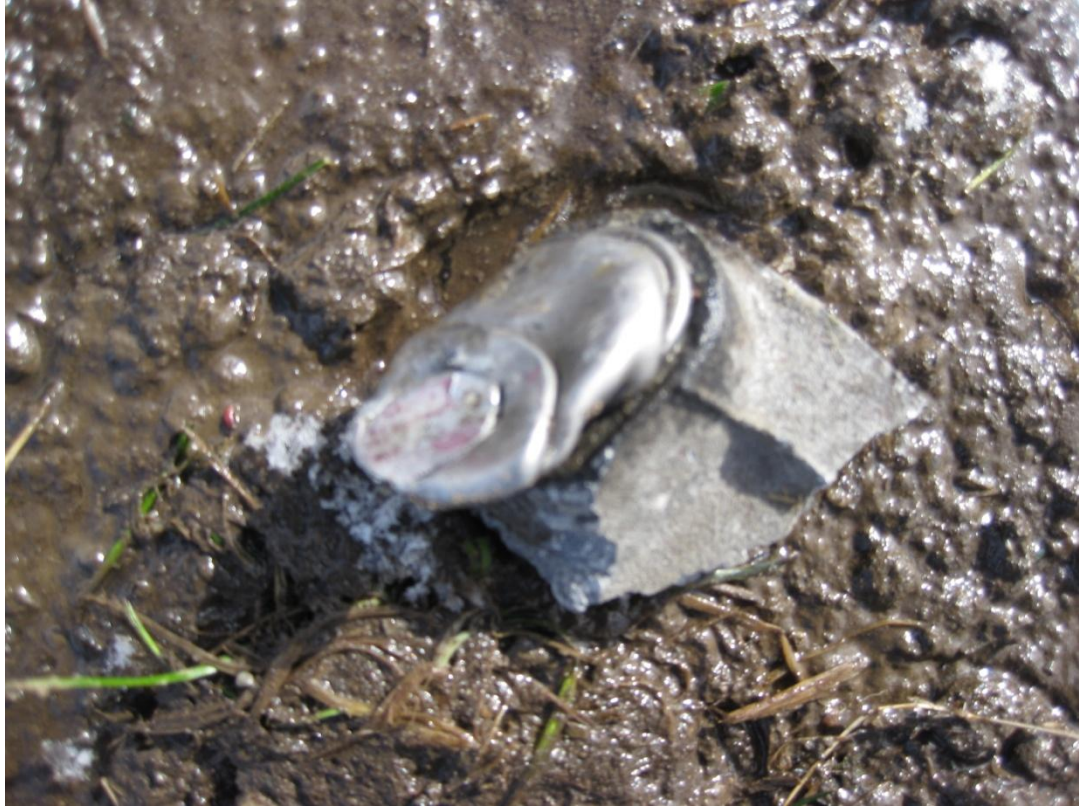
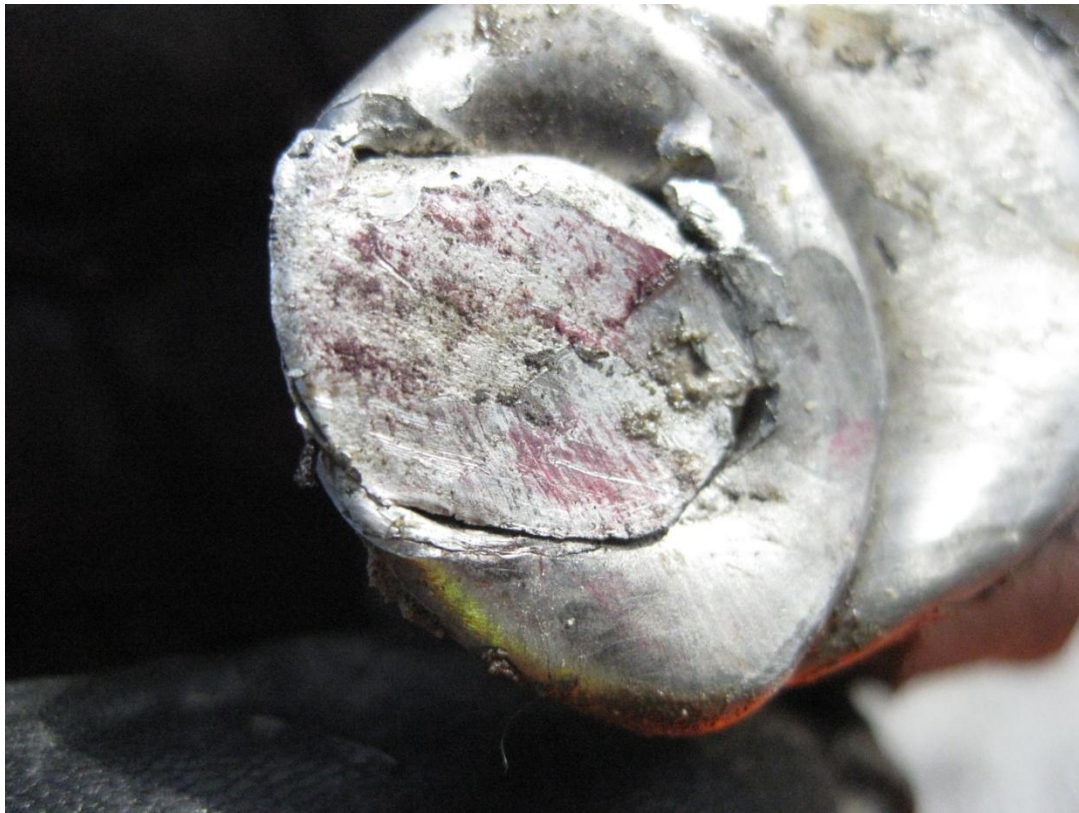
Consider the crushed metal lying on the west roadside and is shown in the top photo on the following page. The red markings on the crushed material indicate that the red painted surface of the Avalanche was in contact with this object and this object is likely from the Tanker truck. One can look at the pattern of marking on the top of the crushed material as shown in the bottom photo on the following page.

Both the manner of crush as well as the angle of the red marks and scratches into the metal can tell you how the two vehicles interacted when this contact occurred. Note that upon the early stage of impact (i.e. first 100 milliseconds) there is little rotation or sliding between contacting surfaces when there is substantial engagement between the structures (i.e. not a sideswipe collision). Since I have not seen the two vehicles nor do I expect to be involved in an official investigation of this incident I will not say anything further but let you imagine what this evidence might mean.

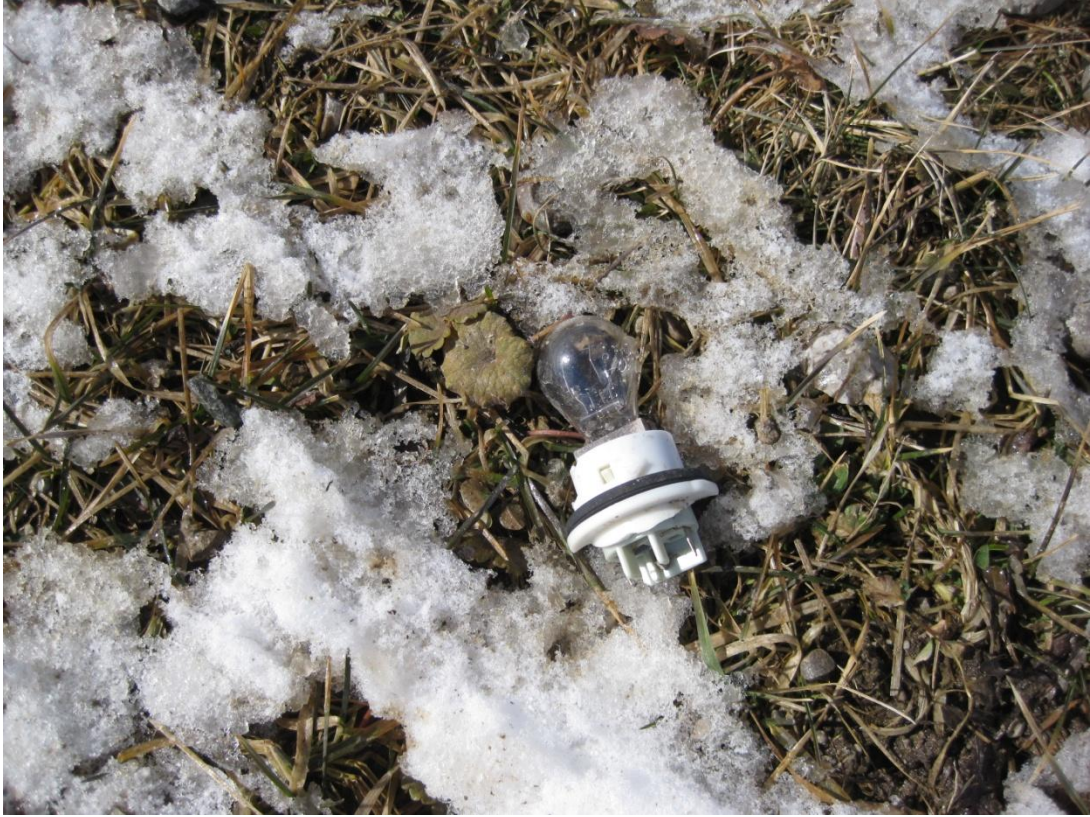
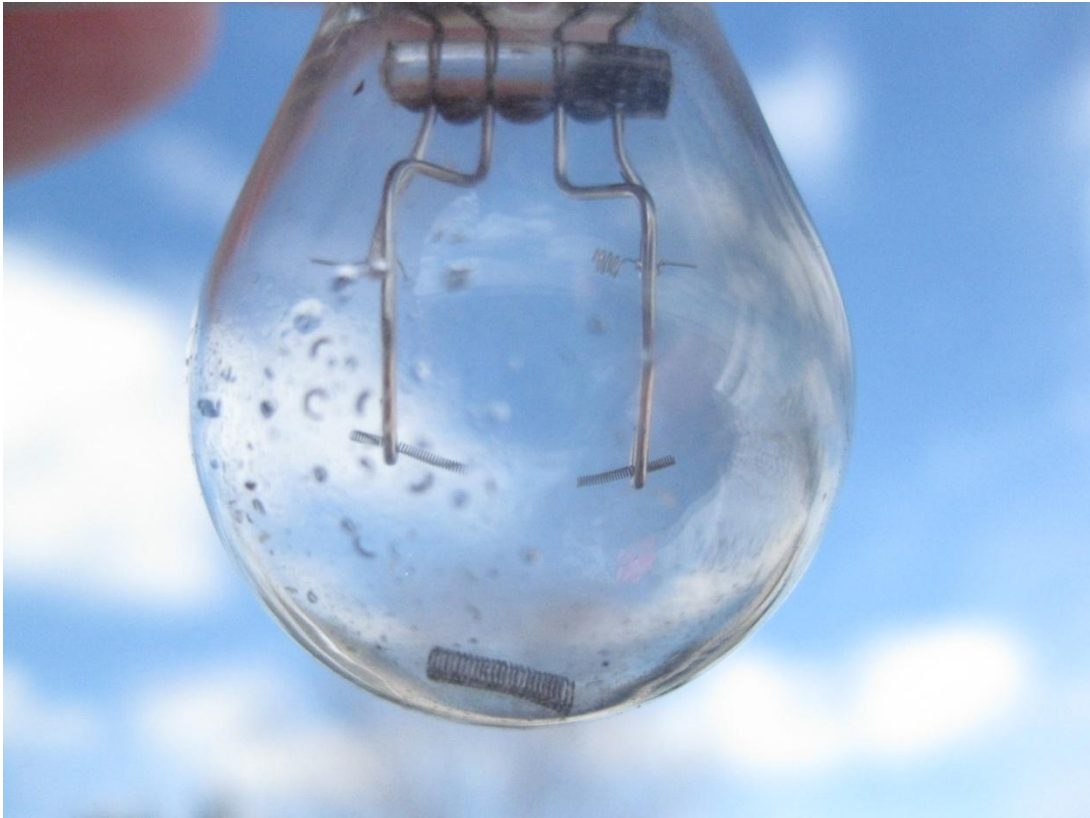
We can also study other minor evidence such as the light bulb housing shown in the top photo of Page 12. By lifting the bulb upside down you can see in the bottom photo that there is a fractured tungsten filament lying loose on the bottom of the glass and that the four posts indicate that this bulb contains filaments for the brake light as well as the parking (identification) light. These kinds of bulbs are normally found in the rear tail-light housing of light vehicles and I am going to hazard a guess that this is related to either the left or right rear corners of the Avalanche. Now, what characteristics do you see in the tungsten filaments?

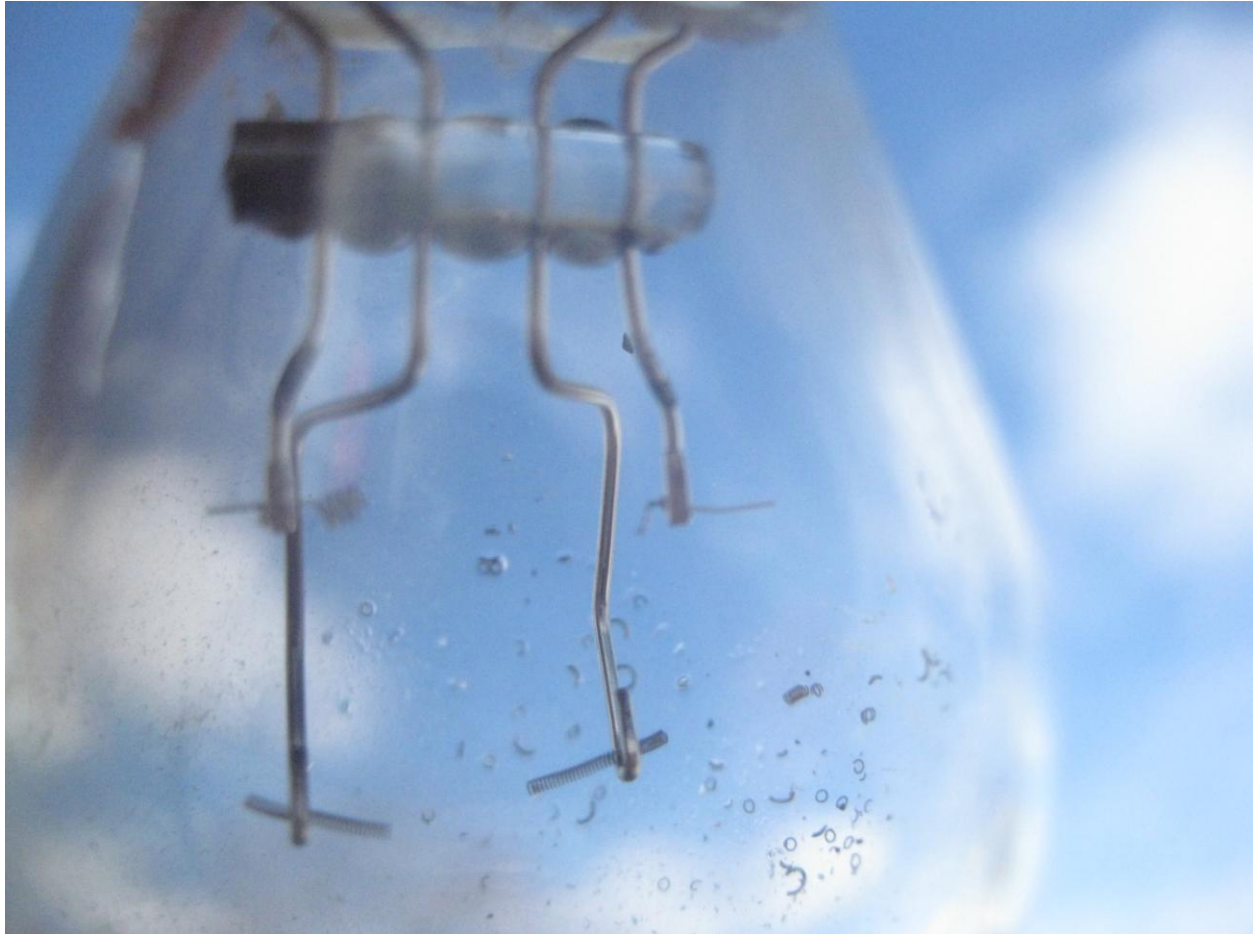
Let us recall that when a light is "on" the tungsten becomes soft and when an impact force occurs "near" its location it will stretch. When a light is "off" the tungsten is brittle and if an impact force occurs "near" its location it may fracture. Just to give you more information, below is another view of the bulb. Look closely at the sides of the glass. Enough said.
